MISSOURI DEPARTMENT OF NATURAL RESOURCES
STATE HISTORIC PRESERVATION OFFICE, P.O. Box 176, Jefferson City, MO 65102
ARCHITECTURAL/HISTORIC INVENTORY FORM

1. Survey No. BO-AS-011-0087		2. Survey name: North Central Columbia Survey Phase II	
3. County: Boone		4. Address (Street No.) 902	Street (name) N. Seventh Street
5. City: Columbia	Vicinity: <input type="checkbox"/>	6. Geographical Reference:	7. Township/Range/Section: T: R: S:
8. Historic name (if known):		9. Present/other name (if known):	
10. Ownership: <input checked="" type="checkbox"/> Private <input type="checkbox"/> Public		11a. Historic use (if known): Domestic/single dwelling	11b. Current use: Domestic/single dwelling

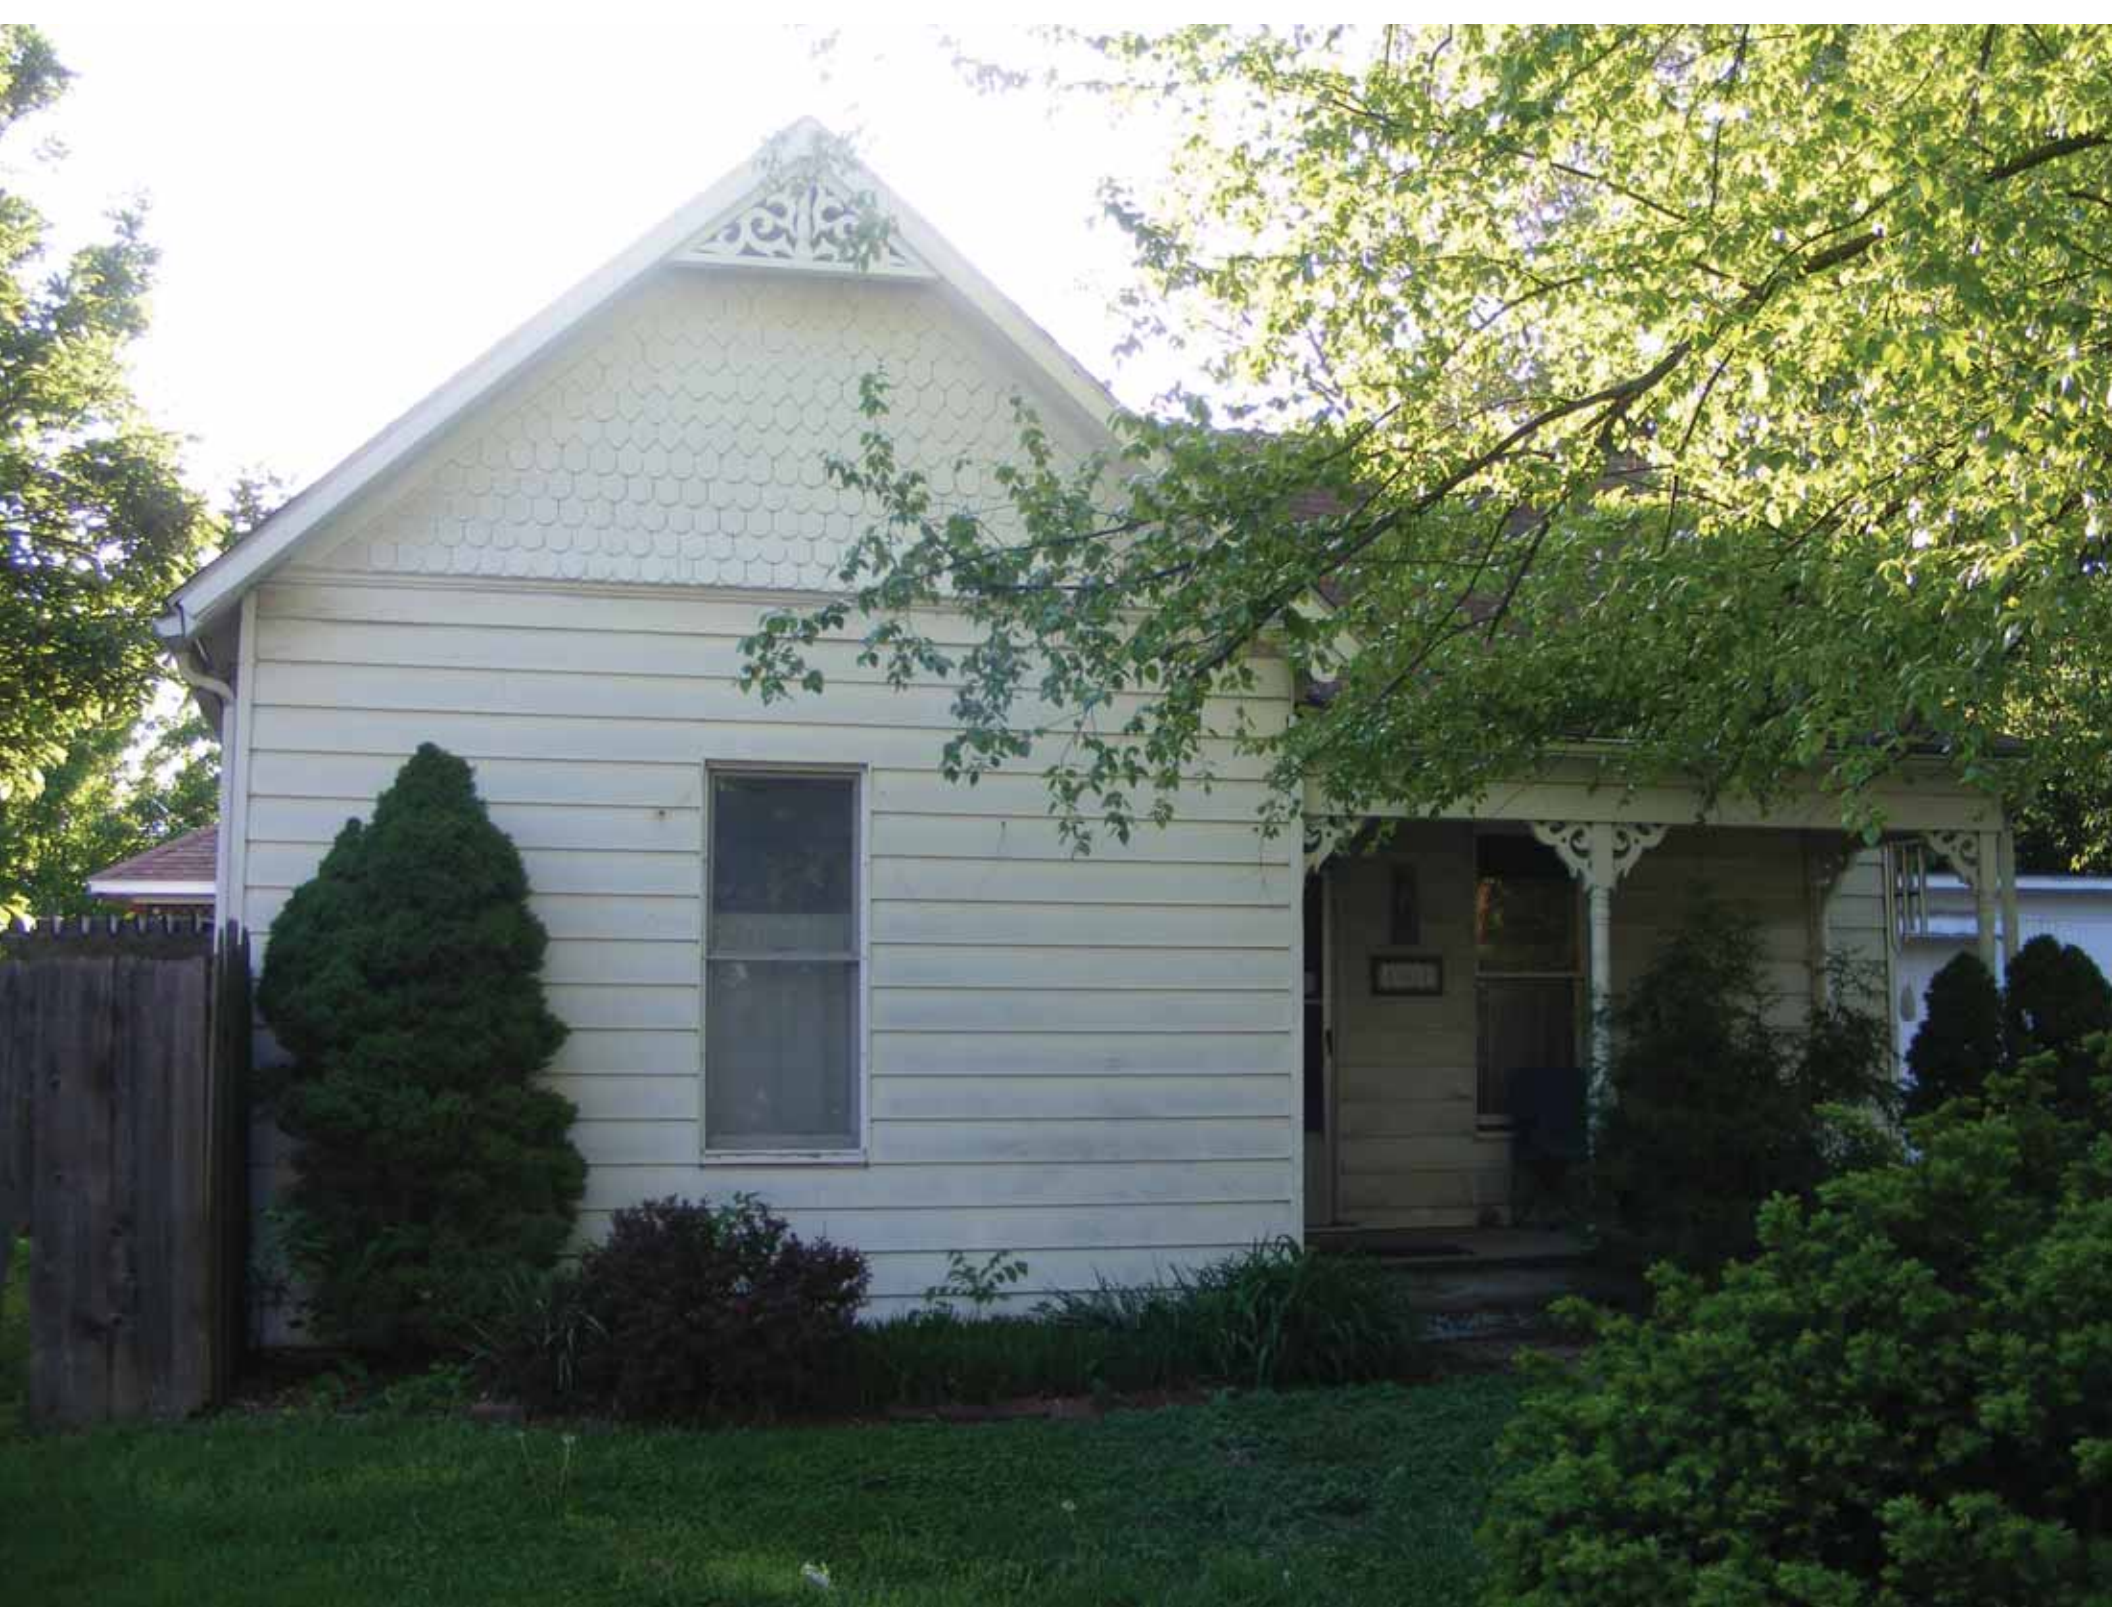
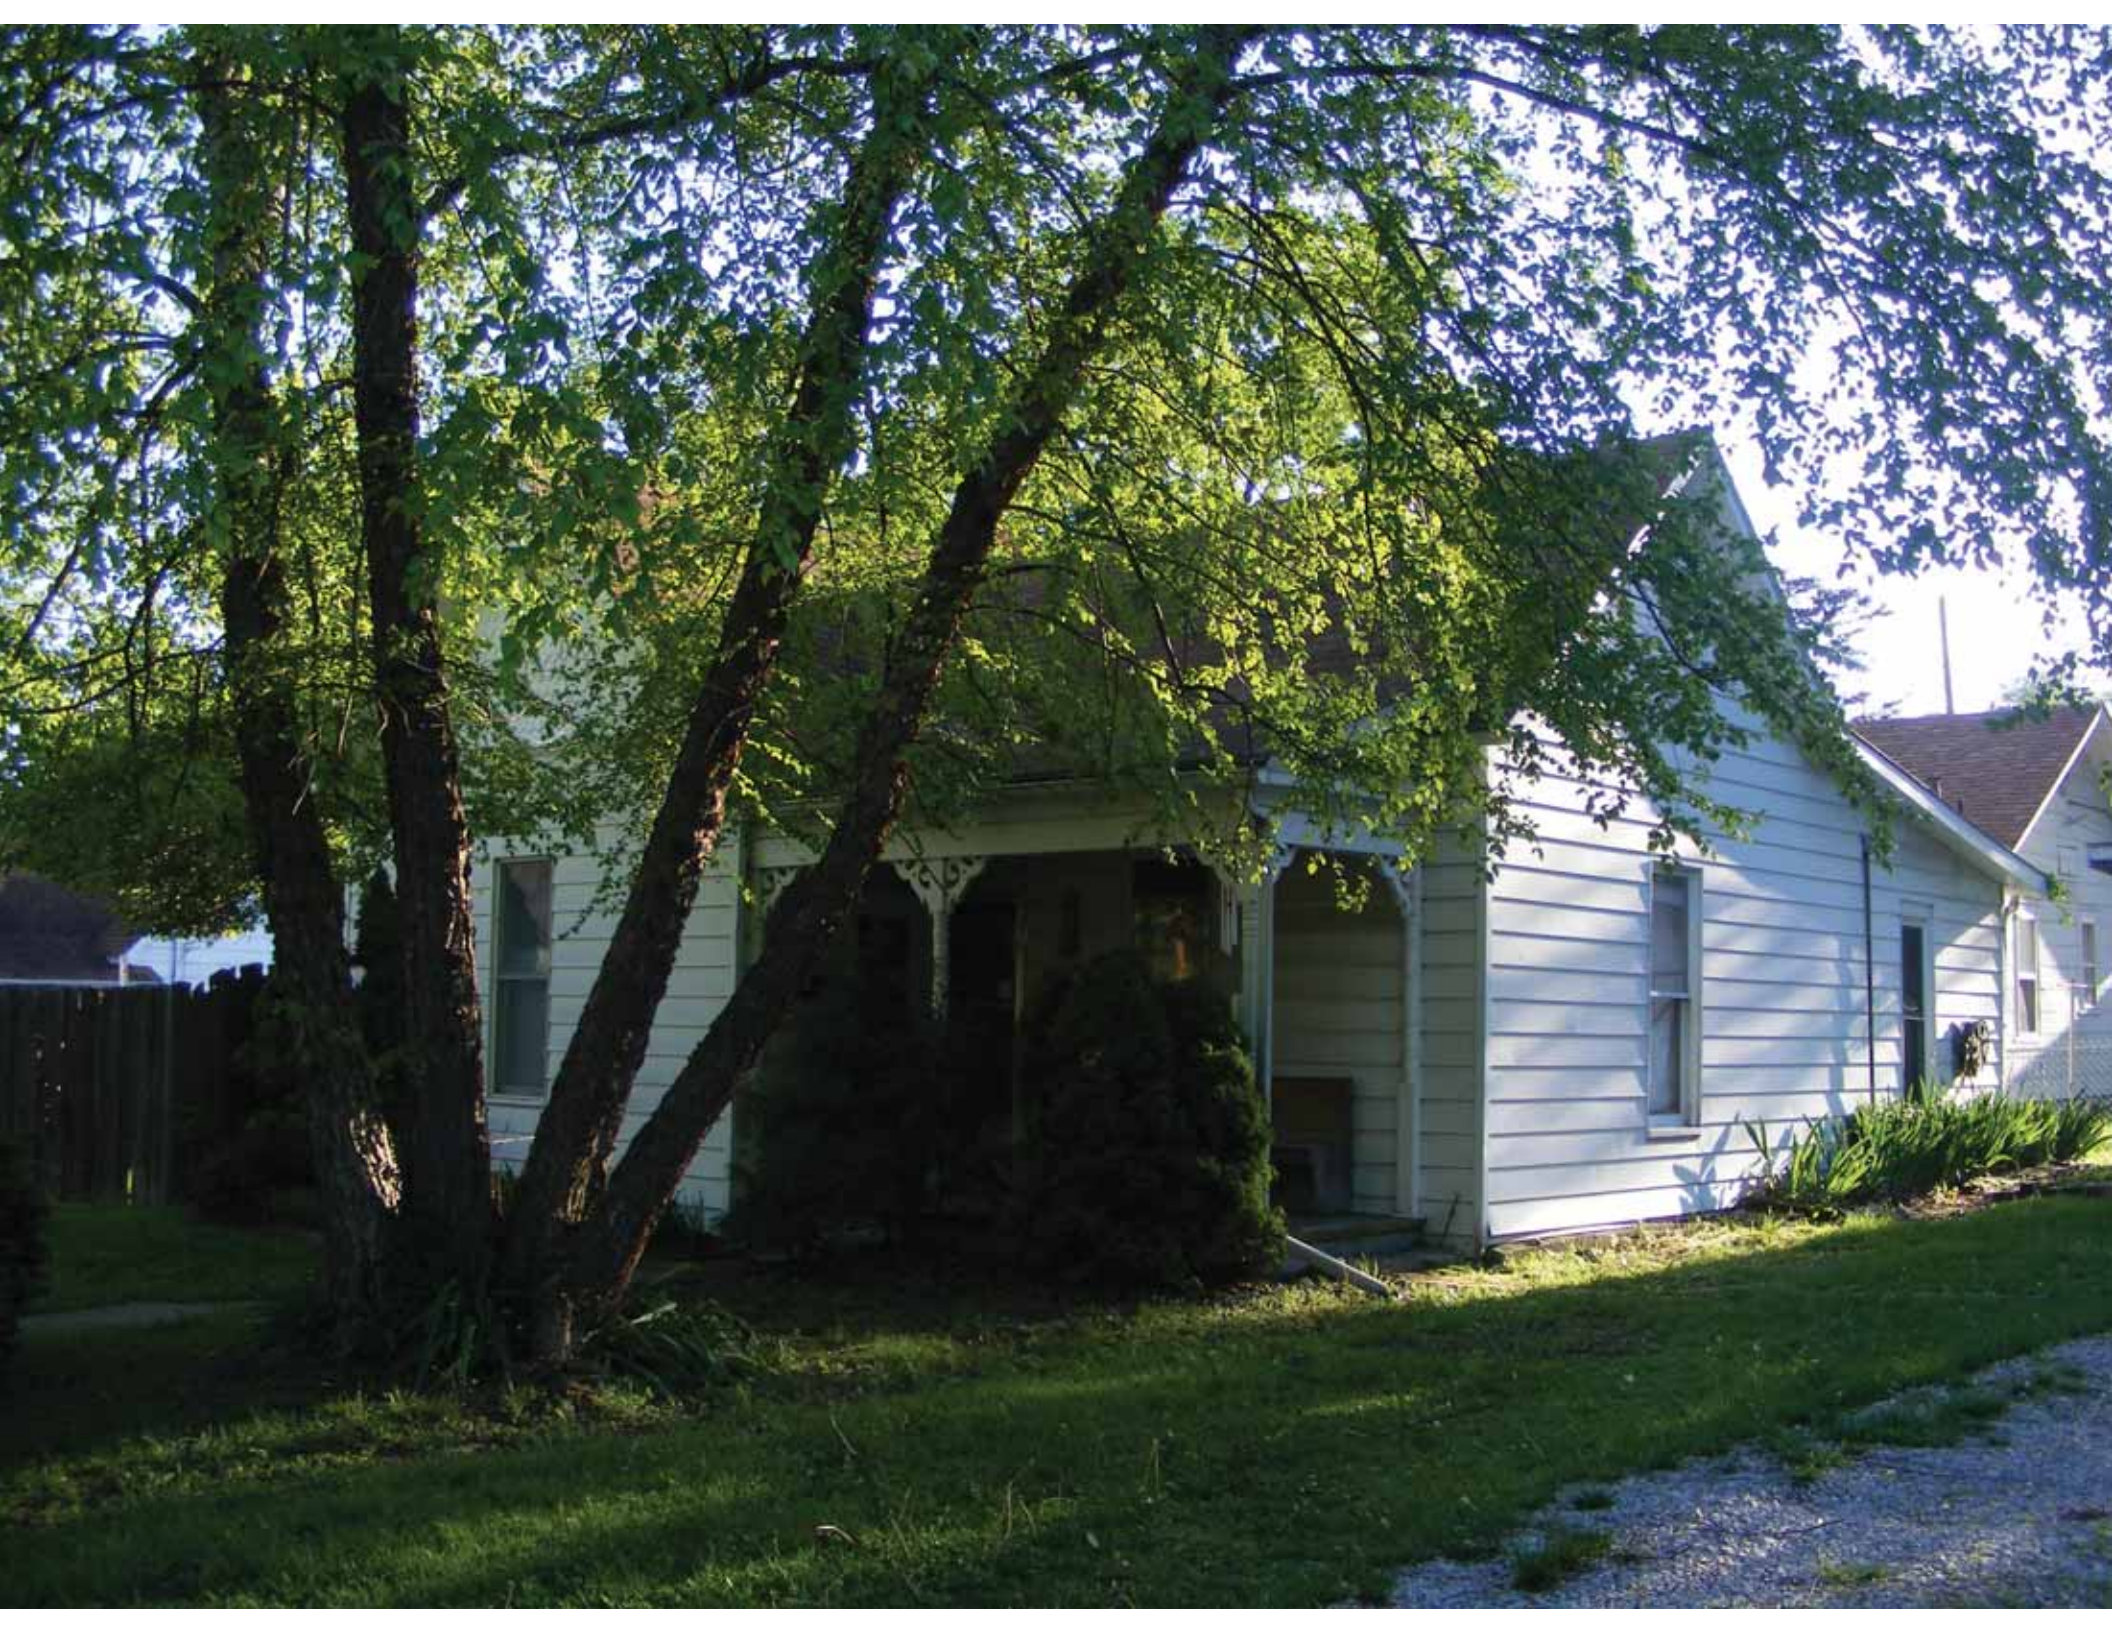
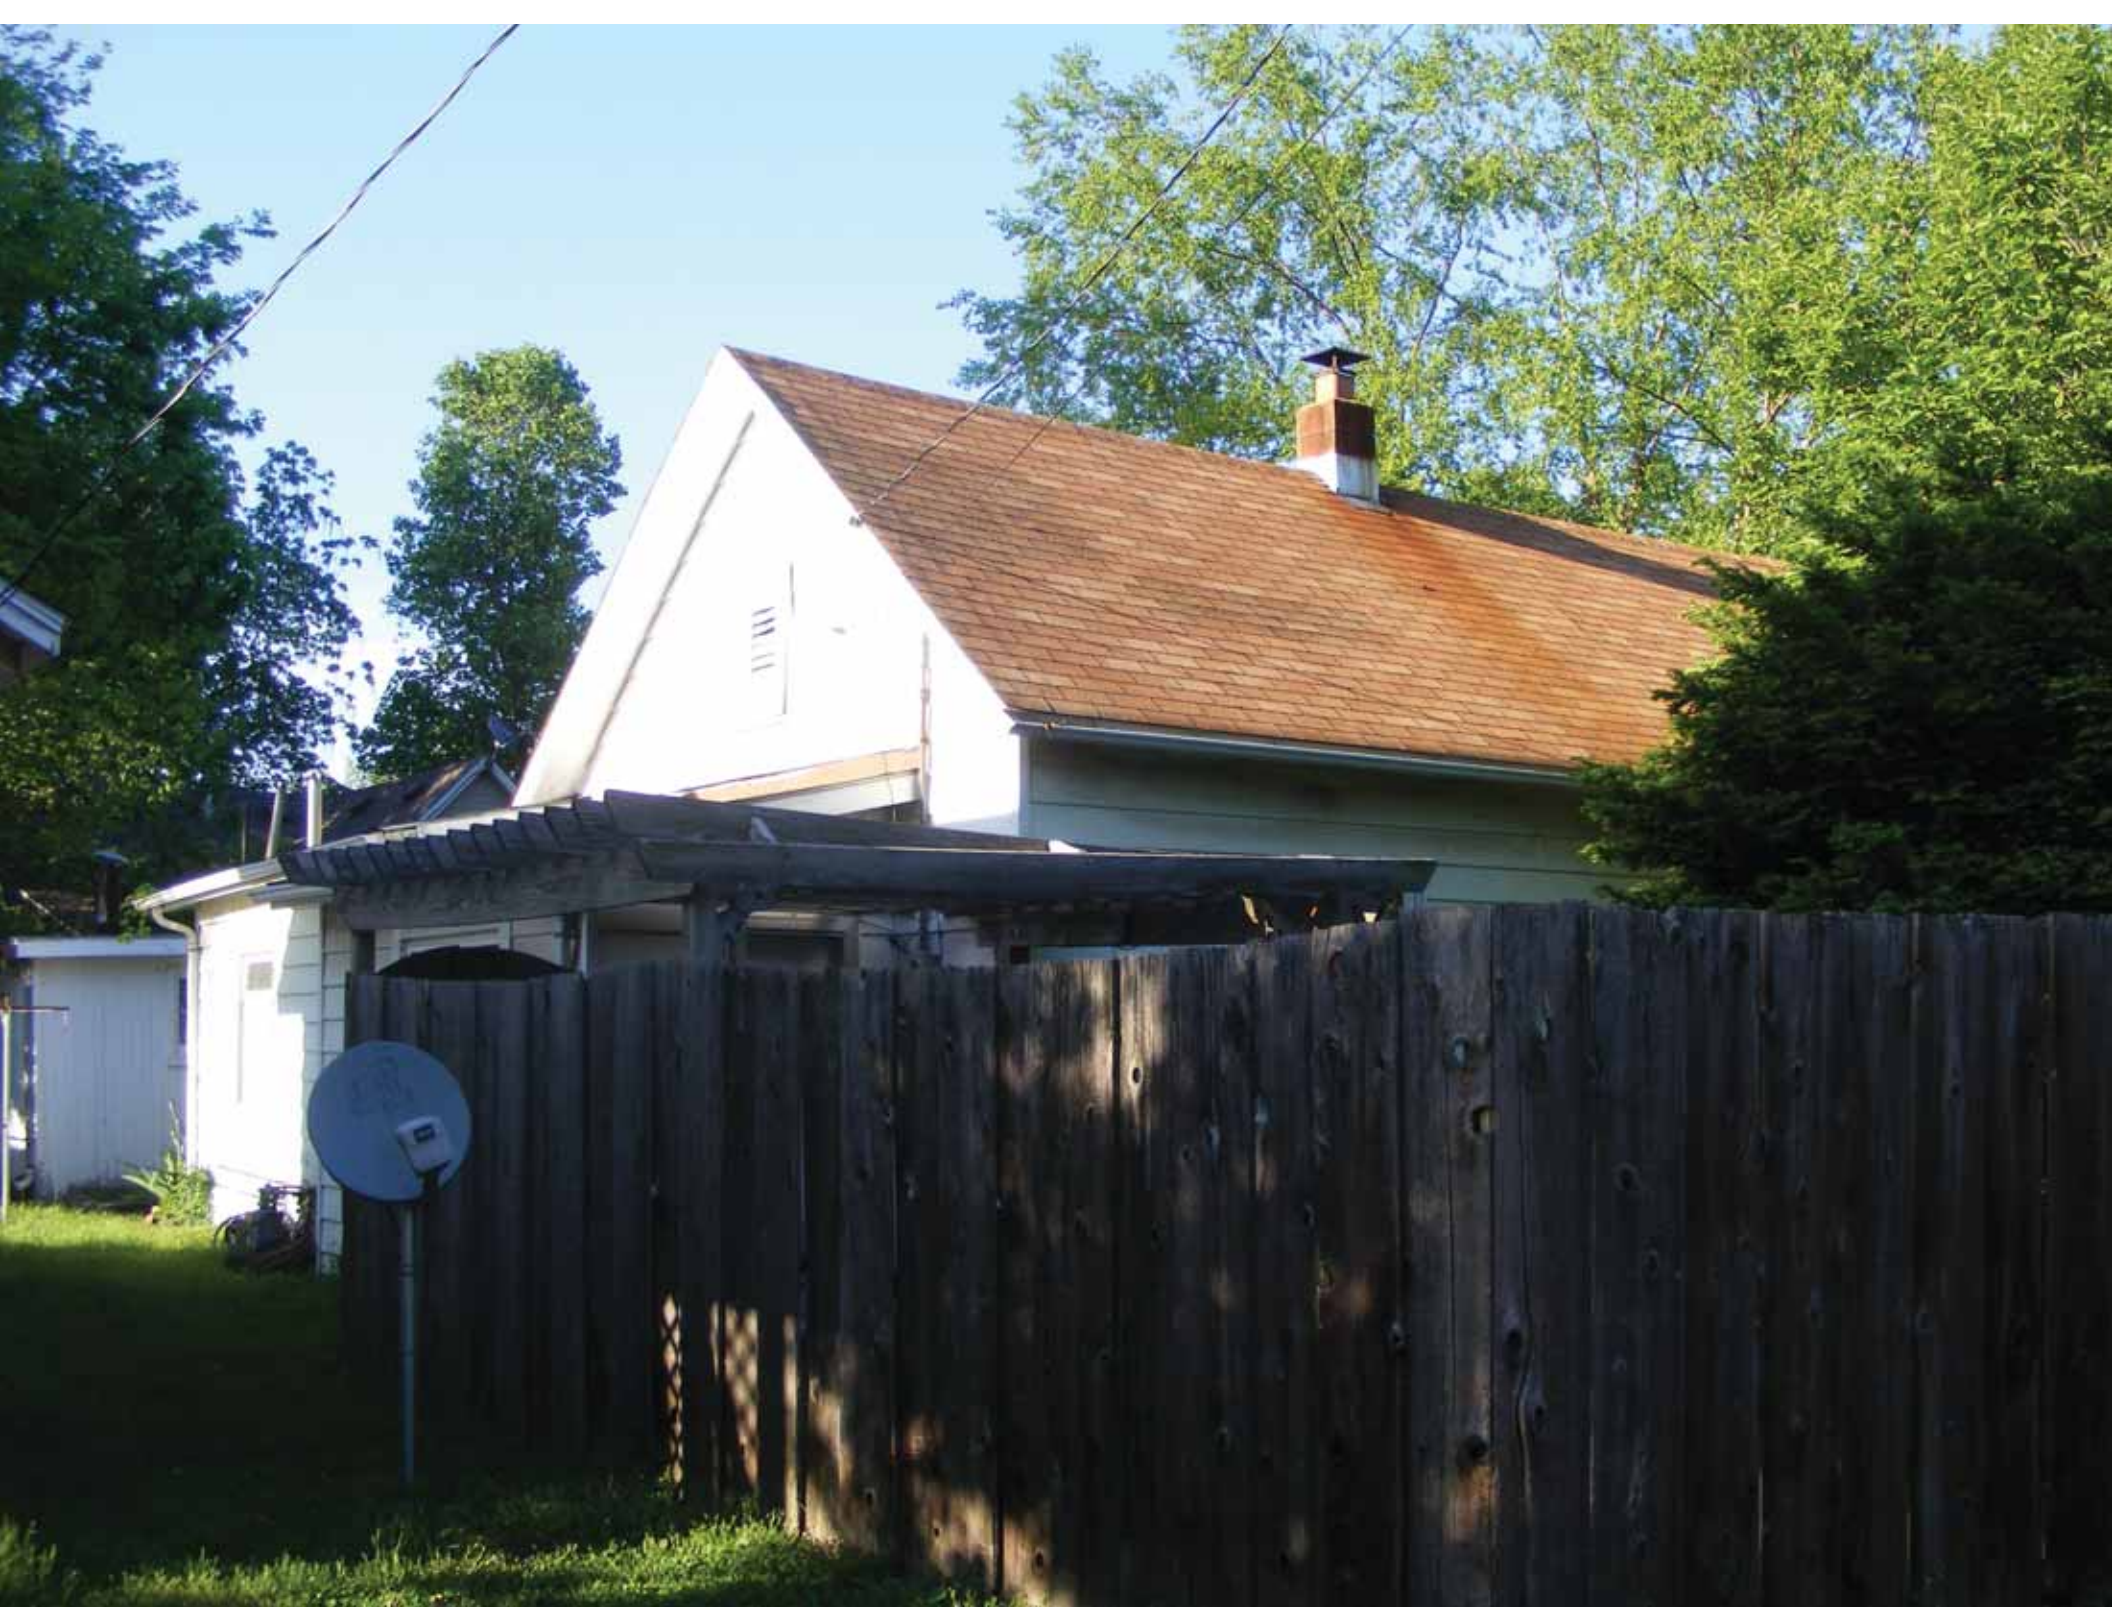
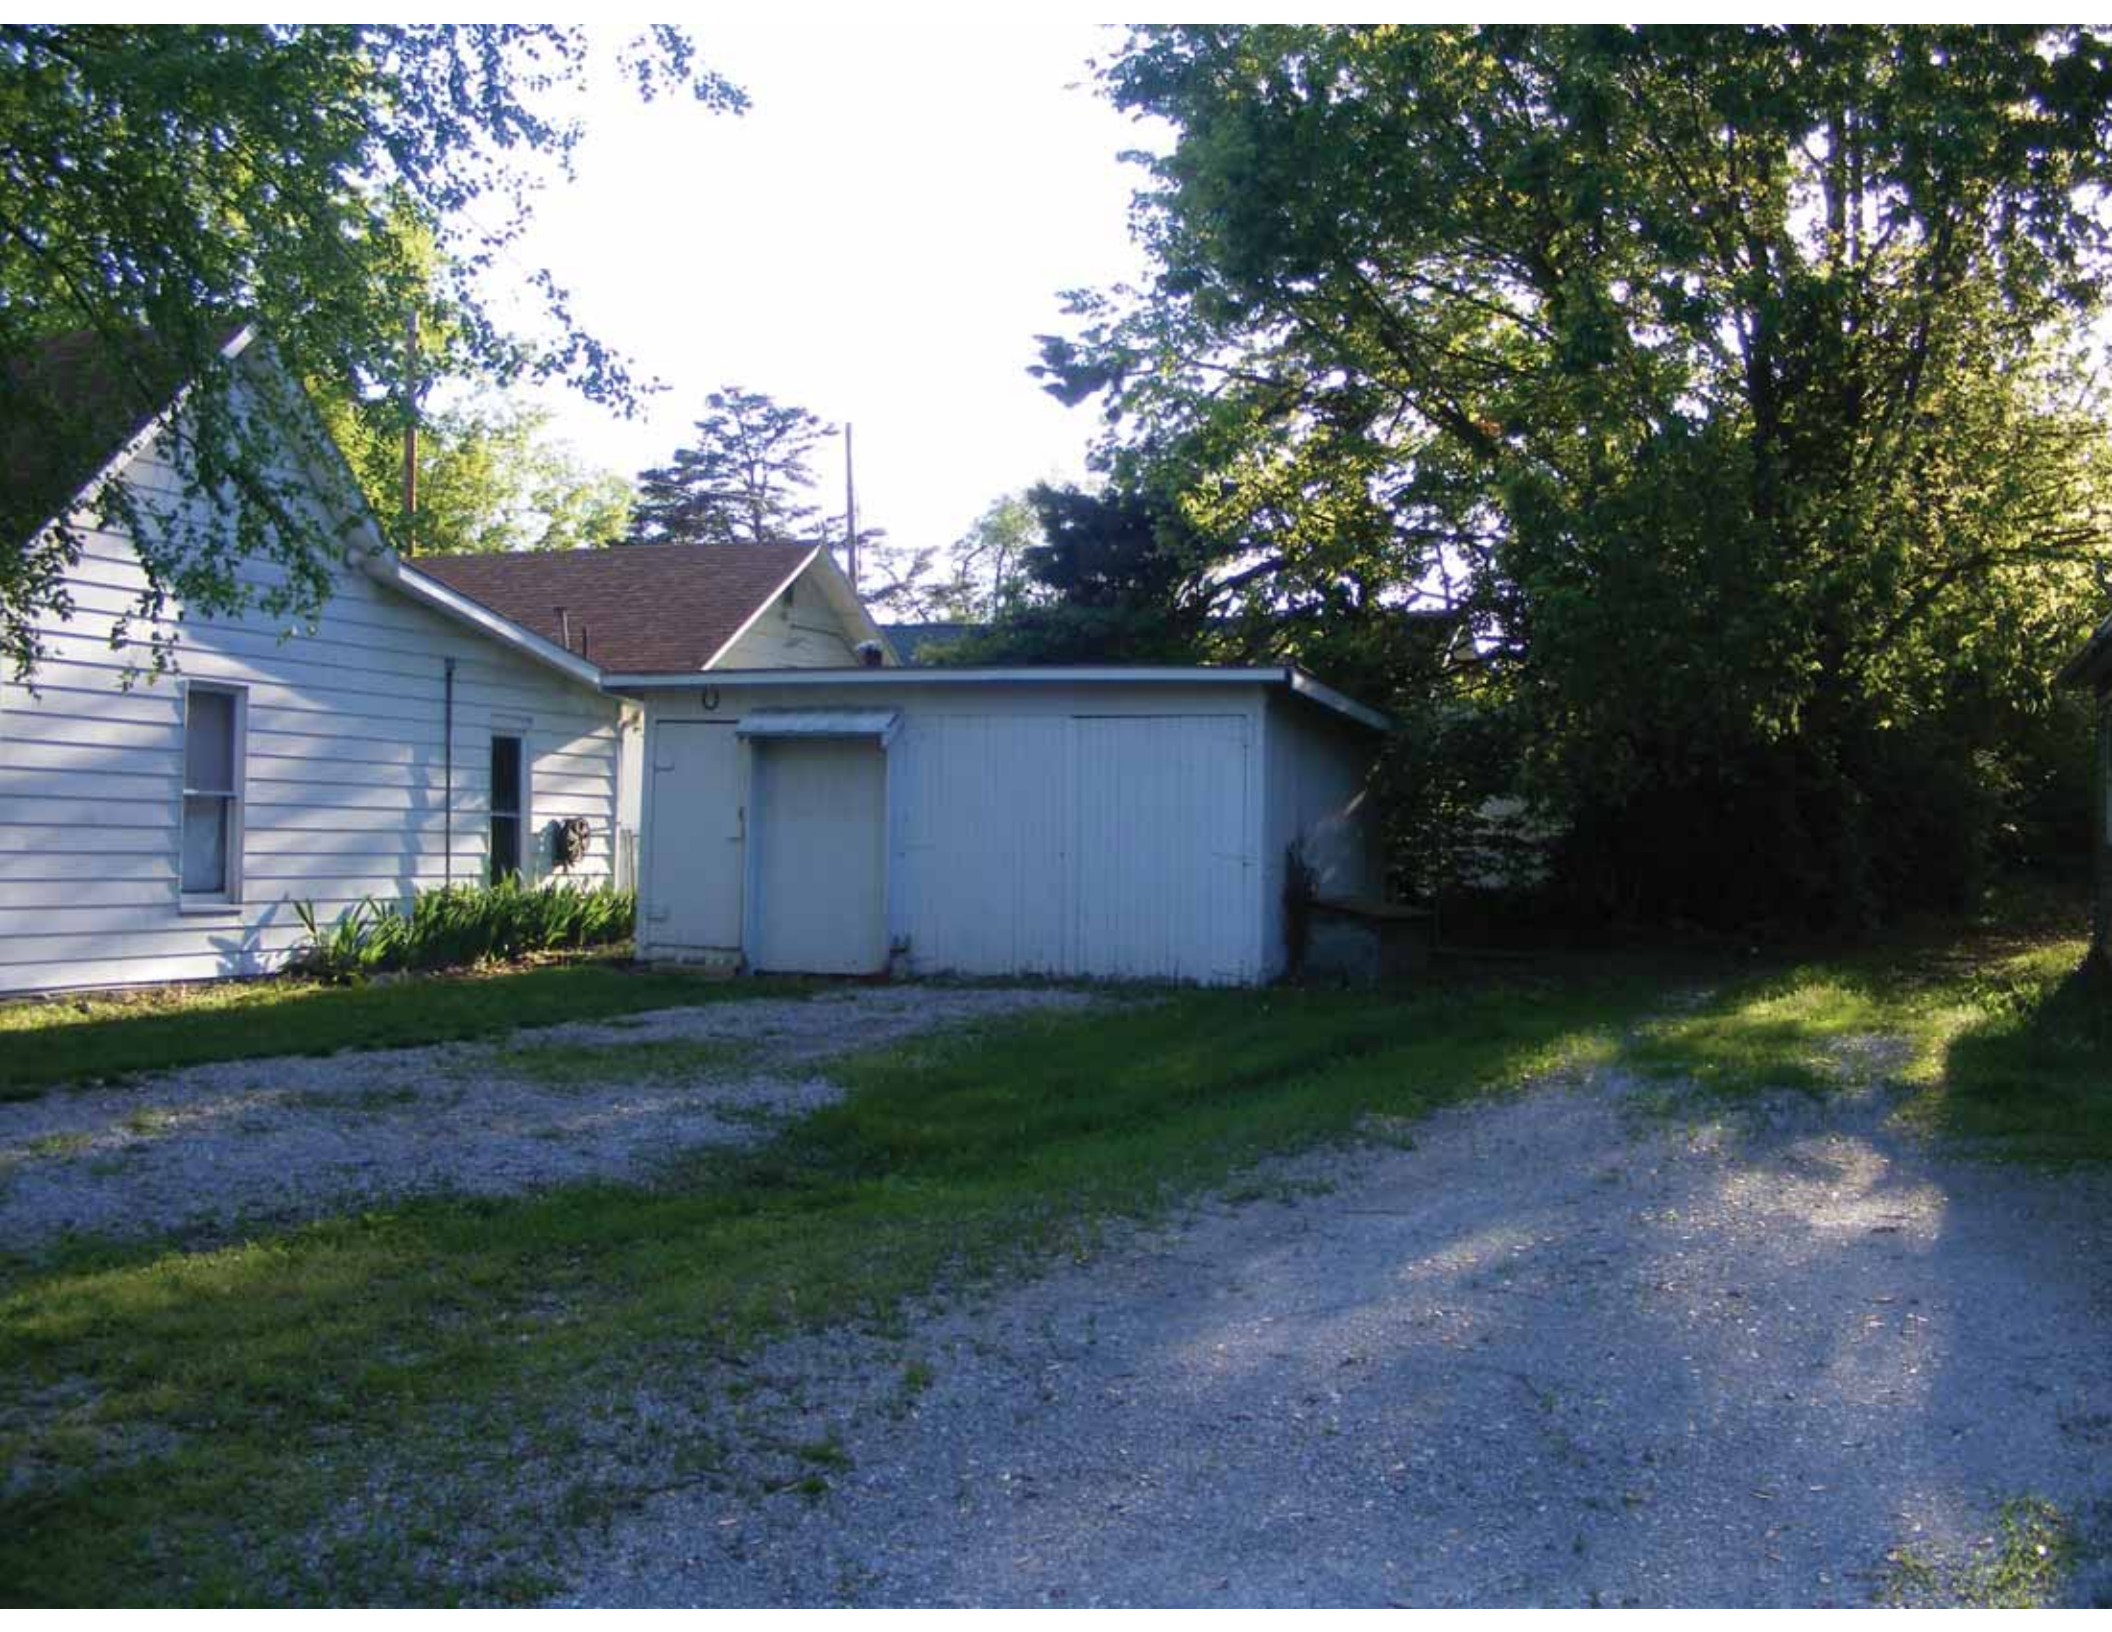
This single-story dwelling has a cross-gabled roof clad with asphalt shingles. The dwelling has a vinyl clad exterior. The foundation is stone and concrete. On the façade (east elevation) is a half-width porch. The porch has a shed roof supported by original milled columns with decorative bargeboard. Within the porch bay is a single door offset by a one-over-one window. At the south end of the porch is the front facing gabled wing, which holds a single one-over-one window (east elevation). Above the window, the gable field is filled with fish scale shingles. The gable field peak features original bargeboard. The rear elevation supports a single-story shed wing. Attached to the west elevation of the shed wing is a second cross-gabled wing.
