MISSOURI DEPARTMENT OF NATURAL RESOURCES
STATE HISTORIC PRESERVATION OFFICE, P.O. Box 176, Jefferson City, MO 65102
ARCHITECTURAL/HISTORIC INVENTORY FORM

1. Survey No. BO-AS-011-0087		2. Survey name: North Central Columbia Survey Phase II	
3. County: Boone		4. Address (Street No.) 902	Street (name) N. Seventh Street
5. City: Columbia	Vicinity: <input type="checkbox"/>	6. Geographical Reference:	7. Township/Range/Section: T: R: S:
8. Historic name (if known):		9. Present/other name (if known):	
10. Ownership: <input checked="" type="checkbox"/> Private <input type="checkbox"/> Public		11a. Historic use (if known): Domestic/single dwelling	11b. Current use: Domestic/single dwelling

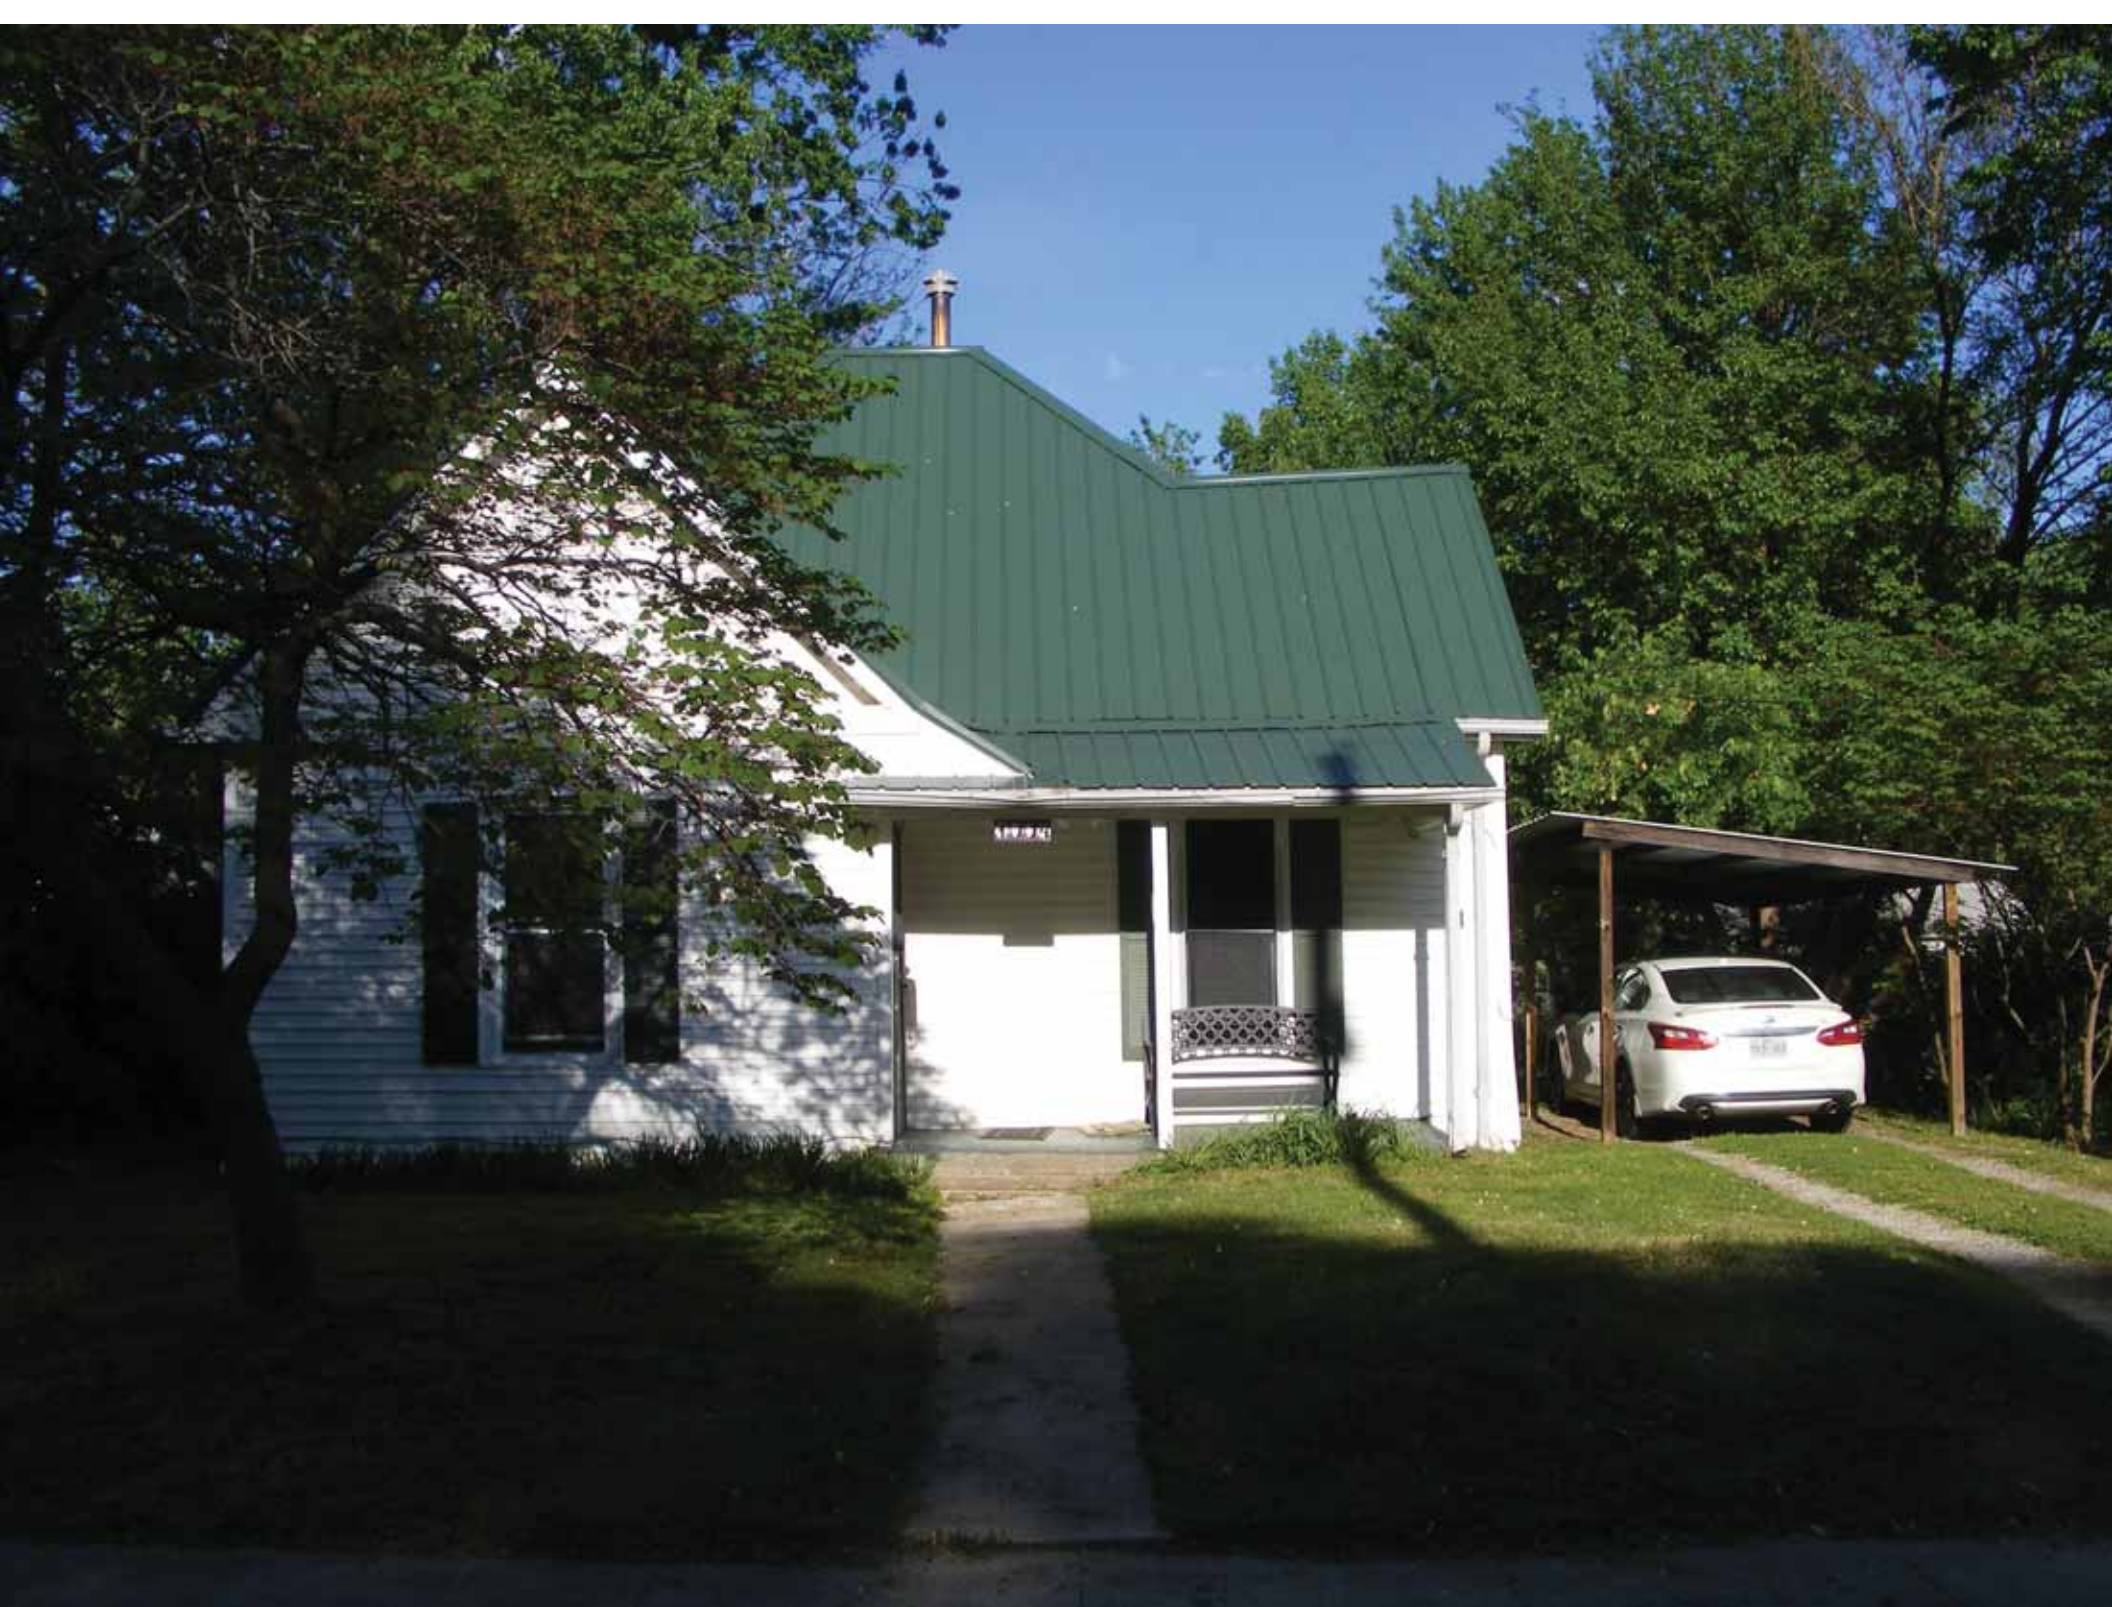
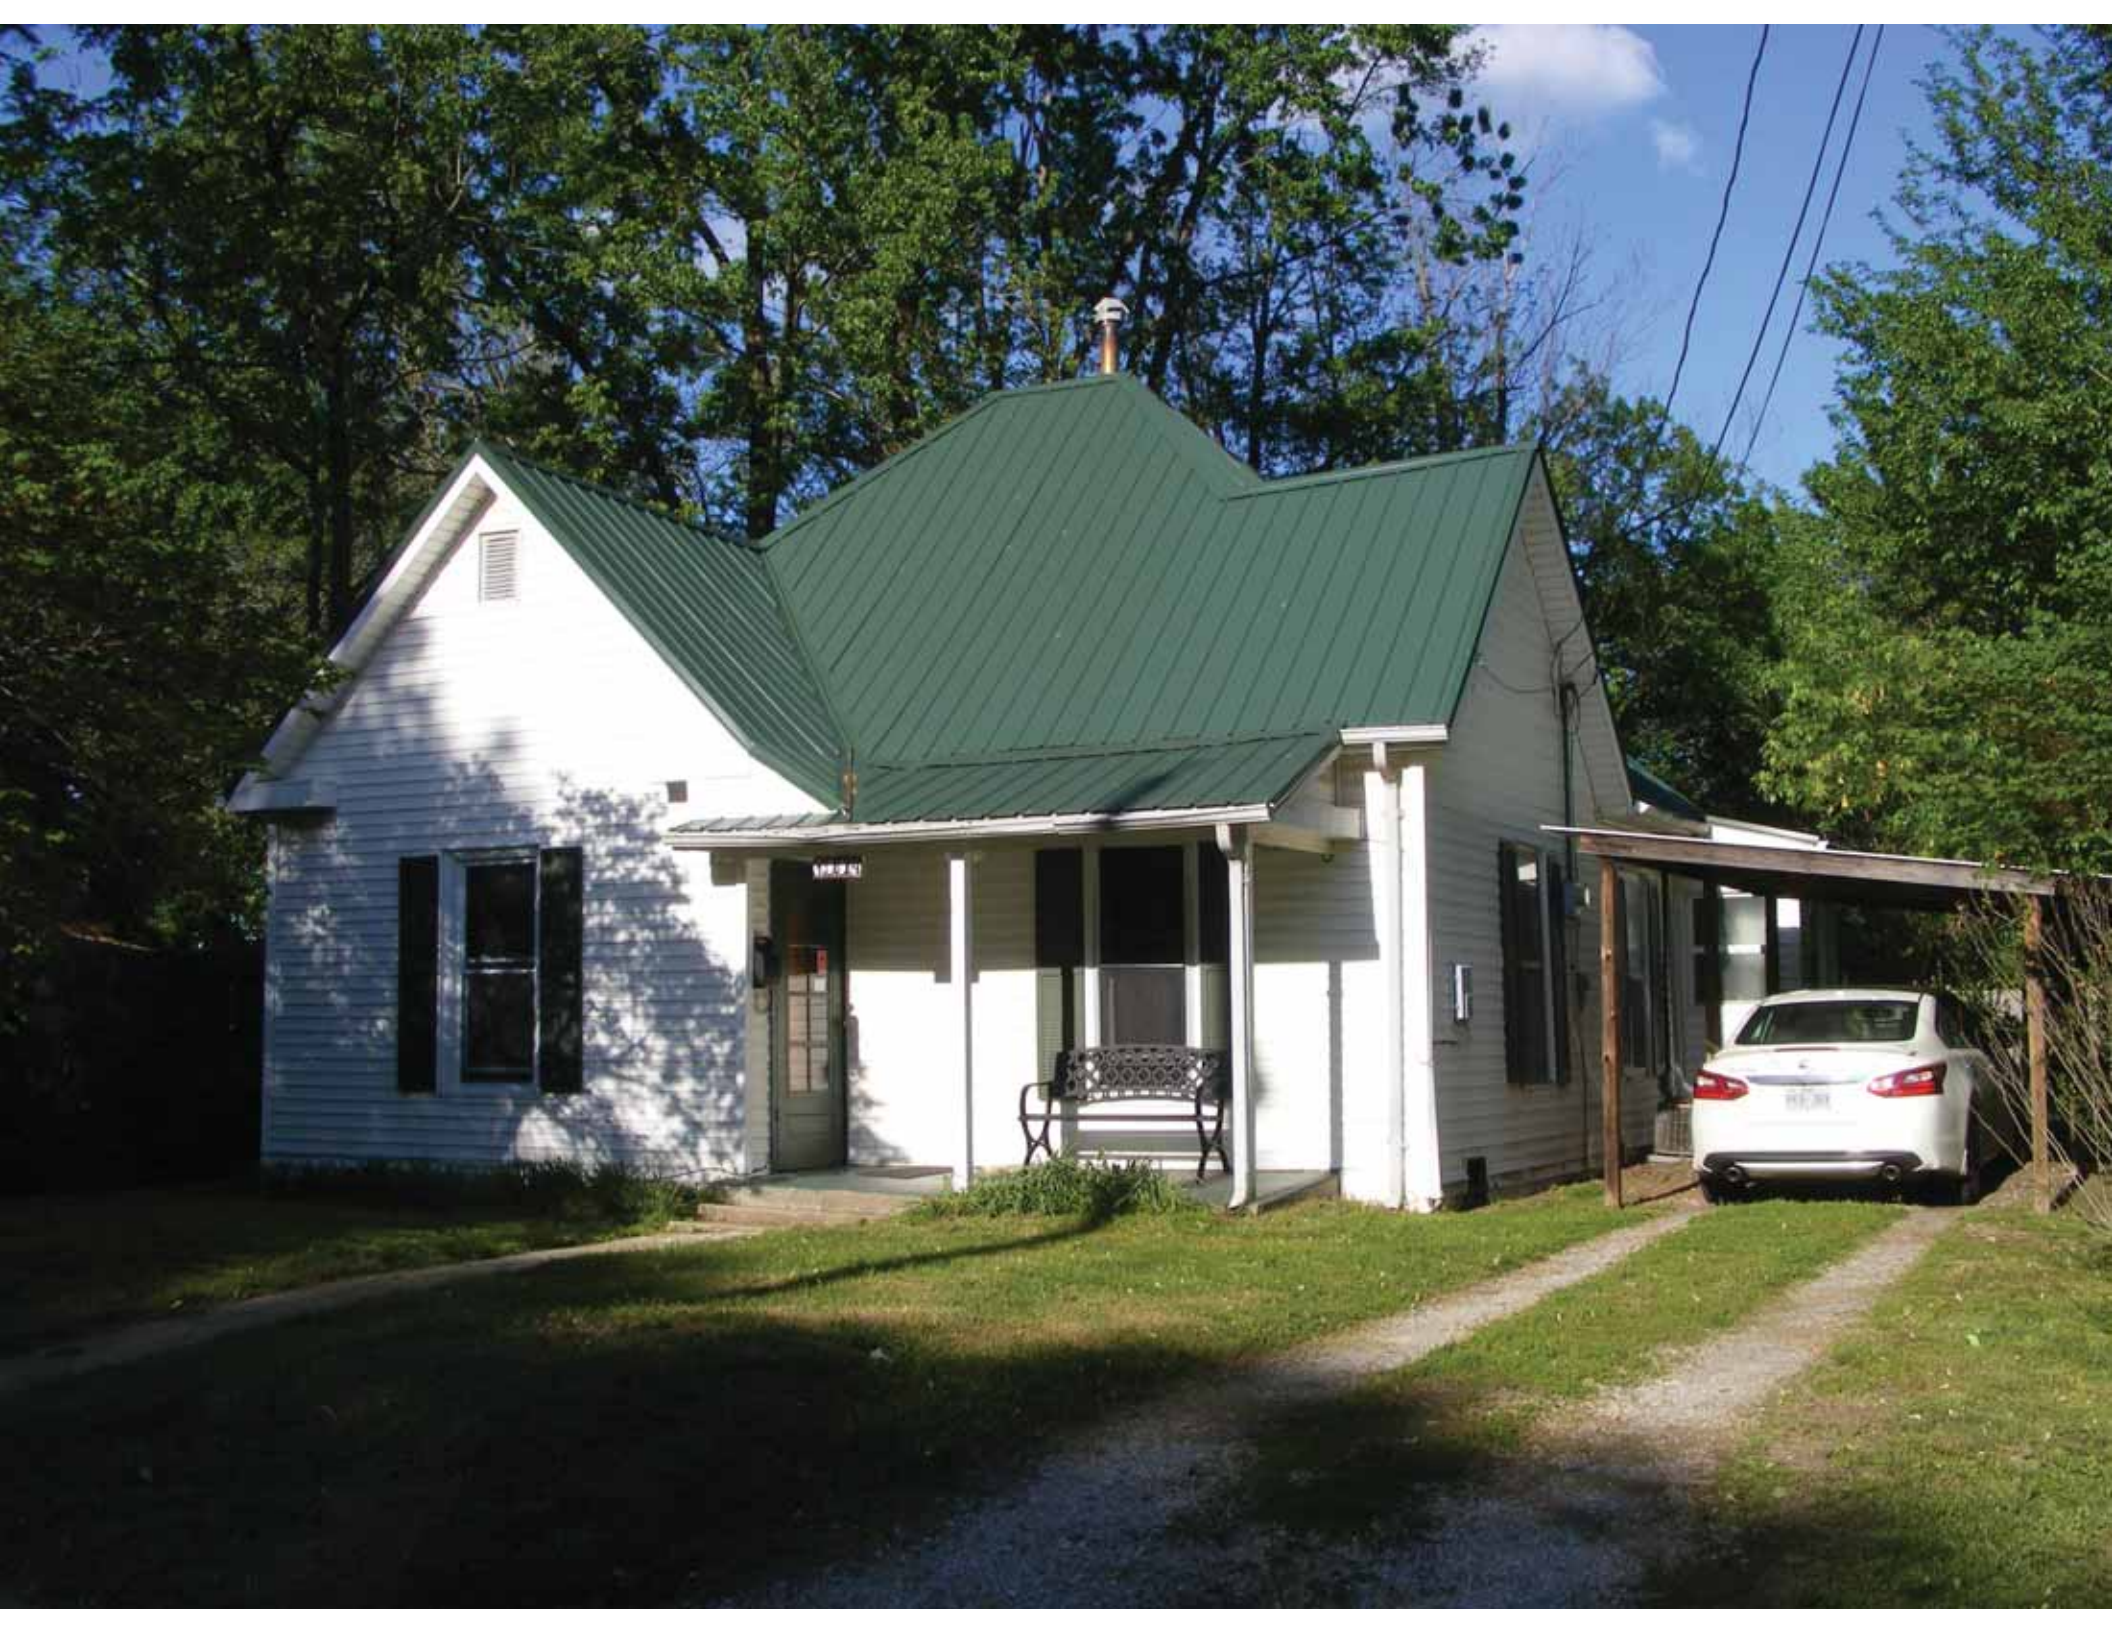
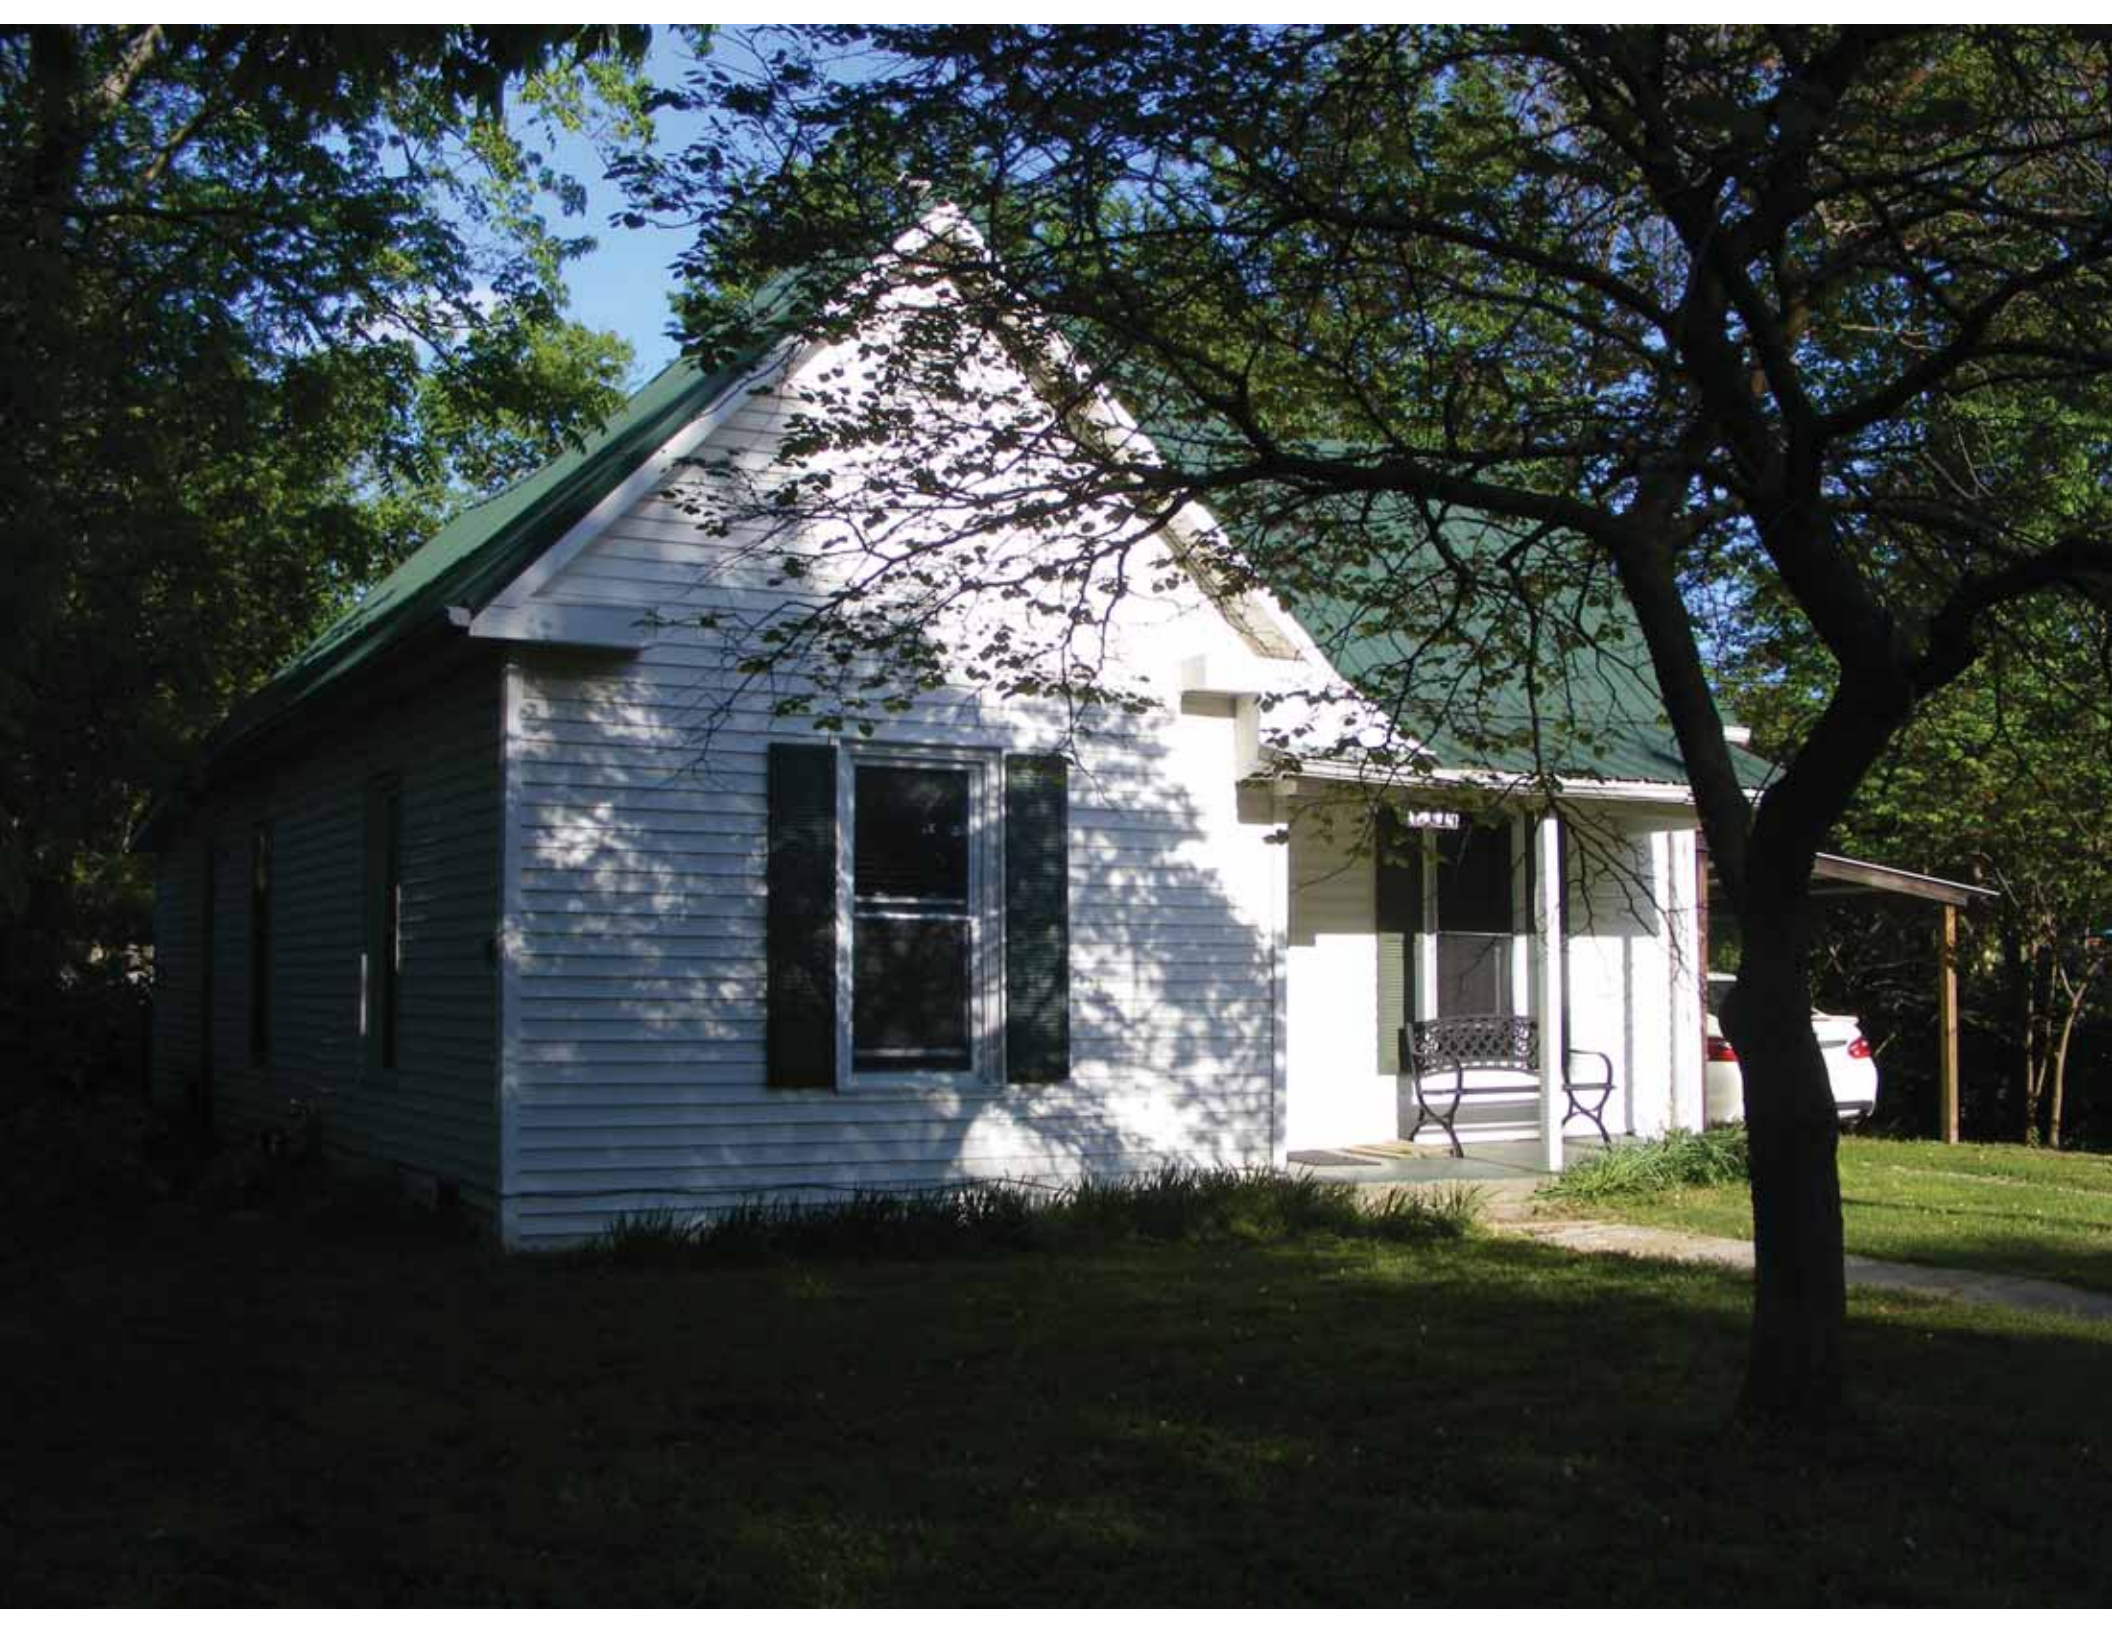
The dwelling has a hip on cross-gable metal clad roof, exterior synthetic siding, enclosed eaves and gable returns. The exterior is clad with vinyl siding that covers the foundation. The front gabled elevation holds a replacement one-over-one window with faux shutters. Remaining windows are of similar configuration. South of the projecting gabled wing is a half-width shed porch supported by square wood columns. The porch has an entry facing south that holds a multi-light original door. The west elevation of the porch holds a single one-over-one window with faux shutters. At the central hipped roofline ridge is an interior metal flue.

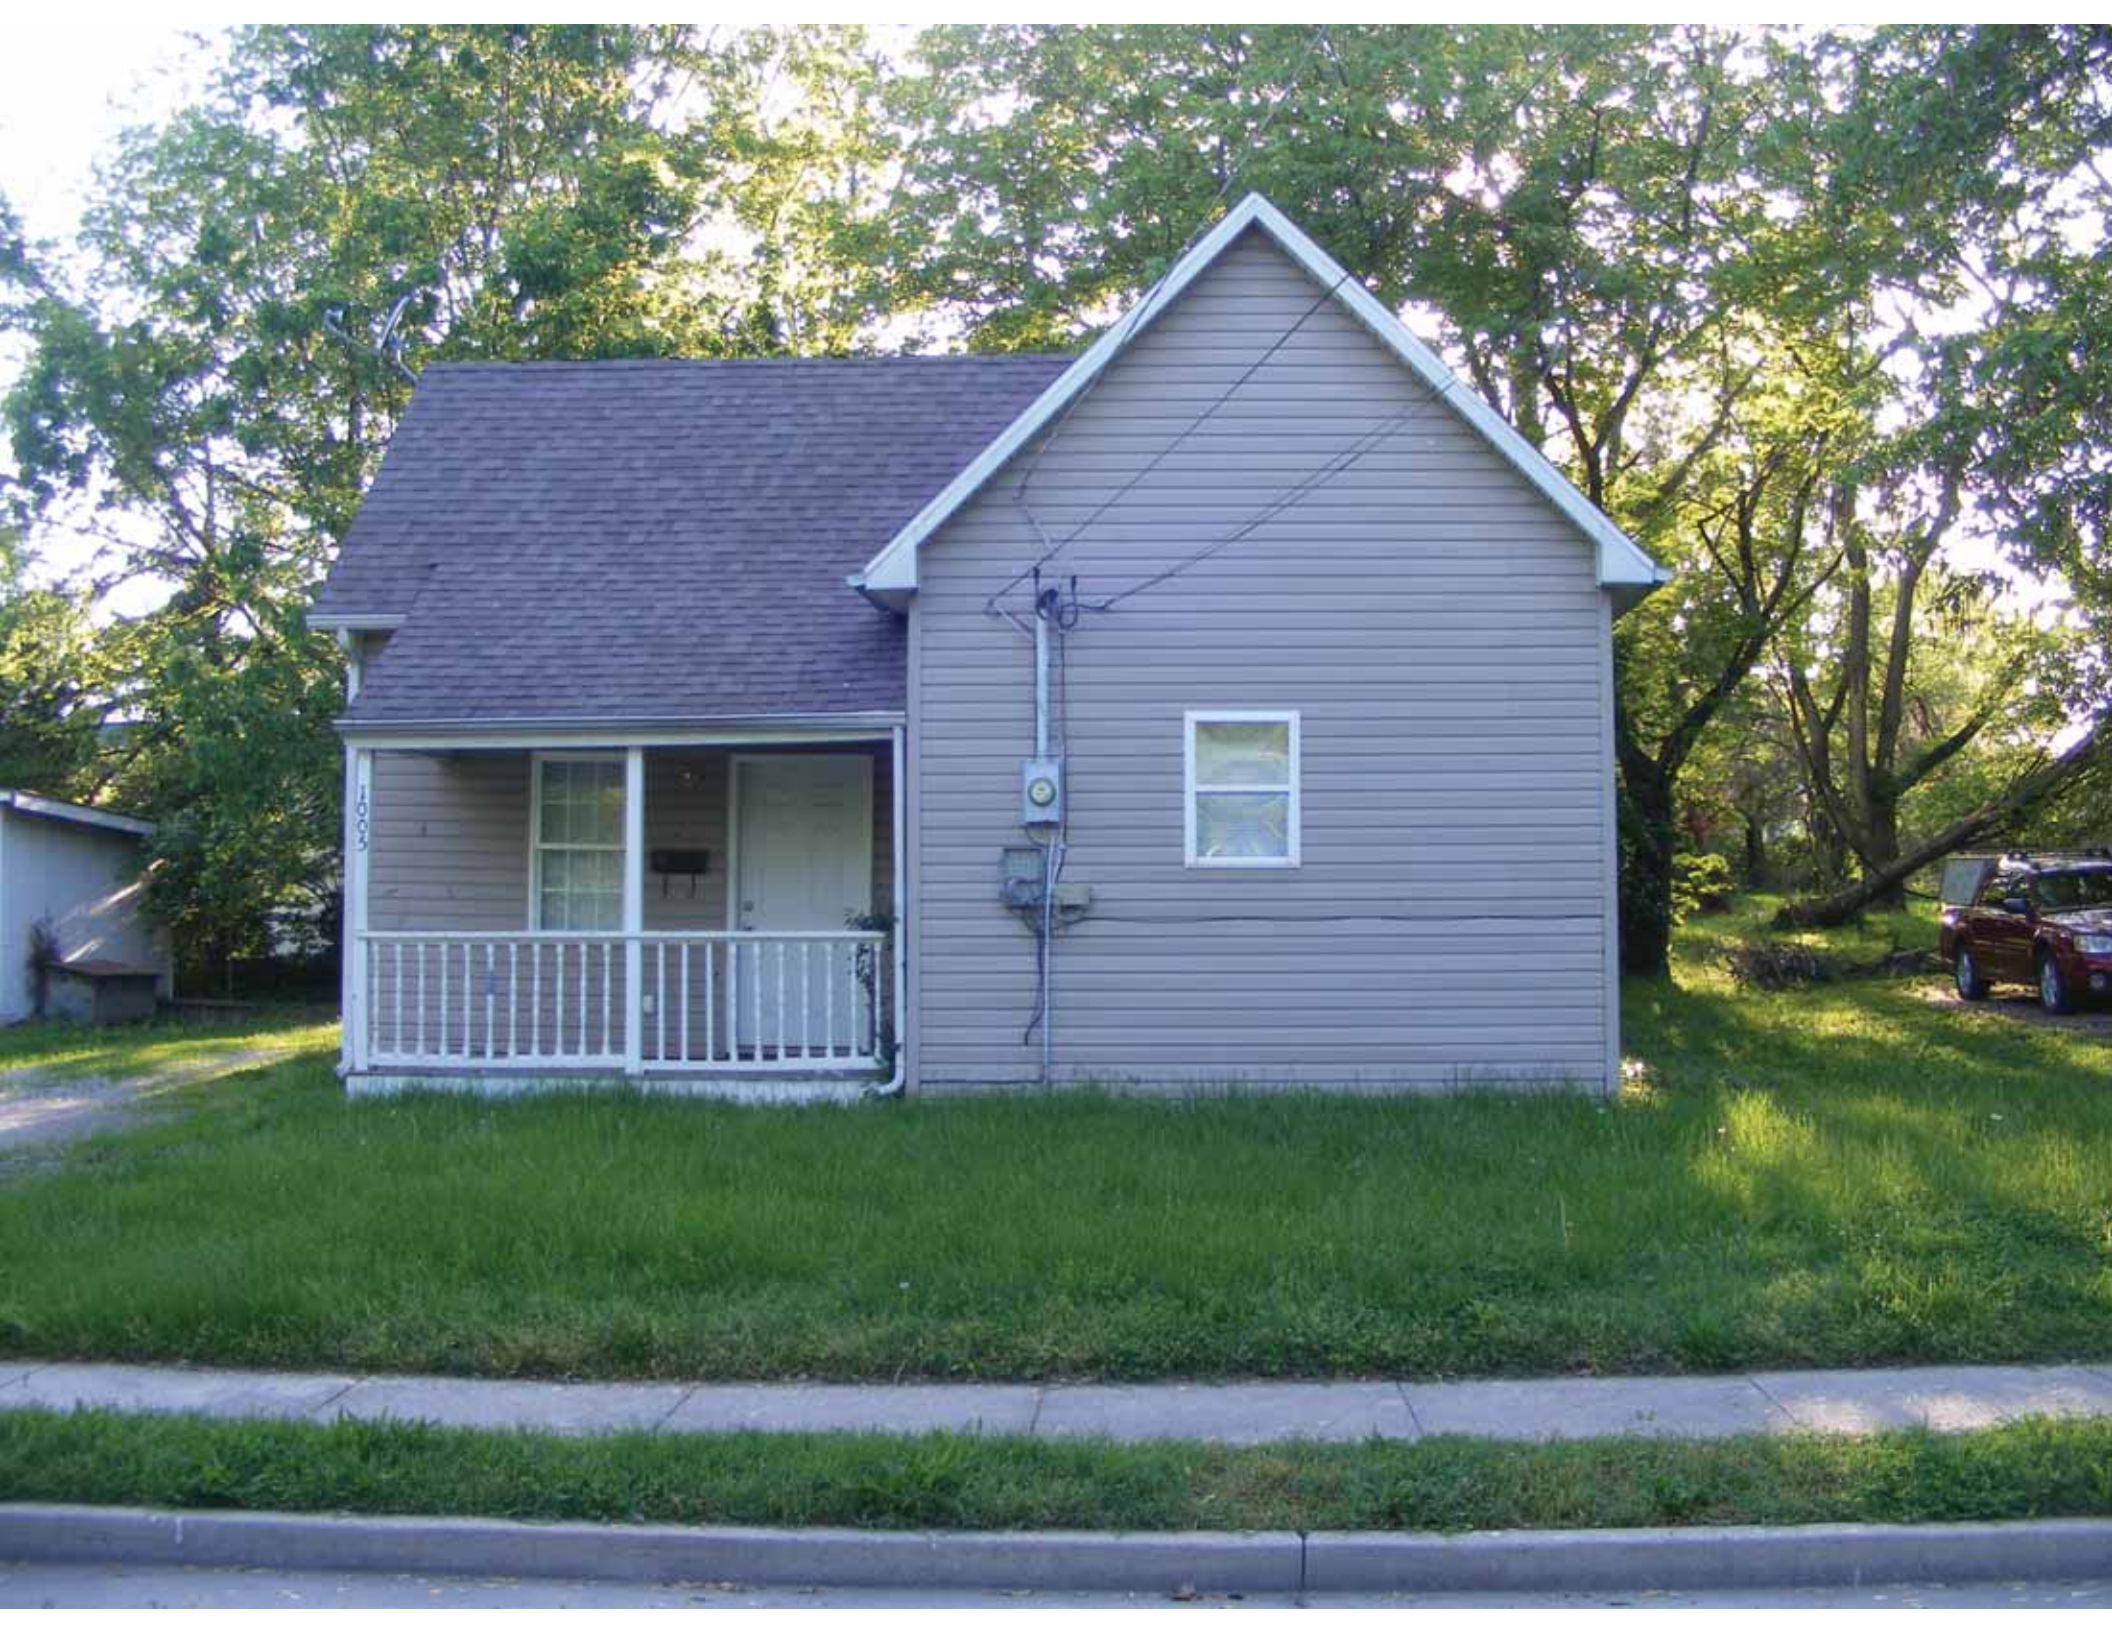
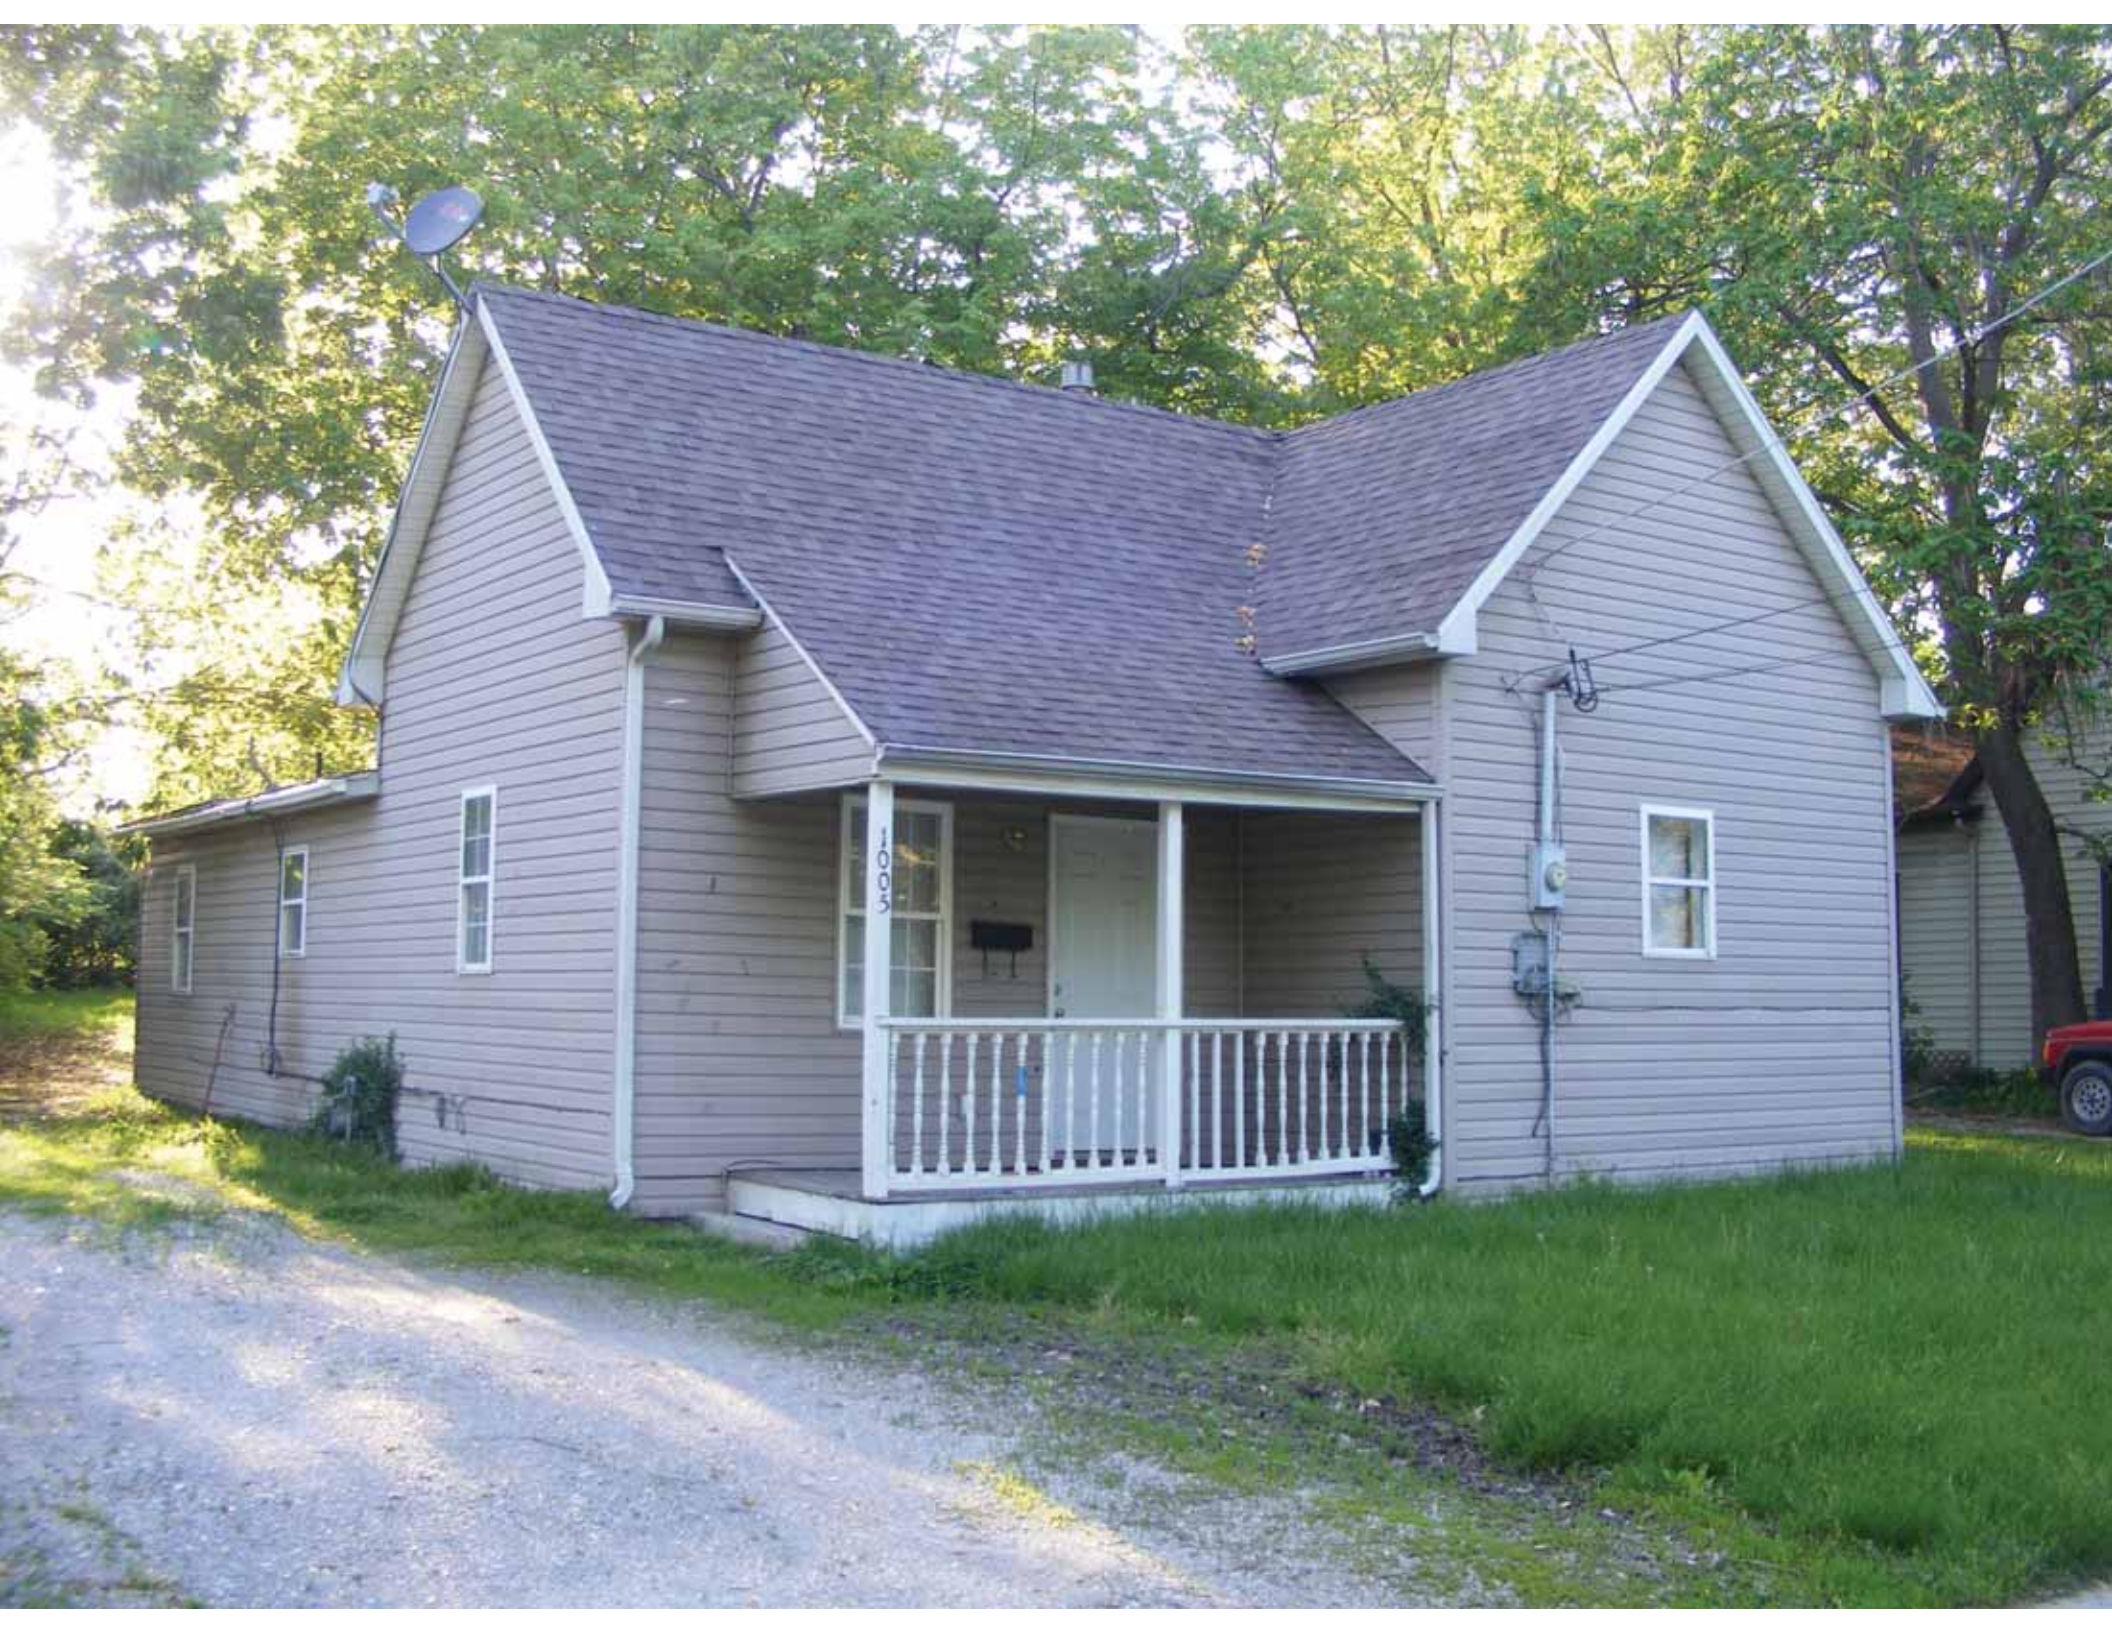
The single-story dwelling has an asphalt-shingled cross-gabled roof, exterior vinyl siding and a covered foundation. Eaves are enclosed. The front facing gable elevation holds a replacement one-over-one window. Offsetting the wing on the south is a half-width shed porch supported by replacement square columns. A non-original balustrade surrounds the porch. Within the porch bay is an entry filled with a c. 2010 paneled door. The door is offset by a replacement six-over-six window. The dwelling has a rear low gable-to-shed wing.

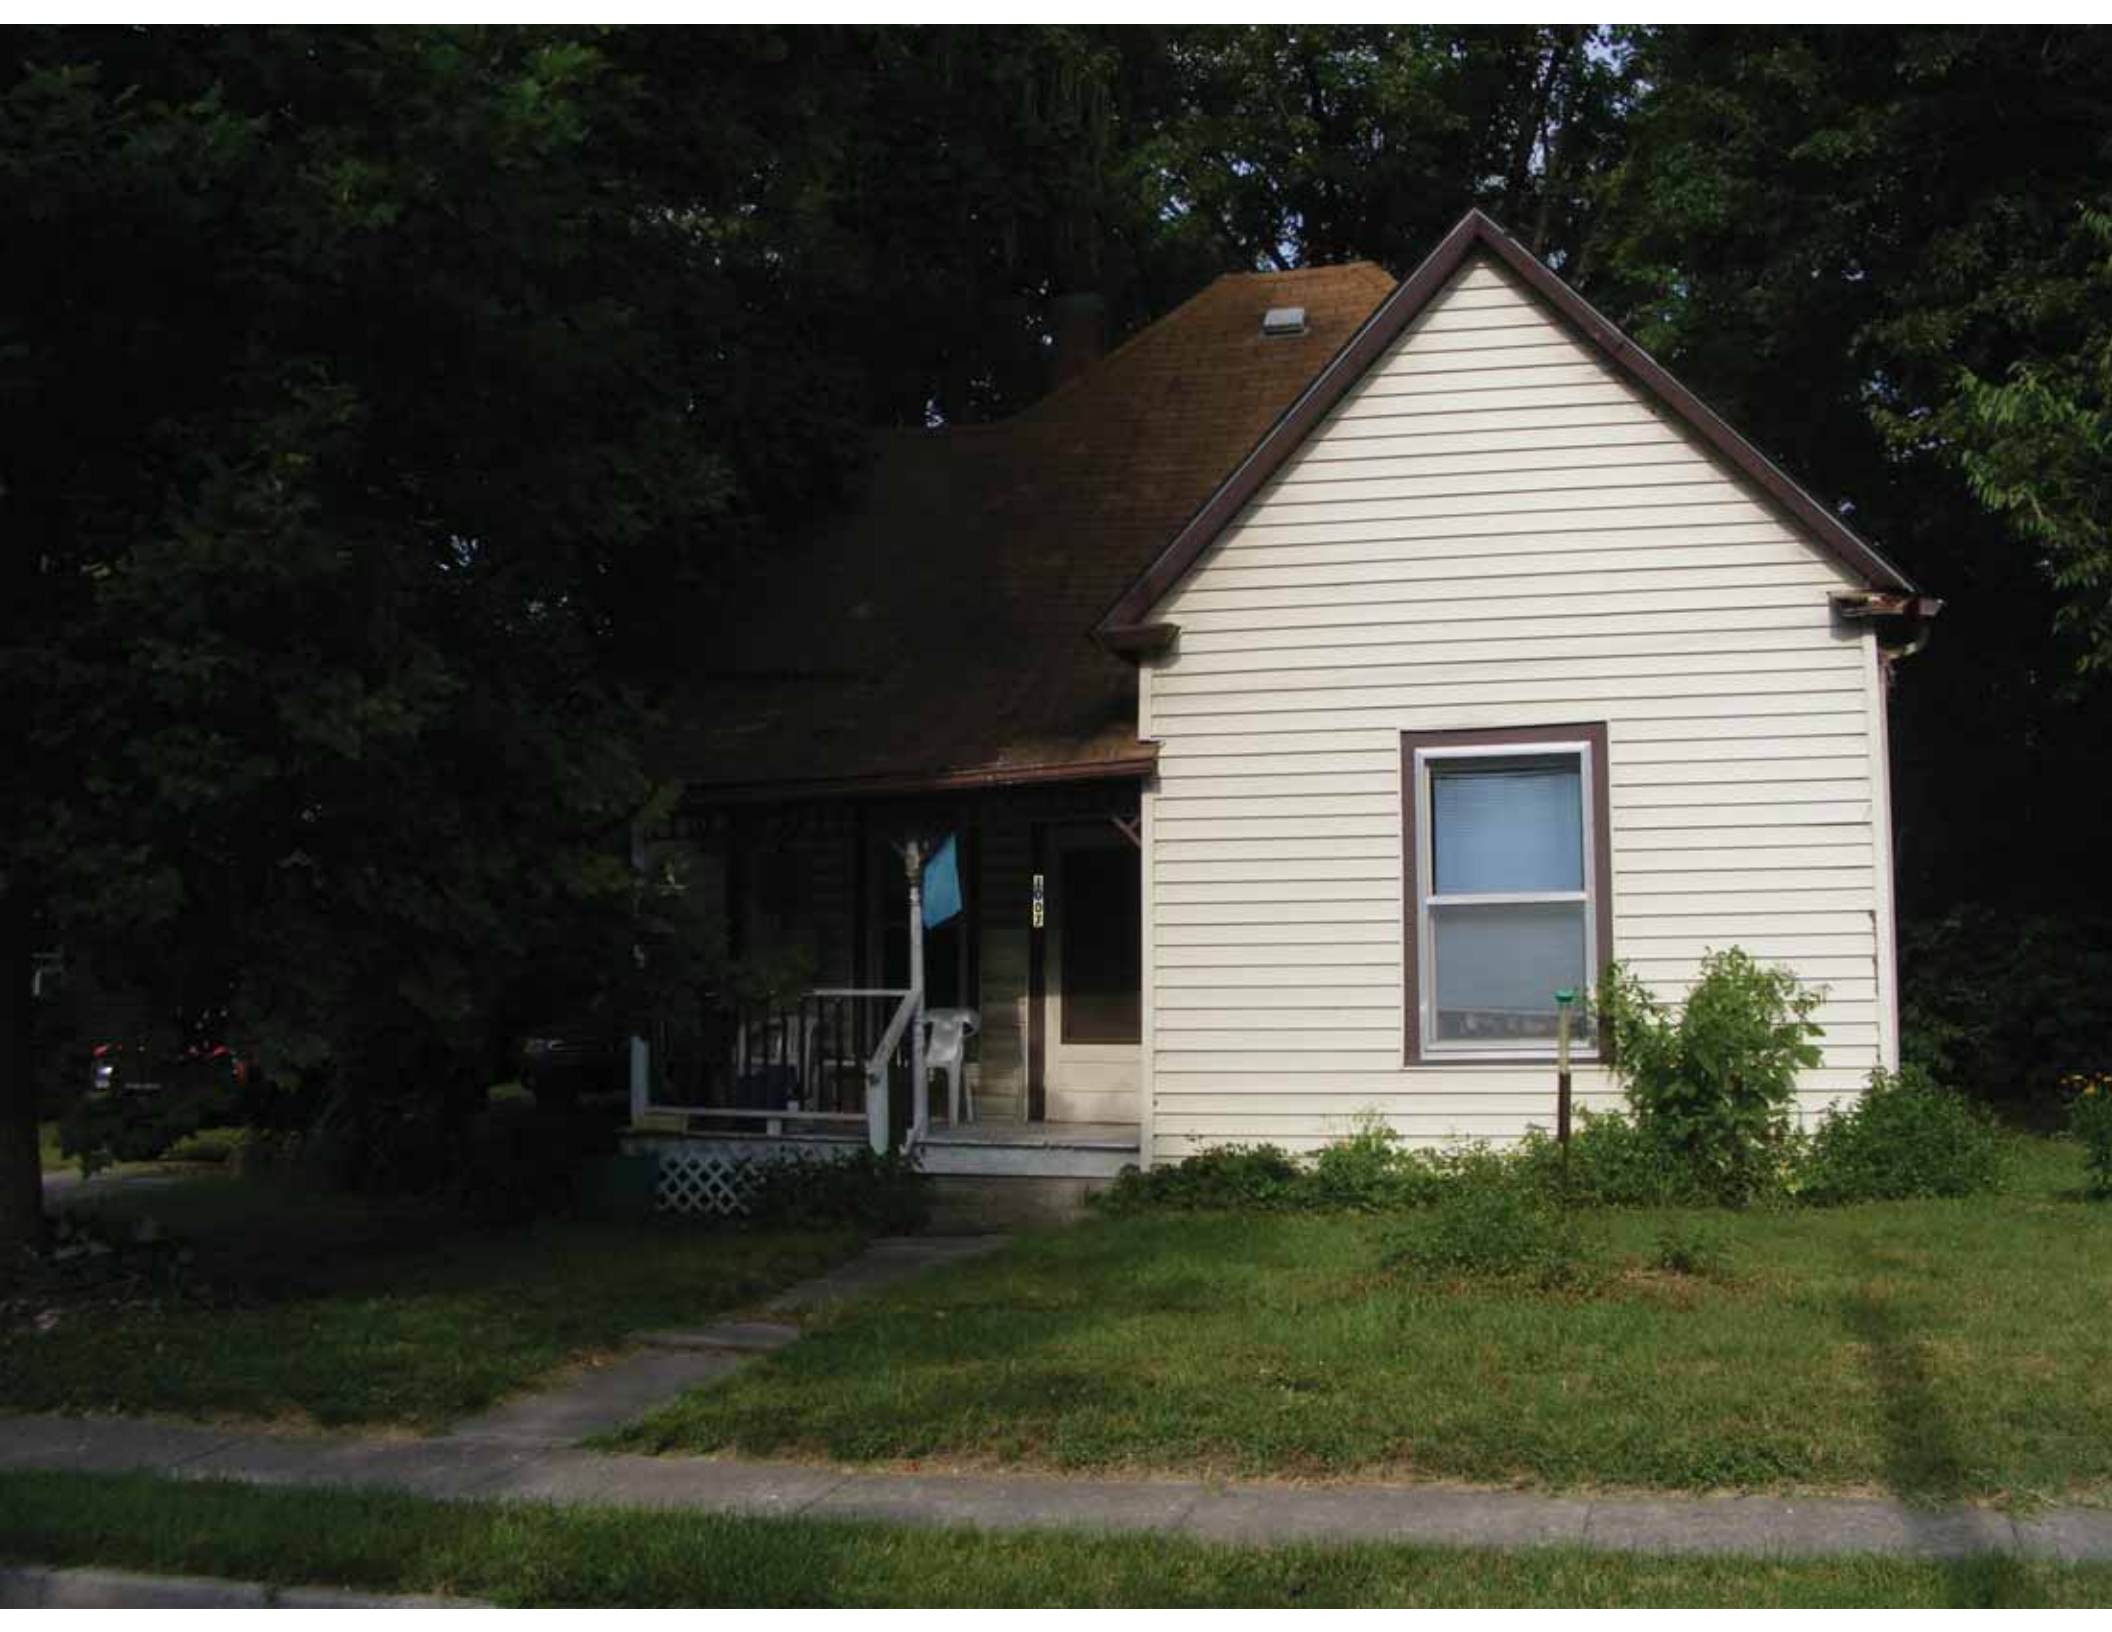
The dwelling has an asphalt shingled hip-on-gable roof, exterior vinyl siding and a concrete foundation (pier foundation below the porch floor, covered by lattice). The primary (east) elevation features a front-gabled wing with a single one-over-one window. Offsetting the wing's south elevation is a half-width porch supported by milled and chamfered columns. The milled columns have upper decorative bargeboard. Within the porch bay are two entries – one facing south and one facing east. The south entry holds a horizontal-light paneled storm door (c. 1945) and original single-light door. The remaining entry door is obscured by the contemporary storm door but appears solid. The east facing door is offset by a single one-over-one window. Remaining windows are of similar configuration.
