MISSOURI DEPARTMENT OF NATURAL RESOURCES
STATE HISTORIC PRESERVATION OFFICE, P.O. Box 176, Jefferson City, MO 65102
ARCHITECTURAL/HISTORIC INVENTORY FORM

1. Survey No. BO-AS-011-0087		2. Survey name: North Central Columbia Survey Phase II	
3. County: Boone		4. Address (Street No.) 902	Street (name) N. Seventh Street
5. City: Columbia	Vicinity: <input type="checkbox"/>	6. Geographical Reference:	7. Township/Range/Section: T: R: S:
8. Historic name (if known):		9. Present/other name (if known):	
10. Ownership: <input checked="" type="checkbox"/> Private <input type="checkbox"/> Public		11a. Historic use (if known): Domestic/single dwelling	11b. Current use: Domestic/single dwelling

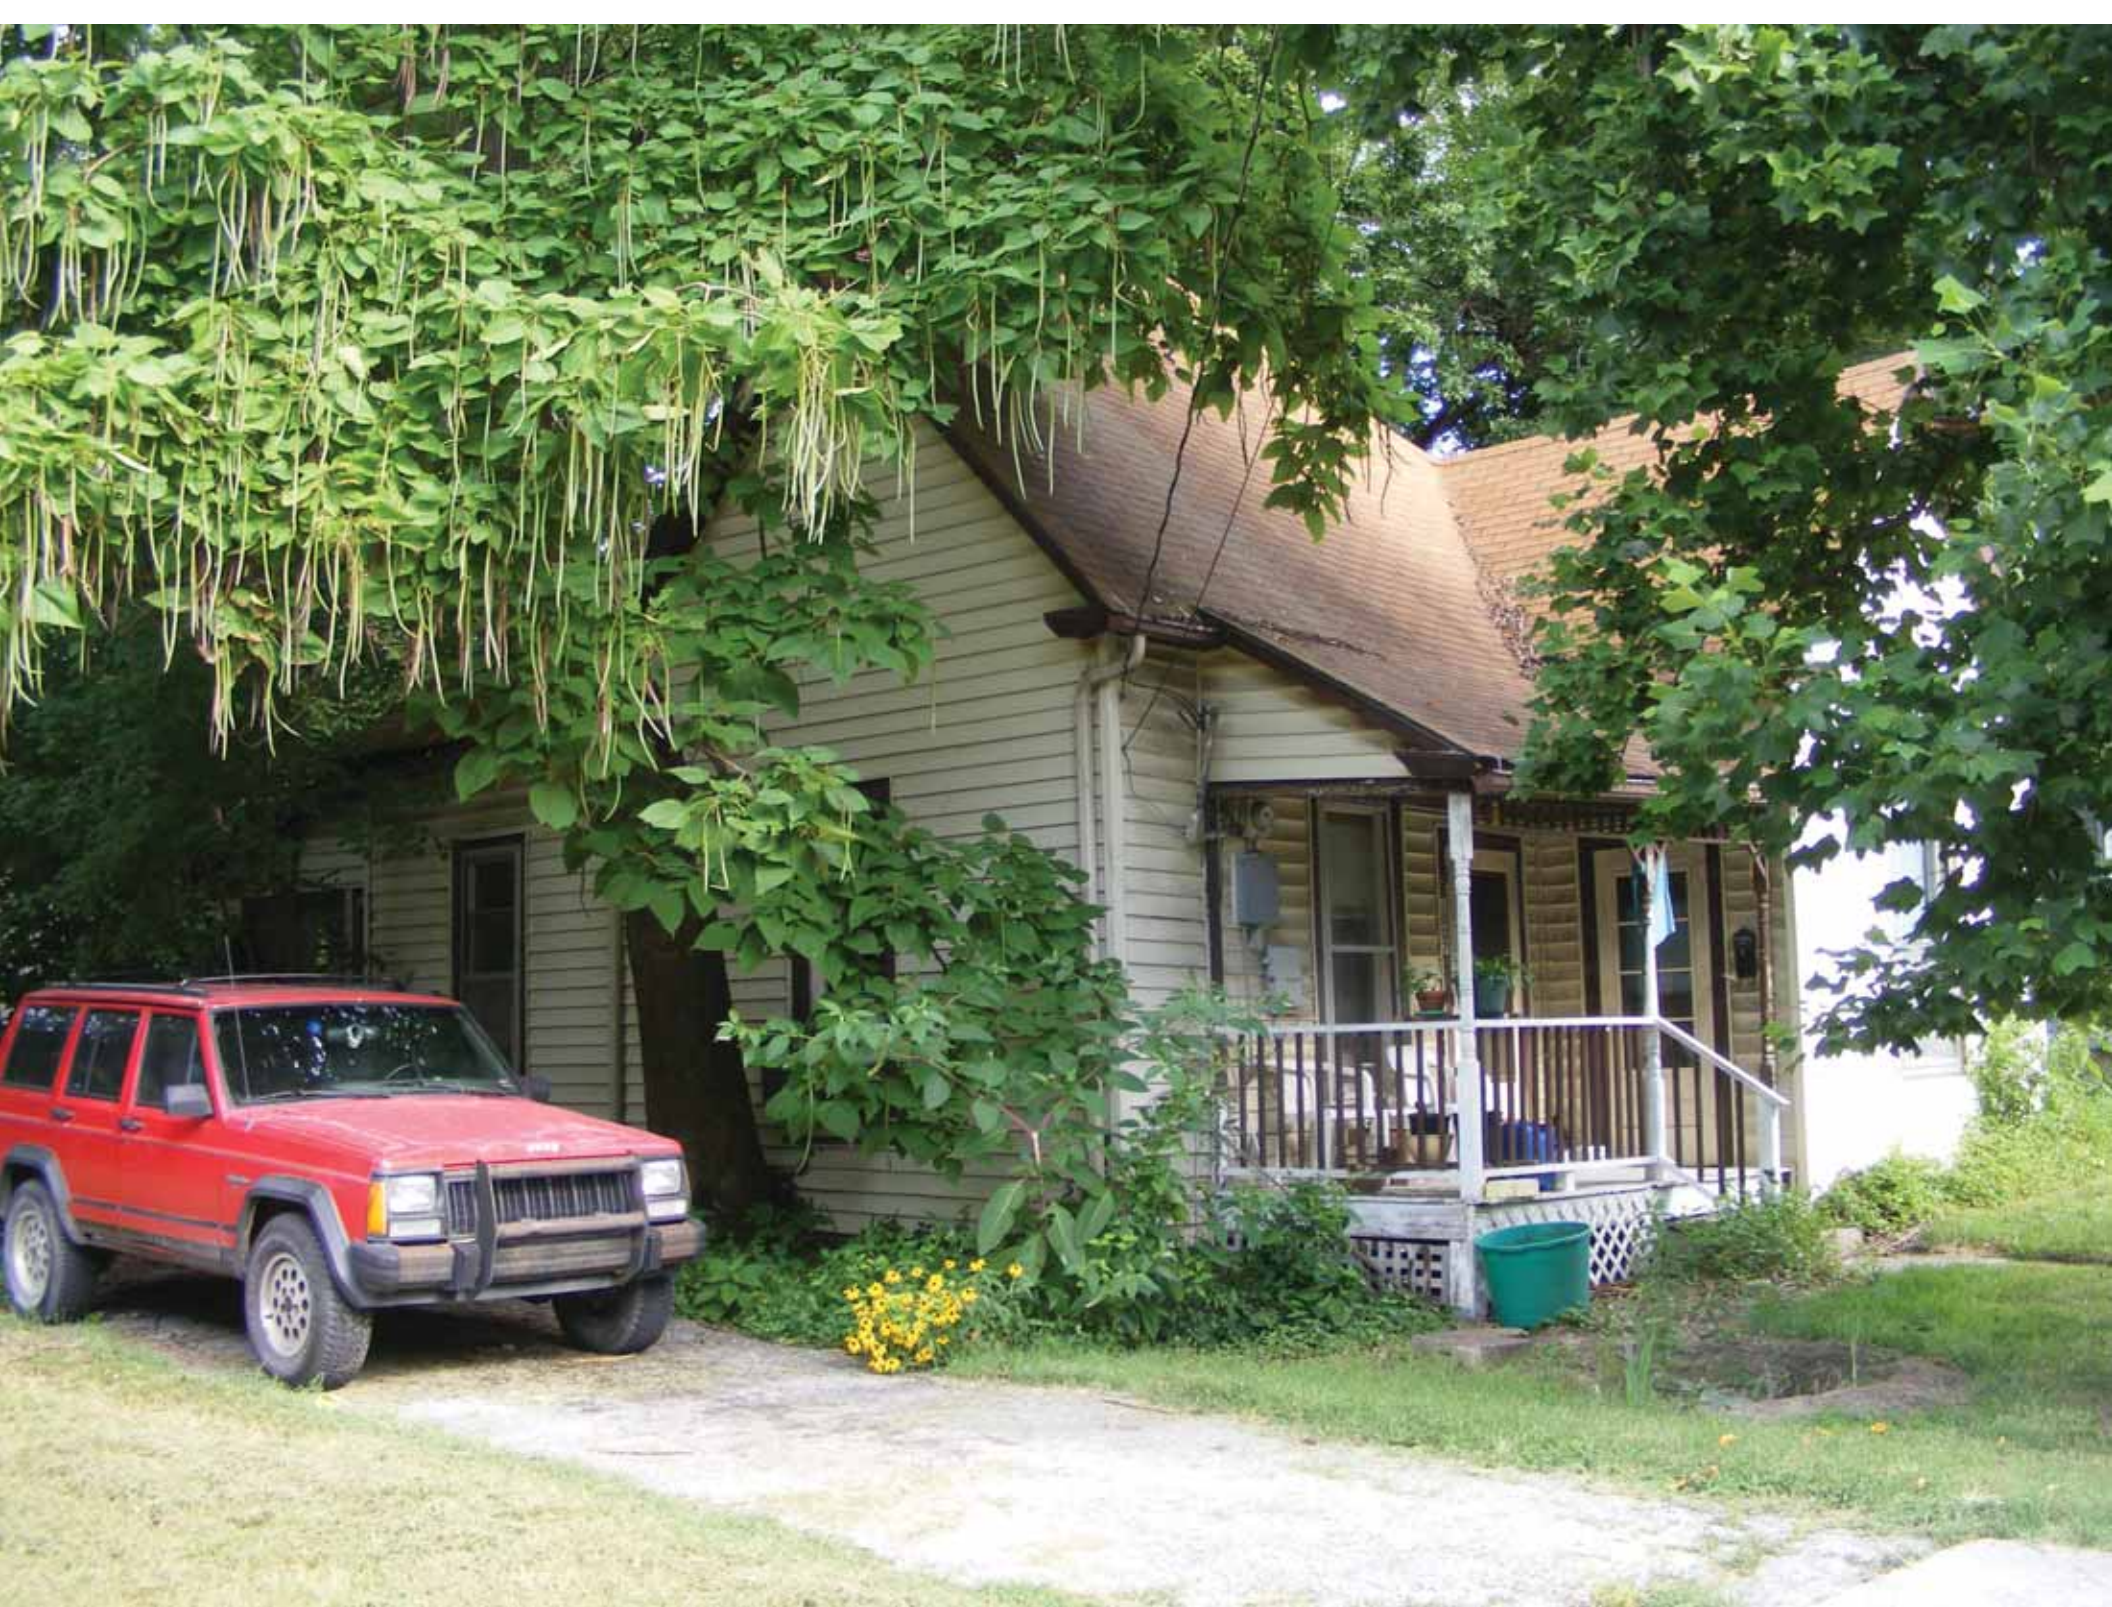
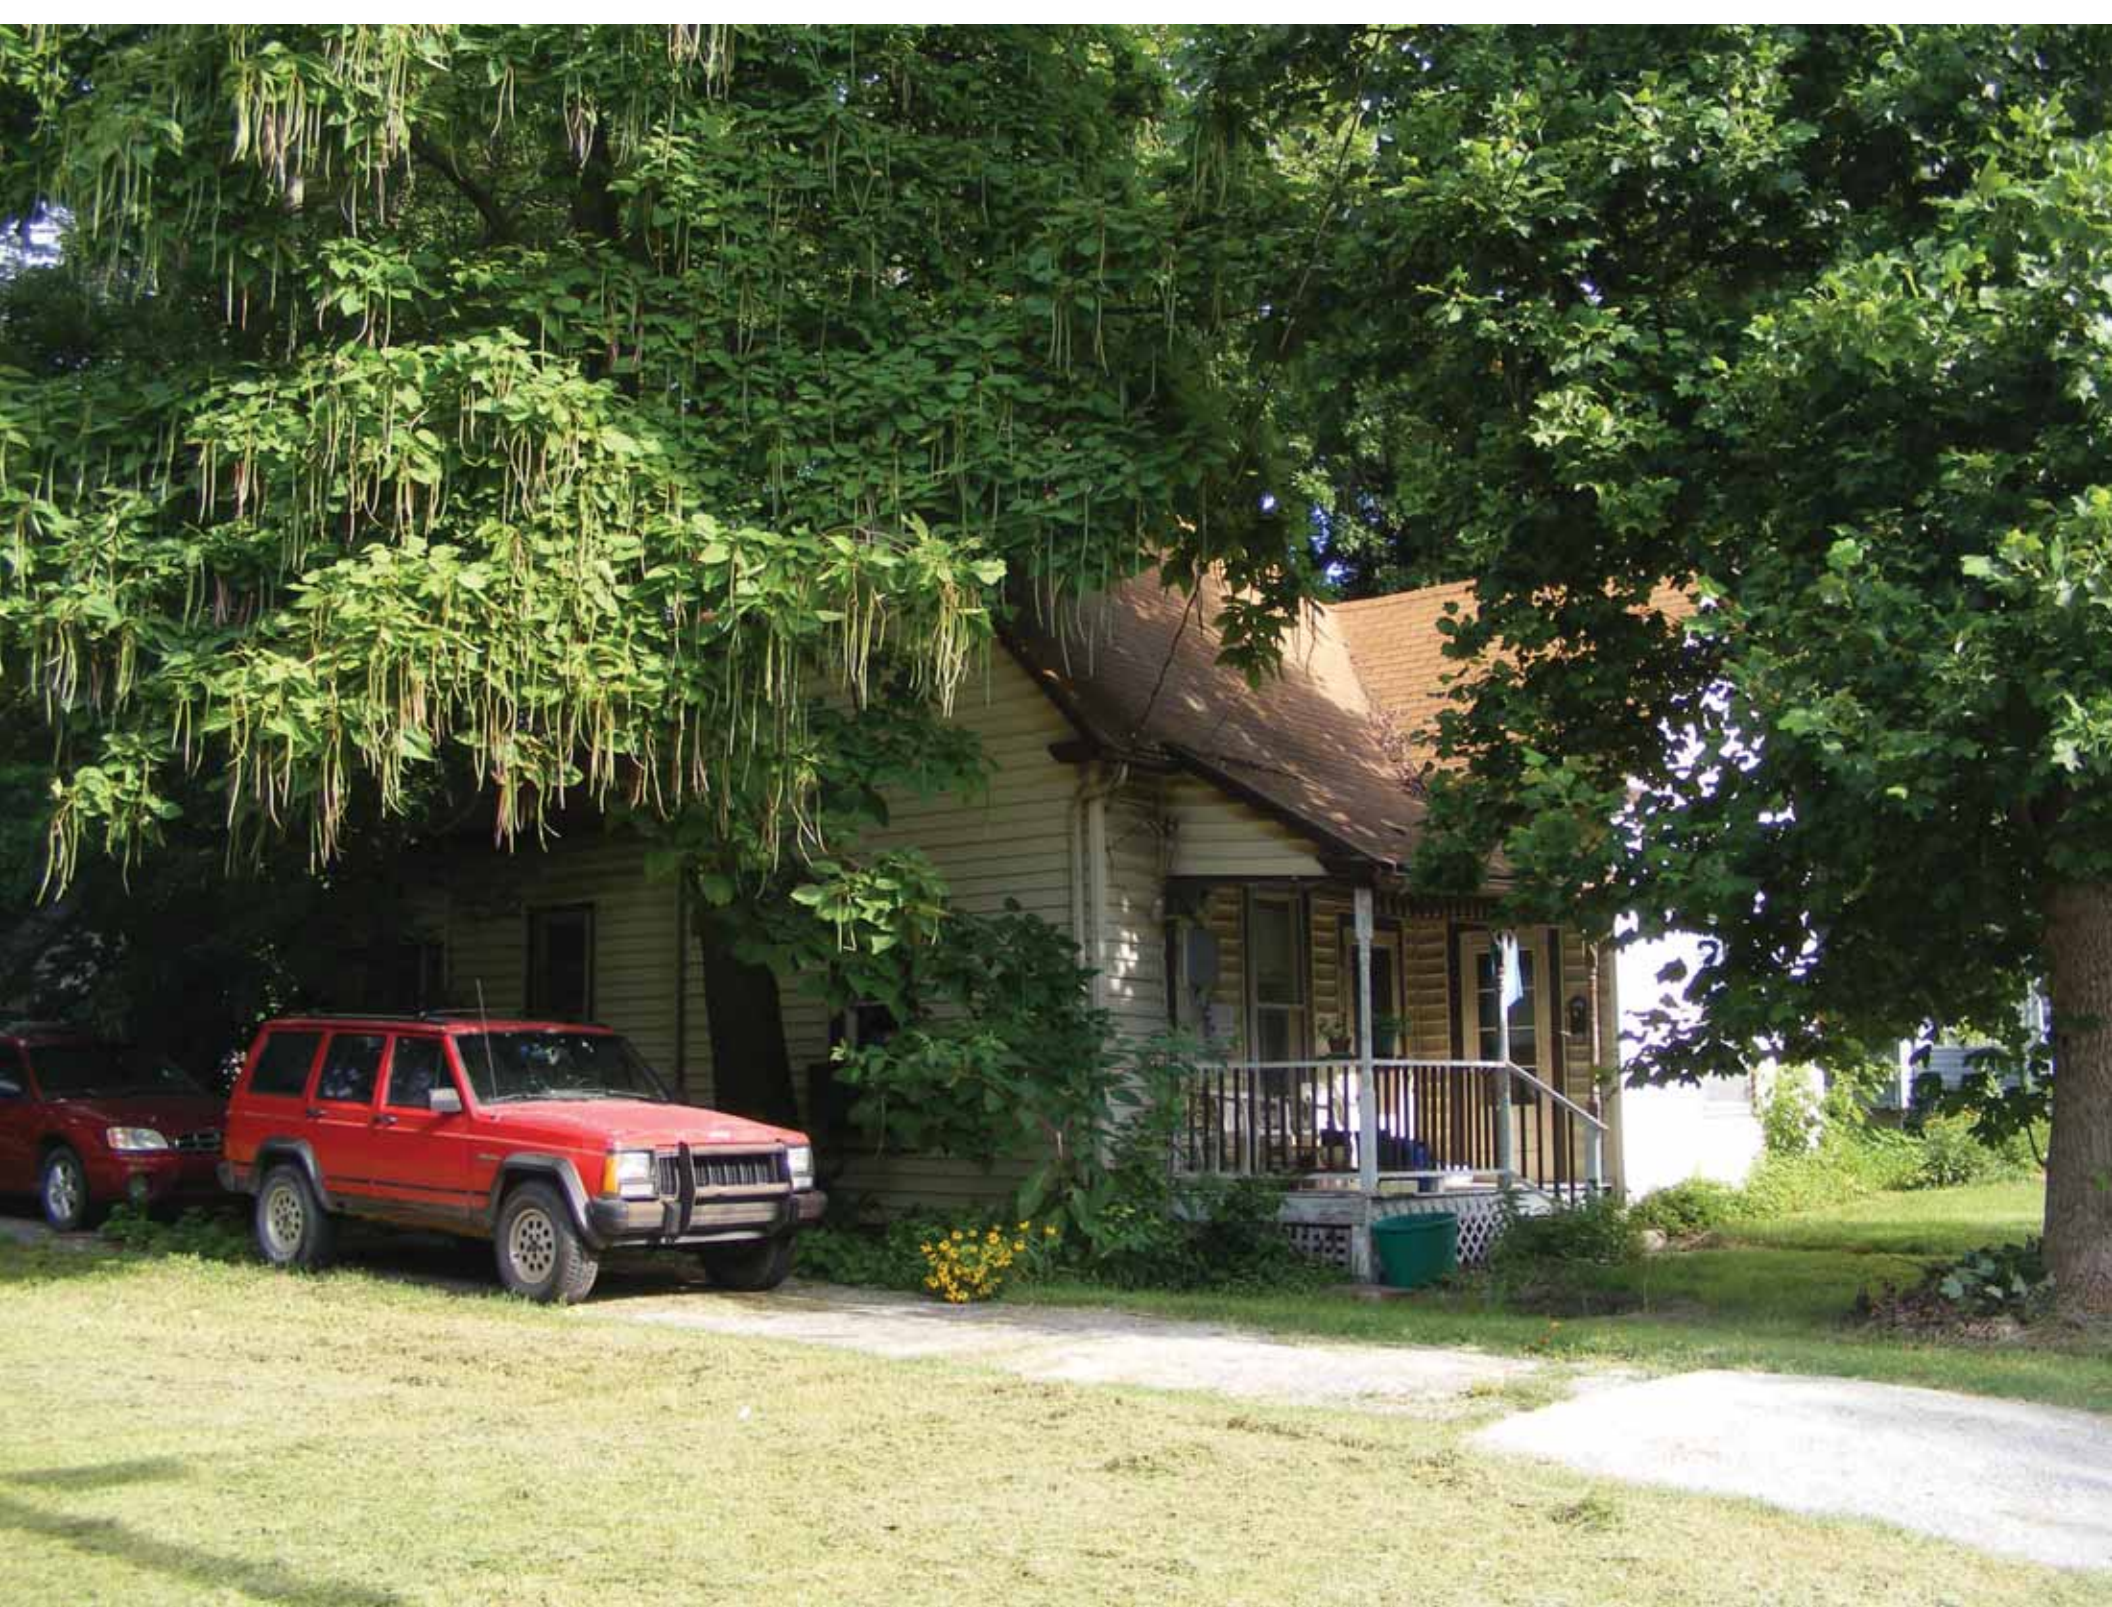
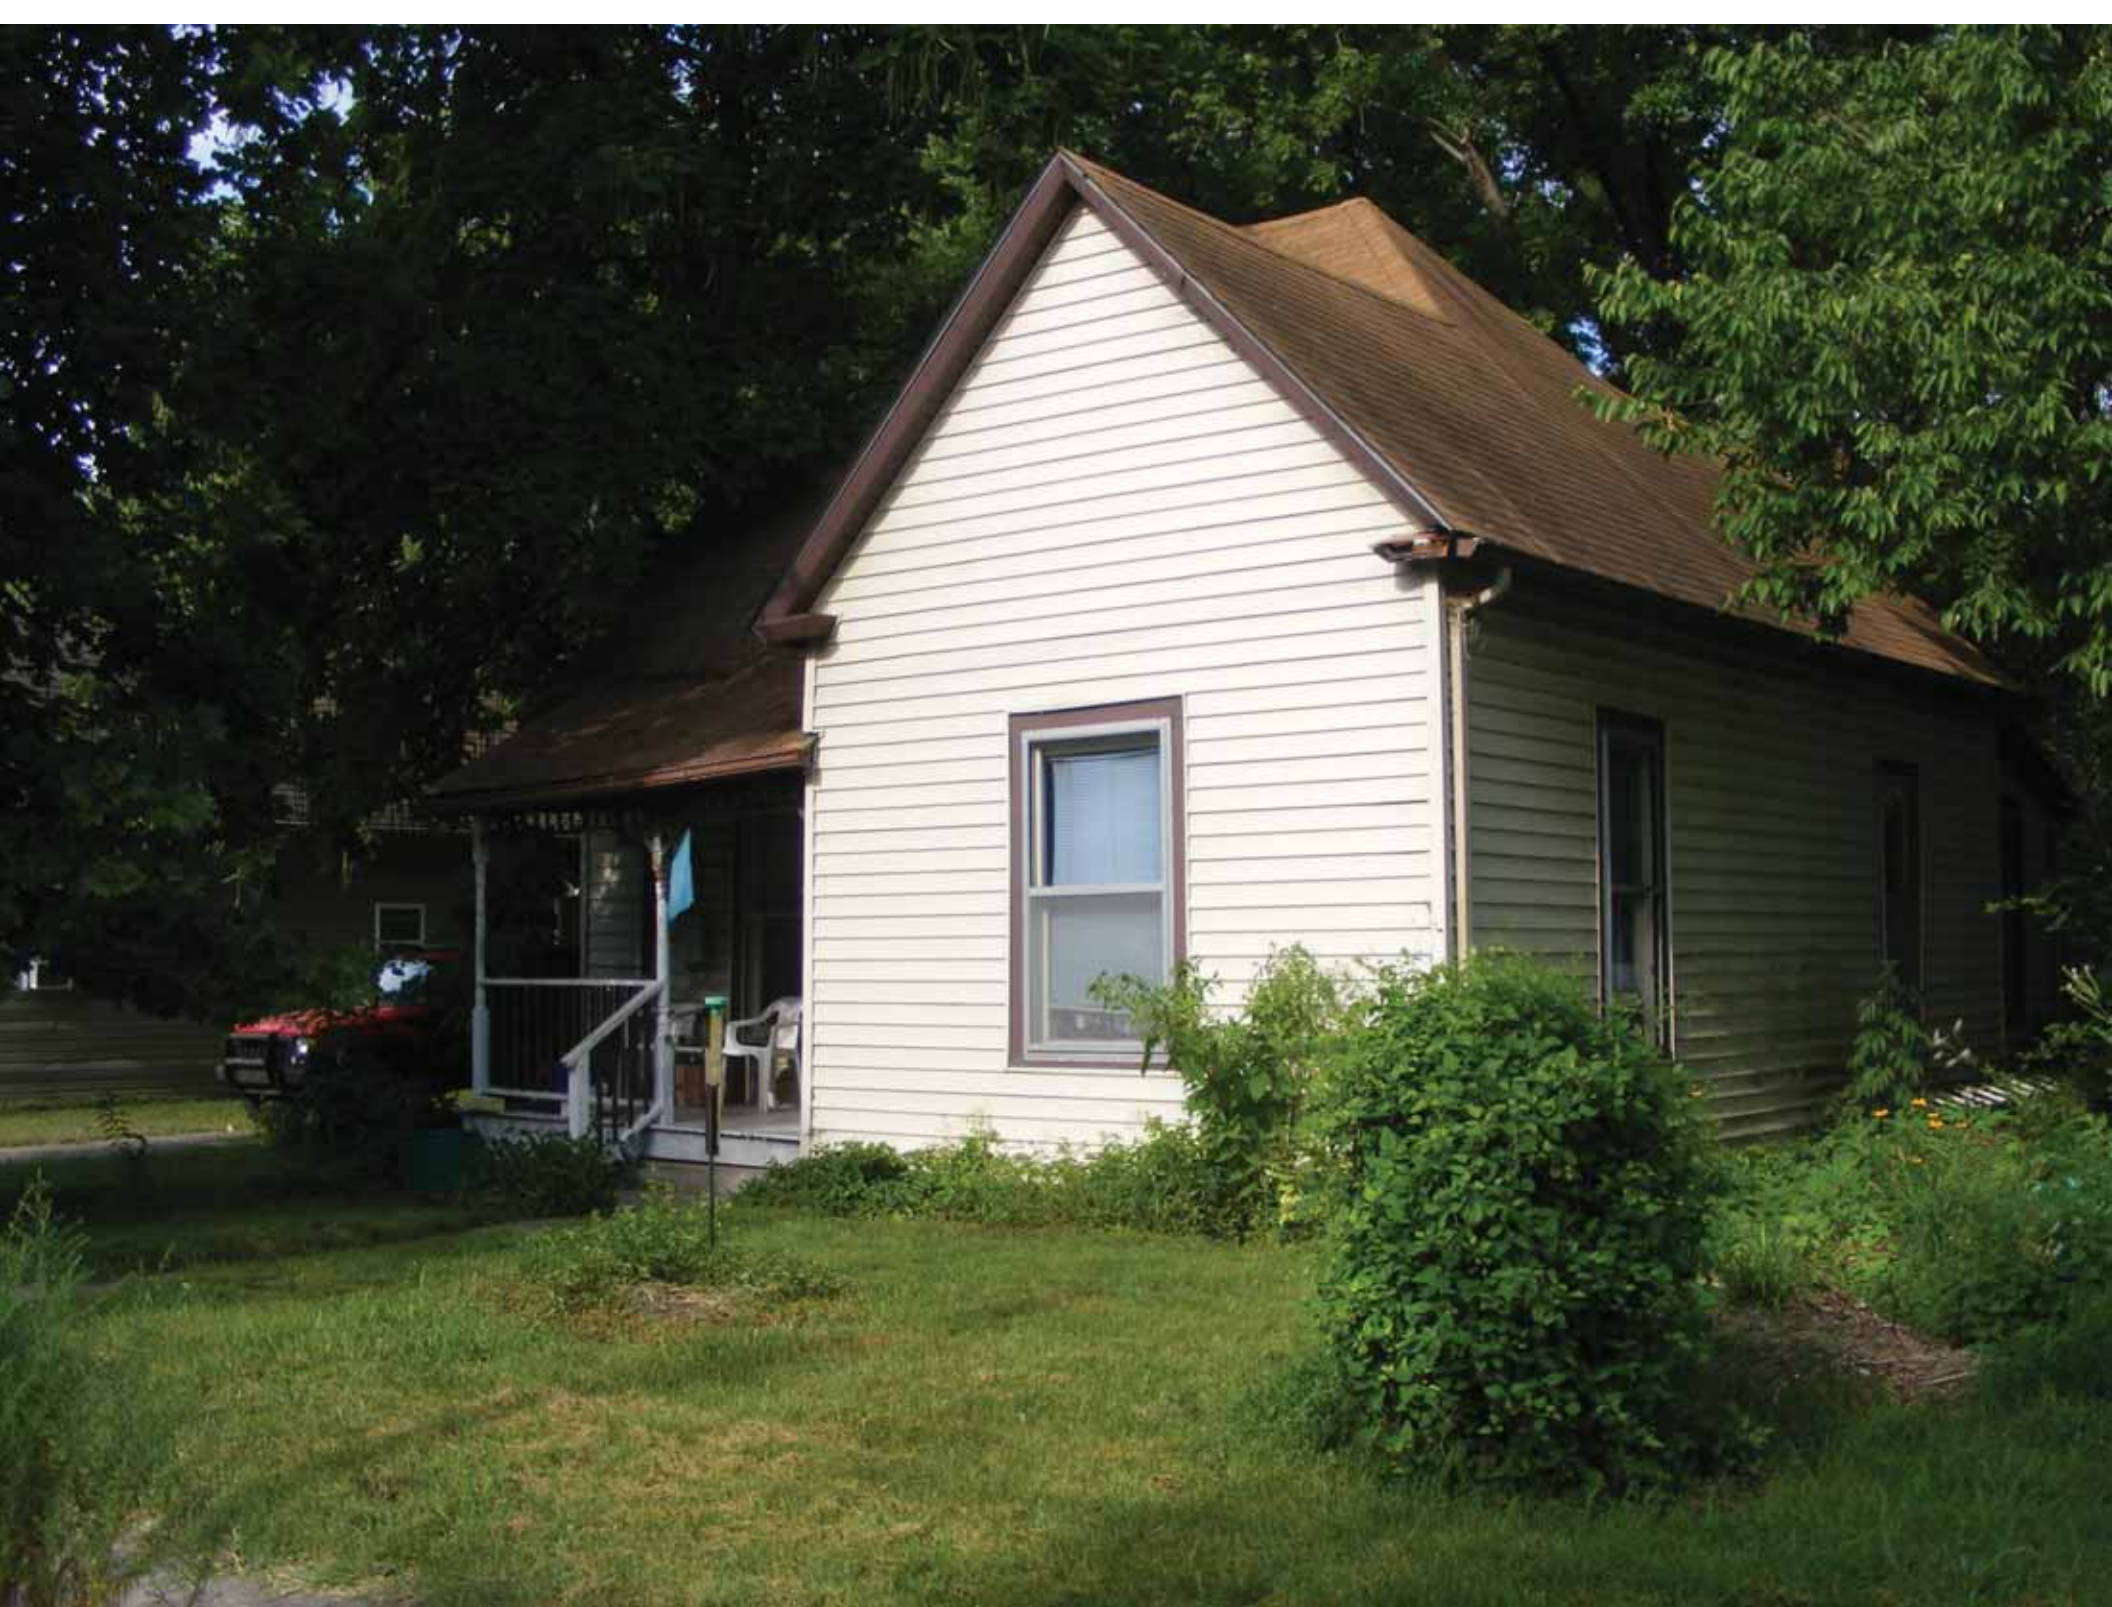
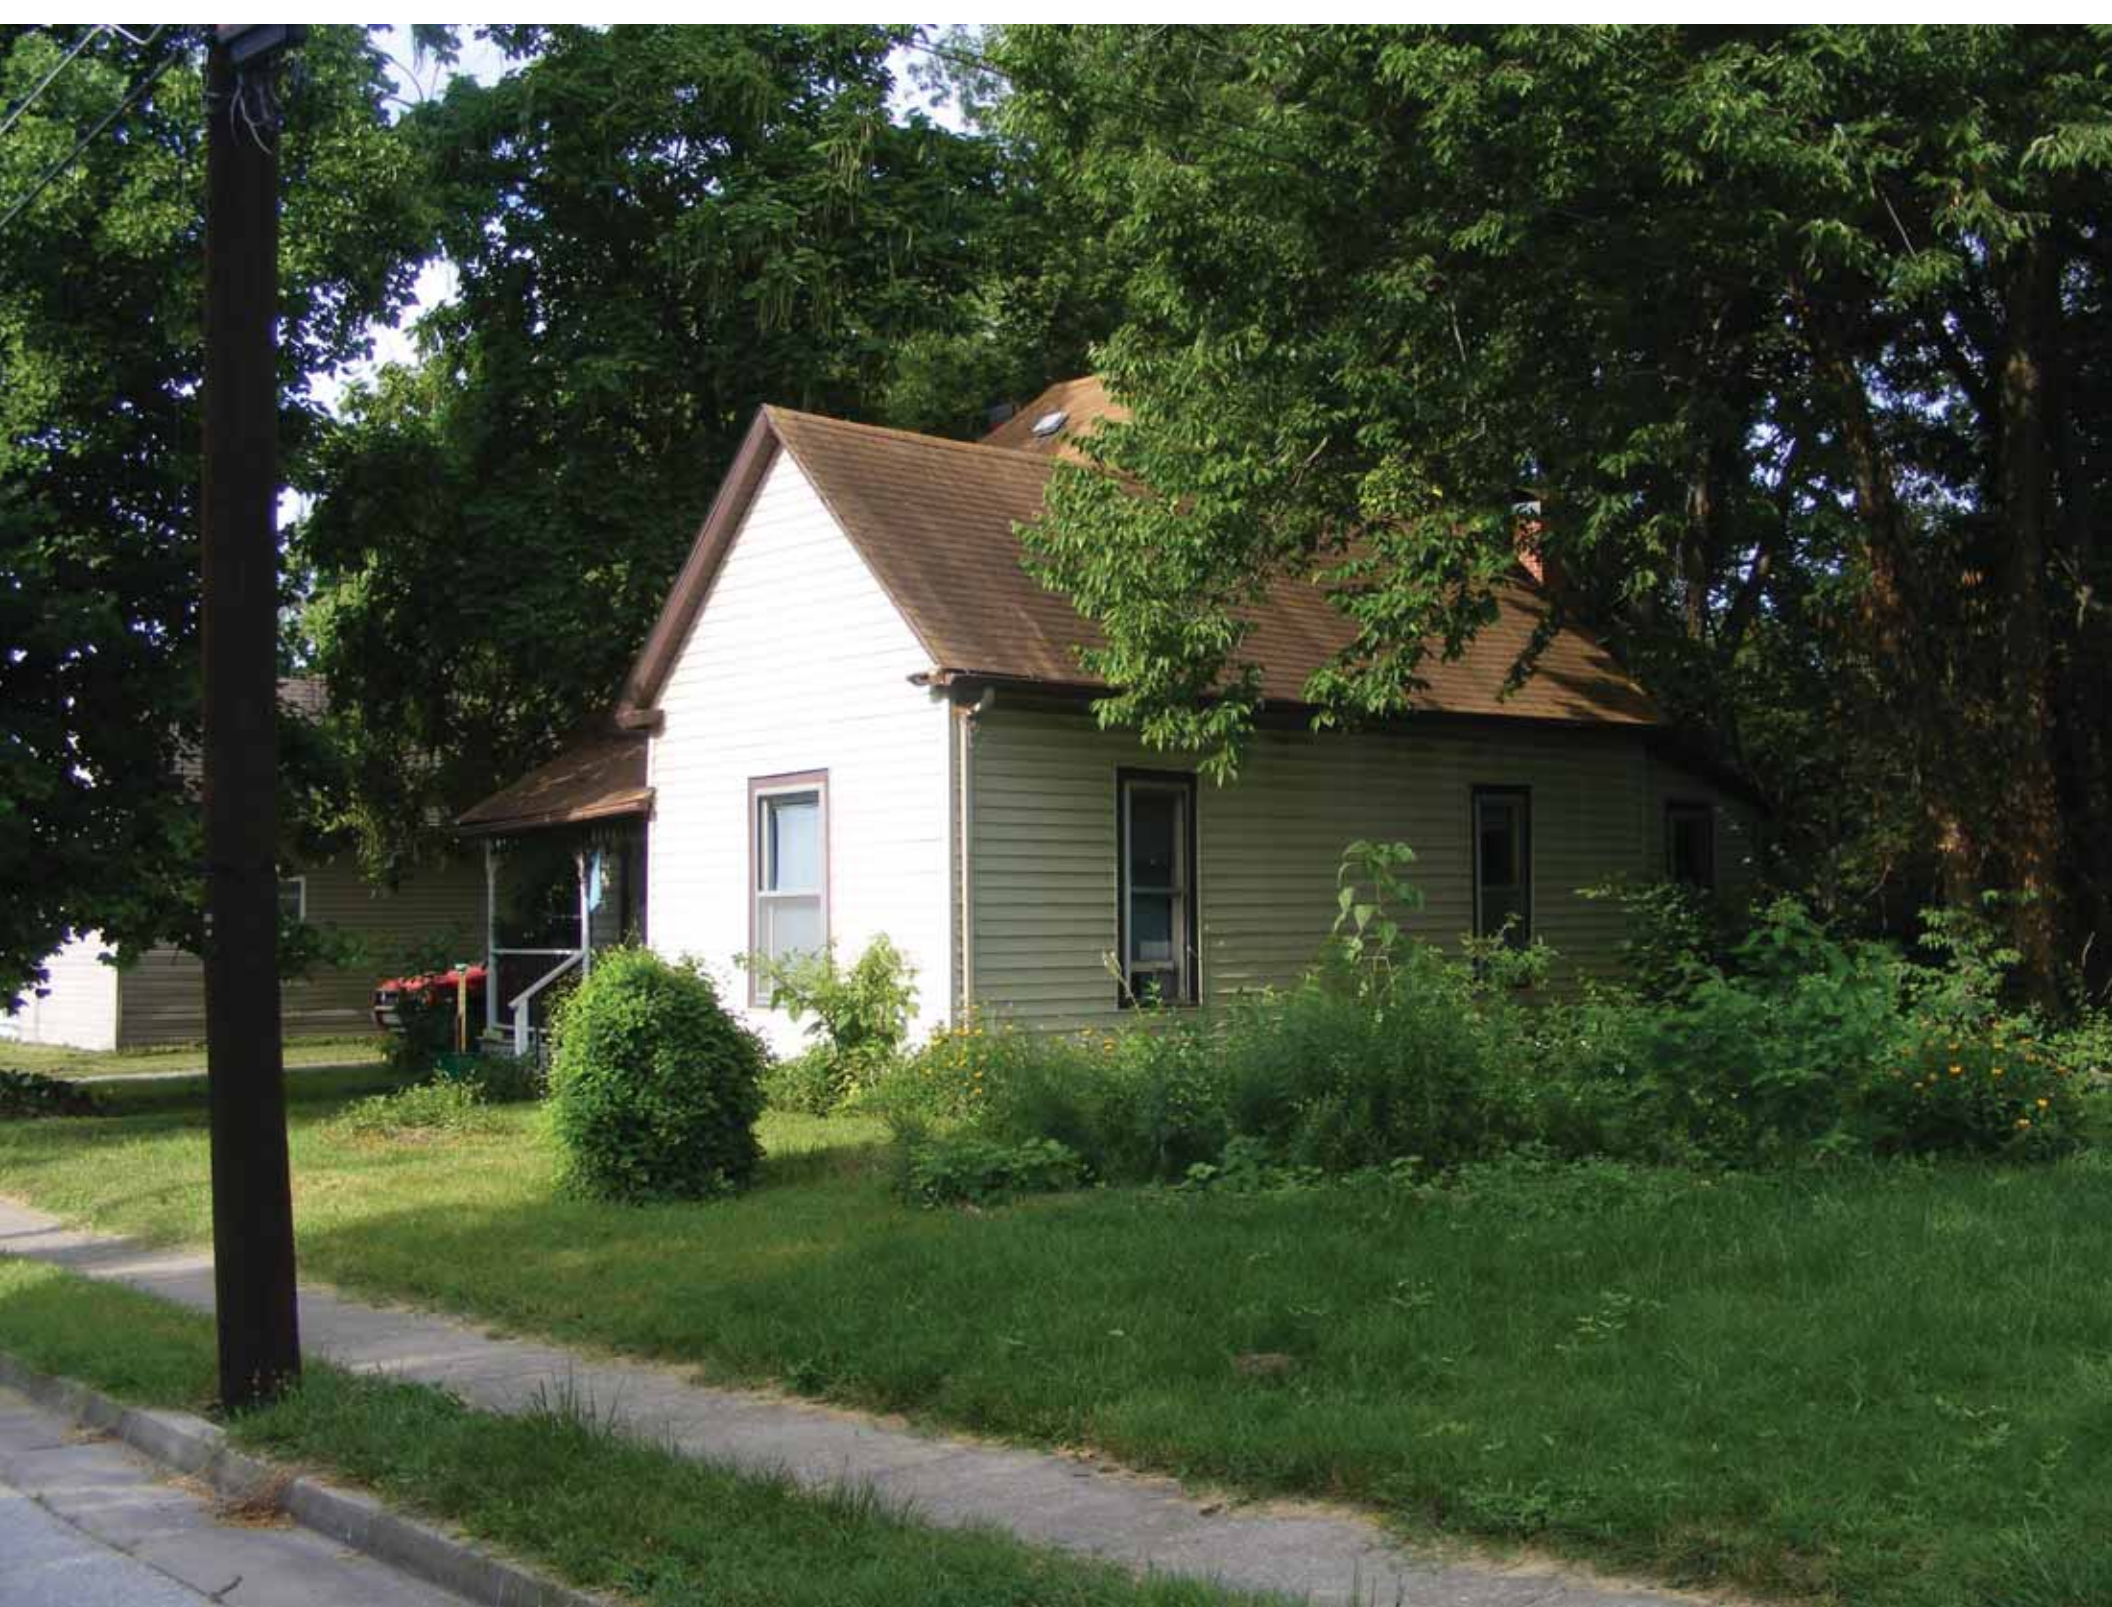
The dwelling has an asphalt shingled hip-on-gable roof, exterior vinyl siding and a concrete foundation (pier foundation below the porch floor, covered by lattice). The primary (east) elevation features a front-gabled wing with a single one-over-one window. Offsetting the wing's south elevation is a half-width porch supported by milled and chamfered columns. The milled columns have upper decorative bargeboard. Within the porch bay are two entries – one facing south and one facing east. The south entry holds a horizontal-light paneled storm door (c. 1945) and original single-light door. The remaining entry door is obscured by the contemporary storm door but appears solid. The east facing door is offset by a single one-over-one window. Remaining windows are of similar configuration.
