MISSOURI DEPARTMENT OF NATURAL RESOURCES
STATE HISTORIC PRESERVATION OFFICE, P.O. Box 176, Jefferson City, MO 65102
ARCHITECTURAL/HISTORIC INVENTORY FORM

1. Survey No. BO-AS-011-0087		2. Survey name: North Central Columbia Survey Phase II	
3. County: Boone		4. Address (Street No.) 902	Street (name) N. Seventh Street
5. City: Columbia	Vicinity: <input type="checkbox"/>	6. Geographical Reference:	7. Township/Range/Section: T: R: S:
8. Historic name (if known):		9. Present/other name (if known):	
10. Ownership: <input checked="" type="checkbox"/> Private <input type="checkbox"/> Public		11a. Historic use (if known): Domestic/single dwelling	11b. Current use: Domestic/single dwelling

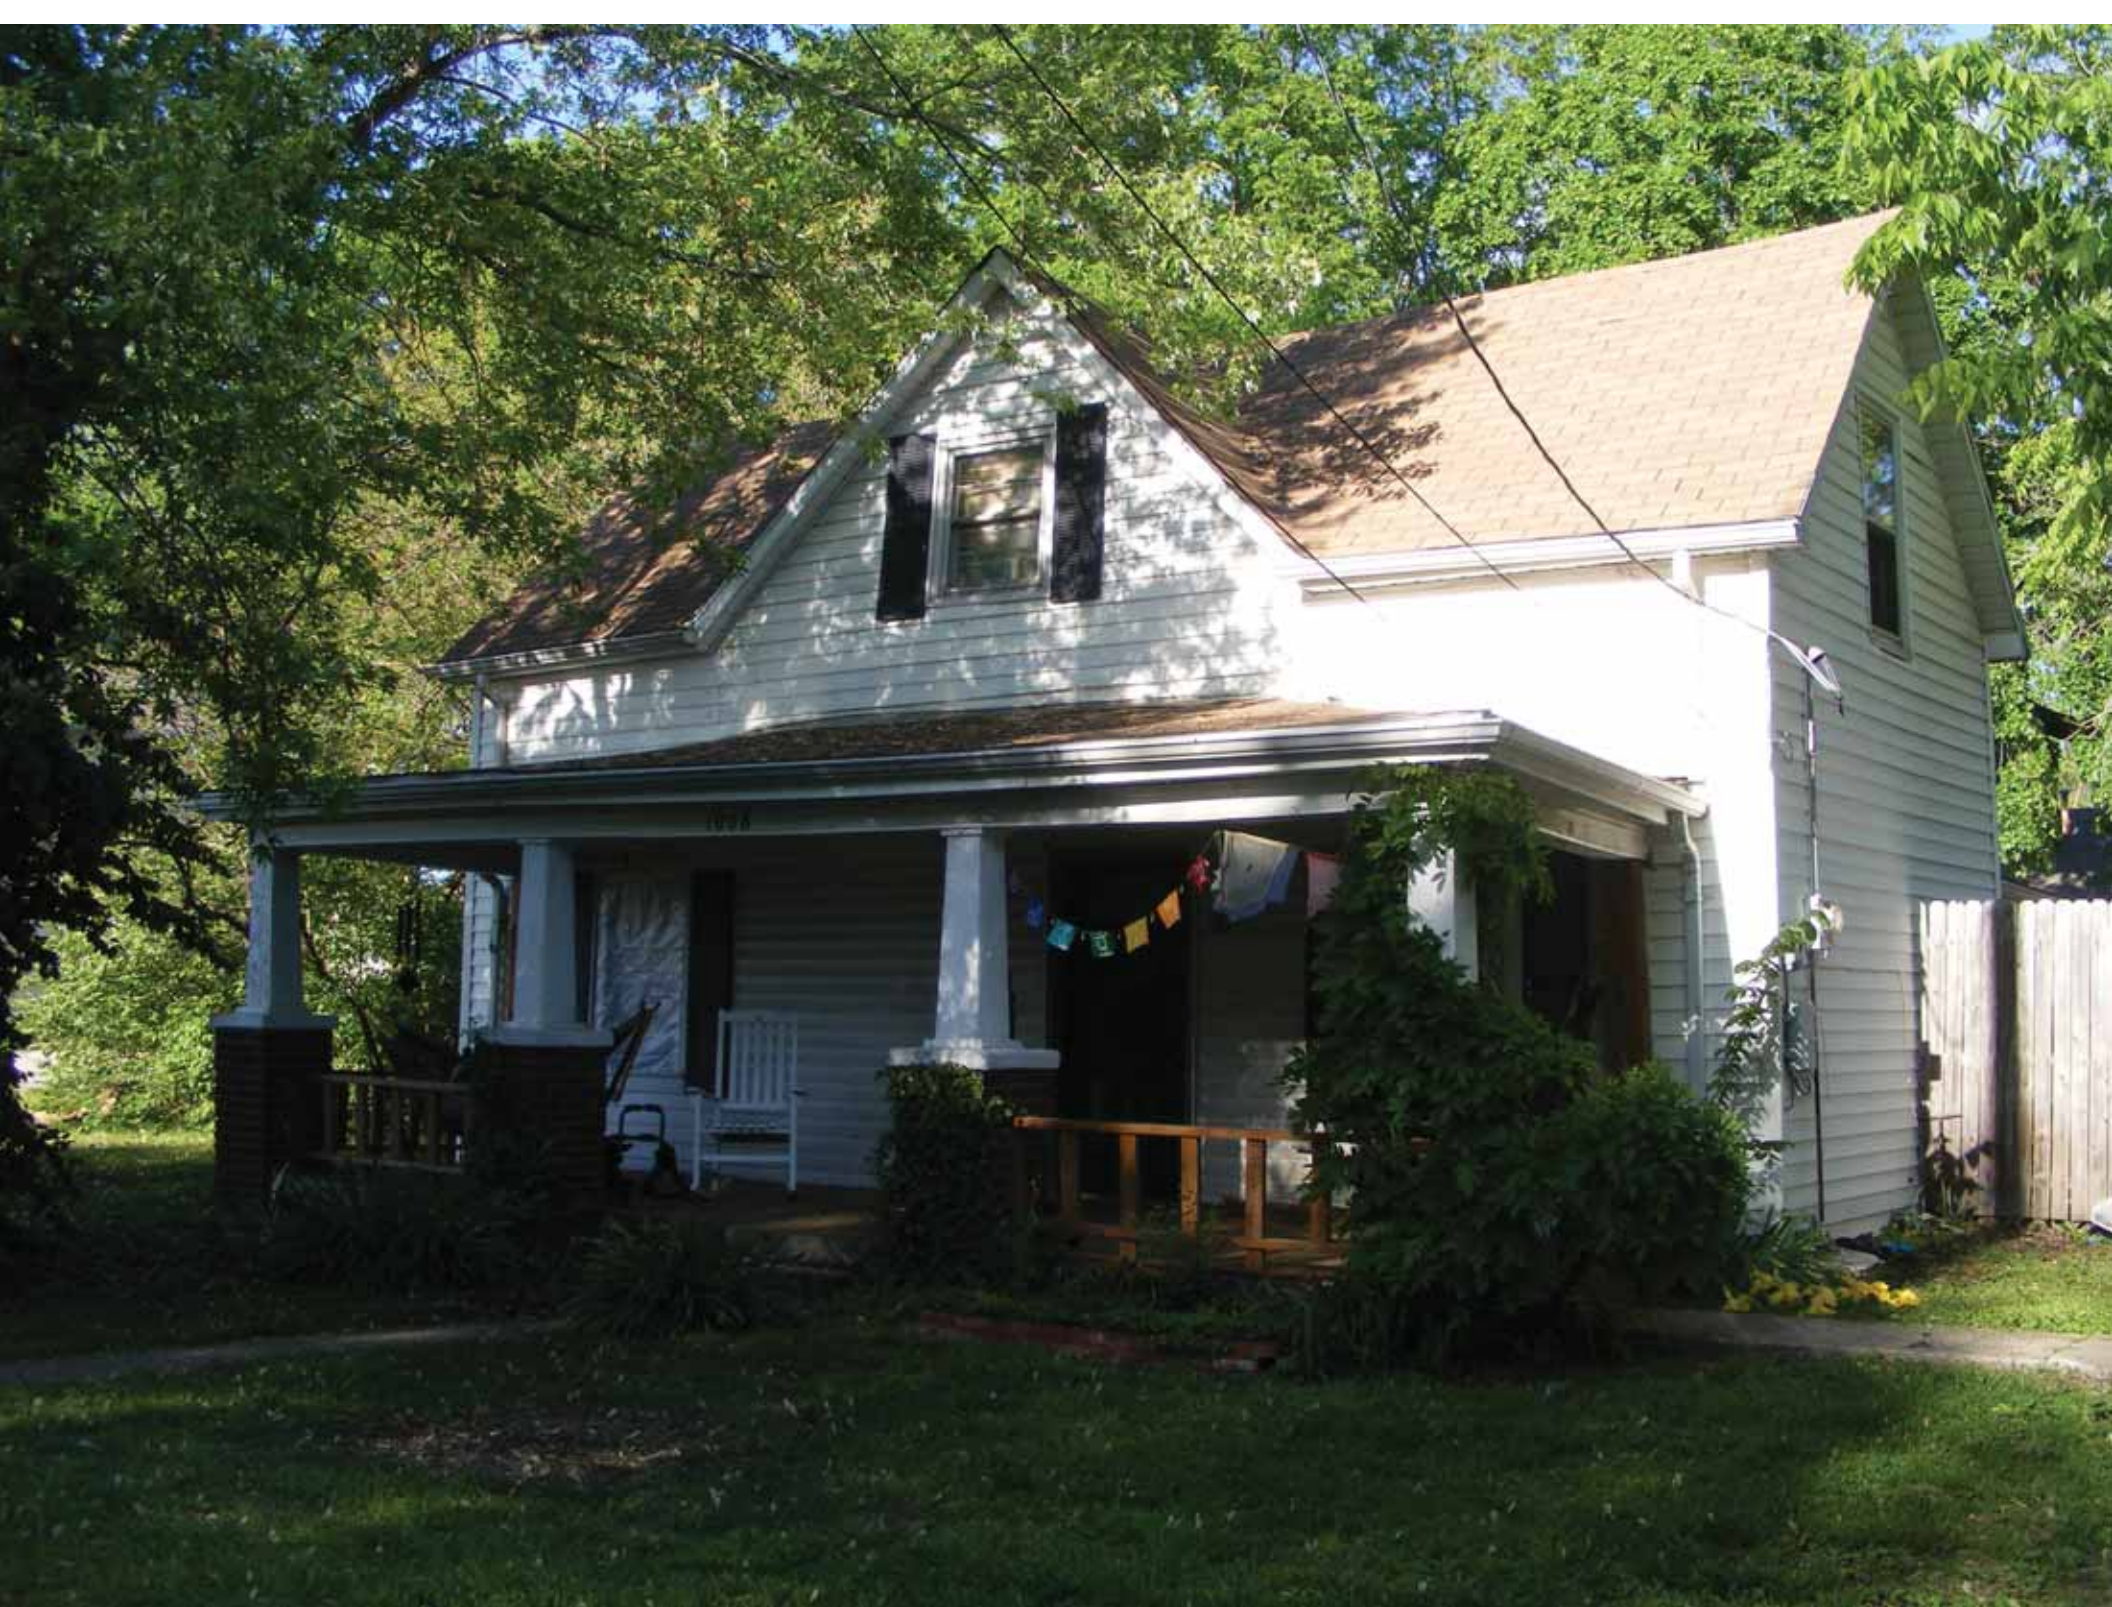
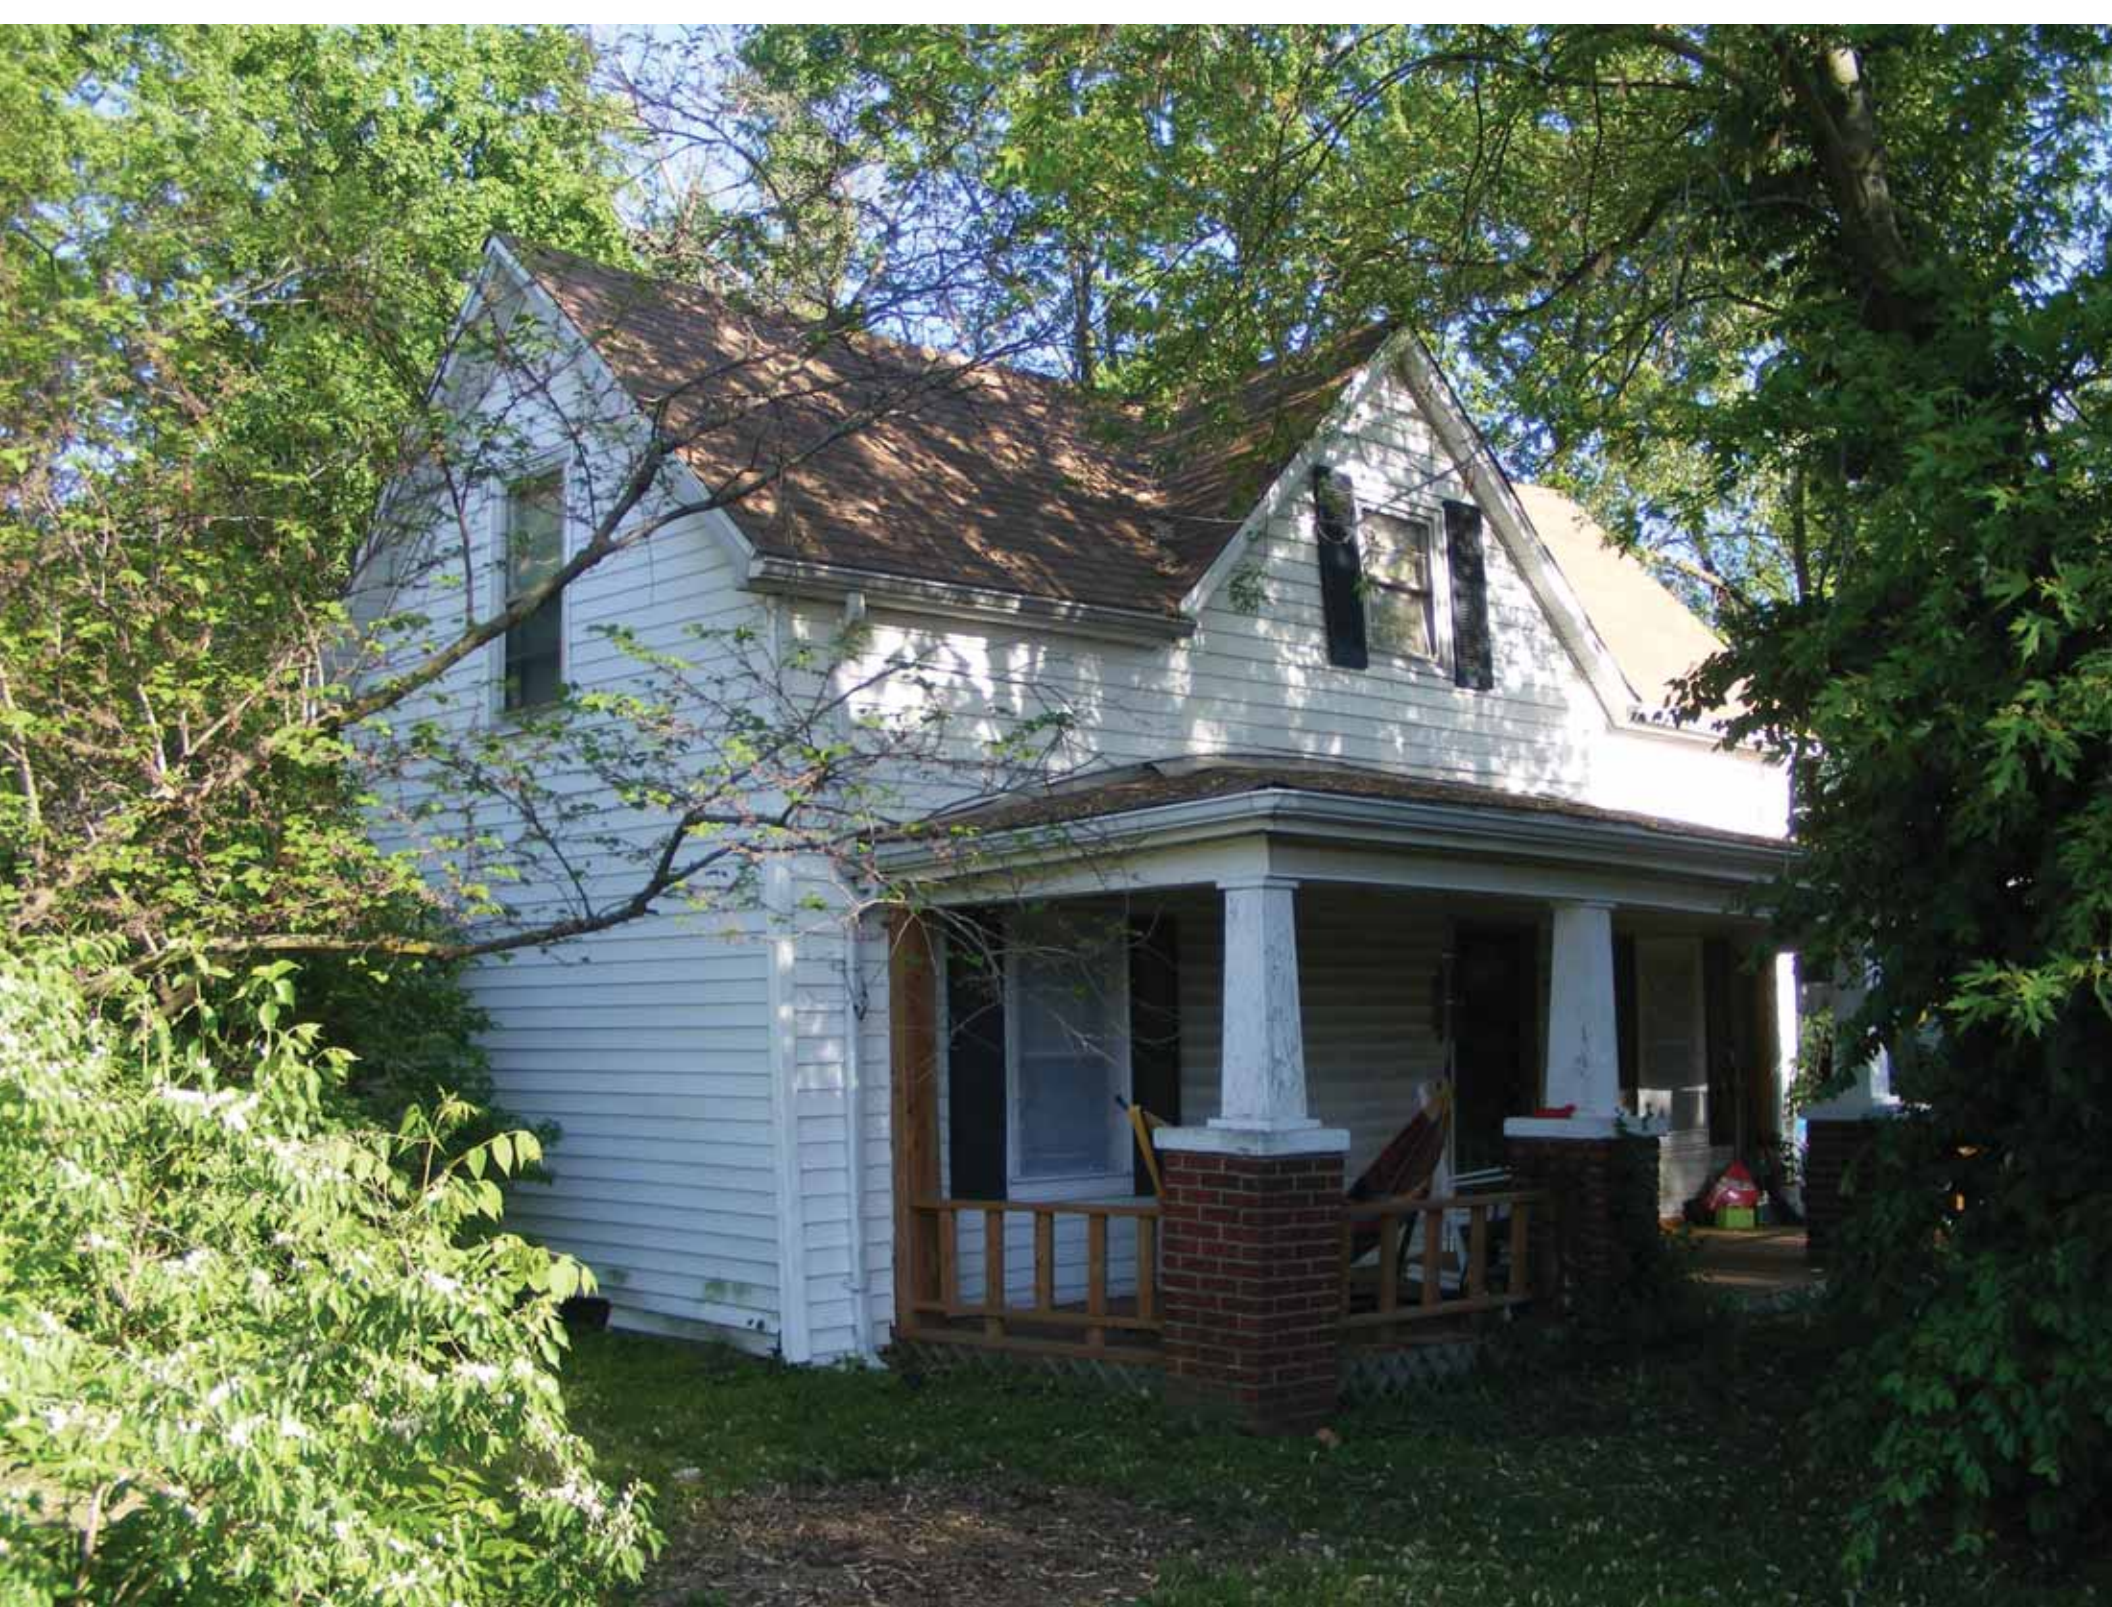
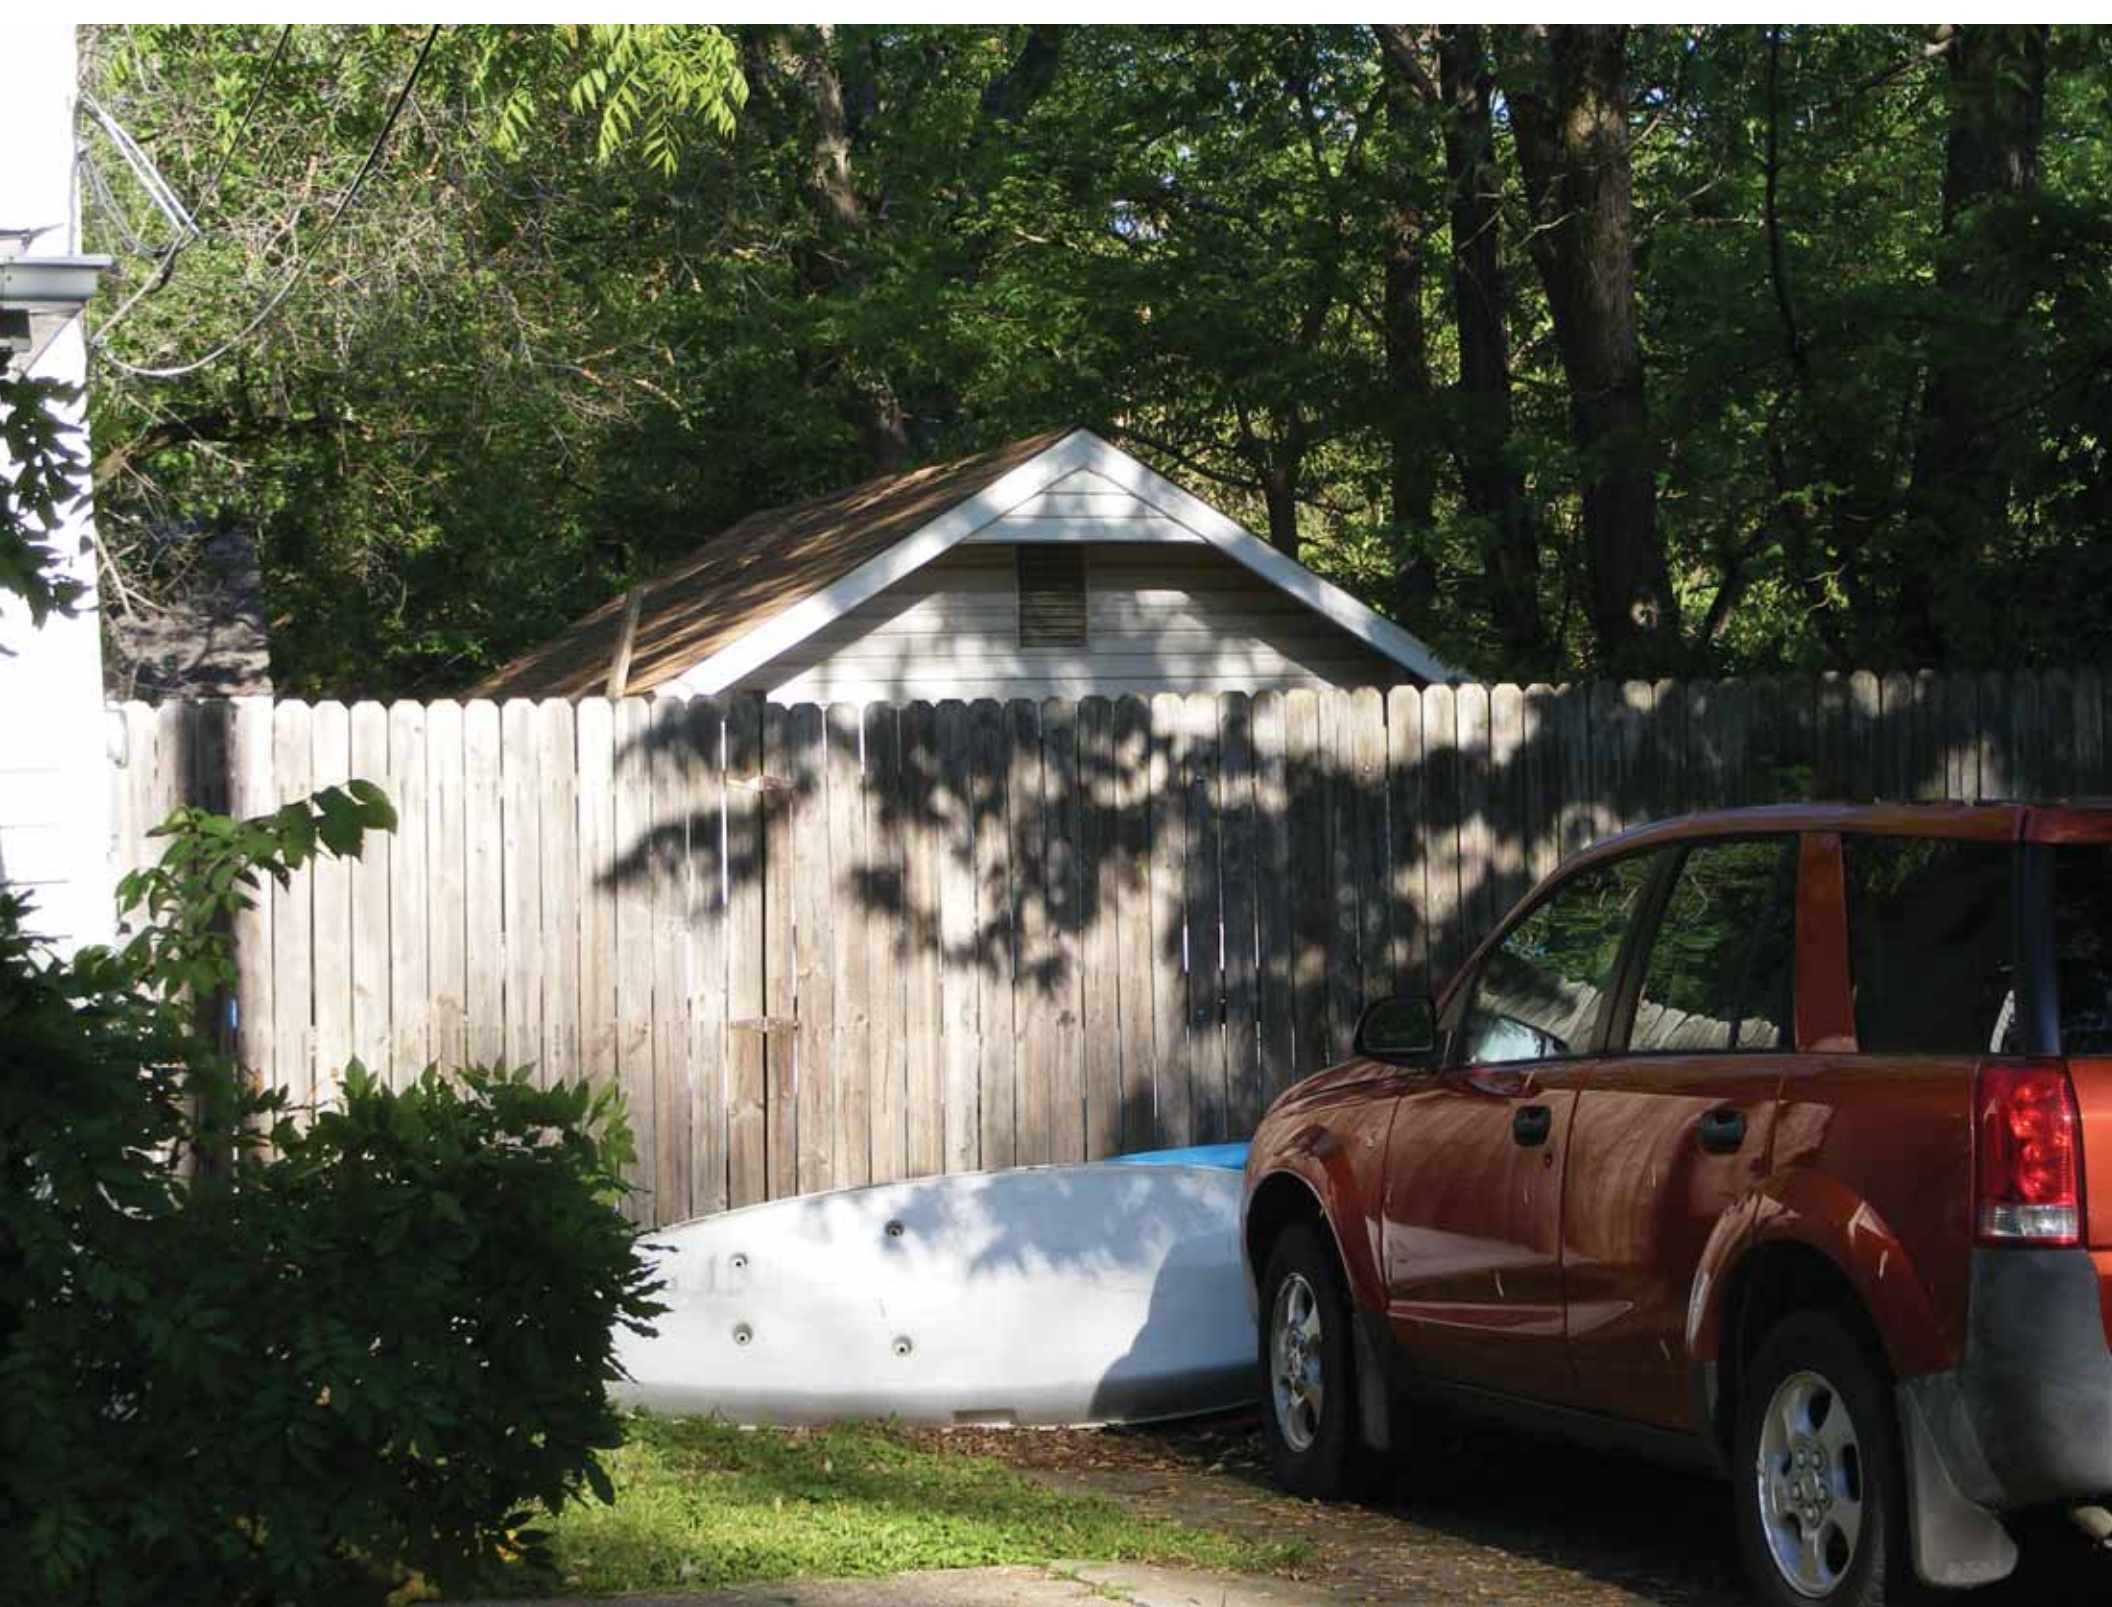
The dwelling has an end-gable plan asphalt shingled roof, exterior vinyl siding and a covered foundation. The façade (west elevation) features a central gabled wall dormer with a one-over-one window. The window has faux shutters. Below the wall dormer is a three-quarters width hipped Craftsman style porch supported by tapered piers on brick columns. A contemporary balustrade spans much of the porch. Within the porch bay is a slightly off-center door flanked by one-over-one windows with faux shutters.

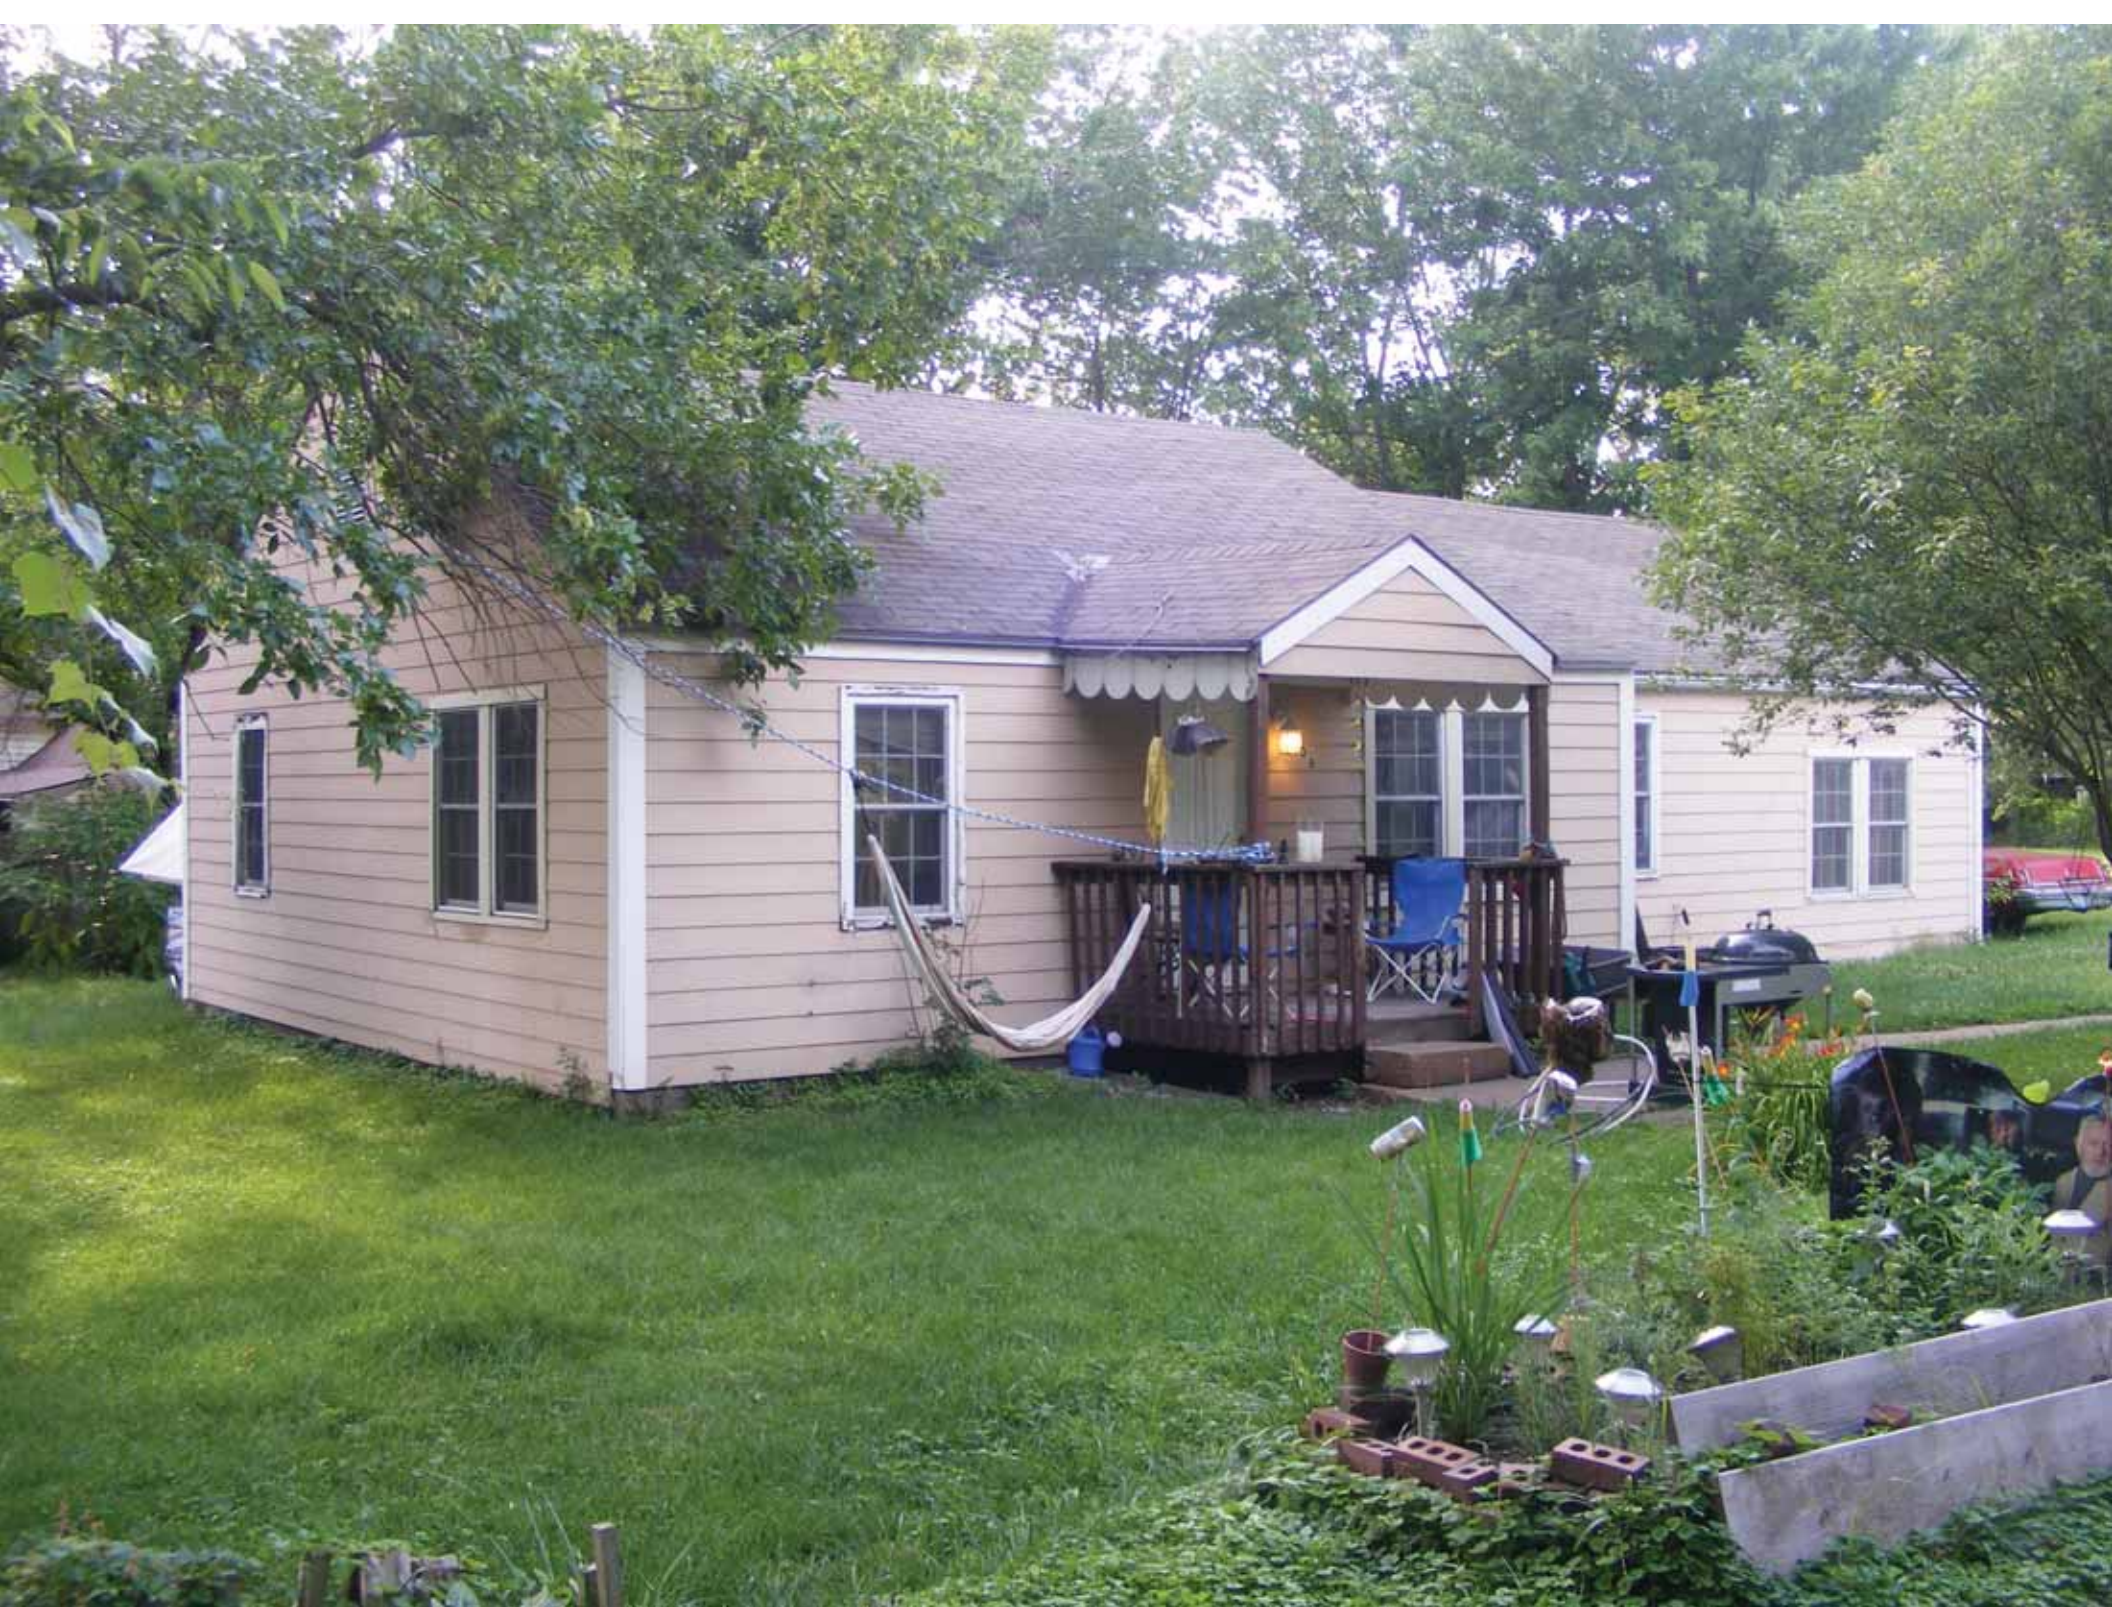
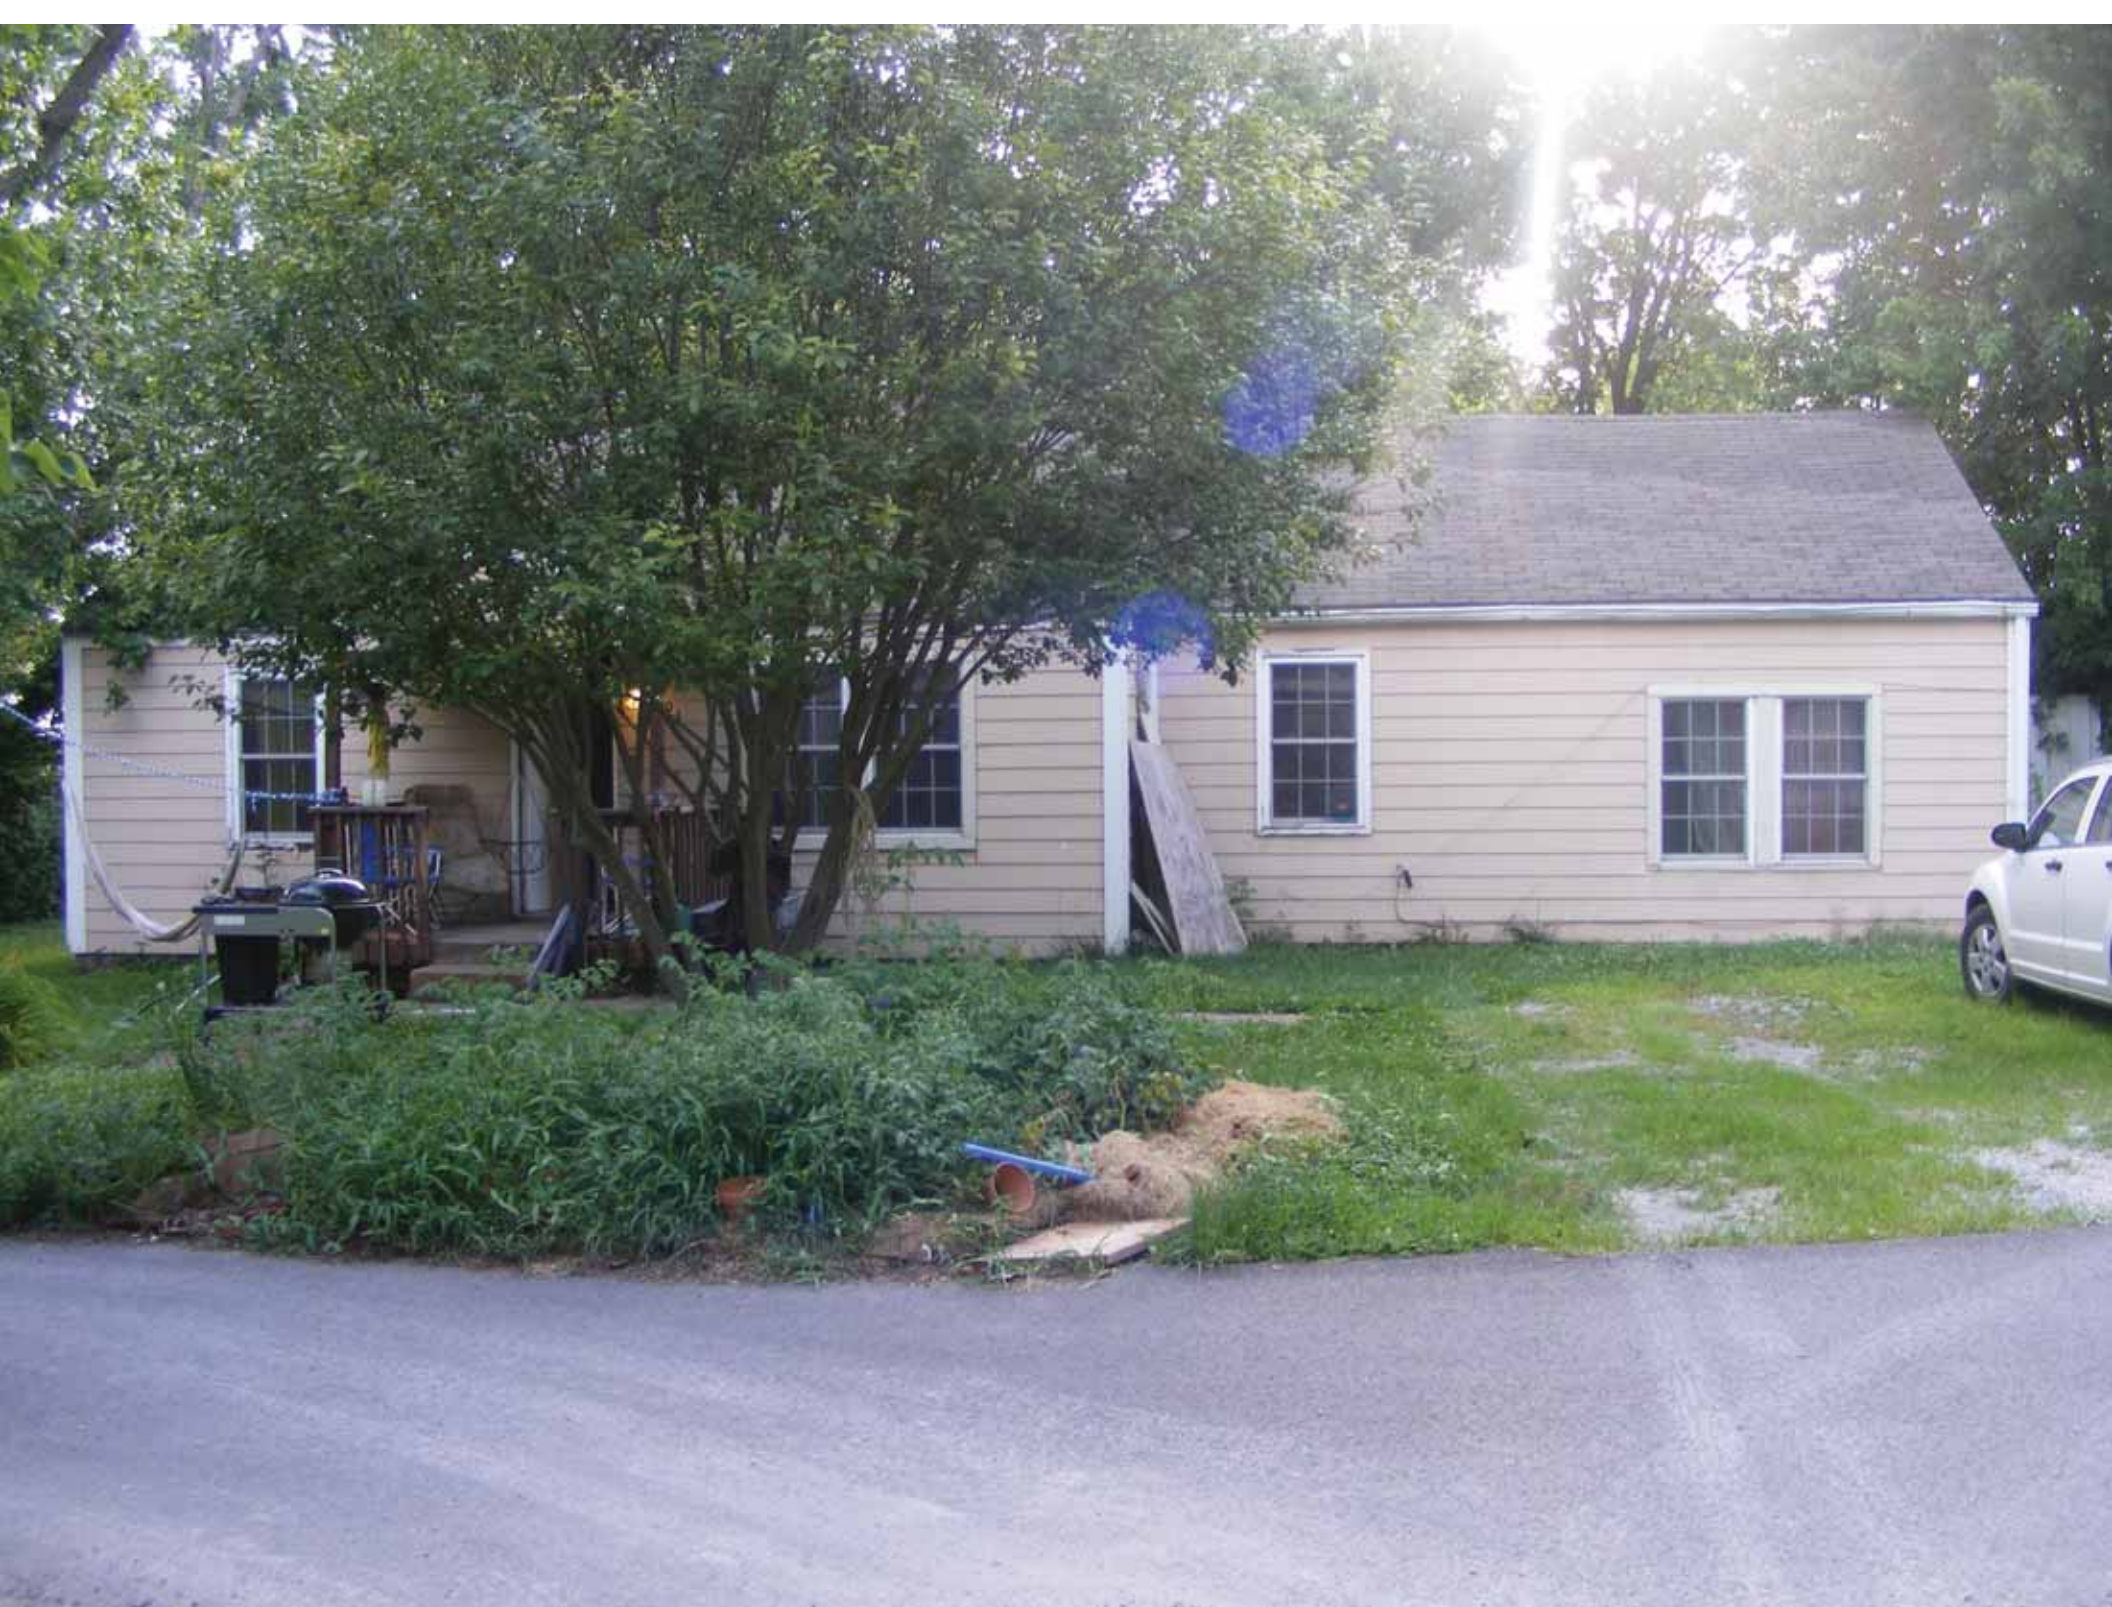
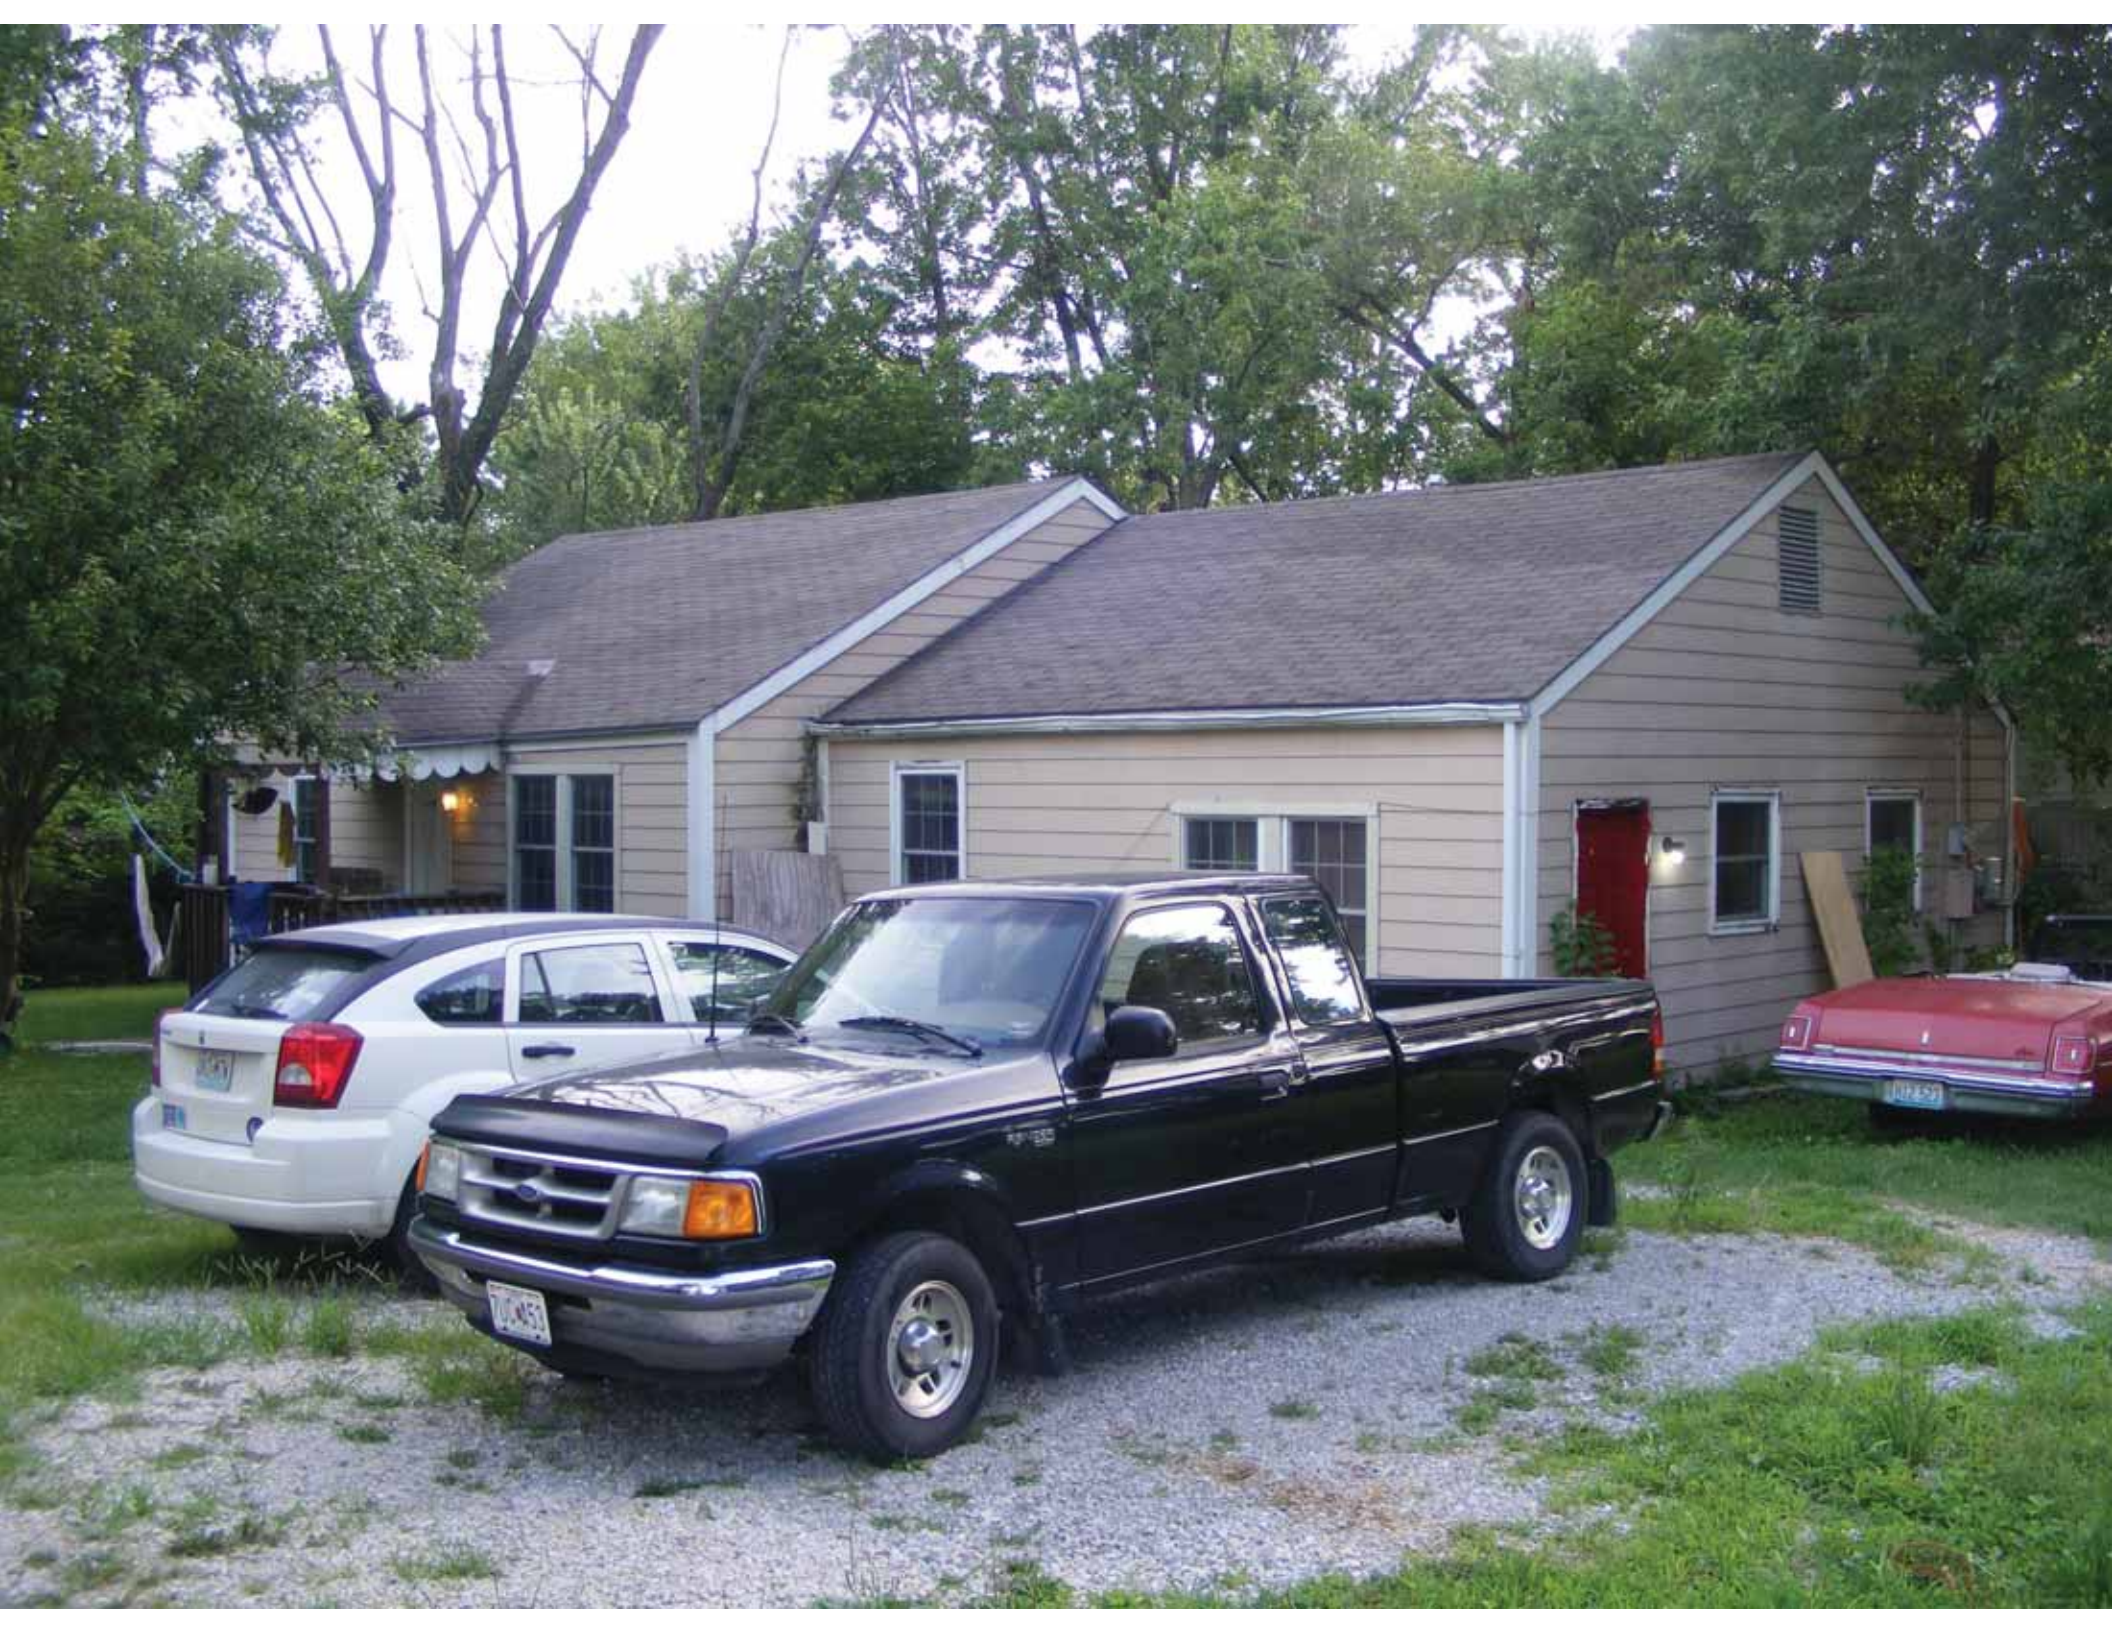
The dwelling has an asphalt-shingled gabled roof, what appears to be replacement wide board (possibly pressed wood) siding and a concrete foundation. The primary wing (south end) features a small central porch with original metal scallops below the sides of the gabled porch roof. The porch has a concrete stoop base, surrounded by a non-original wood balustrade. Replacement wood columns support the porch roof. Within the porch bay is a replacement paneled door. The porch is offset by single (south) and paired (north) six-over-six replacement windows. Remaining windows are of similar configuration. A set back linear wing at the north end of the dwelling features single and paired windows on the façade (east elevation). The wing's north elevation has a secondary entry bay filled with a solid door, offset by two one-over-one windows. Gable fields are filled with original louvered vents.
