MISSOURI DEPARTMENT OF NATURAL RESOURCES
STATE HISTORIC PRESERVATION OFFICE, P.O. Box 176, Jefferson City, MO 65102
ARCHITECTURAL/HISTORIC INVENTORY FORM

1. Survey No. BO-AS-011-0087		2. Survey name: North Central Columbia Survey Phase II	
3. County: Boone		4. Address (Street No.) 902	Street (name) N. Seventh Street
5. City: Columbia	Vicinity: <input type="checkbox"/>	6. Geographical Reference:	7. Township/Range/Section: T: R: S:
8. Historic name (if known):		9. Present/other name (if known):	
10. Ownership: <input checked="" type="checkbox"/> Private <input type="checkbox"/> Public		11a. Historic use (if known): Domestic/single dwelling	11b. Current use: Domestic/single dwelling

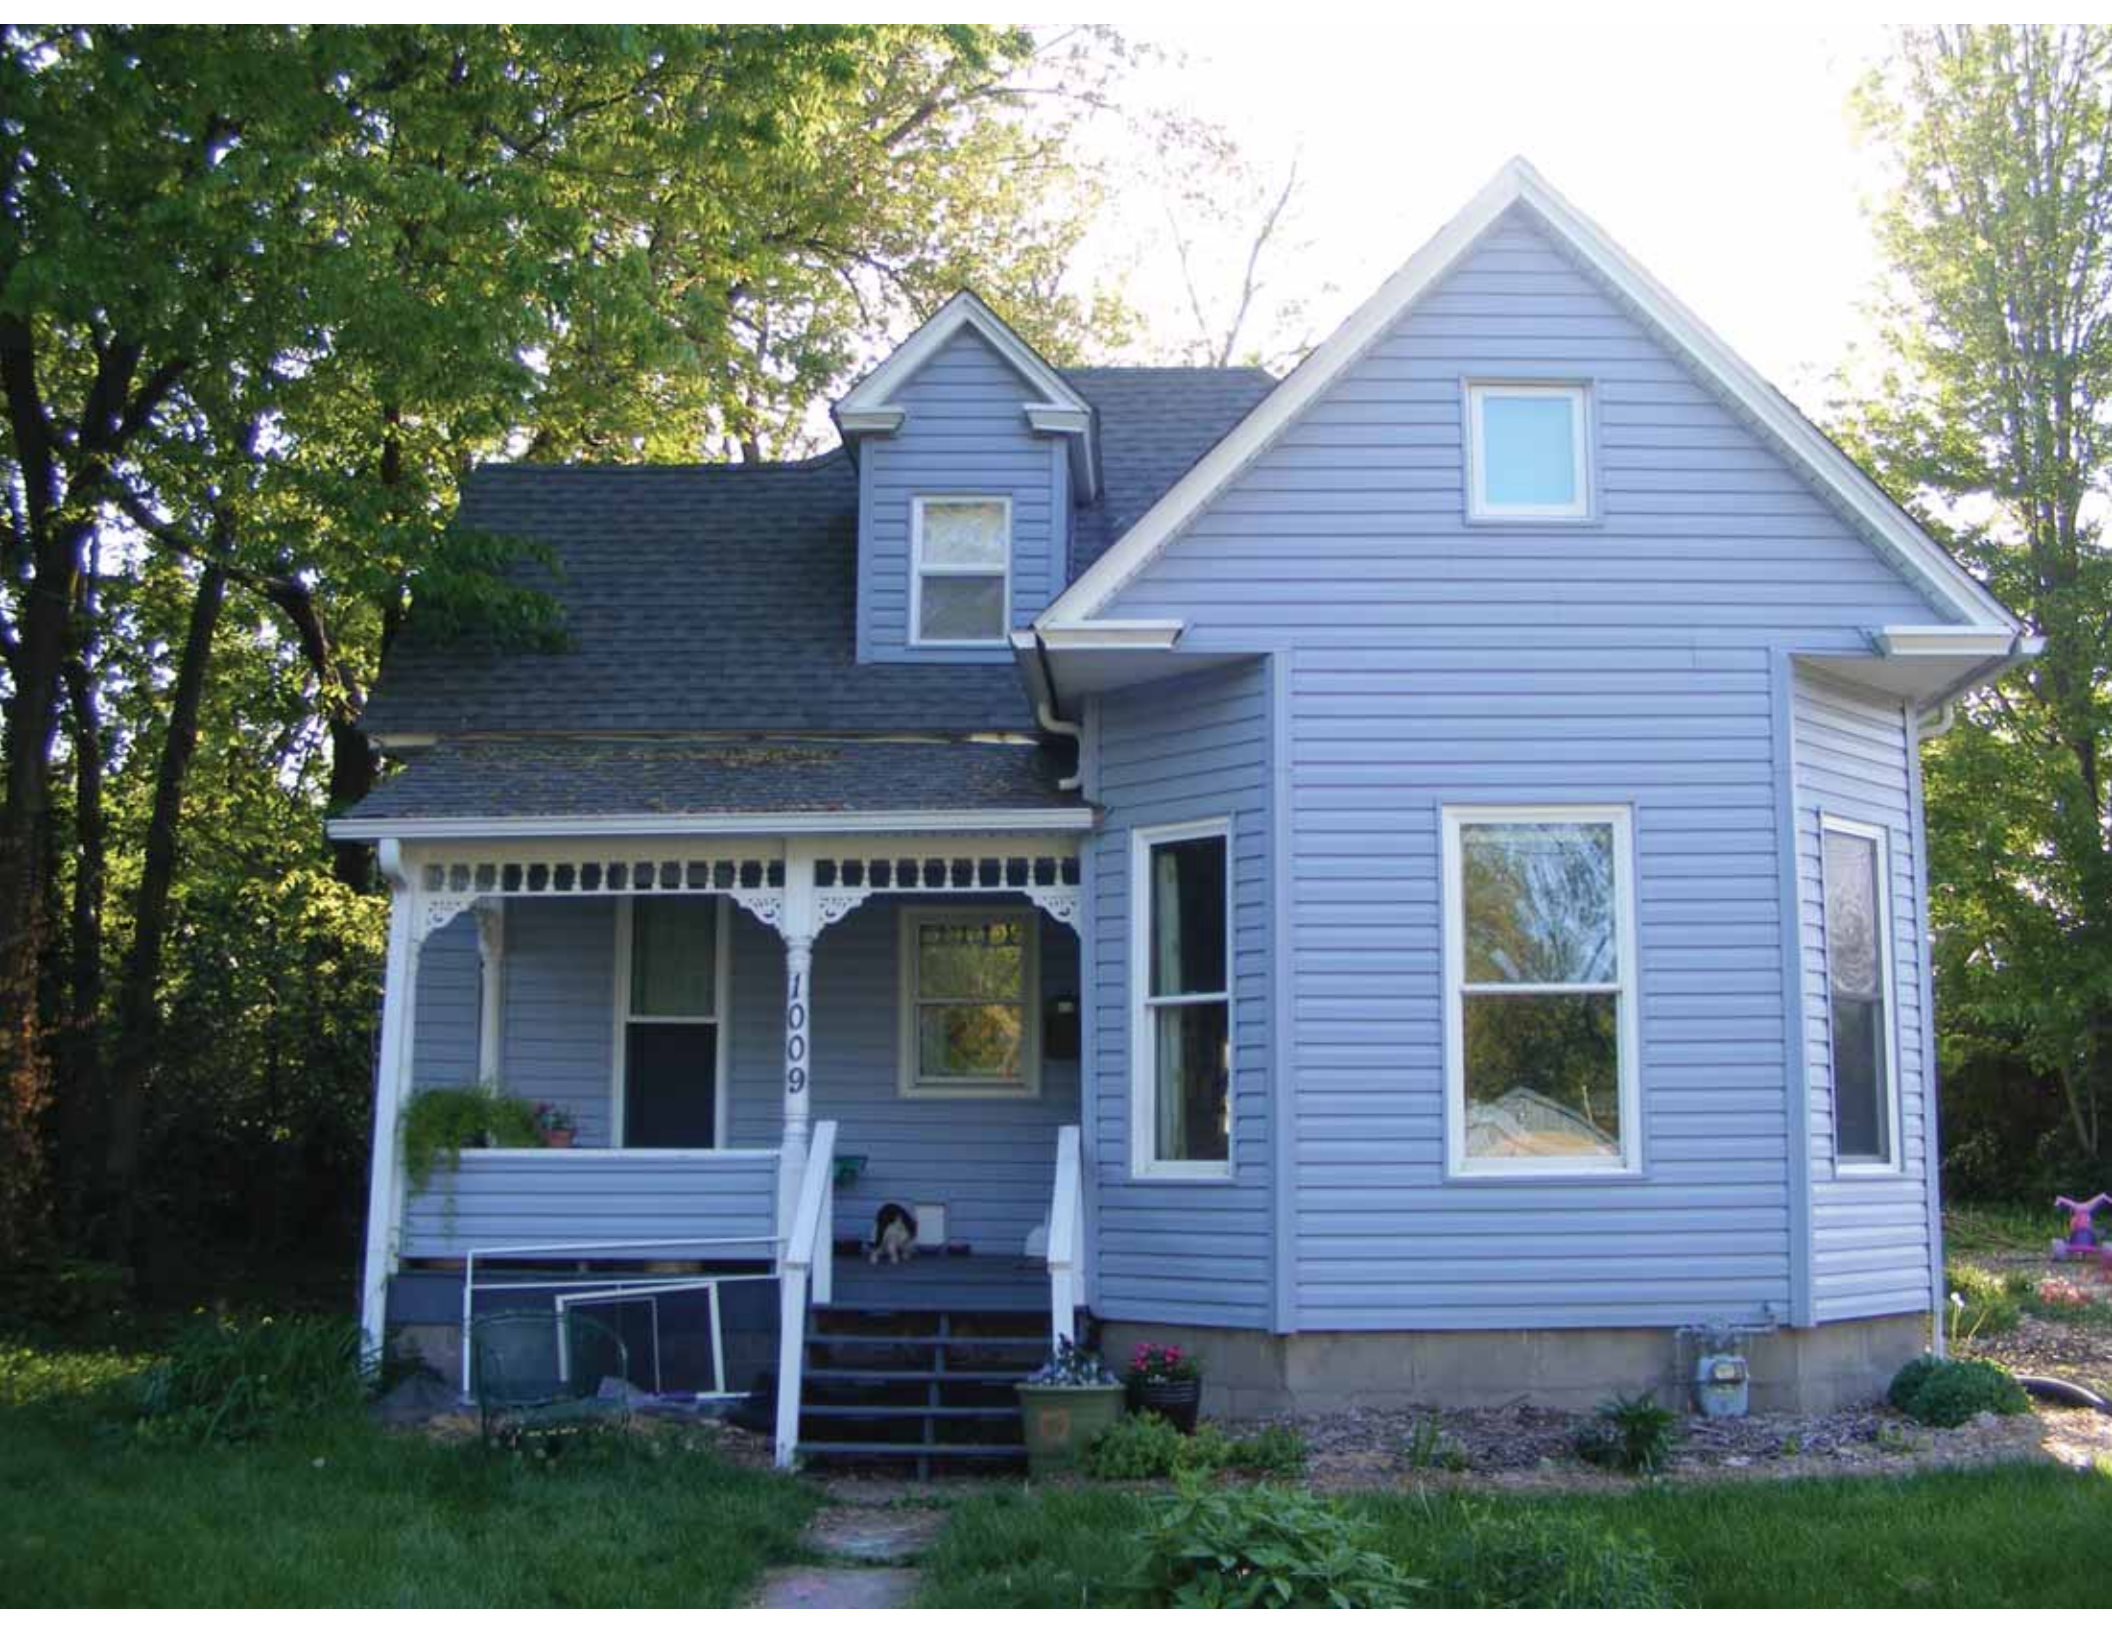
The 1.5-story dwelling has a hip on gable asphalt shingled roof, exterior vinyl siding and a concrete foundation. The primary (east) elevation has a beveled front facing gabled wing with a single one-over-one window on each of the three projecting walls. Above the central window is a fixed sash light. Gable returns frame the upper half-story bay. The southern half of the façade (east elevation) supports a shed single-story porch with milled columns and decorative bargeboard. Above the porch is a gabled dormer with returns. The dormer holds a one-over-one window. Within the porch bay, the primary entry faces south, filled with a 9-light paneled door. The east wall of the porch holds two one-over-one windows.

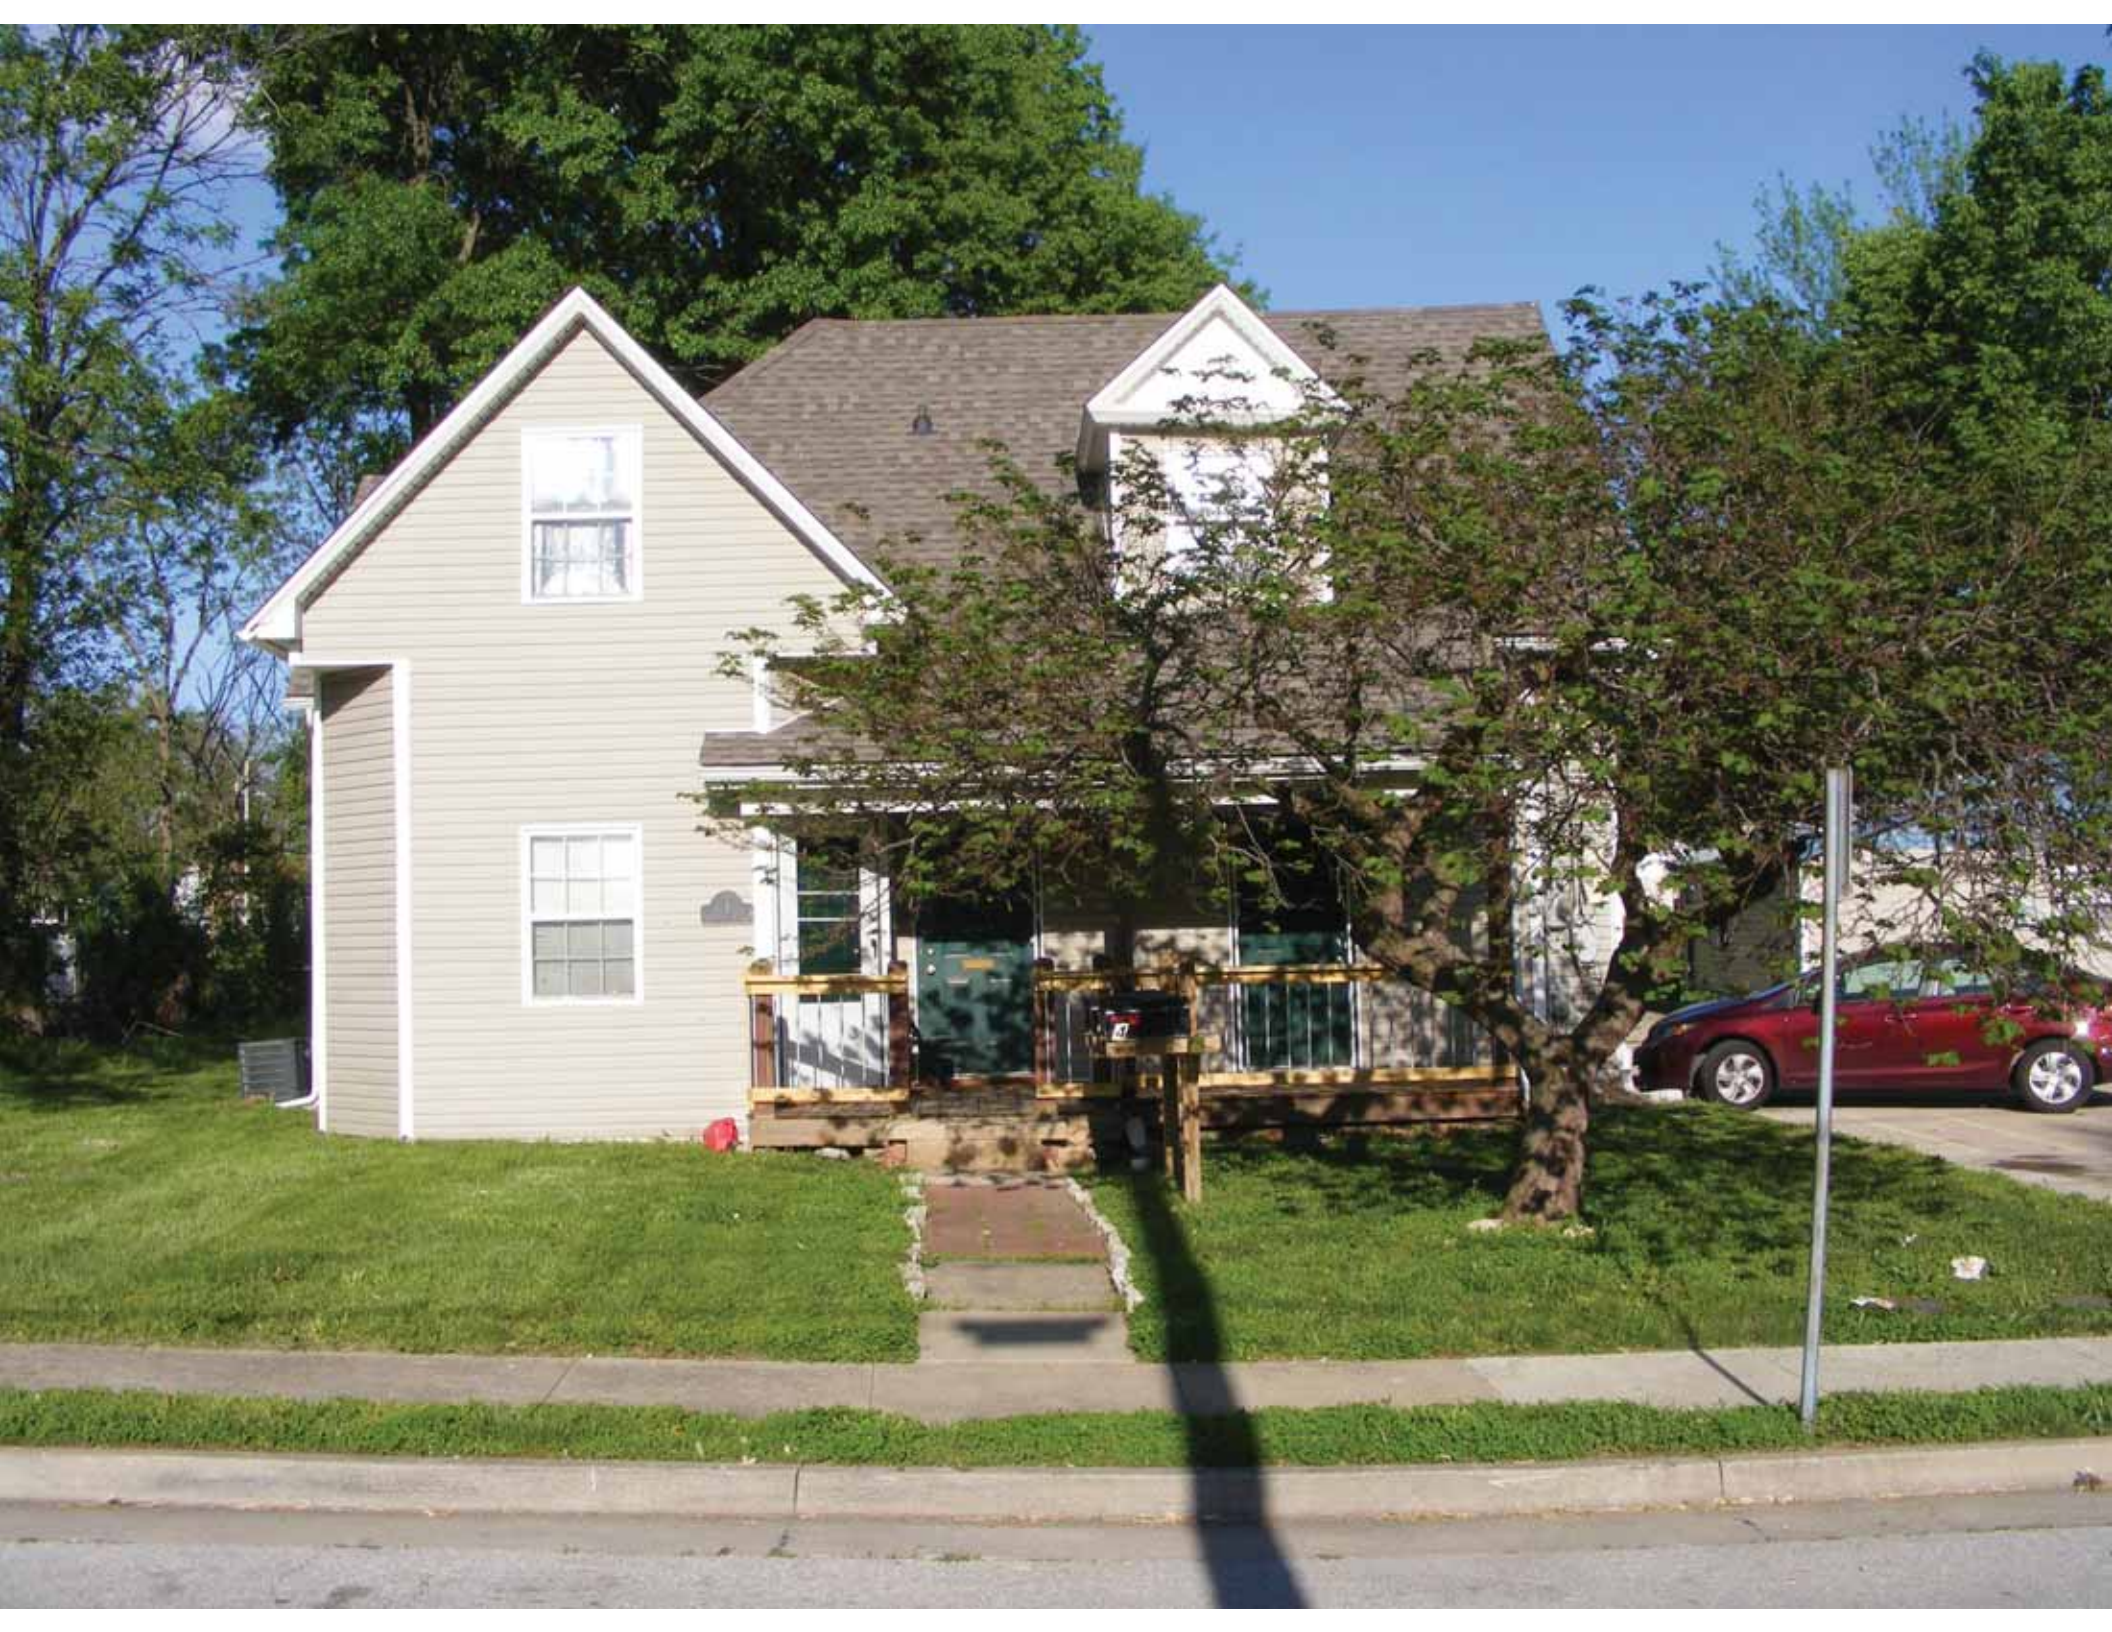
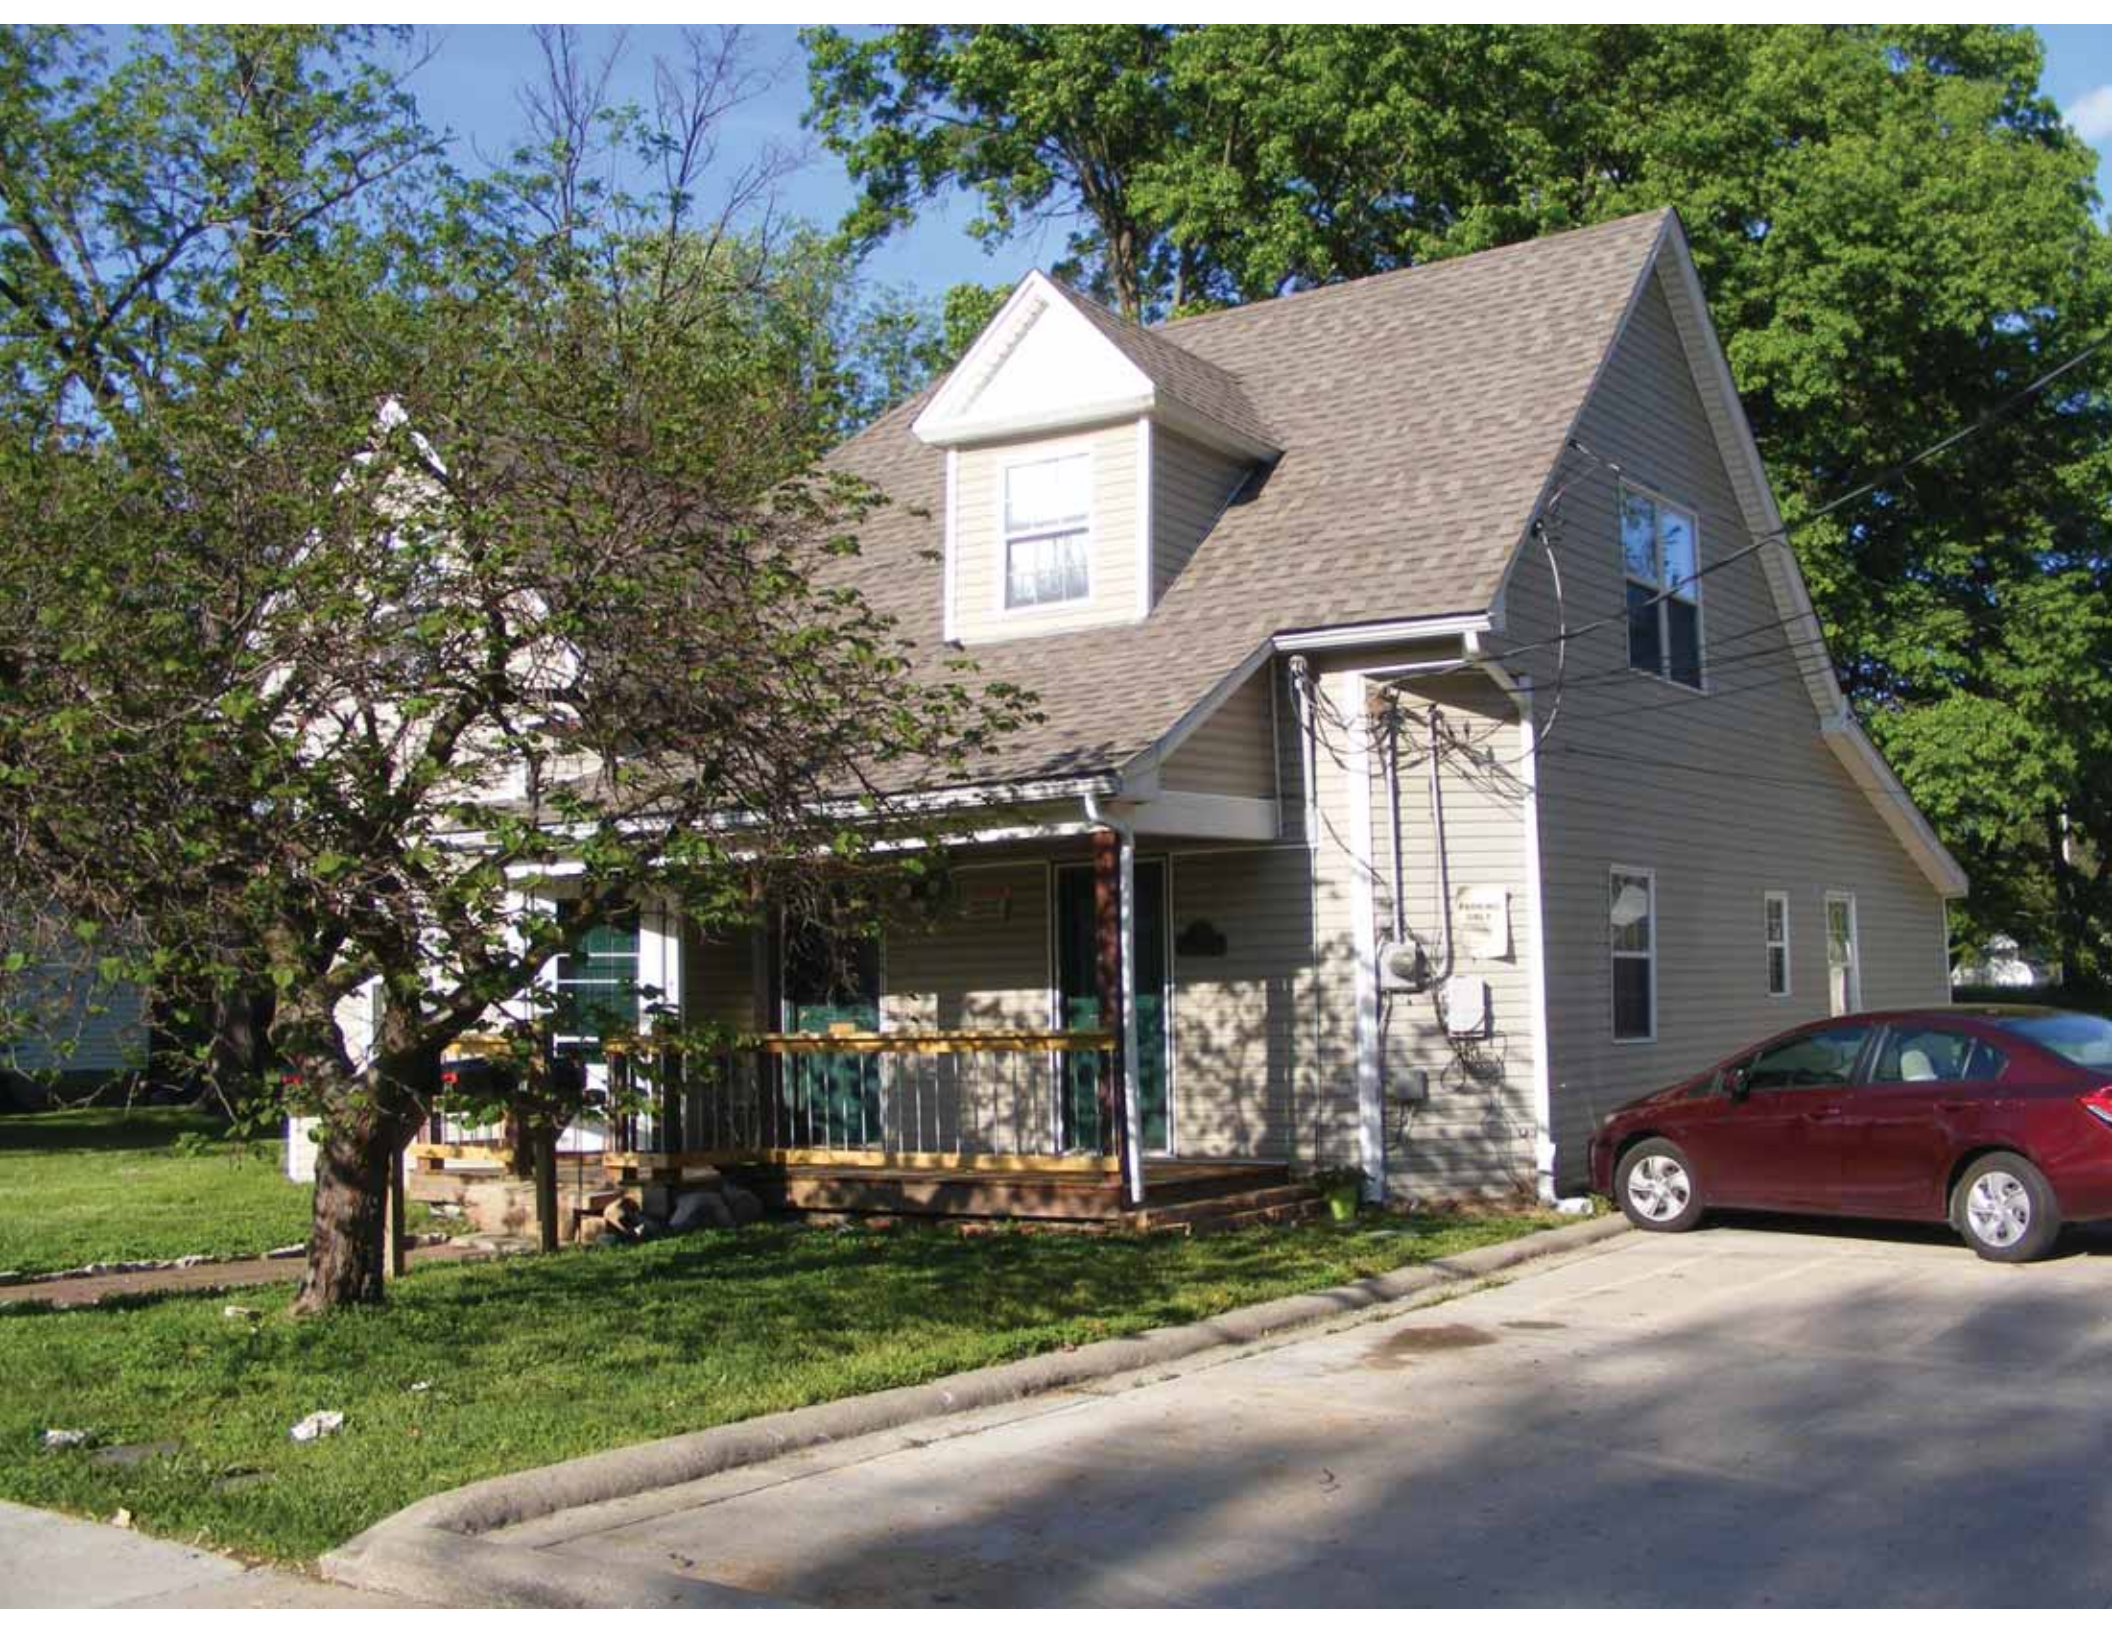
The dwelling has been modified from a single to multiple family residential property. The roof is steeply pitched, clad with asphalt shingles. The exterior is clad with synthetic siding that covers the foundation. Eaves are enclosed. On the façade (west) elevation is a central shed porch supported by replacement wood columns and surrounded by a non-original frame balustrade. Within the porch bay are two entries with c. 2010 paneled doors. Above the porch is a pedimented gabled dormer with a six-over-six window. Flanking the porch on the façade at the north end is a beveled front gable wing with upper and lower (on the west elevation) six-over-six windows. The dwelling has a rear shed wing and projecting gabled wing on the north elevation – both appear original.

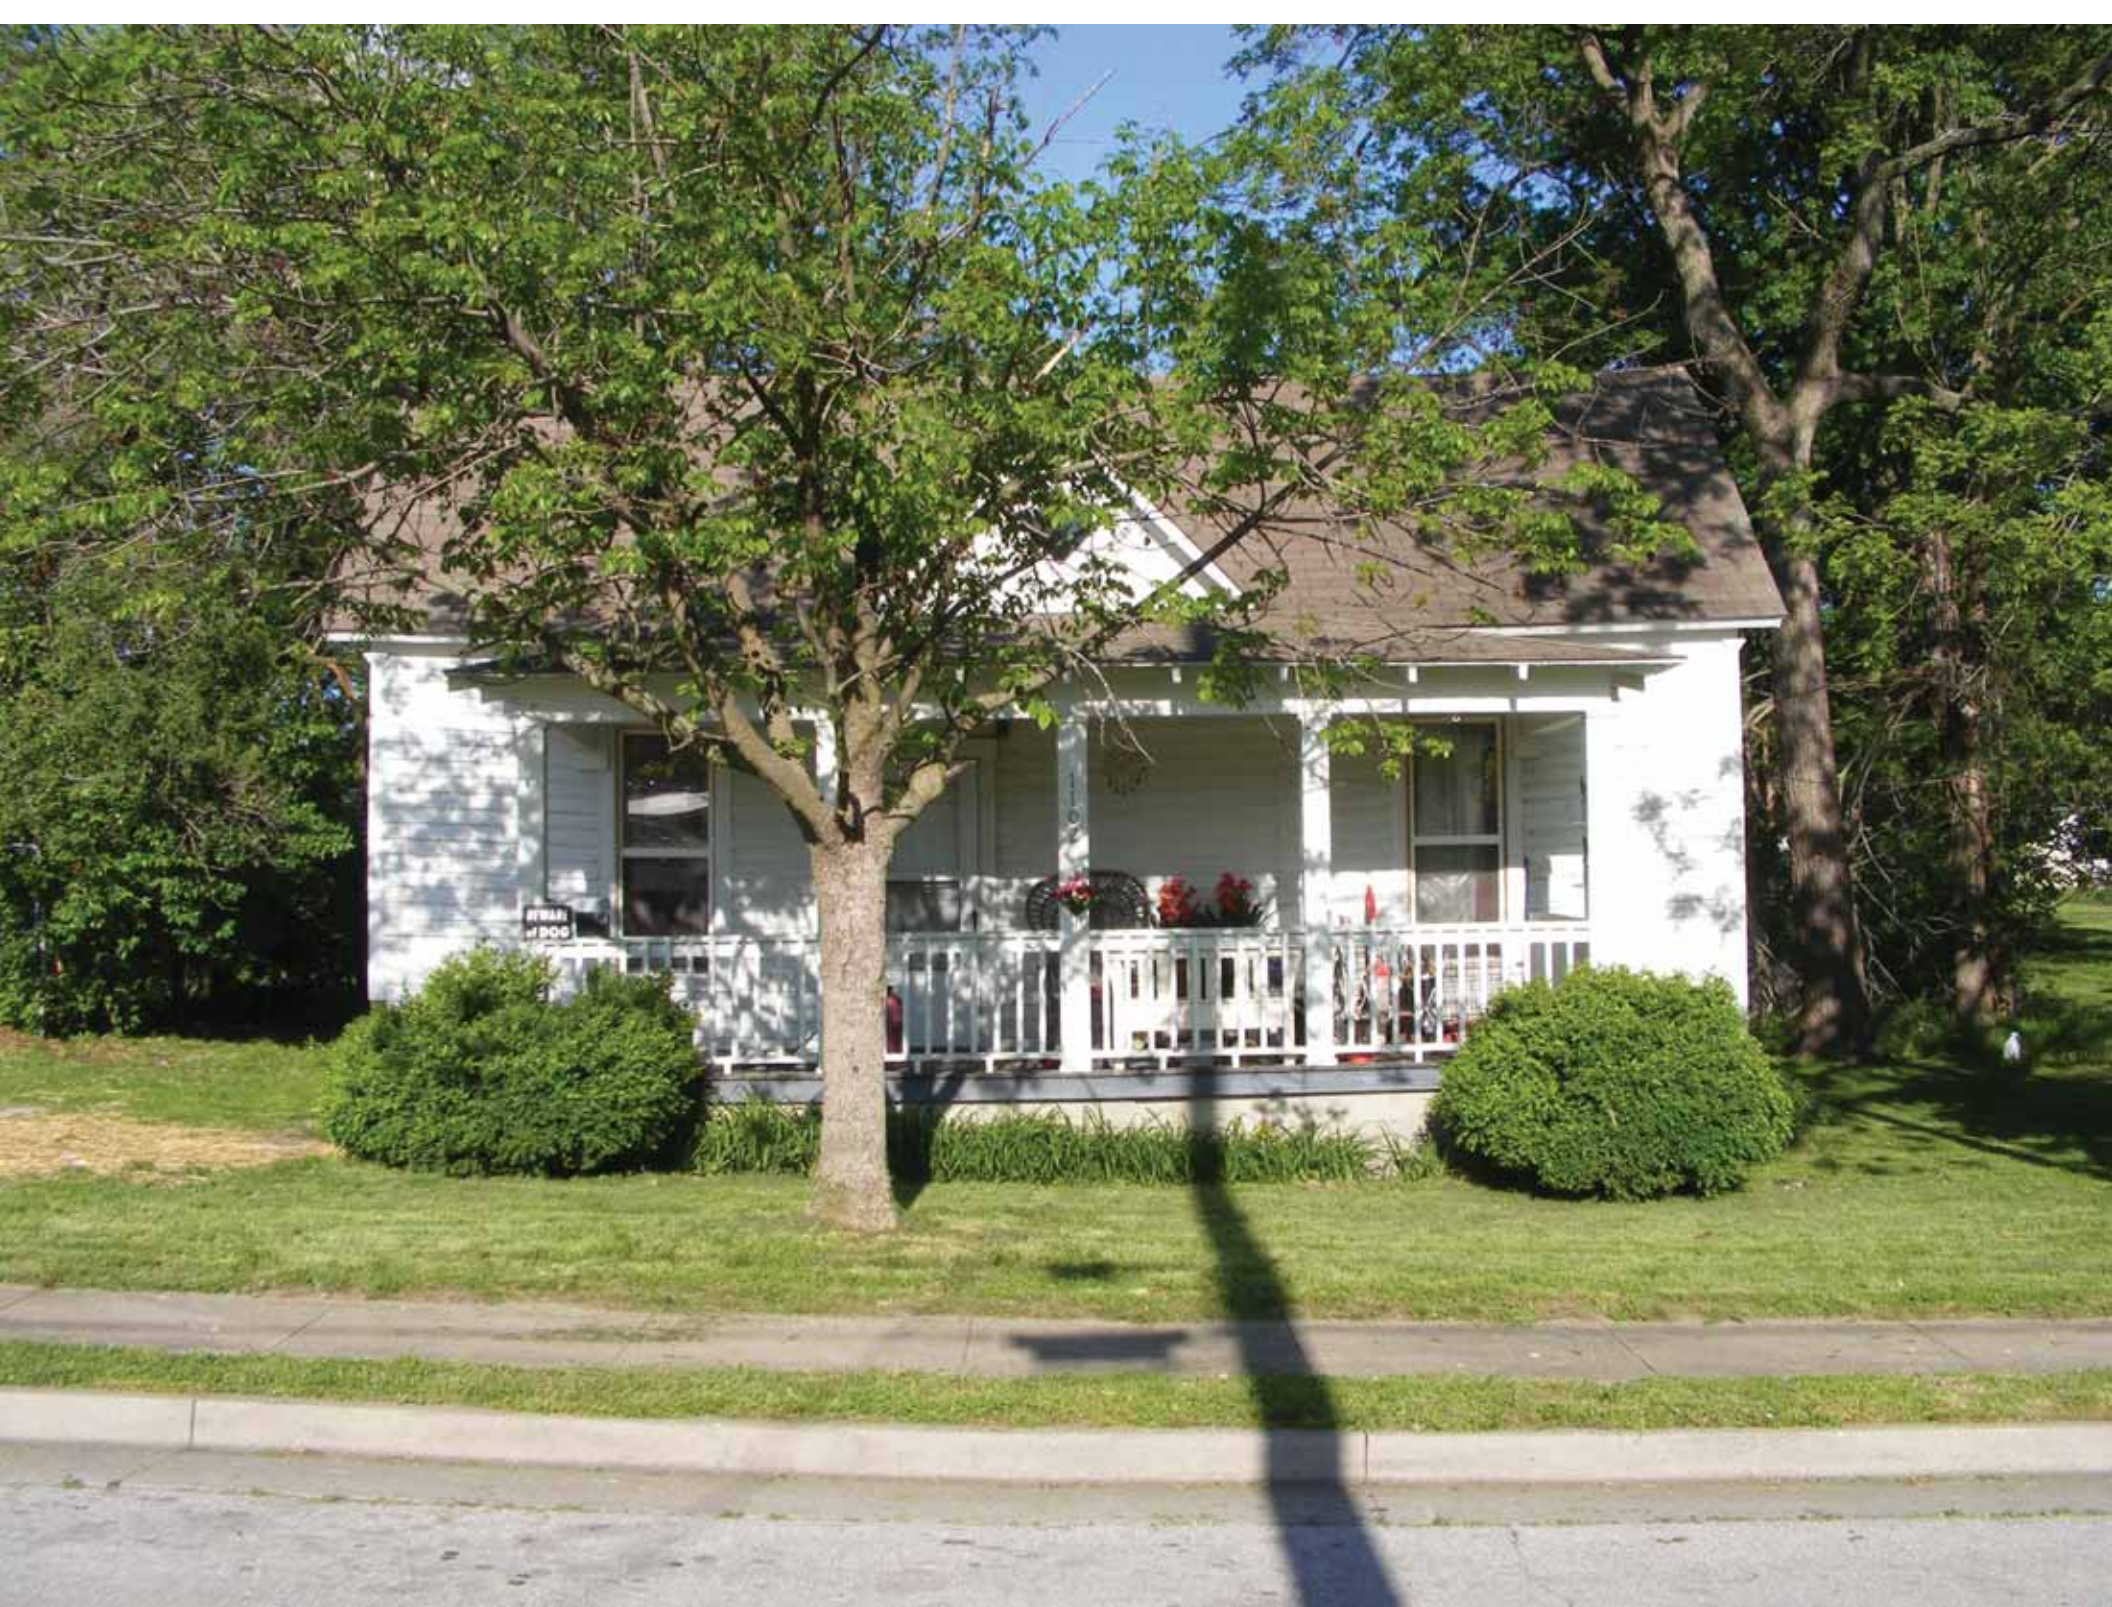
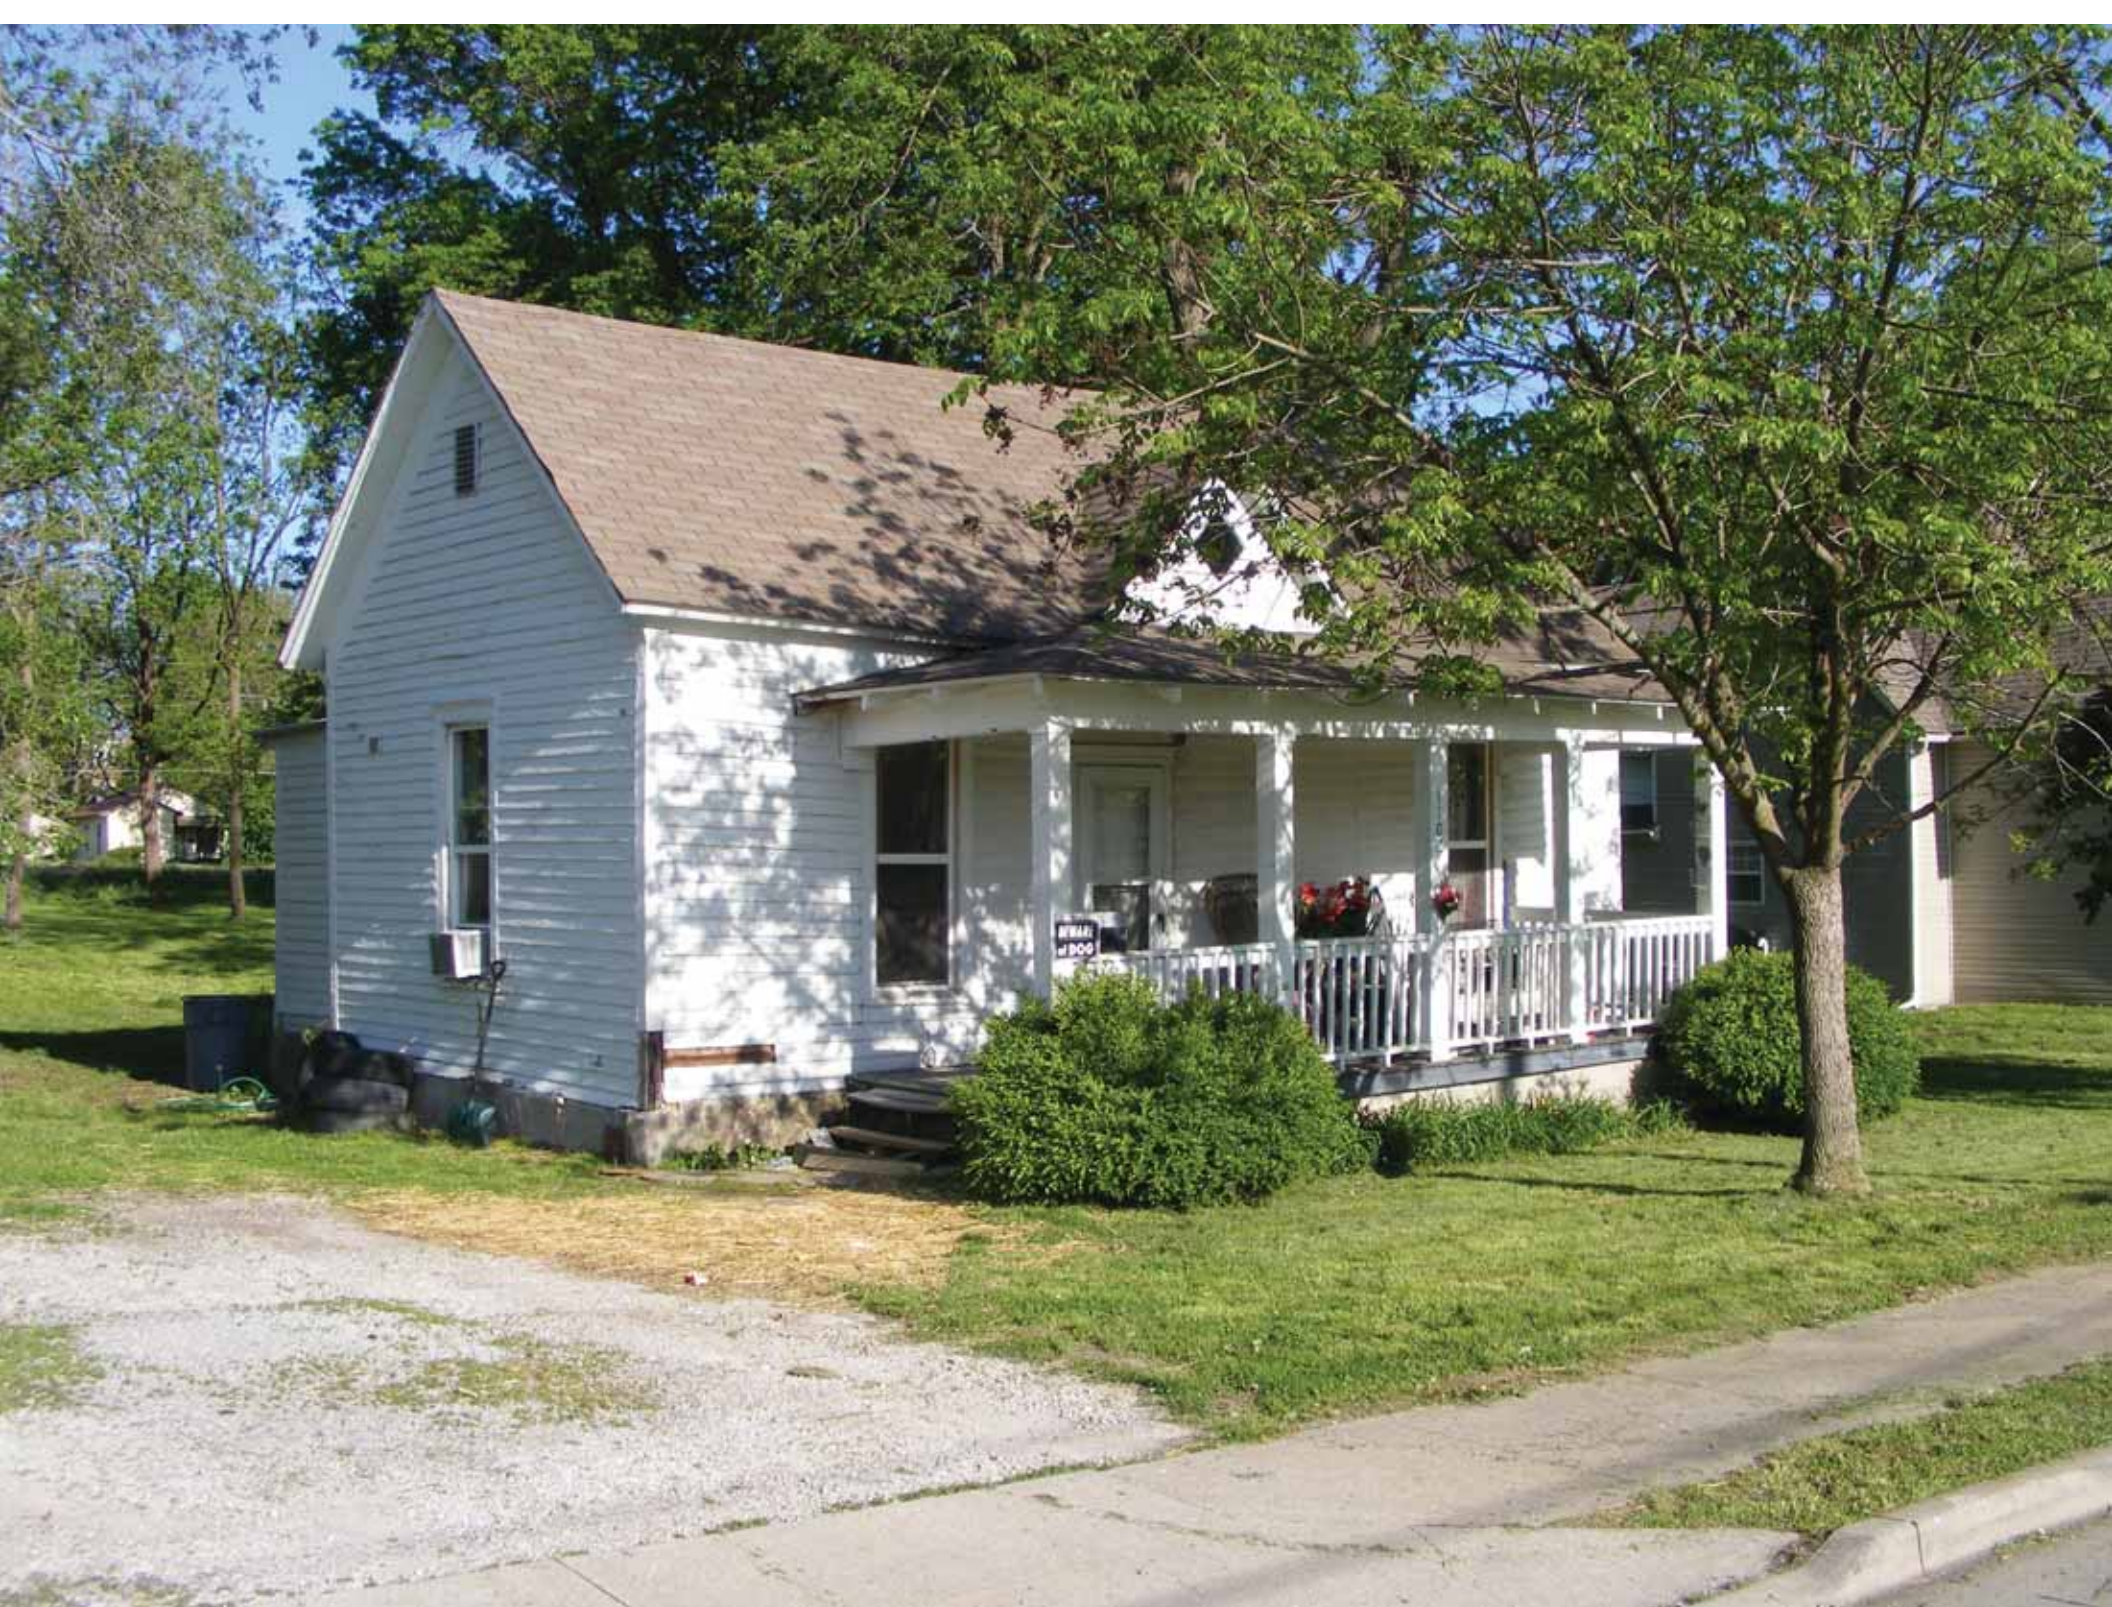
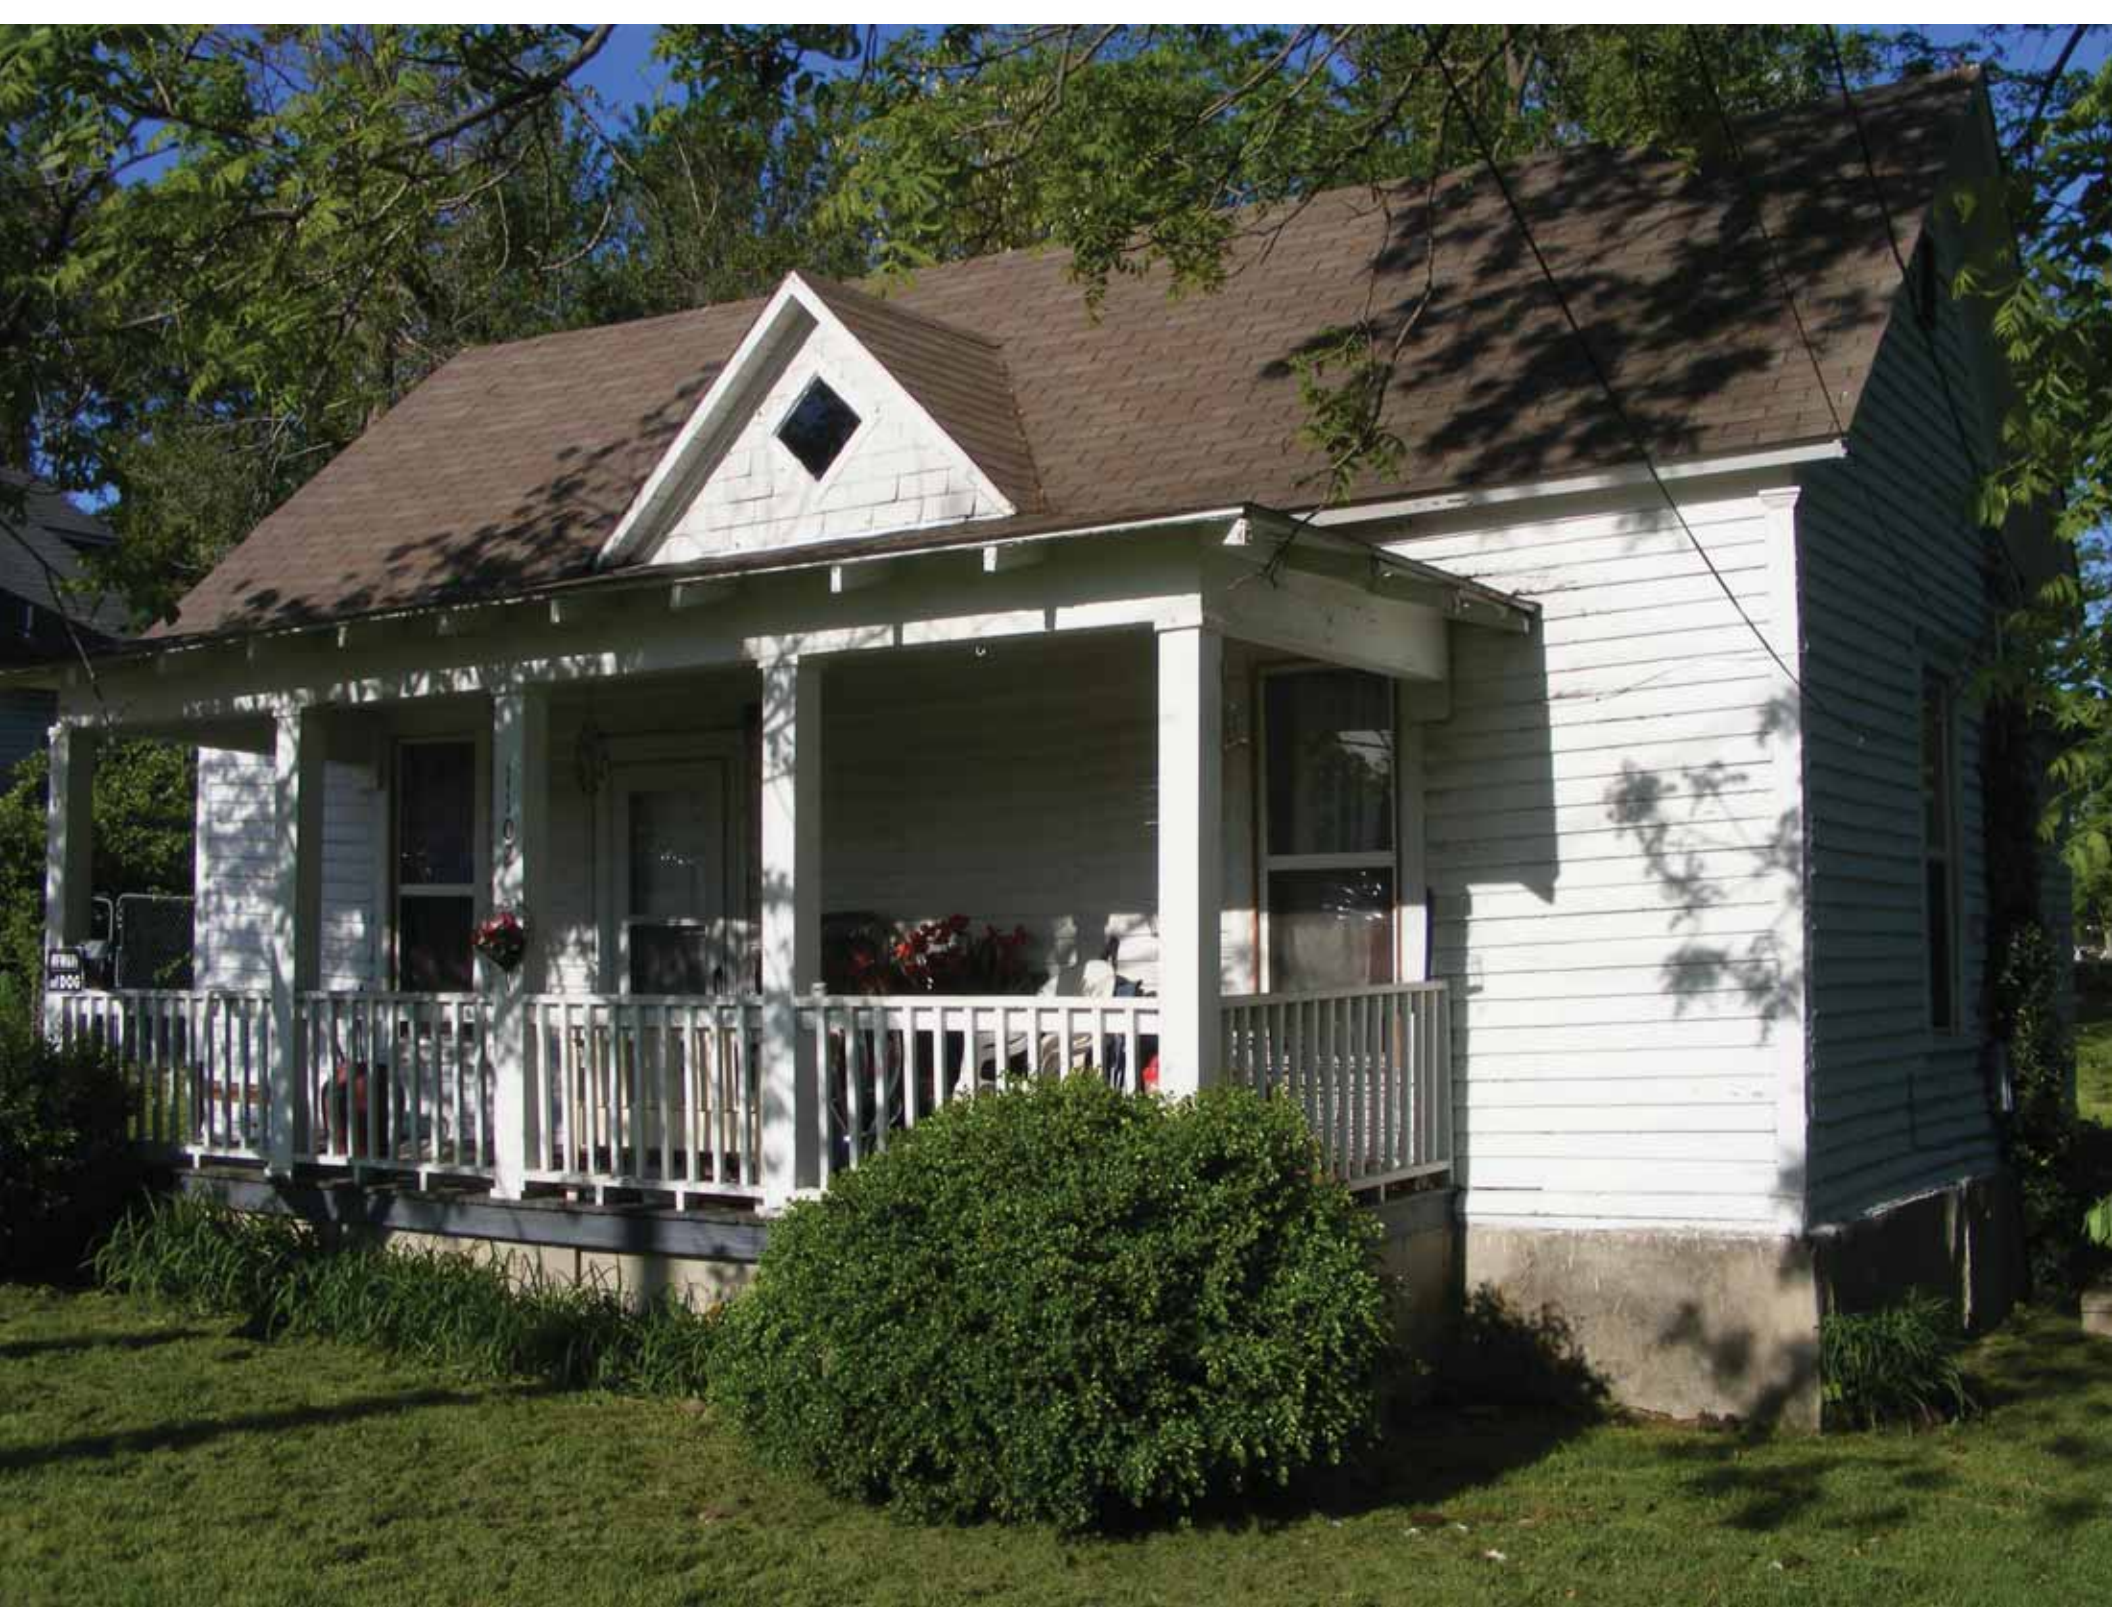
The dwelling has an asphalt shingled roof, exterior weatherboard siding and a concrete foundation. The primary (west) elevation supports a hipped Craftsman influenced porch with exposed rafter tails and square column supports. The porch is surrounded by a wood balustrade that does not appear original. Within the porch bay is an off-center entry bay filled with a paneled door. Flanking the door are one-over-one windows with c. 2000 vinyl storm windows. Above the porch is a front facing gable filled with original wood (or painted asphalt) shingles. The gable has a diamond shaped fixed original light.
