MISSOURI DEPARTMENT OF NATURAL RESOURCES
STATE HISTORIC PRESERVATION OFFICE, P.O. Box 176, Jefferson City, MO 65102
ARCHITECTURAL/HISTORIC INVENTORY FORM

1. Survey No. BO-AS-011-0087		2. Survey name: North Central Columbia Survey Phase II	
3. County: Boone		4. Address (Street No.) 902	Street (name) N. Seventh Street
5. City: Columbia	Vicinity: <input type="checkbox"/>	6. Geographical Reference:	7. Township/Range/Section: T: R: S:
8. Historic name (if known):		9. Present/other name (if known):	
10. Ownership: <input checked="" type="checkbox"/> Private <input type="checkbox"/> Public		11a. Historic use (if known): Domestic/single dwelling	11b. Current use: Domestic/single dwelling

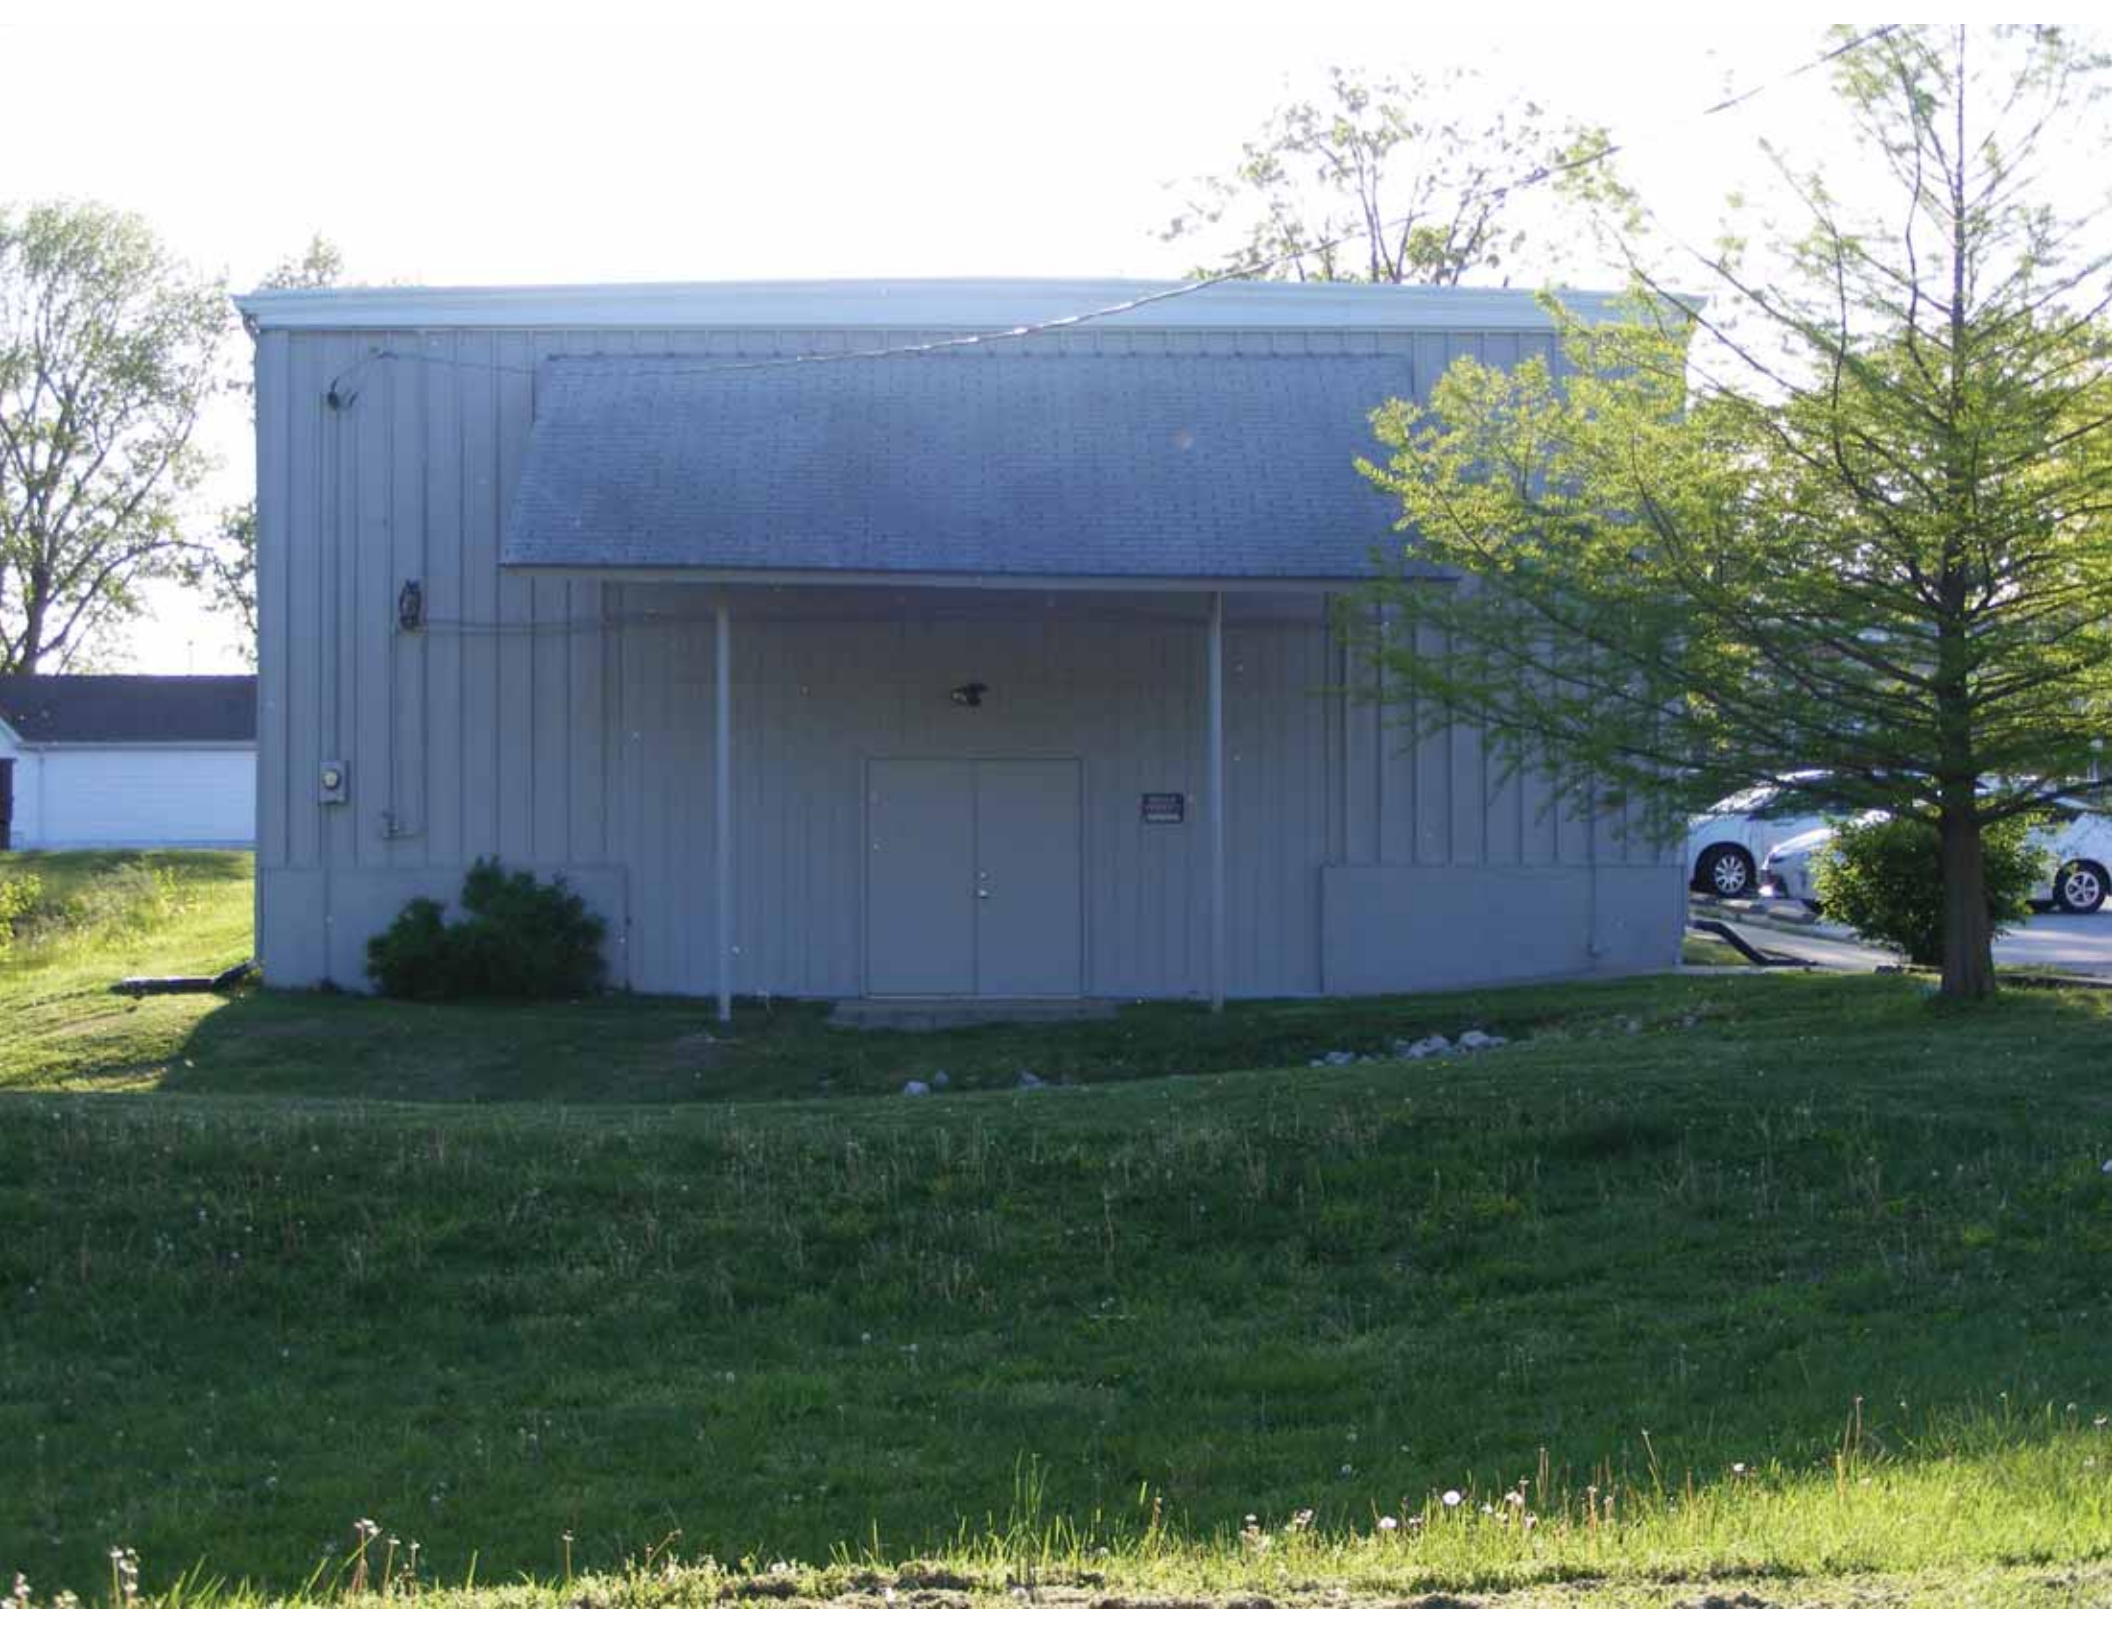
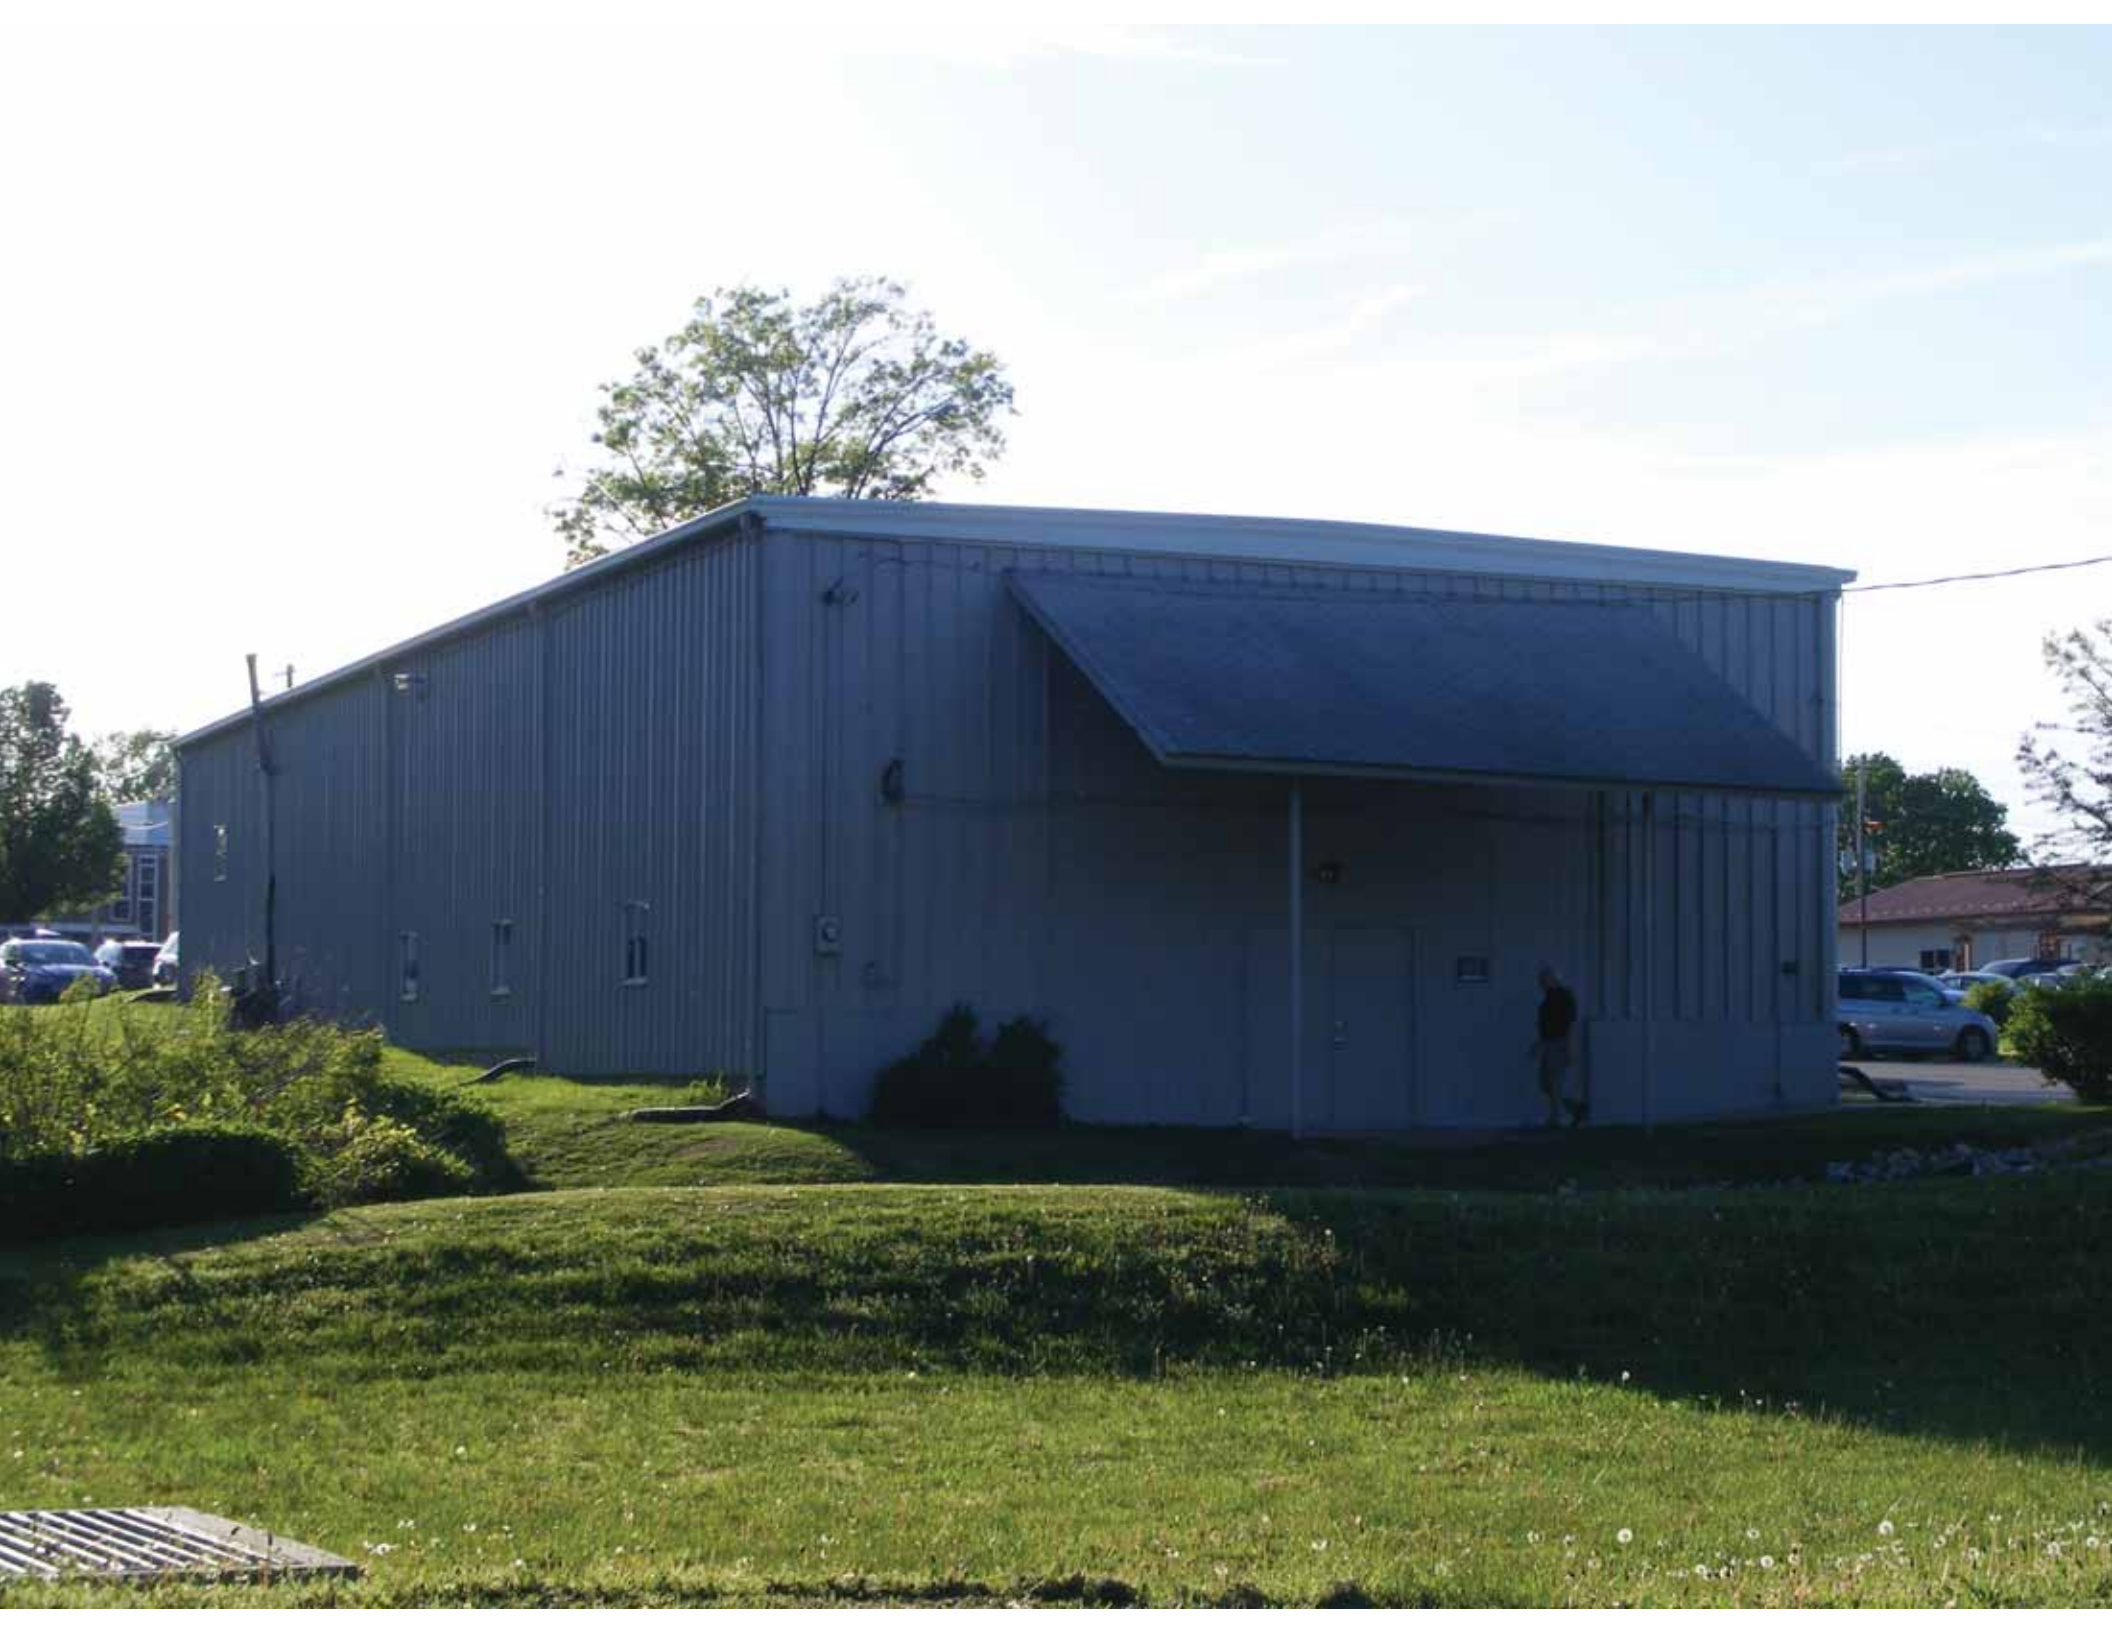
The building is a prefabricated warehouse utilized to support the congregation of First Assembly of God. The building is a flat gabled metal roof, ribbed metal walls and a concrete slab foundation. The primary (east) elevation supports a shed roof porch supported by two slender metal poles. Centered below the asphalt shingled shed roof are paired solid doors. Side (north and south) elevations hold small four-light windows.

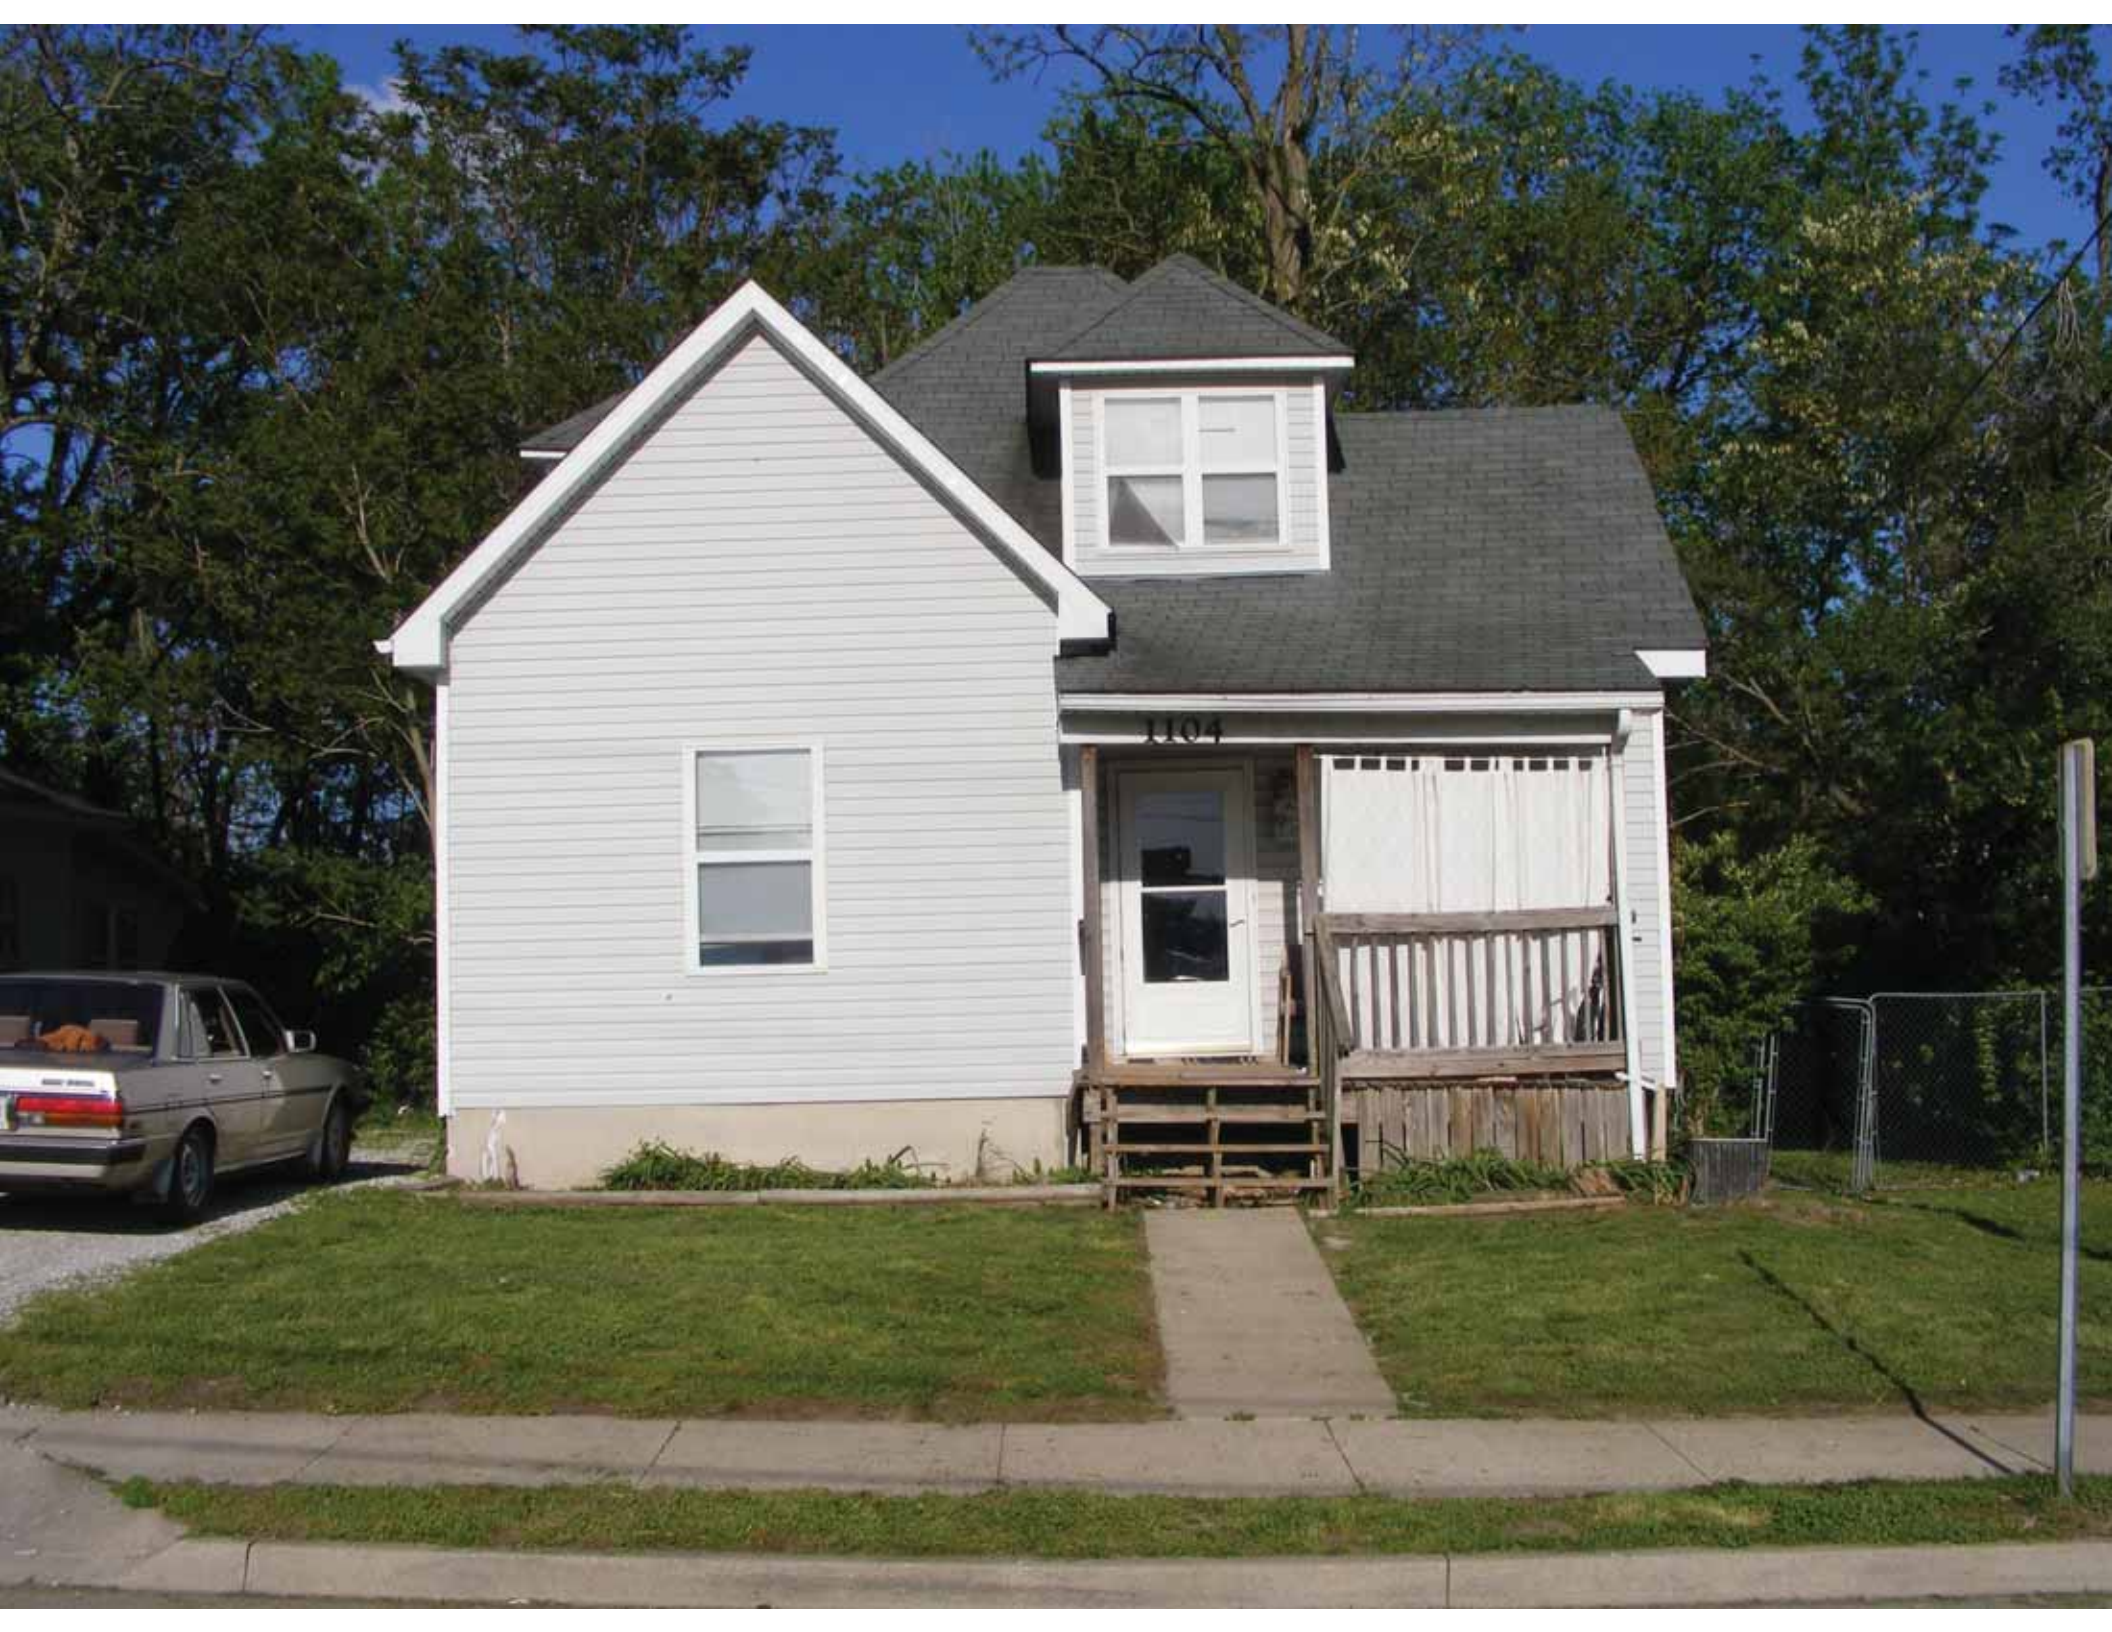
The dwelling has an asphalt-shingled roof, exterior vinyl siding and a concrete foundation. The porch foundation is pier, covered with vertical boards below the porch floor. The roof is gabled with a central high hip. Dormers have pyramidal roofs. The primary (west) elevation has a front facing gabled wing (north end) that holds a one-over-one window with a c. 2015 vinyl storm window. Remaining windows are of similar configuration. Offsetting the gabled wing is a half-width shed porch supported by slender wood replacement columns. The dwelling has a frame balustrade. Within the porch bay is a single door offset by a one-over-one window. Above the porch is a dormer with paired one-over-one windows.

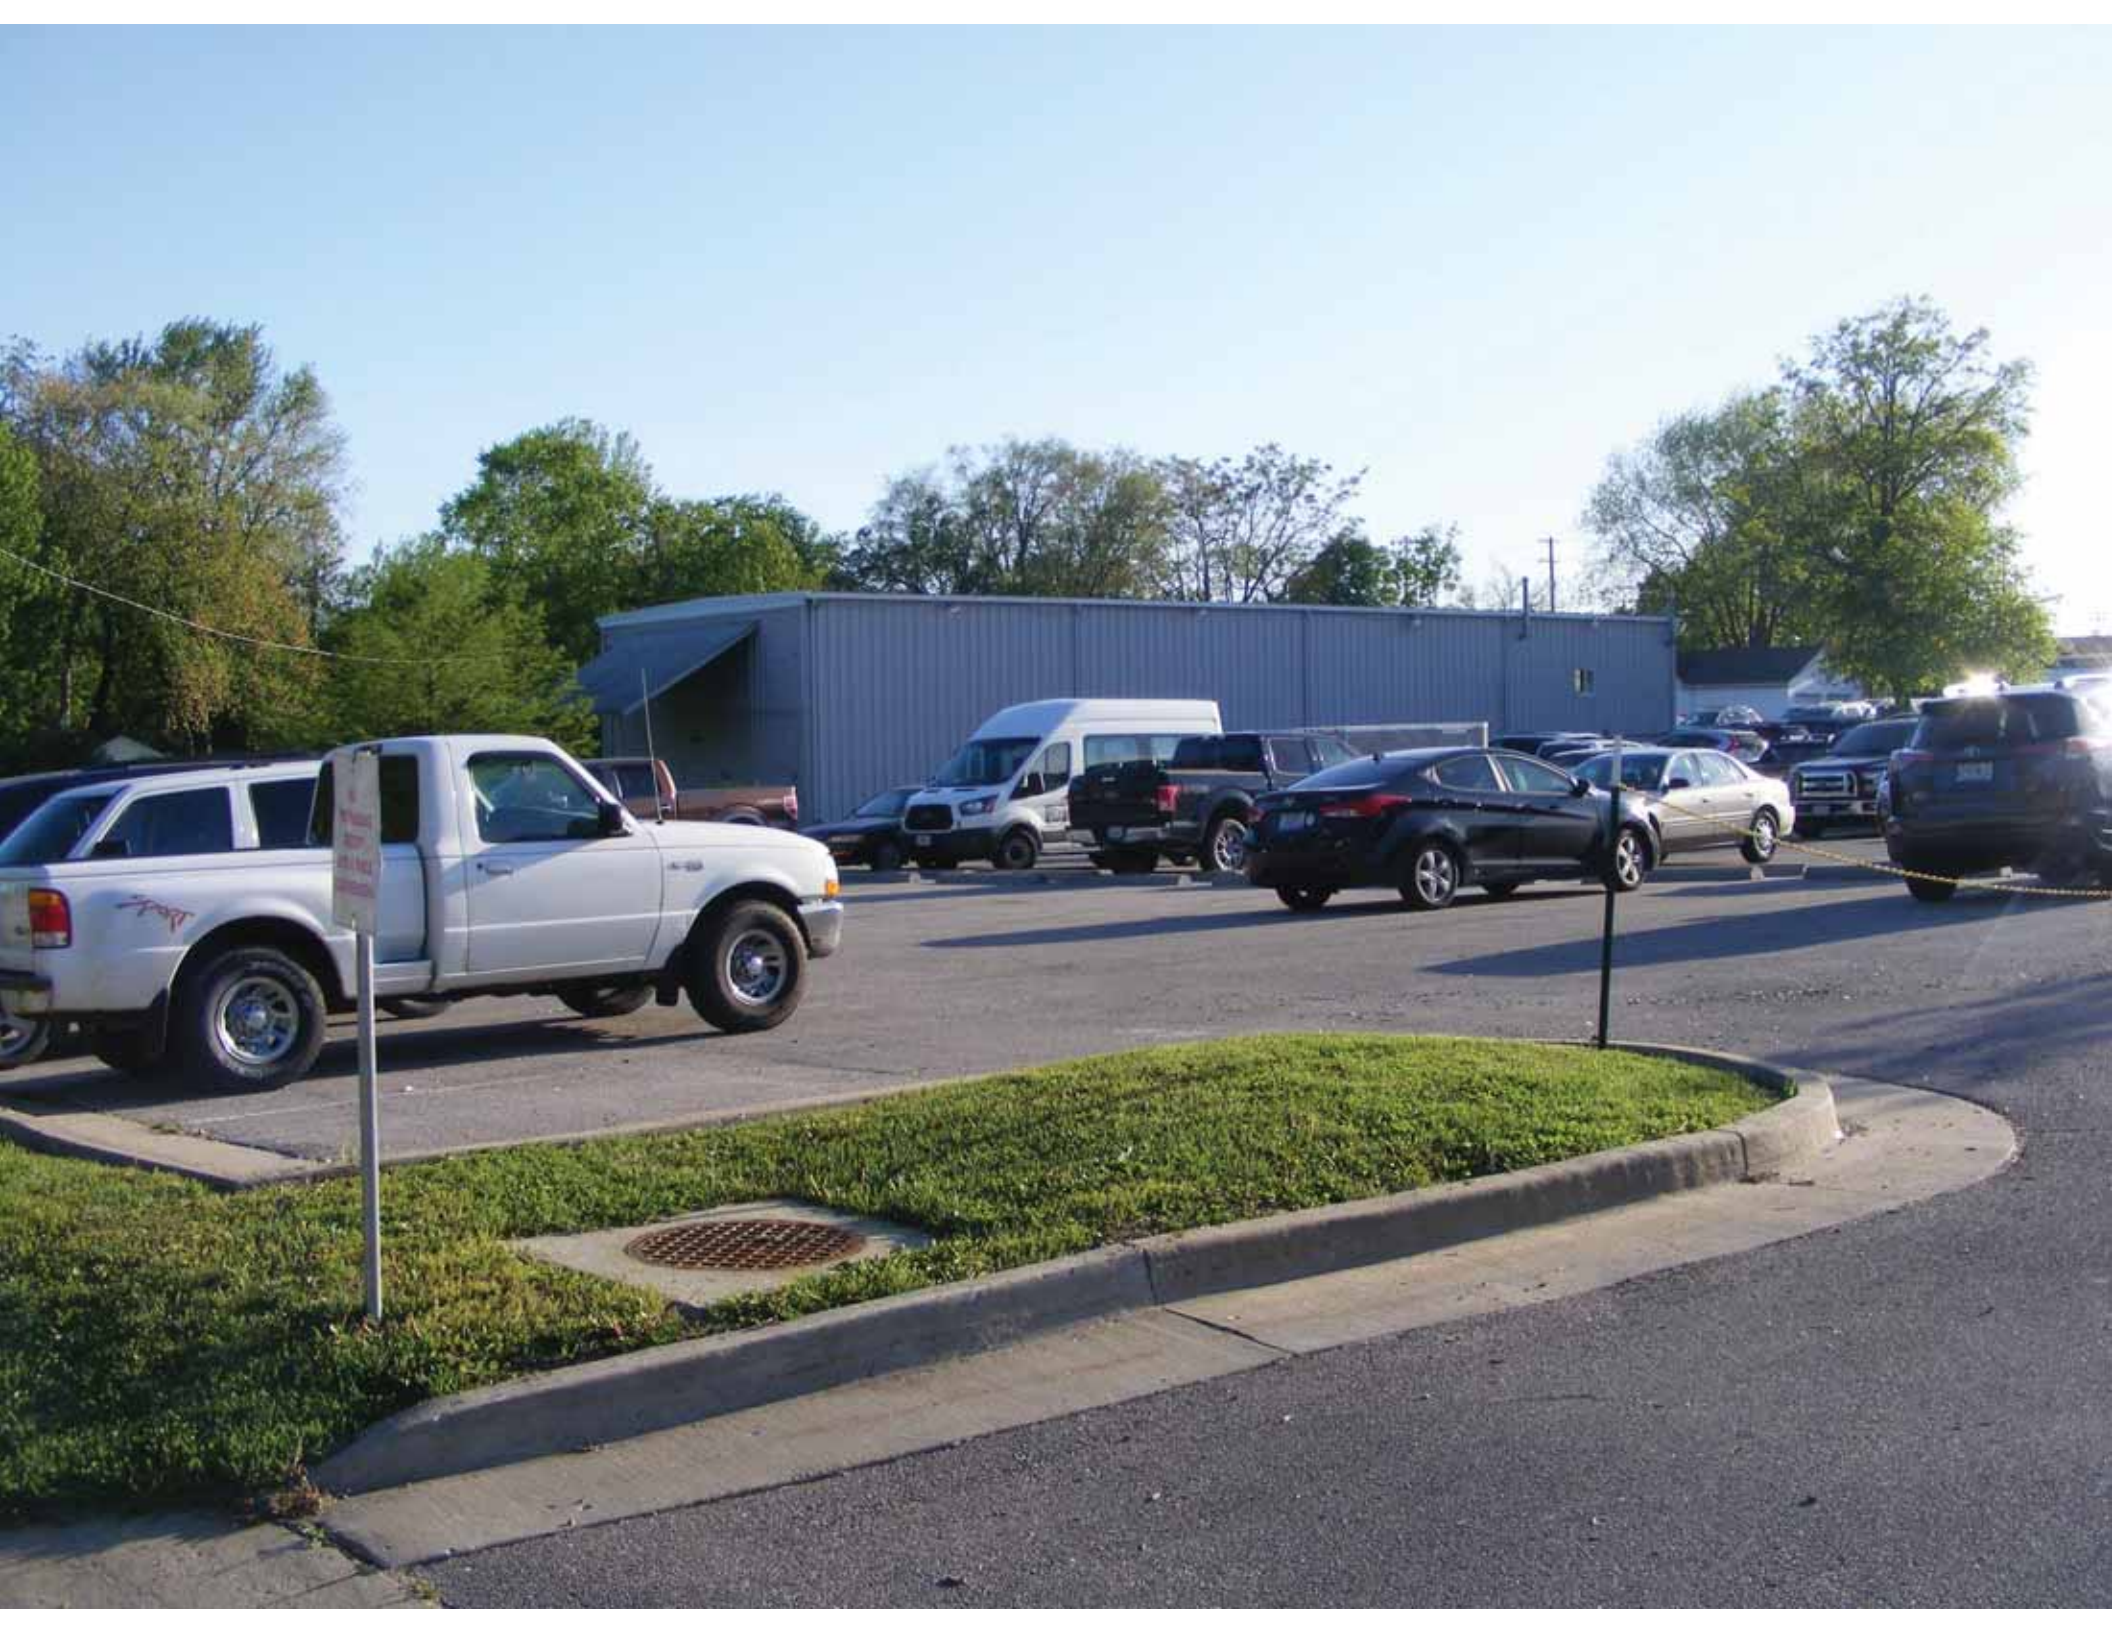
The property at 1105 Coats Street is an asphalt-paved parking lot utilized by Assembly of God Church. The parking lot has marked areas for automobile parking. The lot is adjoined by additional parking on the north (a separate parcel addressed as 1109 Coats Street). Both parcel parking lots support an estimated 75 individual parking spaces and encompass approximately 550 square feet.

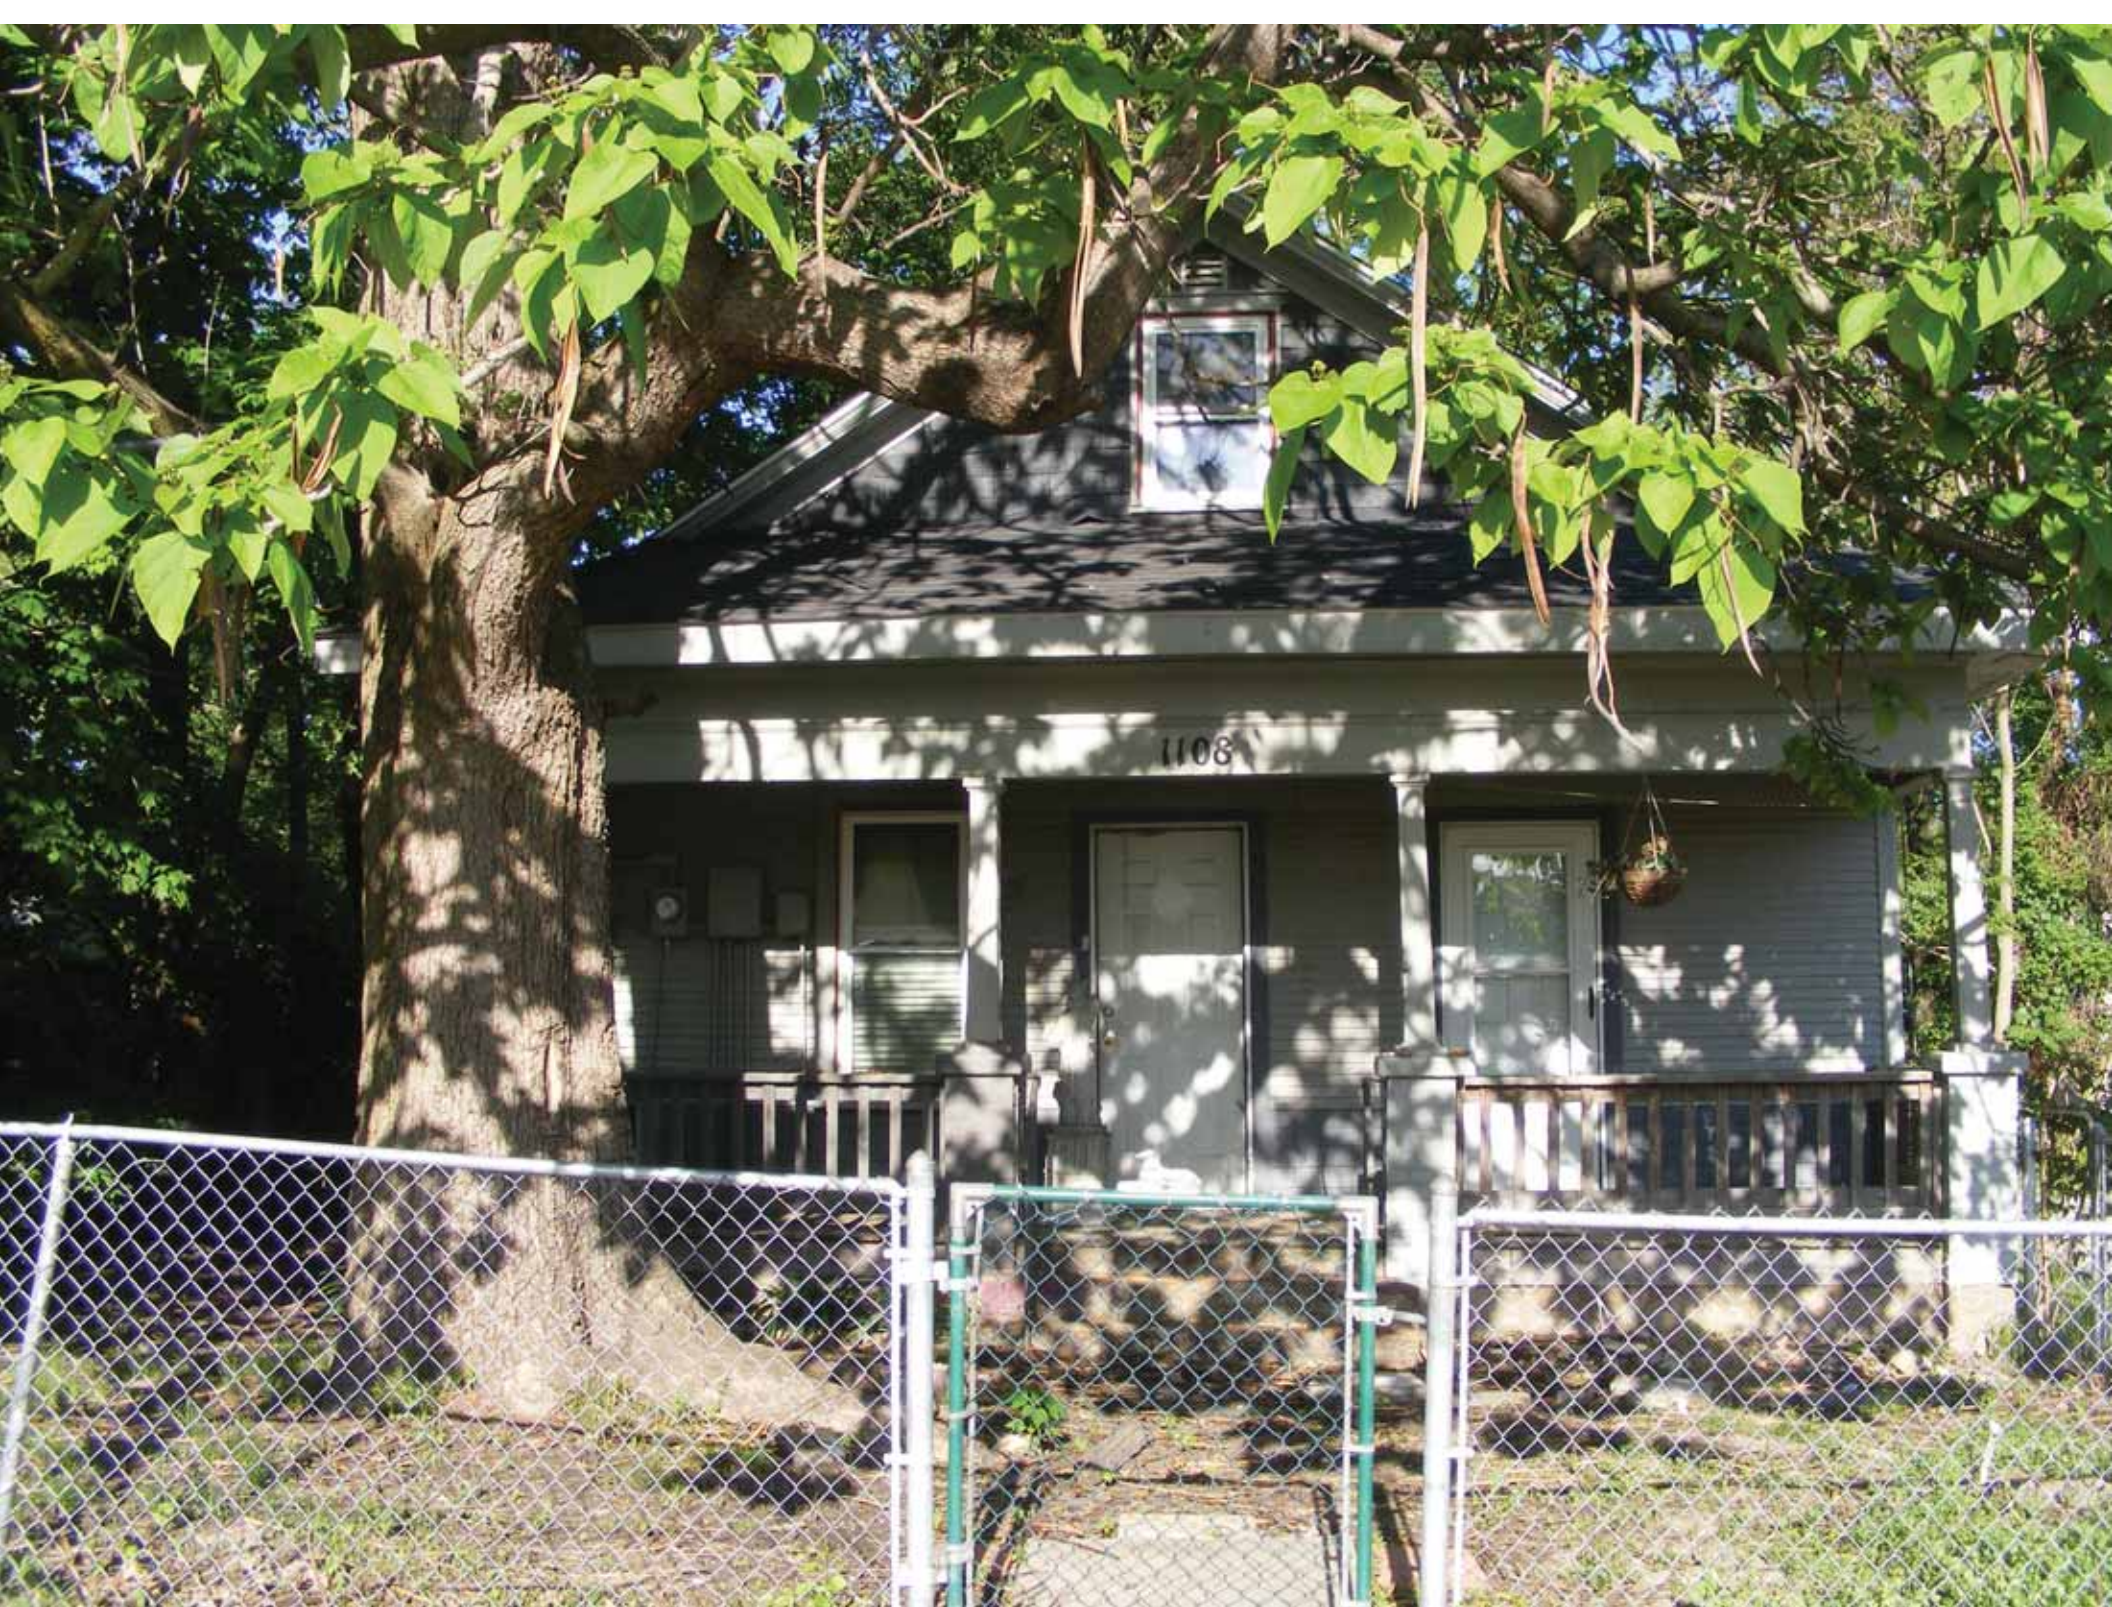
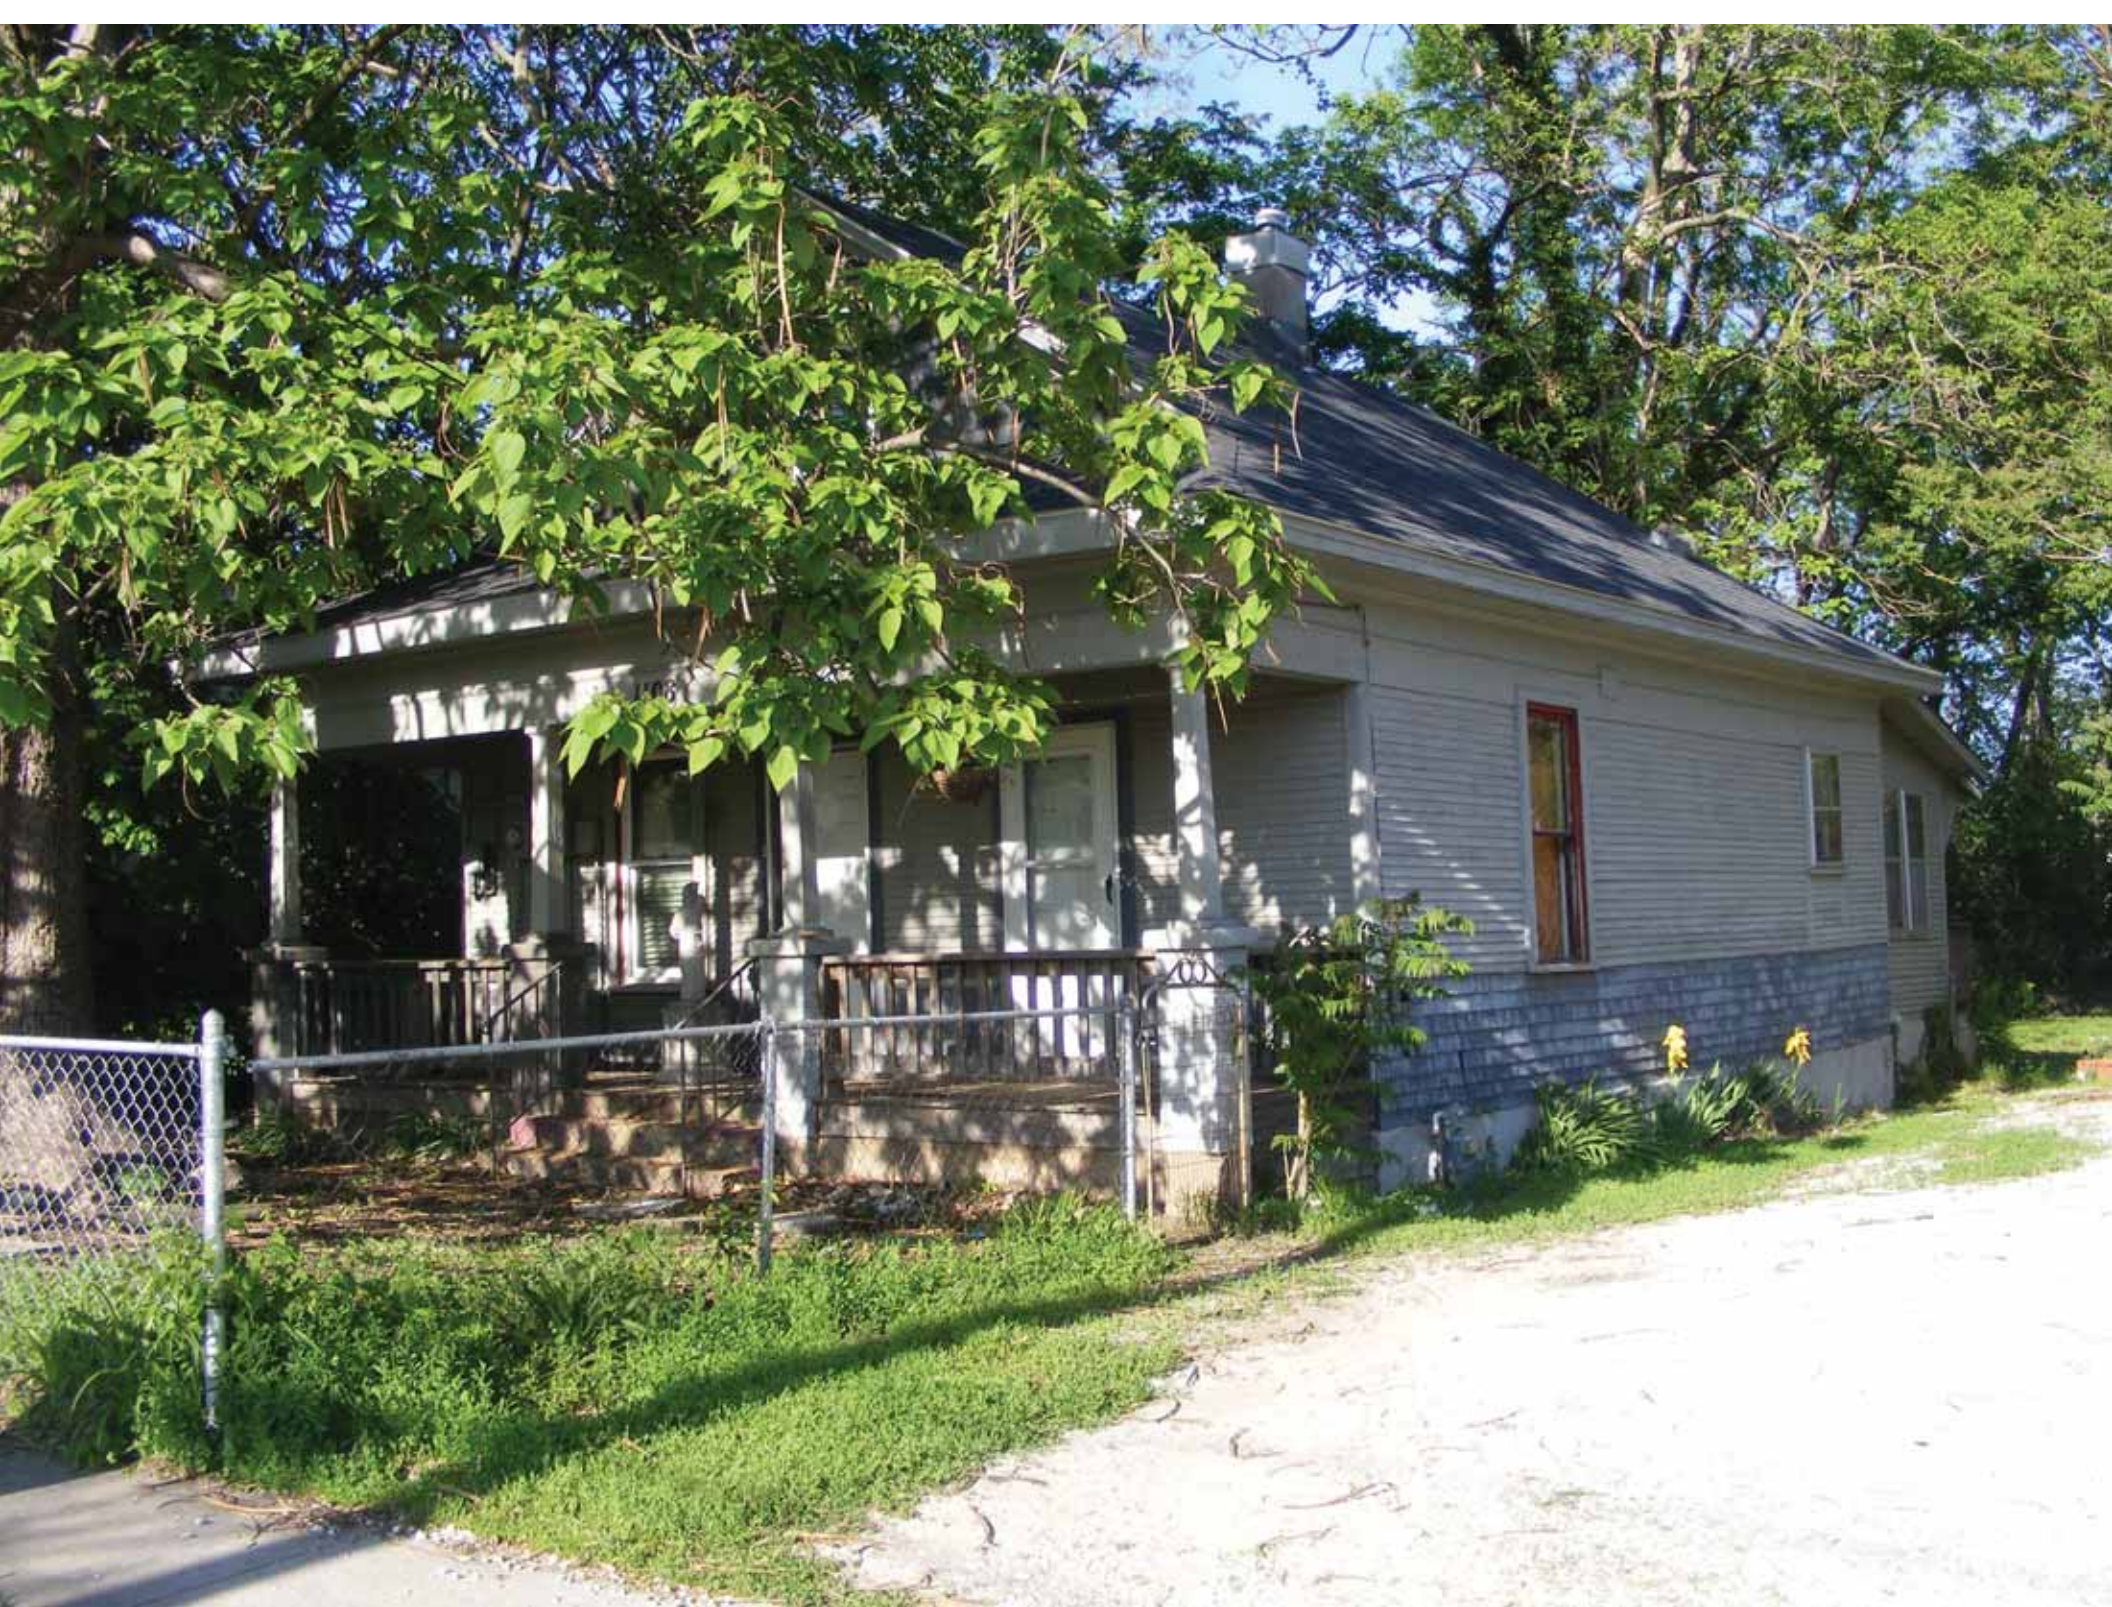
The gable-front plan Bungalow has an asphalt shingled roof, original weatherboard and wood shingle siding and a concrete foundation. The chimney at the center of the roofline is sheathed with concrete. On the façade (east elevation) is a hipped full-width porch supported by tapered wood columns on brick piers. The porch has a frame balustrade. Within the porch bay are two entries filled with c. 2010 paneled doors. Offsetting the doors on the north end is a one-over-one window. The gable field above the porch is clad with asphalt shingles and supports a one-over-one window. There is a louvered vent above the window.
