MISSOURI DEPARTMENT OF NATURAL RESOURCES
STATE HISTORIC PRESERVATION OFFICE, P.O. Box 176, Jefferson City, MO 65102
ARCHITECTURAL/HISTORIC INVENTORY FORM

1. Survey No. BO-AS-011-0087		2. Survey name: North Central Columbia Survey Phase II	
3. County: Boone		4. Address (Street No.) 902	Street (name) N. Seventh Street
5. City: Columbia	Vicinity: <input type="checkbox"/>	6. Geographical Reference:	7. Township/Range/Section: T: R: S:
8. Historic name (if known):		9. Present/other name (if known):	
10. Ownership: <input checked="" type="checkbox"/> Private <input type="checkbox"/> Public		11a. Historic use (if known): Domestic/single dwelling	11b. Current use: Domestic/single dwelling

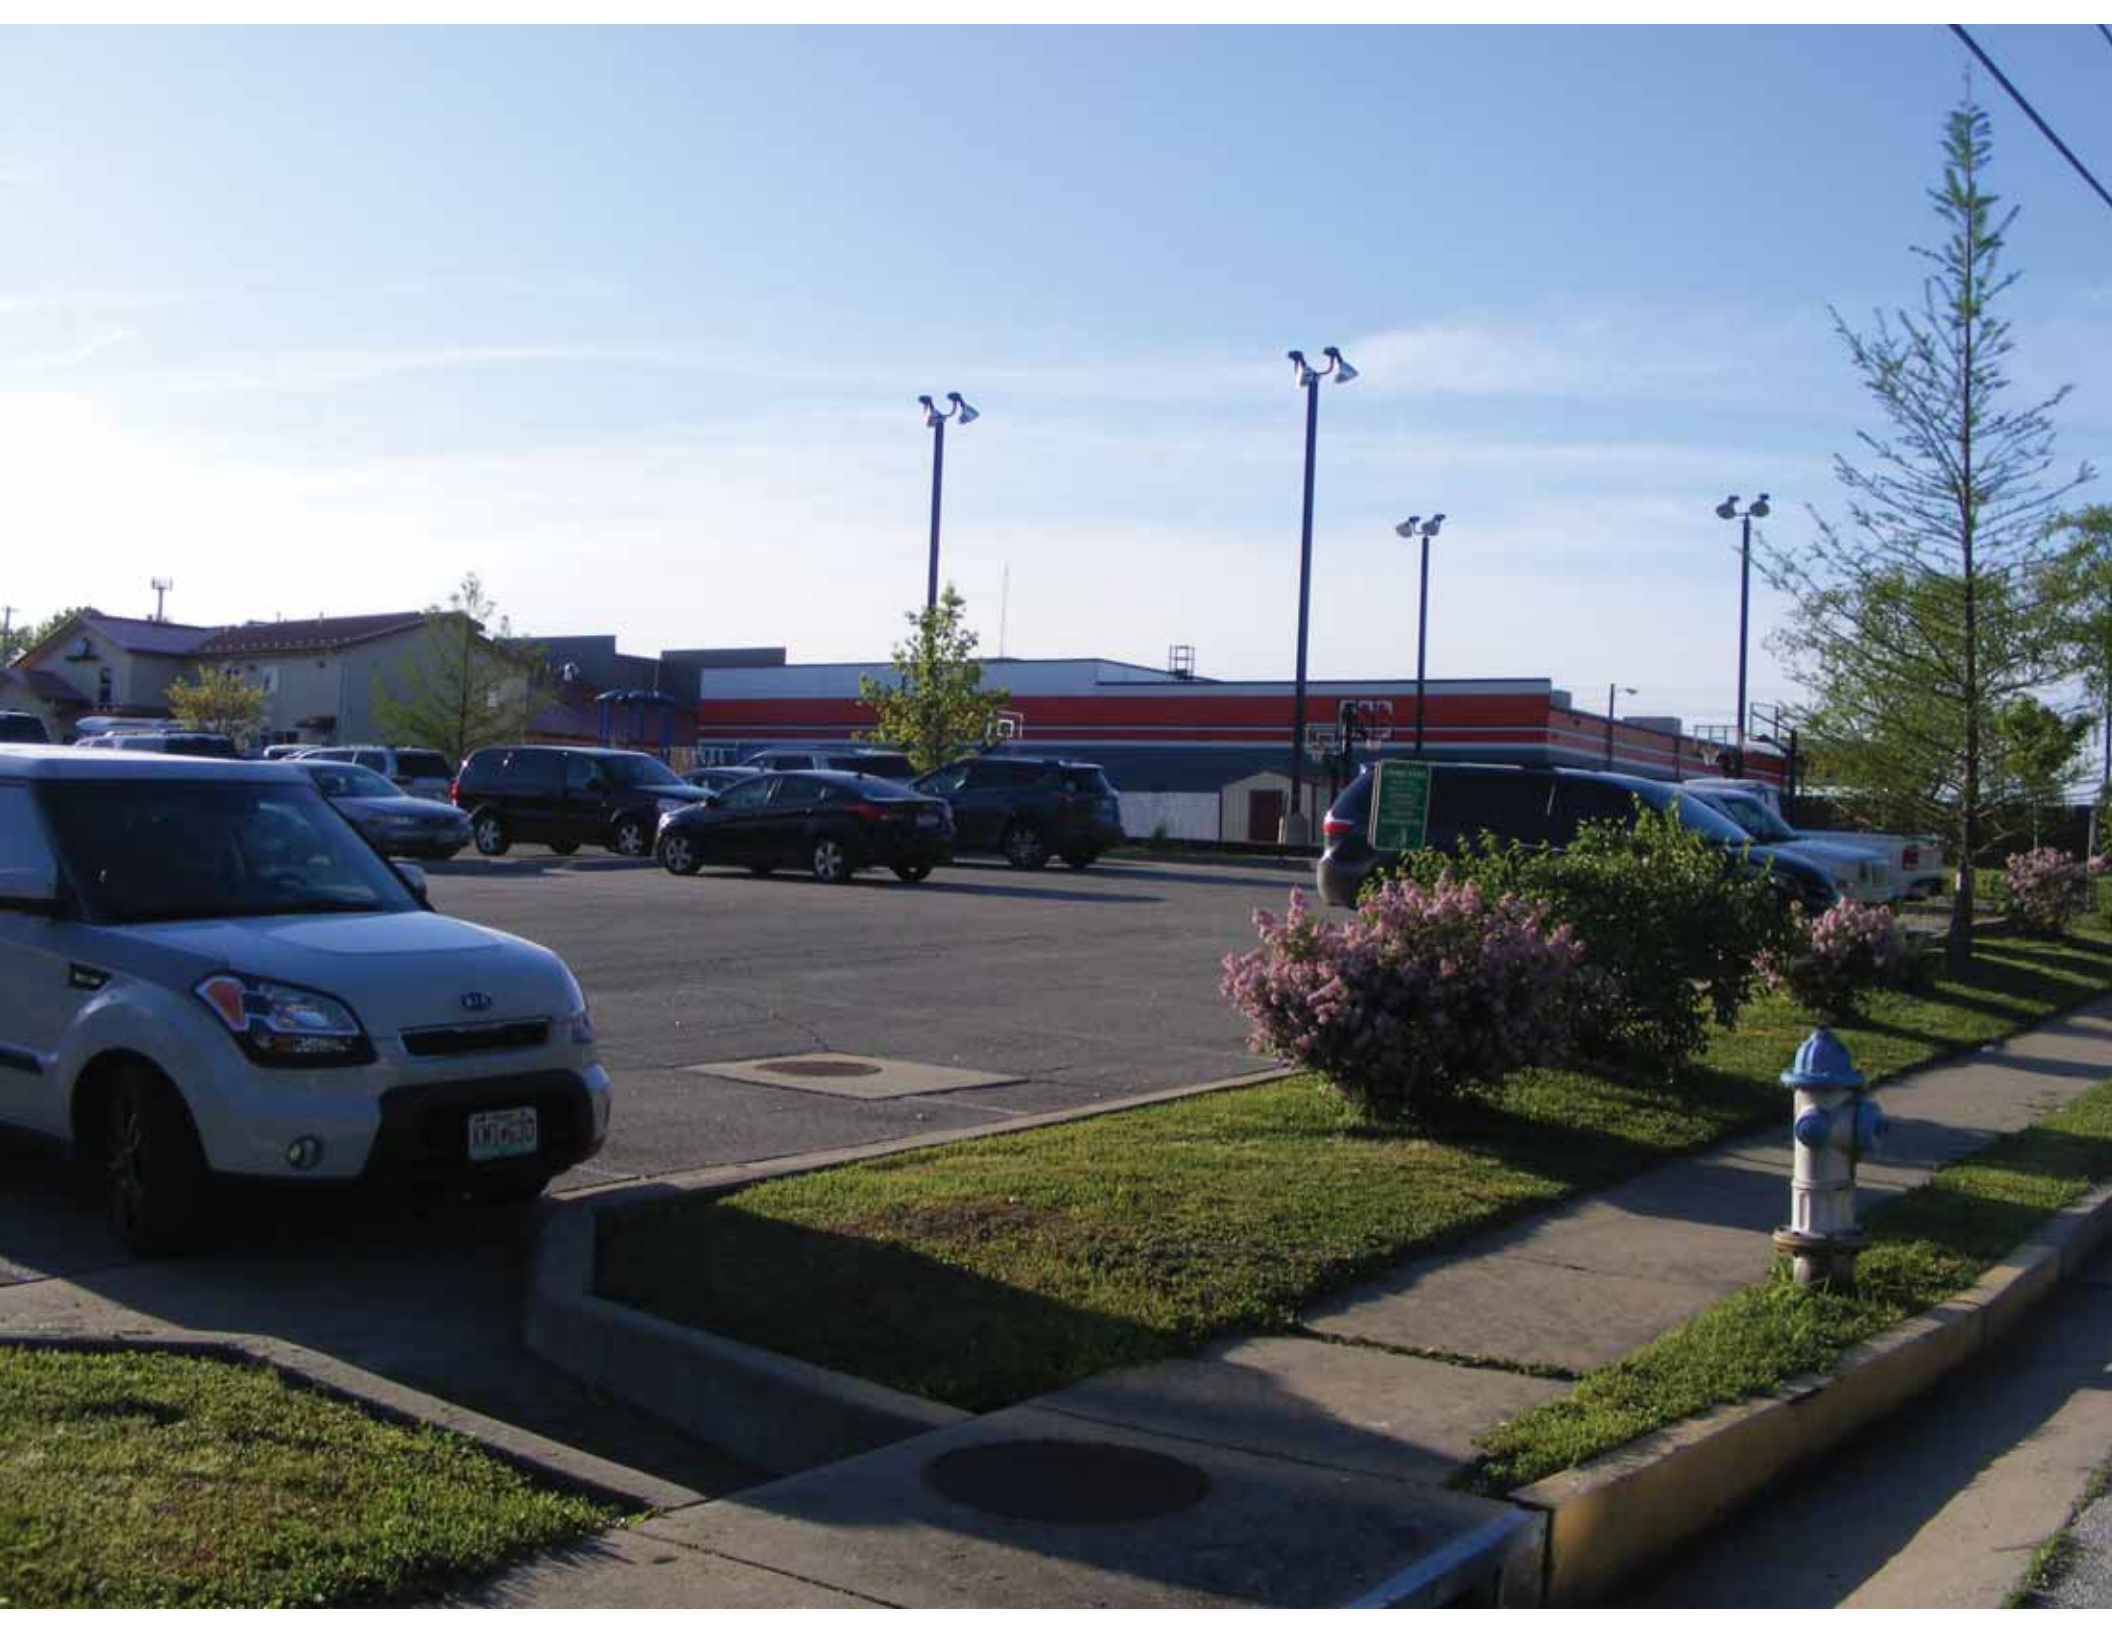
The property at 1109 Coats Street is an asphalt-paved parking lot utilized by Assembly of God Church. The parking lot has marked areas for automobile parking. The lot is adjoined by additional parking on the south (a separate parcel addressed as 1105 Coats Street). Both parcel parking lots support an estimated 75 individual parking spaces and encompass approximately 550 square feet.

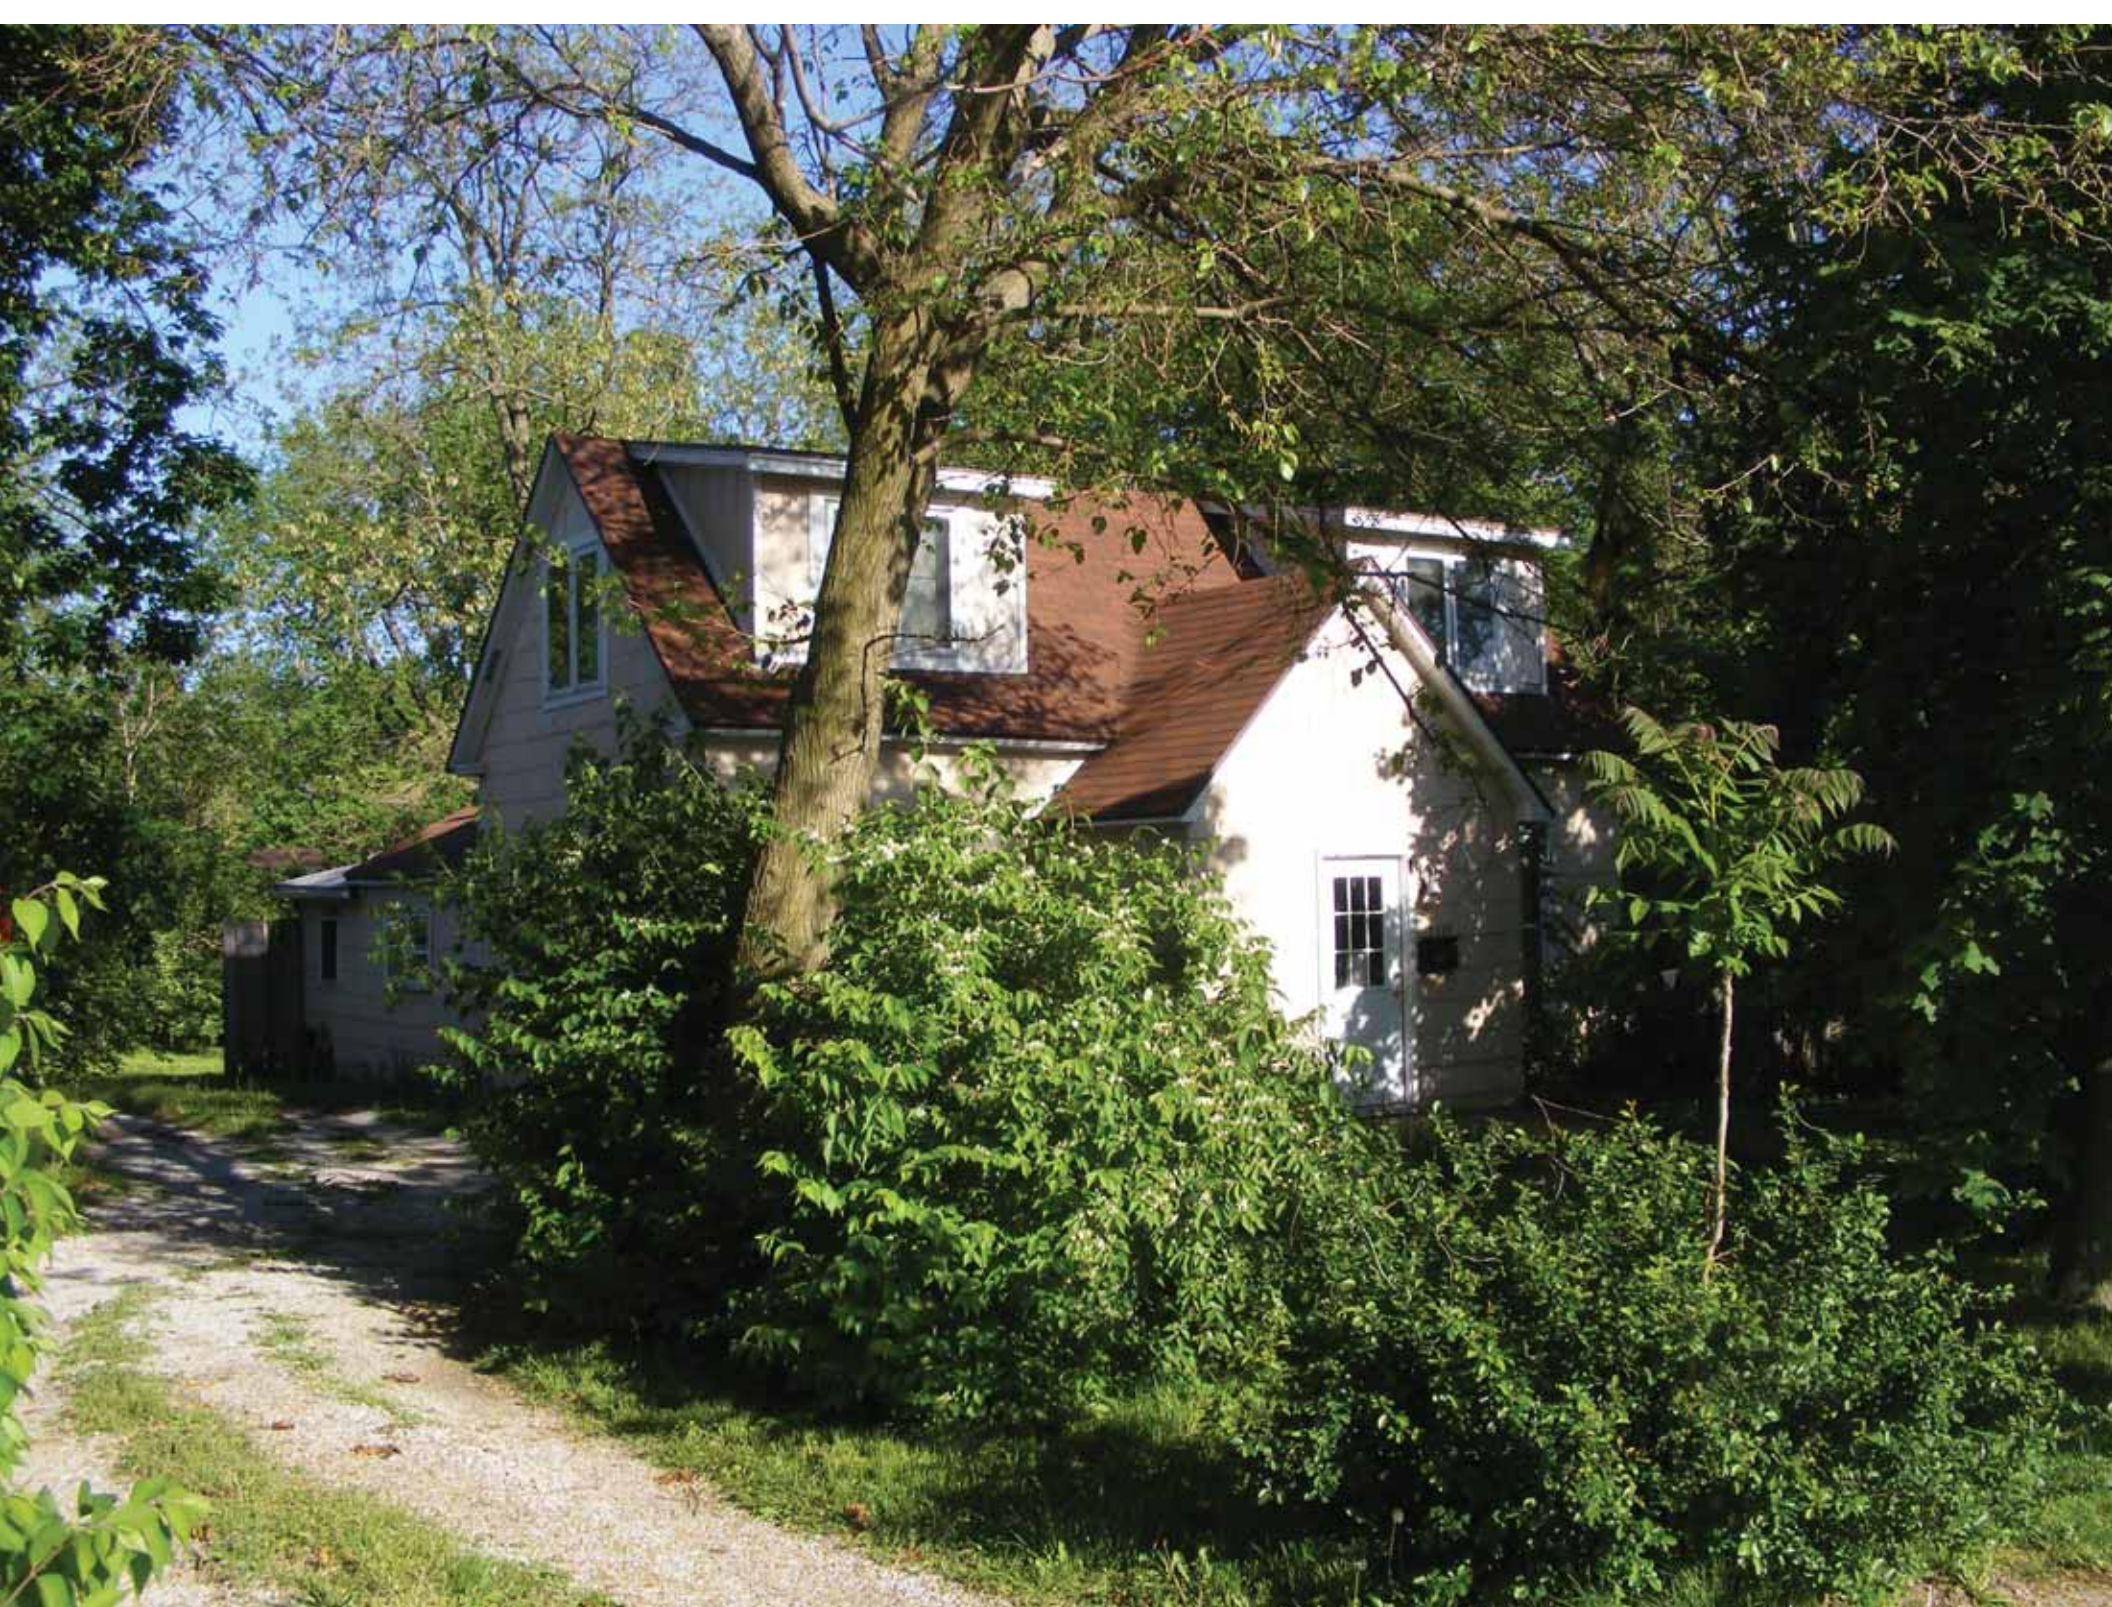
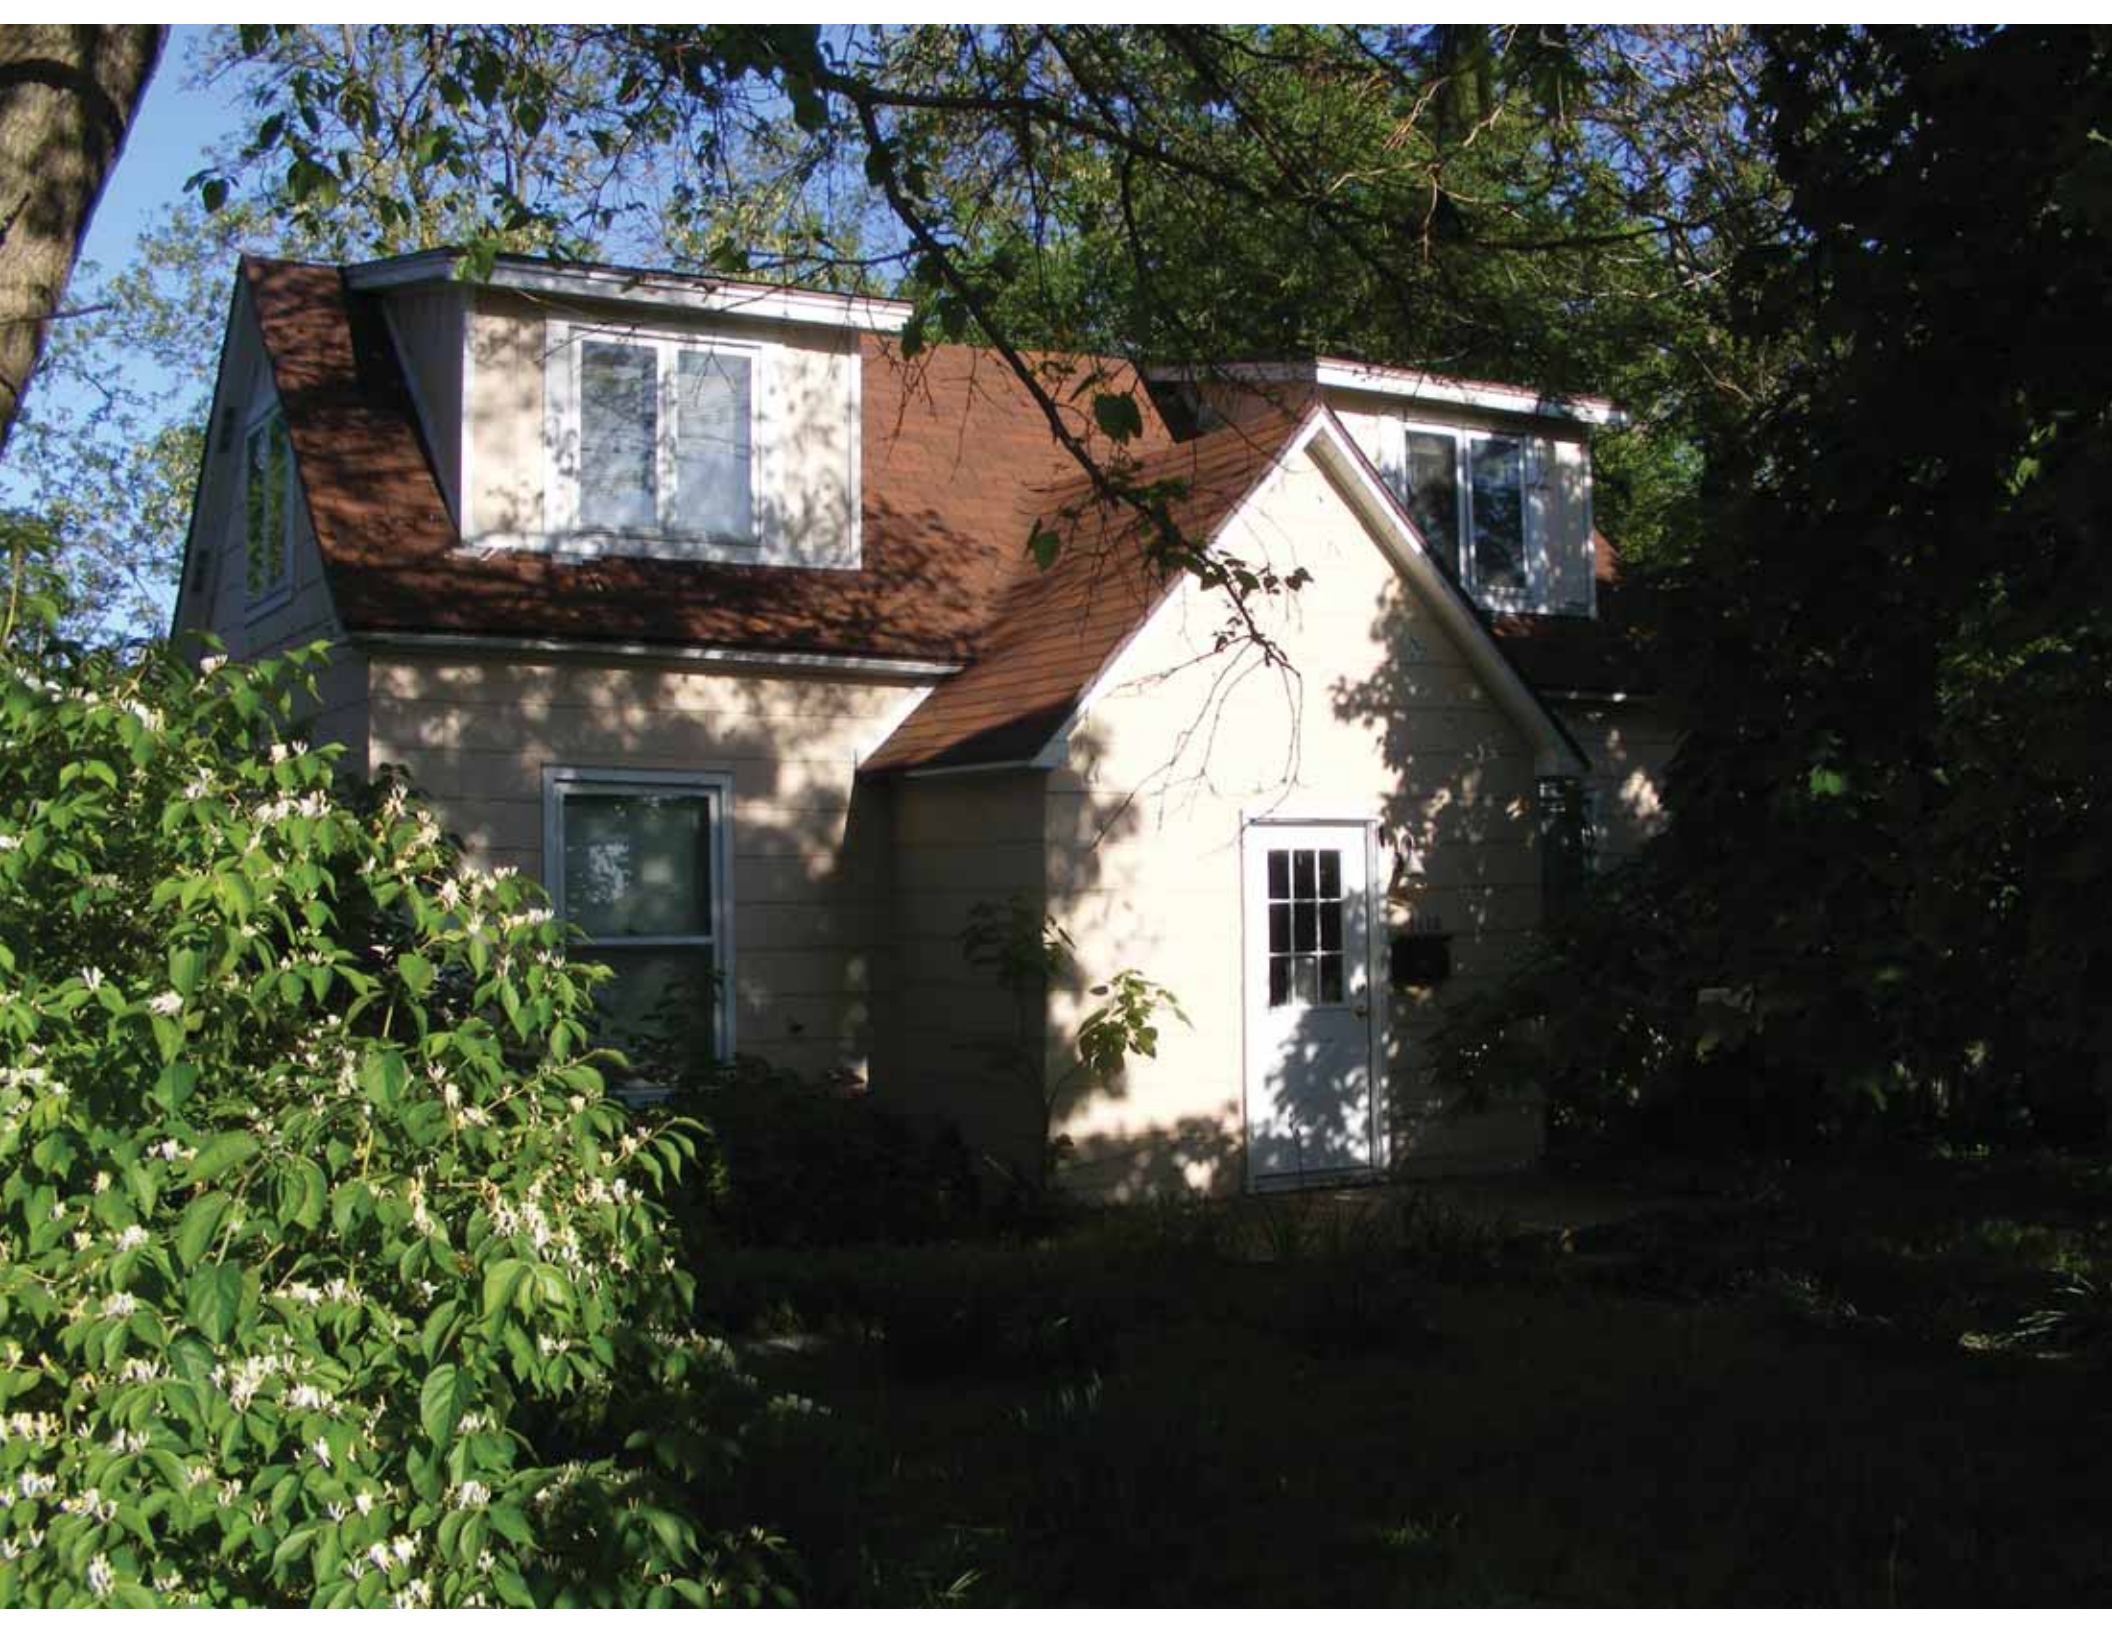
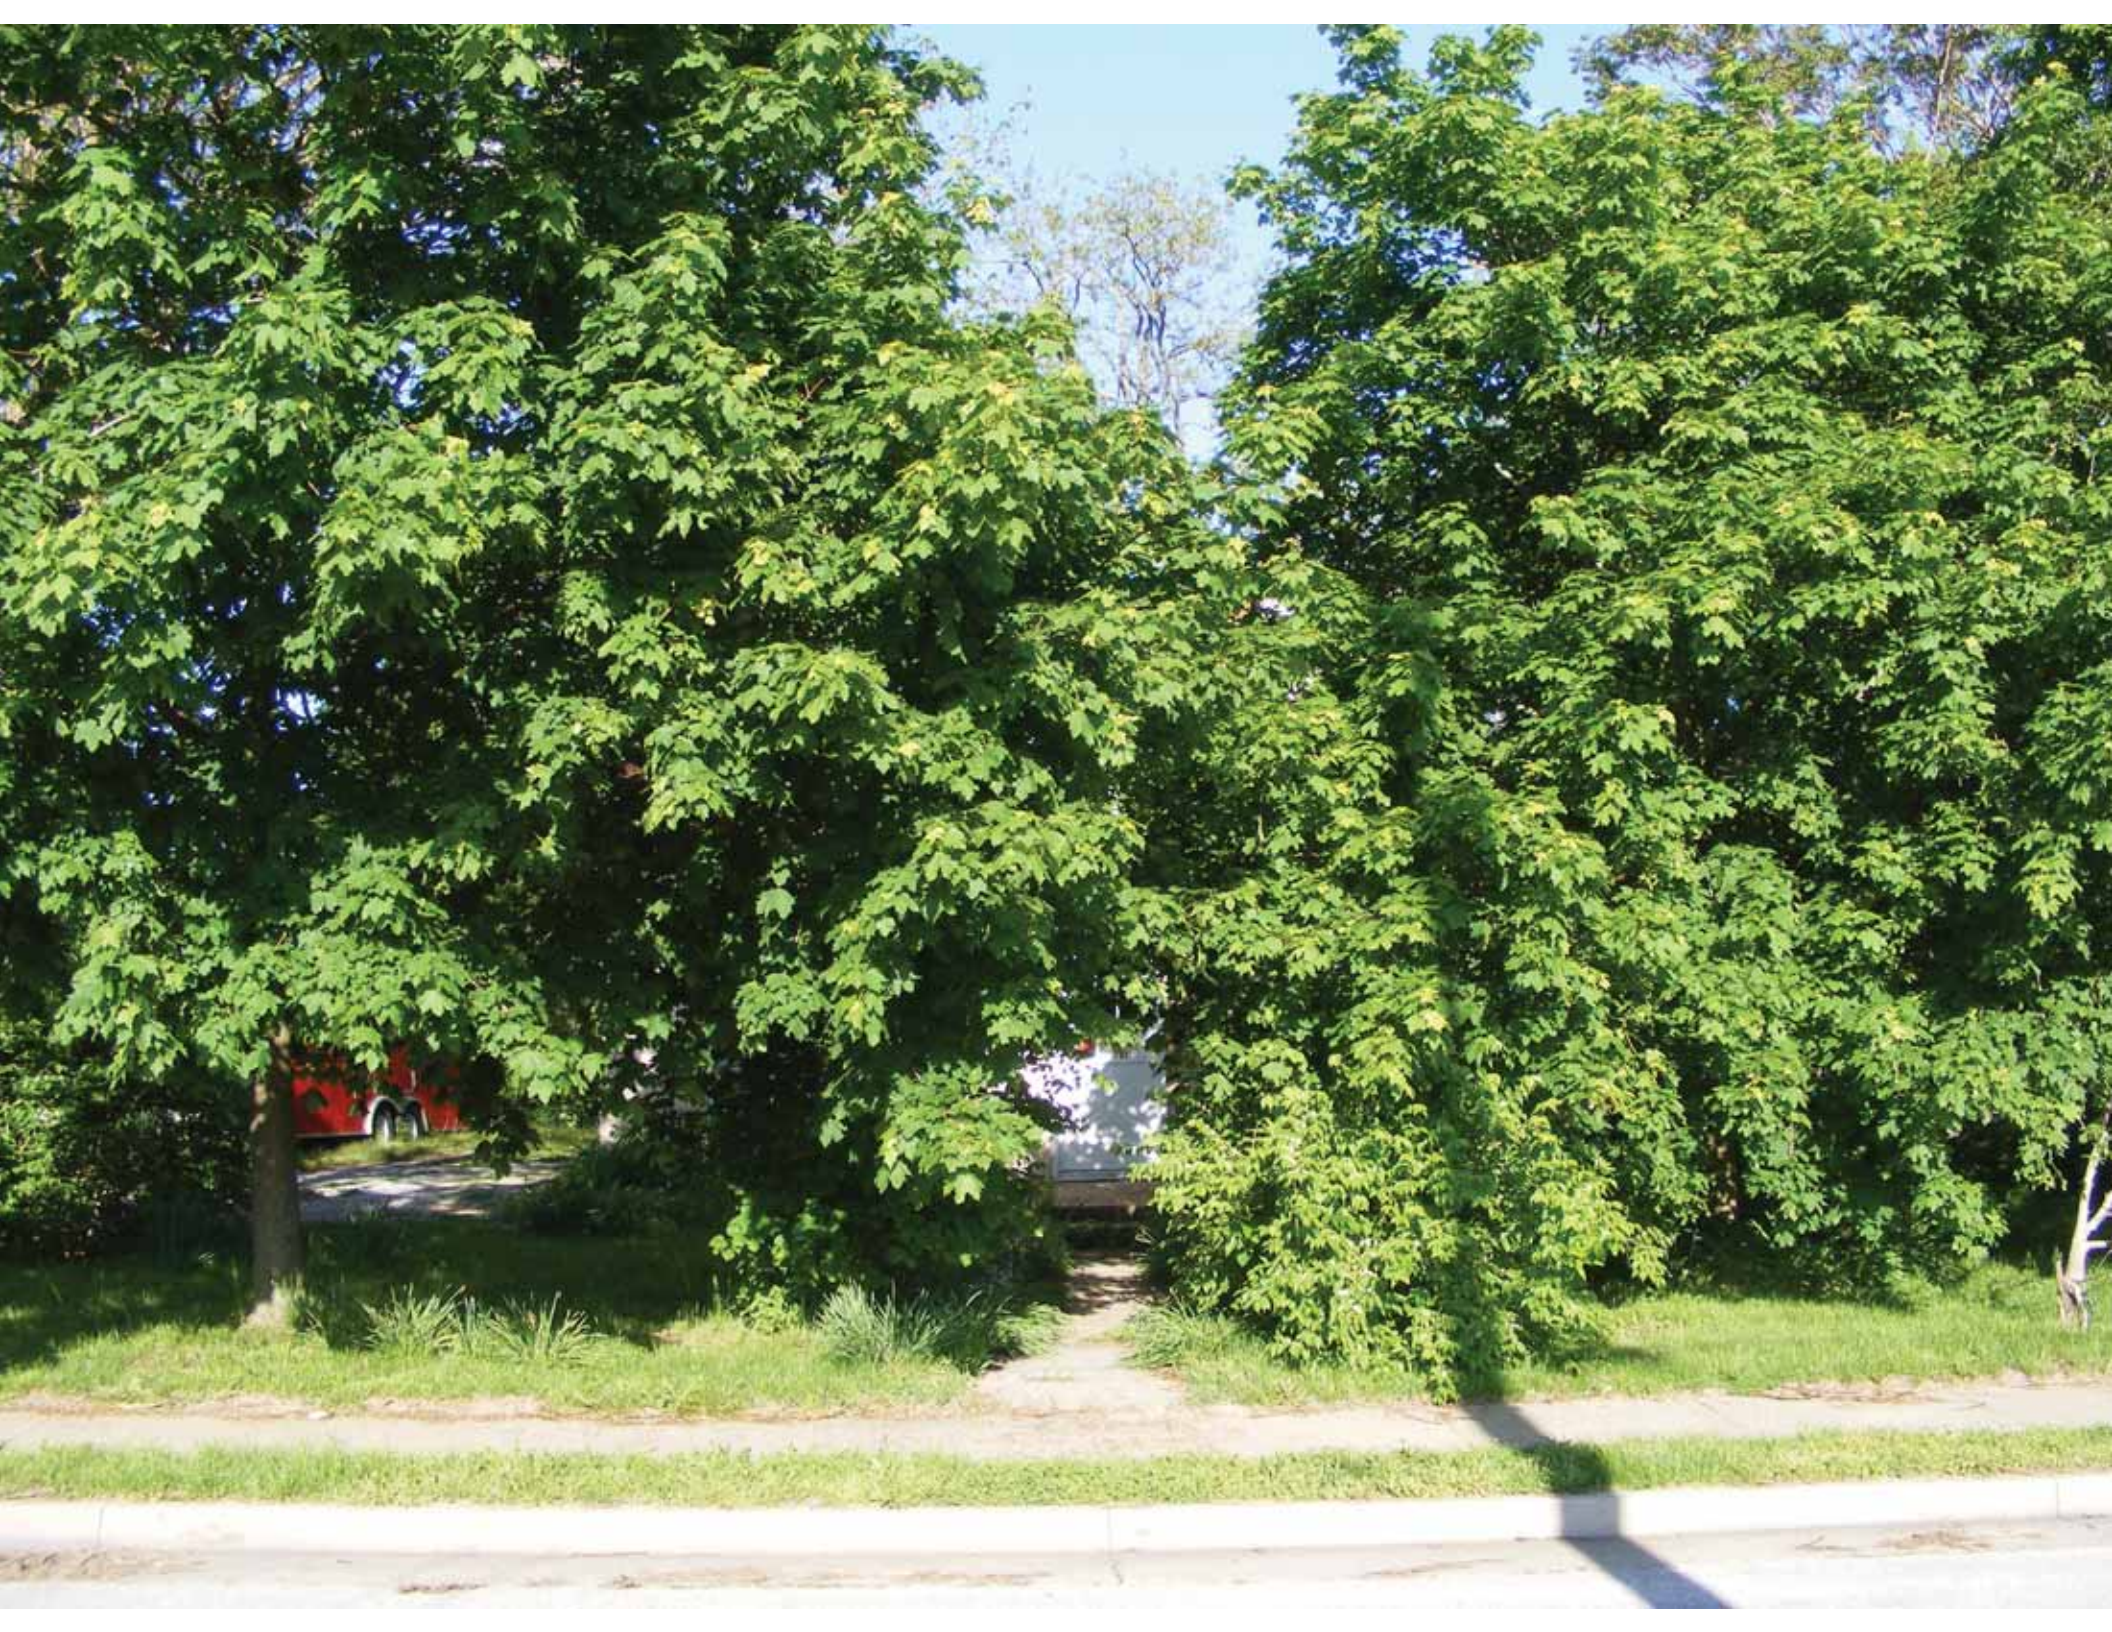
The dwelling has an asphalt shingled gabled roof, exterior asbestos shingle siding and a concrete foundation. The primary (west) elevation has a central enclosed portico with an east elevation nine-light contemporary door. Flanking the projecting entry bay are single one-over-one windows. Above each of the first-floor windows are shed dormers with replacement one-by-one windows. Gable fields (north and south elevations) have paired one-over-one windows.

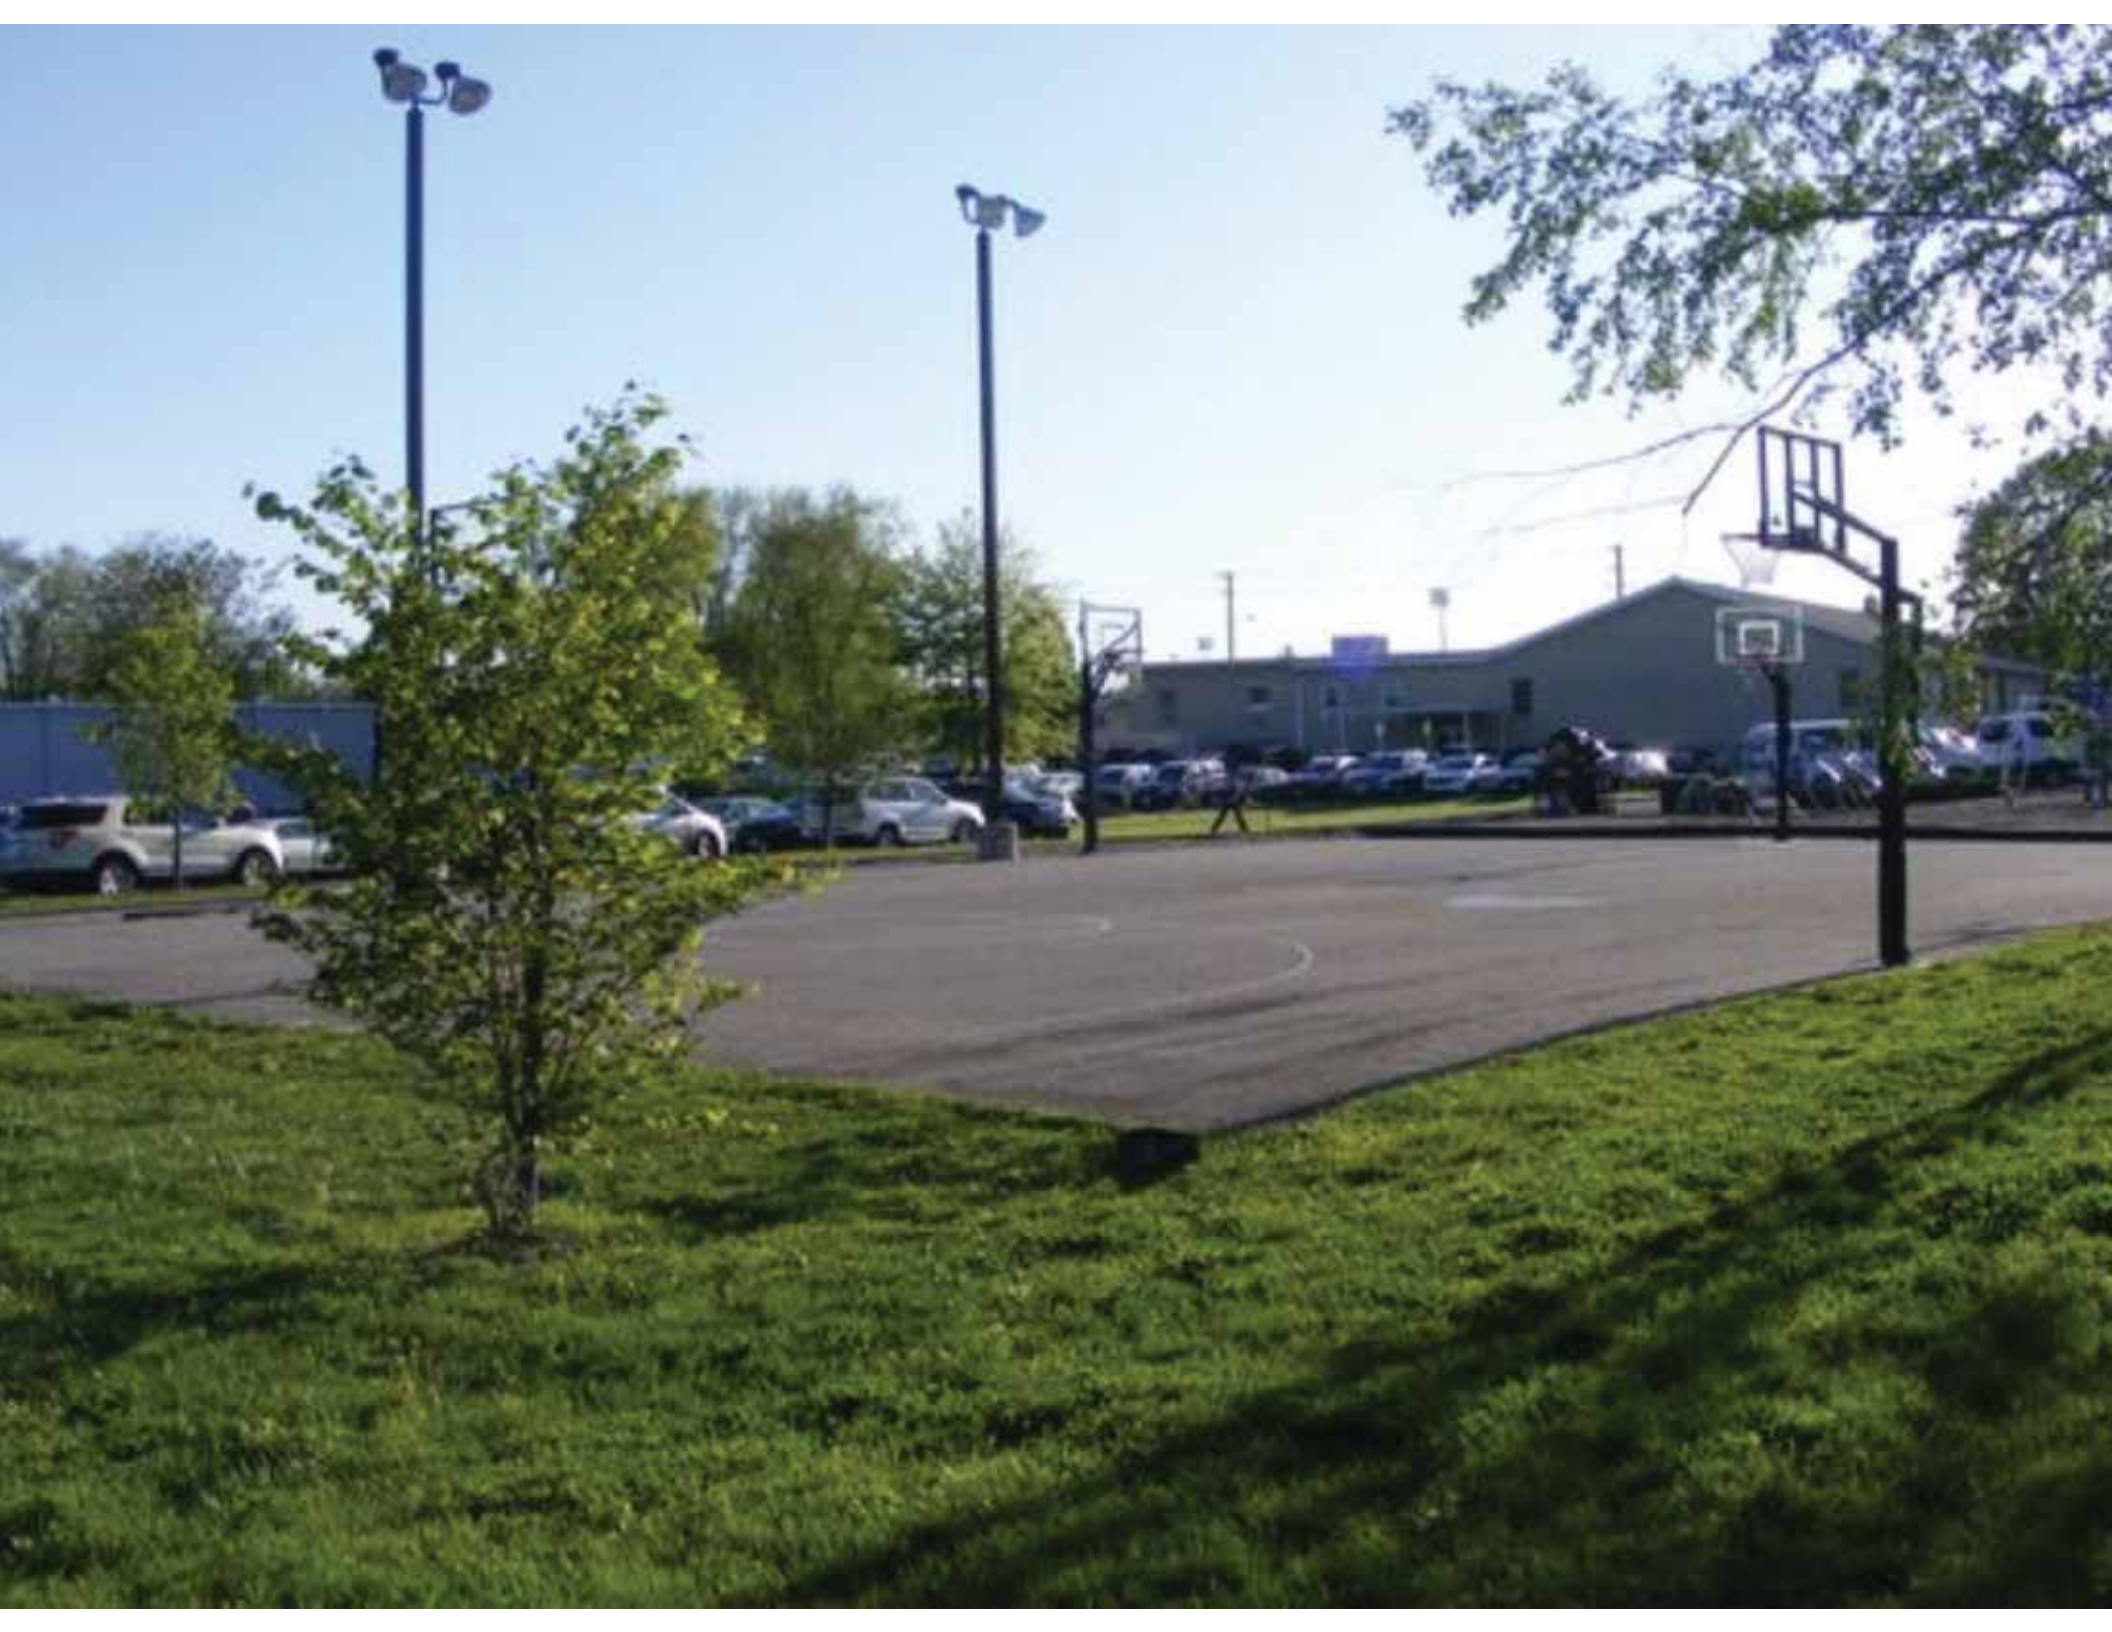
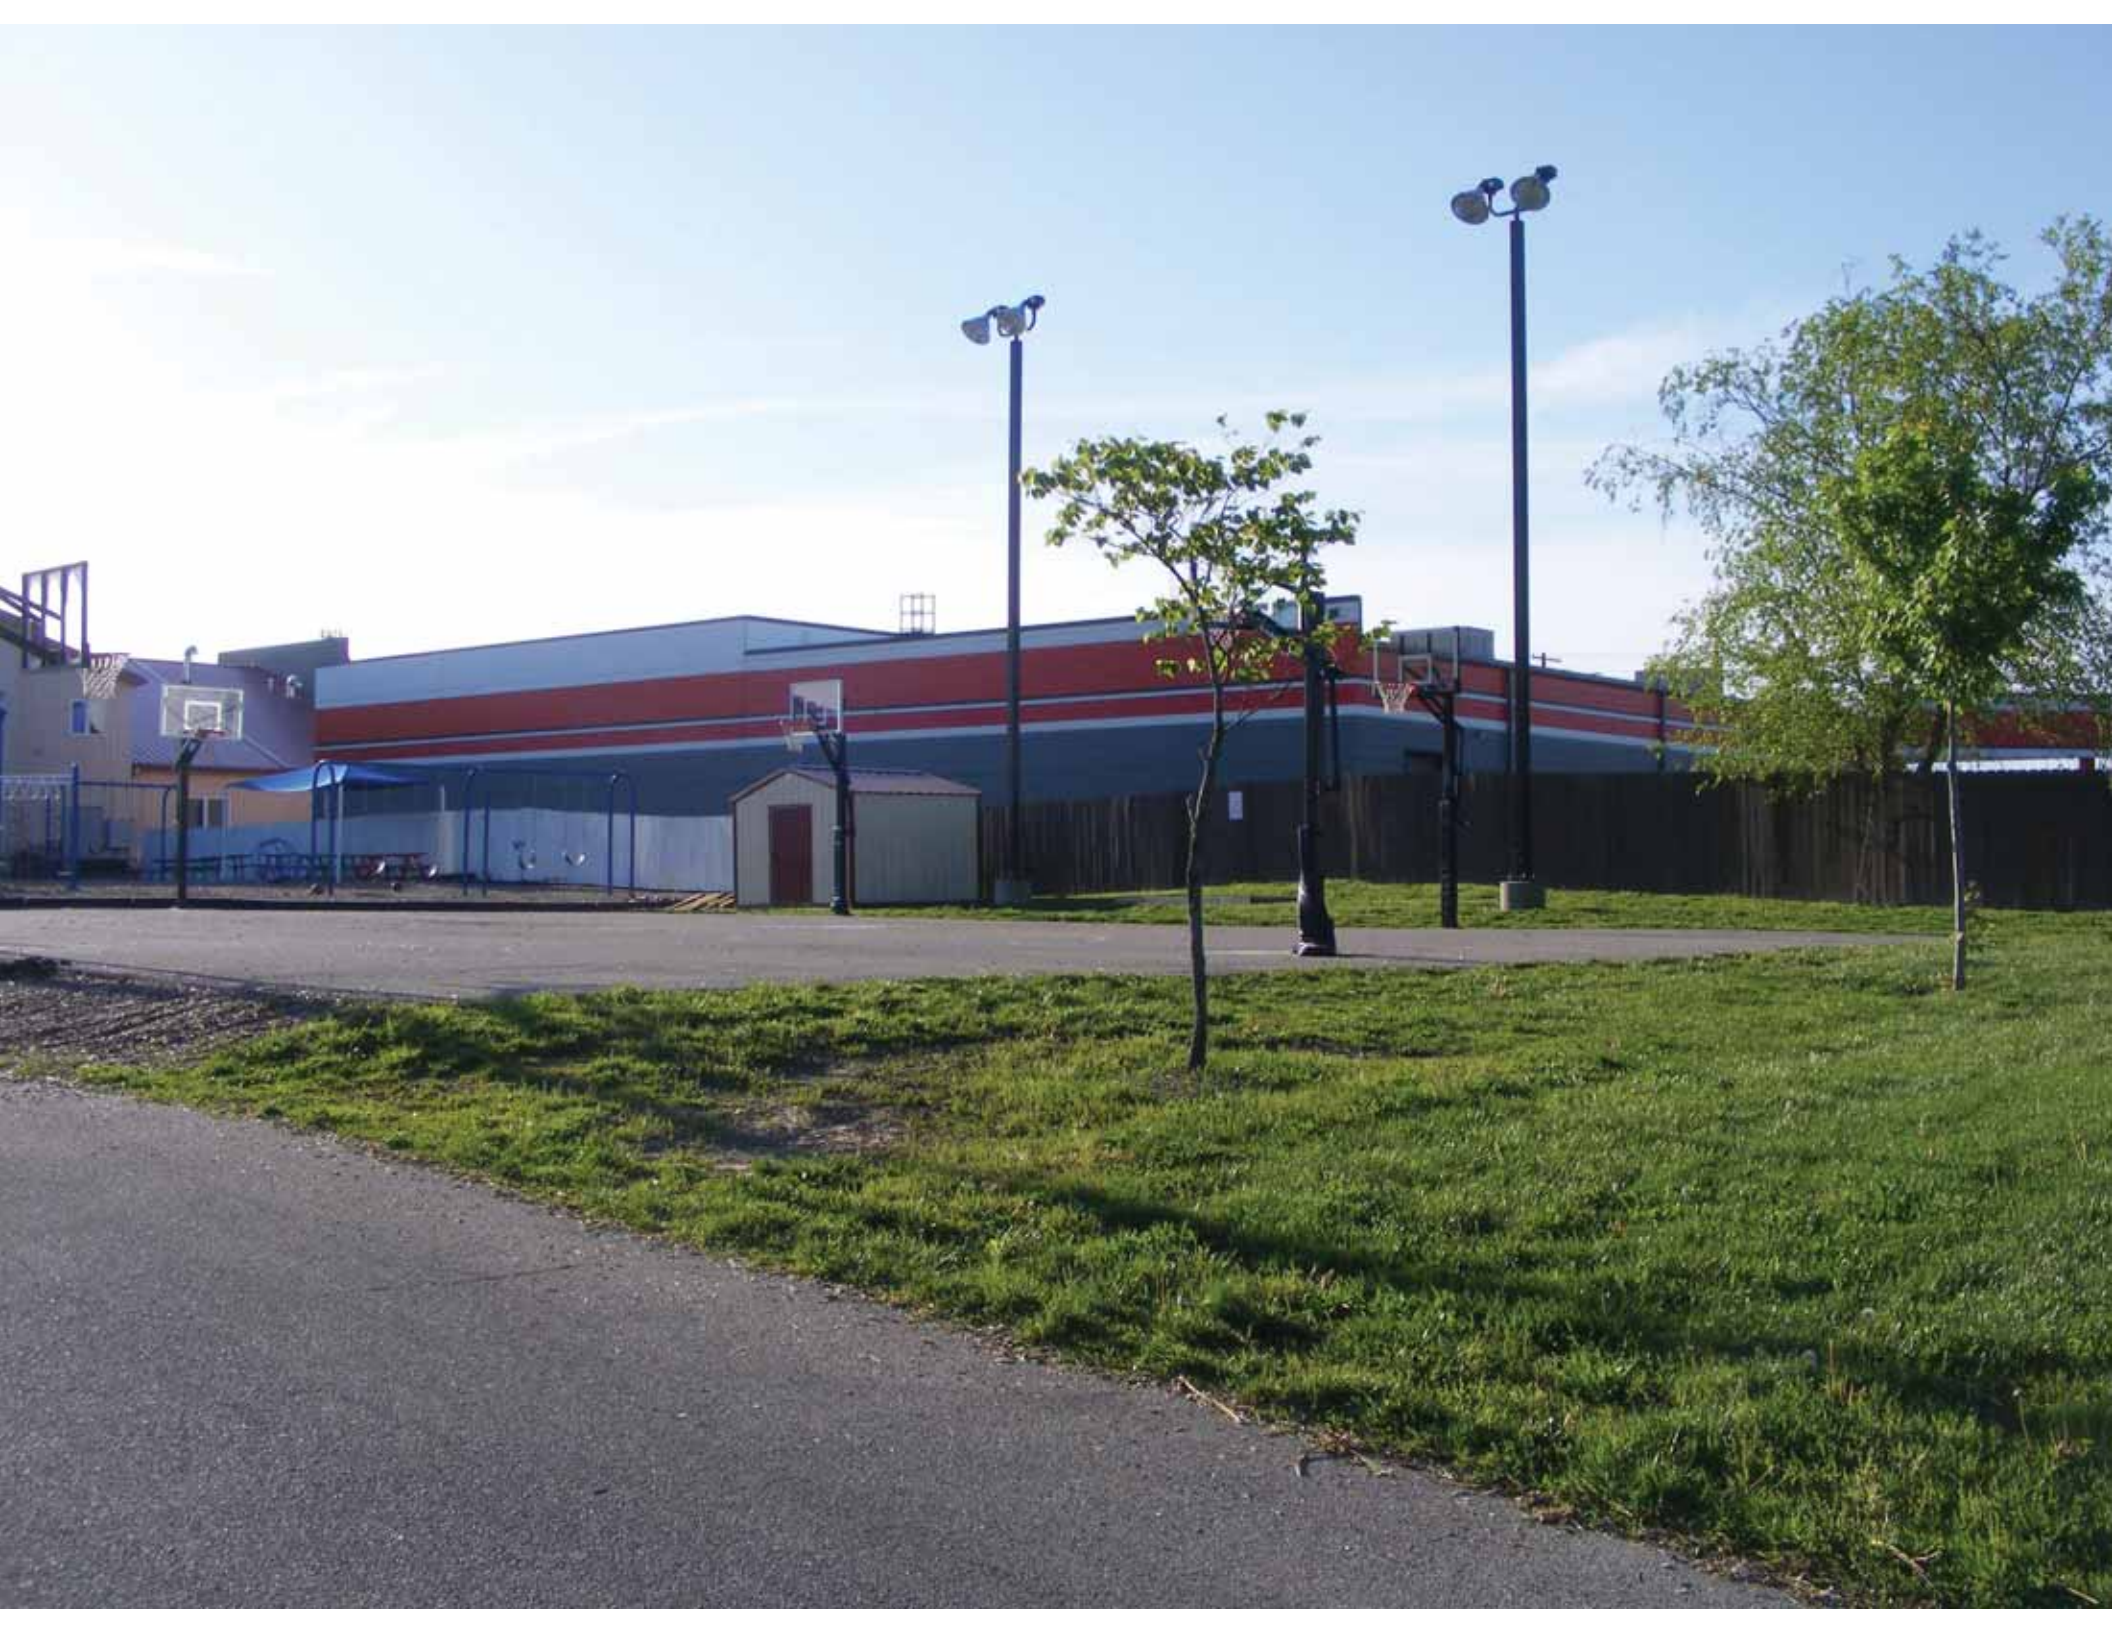
The property at 1105 Coats Street is an asphalt-paved parking lot utilized by Assembly of God Church. The parking lot has marked areas for automobile parking, supporting an estimated 75 individual parking spaces. The parking lot covers approximately 550 square feet.
