MISSOURI DEPARTMENT OF NATURAL RESOURCES
STATE HISTORIC PRESERVATION OFFICE, P.O. Box 176, Jefferson City, MO 65102
ARCHITECTURAL/HISTORIC INVENTORY FORM

1. Survey No. BO-AS-011-0087		2. Survey name: North Central Columbia Survey Phase II	
3. County: Boone		4. Address (Street No.) 902	Street (name) N. Seventh Street
5. City: Columbia	Vicinity: <input type="checkbox"/>	6. Geographical Reference:	7. Township/Range/Section: T: R: S:
8. Historic name (if known):		9. Present/other name (if known):	
10. Ownership: <input checked="" type="checkbox"/> Private <input type="checkbox"/> Public		11a. Historic use (if known): Domestic/single dwelling	11b. Current use: Domestic/single dwelling

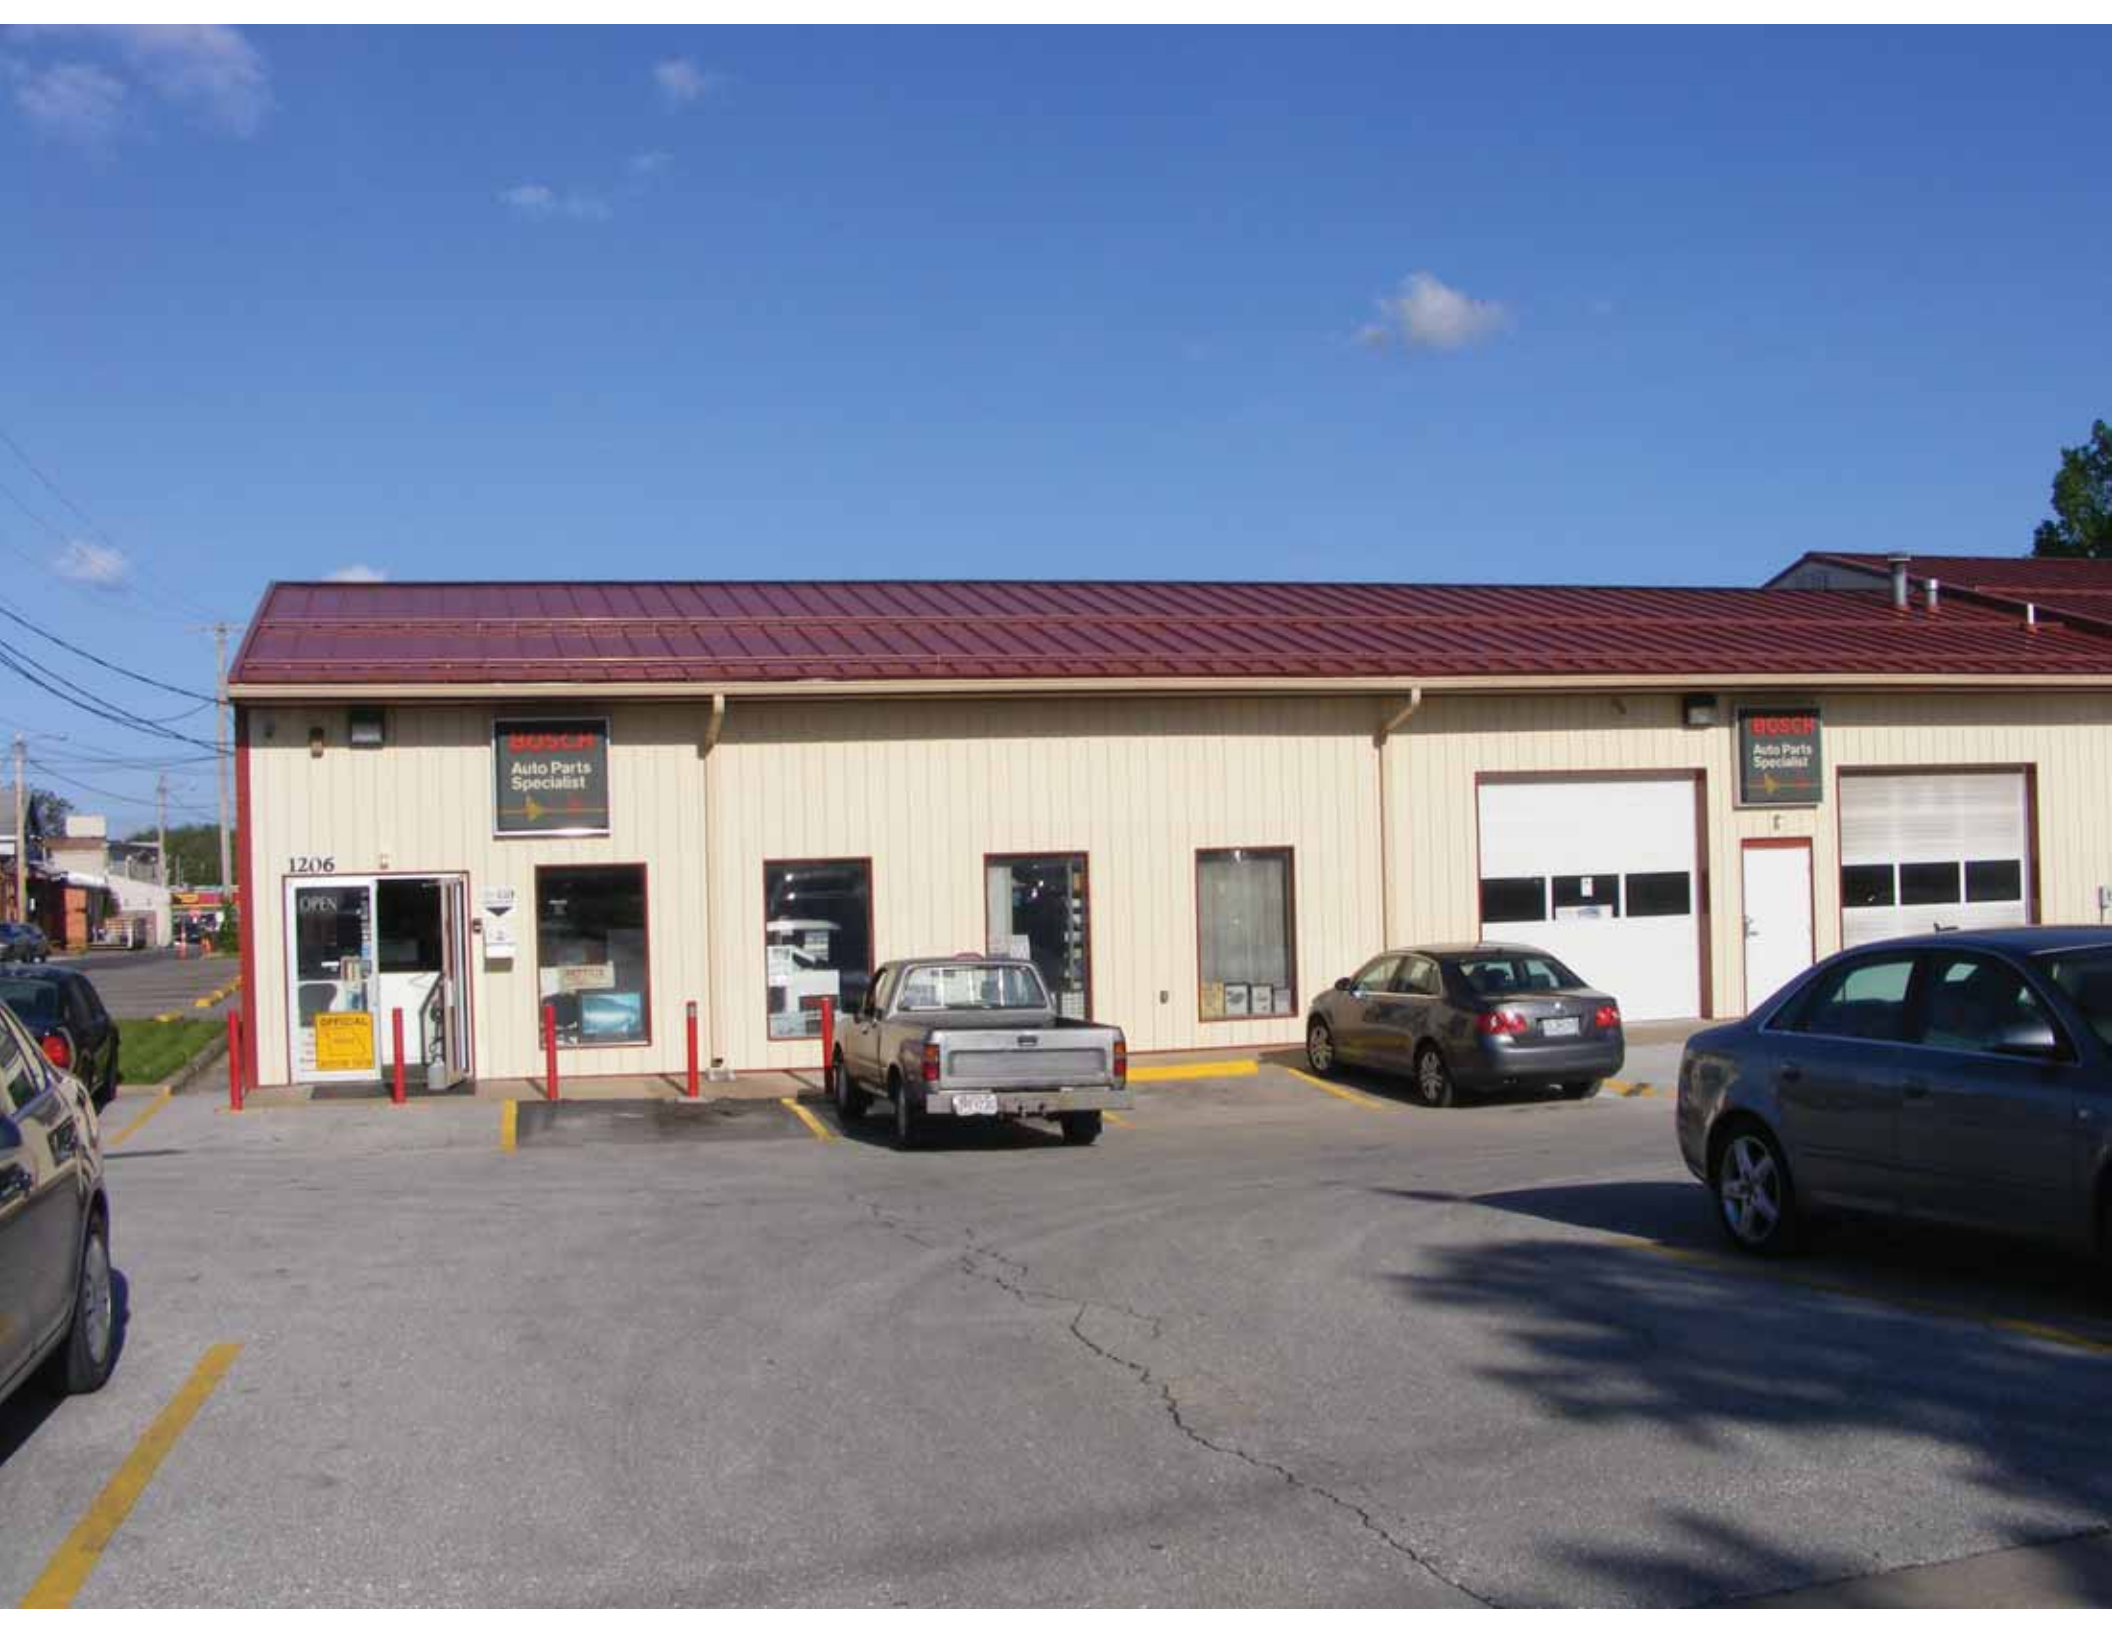
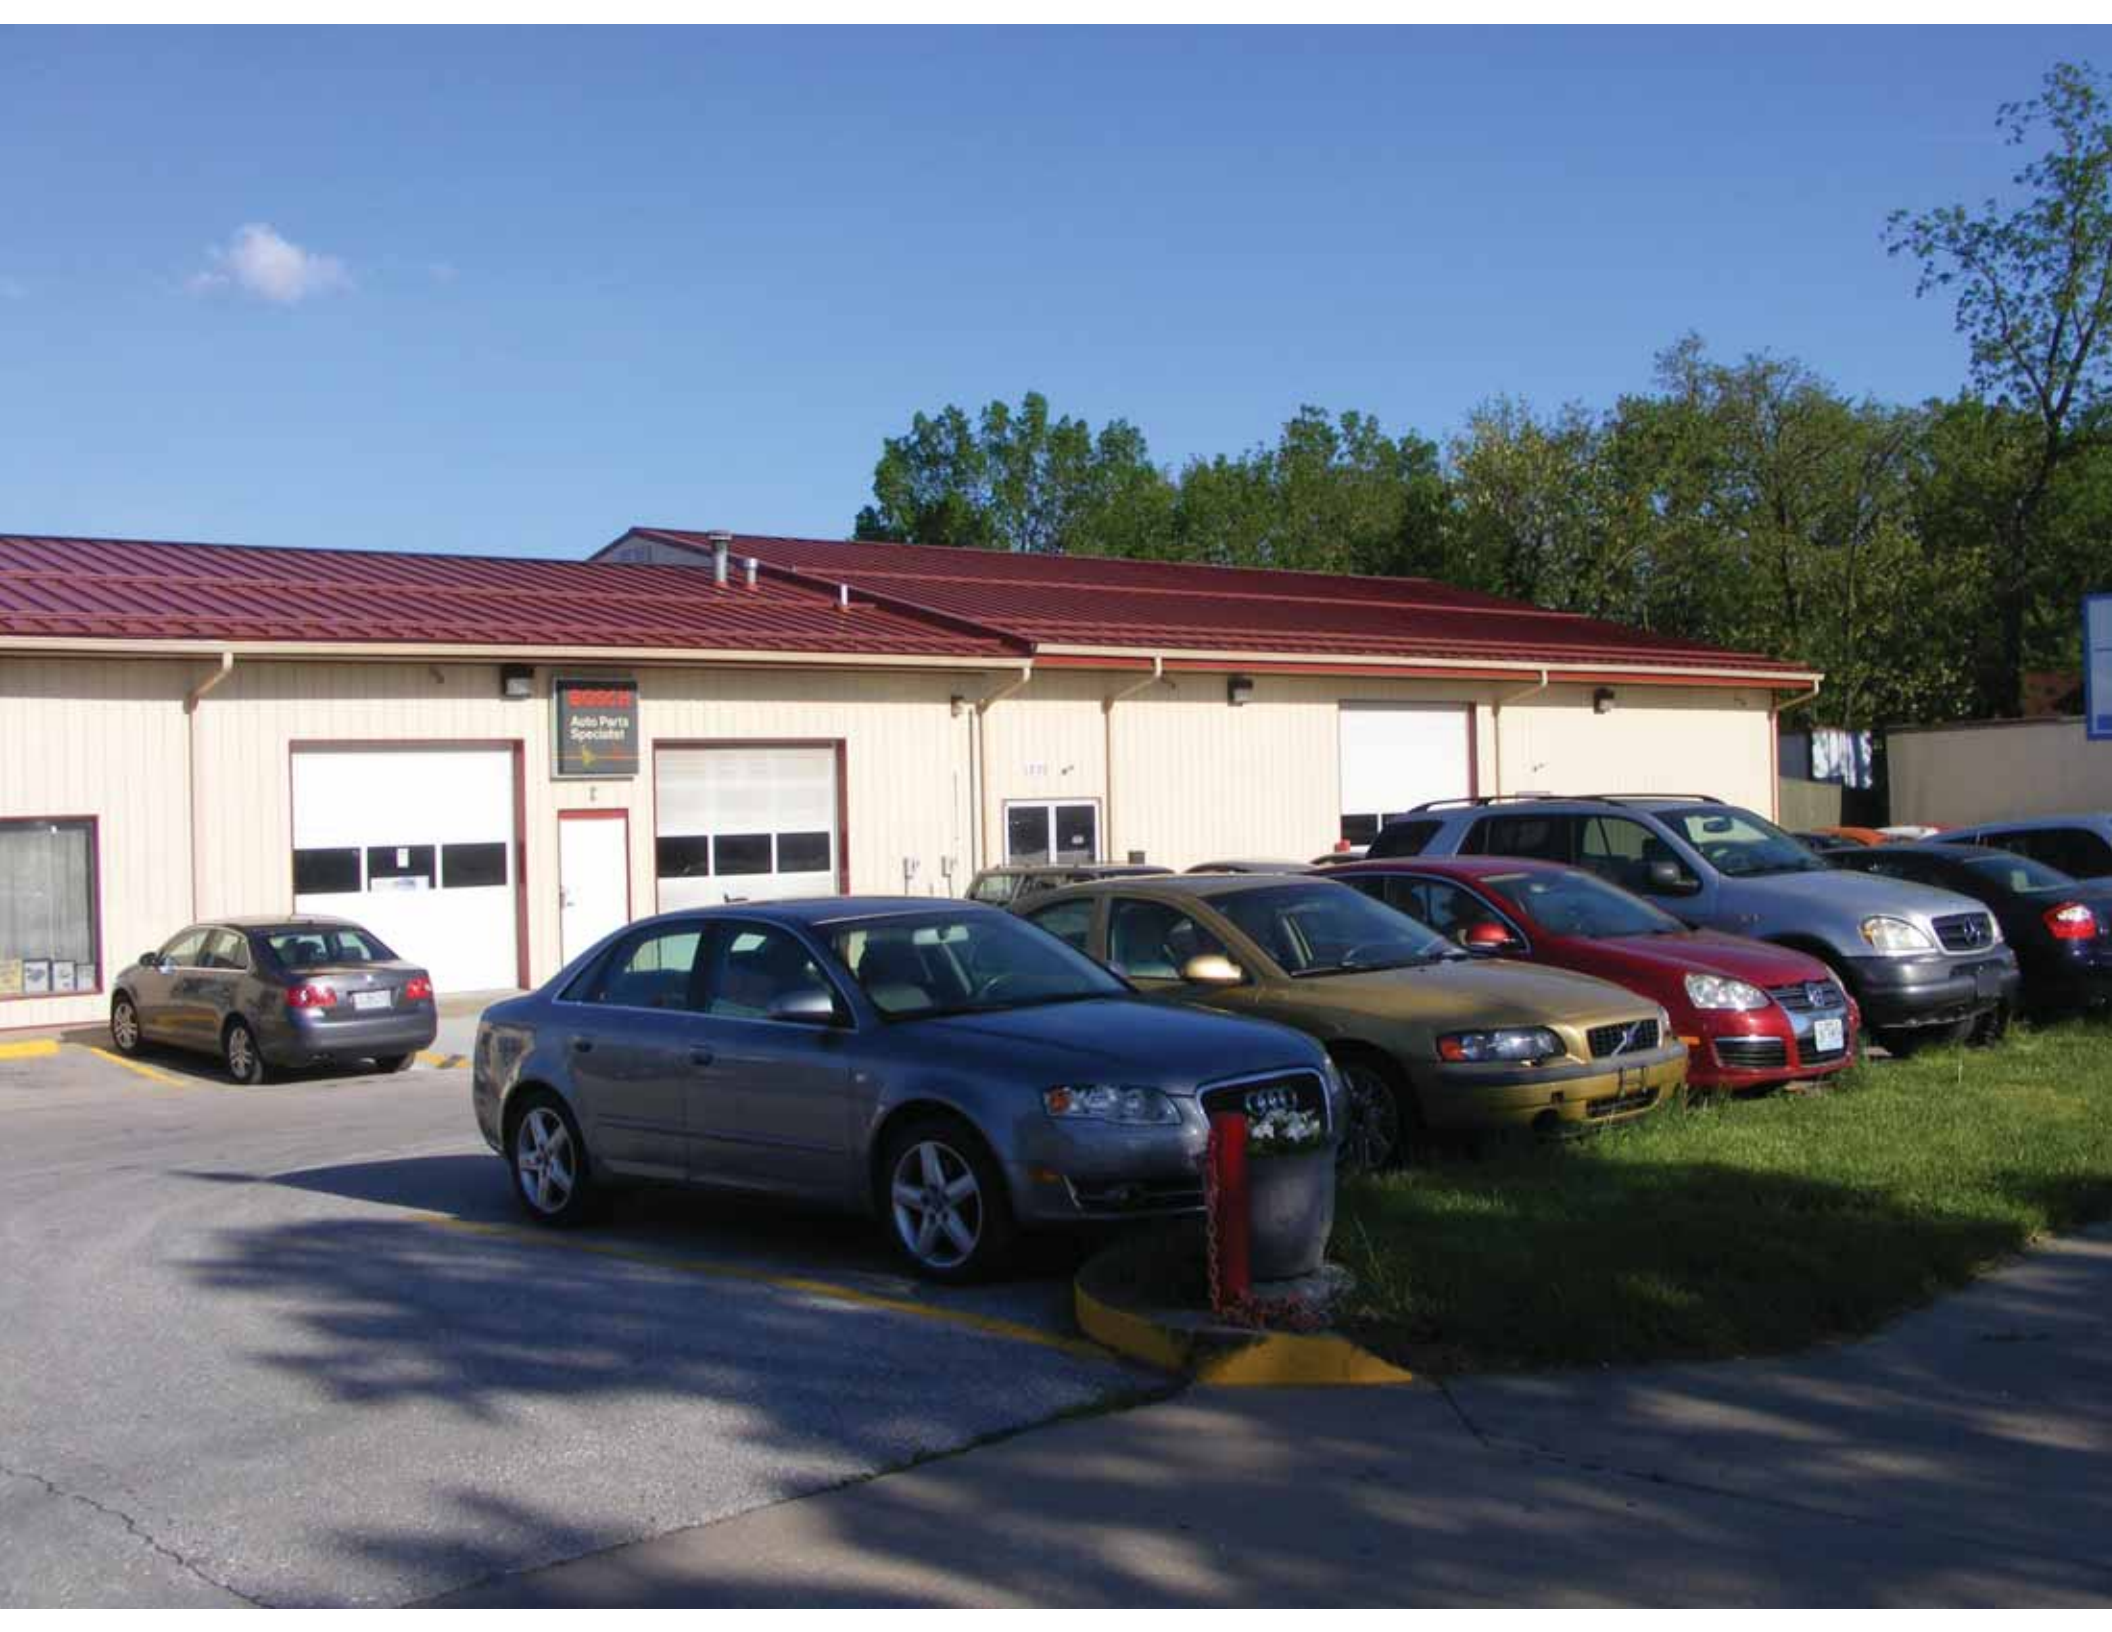
The building has a metal seamed low-gable roof, exterior seamed metal walls and a slab concrete foundation. The roofline extends slightly above the elevation wall and a concrete walk bounding the façade. The primary (east) elevation is composed of nine bays as follows – north to south – paired glass and aluminum doors, four fixed sash commercial windows, an overhead track door with three lights, a solid pedestrian door, a second overhead track door with three lights, paired glass and aluminum doors, a third overhead track door with three lights and a solid pedestrian door. The north elevation, which faces North Boulevard, features a solid pedestrian door and overhead track three-light door (east end). The remaining elevation holds four fixed sash commercial windows (center and west end). The building's business name is secured on a sign attached to the wall above the windows.

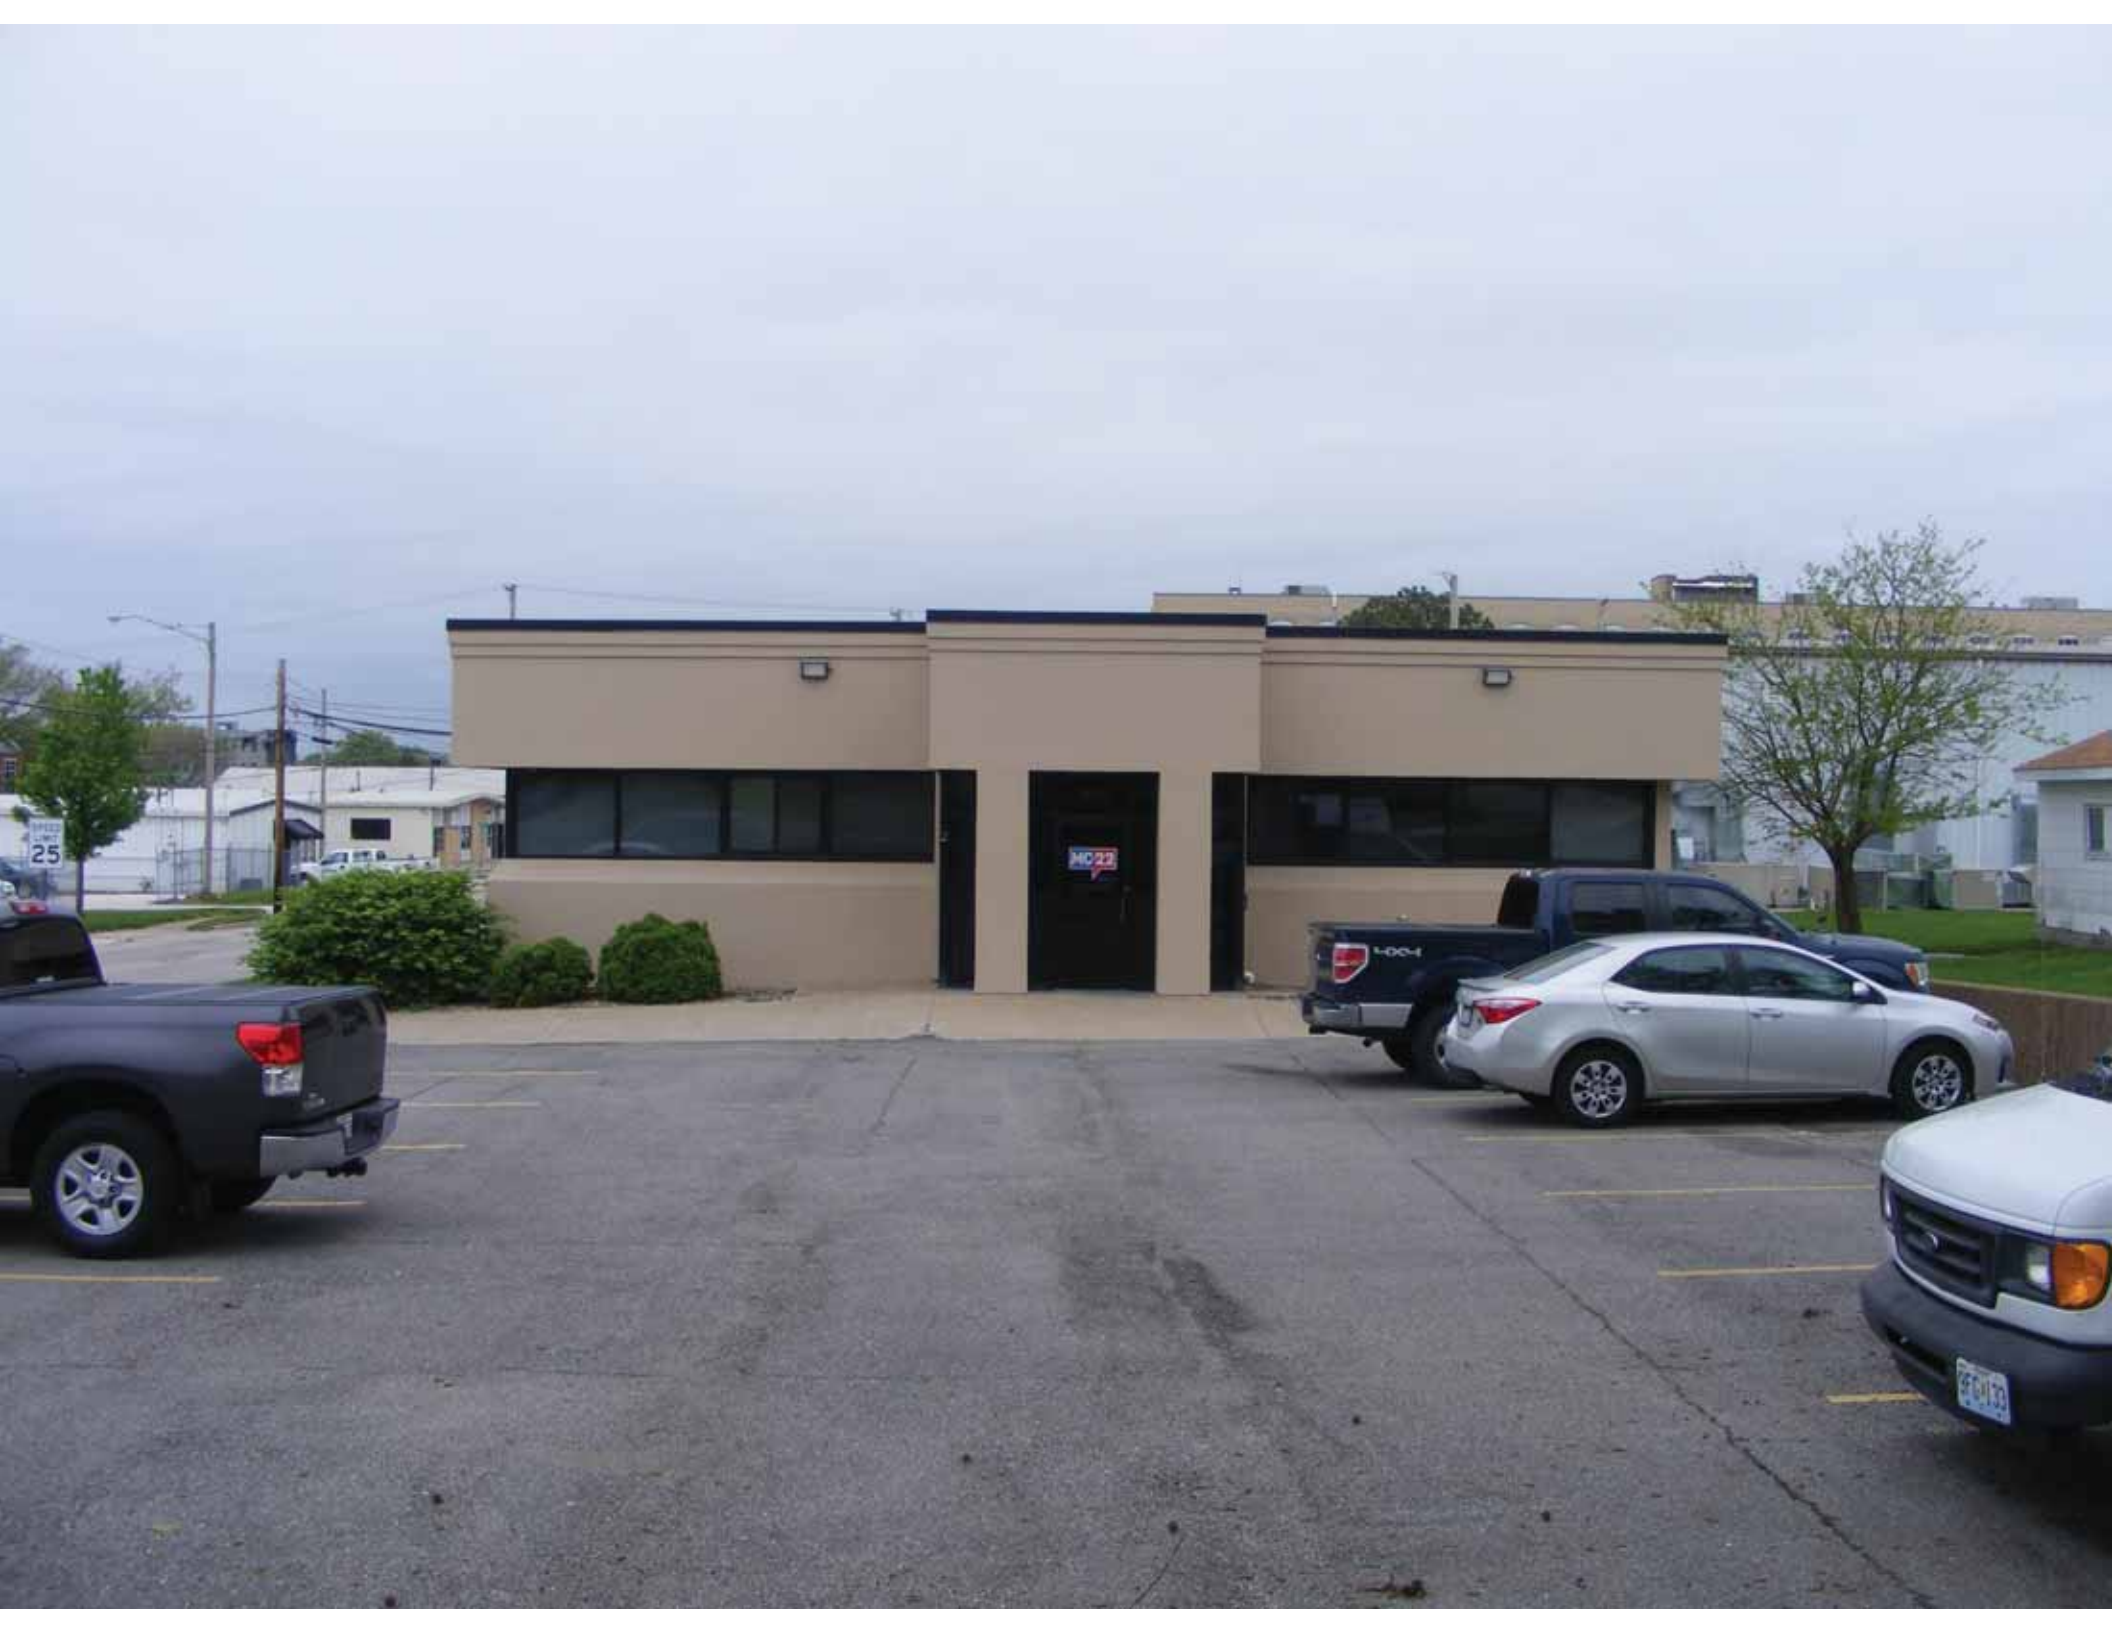
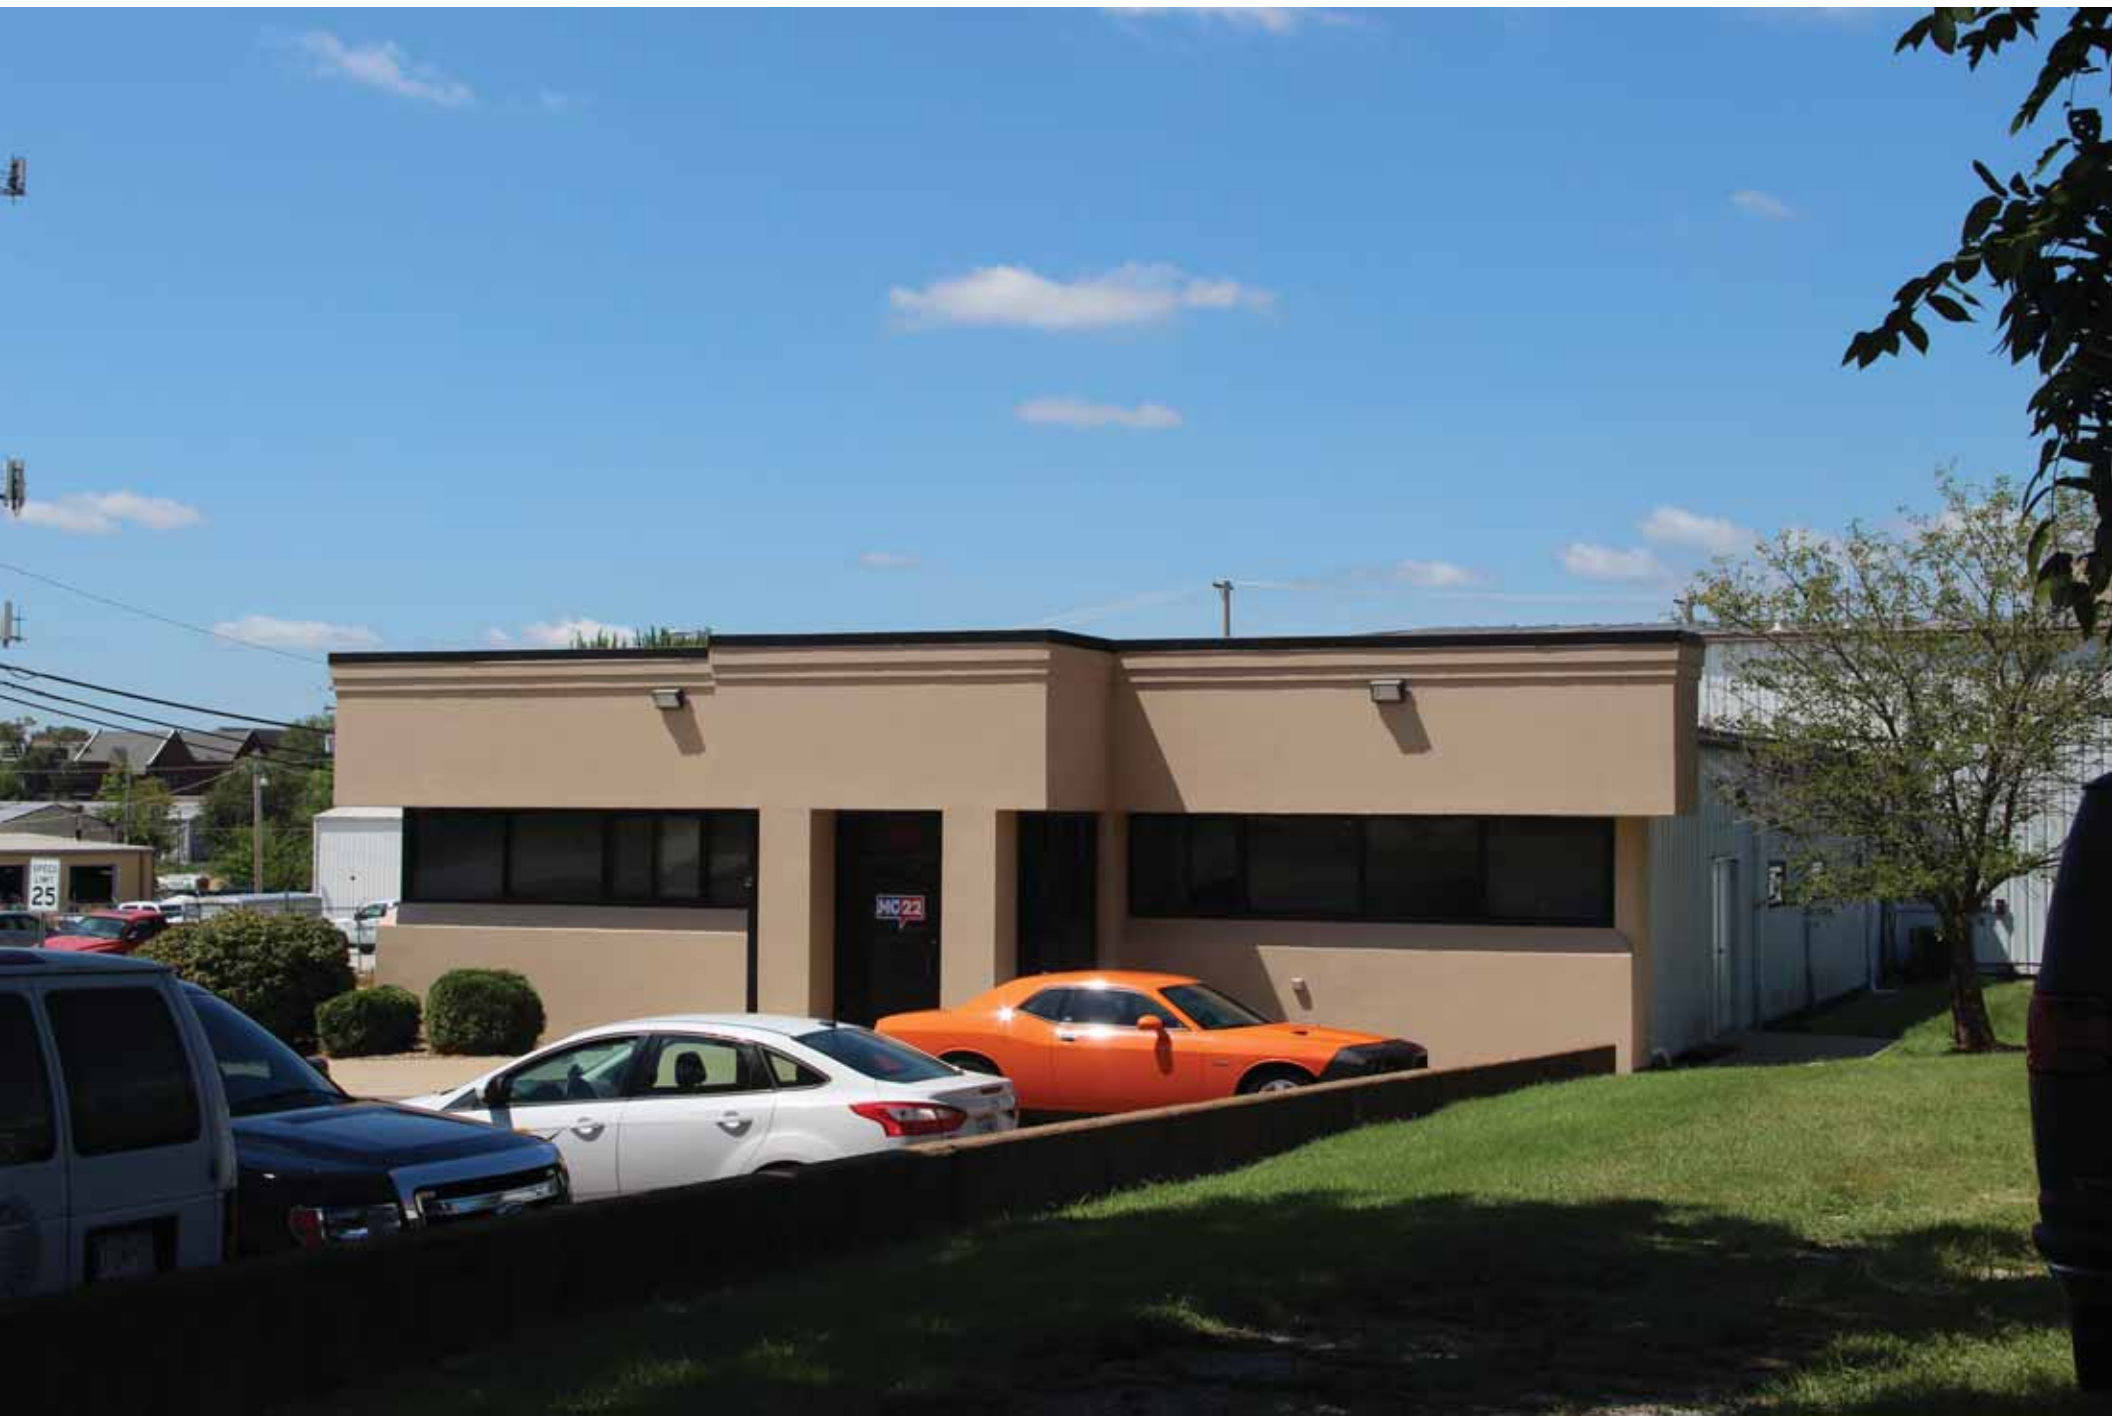
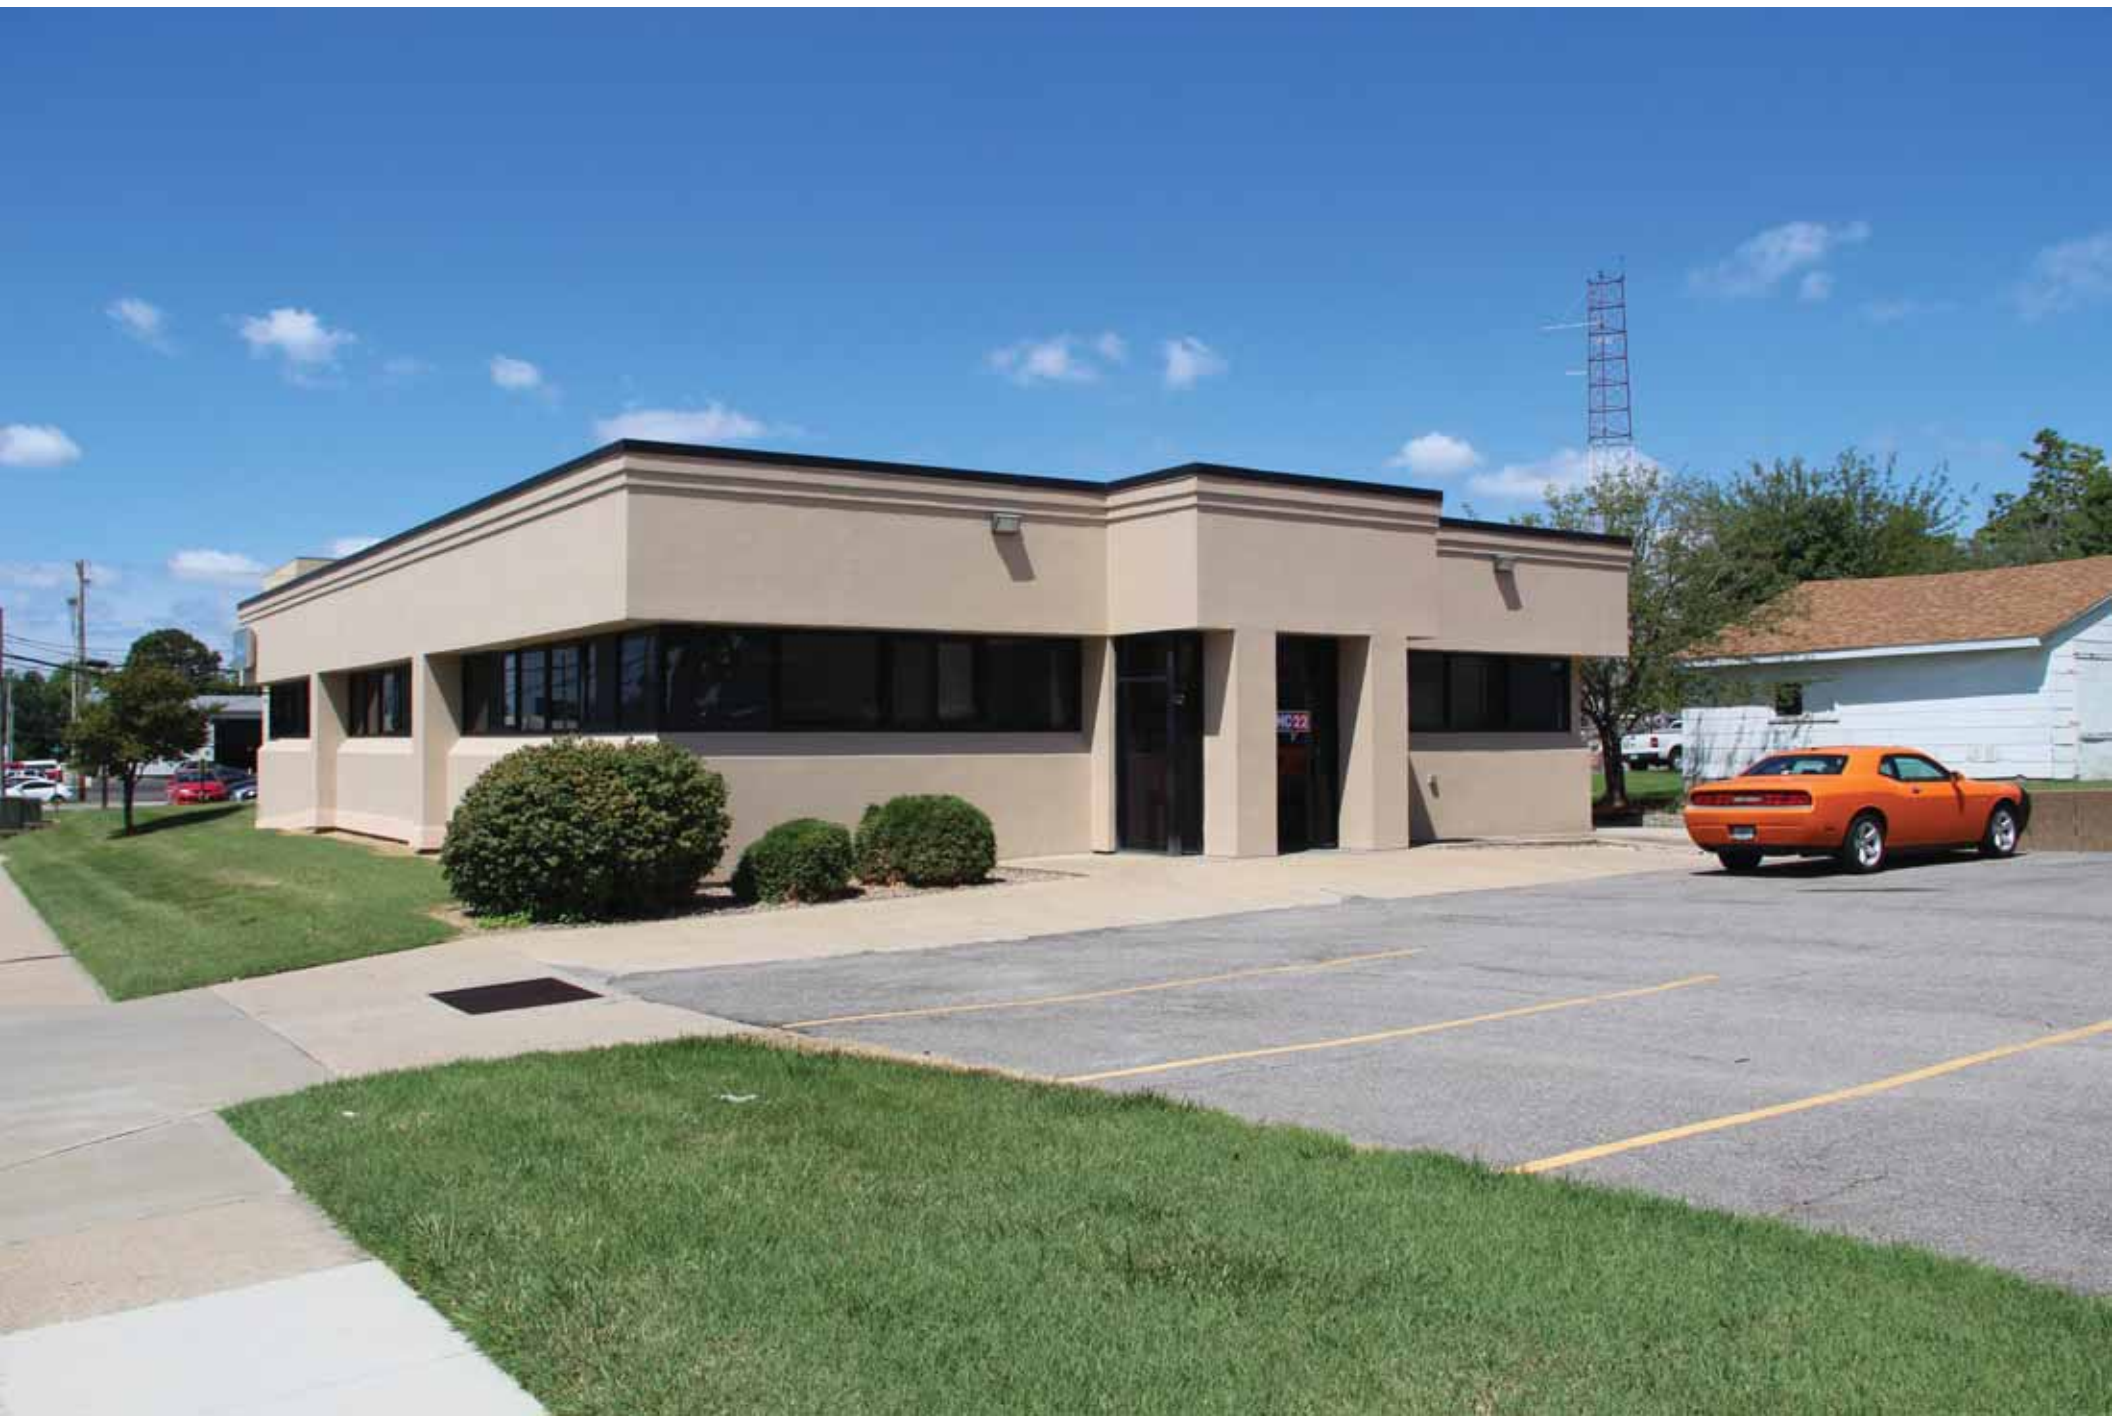
41. (cont.) Description of primary resource. Expand box as necessary, or add continuation pages.
This is a single story EIFS clad commercial building with a flat roof with an attached single story commercial metal and EIFS sided building on the rear elevation. The single story EIFS clad building features a centered projecting bay entrance with three metal/glass doors each side of the bay. Centered on the façade is a band of metal/glass windows that wraps the building. Side elevations feature two projecting perpendicular narrow columns diving the band of windows. The single story metal building attached at the rear elevation features an EIFS clad façade, low-pitched front gable and metal/glass entrance with display windows. The entrance holds a ADA concrete access ramp with iron railings. A shed cloth awning is above the entrance.

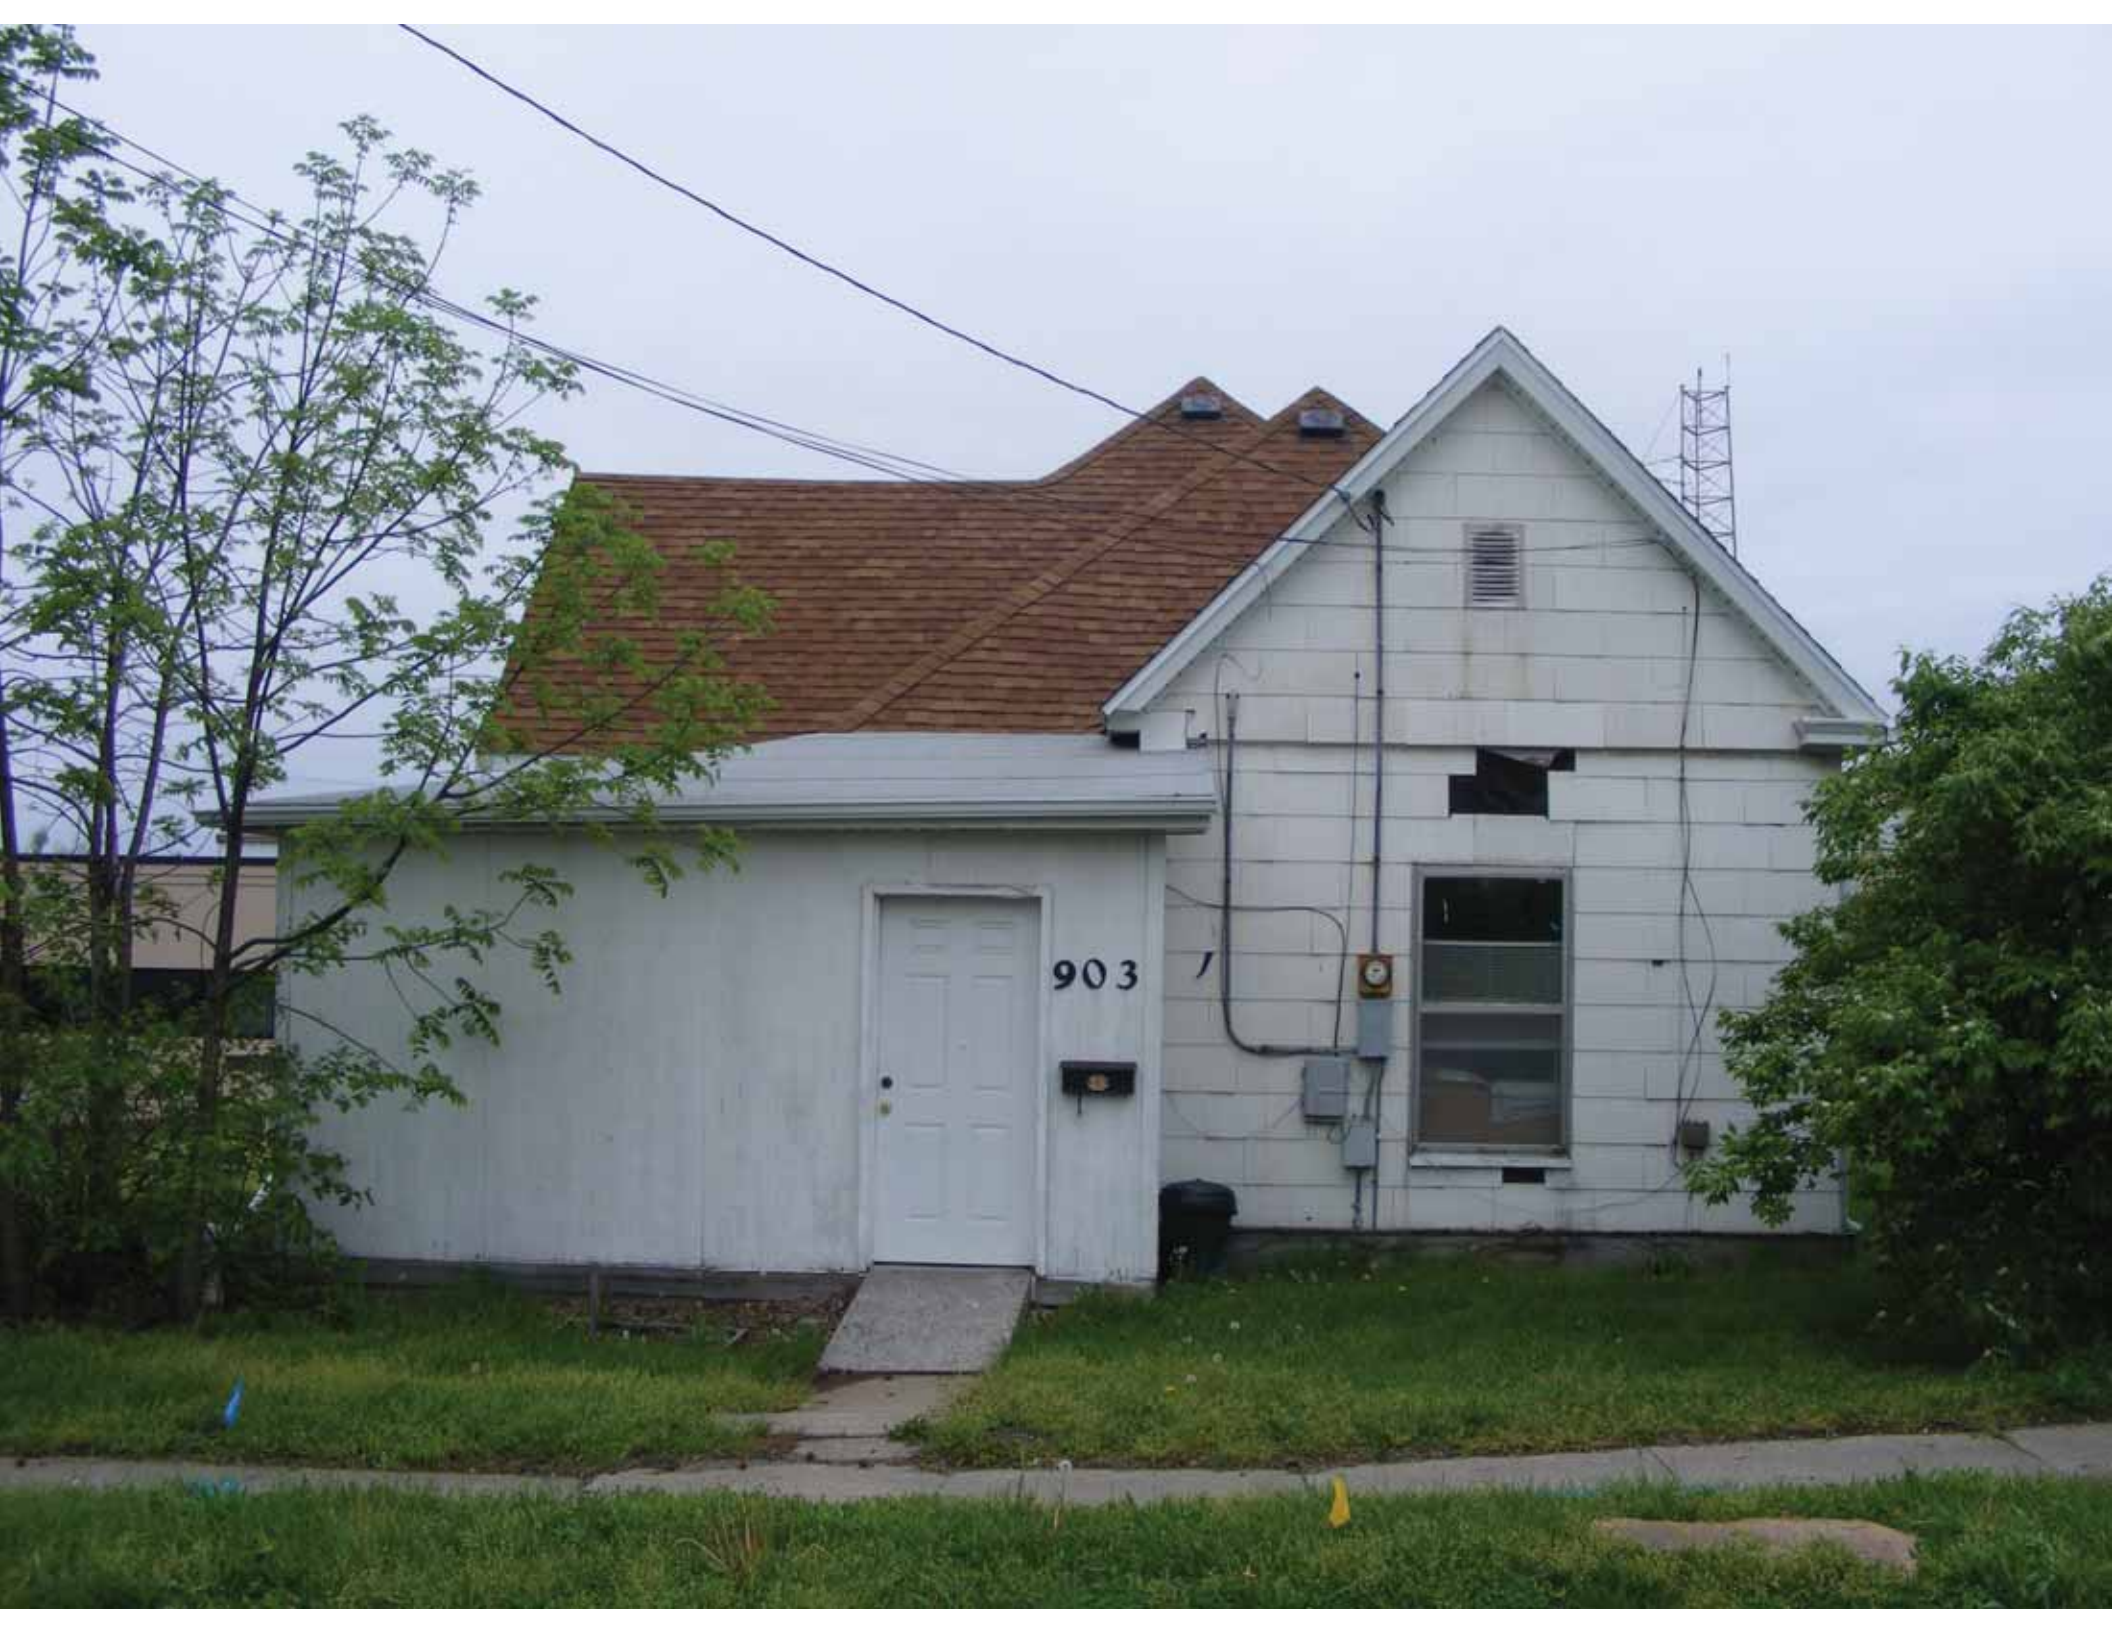
41. (cont.) Description of primary resource. Expand box as necessary, or add continuation pages.
The dwelling is a single-story frame with an asphalt-shingled cross gabled roof and concrete foundation. The exterior has a mixture of asbestos, vinyl and wood siding. The primary elevation holds a front gable with returns and is offset at the north end. Gable end holds a louvered vent and the lower level holds one-over-one window. To the left of the front gable section is a projecting vertical wood clad addition with a low-pitched asphalt-shingled roof. The addition holds an off-set entrance with a metal paneled door. Side elevations hold one-over-one windows and some windows are covered over.
