MISSOURI DEPARTMENT OF NATURAL RESOURCES
STATE HISTORIC PRESERVATION OFFICE, P.O. Box 176, Jefferson City, MO 65102
ARCHITECTURAL/HISTORIC INVENTORY FORM

1. Survey No. BO-AS-011-0087		2. Survey name: North Central Columbia Survey Phase II	
3. County: Boone		4. Address (Street No.) 902	Street (name) N. Seventh Street
5. City: Columbia	Vicinity: <input type="checkbox"/>	6. Geographical Reference:	7. Township/Range/Section: T: R: S:
8. Historic name (if known):		9. Present/other name (if known):	
10. Ownership: <input checked="" type="checkbox"/> Private <input type="checkbox"/> Public		11a. Historic use (if known): Domestic/single dwelling	11b. Current use: Domestic/single dwelling

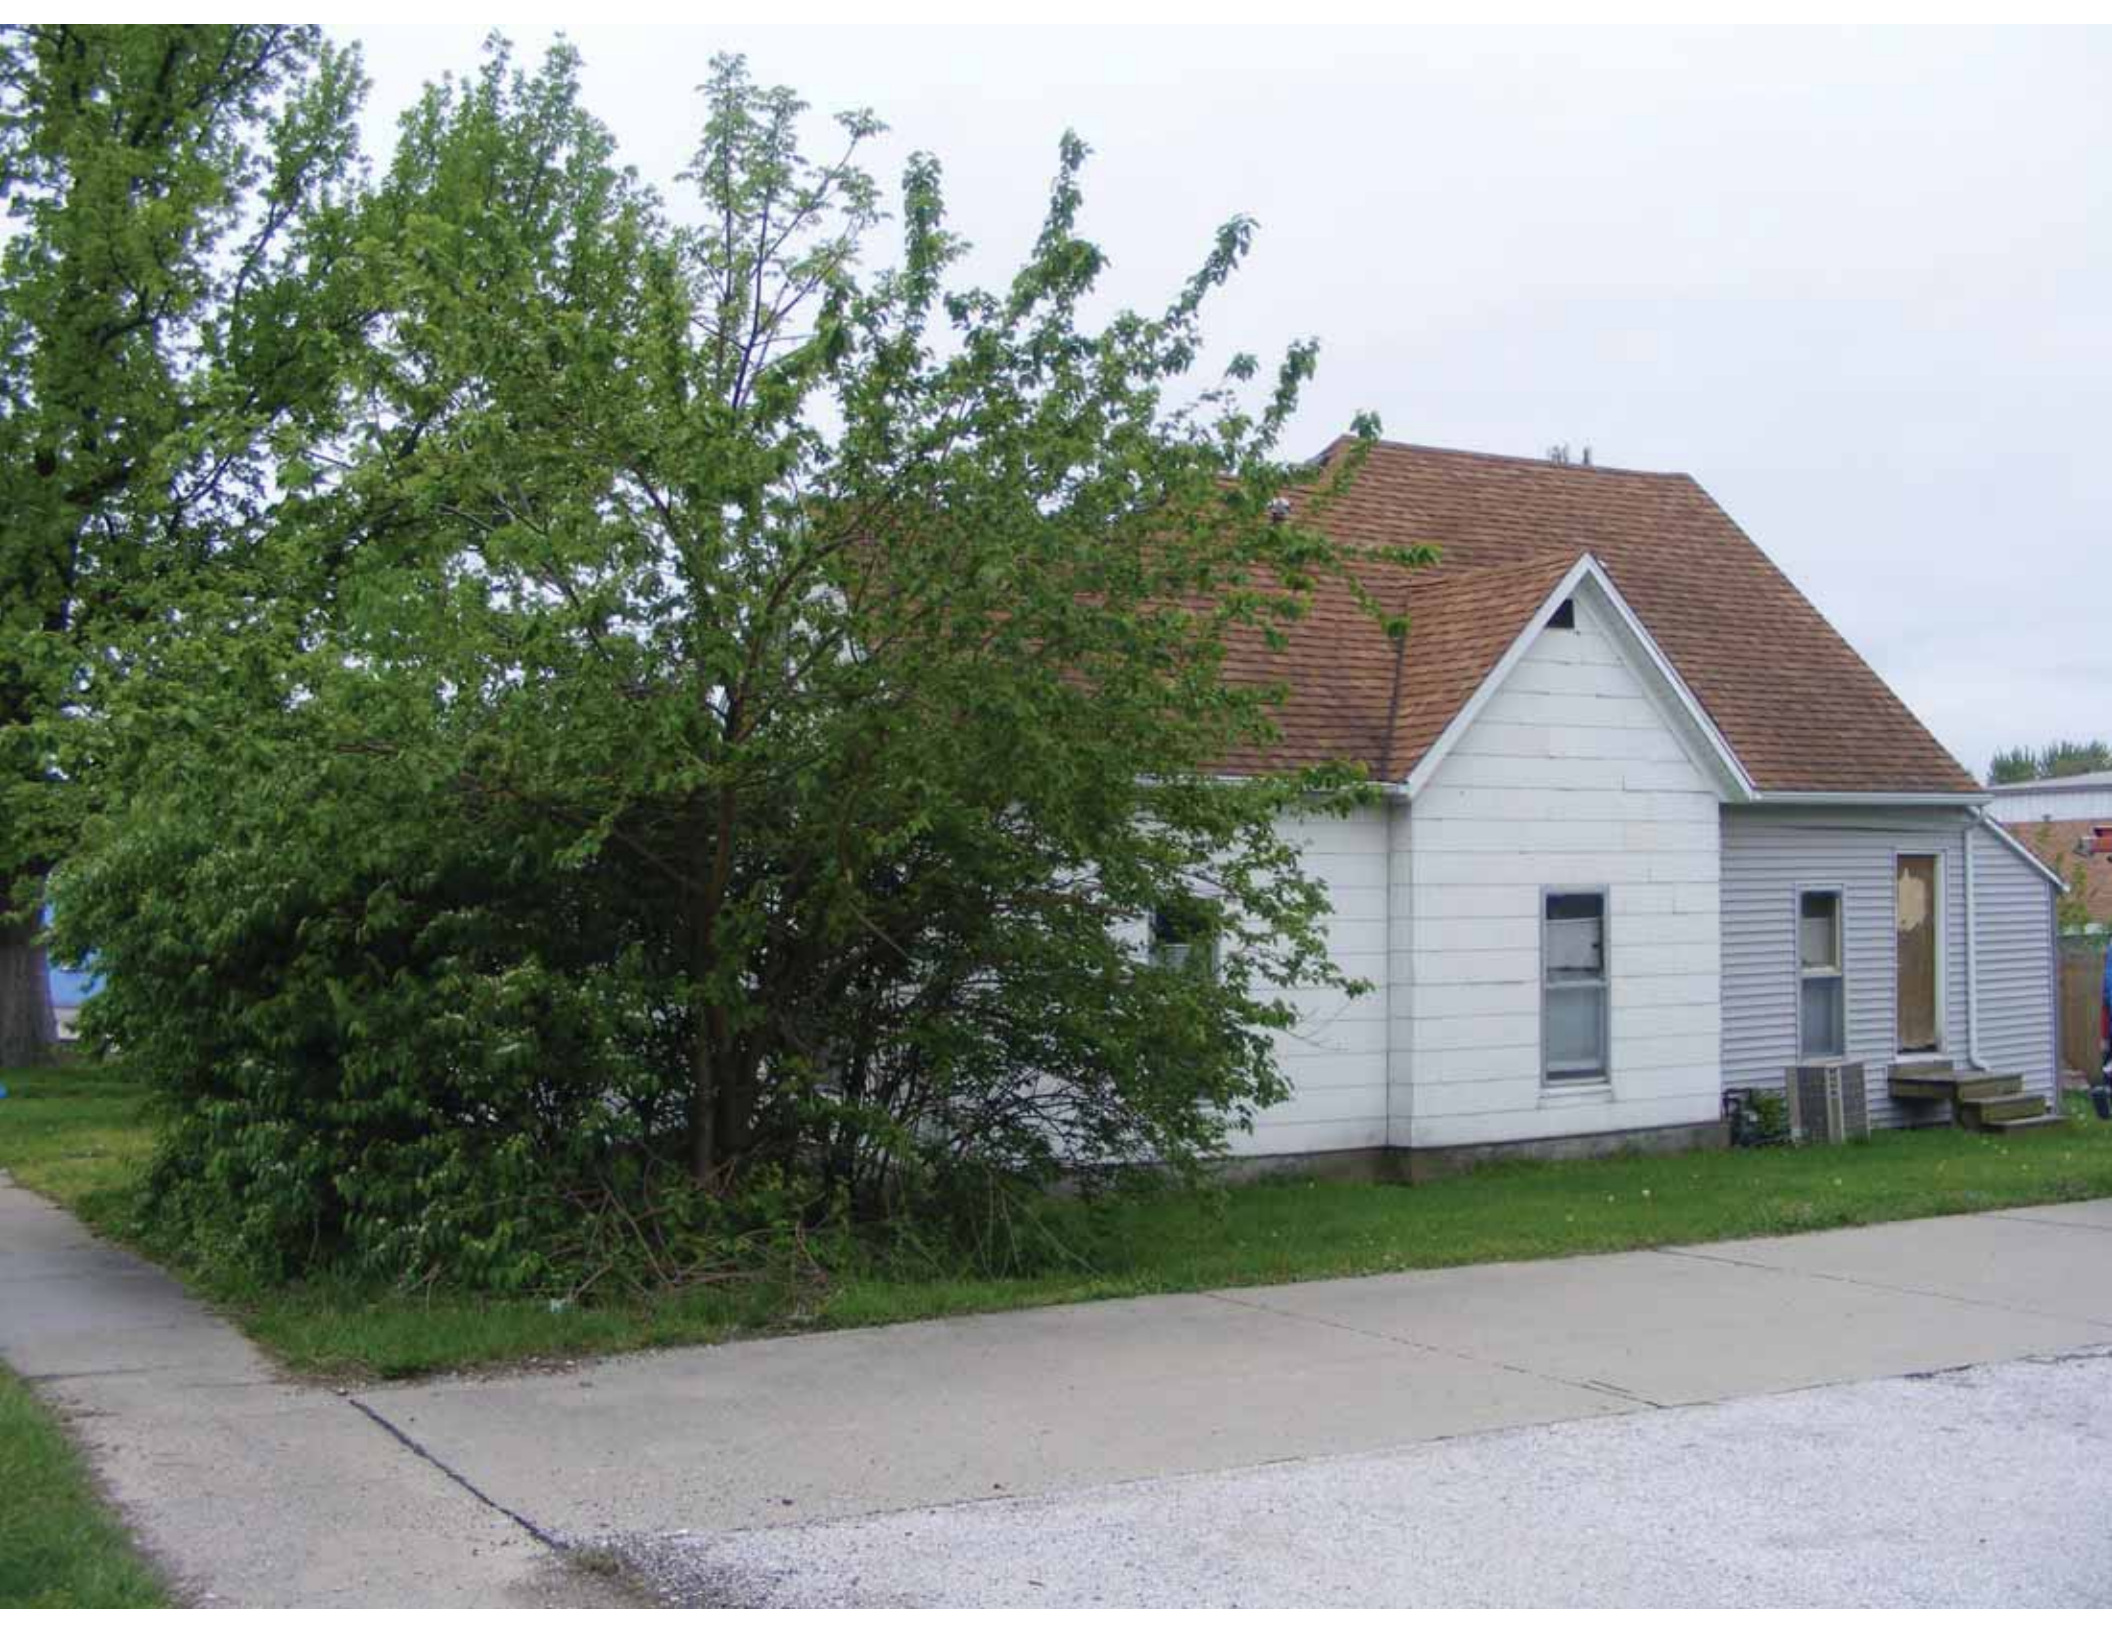
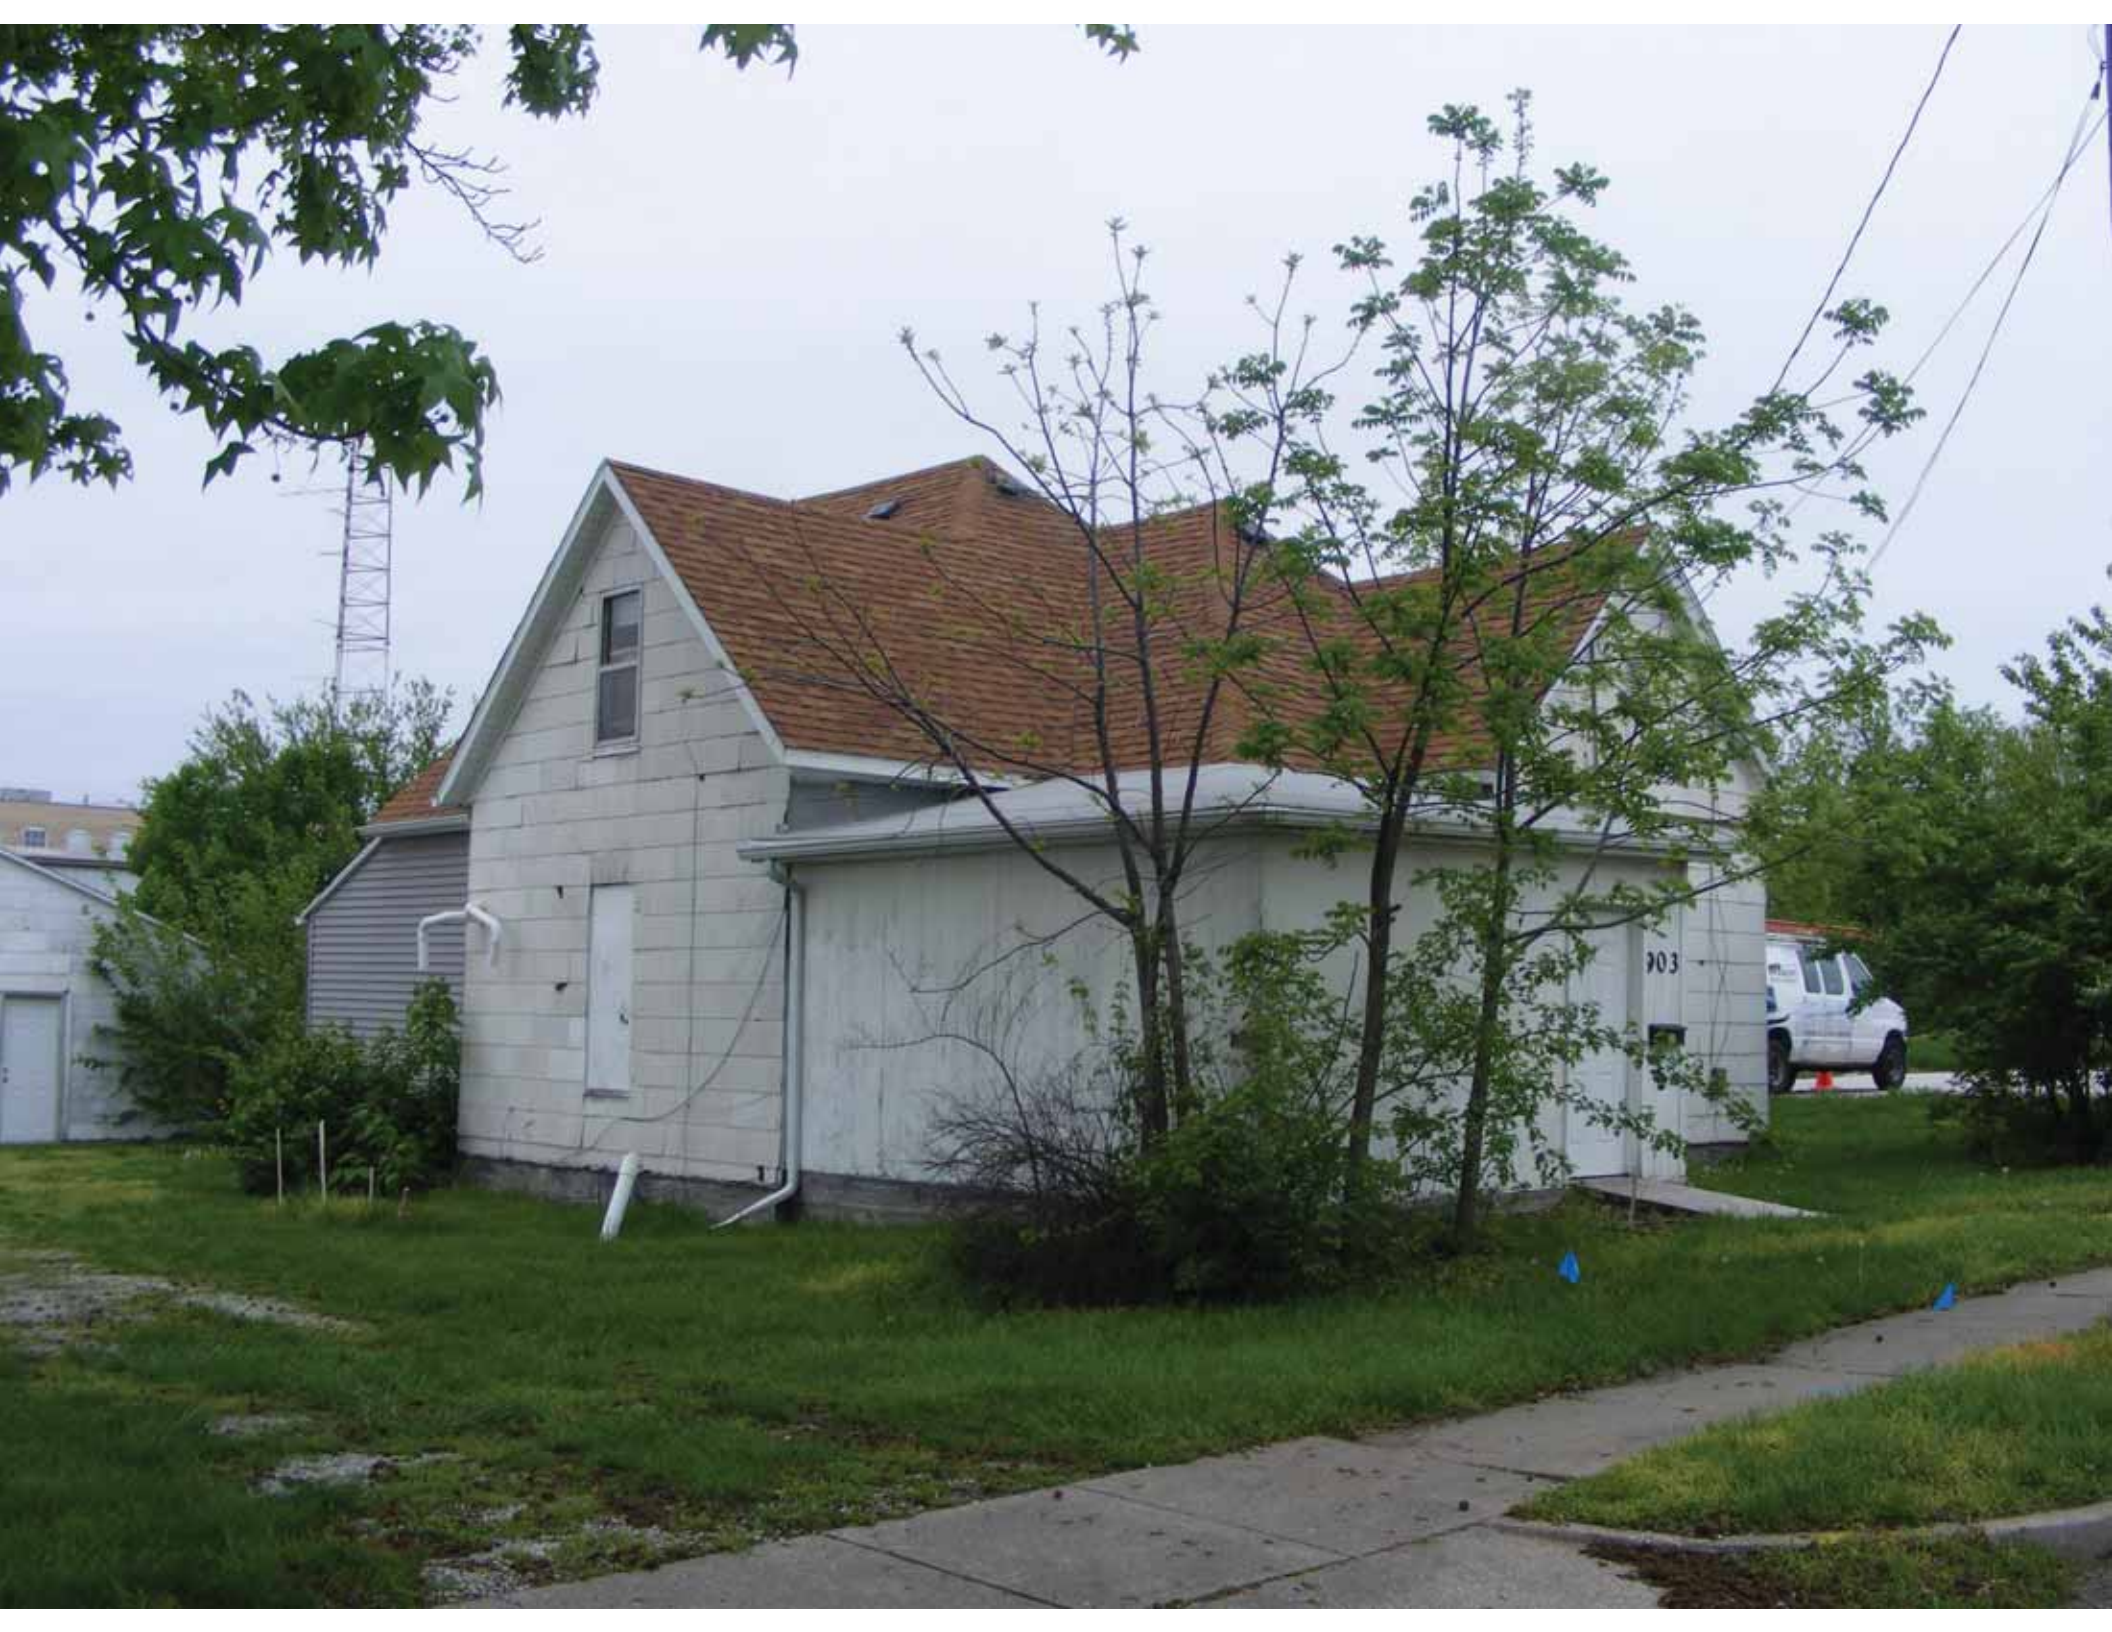
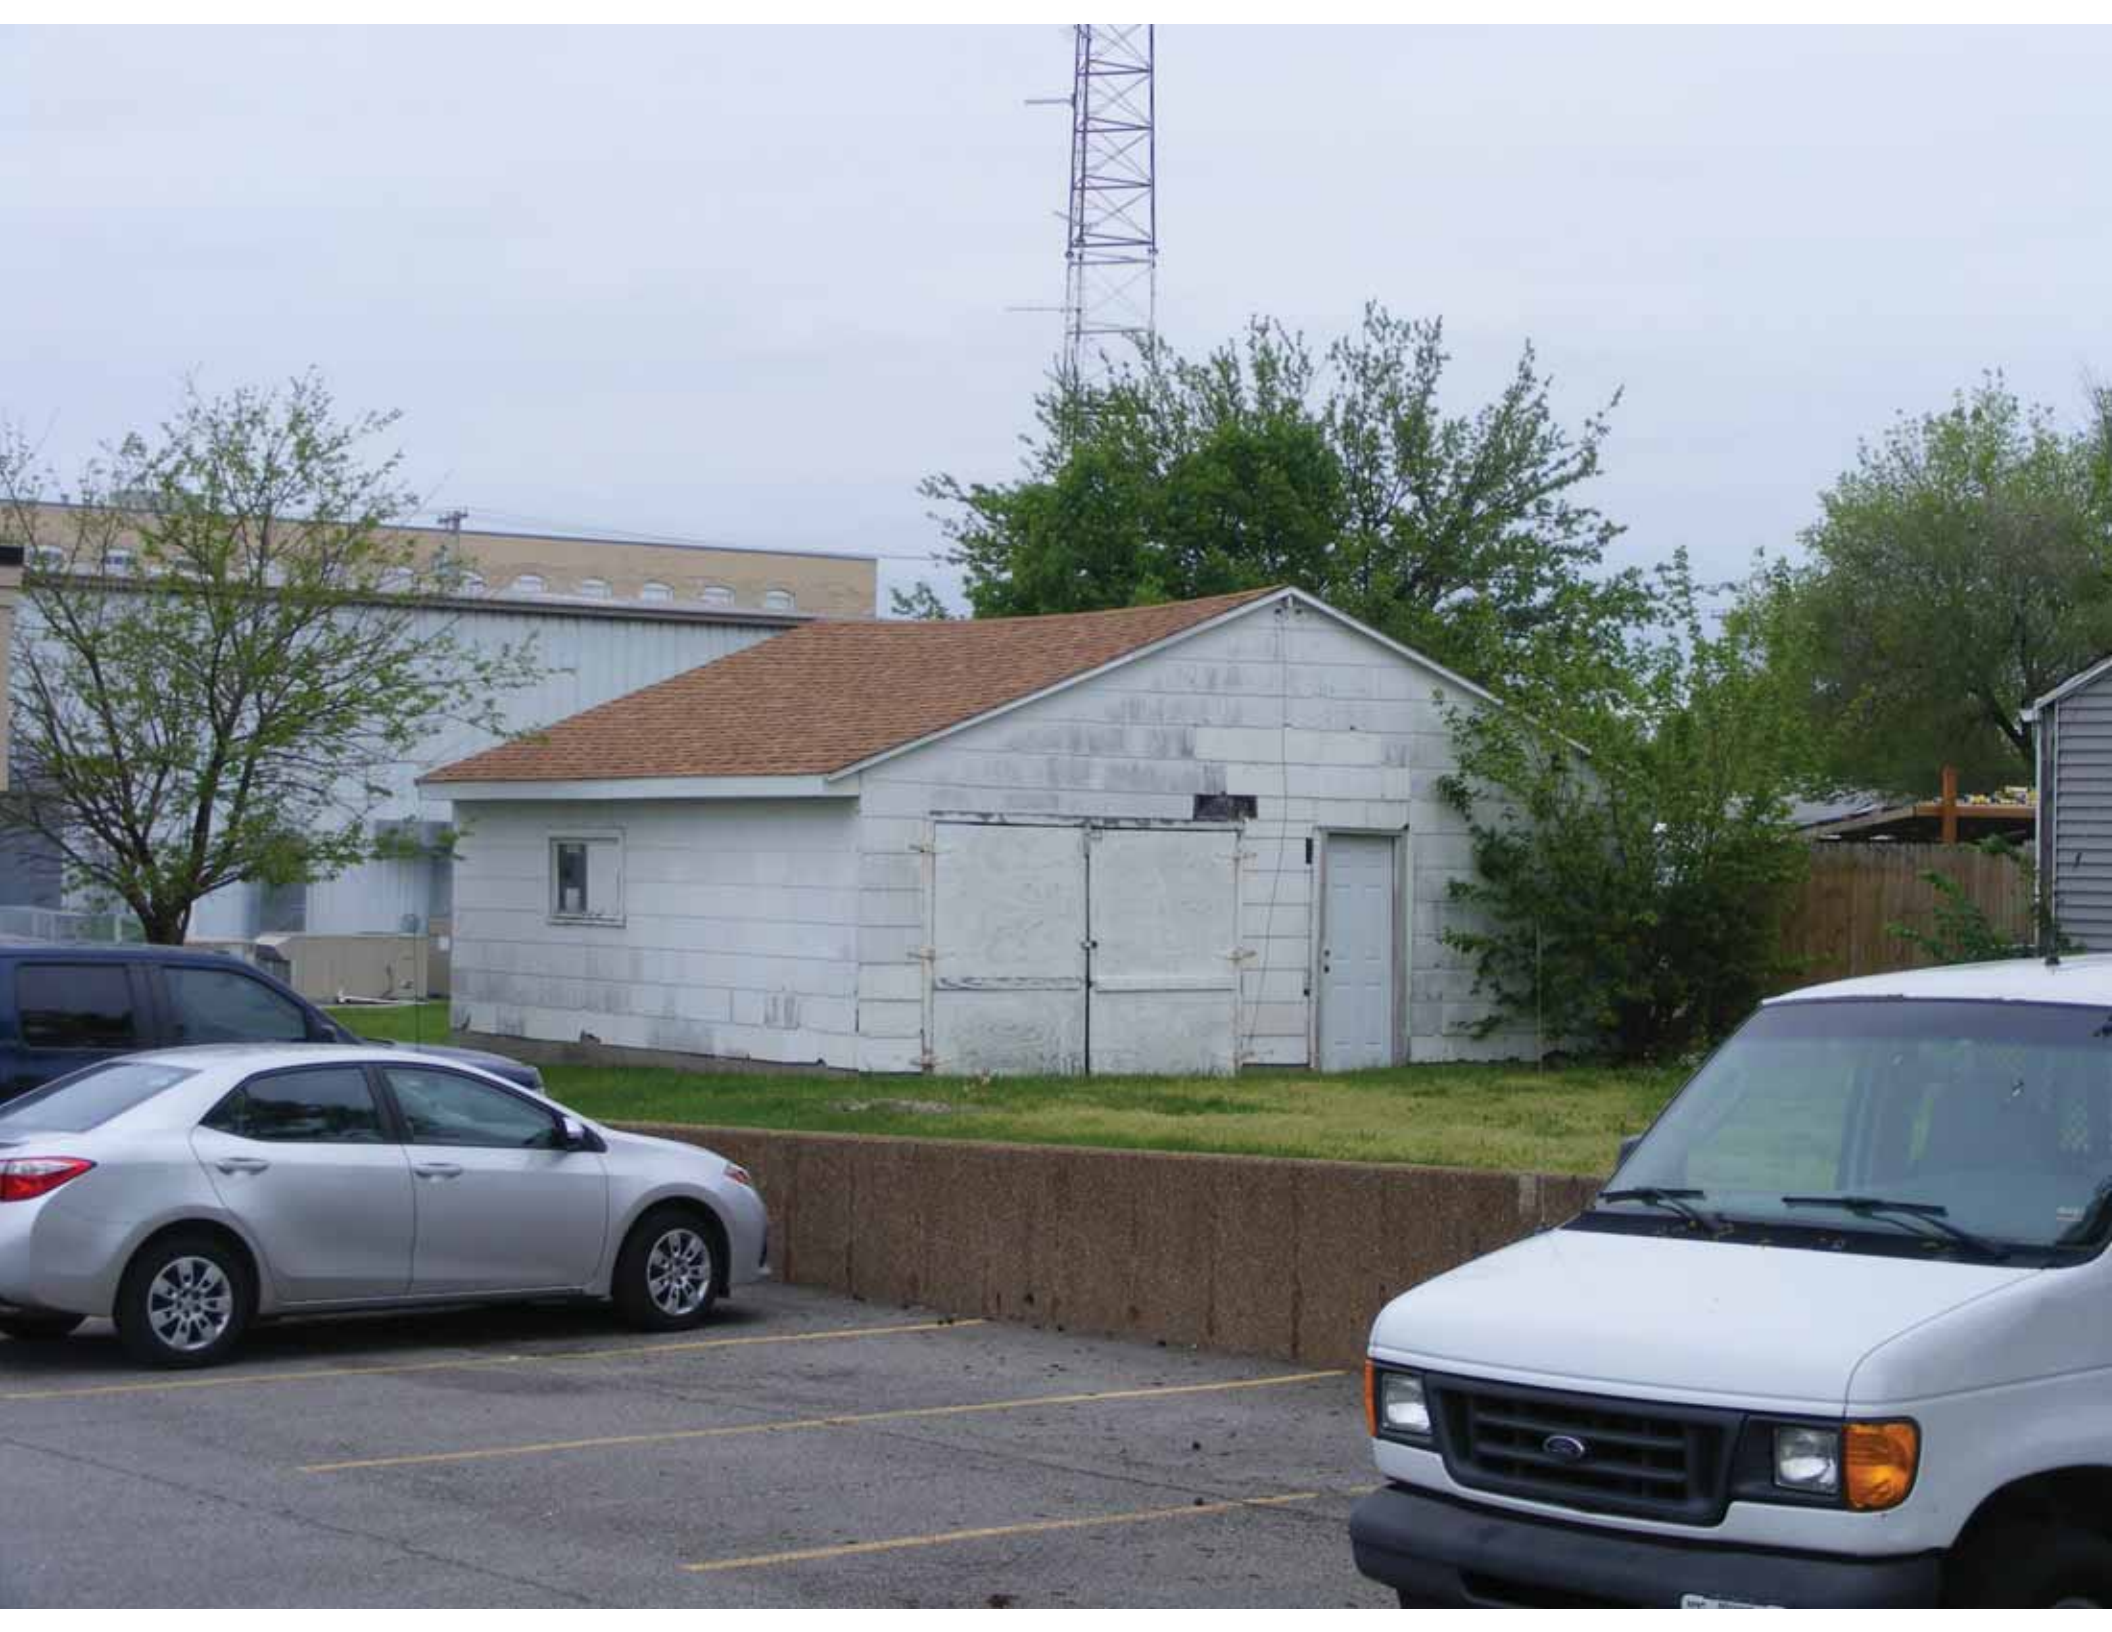
41. (cont.) Description of primary resource. Expand box as necessary, or add continuation pages.
The dwelling is a single-story frame with an asphalt-shingled cross gabled roof and concrete foundation. The exterior has a mixture of asbestos, vinyl and wood siding. The primary elevation holds a front gable with returns and is offset at the north end. Gable end holds a louvered vent and the lower level holds one-over-one window. To the left of the front gable section is a projecting vertical wood clad addition with a low-pitched asphalt-shingled roof. The addition holds an off-set entrance with a metal paneled door. Side elevations hold one-over-one windows and some windows are covered over.

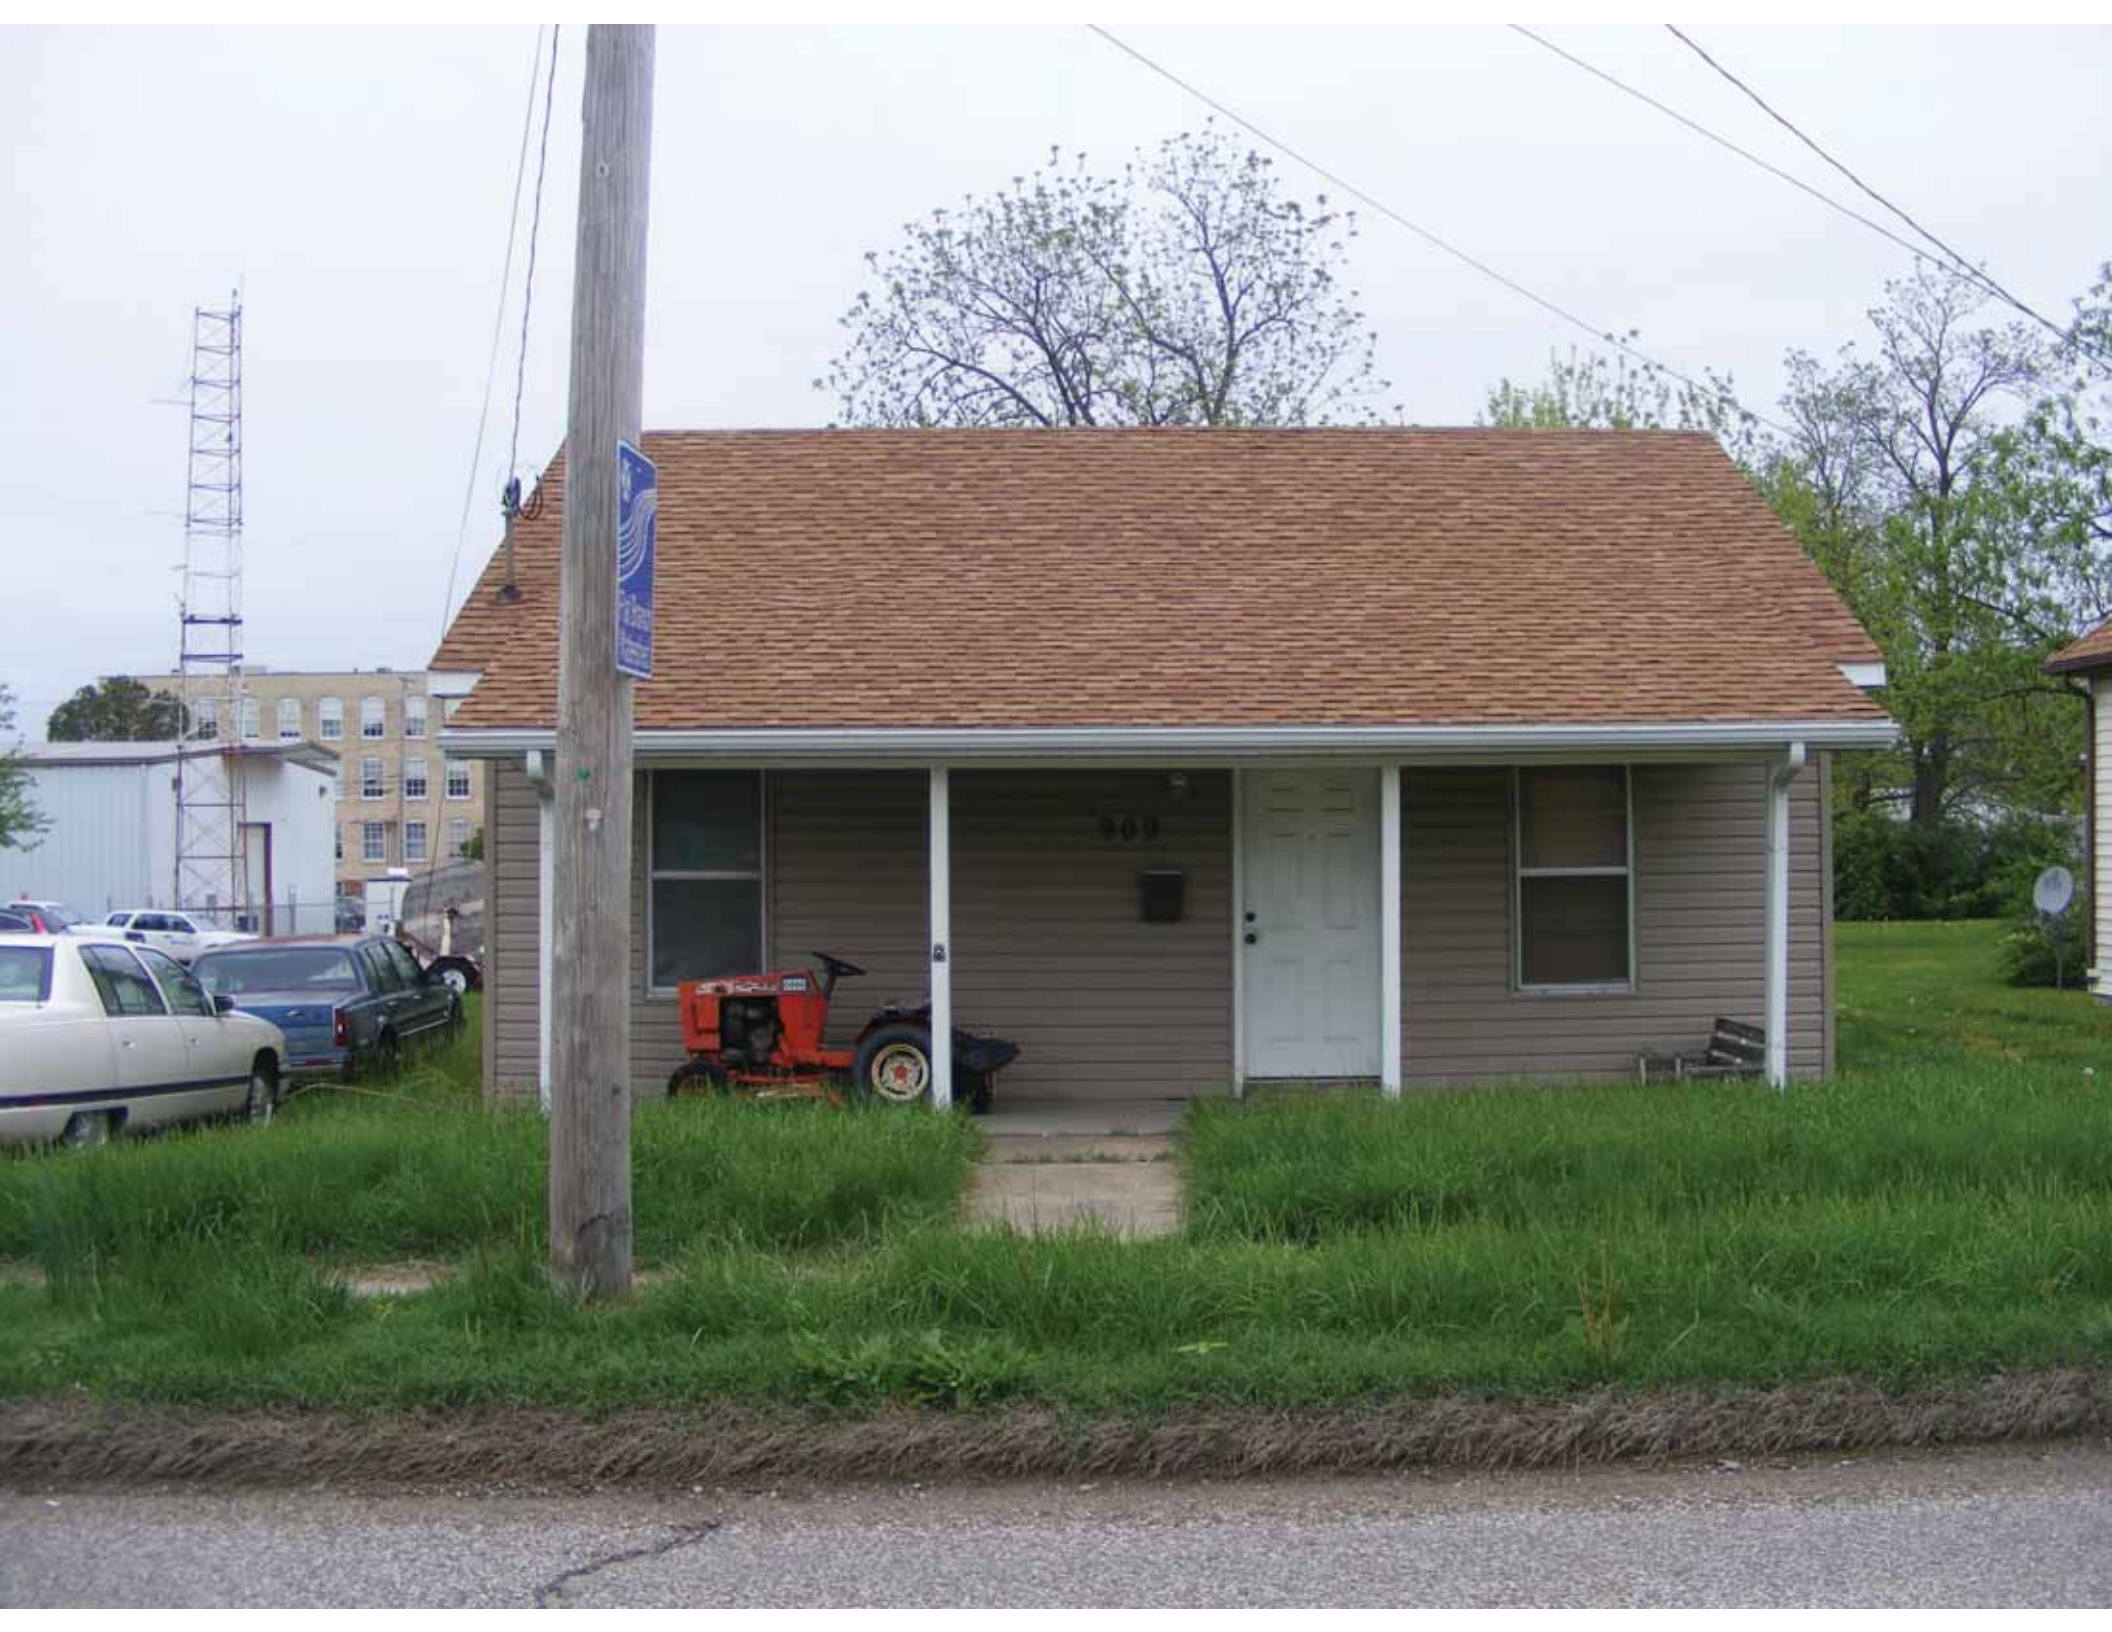
41. (cont.) Description of primary resource. Expand box as necessary, or add continuation pages.
The dwelling is a single-story with an asphalt-shingled side gabled roof, exterior vinyl siding and a covered foundation. The primary elevation has a shed full-width porch (non-original ca. 1990) supported by square posts and concrete decking. The shed roof intersects the front gable slope. The porch bay holds an off-centered door flanked by one-over-one windows. Side elevations feature one-over-one windows.

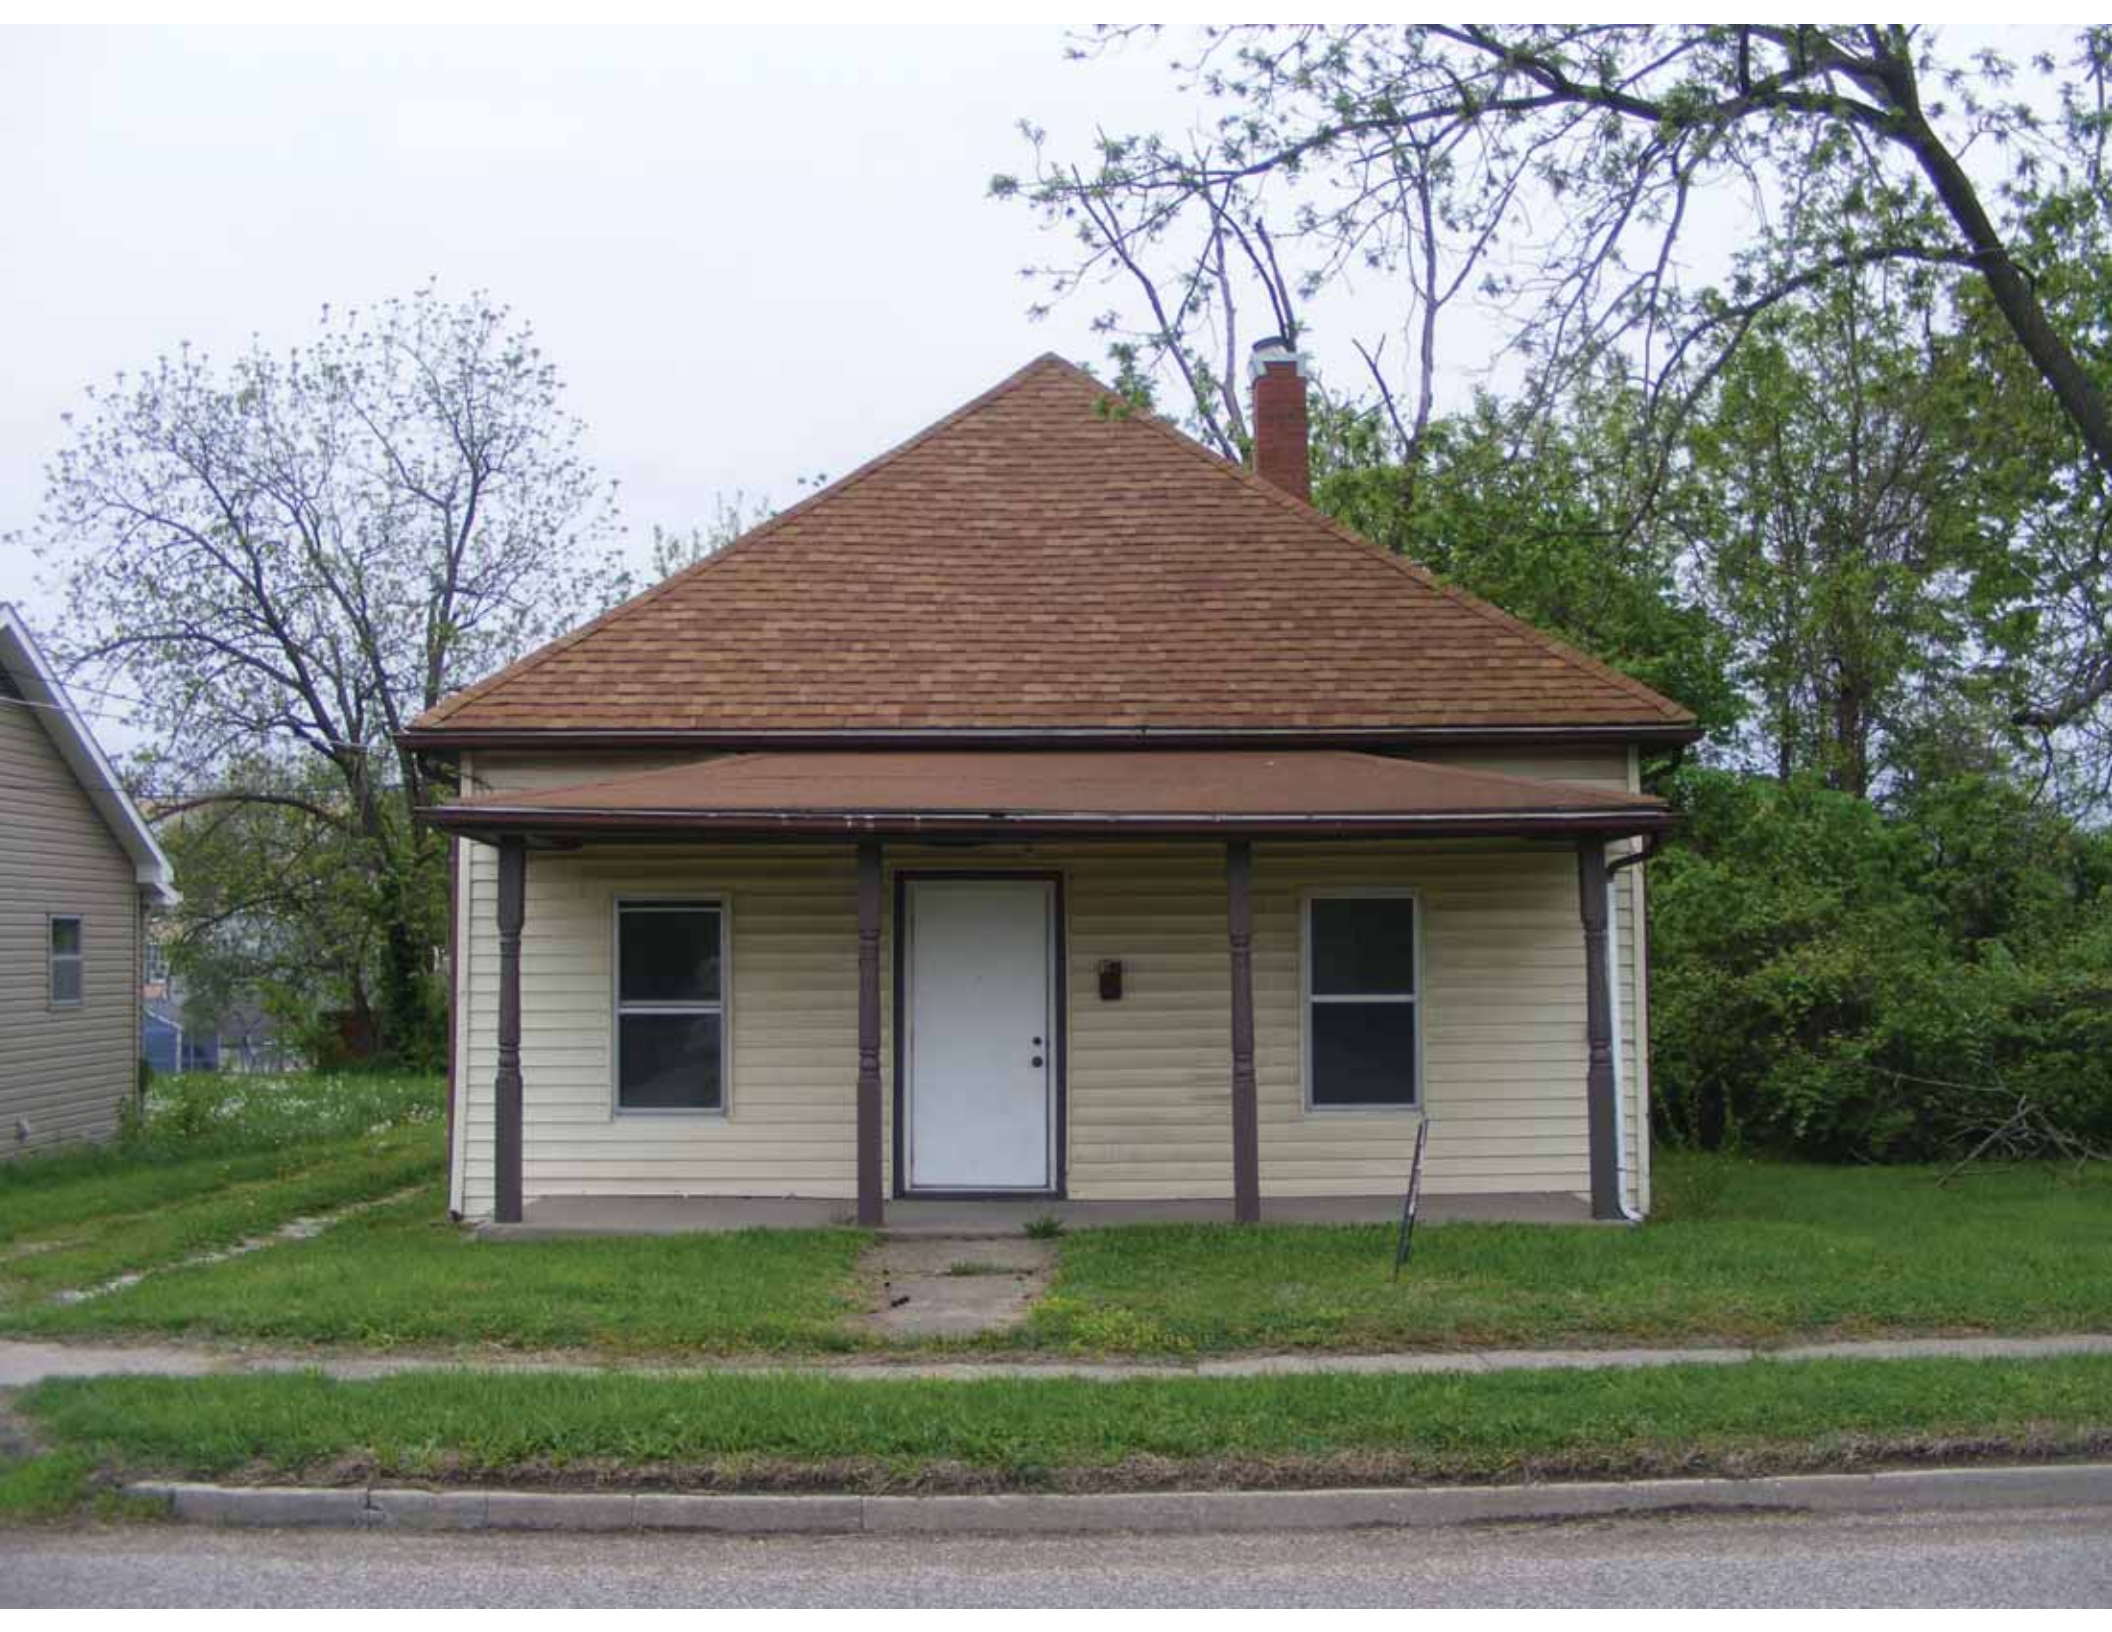
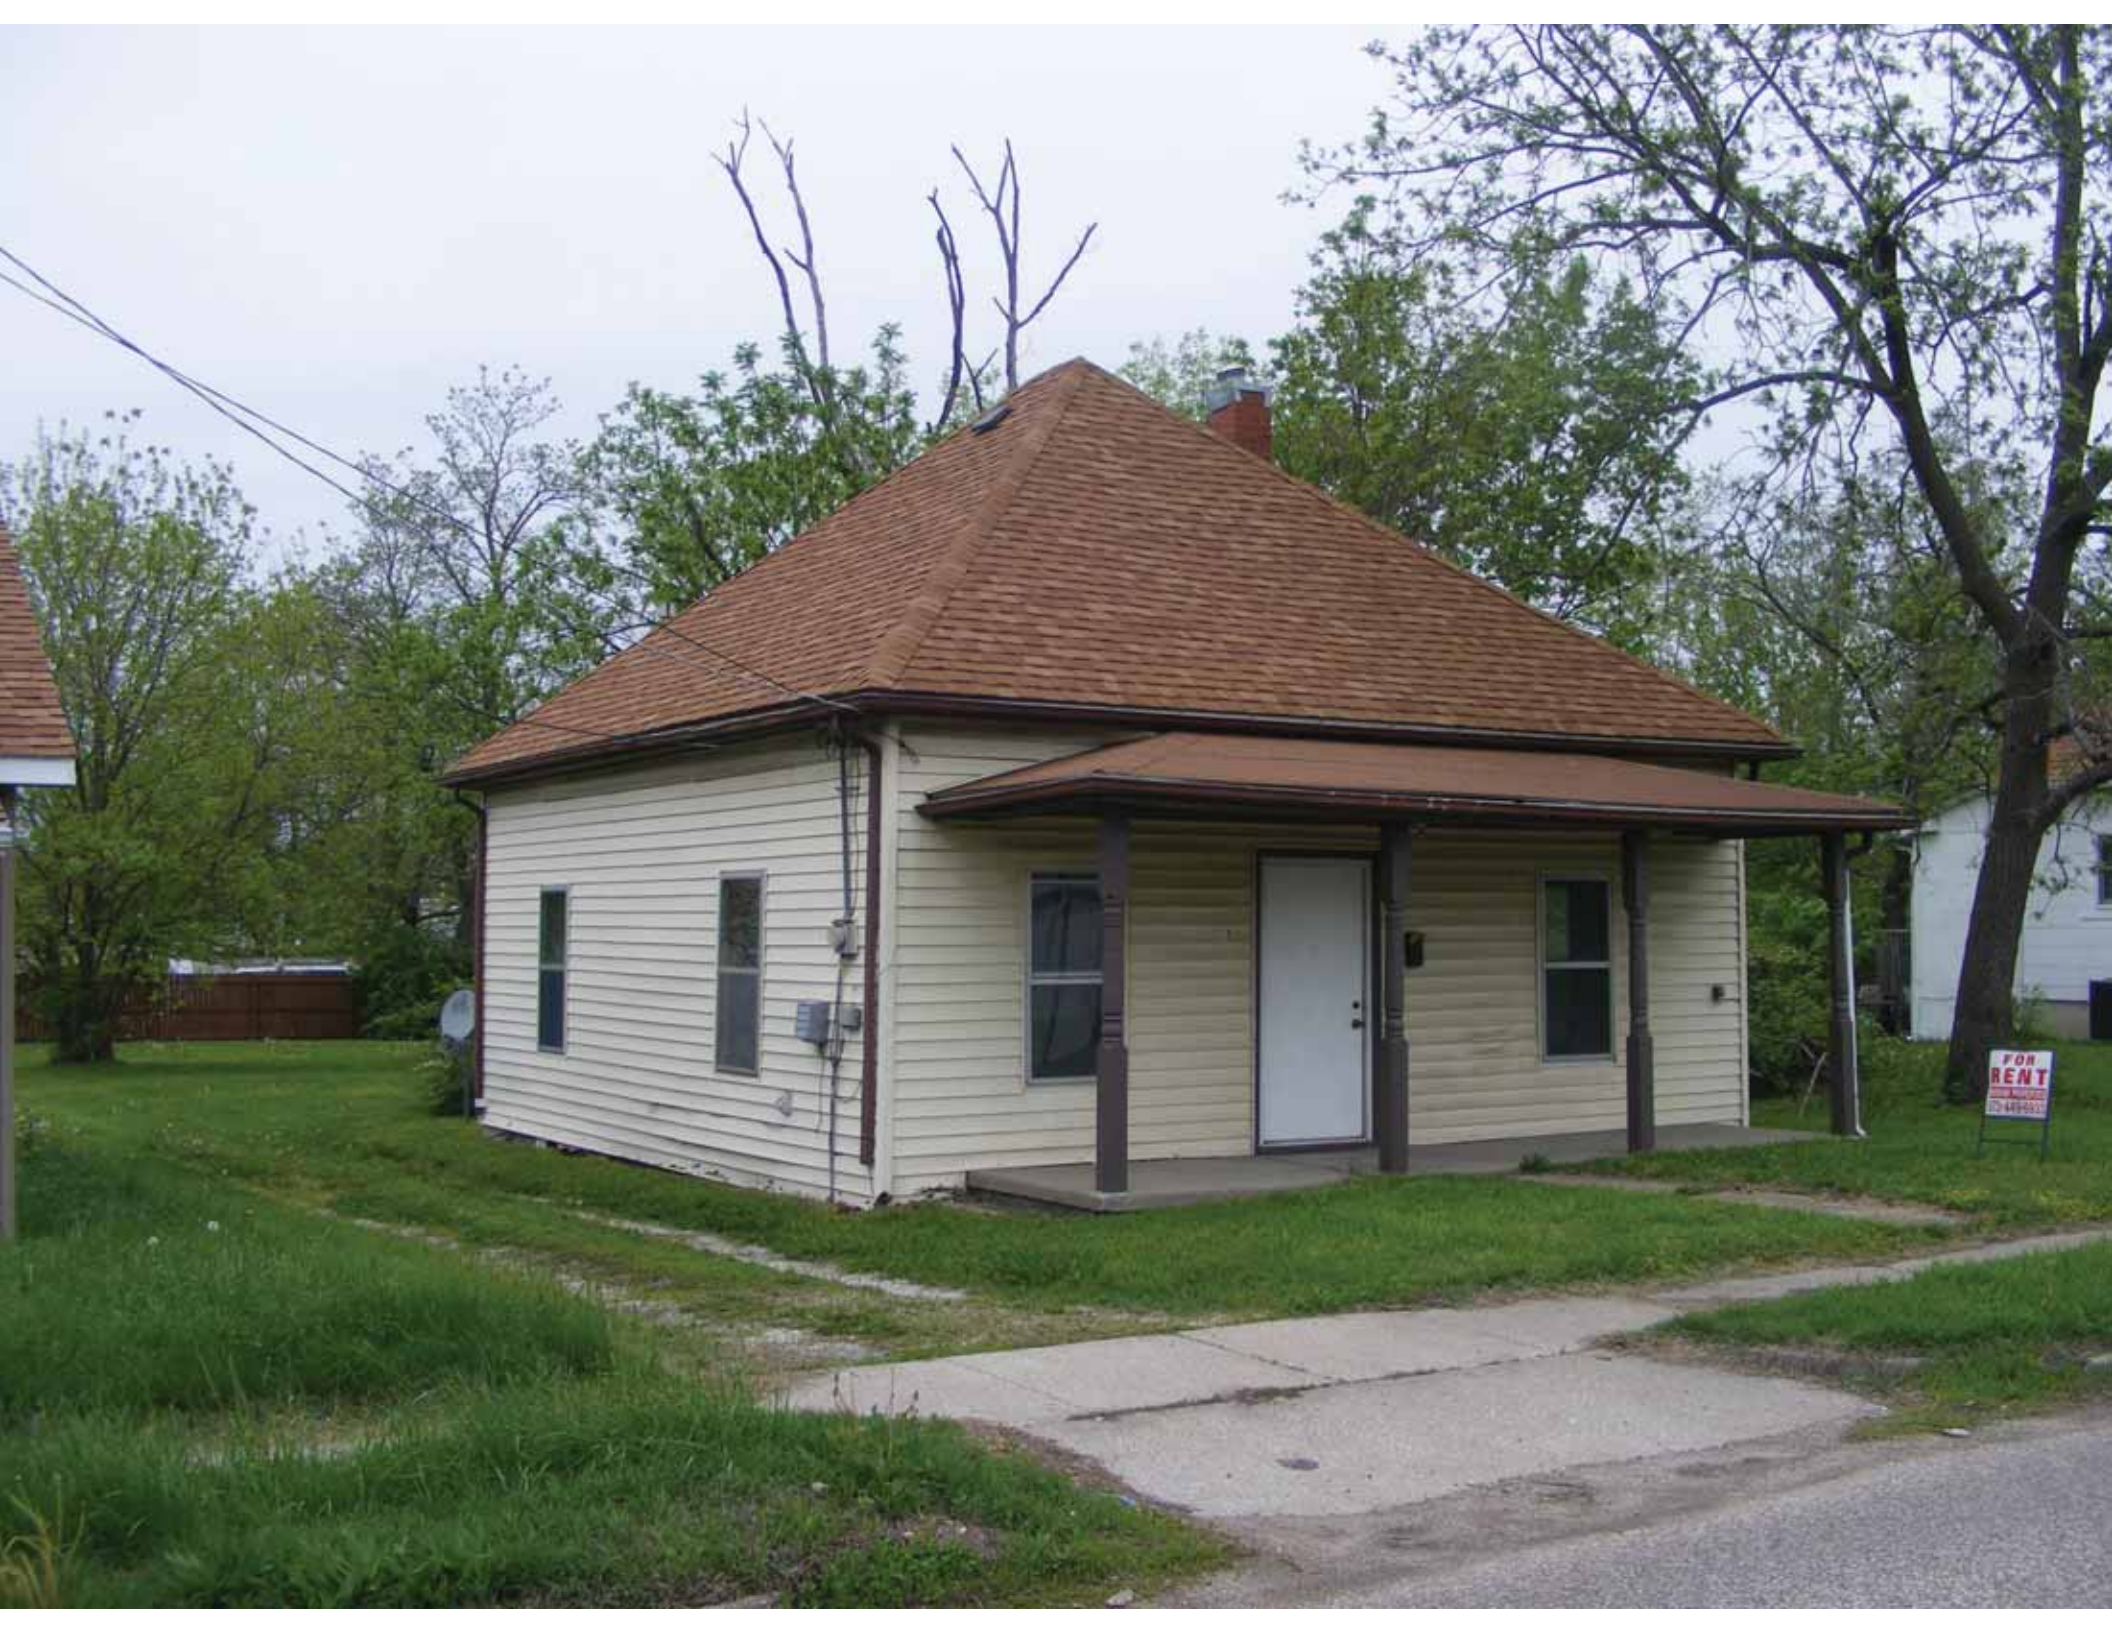
41. (cont.) Description of primary resource. Expand box as necessary, or add continuation pages.
The property is a single-story frame dwelling with an asphalt-shingled pyramidal roof, enclosed eaves, exterior vinyl siding and a covered foundation. Façade holds hipped roof full-width porch supported by wooden spindle columns. Façade holds a centered door (replacement solid paneled) flanked by one-over-one windows. Side elevations hold one-over-one windows.
