MISSOURI DEPARTMENT OF NATURAL RESOURCES
STATE HISTORIC PRESERVATION OFFICE, P.O. Box 176, Jefferson City, MO 65102
ARCHITECTURAL/HISTORIC INVENTORY FORM

1. Survey No. BO-AS-011-0087		2. Survey name: North Central Columbia Survey Phase II	
3. County: Boone		4. Address (Street No.) 902	Street (name) N. Seventh Street
5. City: Columbia	Vicinity: <input type="checkbox"/>	6. Geographical Reference:	7. Township/Range/Section: T: R: S:
8. Historic name (if known):		9. Present/other name (if known):	
10. Ownership: <input checked="" type="checkbox"/> Private <input type="checkbox"/> Public		11a. Historic use (if known): Domestic/single dwelling	11b. Current use: Domestic/single dwelling

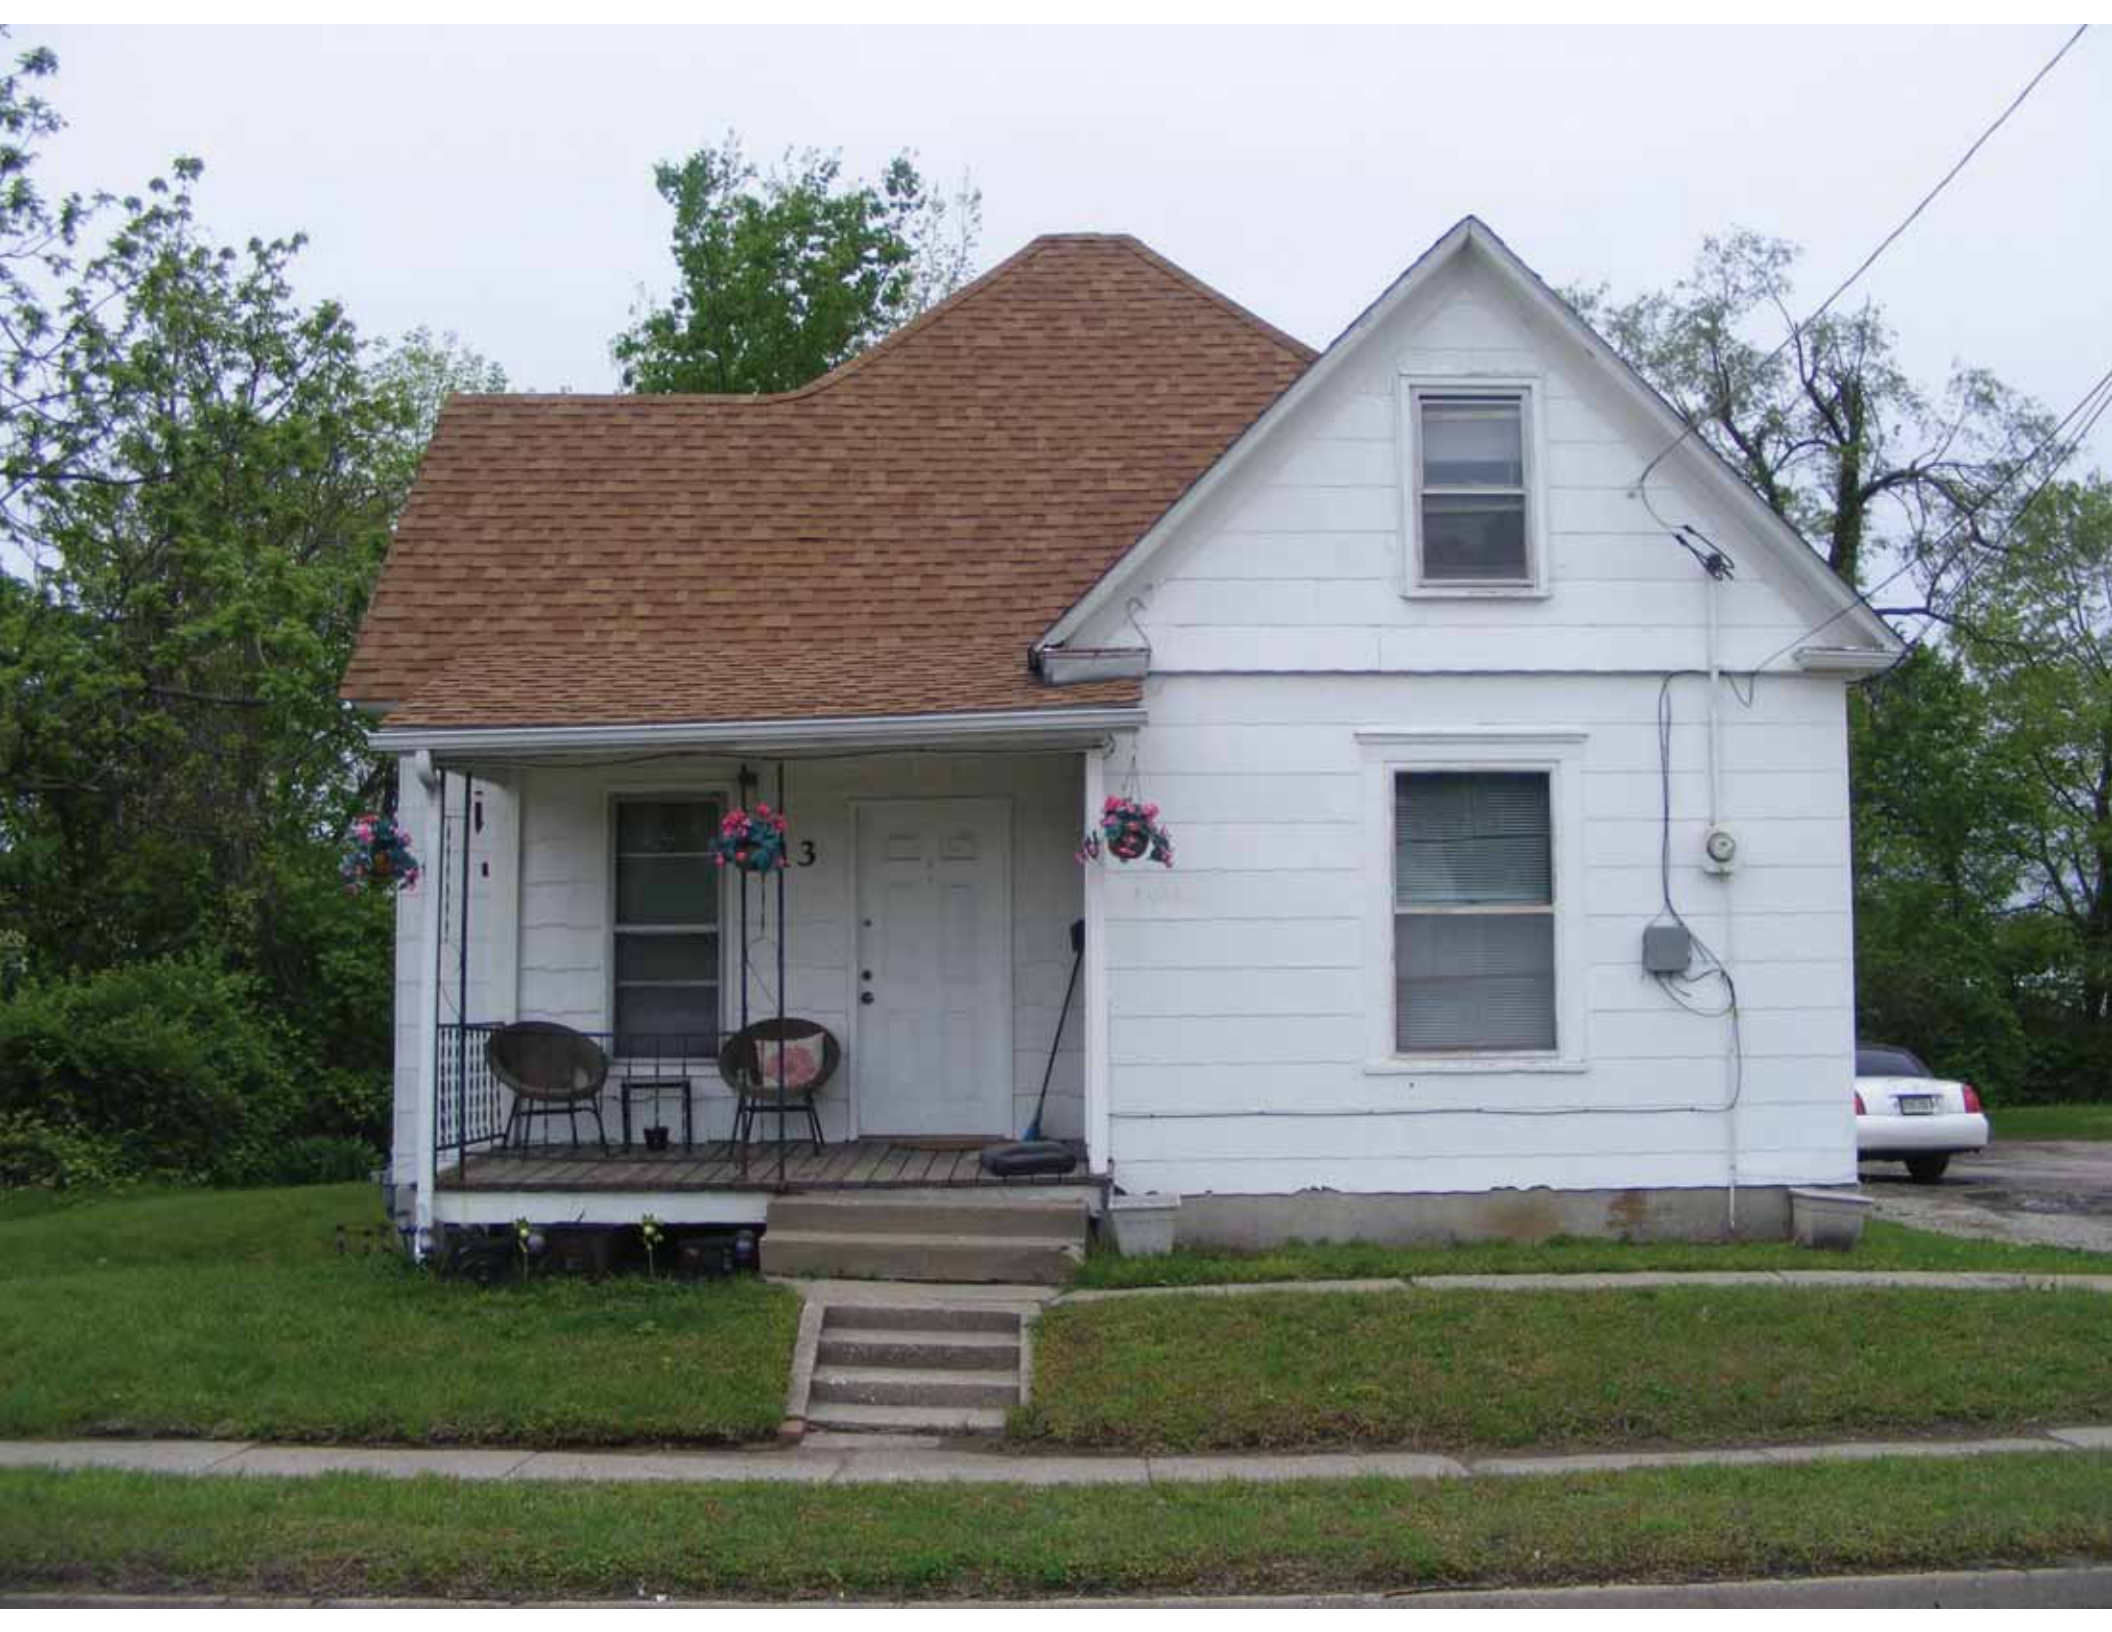
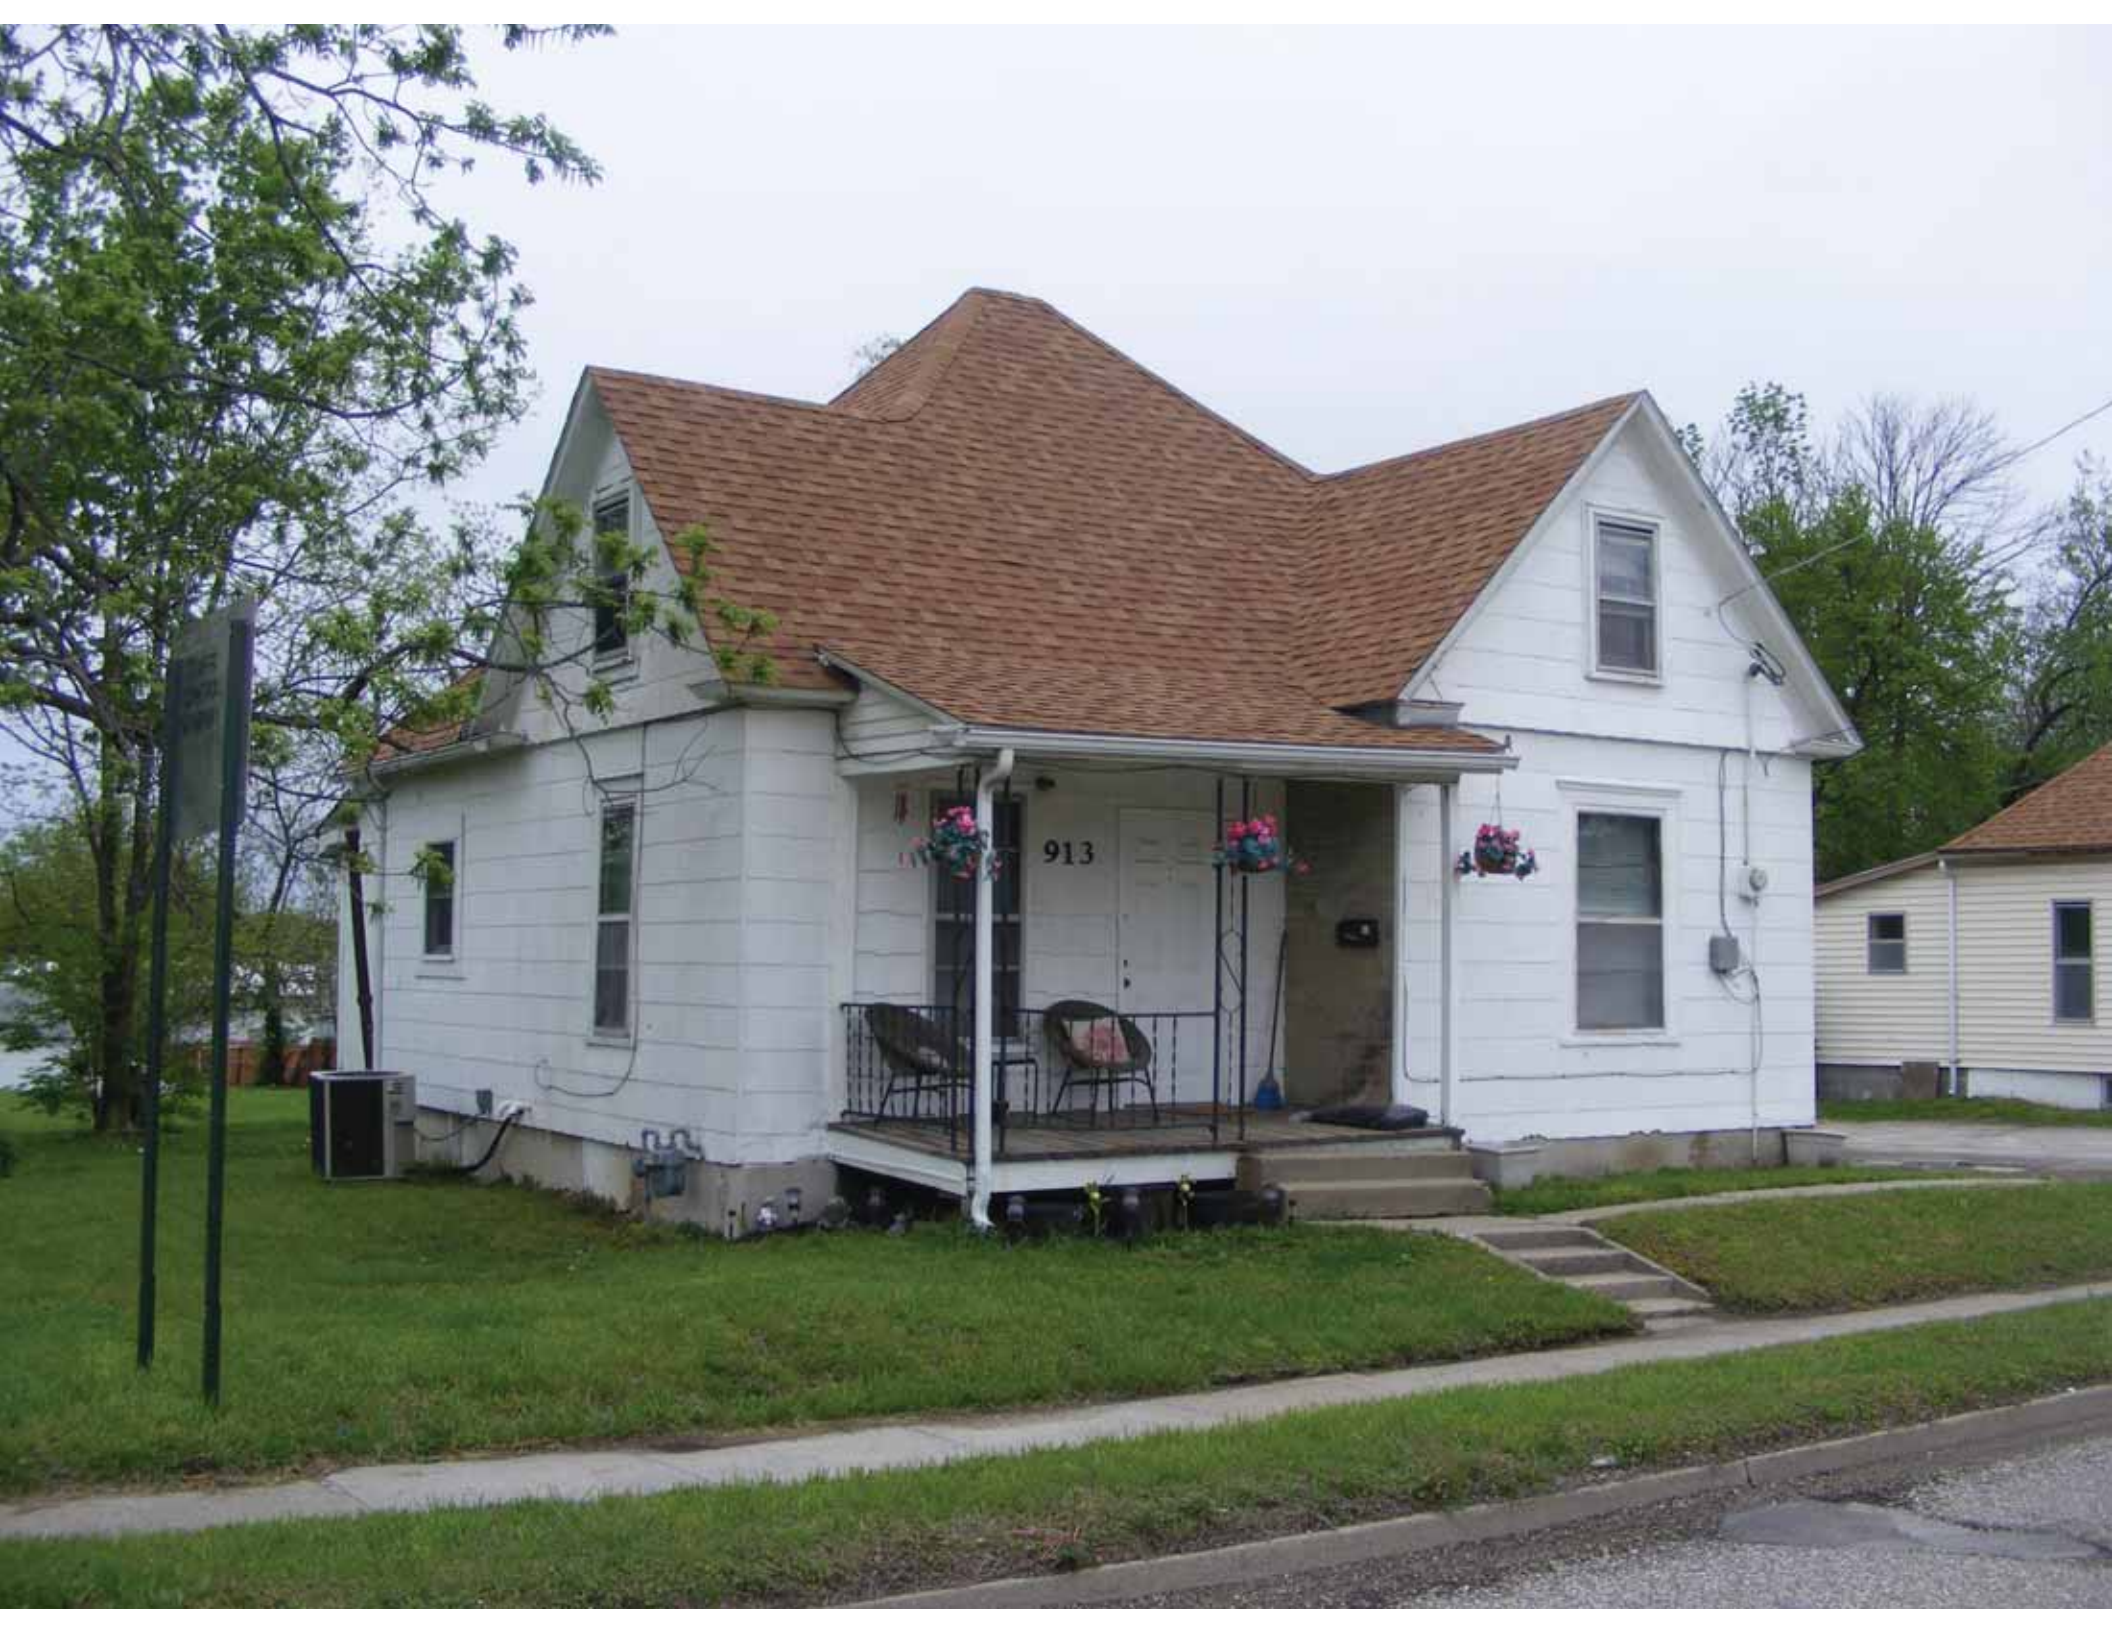
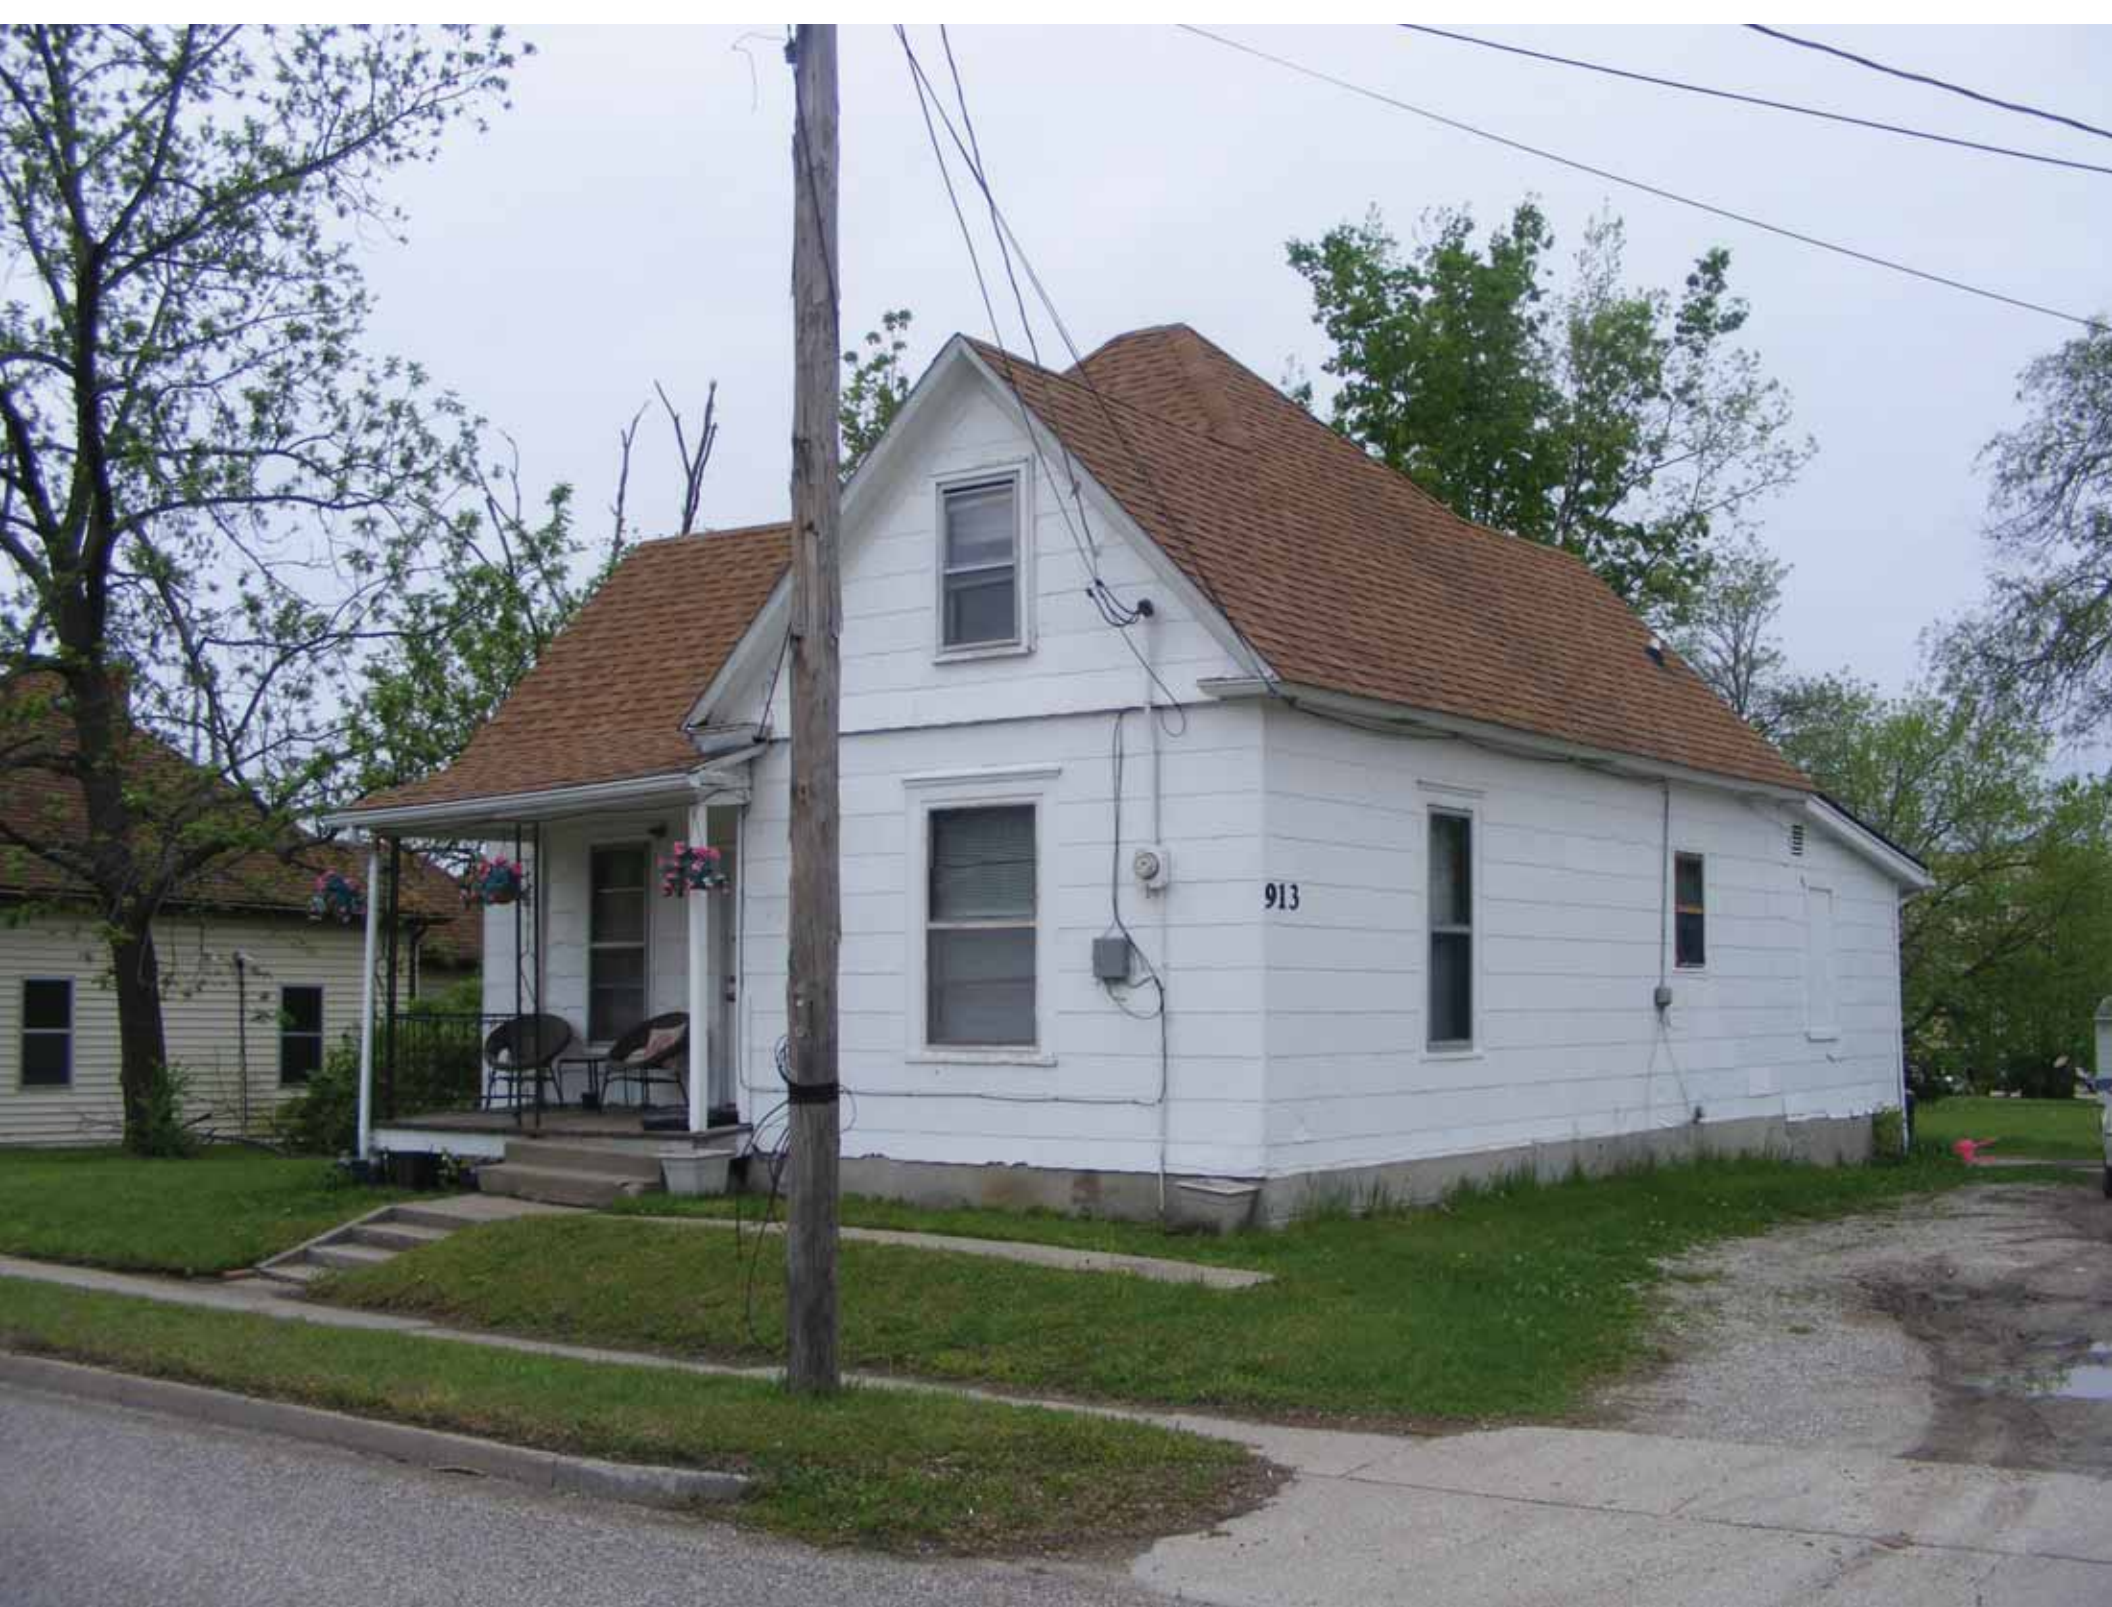
41. (cont.) Description of primary resource. Expand box as necessary, or add continuation pages.
The property is a 1.5 story frame dwelling with an asphalt shingled gable on hip, exterior asbestos siding and a concrete foundation. Façade holds a front gable with two-over-two window (vertical) on the lower level and a one-over-one window in the gable end. To the left of the gable is a partial-width porch, asphalt shingled shed roof supported by decorative iron posts (non-original ca. 1960) and iron railings with a wood plank deck. Porch bay area holds an entrance at the "L" offset to left by a two-over-two window (vertical). Side elevation windows are similar to façade windows. Rear elevation holds an addition with a shed roof.

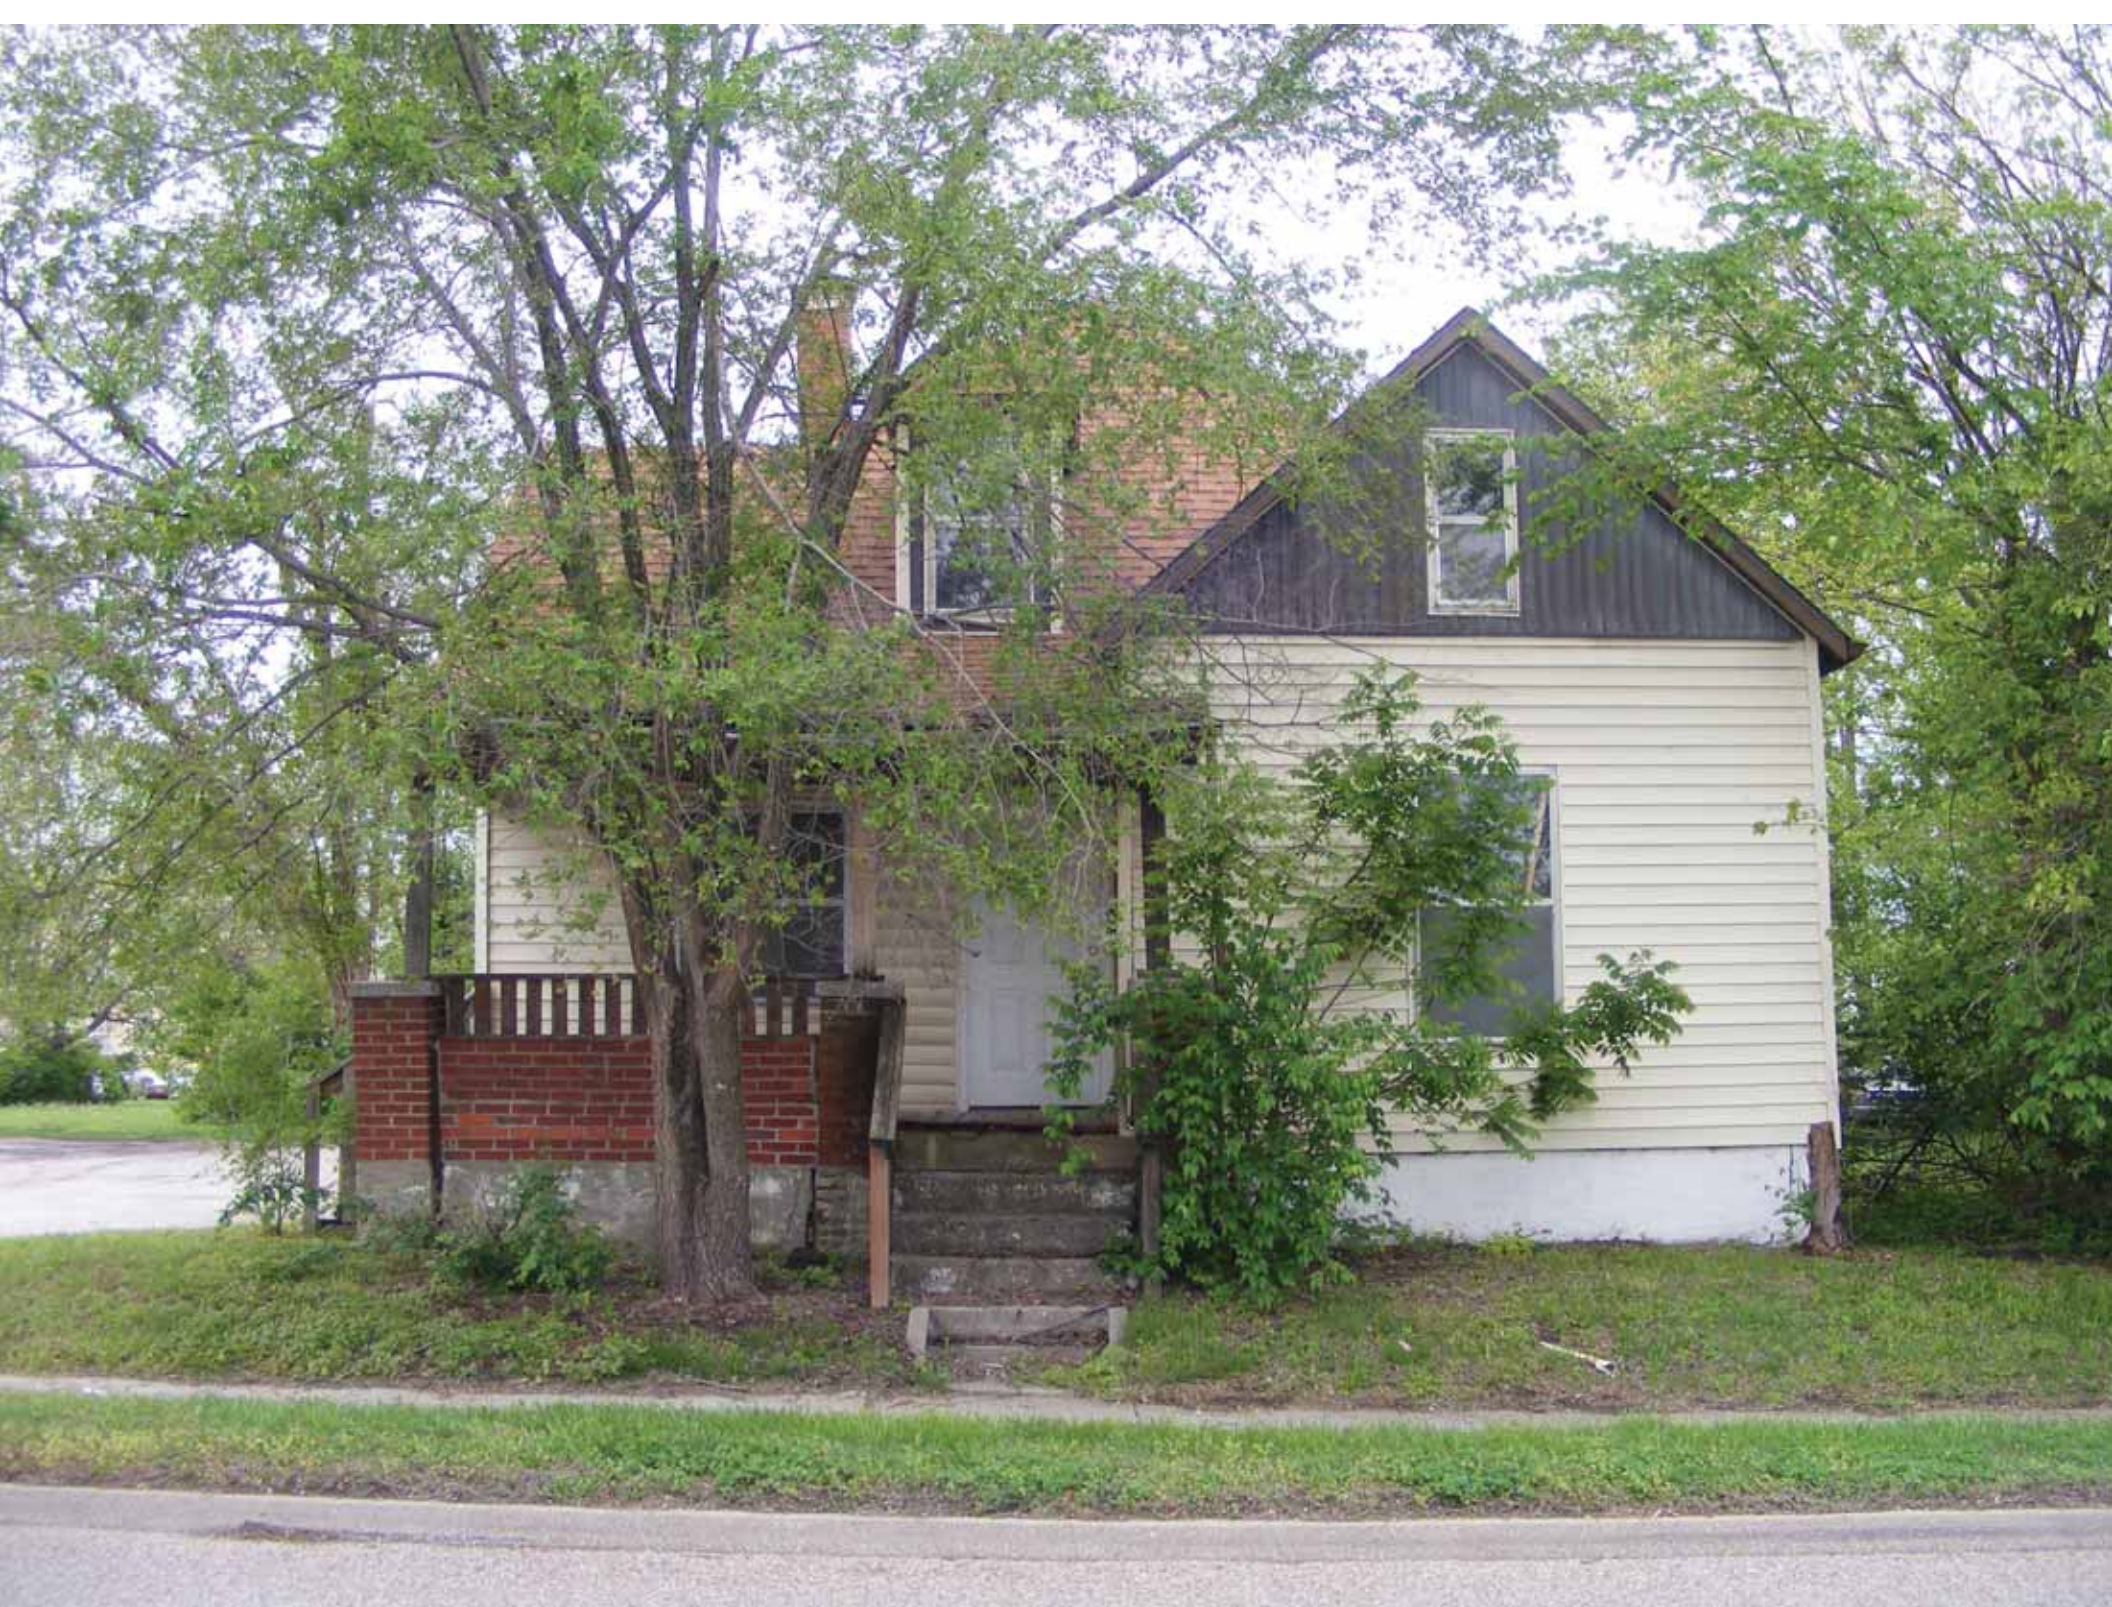
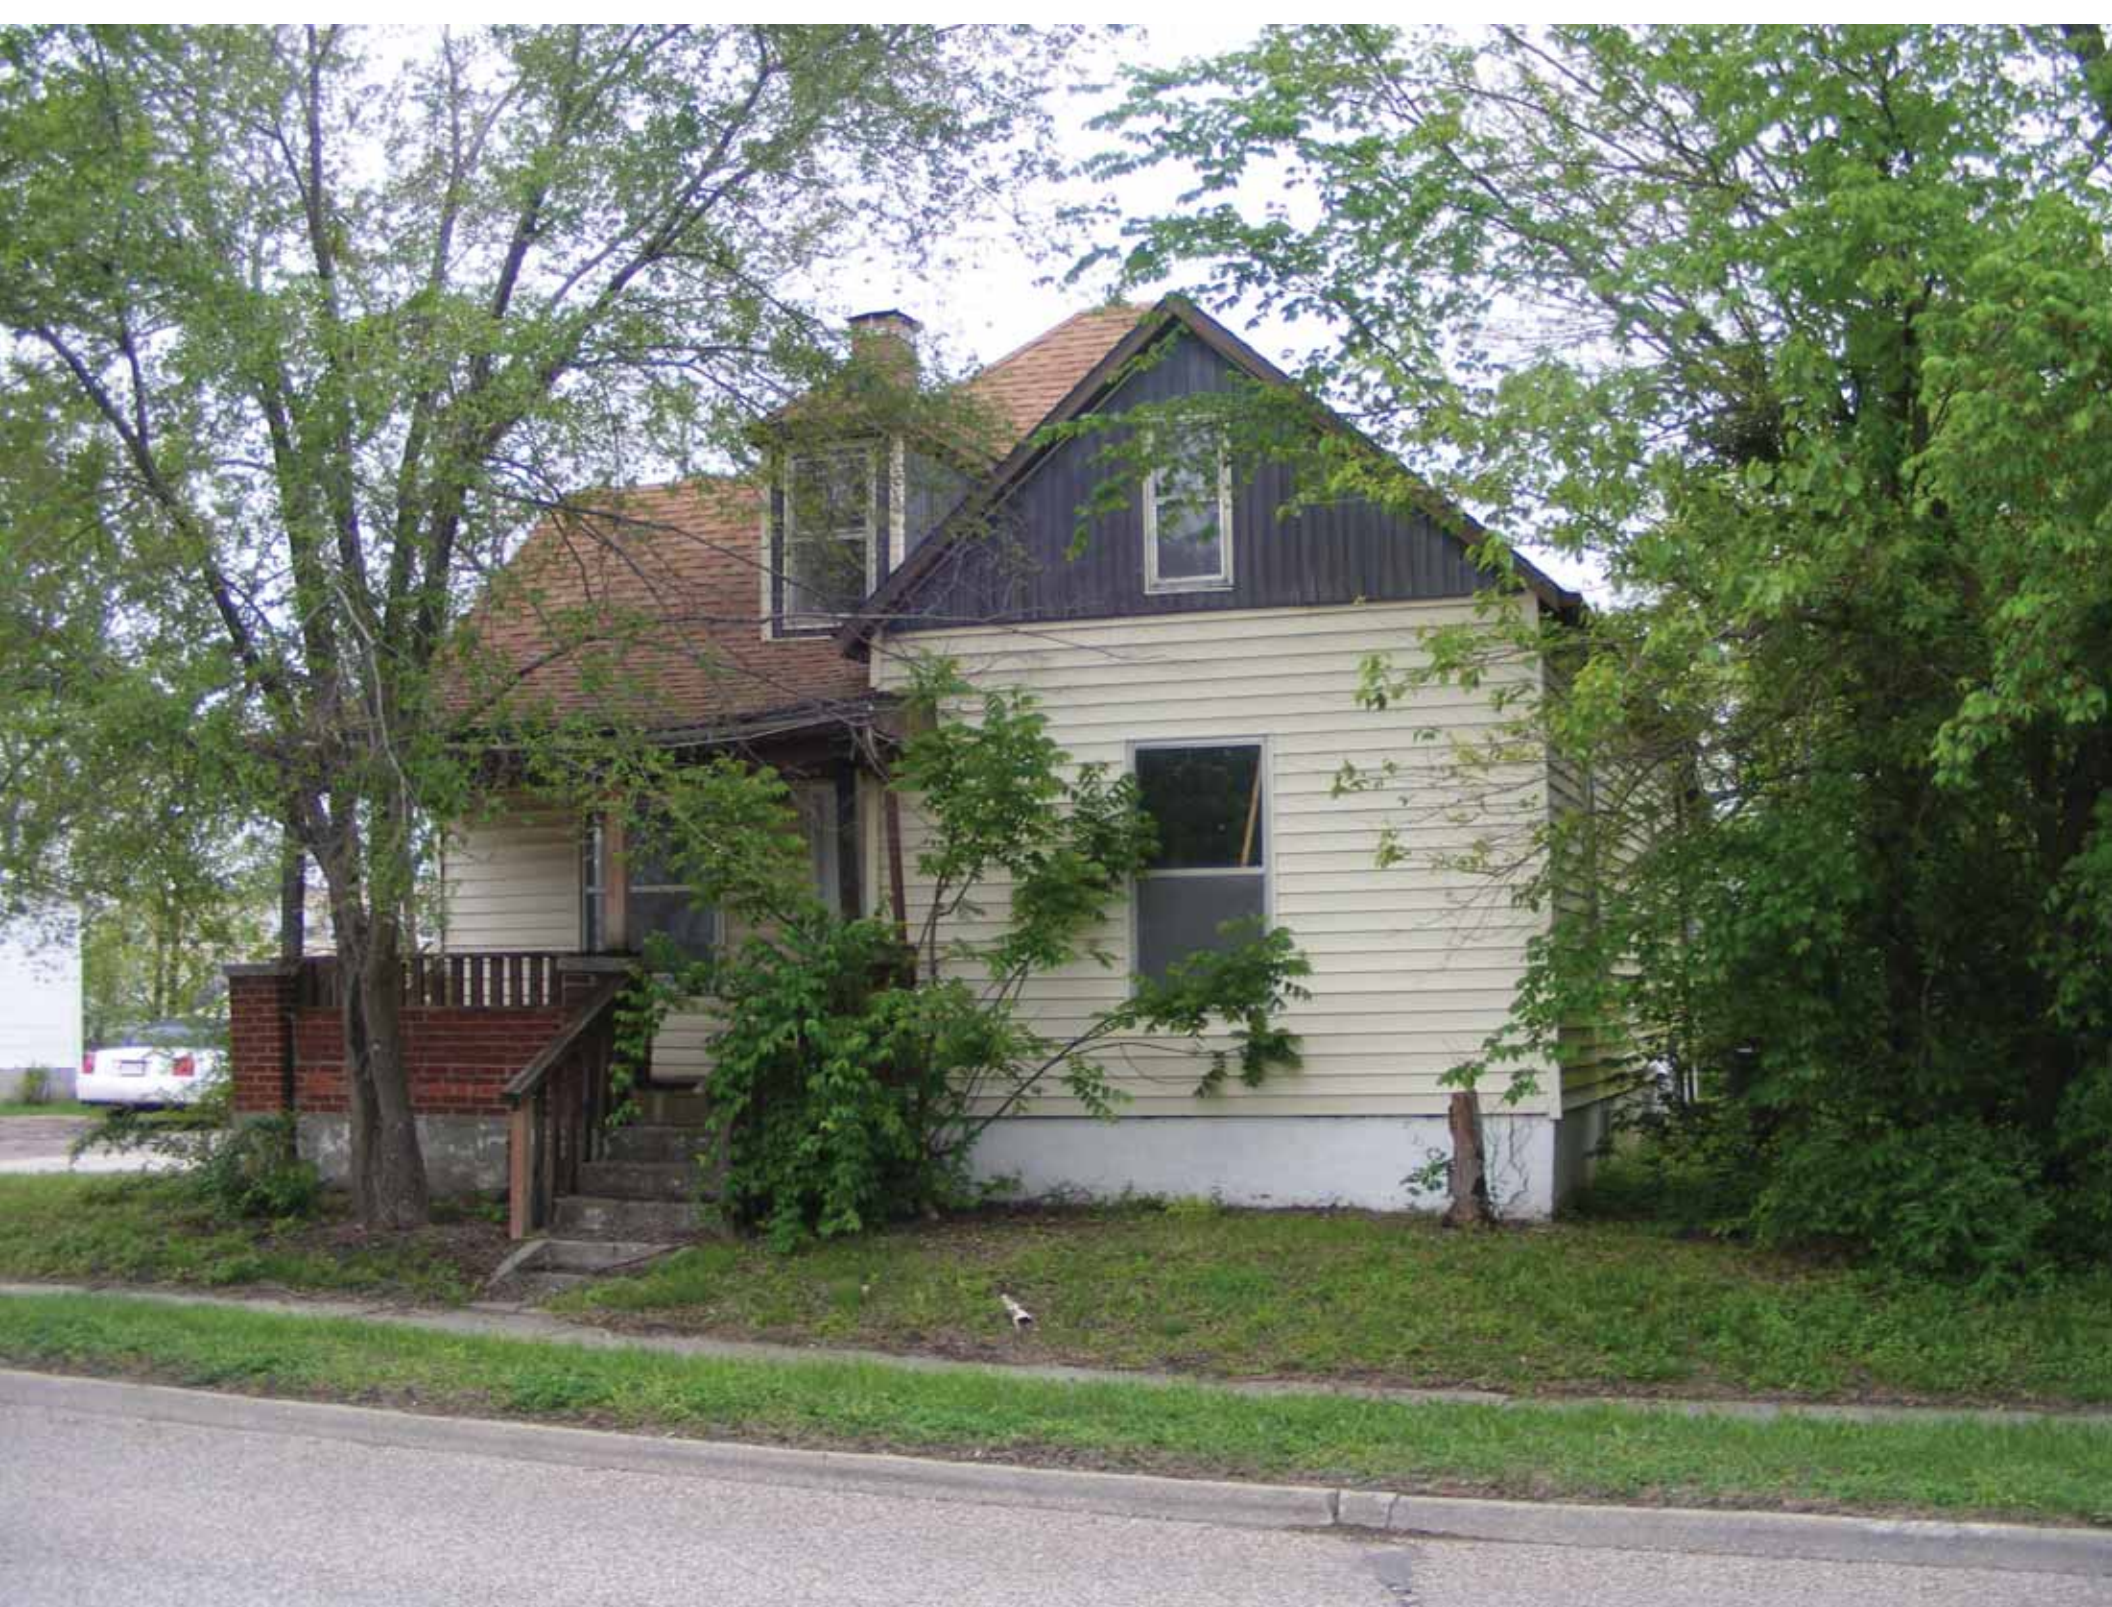
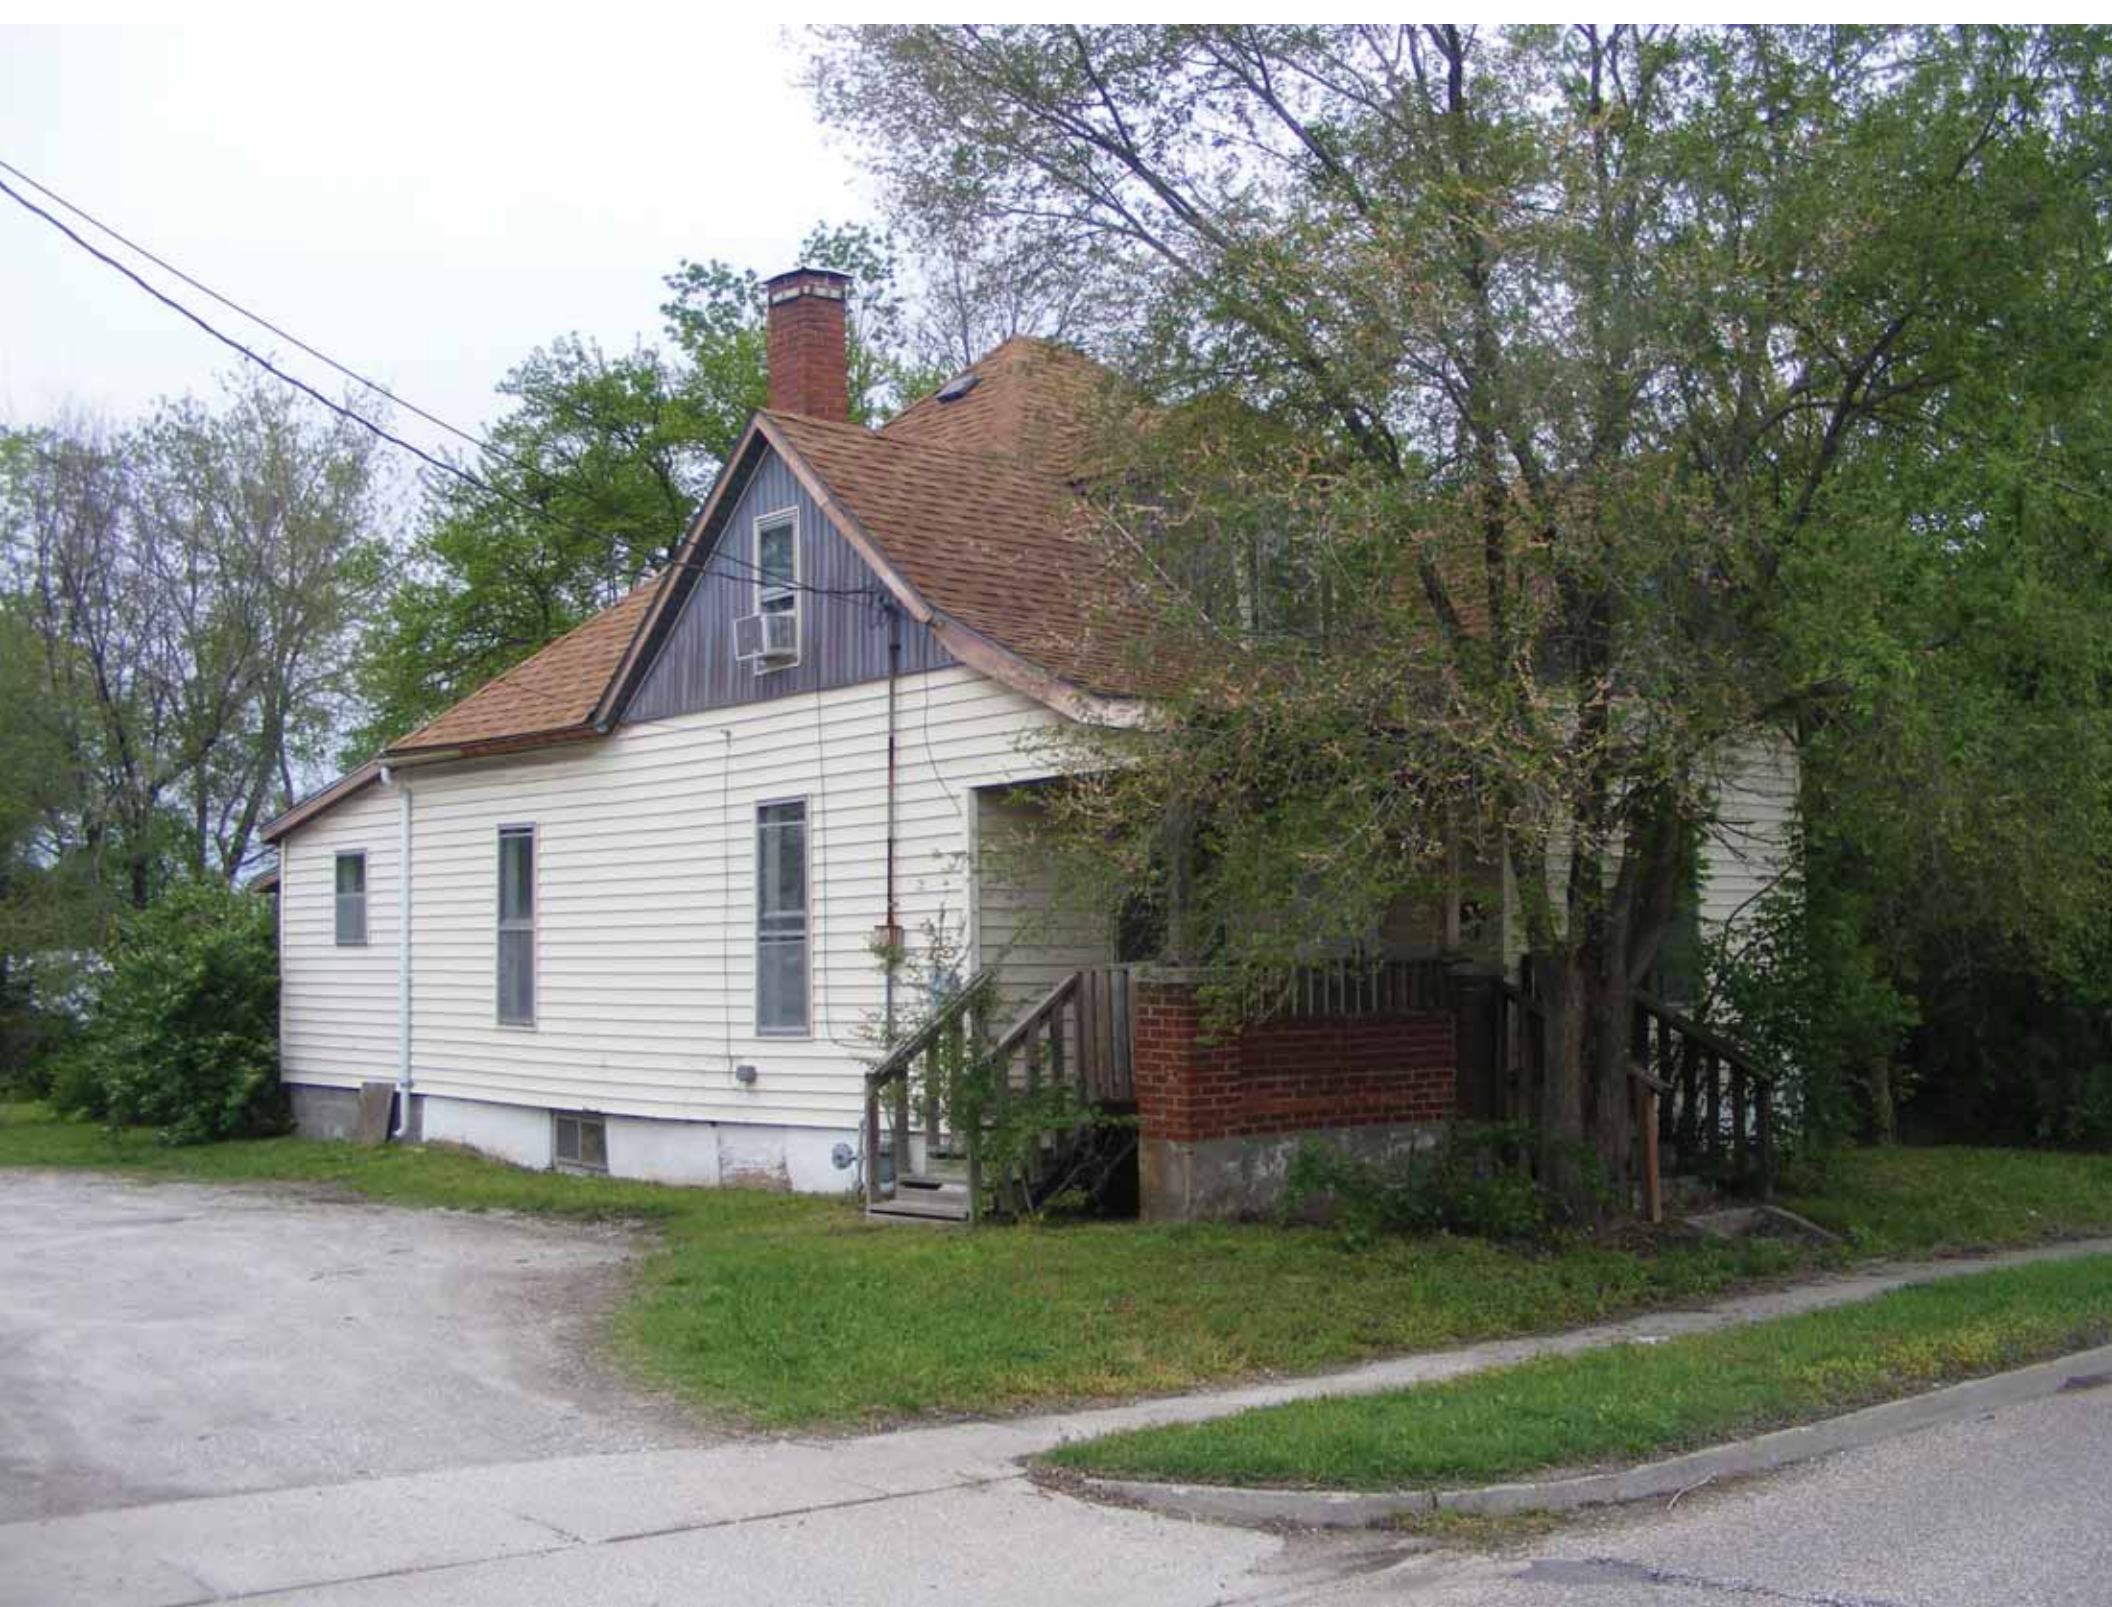
The property is a 1.5 story frame dwelling with an asphalt shingled gable on hip roof and concrete foundation. Exterior cladding is vinyl siding and vertical wood siding in gable ends. Primary elevation holds a front gable with one-over-one windows on lower level and gable end. A partial-width porch with a shed roof supported by square wooden posts (non-original c. 2000) is offset to left of the gable front. Porch features a low brick wall topped by replacement wooden spindles and wooden steps (c.2000). Porch bay area holds an entrance offset to left by a one-over-one window. Front sloping roof line holds an asphalt shingled hip dormer with a one-over-one window. Side elevations hold one-over-one windows (lower level and gable ends). Basement level holds window wells.
