MISSOURI DEPARTMENT OF NATURAL RESOURCES
STATE HISTORIC PRESERVATION OFFICE, P.O. Box 176, Jefferson City, MO 65102
ARCHITECTURAL/HISTORIC INVENTORY FORM

1. Survey No. BO-AS-011-0087		2. Survey name: North Central Columbia Survey Phase II	
3. County: Boone		4. Address (Street No.) 902	Street (name) N. Seventh Street
5. City: Columbia	Vicinity: <input type="checkbox"/>	6. Geographical Reference:	7. Township/Range/Section: T: R: S:
8. Historic name (if known):		9. Present/other name (if known):	
10. Ownership: <input checked="" type="checkbox"/> Private <input type="checkbox"/> Public		11a. Historic use (if known): Domestic/single dwelling	11b. Current use: Domestic/single dwelling

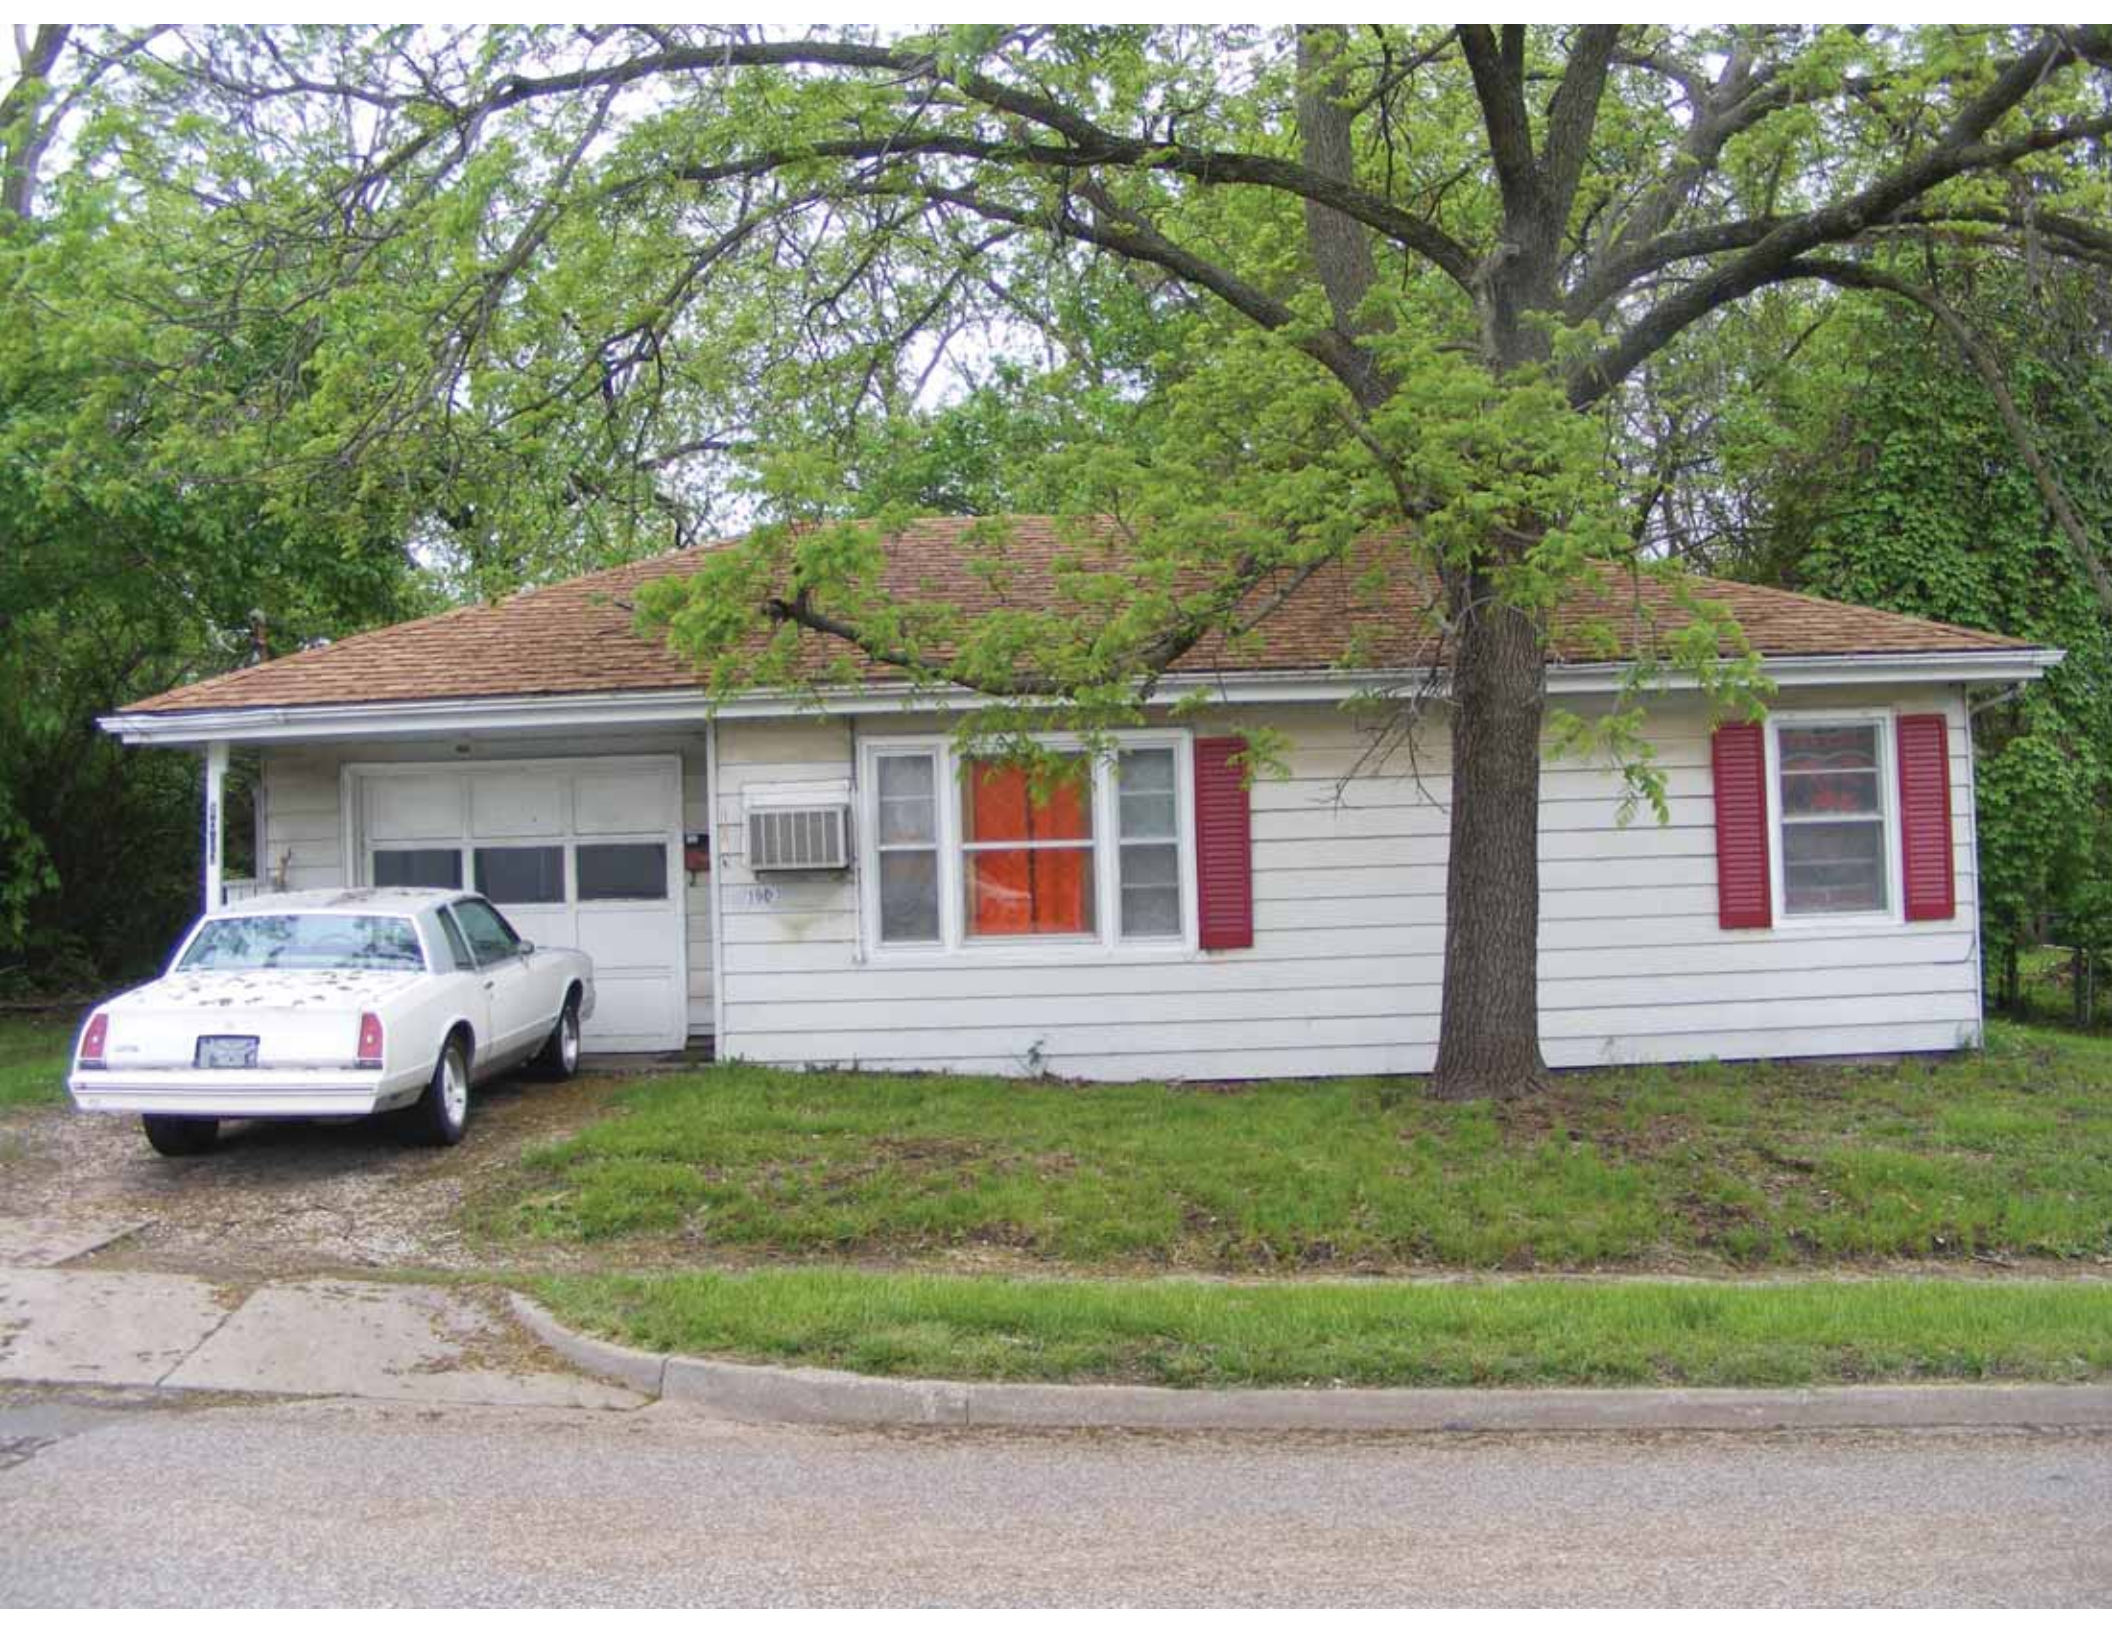
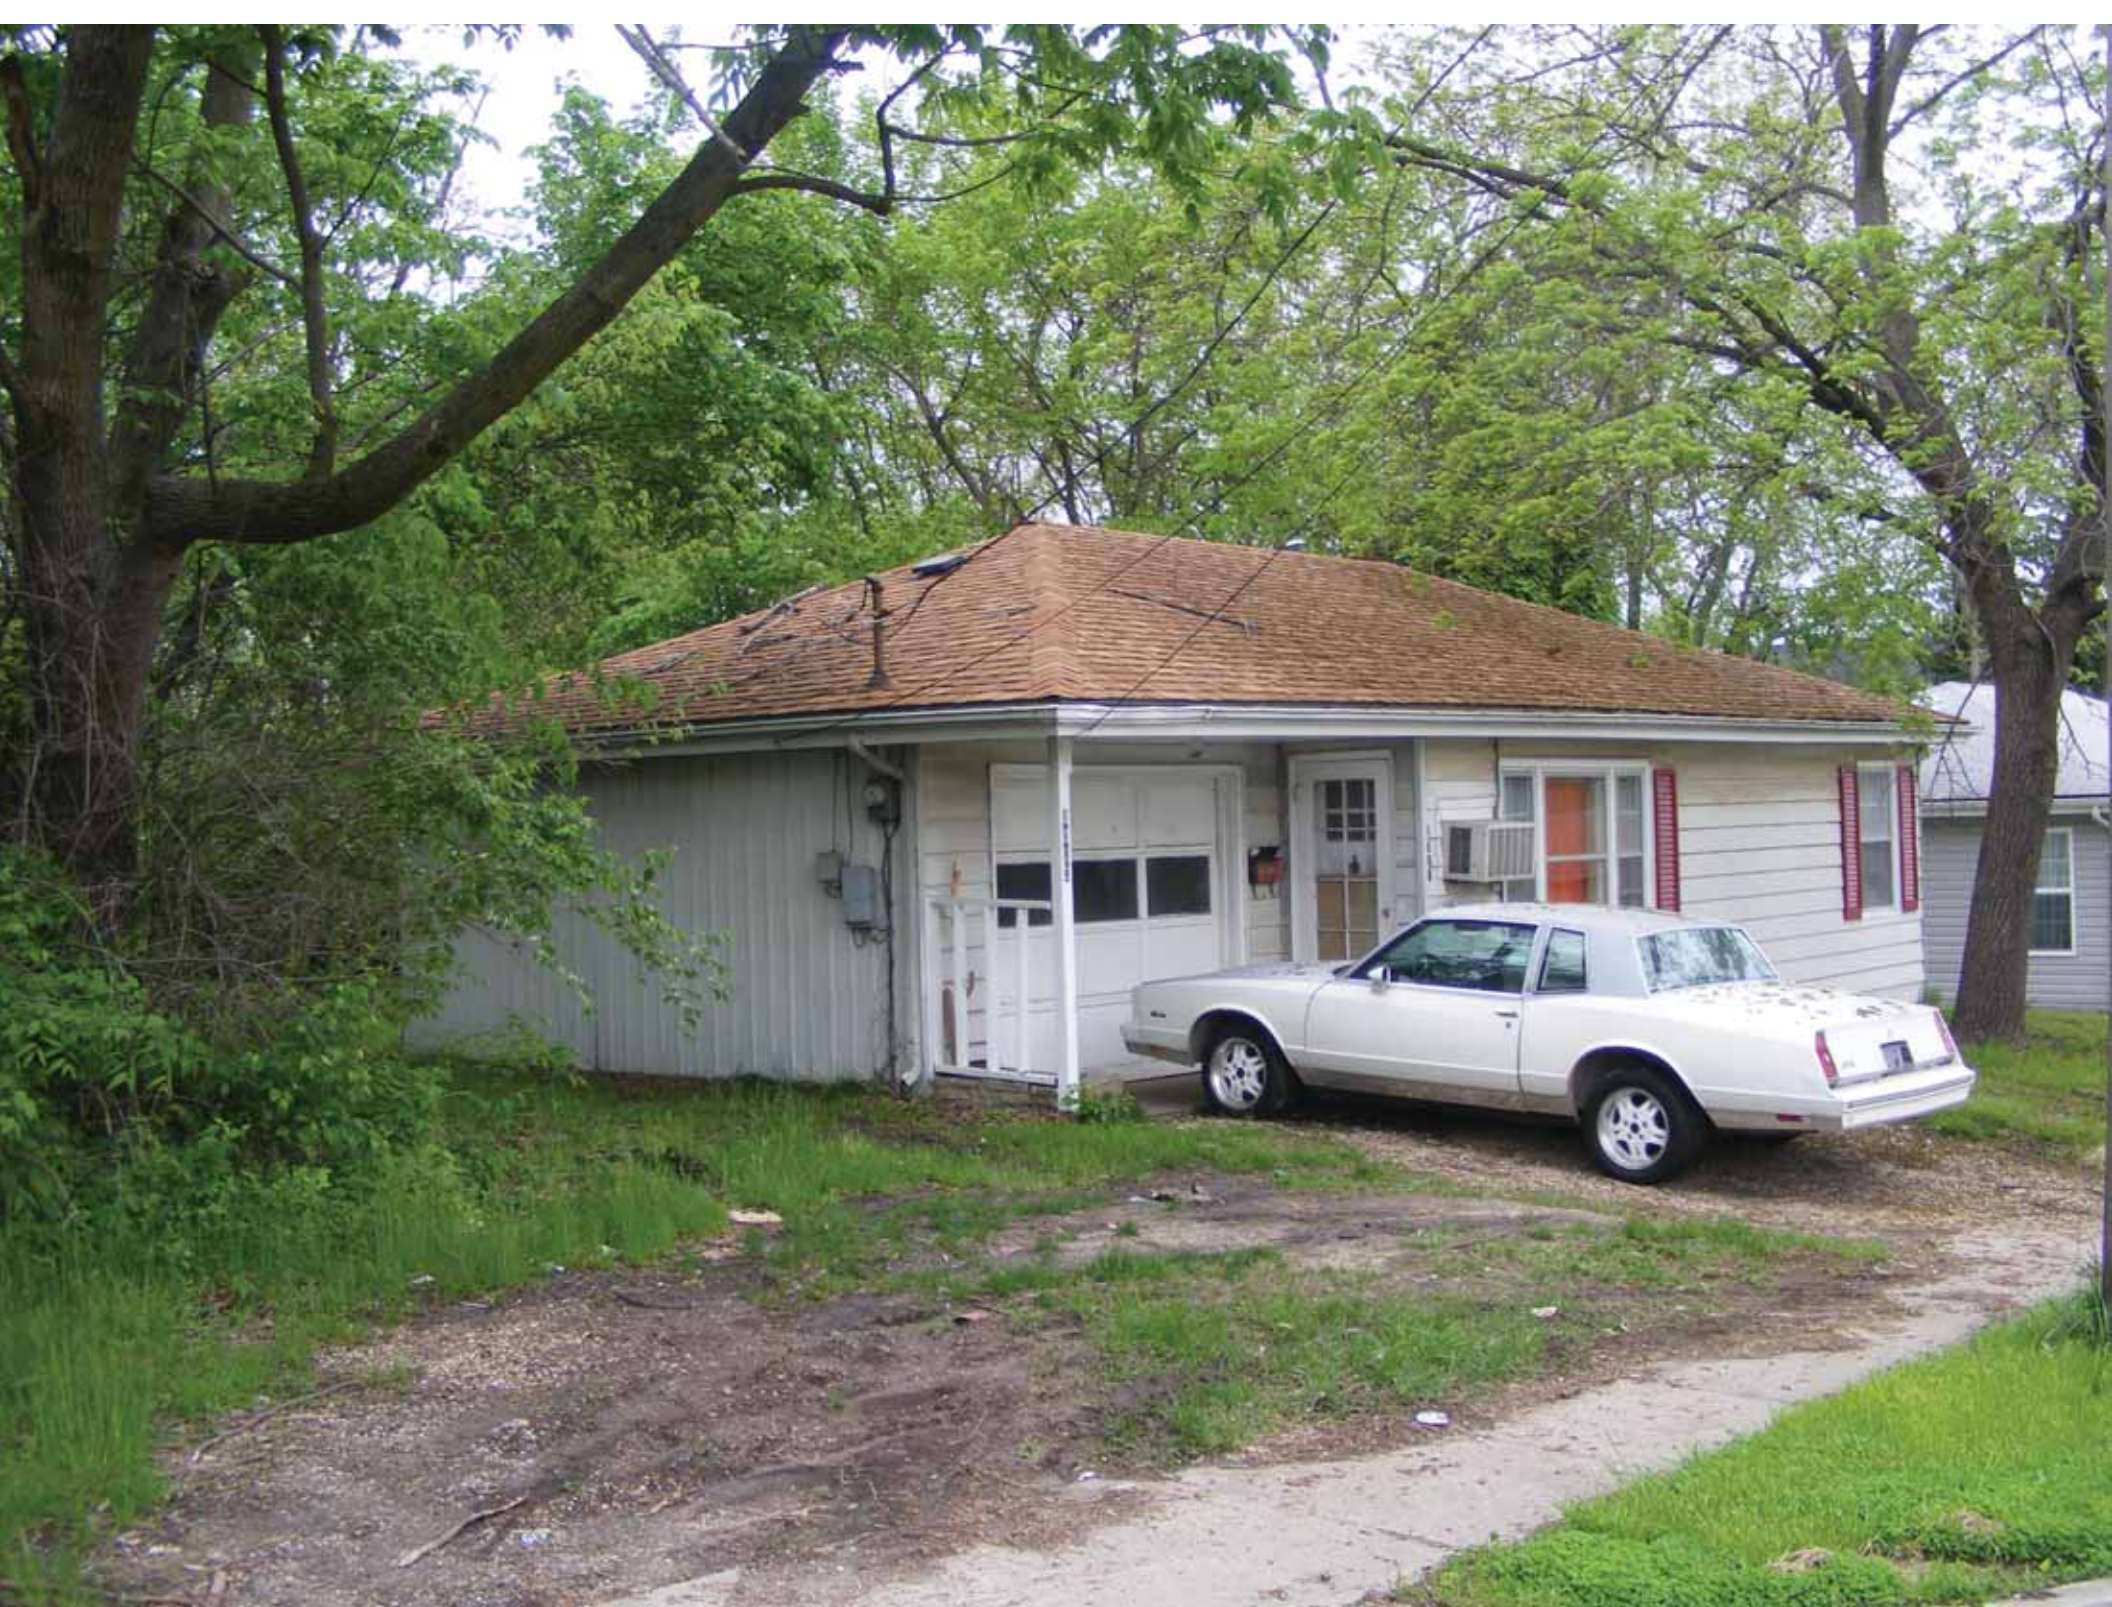
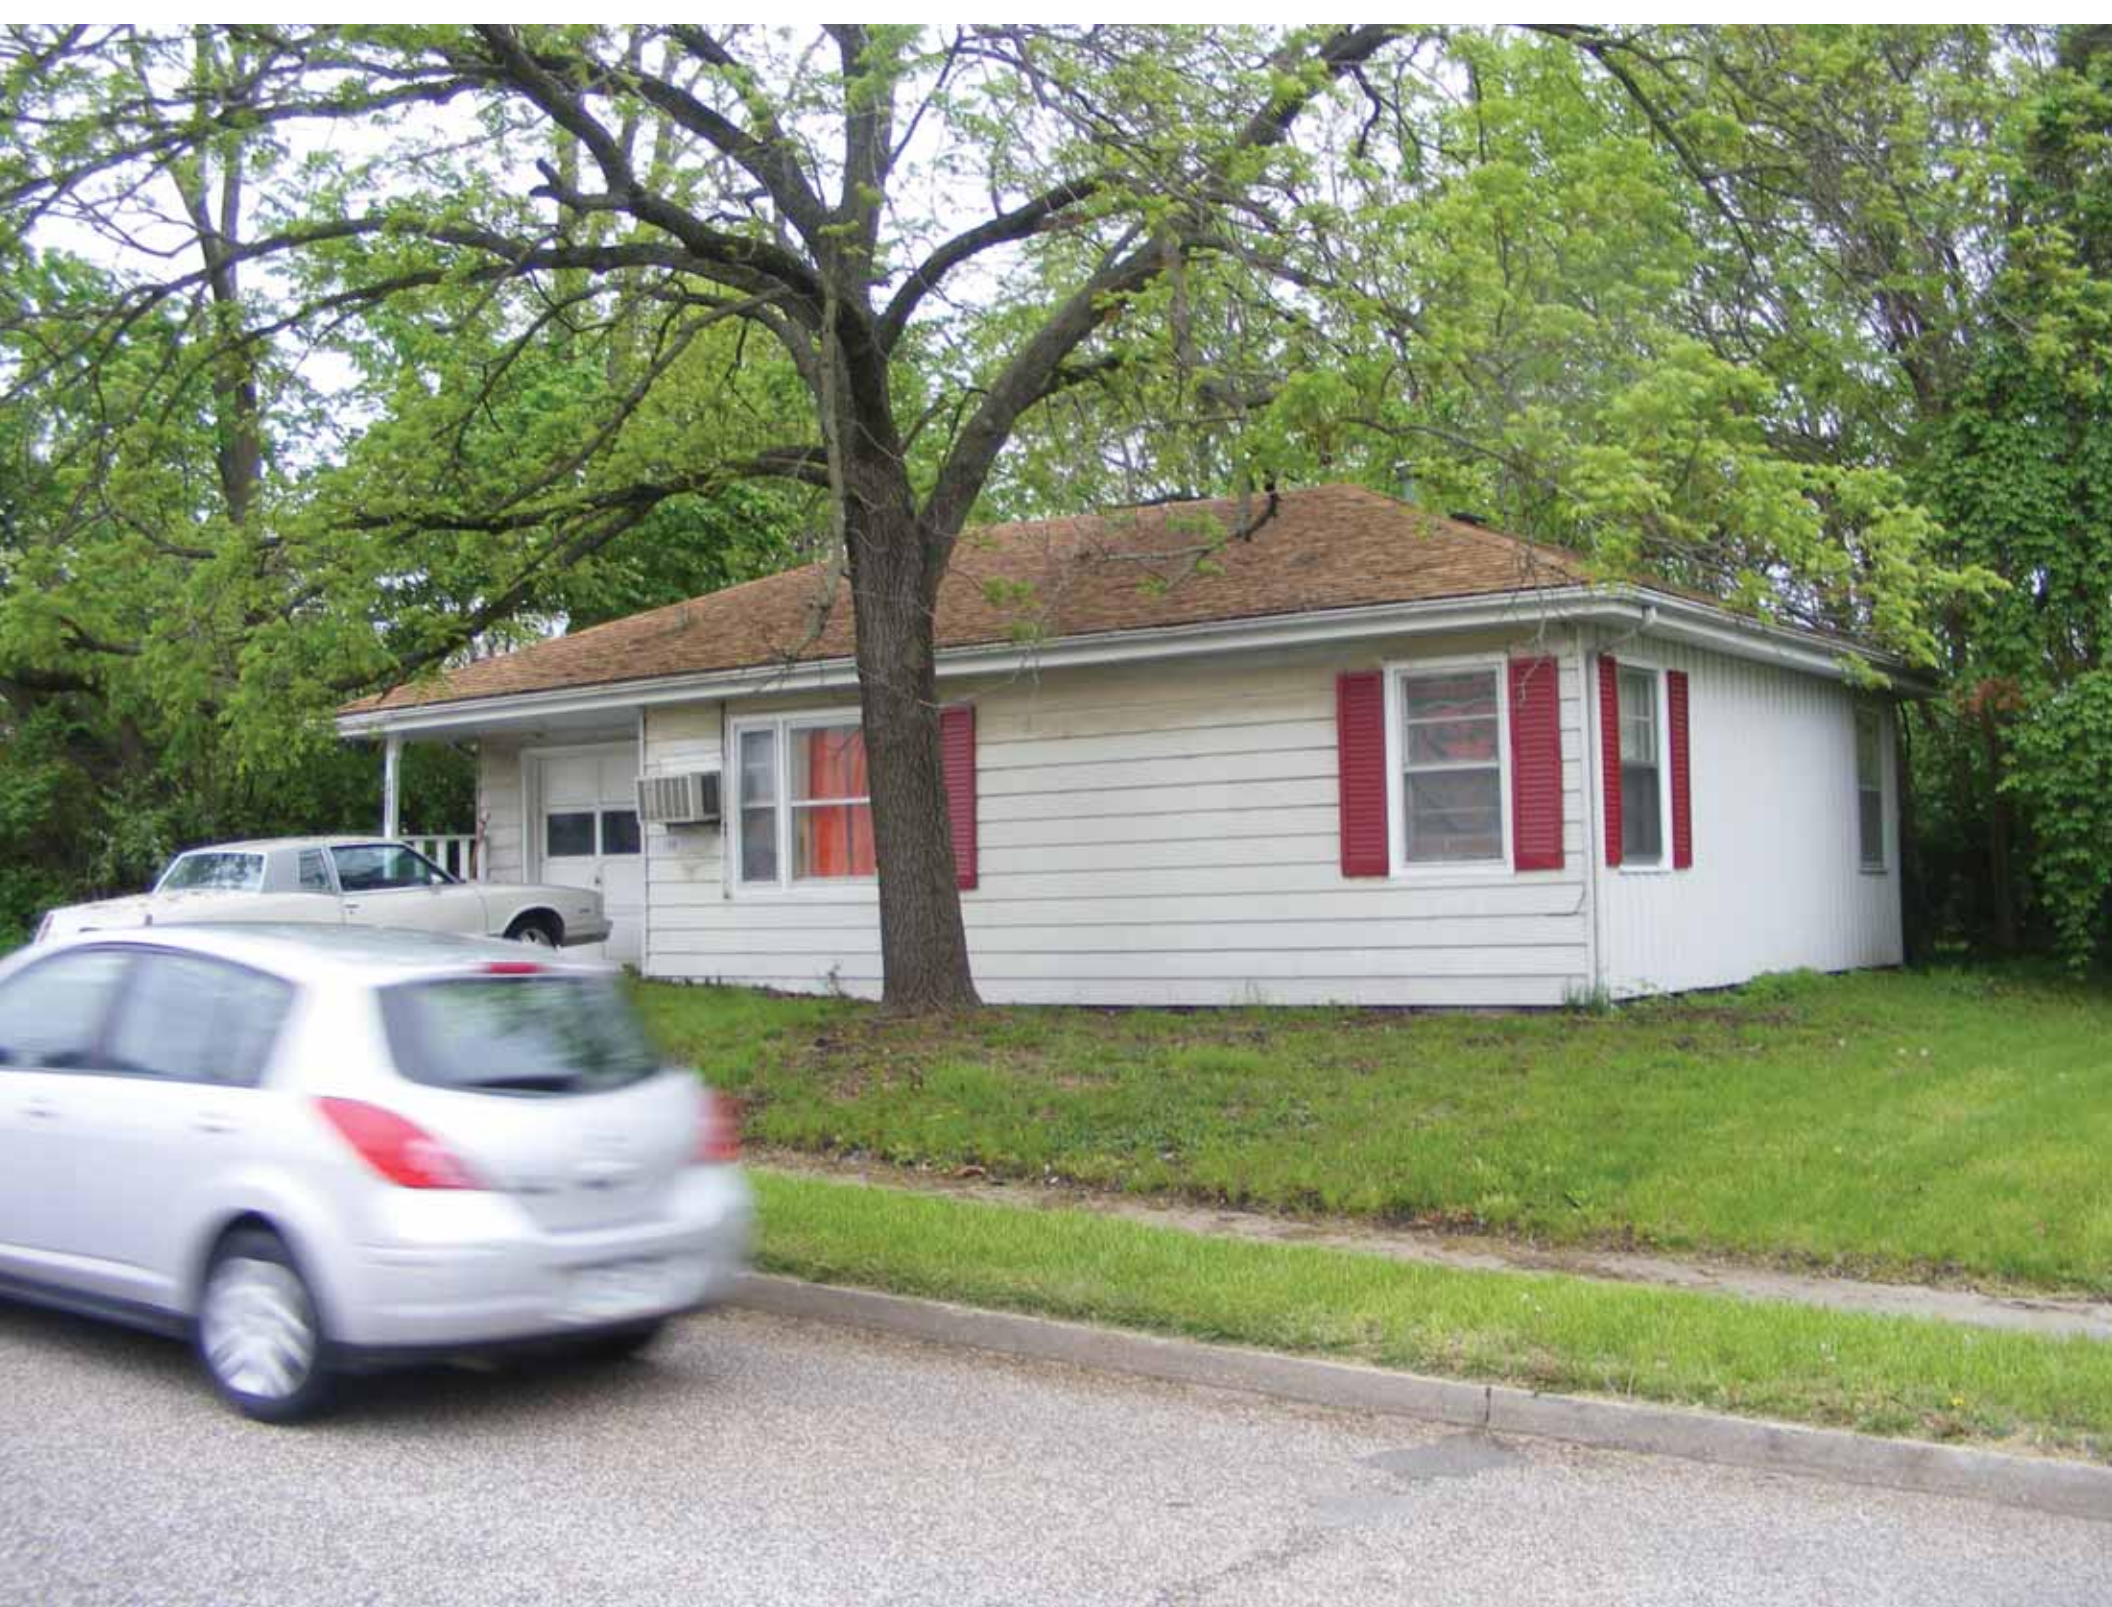
41. (cont.) Description of primary resource. Expand box as necessary, or add continuation pages.
The property is a single-story frame dwelling with a medium-pitched asphalt shingled hip roof, rectangular plan and concrete foundation. Dwelling features metal siding on façade with wood board and batten siding on side elevations. Primary elevation has a projecting section to the right that holds a one-over-one picture window with two-over-two side windows offset to right by a two-over-two (vertical) window. The inset section on primary elevation holds a single bay garage with a wooden paneled door with a row of three lights. Entrance is at the "L" on the projecting section and holds a wooden panel and glass door with a French style outer door. Inset area is sheltered under the hip roof supported by a single wooden column with wooden railing at the left end. Side elevation windows are two-over-two (vertical). Windows are offset by louvered shutters.

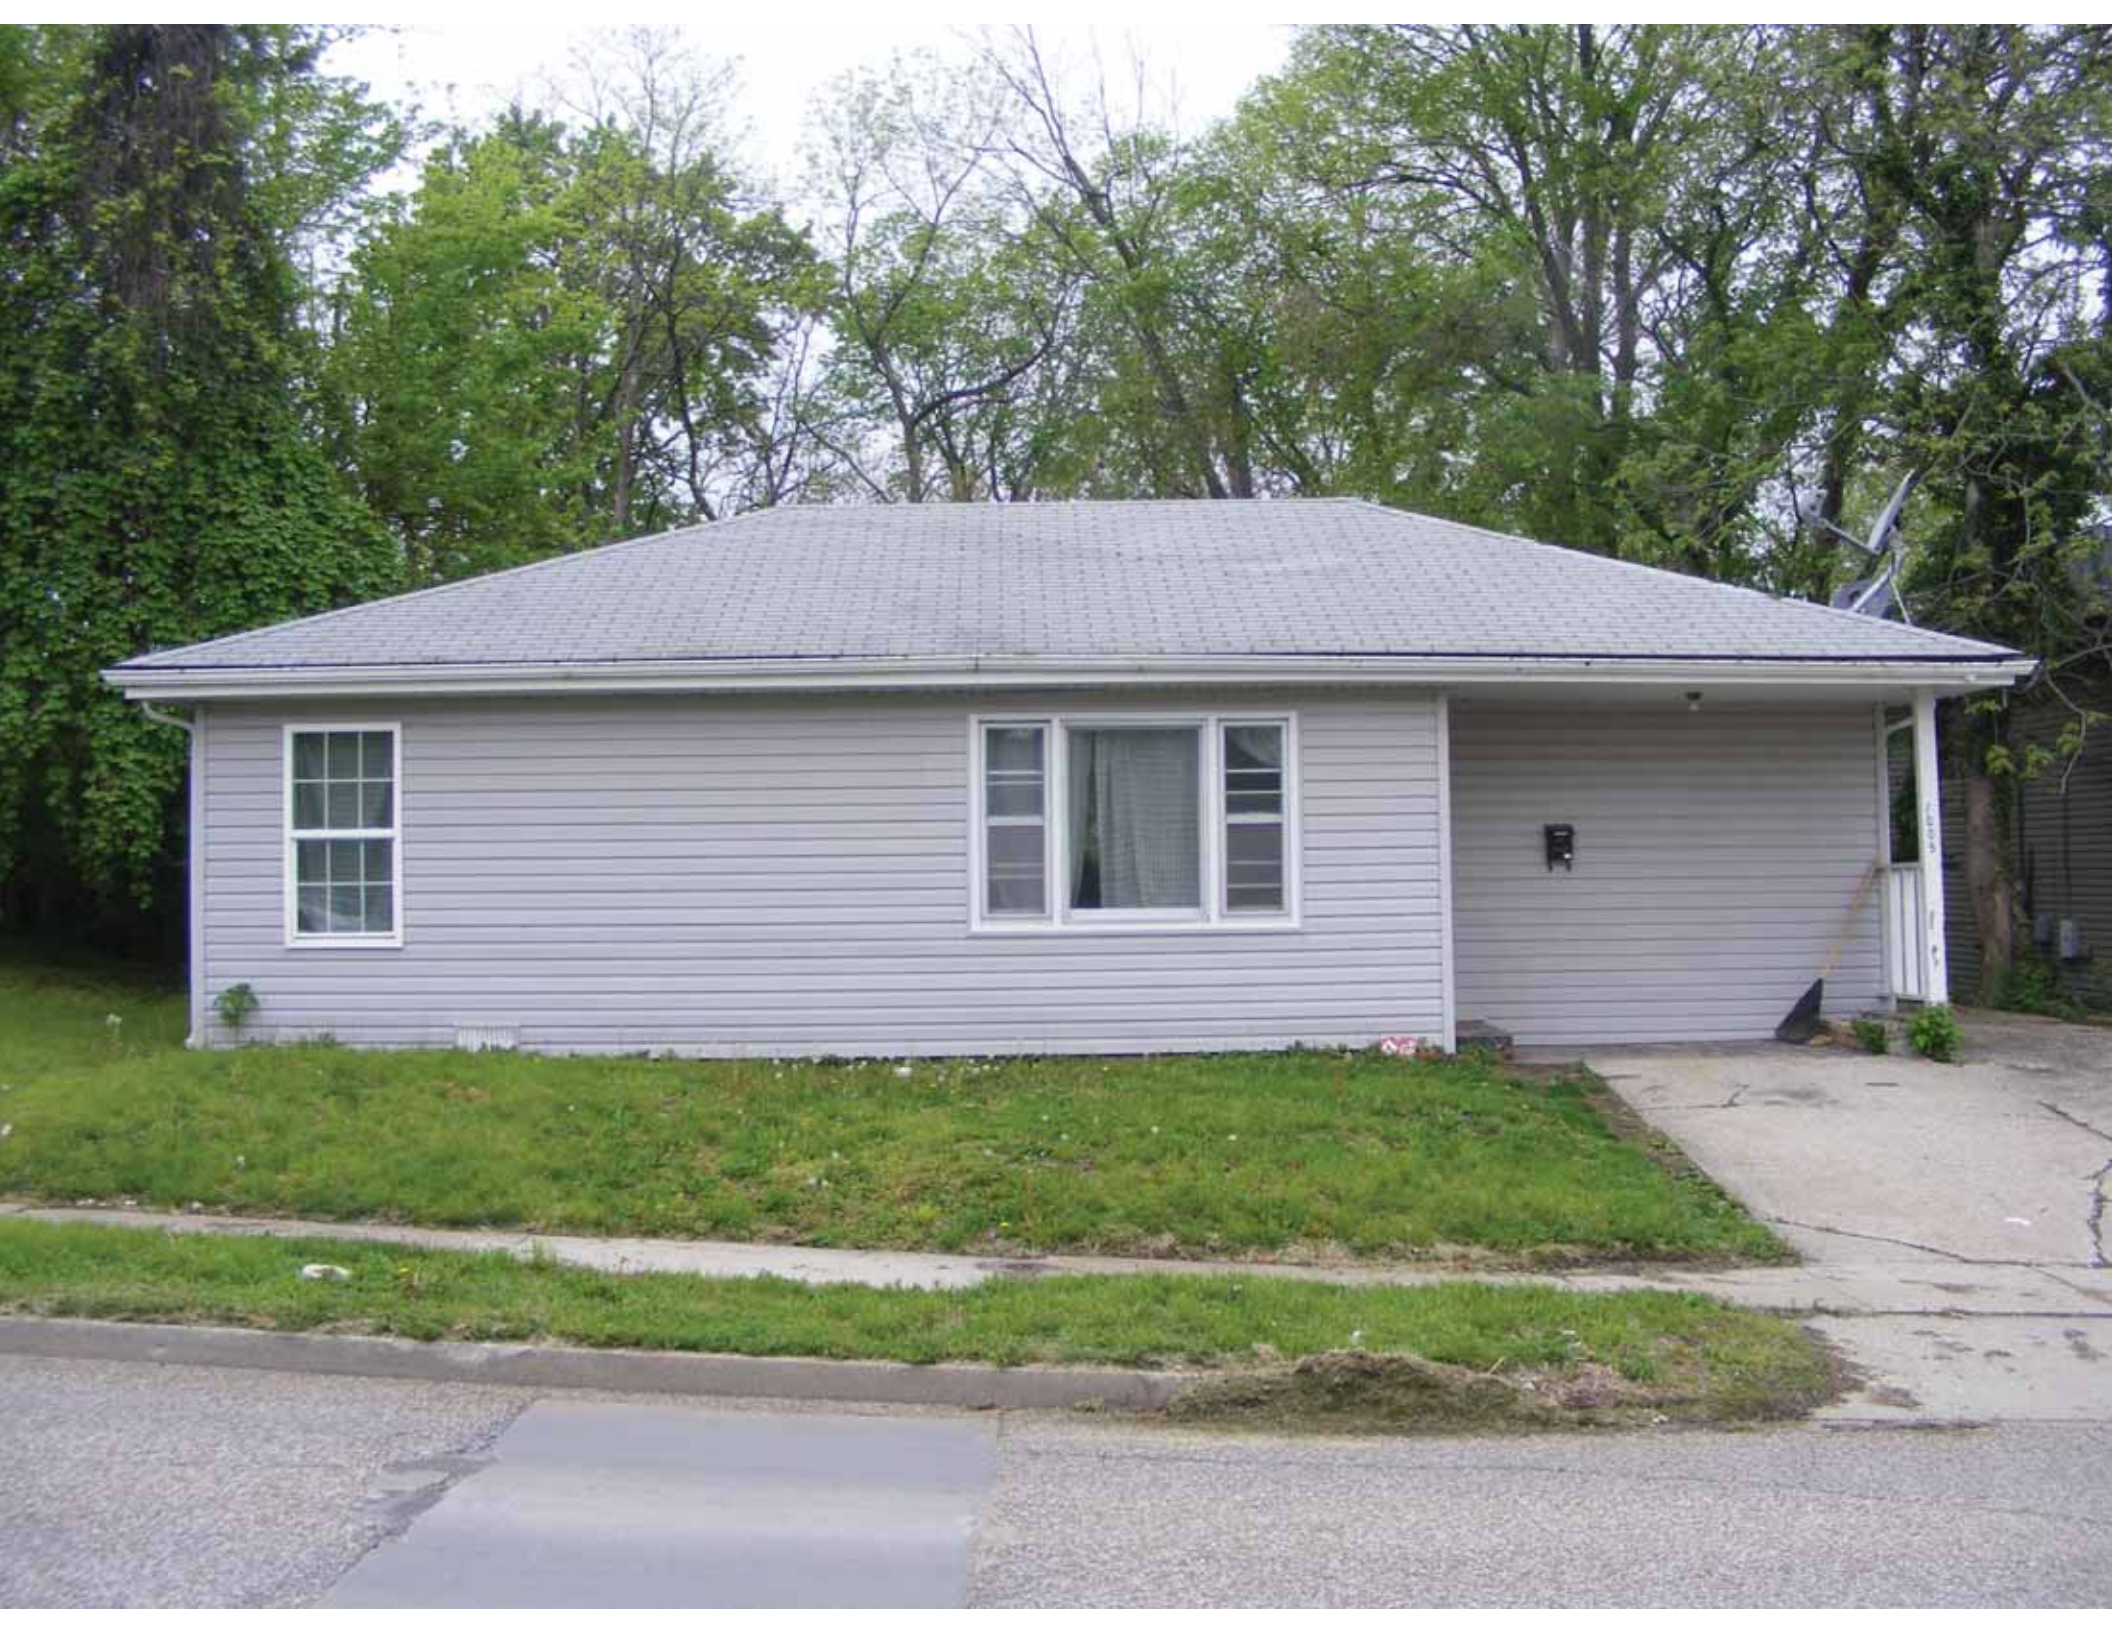
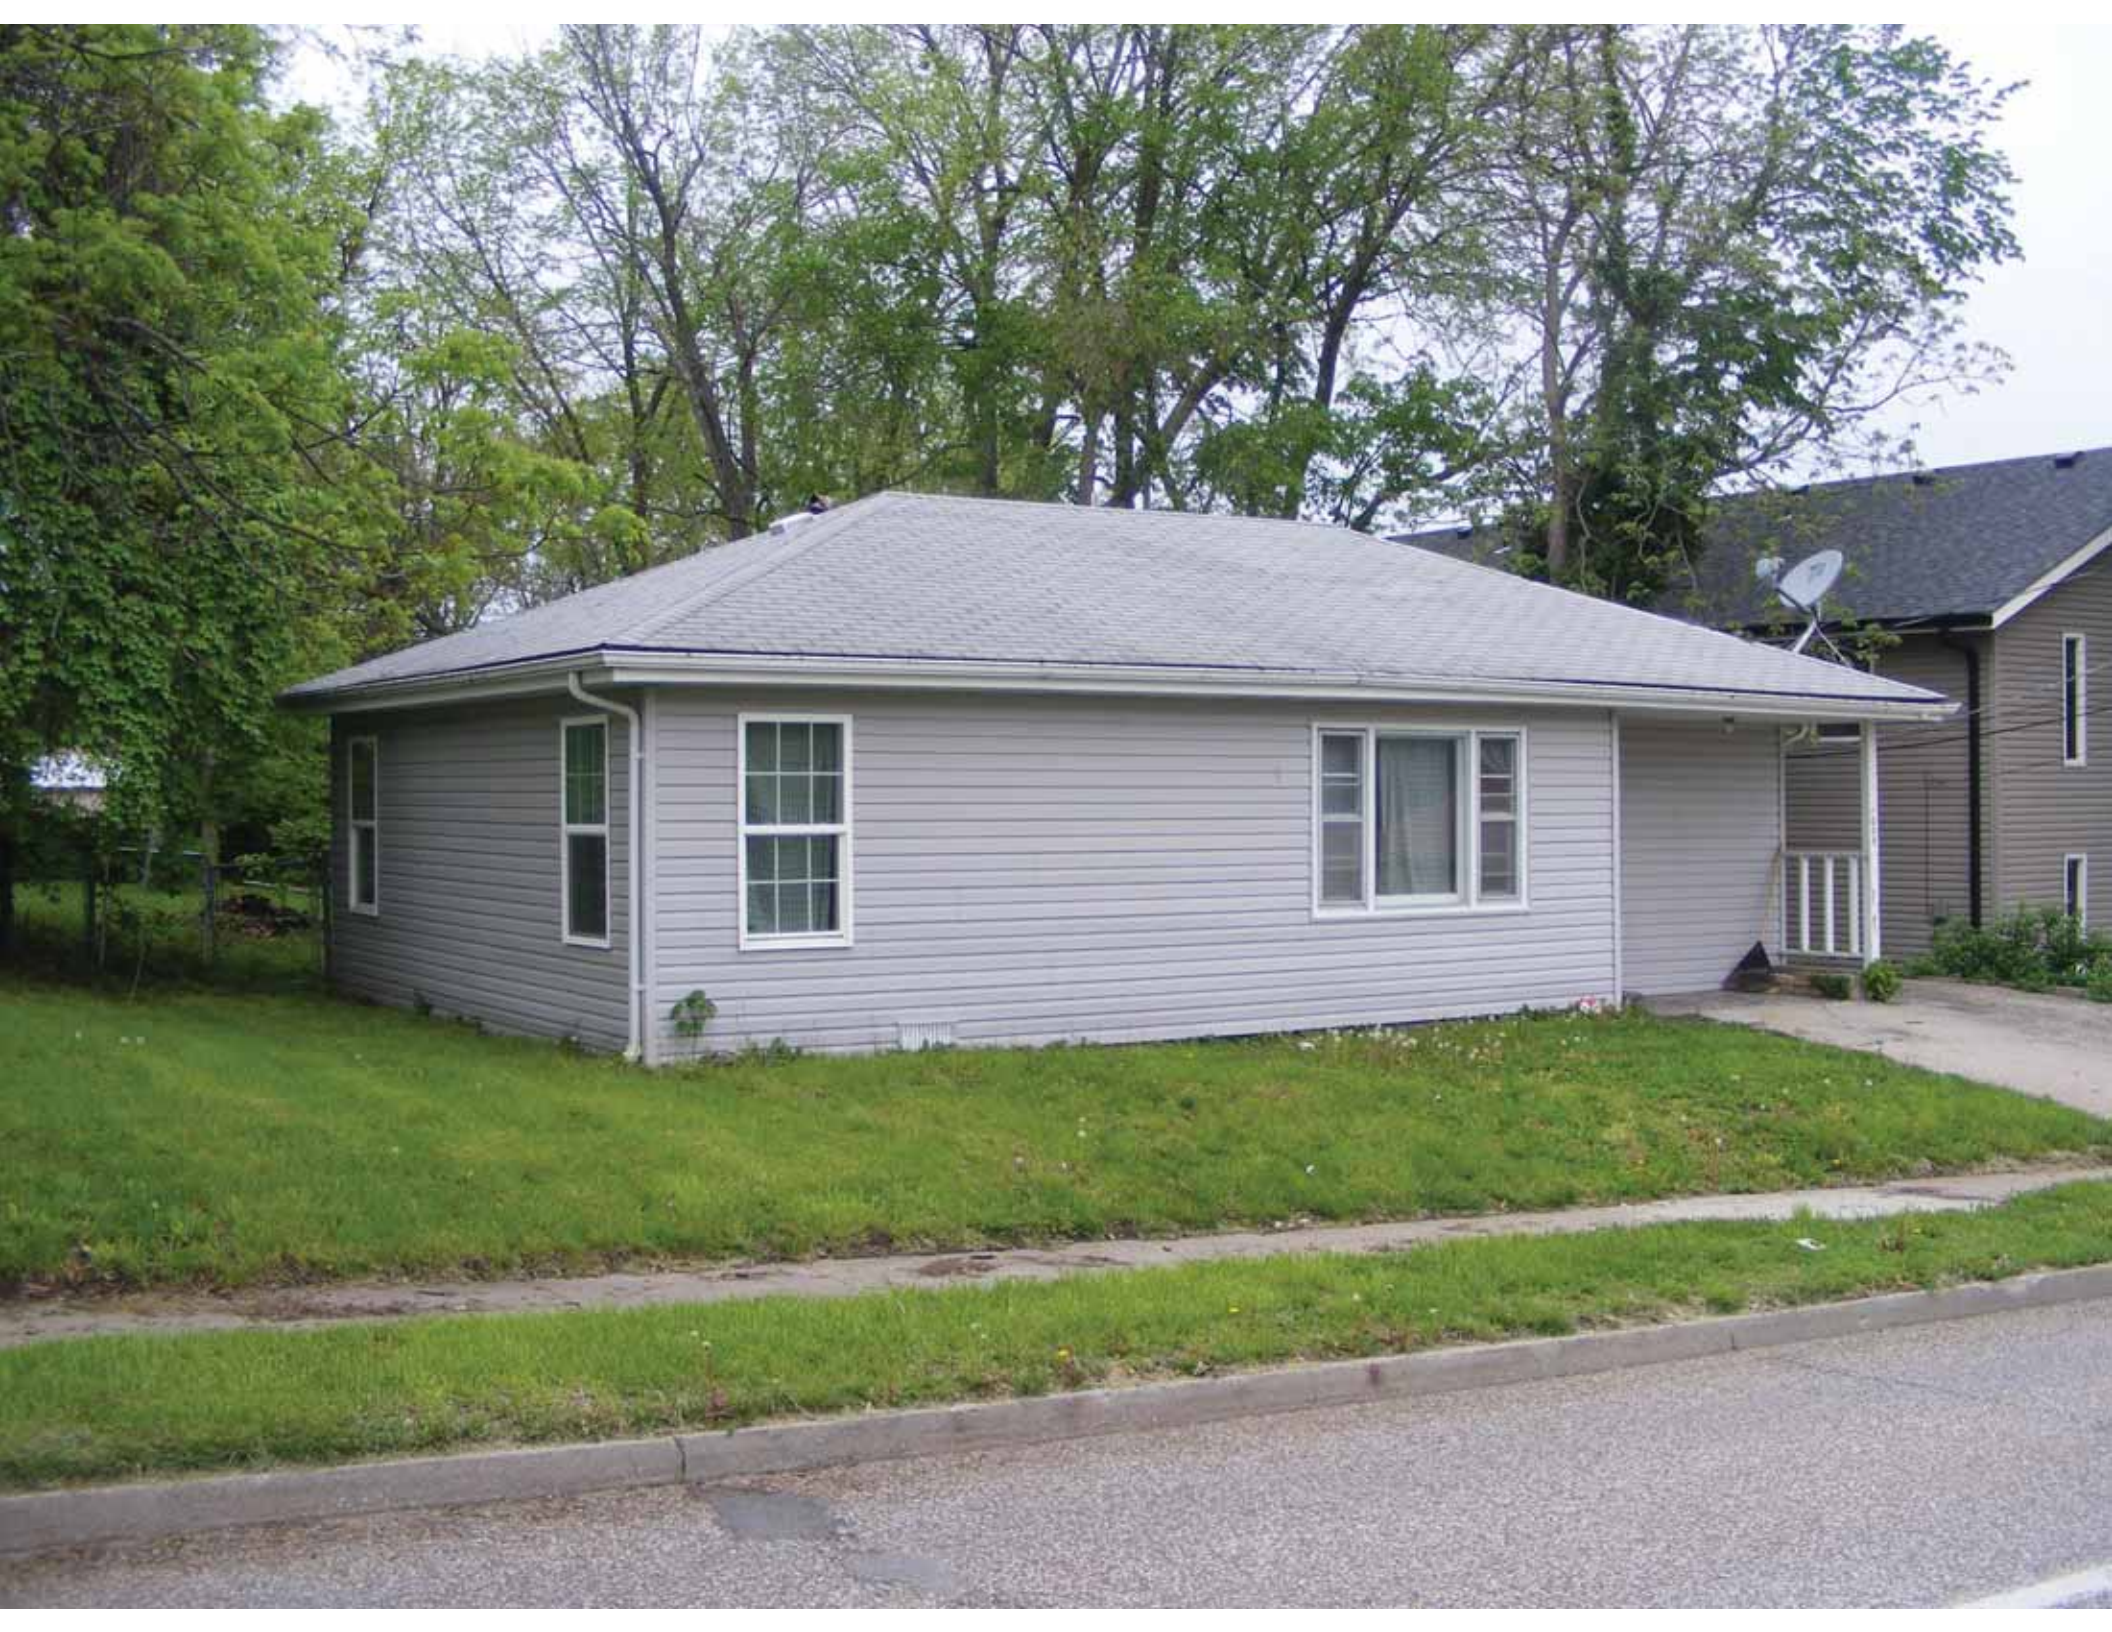
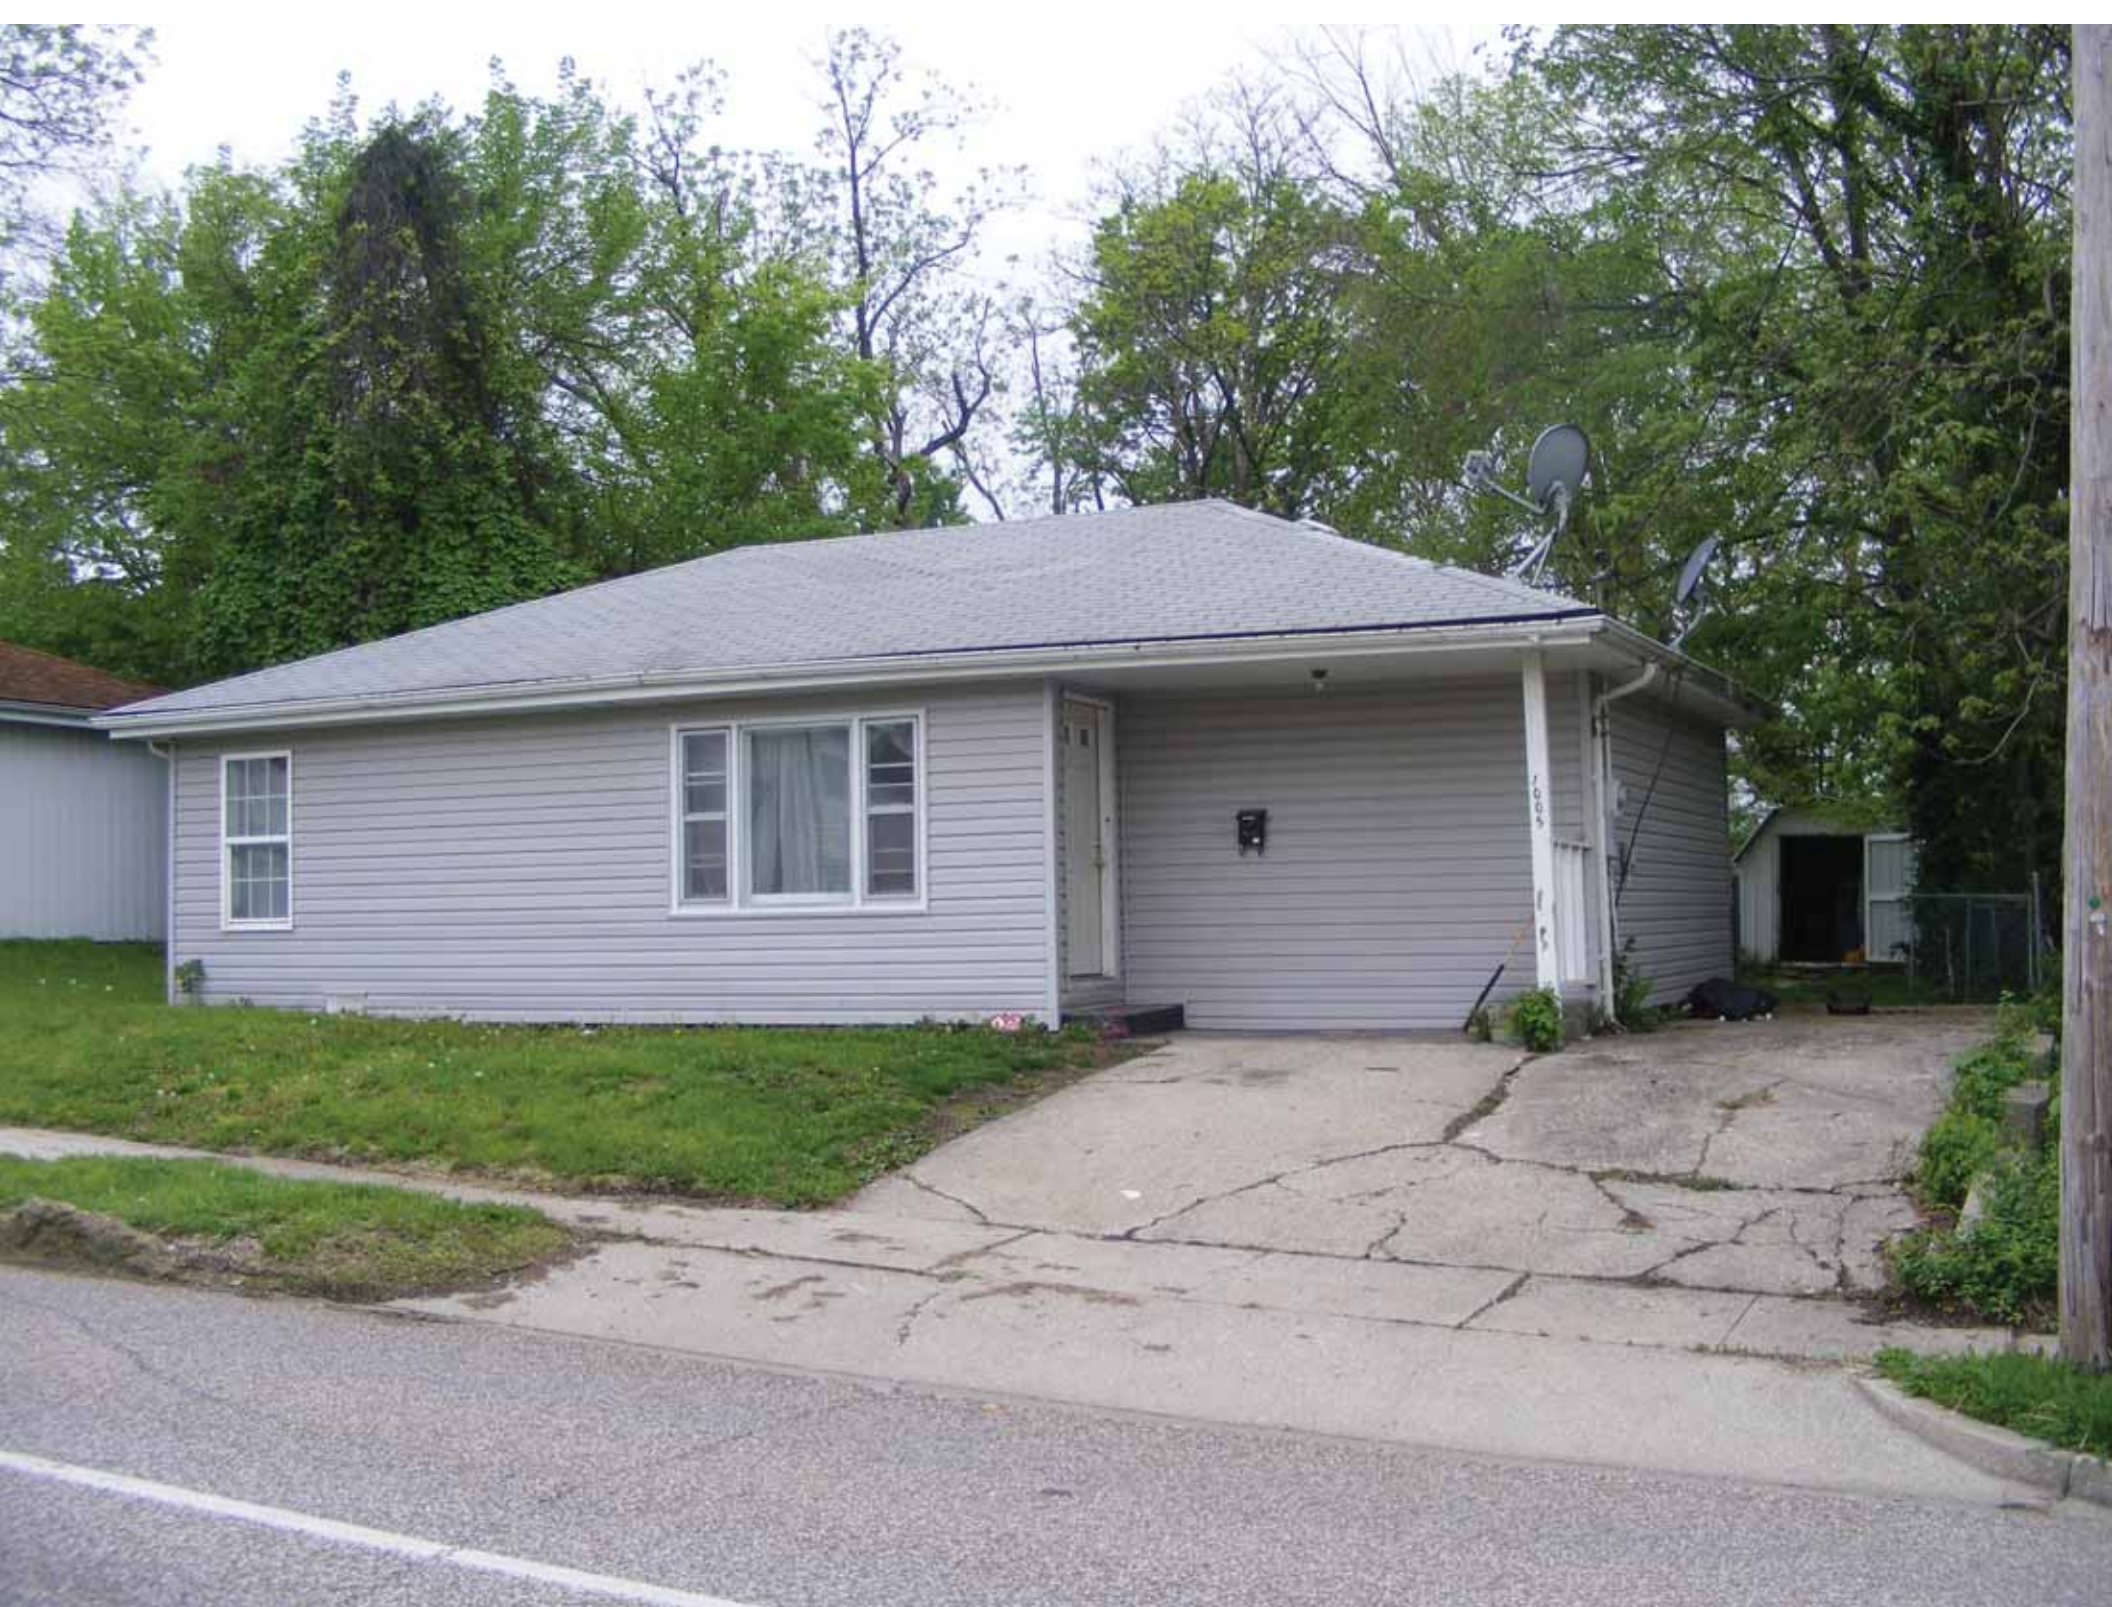
The property is a single-story frame dwelling with an asphalt shingled hip roof, exterior I vinyl siding and a concrete foundation. Primary elevation holds a six-over-six replacement window offset to right by a picture window with vertical two-over-two side windows. An inset bay area is found at the right corner of the primary elevation. Entrance is at the "L" in inset area and located on side elevation wall. Inset area is sheltered under roof supported by square wooden post with railing. Side elevations holds six-over-six windows. Two satellite disk are located on the right side sloping roofline.
