MISSOURI DEPARTMENT OF NATURAL RESOURCES
STATE HISTORIC PRESERVATION OFFICE, P.O. Box 176, Jefferson City, MO 65102
ARCHITECTURAL/HISTORIC INVENTORY FORM

1. Survey No. BO-AS-011-0087		2. Survey name: North Central Columbia Survey Phase II	
3. County: Boone		4. Address (Street No.) 902	Street (name) N. Seventh Street
5. City: Columbia	Vicinity: <input type="checkbox"/>	6. Geographical Reference:	7. Township/Range/Section: T: R: S:
8. Historic name (if known):		9. Present/other name (if known):	
10. Ownership: <input checked="" type="checkbox"/> Private <input type="checkbox"/> Public		11a. Historic use (if known): Domestic/single dwelling	11b. Current use: Domestic/single dwelling

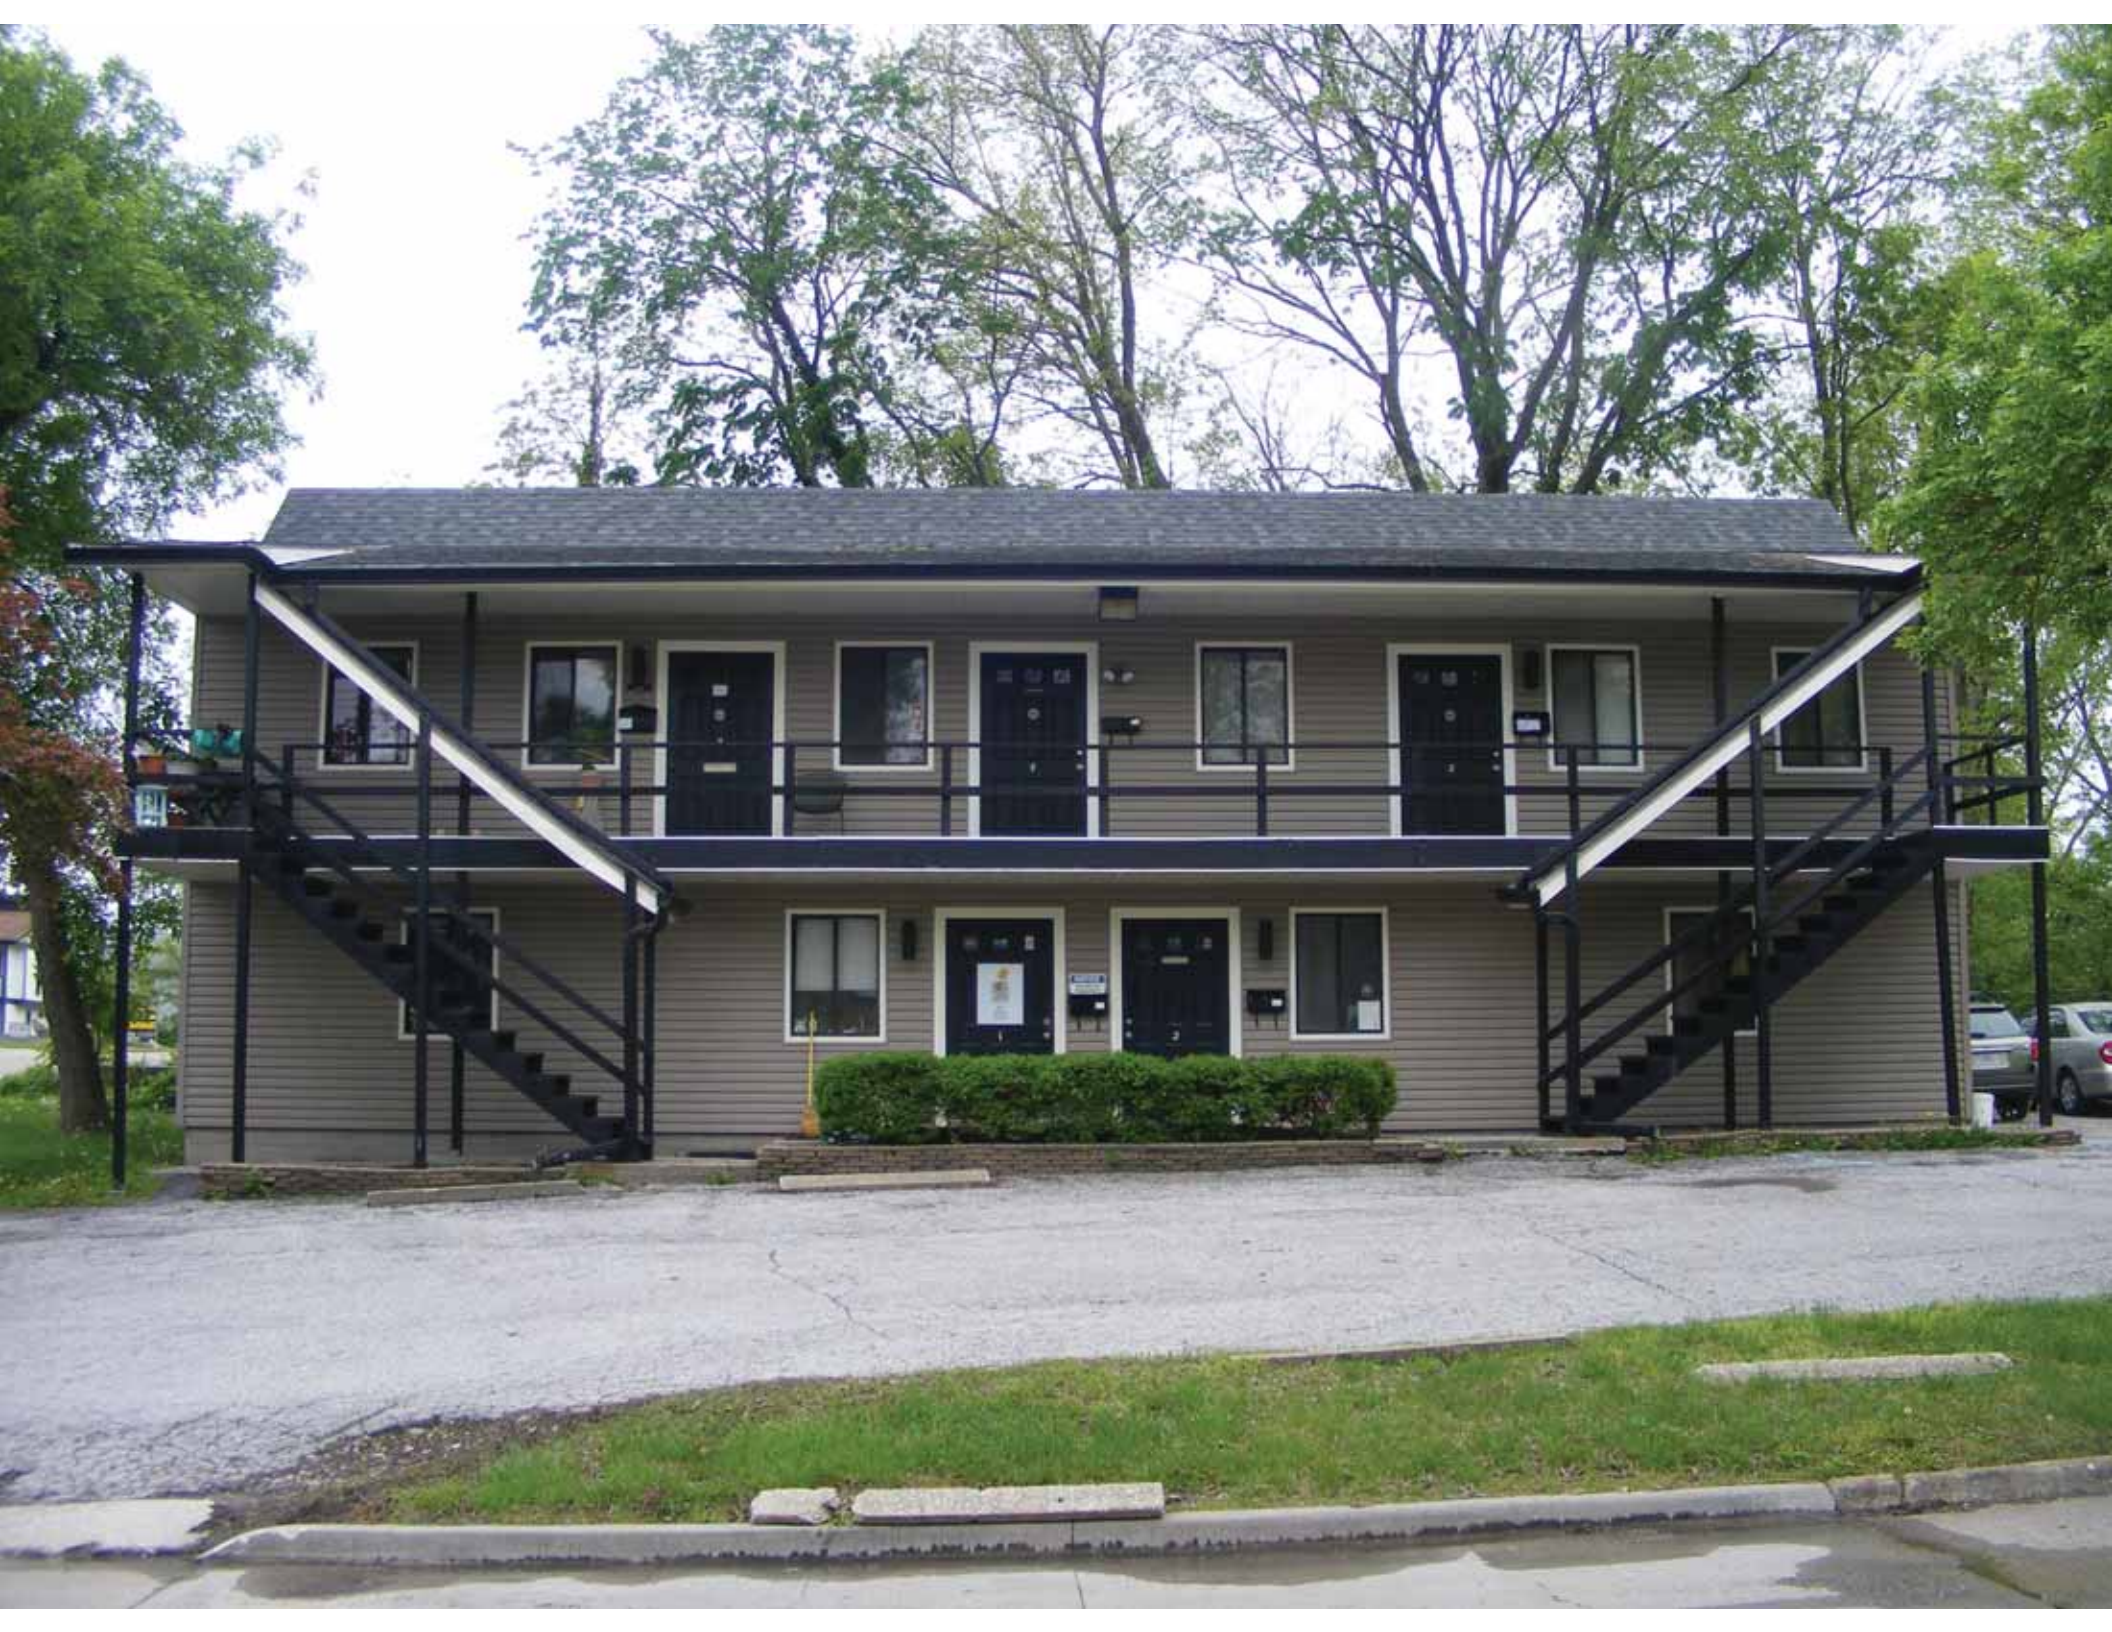
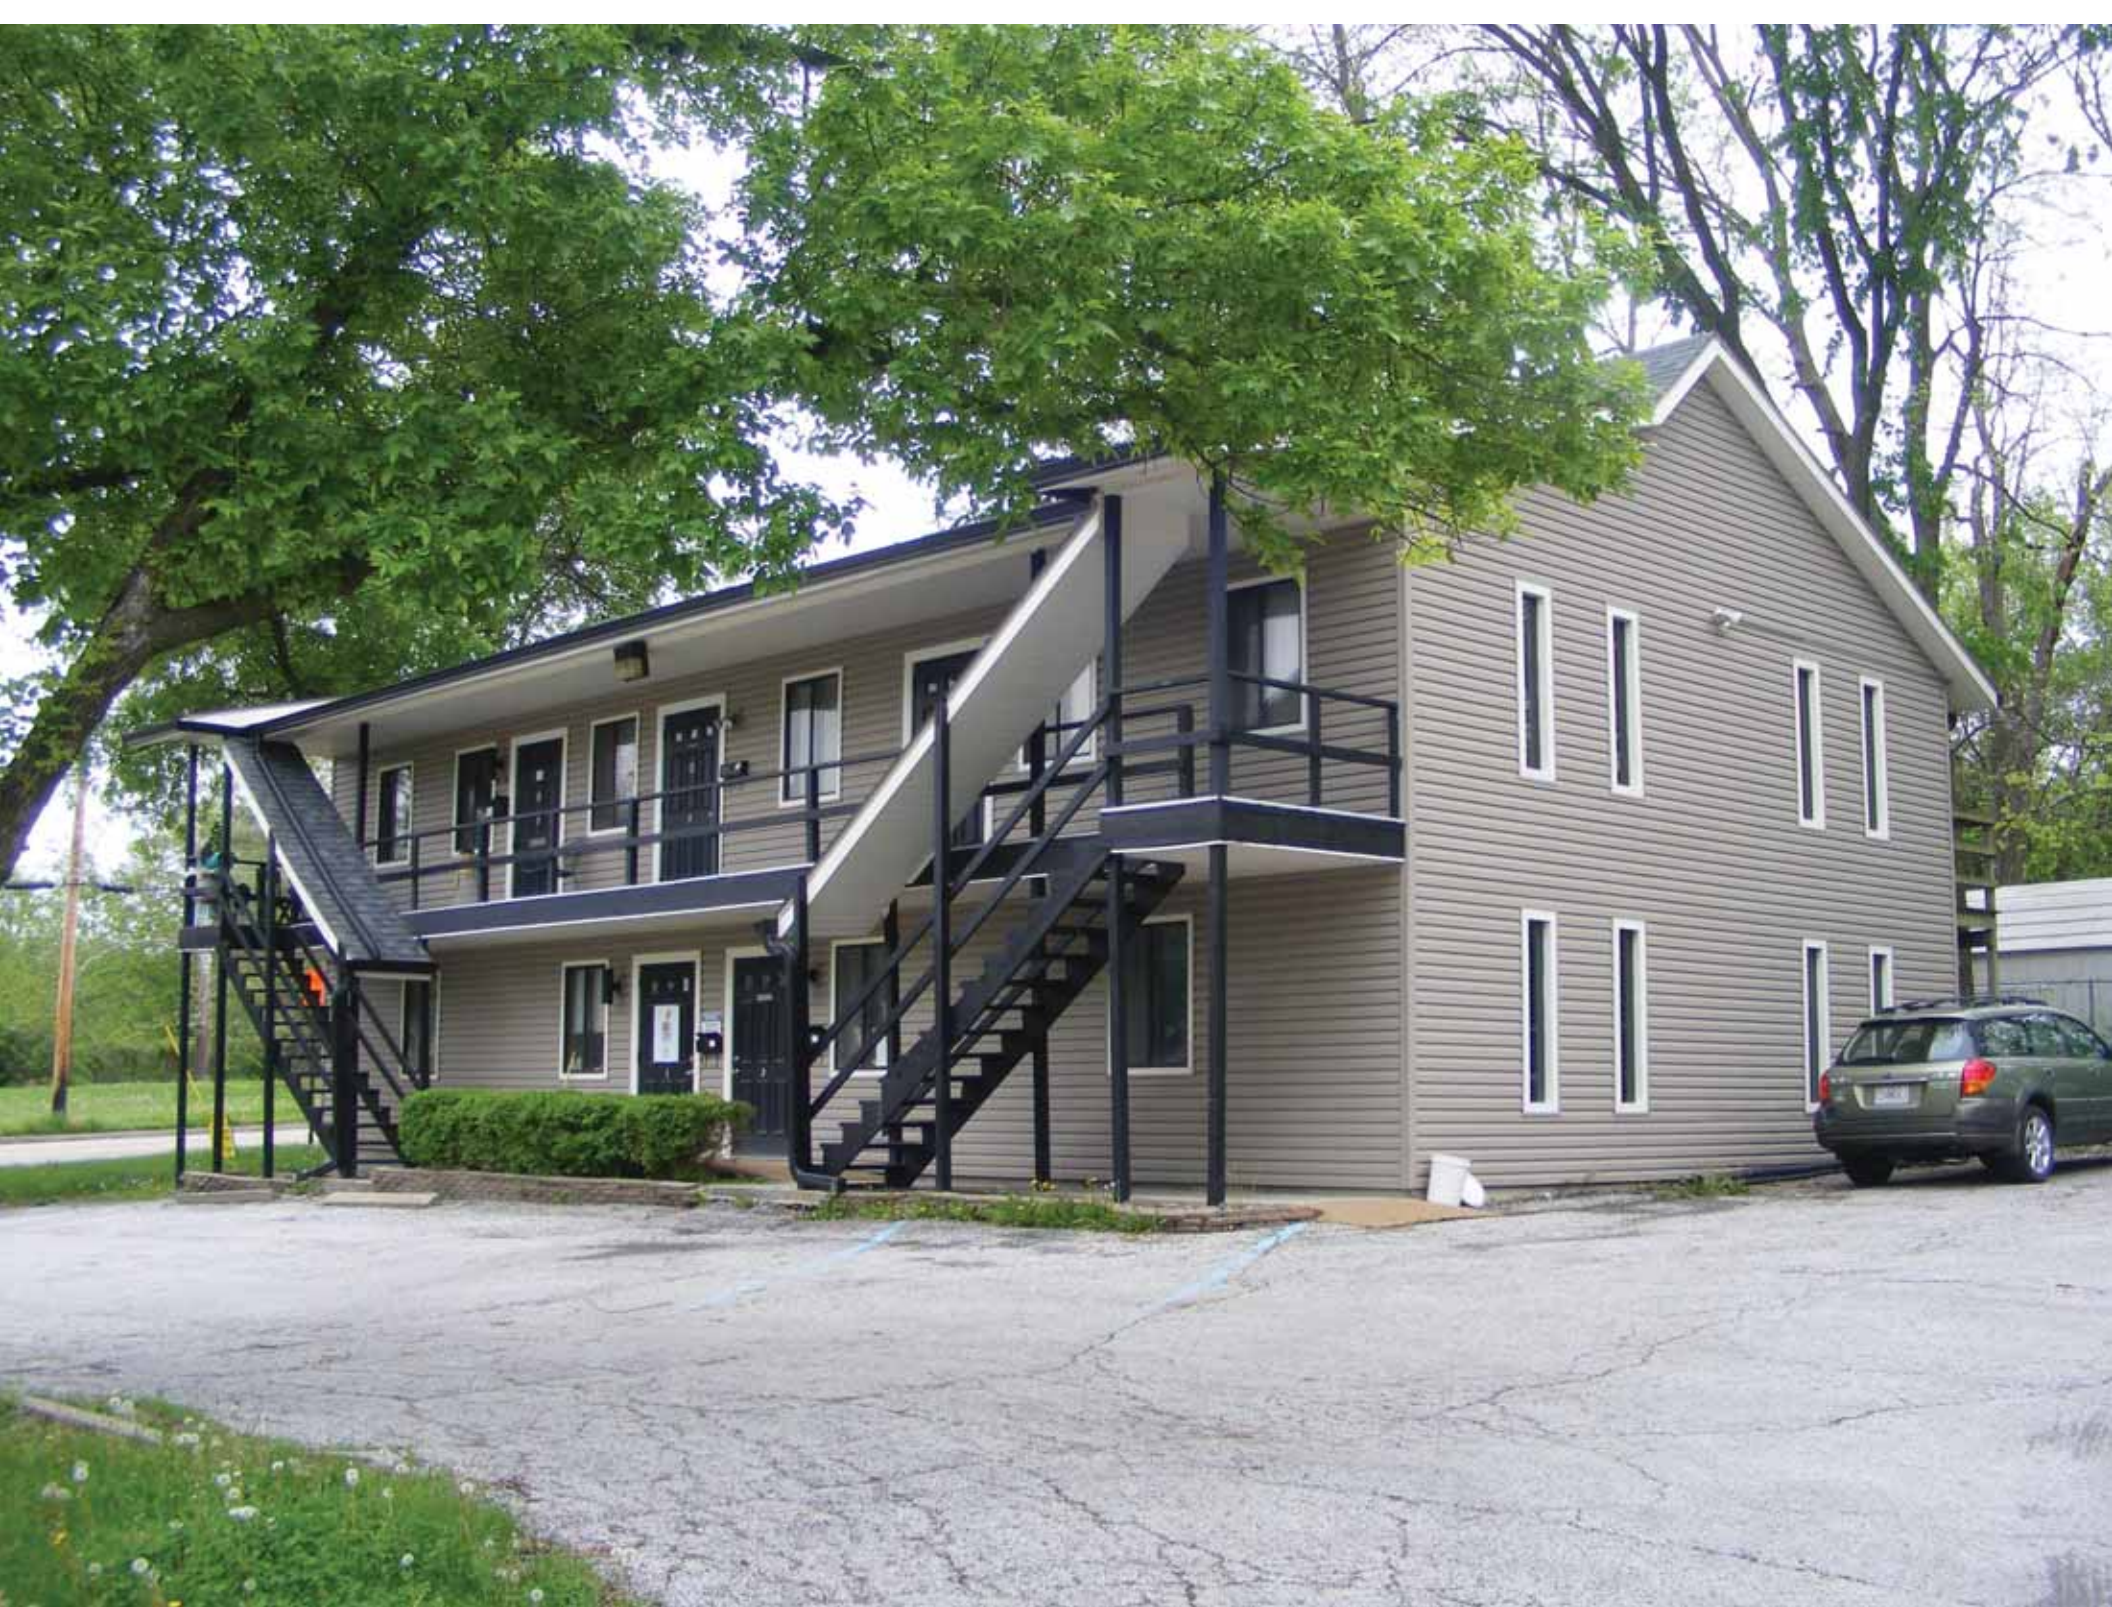
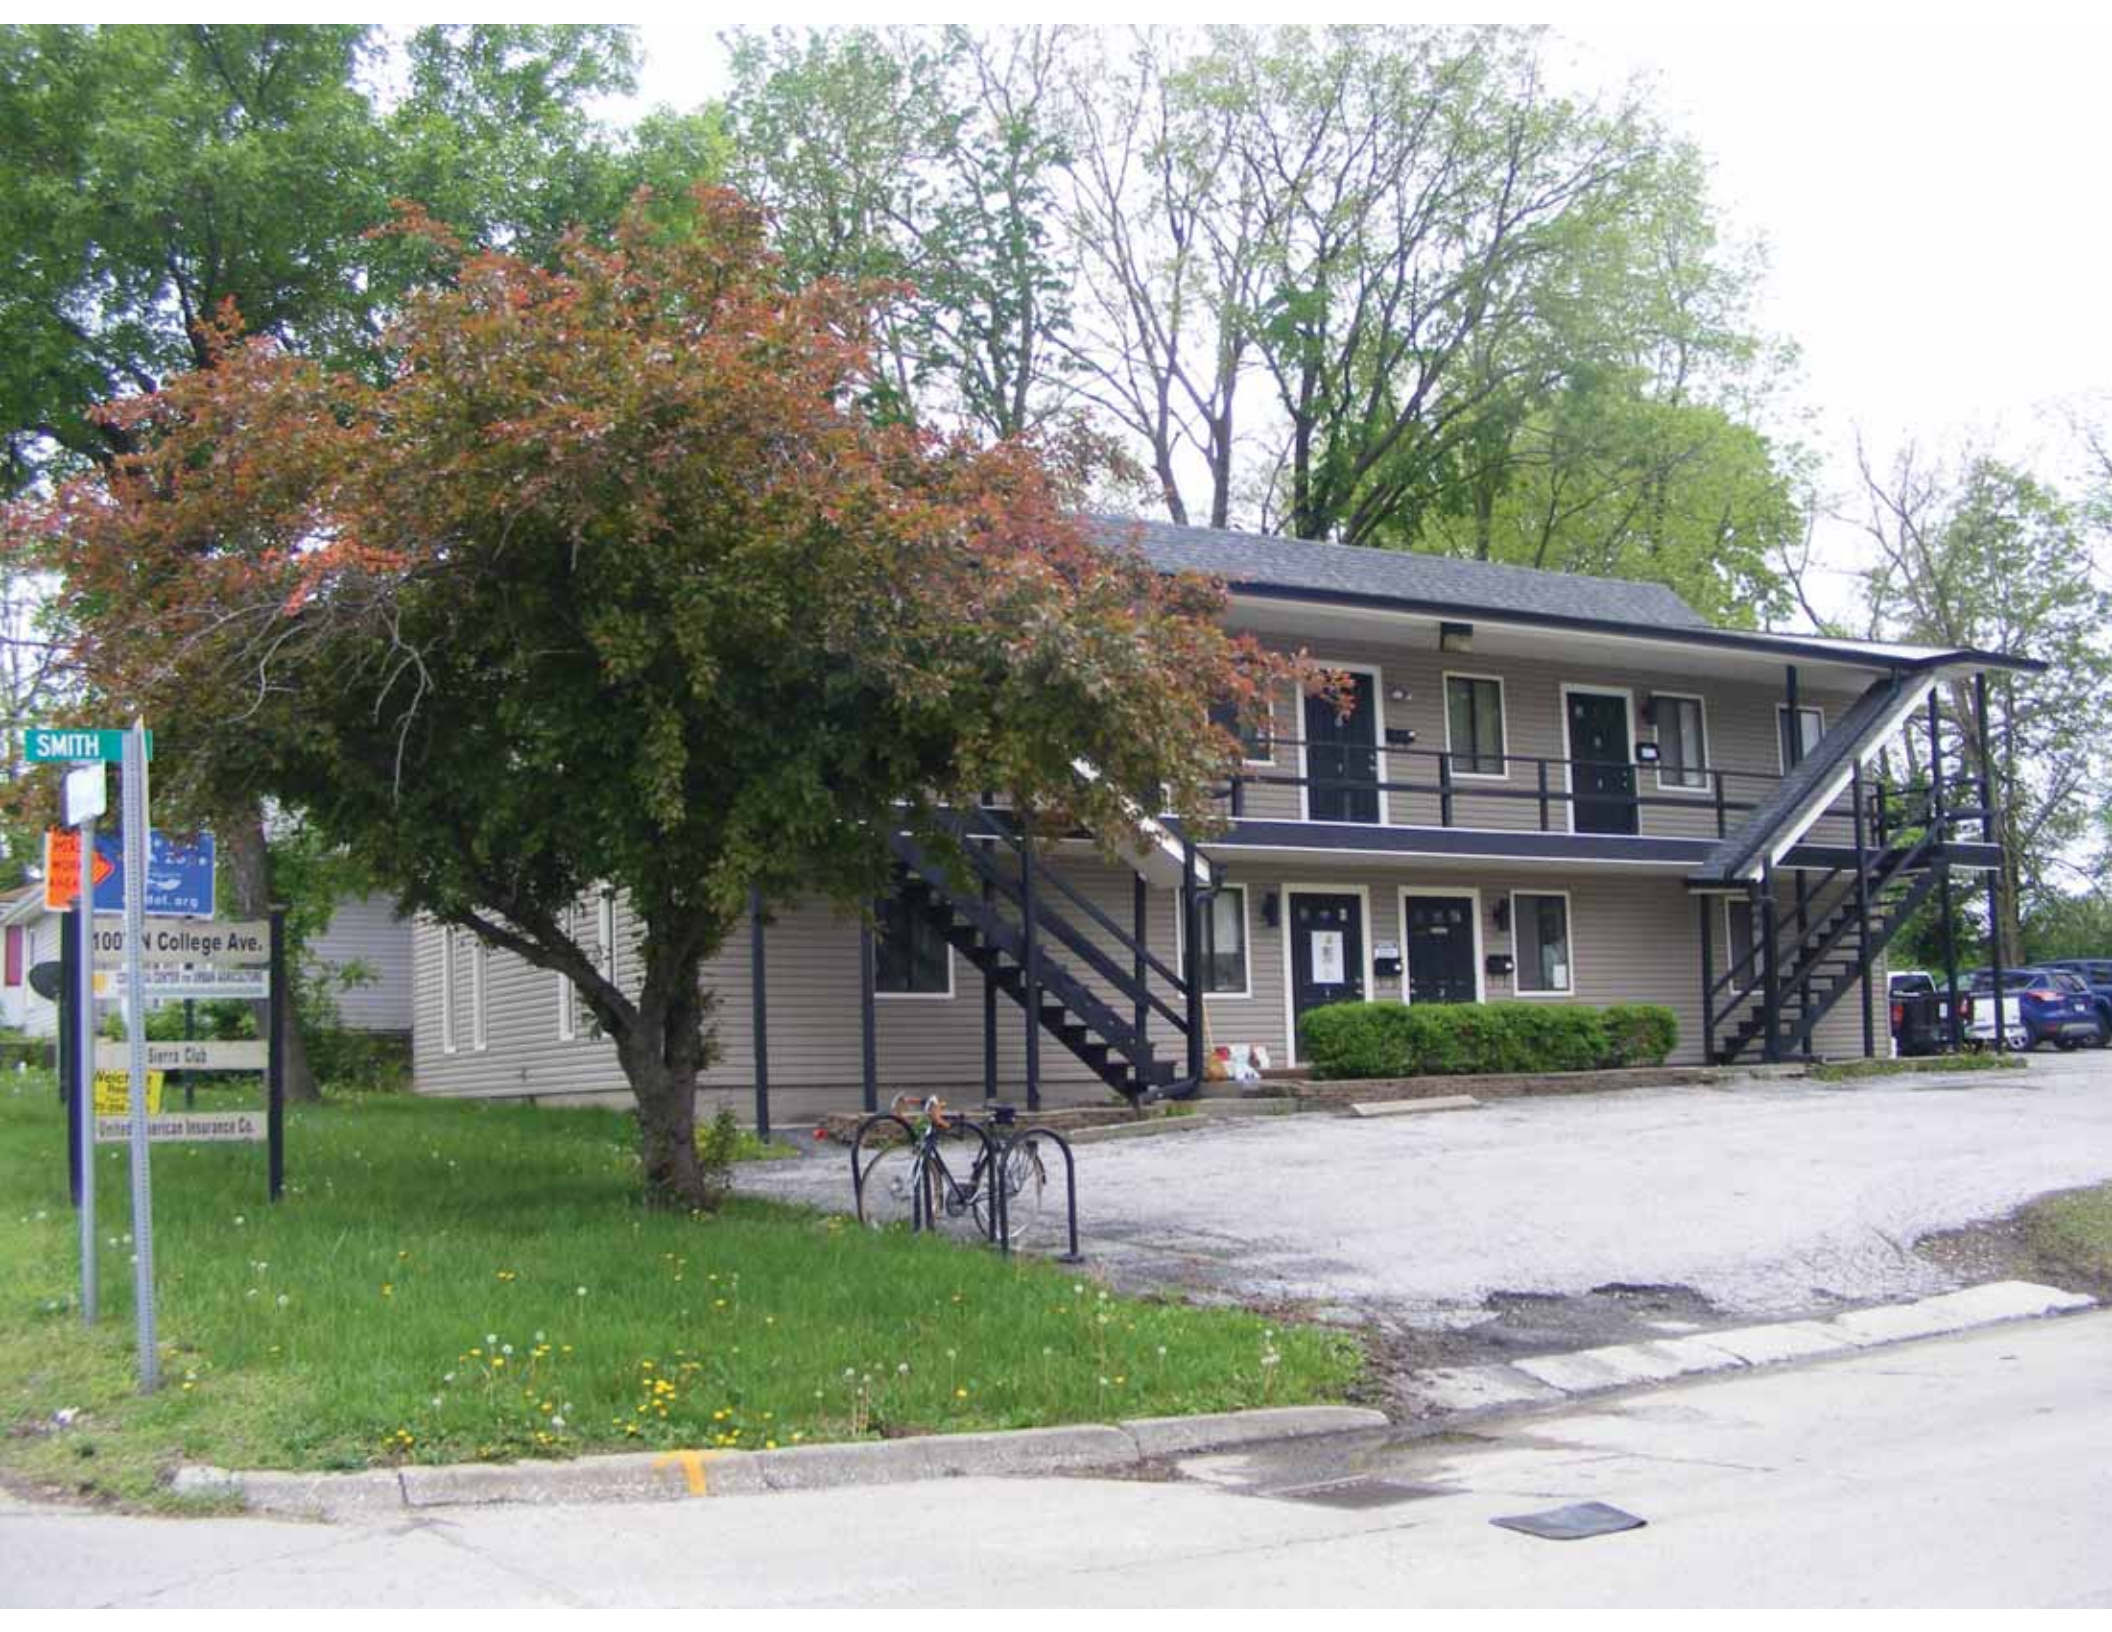
The property is a two-story frame multi-family dwelling with an asphalt shingled side gabled roof, exterior vinyl siding and a concrete foundation. The primary elevation holds sheltered gallery porches (lower and upper level); upper level is sheltered by roofline supported by narrow square wooden posts. At each end of the façade are wooden staircases with wood railings, sheltered by an asphalt shingled sloped awning. Each staircase faces inward toward each other (north-south). The primary elevation on the lower level holds two centered entrances and are flanked by two light slider windows. The upper level holds three entrance and six, two light slider windows. Side elevation hold narrow fixed windows.

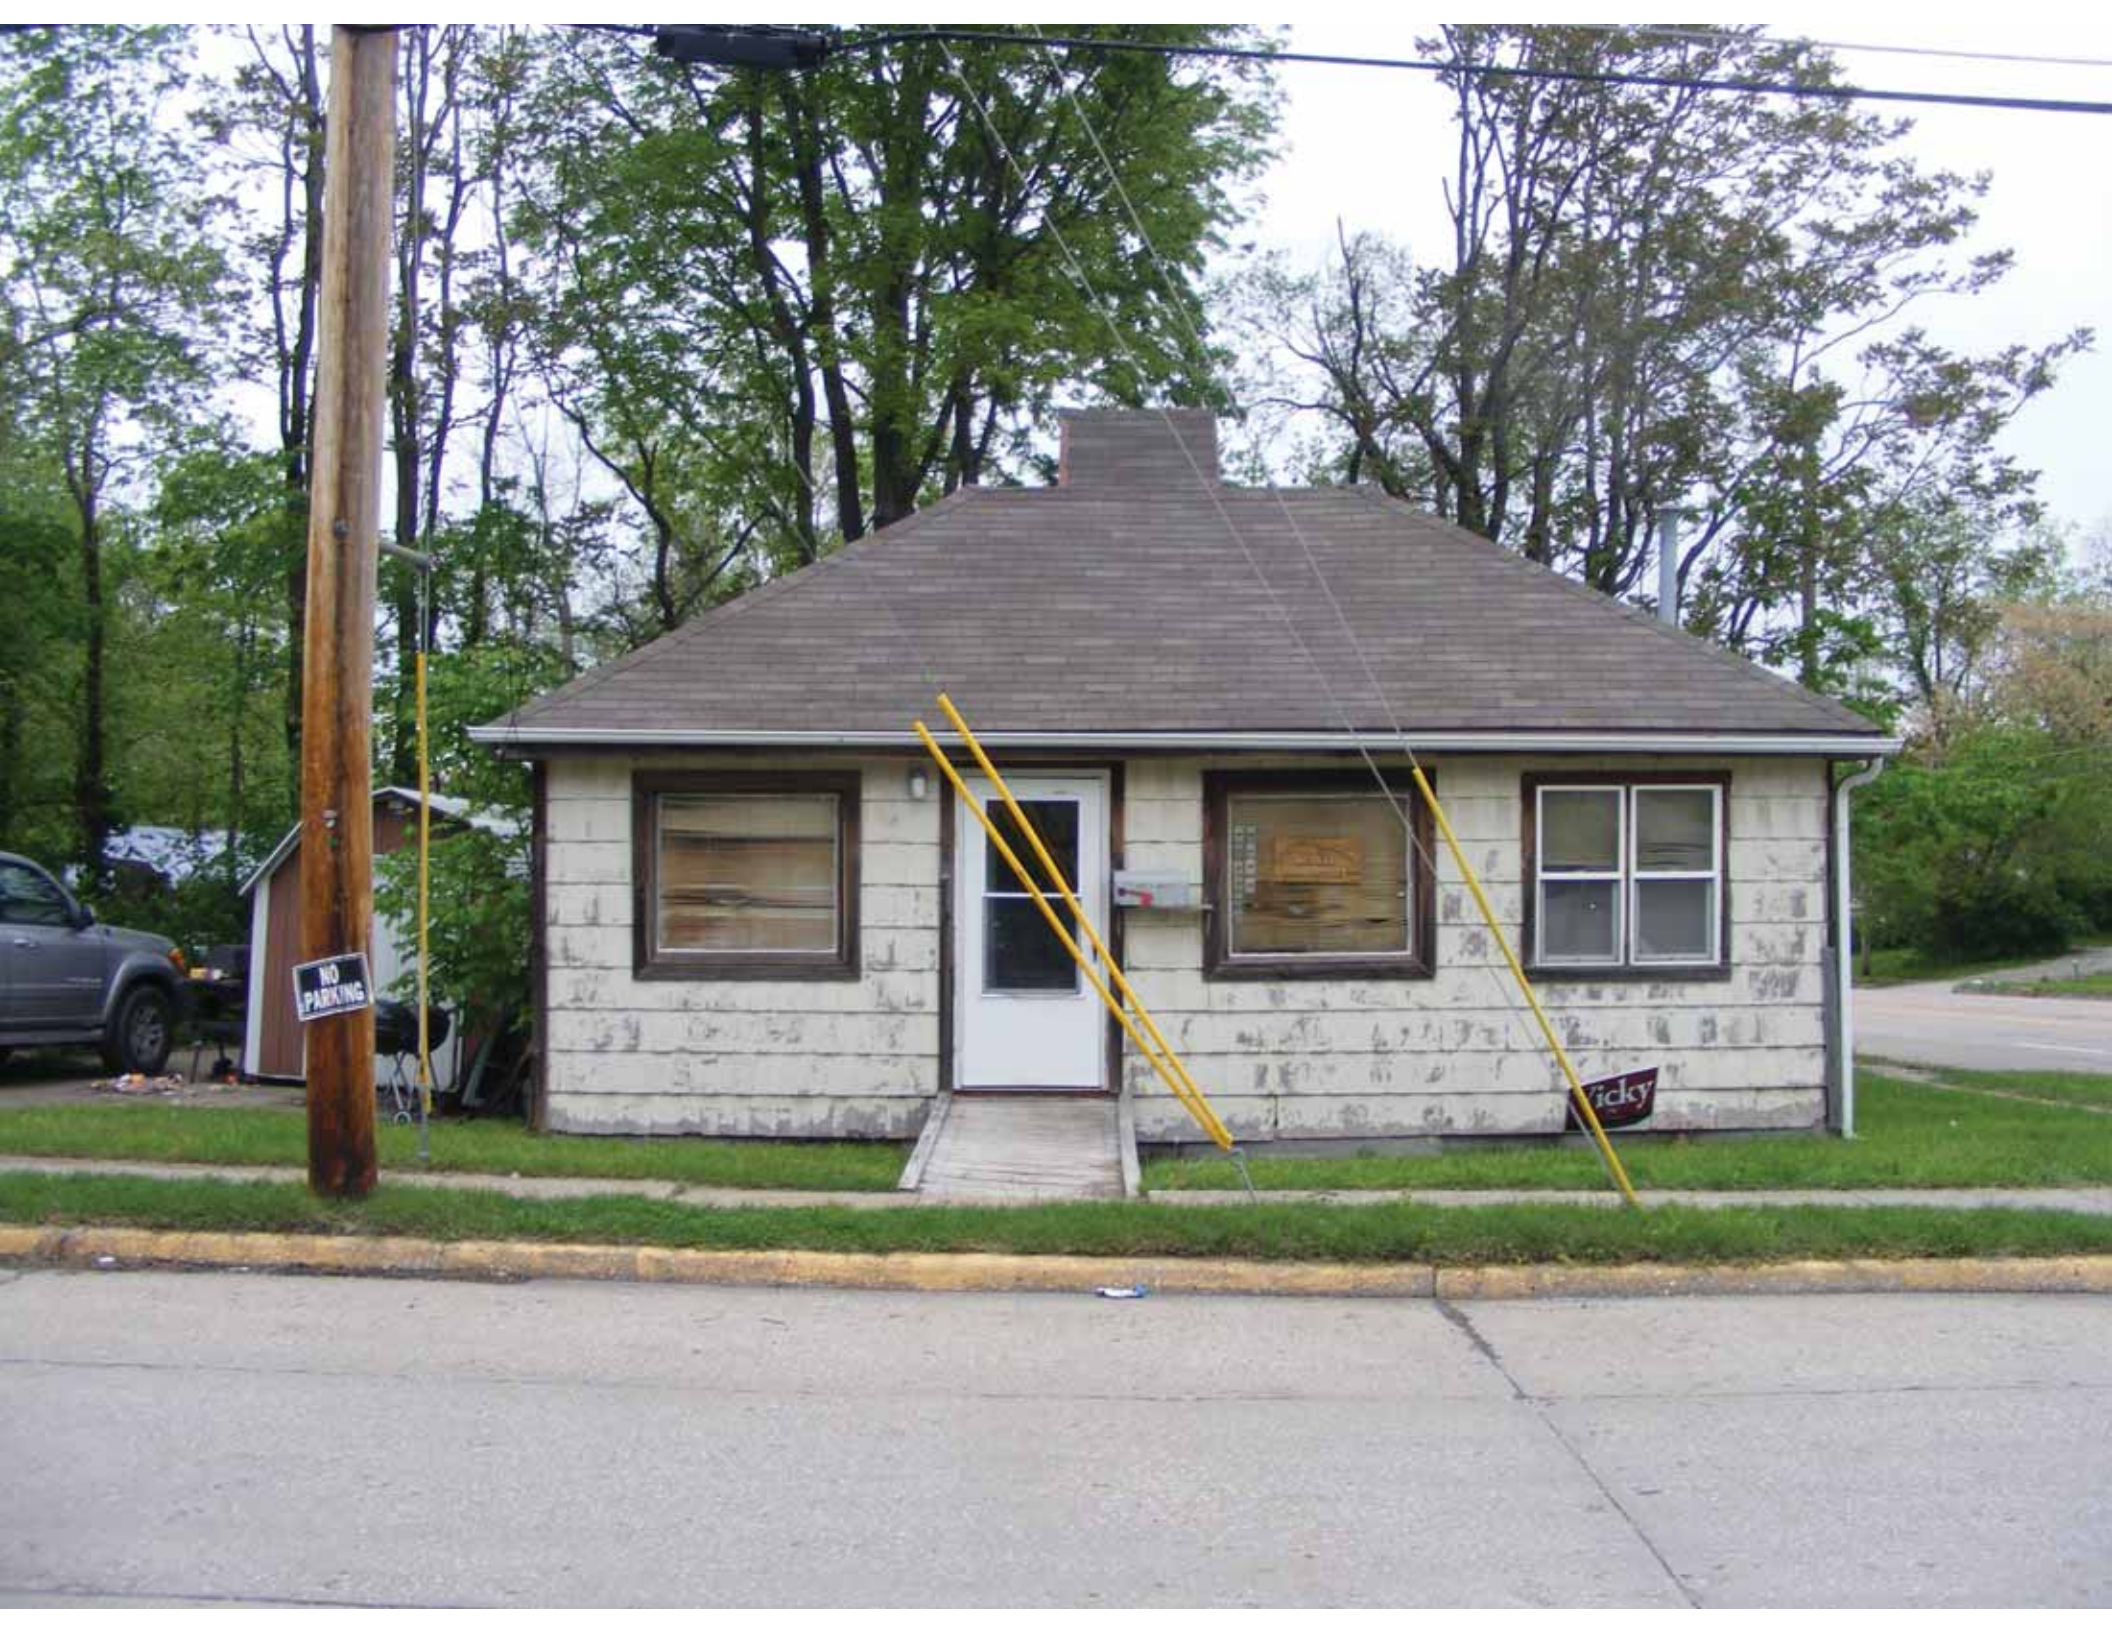
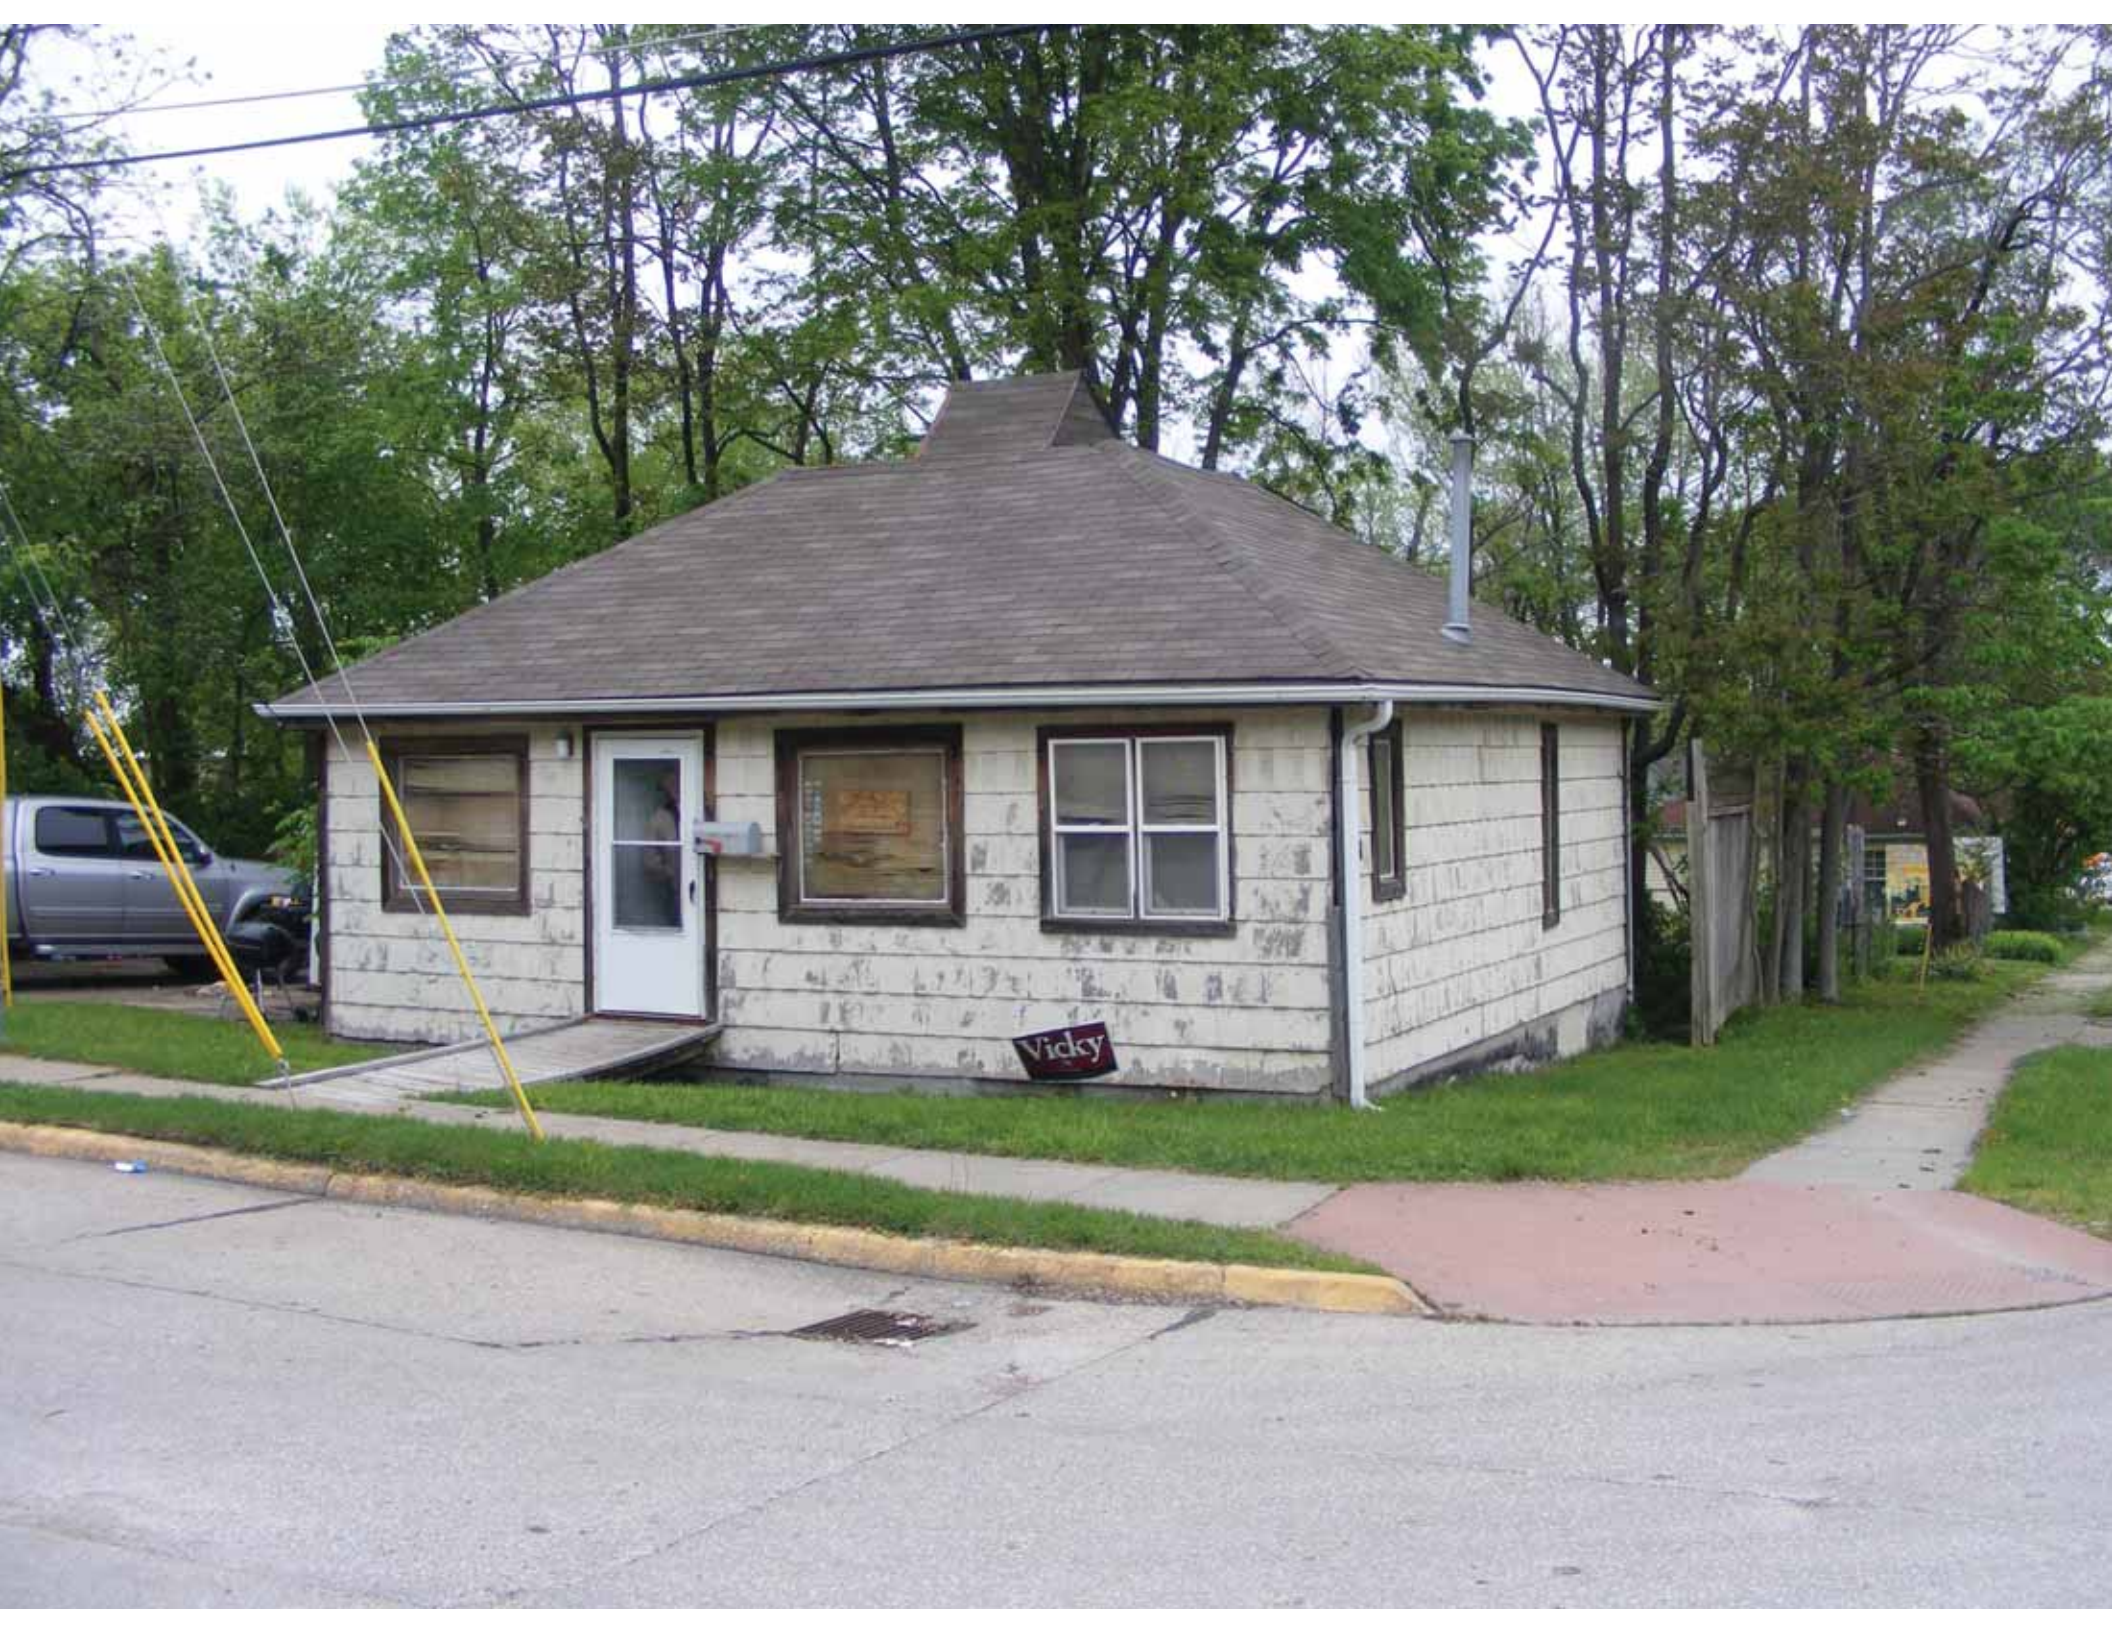
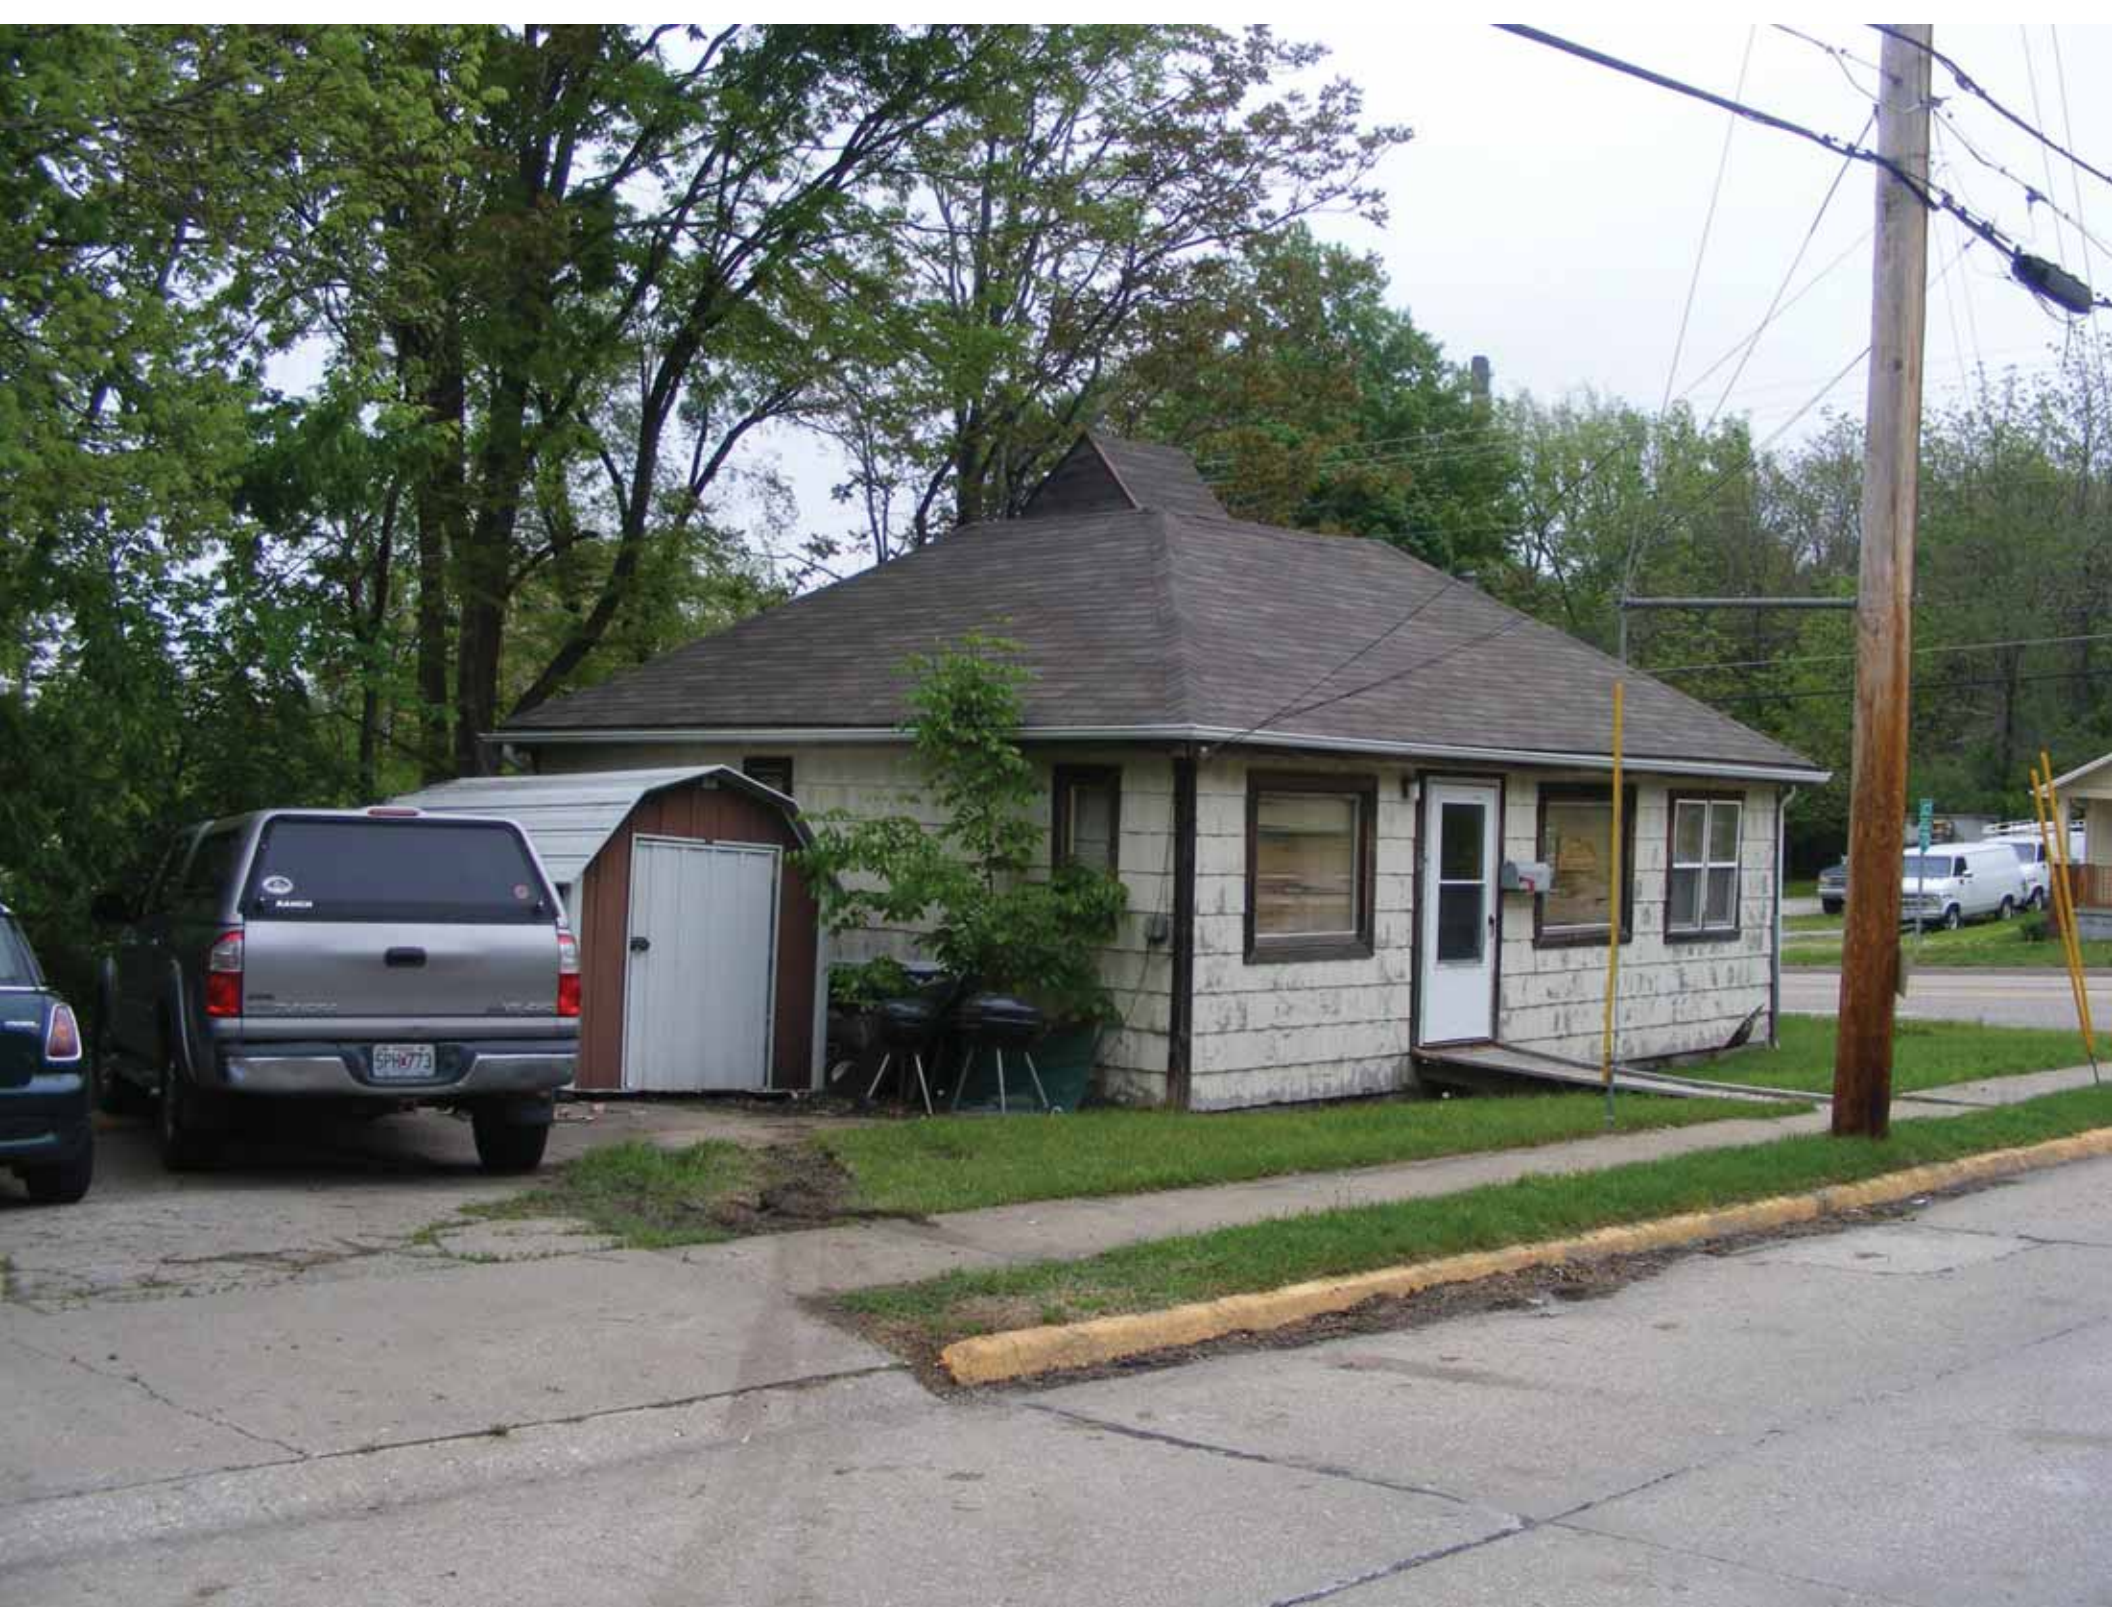
The property is a single-story frame dwelling, asphalt shingled truncated hip, asbestos siding and concrete foundation. Primary elevation holds an off-centered entrance flanked by picture windows and a paired one-over-one window. Side elevations hold fixed windows. Located on the flat section of the roof is small triangle shaped addition (side gable) clad in asphalt shingles. This area may have held a chimney at one time.
