MISSOURI DEPARTMENT OF NATURAL RESOURCES
STATE HISTORIC PRESERVATION OFFICE, P.O. Box 176, Jefferson City, MO 65102
ARCHITECTURAL/HISTORIC INVENTORY FORM

1. Survey No. BO-AS-011-0087		2. Survey name: North Central Columbia Survey Phase II	
3. County: Boone		4. Address (Street No.) 902	Street (name) N. Seventh Street
5. City: Columbia	Vicinity: <input type="checkbox"/>	6. Geographical Reference:	7. Township/Range/Section: T: R: S:
8. Historic name (if known):		9. Present/other name (if known):	
10. Ownership: <input checked="" type="checkbox"/> Private <input type="checkbox"/> Public		11a. Historic use (if known): Domestic/single dwelling	11b. Current use: Domestic/single dwelling

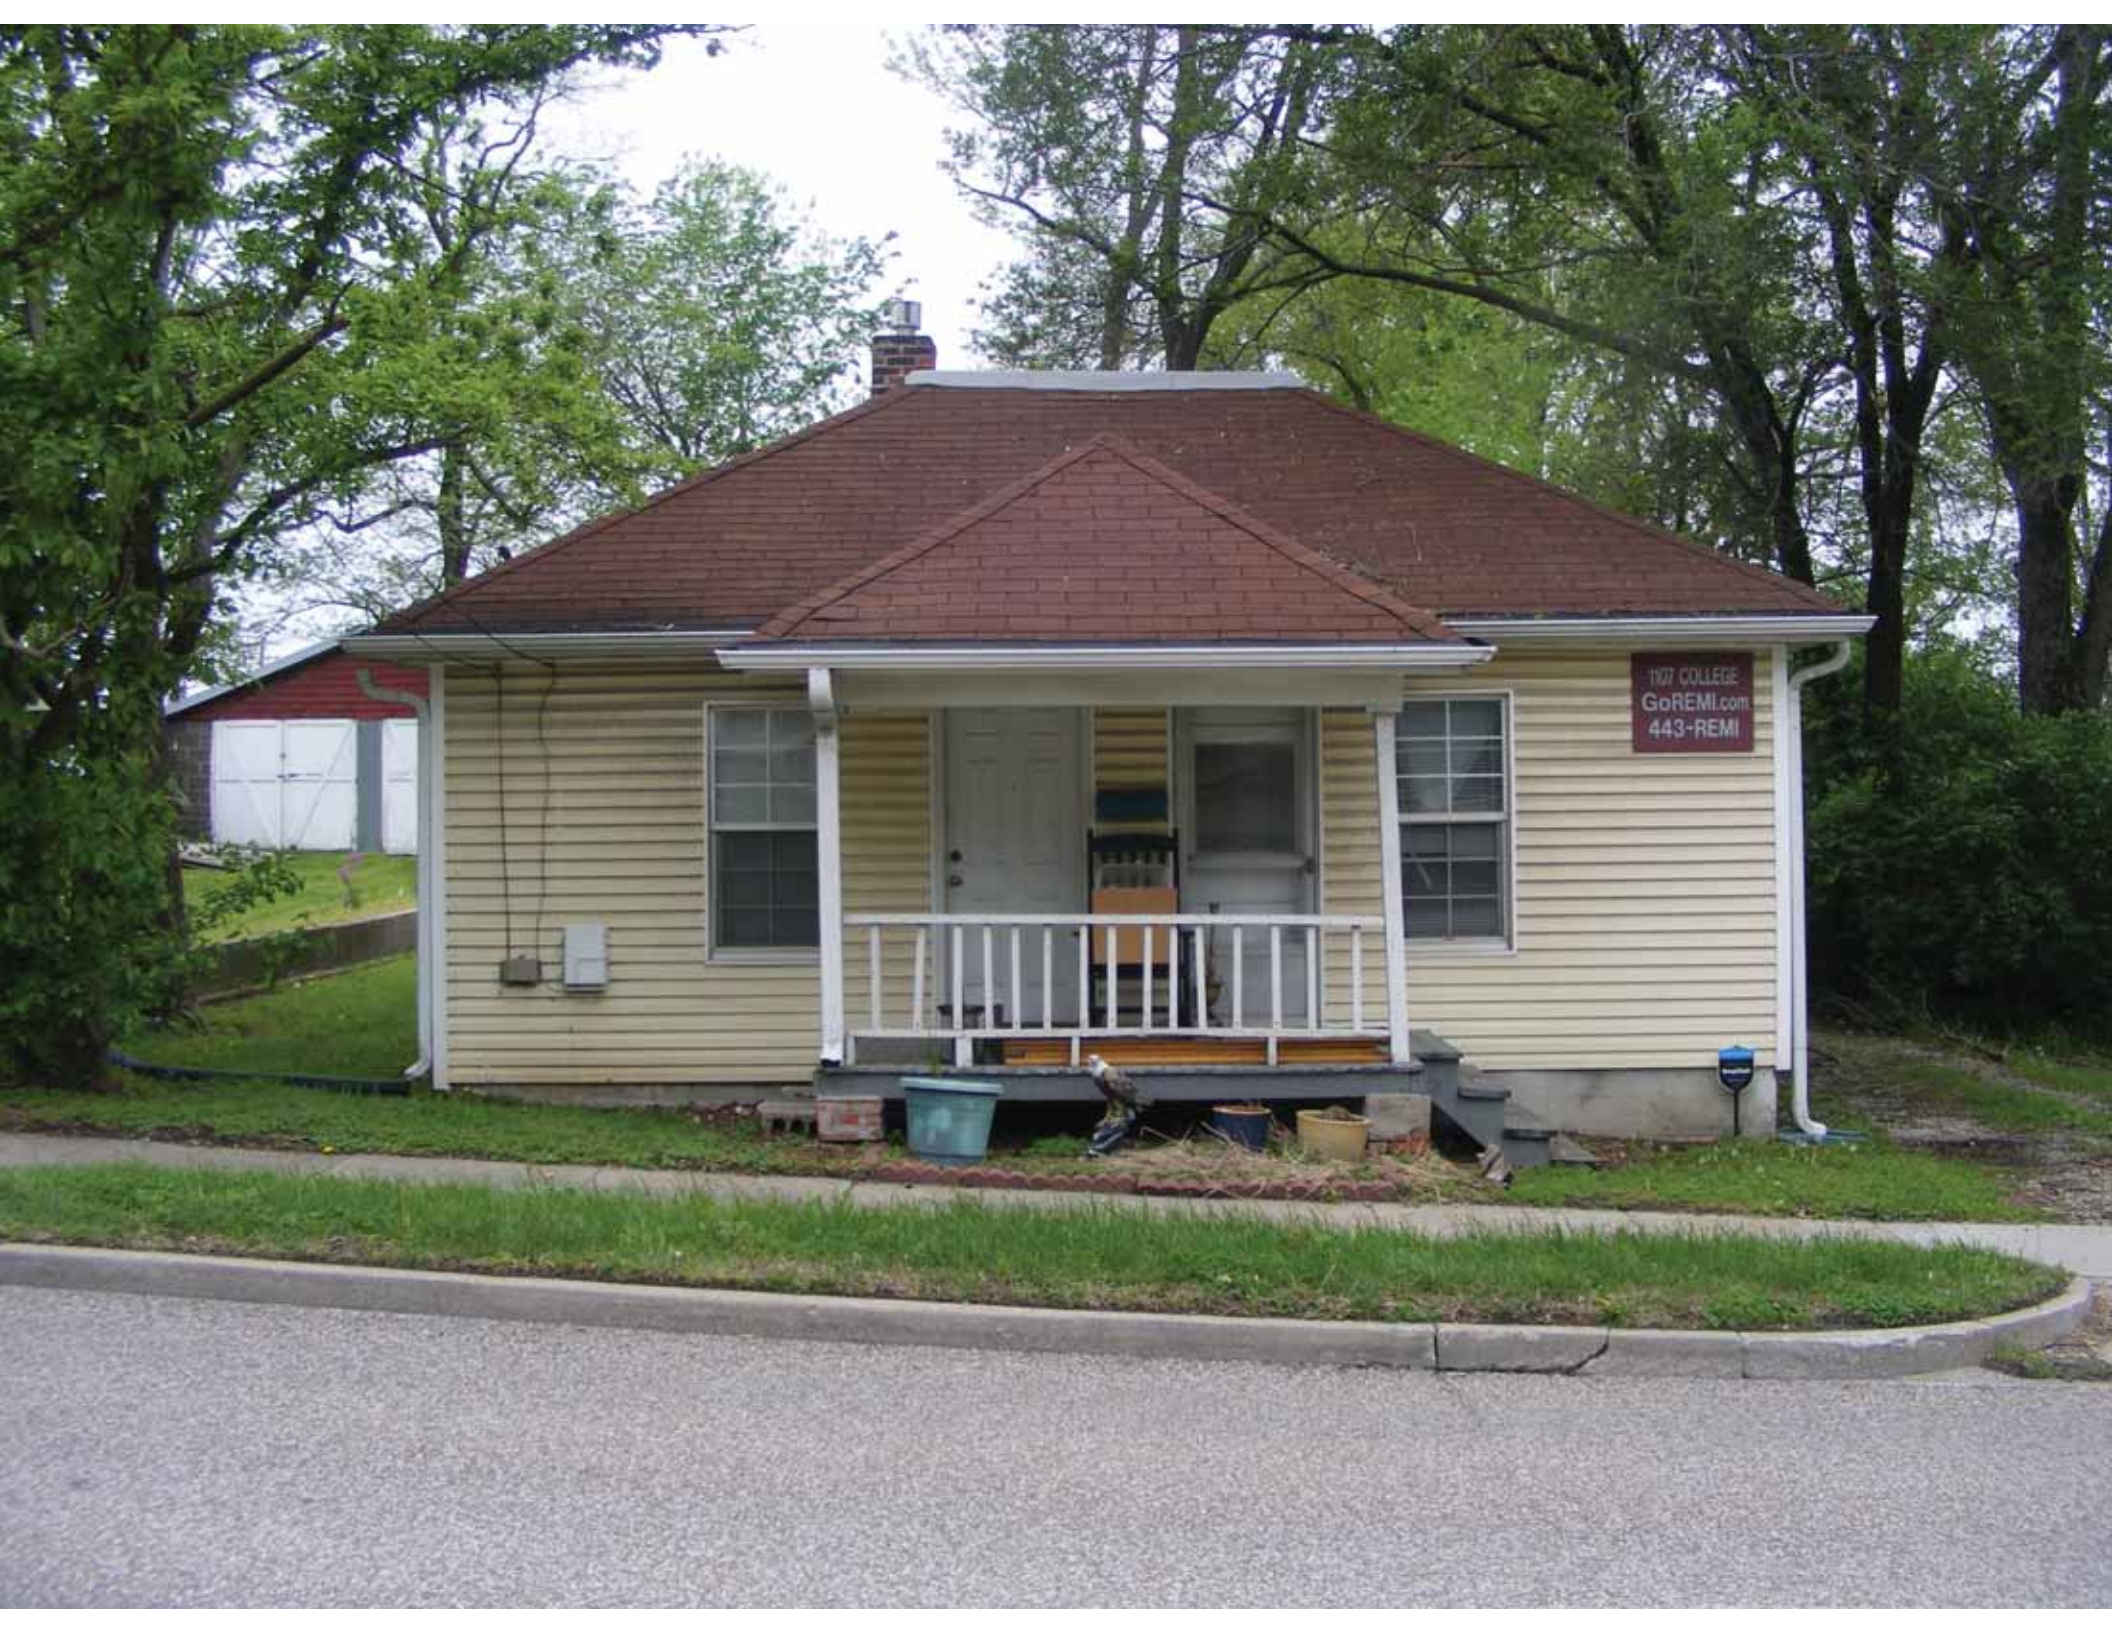
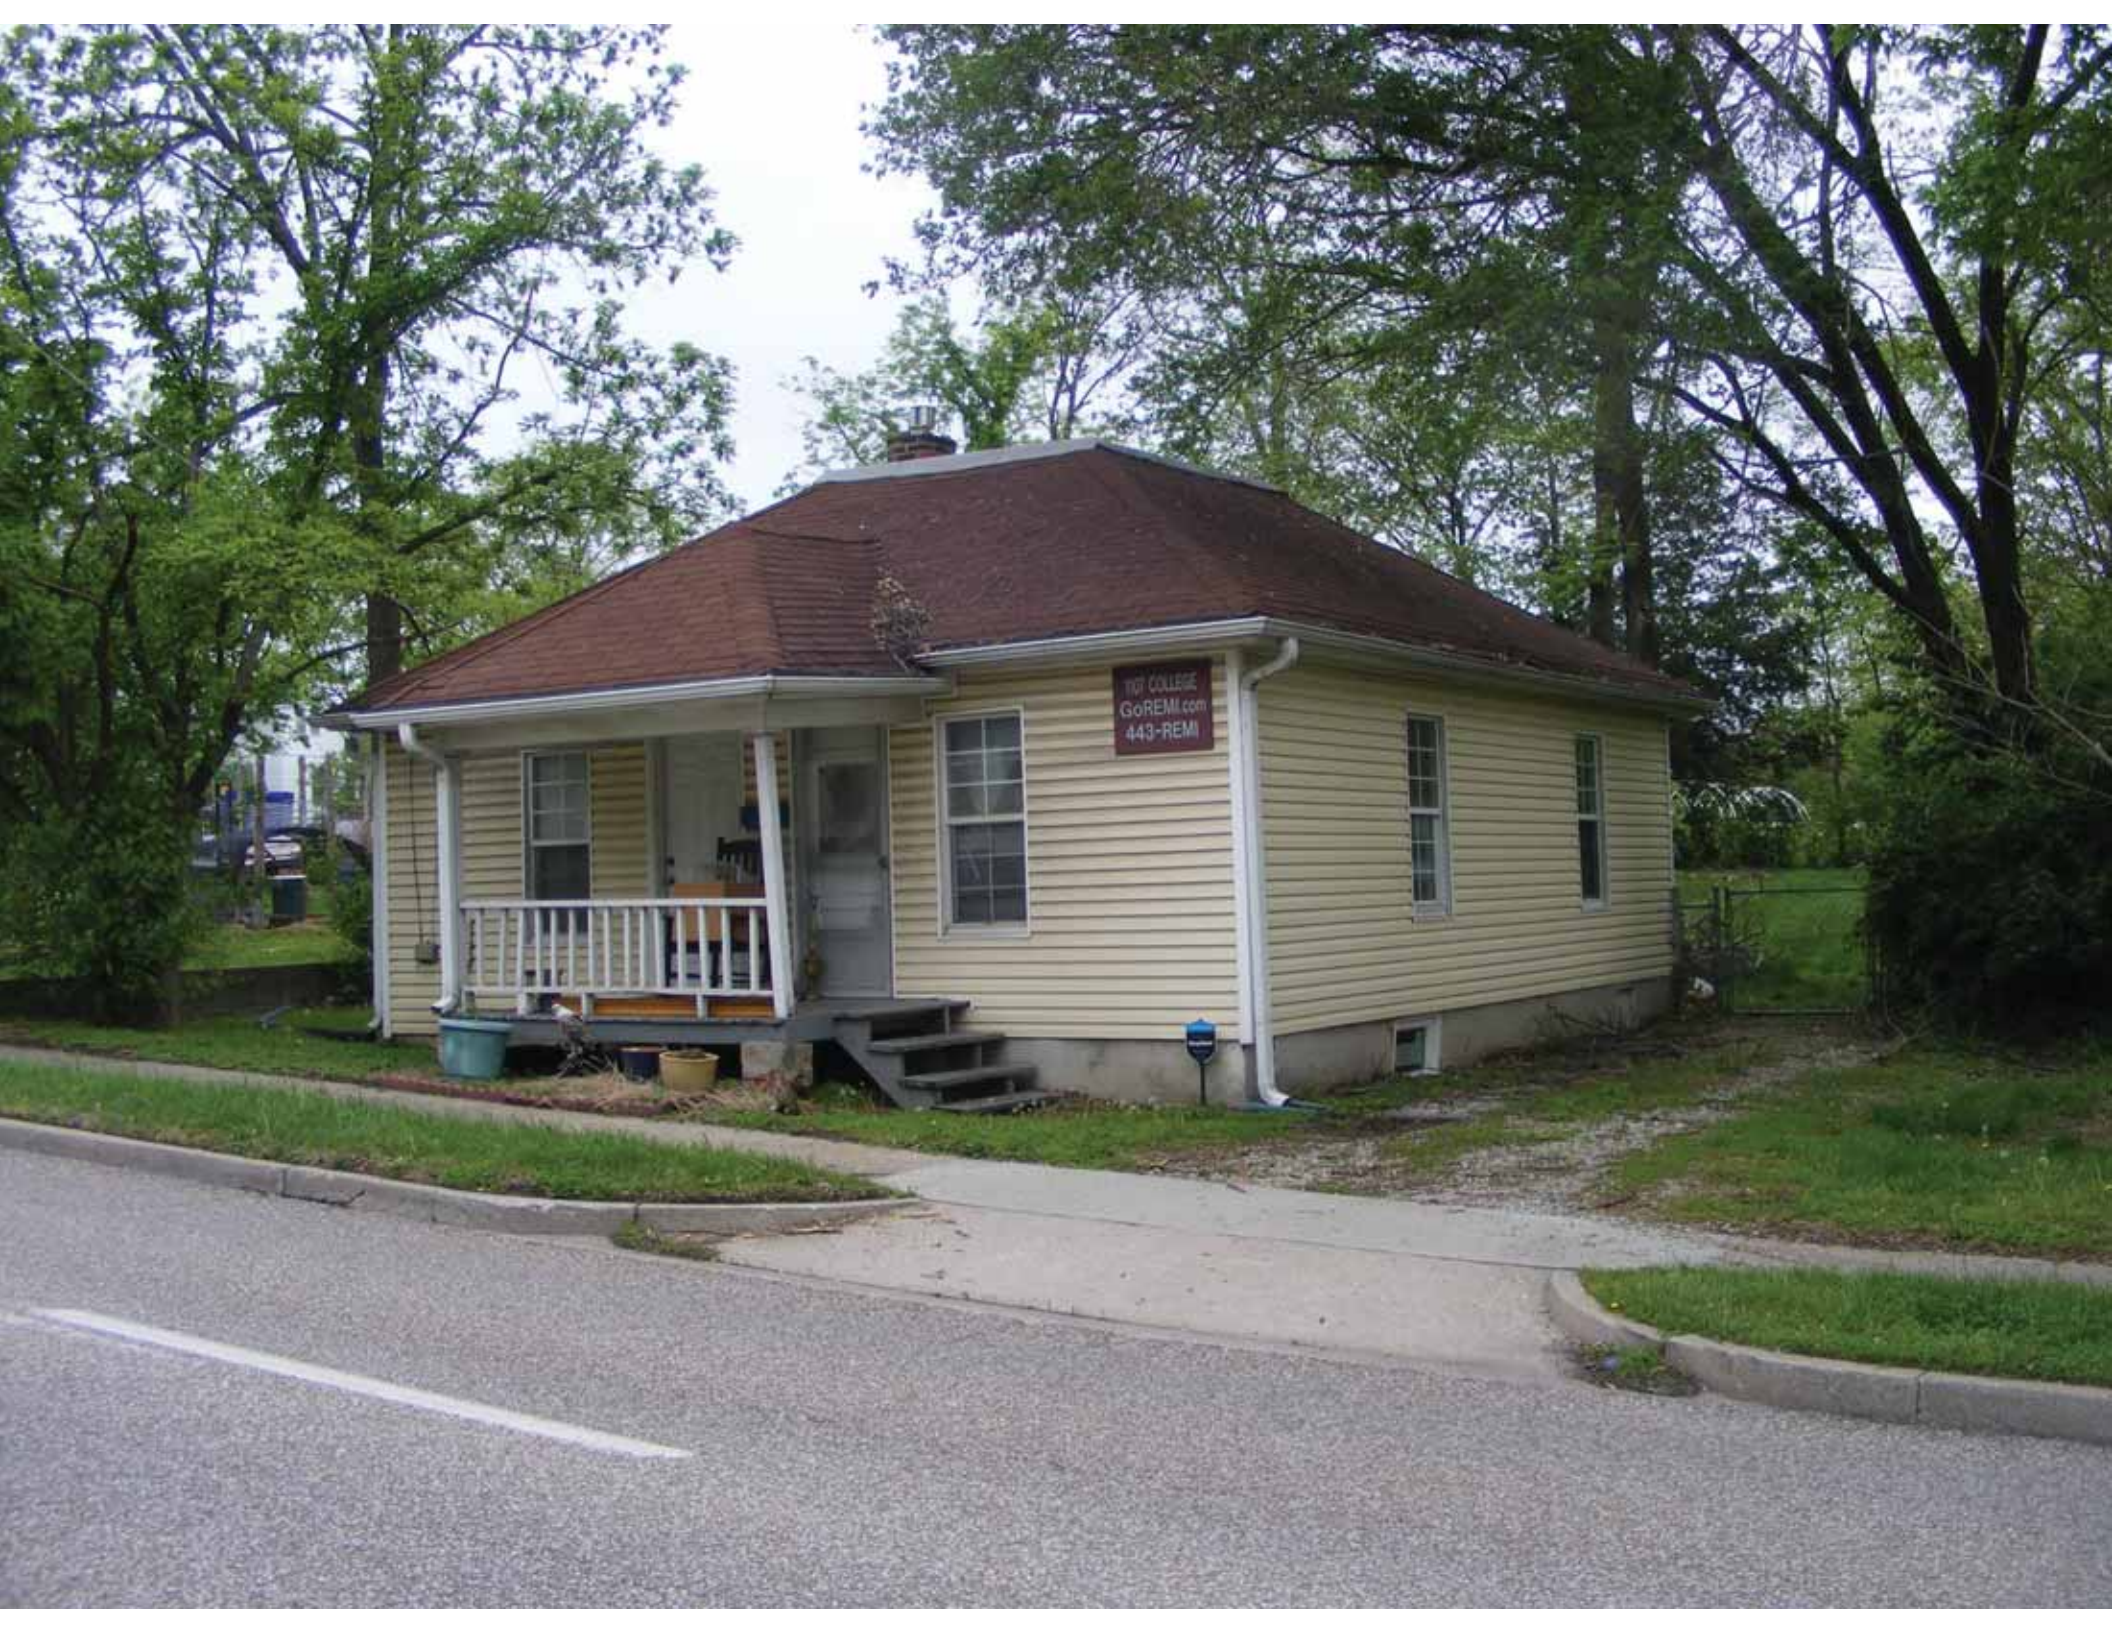
1107 COLLEGE
GoREMI.com
443-REMI

41. (cont.) Description of primary resource. Expand box as necessary, or add continuation pages.
The property is a single-story frame dwelling, asphalt shingled truncated hip with centered hip roof, exterior vinyl siding and a concrete foundation. Primary elevation holds two centered entrances sheltered under the centered hip supported by square posts. Porch has wood railings and wood decking. Entrances are flanked by six-over-six windows. Side elevations hold six-over-six windows.

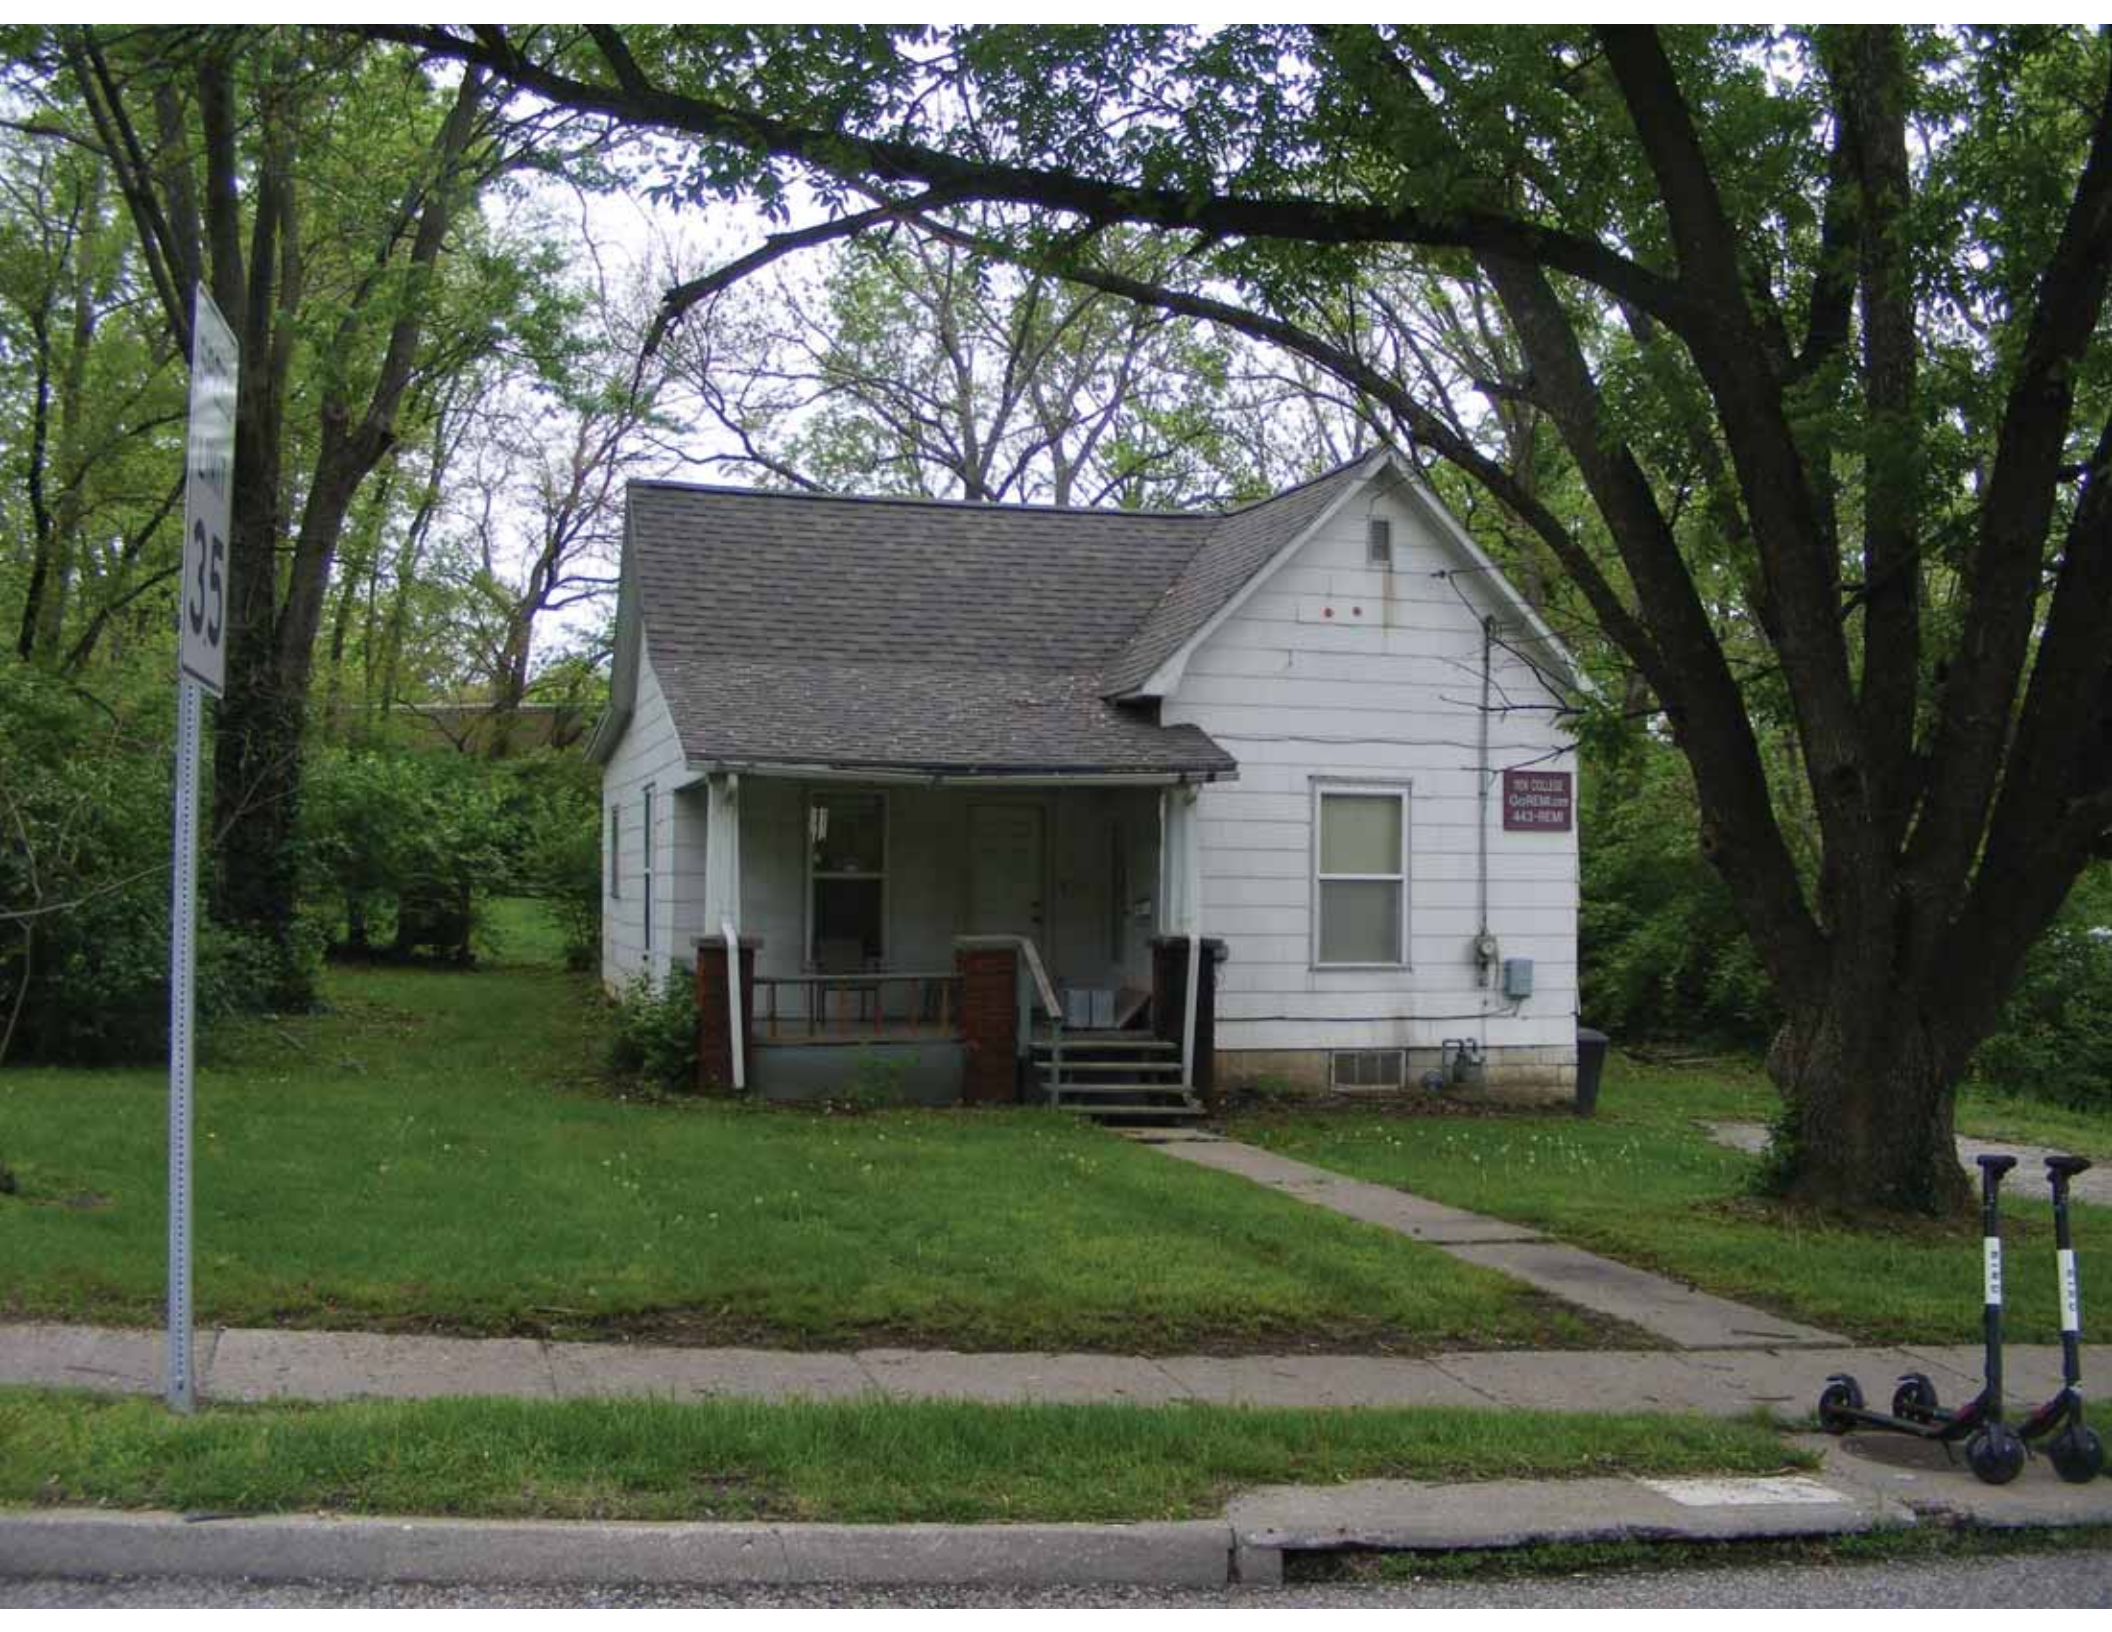
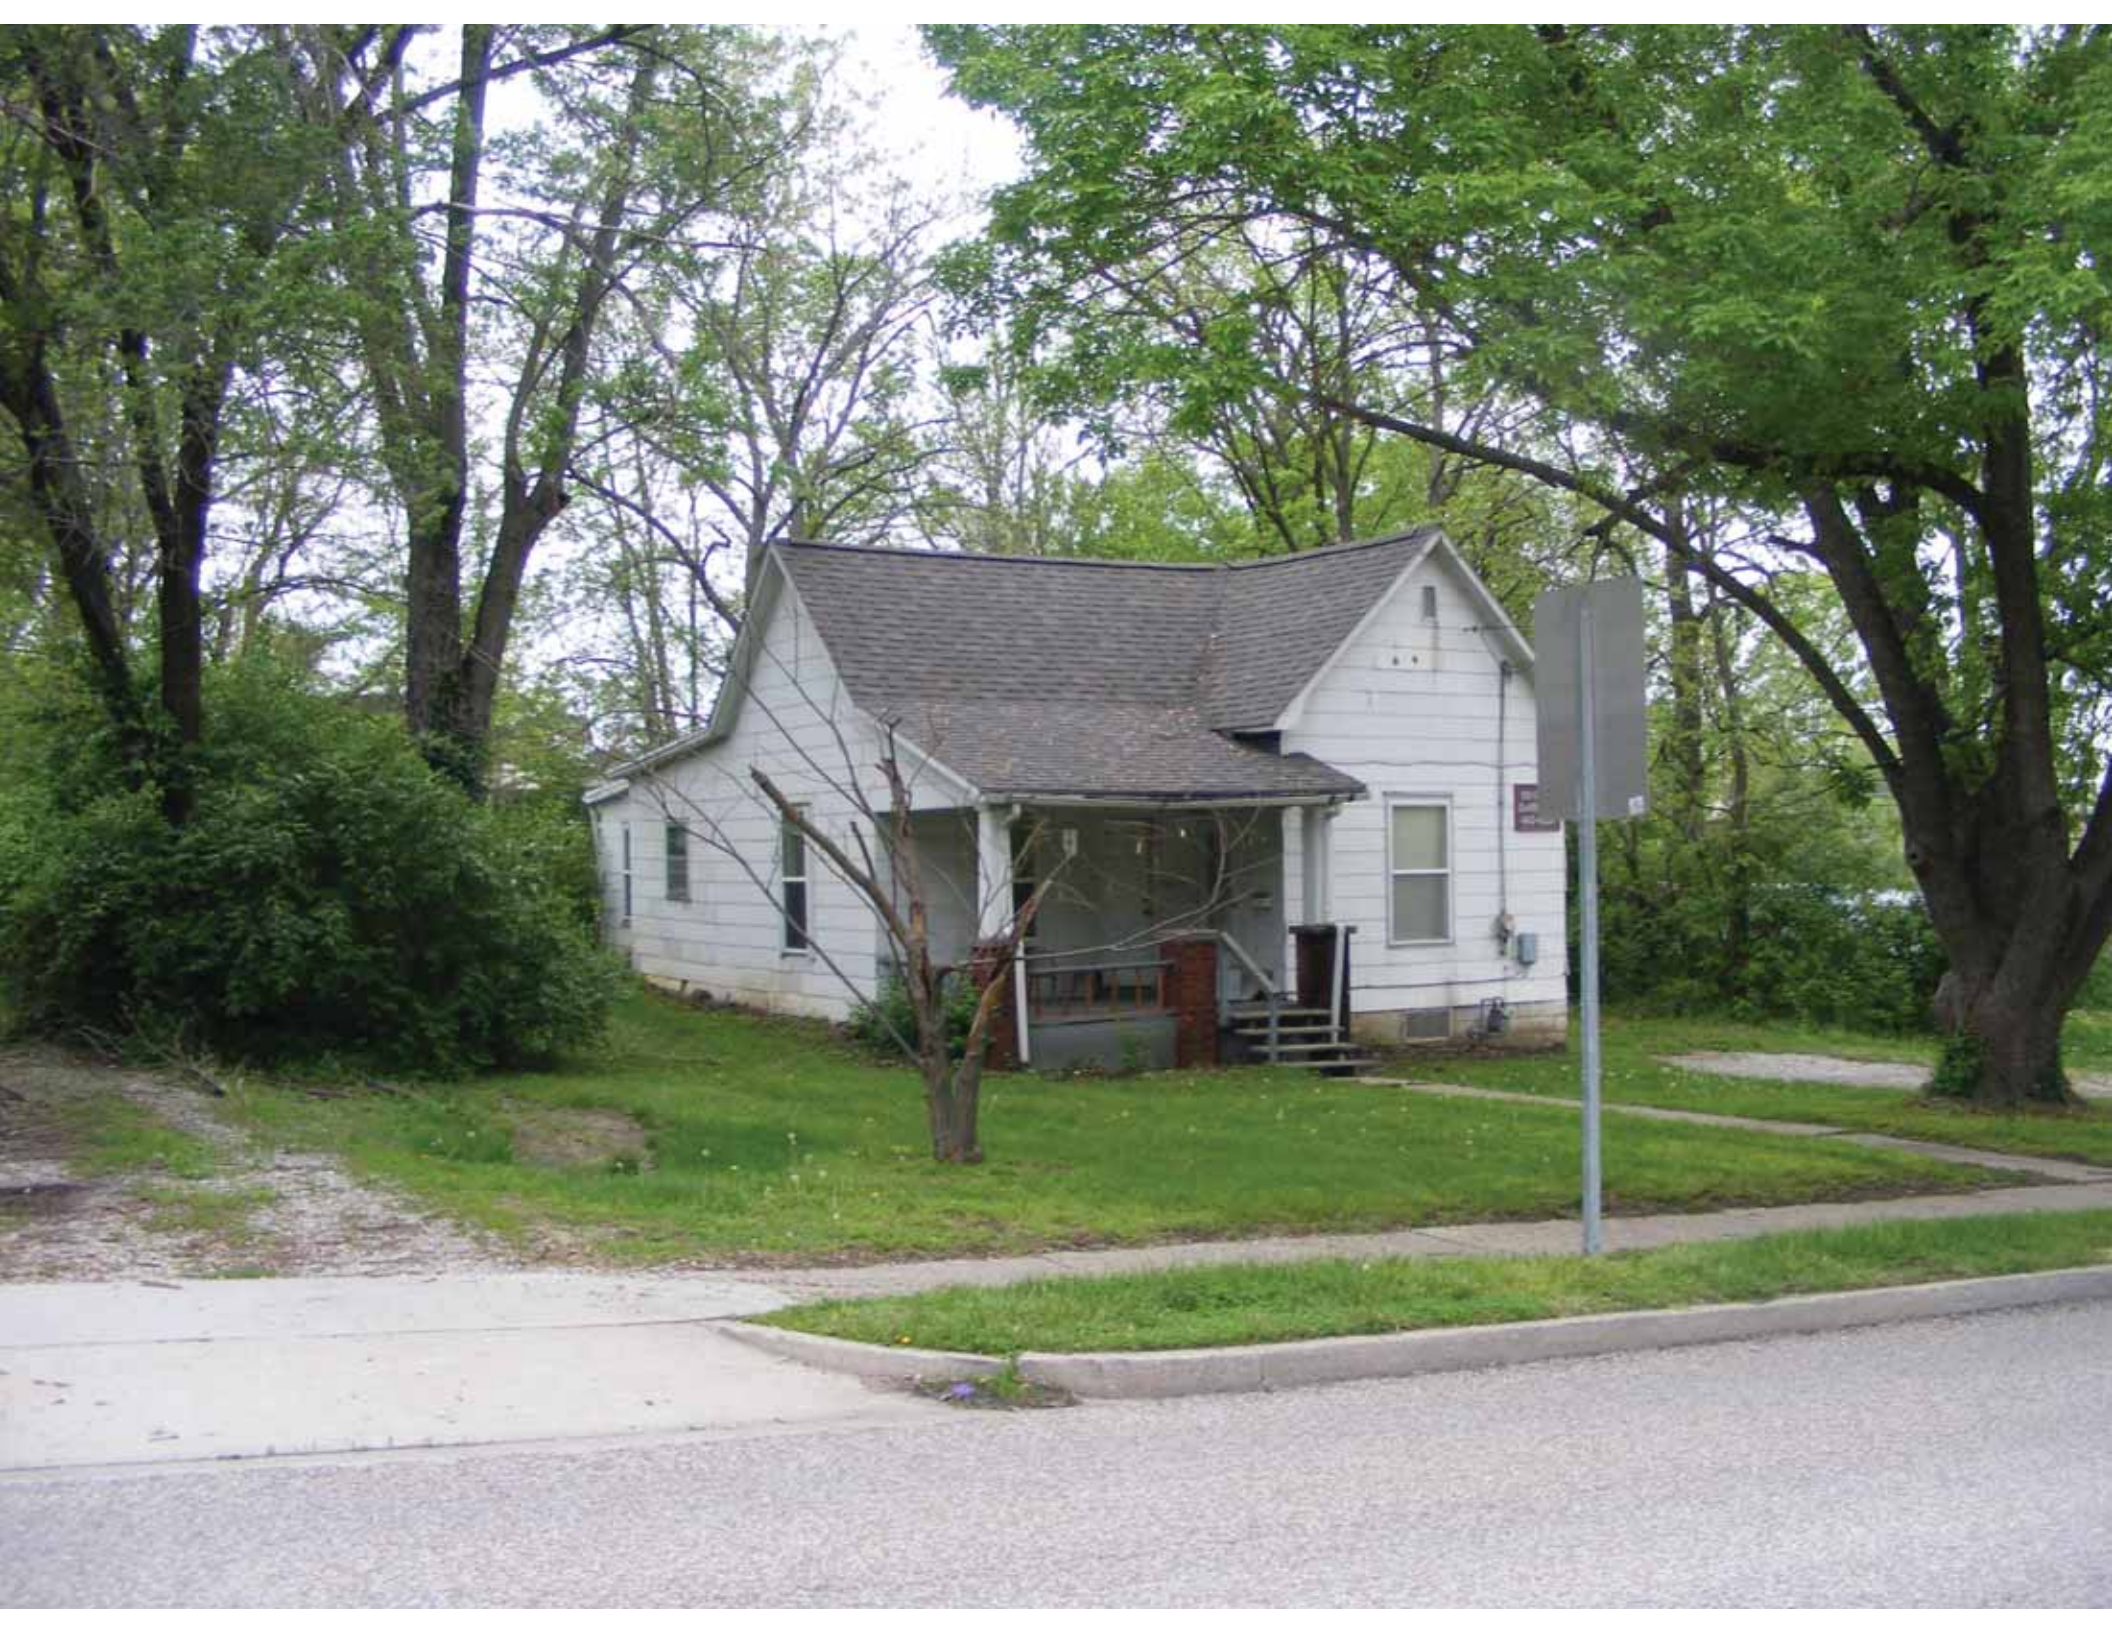
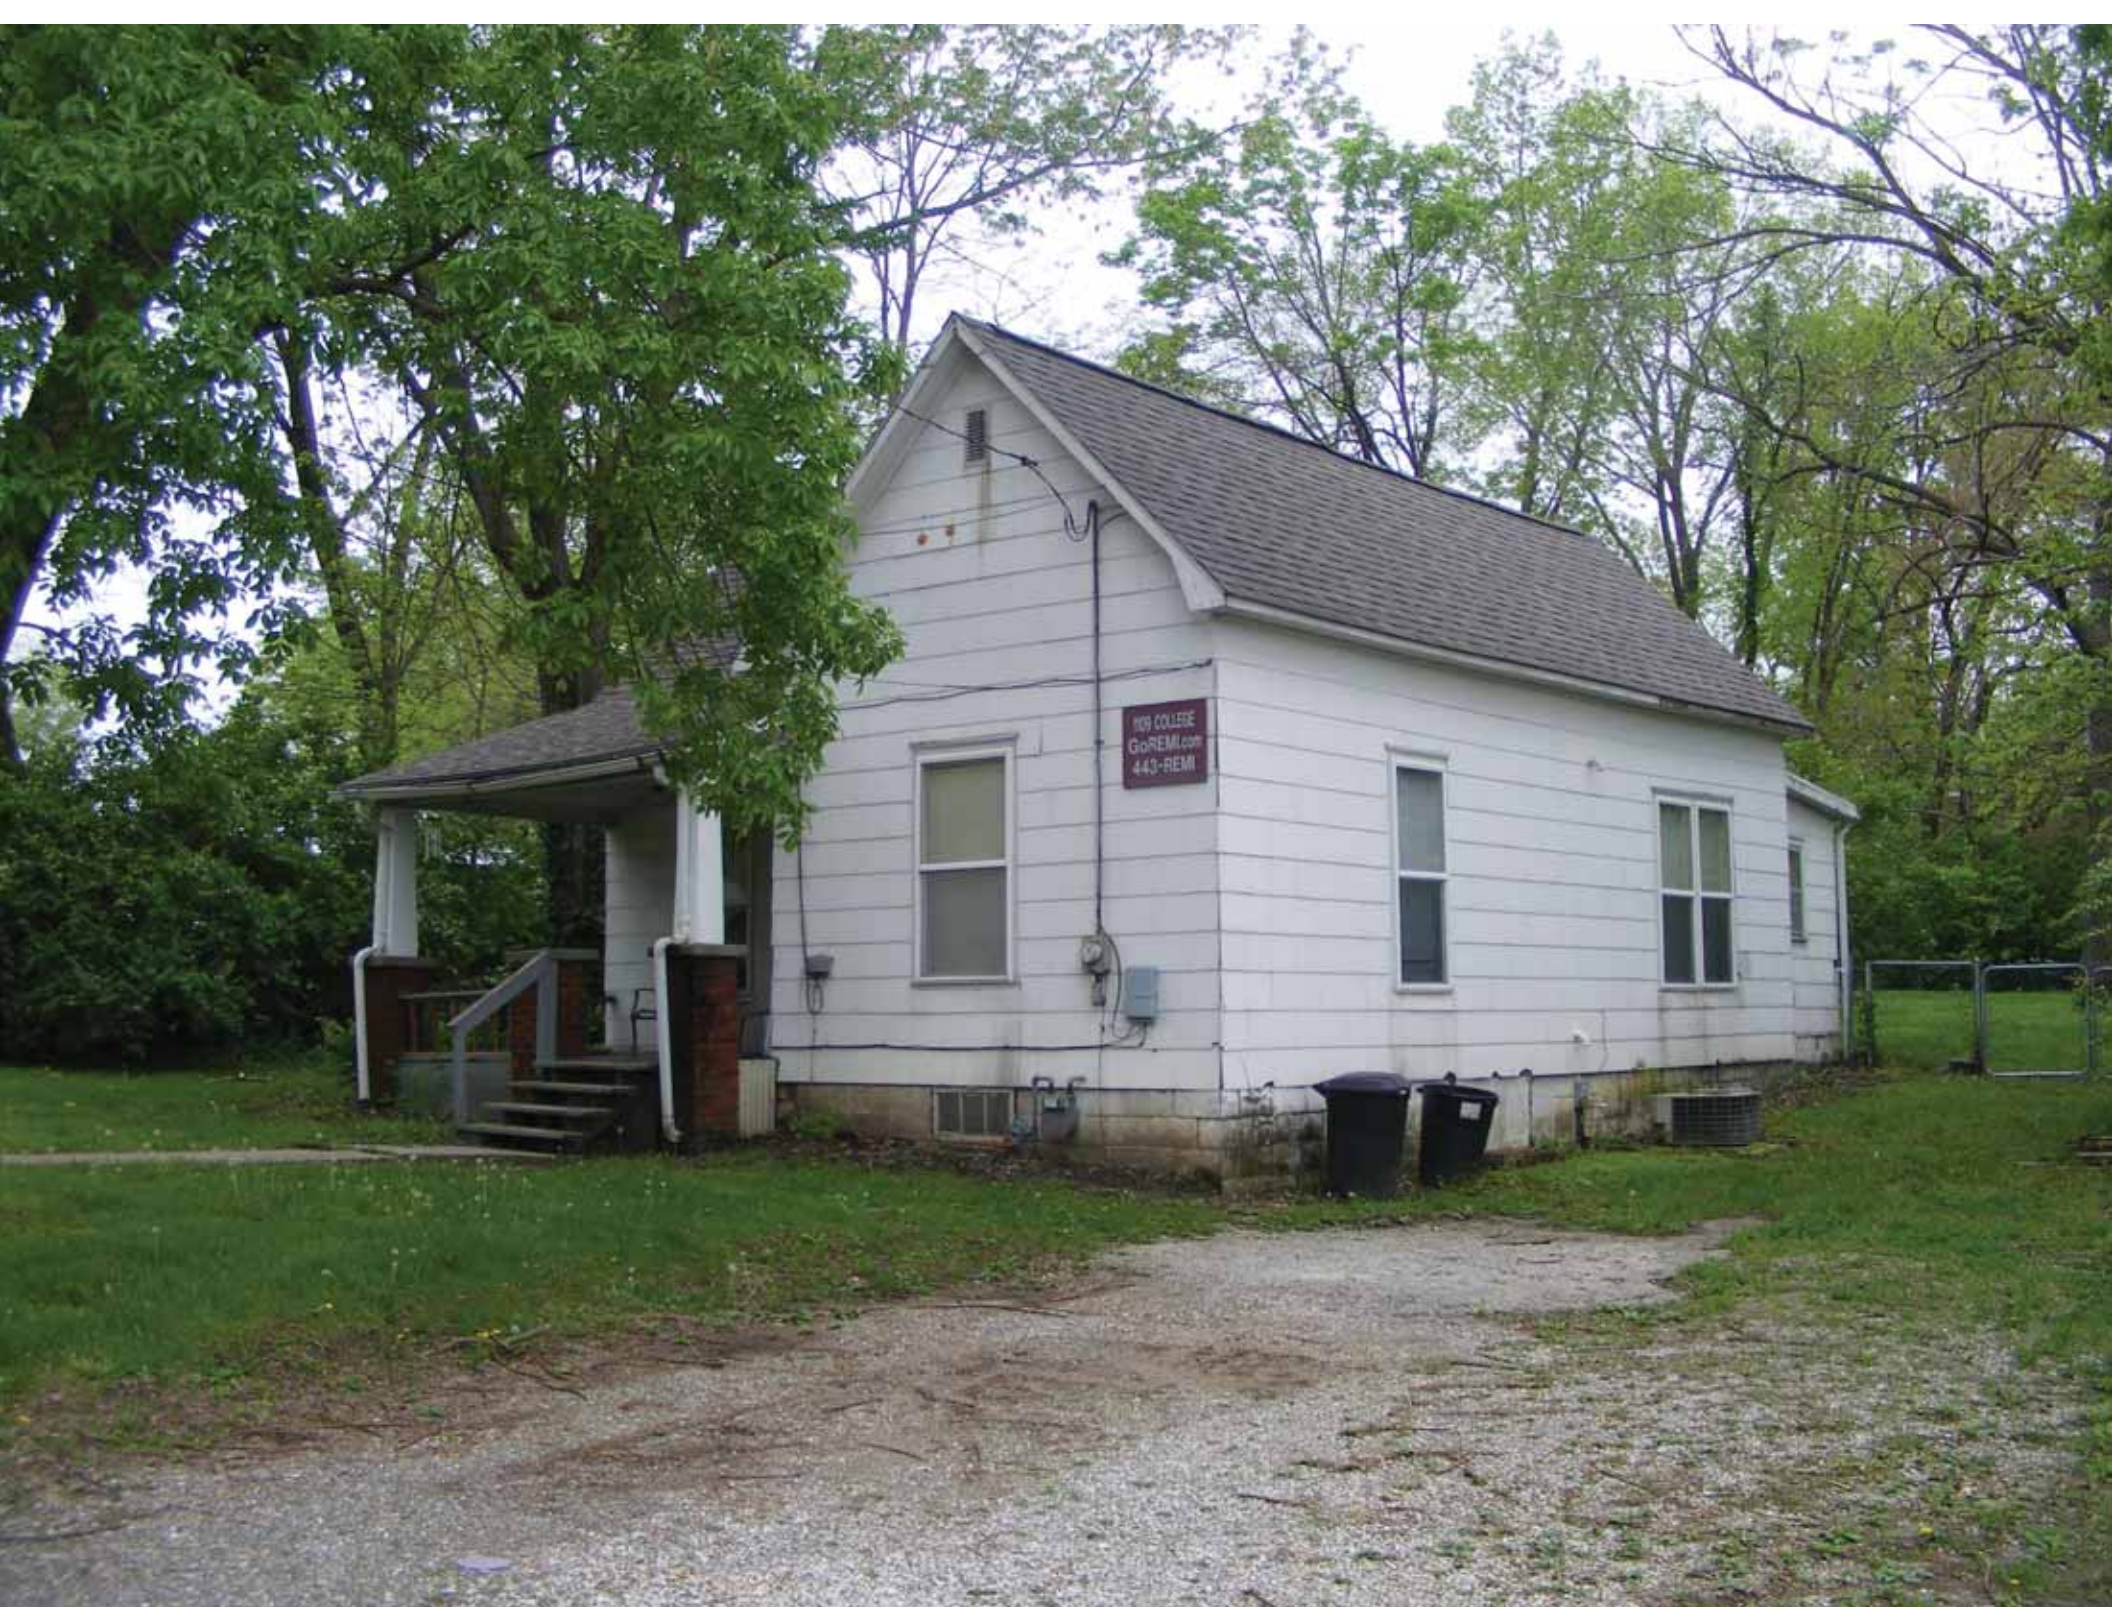
41. (cont.) Description of primary resource. Expand box as necessary, or add continuation pages.
The property is a one story frame dwelling with an asphalt-shingled cross gable roof to shed, exterior asbestos siding and stone foundation. Primary elevation holds a one-over-one window in the front gable off set to the left by a partial-width porch with a shed roof supported by tapered square post on brick piers with wood railings. Porch bay area is inset and holds an entrance door offset to the left by a one-over-one window. Side elevations hold one-over-one windows. Rear elevation has an addition with a shed roof.
