MISSOURI DEPARTMENT OF NATURAL RESOURCES
STATE HISTORIC PRESERVATION OFFICE, P.O. Box 176, Jefferson City, MO 65102
ARCHITECTURAL/HISTORIC INVENTORY FORM

1. Survey No. BO-AS-011-0087		2. Survey name: North Central Columbia Survey Phase II	
3. County: Boone		4. Address (Street No.) 902	Street (name) N. Seventh Street
5. City: Columbia	Vicinity: <input type="checkbox"/>	6. Geographical Reference:	7. Township/Range/Section: T: R: S:
8. Historic name (if known):		9. Present/other name (if known):	
10. Ownership: <input checked="" type="checkbox"/> Private <input type="checkbox"/> Public		11a. Historic use (if known): Domestic/single dwelling	11b. Current use: Domestic/single dwelling

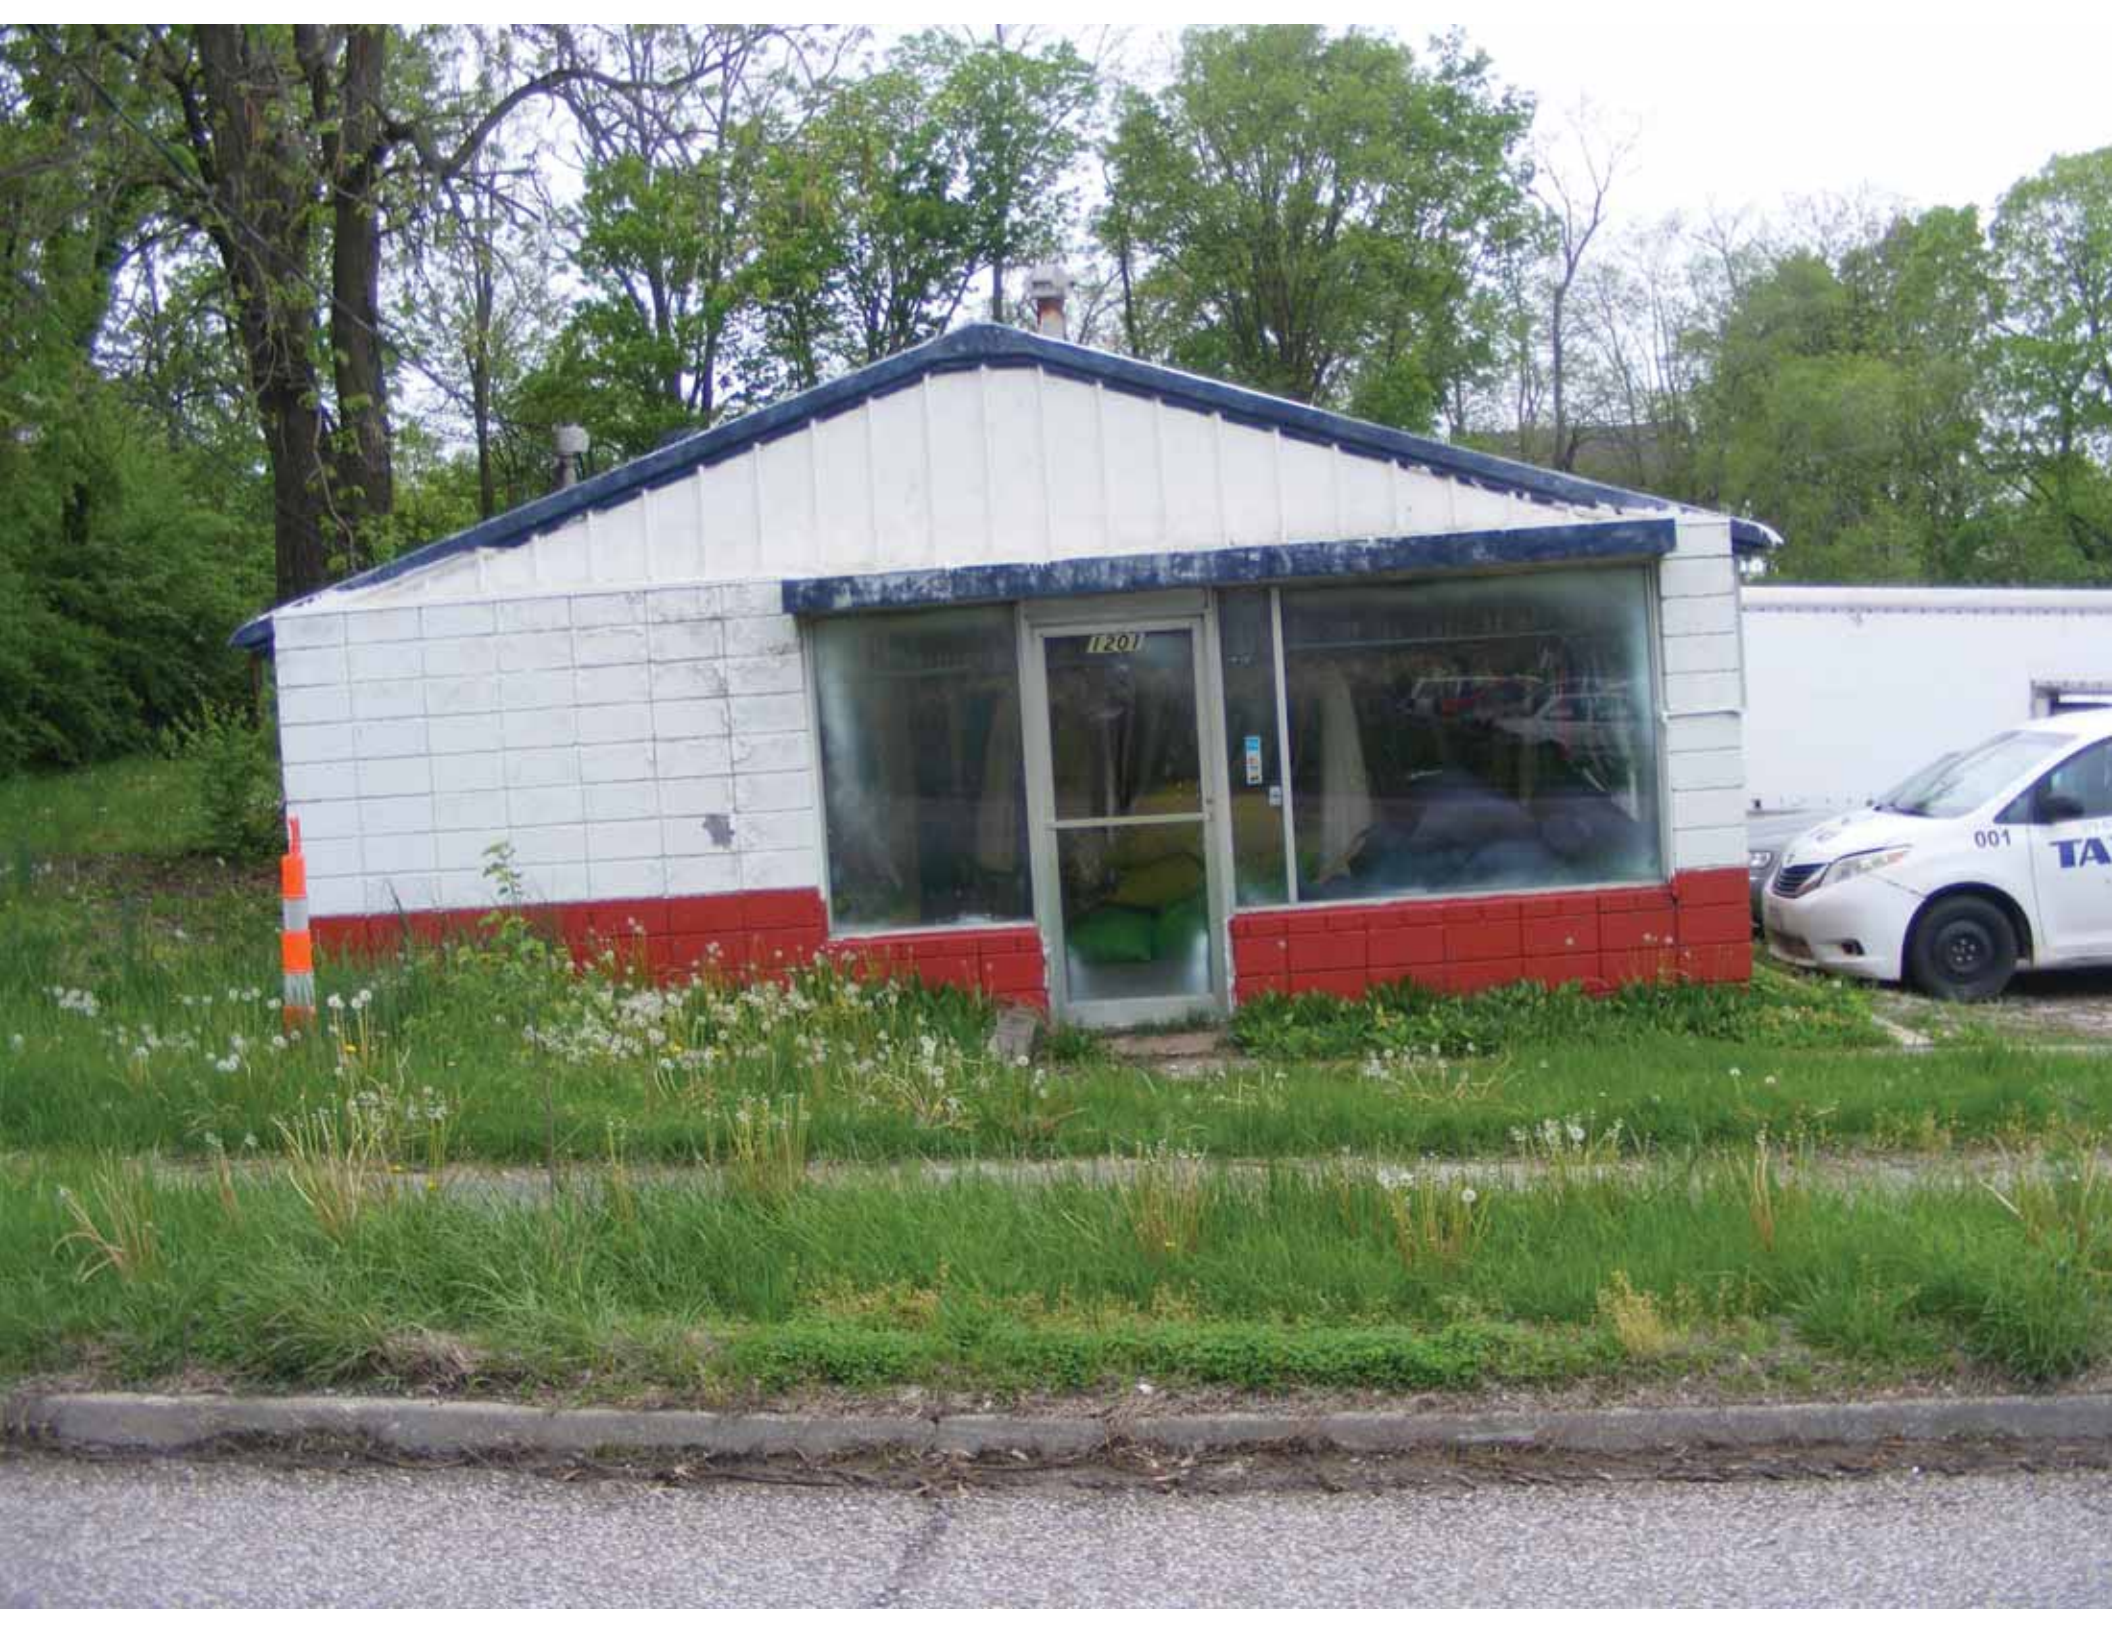
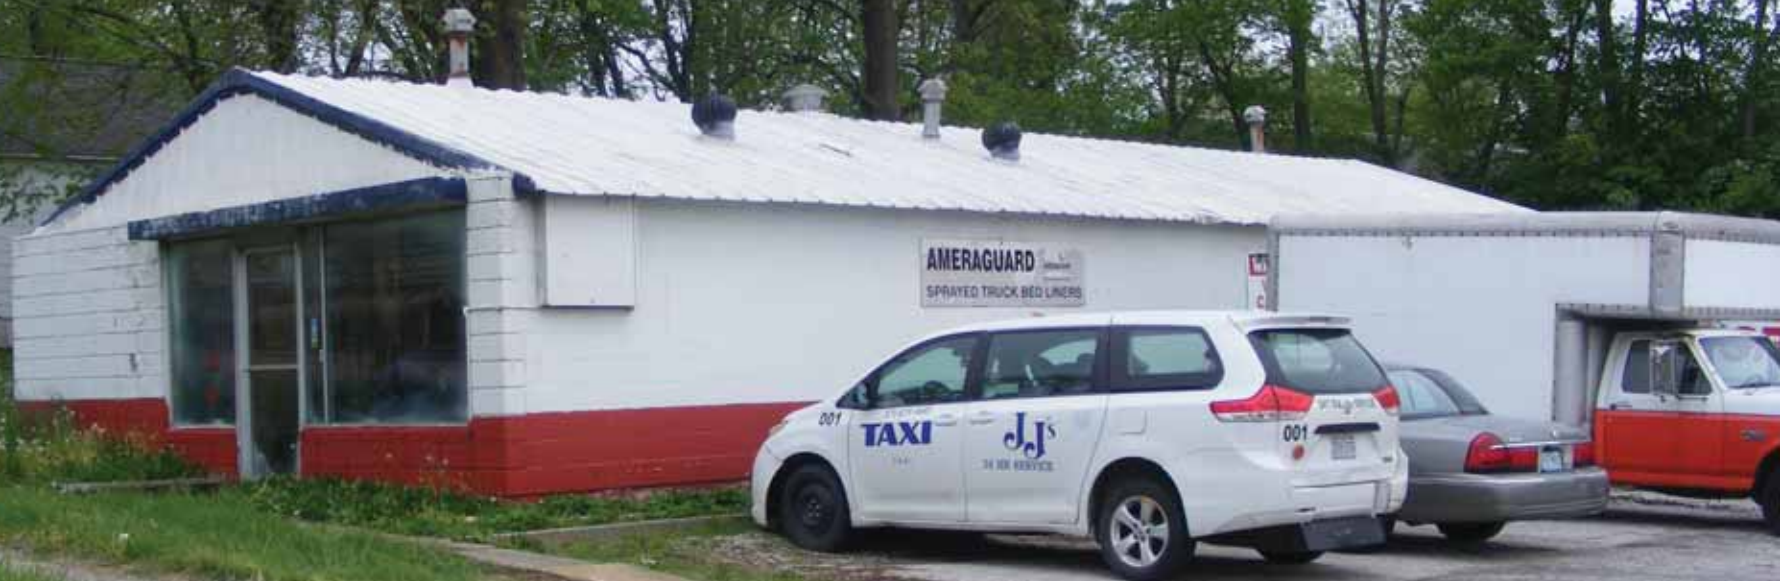
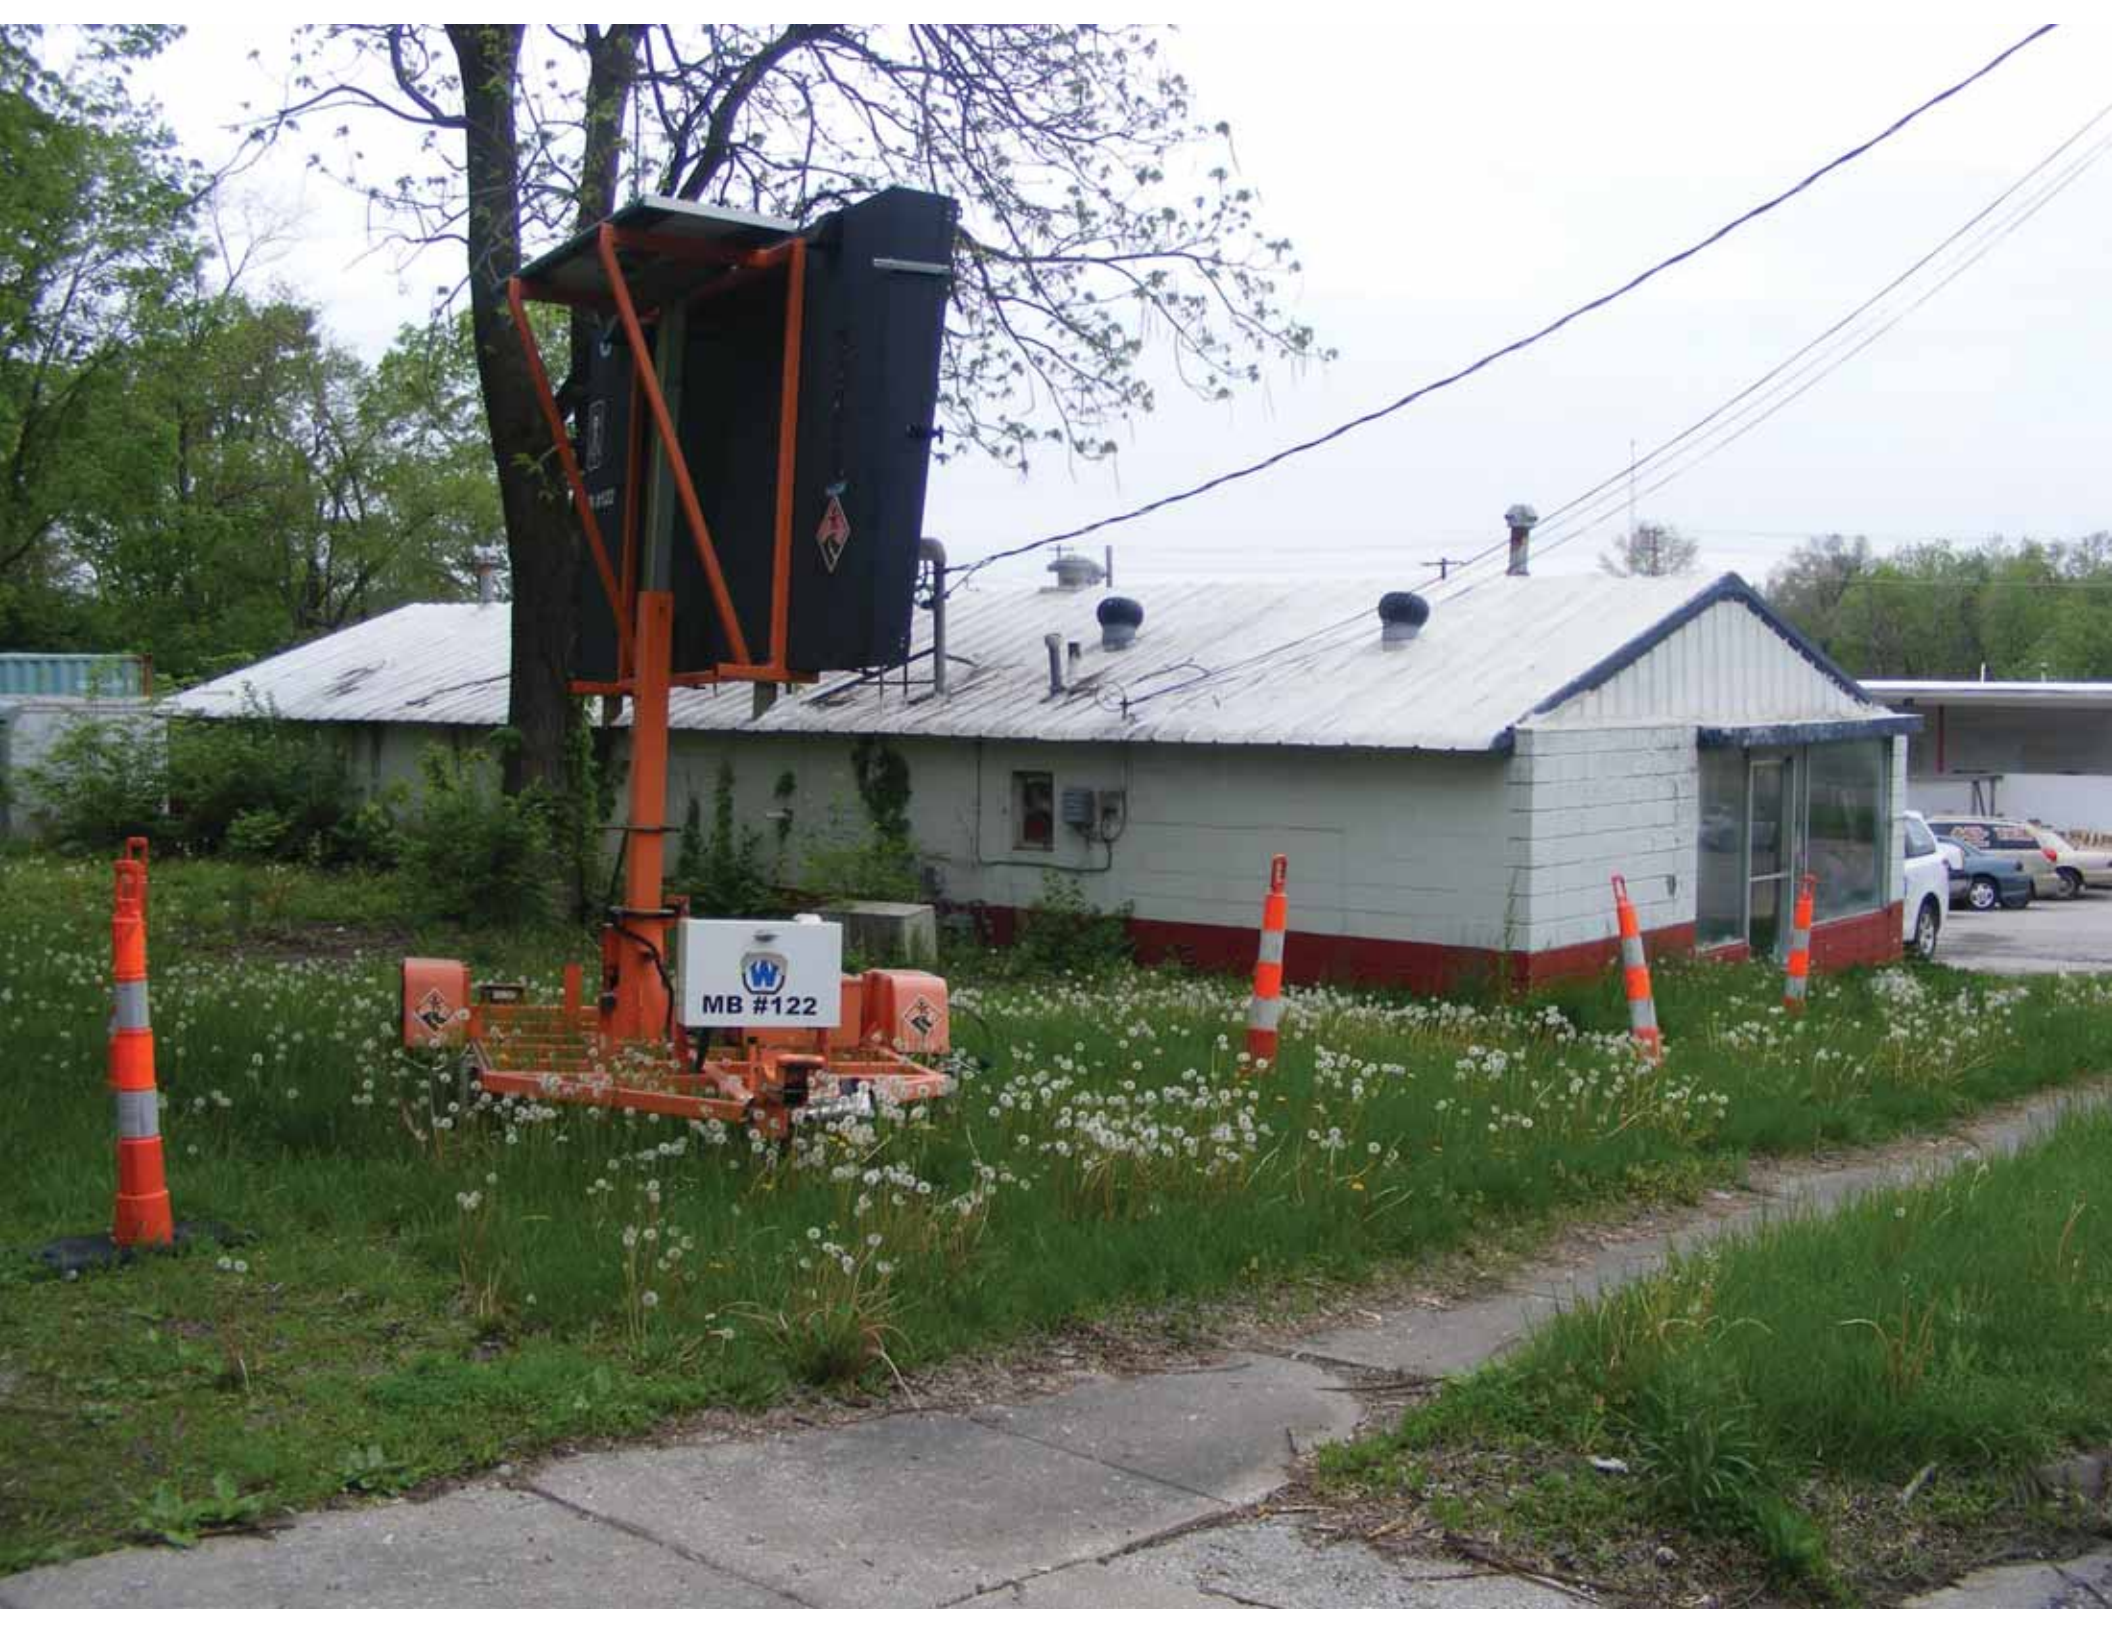
41. (cont.) Description of primary resource. Expand box as necessary, or add continuation pages.
The property is a one story metal seamed front gable concrete block commercial building with a concrete foundation. Primary elevation holds an offset entrance flanked by fixed display windows. Gable end holds vertical siding. Side elevation are void of openings. Roof appears to be altered and has several metal exhaust flues/pipes.

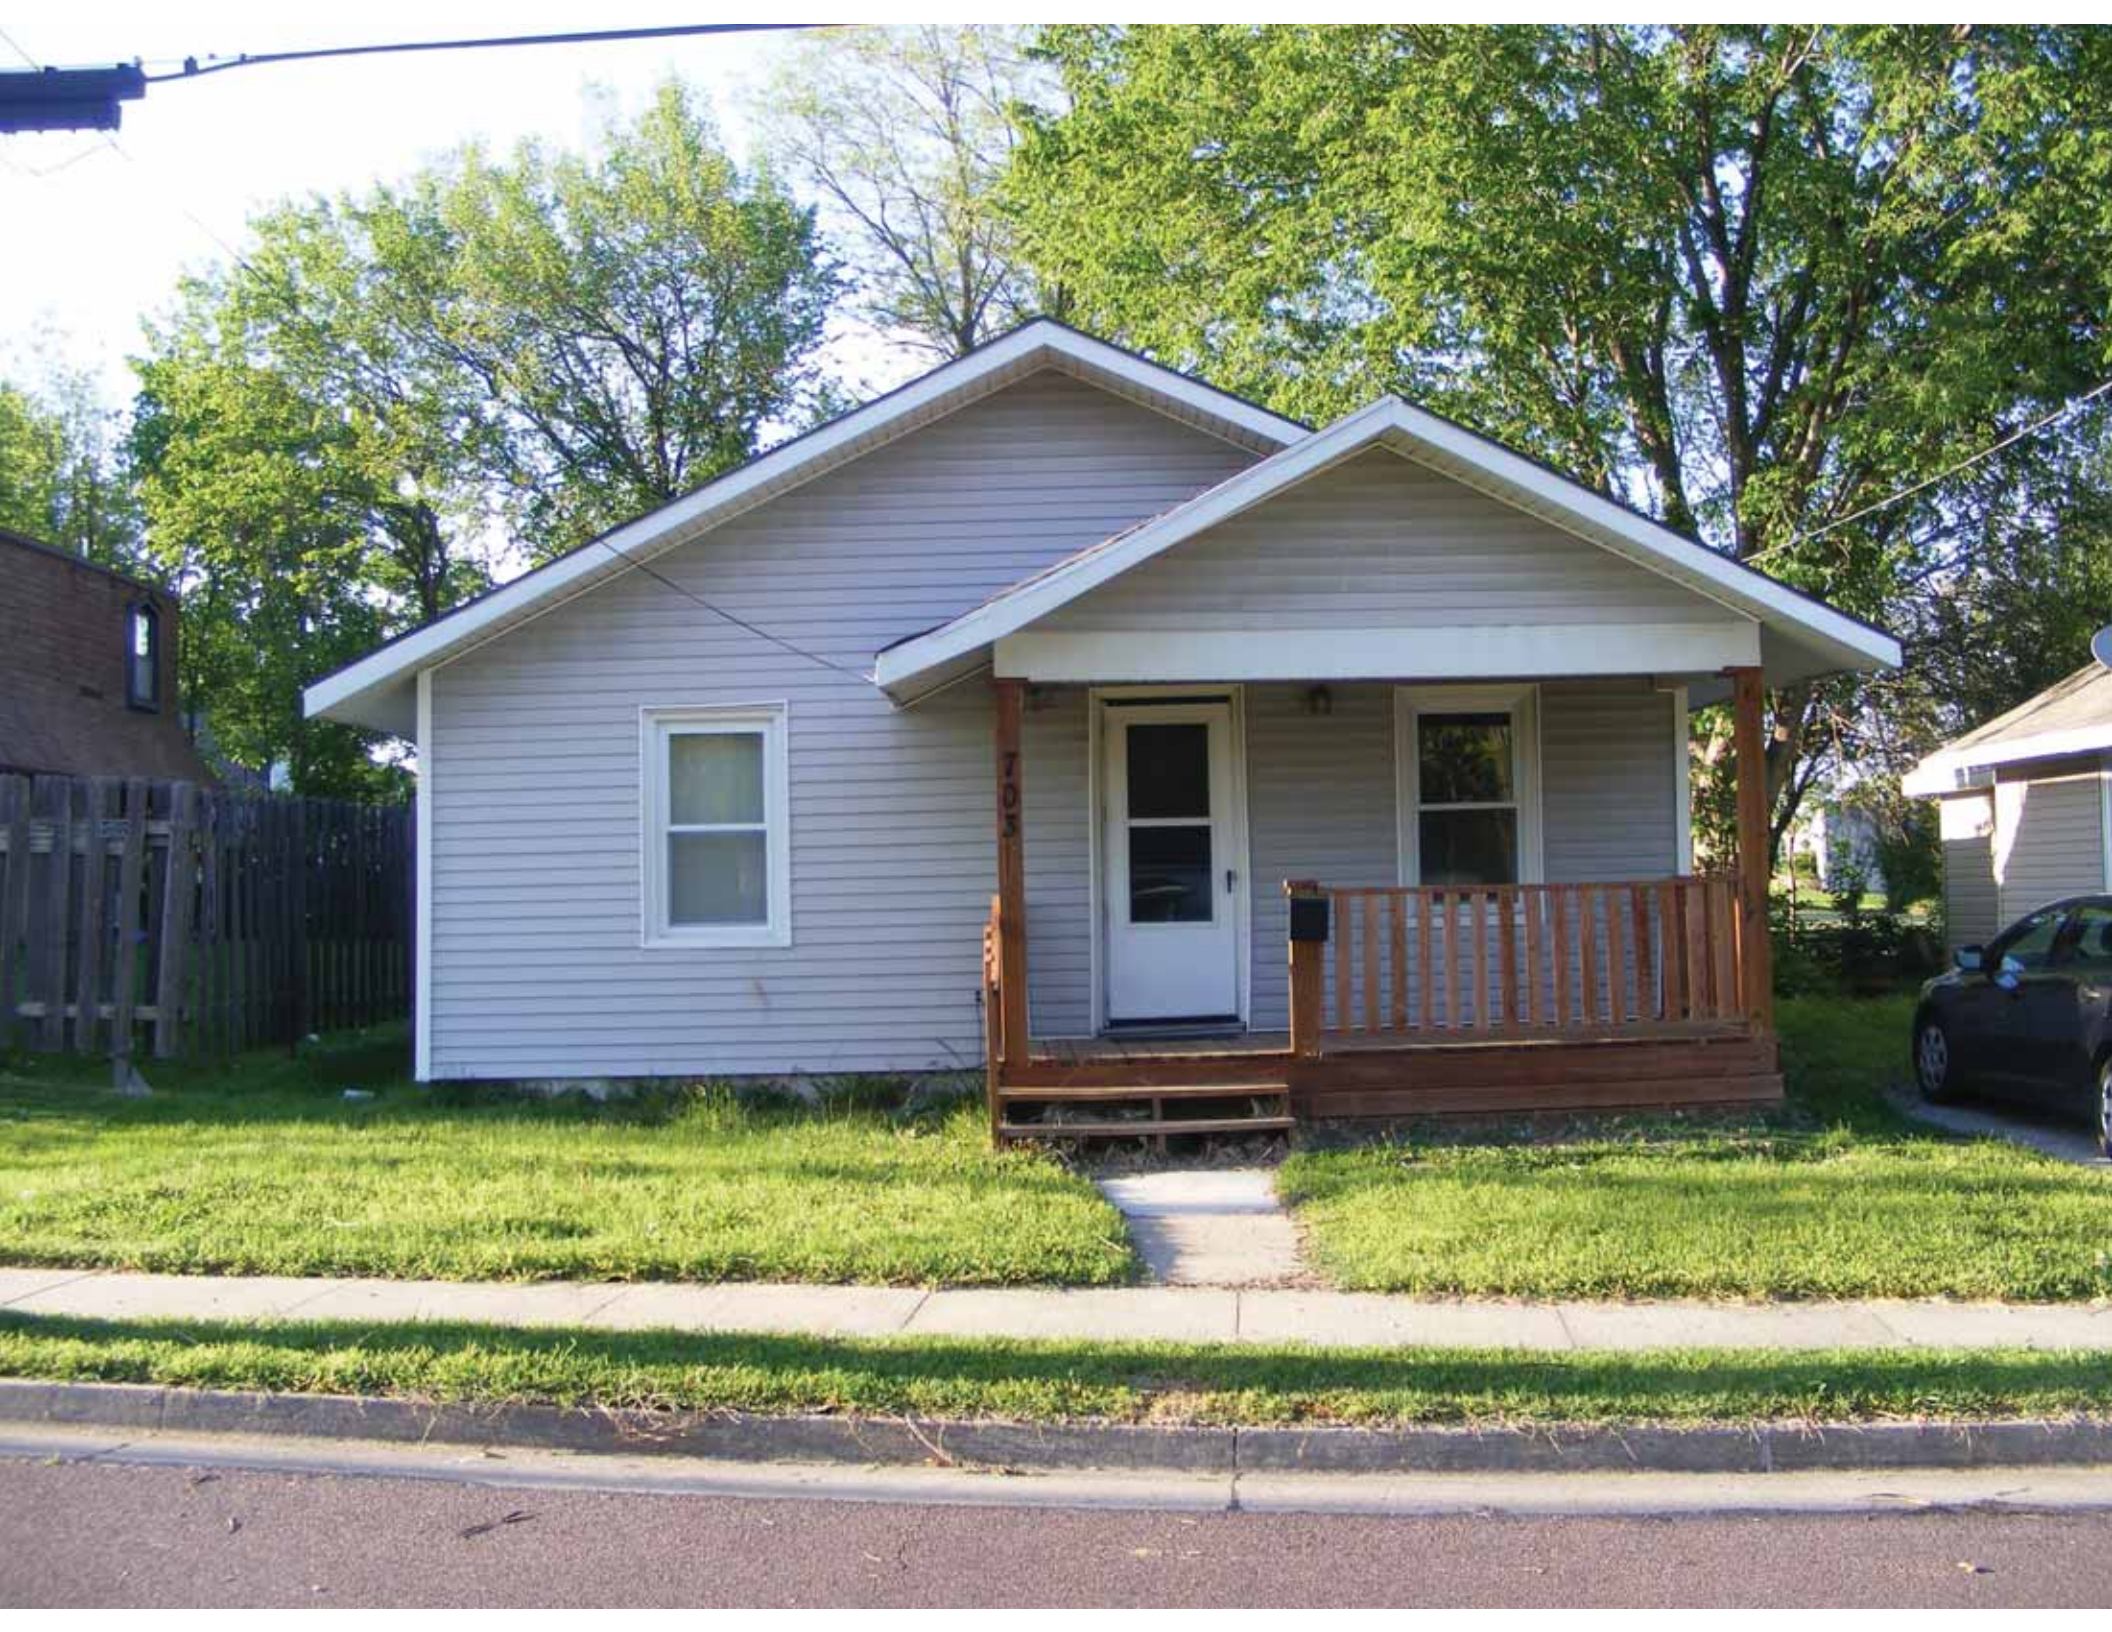
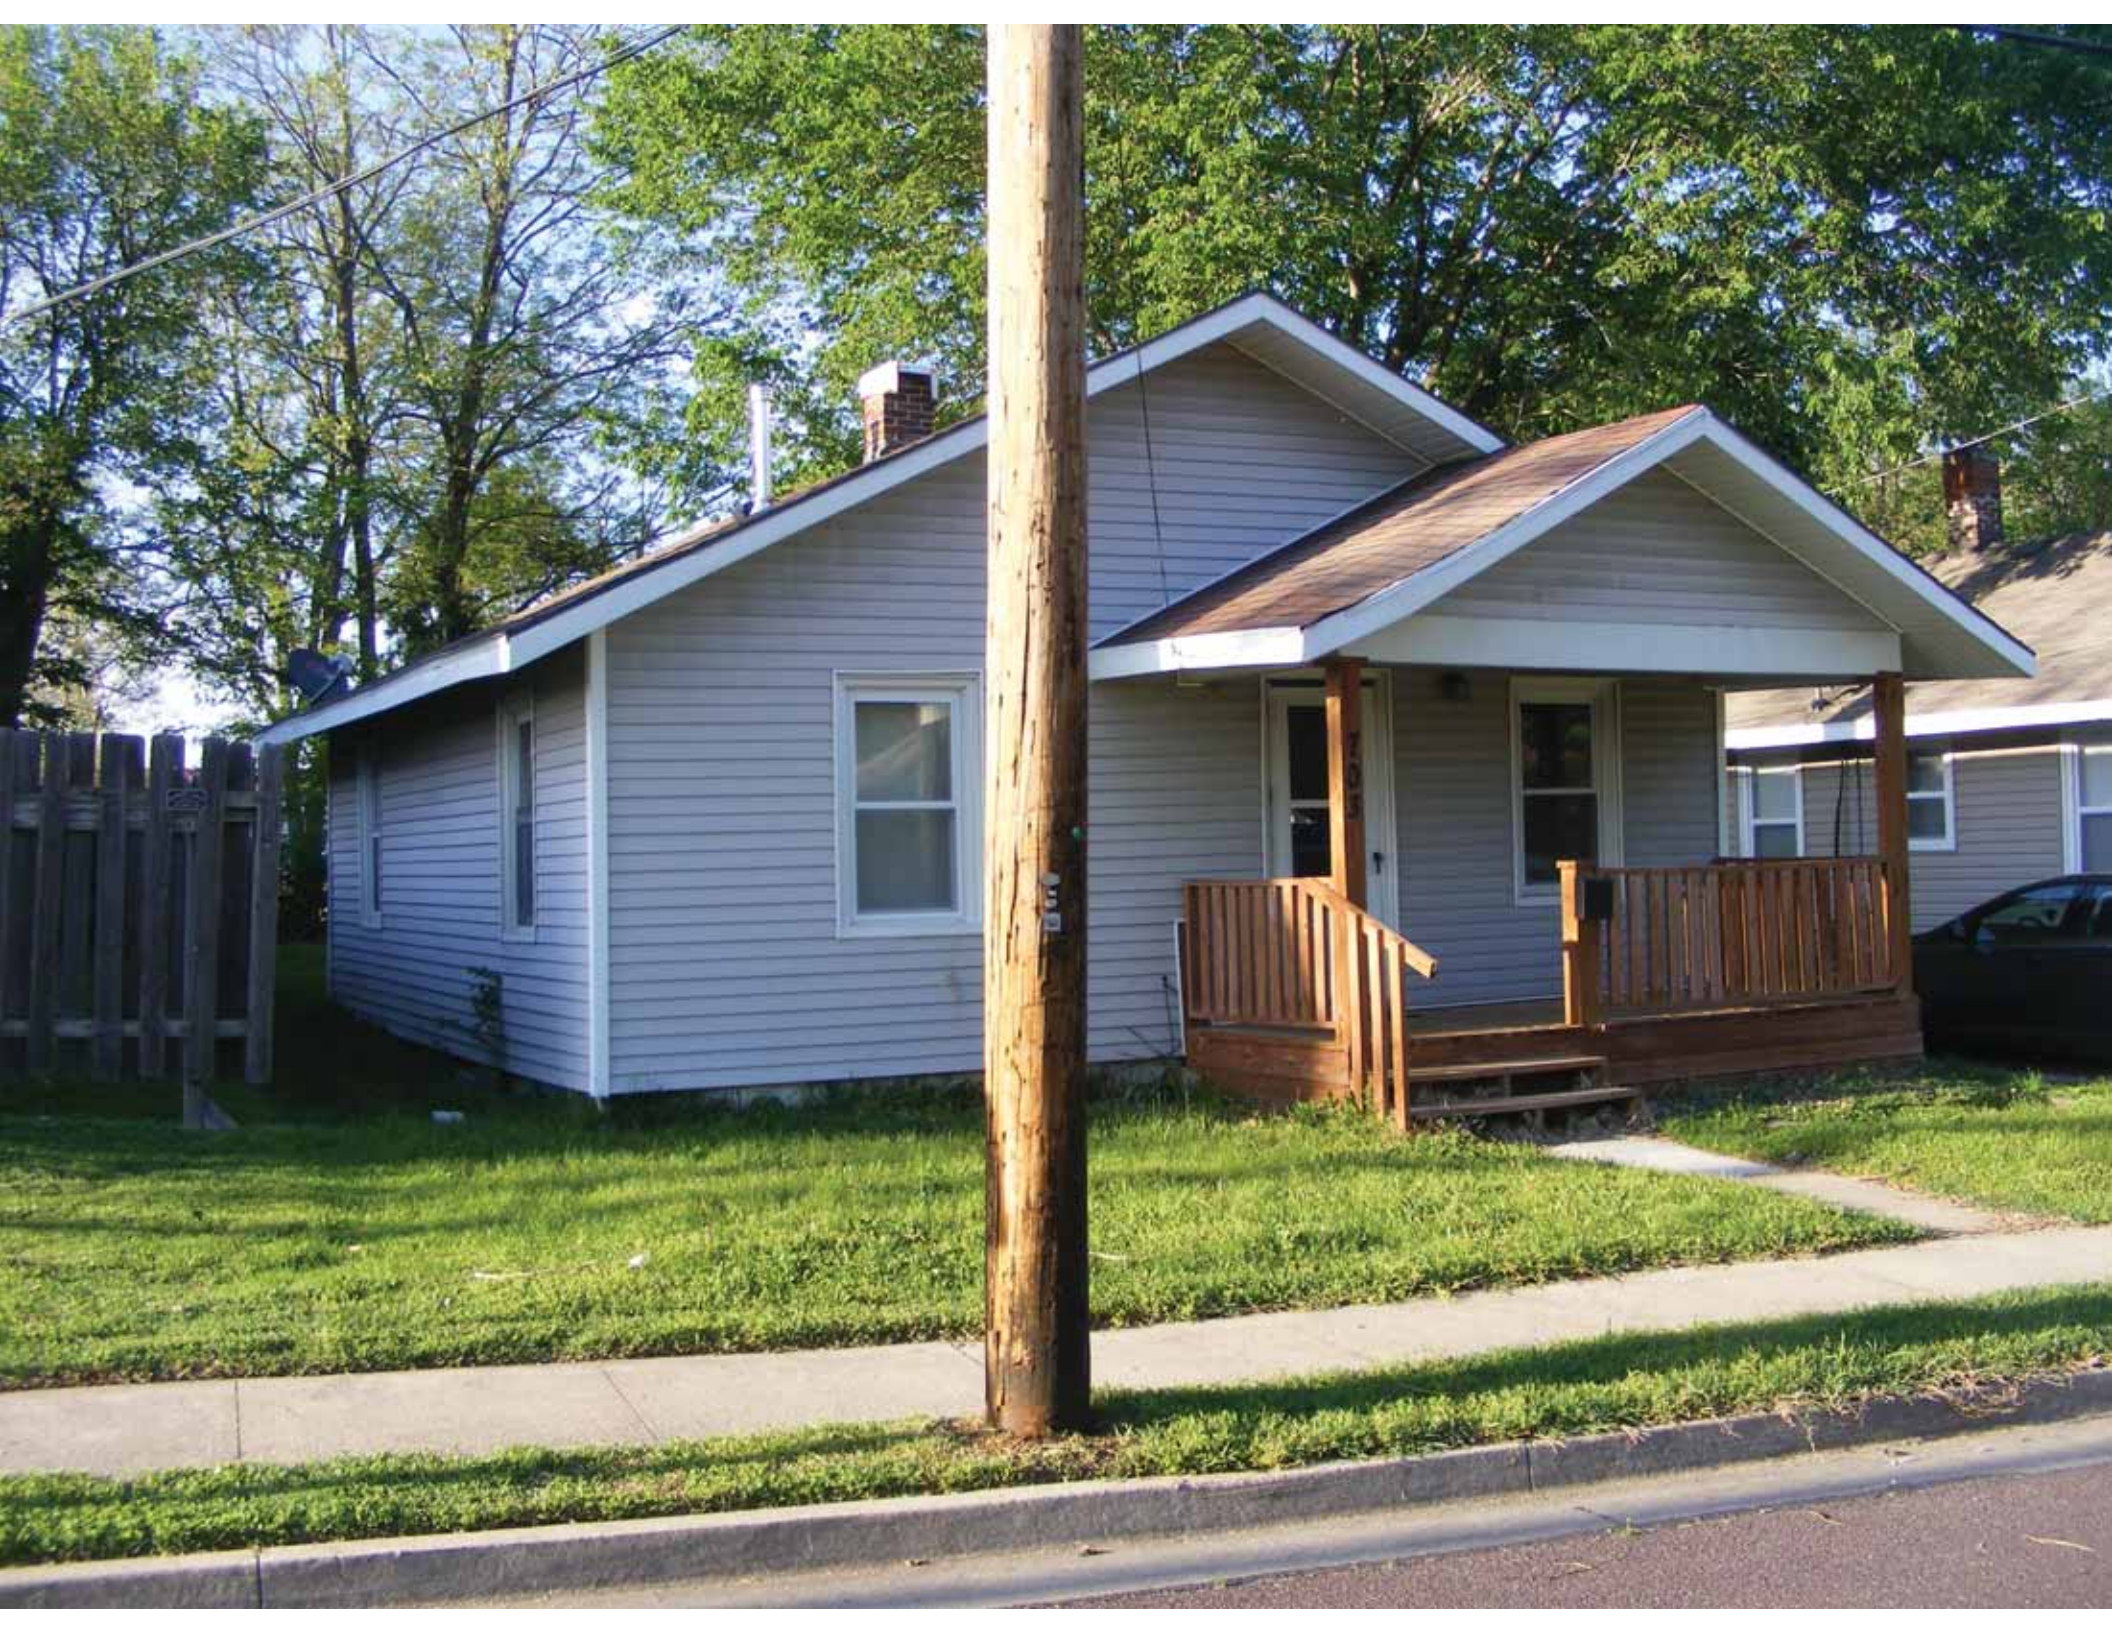
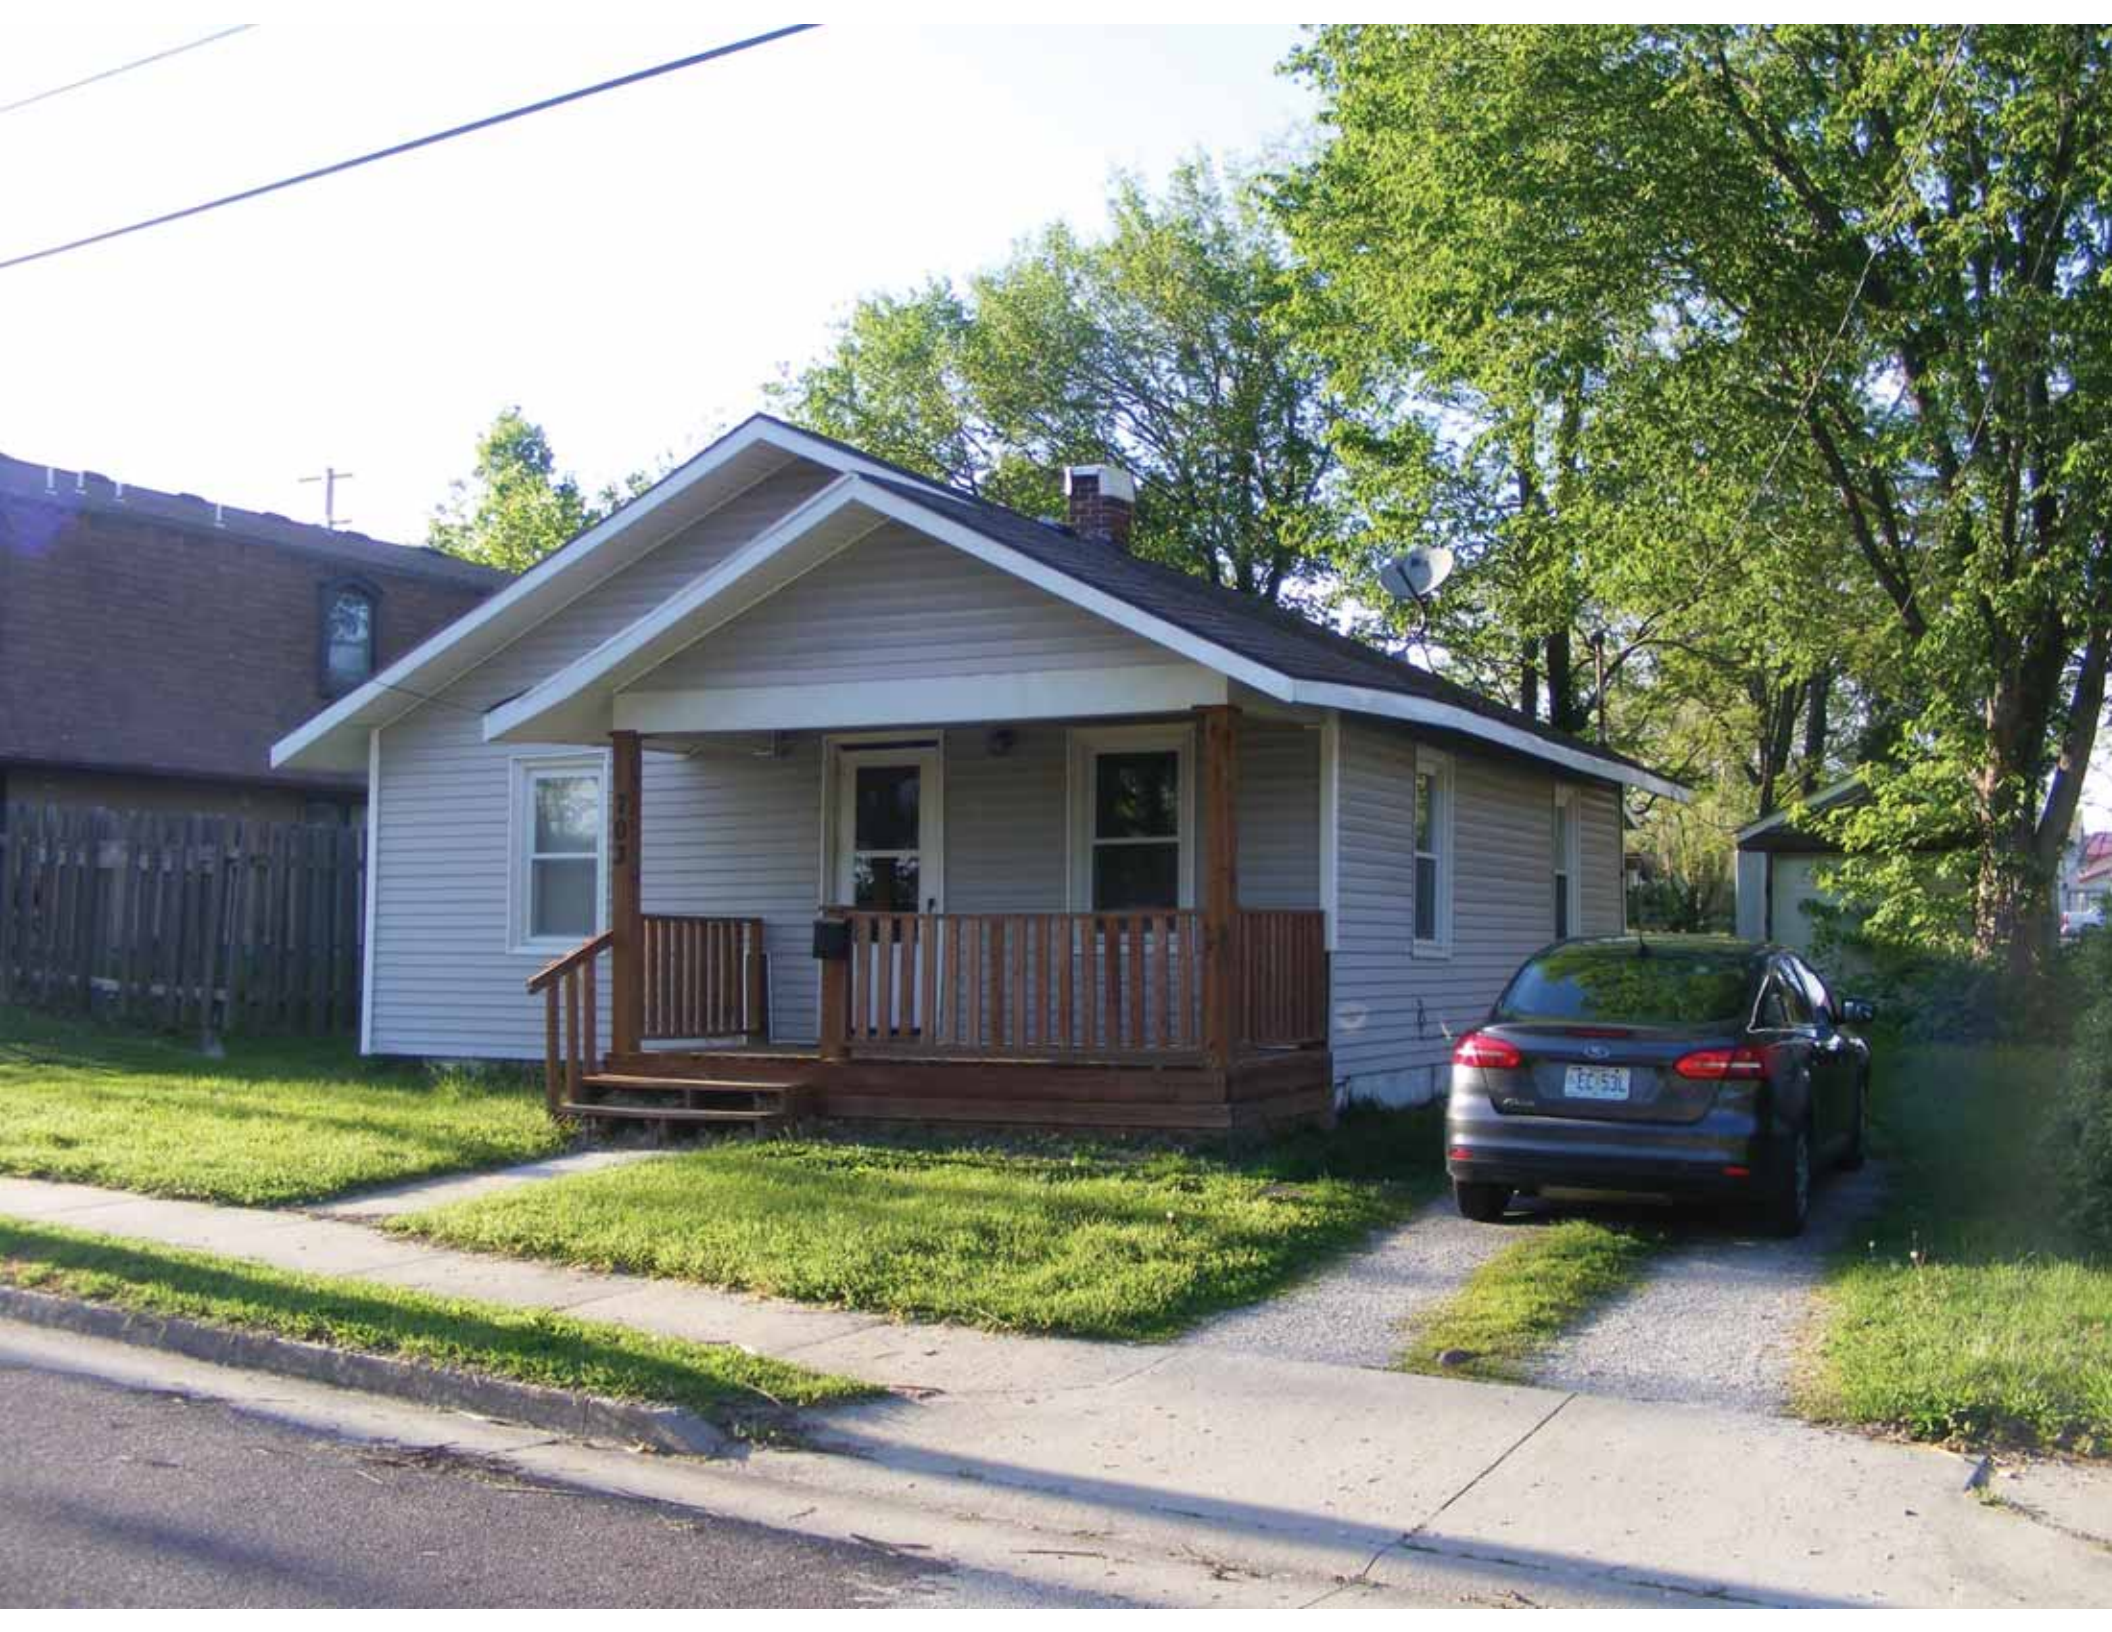
The gable-front plan Bungalow has an asphalt-shingled roof, exterior synthetic siding and a concrete foundation. Windows are c. 2019 one-over-one. The façade (south elevation) supports an off-center half-width gabled porch supported by c. 2019 wood columns. A c. 2019 frame balustrade surrounds the porch. Within the porch bay are a single door offset by a one-over-one window. The door is obscured by a contemporary storm door.
