MISSOURI DEPARTMENT OF NATURAL RESOURCES
STATE HISTORIC PRESERVATION OFFICE, P.O. Box 176, Jefferson City, MO 65102
ARCHITECTURAL/HISTORIC INVENTORY FORM

1. Survey No. BO-AS-011-0087		2. Survey name: North Central Columbia Survey Phase II	
3. County: Boone		4. Address (Street No.) 902	Street (name) N. Seventh Street
5. City: Columbia	Vicinity: <input type="checkbox"/>	6. Geographical Reference:	7. Township/Range/Section: T: R: S:
8. Historic name (if known):		9. Present/other name (if known):	
10. Ownership: <input checked="" type="checkbox"/> Private <input type="checkbox"/> Public		11a. Historic use (if known): Domestic/single dwelling	11b. Current use: Domestic/single dwelling

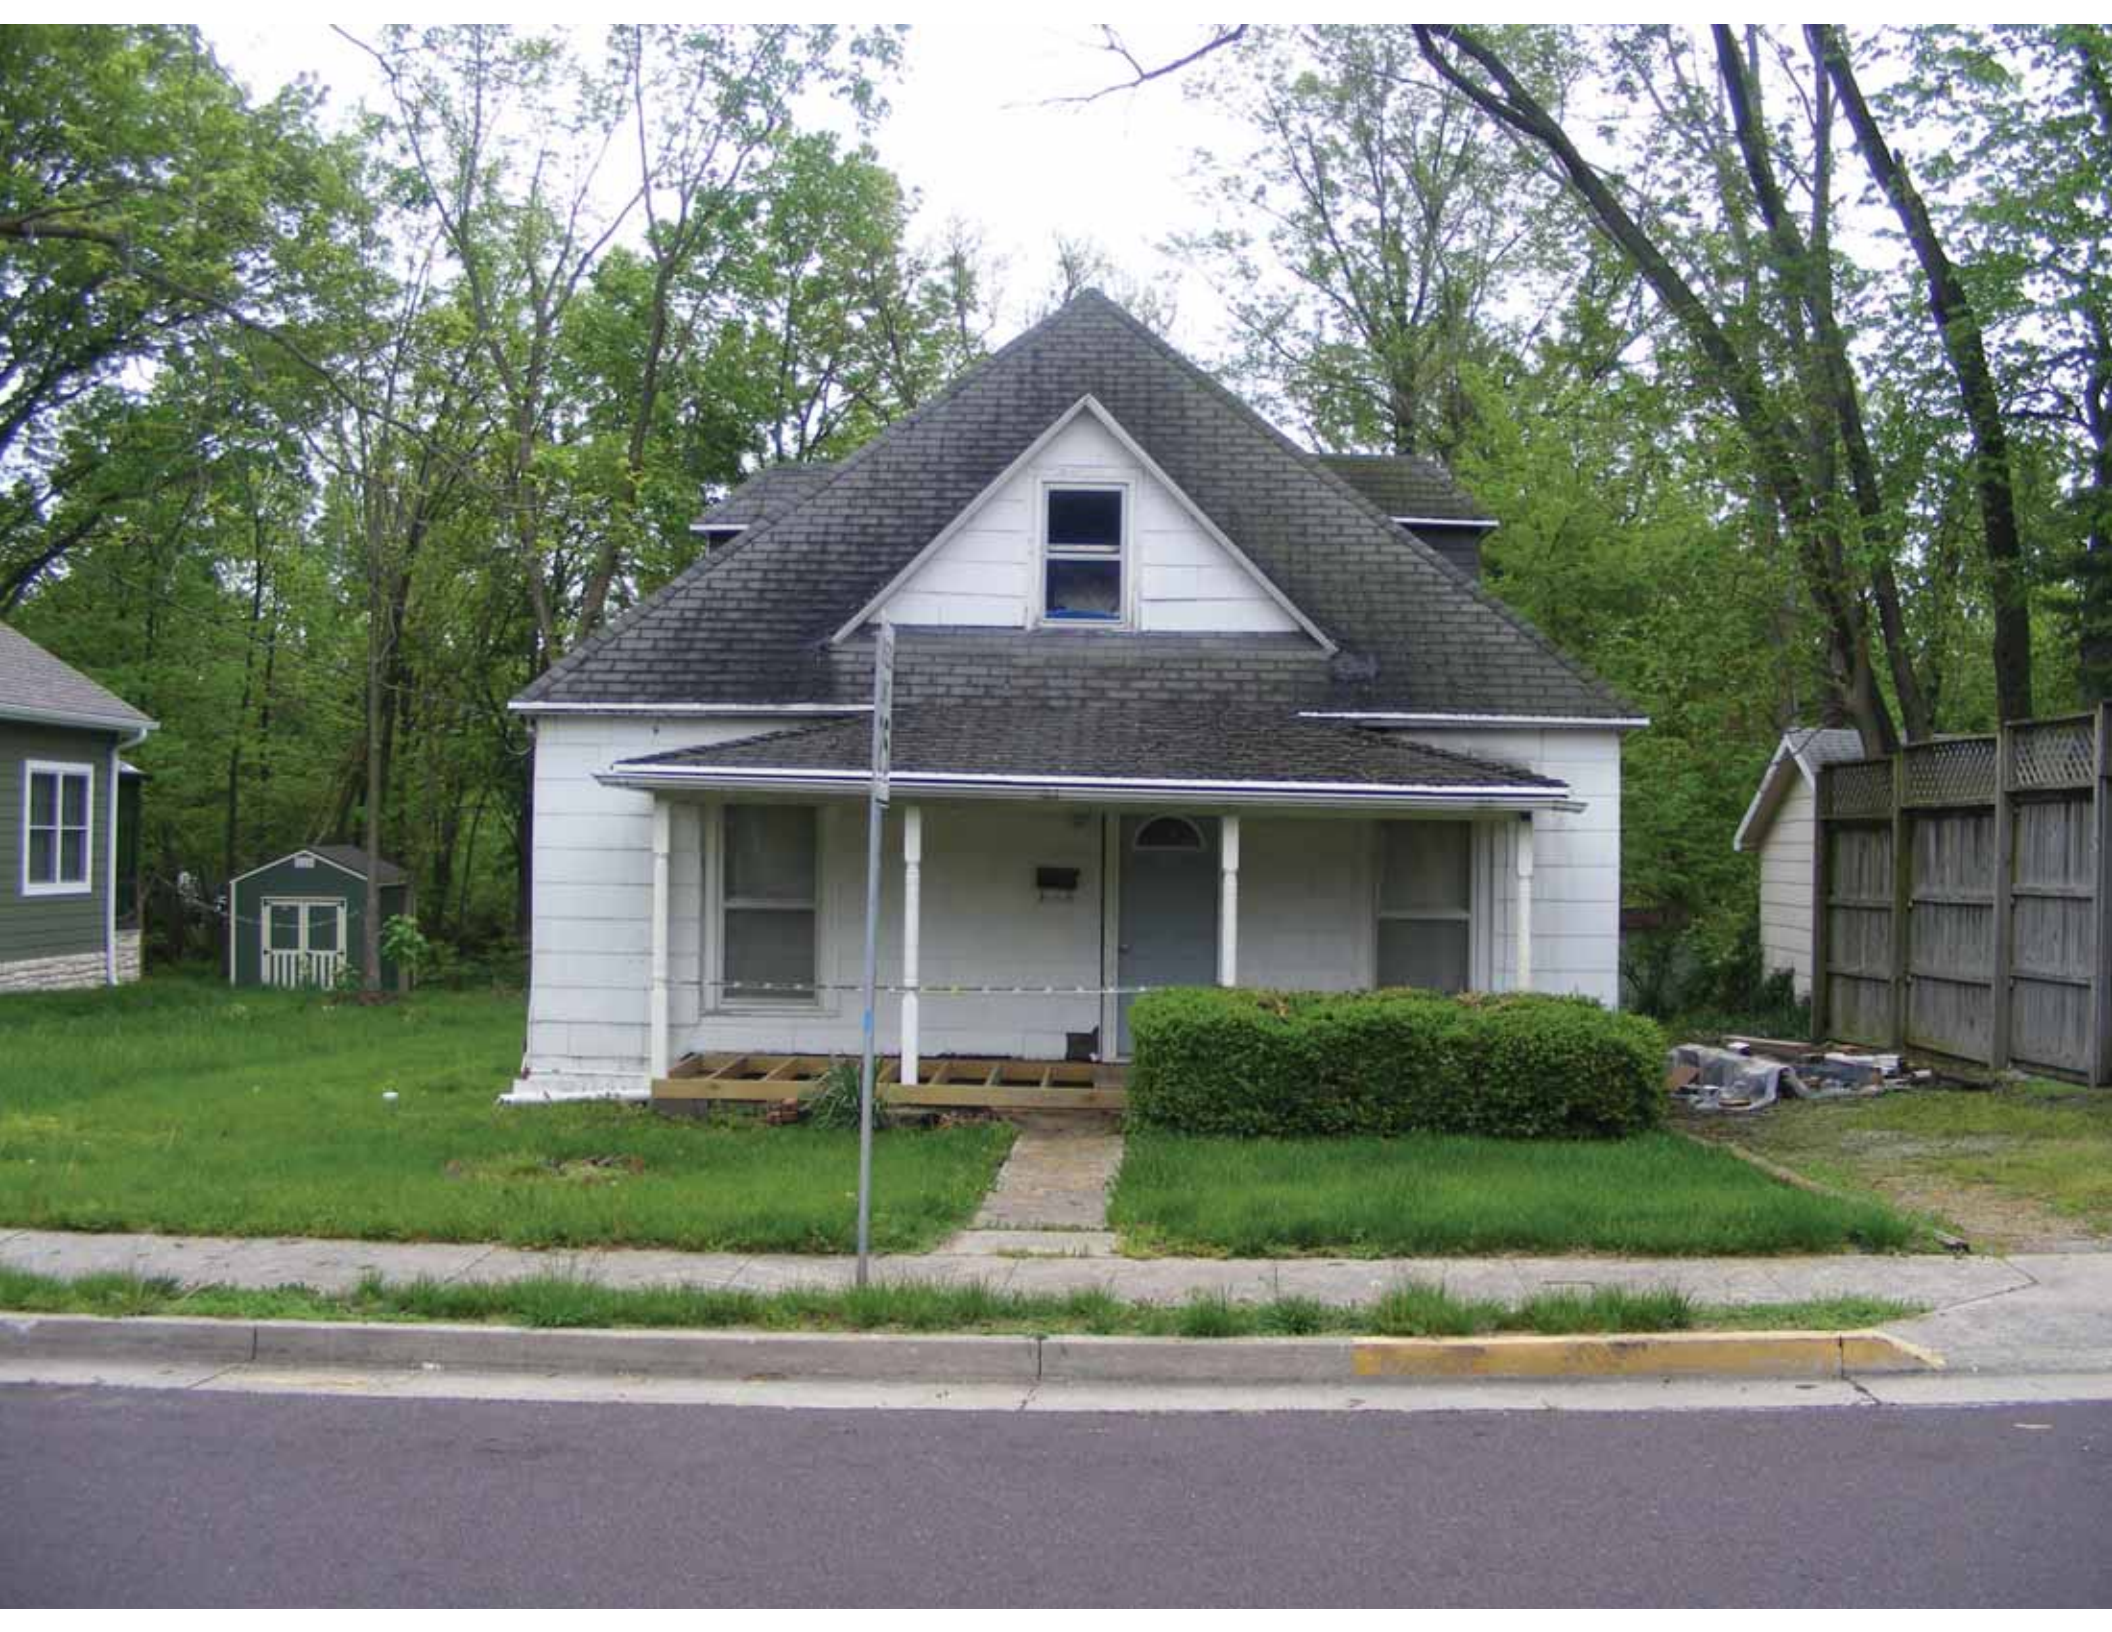
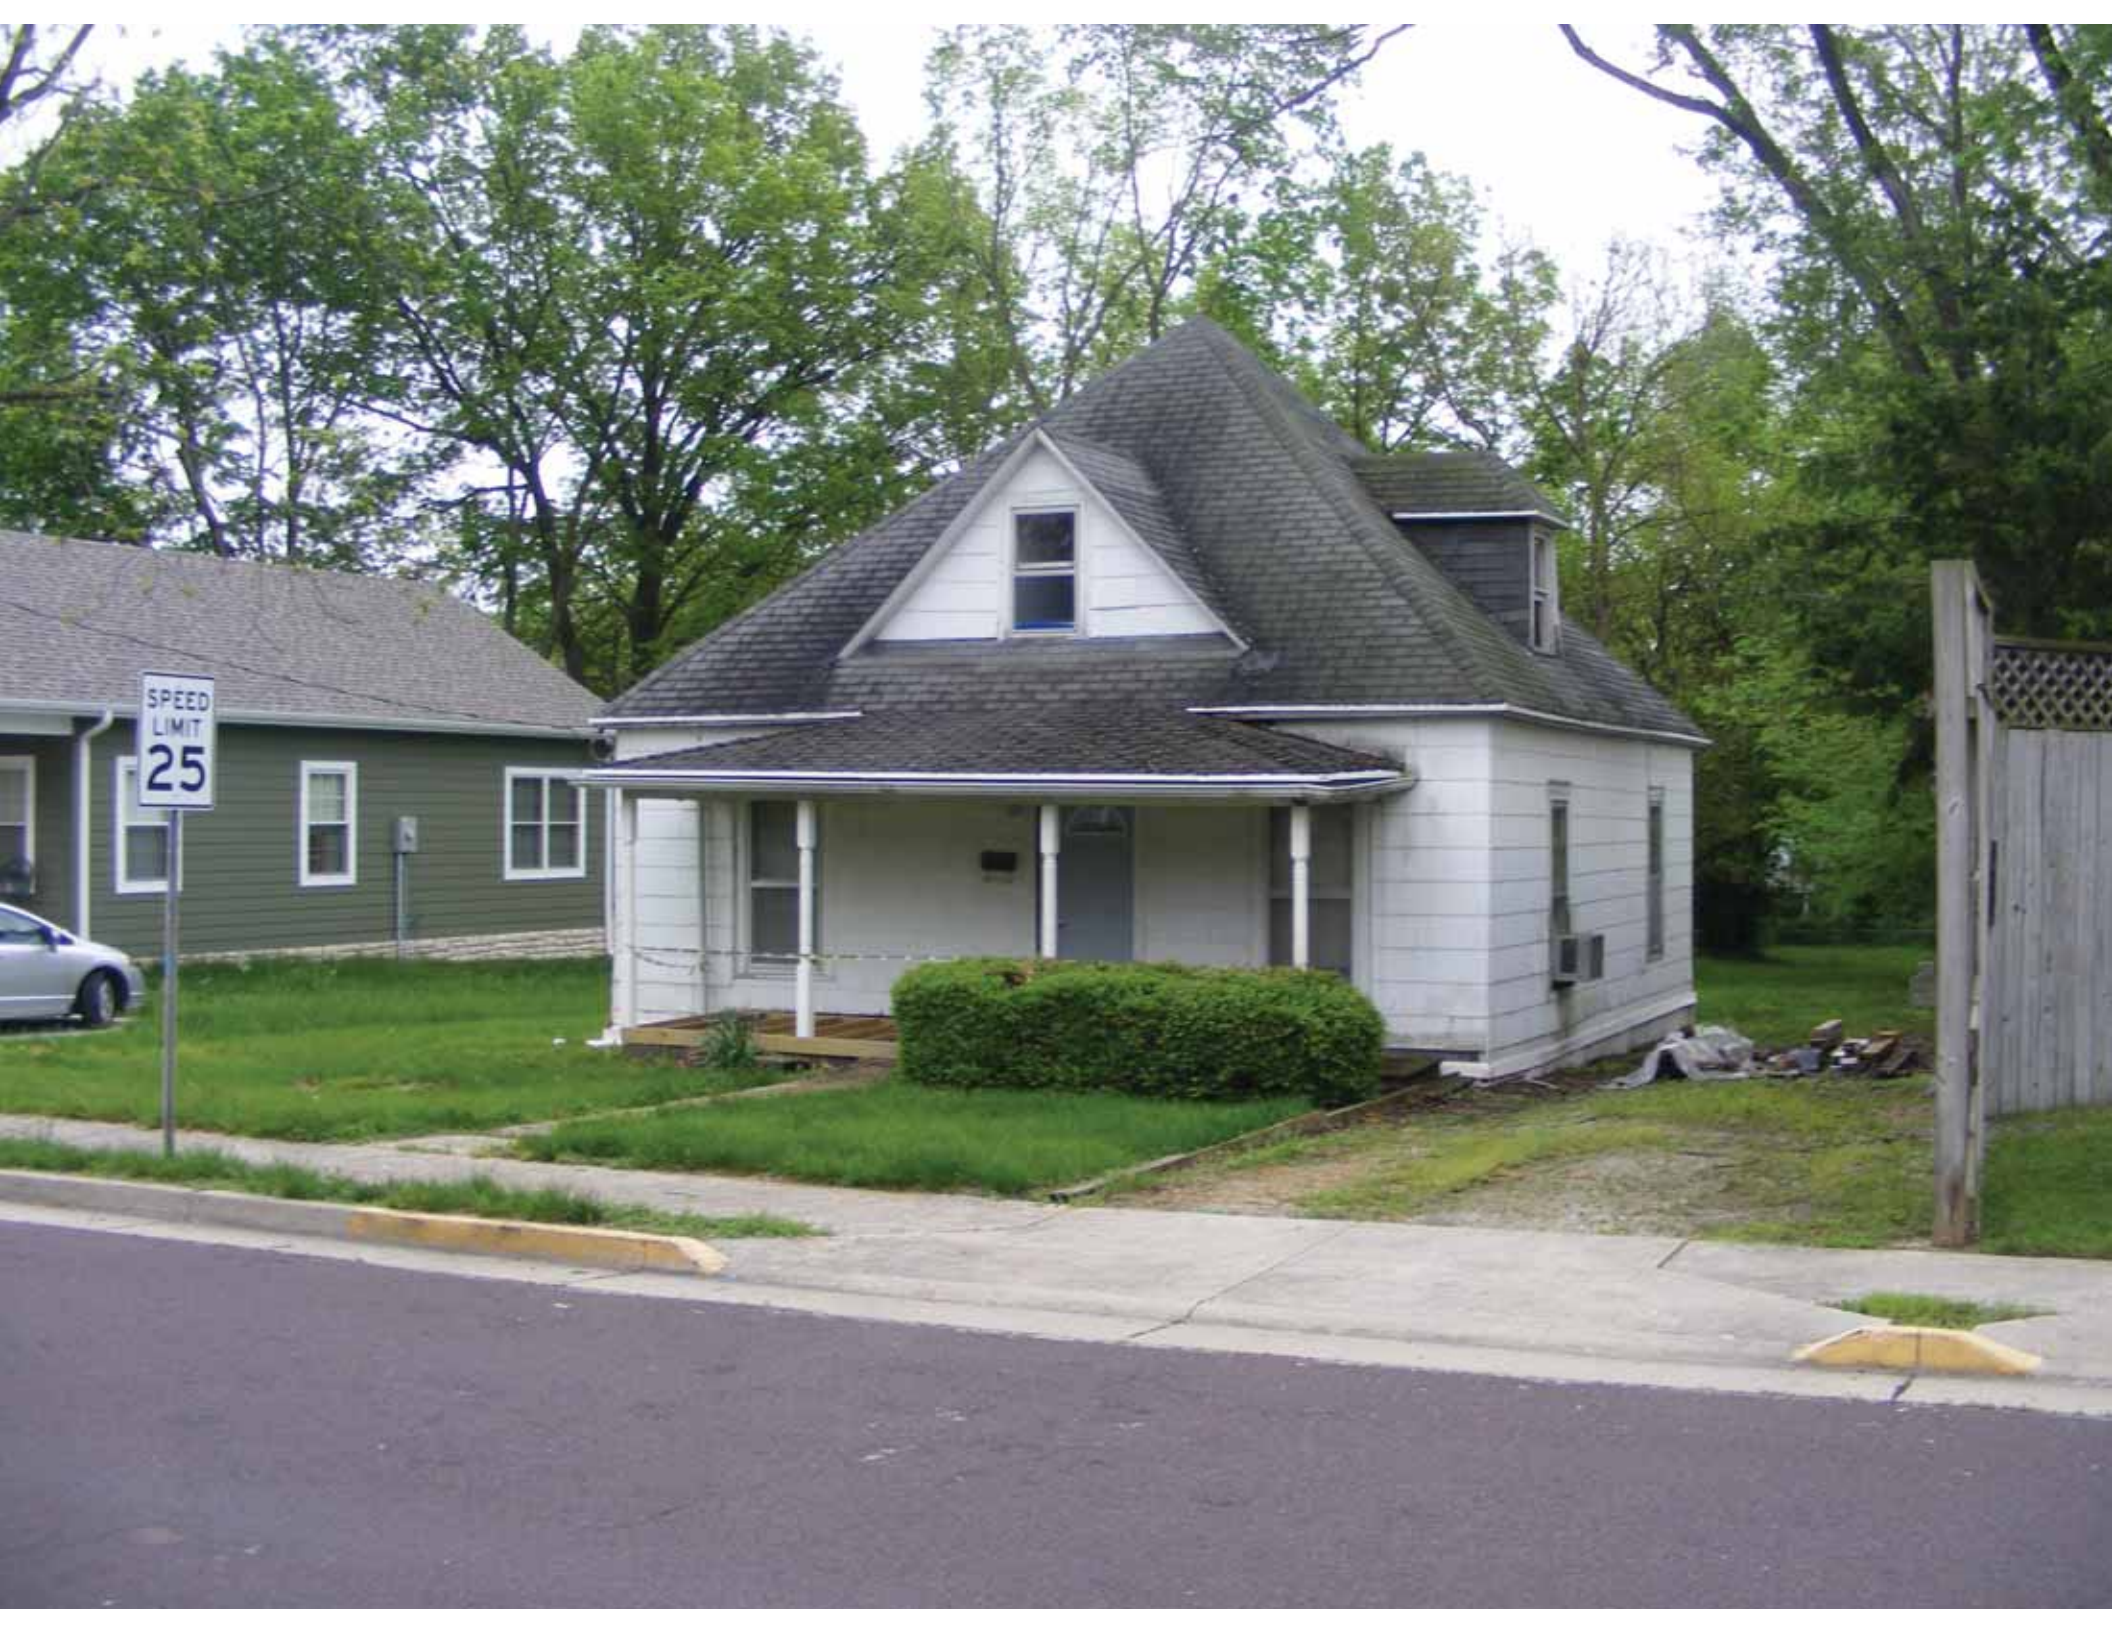
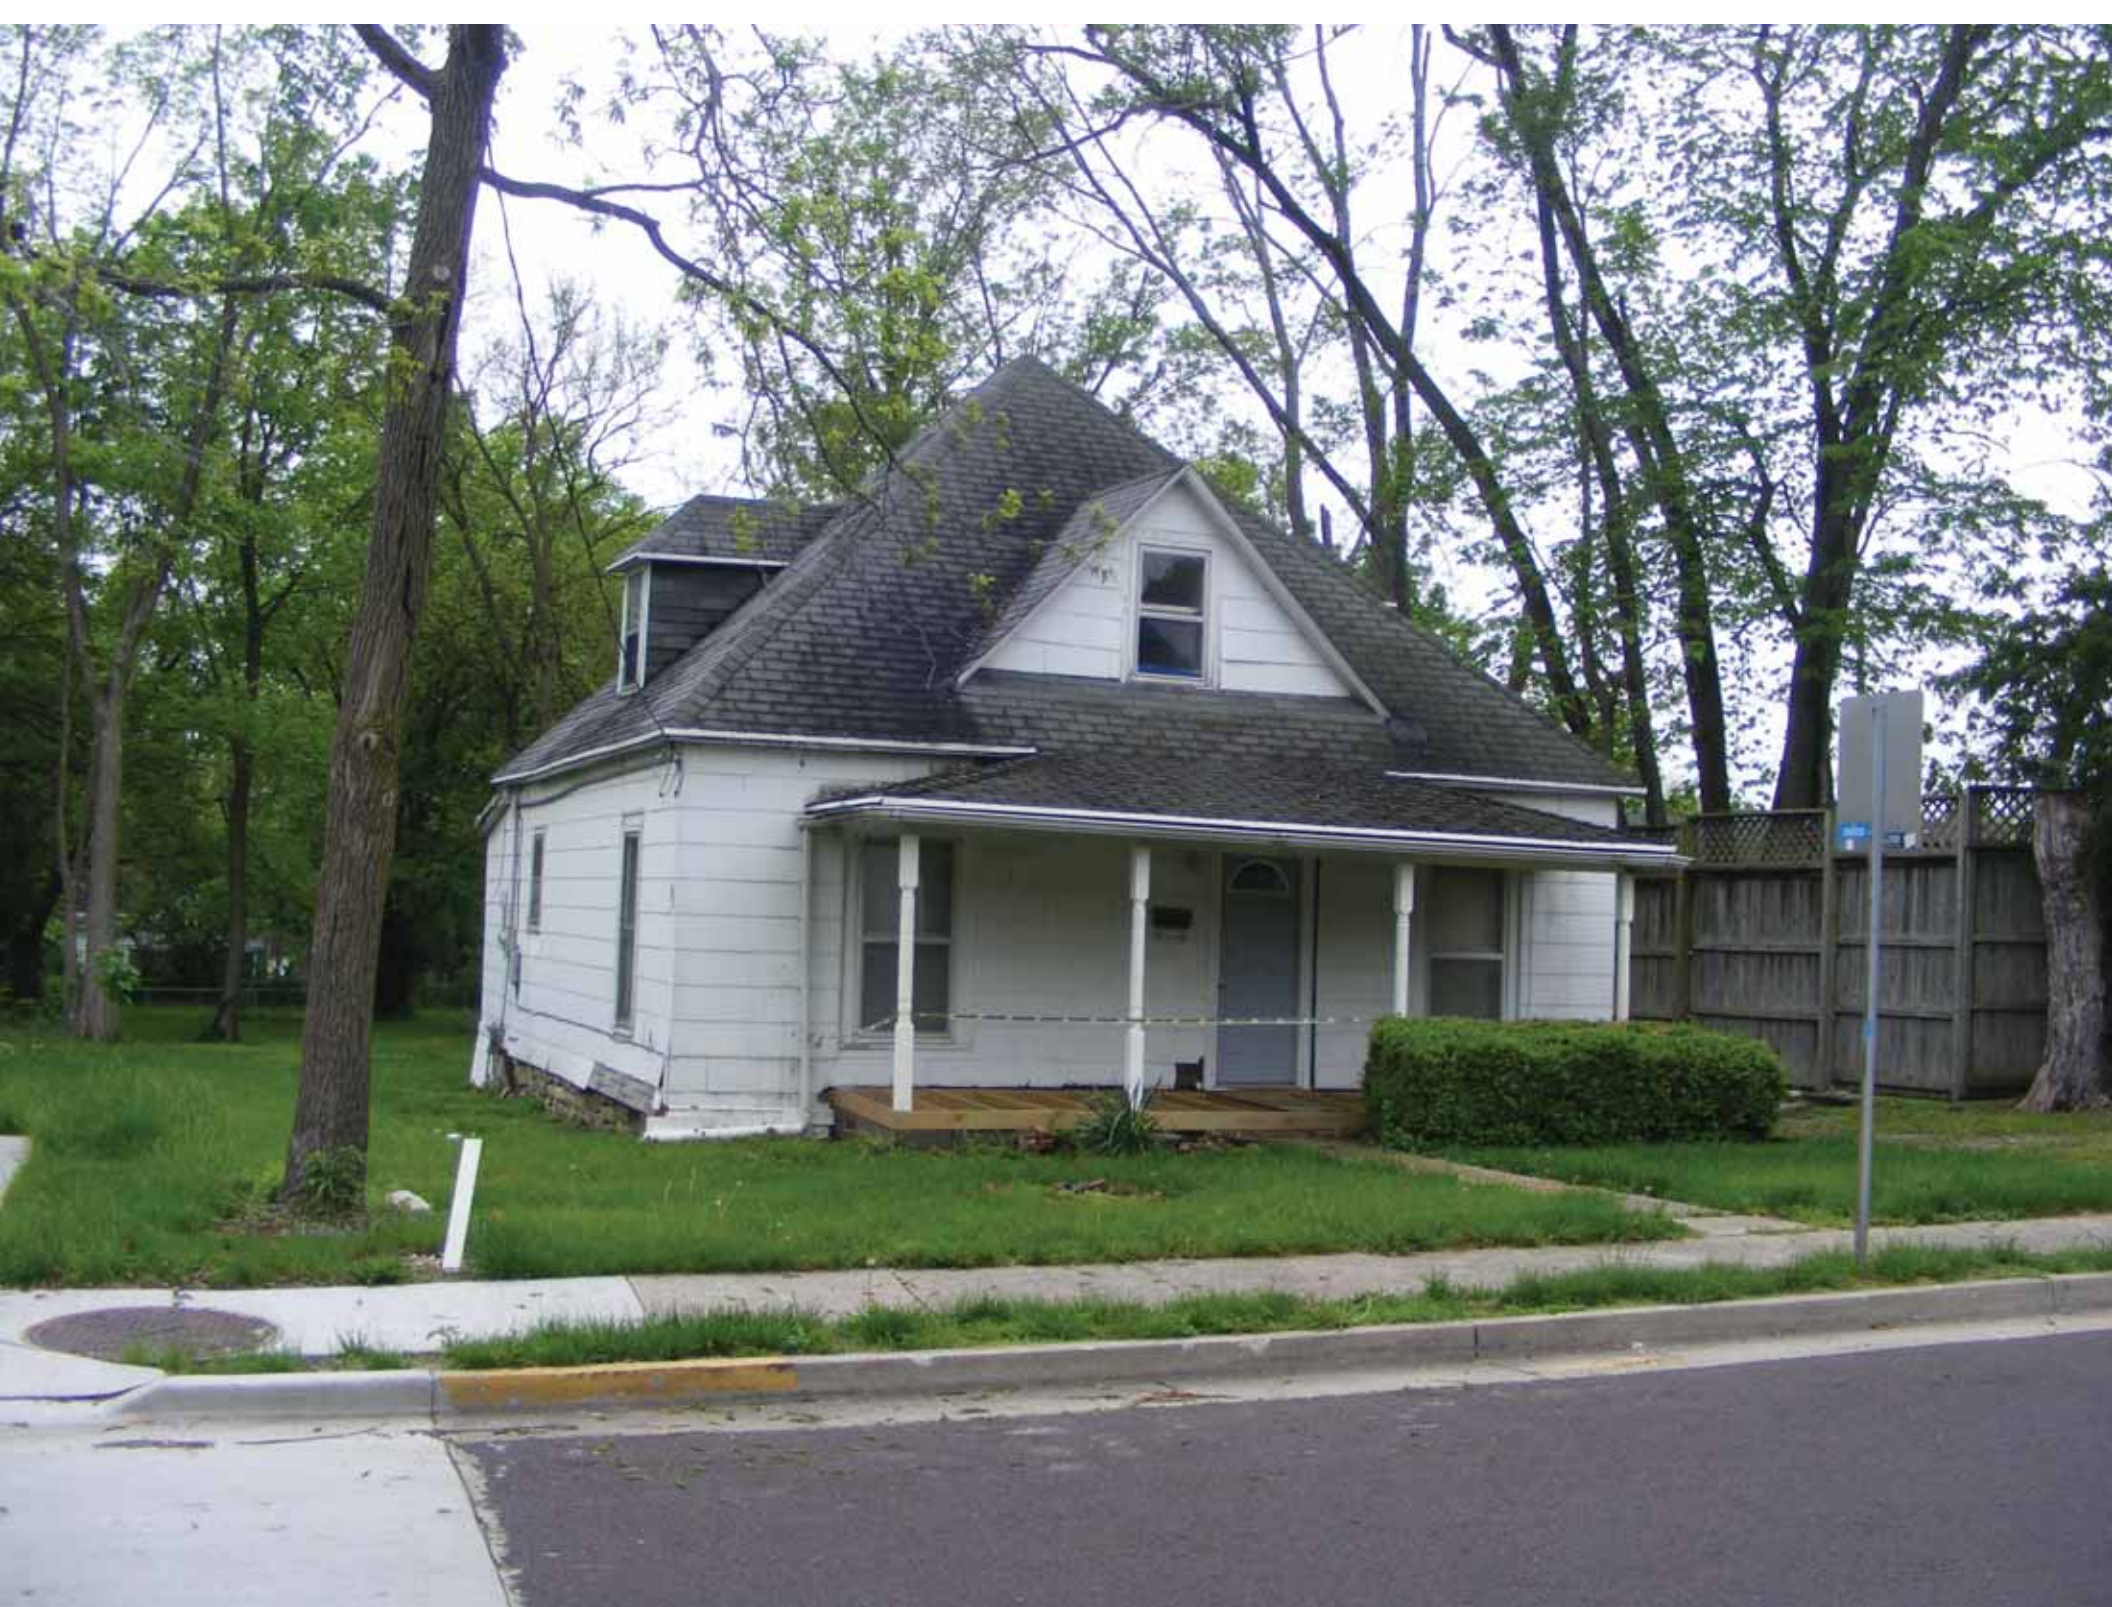
The dwelling has an asphalt-shingled pyramidal roof, exterior asbestos shingle siding and a stone (east) and concrete (west) foundation. On the façade (north elevation) is a central hipped porch supported by original milled columns. The porch base is under reconstruction (frame materials). It also appears that the stone foundation is being replaced with concrete. Within the porch bay is a central entry filled with a contemporary door with an upper fanlight. The door is flanked by individual one-over-one windows. Above the porch is a gabled dormer with a one-over-one window. Side (east and west) dormers have hipped roofs/ Side dormer walls are clad with asphalt shingles. The side dormers support one-over-one windows.

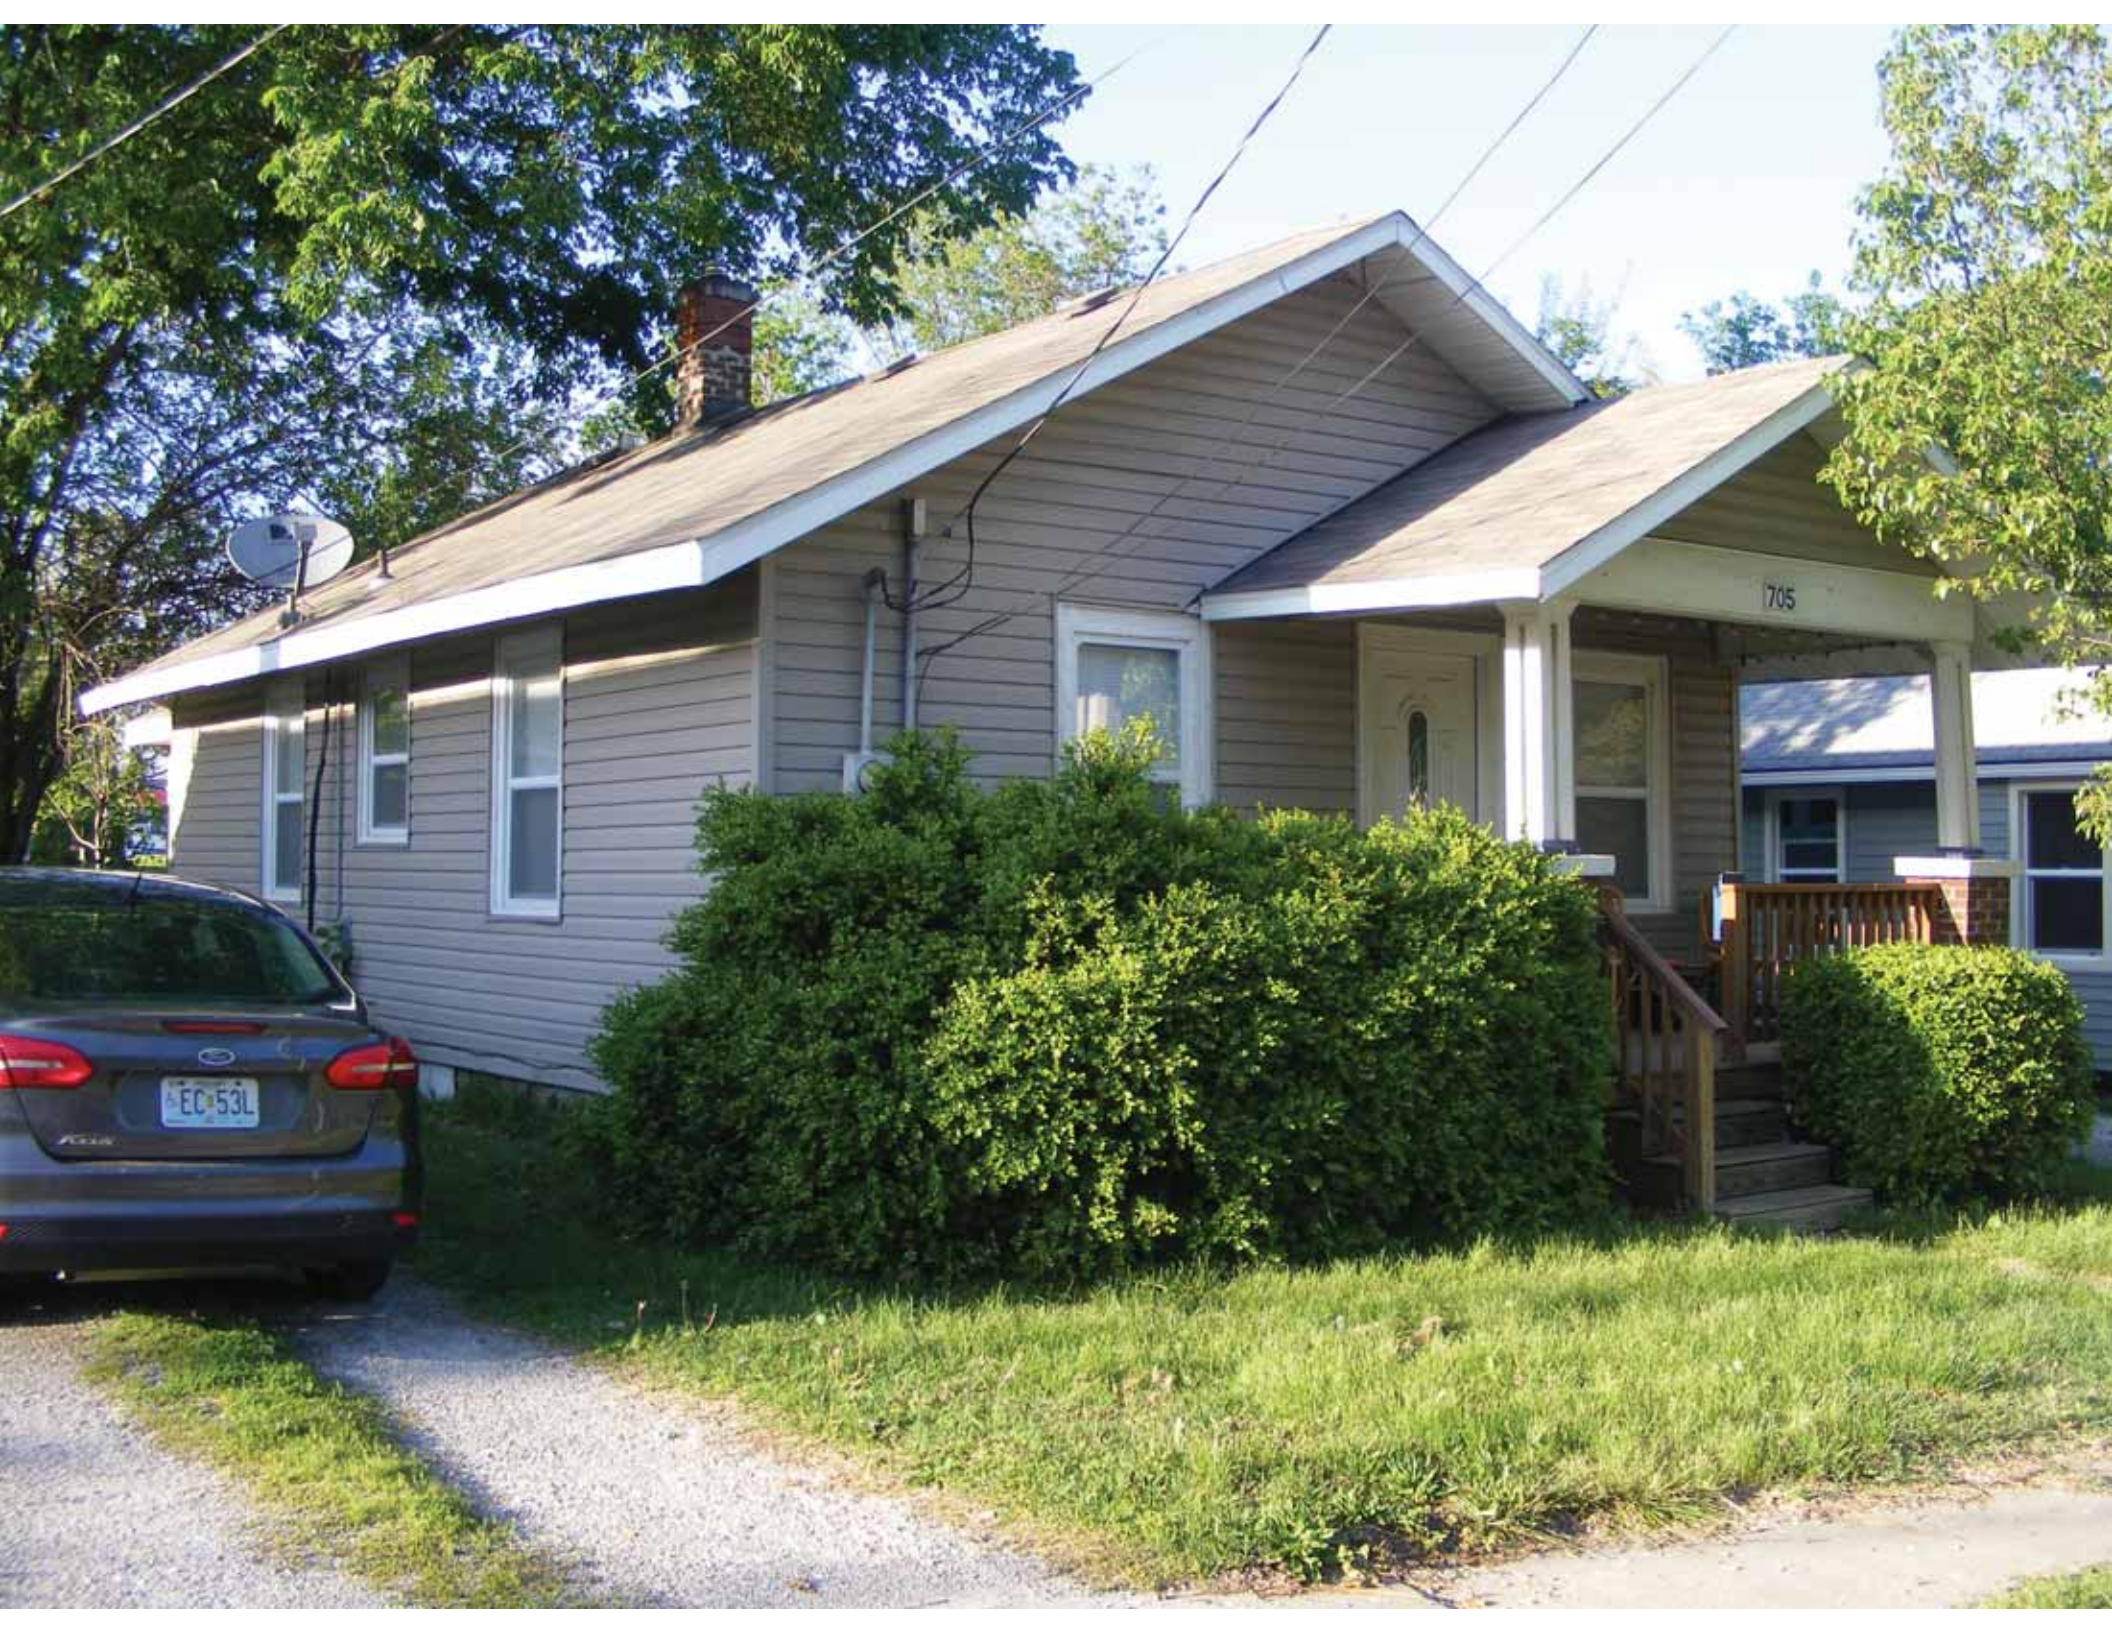
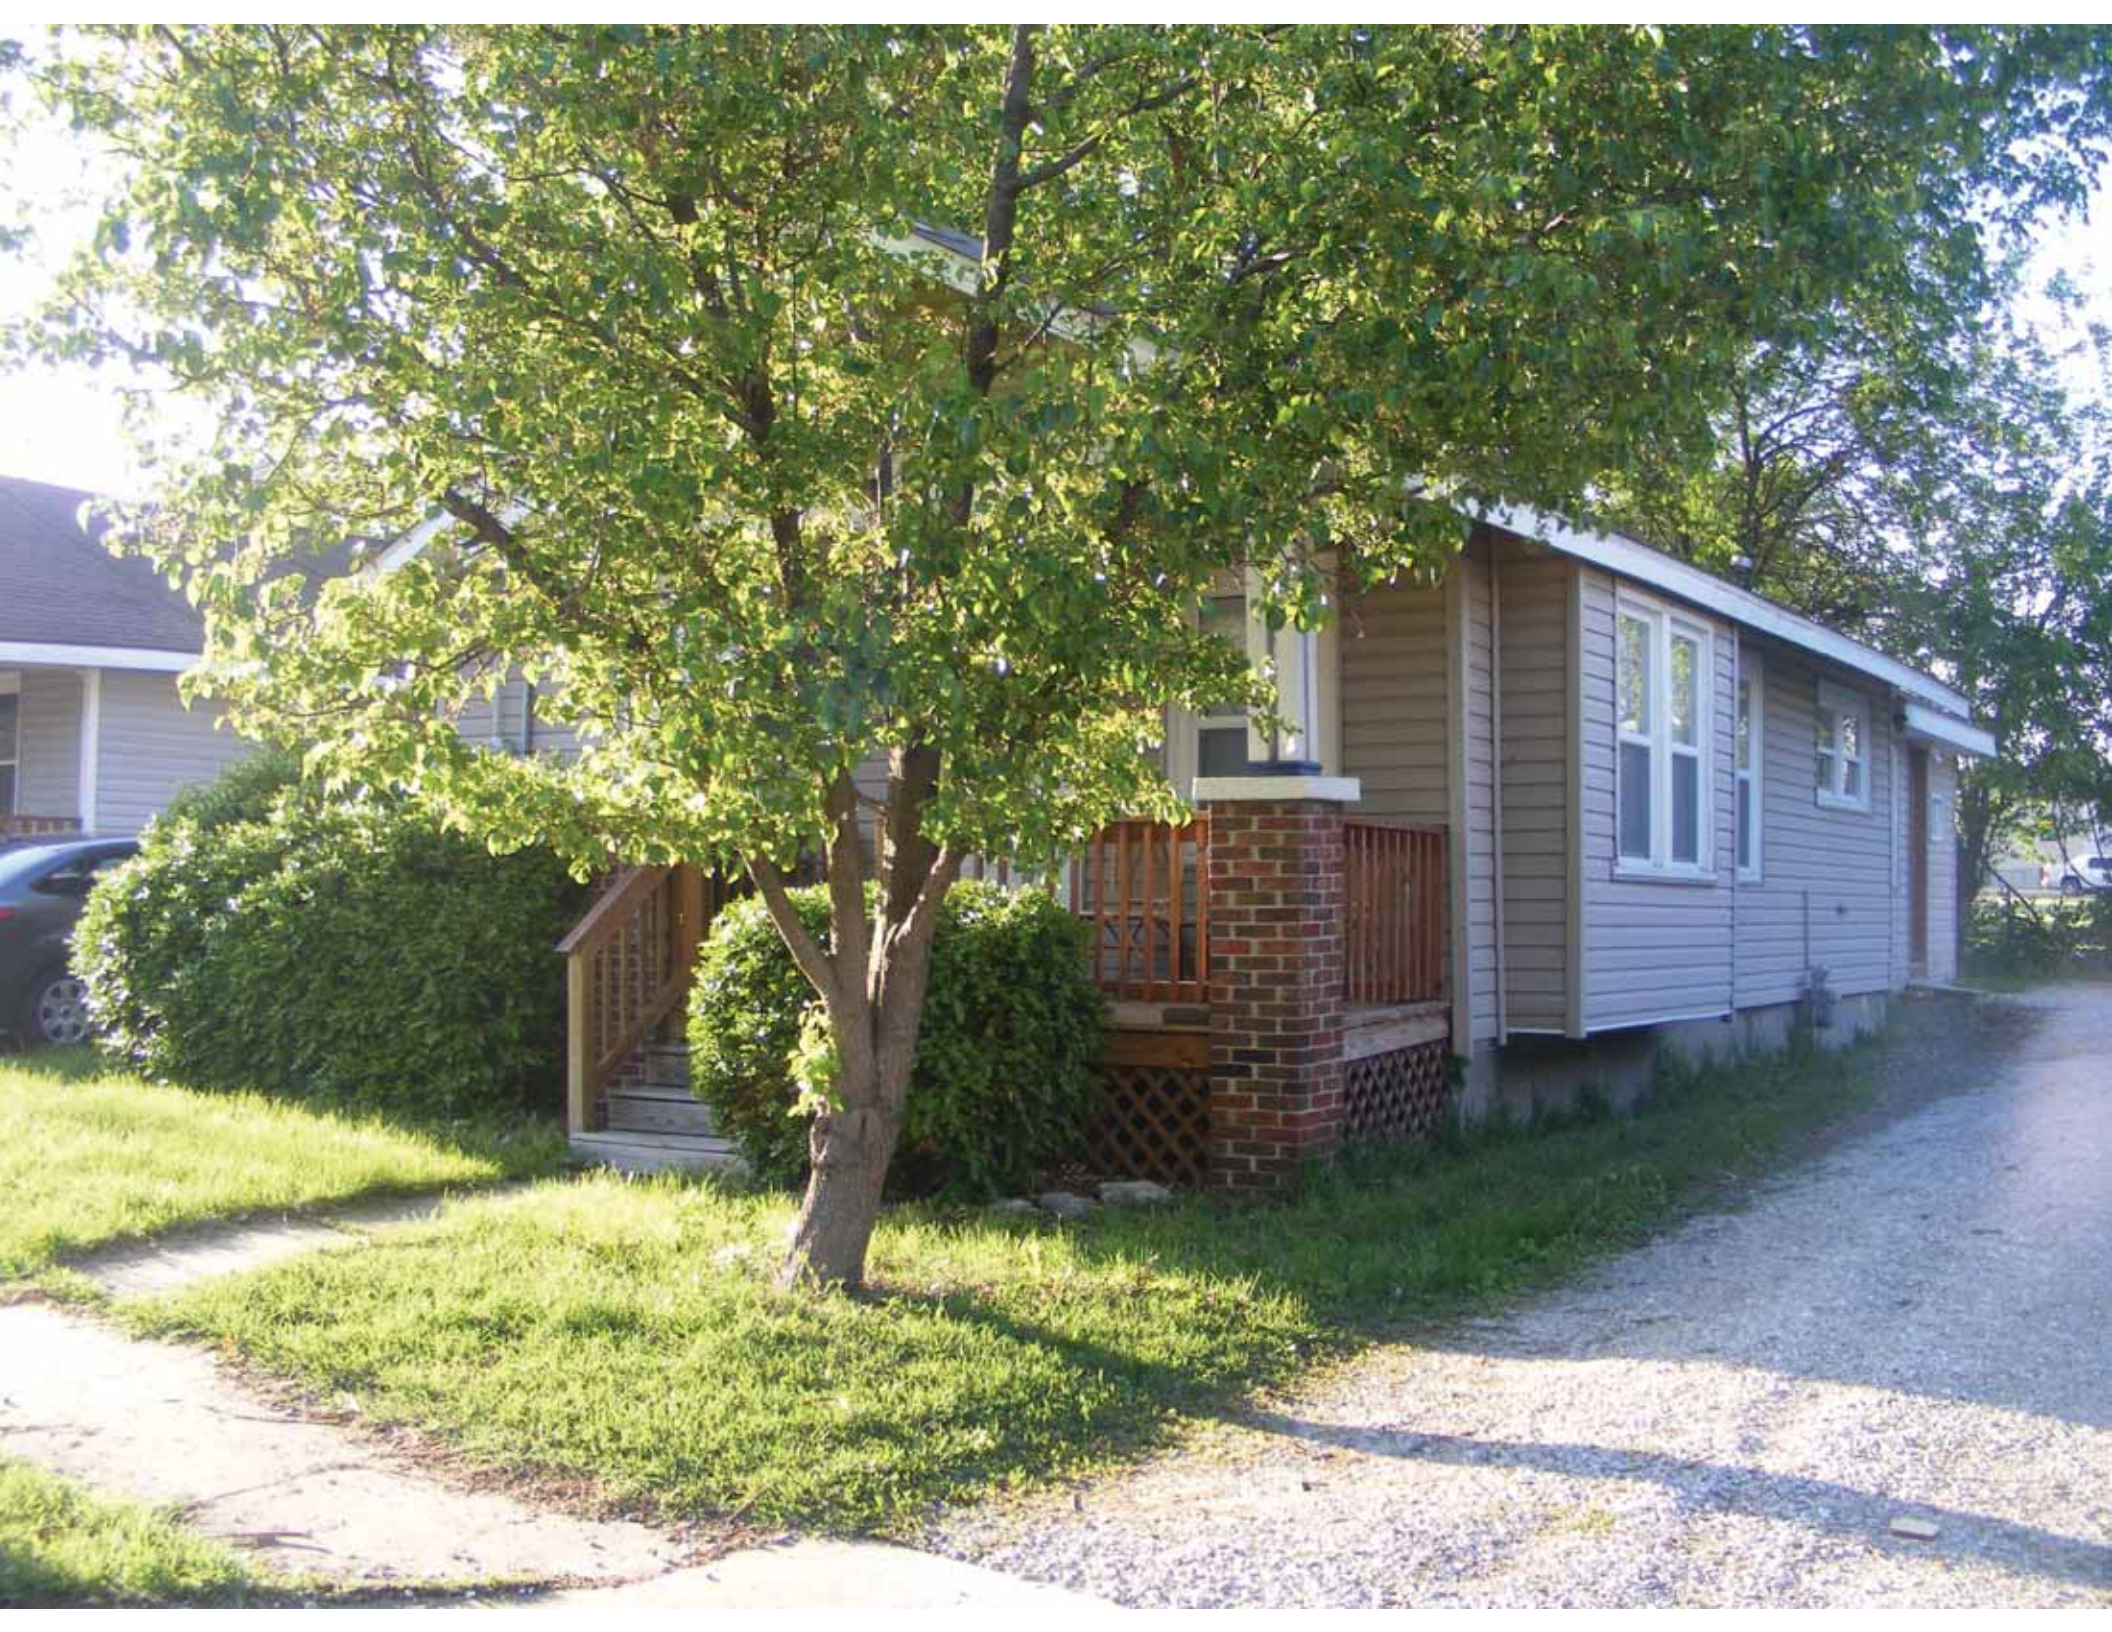
705

The gable-front plan dwelling has an asphalt shingled roof, exterior vinyl siding and a concrete foundation. The dwelling has an off-center half-width porch on the façade supported by slender paired columns on brick piers. A non-original balustrade surrounds the porch. Within the porch bay is a c. 2015 door offset by a one-over-one window. Windows are replacement c. 2015.
