MISSOURI DEPARTMENT OF NATURAL RESOURCES
STATE HISTORIC PRESERVATION OFFICE, P.O. Box 176, Jefferson City, MO 65102
ARCHITECTURAL/HISTORIC INVENTORY FORM

1. Survey No. BO-AS-011-0087		2. Survey name: North Central Columbia Survey Phase II	
3. County: Boone		4. Address (Street No.) 902	Street (name) N. Seventh Street
5. City: Columbia	Vicinity: <input type="checkbox"/>	6. Geographical Reference:	7. Township/Range/Section: T: R: S:
8. Historic name (if known):		9. Present/other name (if known):	
10. Ownership: <input checked="" type="checkbox"/> Private <input type="checkbox"/> Public		11a. Historic use (if known): Domestic/single dwelling	11b. Current use: Domestic/single dwelling

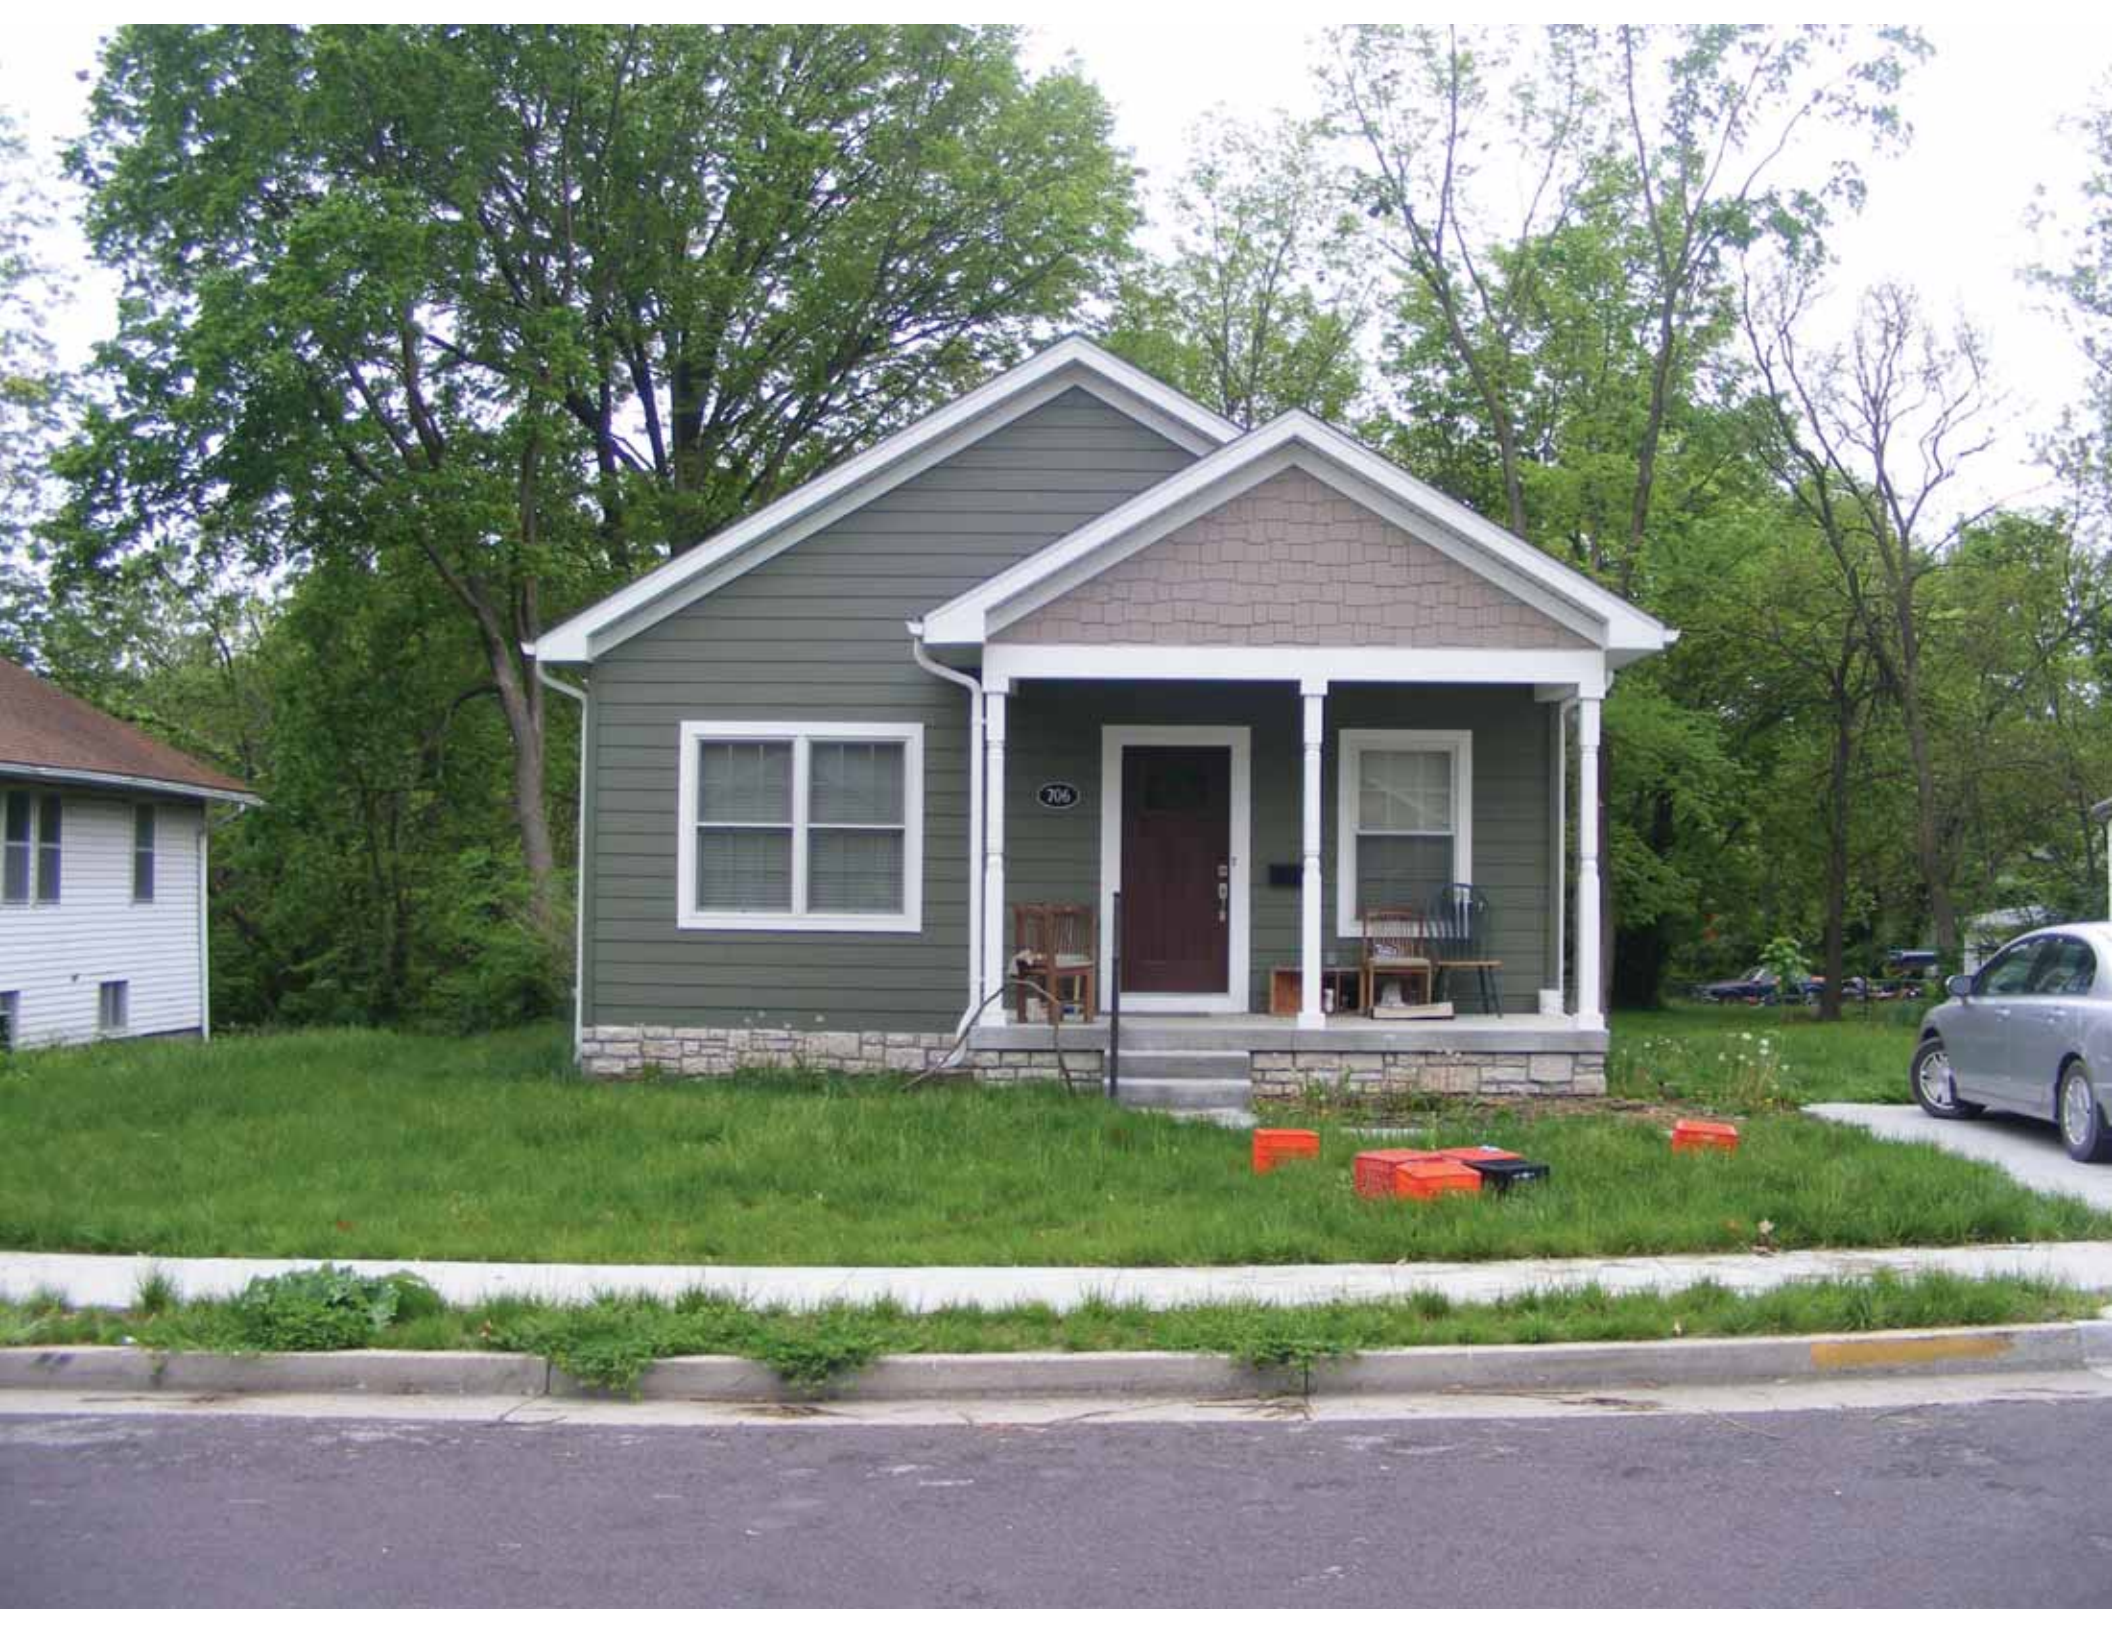
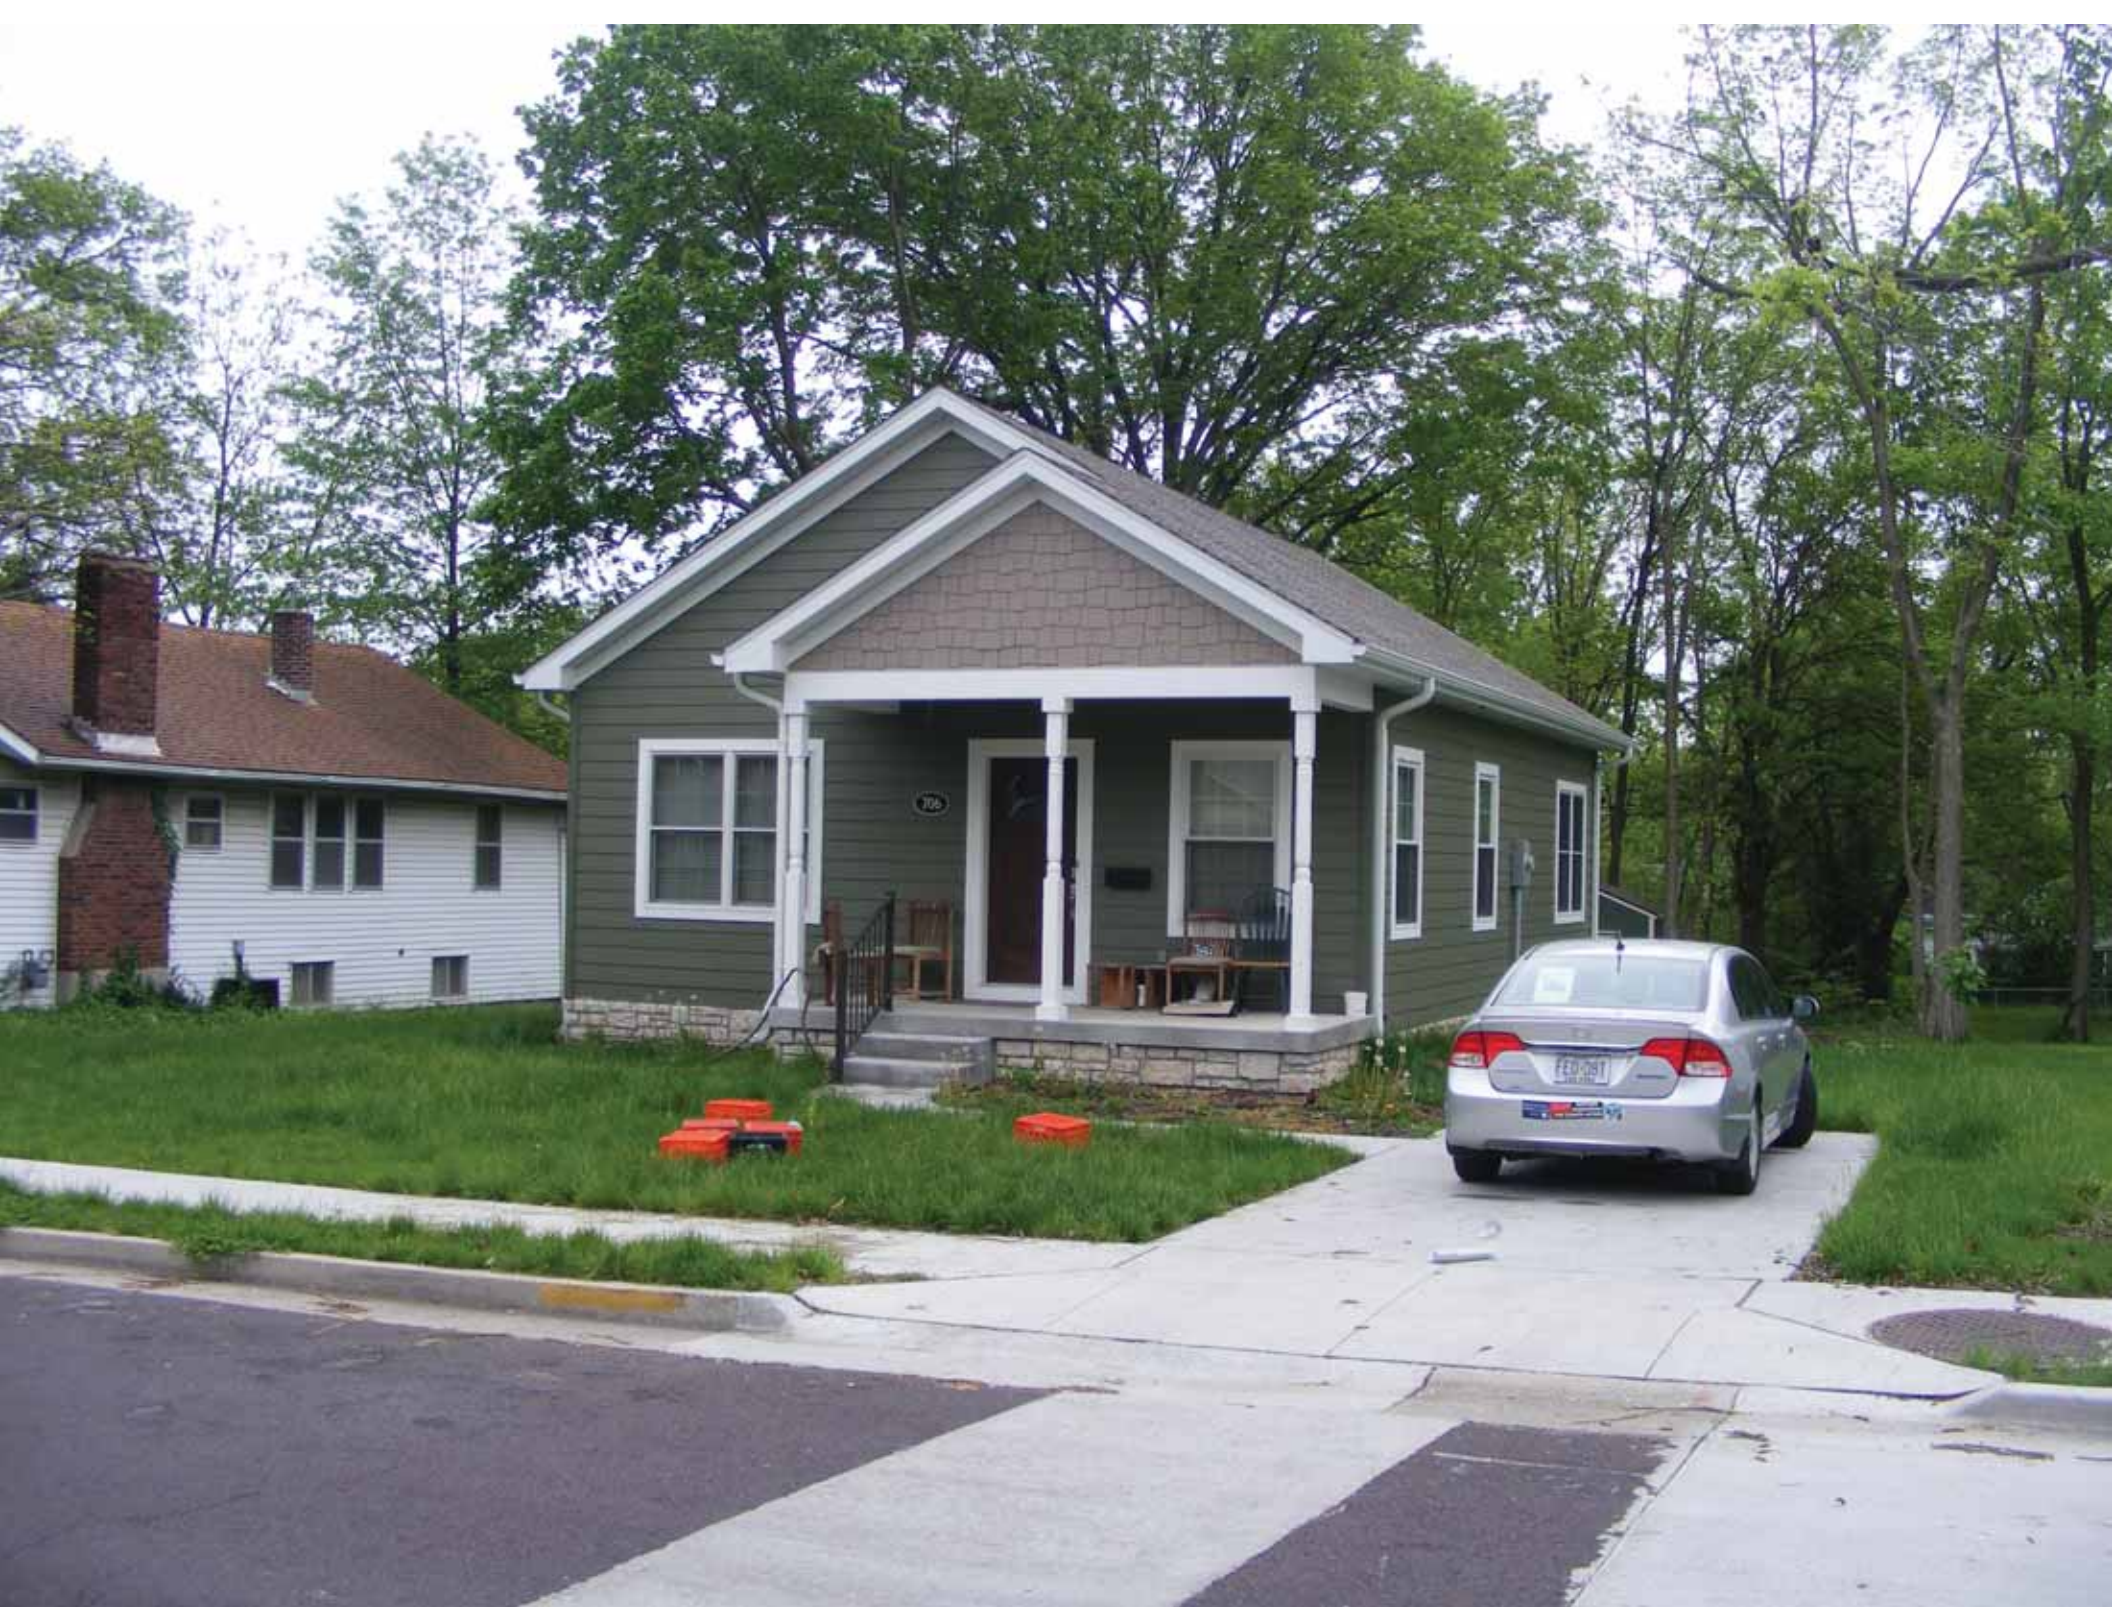
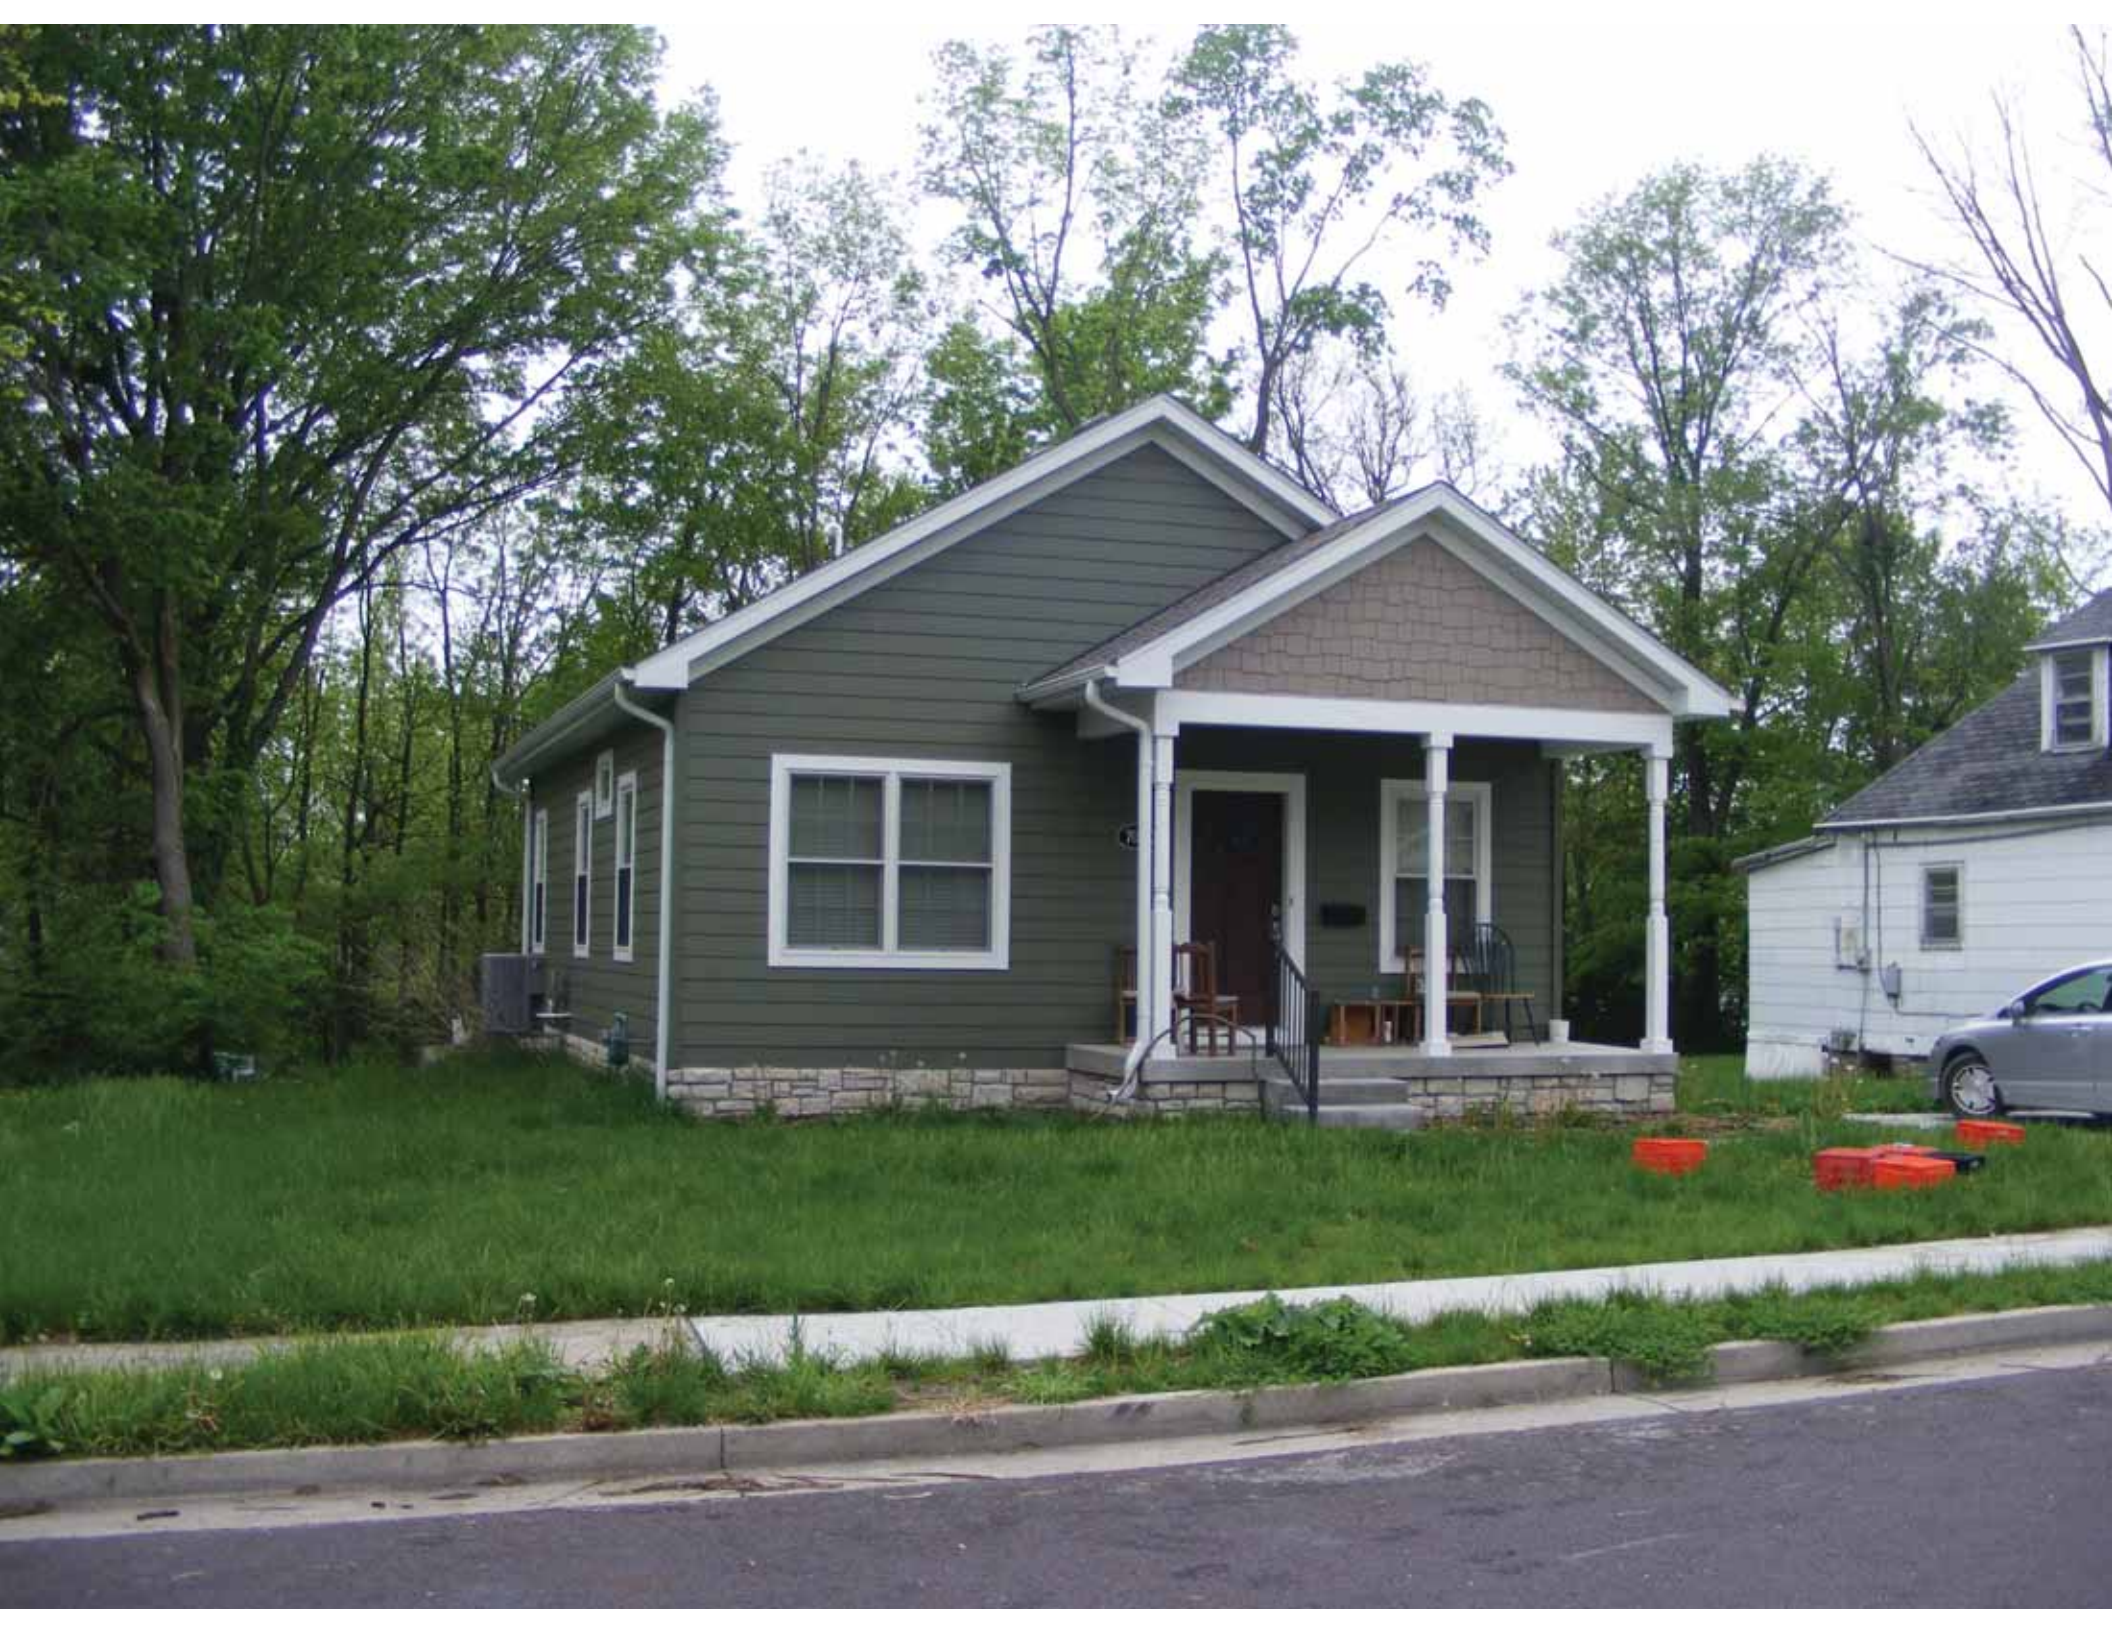
This 2019 dwelling mimics the neighborhood's Craftsman housing stock constructed in the 1920s. The dwelling has a front gable plan with an off-center porch supported by milled columns. The exterior is clad with wide boards – possibly pressed wood. The porch gable field is filled with faux wood shingle siding. The foundation is covered with limestone veneer. Within the porch bay is a solid paneled door. Windows are paired and single six-over-six design.

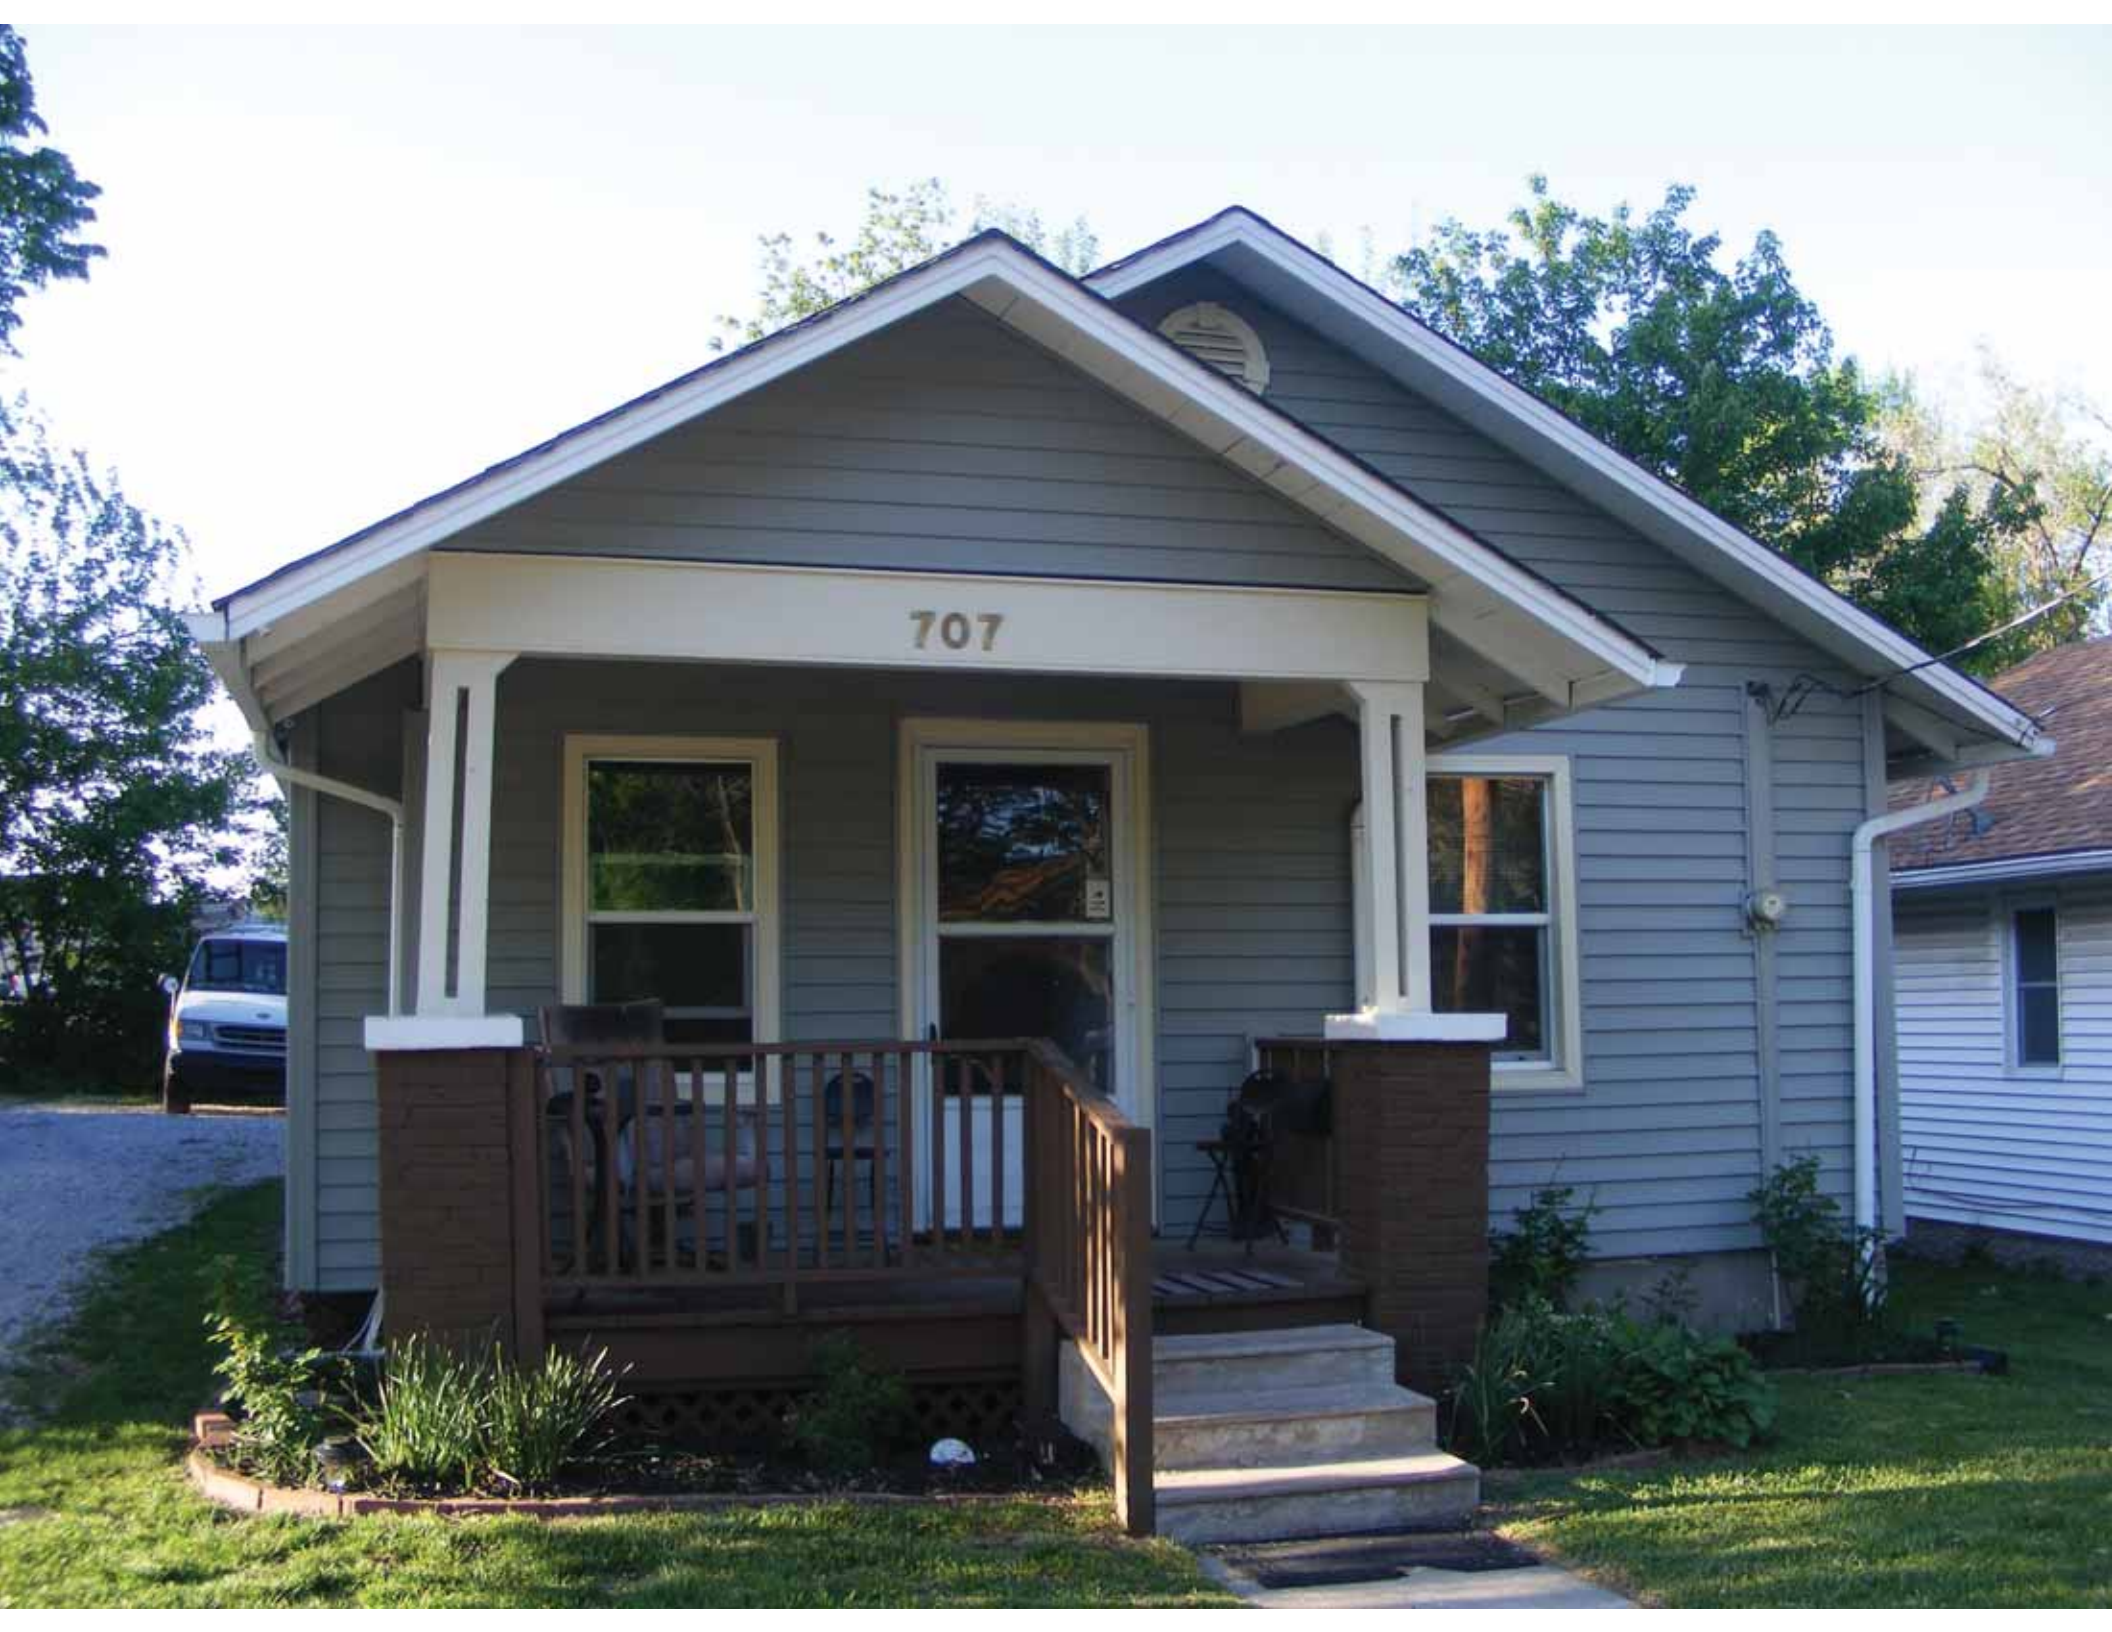
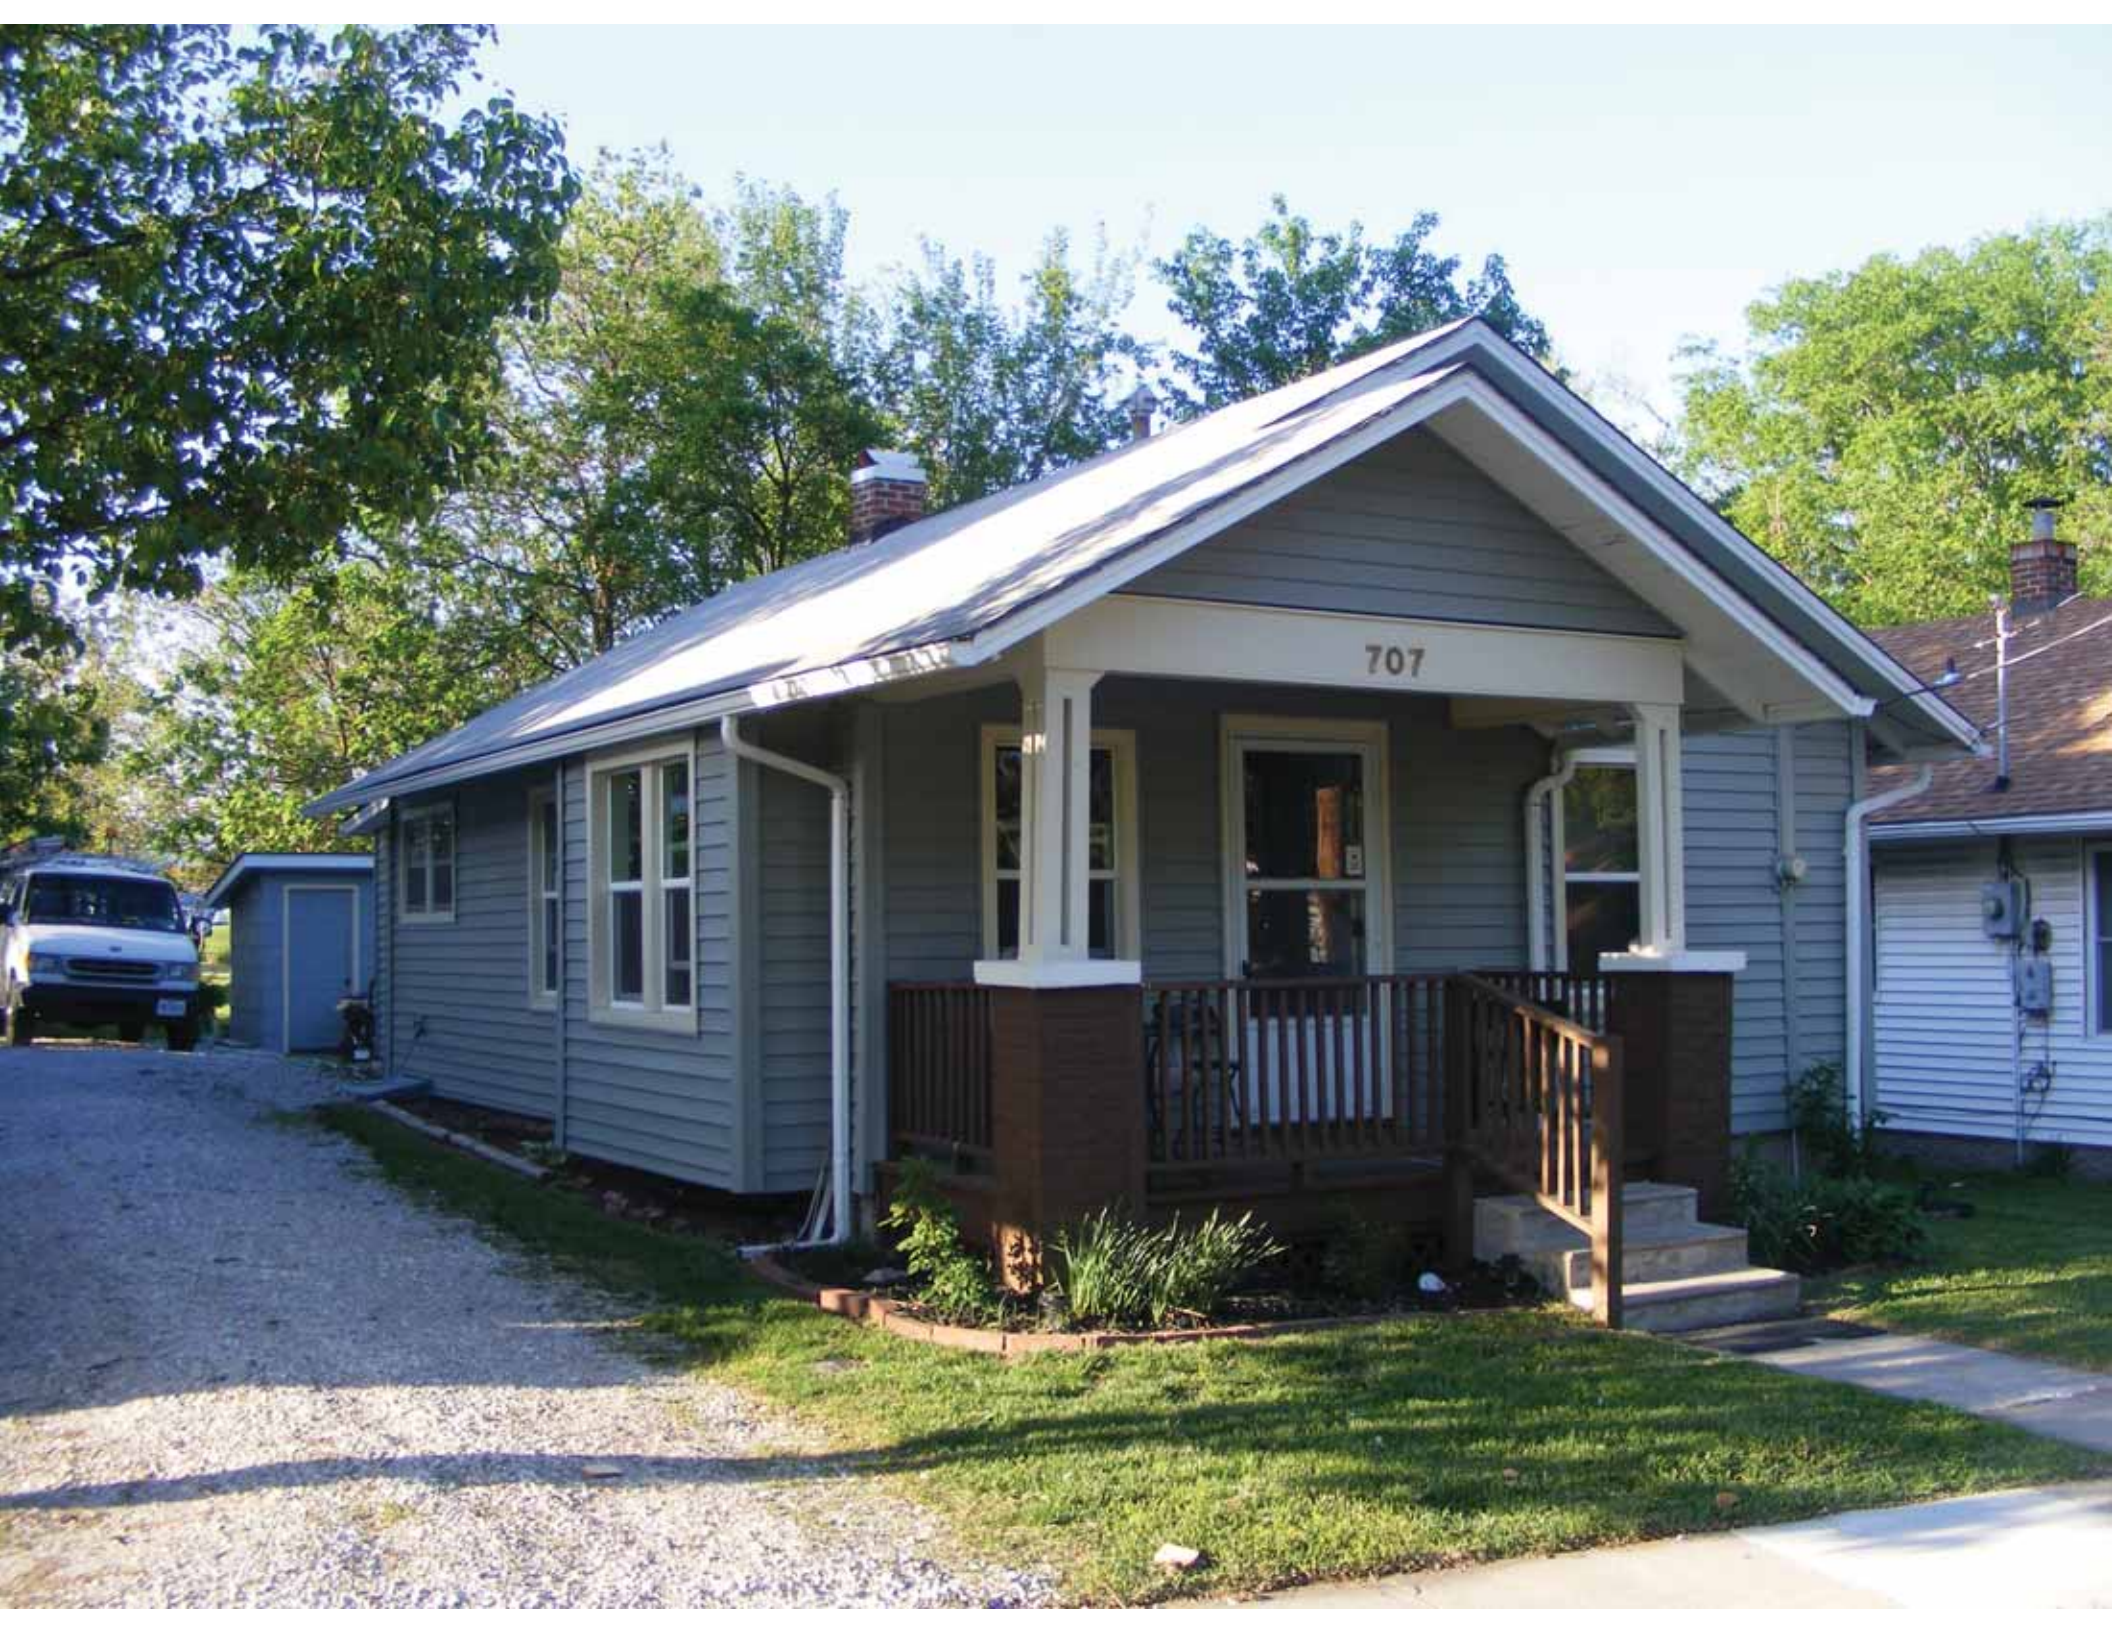
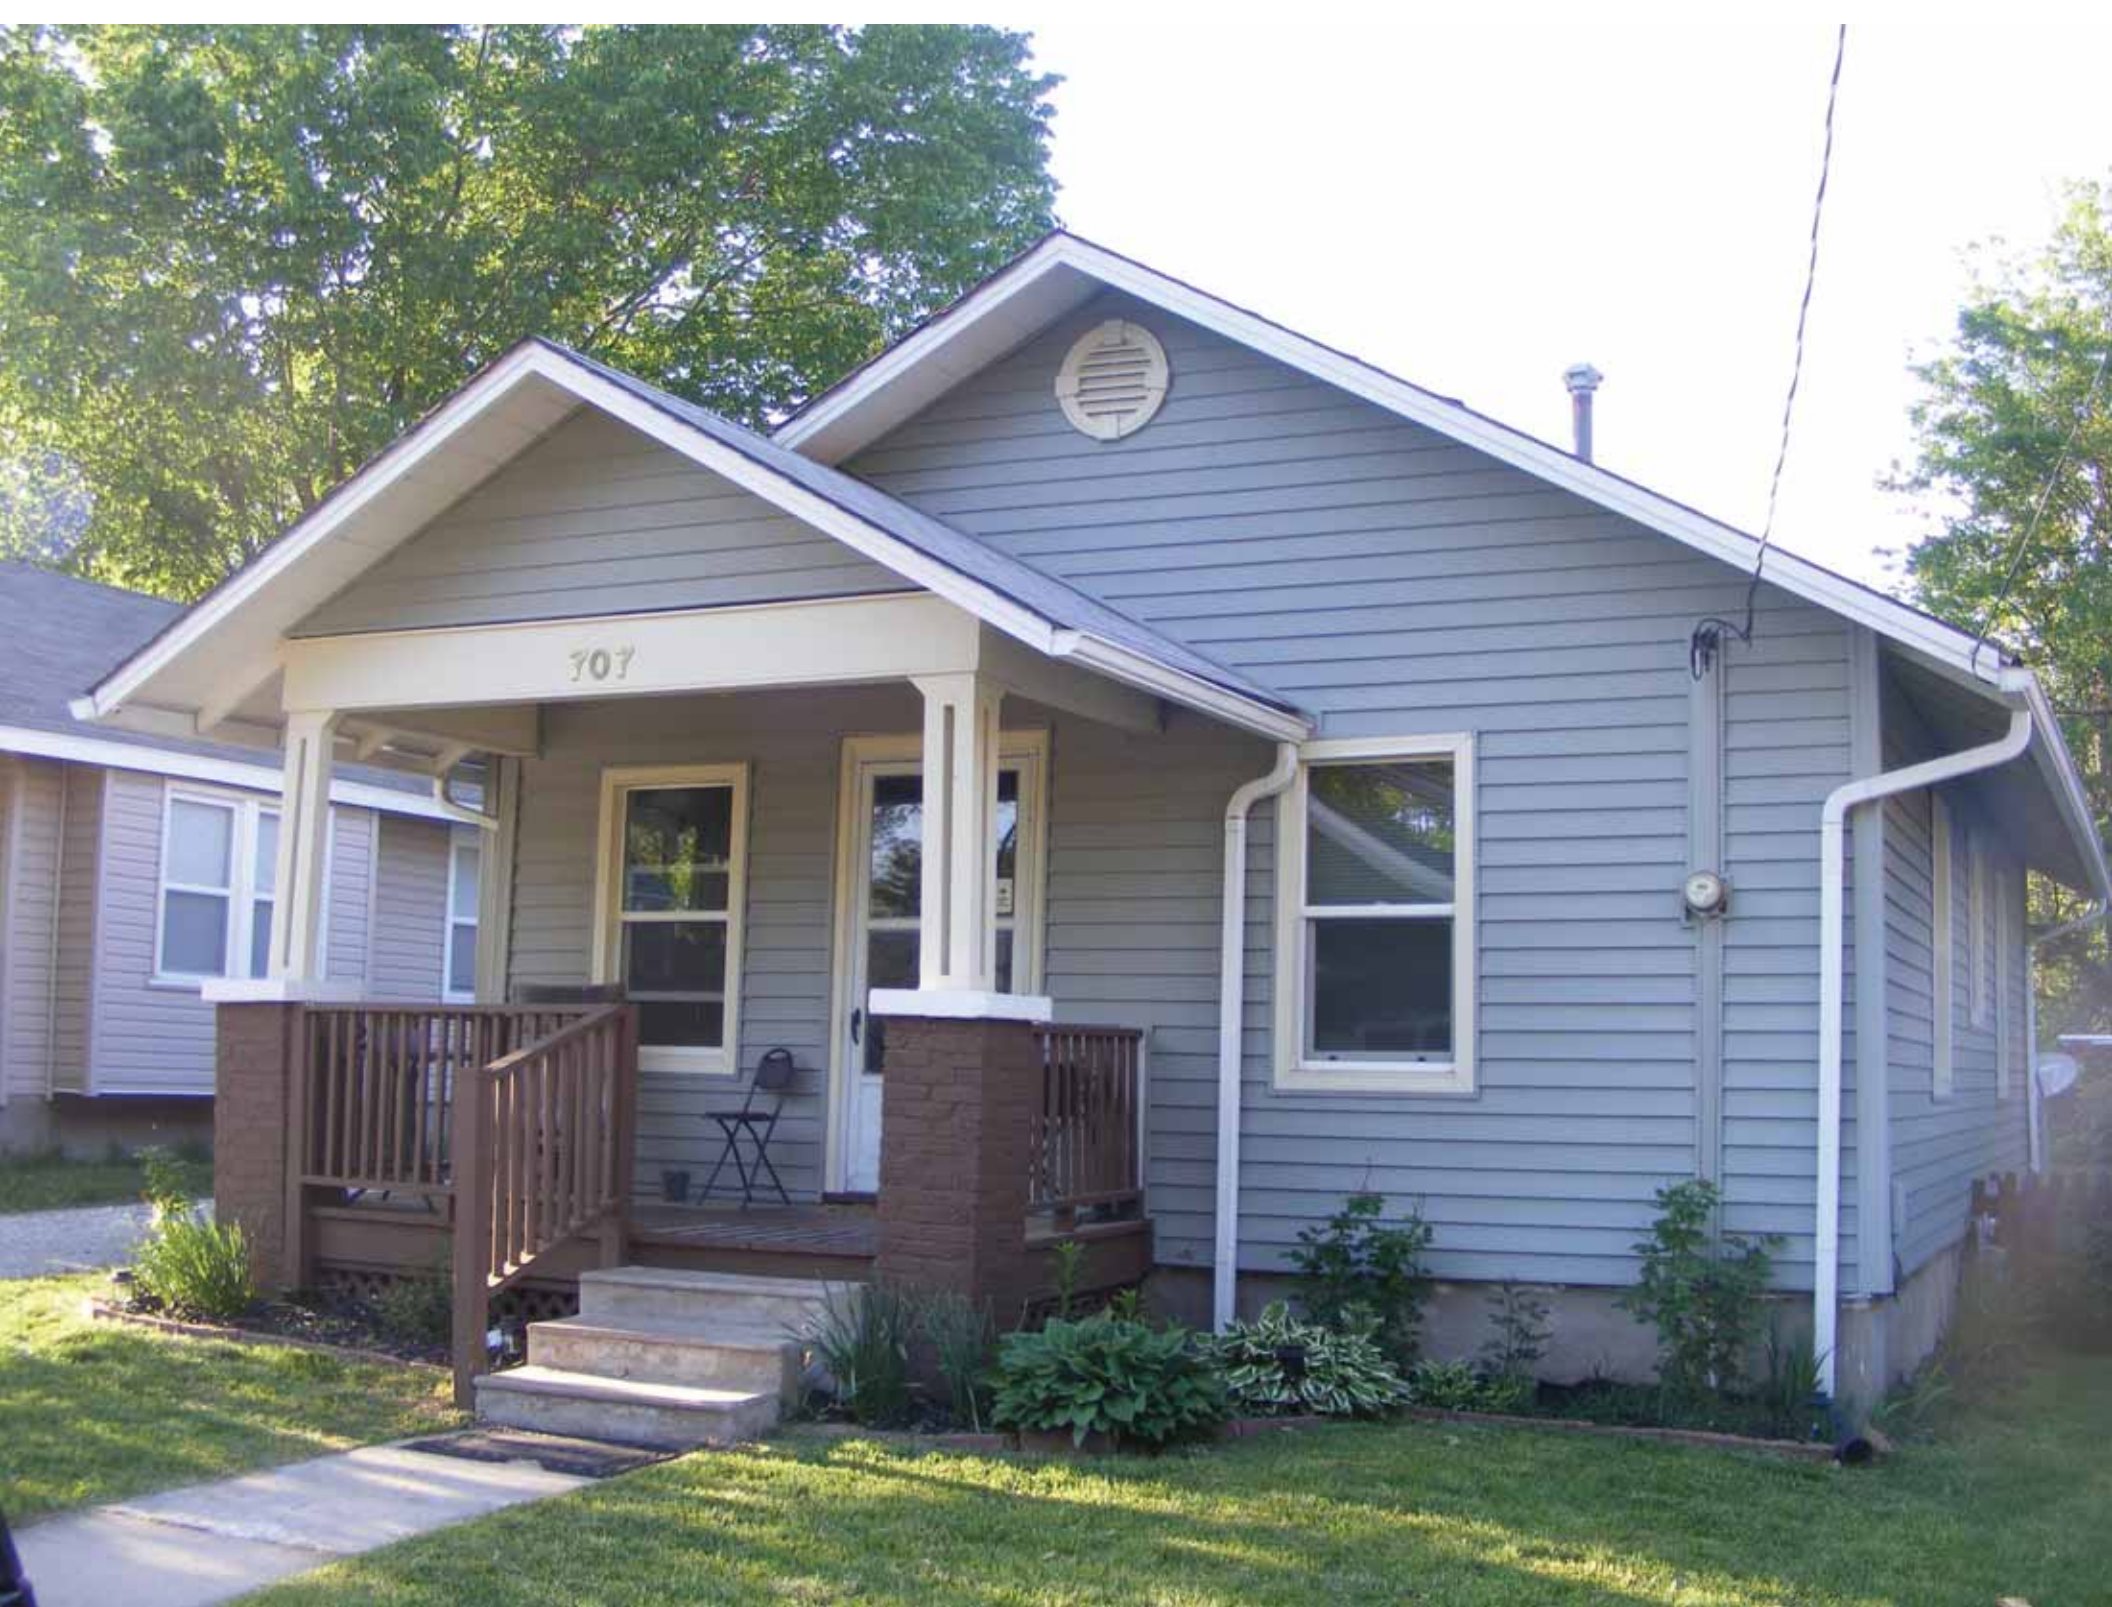
707

The dwelling has an asphalt shingled roof, exterior vinyl siding and a concrete foundation. Windows are replacement one-over-one. The primary (south) elevation supports an off-center gabled porch supported by triple slender columns on brick piers. A contemporary balustrade surrounds the porch. The façade door is centered and flanked by one-over-one windows.
