MISSOURI DEPARTMENT OF NATURAL RESOURCES
STATE HISTORIC PRESERVATION OFFICE, P.O. Box 176, Jefferson City, MO 65102
ARCHITECTURAL/HISTORIC INVENTORY FORM

1. Survey No. BO-AS-011-0087		2. Survey name: North Central Columbia Survey Phase II	
3. County: Boone		4. Address (Street No.) 902	Street (name) N. Seventh Street
5. City: Columbia	Vicinity: <input type="checkbox"/>	6. Geographical Reference:	7. Township/Range/Section: T: R: S:
8. Historic name (if known):		9. Present/other name (if known):	
10. Ownership: <input checked="" type="checkbox"/> Private <input type="checkbox"/> Public		11a. Historic use (if known): Domestic/single dwelling	11b. Current use: Domestic/single dwelling

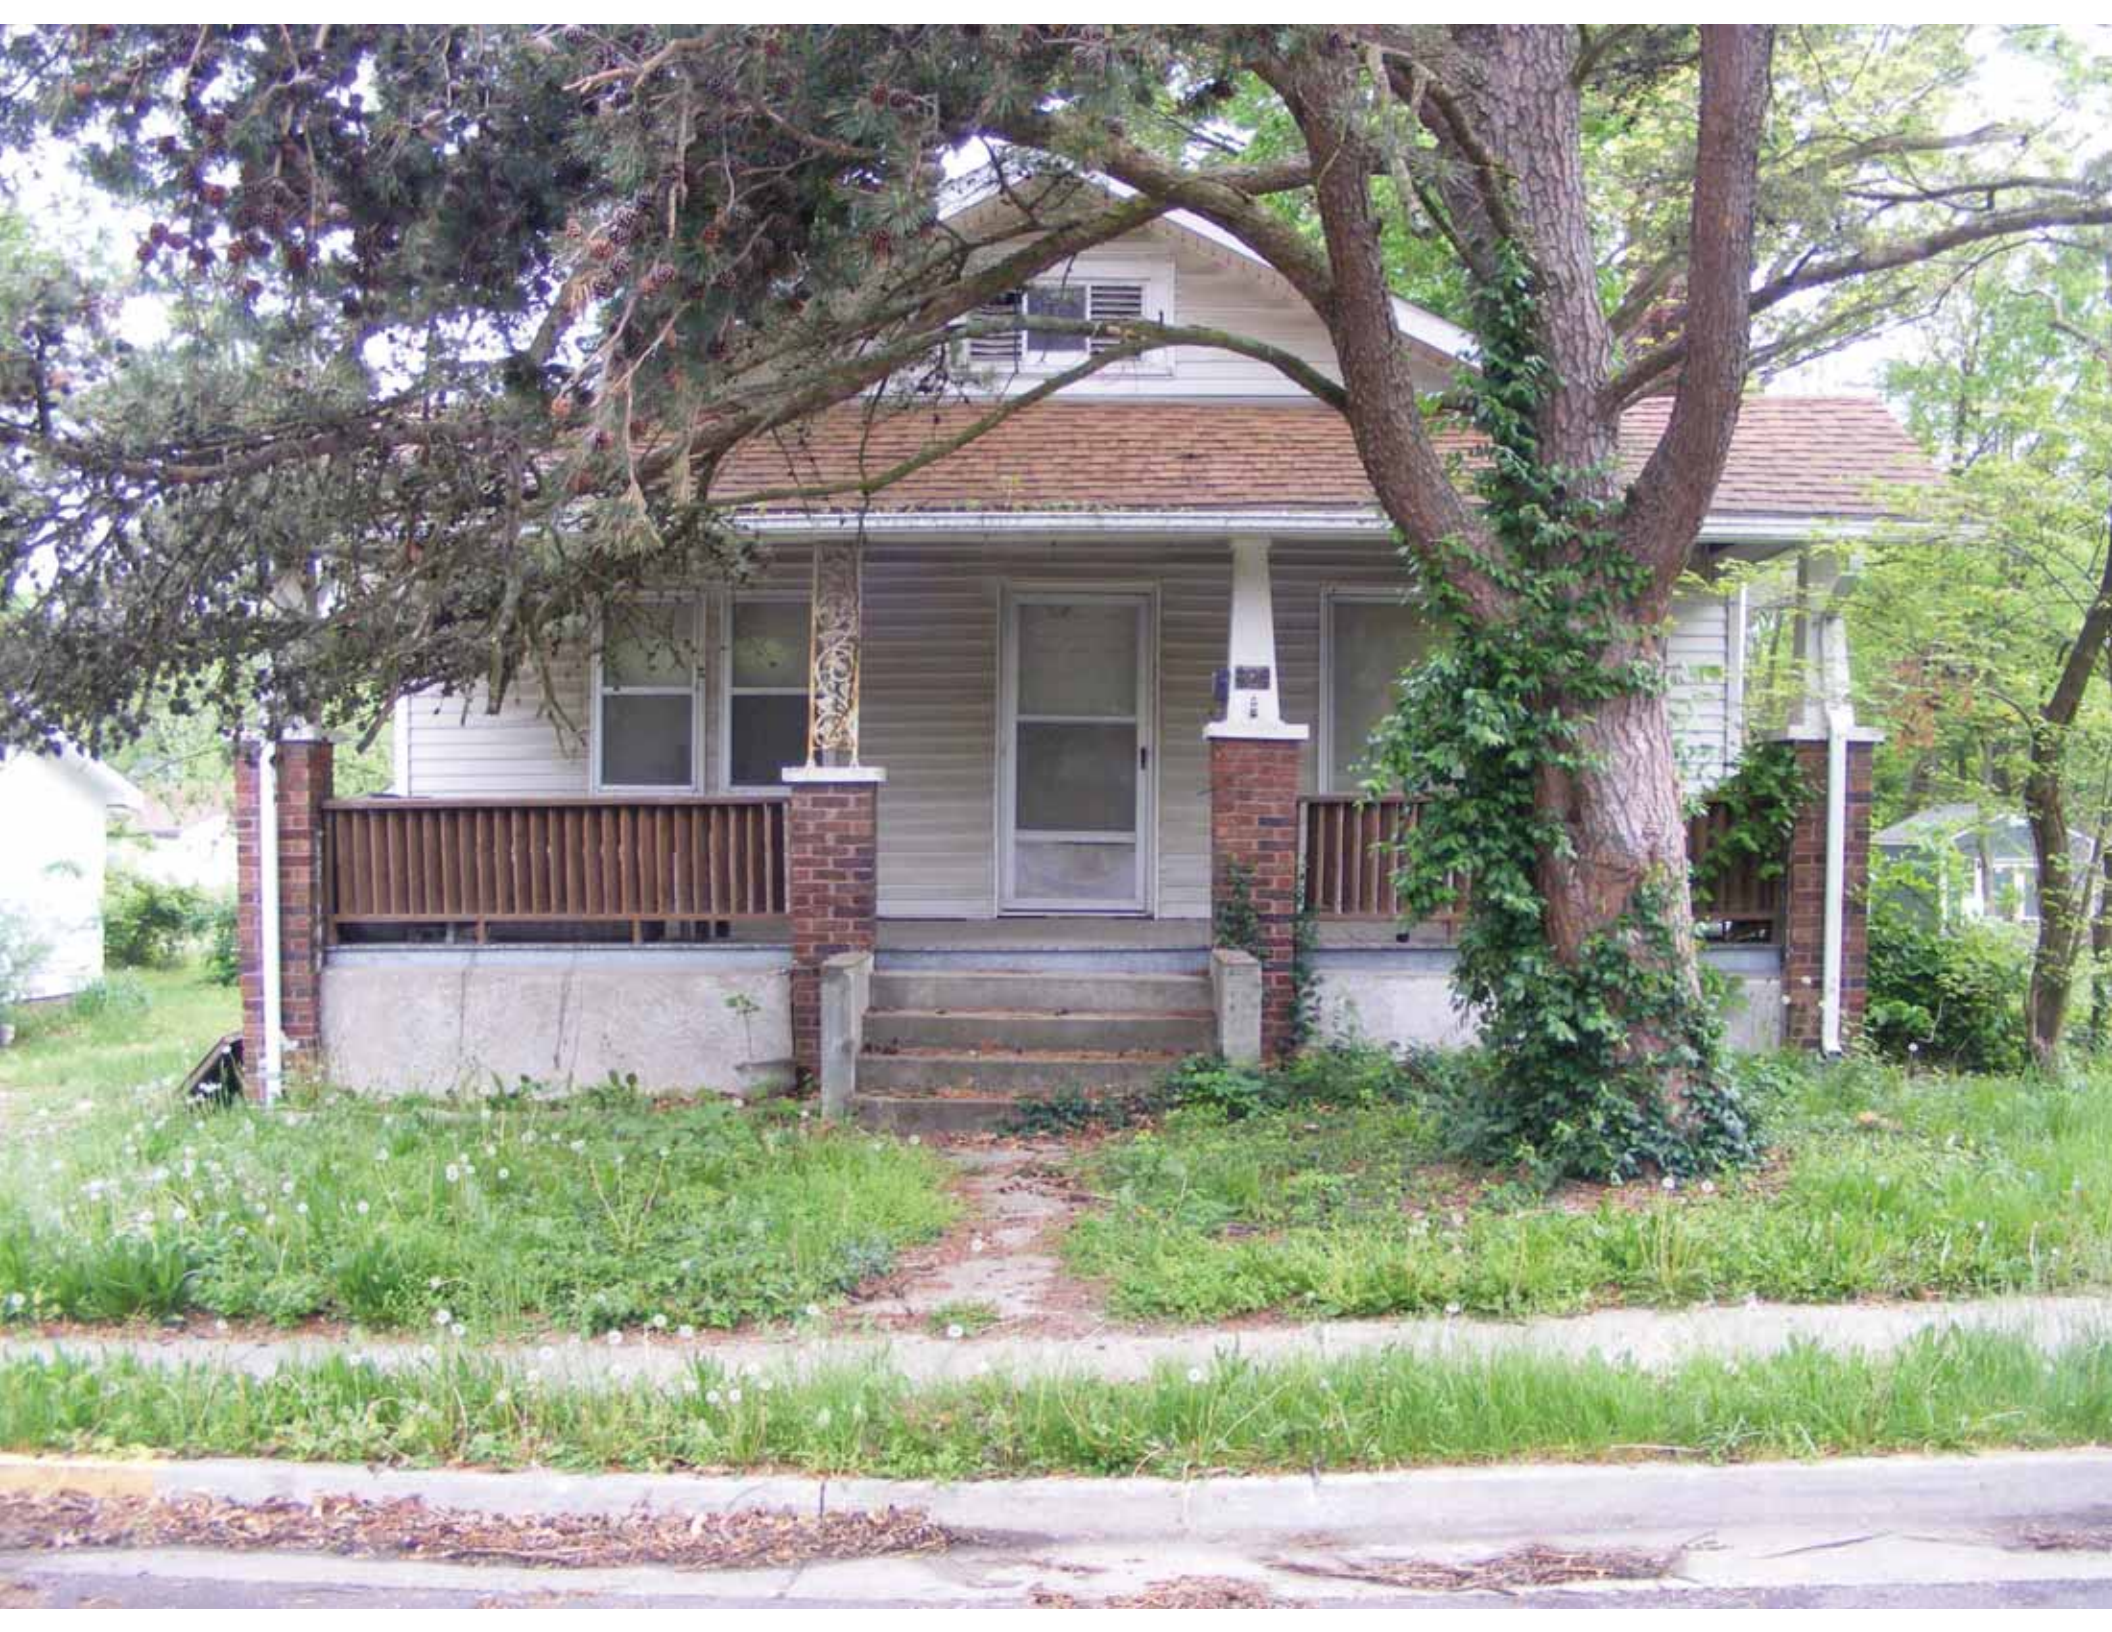
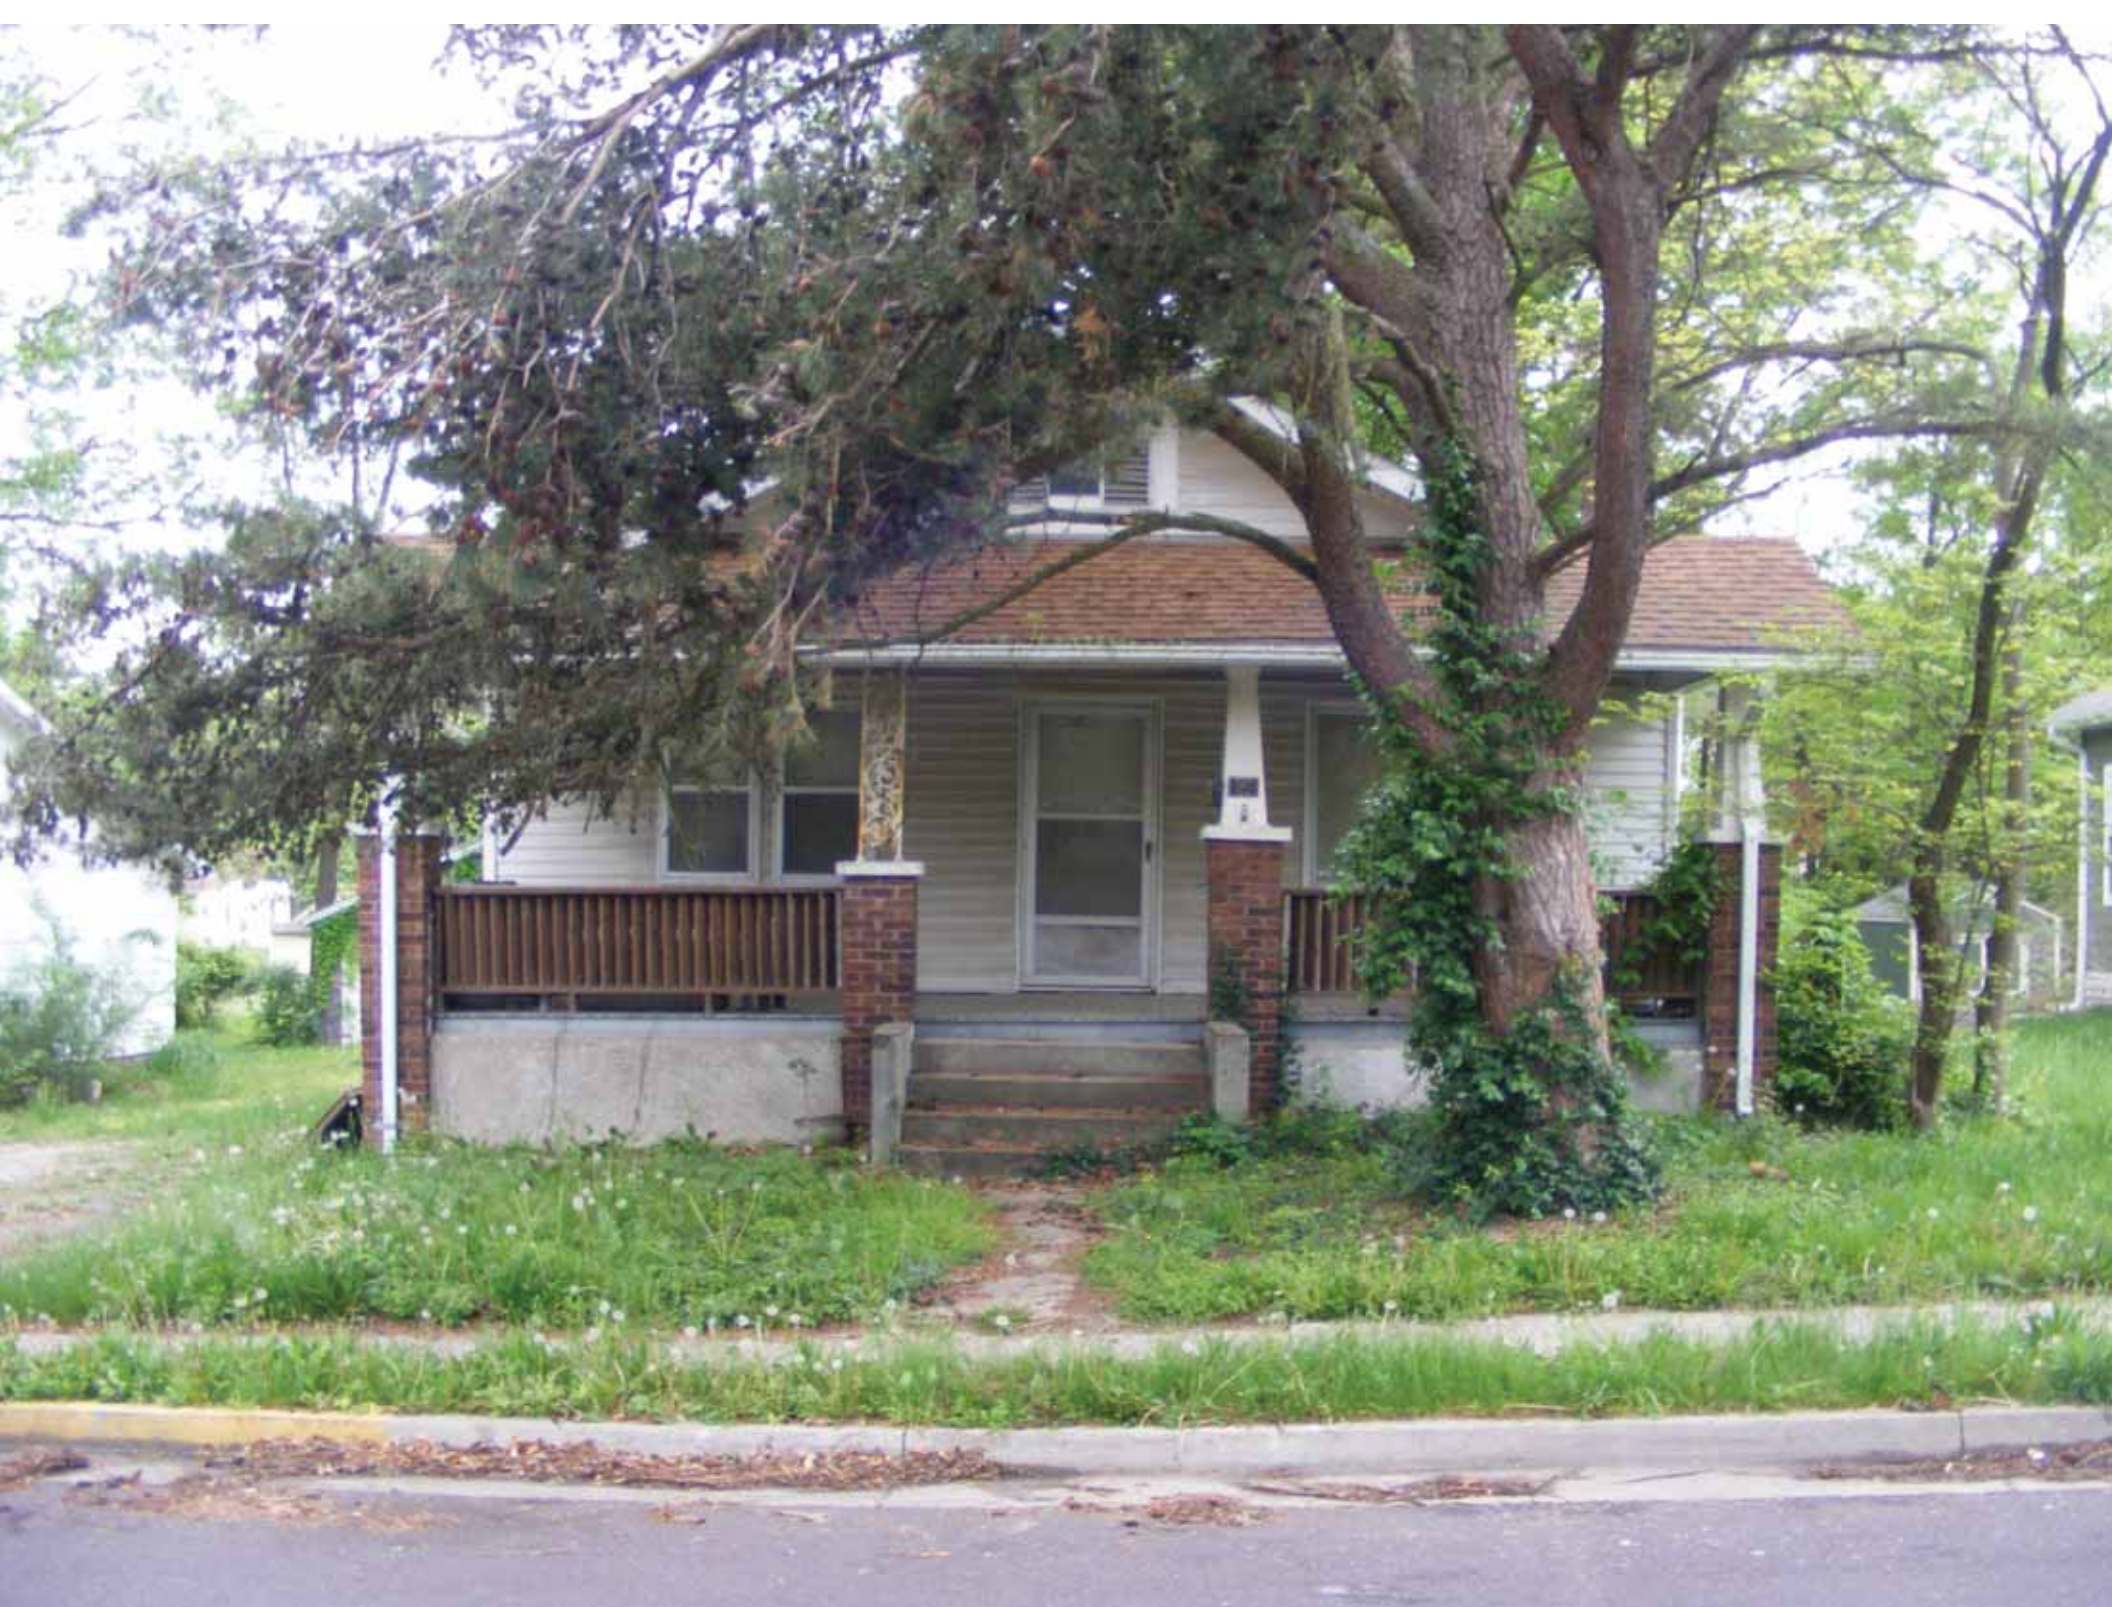
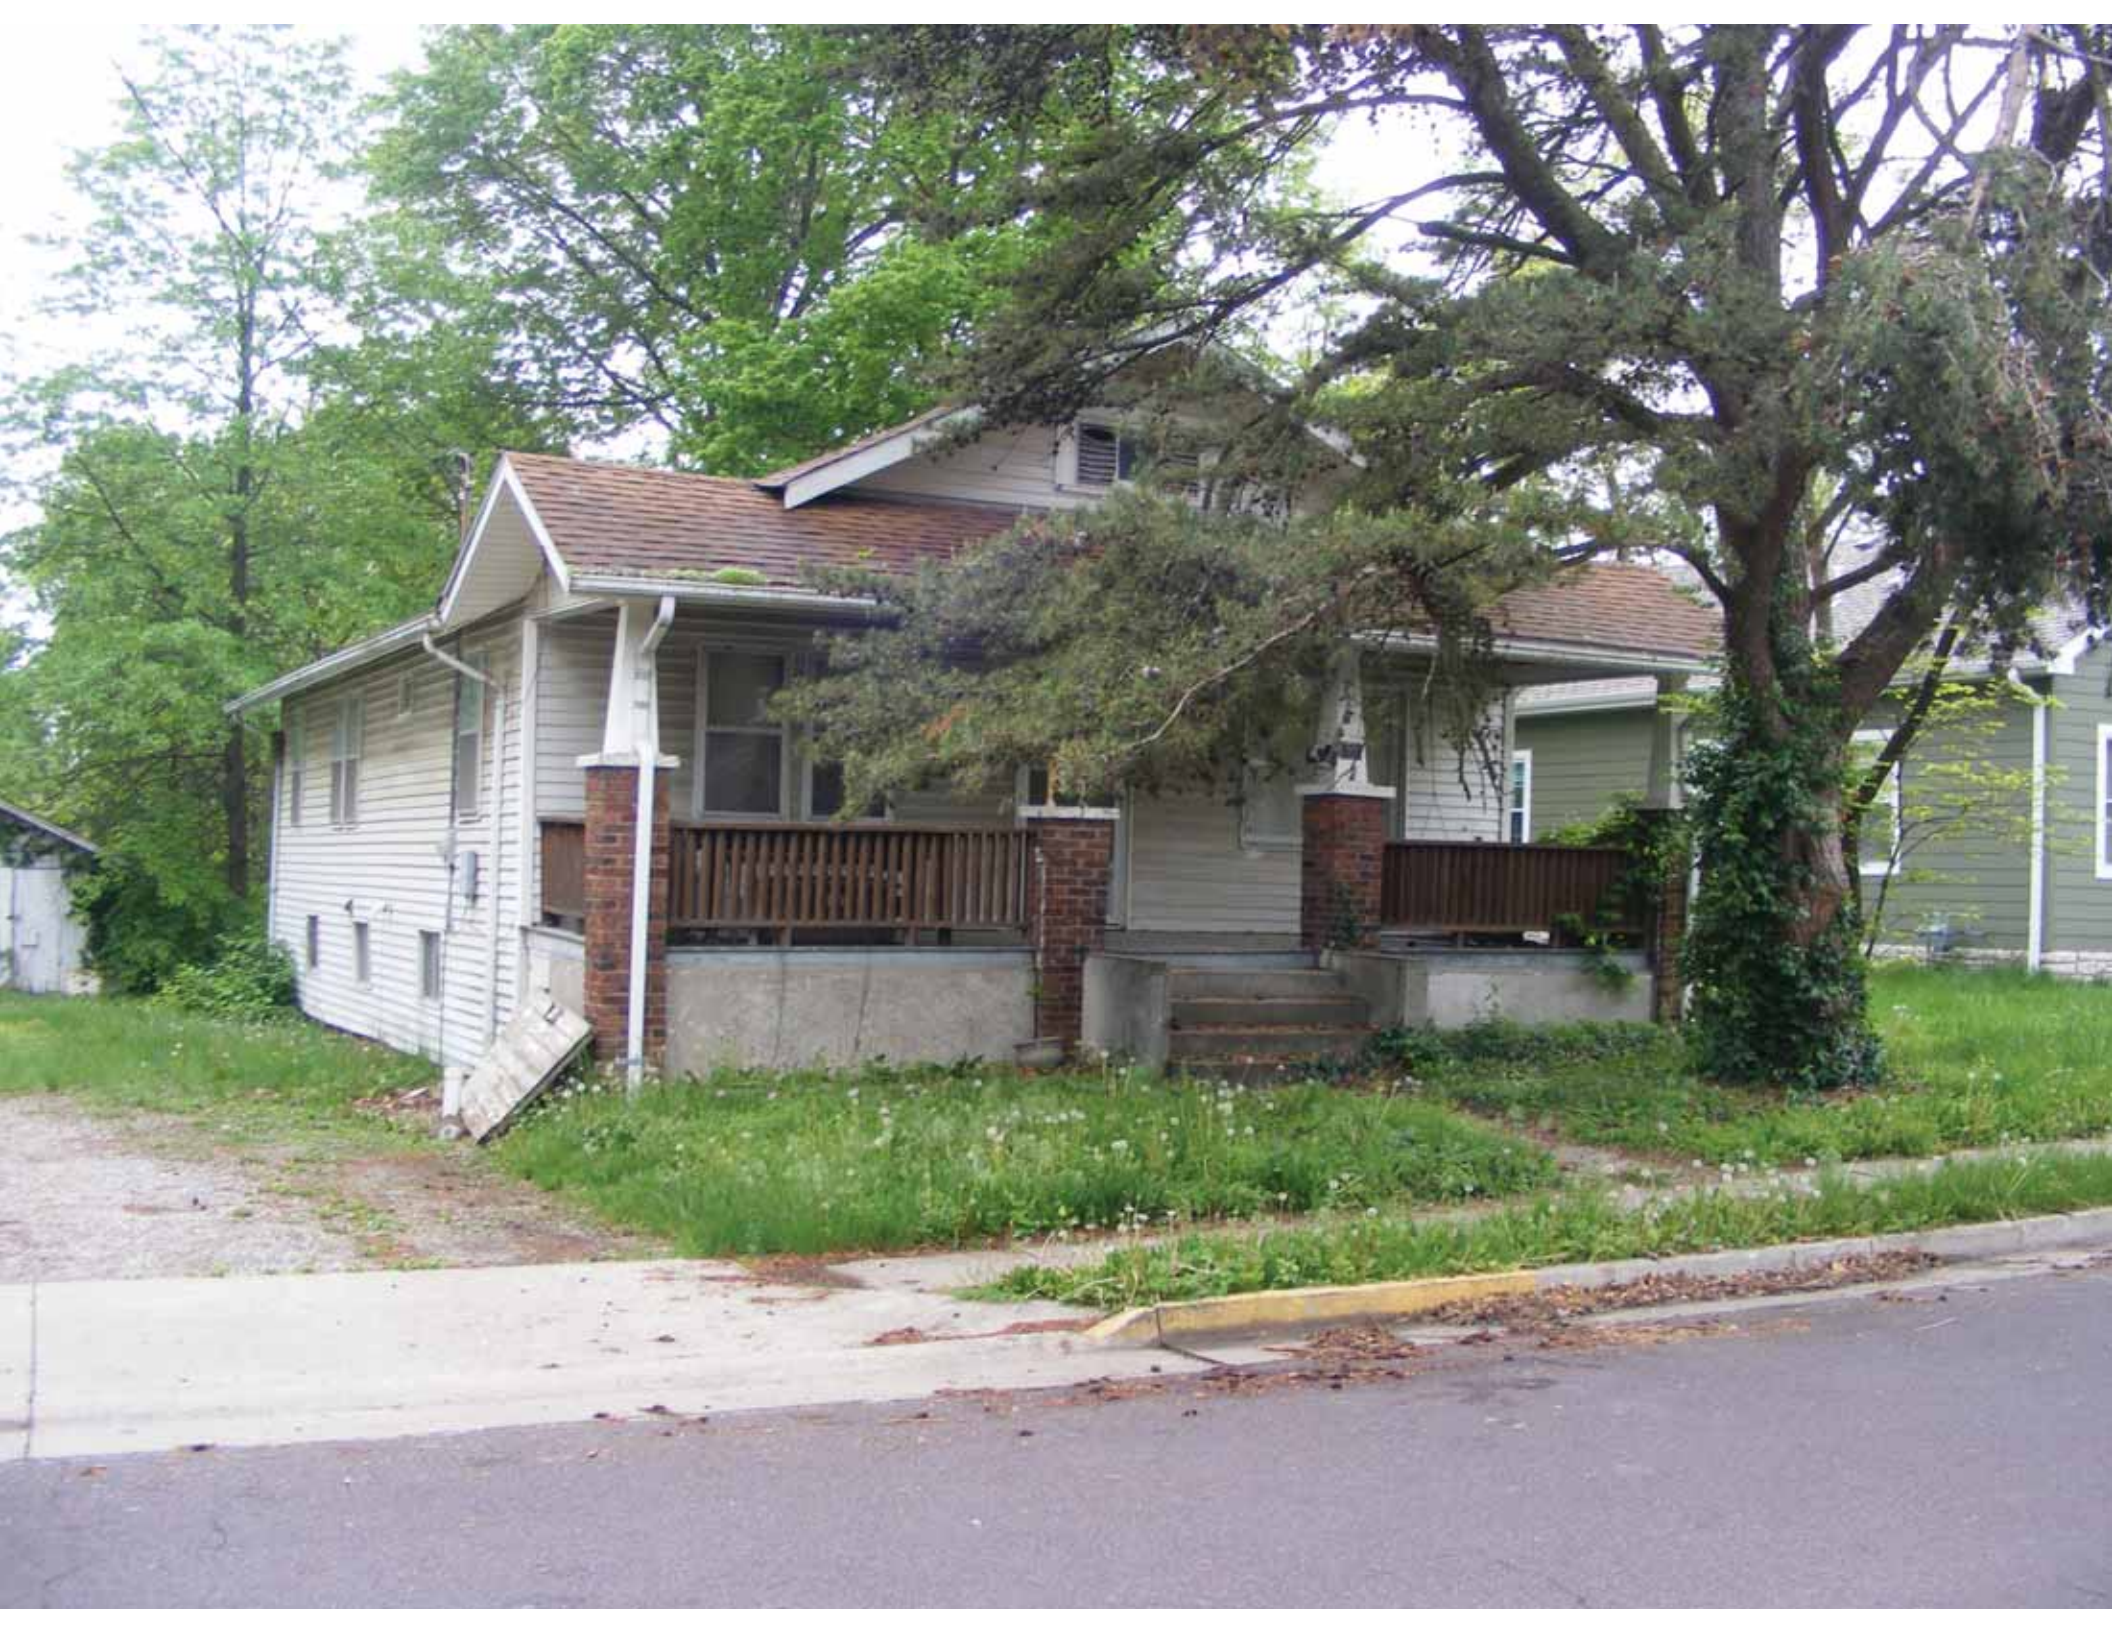
The dwelling has an asphalt-shingled gable-front roof, exterior synthetic siding and a concrete foundation. The primary (north) elevation has a cross-gabled front porch supported by tapered piers on brick columns. One column is replacement wrought iron on a brick pier. A contemporary balustrade spans the porch. Within the porch bay is a central entry bay flanked by paired one-over-one replacement windows. The entry bay is filled with a c. 2000 paneled door. The front gable field retains a louvered vent. The west elevation supports an exterior end brick chimney.

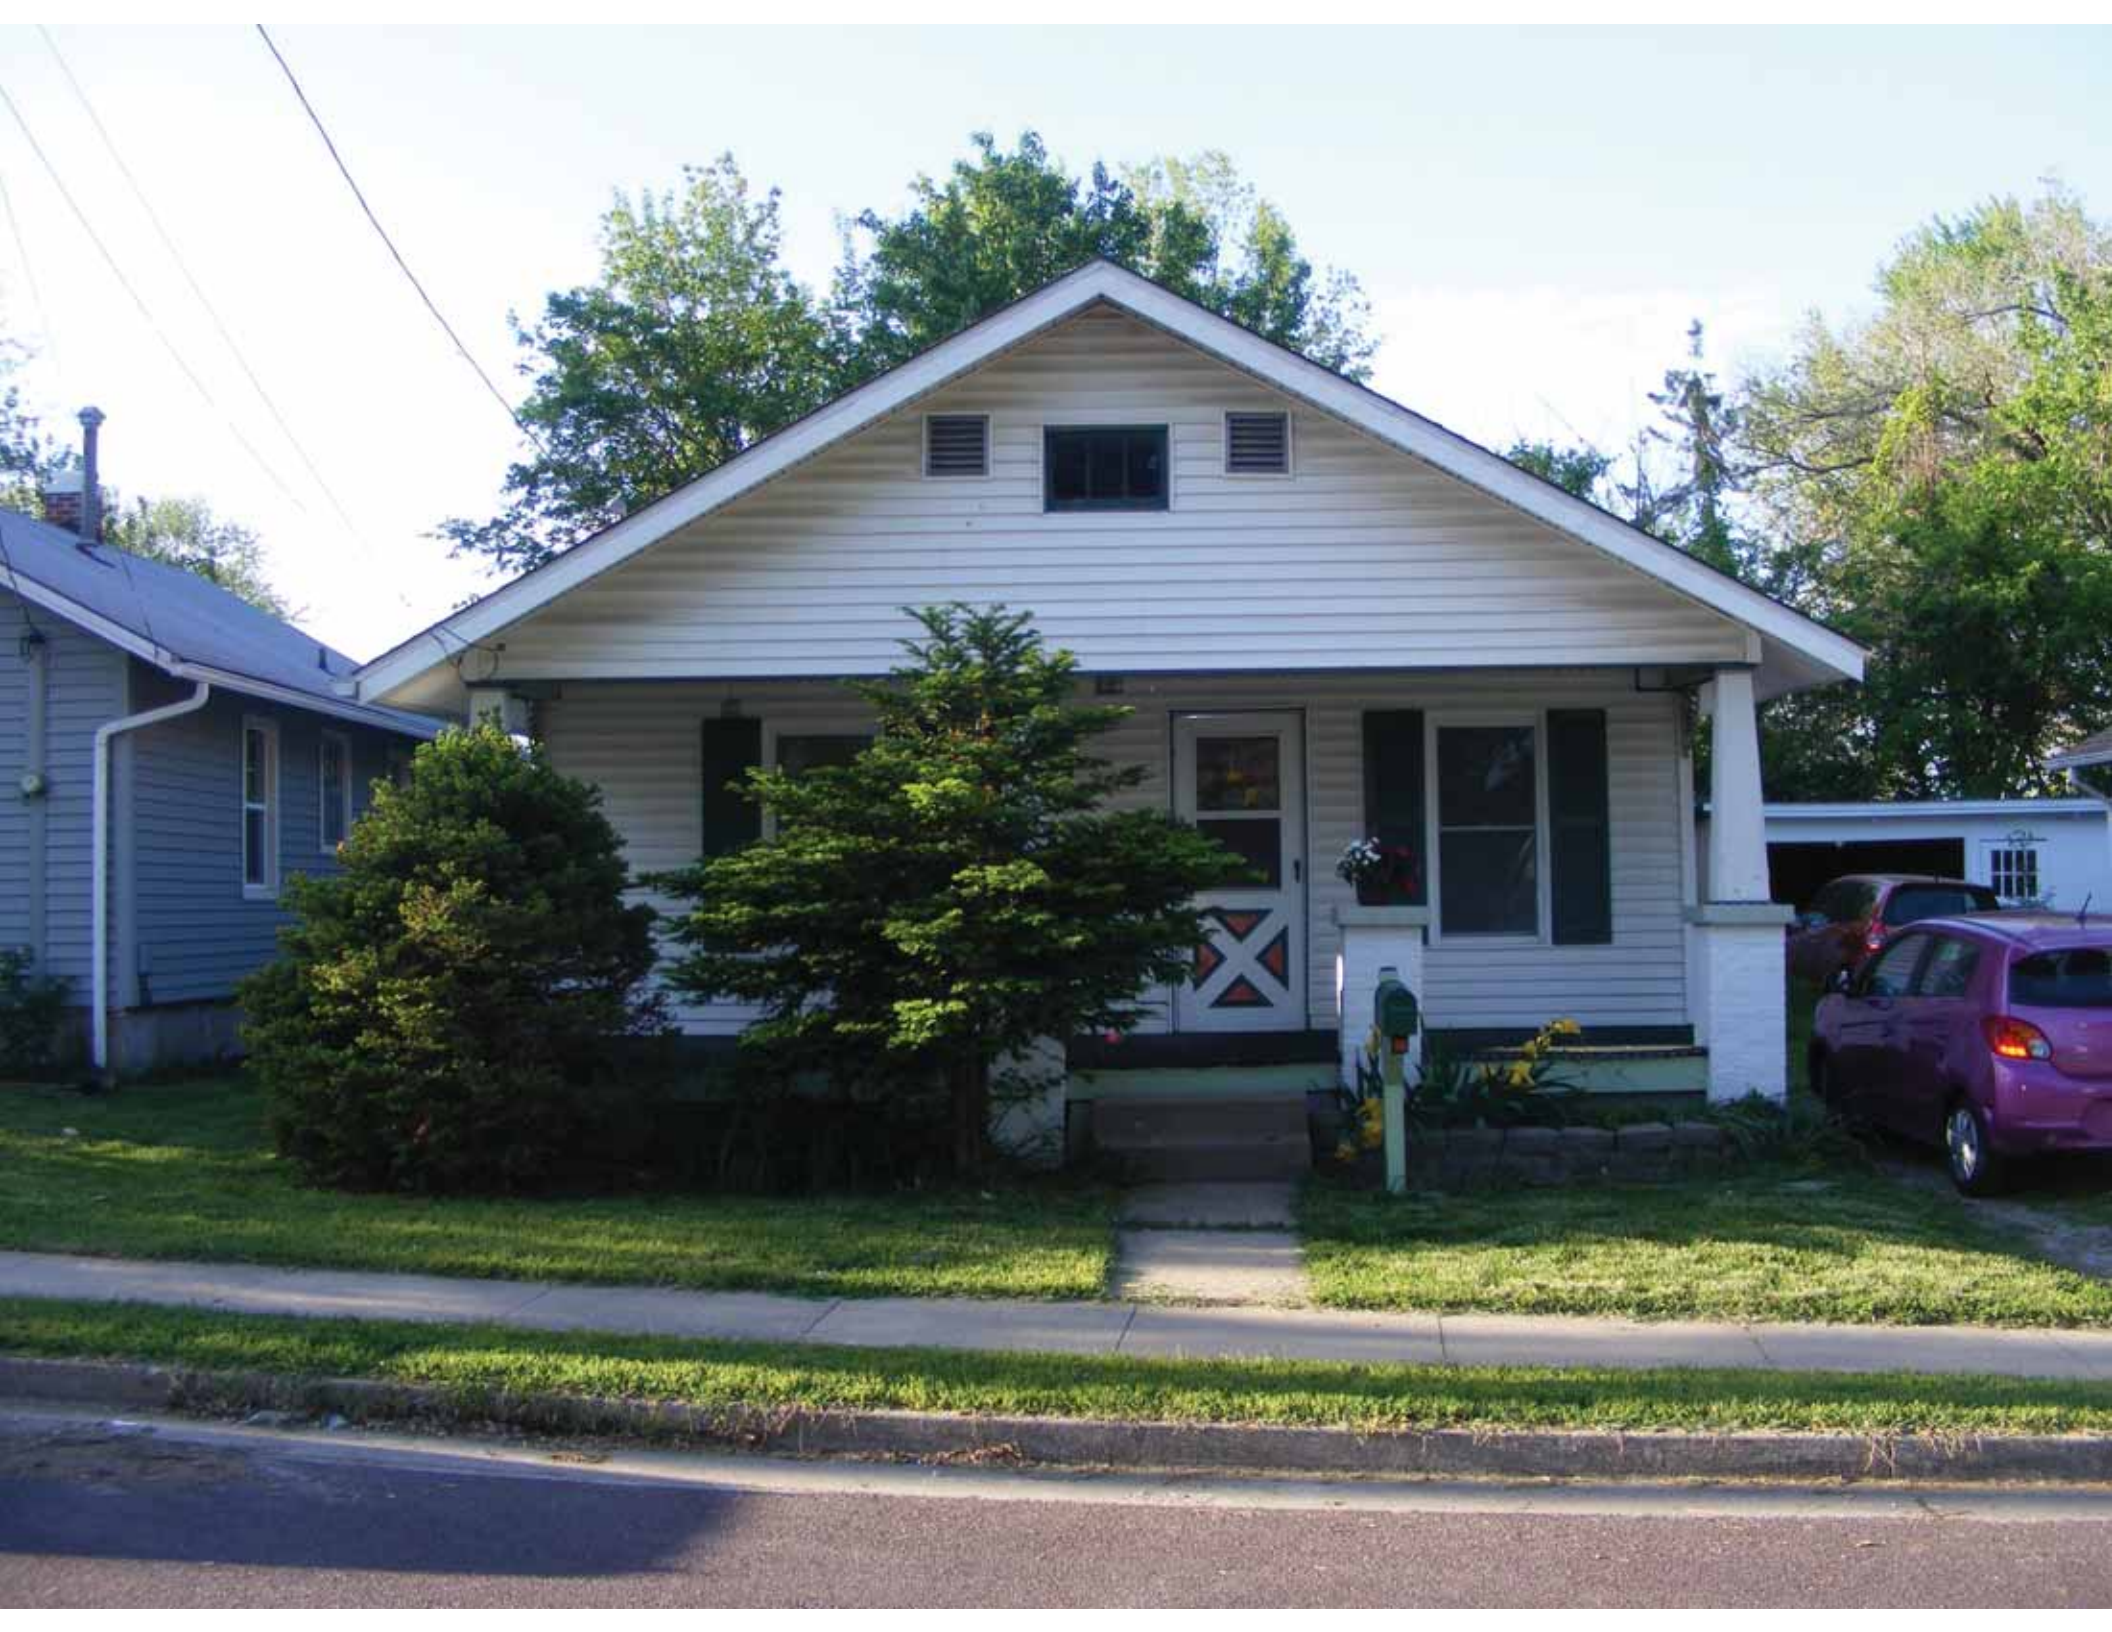
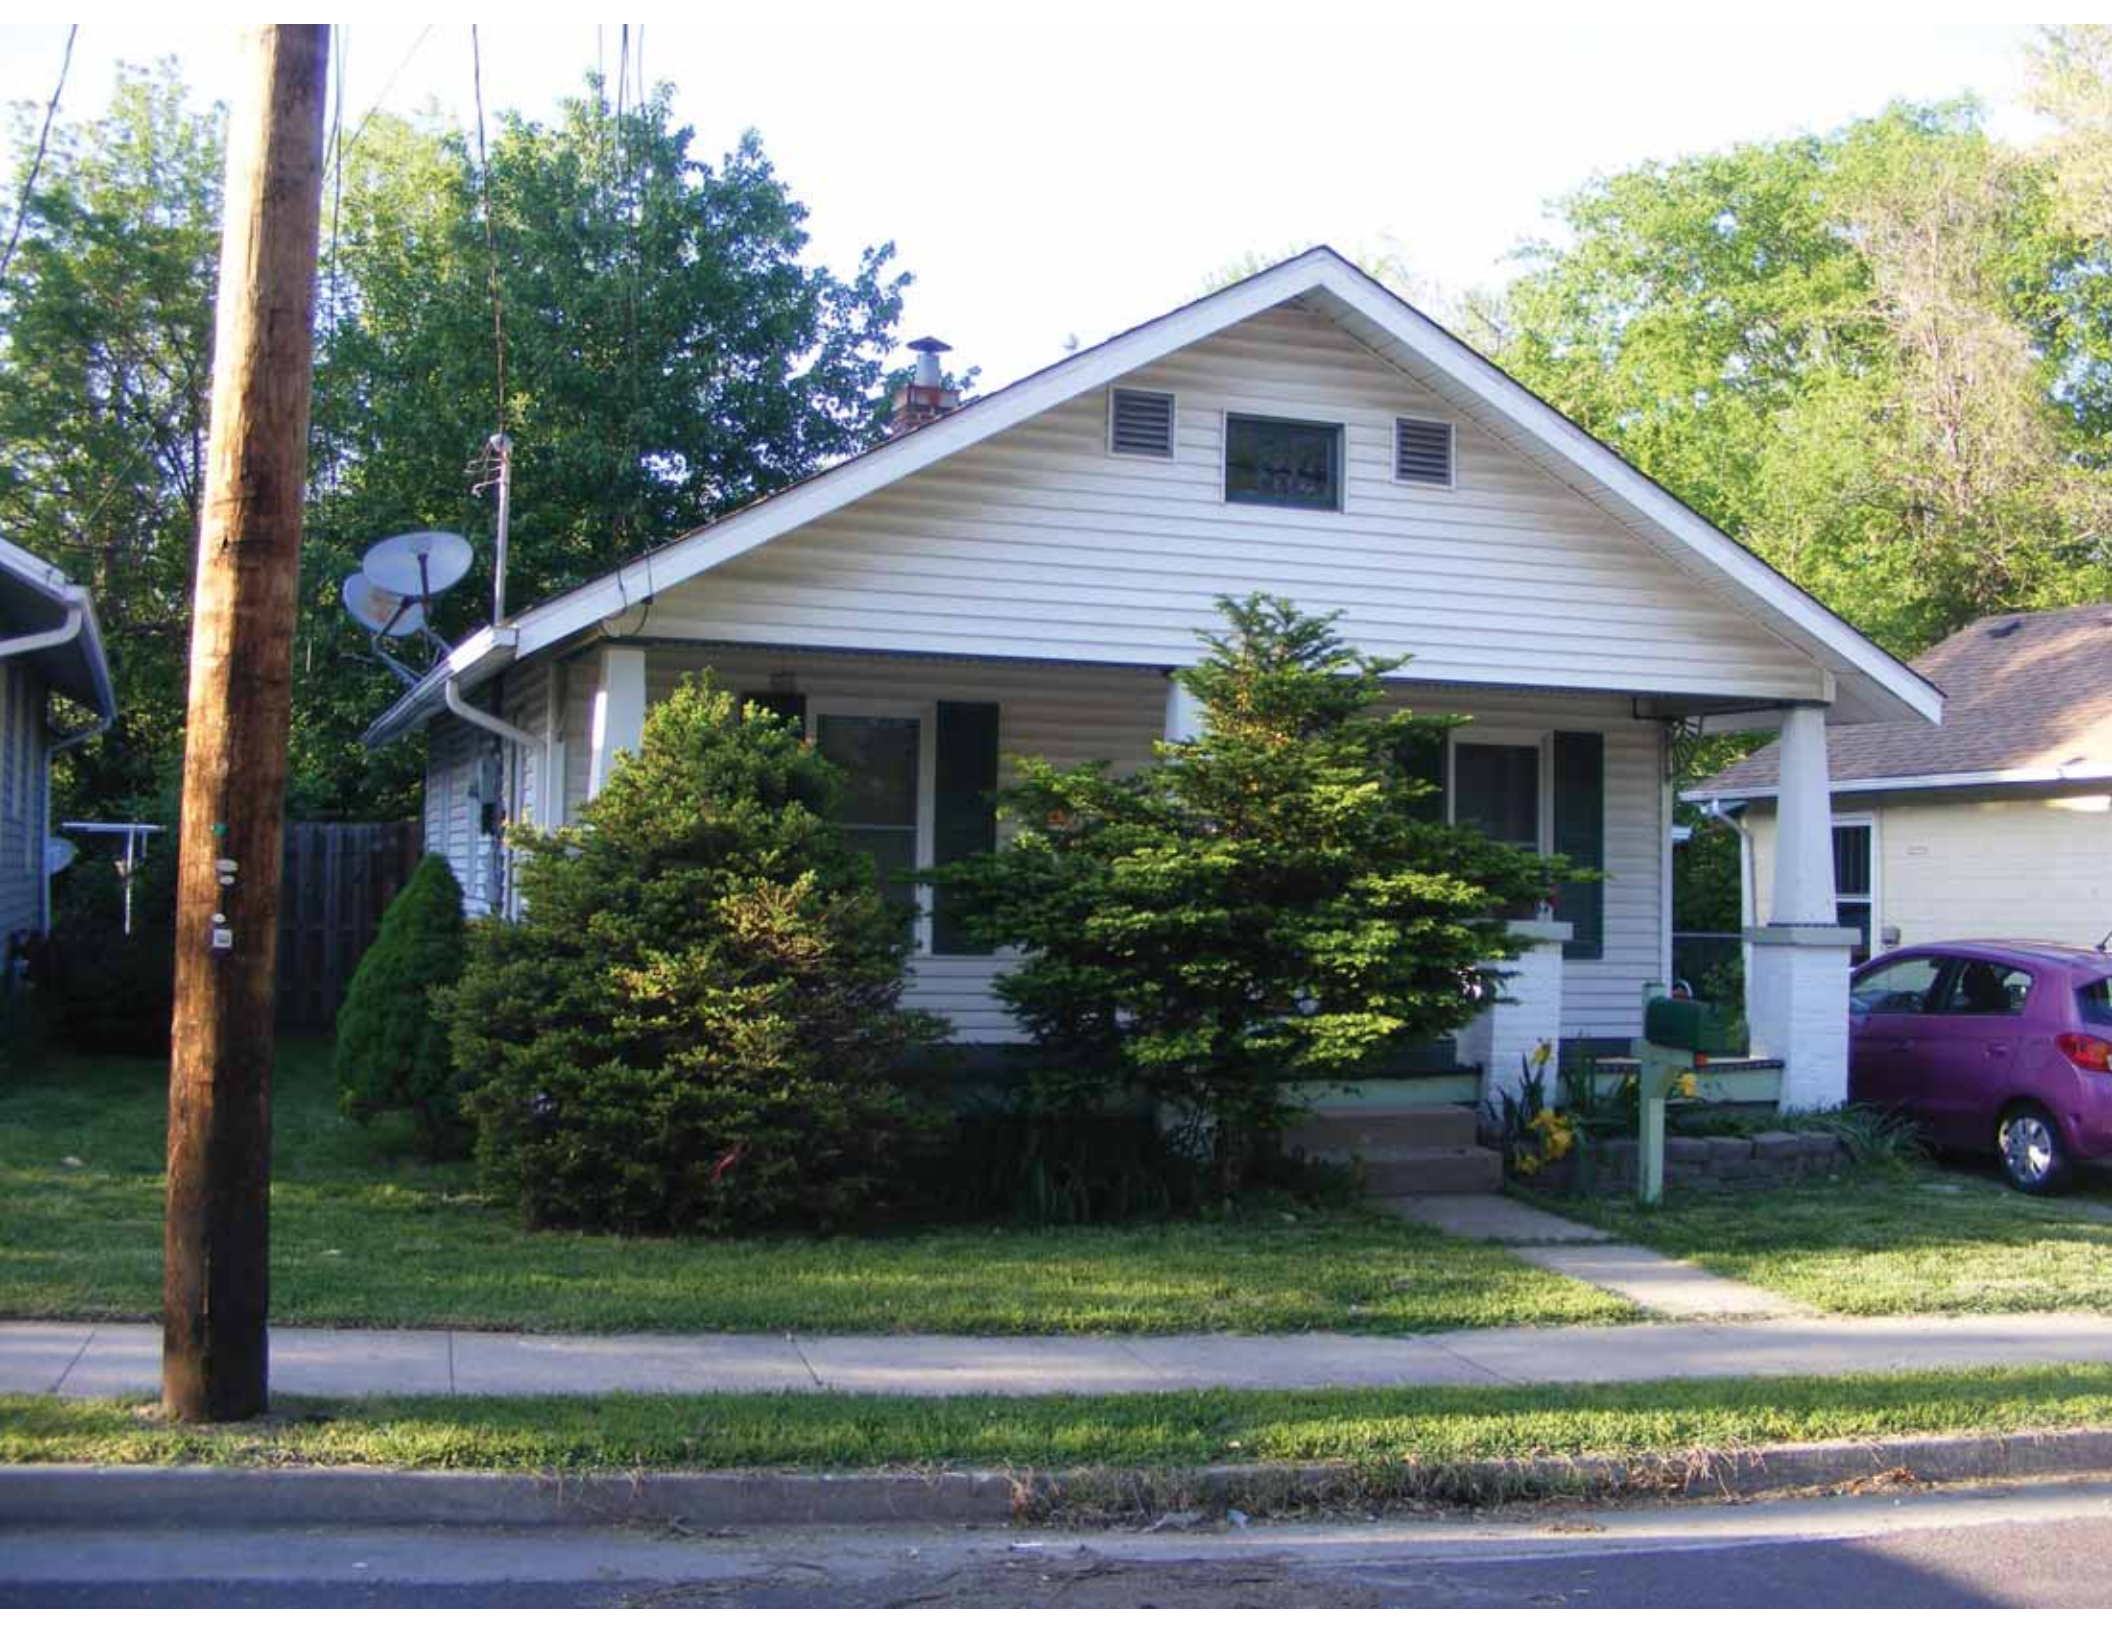
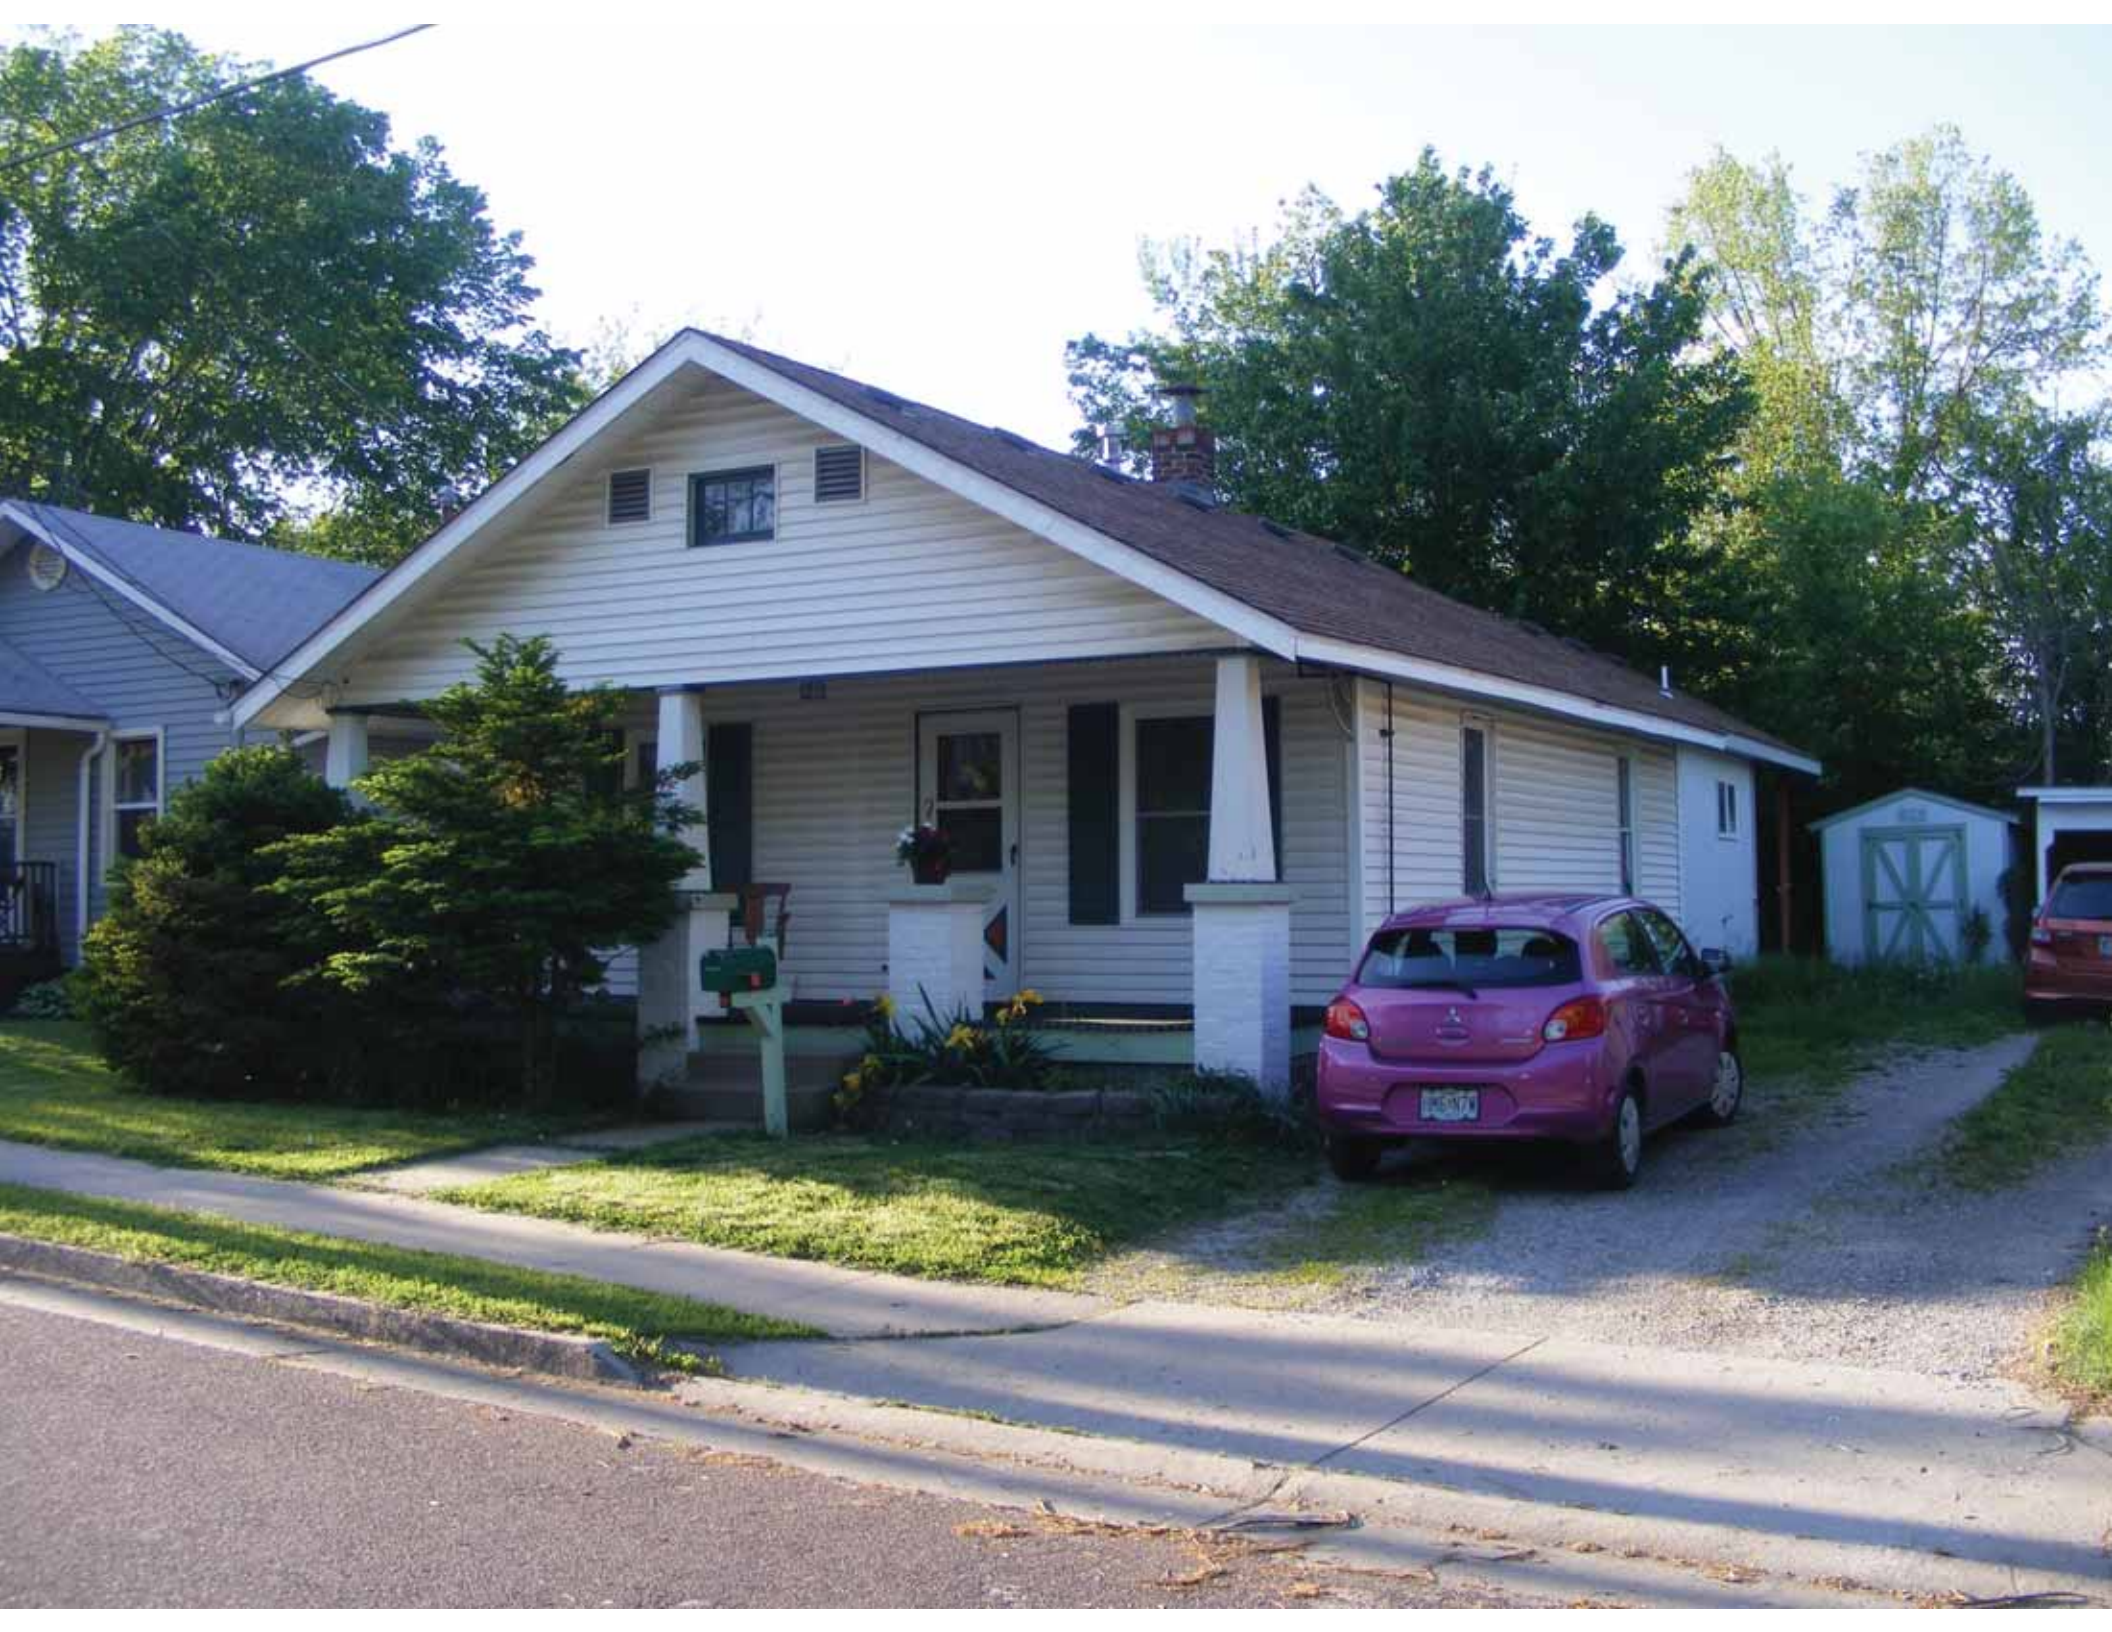
The gable-front plan dwelling has an asphalt-shingled roof, exterior synthetic siding and a concrete foundation. The façade (south elevation) has a full-width integral porch supported by tapered columns on brick piers. Above the porch, the gable field holds an original six-light window flanked by louvered vents. Within the porch bay is a three-light Craftsman style door with contemporary storm door. The entry bay is flanked by one-over-one replacement windows with faux shutters. A rear wing is clad with vertical boards and supports a sliding two-light window on the east elevation. At the roofline ridge is a central brick chimney.
