MISSOURI DEPARTMENT OF NATURAL RESOURCES
STATE HISTORIC PRESERVATION OFFICE, P.O. Box 176, Jefferson City, MO 65102
ARCHITECTURAL/HISTORIC INVENTORY FORM

1. Survey No. BO-AS-011-0087		2. Survey name: North Central Columbia Survey Phase II	
3. County: Boone		4. Address (Street No.) 902	Street (name) N. Seventh Street
5. City: Columbia	Vicinity: <input type="checkbox"/>	6. Geographical Reference:	7. Township/Range/Section: T: R: S:
8. Historic name (if known):		9. Present/other name (if known):	
10. Ownership: <input checked="" type="checkbox"/> Private <input type="checkbox"/> Public		11a. Historic use (if known): Domestic/single dwelling	11b. Current use: Domestic/single dwelling

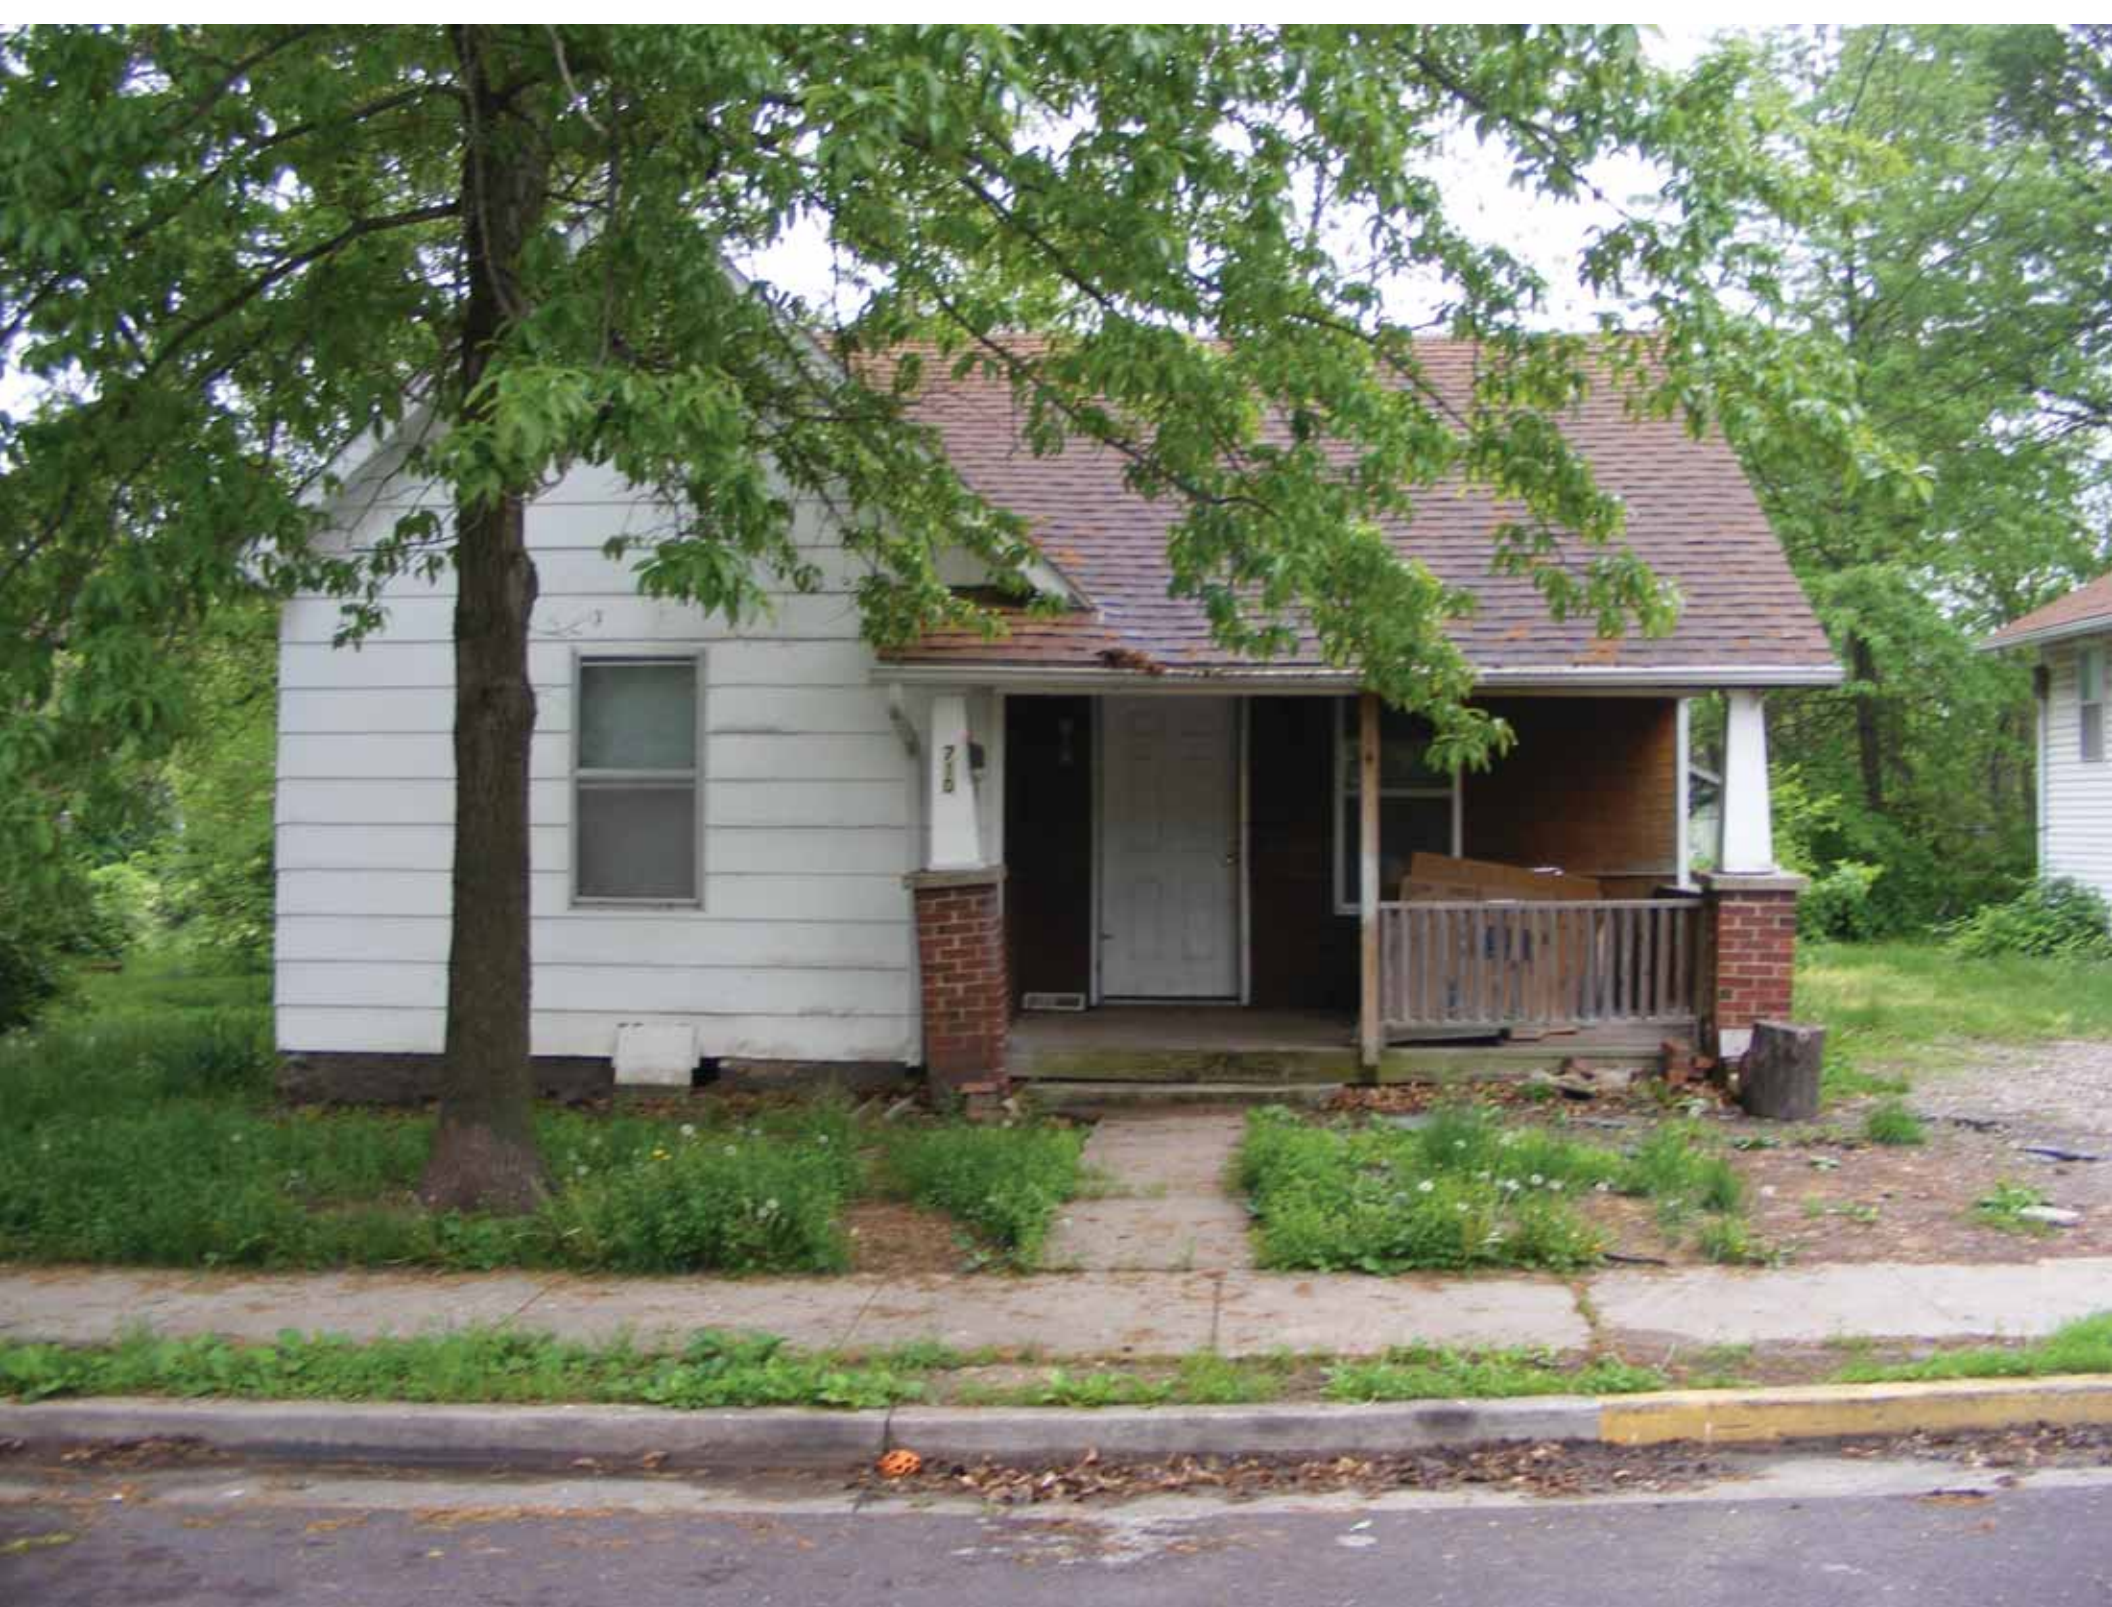
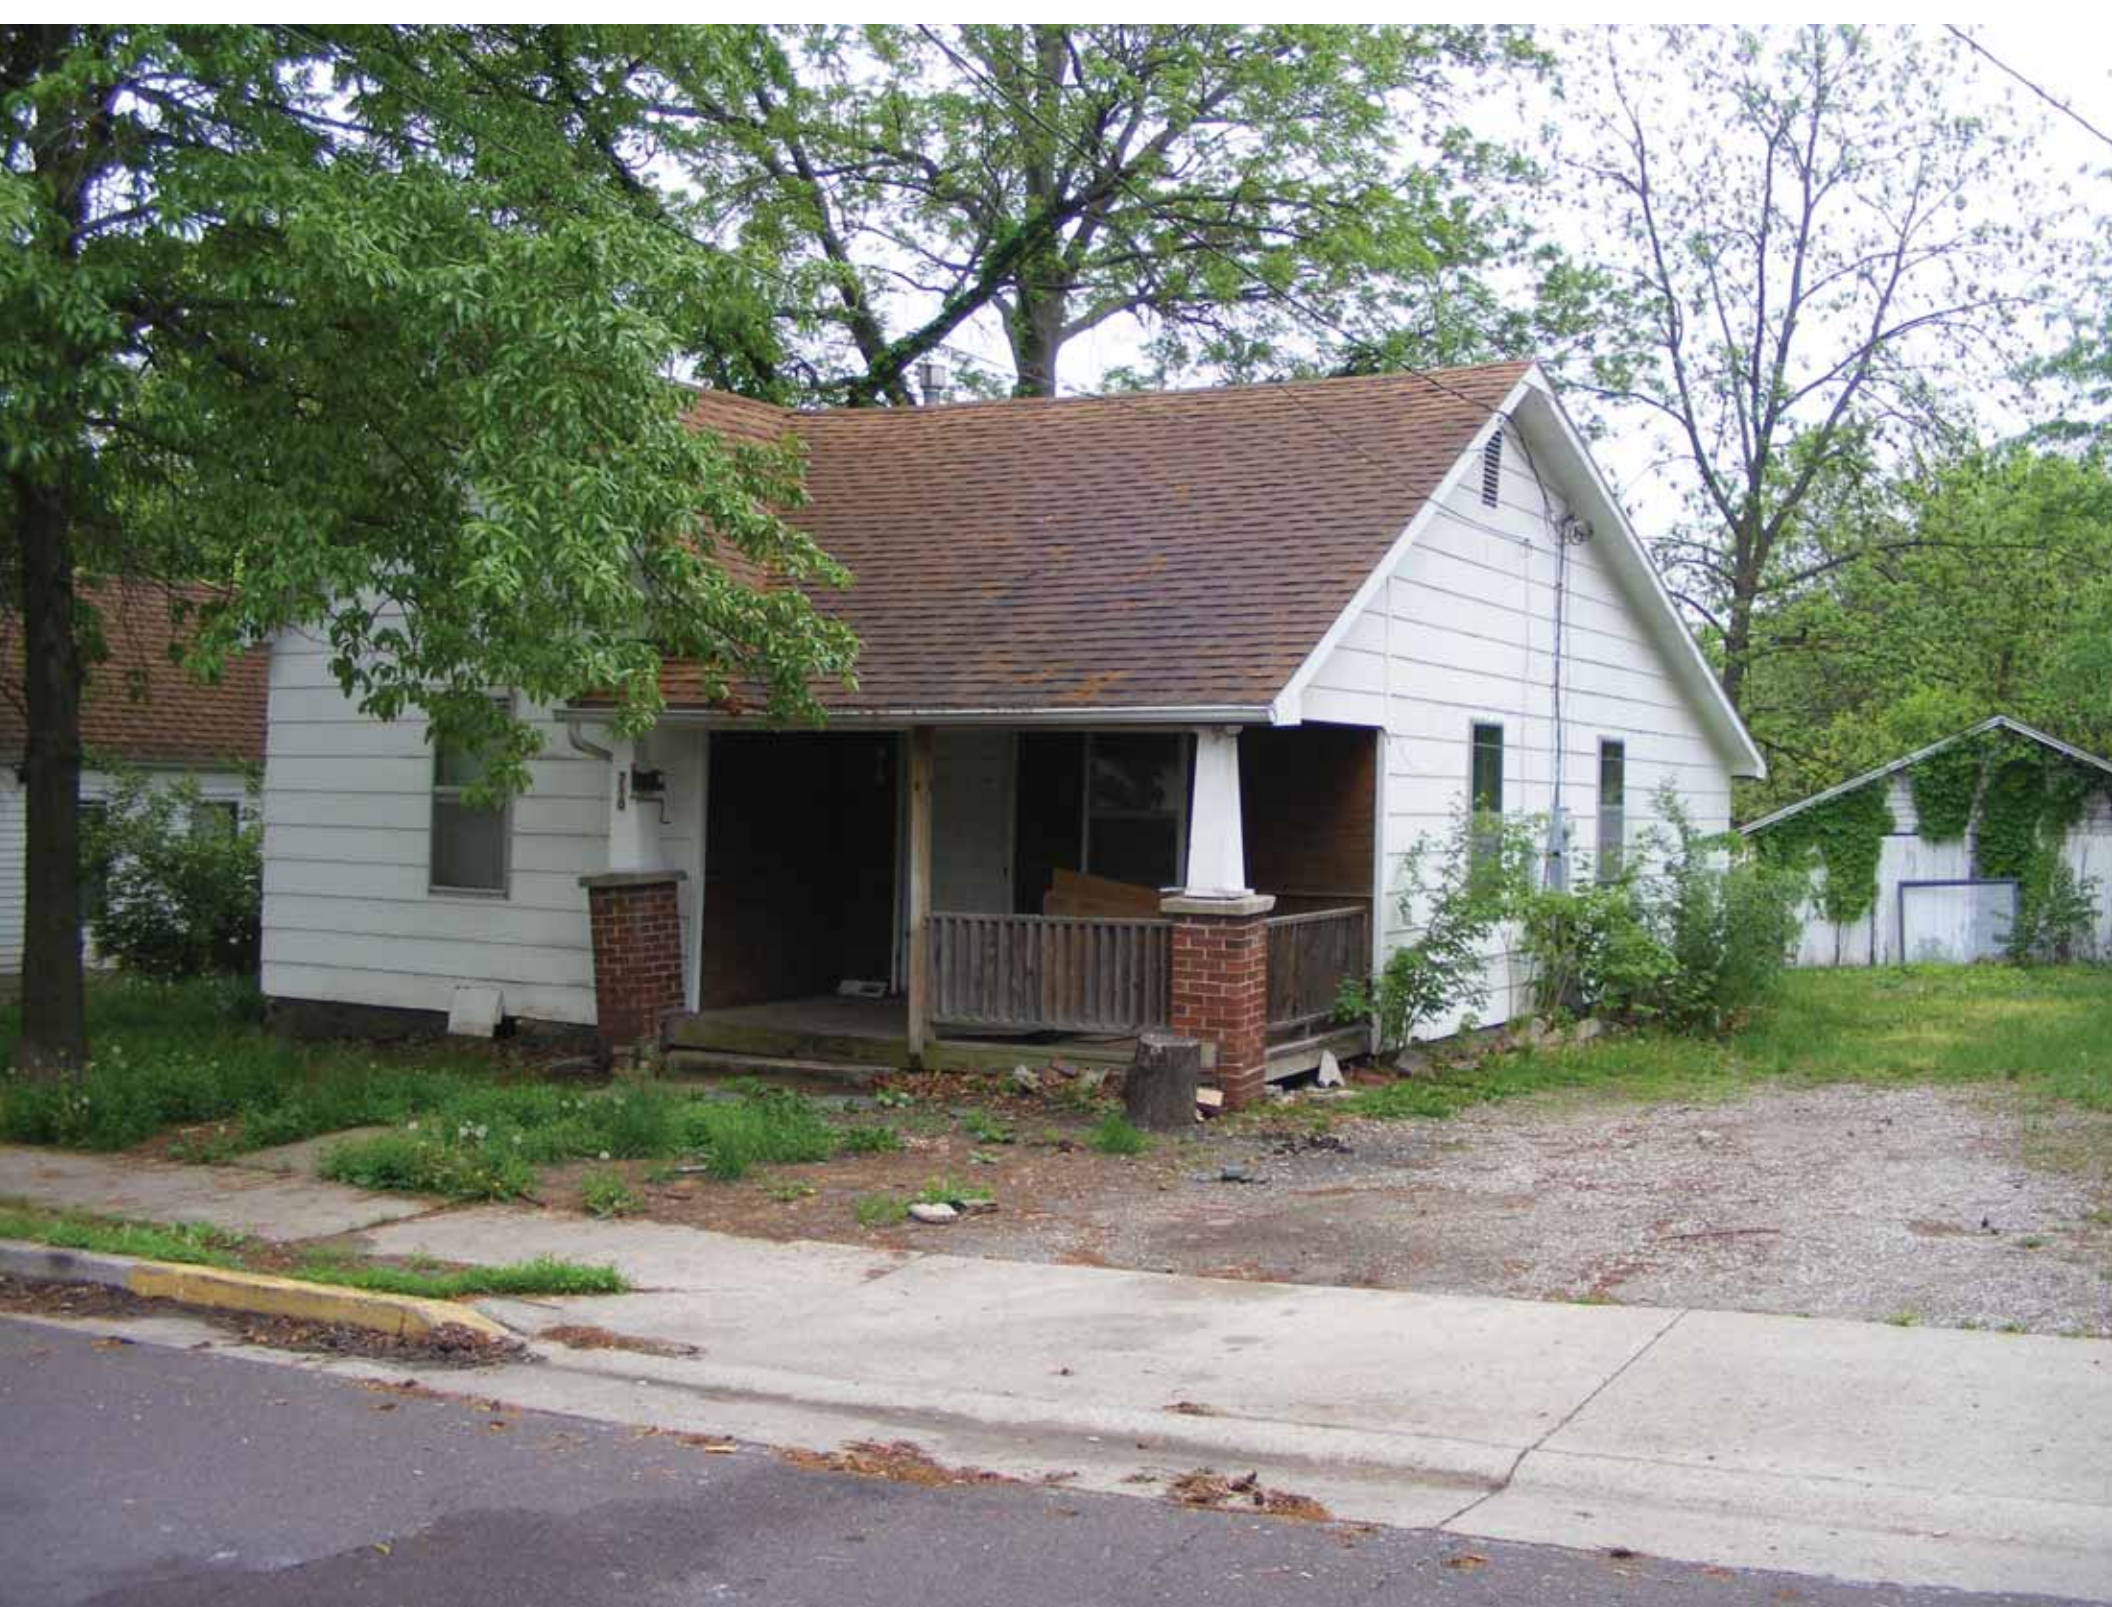
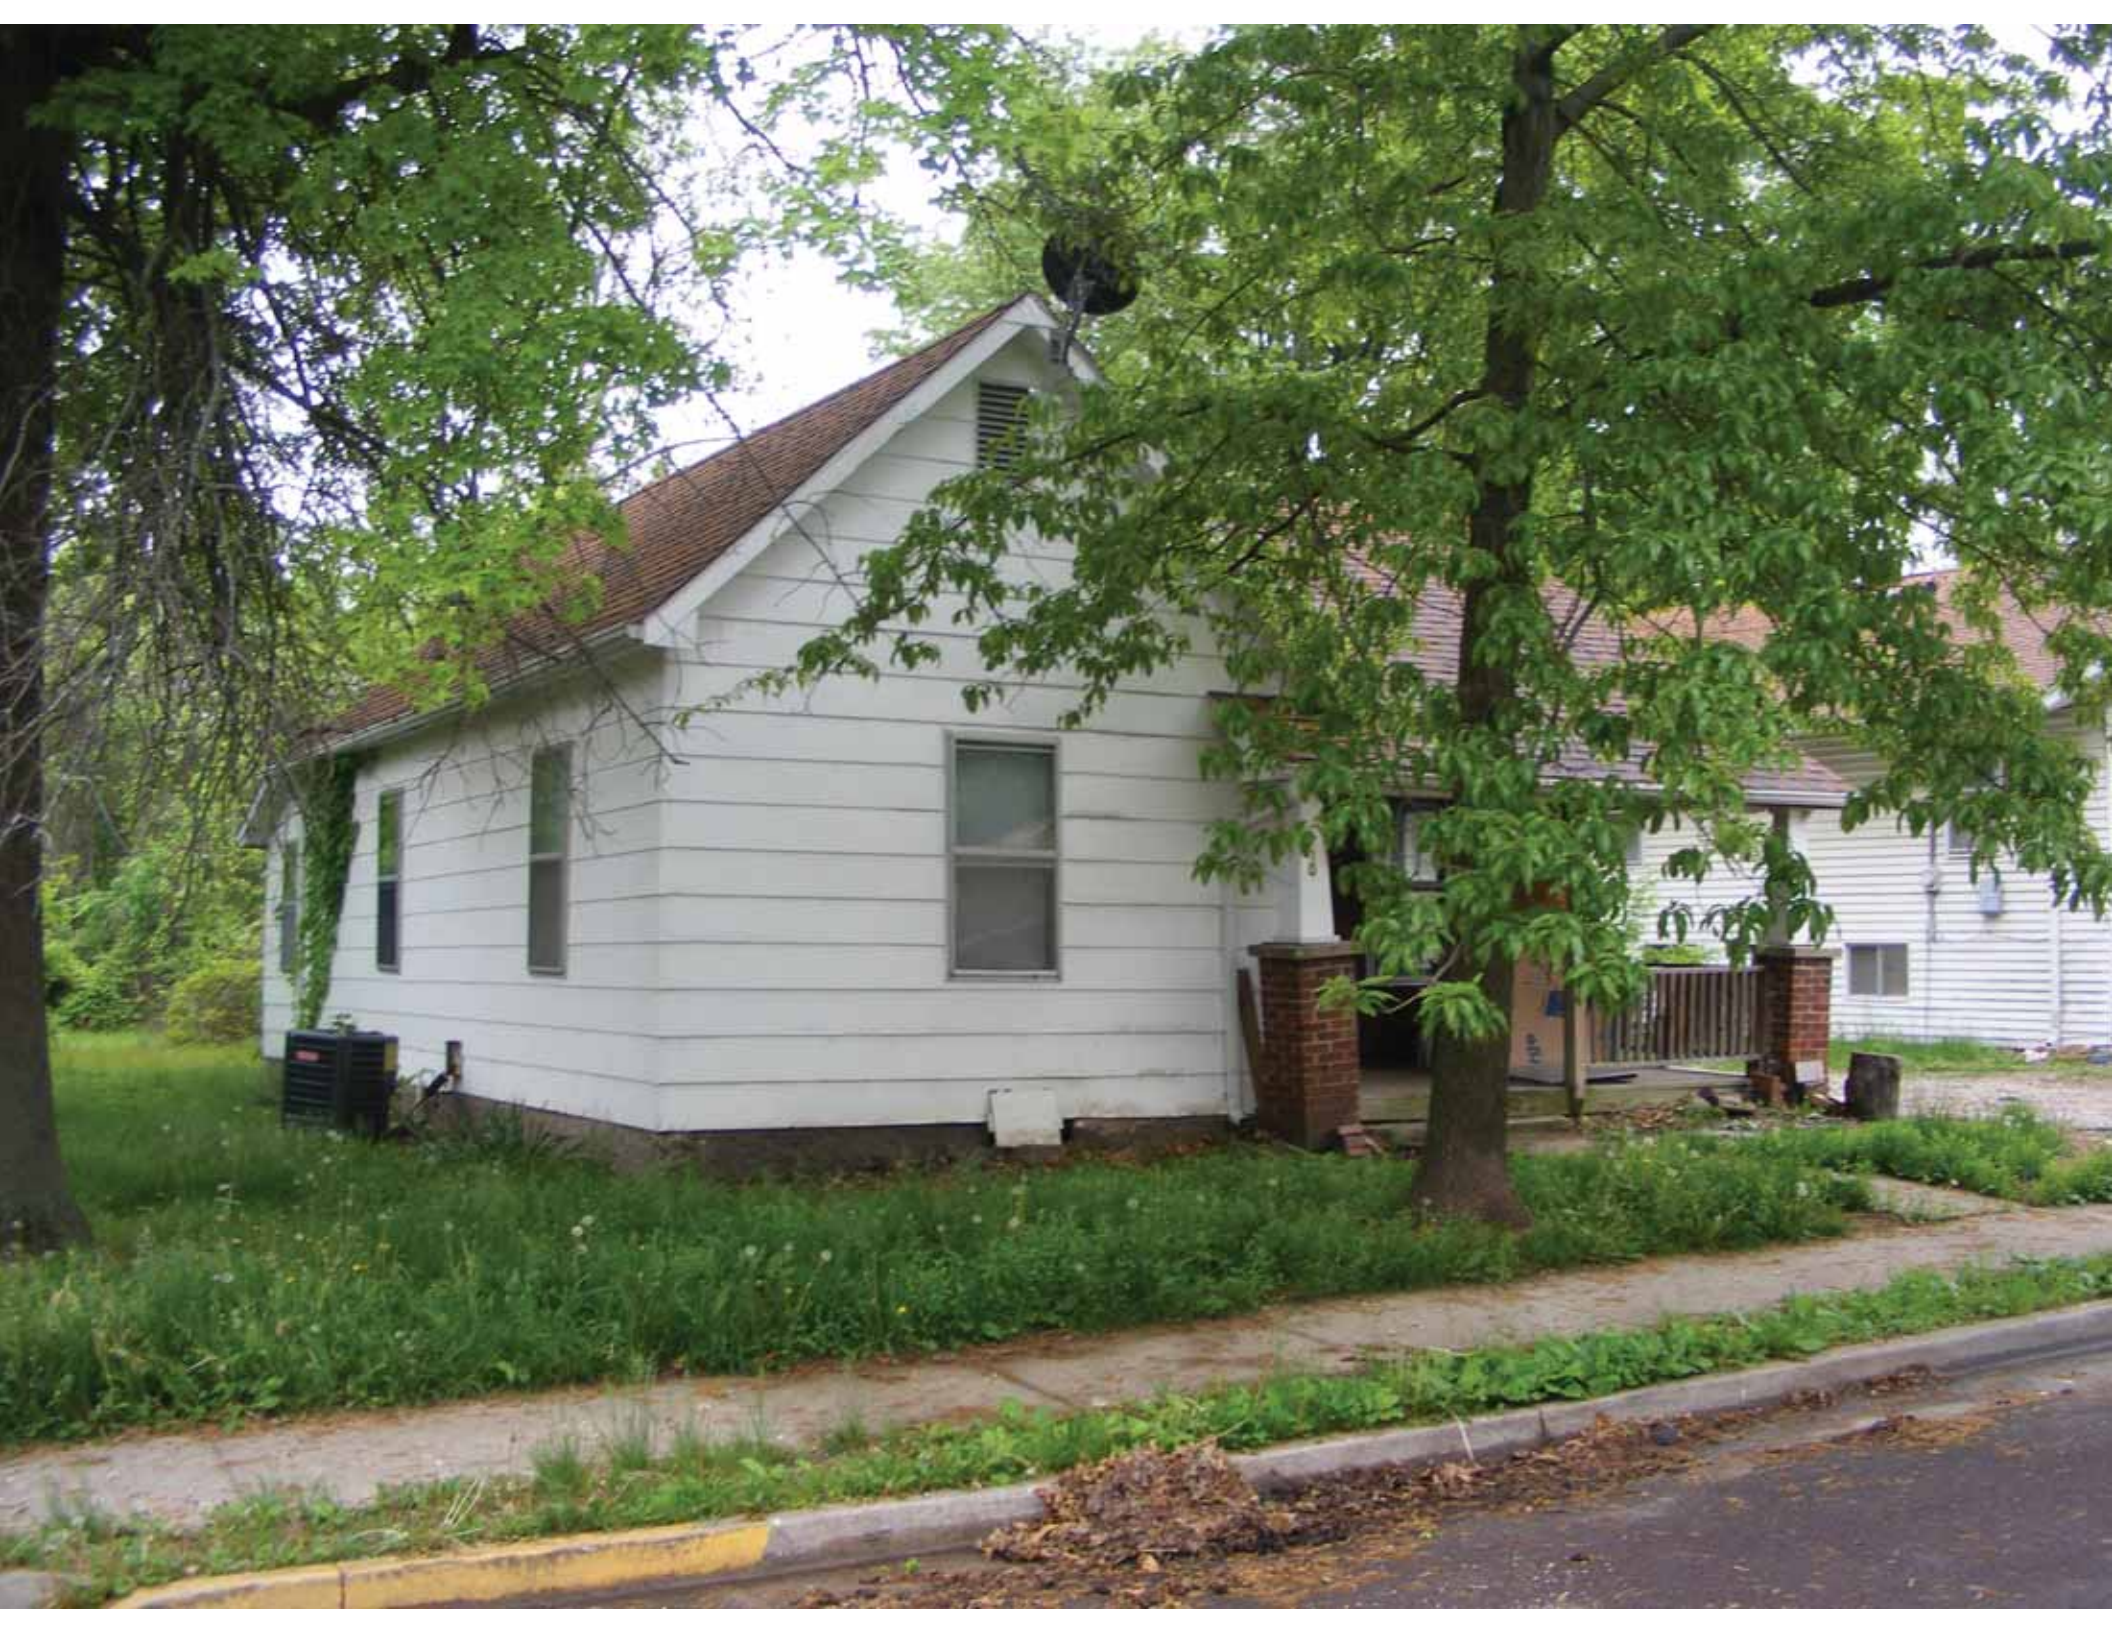
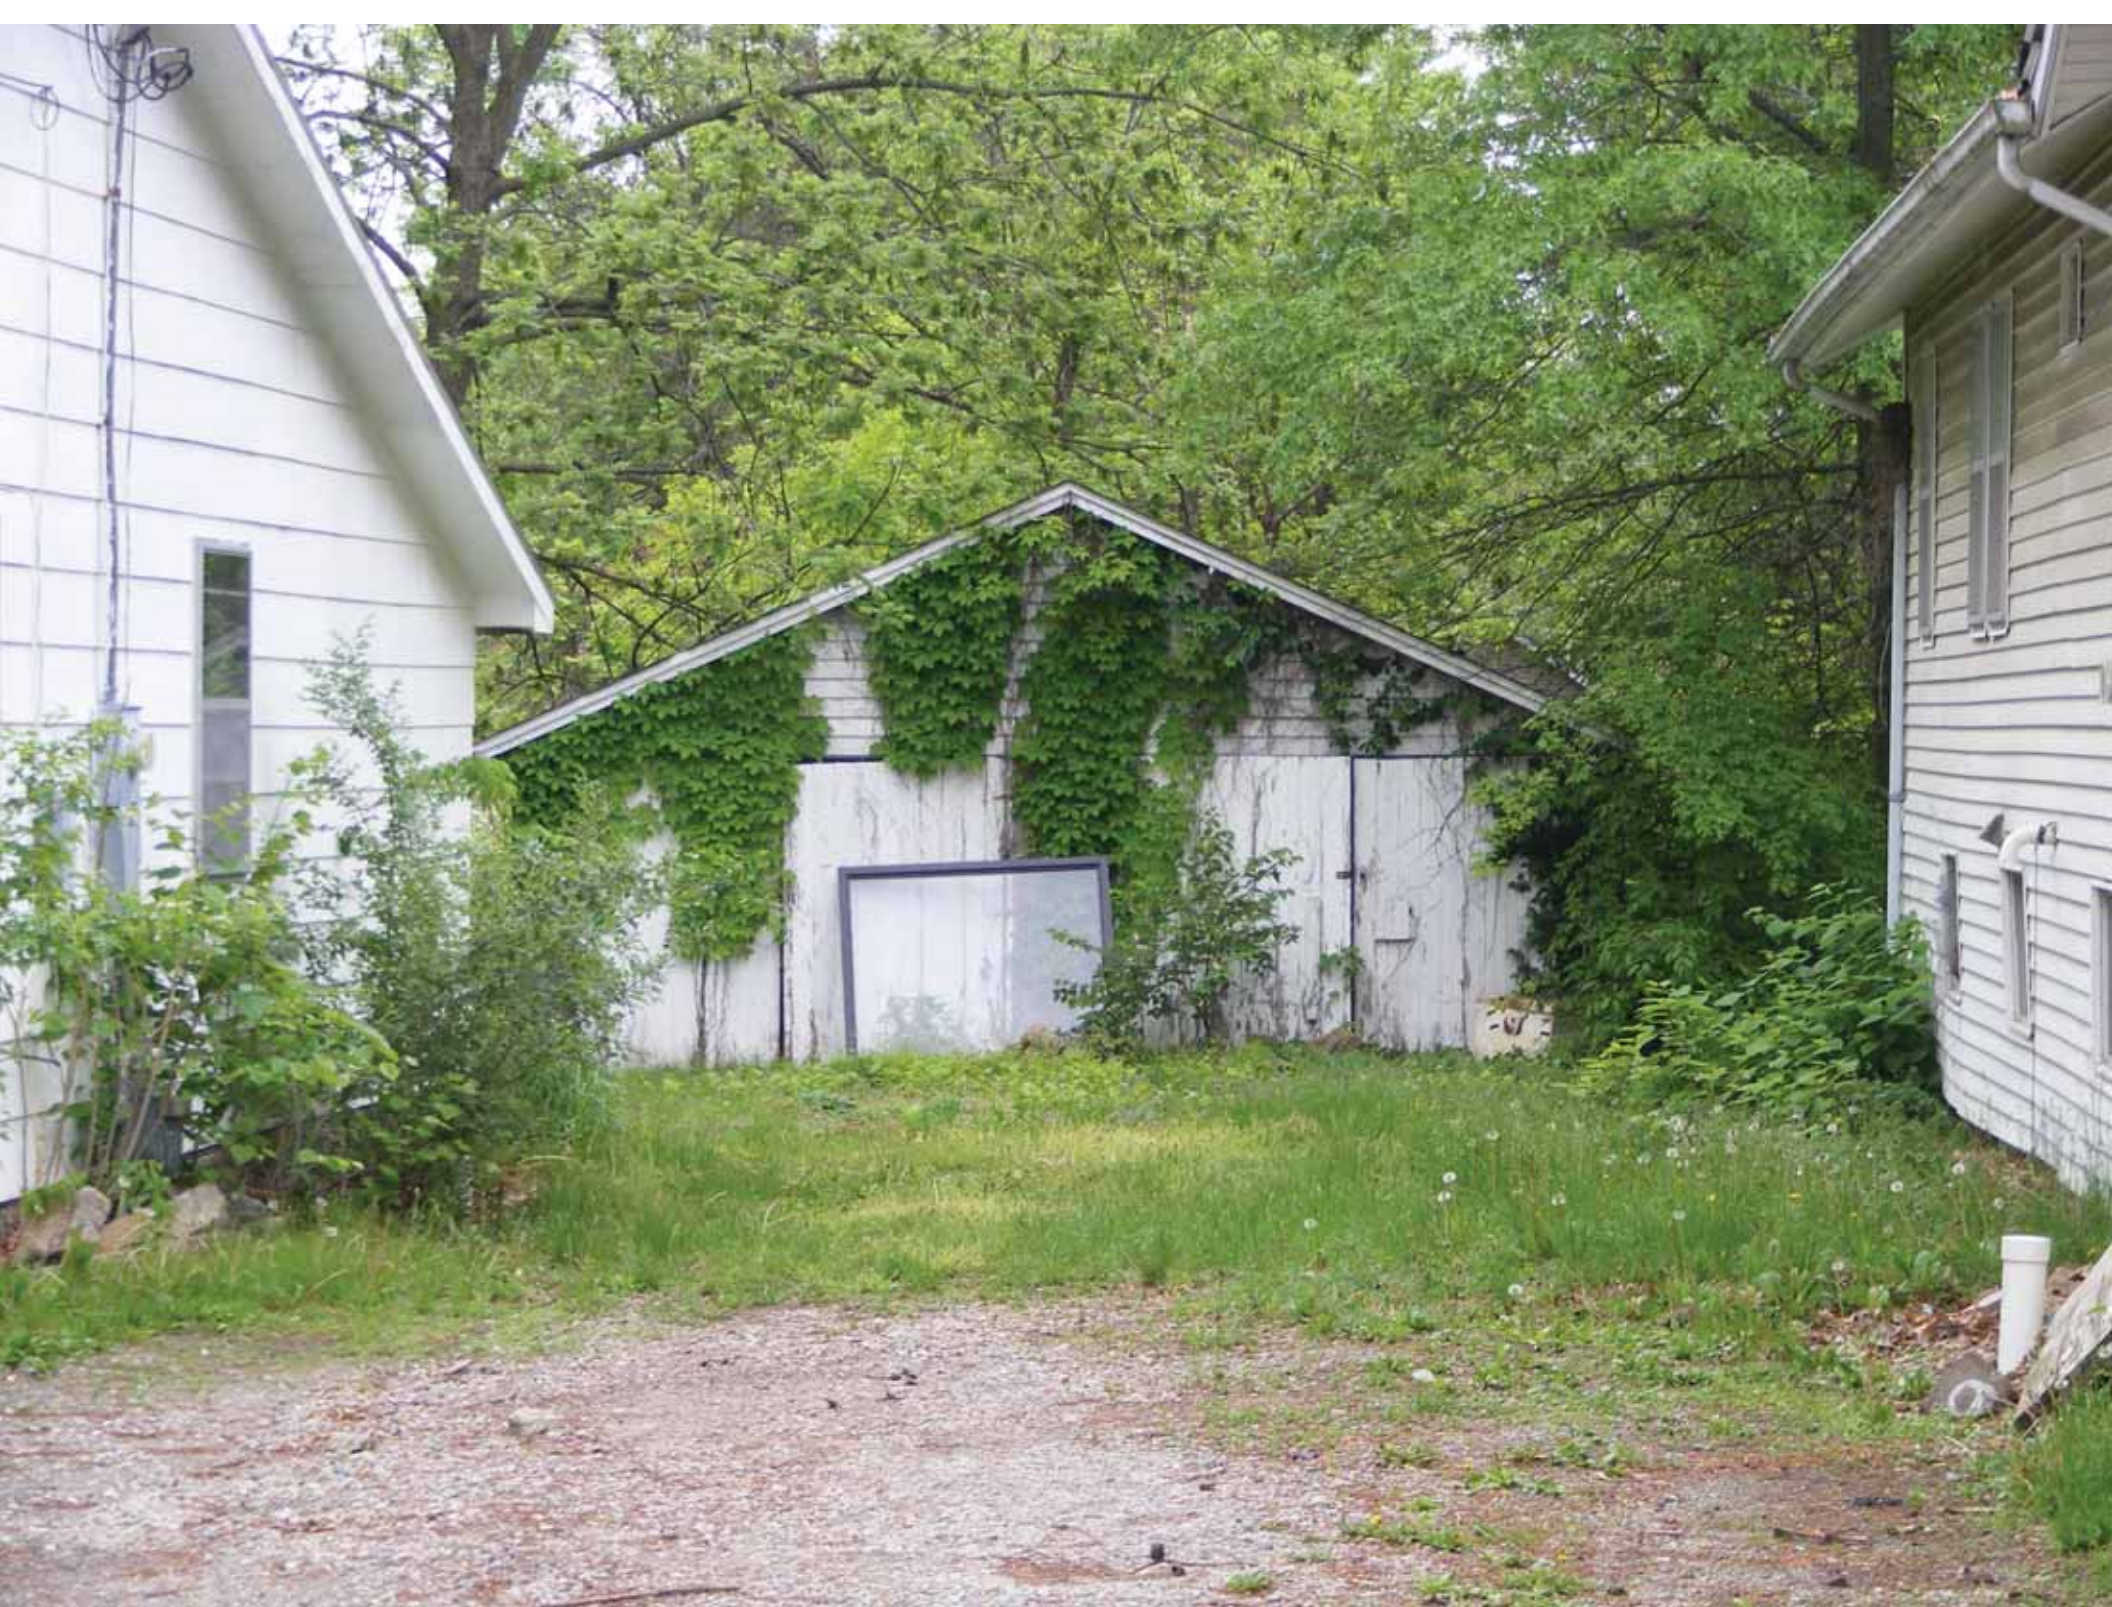
The dwelling has an asphalt-shingled roof and a foundation composed of stone and concrete. The dwelling is largely clad with what appears to be Masonite board siding. Within the porch, the exterior is clad with dropped horizontal wood siding. The porch is shed, supported by tapered piers on brick columns. Within the porch bay is a c. 2000 paneled door offset by a one-over-one window. The east porch wall is composed of the front facing gabled wing which supports a single one-over-one window. End gable fields (east and west) hold louvered vents. Side elevations hold single one-over-one windows. The dwelling has a rear shed wing.

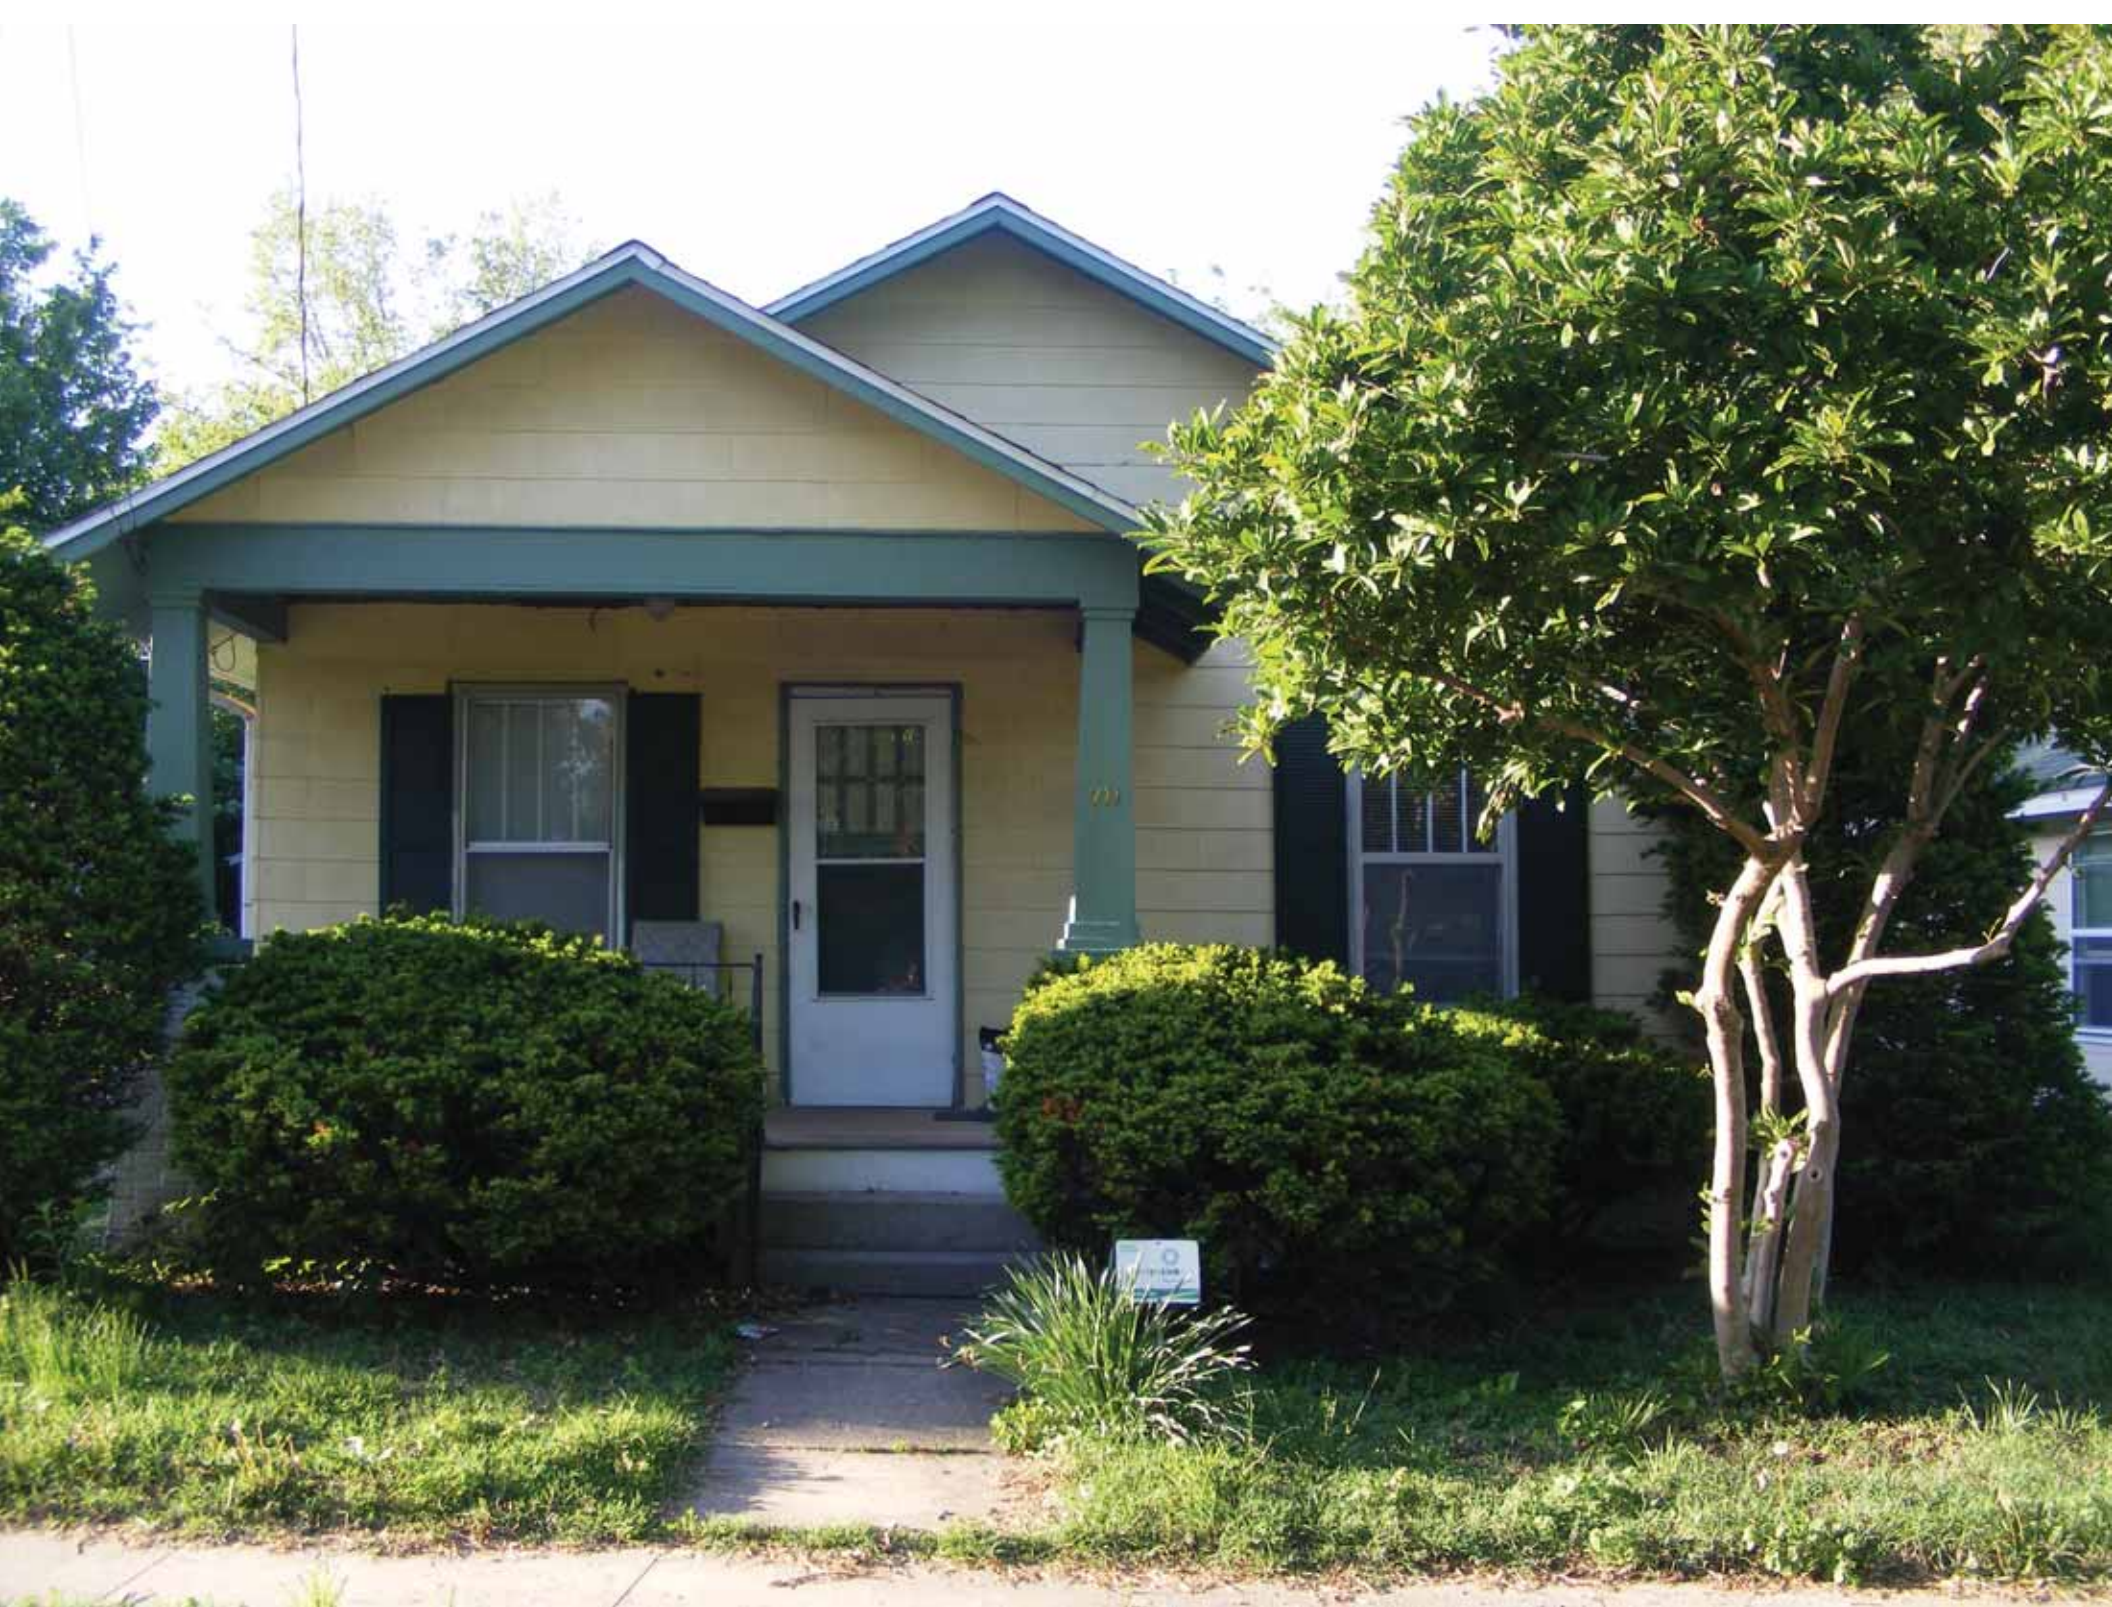
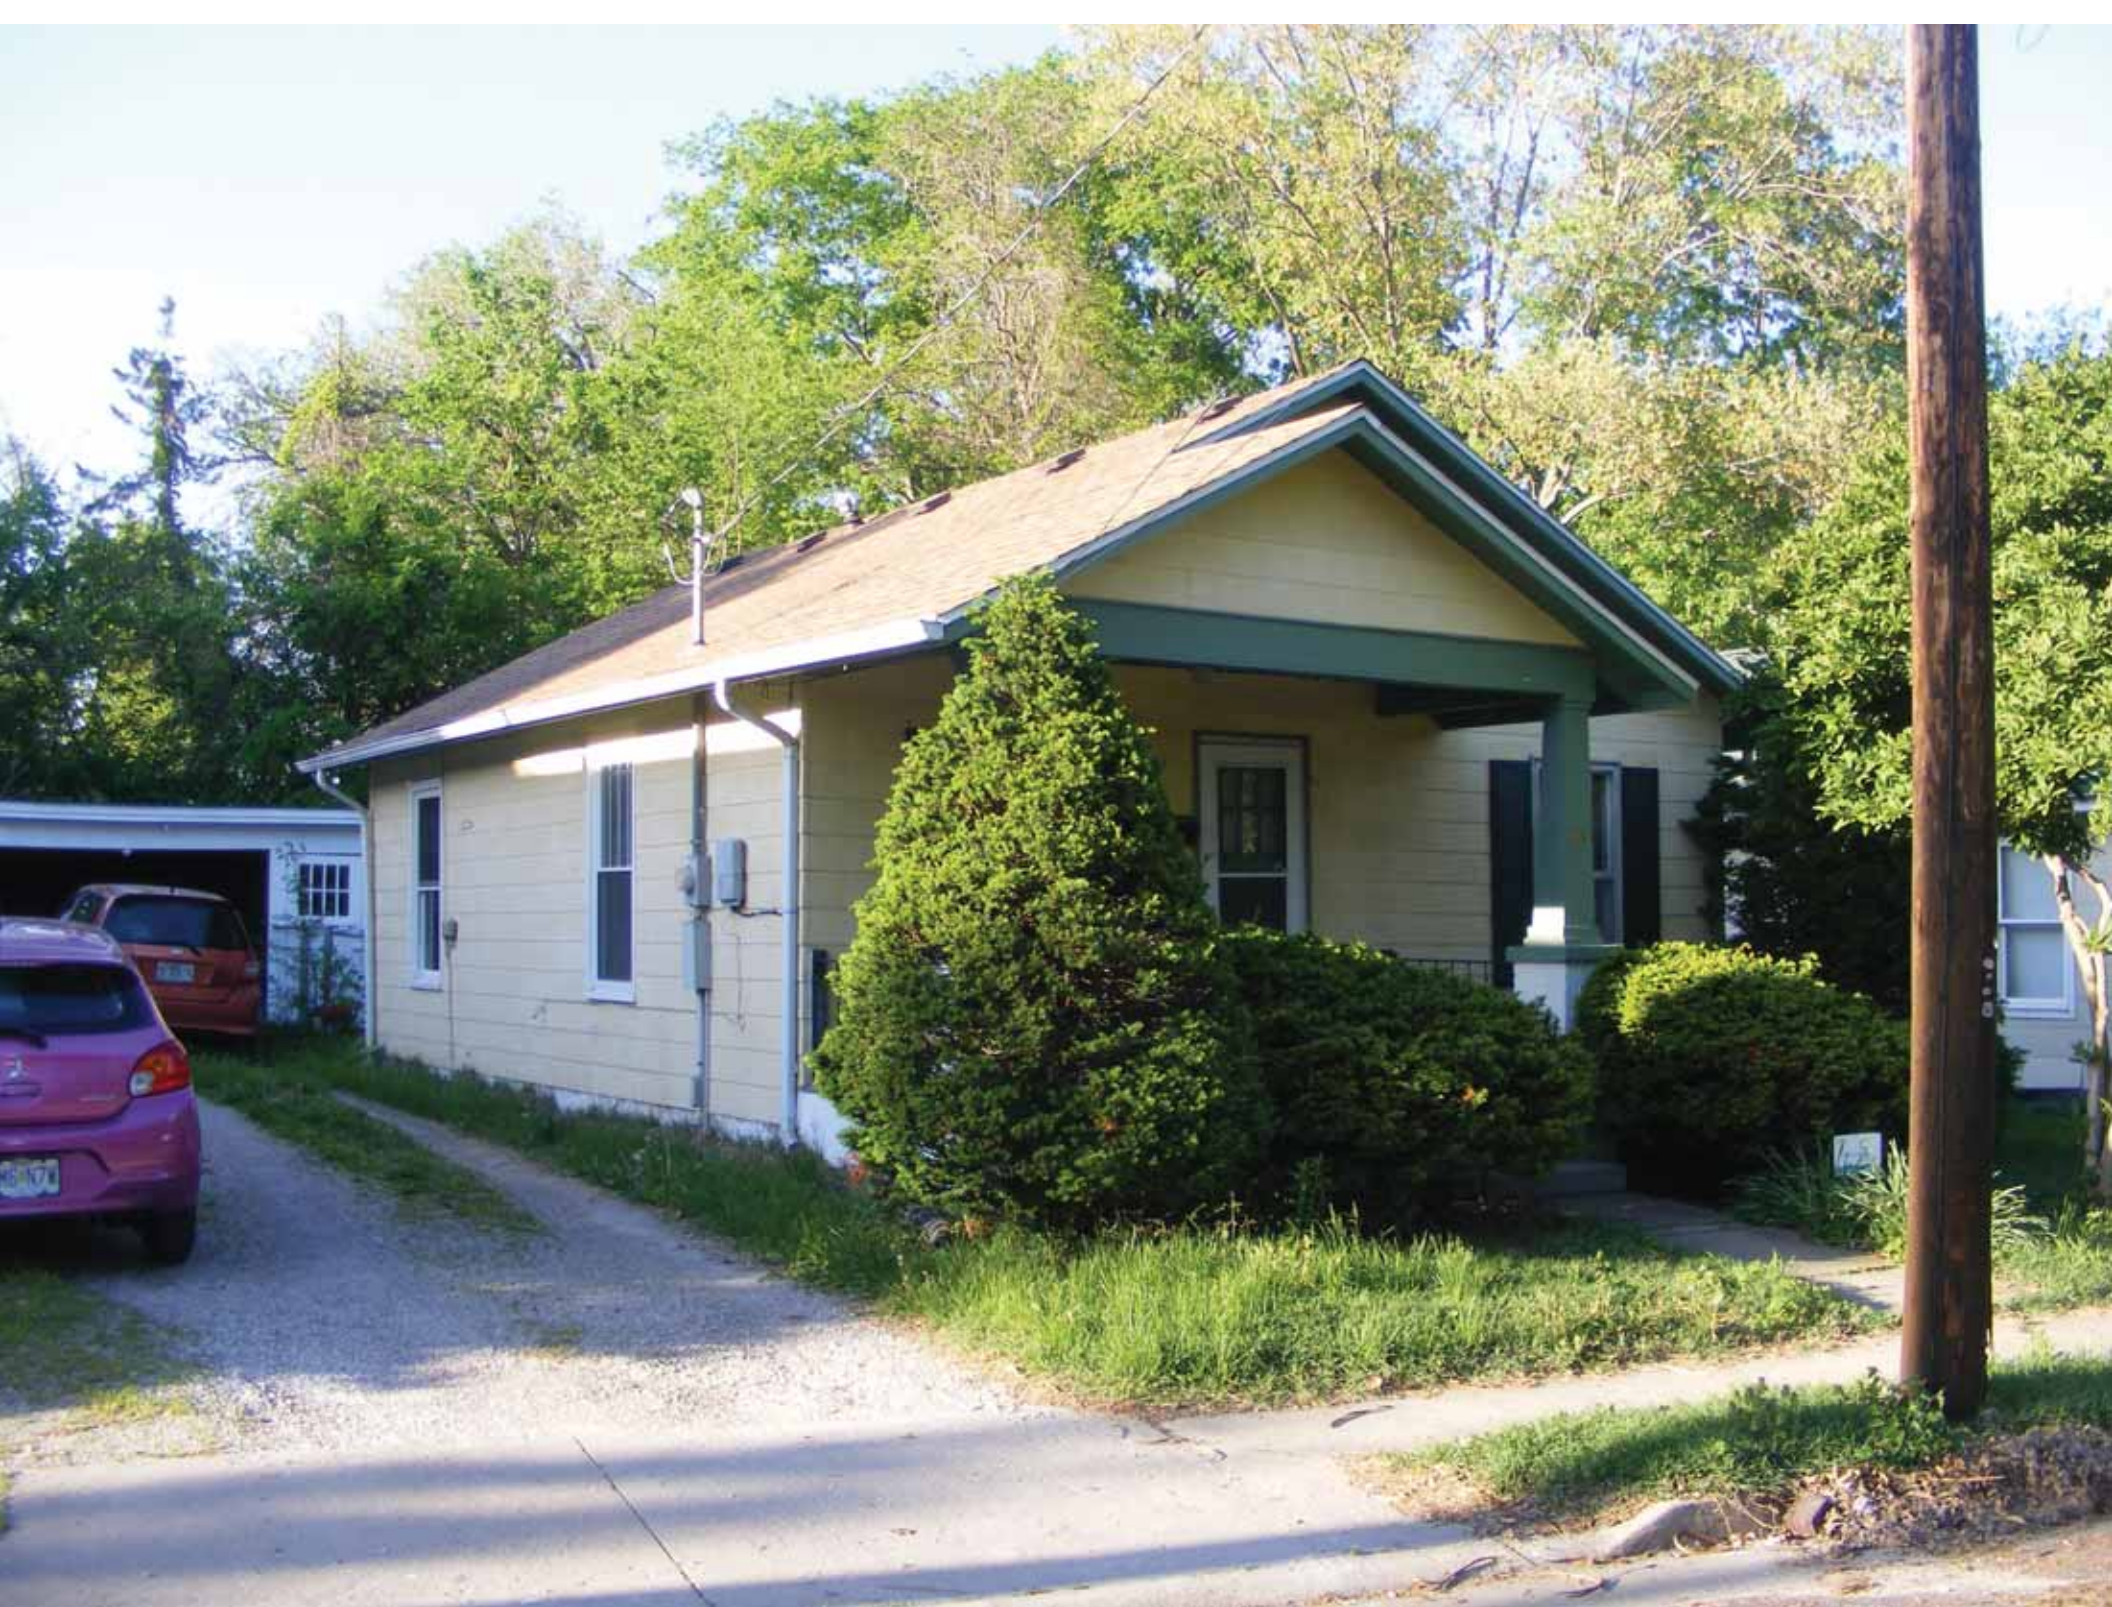
The gable-front plan dwelling has an asphalt shingled roof, exterior asbestos shingle siding and a concrete foundation. The primary (south) elevation has an off-center gabled porch supported by two tapered piers resting on brick piers. Within the porch bay is an original Craftsman style eight-light door. A wrought iron balustrade surrounds the porch. The door is flanked by original four-over-one windows with shutters. Side elevations hold single windows of similar configuration – some windows are one-over-one.
