MISSOURI DEPARTMENT OF NATURAL RESOURCES
STATE HISTORIC PRESERVATION OFFICE, P.O. Box 176, Jefferson City, MO 65102
ARCHITECTURAL/HISTORIC INVENTORY FORM

1. Survey No. BO-AS-011-0087		2. Survey name: North Central Columbia Survey Phase II	
3. County: Boone		4. Address (Street No.) 902	Street (name) N. Seventh Street
5. City: Columbia	Vicinity: <input type="checkbox"/>	6. Geographical Reference:	7. Township/Range/Section: T: R: S:
8. Historic name (if known):		9. Present/other name (if known):	
10. Ownership: <input checked="" type="checkbox"/> Private <input type="checkbox"/> Public		11a. Historic use (if known): Domestic/single dwelling	11b. Current use: Domestic/single dwelling

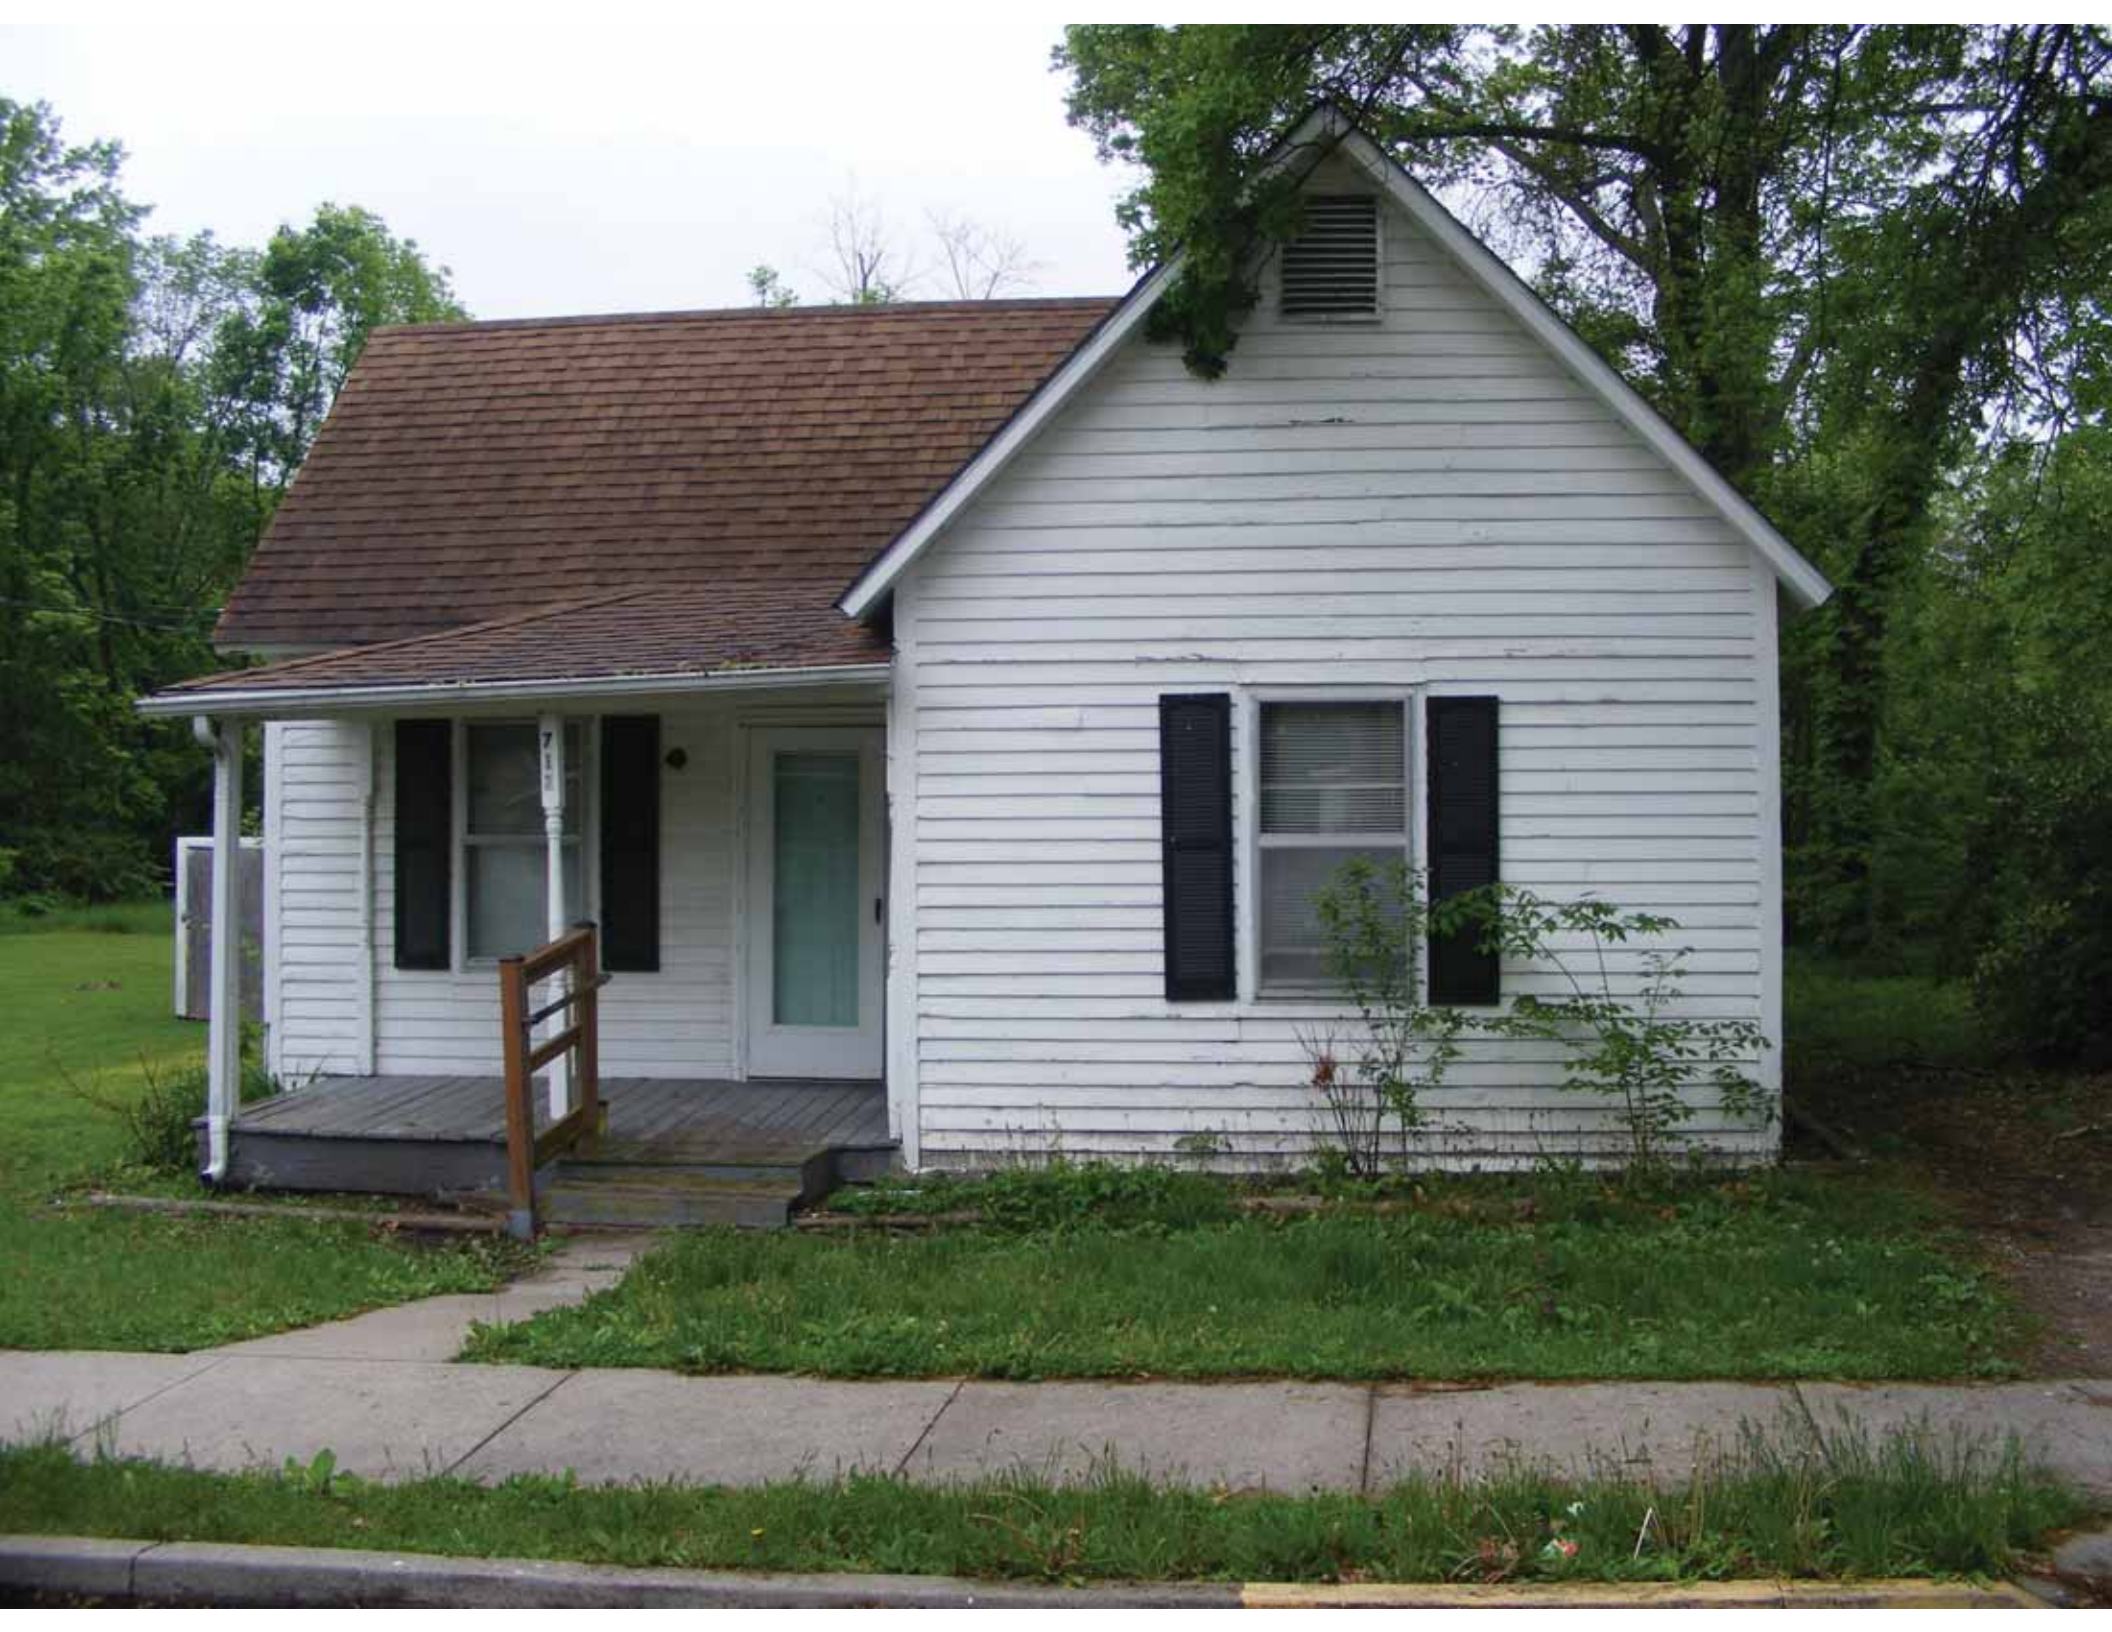
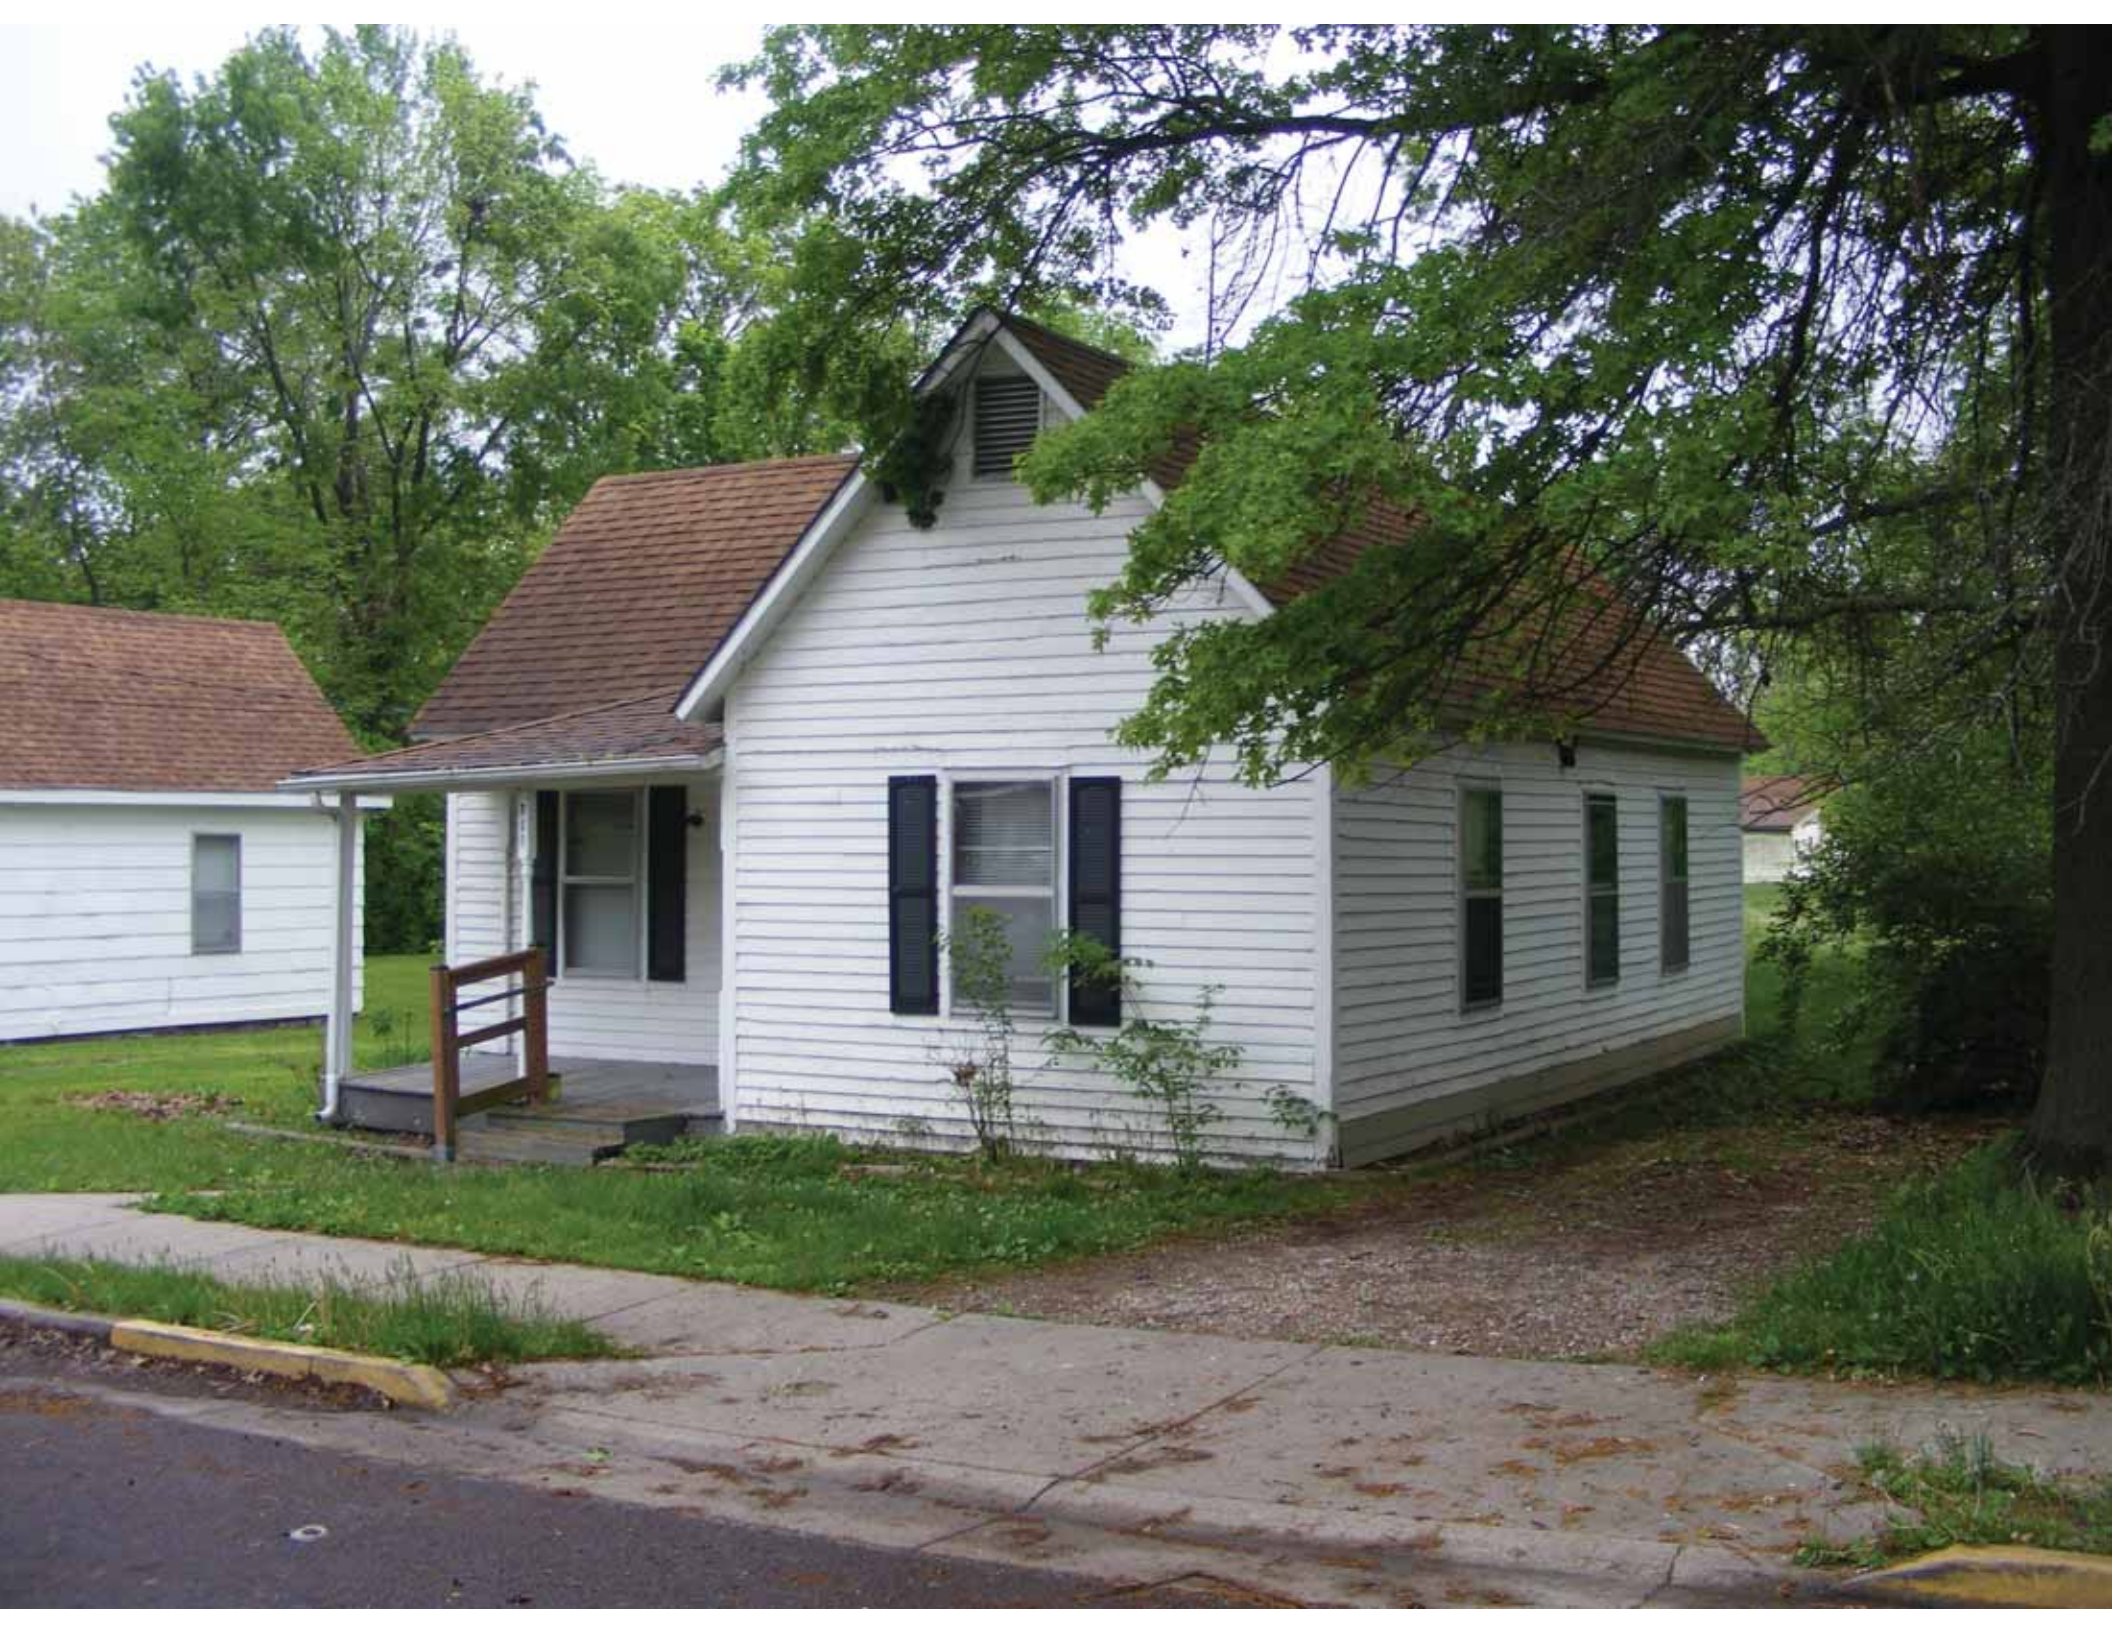
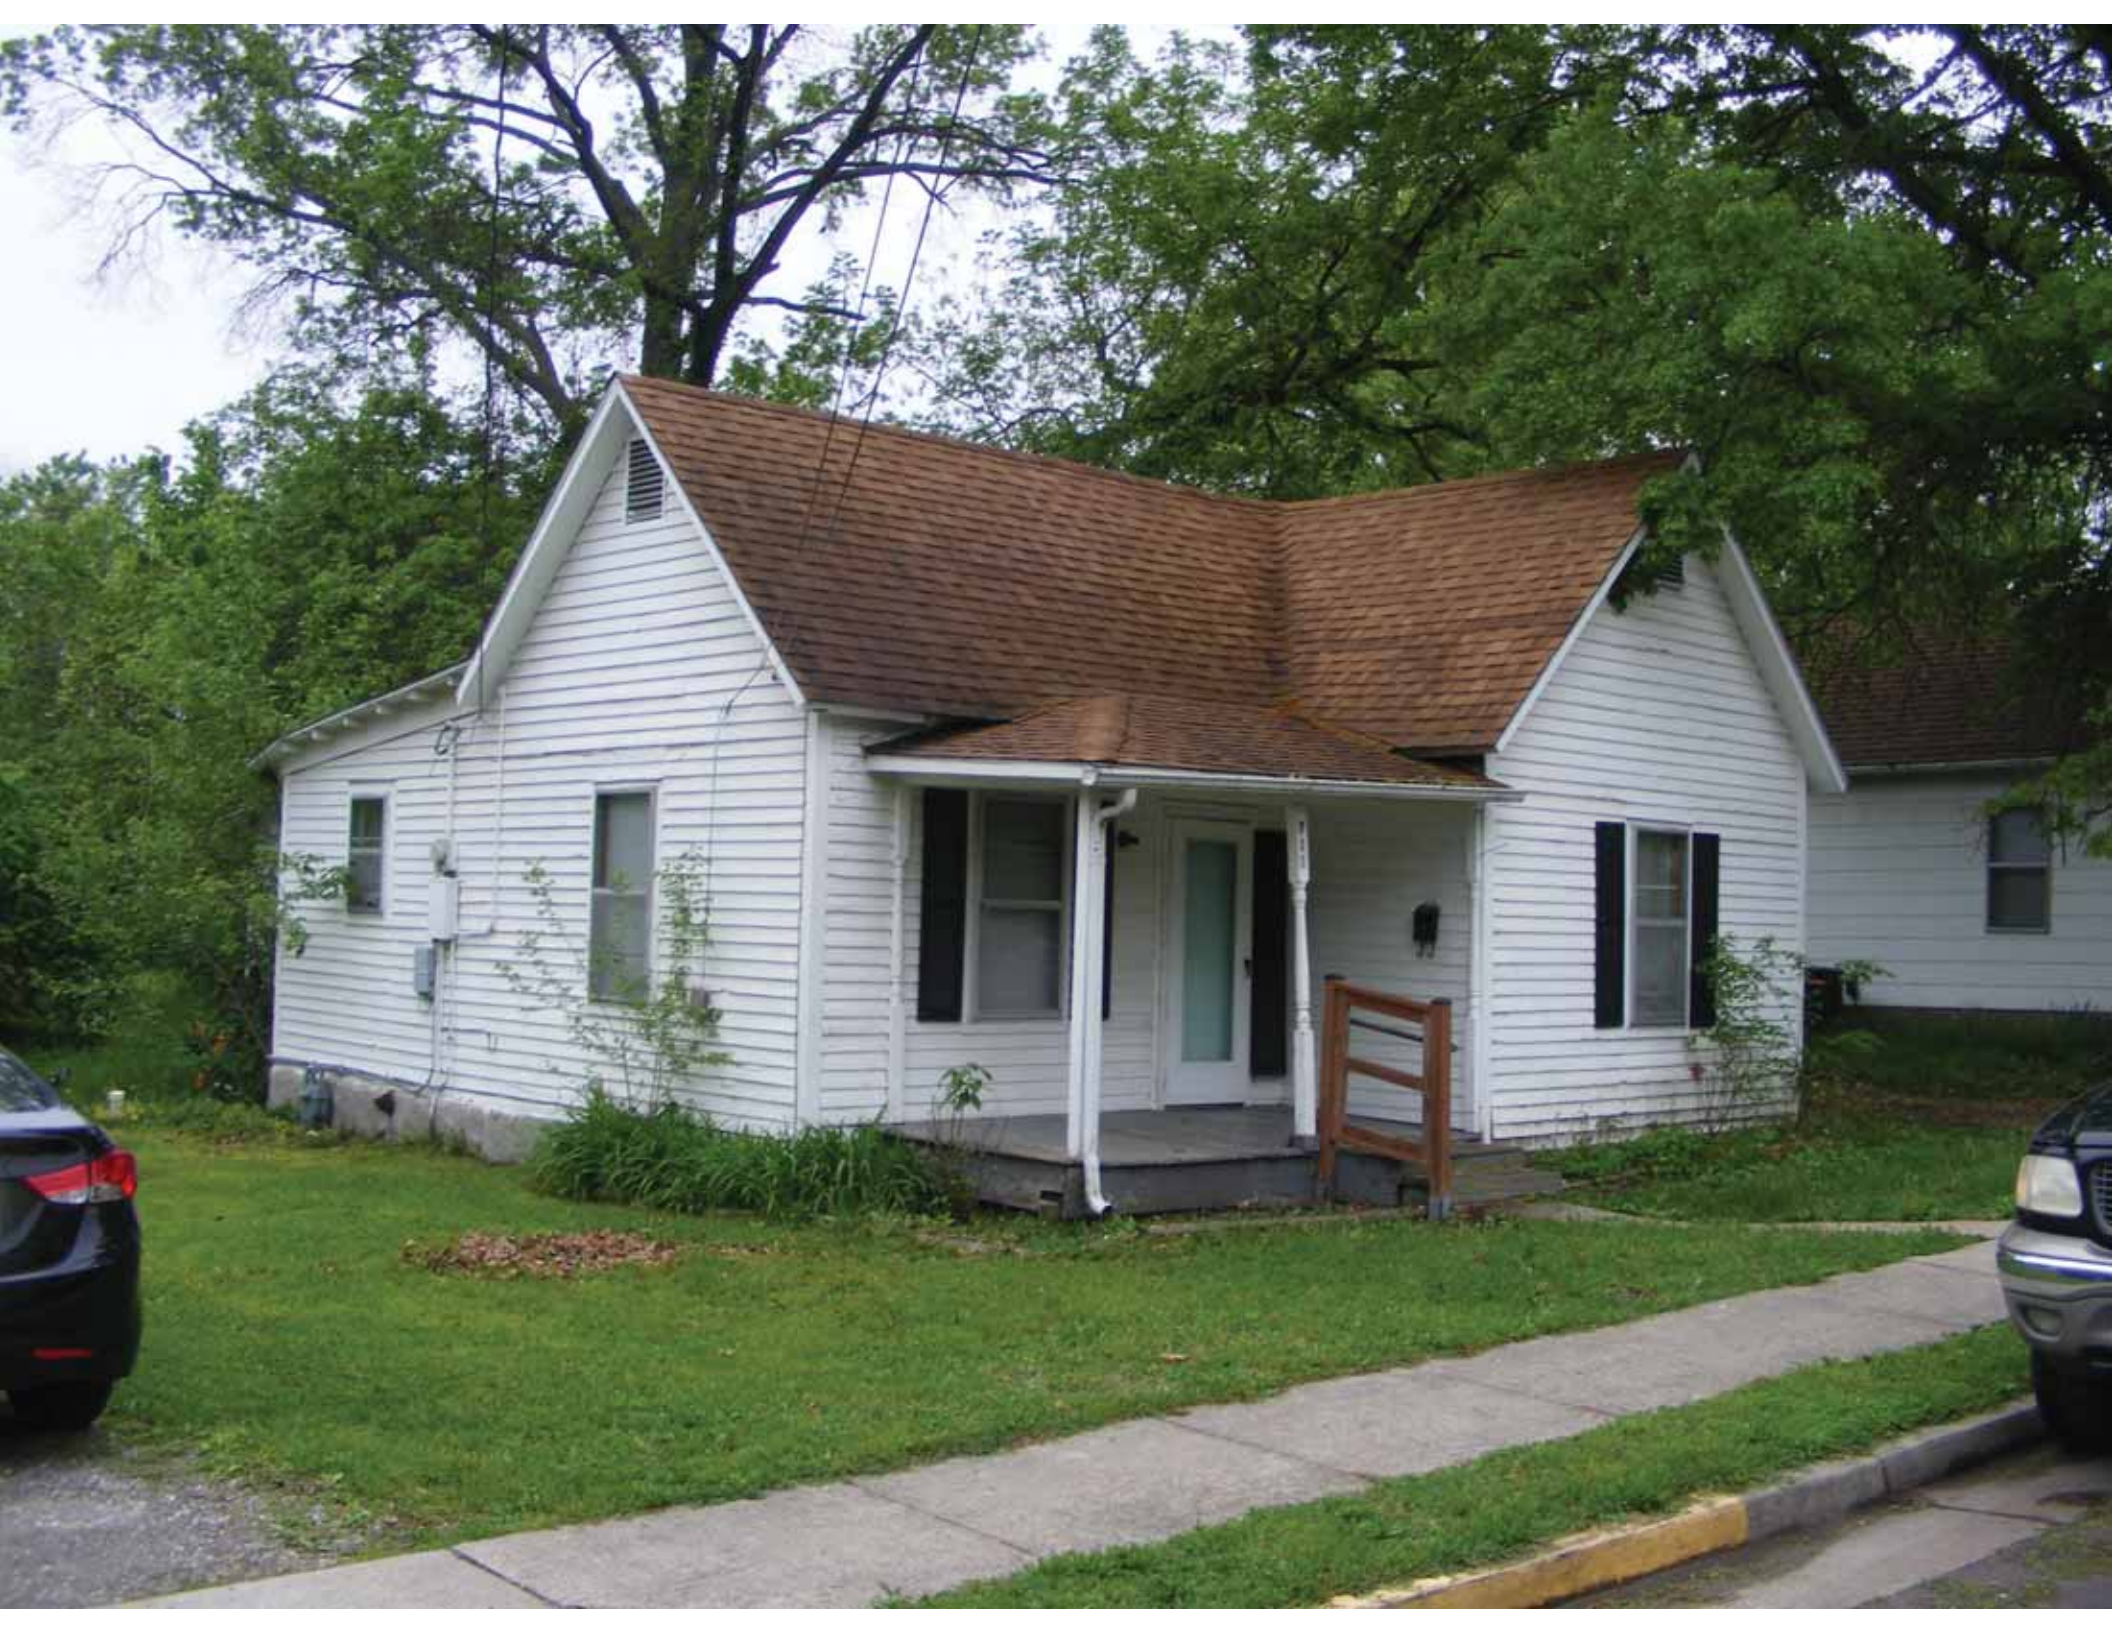
The dwelling has a cross-gable plan asphalt shingled roof, exterior weatherboard siding and a concrete foundation. Windows are one-over-one and appear original. Façade windows have faux shutters. A hipped porch is situated across the eastern half of the façade, supported by one milled and one square column. The façade (south elevation) retains an engaged milled column offset by a one-over-one window within the porch bay. The window is offset by a single-light storm door and paneled contemporary door. The front facing gable has a one-over-one window. Gable fields retain louvered vents. The dwelling has a rear shed wing with exposed rafter tails.
