MISSOURI DEPARTMENT OF NATURAL RESOURCES
STATE HISTORIC PRESERVATION OFFICE, P.O. Box 176, Jefferson City, MO 65102
ARCHITECTURAL/HISTORIC INVENTORY FORM

1. Survey No. BO-AS-011-0087		2. Survey name: North Central Columbia Survey Phase II	
3. County: Boone		4. Address (Street No.) 902	Street (name) N. Seventh Street
5. City: Columbia	Vicinity: <input type="checkbox"/>	6. Geographical Reference:	7. Township/Range/Section: T: R: S:
8. Historic name (if known):		9. Present/other name (if known):	
10. Ownership: <input checked="" type="checkbox"/> Private <input type="checkbox"/> Public		11a. Historic use (if known): Domestic/single dwelling	11b. Current use: Domestic/single dwelling

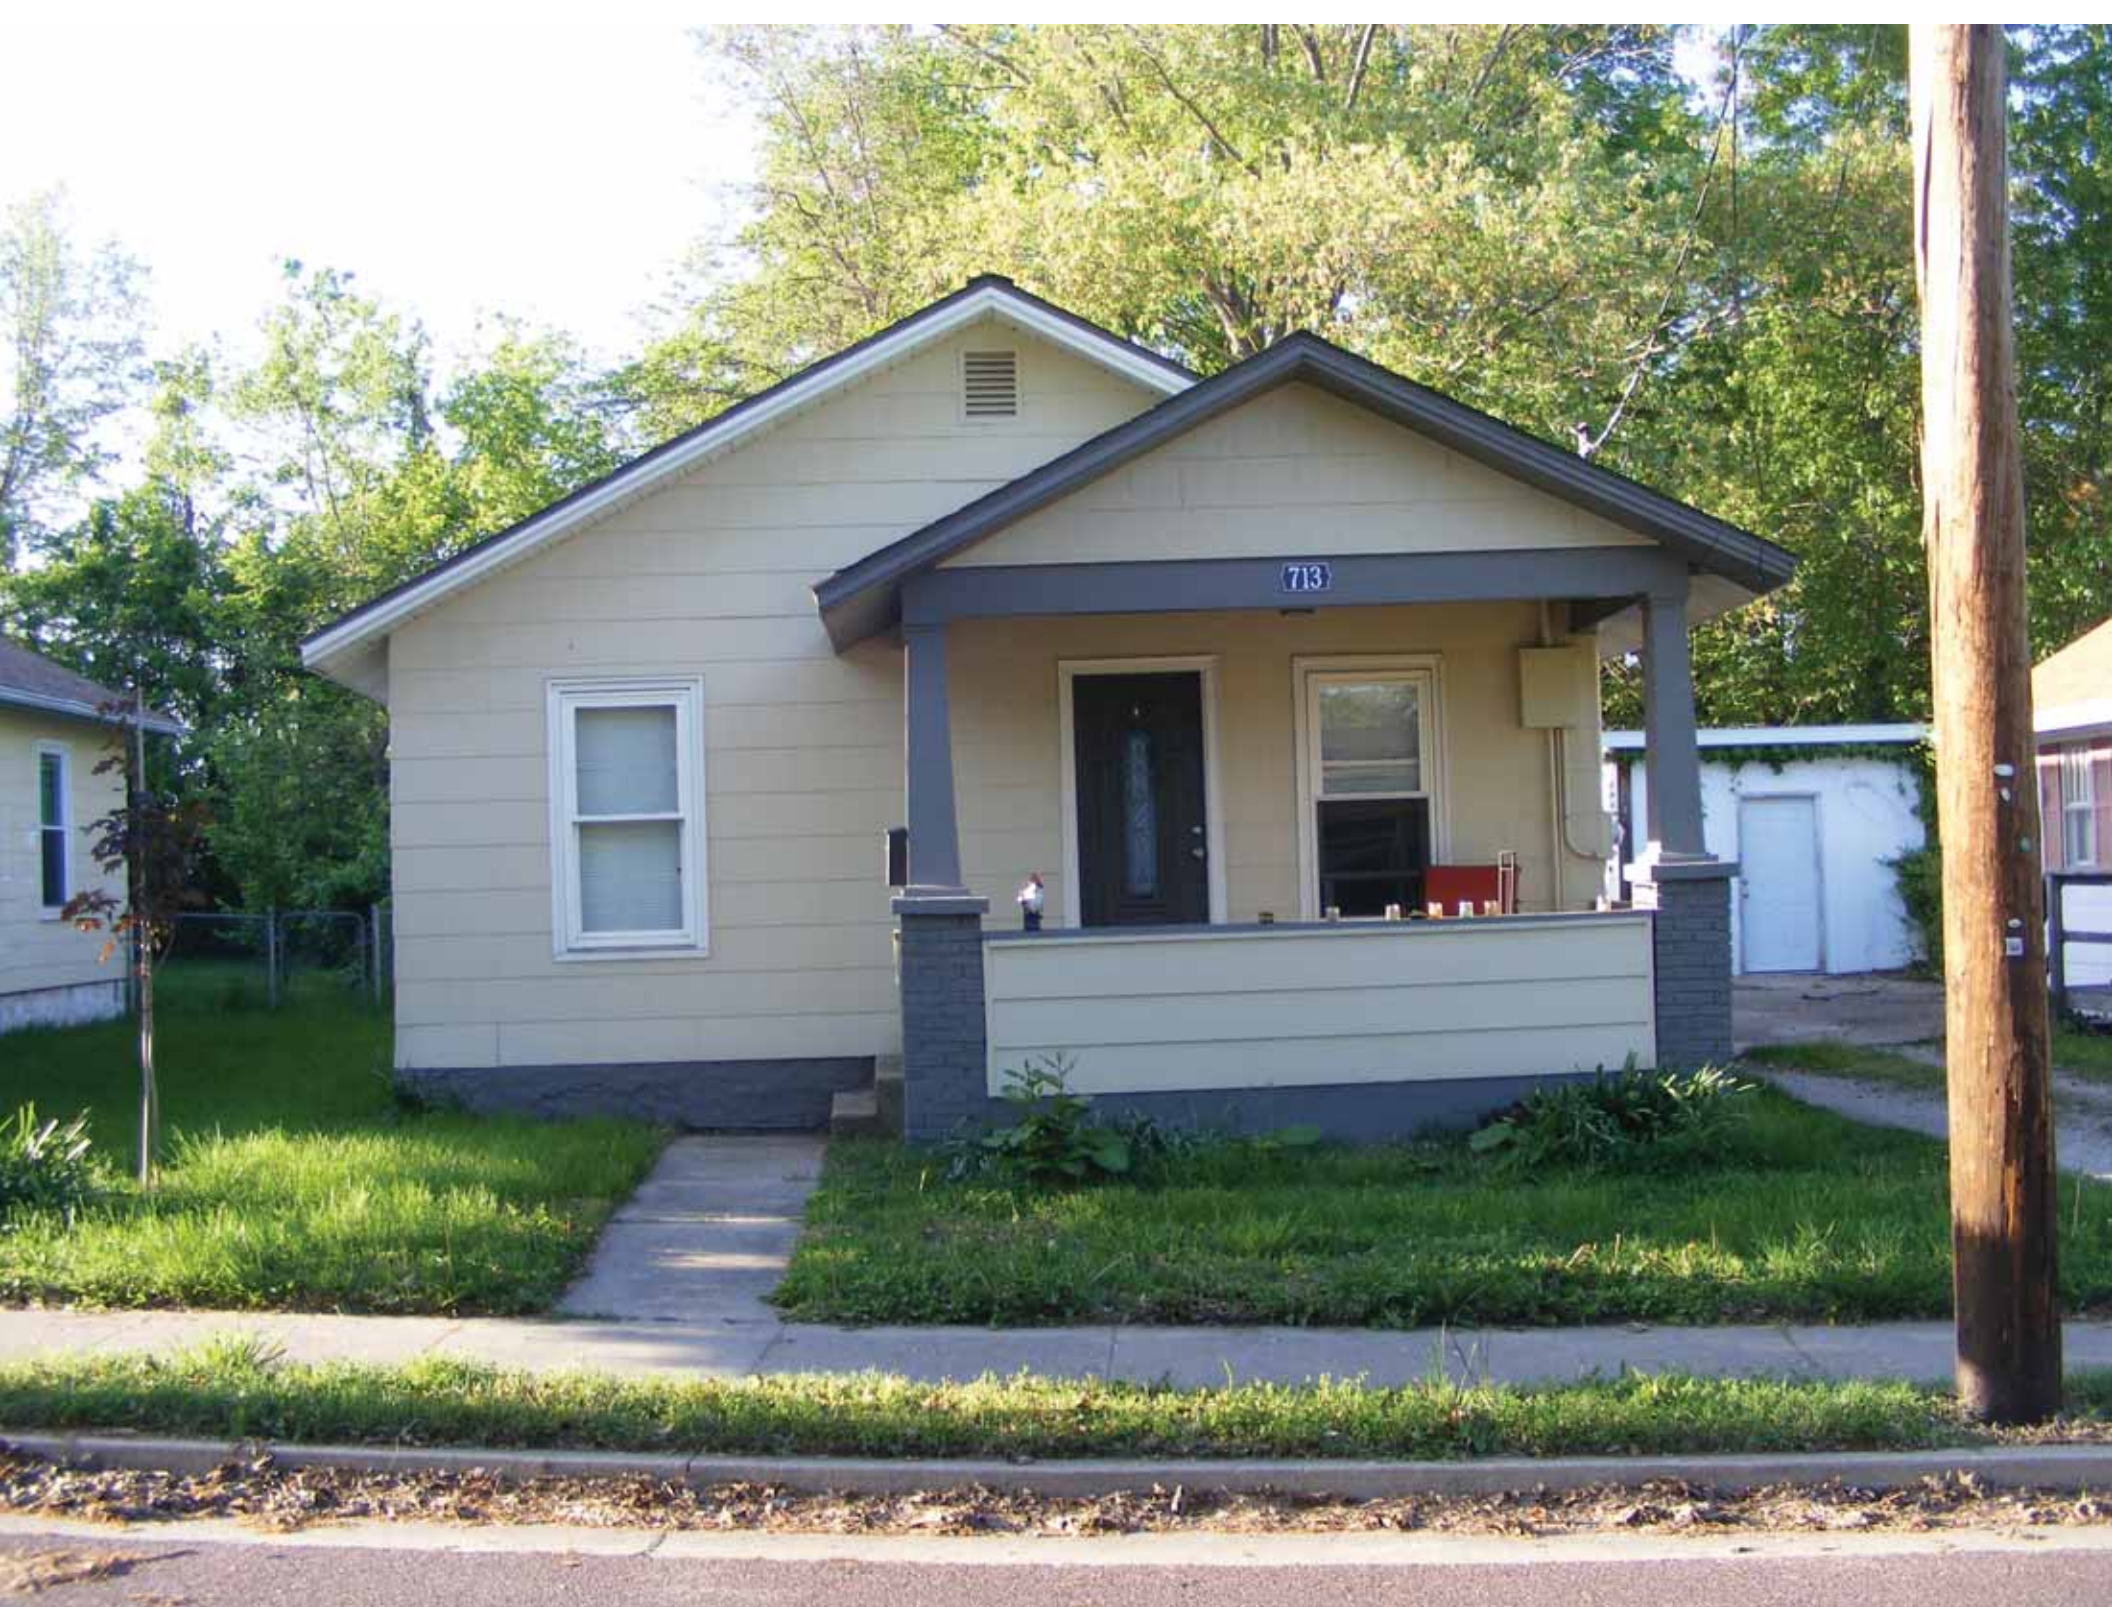
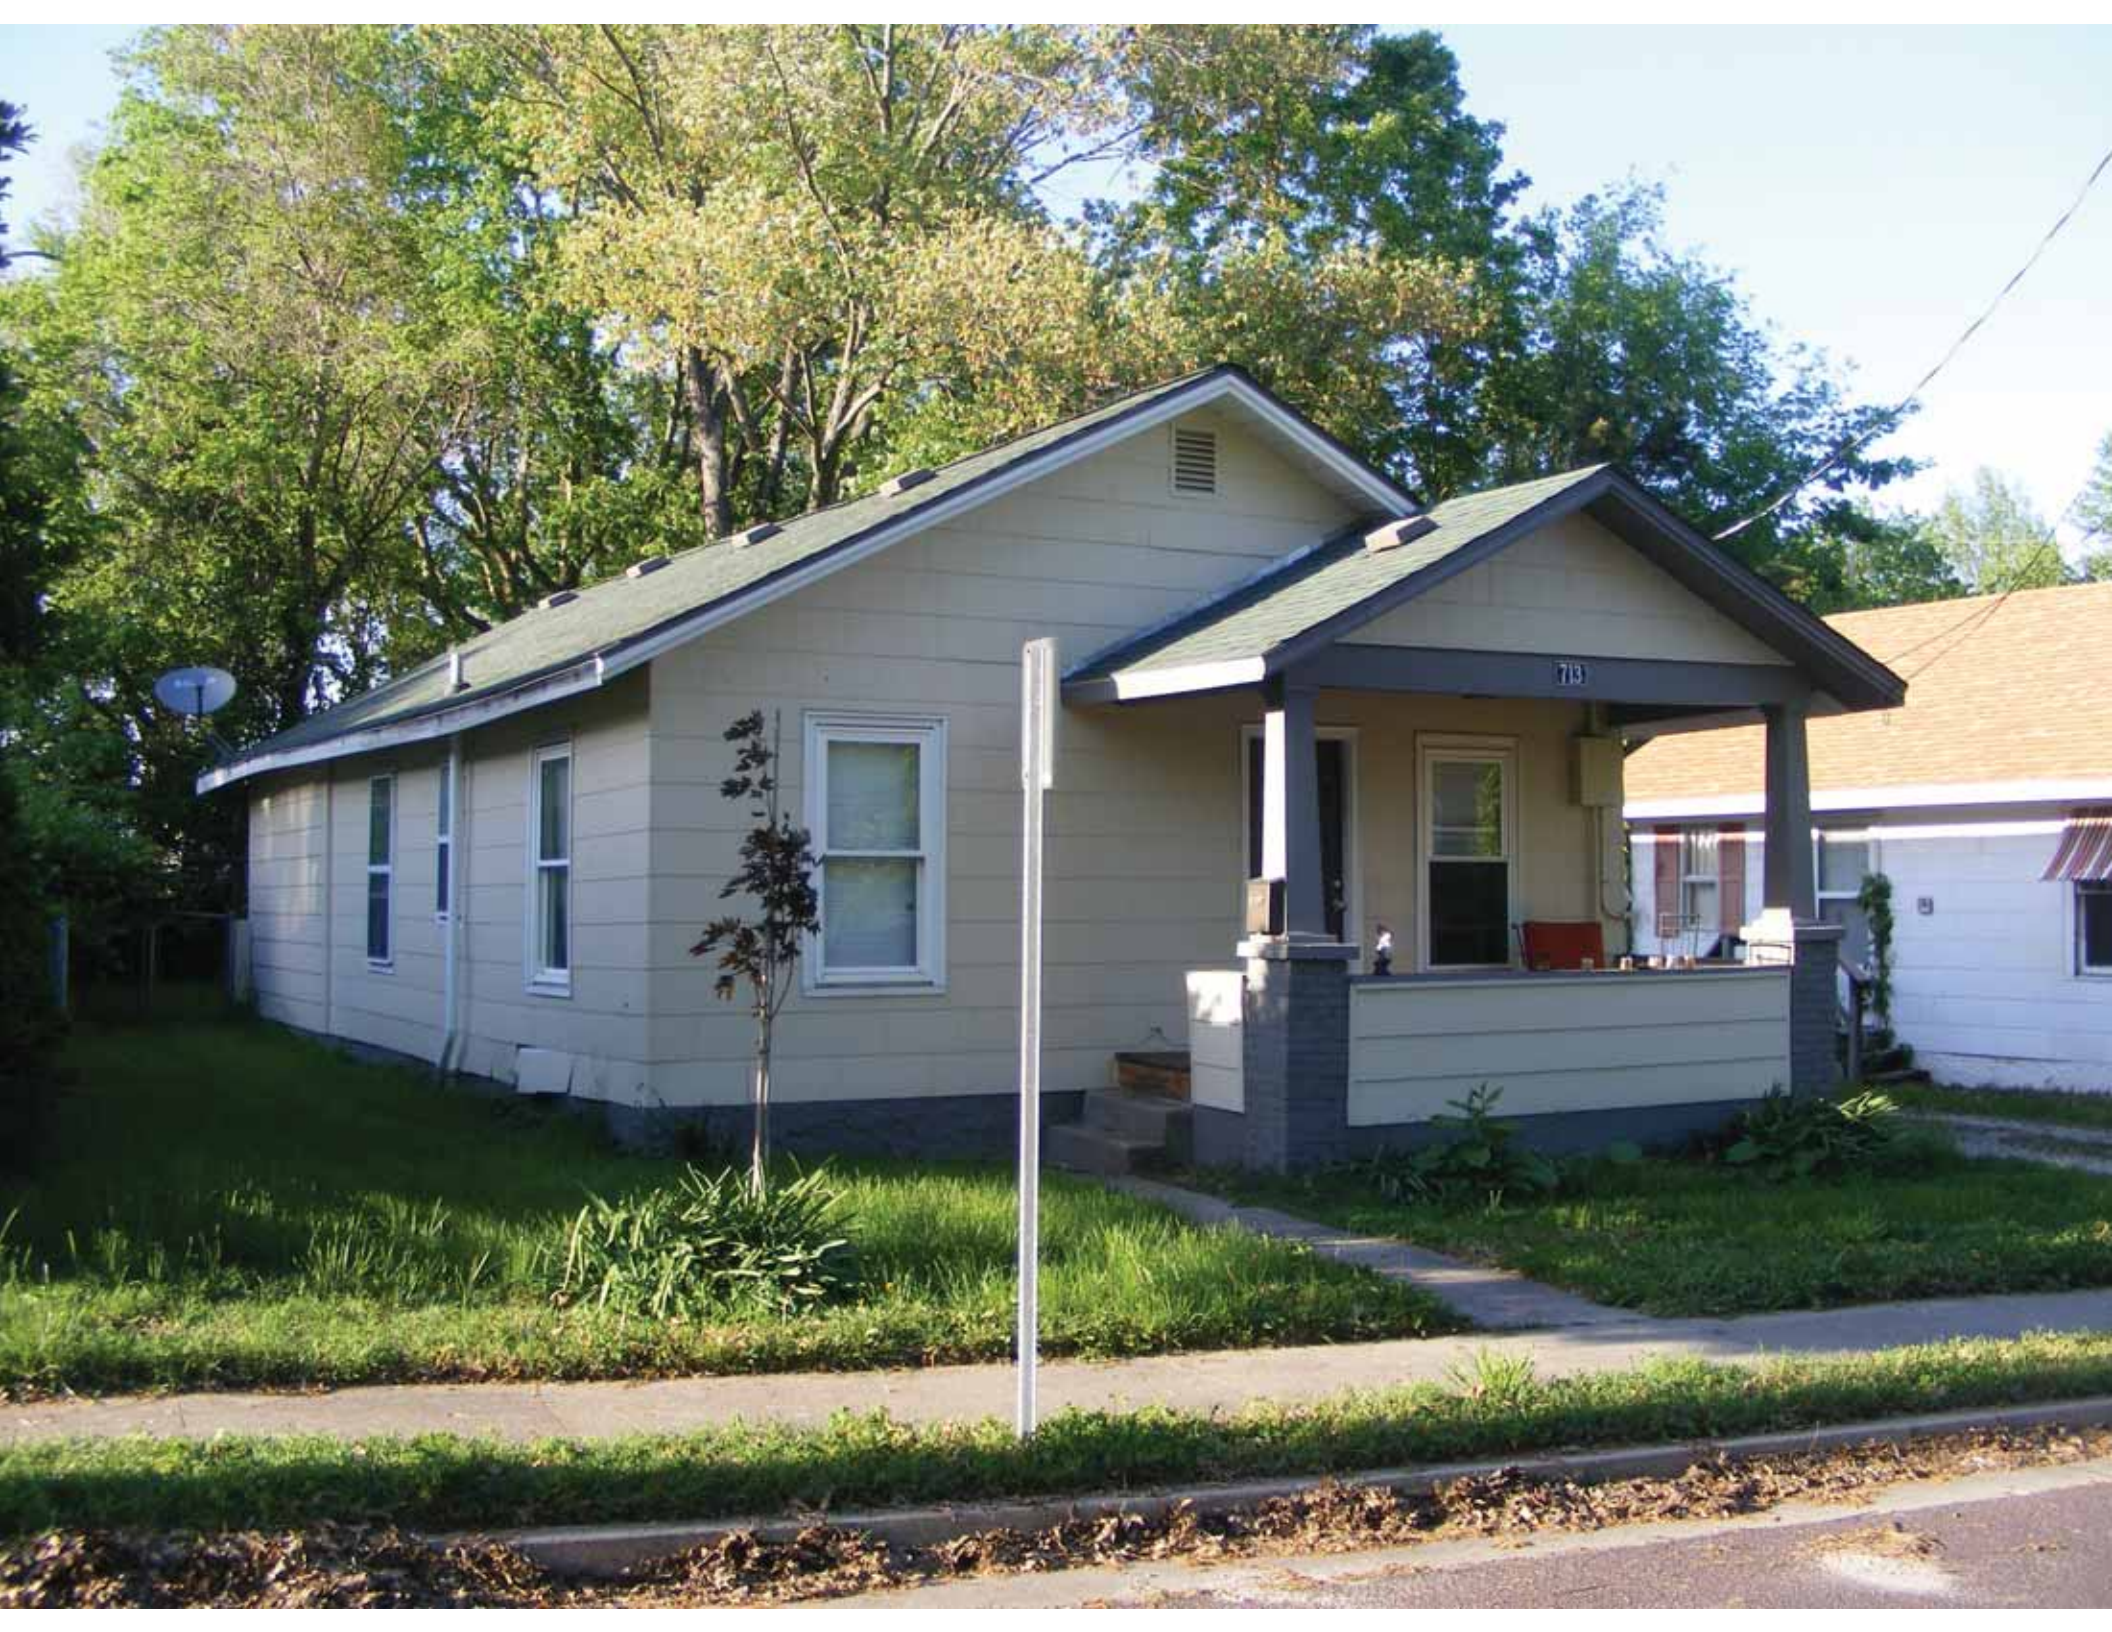
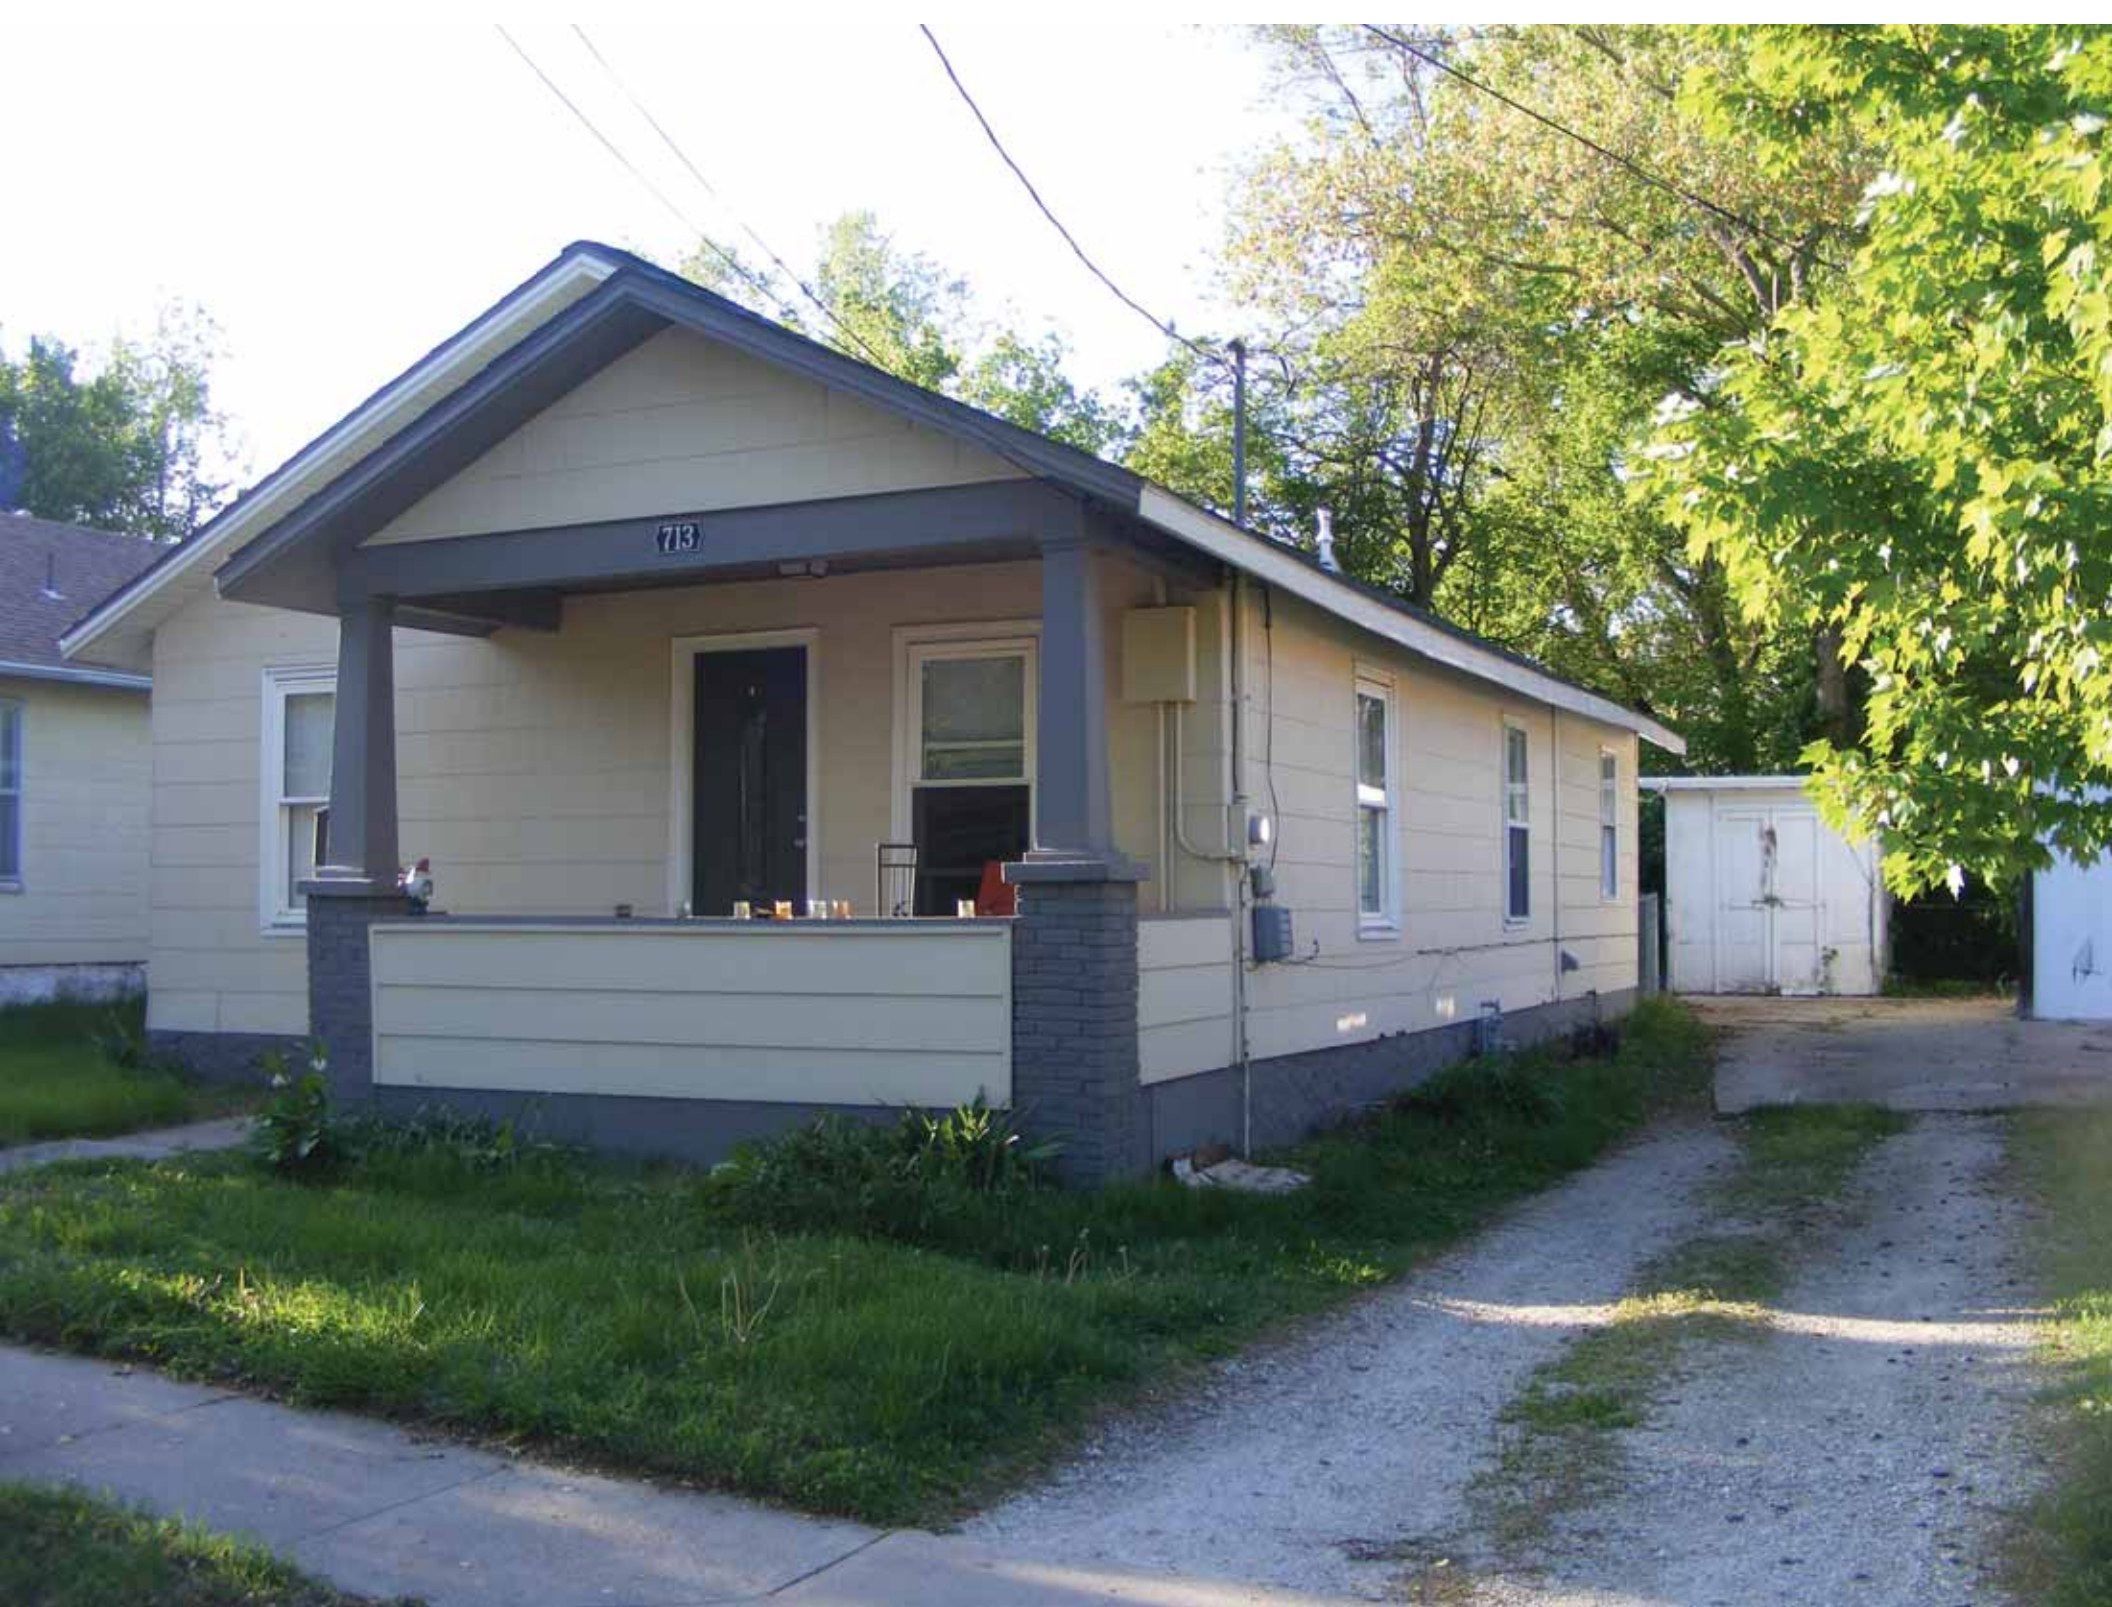
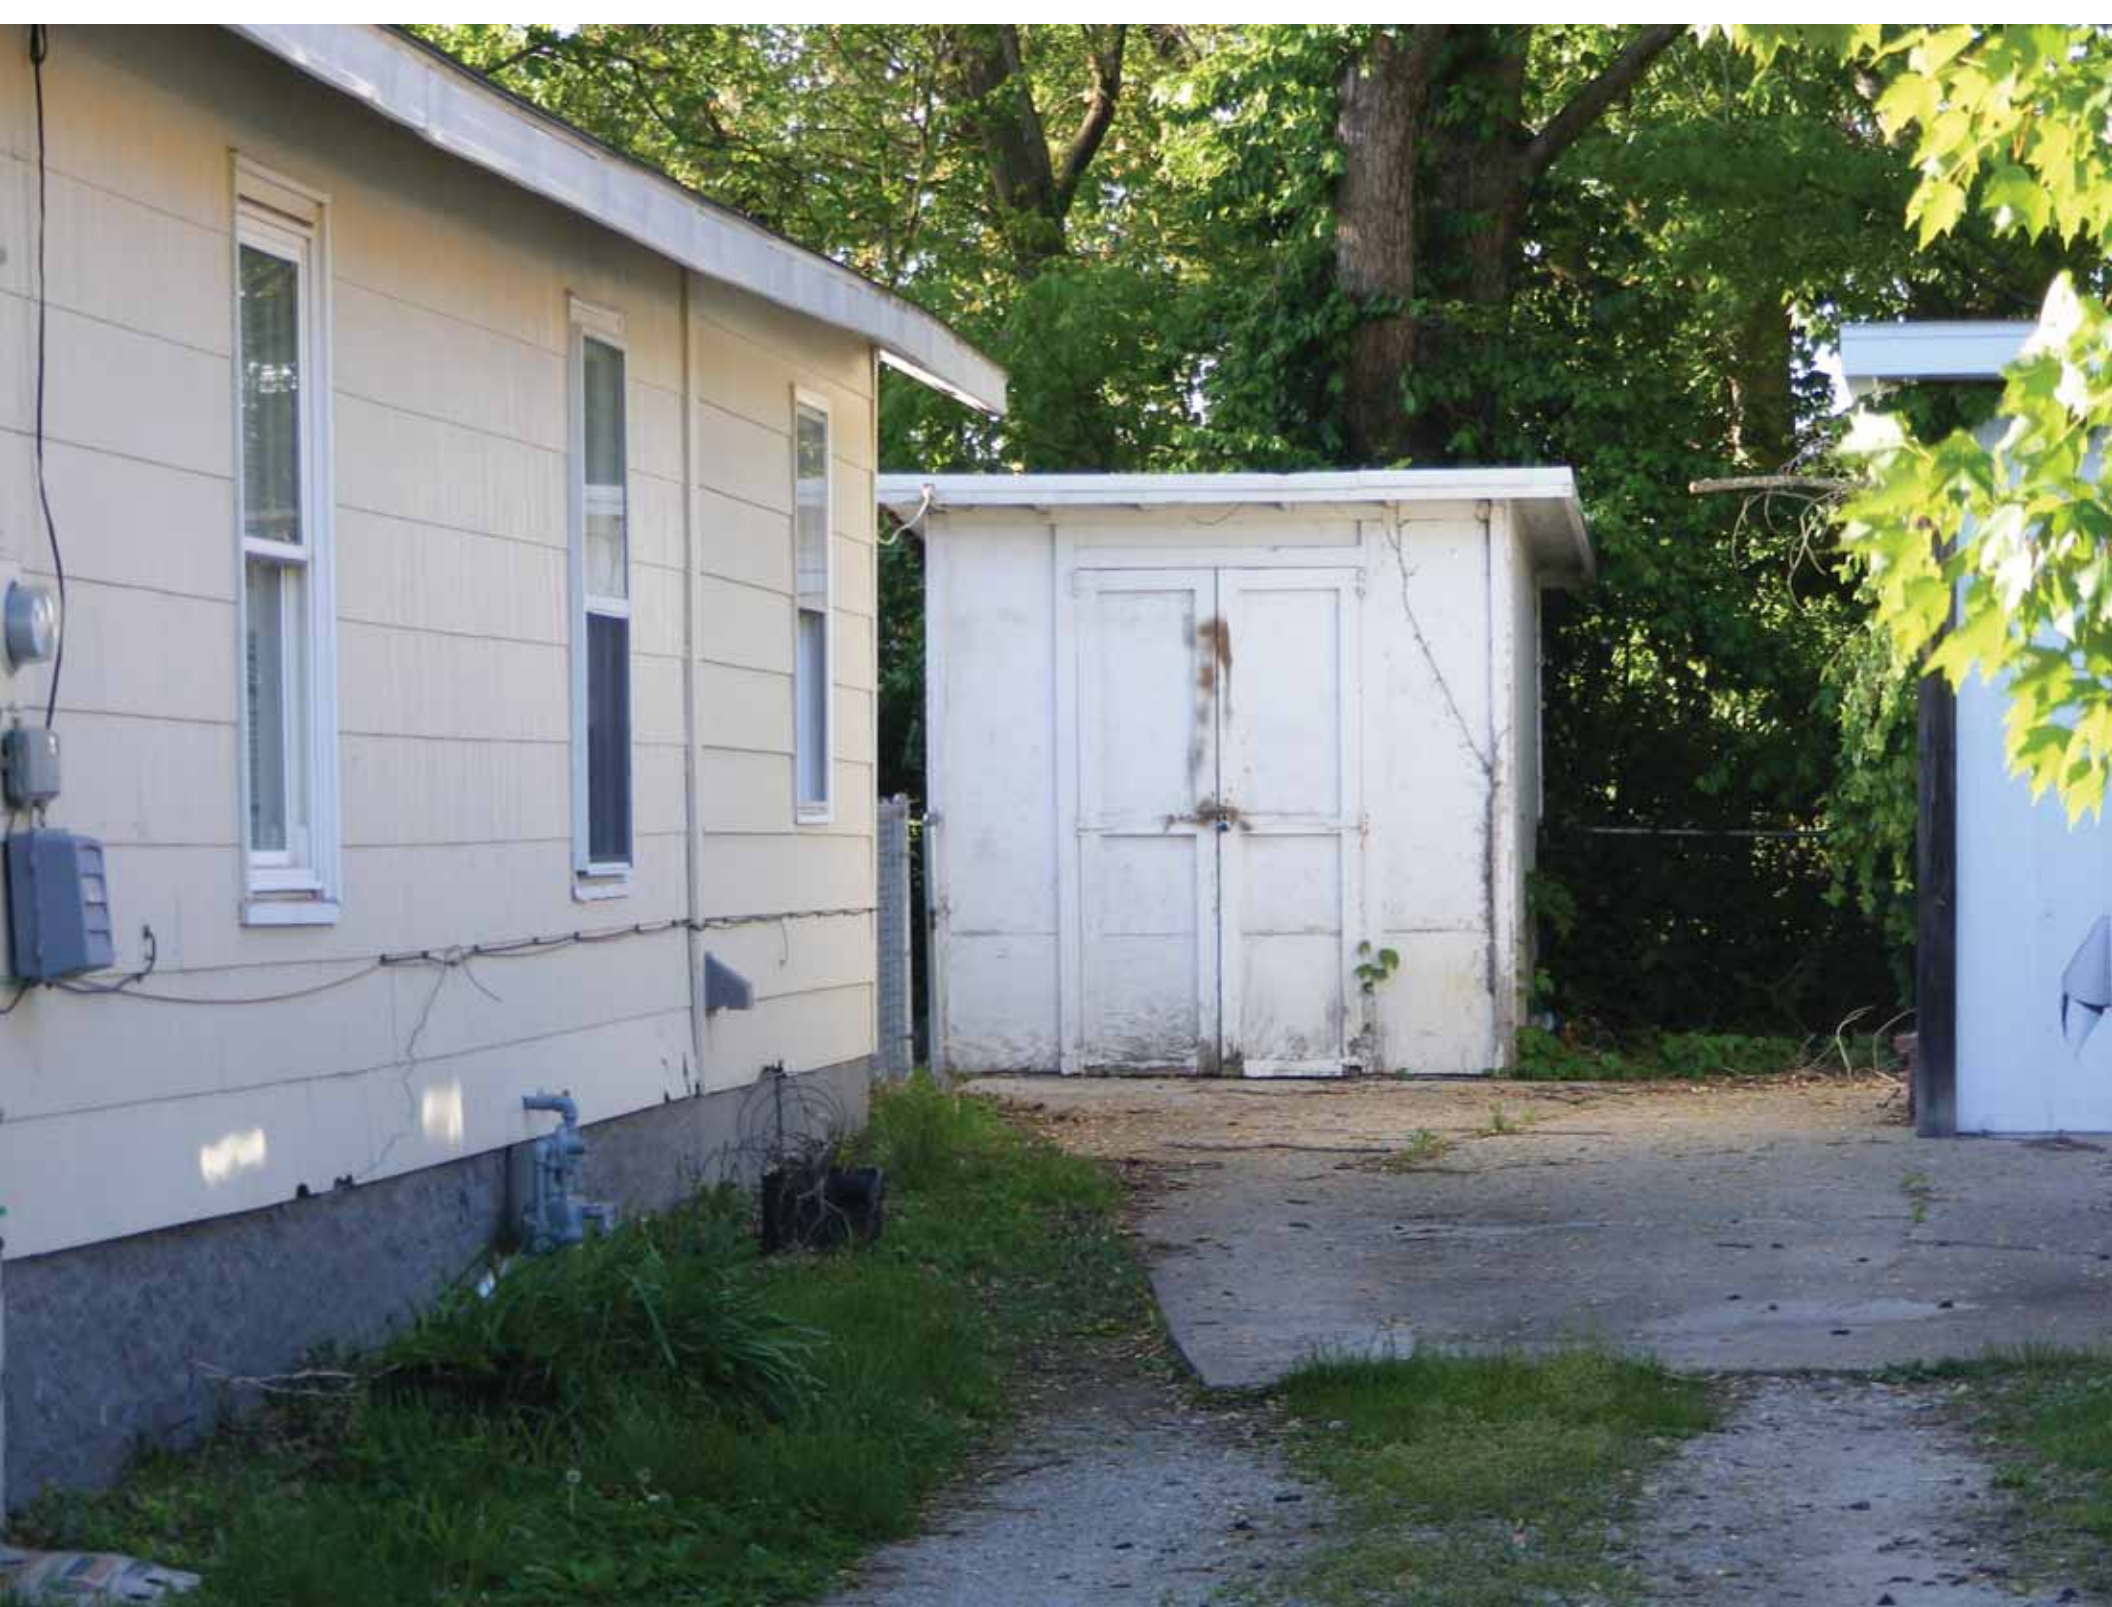
The gable-front plan dwelling has an asphalt shingled gable roof, enclosed eaves, asbestos shingle siding and a rubble concrete foundation. The primary (south) elevation supports an off-center gabled porch supported by two tapered columns on brick piers. The porch balustrade is clad with asbestos shingles. Within the porch bay is a primary entry filled with a contemporary single-light door. The door is flanked by one-over-one replacement windows. The front gable field retains a louvered vent.
