MISSOURI DEPARTMENT OF NATURAL RESOURCES
STATE HISTORIC PRESERVATION OFFICE, P.O. Box 176, Jefferson City, MO 65102
ARCHITECTURAL/HISTORIC INVENTORY FORM

1. Survey No. BO-AS-011-0087		2. Survey name: North Central Columbia Survey Phase II	
3. County: Boone		4. Address (Street No.) 902	Street (name) N. Seventh Street
5. City: Columbia	Vicinity: <input type="checkbox"/>	6. Geographical Reference:	7. Township/Range/Section: T: R: S:
8. Historic name (if known):		9. Present/other name (if known):	
10. Ownership: <input checked="" type="checkbox"/> Private <input type="checkbox"/> Public		11a. Historic use (if known): Domestic/single dwelling	11b. Current use: Domestic/single dwelling

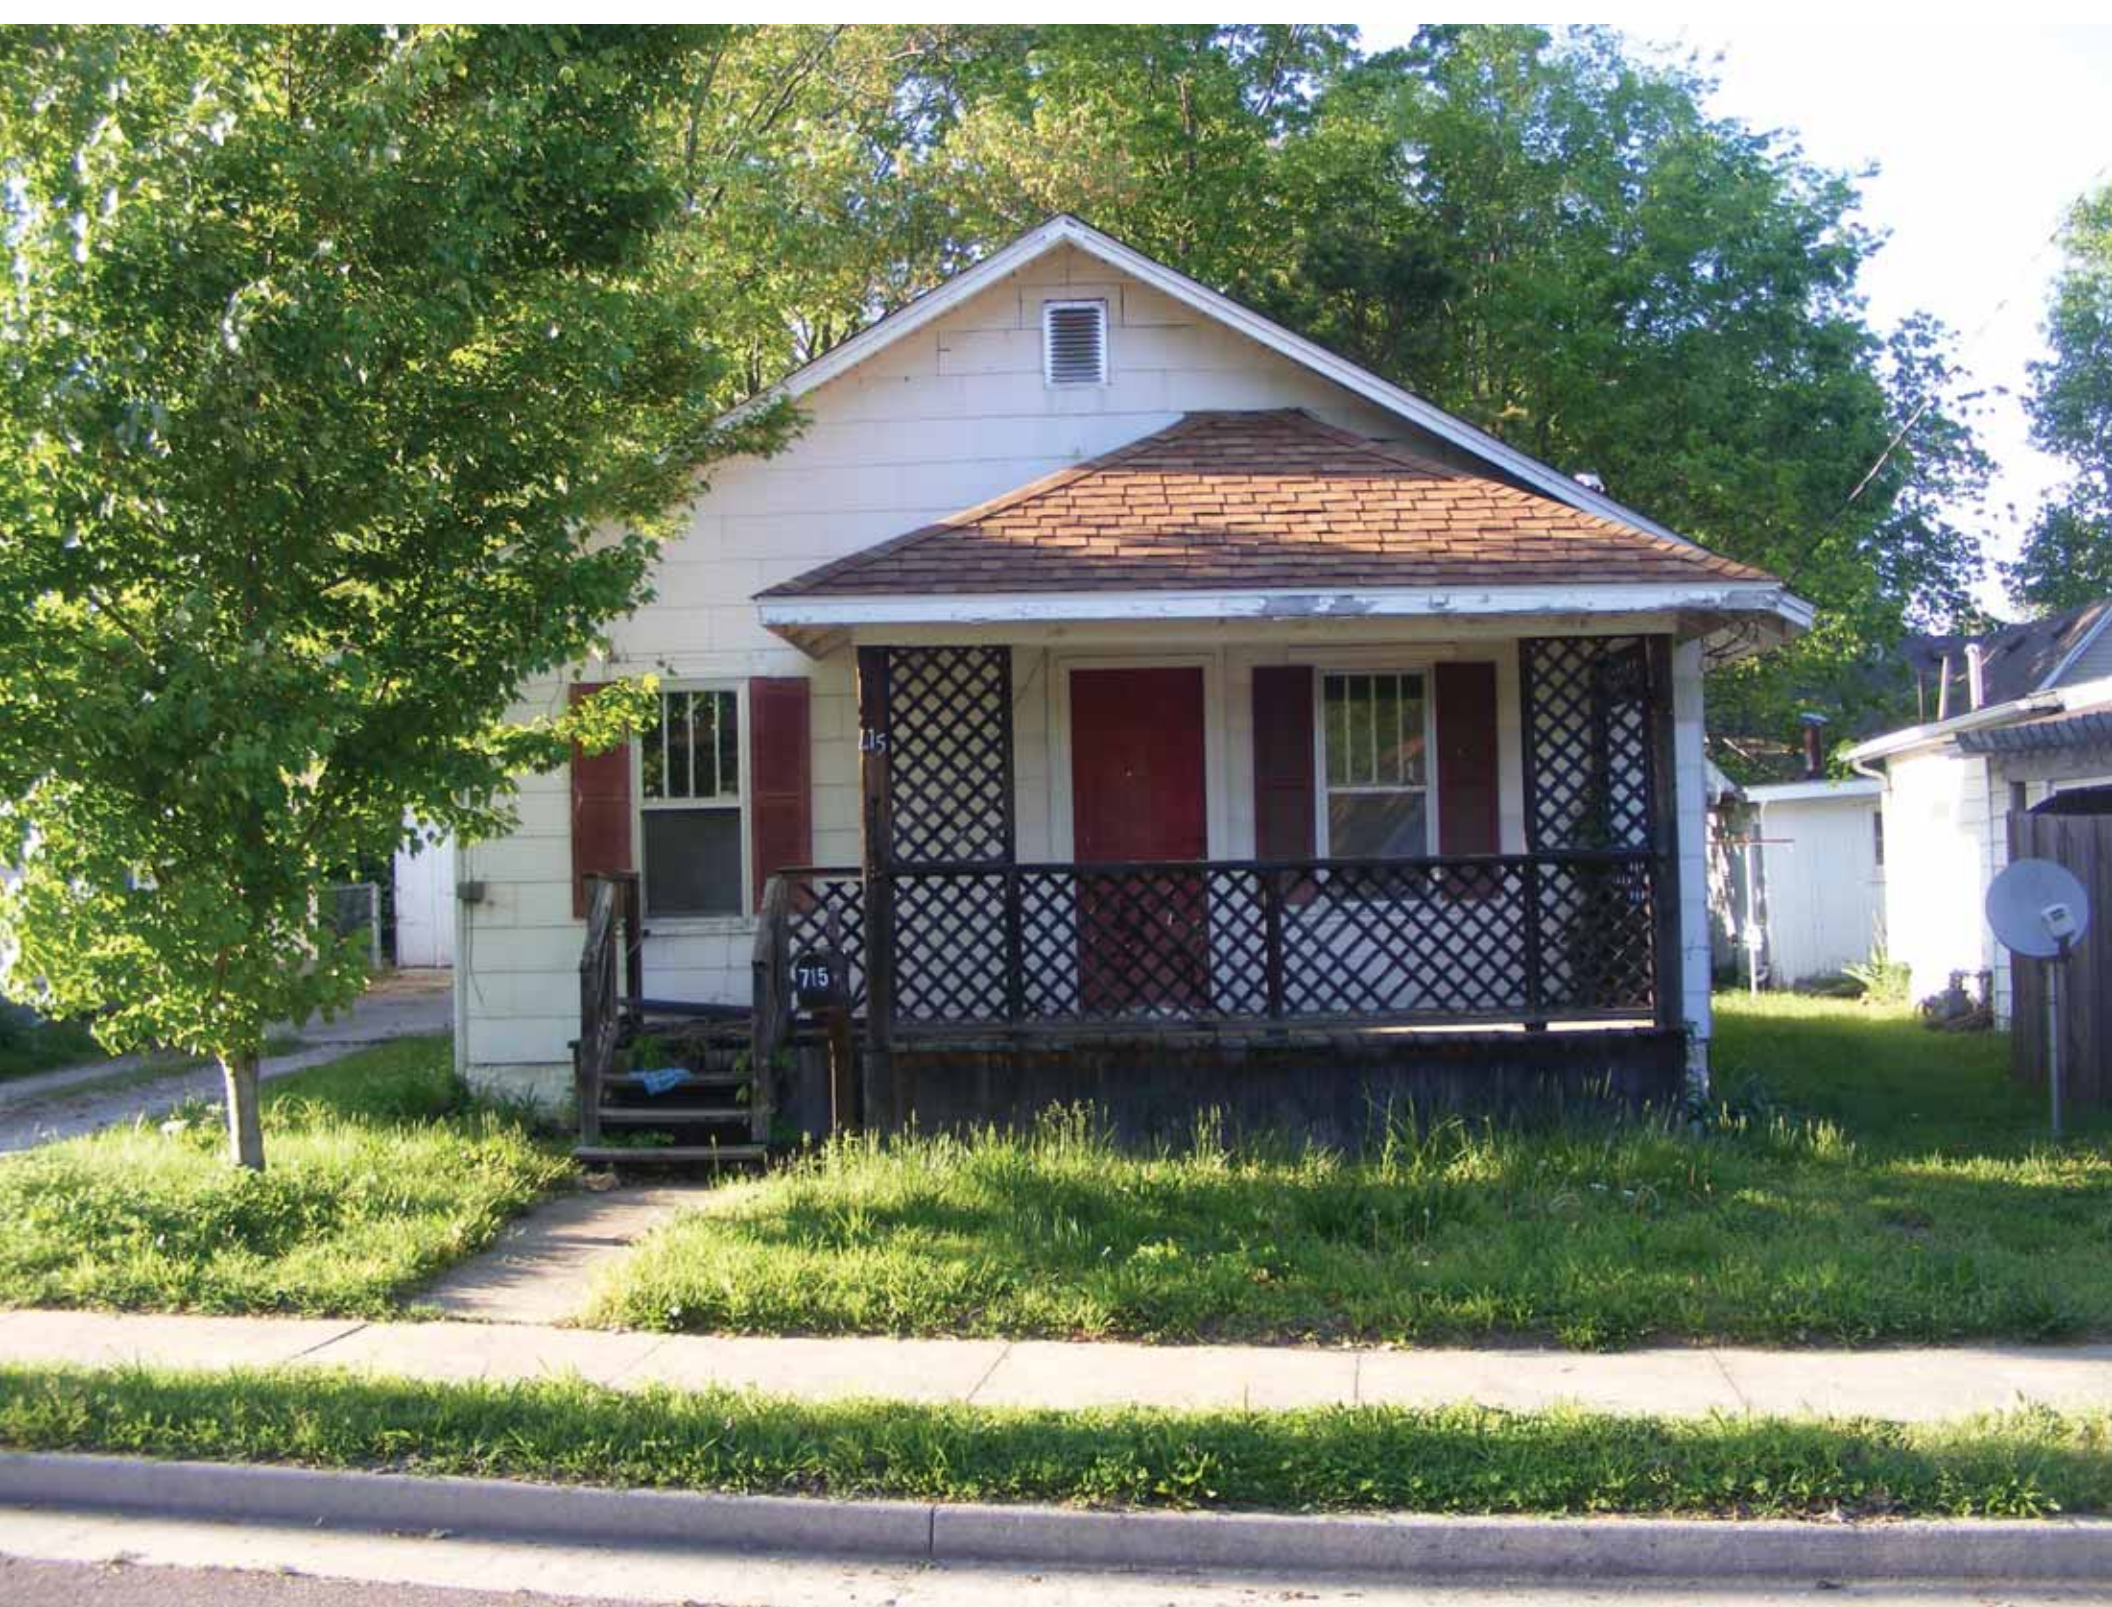
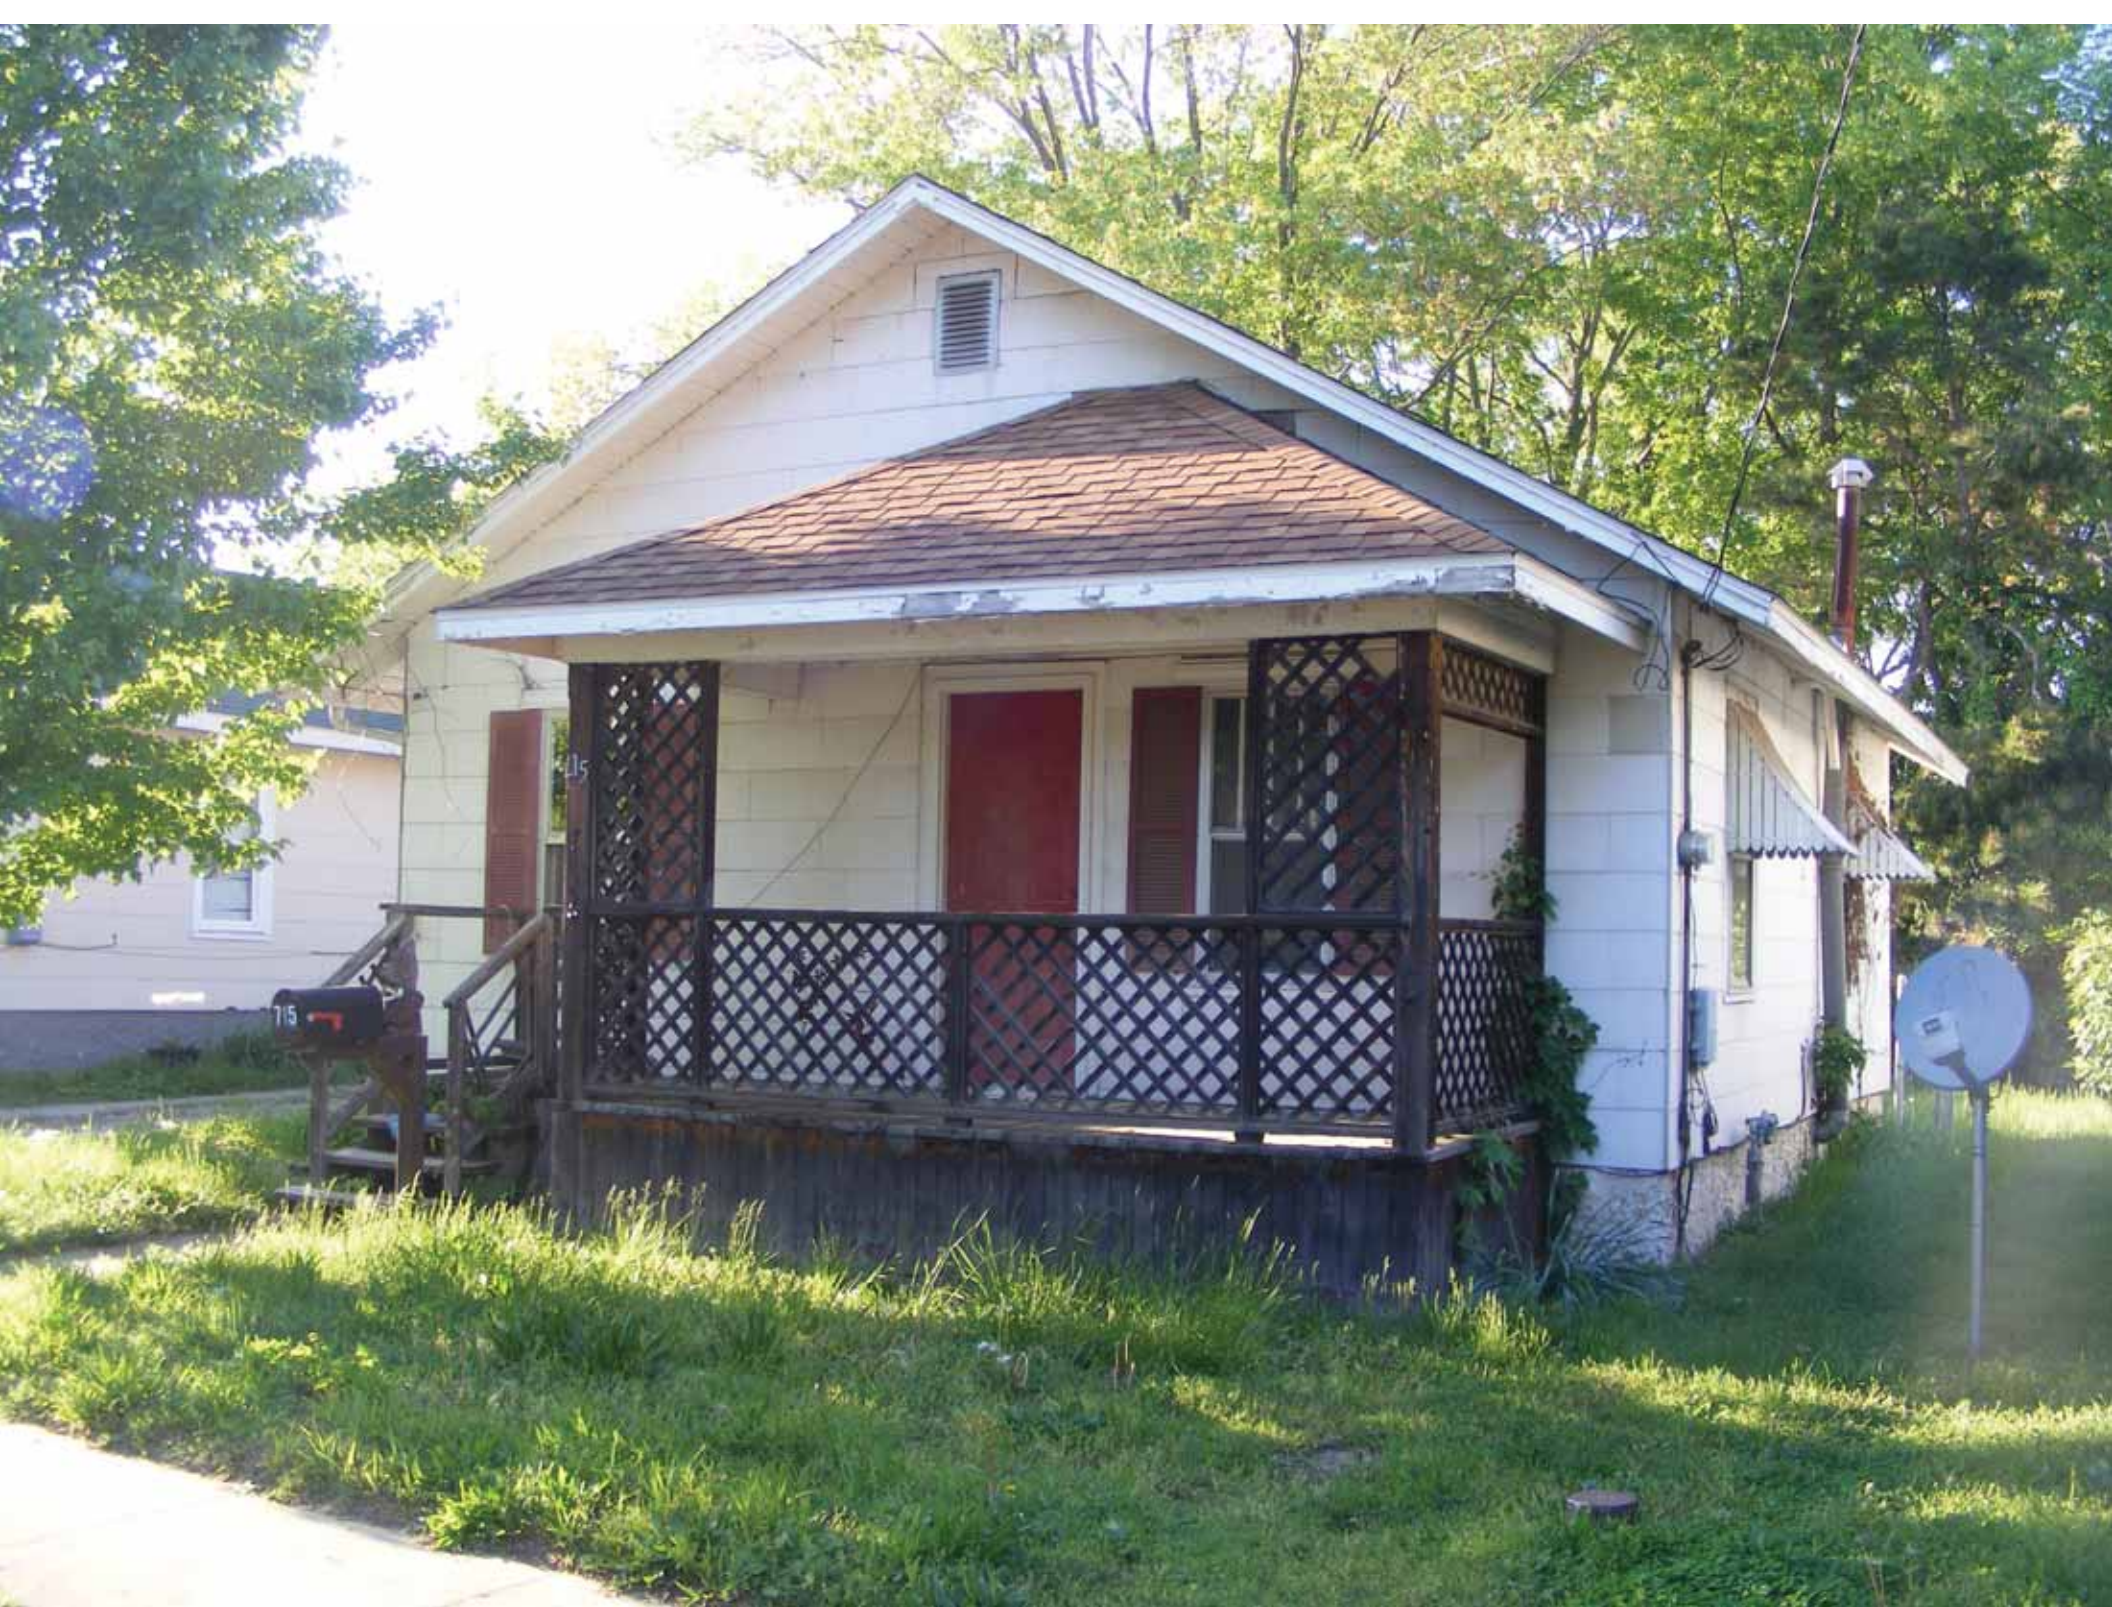
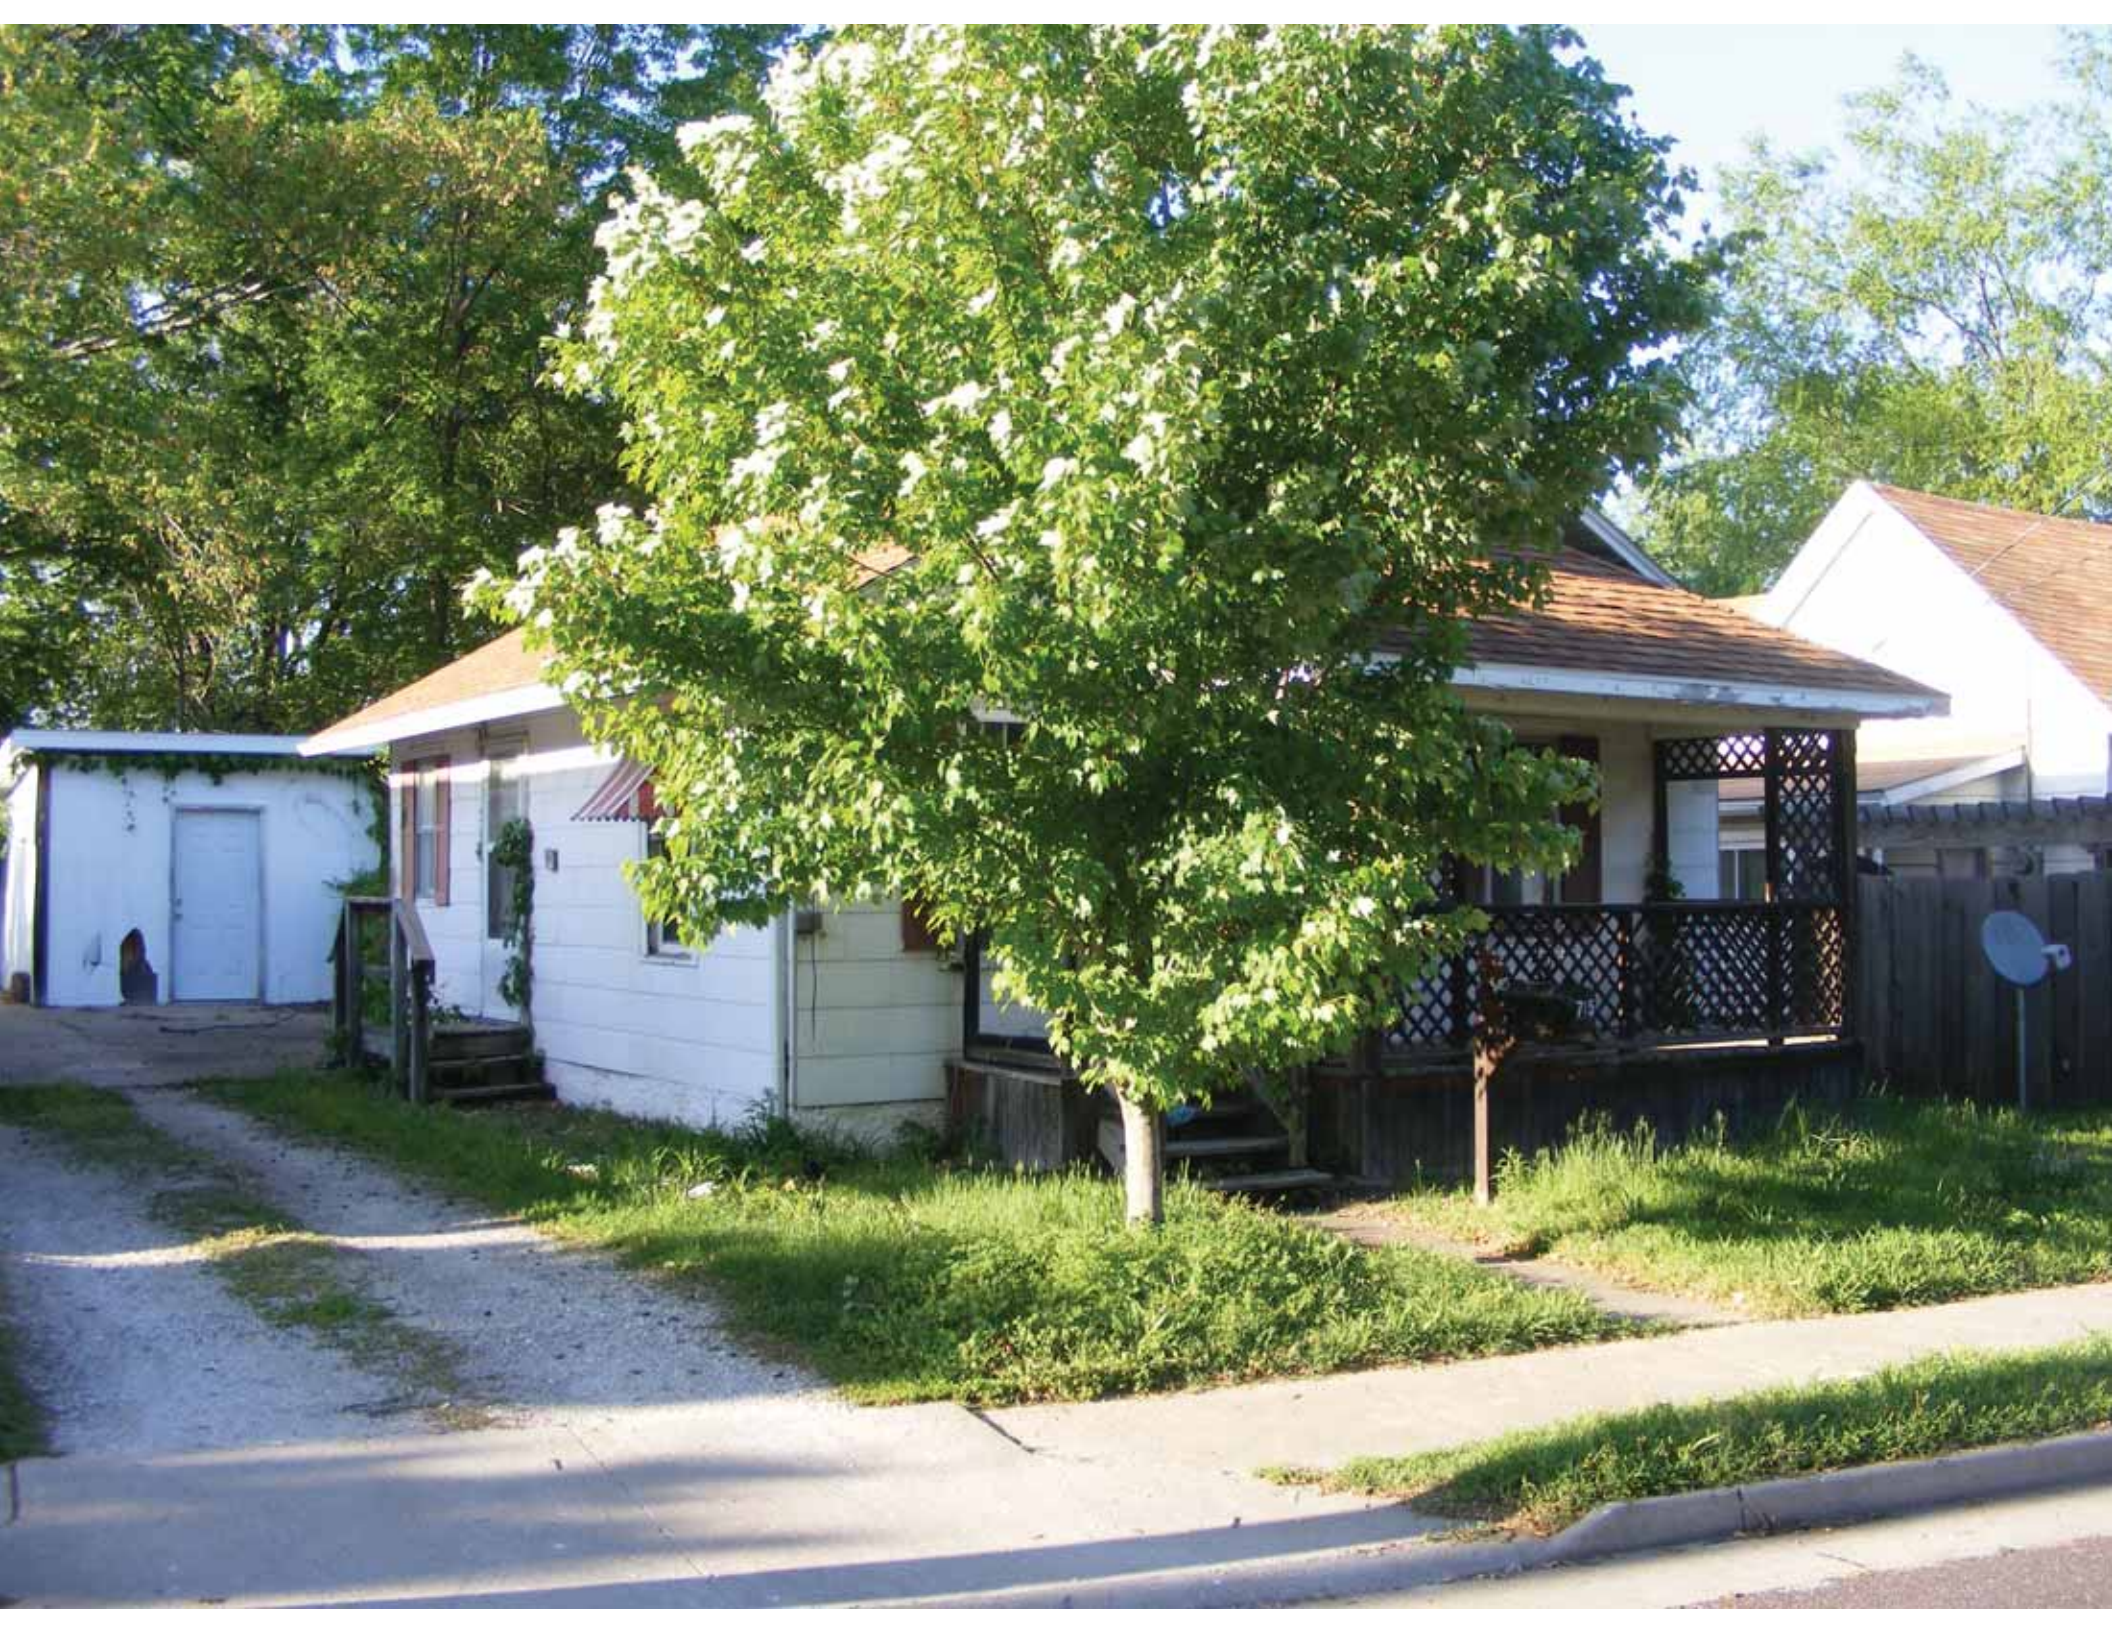
The dwelling has an asphalt-shingled front gabled roof, exterior asbestos shingle siding and a concrete foundation. The primary (south) elevation has an off-center hipped roof supported by non-original wood columns. The balustrade is lattice. Lattice offsets the porch columns as well. Within the porch bay is a c. 2000 paneled door flanked by original four-over-one windows with faux shutters. The front gable field holds a louvered vent. The west elevation has a secondary entry and original windows. One window has a metal awning.
