MISSOURI DEPARTMENT OF NATURAL RESOURCES
STATE HISTORIC PRESERVATION OFFICE, P.O. Box 176, Jefferson City, MO 65102
ARCHITECTURAL/HISTORIC INVENTORY FORM

1. Survey No. BO-AS-011-0087		2. Survey name: North Central Columbia Survey Phase II	
3. County: Boone		4. Address (Street No.) 902	Street (name) N. Seventh Street
5. City: Columbia	Vicinity: <input type="checkbox"/>	6. Geographical Reference:	7. Township/Range/Section: T: R: S:
8. Historic name (if known):		9. Present/other name (if known):	
10. Ownership: <input checked="" type="checkbox"/> Private <input type="checkbox"/> Public		11a. Historic use (if known): Domestic/single dwelling	11b. Current use: Domestic/single dwelling

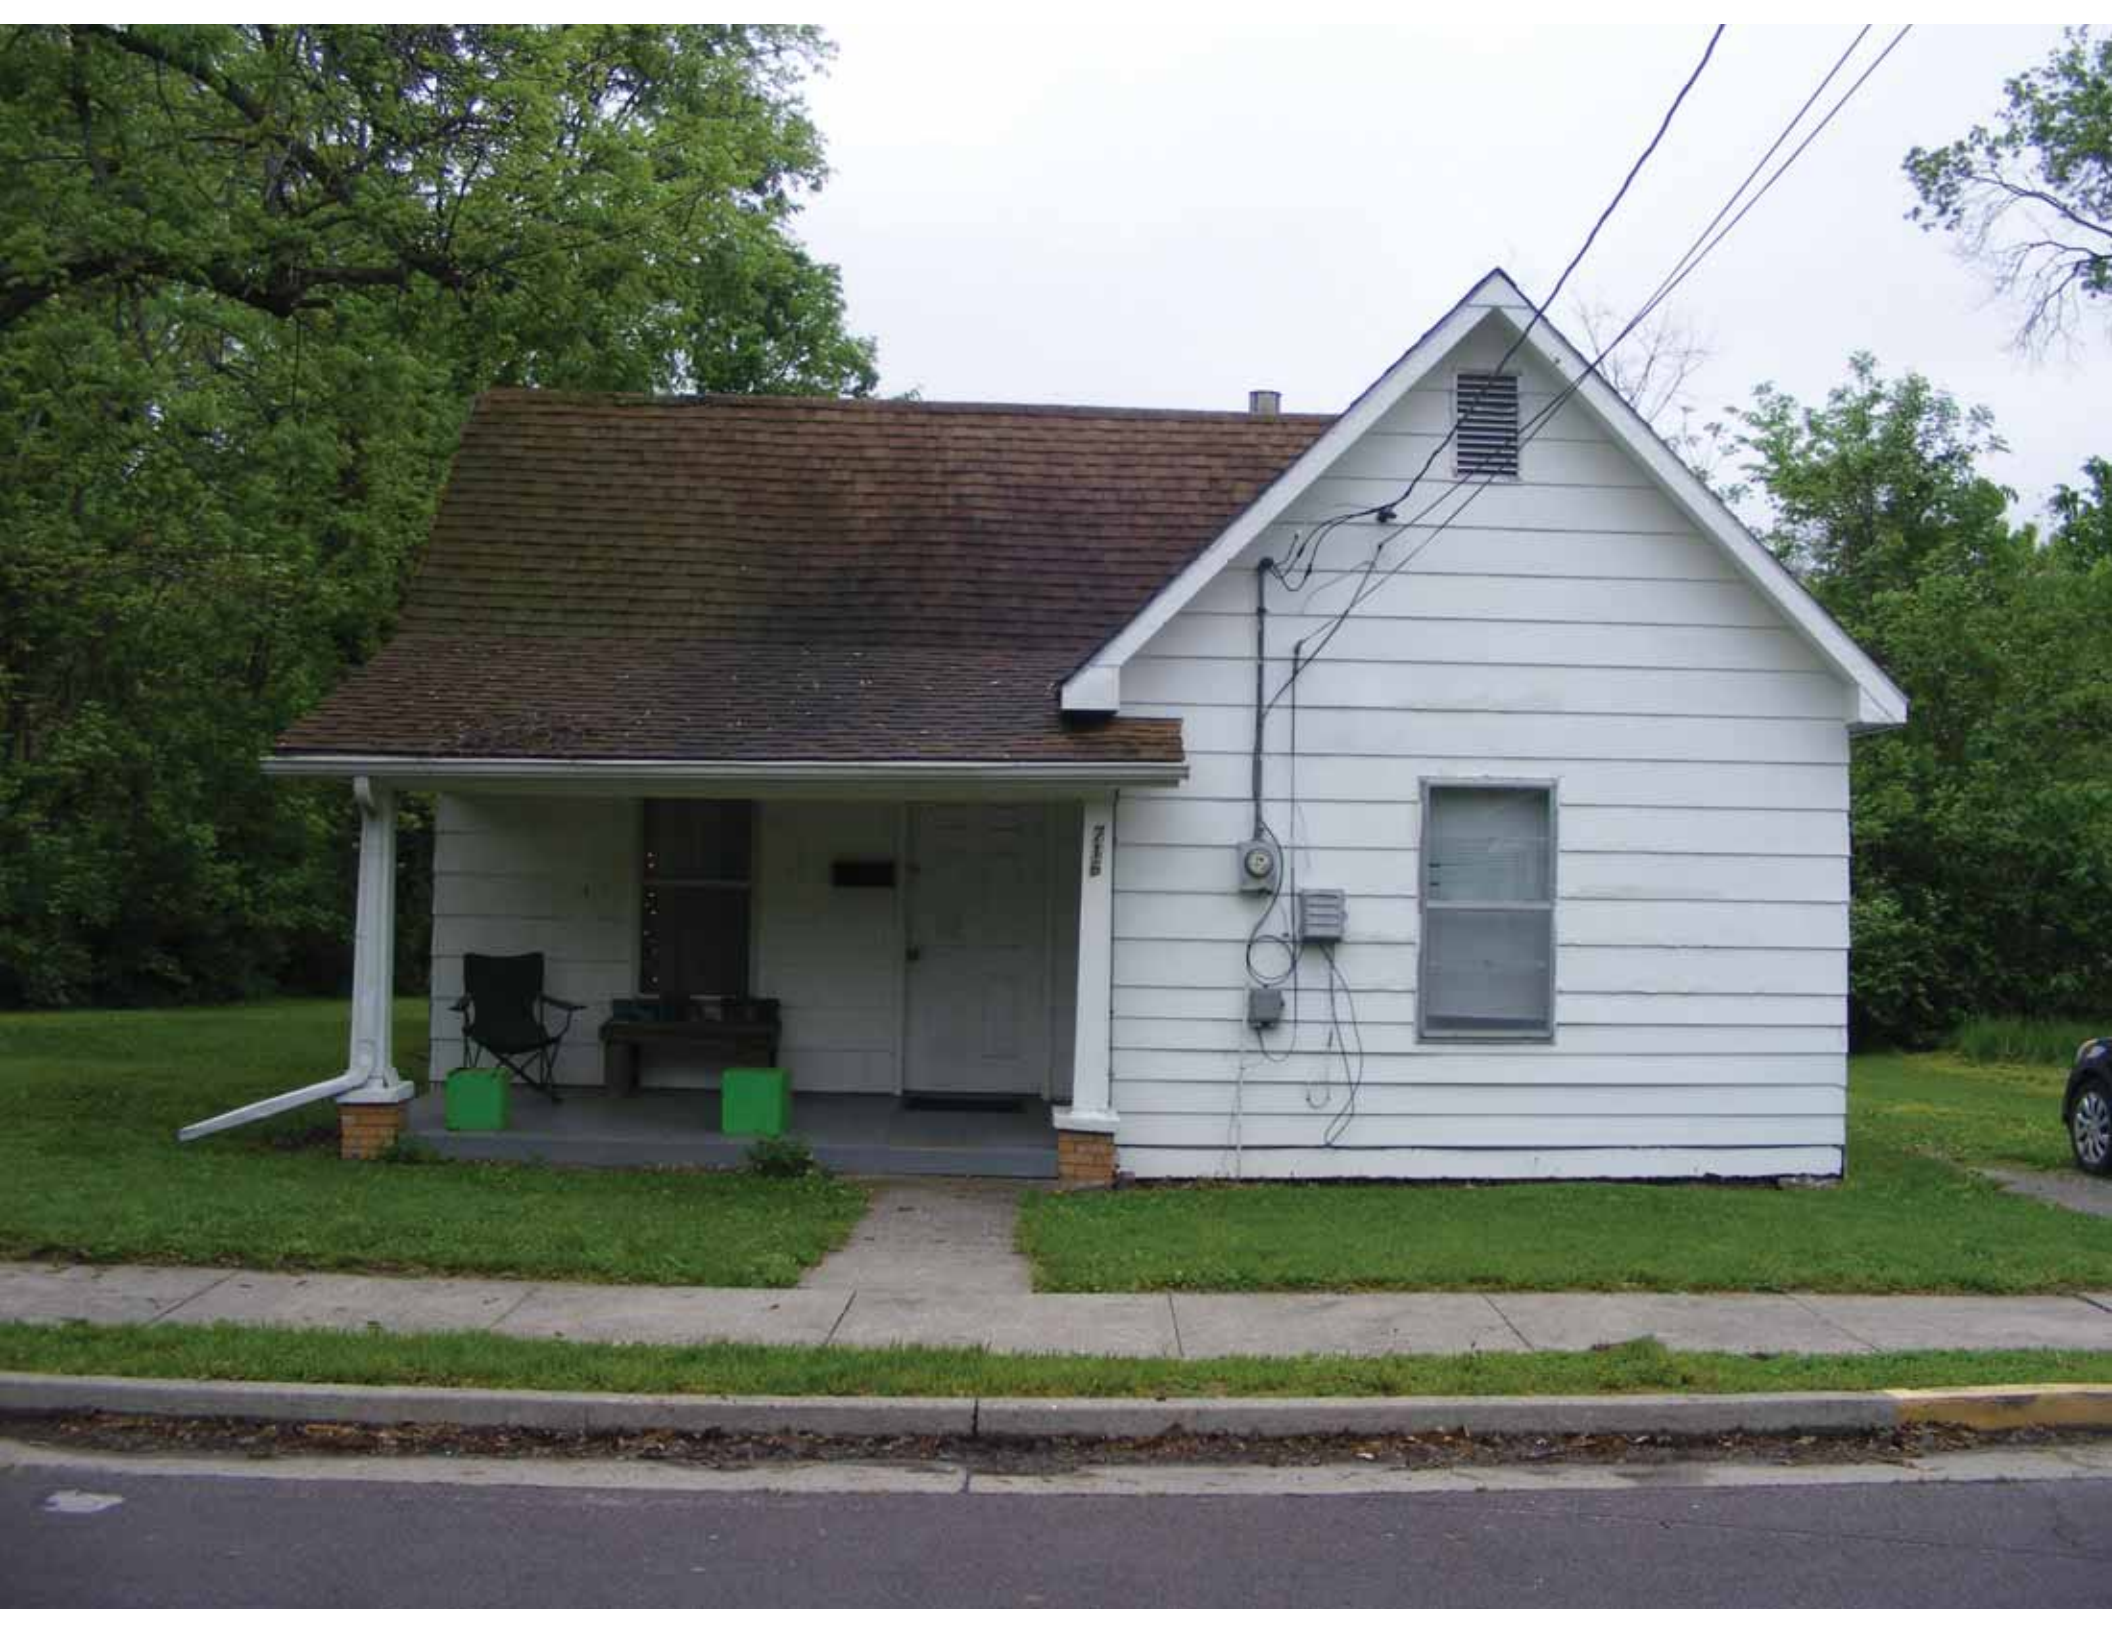
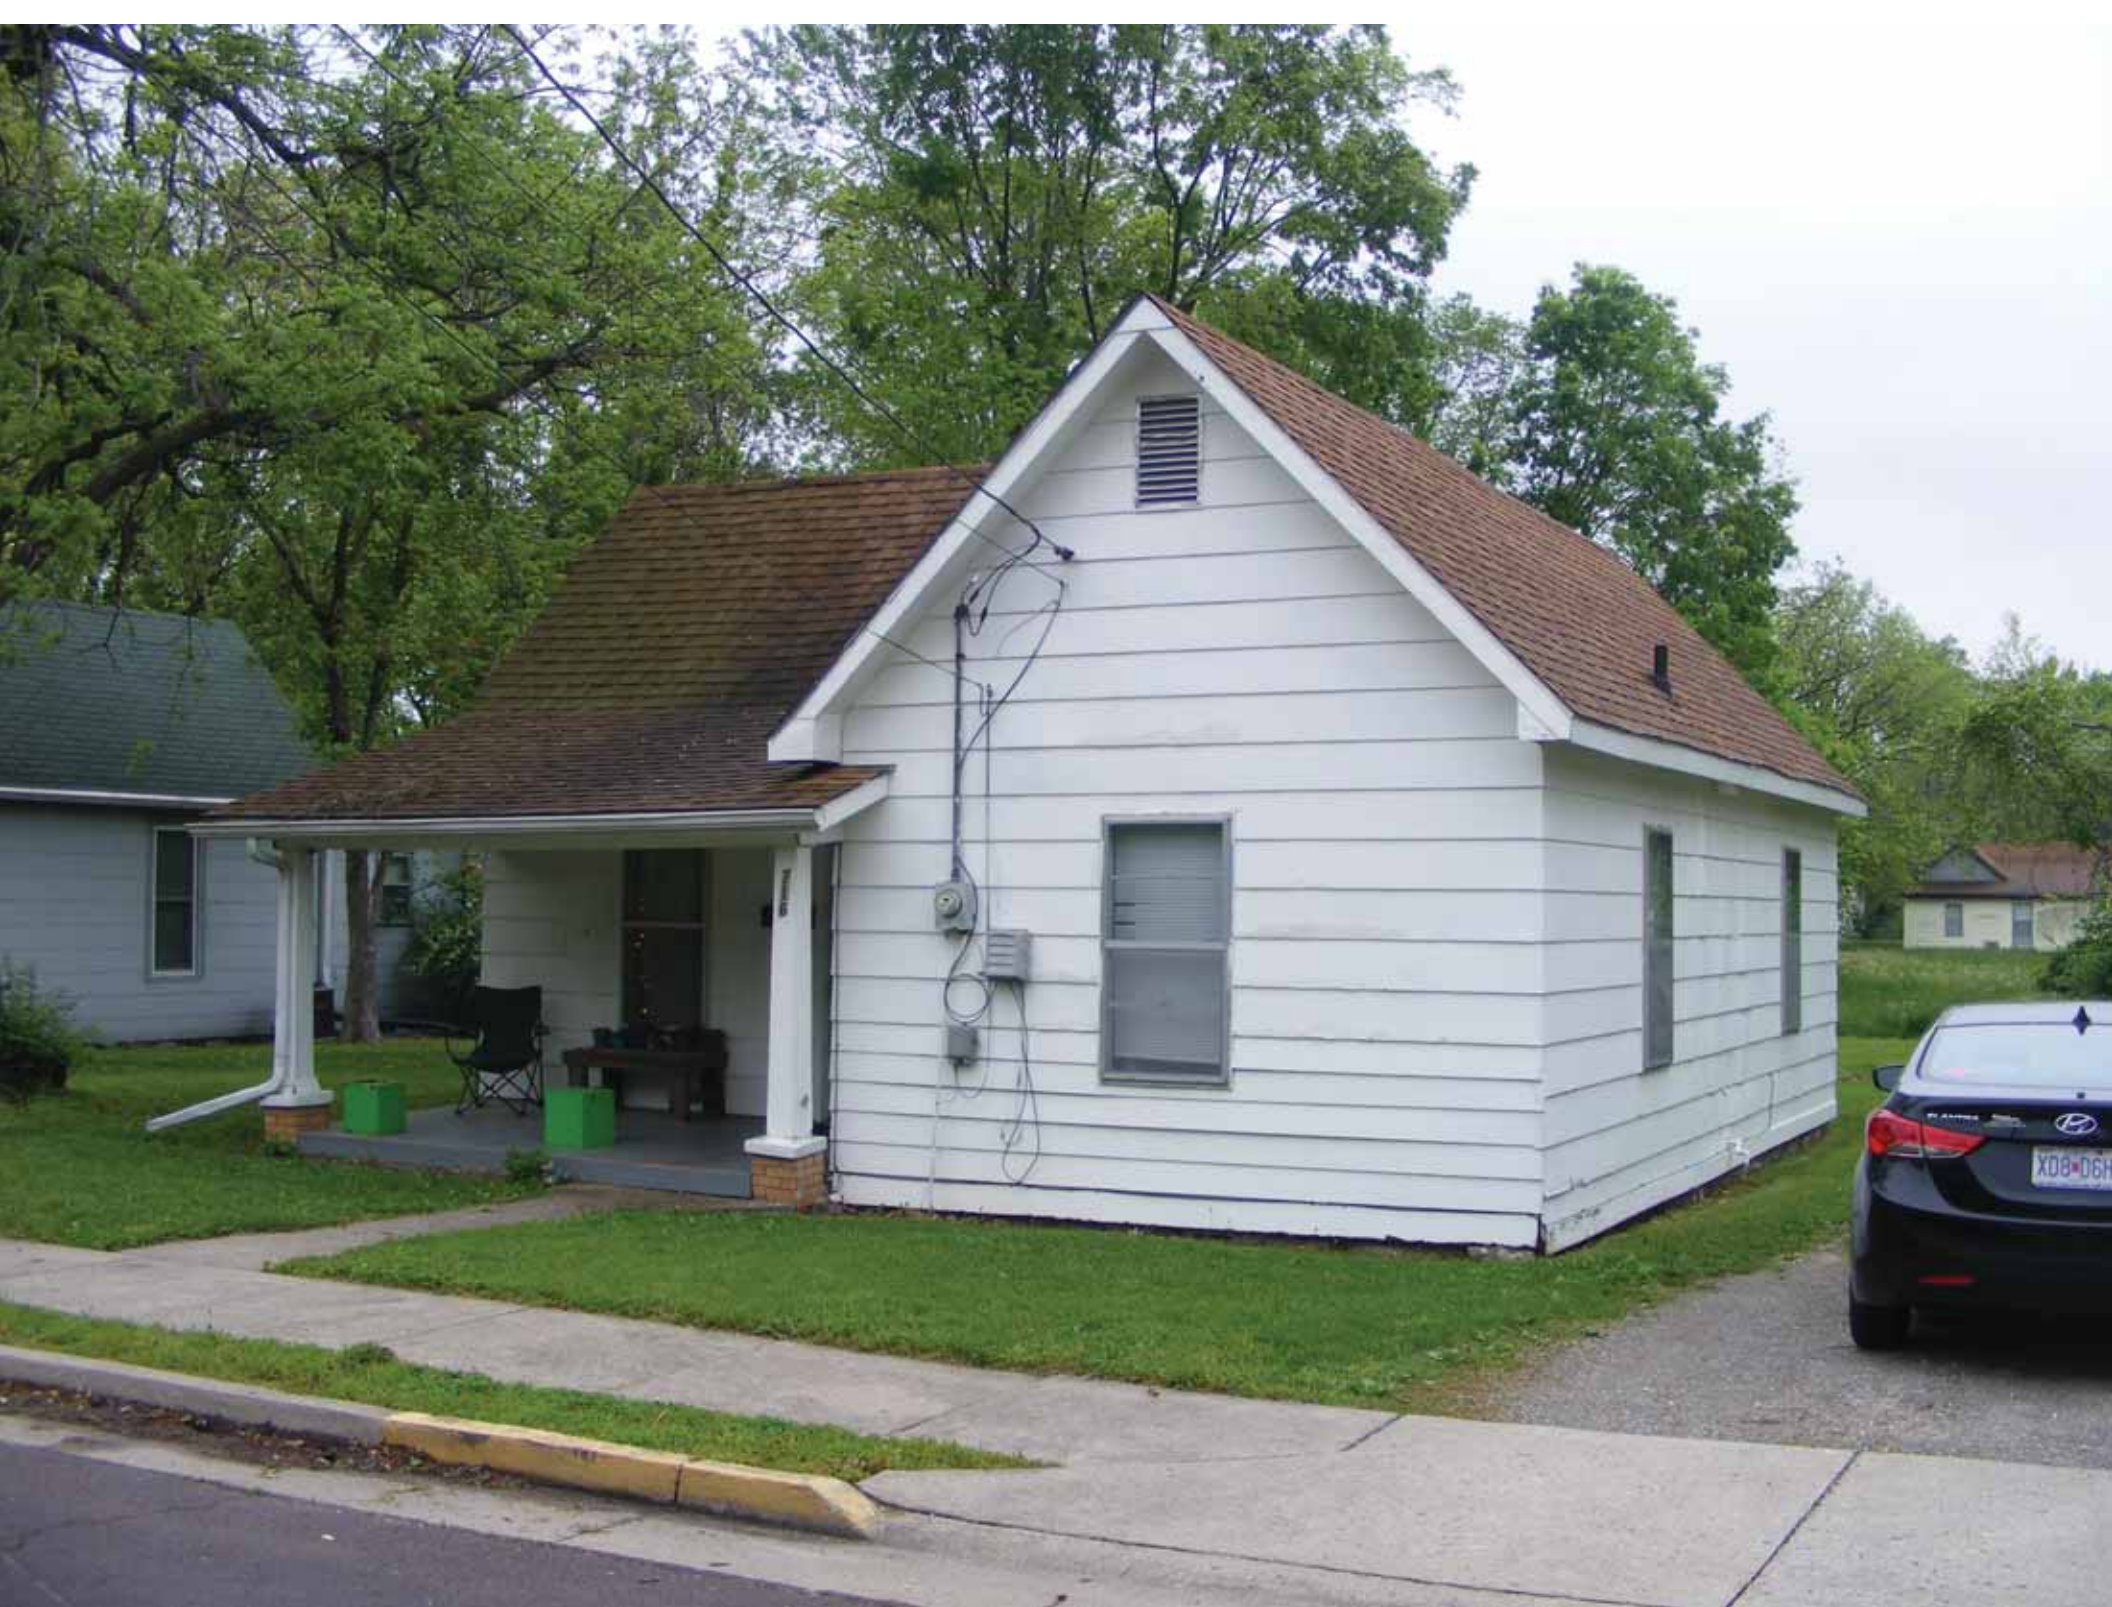
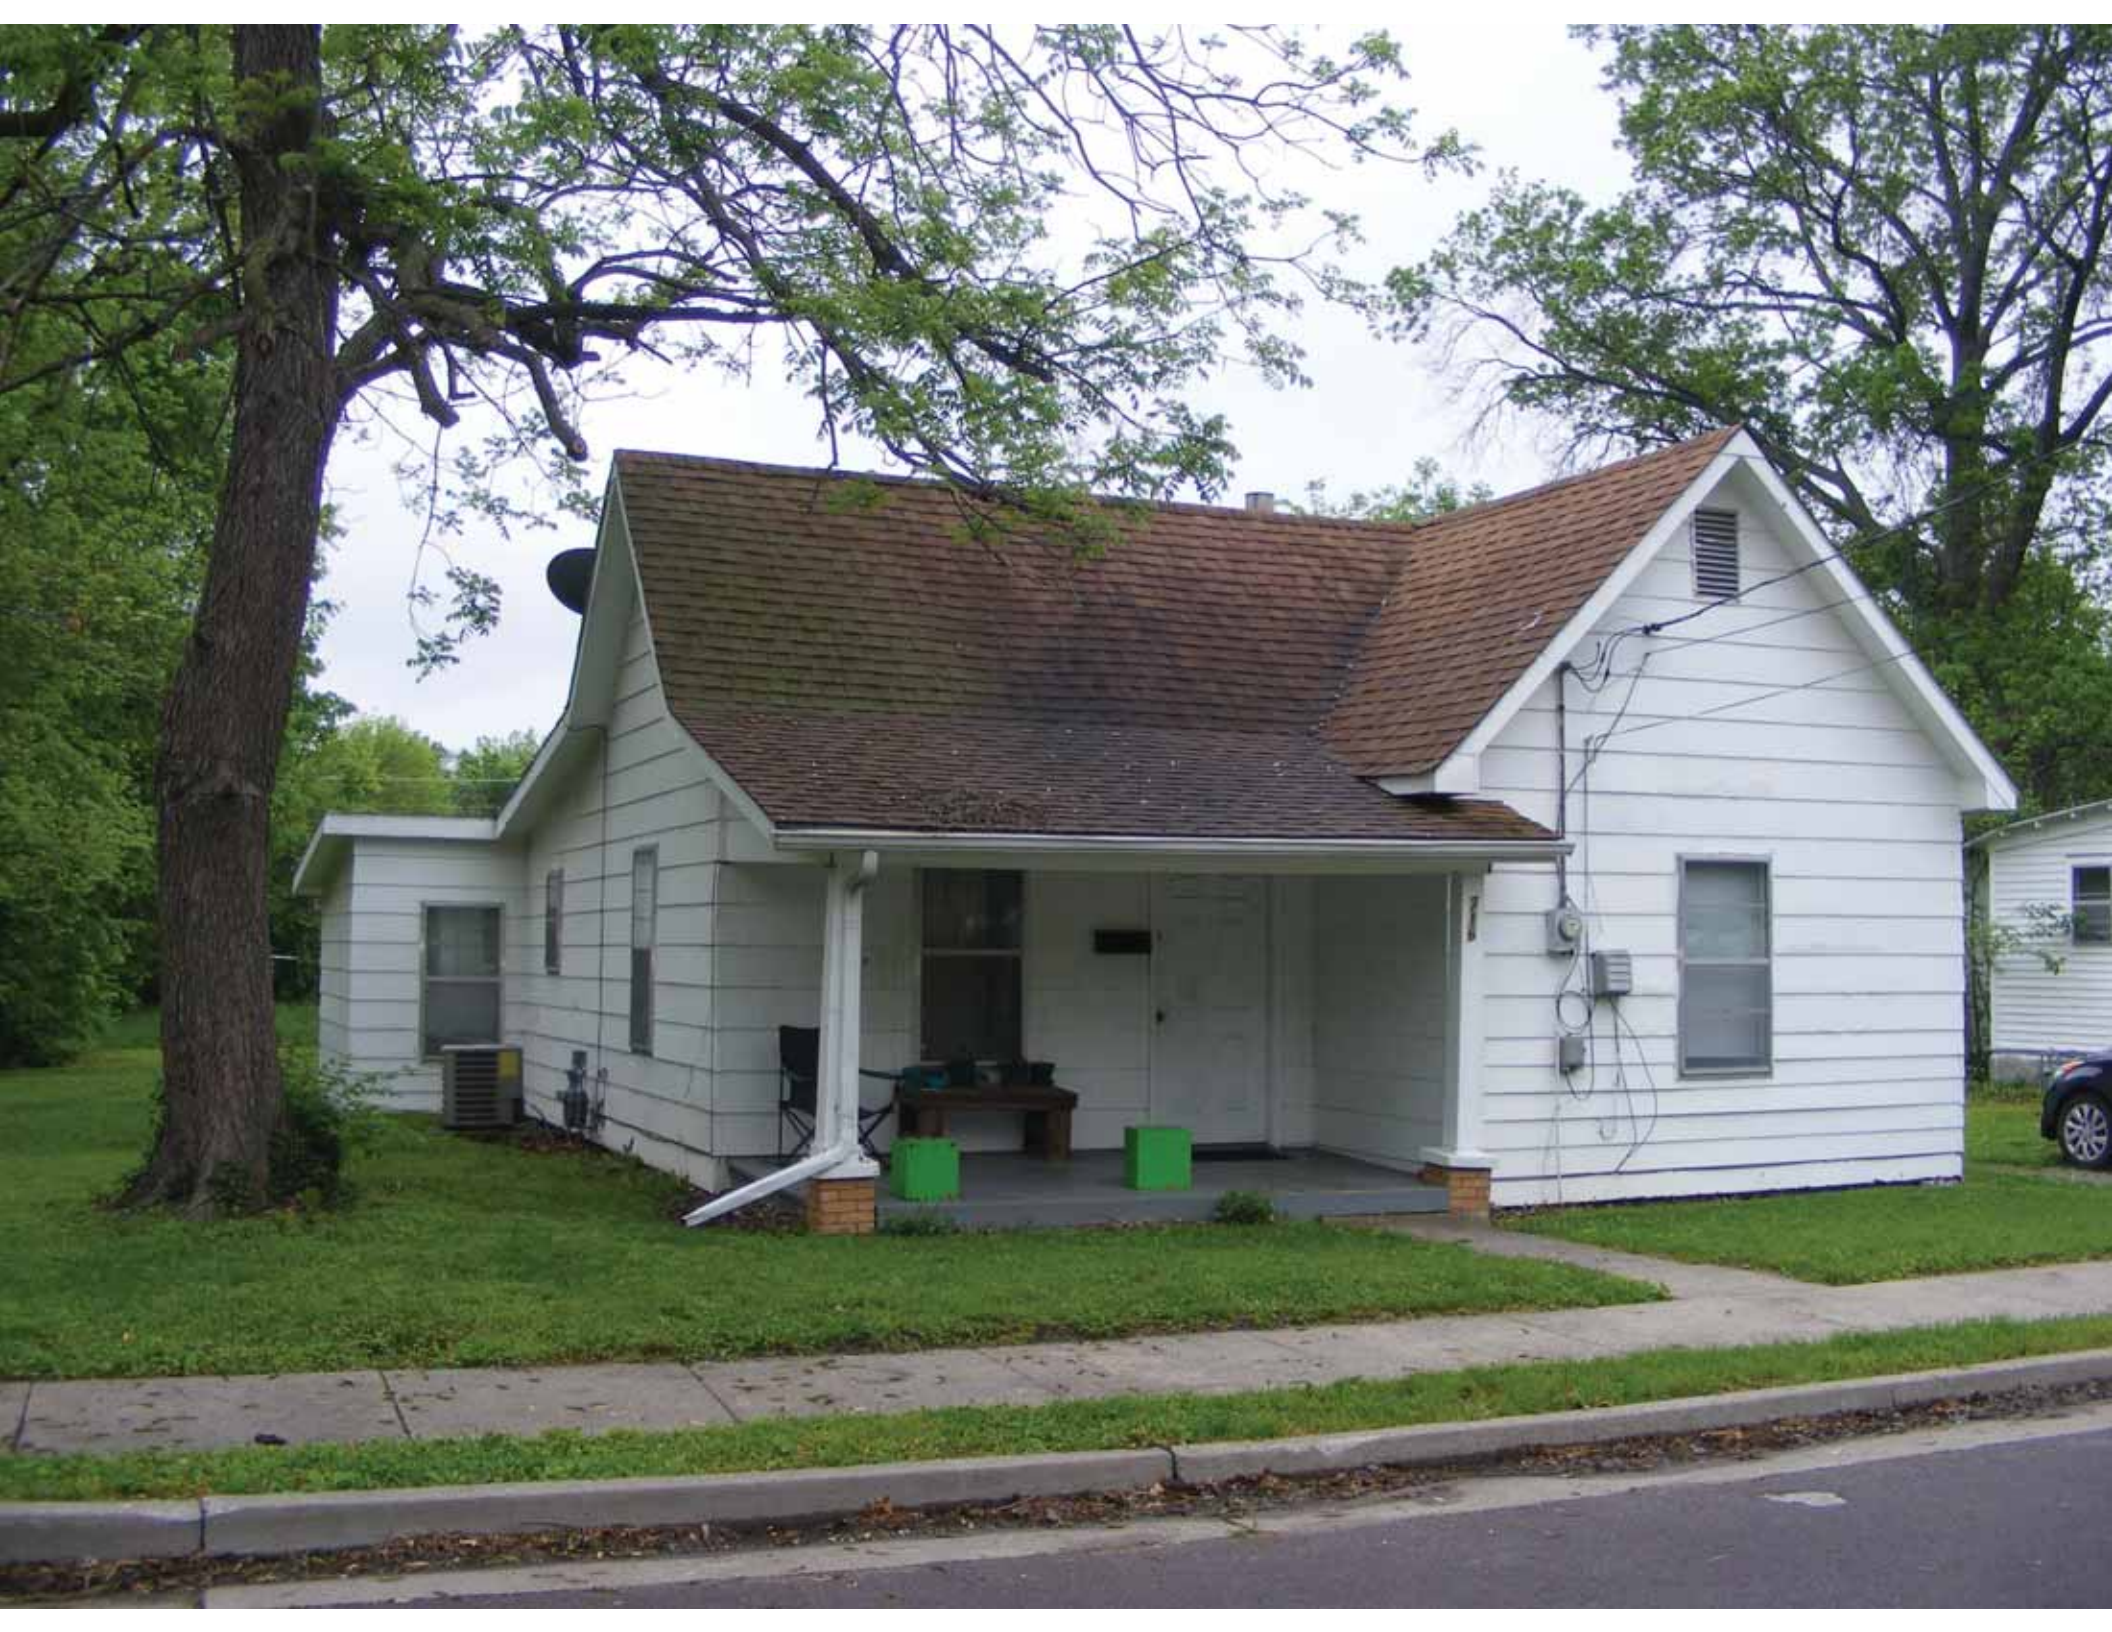
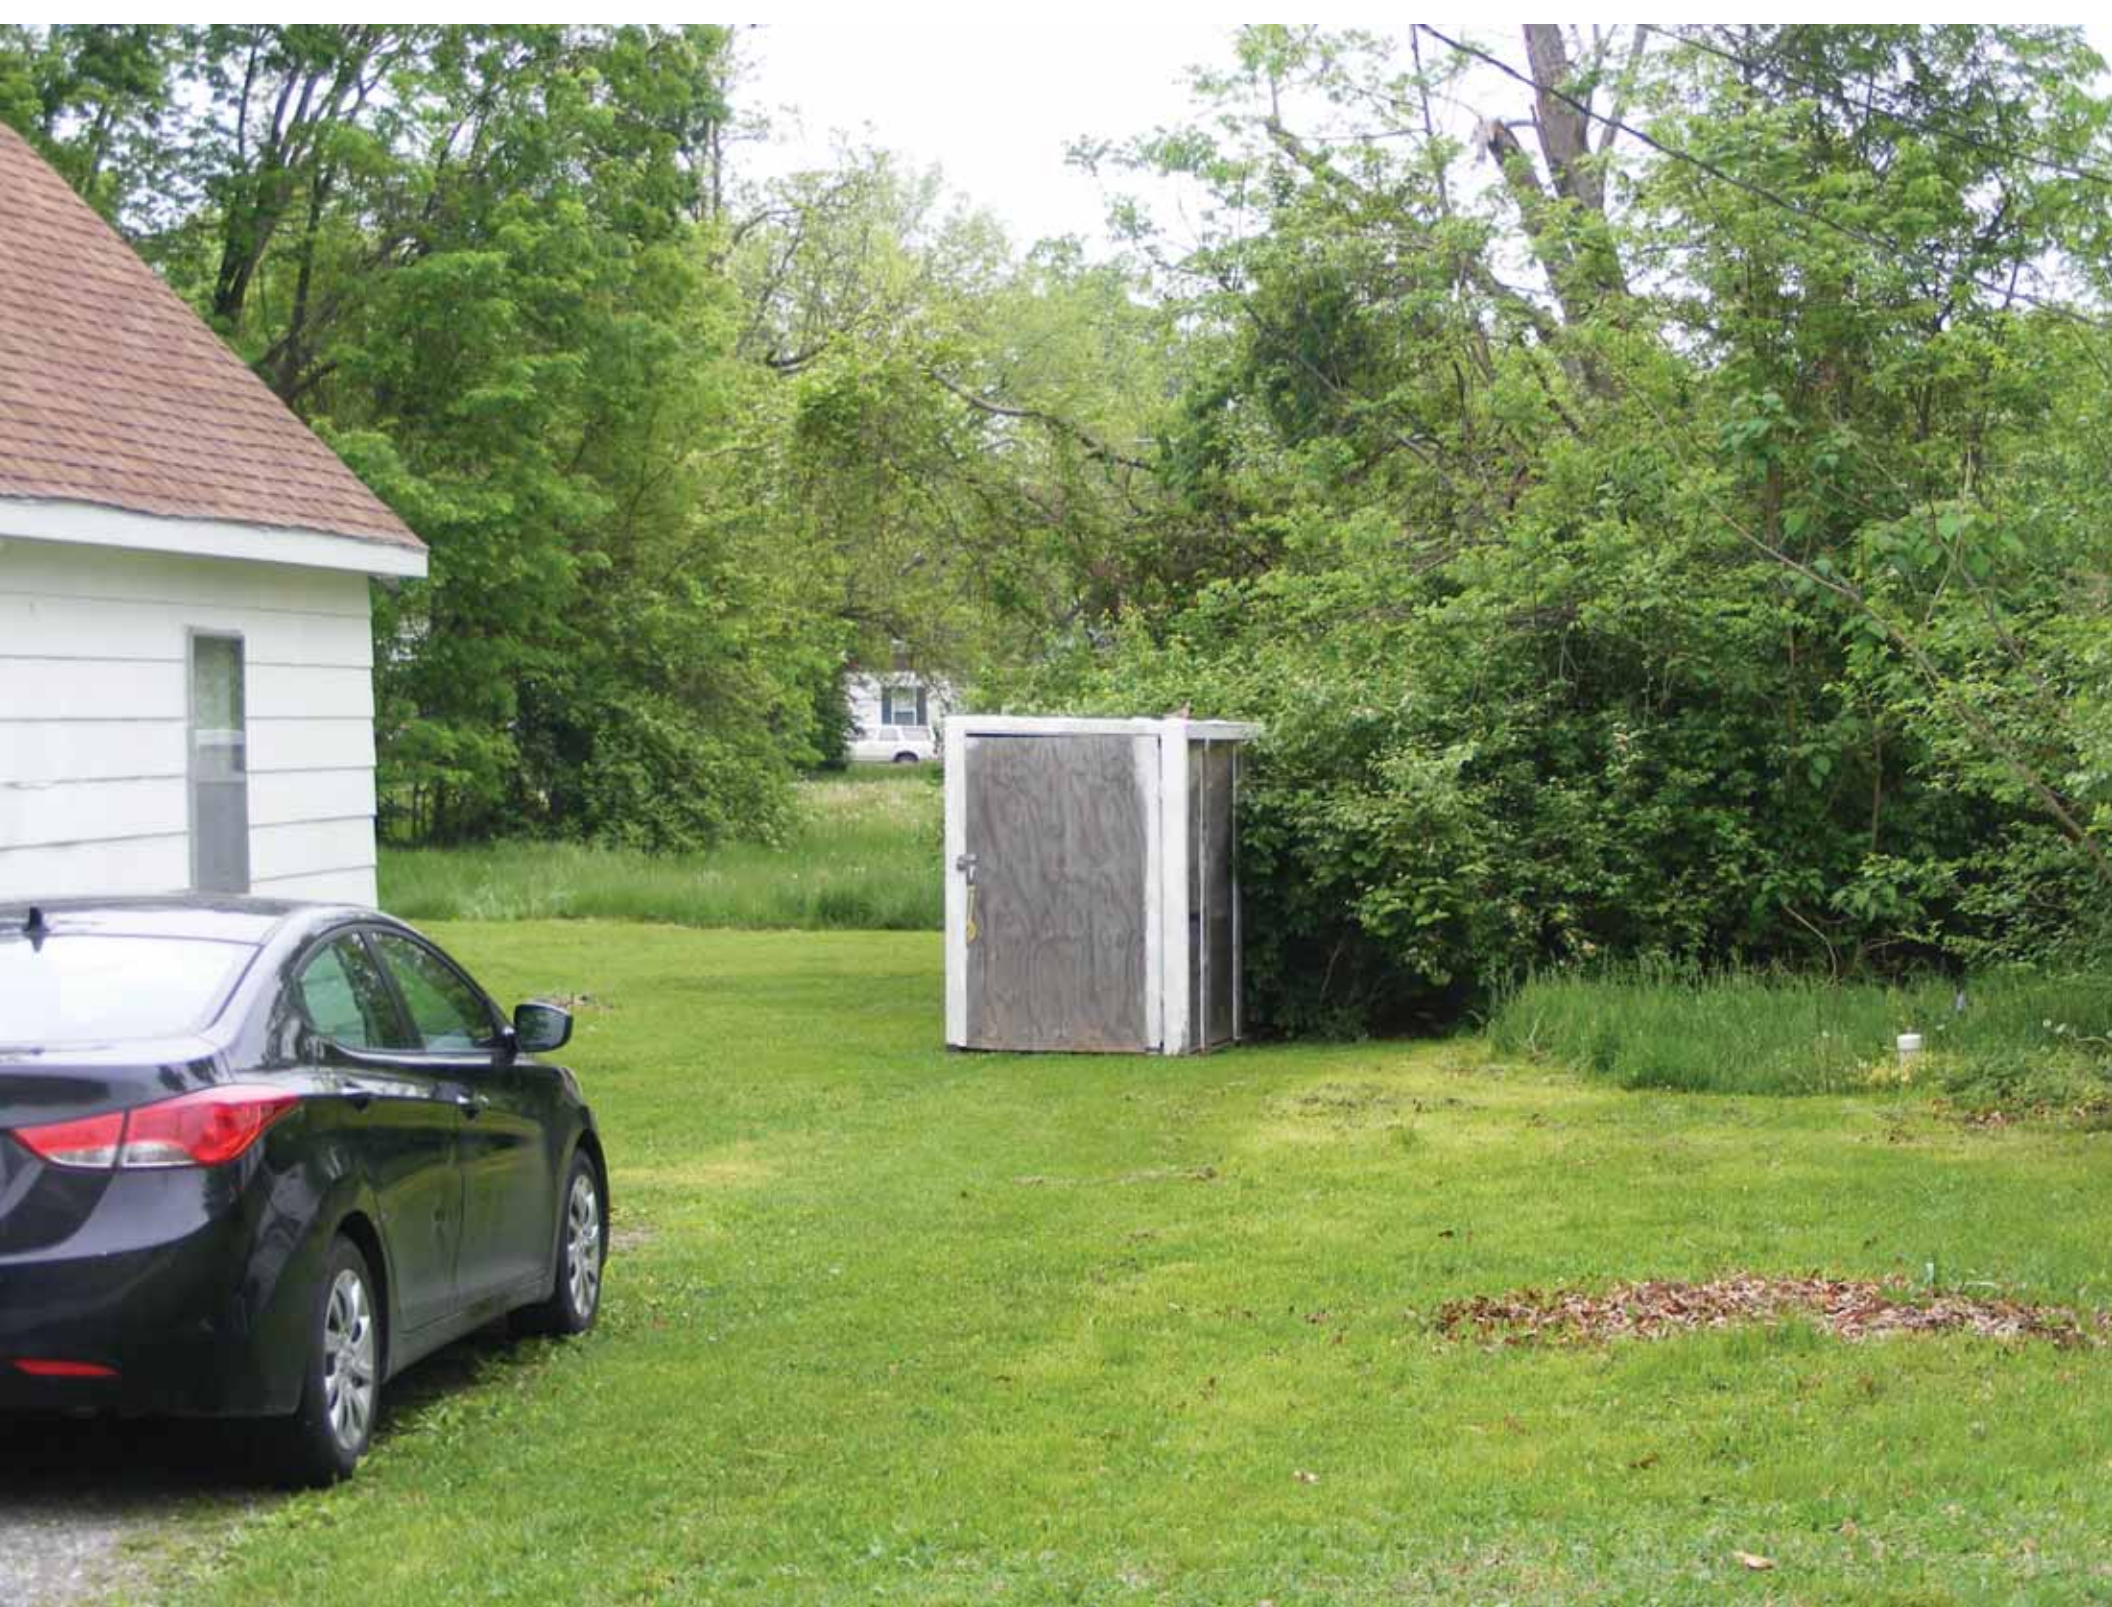
The dwelling has a cross-gabled asphalt shingled roof, exterior synthetic siding and a concrete foundation. The primary (north) elevation supports a half-width shed porch supported by tapered columns on low brick piers. Within the porch bay is a contemporary paneled door offset by a replacement one-over-one window. Remaining windows are of similar configuration. The front gabled wing holds a one-over-one window. Above the window, the gable field has a louvered vent.
