MISSOURI DEPARTMENT OF NATURAL RESOURCES
STATE HISTORIC PRESERVATION OFFICE, P.O. Box 176, Jefferson City, MO 65102
ARCHITECTURAL/HISTORIC INVENTORY FORM

1. Survey No. BO-AS-011-0087		2. Survey name: North Central Columbia Survey Phase II	
3. County: Boone		4. Address (Street No.) 902	Street (name) N. Seventh Street
5. City: Columbia	Vicinity: <input type="checkbox"/>	6. Geographical Reference:	7. Township/Range/Section: T: R: S:
8. Historic name (if known):		9. Present/other name (if known):	
10. Ownership: <input checked="" type="checkbox"/> Private <input type="checkbox"/> Public		11a. Historic use (if known): Domestic/single dwelling	11b. Current use: Domestic/single dwelling

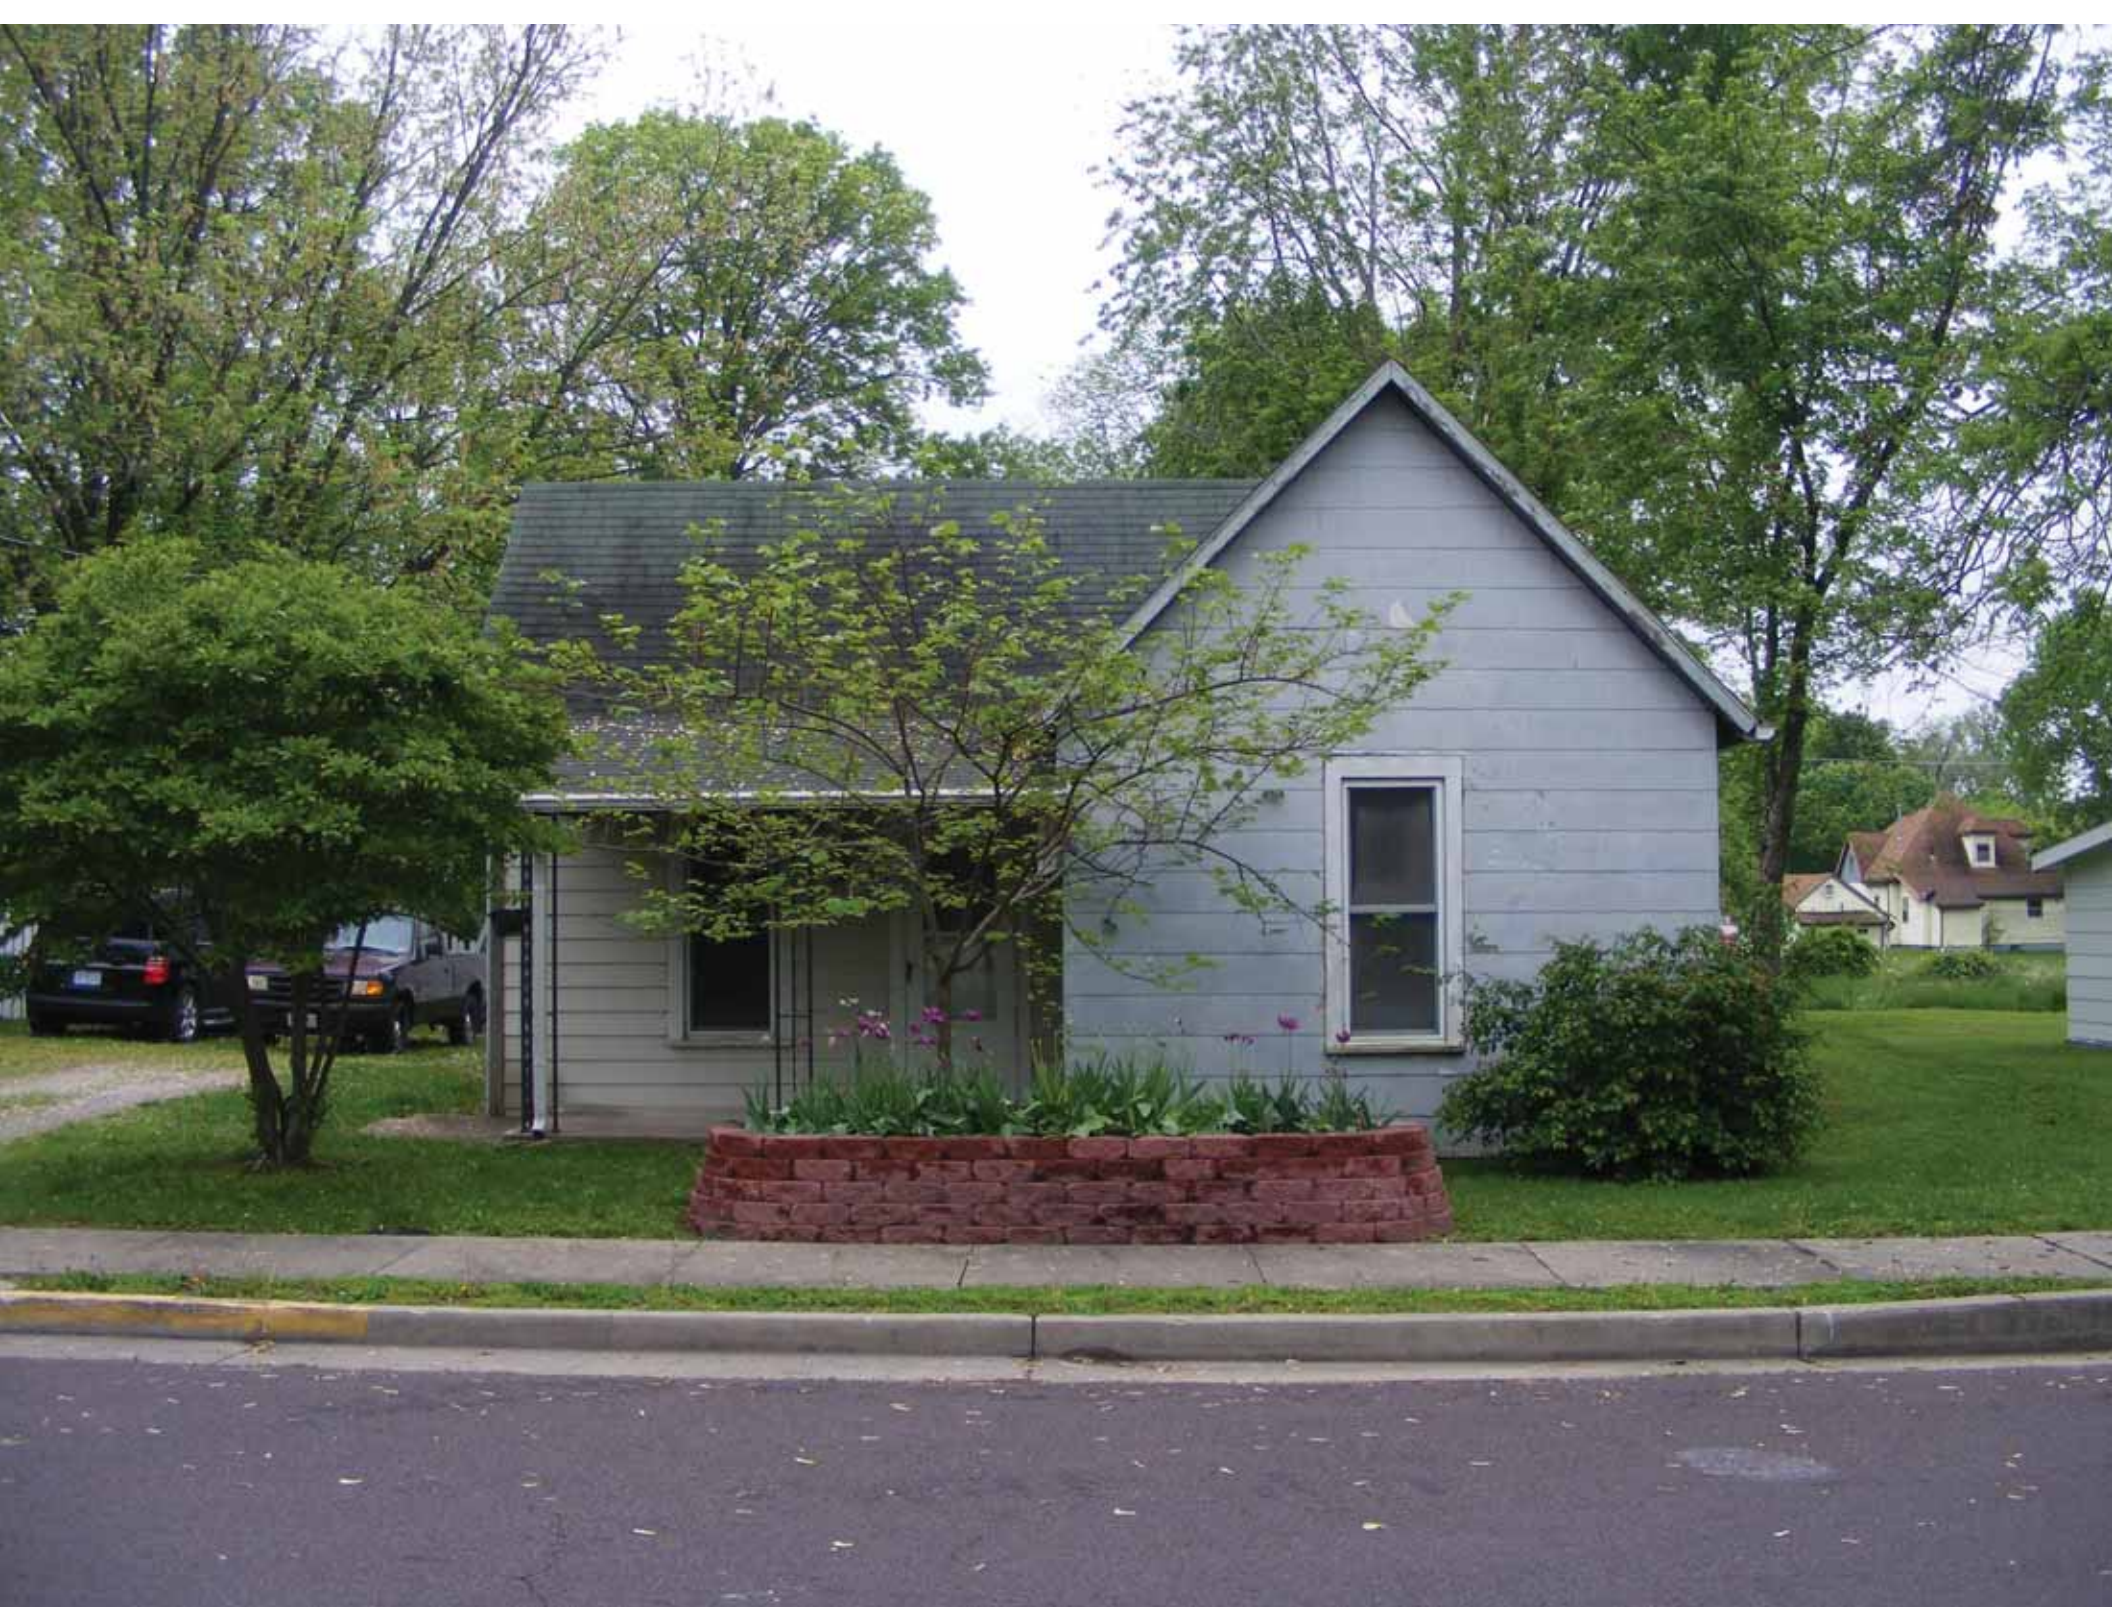
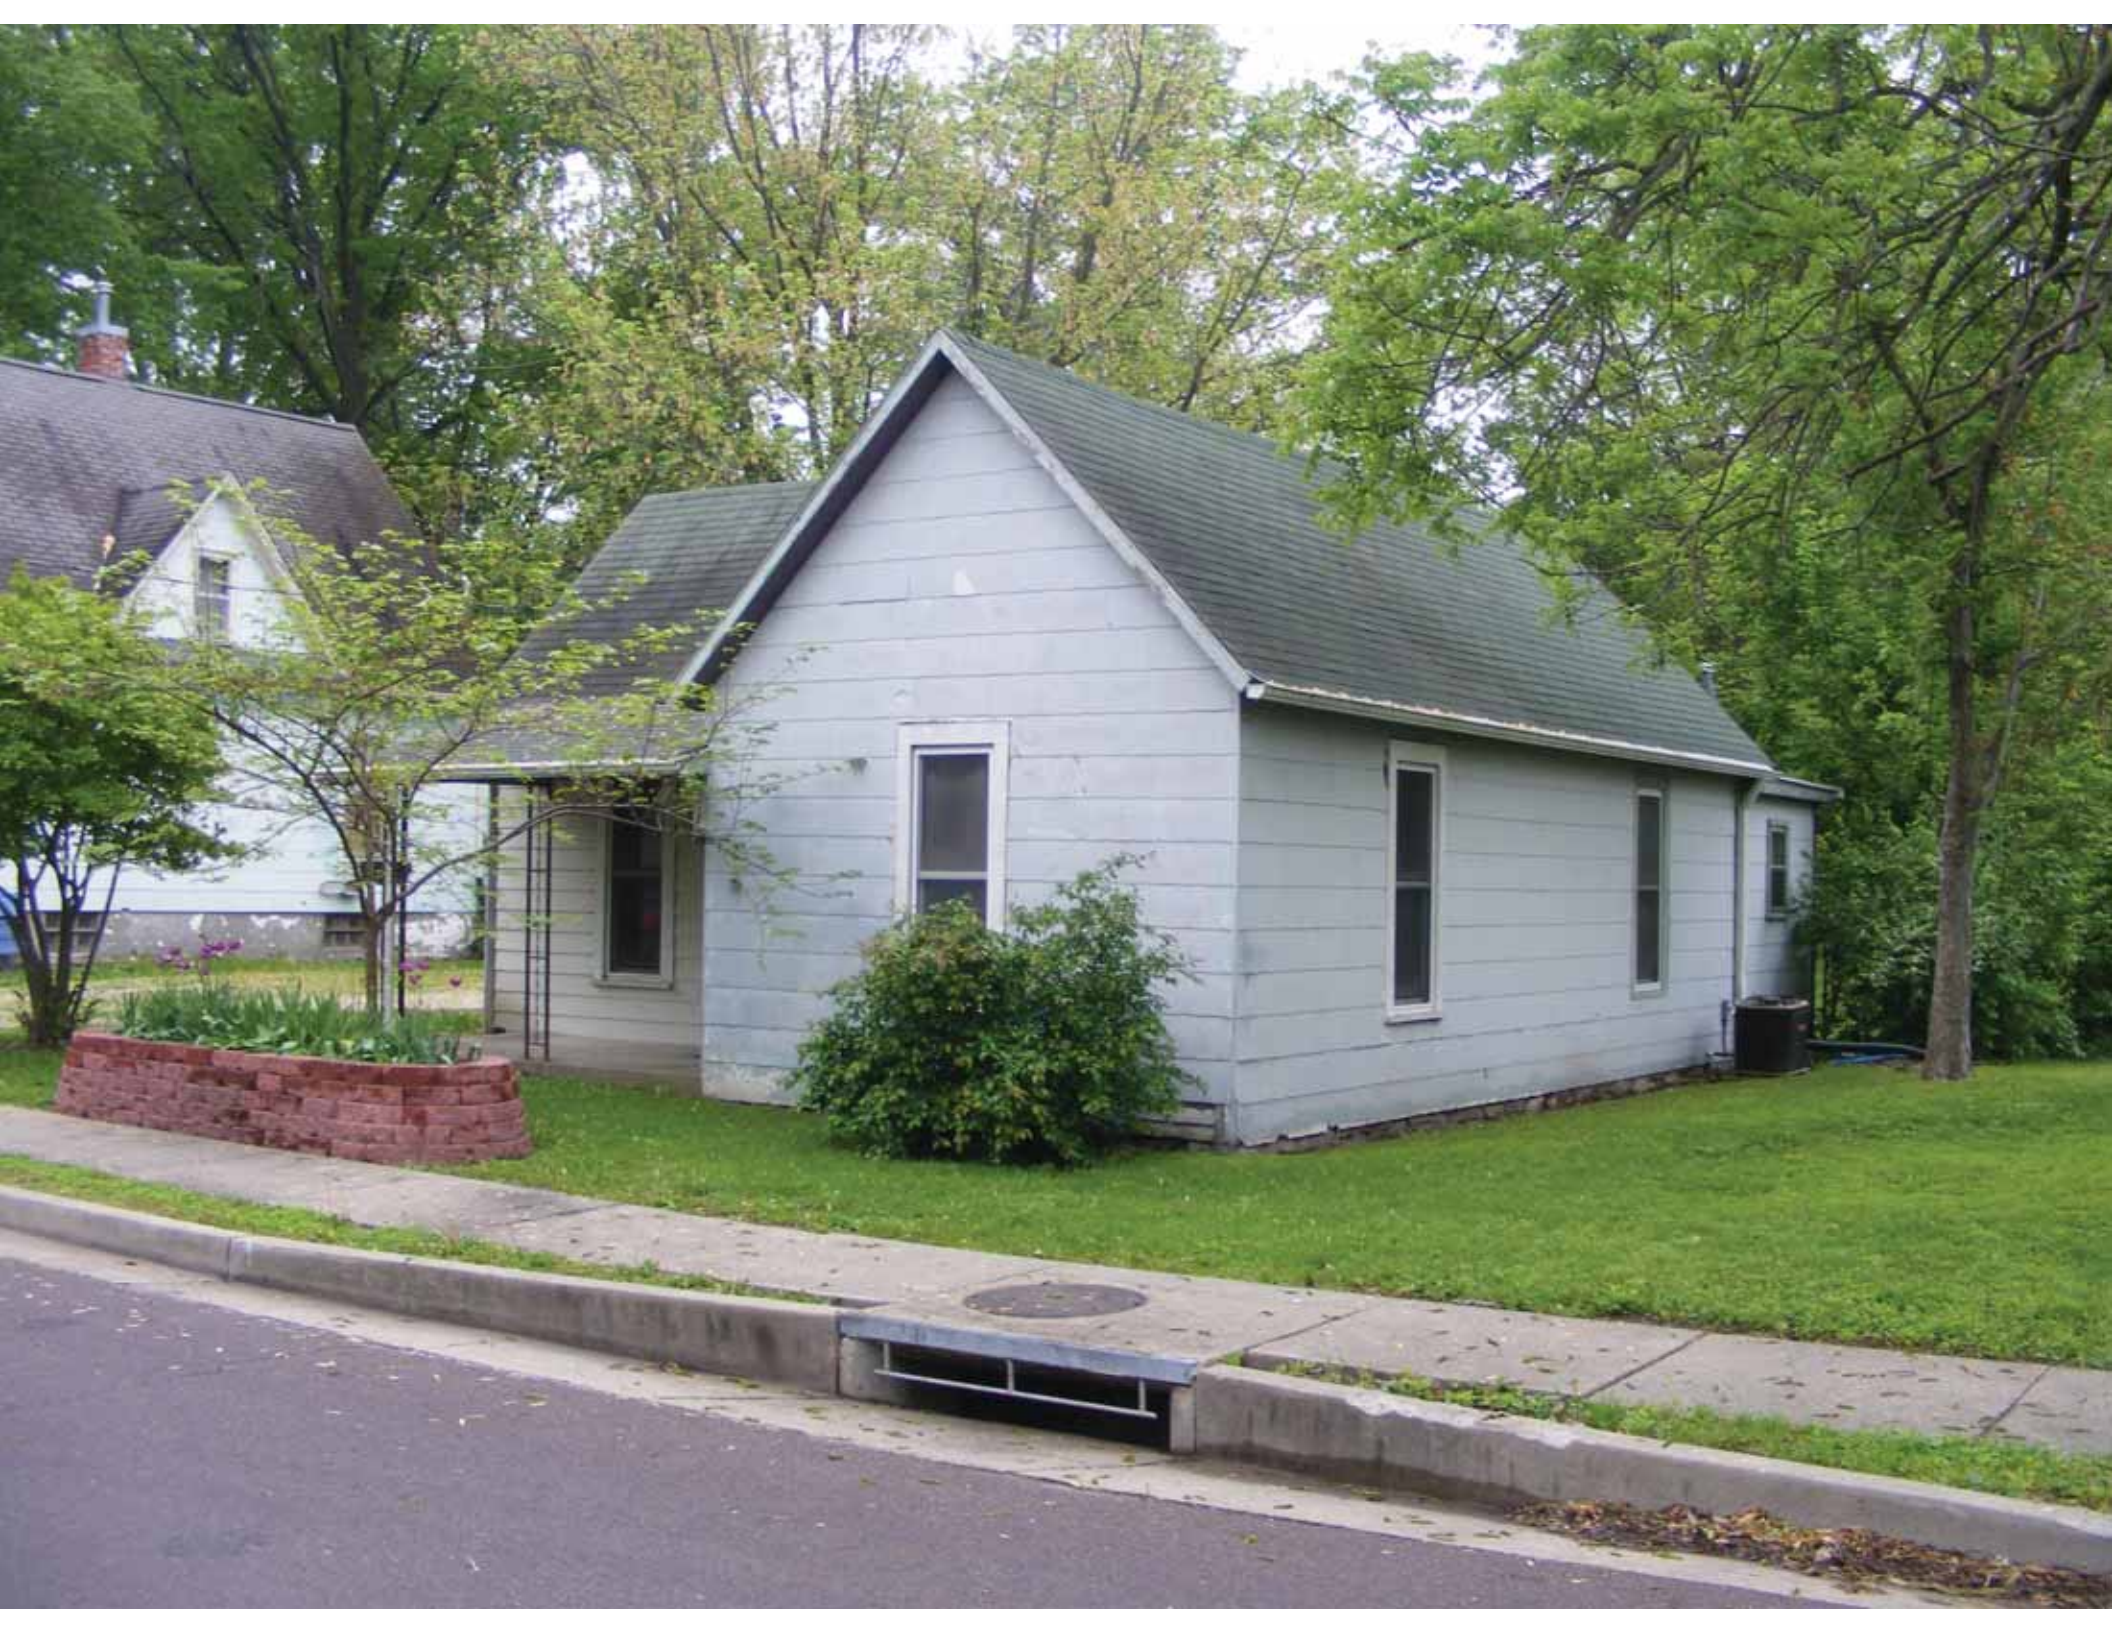
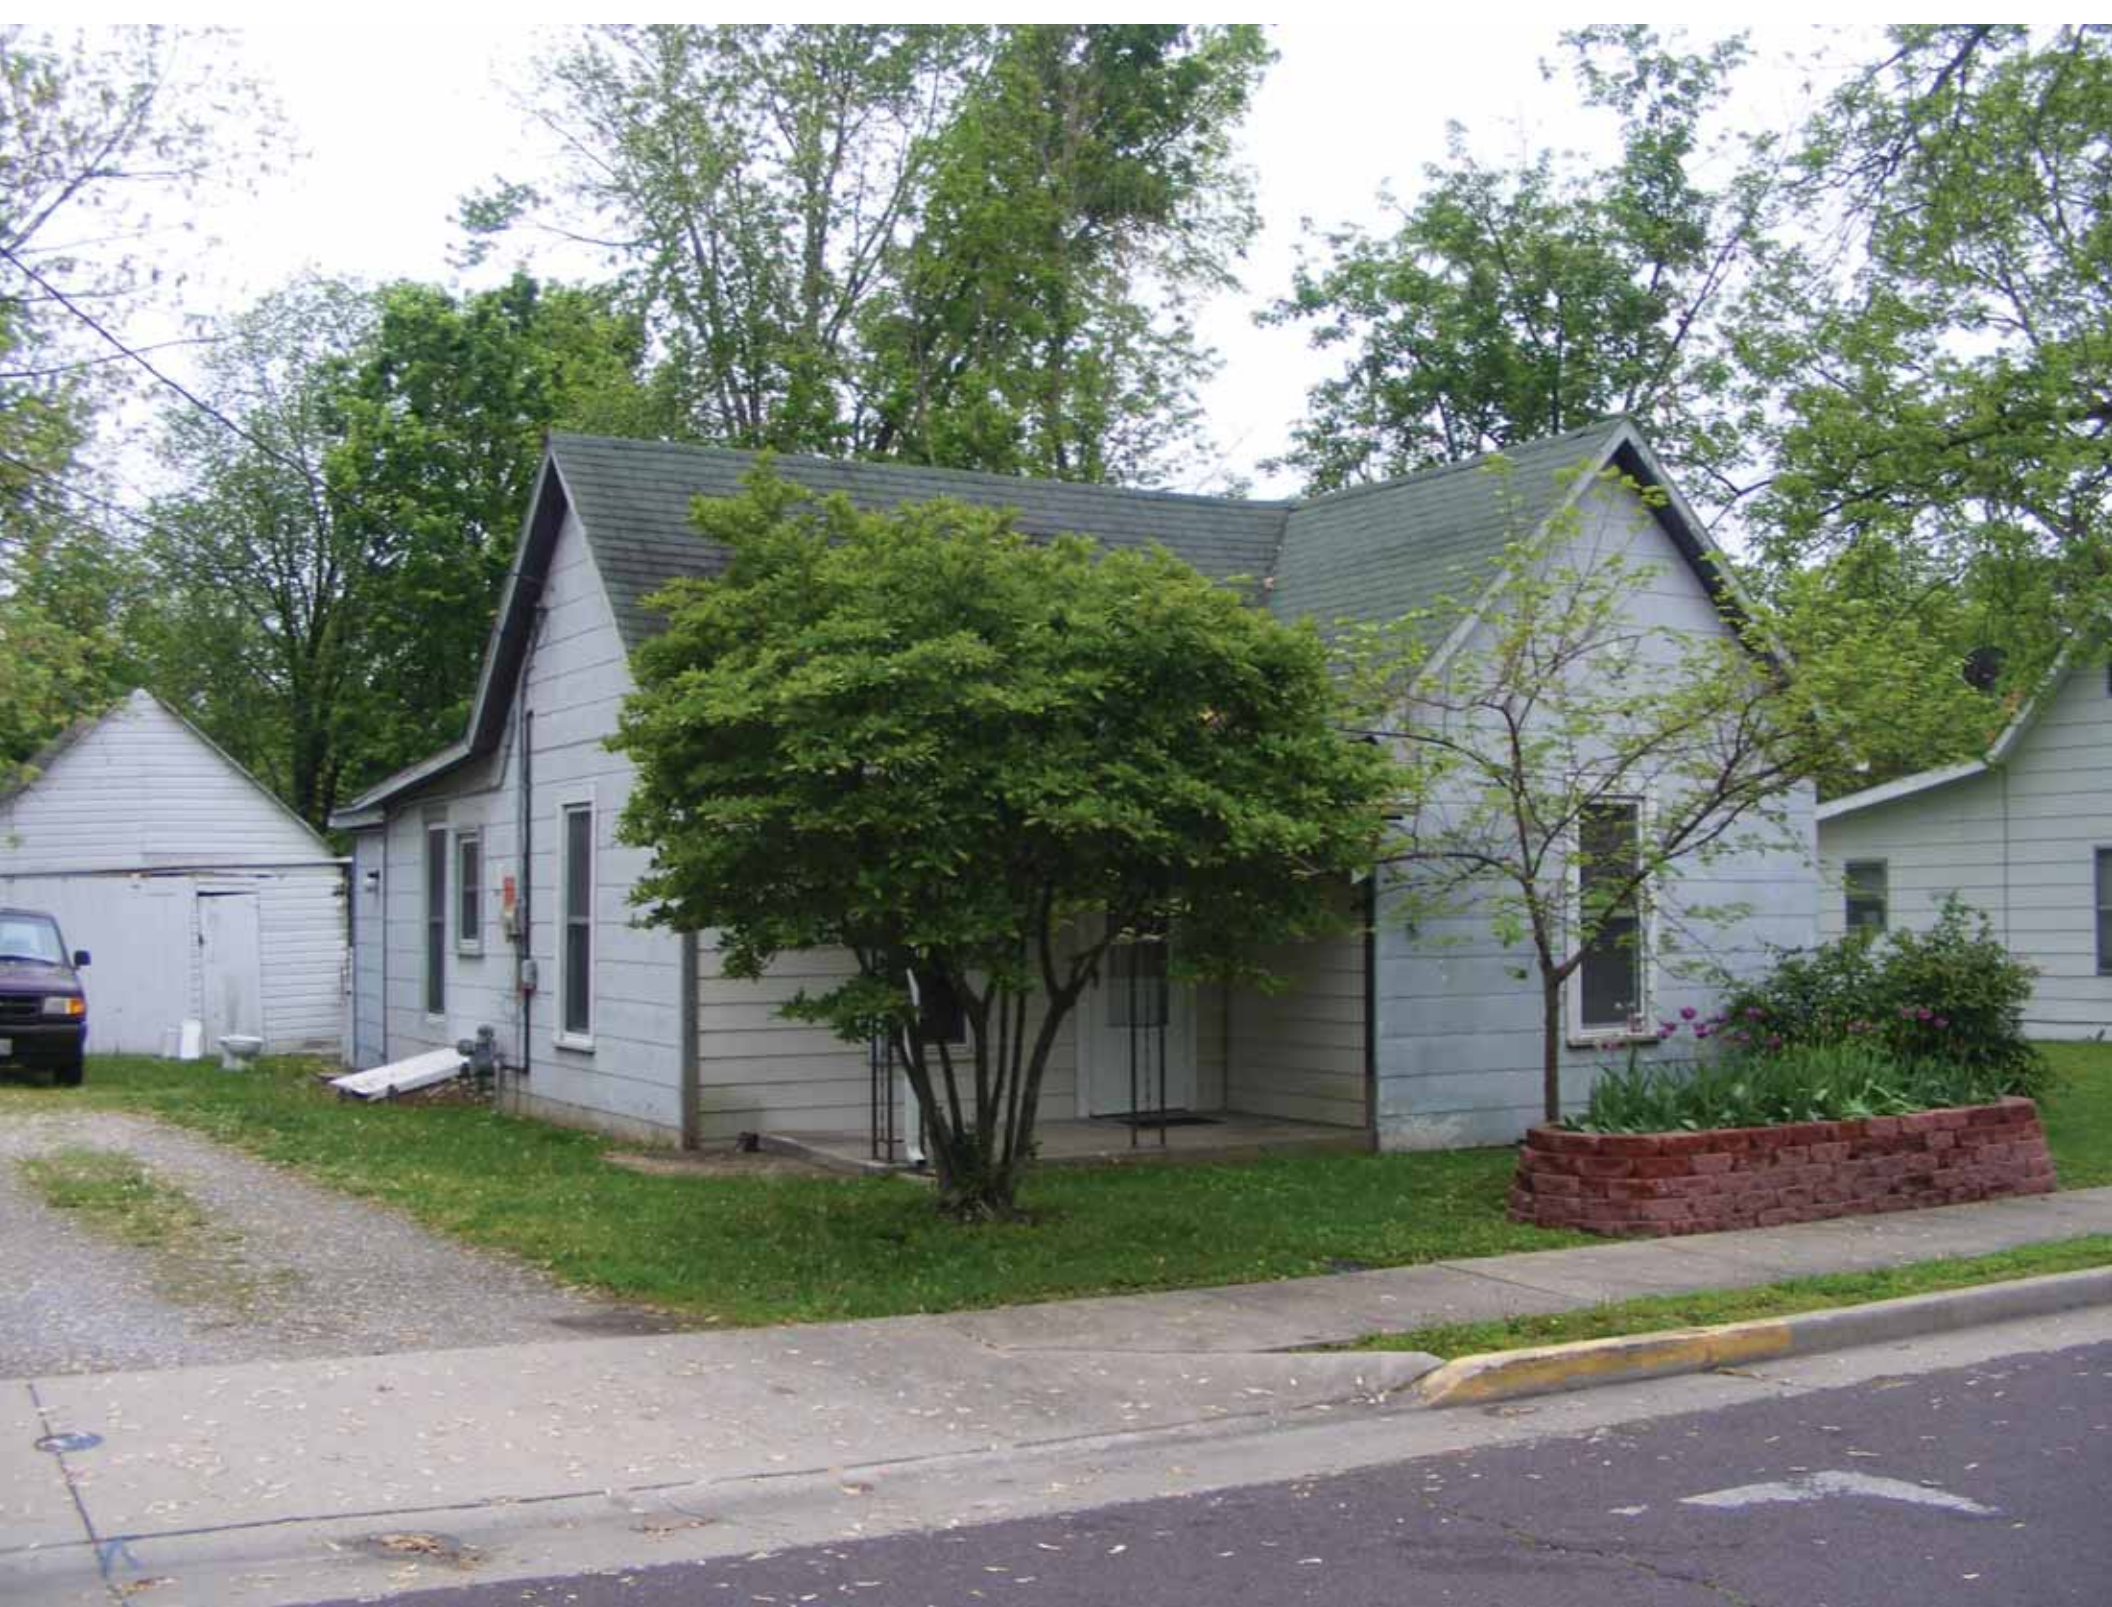
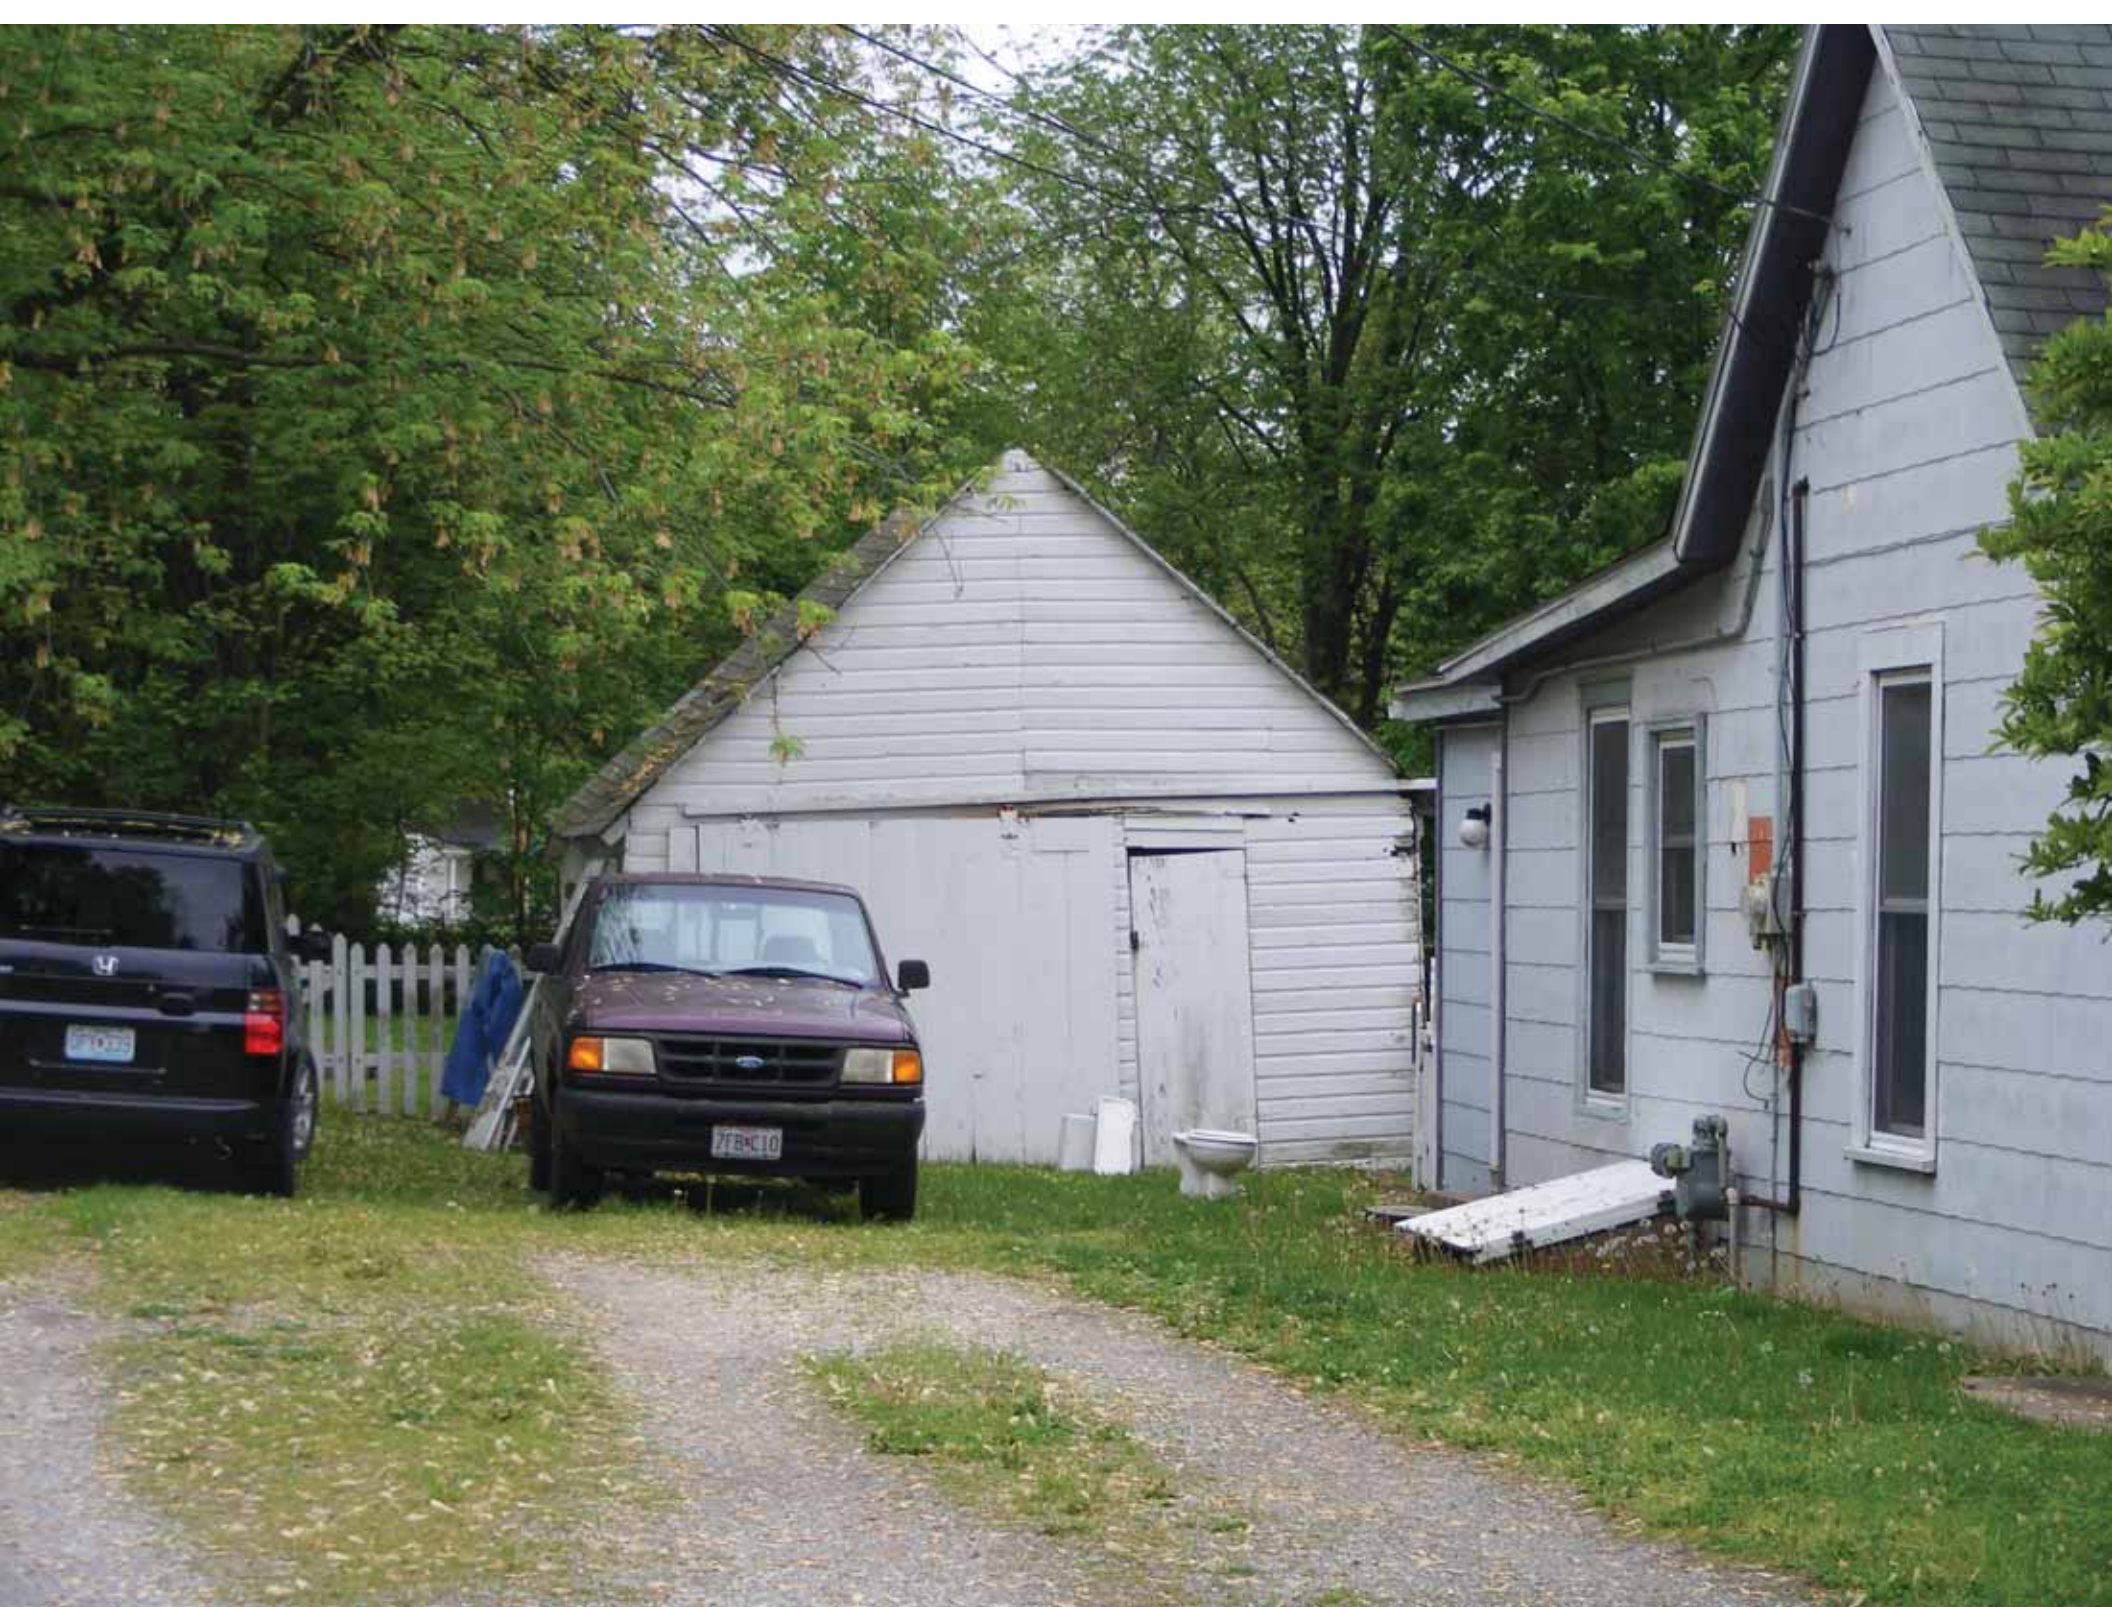
The gable and wing plan dwelling has an asphalt-shingled roof, exterior asbestos shingles and a concrete and stone rubble foundation. The primary (north) elevation features a shed half-width porch supported by wrought iron columns. Windows appear to be original, obscured by vinyl storm windows. The windows are one-over-one. The porch bay holds a single window and entry bay filled with a single-light paneled door. The dwelling has a rear wing. At the east elevation near the foundation is what appears to be an entrance to a cellar.

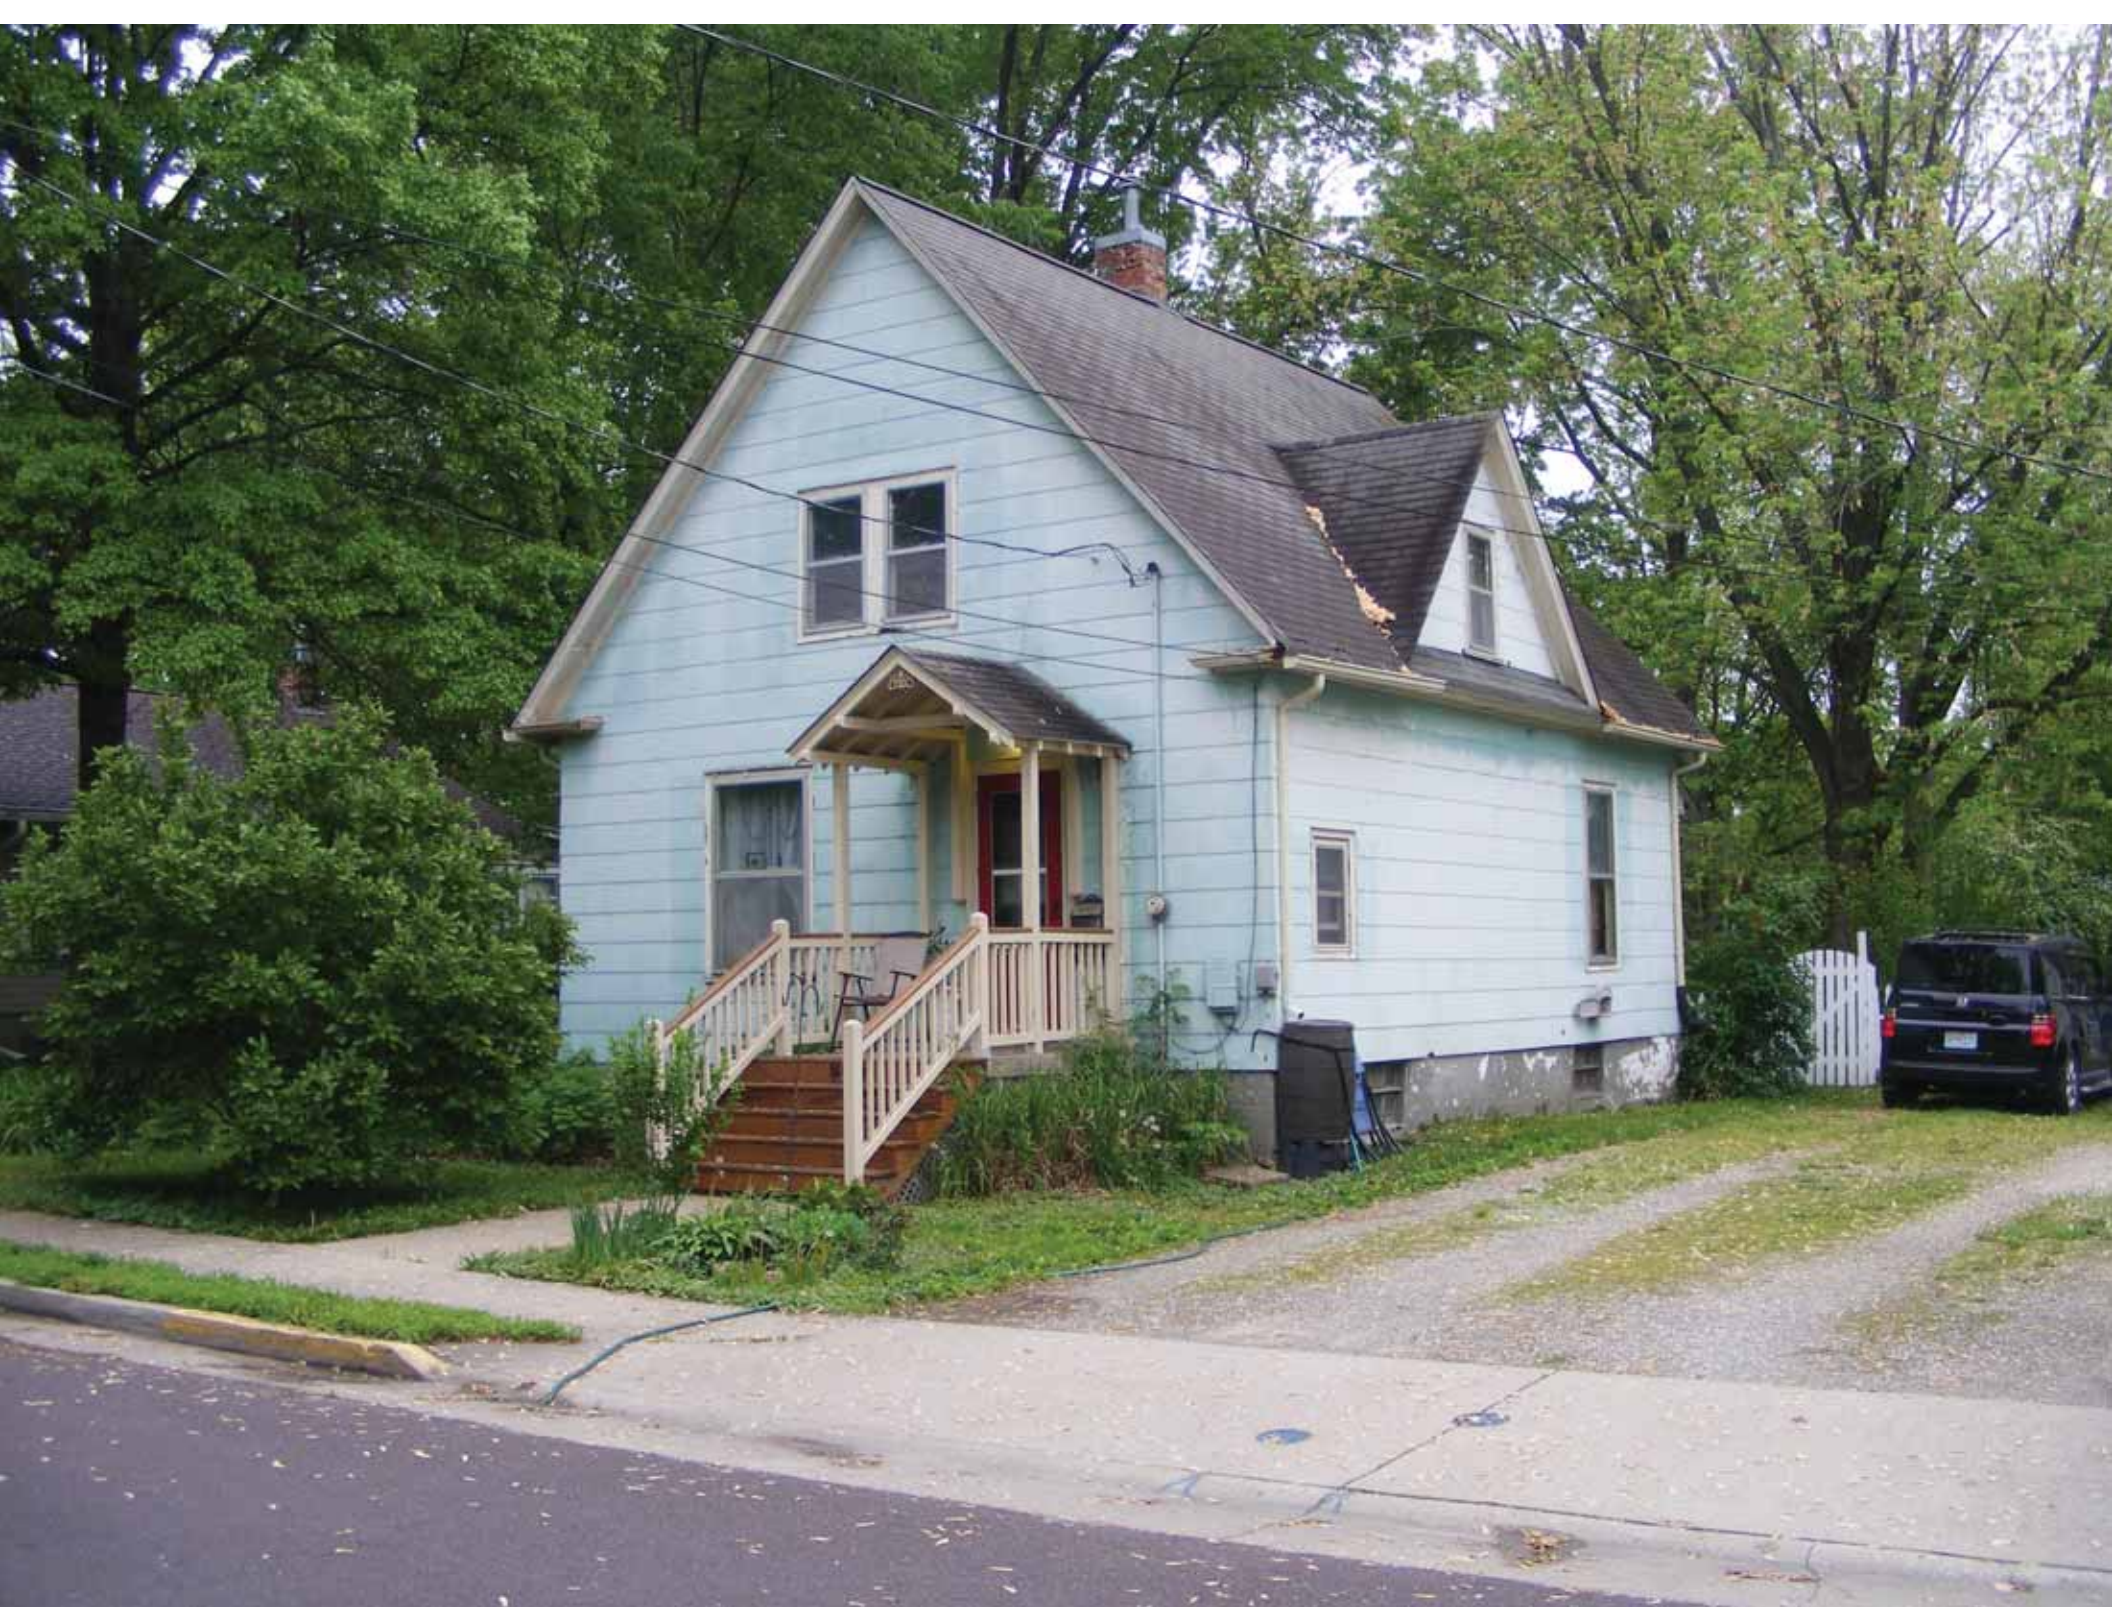
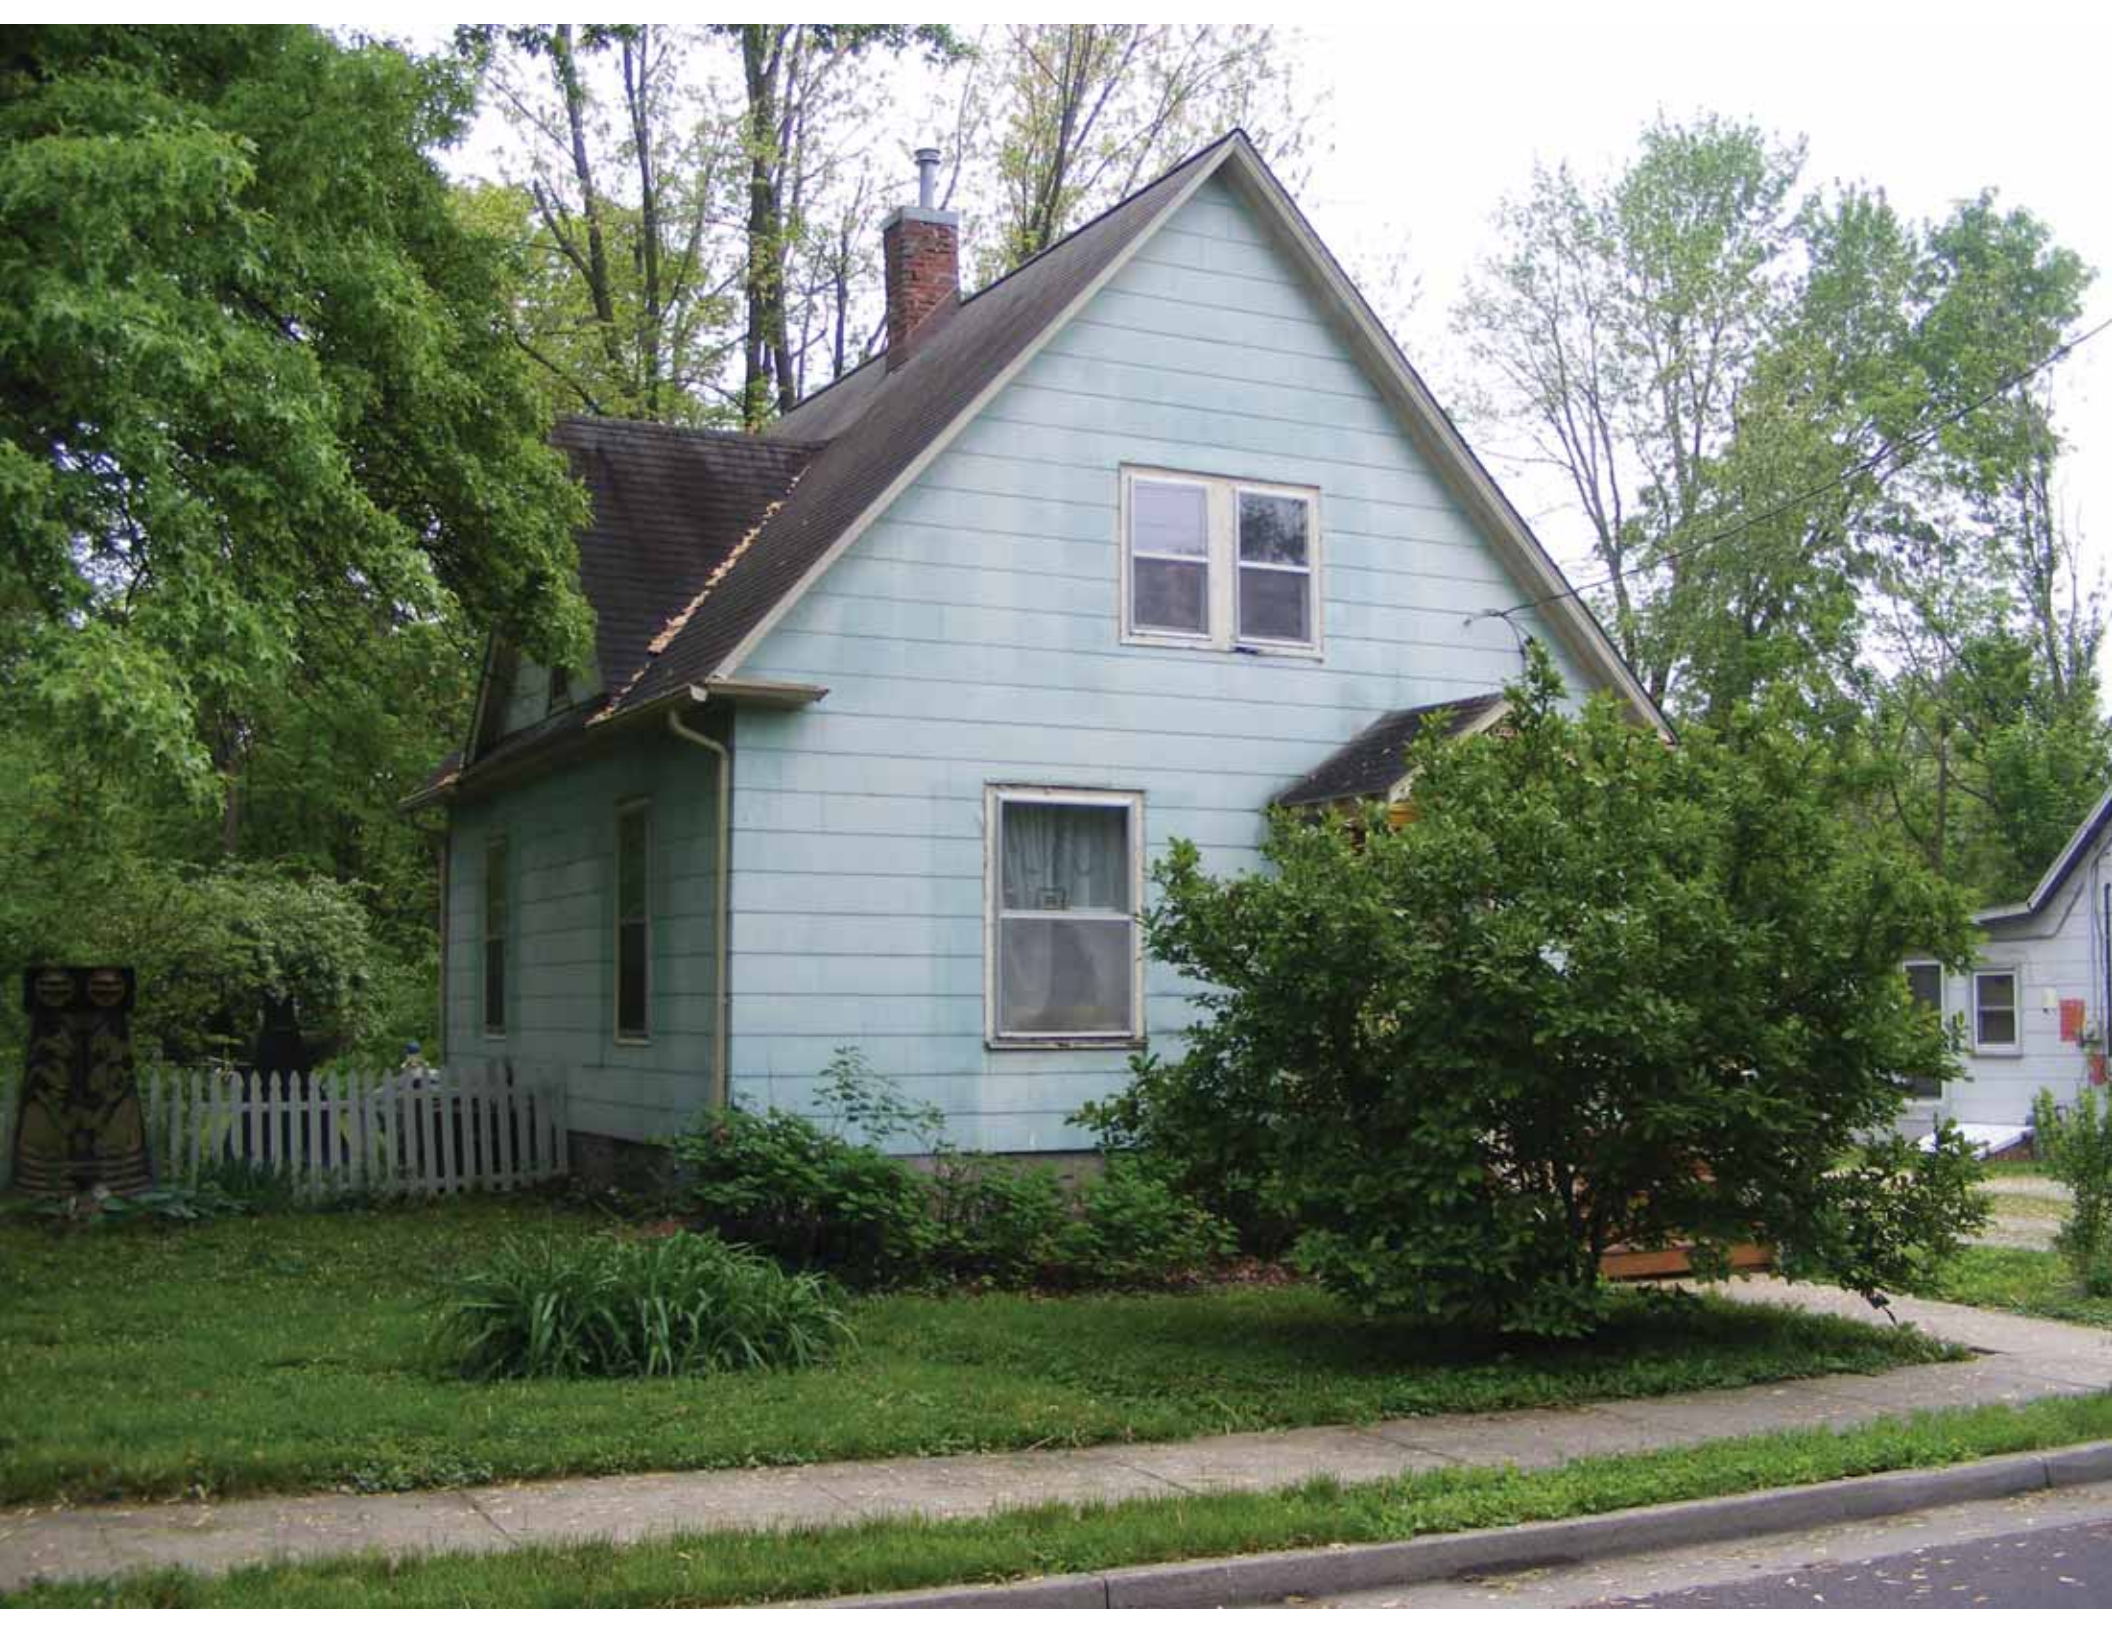
The gable-front plan dwelling has an asphalt shingled steeply pitched gable roof, exterior asbestos shingle siding and a poured concrete foundation. Basement windows are visible within the raised foundation. The primary (north elevation) features an off-center porch that appears to have been reconstructed or is entirely new (c. 2000). The portico has a gabled roof with exposed rafter tails, supported by four square wood columns. A frame balustrade surrounds the porch and extends along the steps as handrails. Within the portico is the primary entry filled with an original single-light wood paneled door. Above the porch, the gable field has paired one-over-one windows. The front gable retains original returns. At the roofline ridge is a central brick chimney. Side elevations have gabled wall dormers with one-over-one windows.
