MISSOURI DEPARTMENT OF NATURAL RESOURCES
STATE HISTORIC PRESERVATION OFFICE, P.O. Box 176, Jefferson City, MO 65102
ARCHITECTURAL/HISTORIC INVENTORY FORM

1. Survey No. BO-AS-011-0087		2. Survey name: North Central Columbia Survey Phase II	
3. County: Boone		4. Address (Street No.) 902	Street (name) N. Seventh Street
5. City: Columbia	Vicinity: <input type="checkbox"/>	6. Geographical Reference:	7. Township/Range/Section: T: R: S:
8. Historic name (if known):		9. Present/other name (if known):	
10. Ownership: <input checked="" type="checkbox"/> Private <input type="checkbox"/> Public		11a. Historic use (if known): Domestic/single dwelling	11b. Current use: Domestic/single dwelling

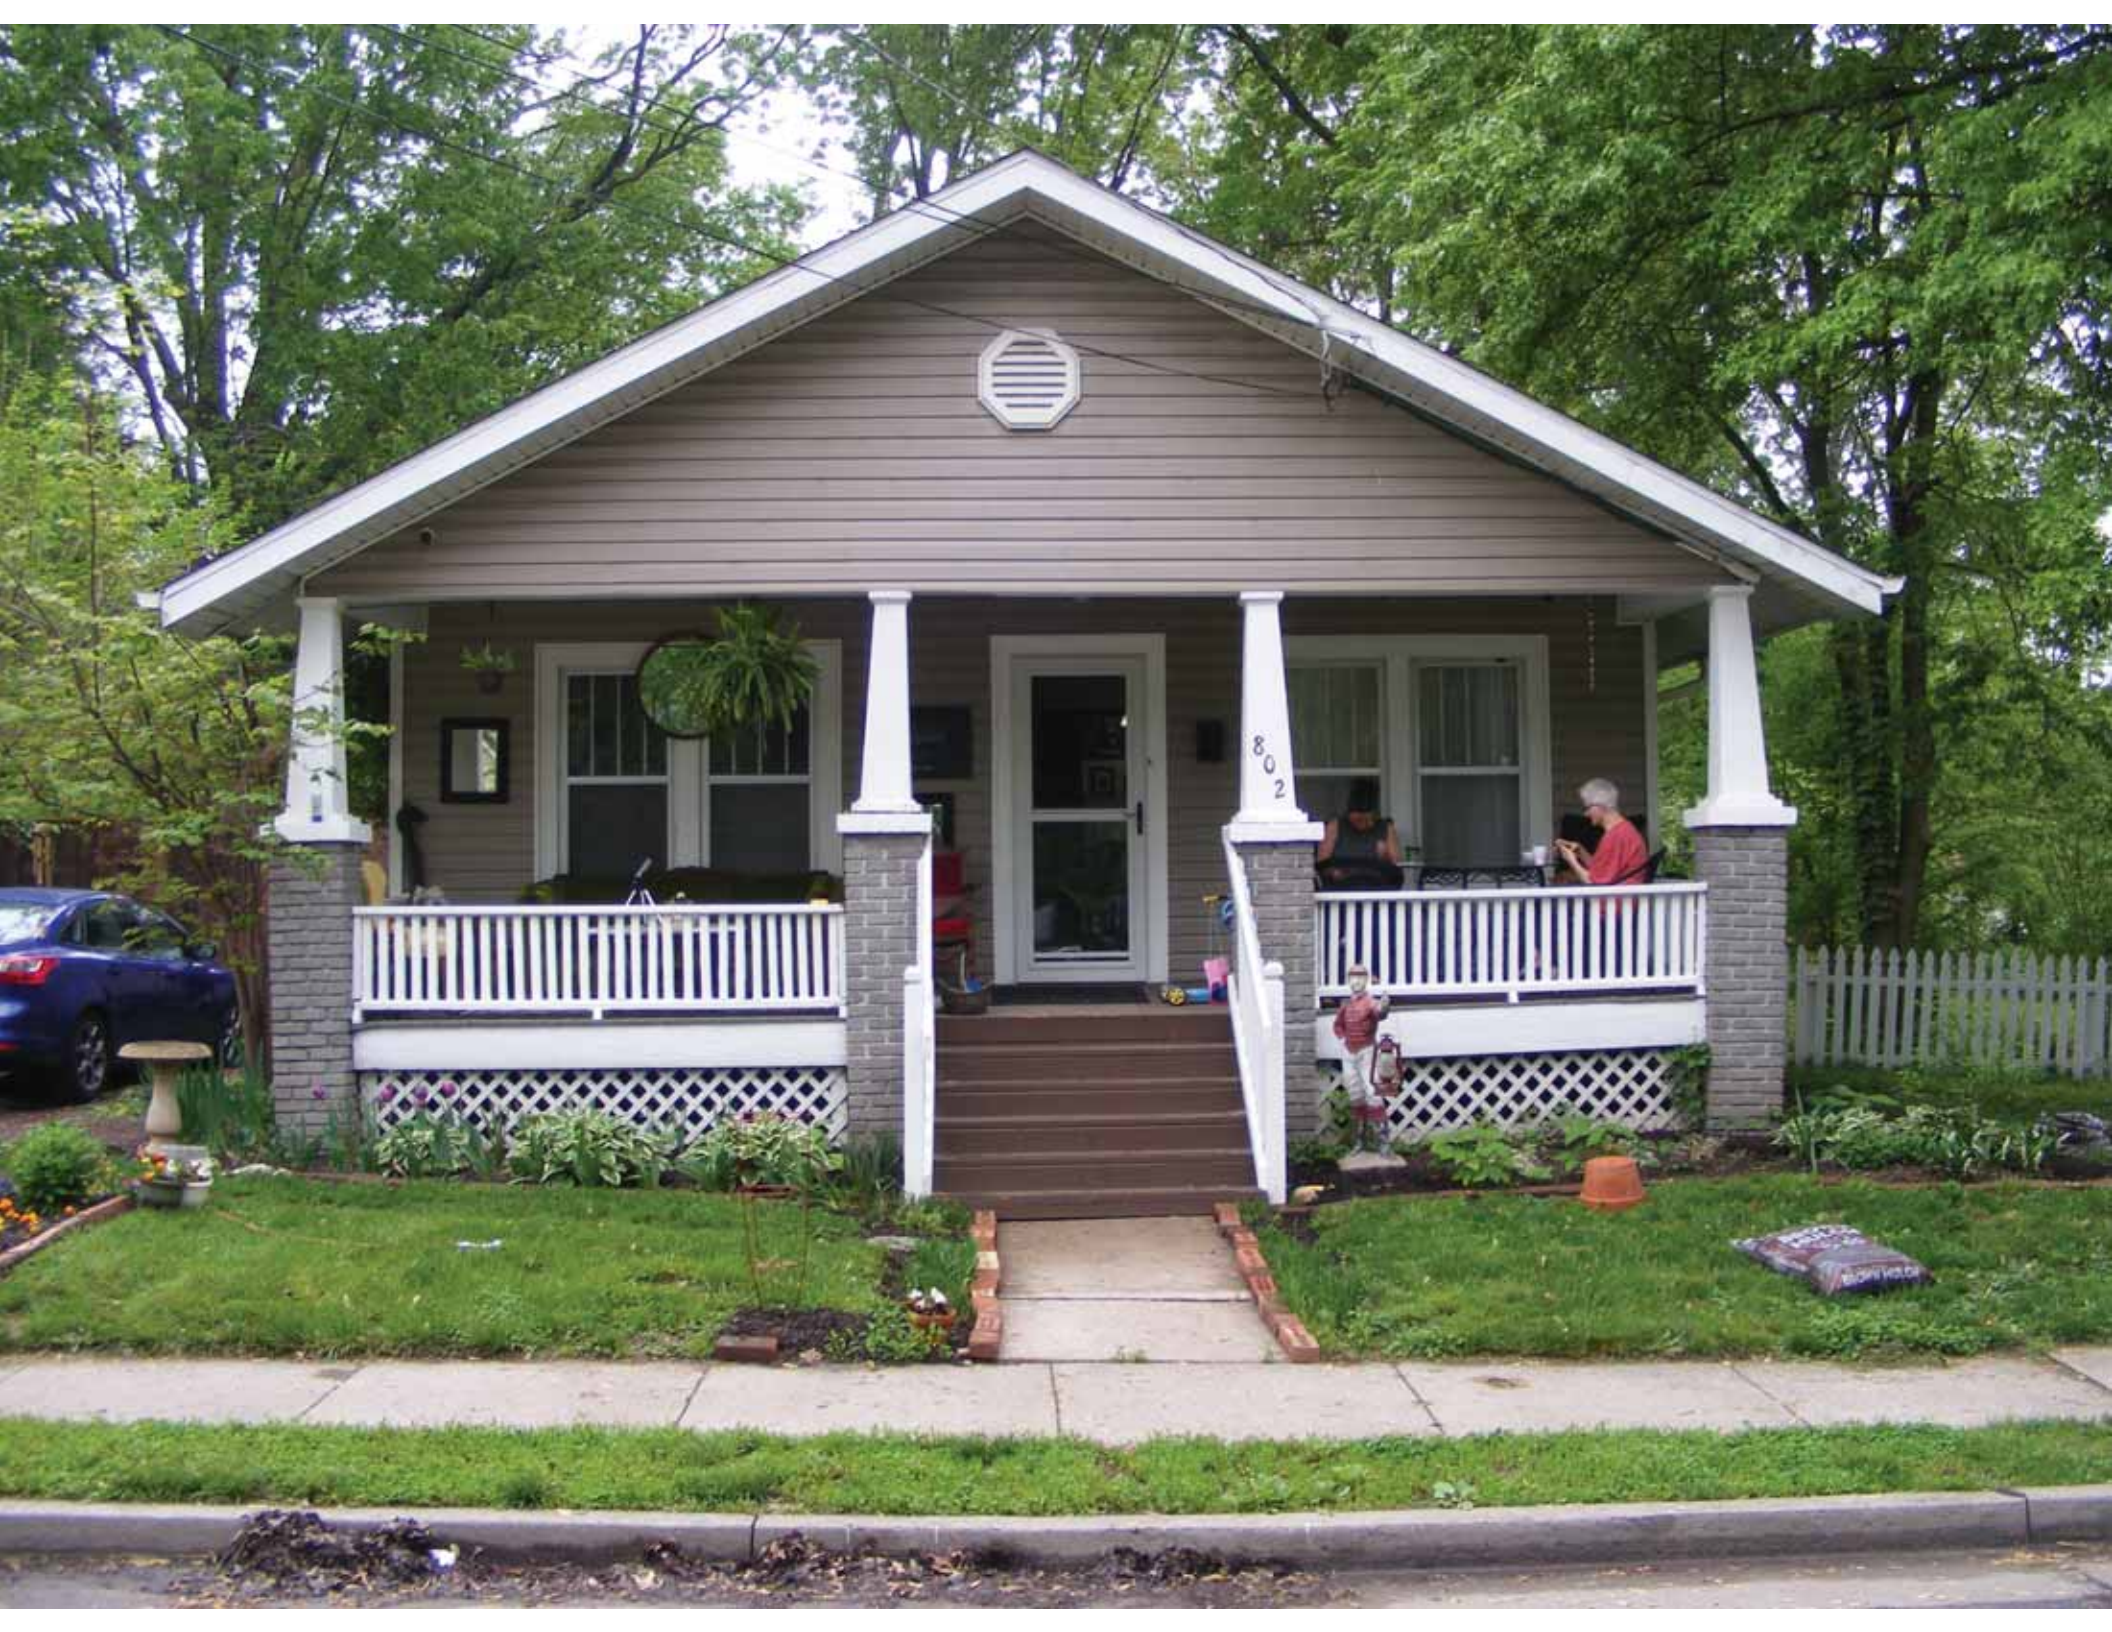
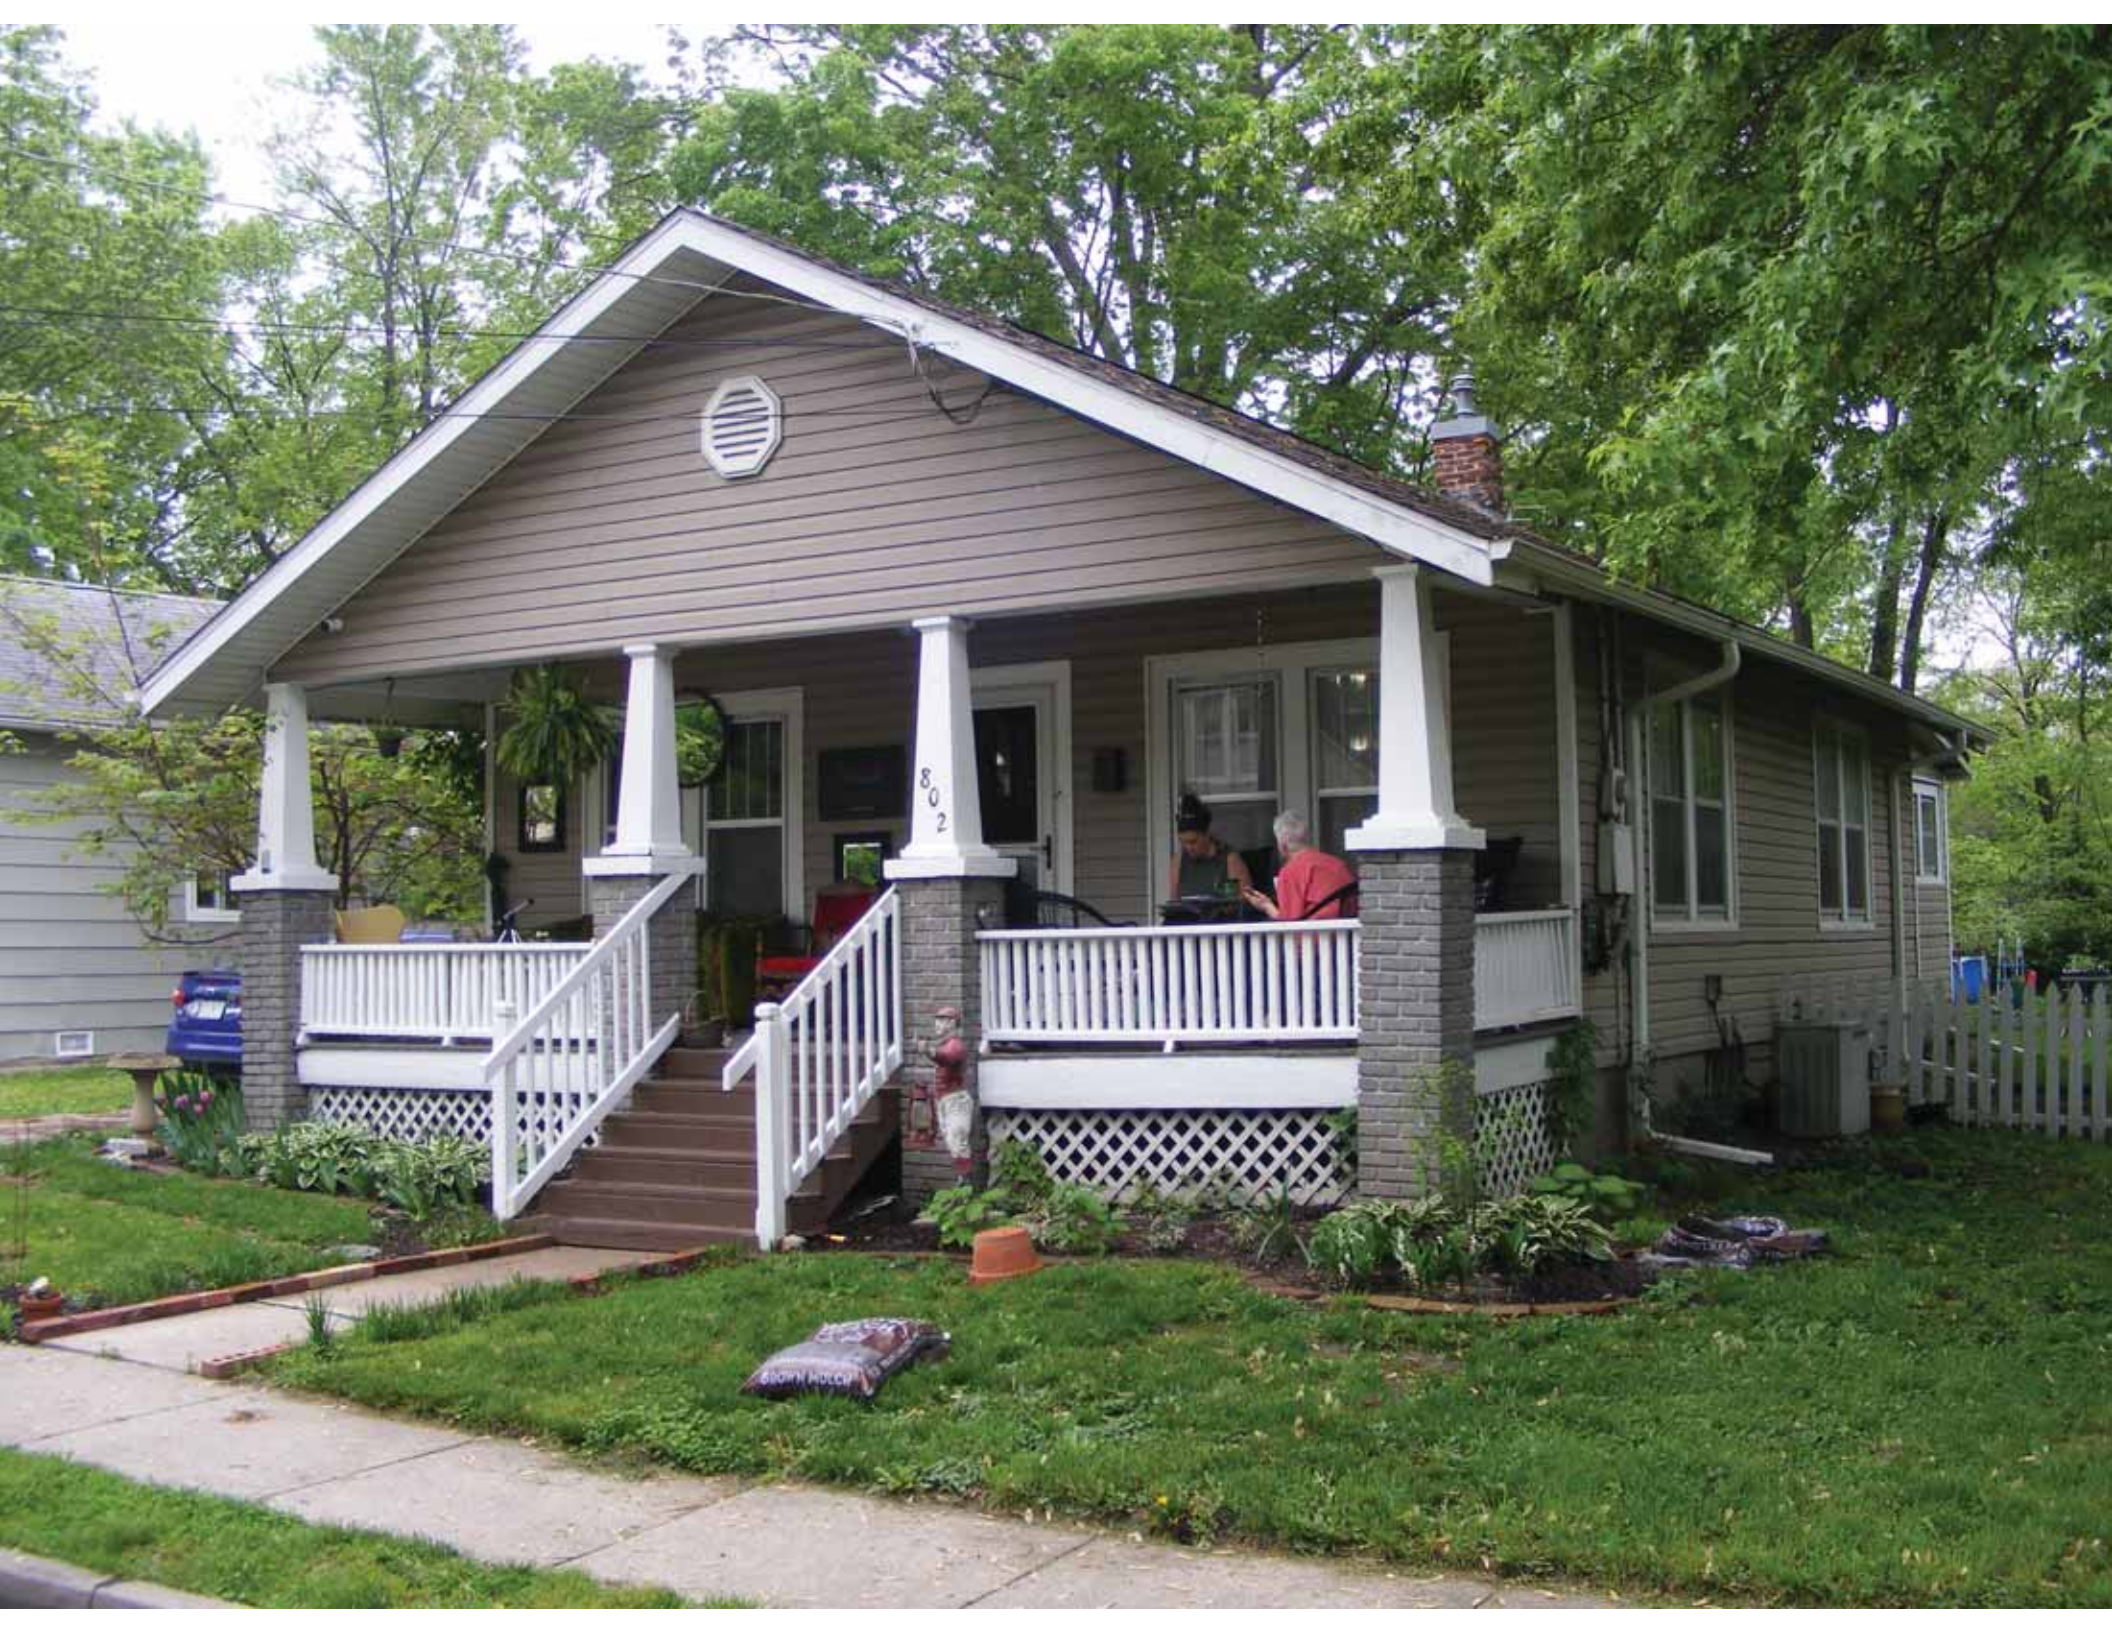
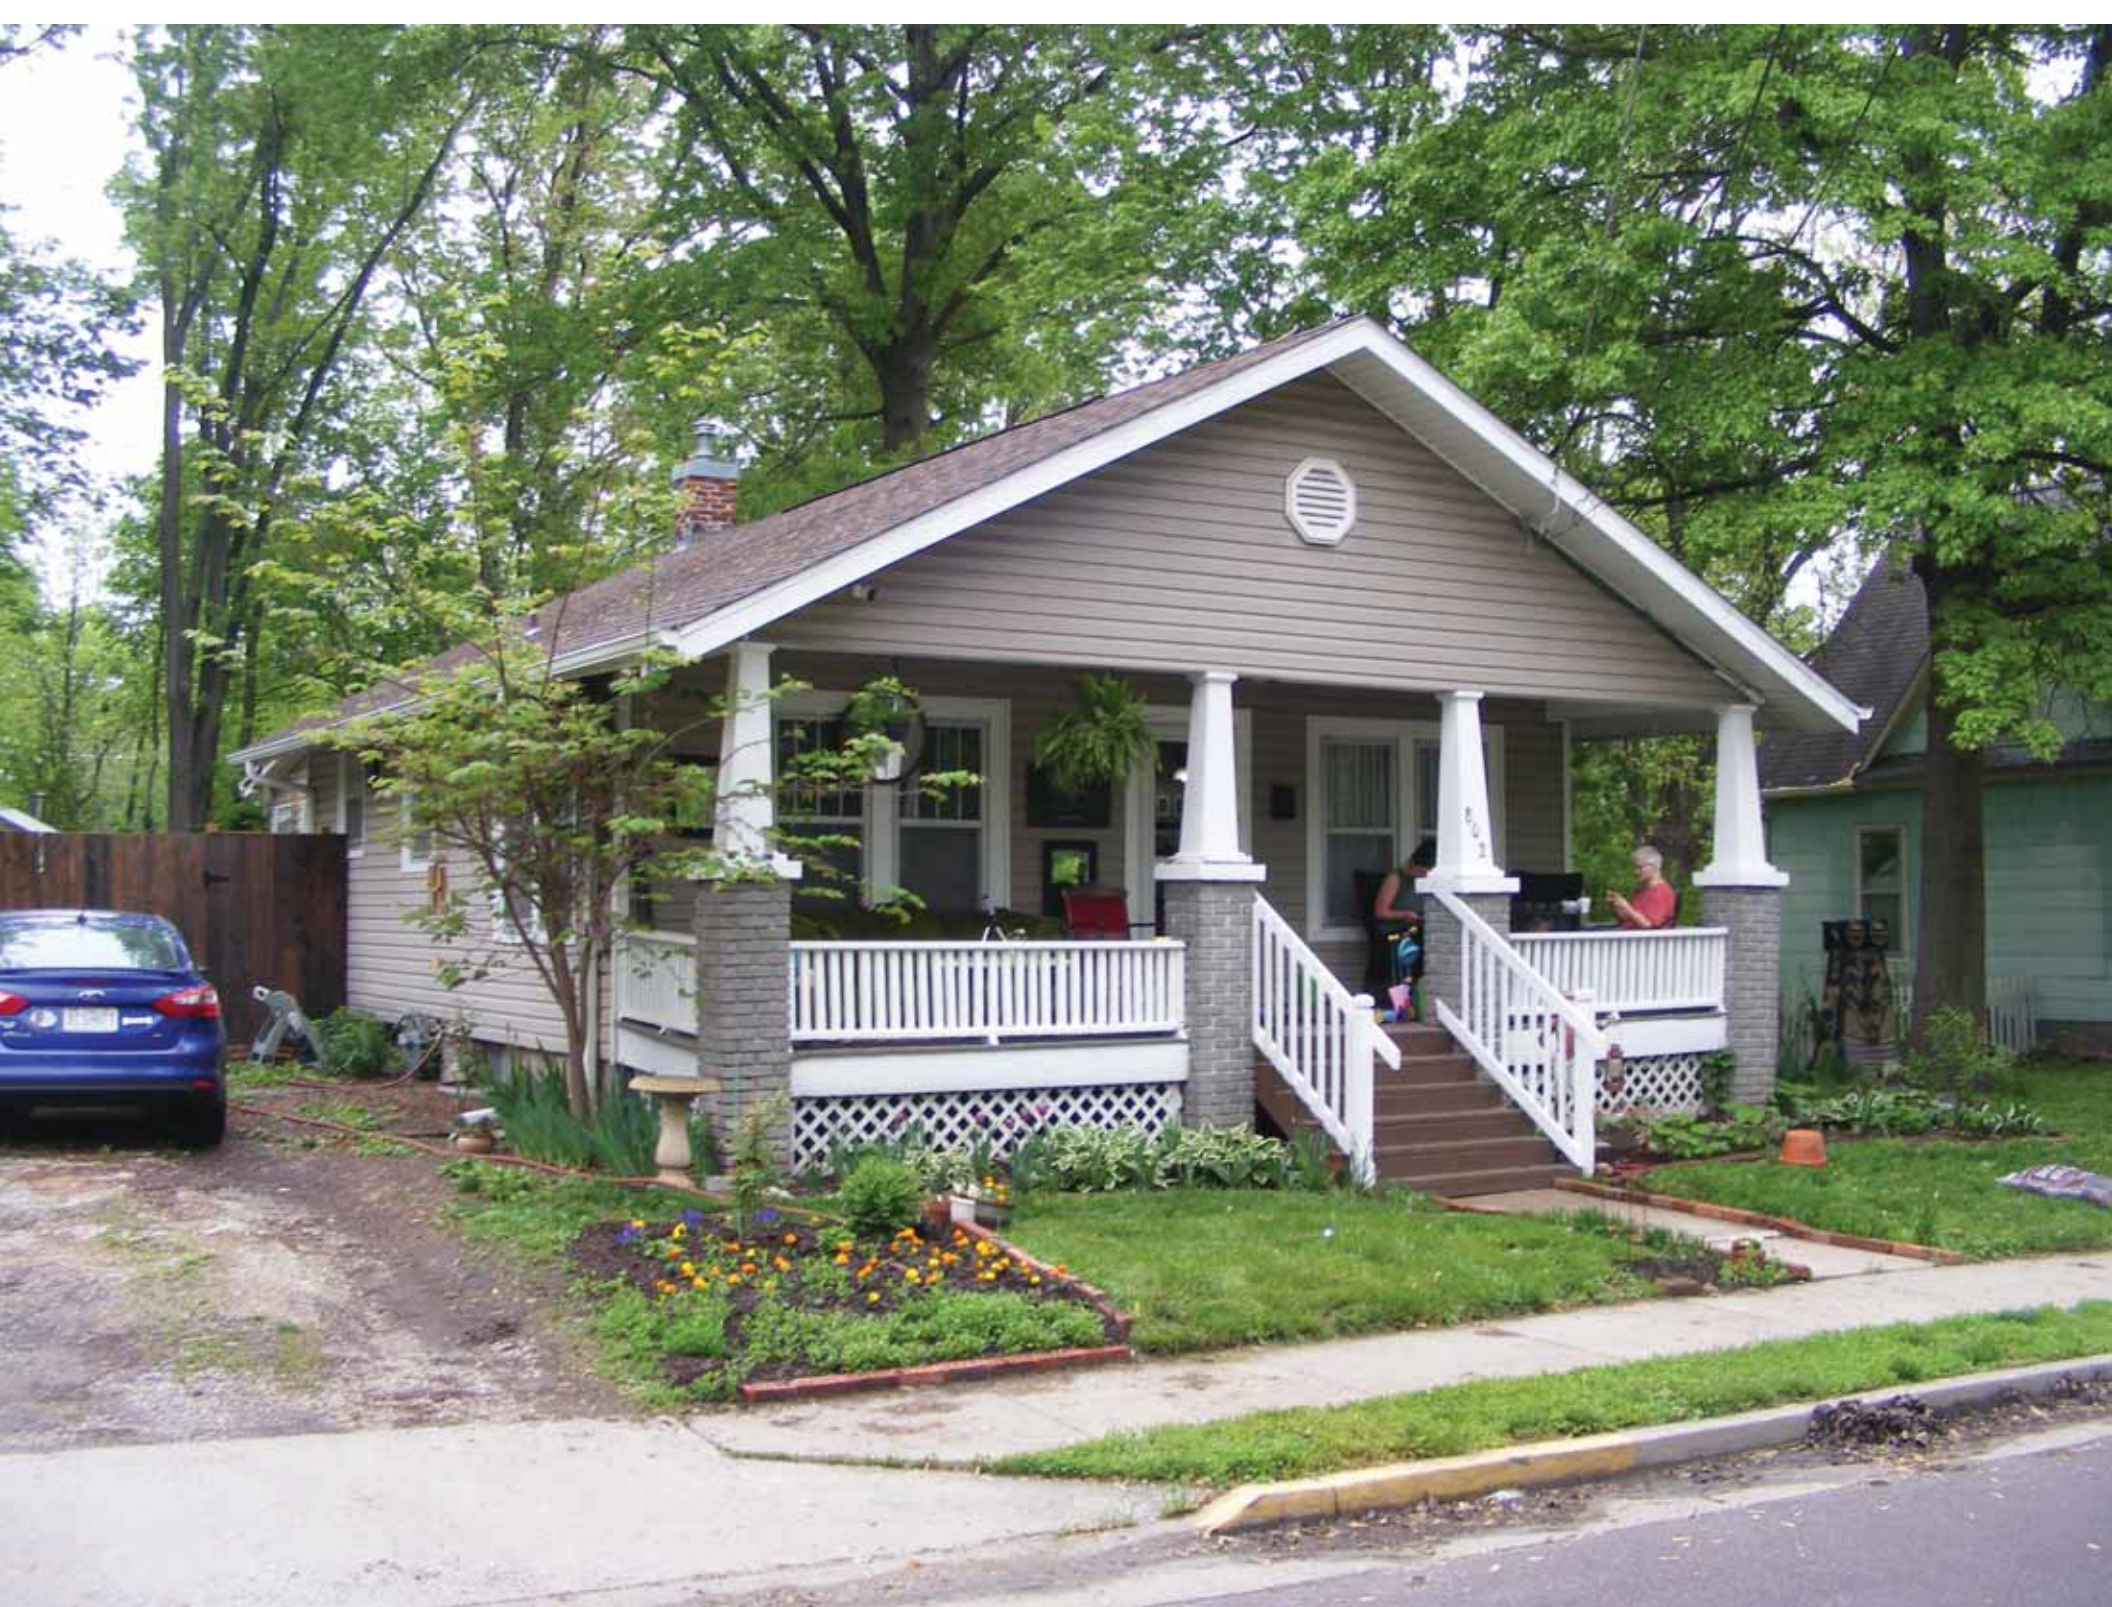
The gable-front plan Bungalow has an asphalt-shingled roof, exterior synthetic siding and a raised concrete foundation. An interior brick flue is visible near the west elevation. The façade (north elevation) supports a full-width gabled porch supported by tapered piers on brick columns. A frame balustrade surrounds the porch and extends as handrails along the steps leading to the porch. Lattice obscures the area below the porch floor. Within the porch bay is a central entry flanked by paired original four-over-one windows. Above the porch, the gable field holds an octagonal vent. Eaves are enclosed. The dwelling has a rear small shed wing.

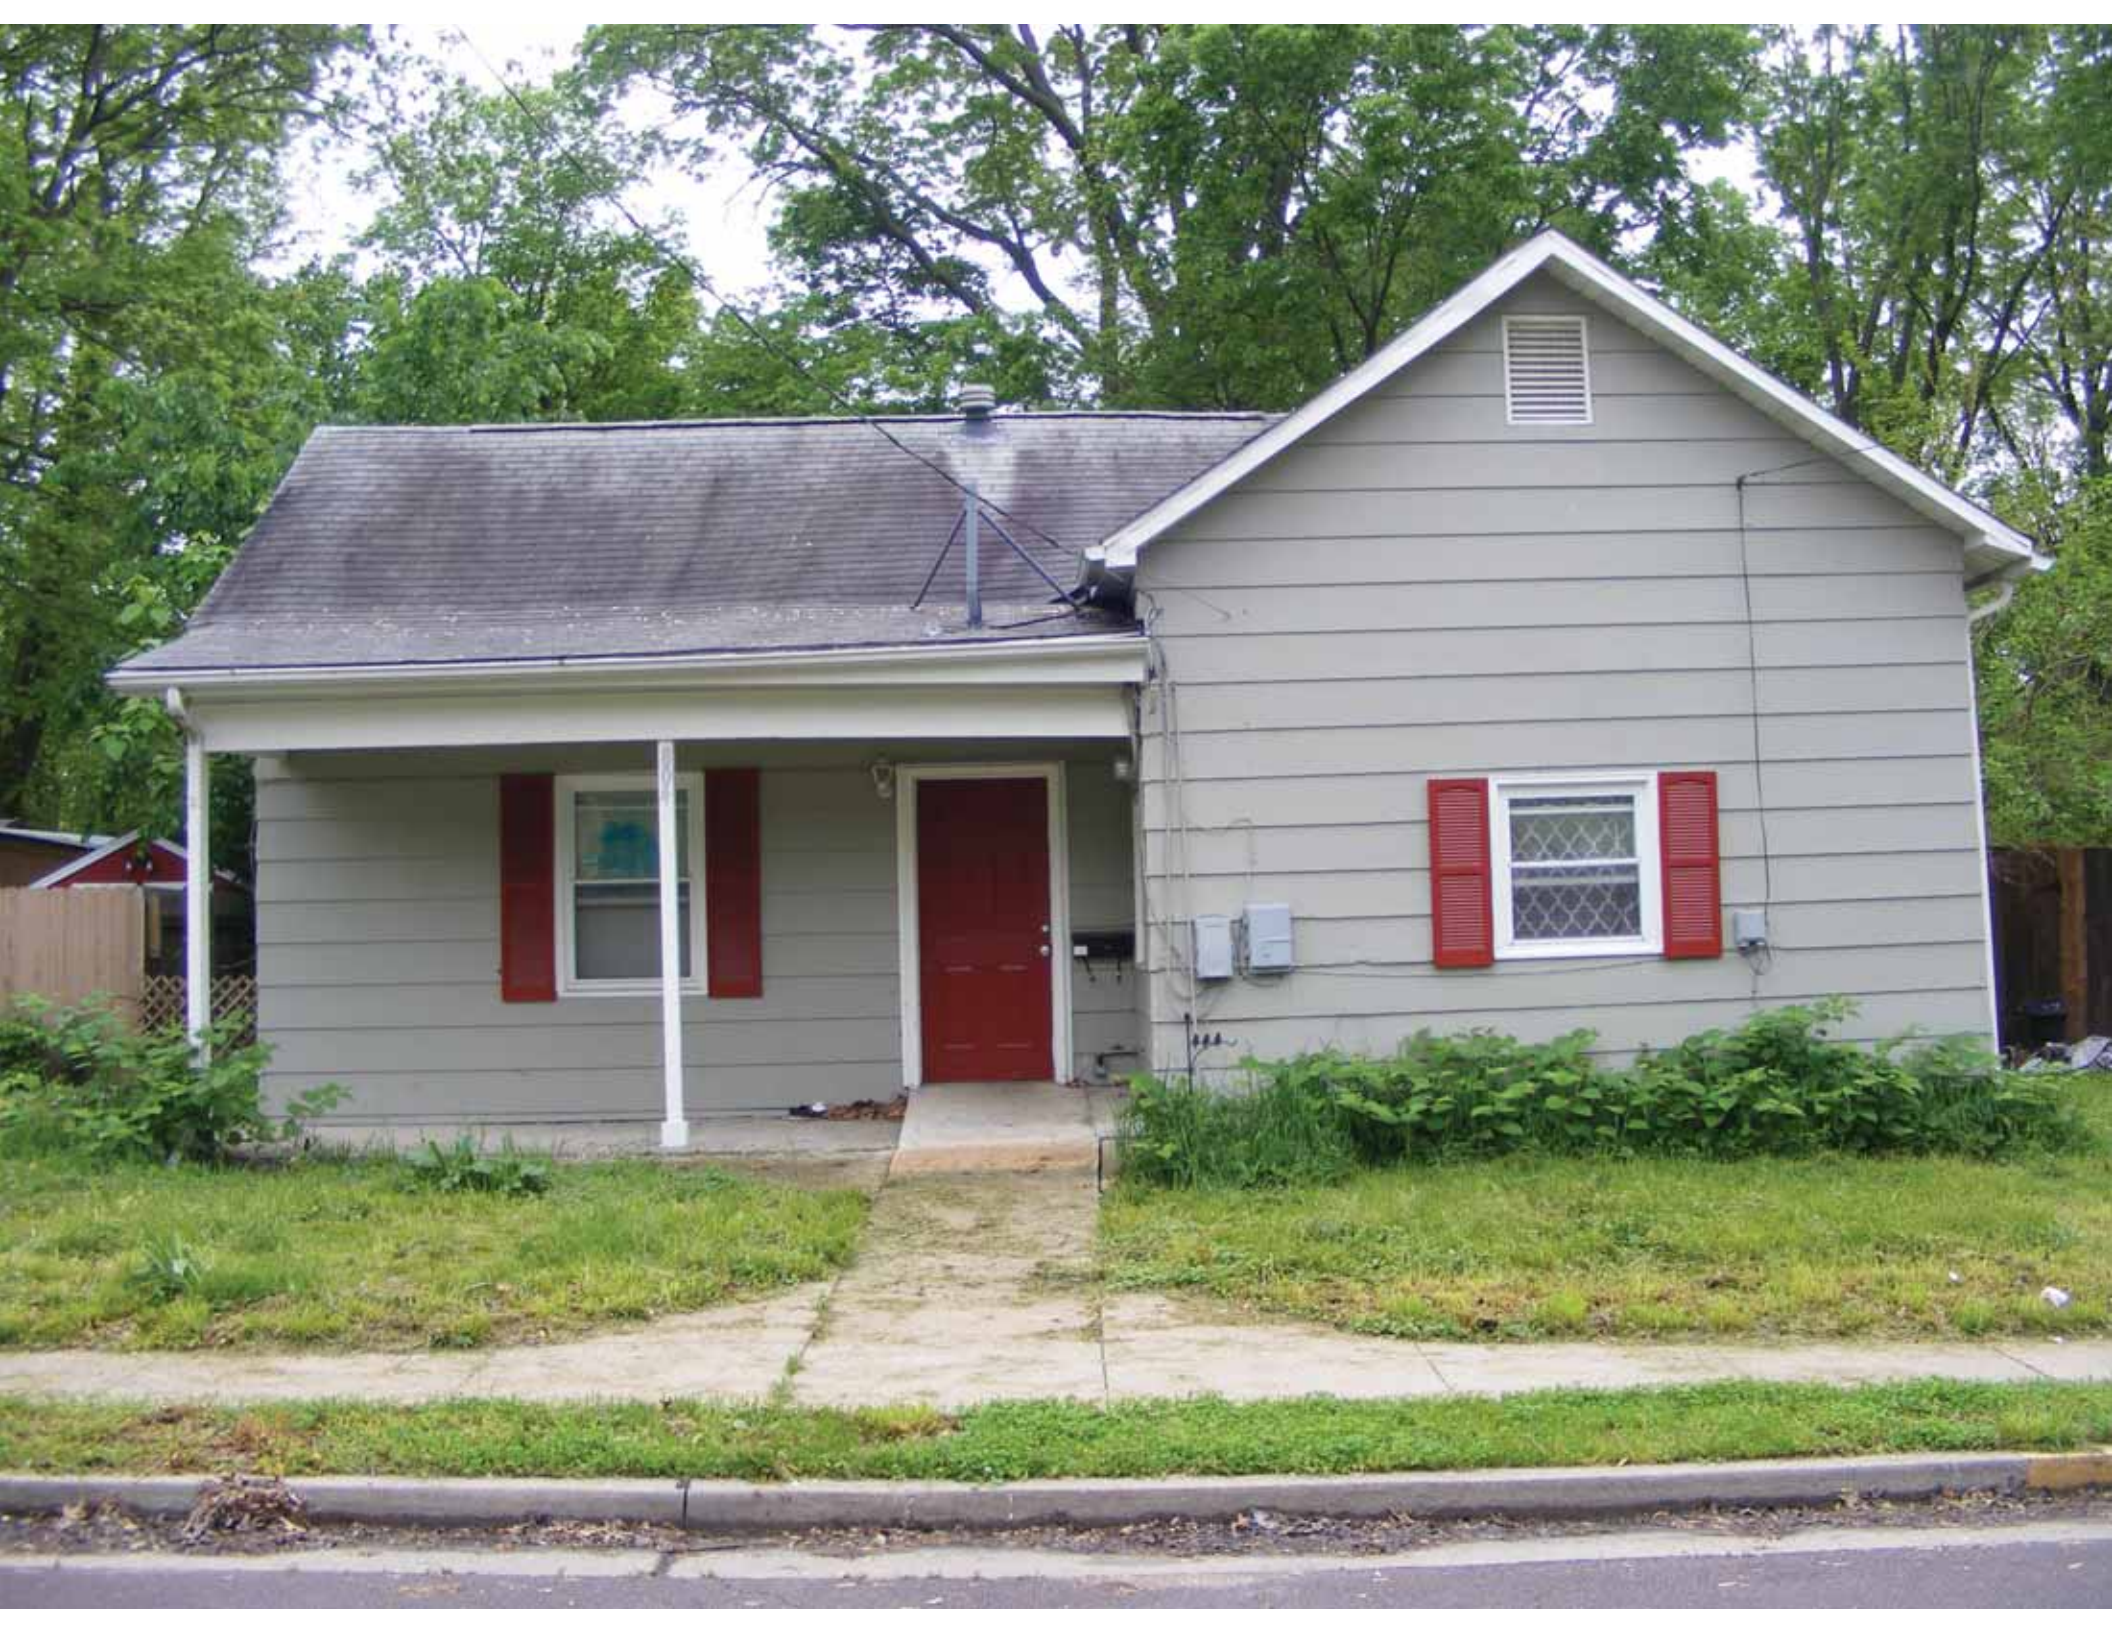
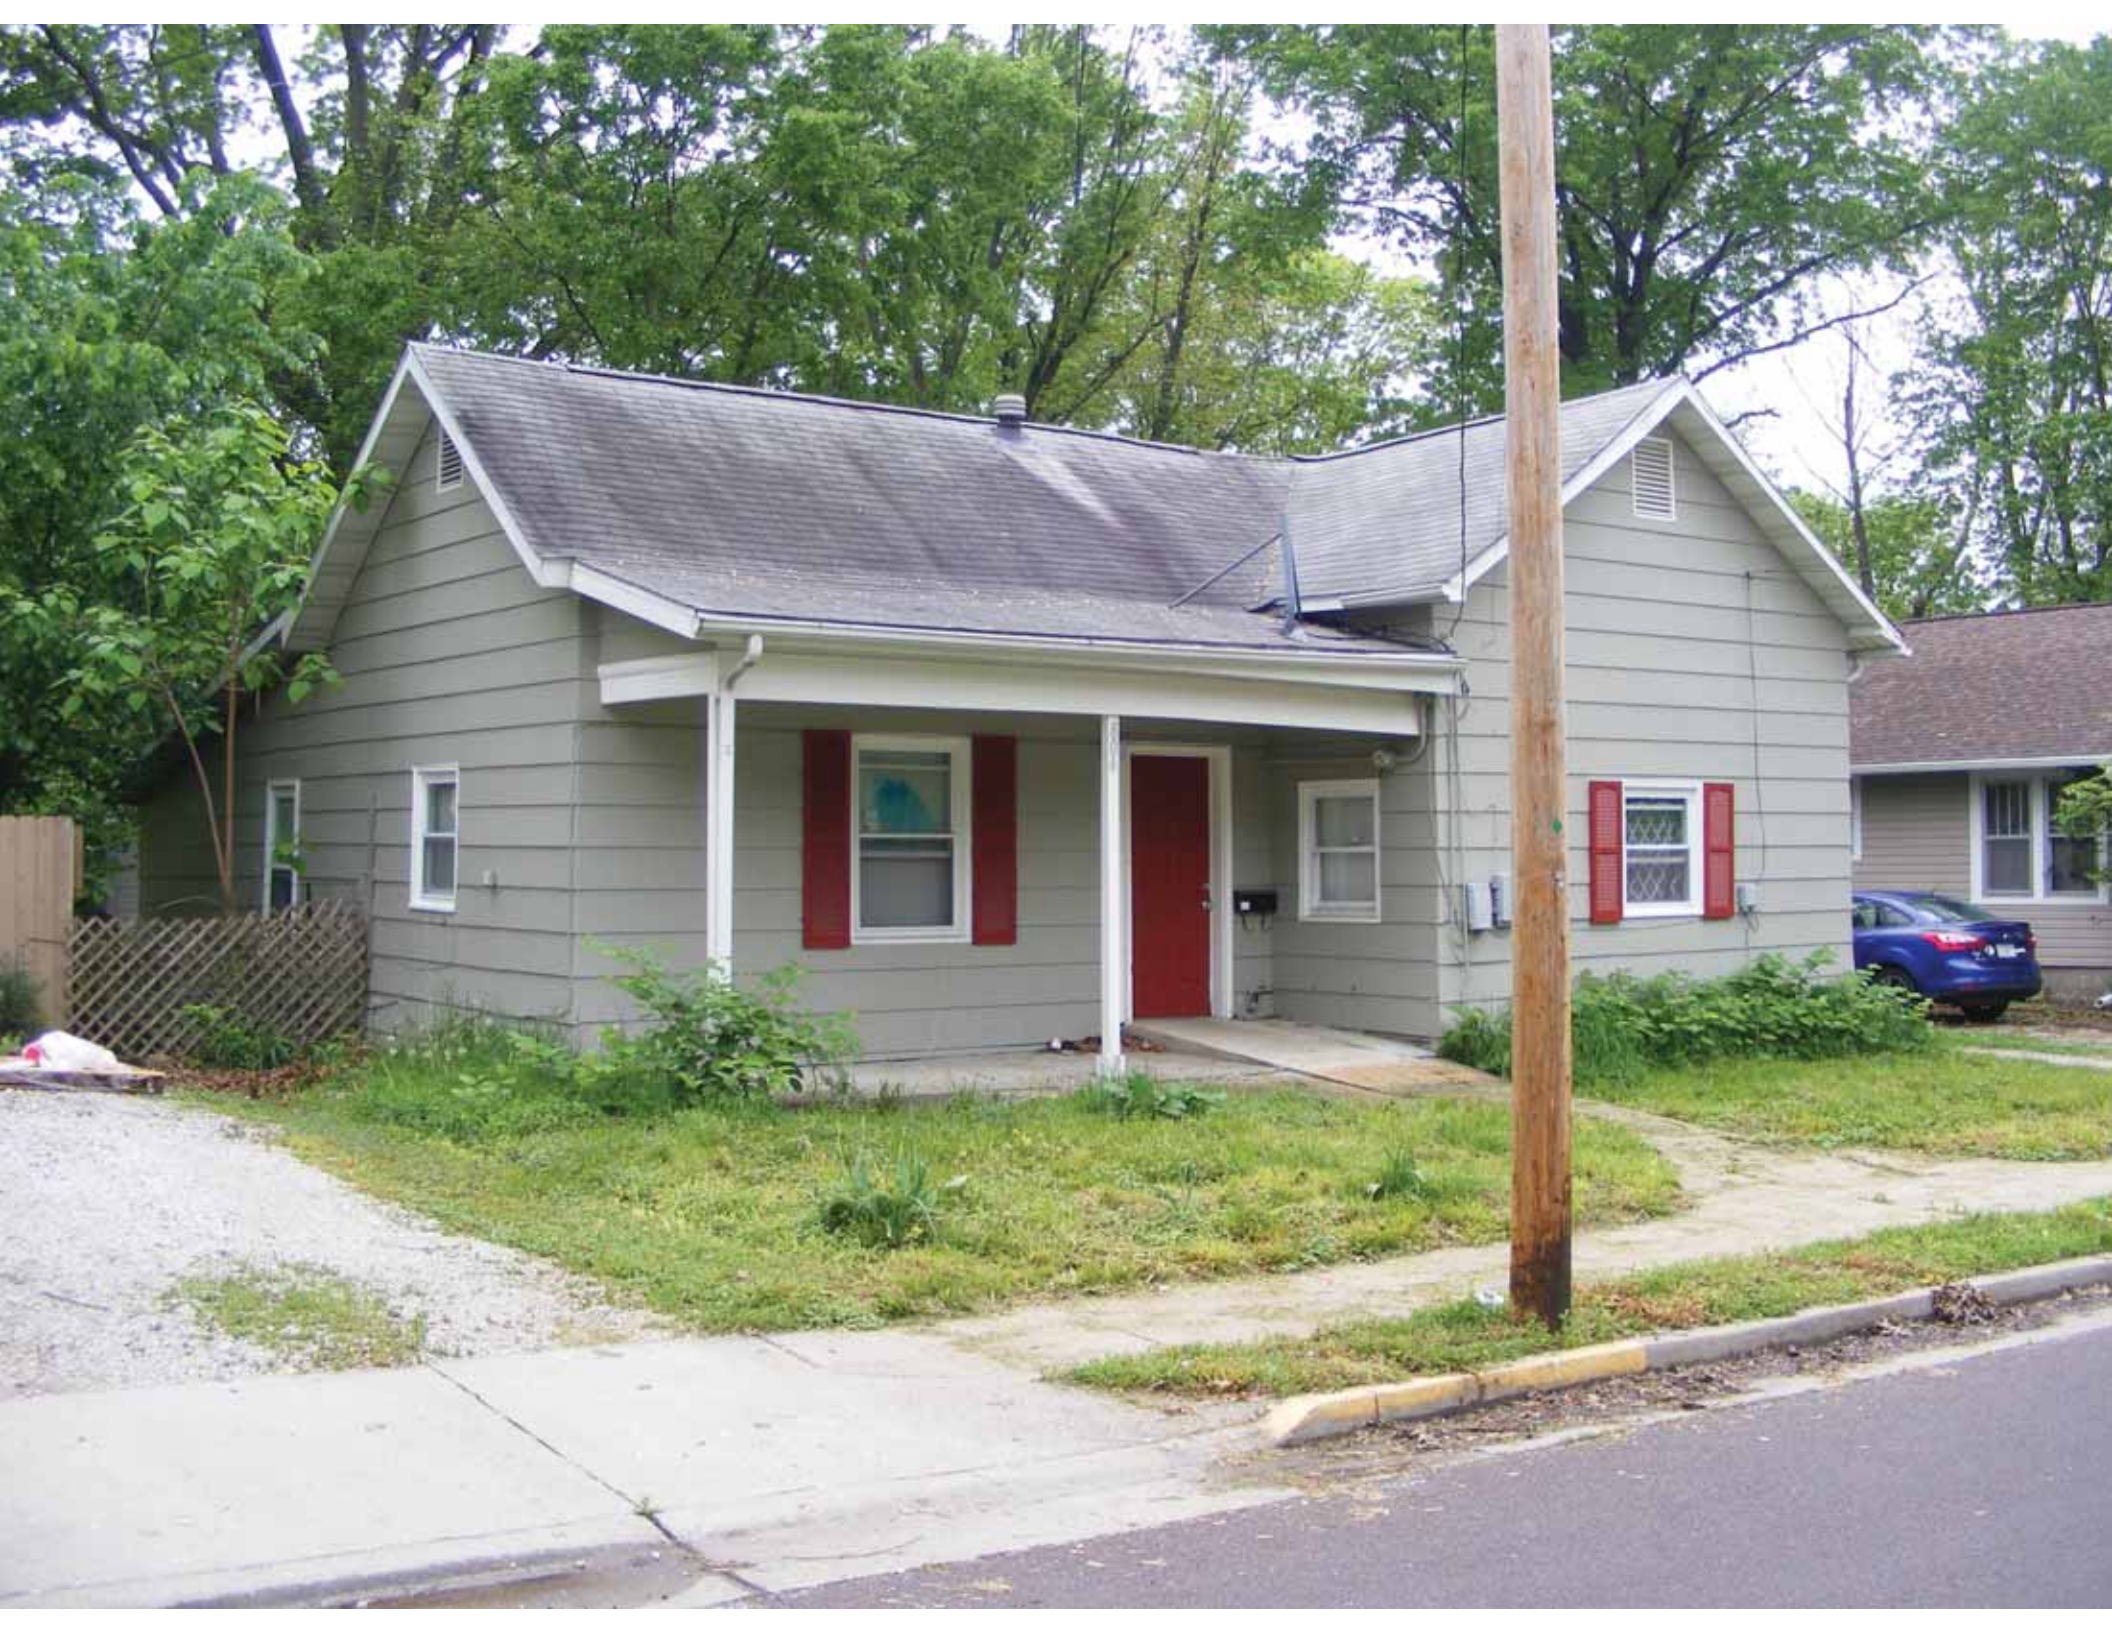
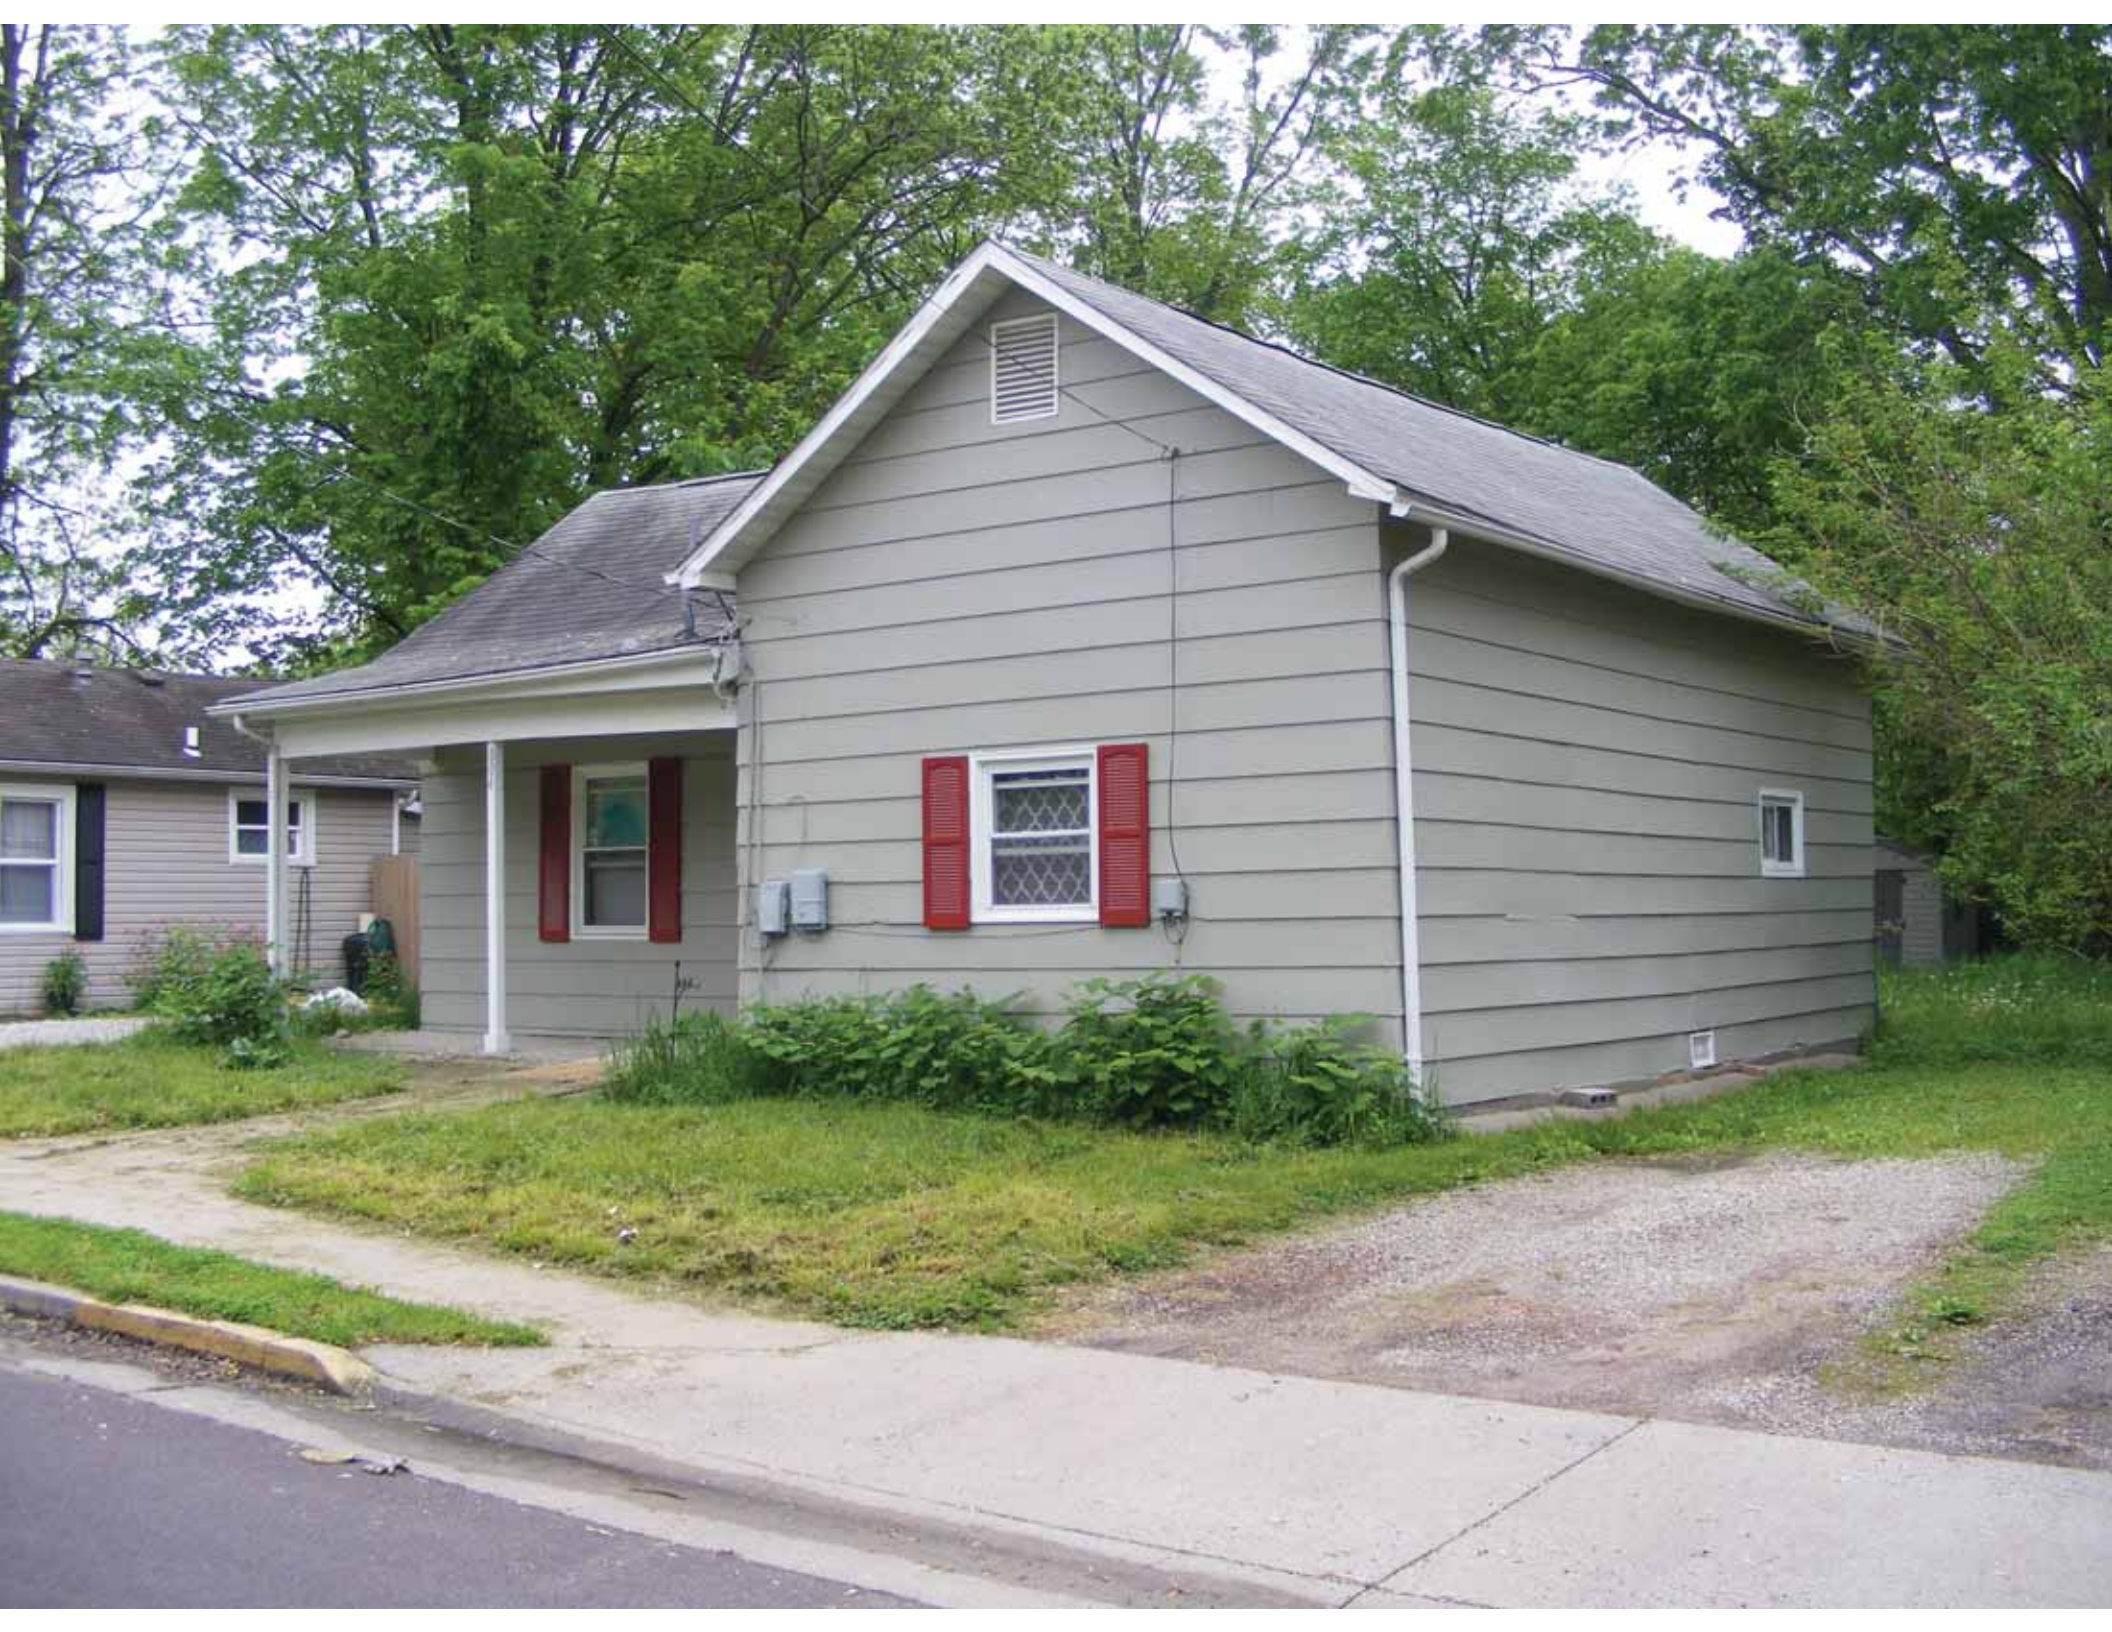
The dwelling has an asphalt-shingled cross gable roof, exterior asbestos shingle siding and a concrete foundation. The façade (north elevation) features a half-width shed porch supported by square columns. Within the porch bay is a solid c. 2000 paneled door offset on the east by a one-over-one replacement window with faux shutters. On the east wall of the projecting gabled wing (within the porch bay) is a one-over-one window. The front facing gable wall (north elevation) holds a single one-over-one window with faux shutters. The gable field holds a louvered vent. All windows appear to be replacement. The dwelling has a rear shed wing.
