MISSOURI DEPARTMENT OF NATURAL RESOURCES
STATE HISTORIC PRESERVATION OFFICE, P.O. Box 176, Jefferson City, MO 65102
ARCHITECTURAL/HISTORIC INVENTORY FORM

1. Survey No. BO-AS-011-0087		2. Survey name: North Central Columbia Survey Phase II	
3. County: Boone		4. Address (Street No.) 902	Street (name) N. Seventh Street
5. City: Columbia	Vicinity: <input type="checkbox"/>	6. Geographical Reference:	7. Township/Range/Section: T: R: S:
8. Historic name (if known):		9. Present/other name (if known):	
10. Ownership: <input checked="" type="checkbox"/> Private <input type="checkbox"/> Public		11a. Historic use (if known): Domestic/single dwelling	11b. Current use: Domestic/single dwelling

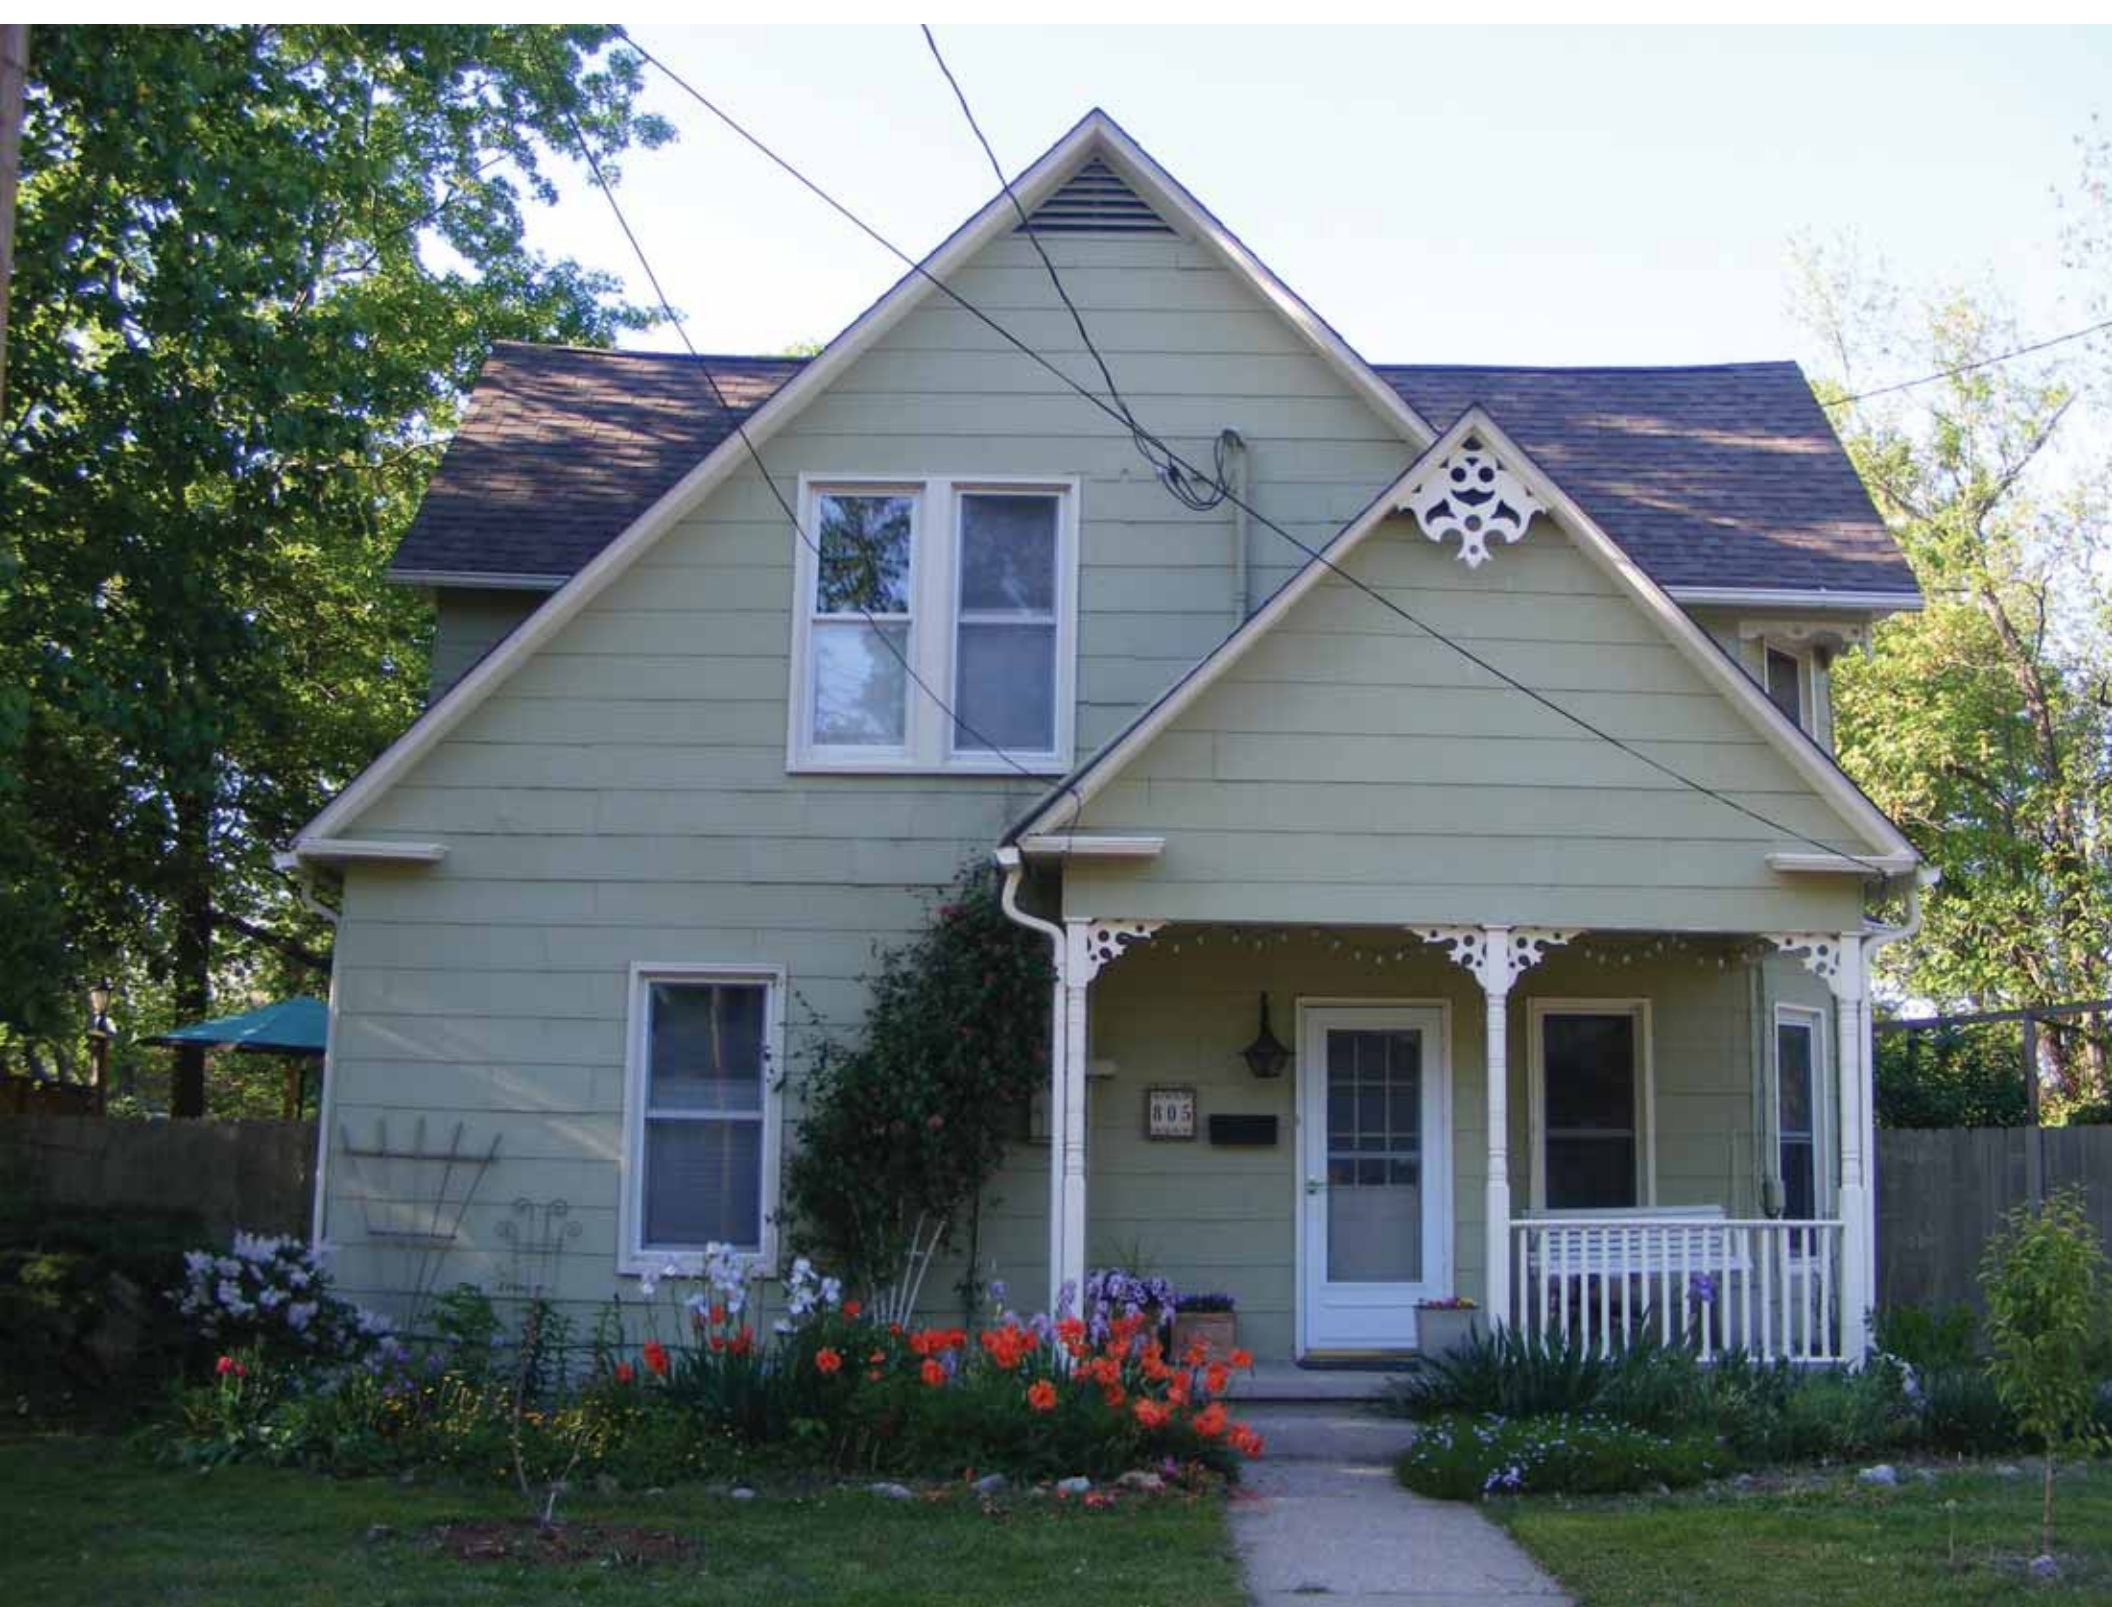
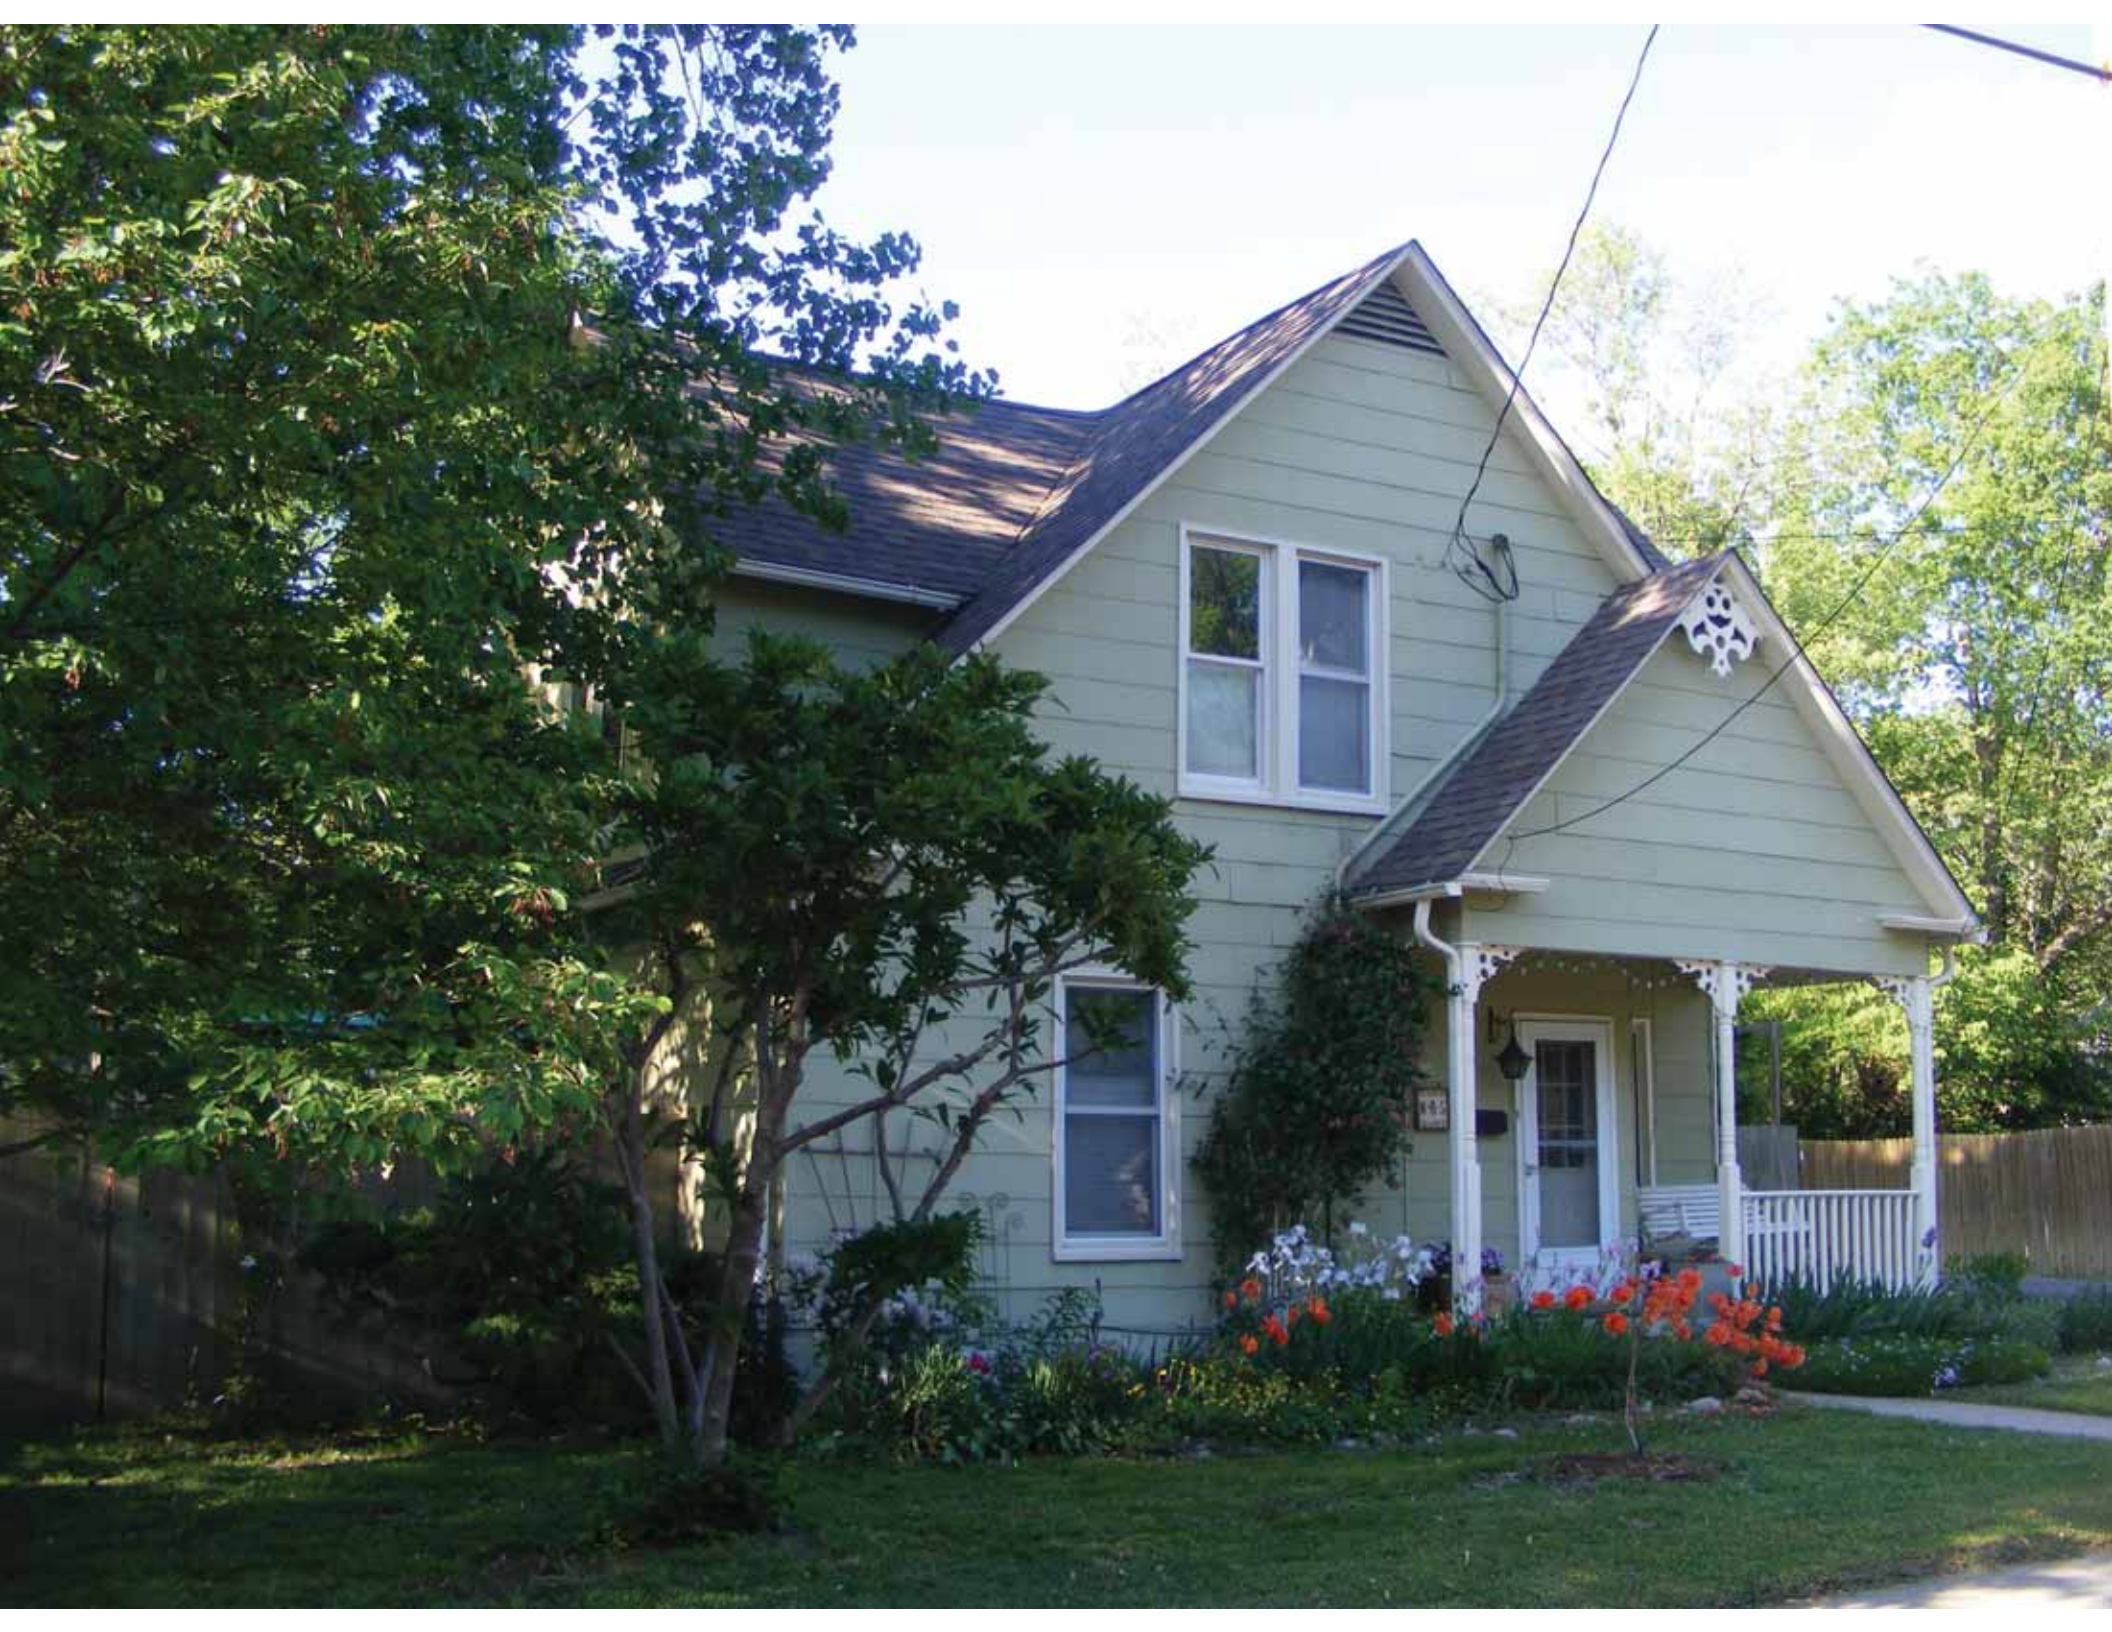
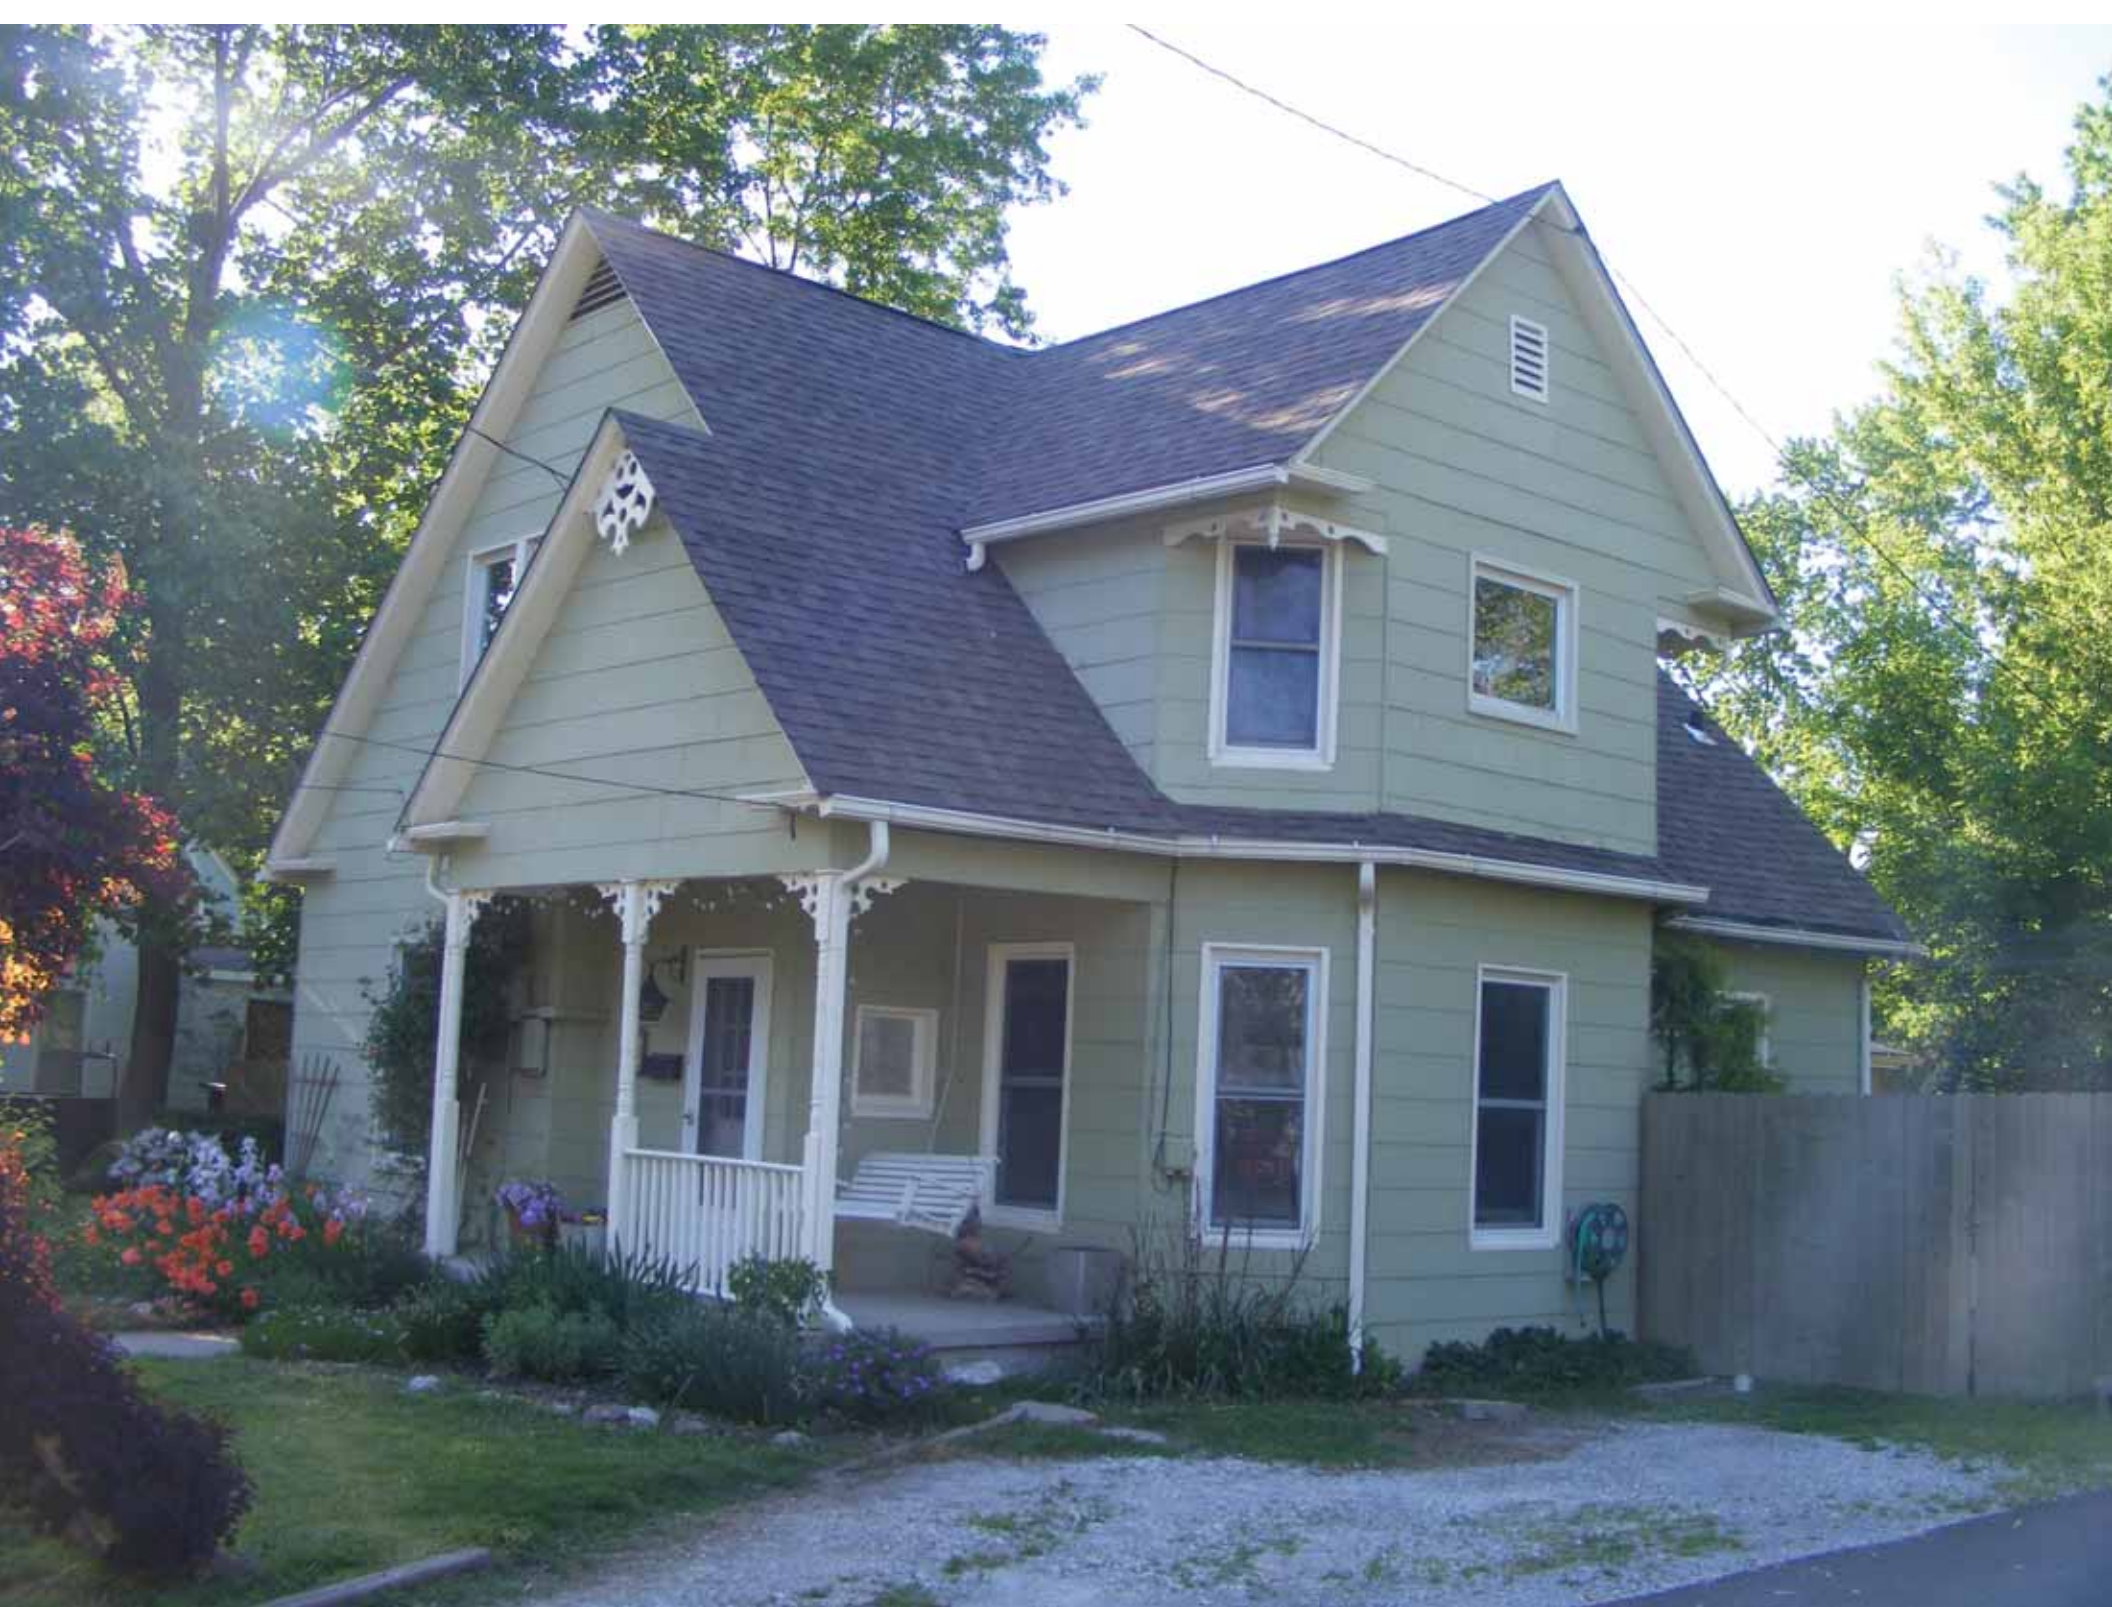
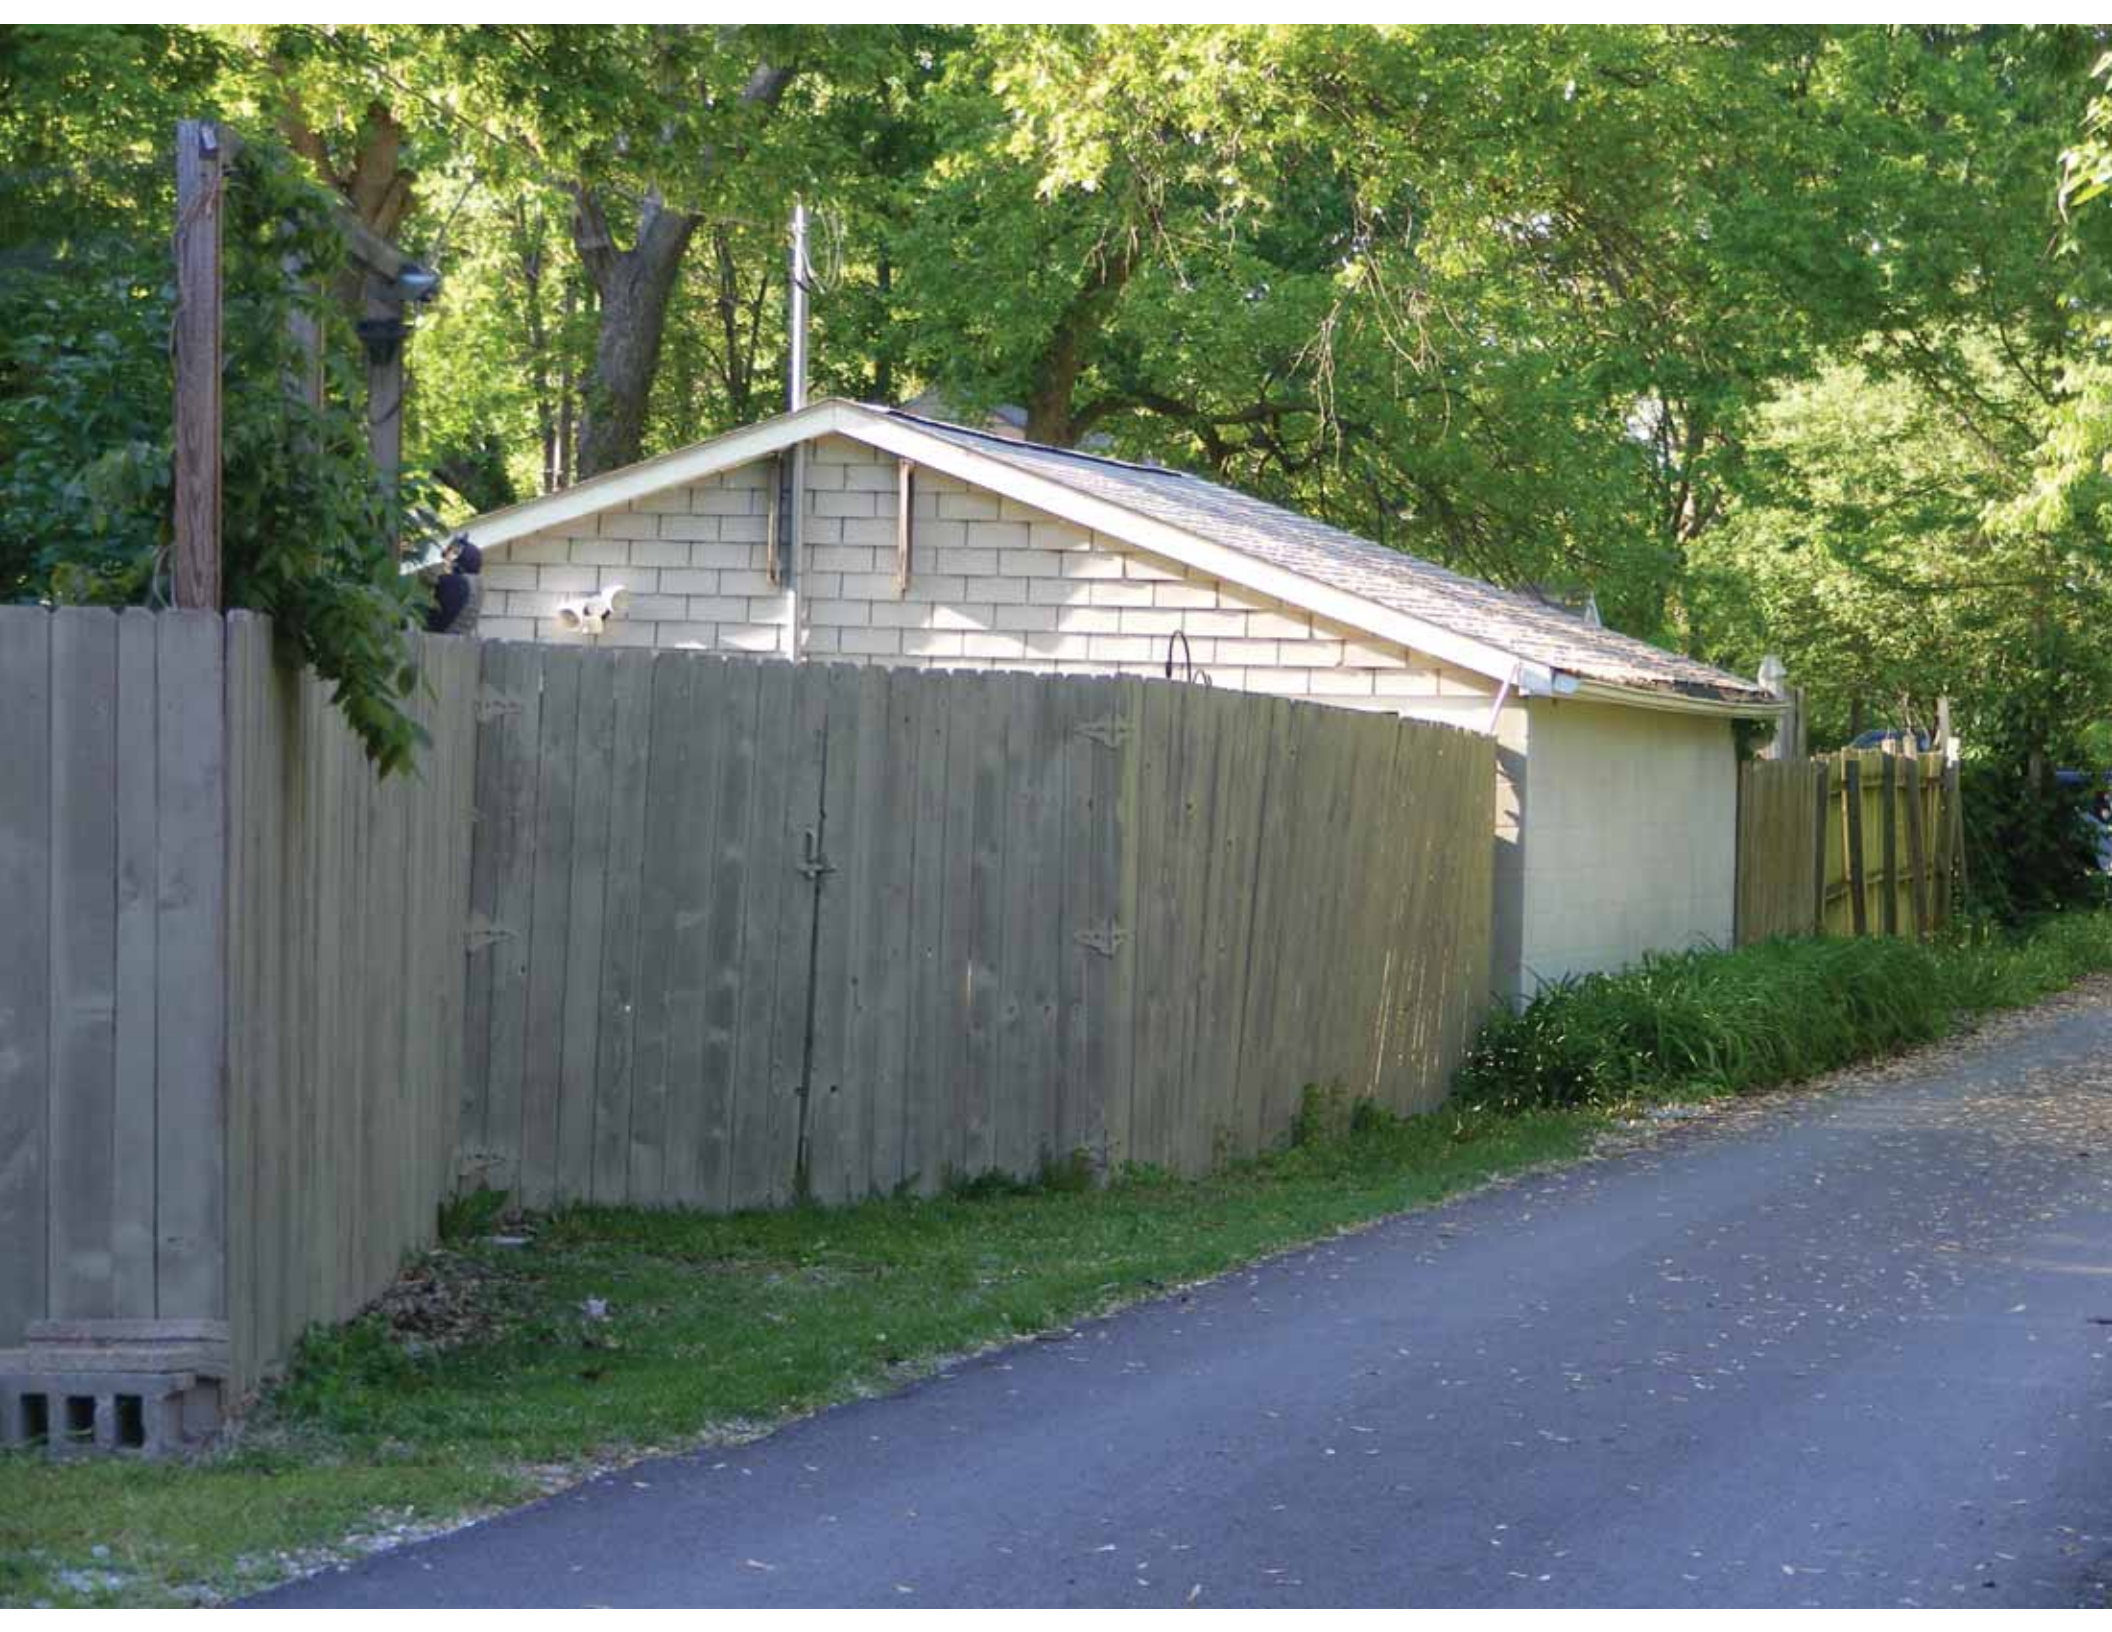
The dwelling has a cross gabled asphalt shingled roof, exterior asbestos shingle siding and a partially covered concrete foundation. The primary (south) elevation has an off-center gabled porch with gable returns. The porch is supported by milled columns with upper bargeboard. Bargeboard also adorns the porch gable field. A frame balustrade surrounds the porch. Within the porch bay is a nine-light paneled door. Windows are one-over-one and appear original with vinyl sash storm windows. In the primary gable field is a louvered vent. Below the vent are paired off-center one-over-one windows. The west elevation has a projecting two-story bay with angled walls. Each of the walls holds a one-over-one window with exception of the upper west elevation which holds a single-sash replacement window. The gable field has a louvered vent. The roof overhang (above angled upper windows) supports decorative millwork with a central dropped spindle. The rear elevation has a gabled dormer with paired windows.
