MISSOURI DEPARTMENT OF NATURAL RESOURCES
STATE HISTORIC PRESERVATION OFFICE, P.O. Box 176, Jefferson City, MO 65102
ARCHITECTURAL/HISTORIC INVENTORY FORM

1. Survey No. BO-AS-011-0087		2. Survey name: North Central Columbia Survey Phase II	
3. County: Boone		4. Address (Street No.) 902	Street (name) N. Seventh Street
5. City: Columbia	Vicinity: <input type="checkbox"/>	6. Geographical Reference:	7. Township/Range/Section: T: R: S:
8. Historic name (if known):		9. Present/other name (if known):	
10. Ownership: <input checked="" type="checkbox"/> Private <input type="checkbox"/> Public		11a. Historic use (if known): Domestic/single dwelling	11b. Current use: Domestic/single dwelling

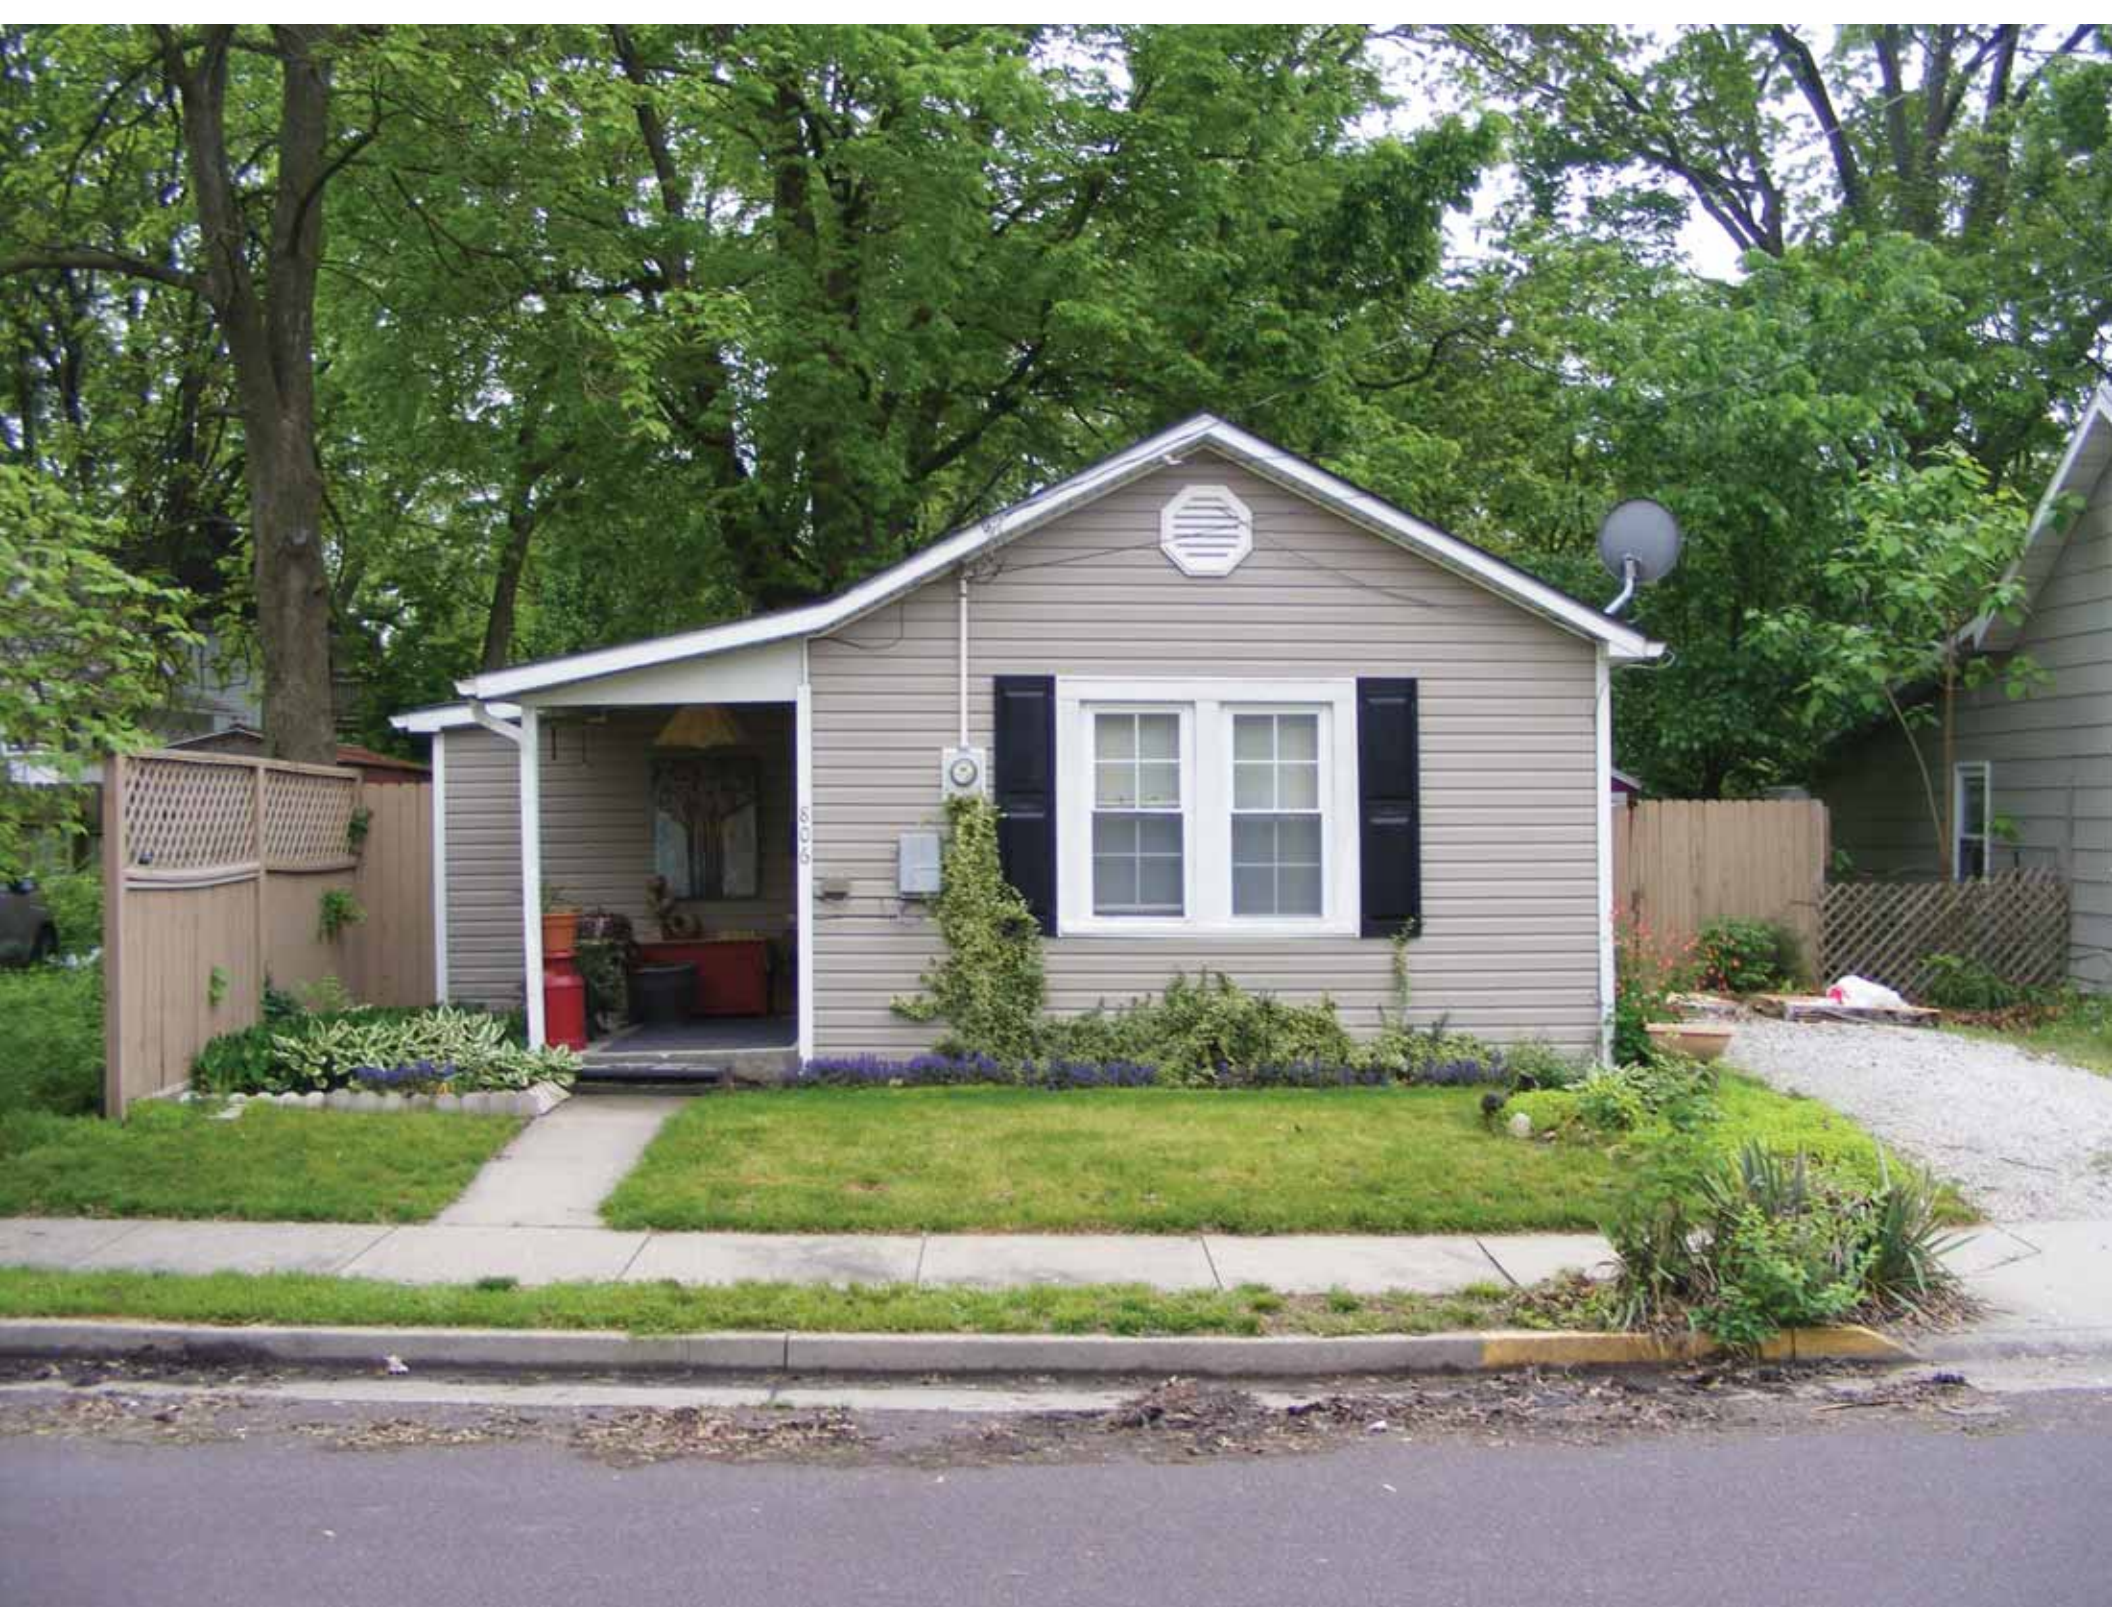
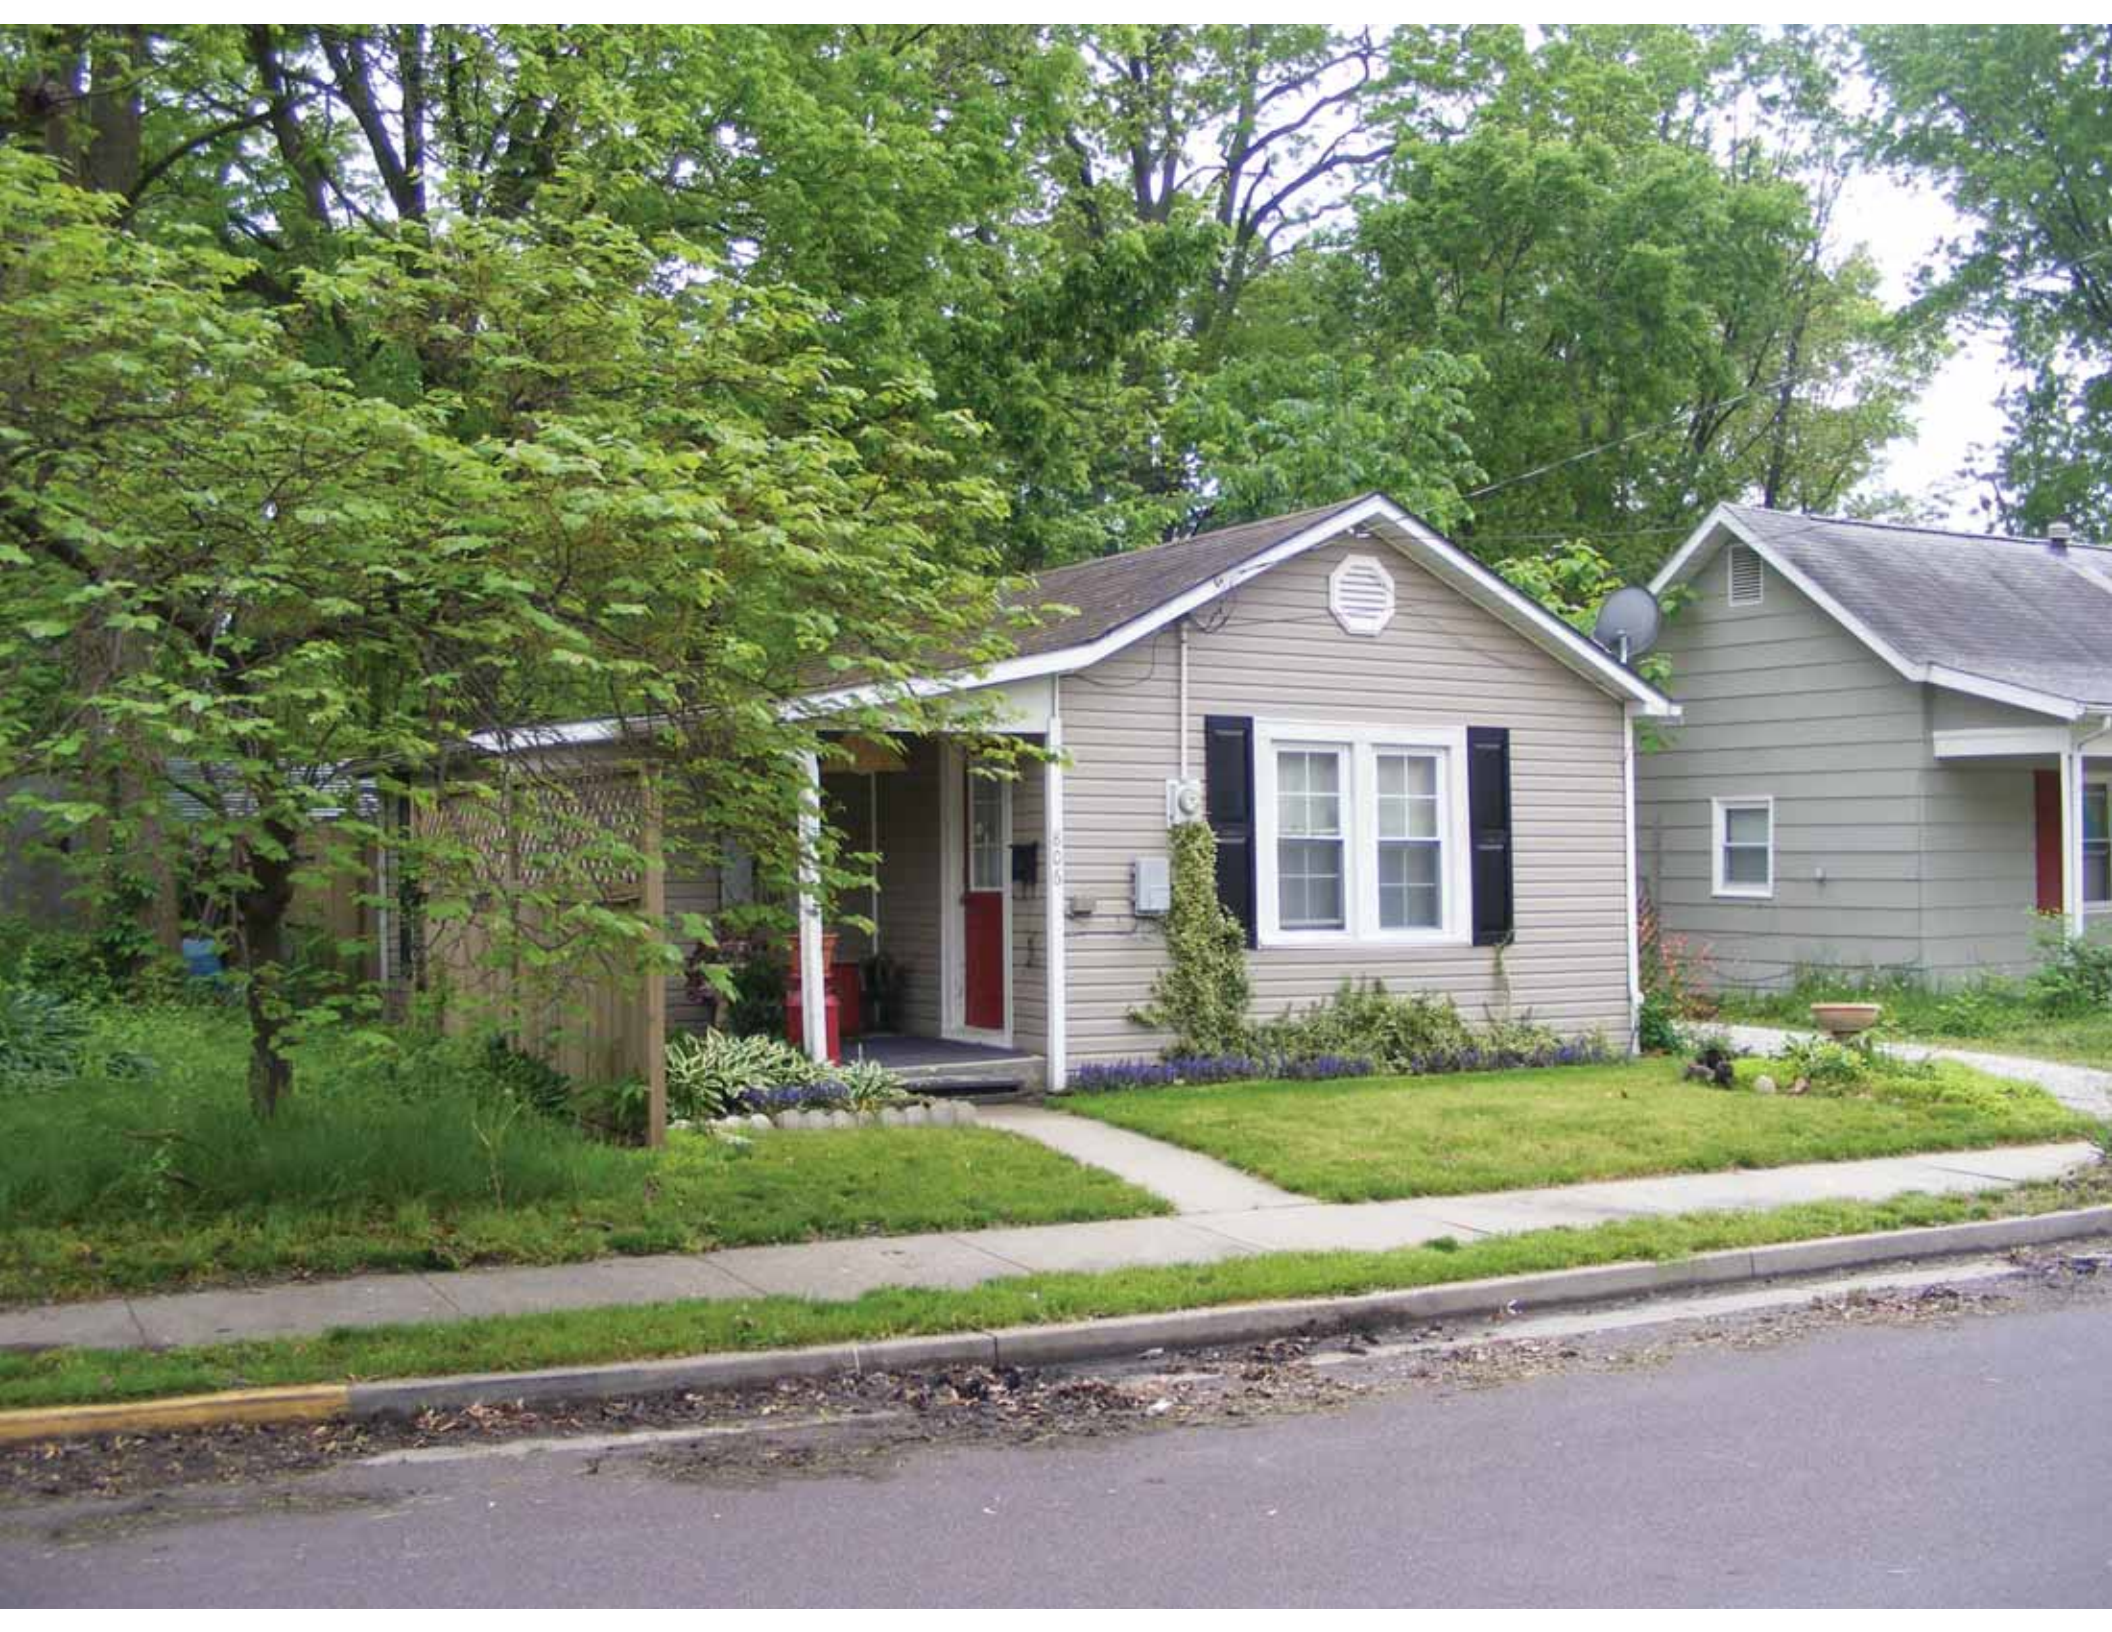
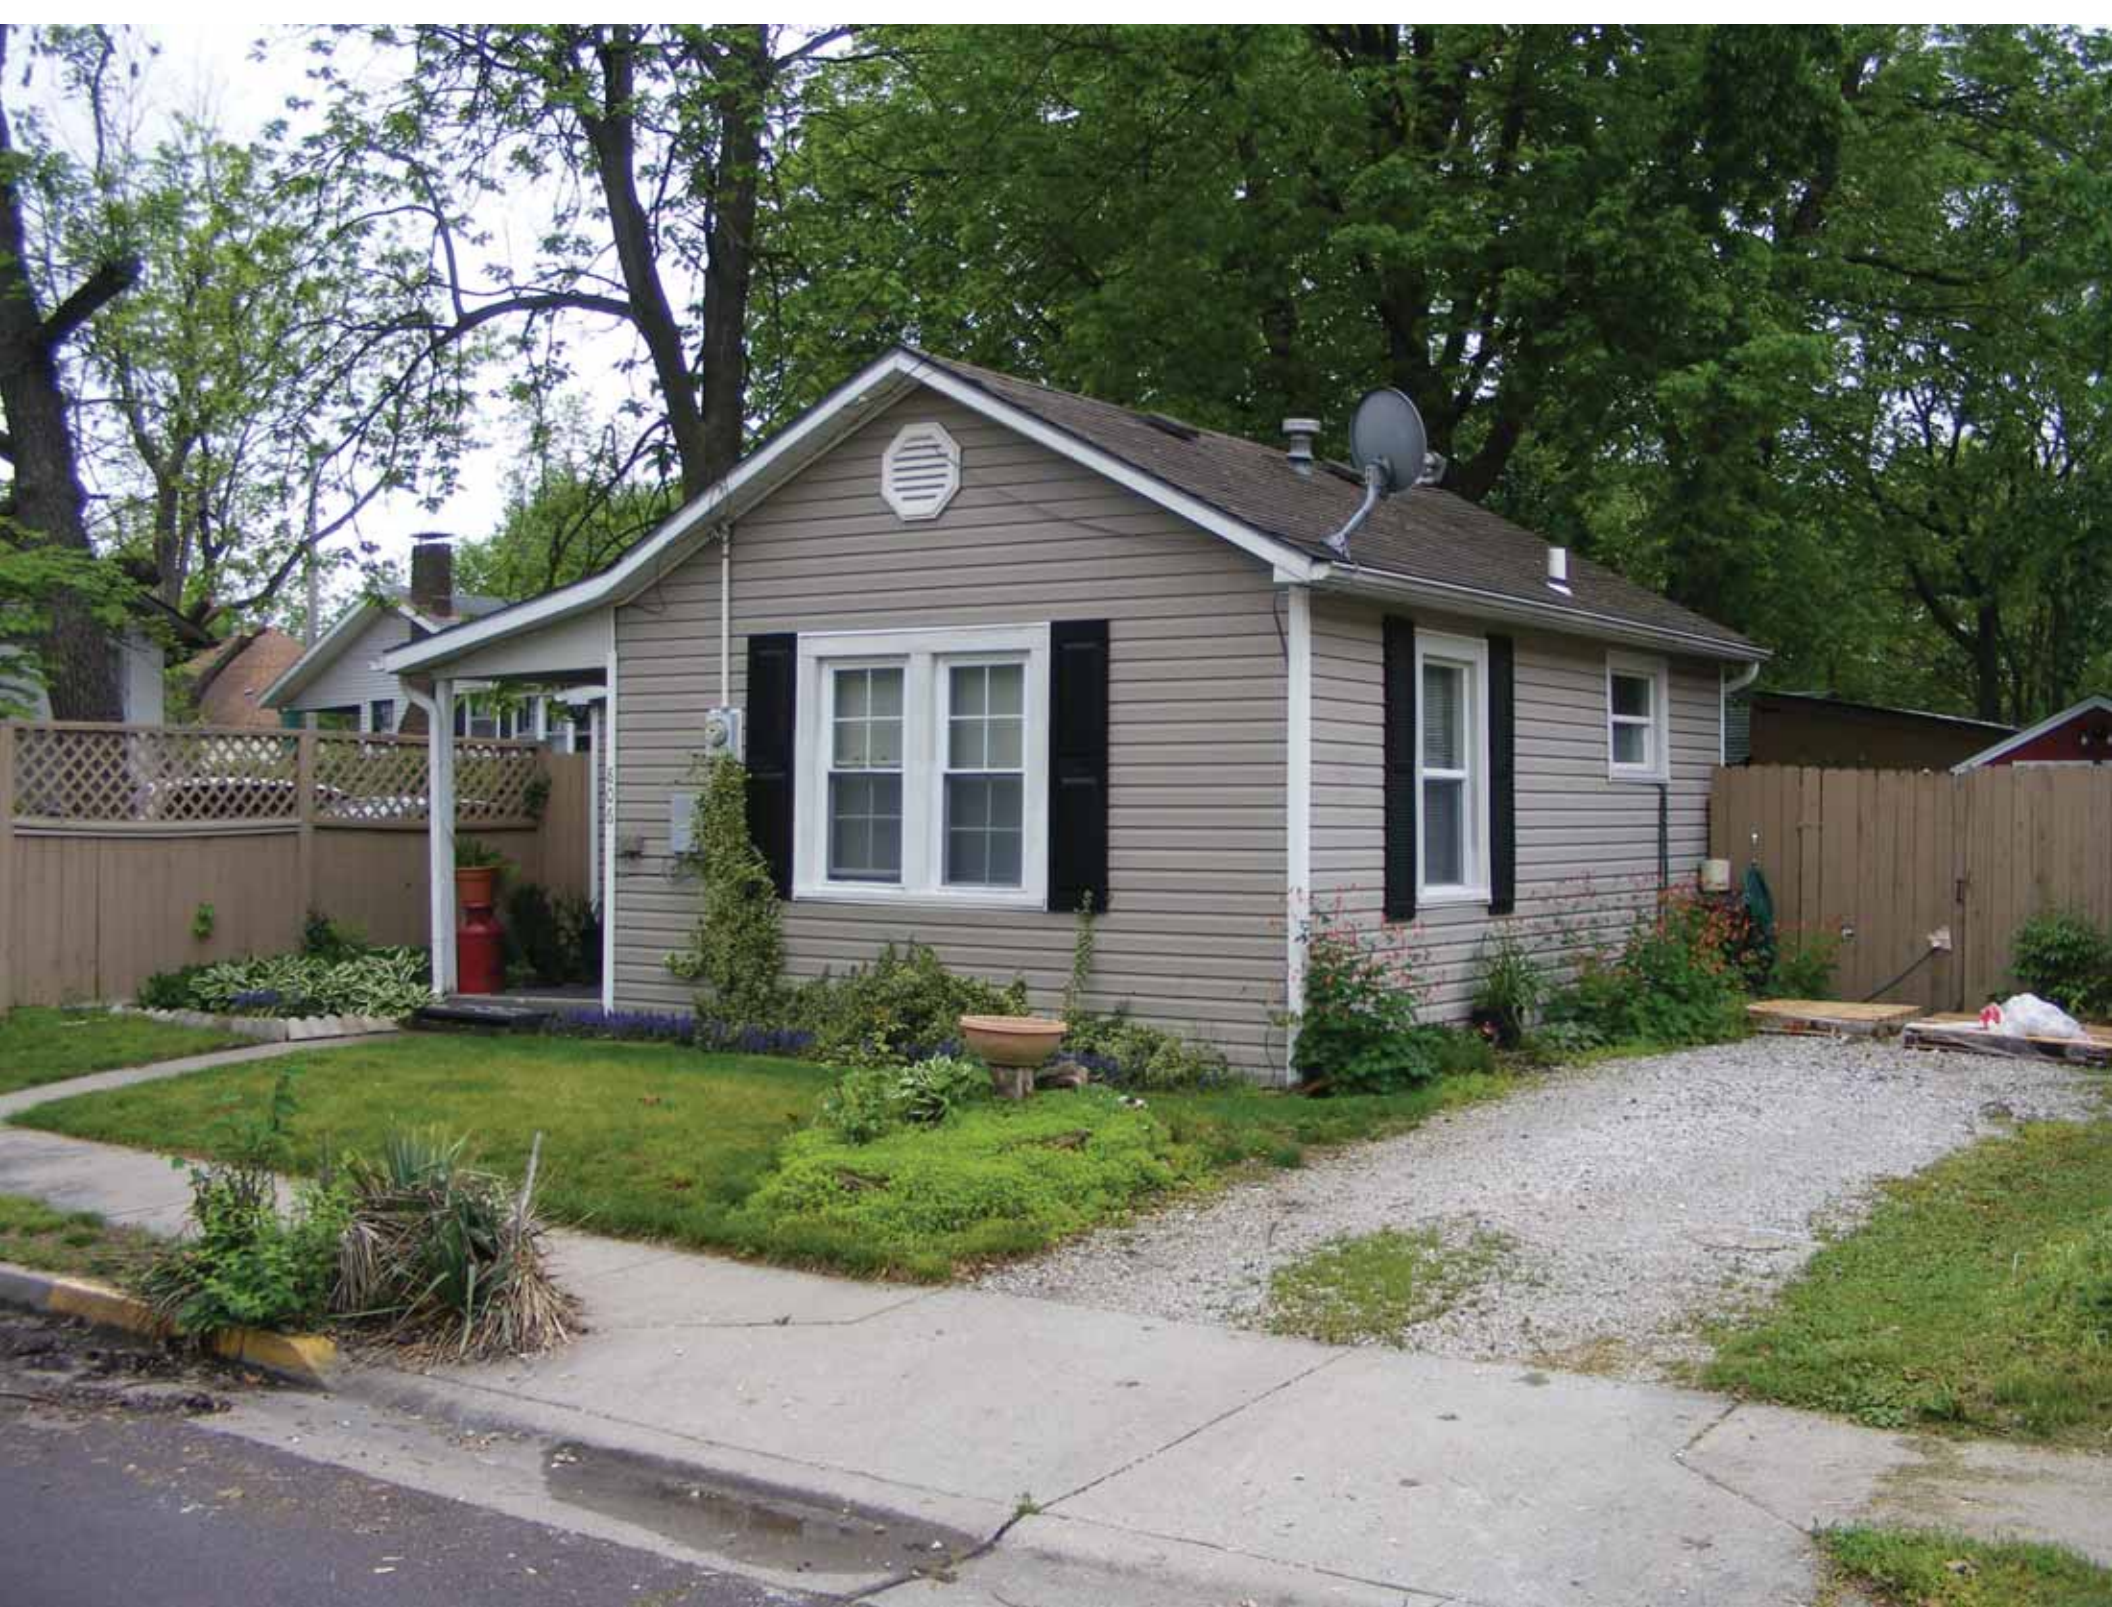
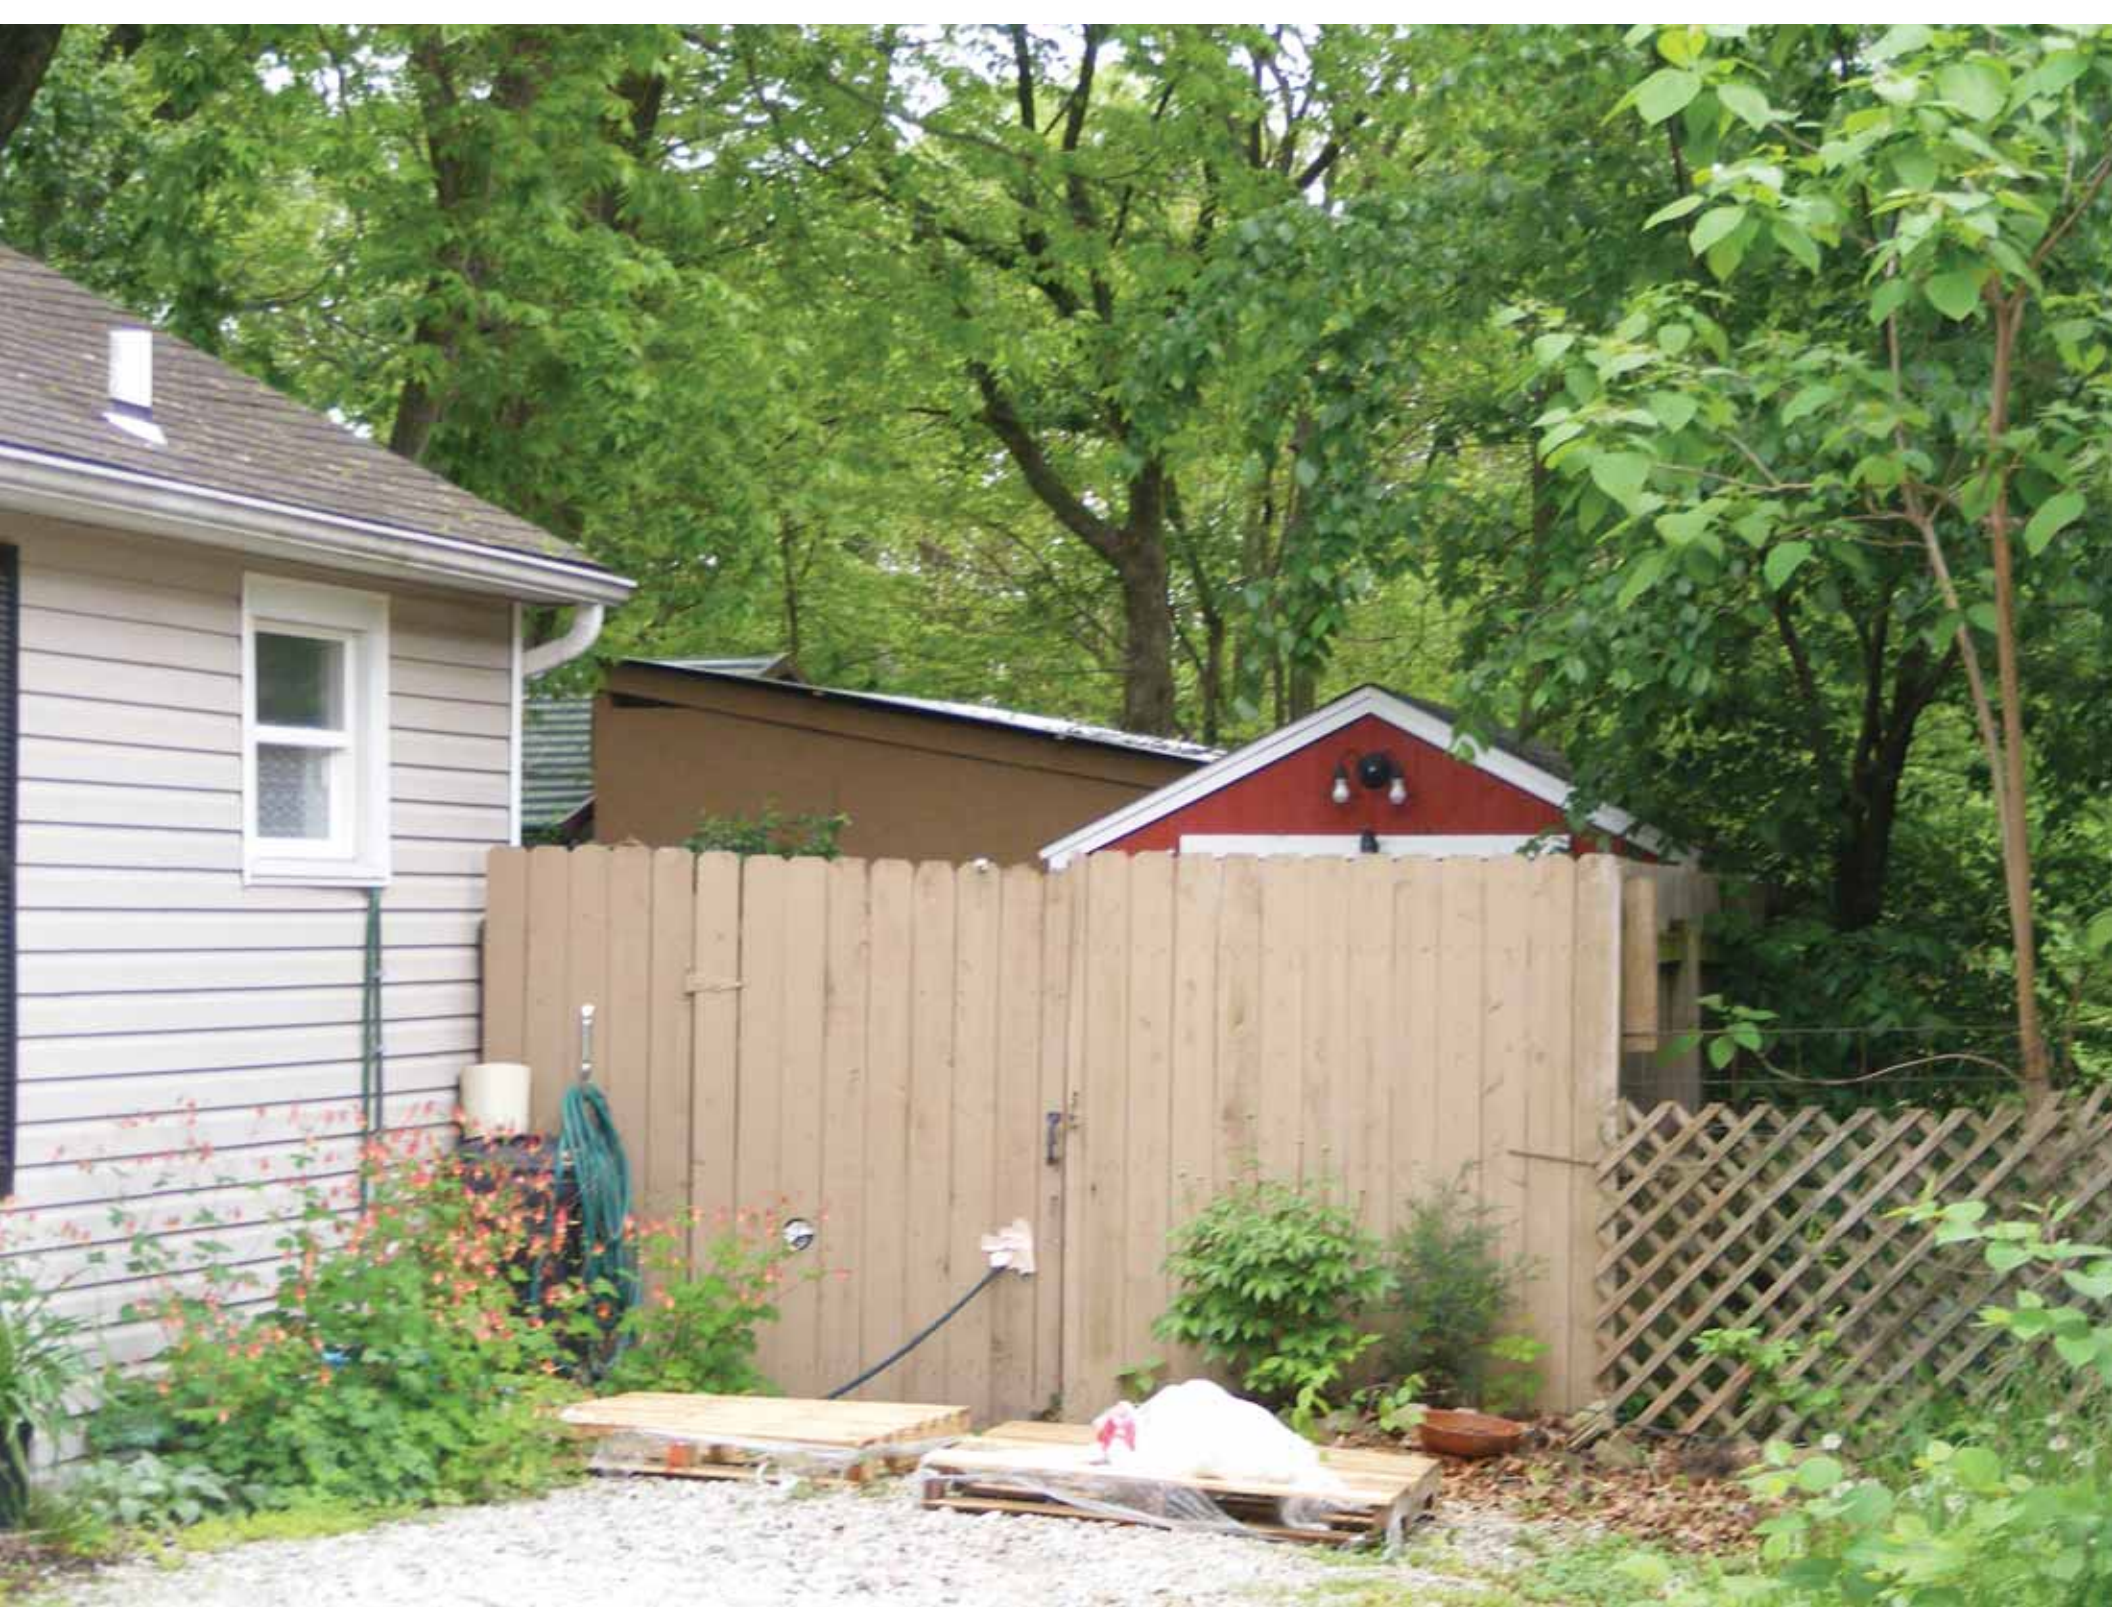
This small dwelling has a gable-front asphalt-shingled roof, exterior vinyl siding and a covered foundation. The primary (north elevation) elevation has paired original four-over-four windows with faux shutters. Remaining windows are largely replacement one-over-one. Some have faux shutters. The gable field has an octagonal louvered vent. A shed incised porch on the east end of the dwelling supports the primary entry, which faces east. The entry bay has a c. 2000 nine-light paneled door. Also in the porch bay on the north elevation is a boxed c. 2000 window.

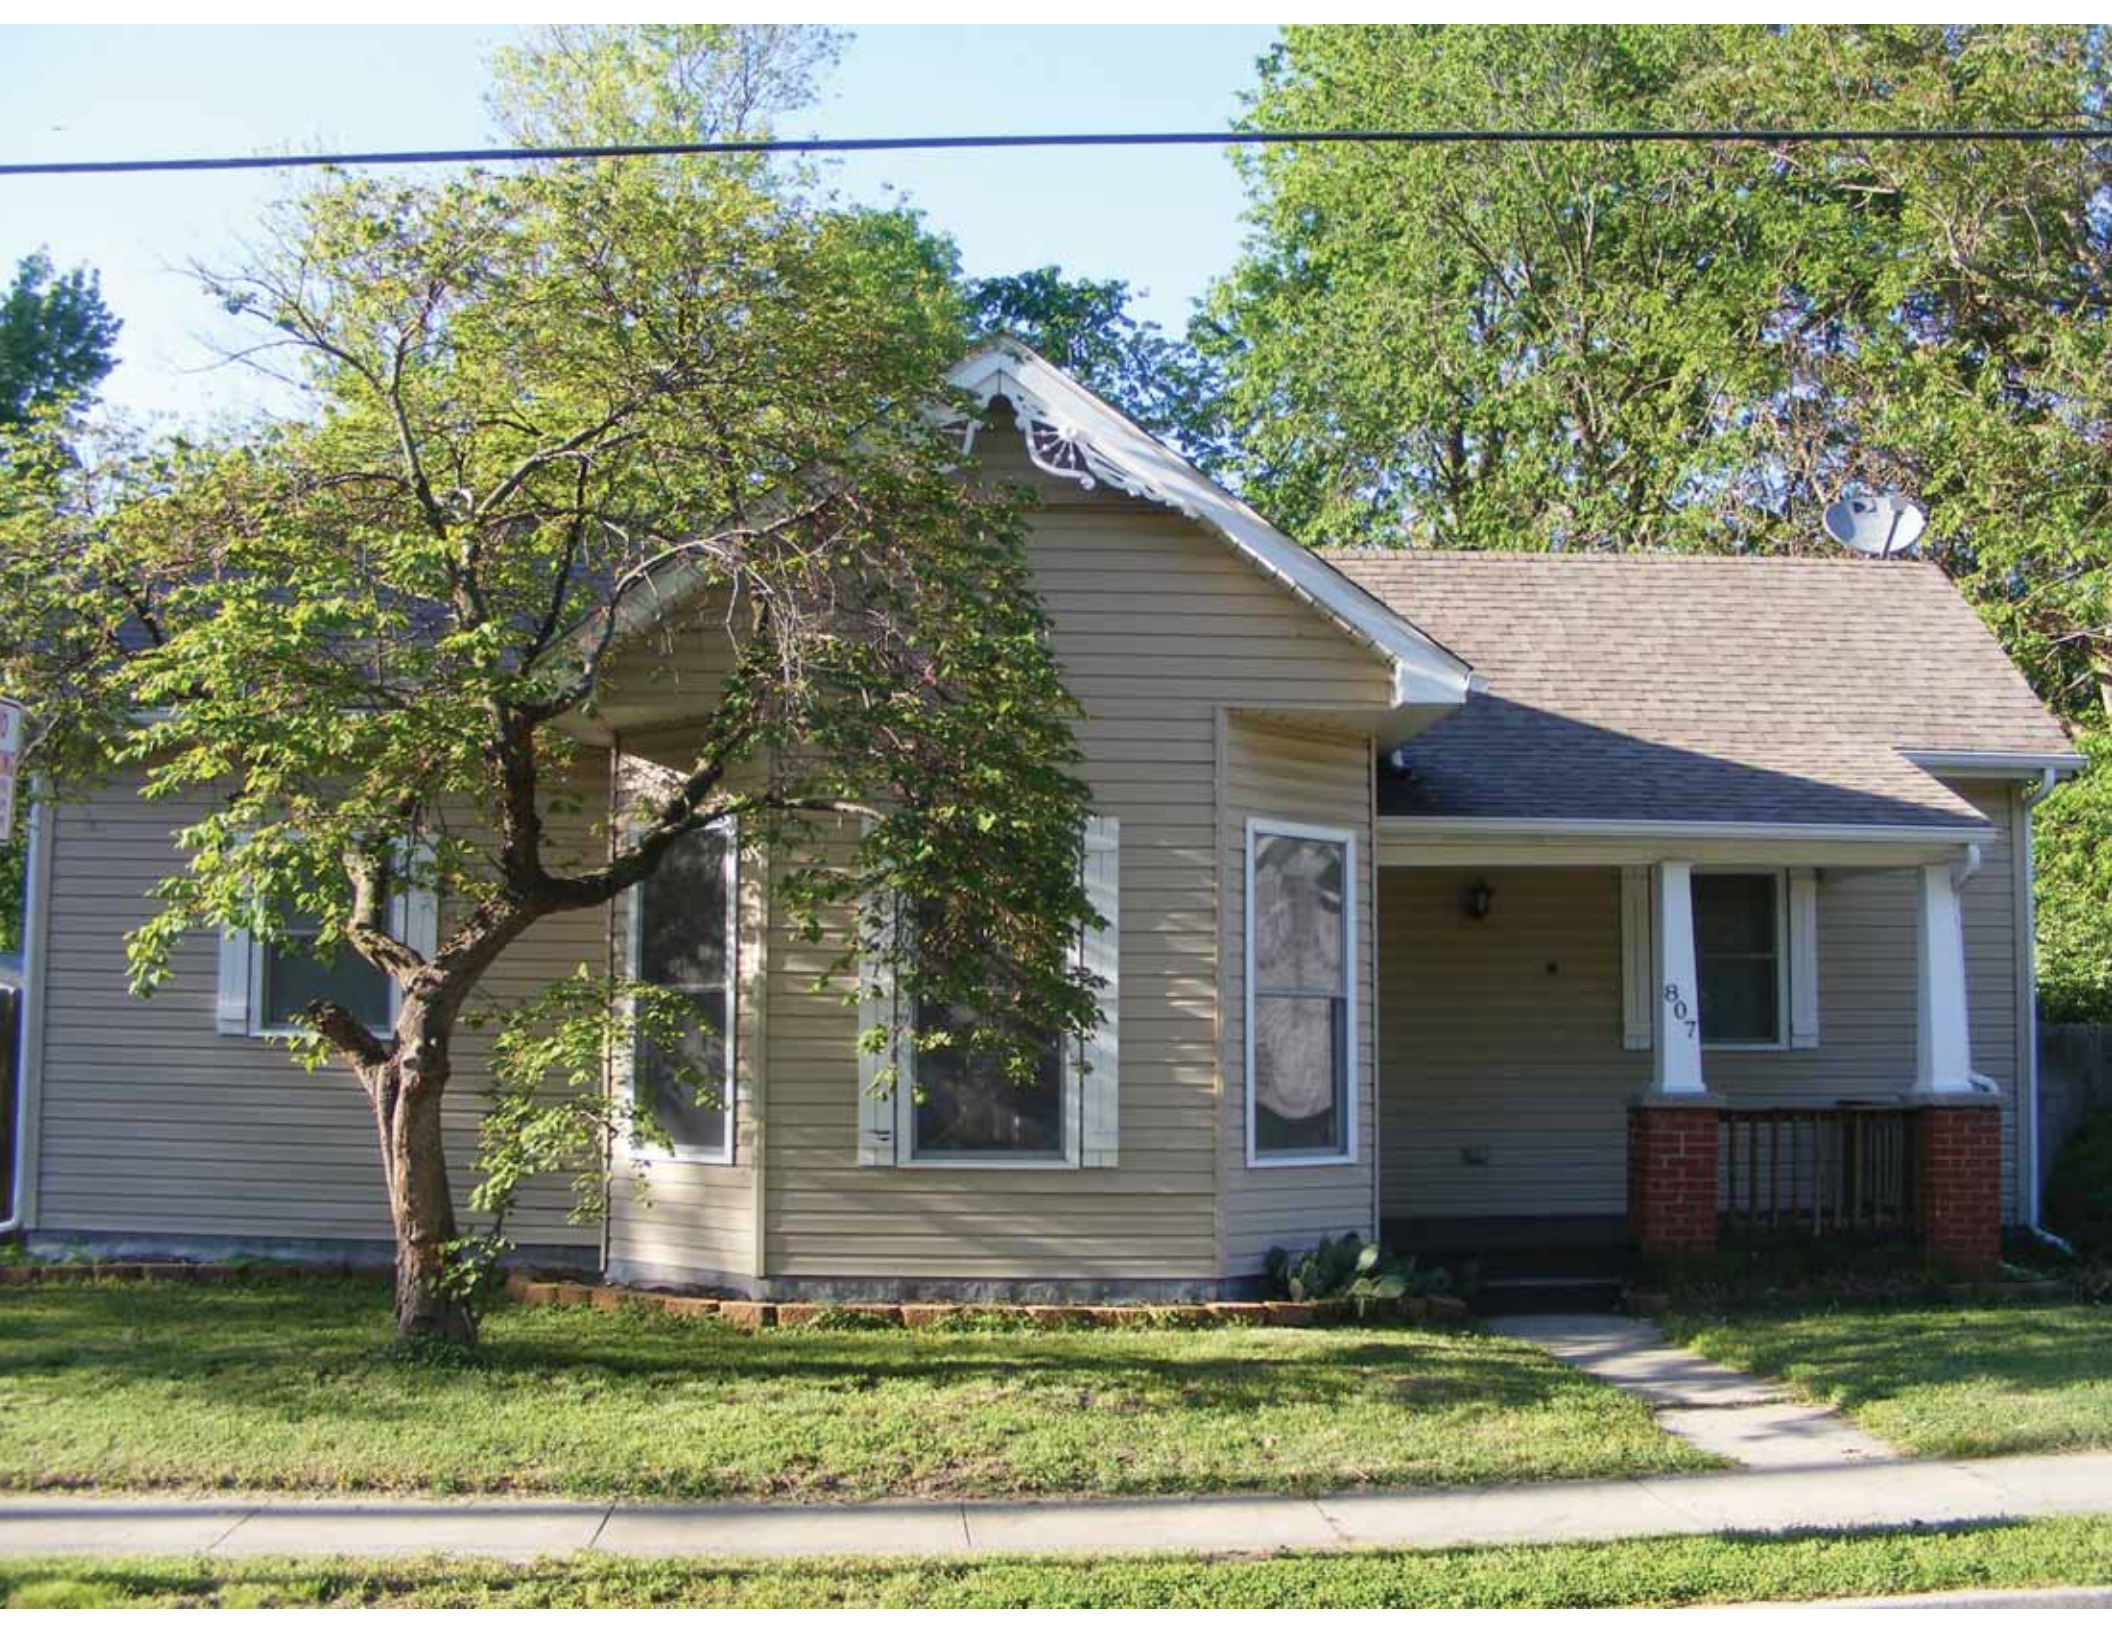
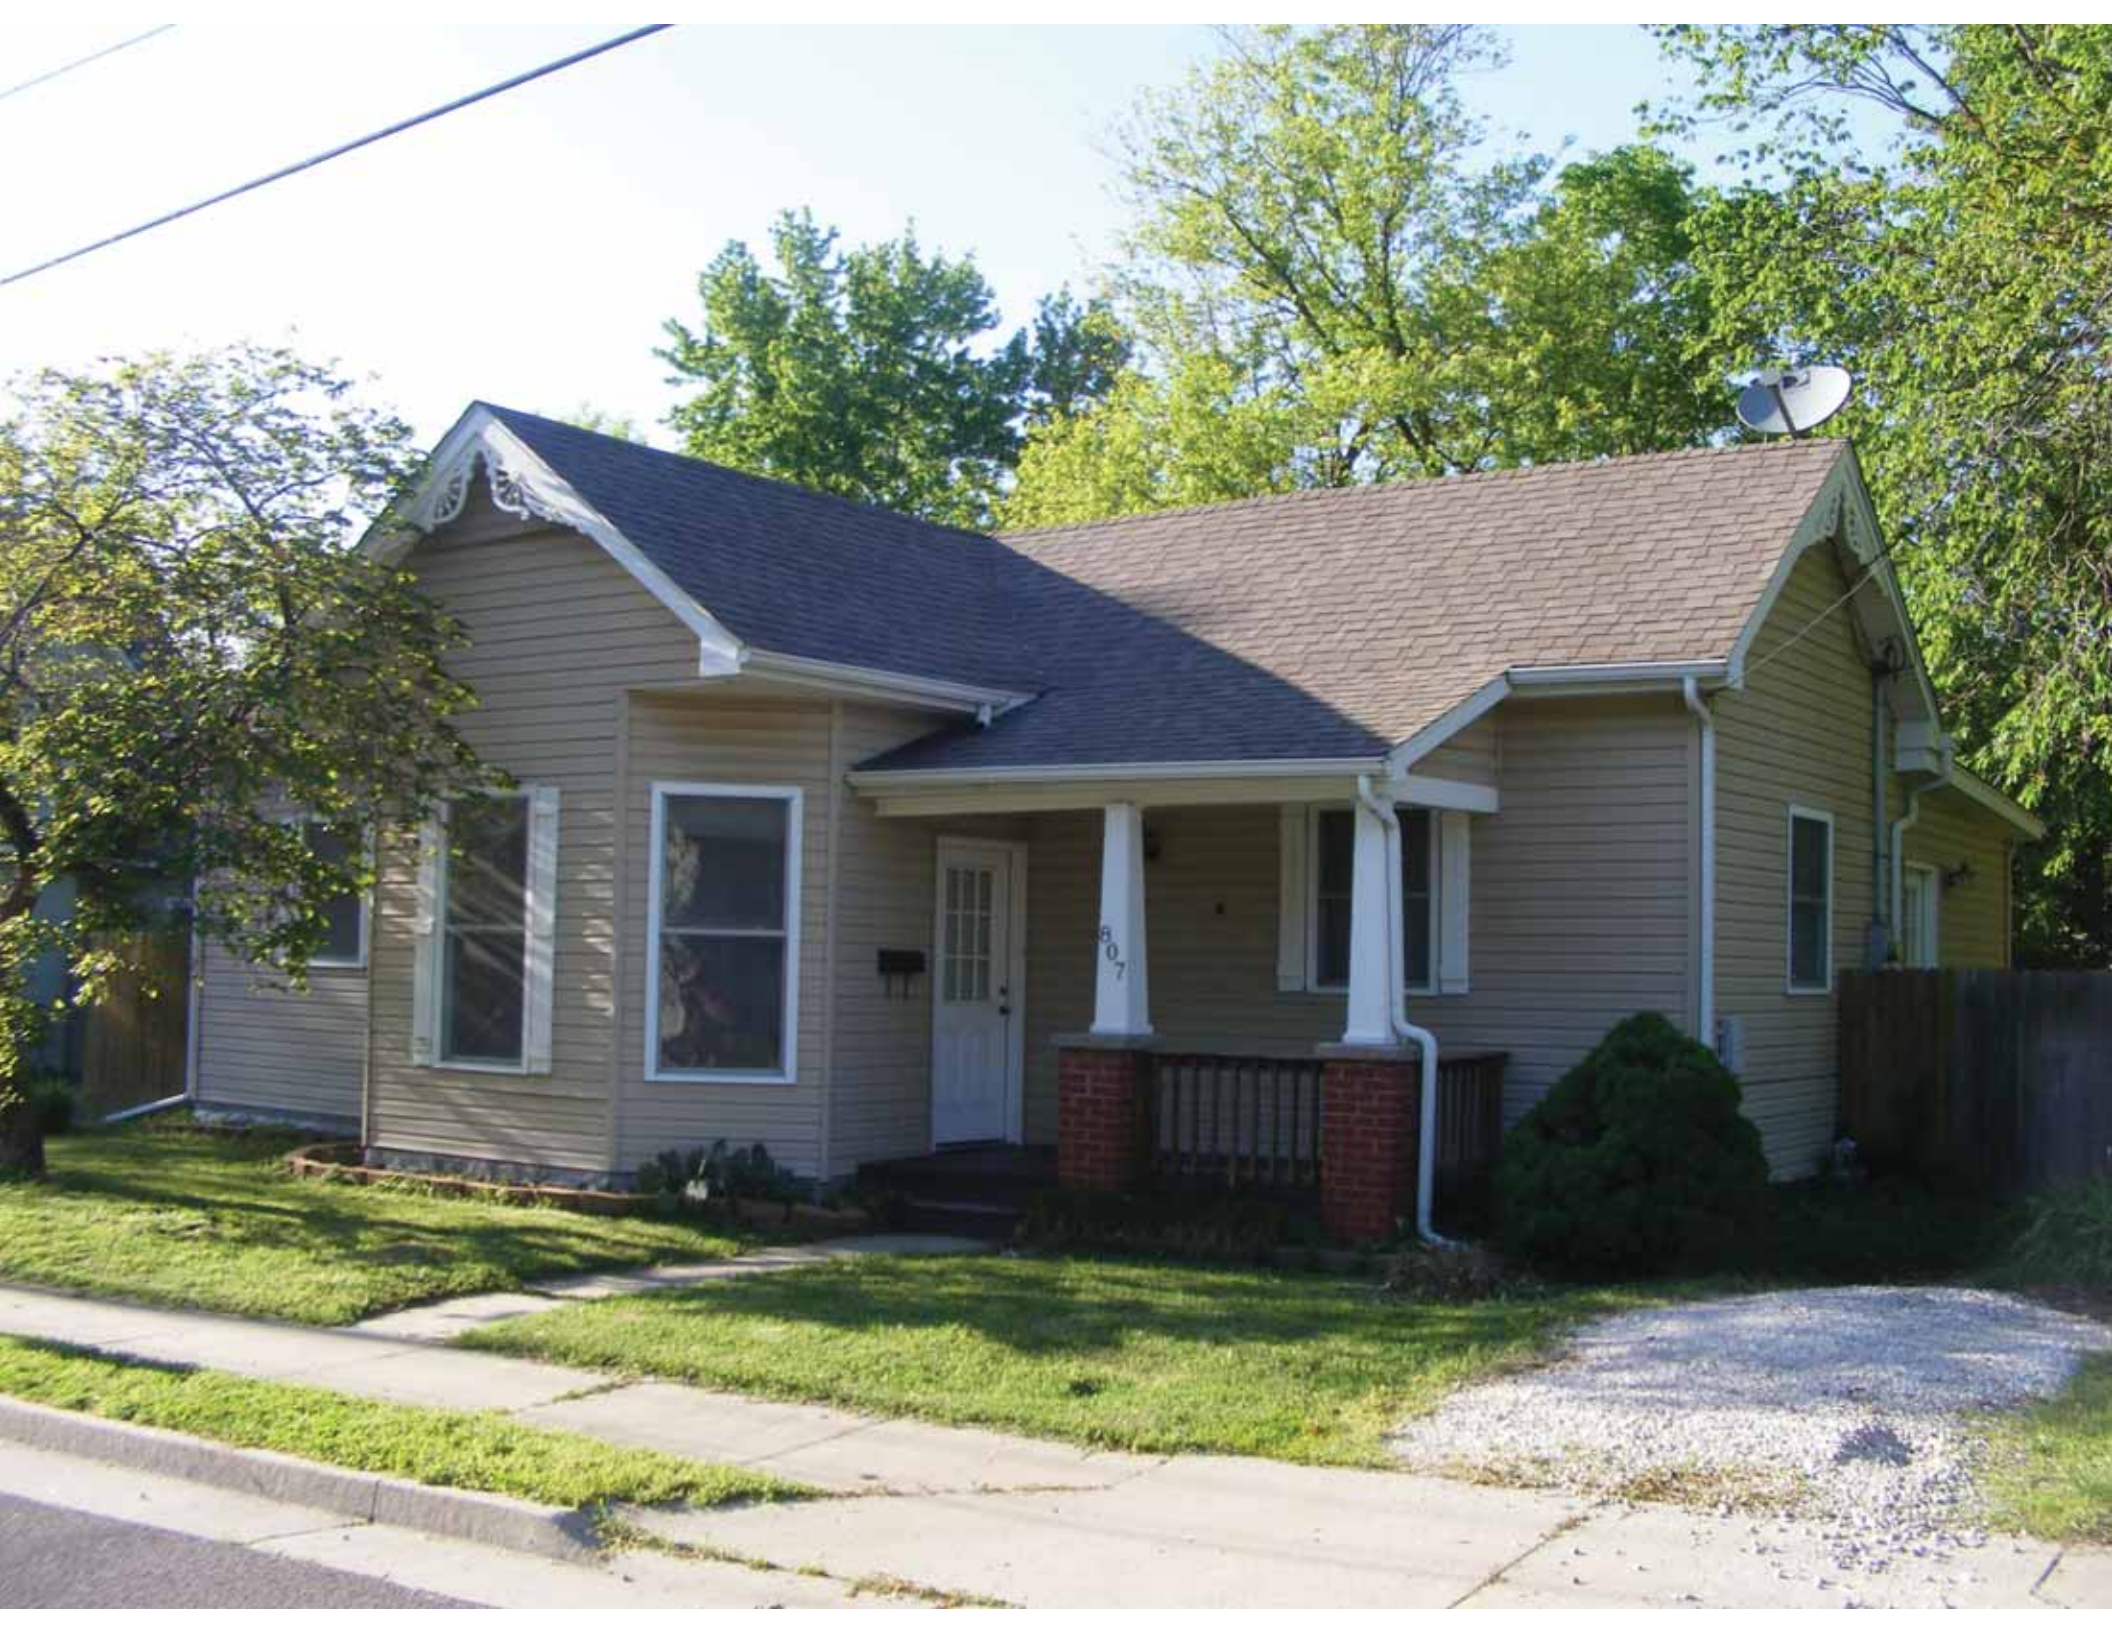
The irregular plan dwelling has an asphalt-shingled cross gabled roof, exterior vinyl siding and a rubble concrete foundation. The façade (south elevation) has a projecting gabled wing with angled walls, each of which holds a replacement one-over-one window. Remaining windows are of similar configuration. Some have faux shutters. Above the front beveled wing, the gable supports bargeboard. Offsetting the wing on the west is a small shed porch with c. 1925 tapered piers on brick posts. The porch has a contemporary frame balustrade. Within the porch bay on the east wall is a contemporary nine-light paneled door. Side gables are filled with bargeboard. The dwelling has a rear shed wing.
