MISSOURI DEPARTMENT OF NATURAL RESOURCES
STATE HISTORIC PRESERVATION OFFICE, P.O. Box 176, Jefferson City, MO 65102
ARCHITECTURAL/HISTORIC INVENTORY FORM

1. Survey No. BO-AS-011-0087		2. Survey name: North Central Columbia Survey Phase II	
3. County: Boone		4. Address (Street No.) 902	Street (name) N. Seventh Street
5. City: Columbia	Vicinity: <input type="checkbox"/>	6. Geographical Reference:	7. Township/Range/Section: T: R: S:
8. Historic name (if known):		9. Present/other name (if known):	
10. Ownership: <input checked="" type="checkbox"/> Private <input type="checkbox"/> Public		11a. Historic use (if known): Domestic/single dwelling	11b. Current use: Domestic/single dwelling

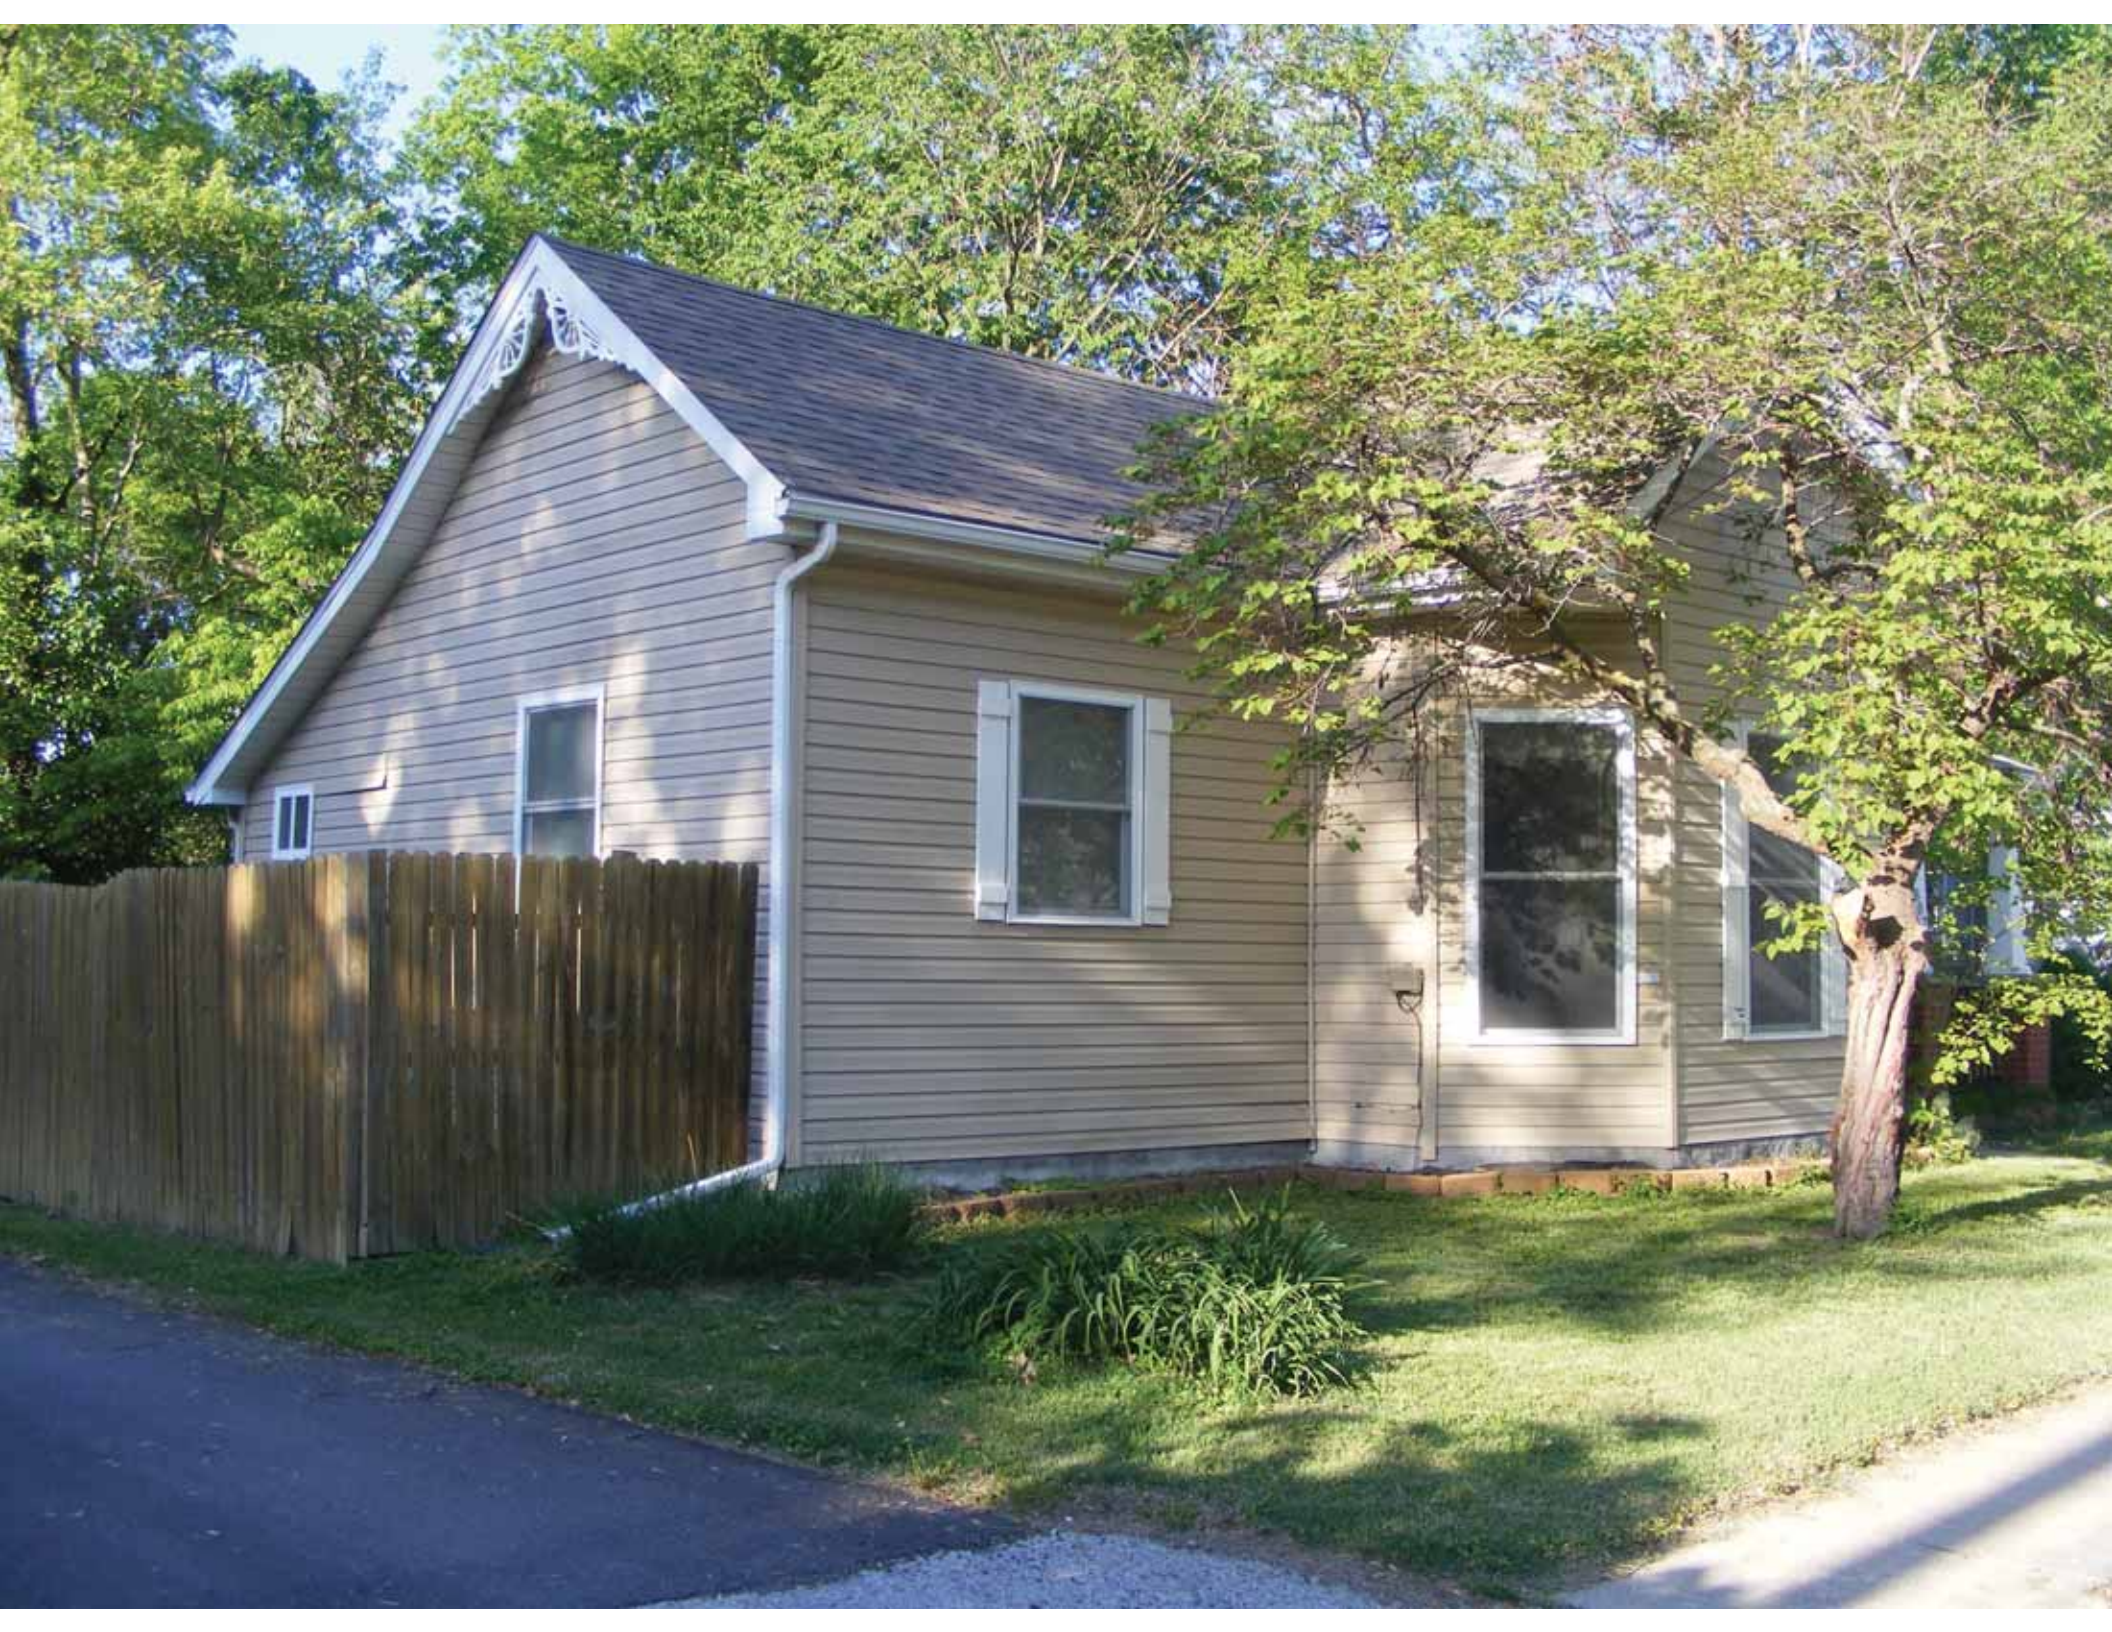
The irregular plan dwelling has an asphalt-shingled cross gabled roof, exterior vinyl siding and a rubble concrete foundation. The façade (south elevation) has a projecting gabled wing with angled walls, each of which holds a replacement one-over-one window. Remaining windows are of similar configuration. Some have faux shutters. Above the front beveled wing, the gable supports bargeboard. Offsetting the wing on the west is a small shed porch with c. 1925 tapered piers on brick posts. The porch has a contemporary frame balustrade. Within the porch bay on the east wall is a contemporary nine-light paneled door. Side gables are filled with bargeboard. The dwelling has a rear shed wing.

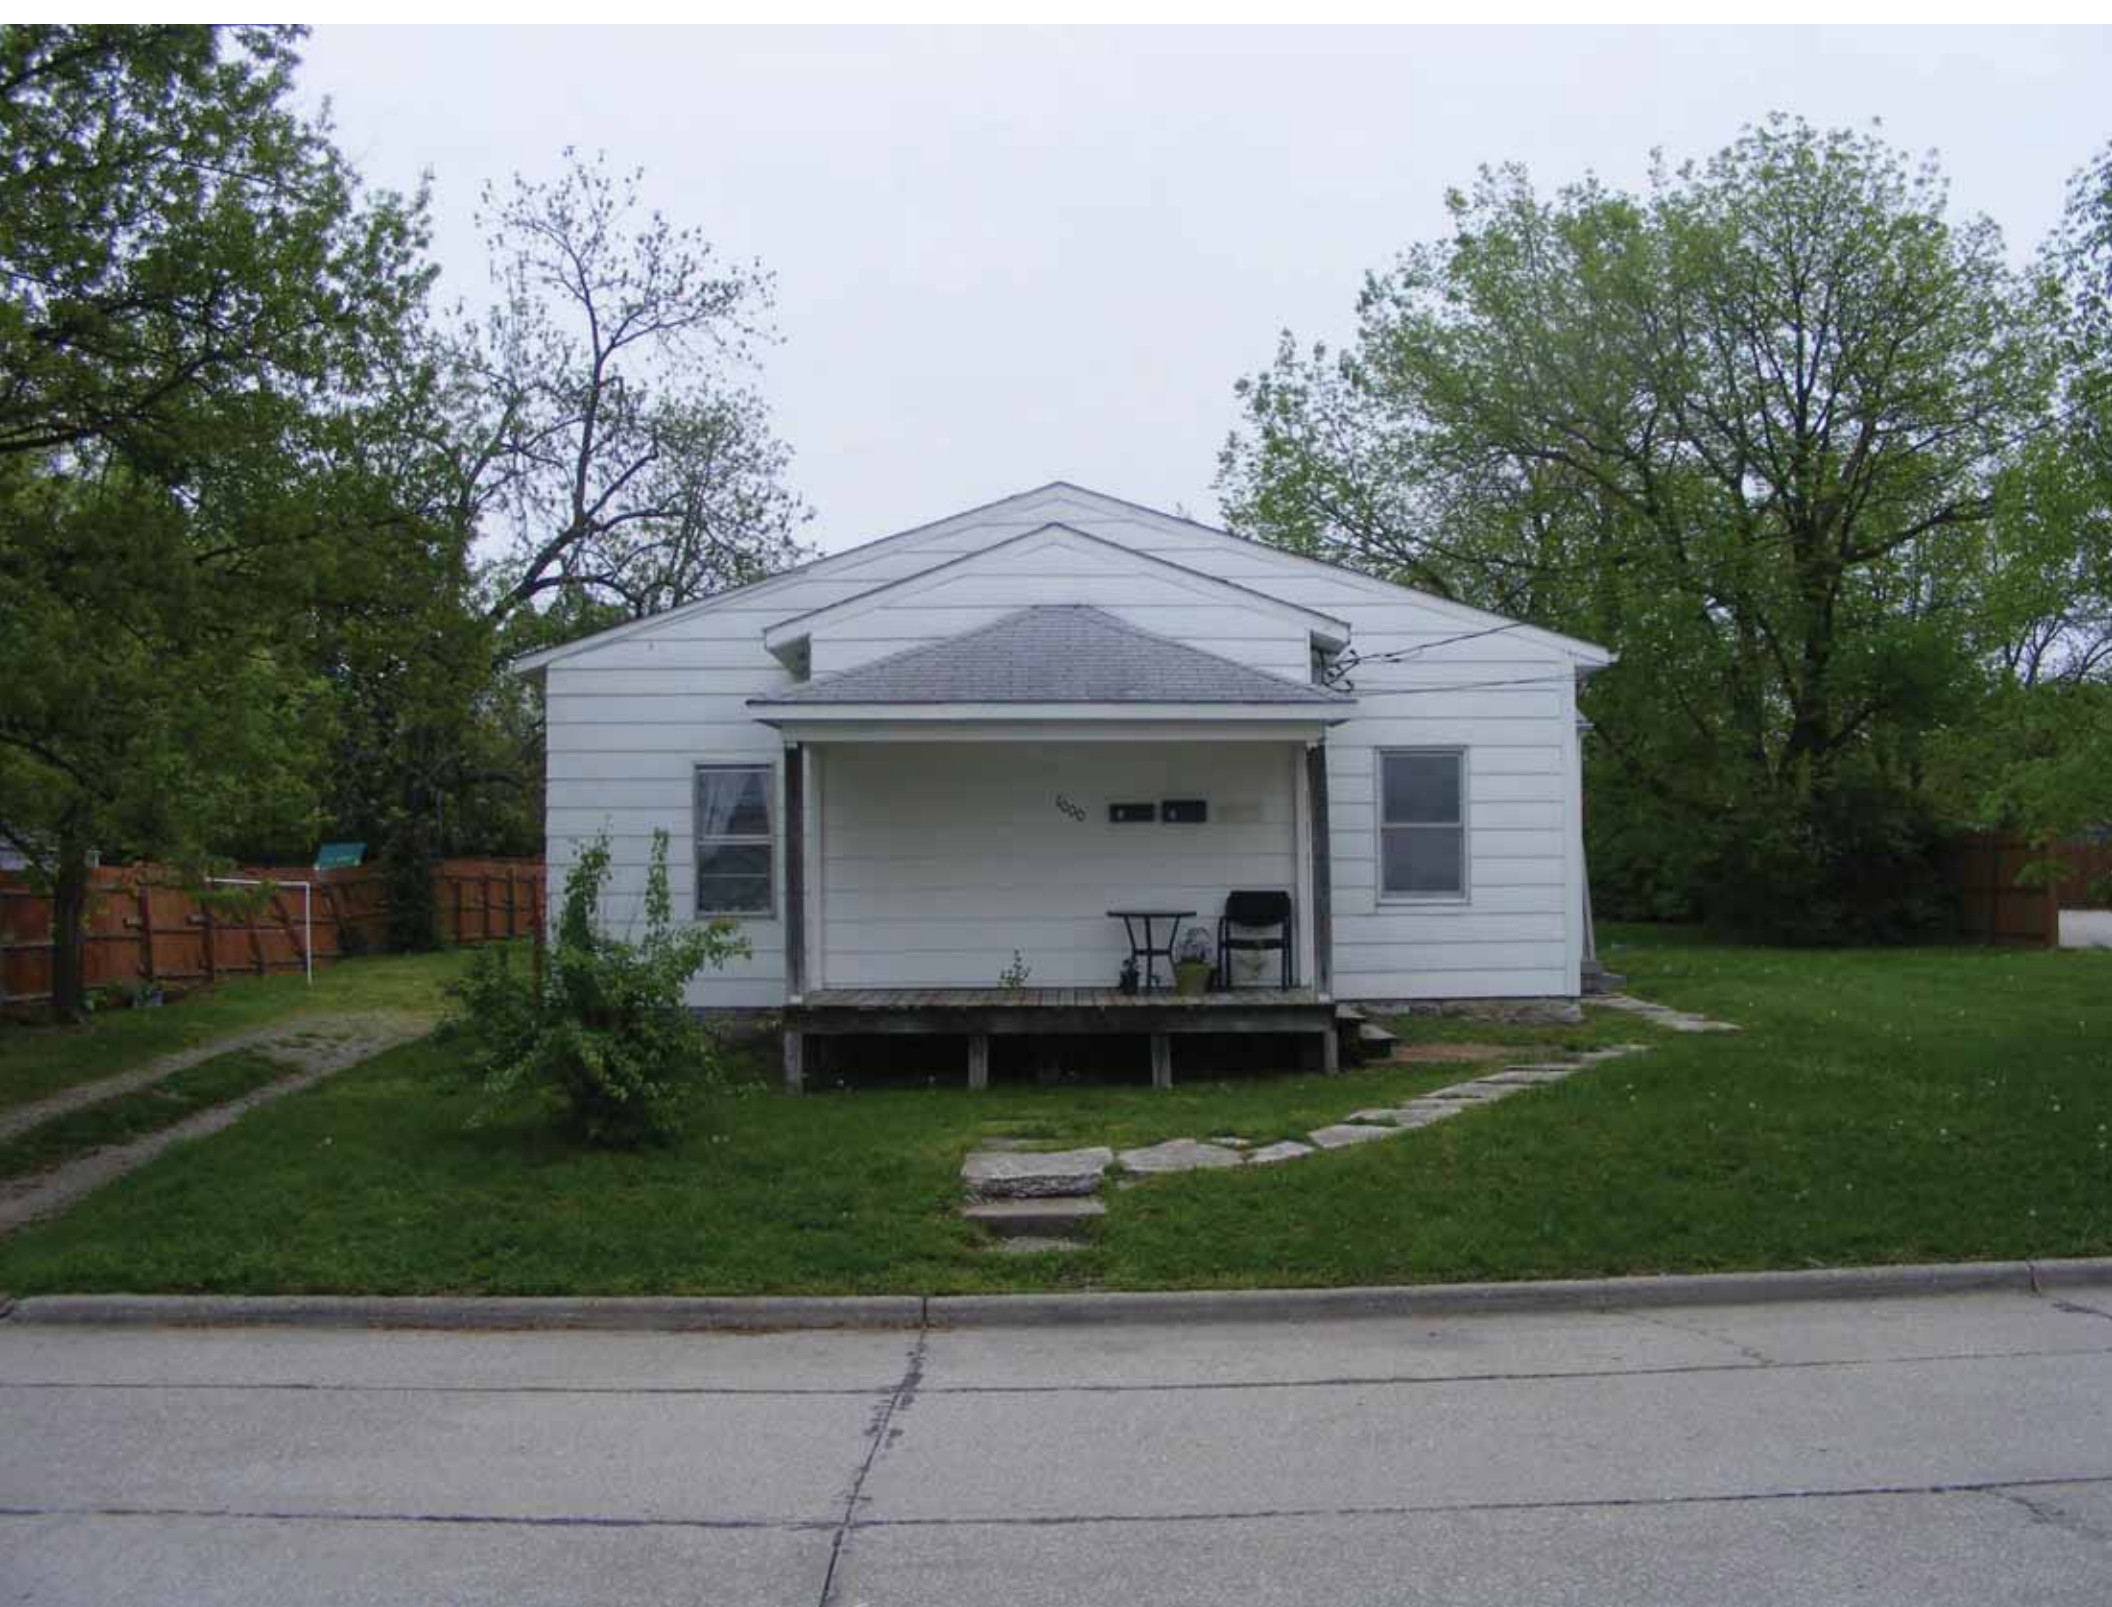
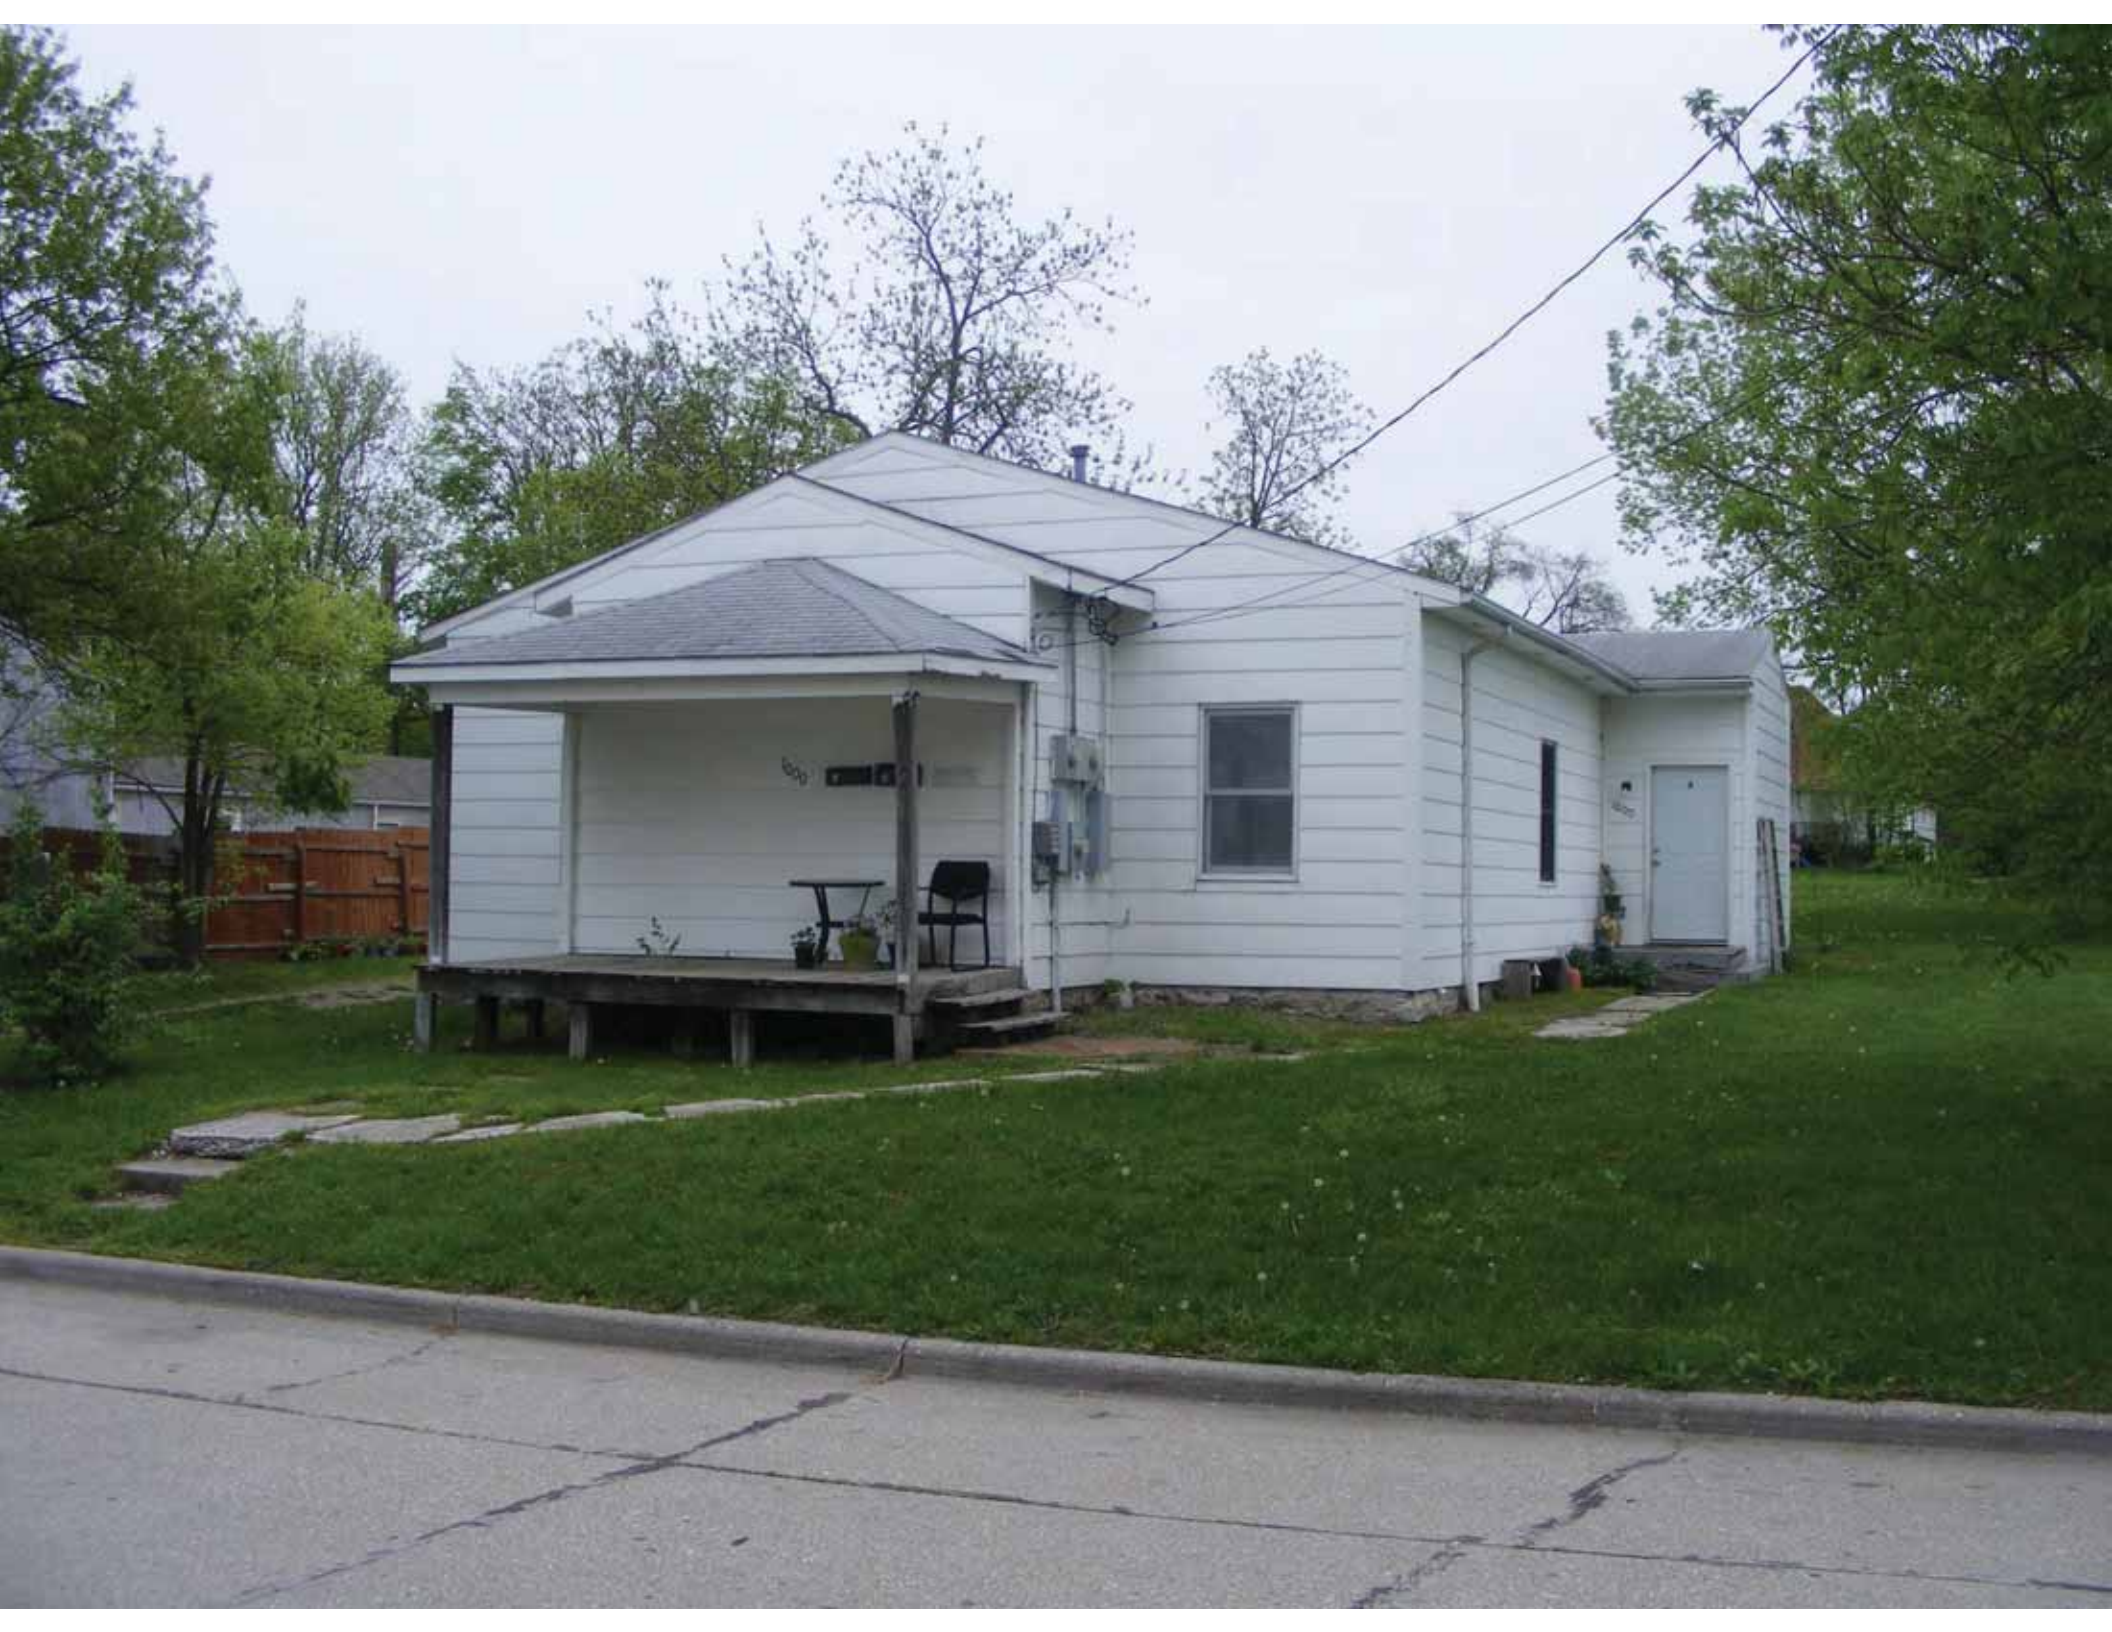
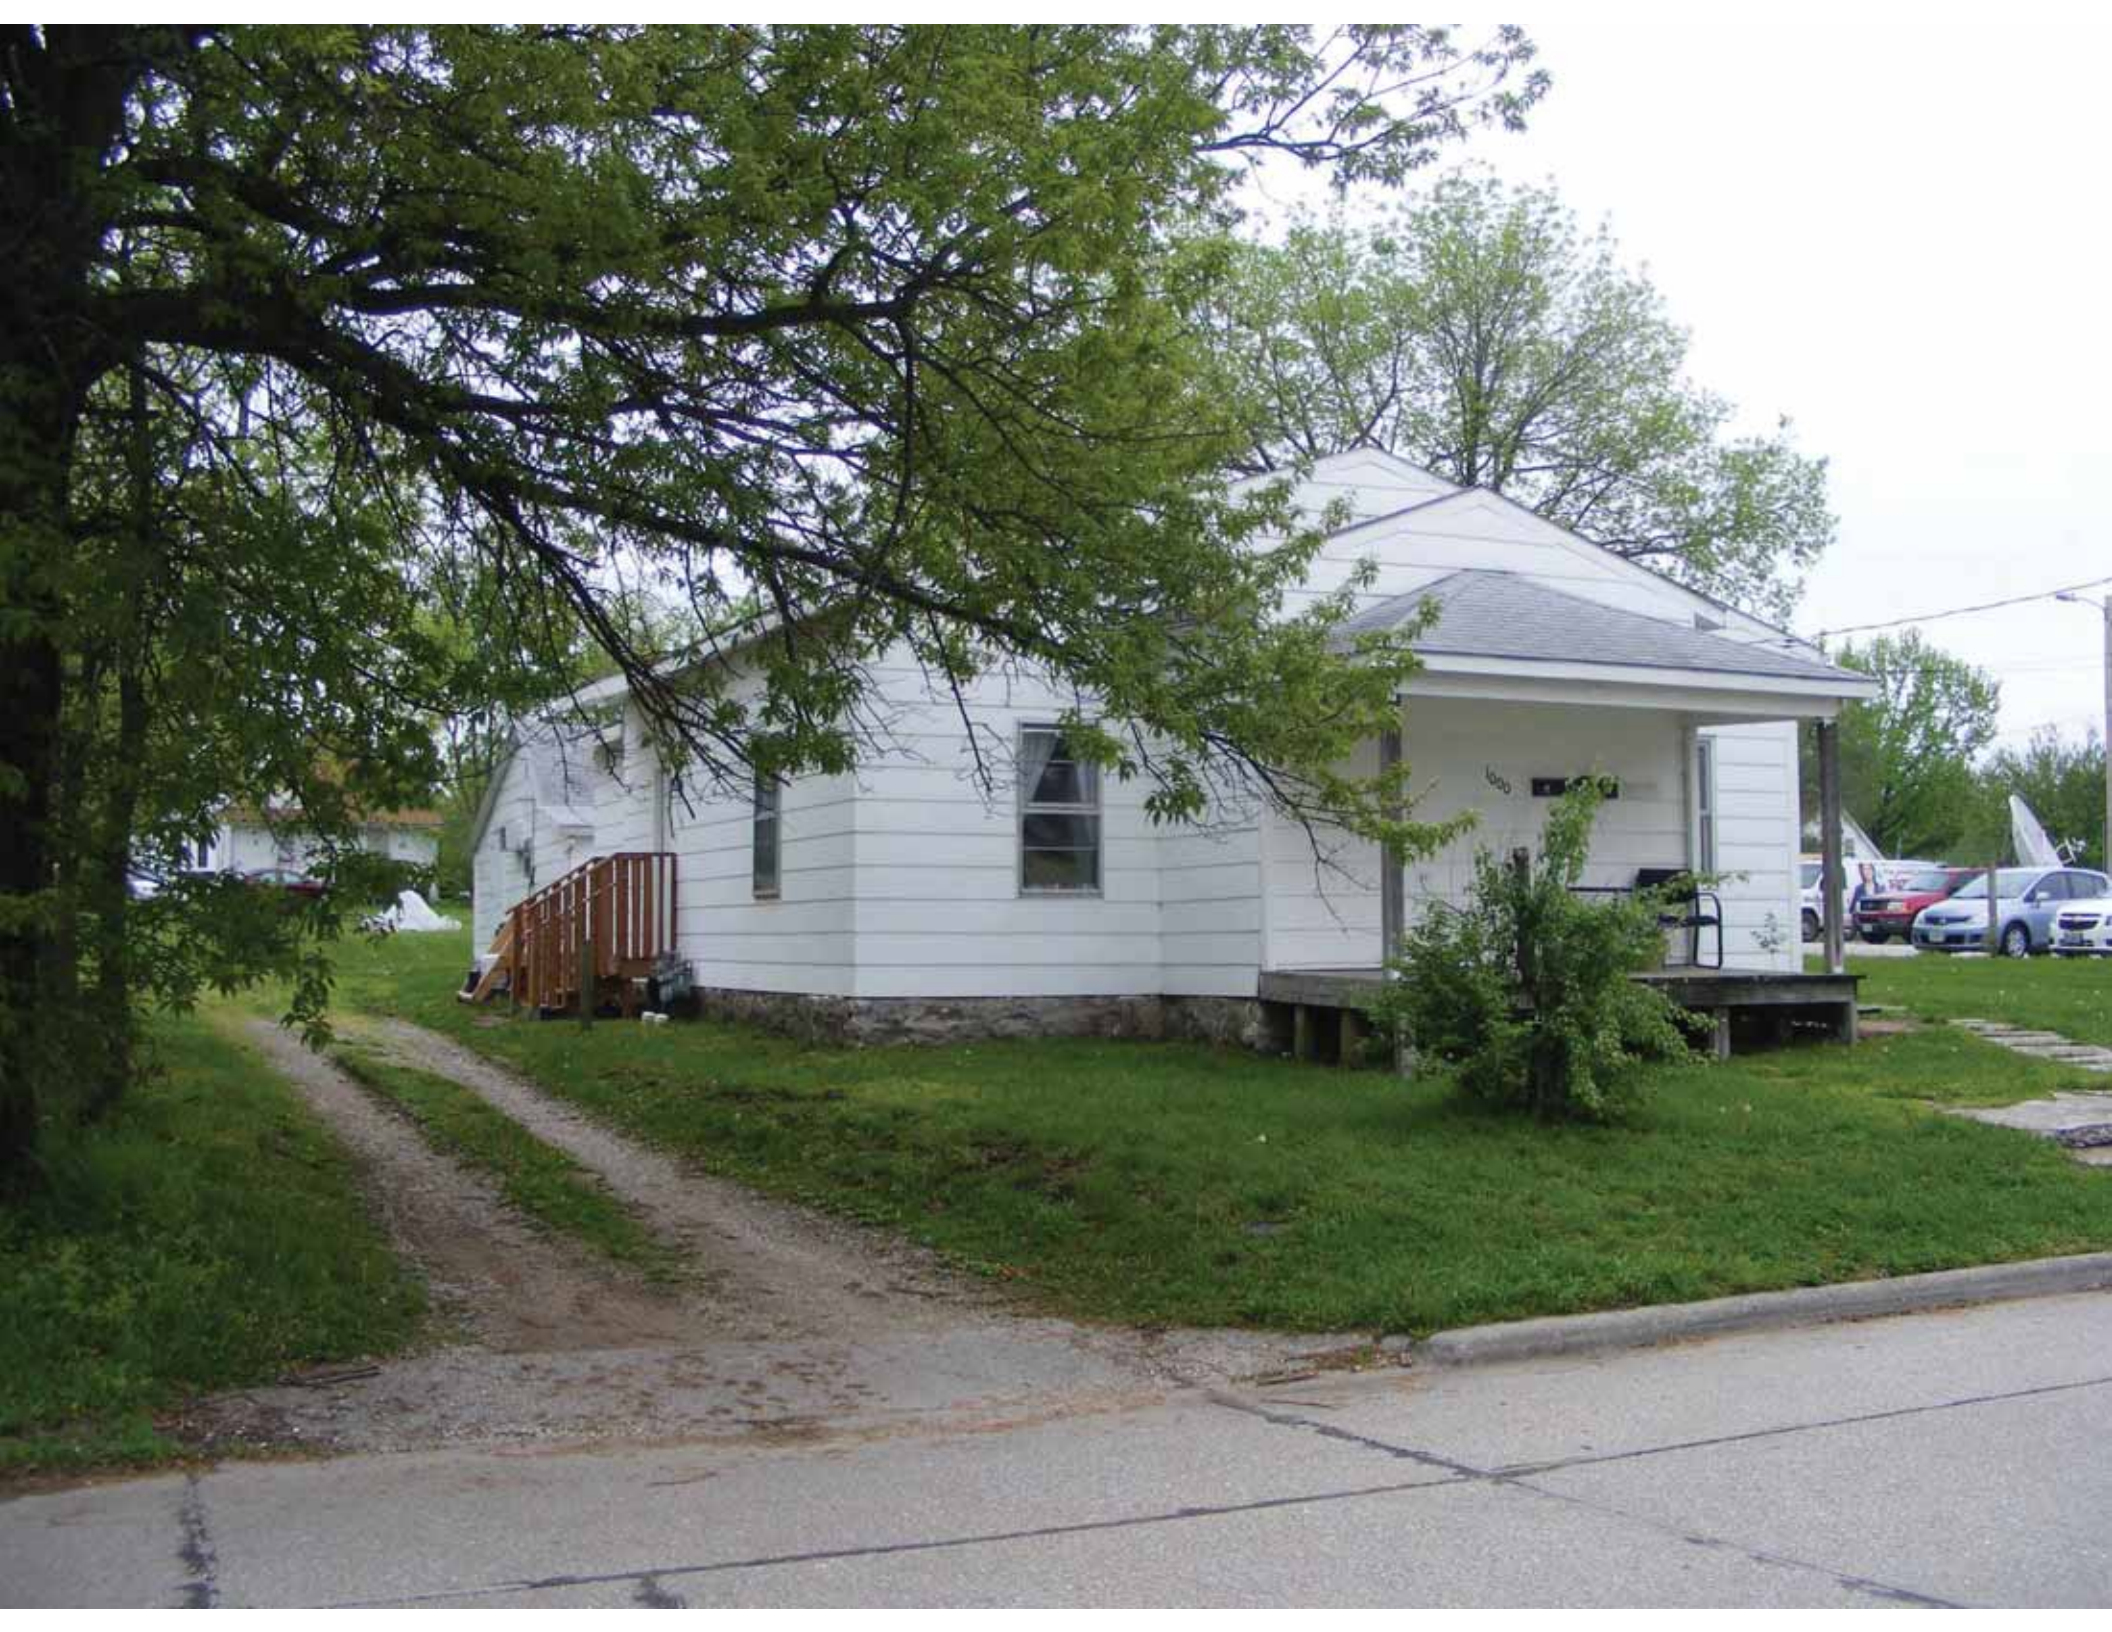
41. (cont.) Description of primary resource. Expand box as necessary, or add continuation pages.
This is a one story wood sided, asphalt-shingled cross gable dwelling converted to a duplex and has a limestone block foundation. The façade holds an enclosed centered porch under a front gable with a lower asphalt-shingled hip porch supported by square wood post with wood decking and steps. The enclosed area is flanked by one-over-one windows. The south elevation holds a single one-over-one window and at the back corner (northeast) is a projecting wing with a stoop concrete and entry (faces west). The north elevation holds a single one-over-one window and a stoop entrance with wooden steps and railing.
