MISSOURI DEPARTMENT OF NATURAL RESOURCES
STATE HISTORIC PRESERVATION OFFICE, P.O. Box 176, Jefferson City, MO 65102
ARCHITECTURAL/HISTORIC INVENTORY FORM

1. Survey No. BO-AS-011-0087		2. Survey name: North Central Columbia Survey Phase II	
3. County: Boone		4. Address (Street No.) 902	Street (name) N. Seventh Street
5. City: Columbia	Vicinity: <input type="checkbox"/>	6. Geographical Reference:	7. Township/Range/Section: T: R: S:
8. Historic name (if known):		9. Present/other name (if known):	
10. Ownership: <input checked="" type="checkbox"/> Private <input type="checkbox"/> Public		11a. Historic use (if known): Domestic/single dwelling	11b. Current use: Domestic/single dwelling

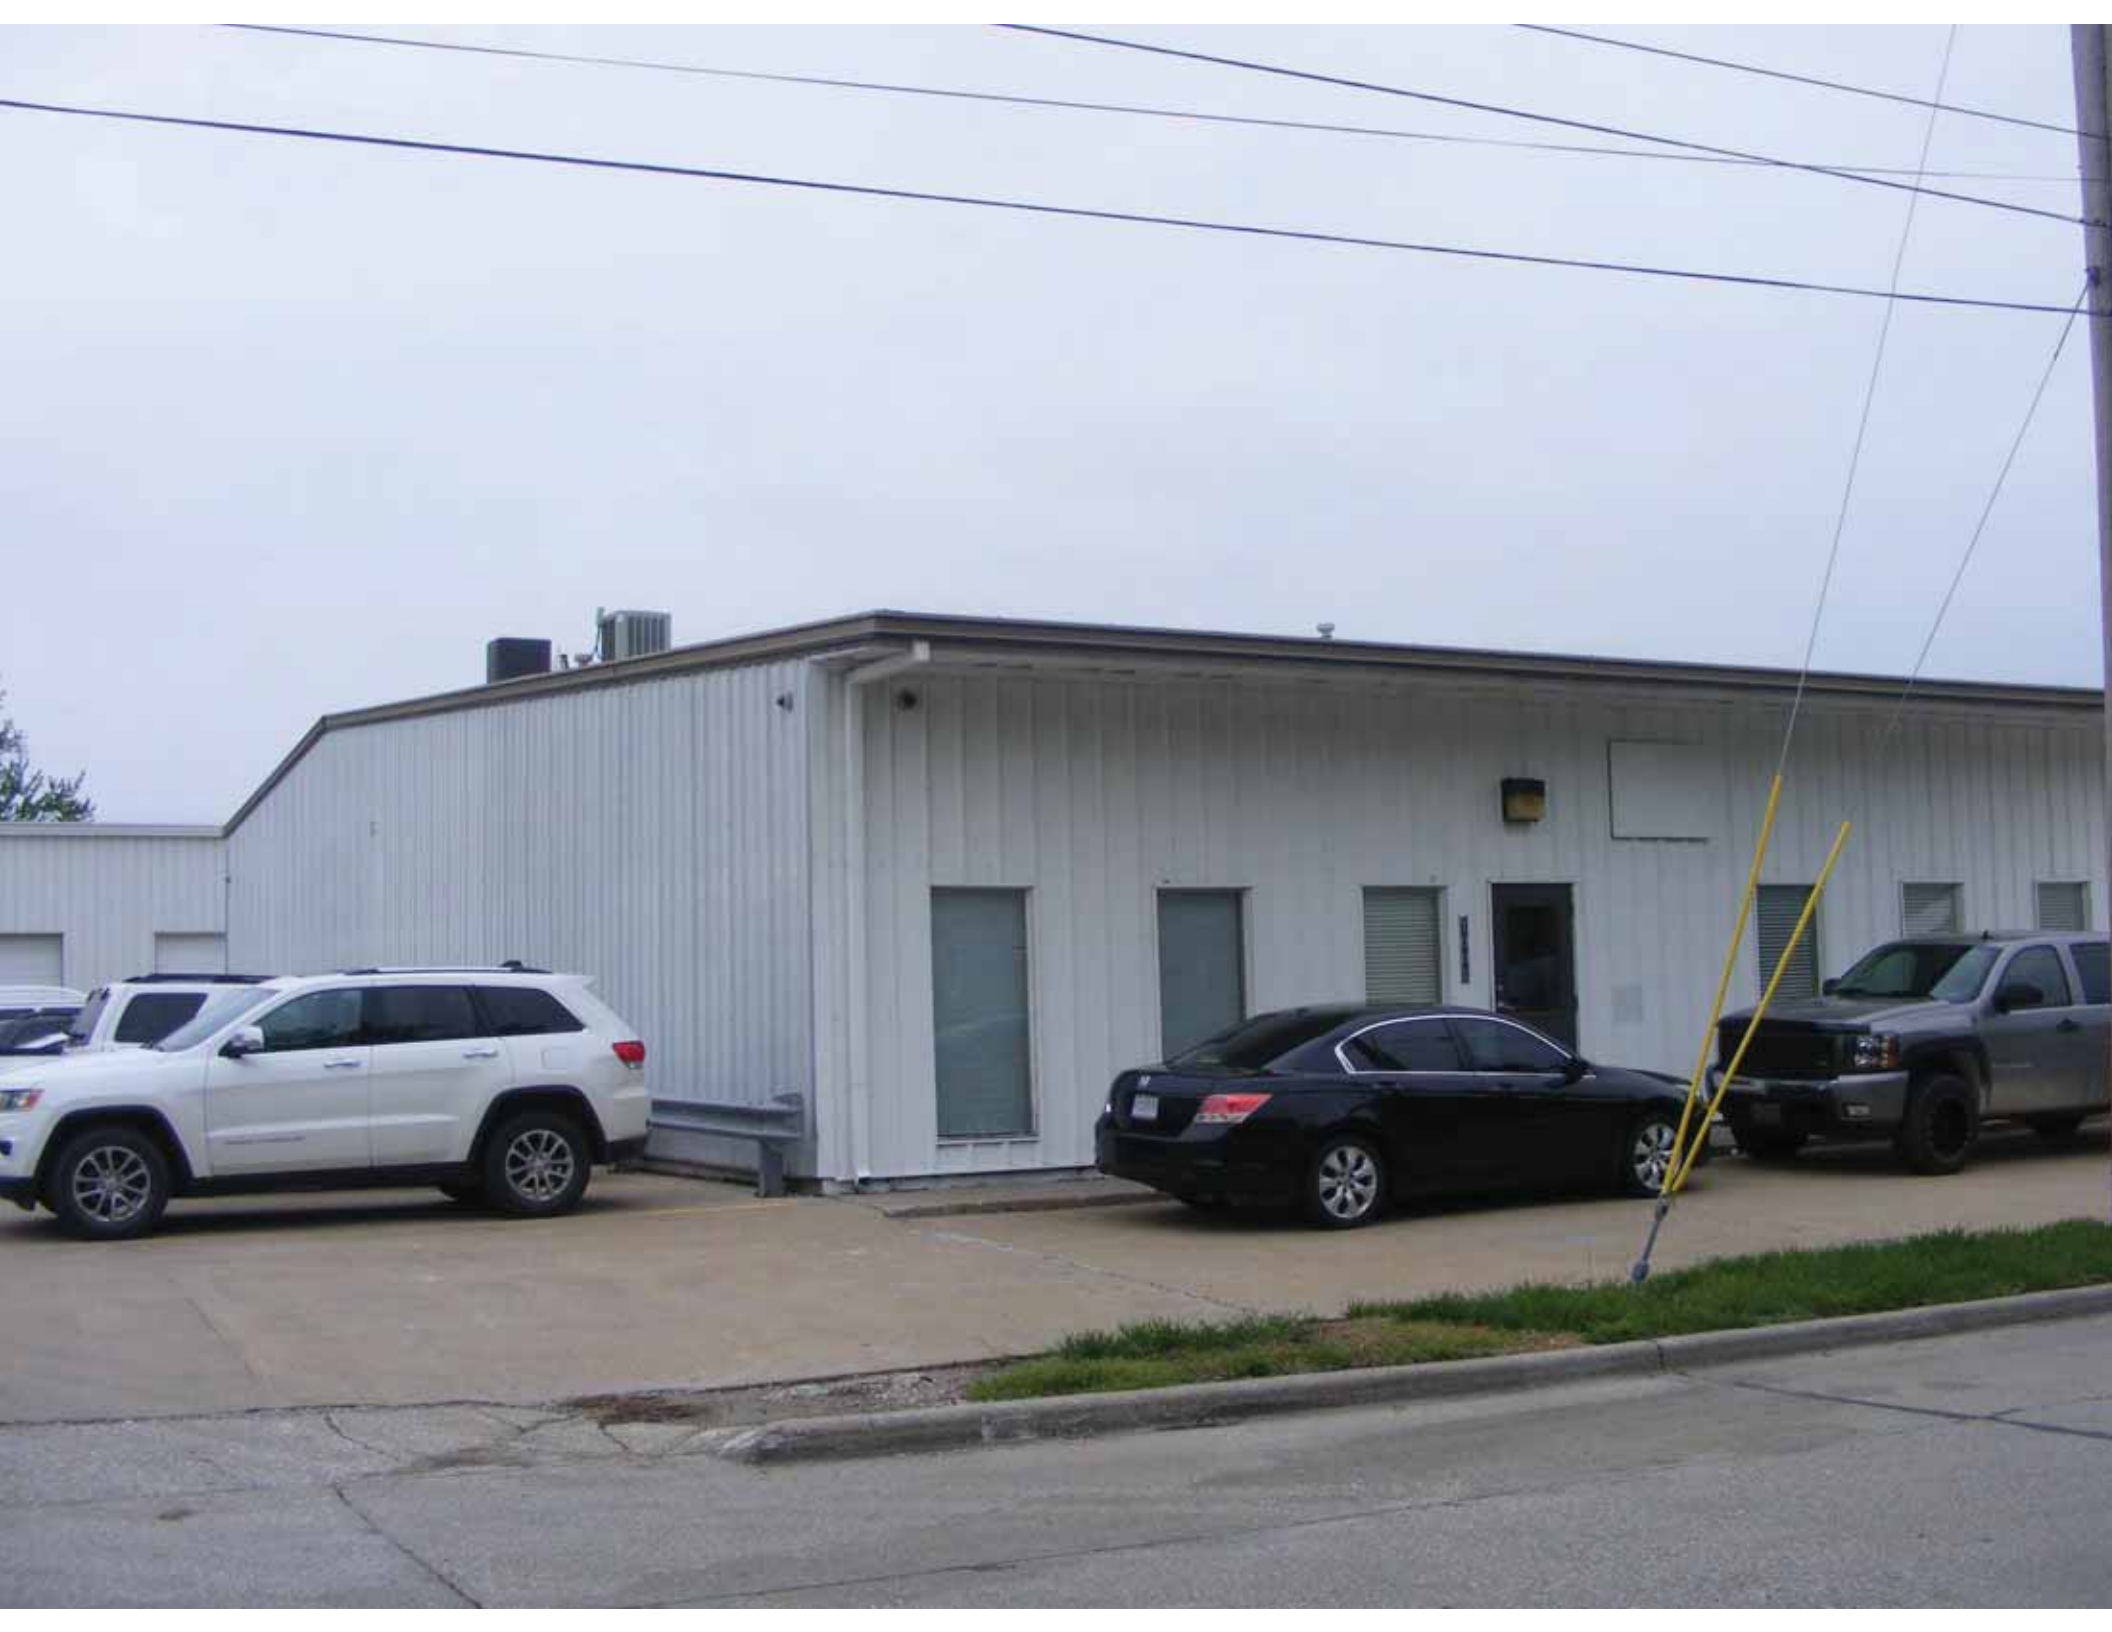
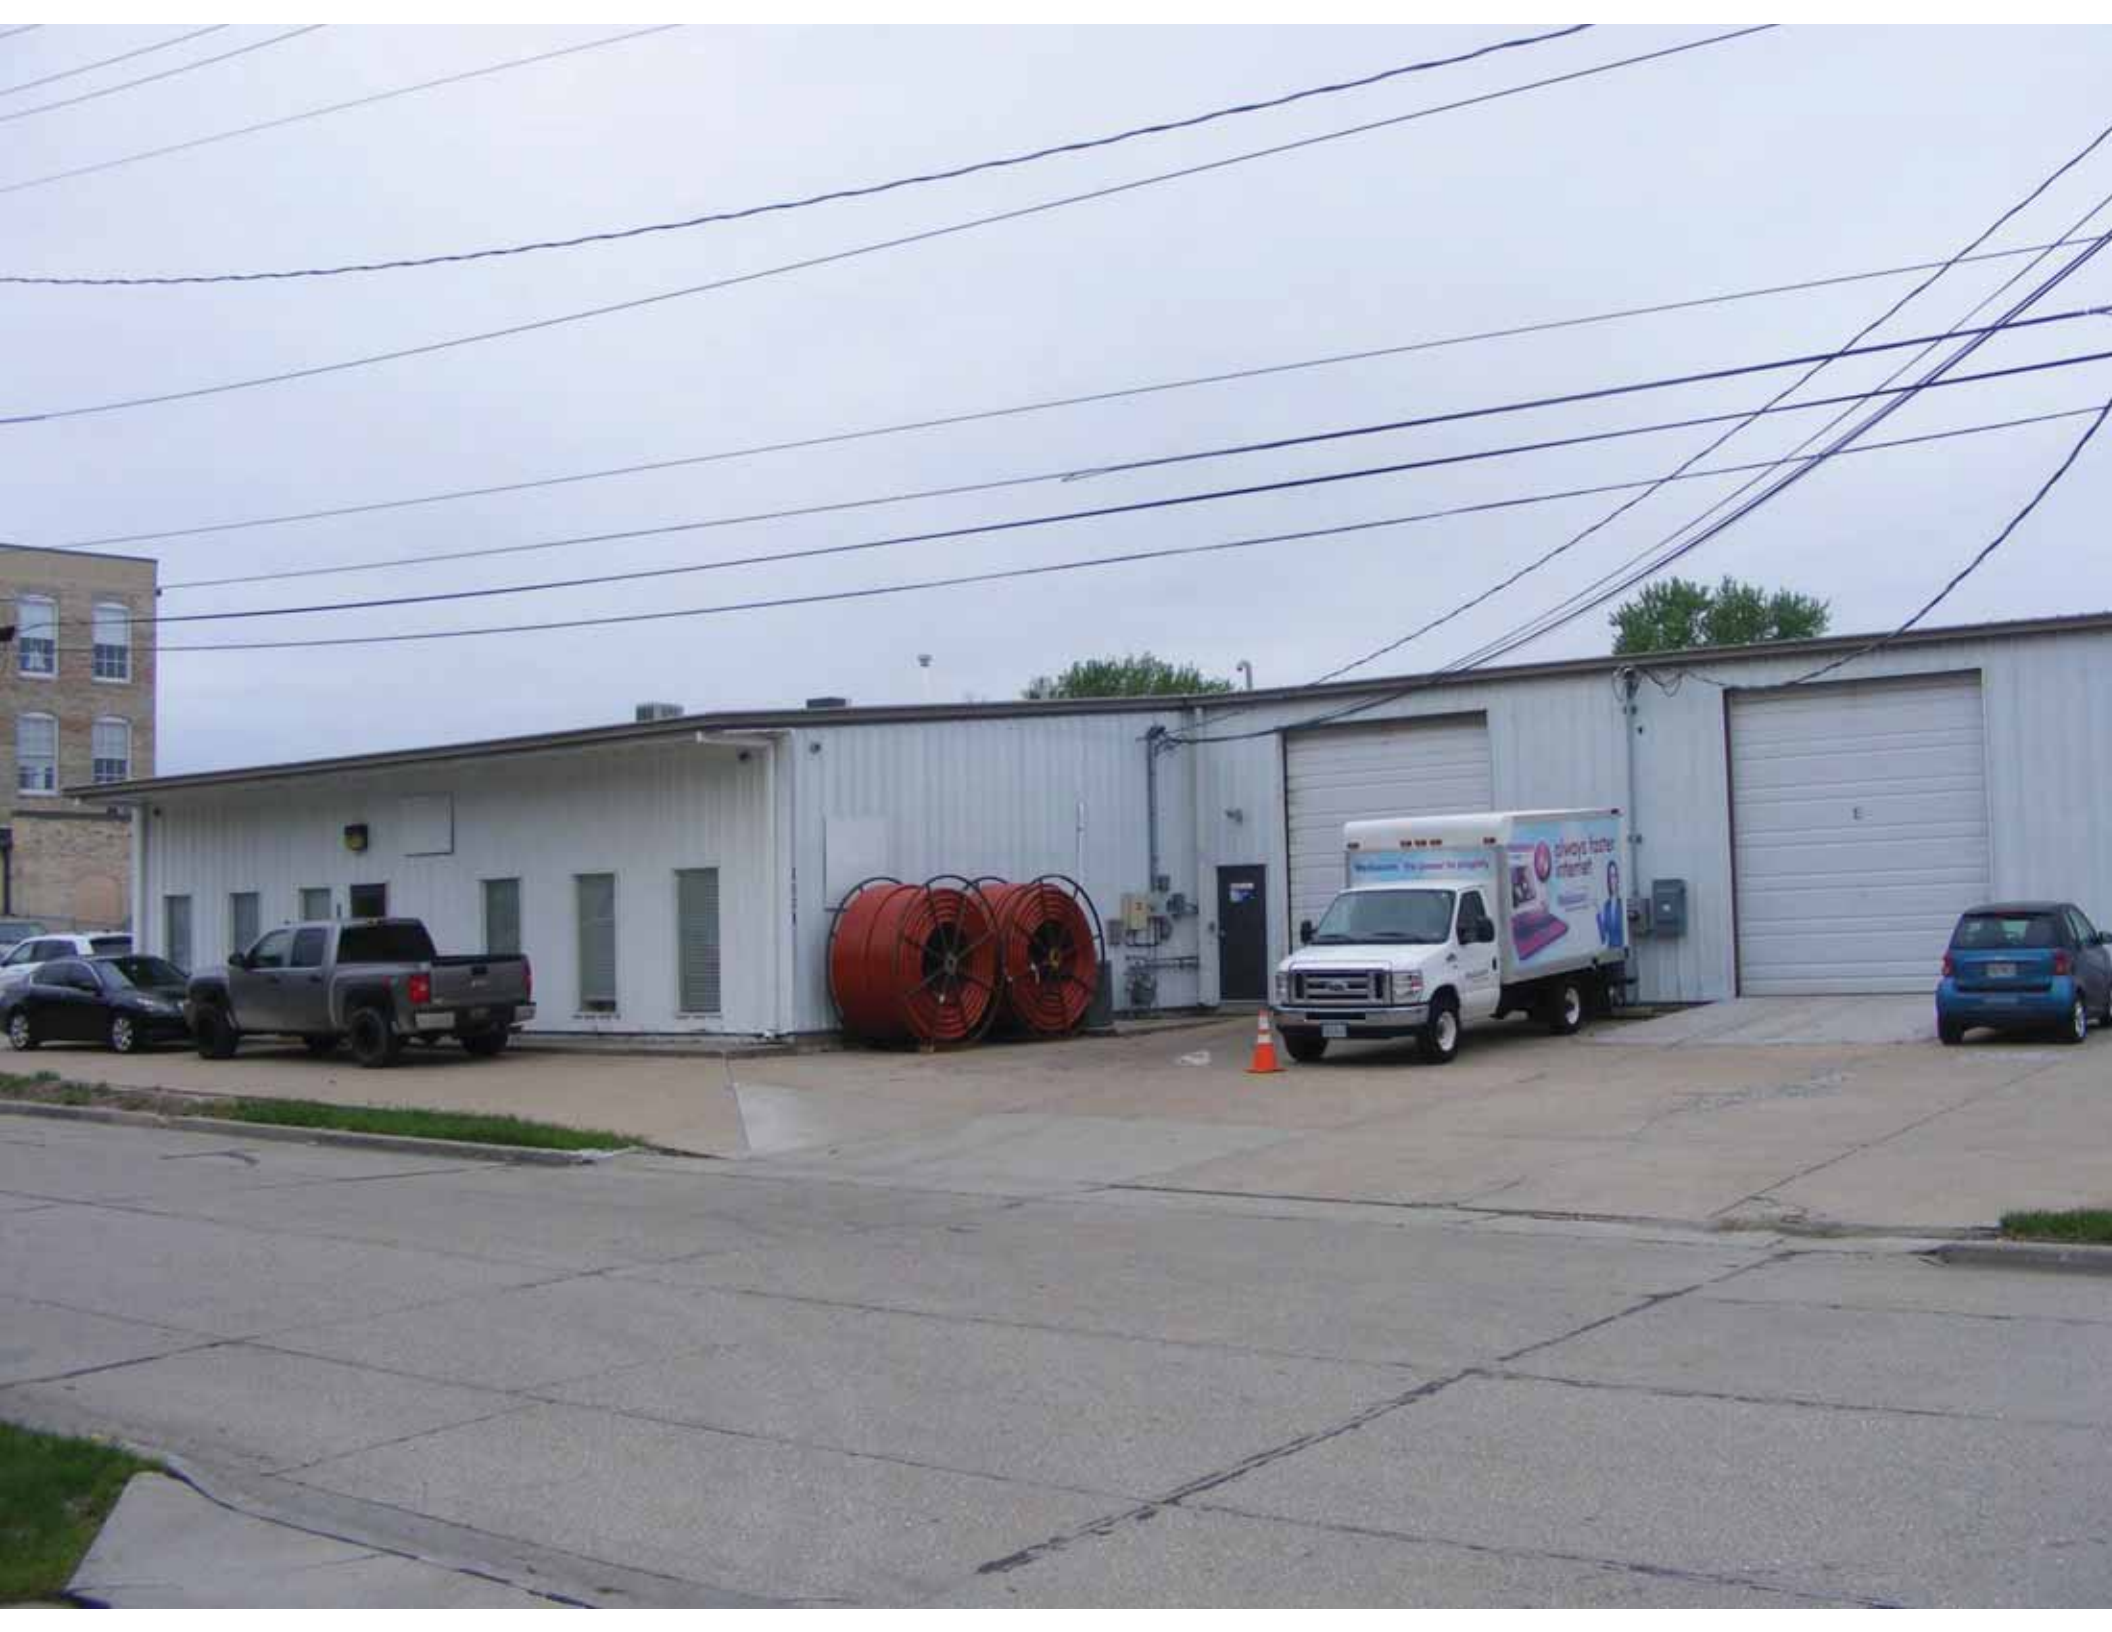
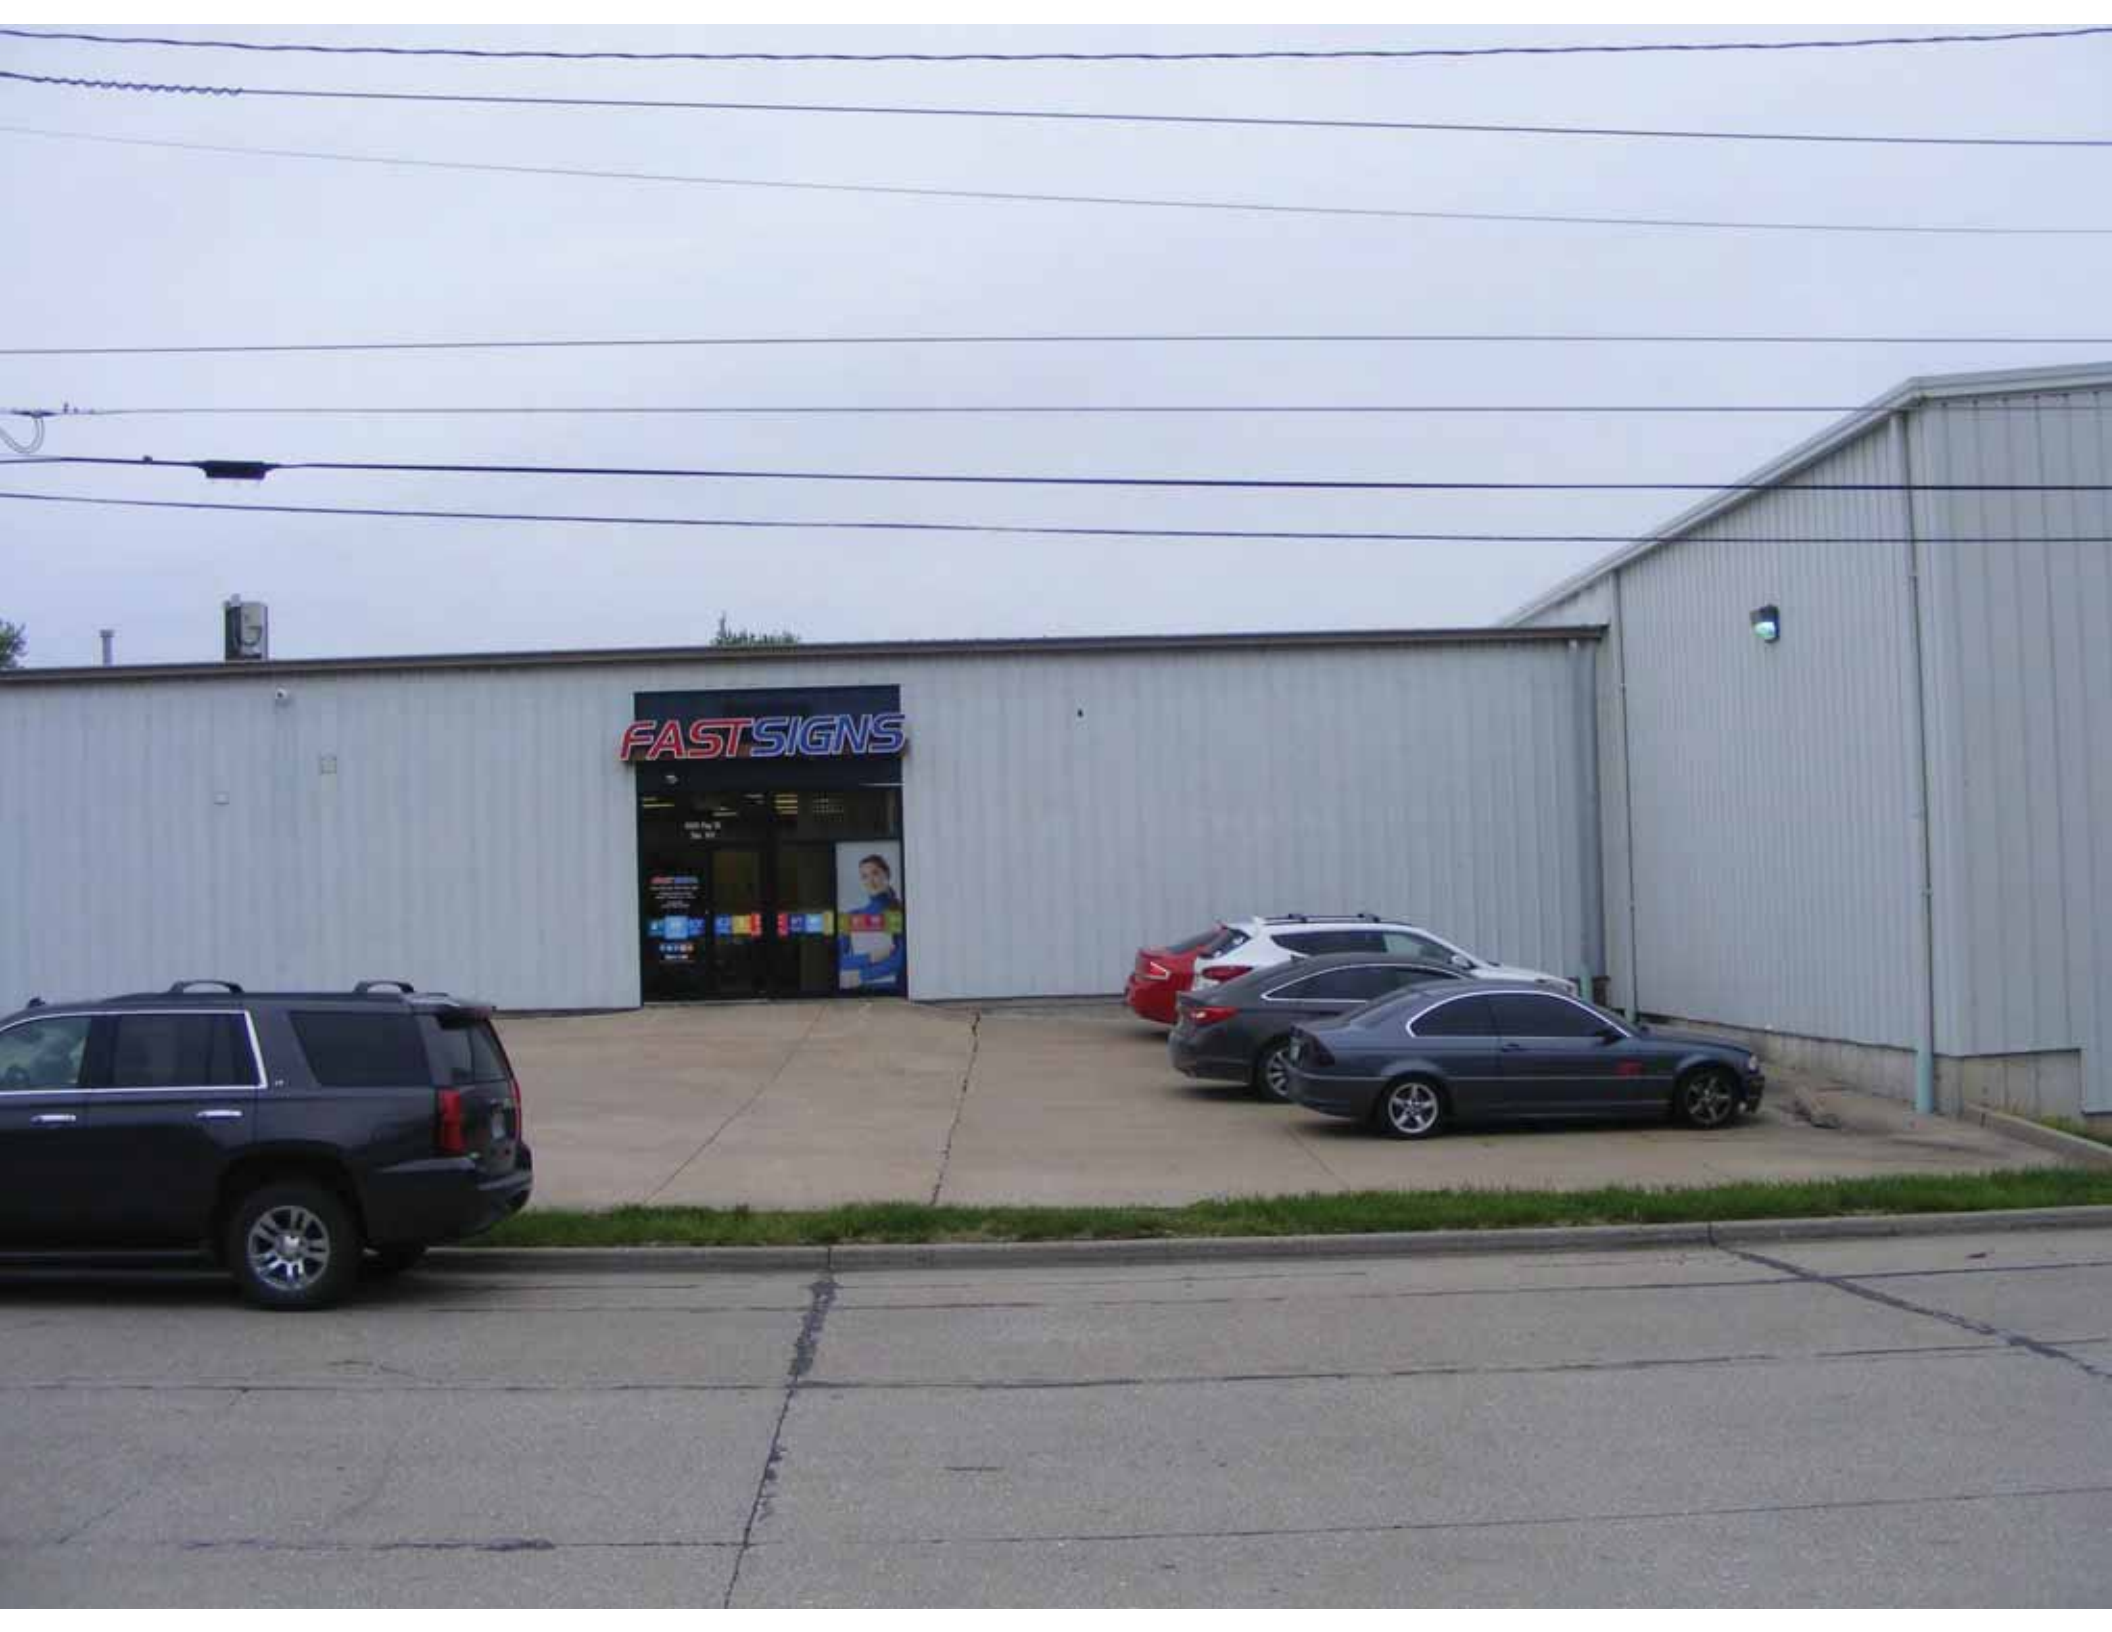
The property is a one story pre-fabricated metal commercial building with a low-pitched side gabled roof with a wide overhanging eave on the façade and a concrete slab foundation. The main building intersects a setback one story pre-fabricated metal commercial building to the right elevation. The primary elevation of the main building holds a glass/metal door flanked by three tall narrow fixed windows on each side. The setback area holds two garage bays and double glass/metal door with transom offset to right by a paired display window with a transom. The left side elevation is void of openings.
