MISSOURI DEPARTMENT OF NATURAL RESOURCES
STATE HISTORIC PRESERVATION OFFICE, P.O. Box 176, Jefferson City, MO 65102
ARCHITECTURAL/HISTORIC INVENTORY FORM

1. Survey No. BO-AS-011-0087		2. Survey name: North Central Columbia Survey Phase II	
3. County: Boone		4. Address (Street No.) 902	Street (name) N. Seventh Street
5. City: Columbia	Vicinity: <input type="checkbox"/>	6. Geographical Reference:	7. Township/Range/Section: T: R: S:
8. Historic name (if known):		9. Present/other name (if known):	
10. Ownership: <input checked="" type="checkbox"/> Private <input type="checkbox"/> Public		11a. Historic use (if known): Domestic/single dwelling	11b. Current use: Domestic/single dwelling

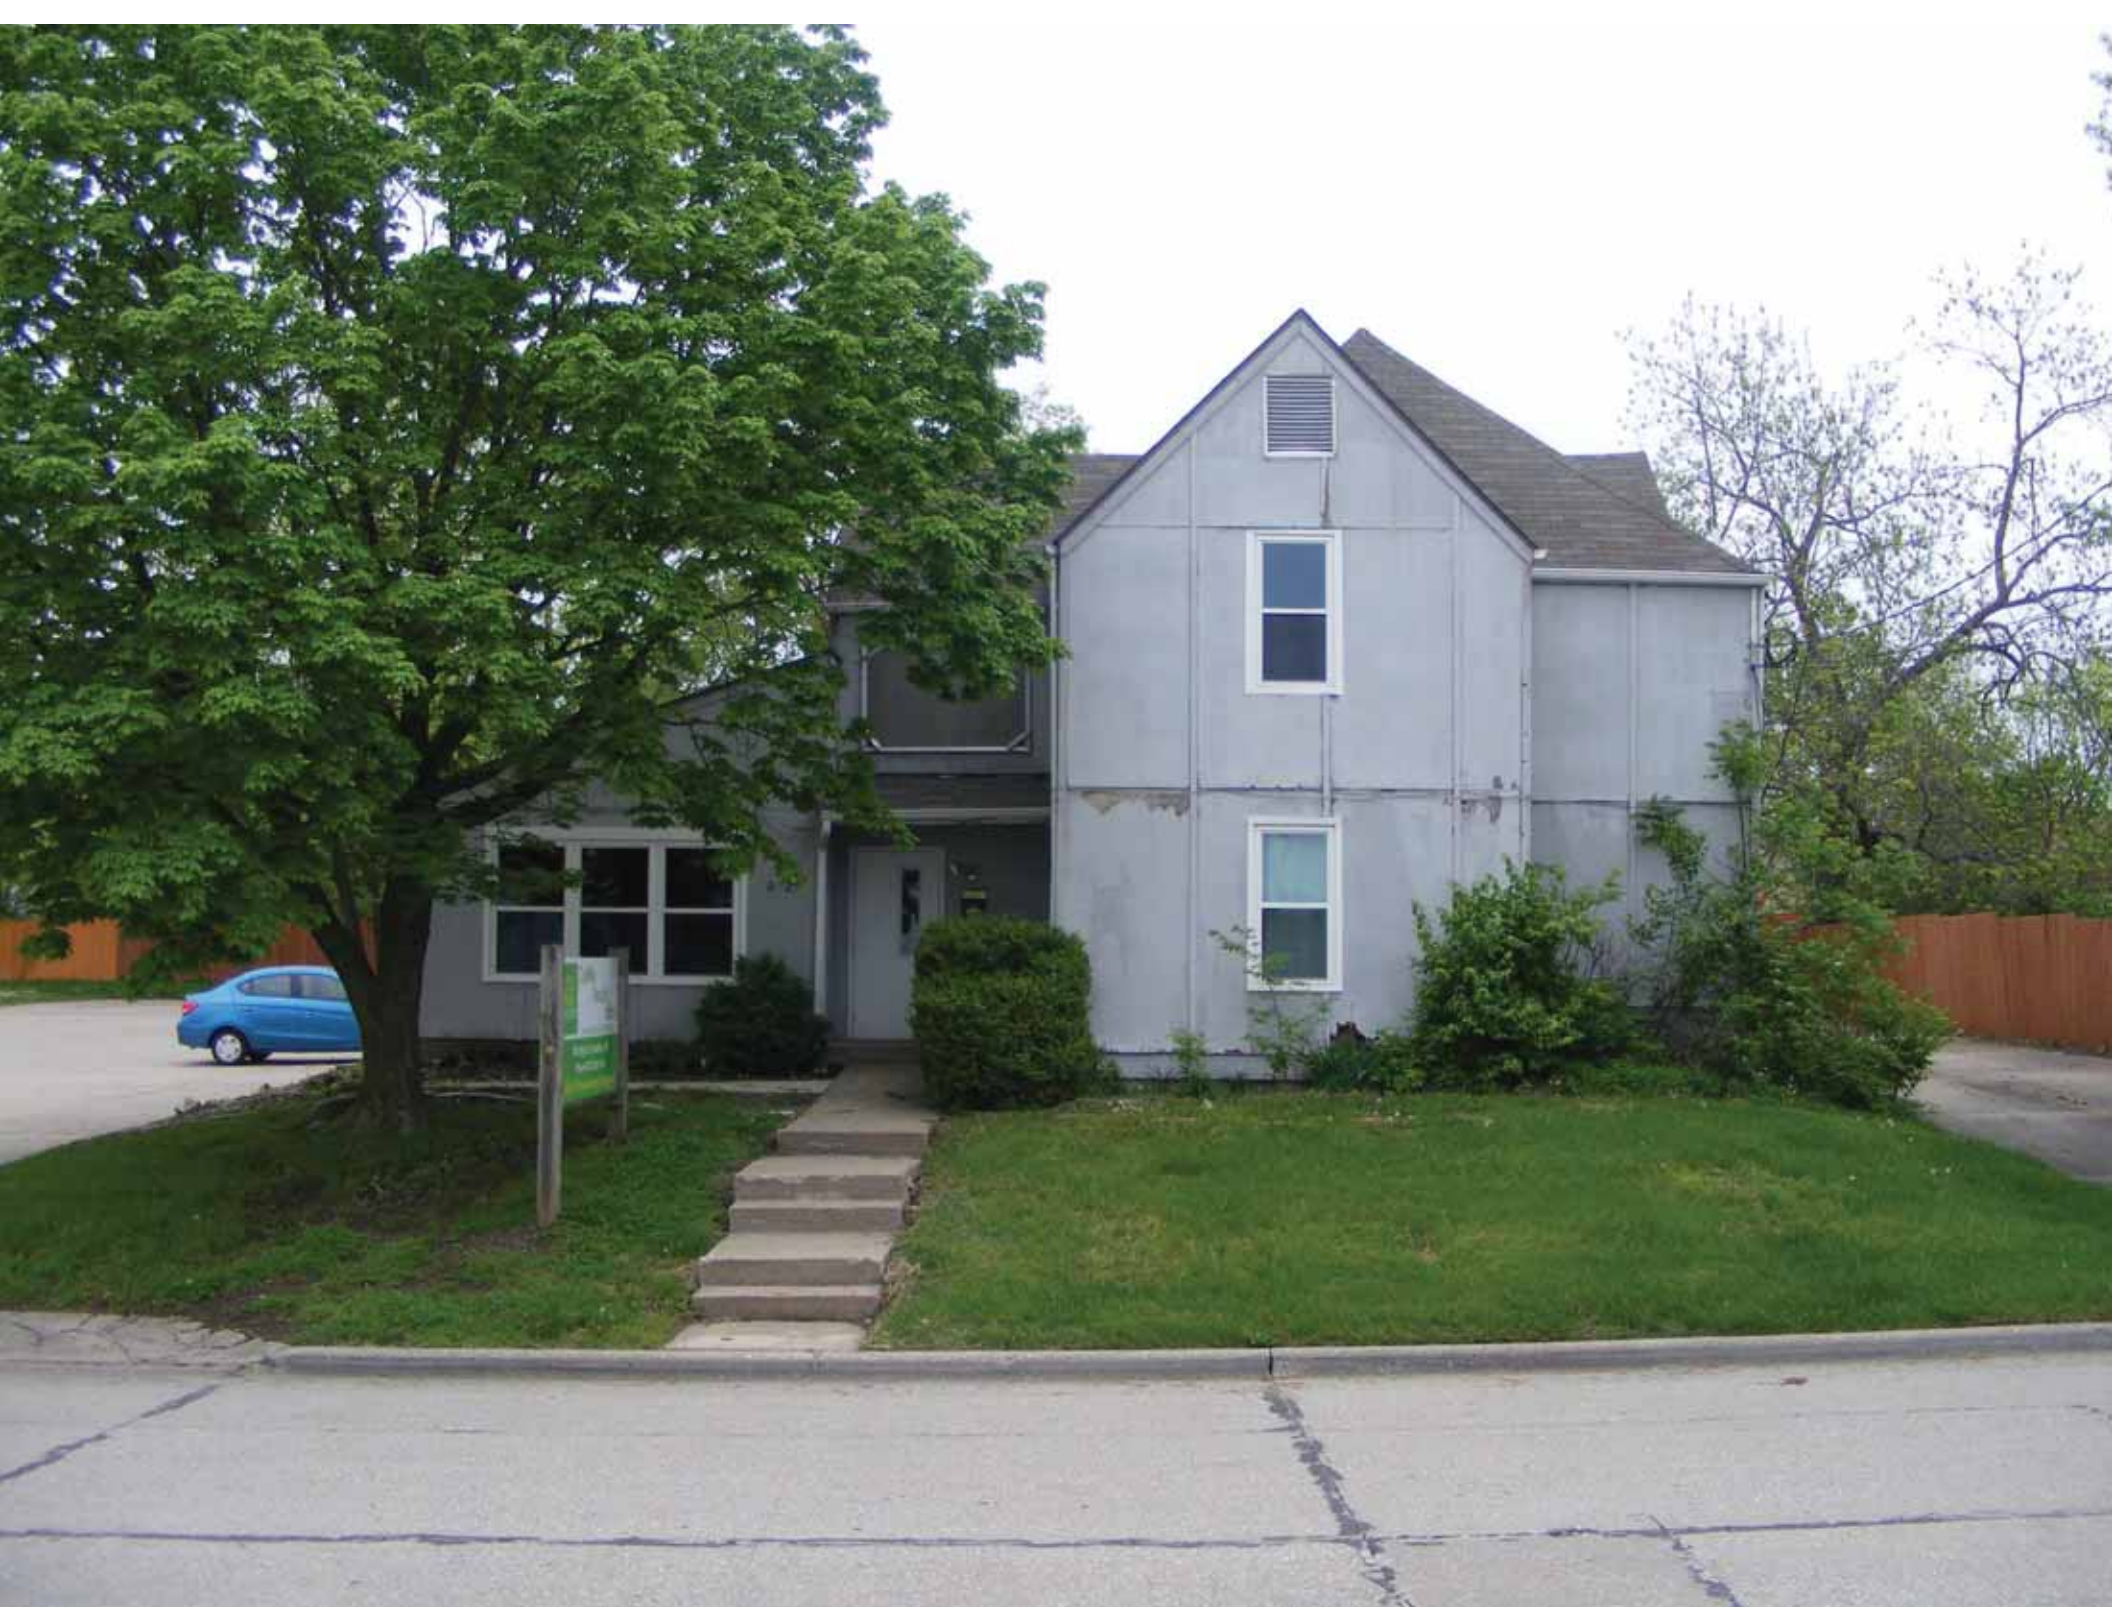
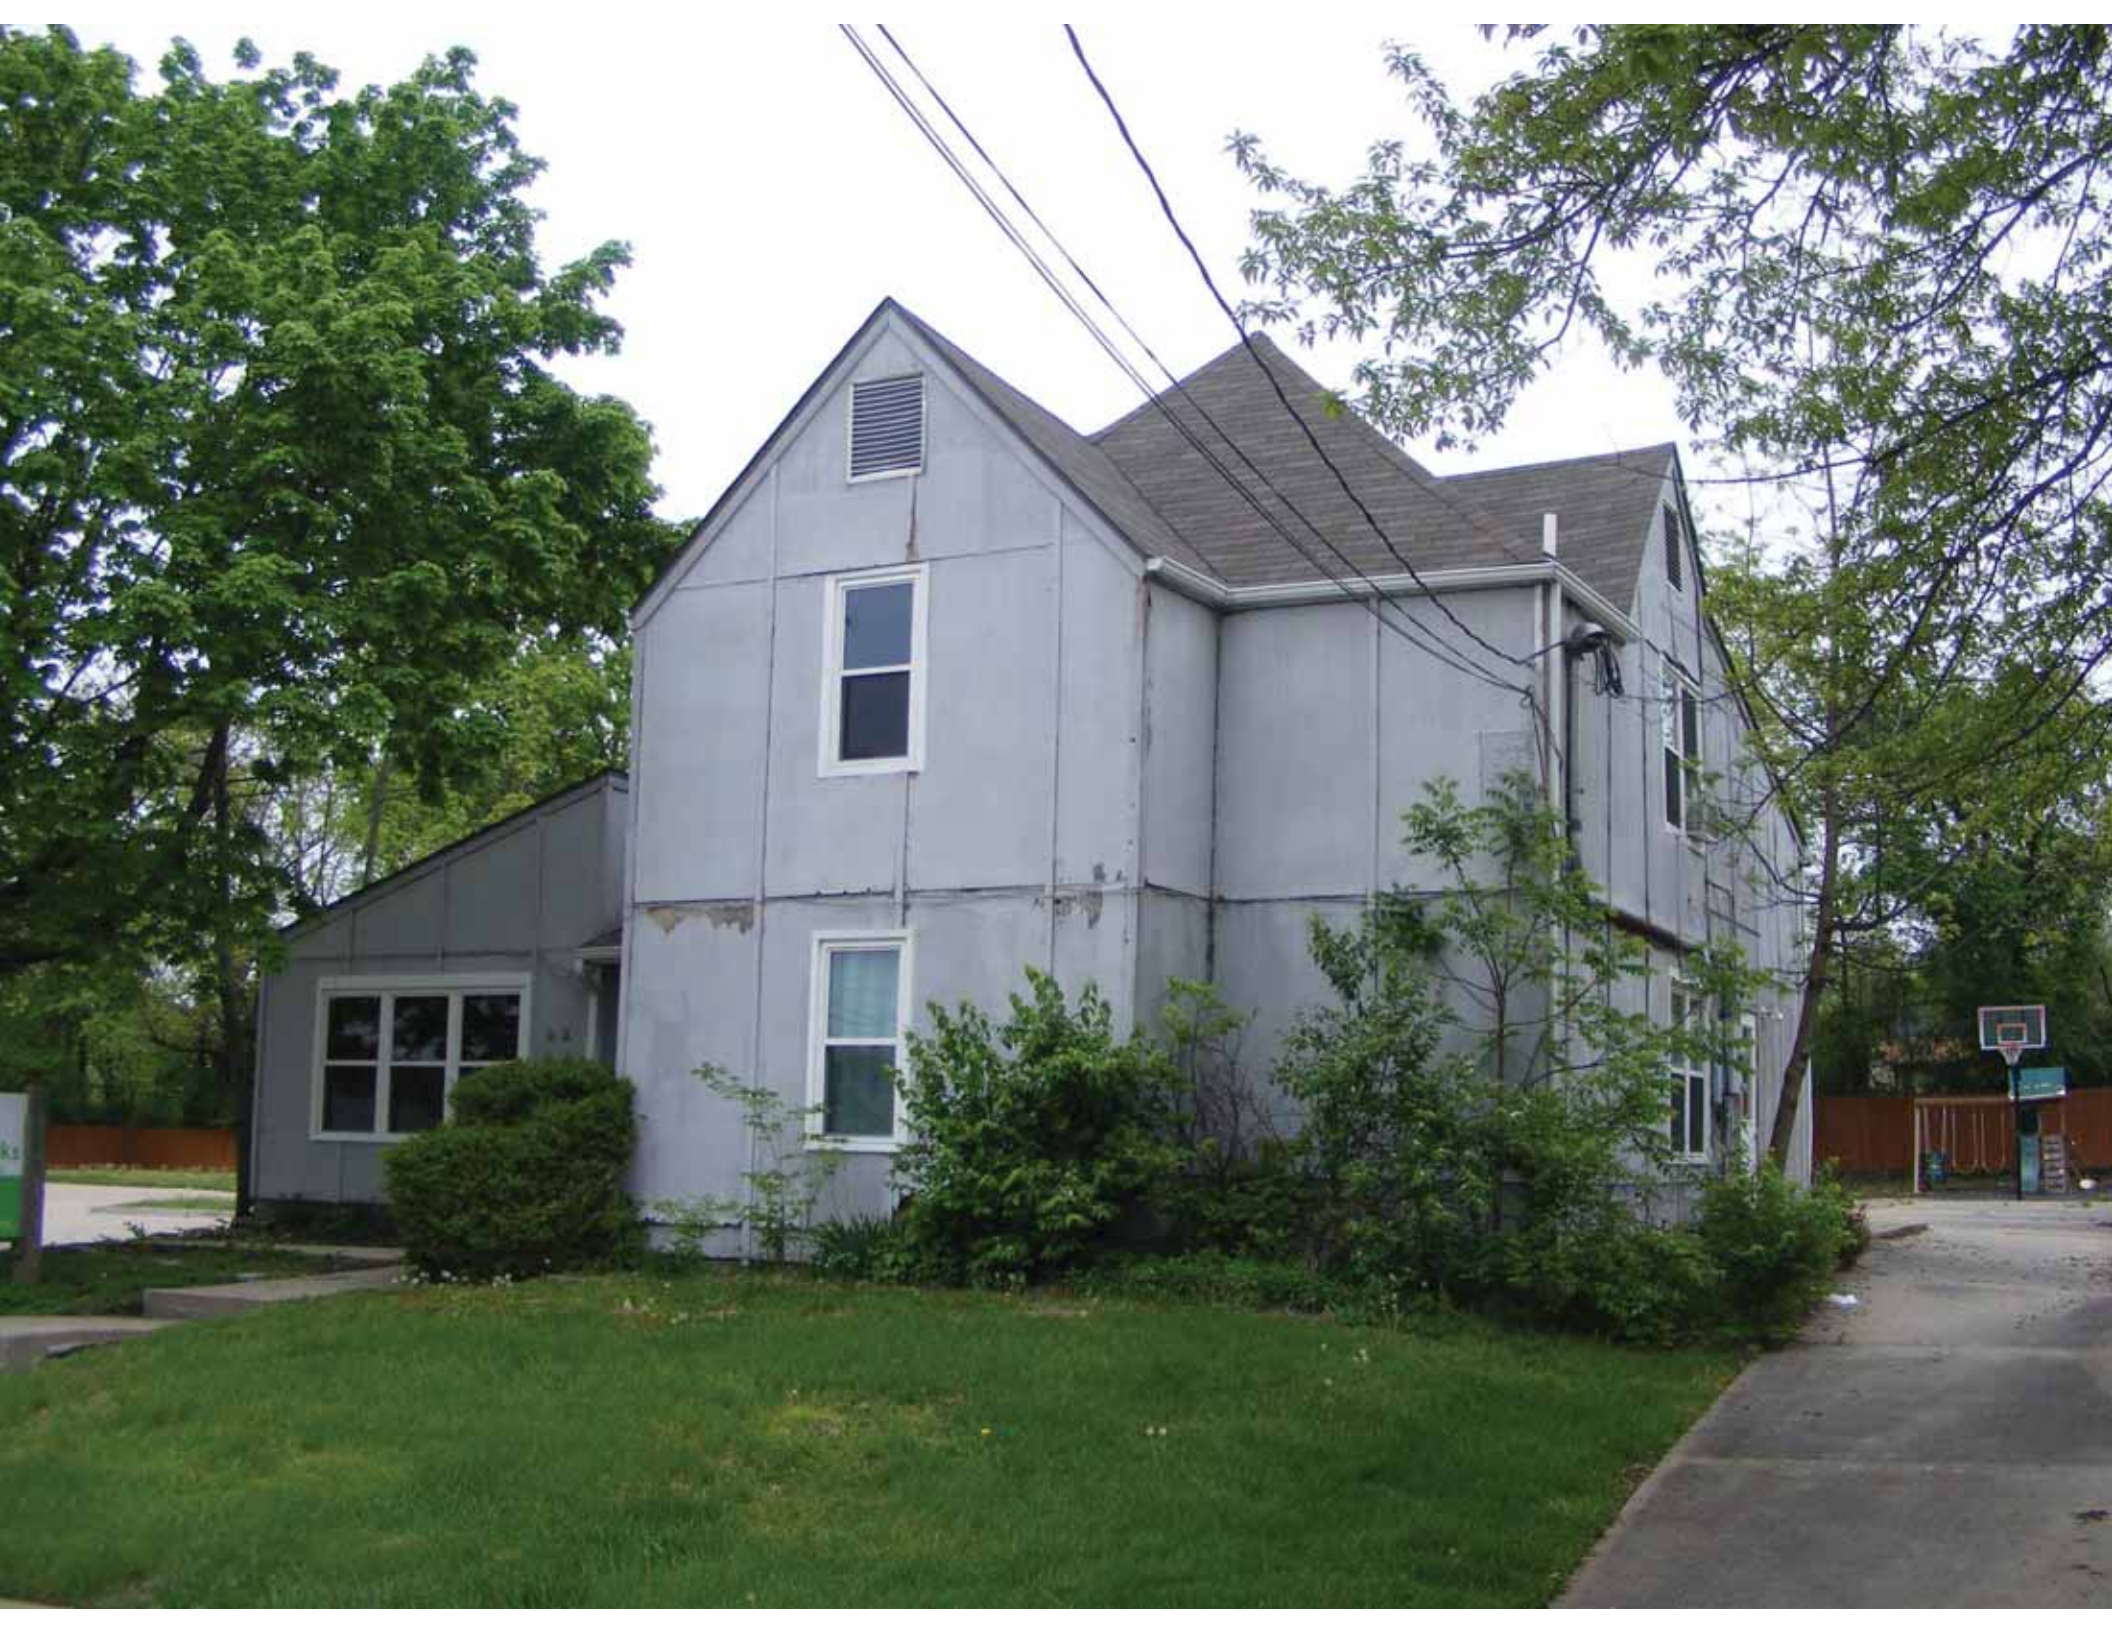
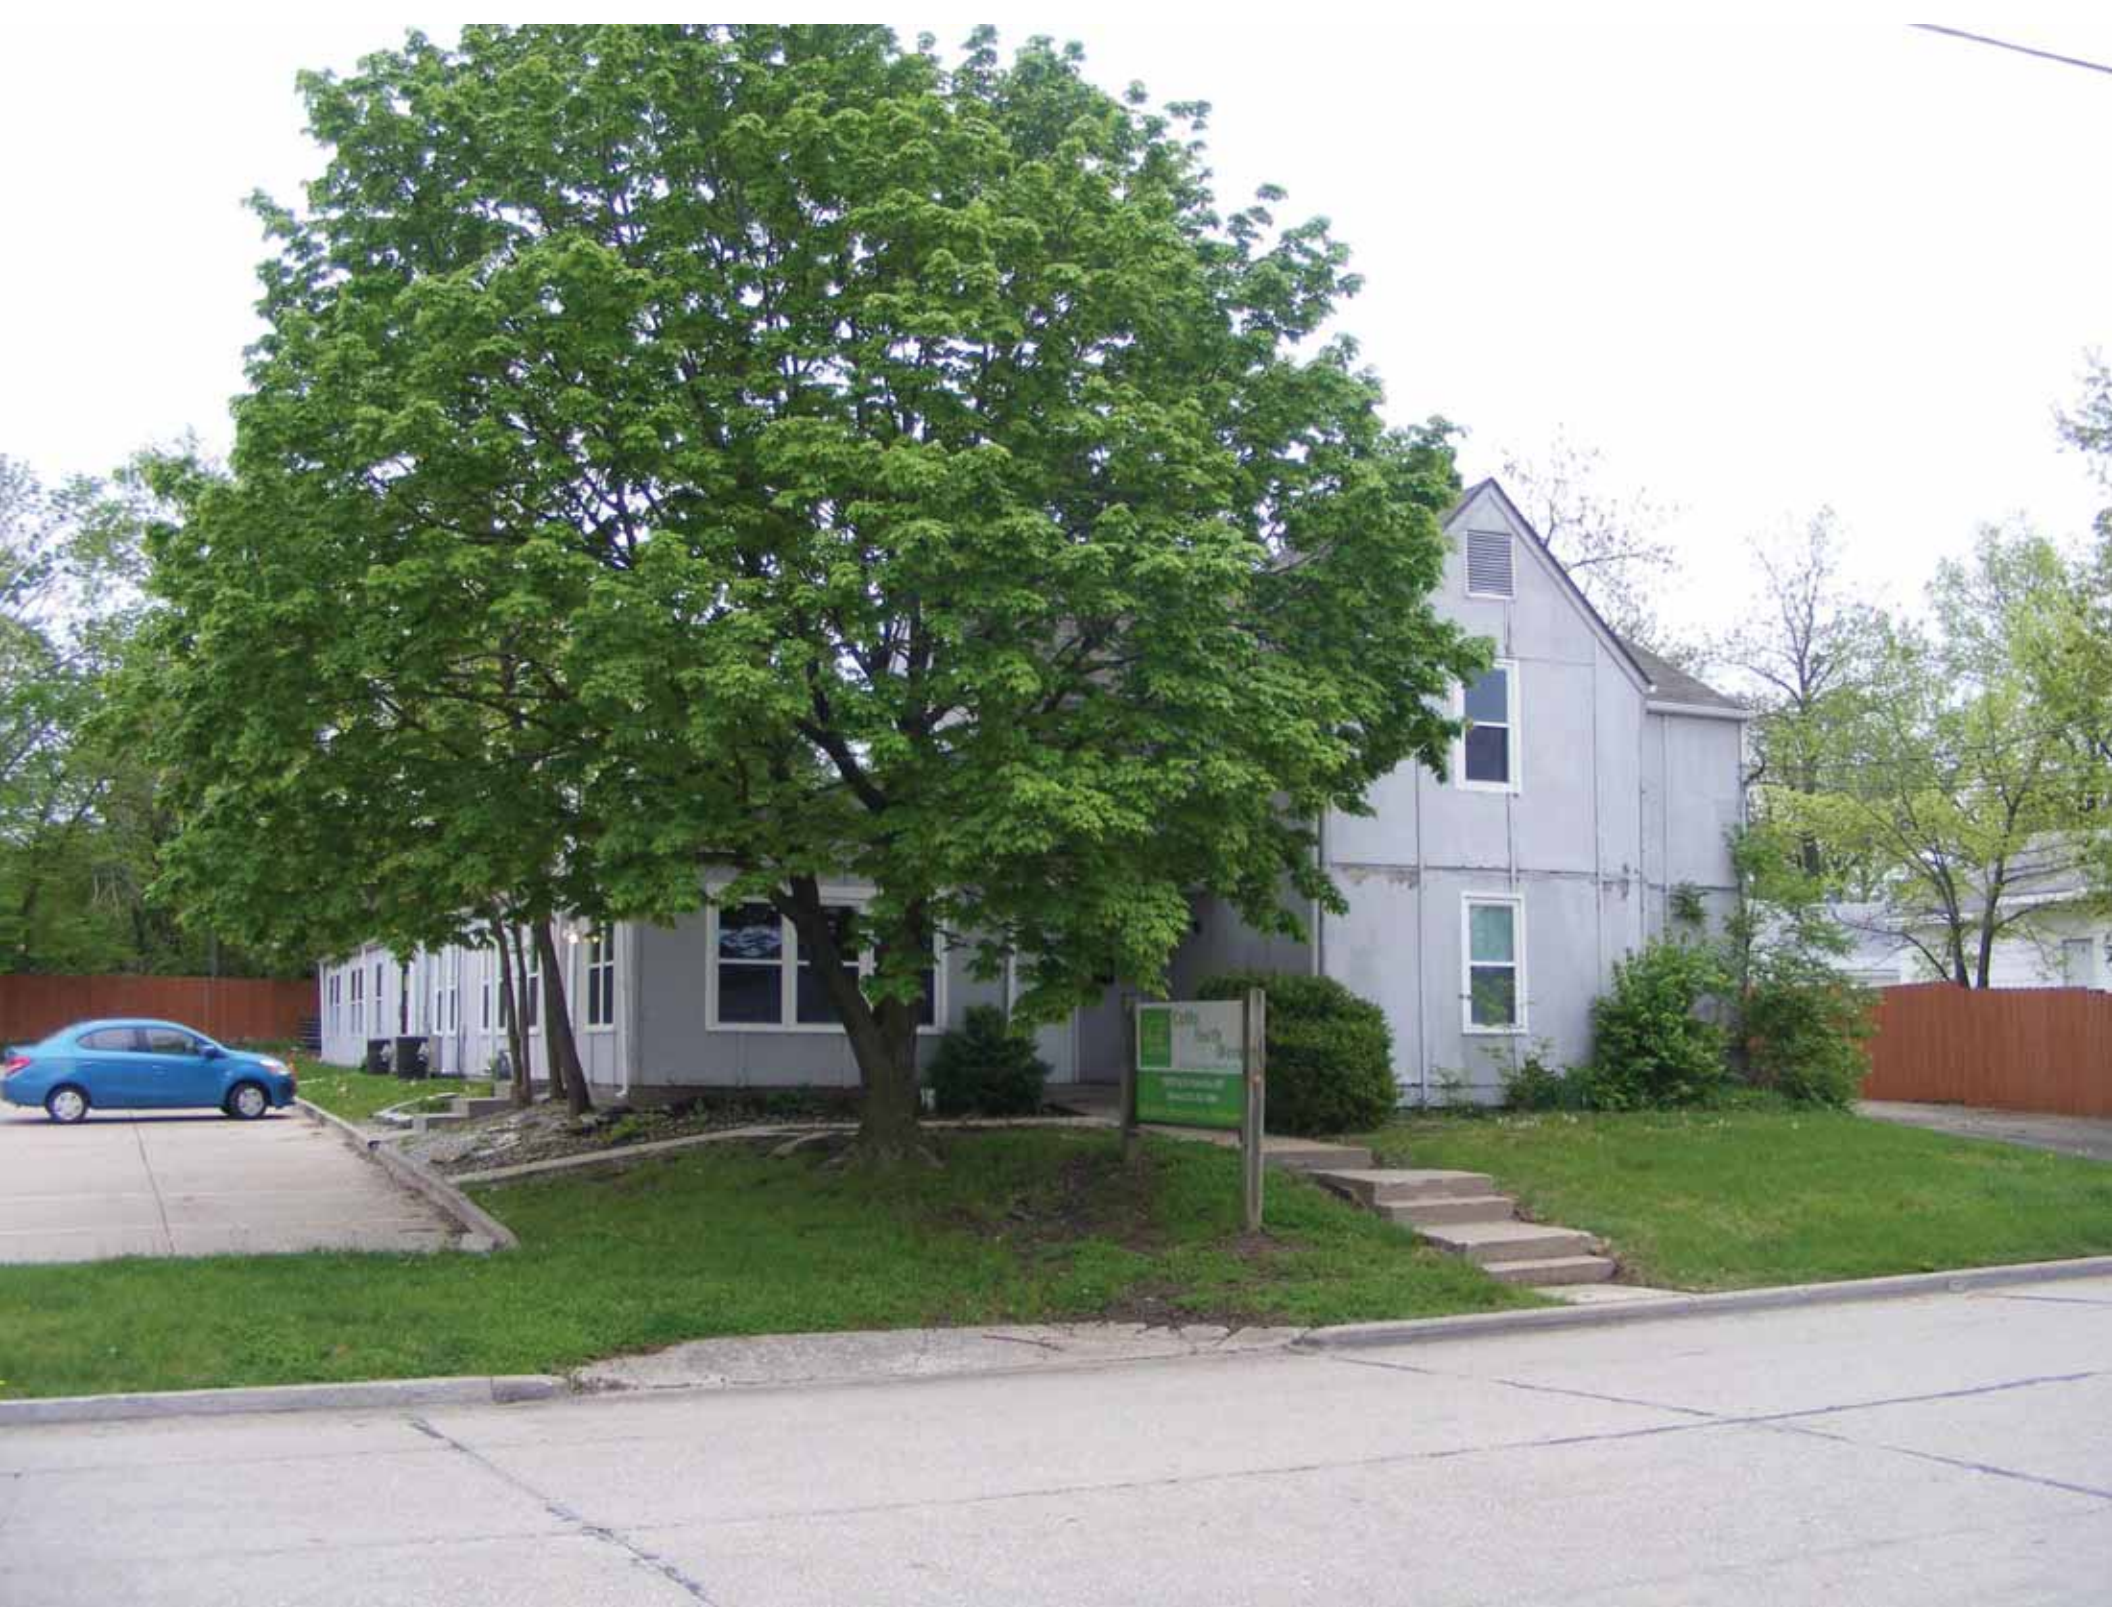
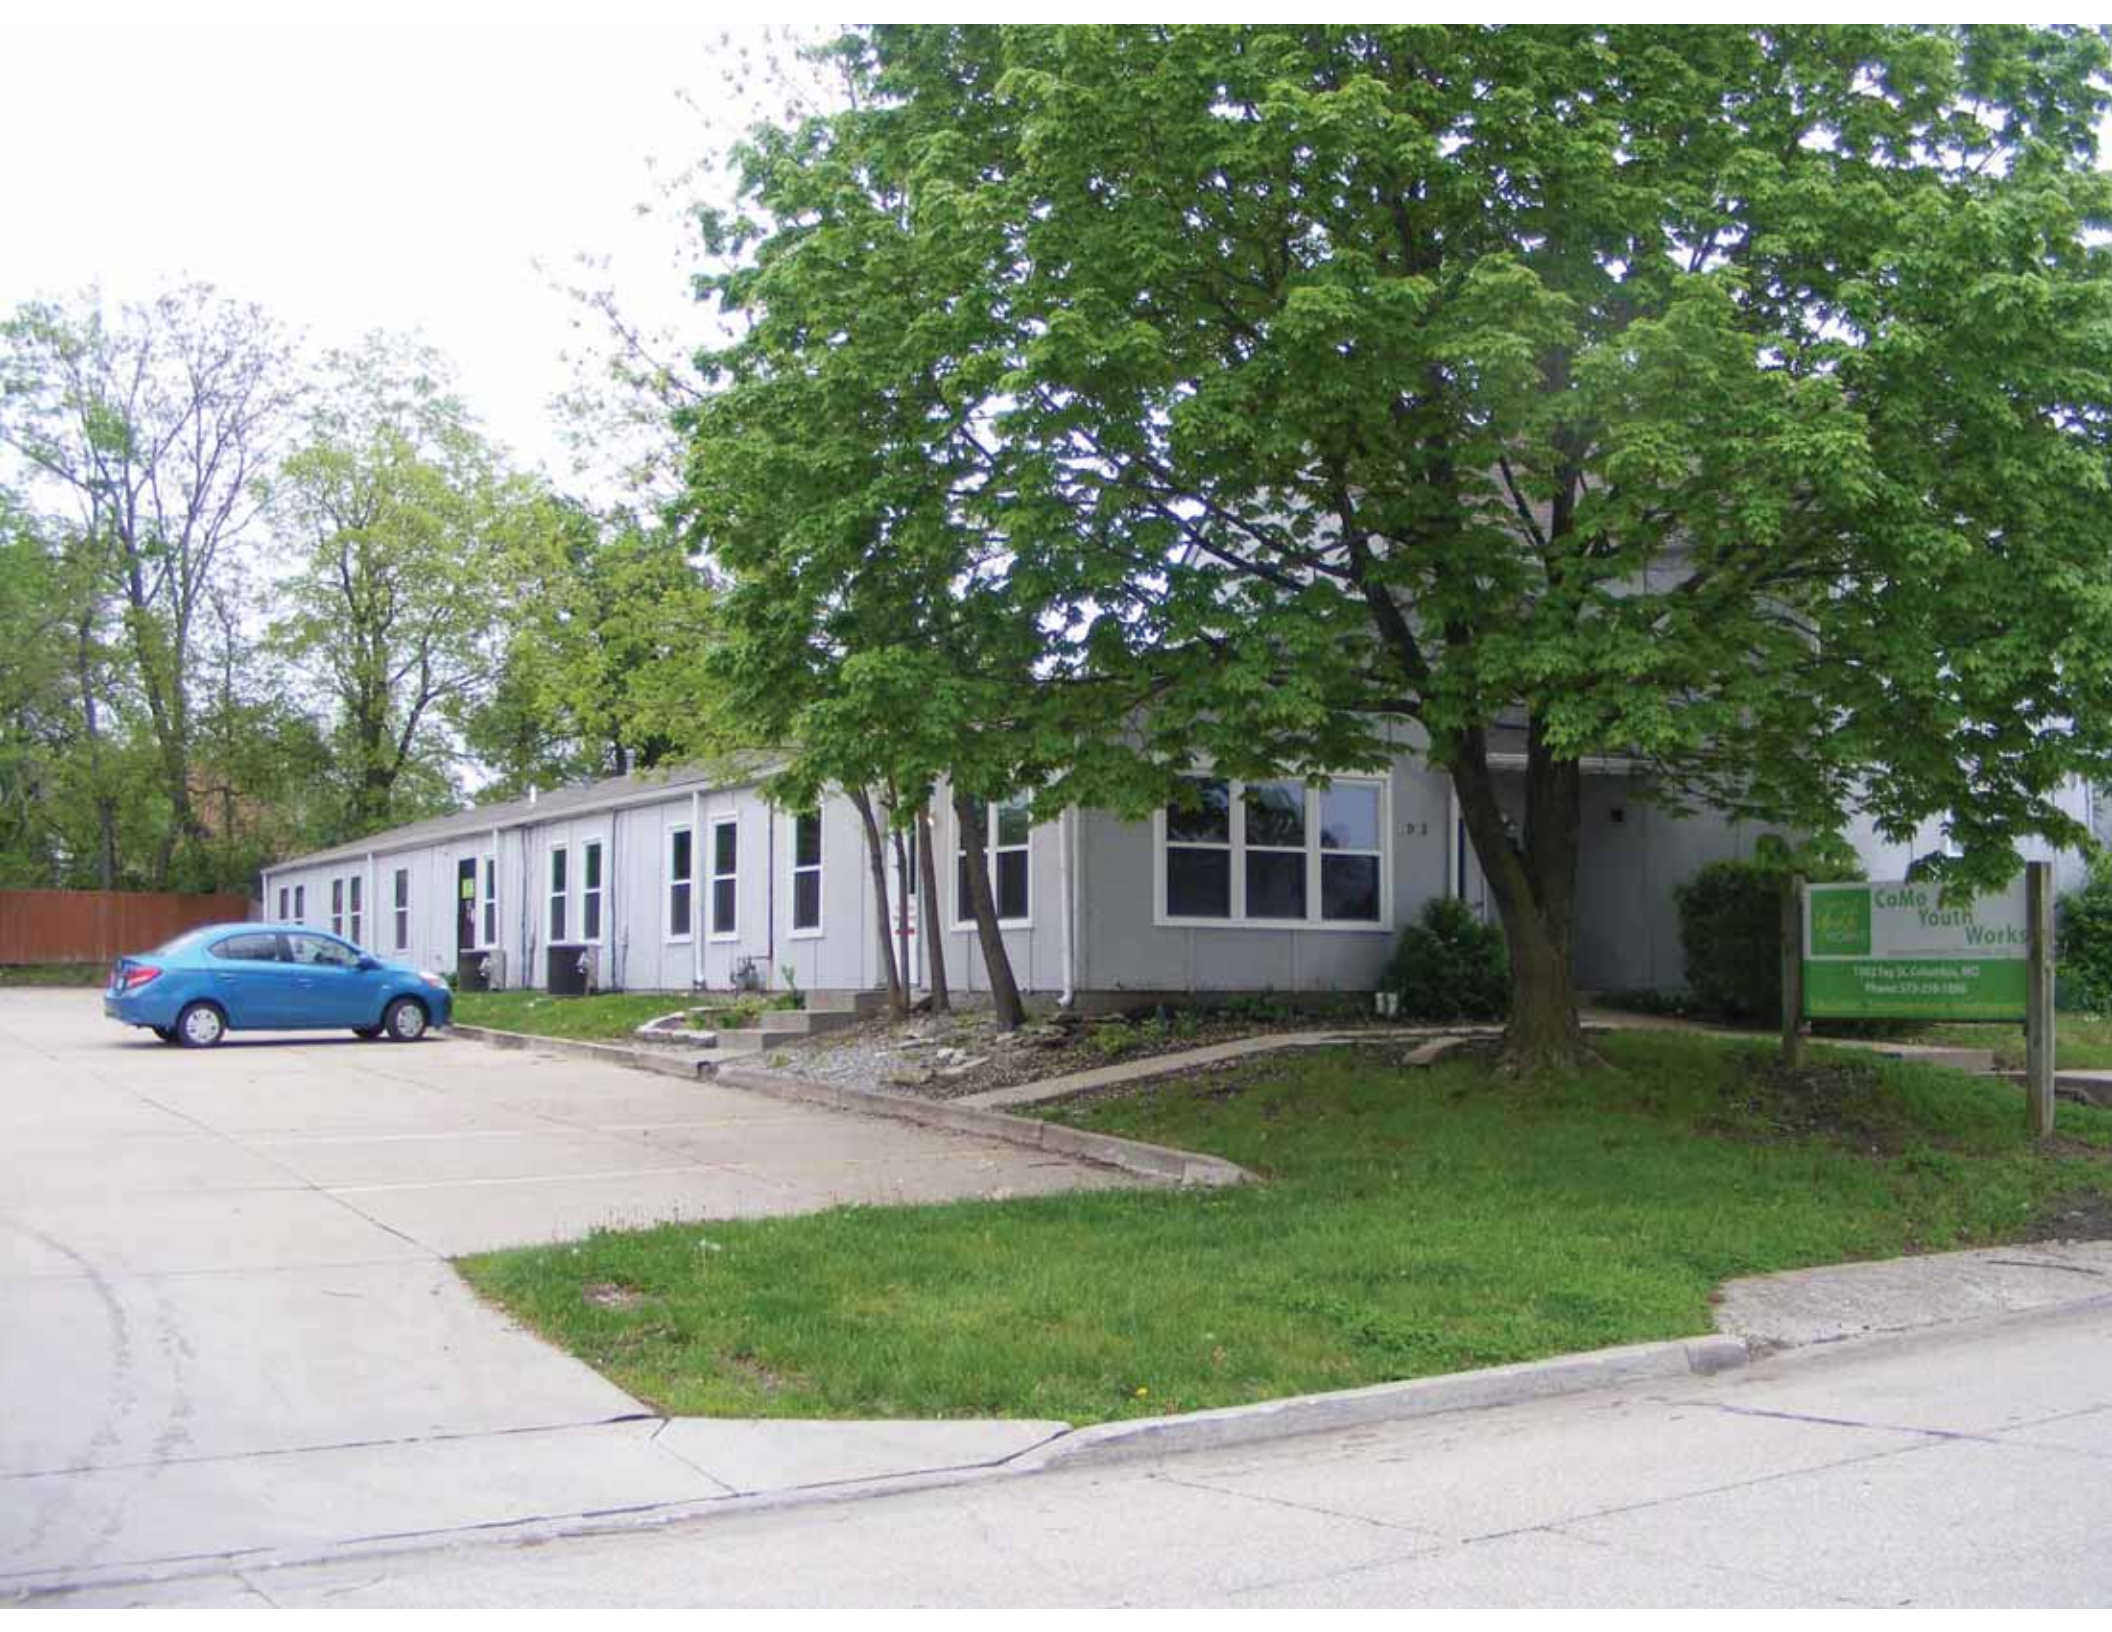
41. (cont.) Description of primary resource. Expand box as necessary, or add continuation pages.
This is a two-story dwelling has an asphalt-shingled cross gable on hip with a concrete foundation and has been converted to commercial use. The building has extensively altered (Ca. 1980) and is clad in non-original plywood type panels with narrow vertical trim board between each panel. A large addition runs the length of the north elevation. The primary elevation holds an off-centered setback stoop sheltered under an asphalt-shingled shed roof and holds an entrance. The stoop is offset to the right by a tripled paired one-over-one windows (addition). To the right of the stoop, the front gable holds one-over-one windows on both levels with a vent in the gable end. The south elevation holds paired one-over-one windows on both levels and a side entrance. The north elevation holds the addition several single and paired one-over-one windows and two entrances.
