MISSOURI DEPARTMENT OF NATURAL RESOURCES
STATE HISTORIC PRESERVATION OFFICE, P.O. Box 176, Jefferson City, MO 65102
ARCHITECTURAL/HISTORIC INVENTORY FORM

1. Survey No. BO-AS-011-0087		2. Survey name: North Central Columbia Survey Phase II	
3. County: Boone		4. Address (Street No.) 902	Street (name) N. Seventh Street
5. City: Columbia	Vicinity: <input type="checkbox"/>	6. Geographical Reference:	7. Township/Range/Section: T: R: S:
8. Historic name (if known):		9. Present/other name (if known):	
10. Ownership: <input checked="" type="checkbox"/> Private <input type="checkbox"/> Public		11a. Historic use (if known): Domestic/single dwelling	11b. Current use: Domestic/single dwelling

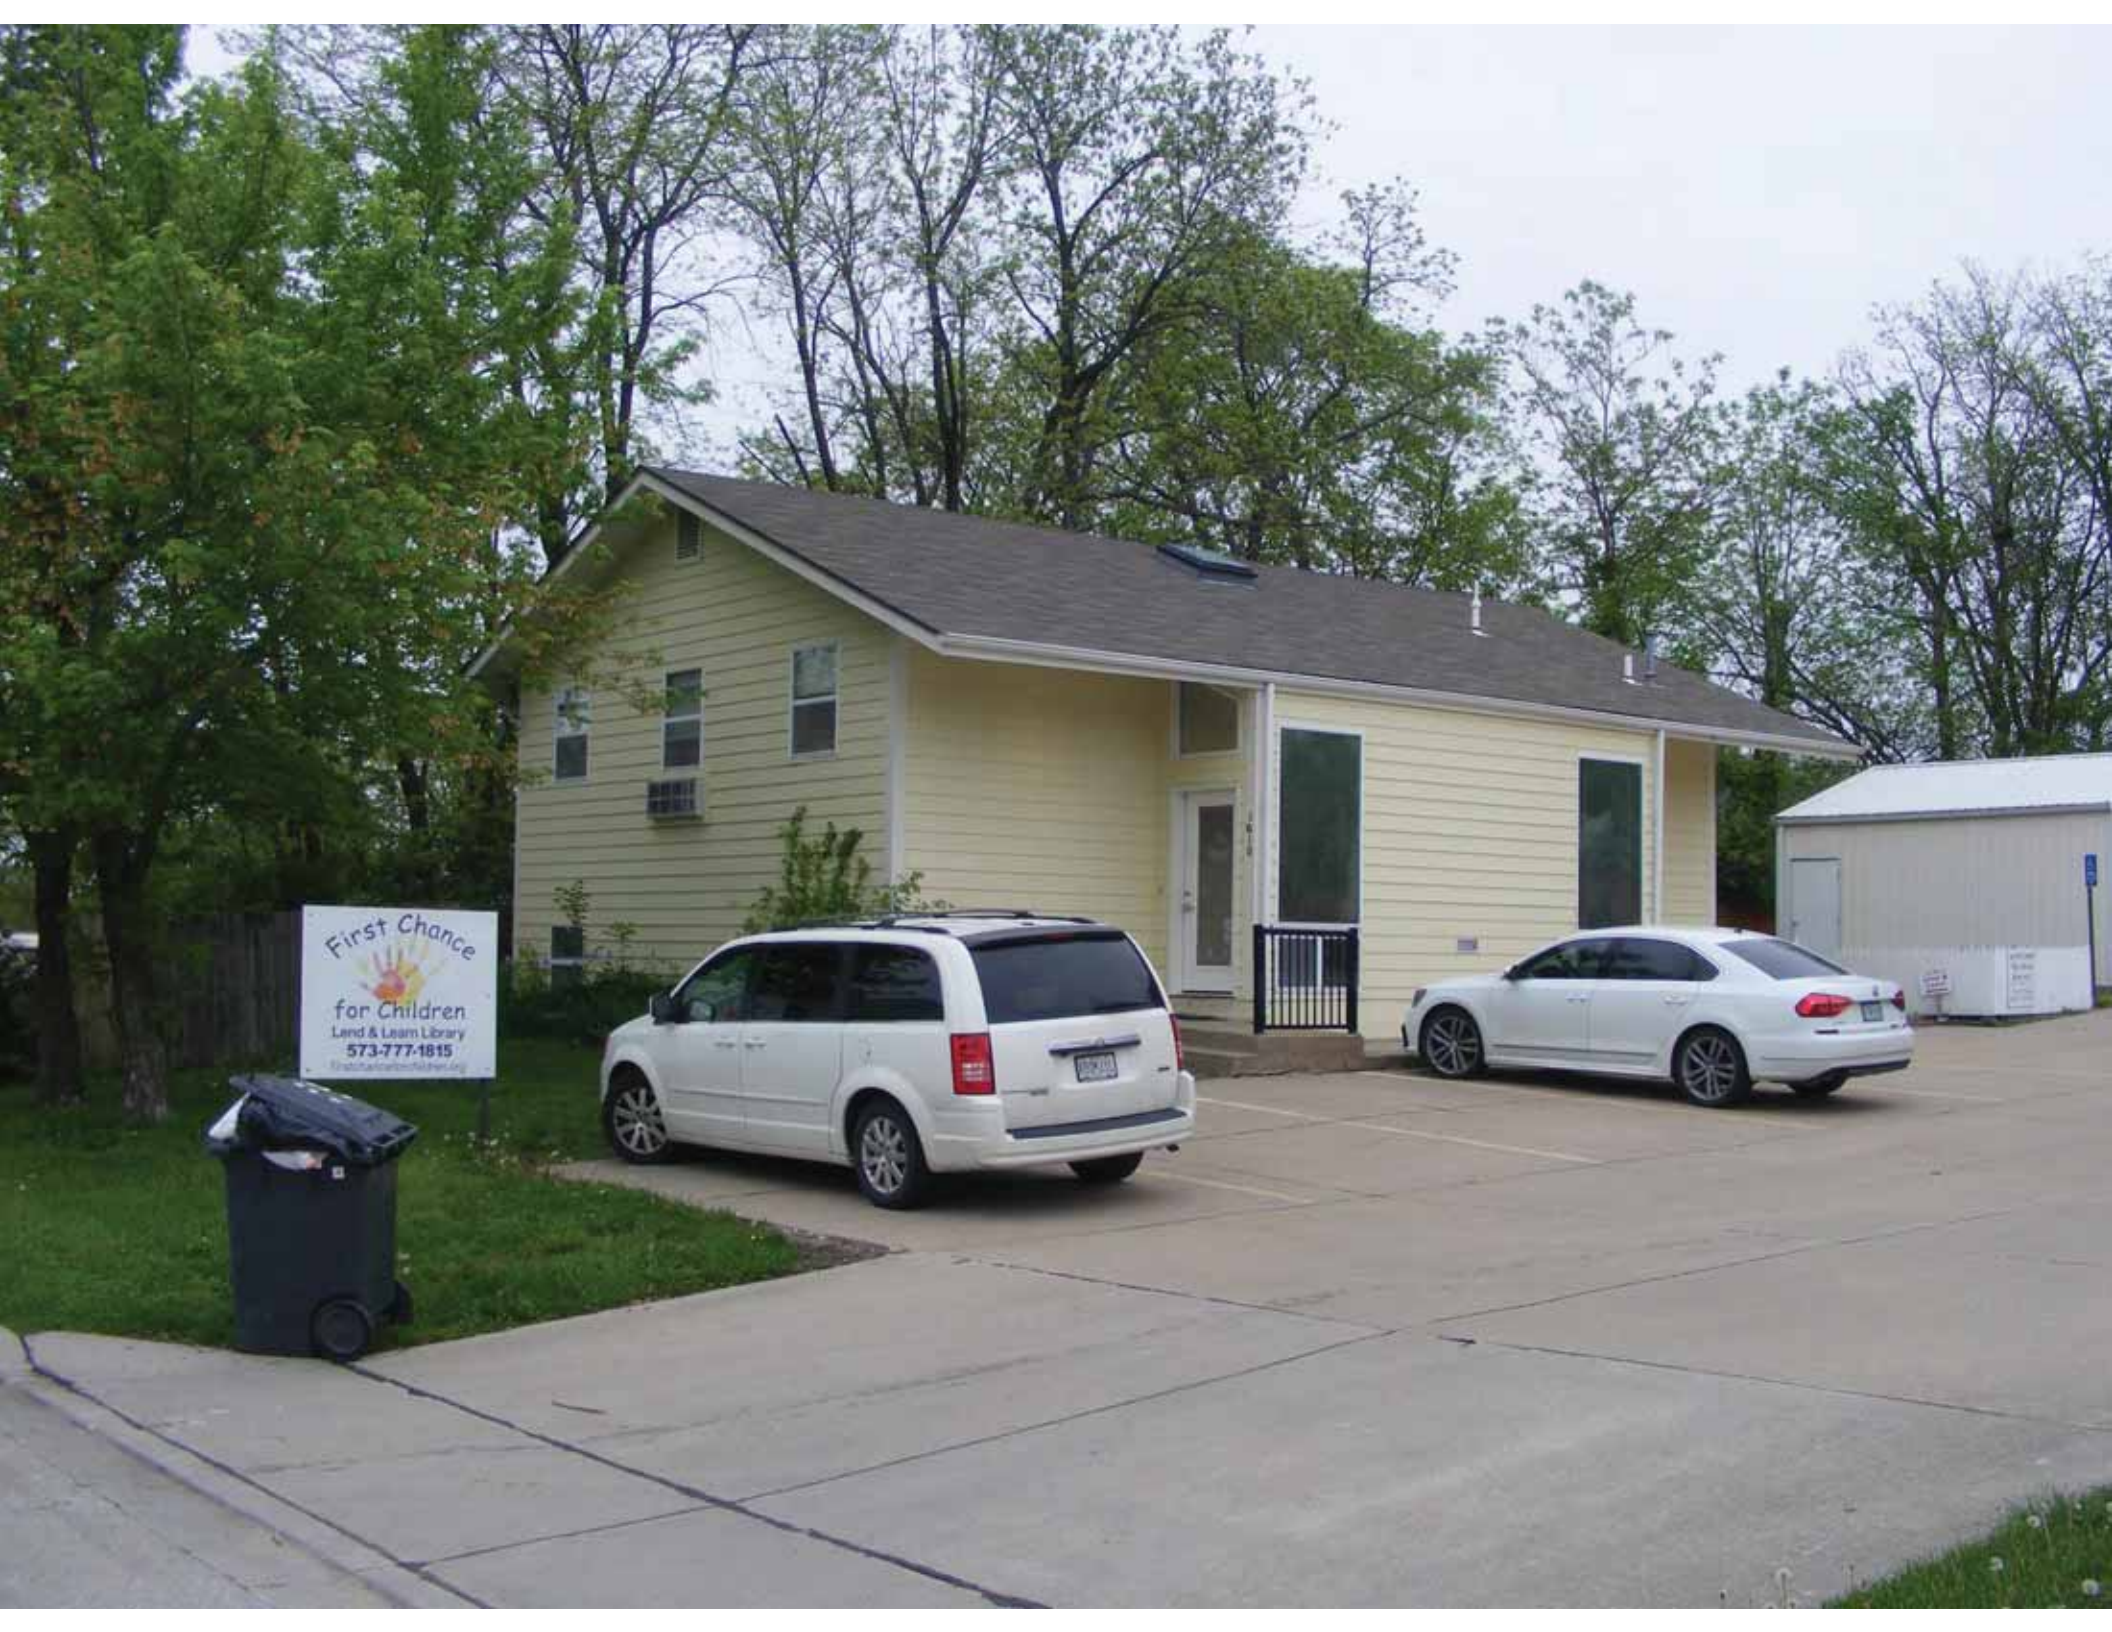
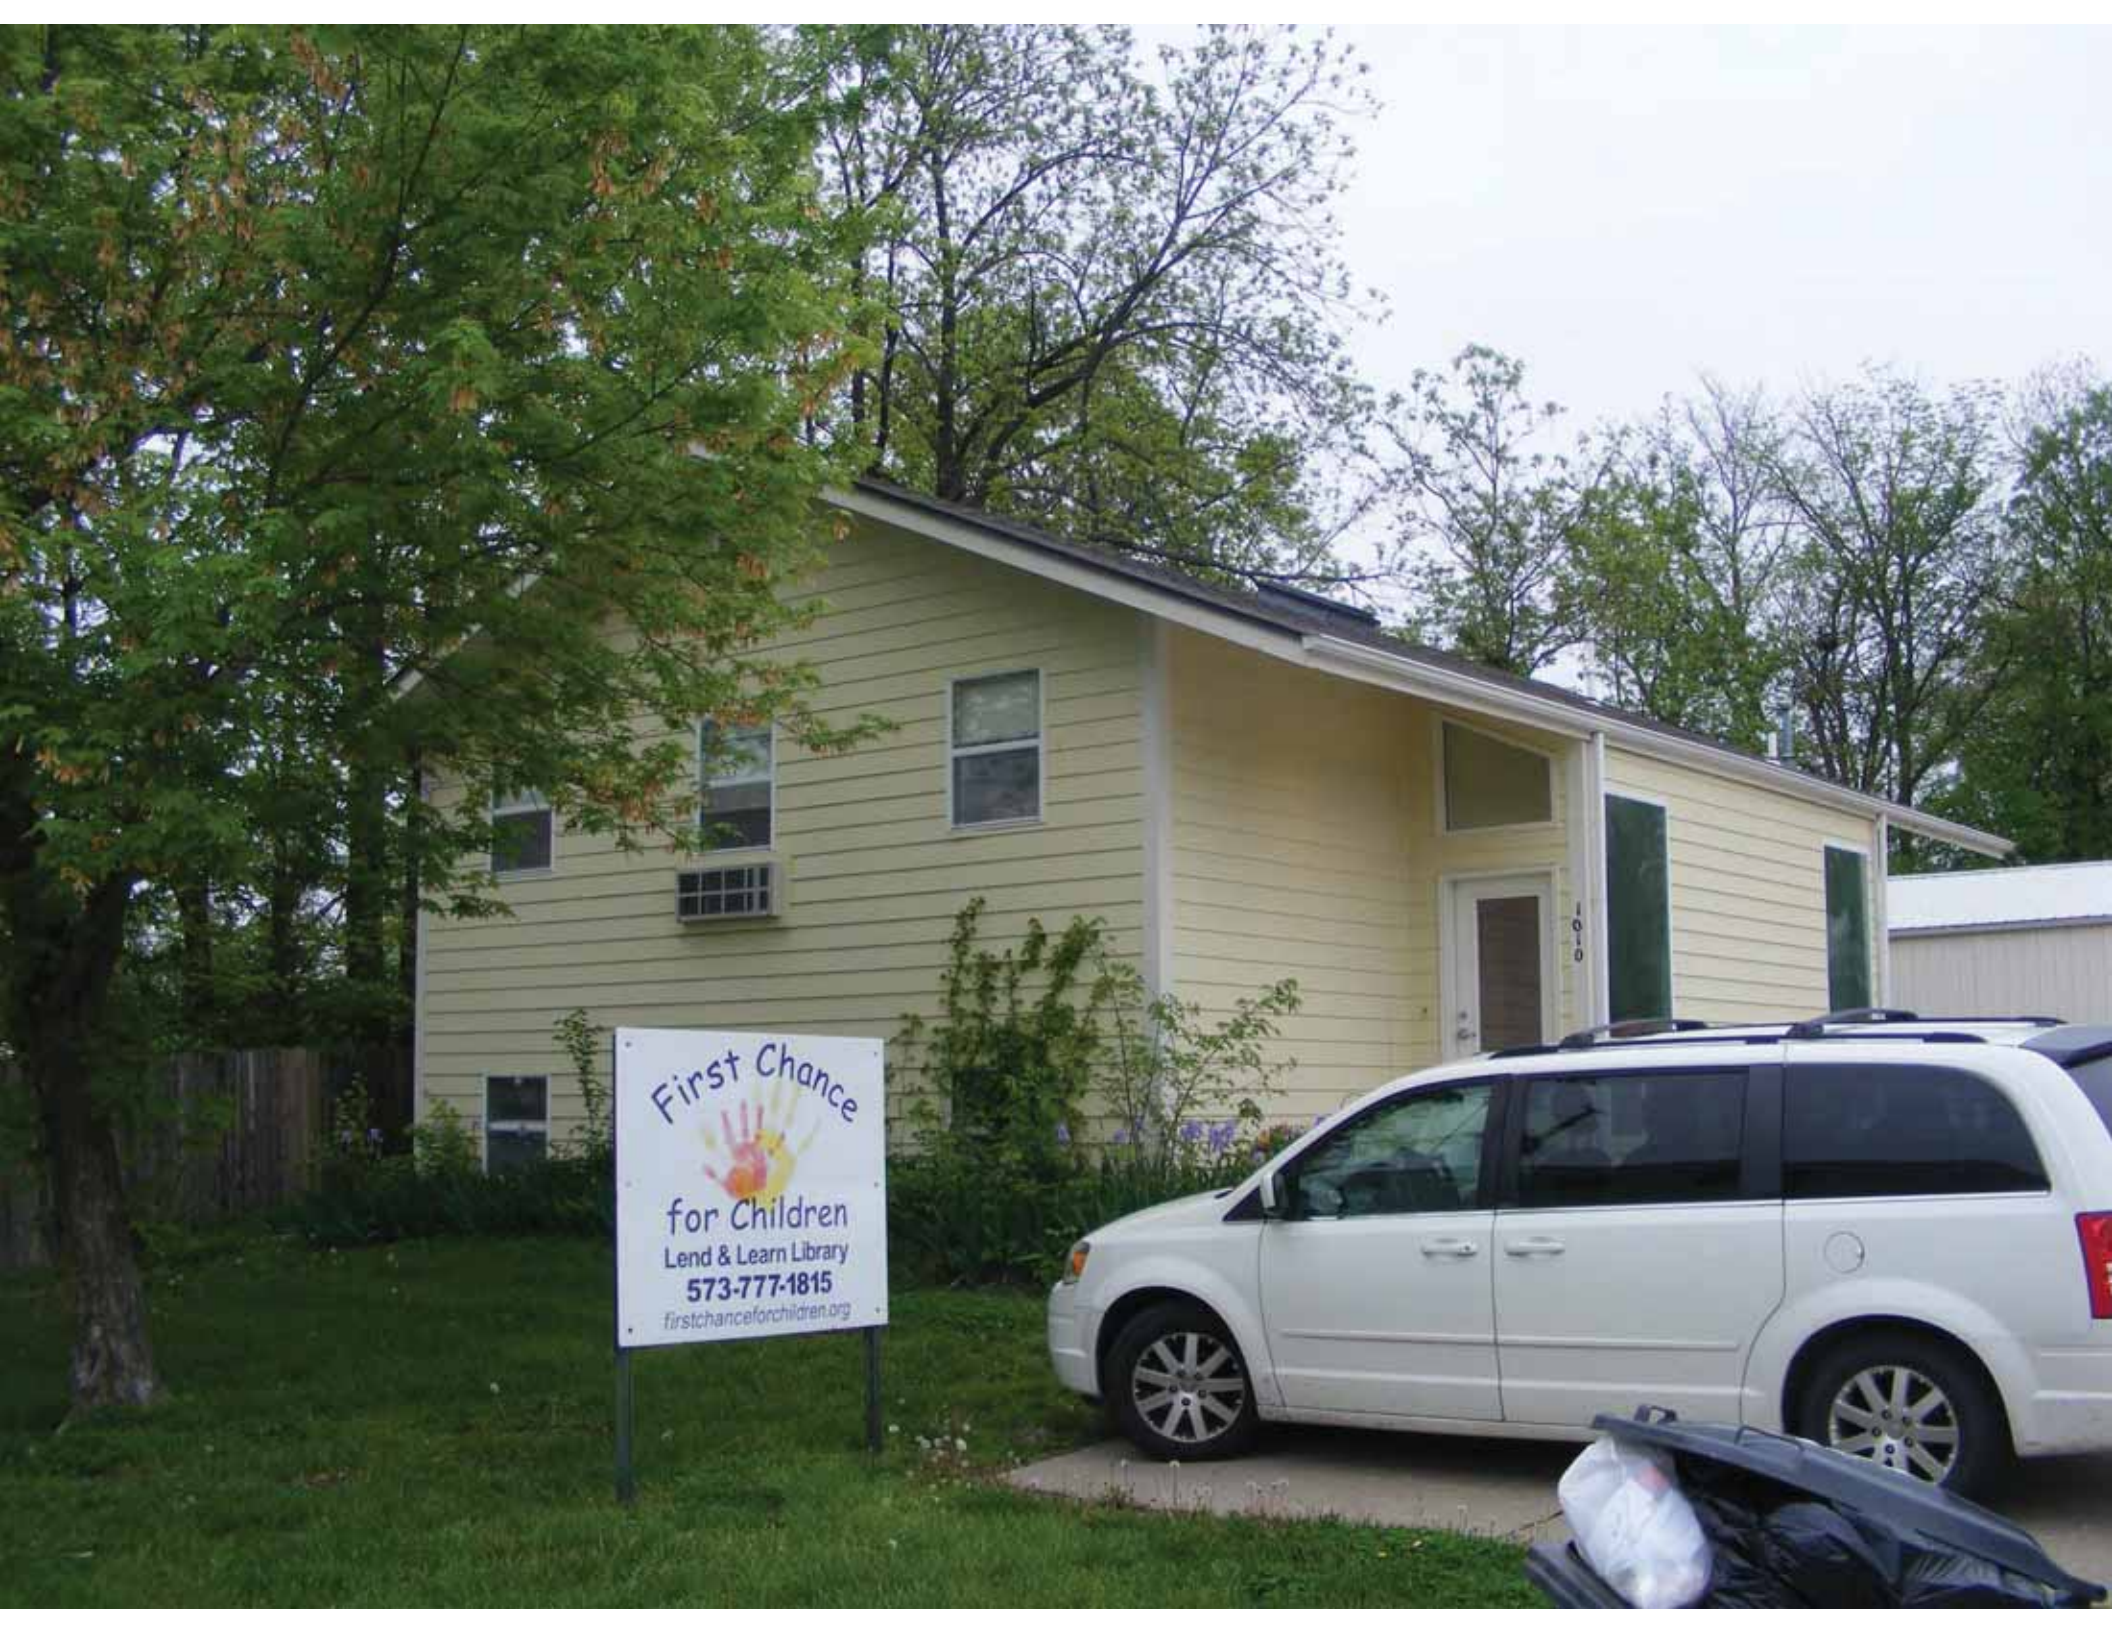
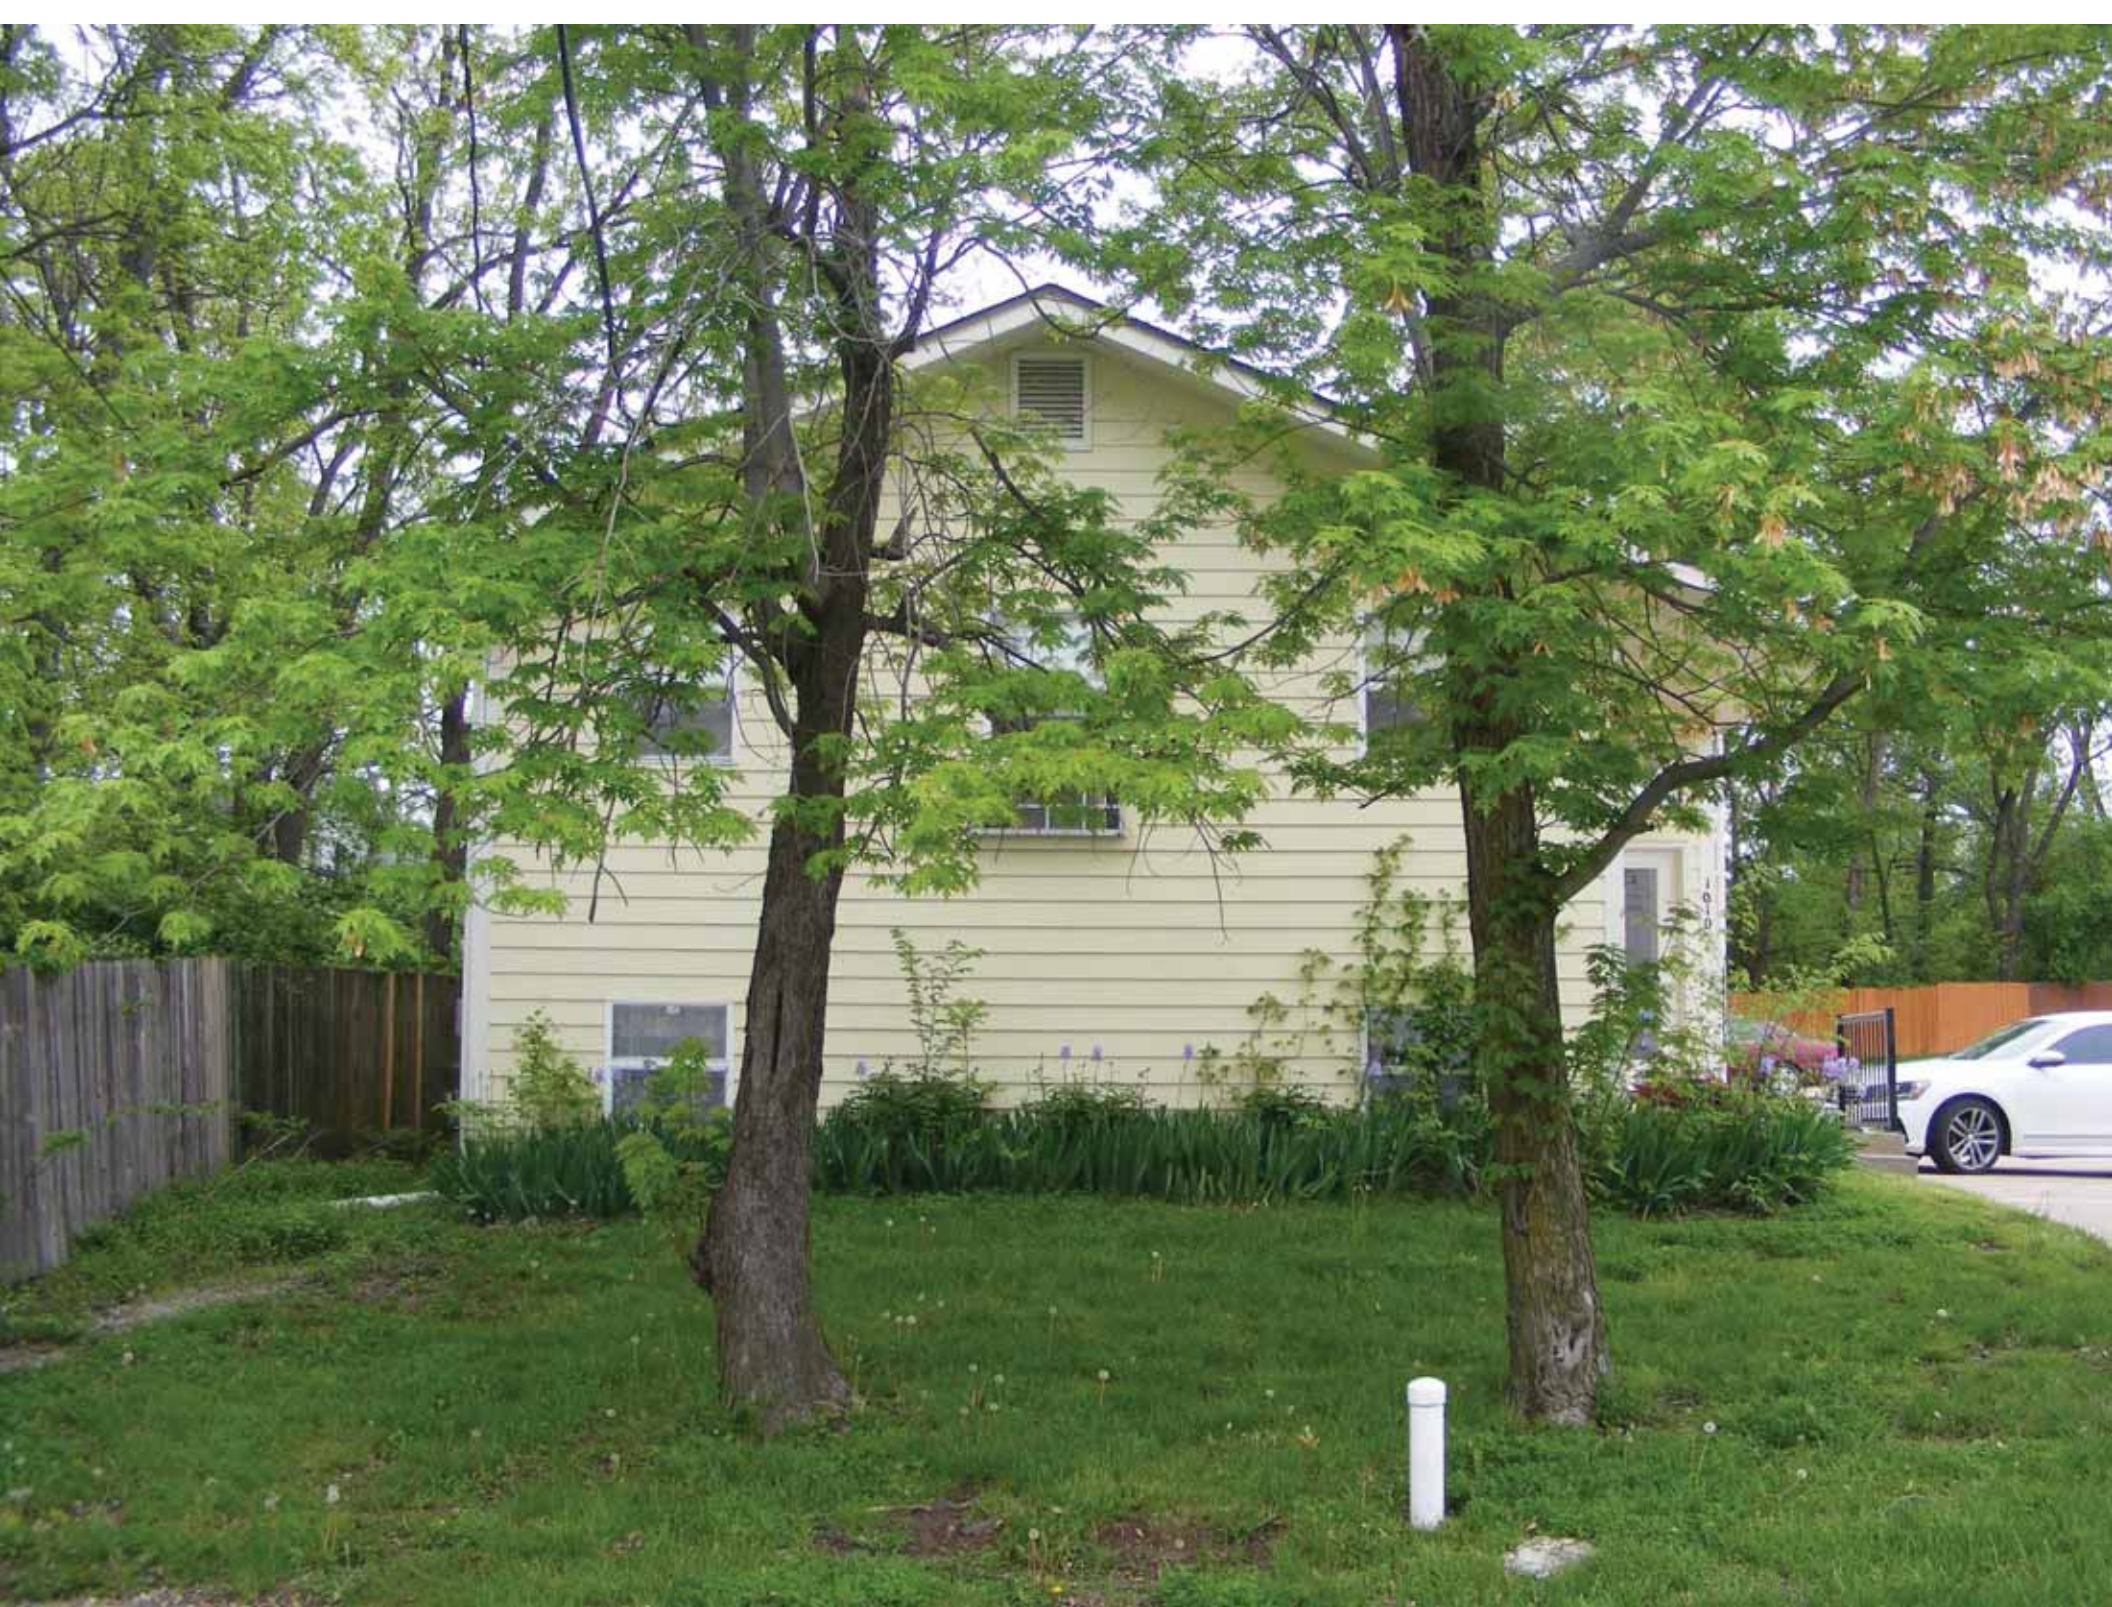
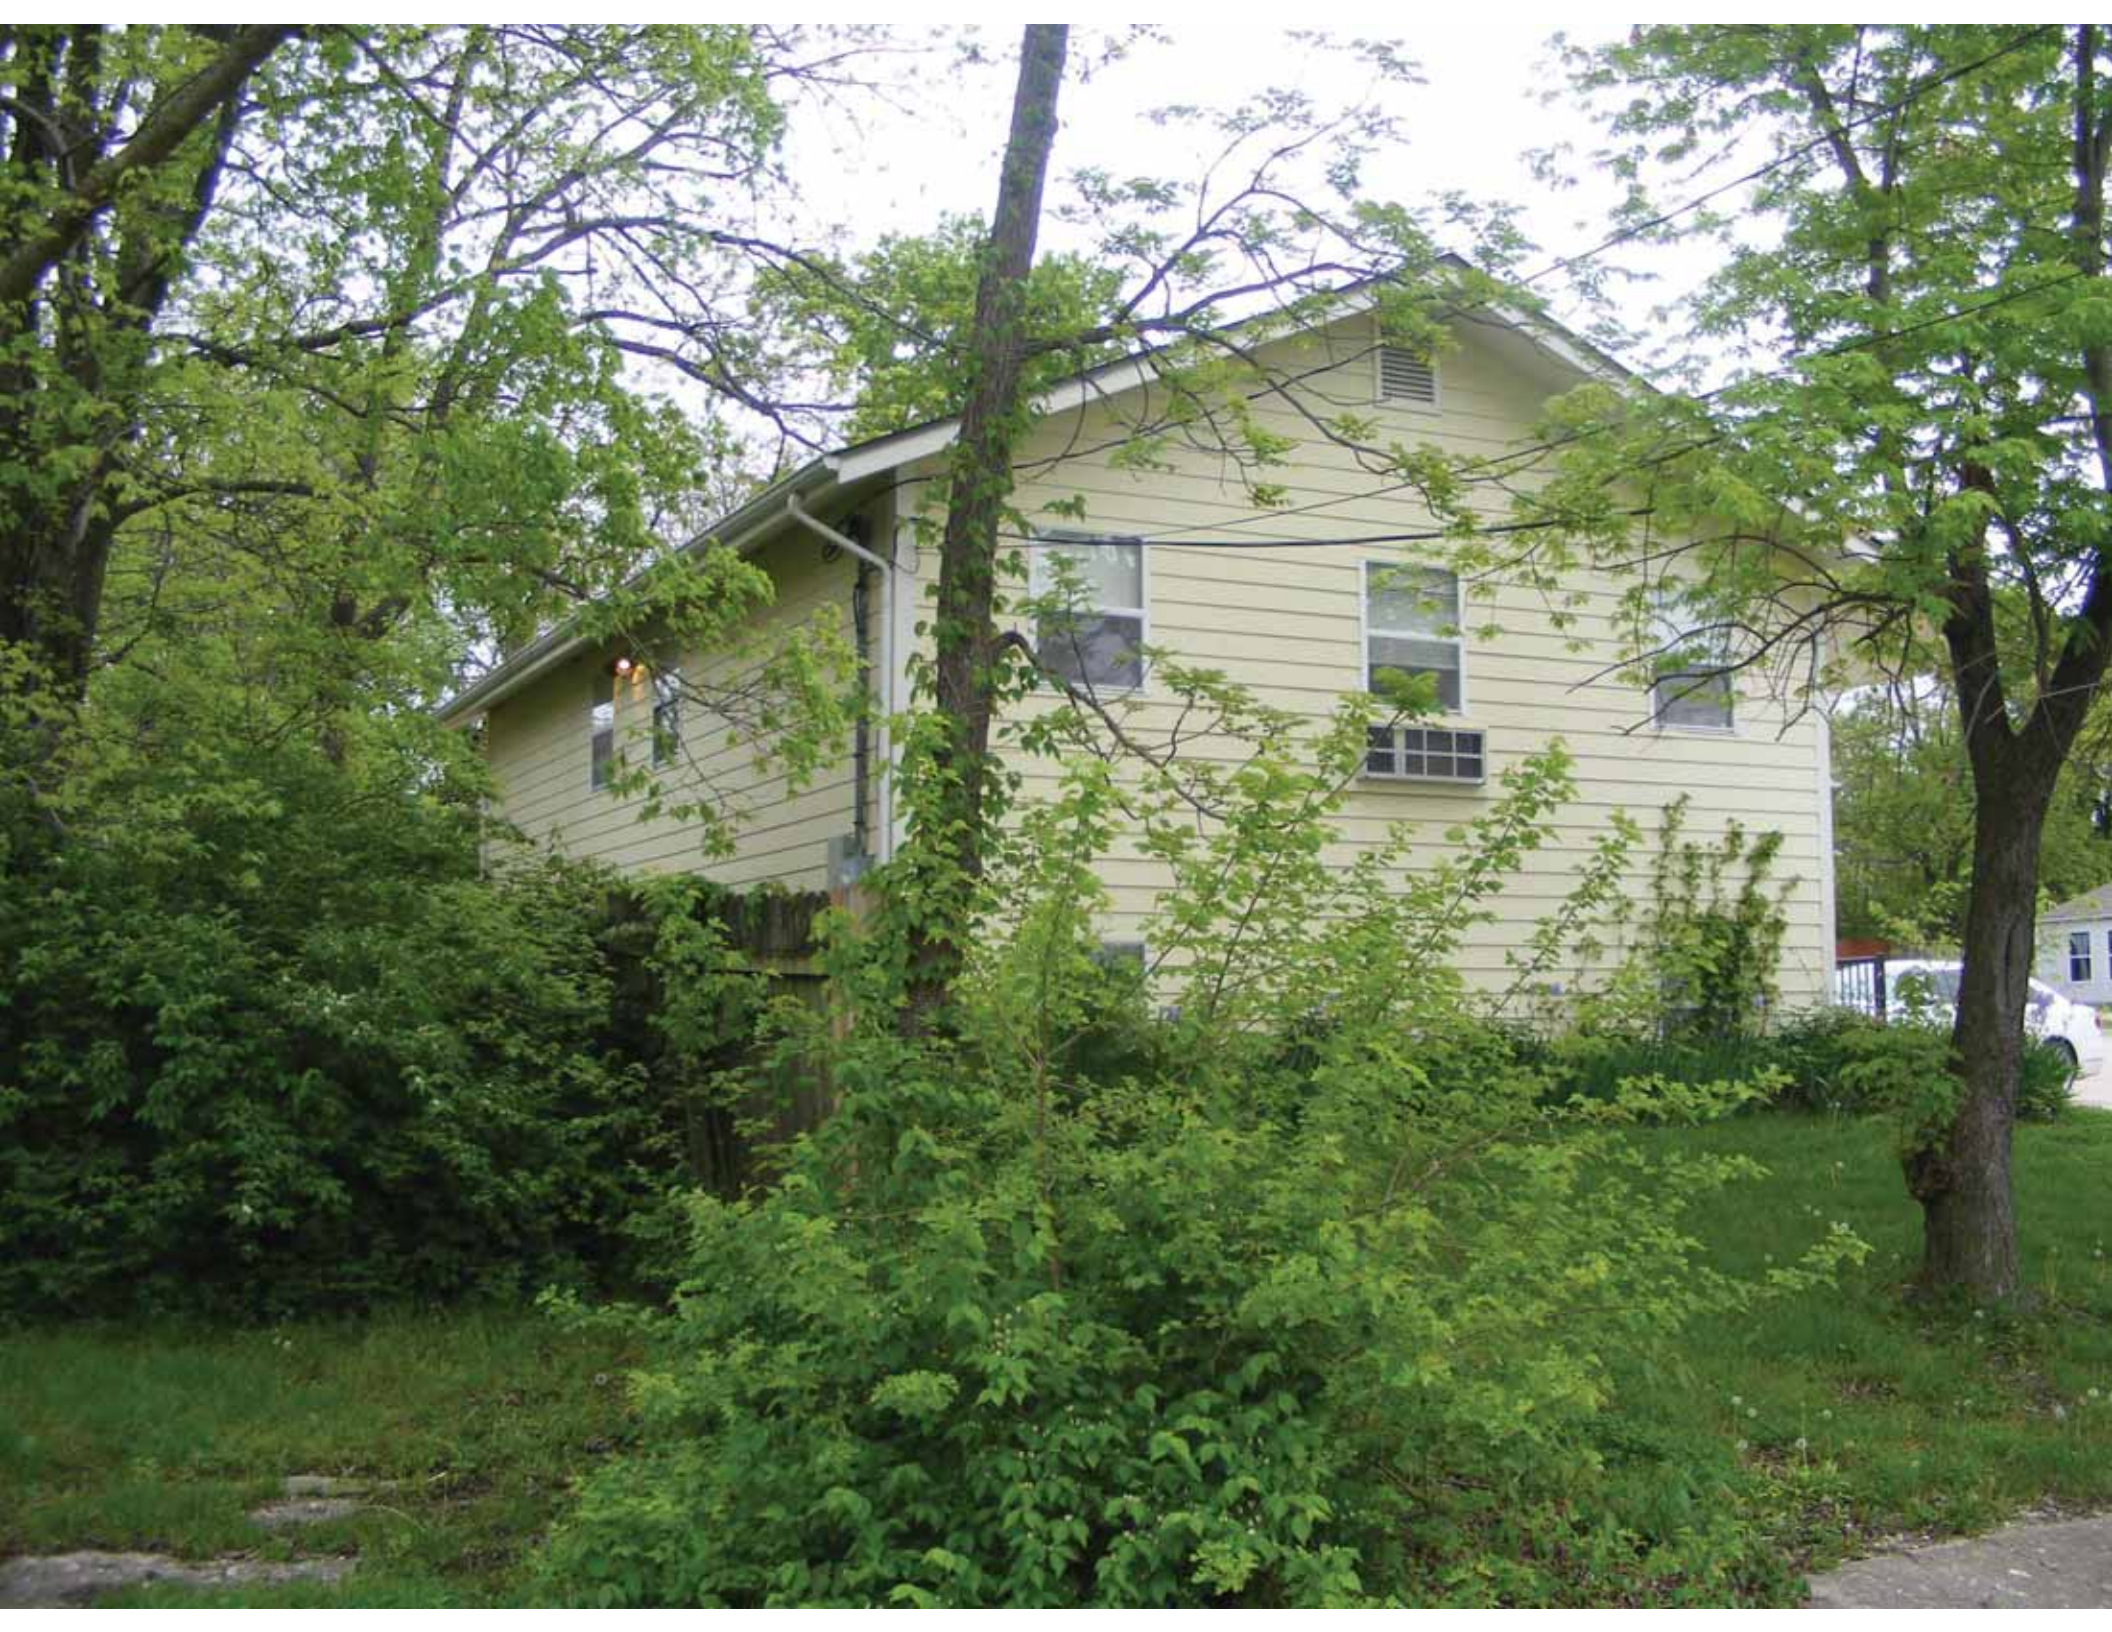
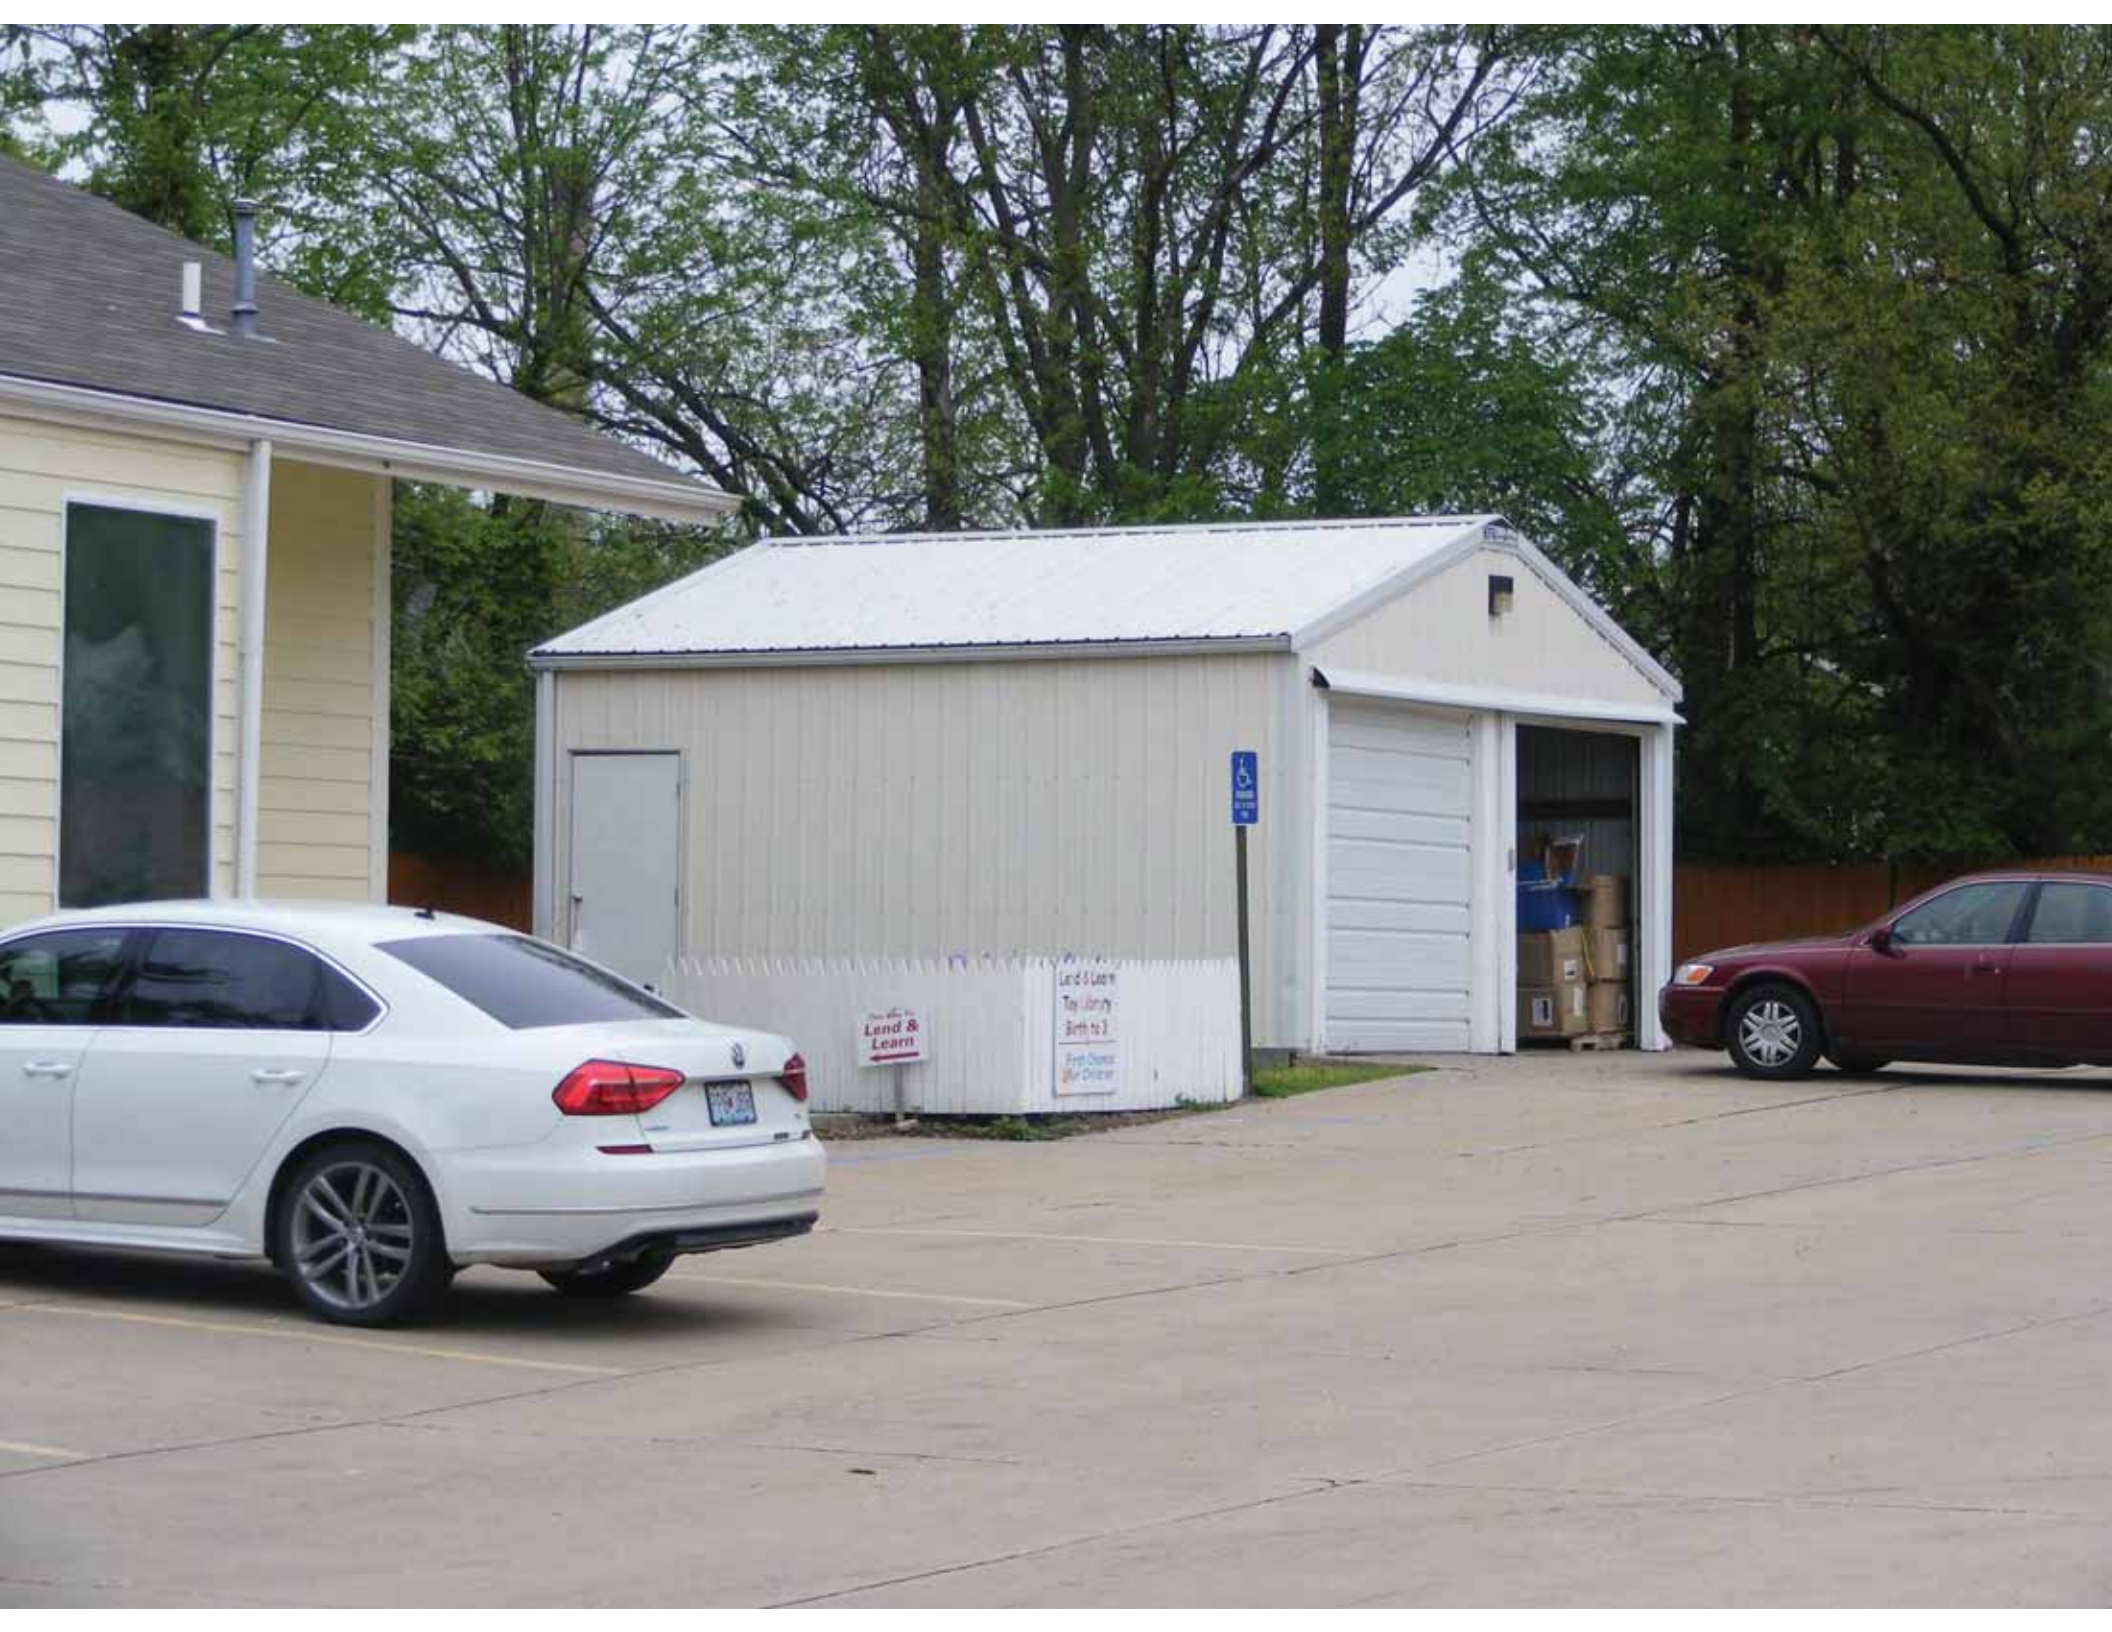
41. (cont.) Description of primary resource. Expand box as necessary, or add continuation pages.
The building is one story vinyl clad, asphalt-shingled side gable with a basement and concrete foundation. The façade holds a projecting enclosed wing under the main roof with two tall narrow fixed windows over paired square fixed windows. The concrete stoop entrance with iron railing is located on the left elevation side of the wing and holds a metal/glass door with a trapezoidal transom. The left elevation holds one-over-one windows and a wall unit air conditioning unit.
