MISSOURI DEPARTMENT OF NATURAL RESOURCES
STATE HISTORIC PRESERVATION OFFICE, P.O. Box 176, Jefferson City, MO 65102
ARCHITECTURAL/HISTORIC INVENTORY FORM

1. Survey No. BO-AS-011-0087		2. Survey name: North Central Columbia Survey Phase II	
3. County: Boone		4. Address (Street No.) 902	Street (name) N. Seventh Street
5. City: Columbia	Vicinity: <input type="checkbox"/>	6. Geographical Reference:	7. Township/Range/Section: T: R: S:
8. Historic name (if known):		9. Present/other name (if known):	
10. Ownership: <input checked="" type="checkbox"/> Private <input type="checkbox"/> Public		11a. Historic use (if known): Domestic/single dwelling	11b. Current use: Domestic/single dwelling

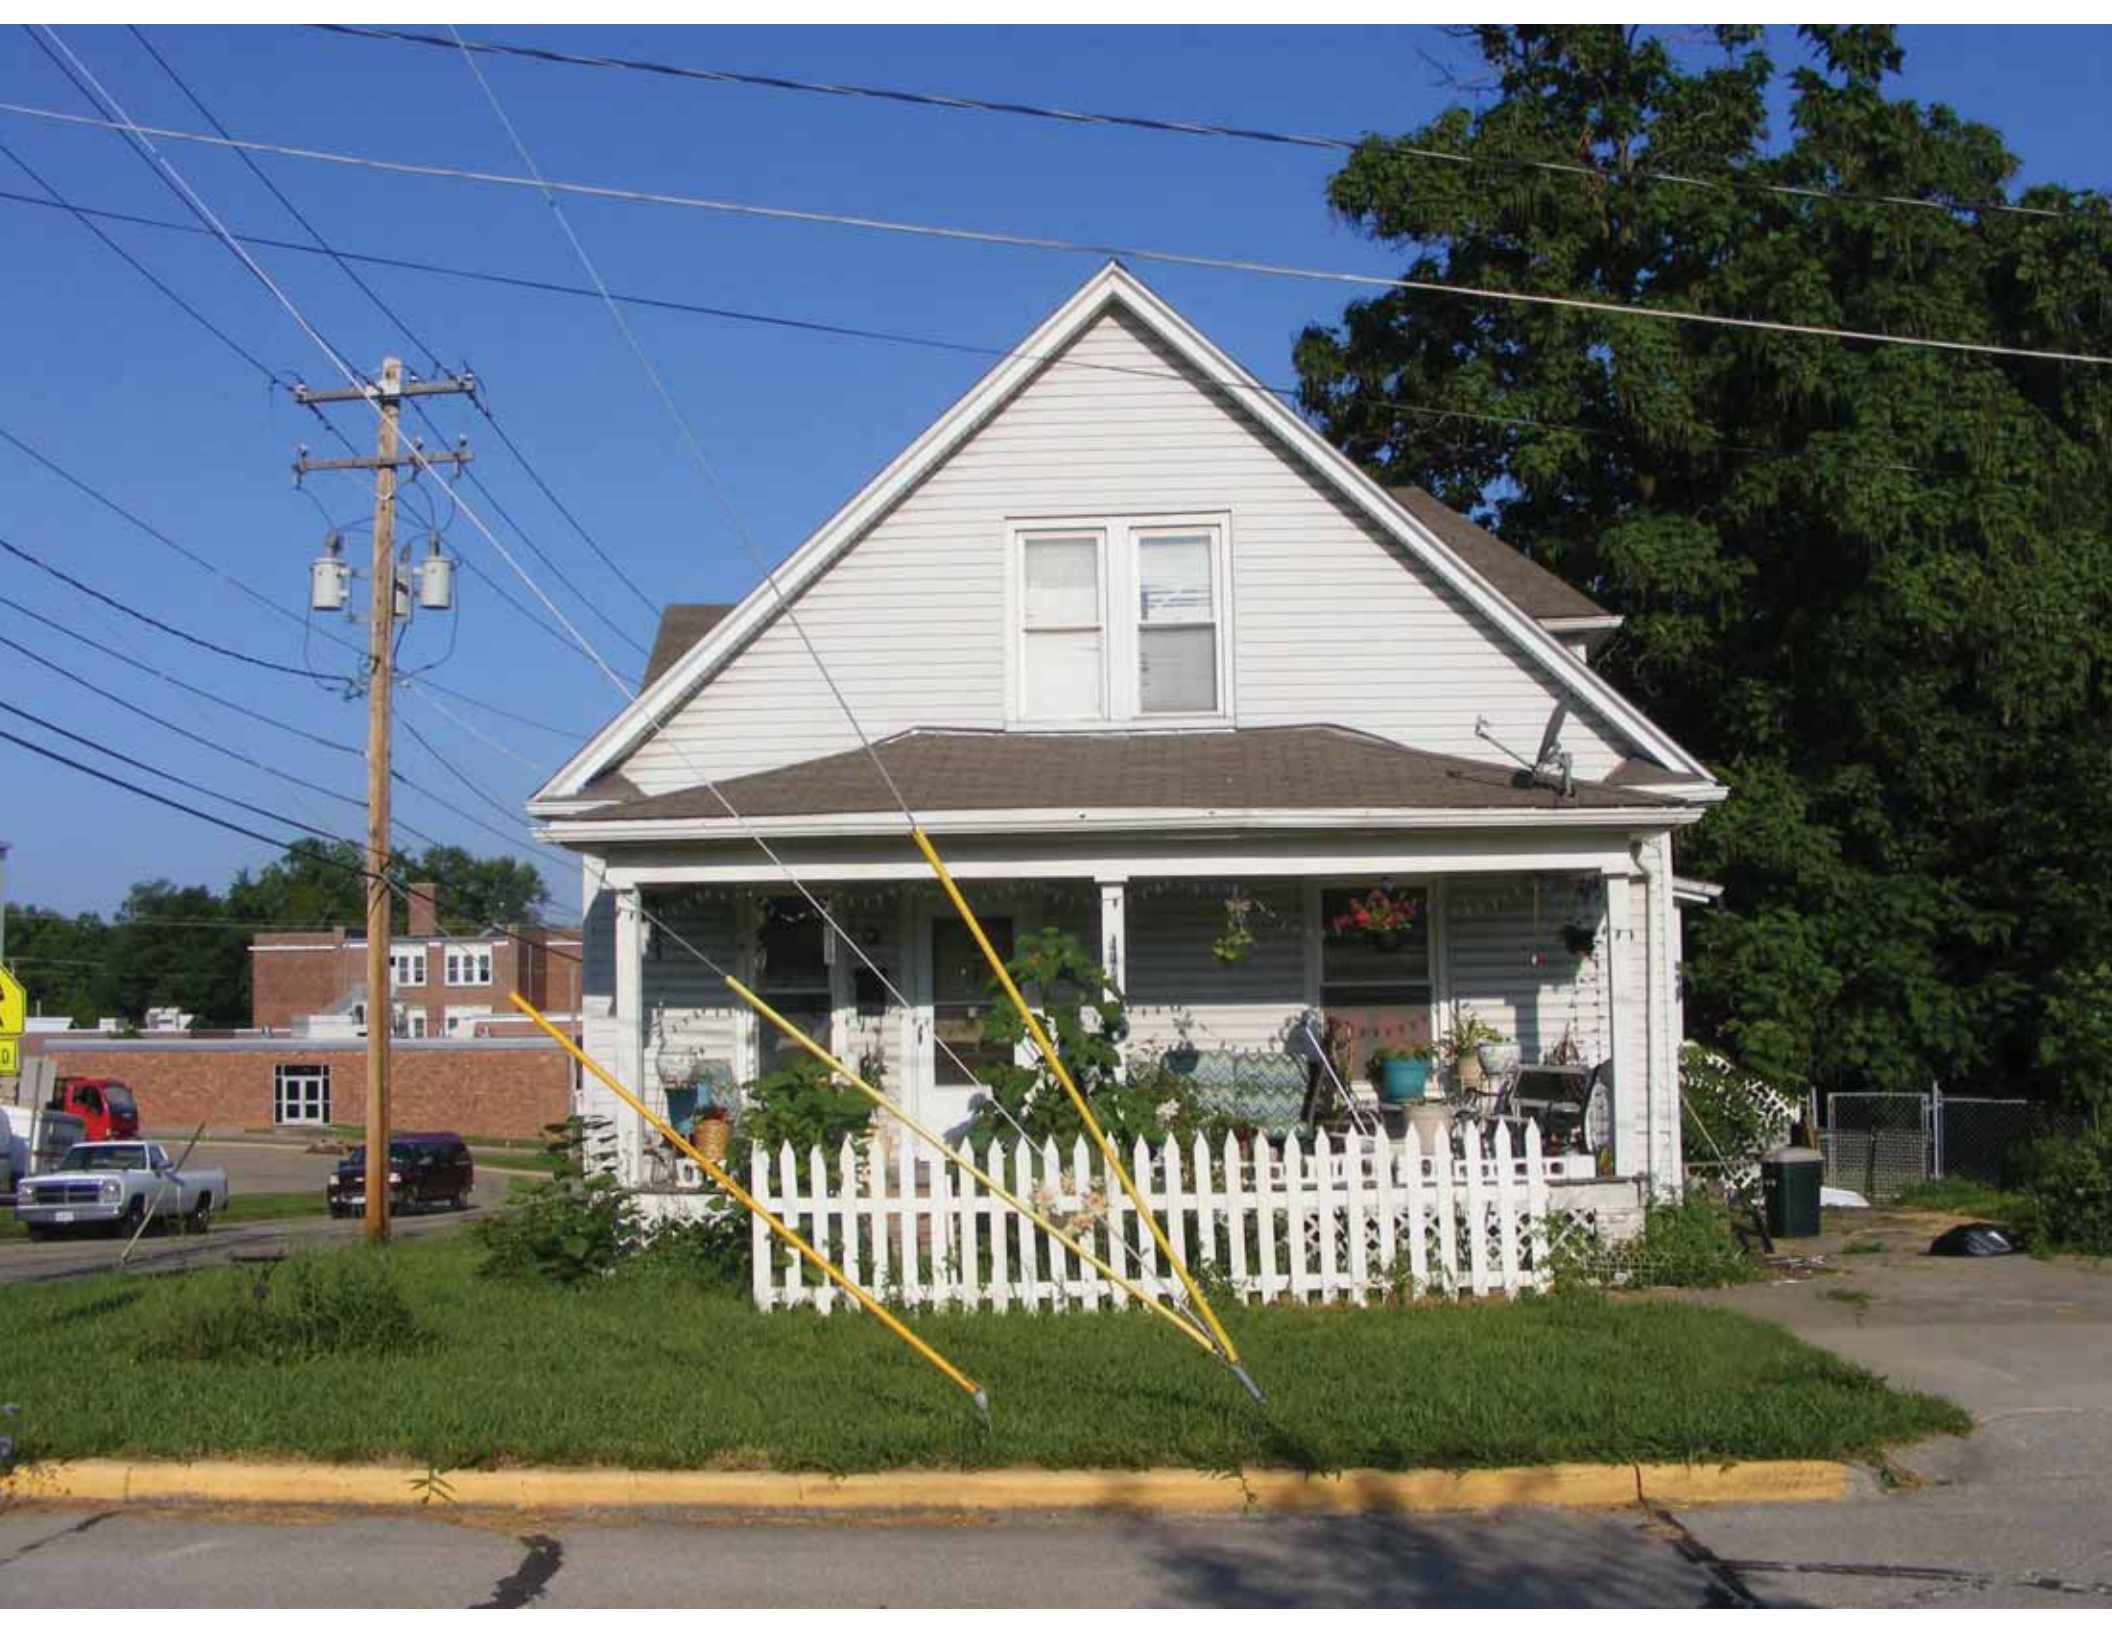
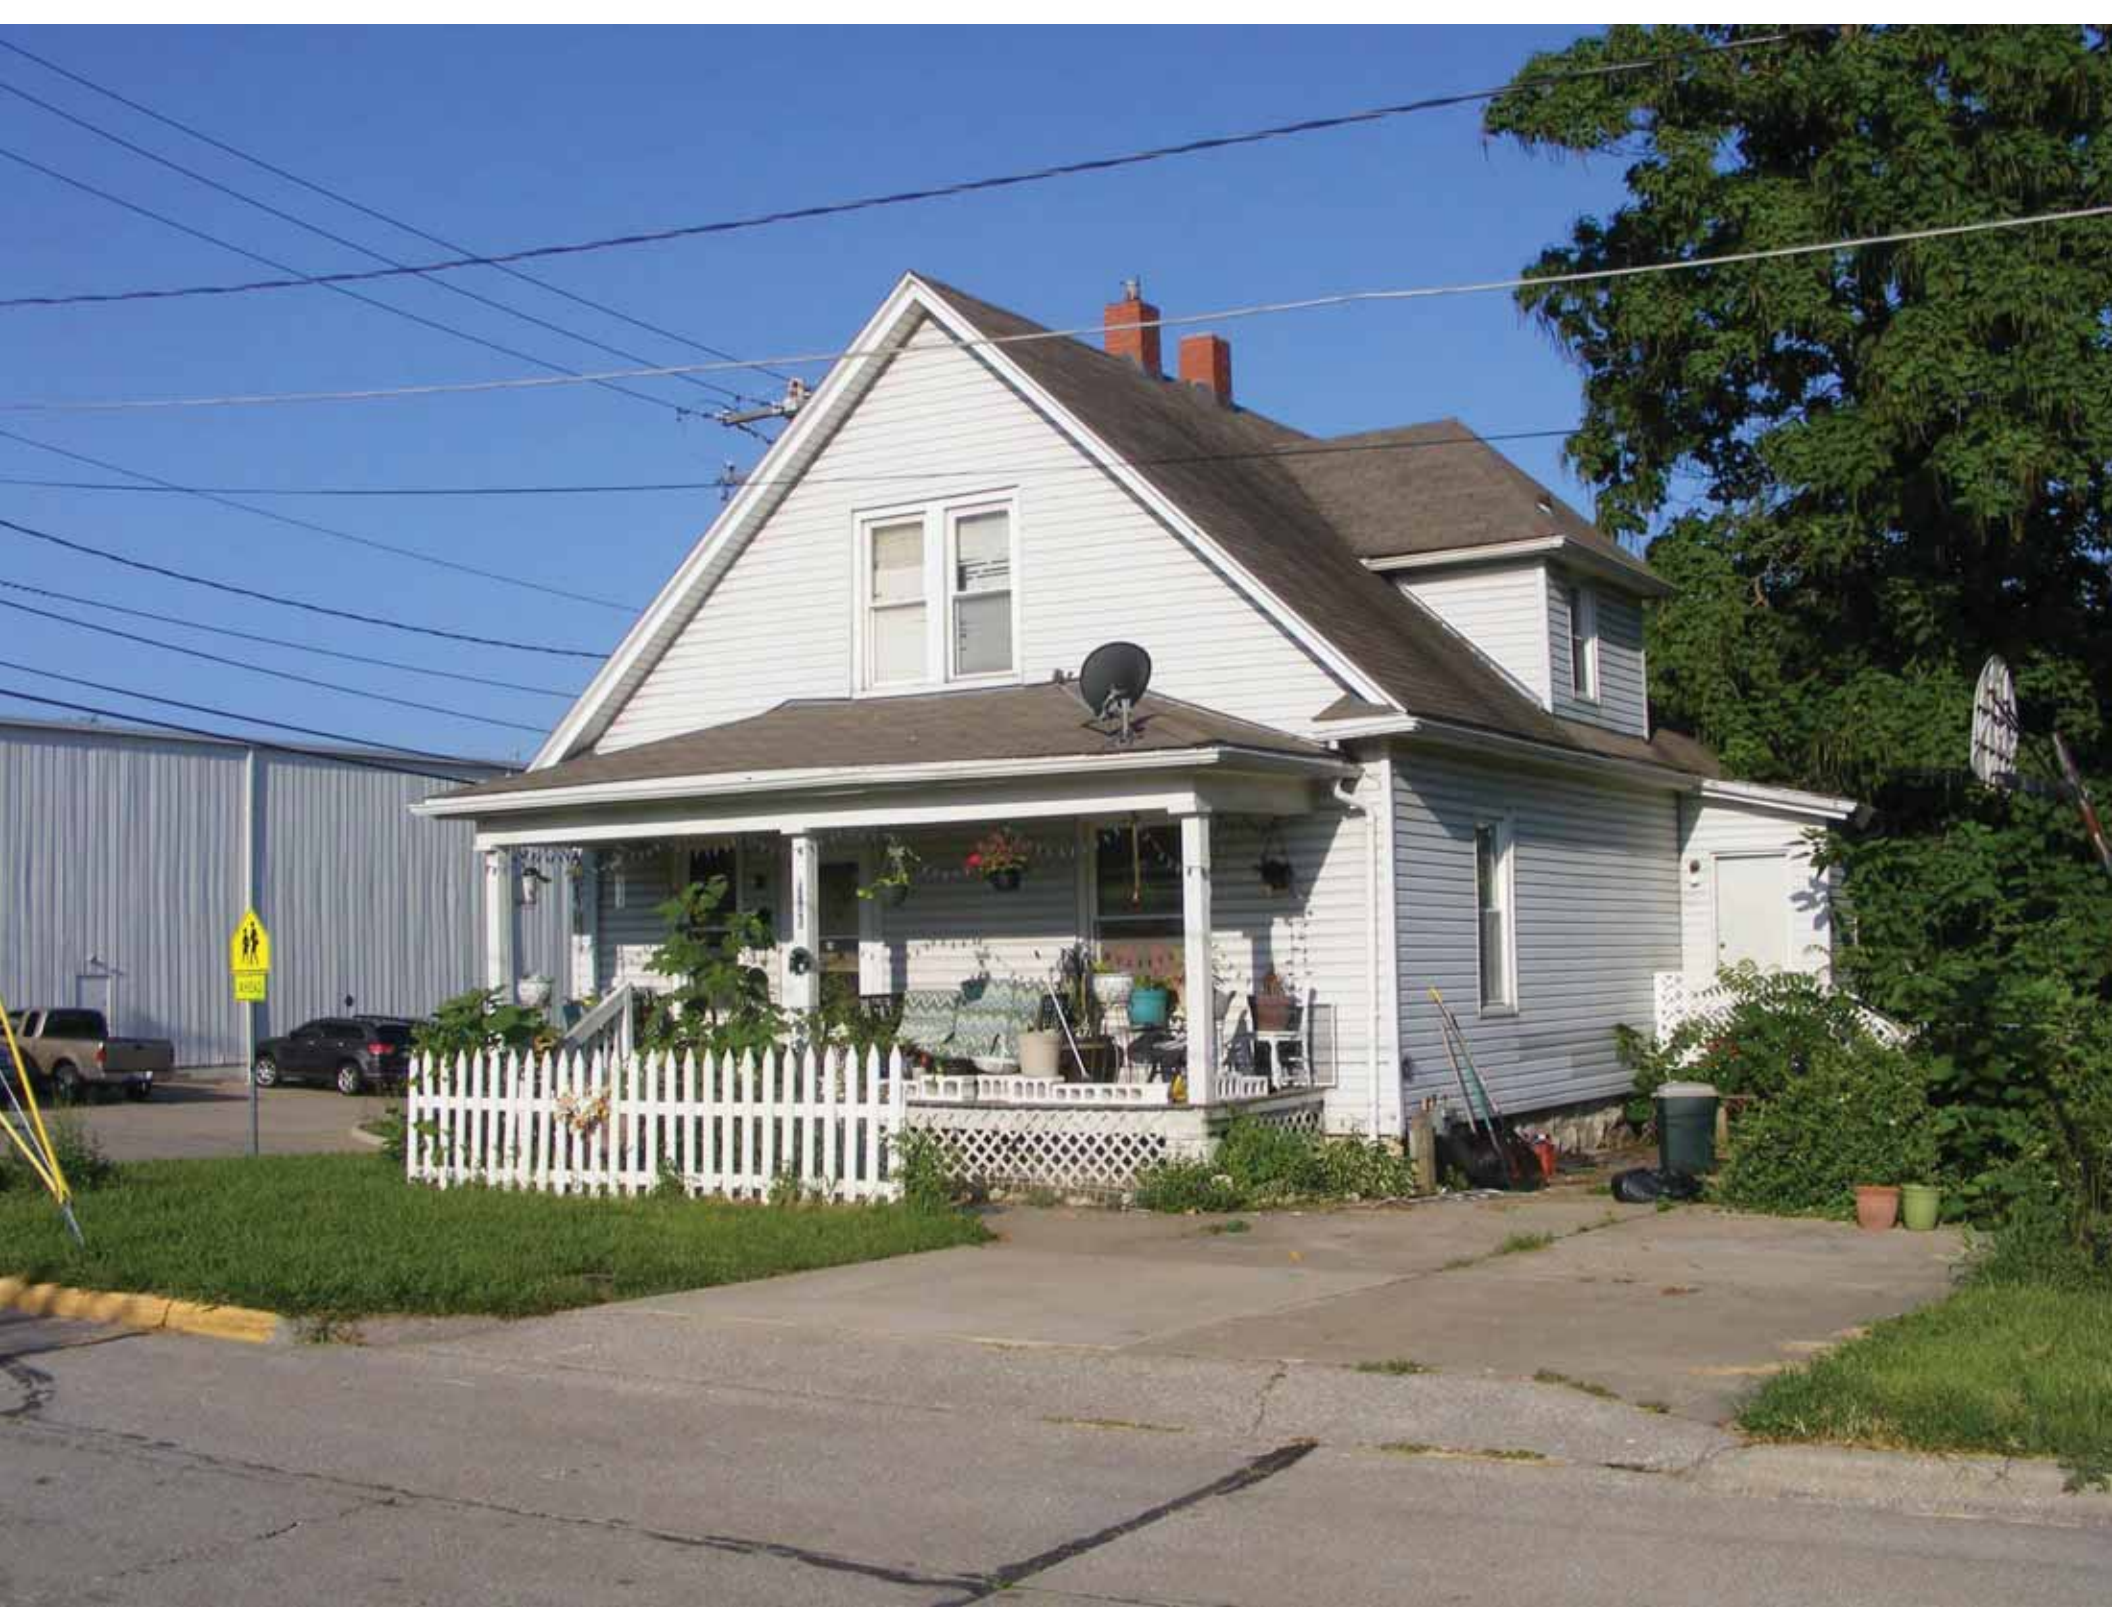
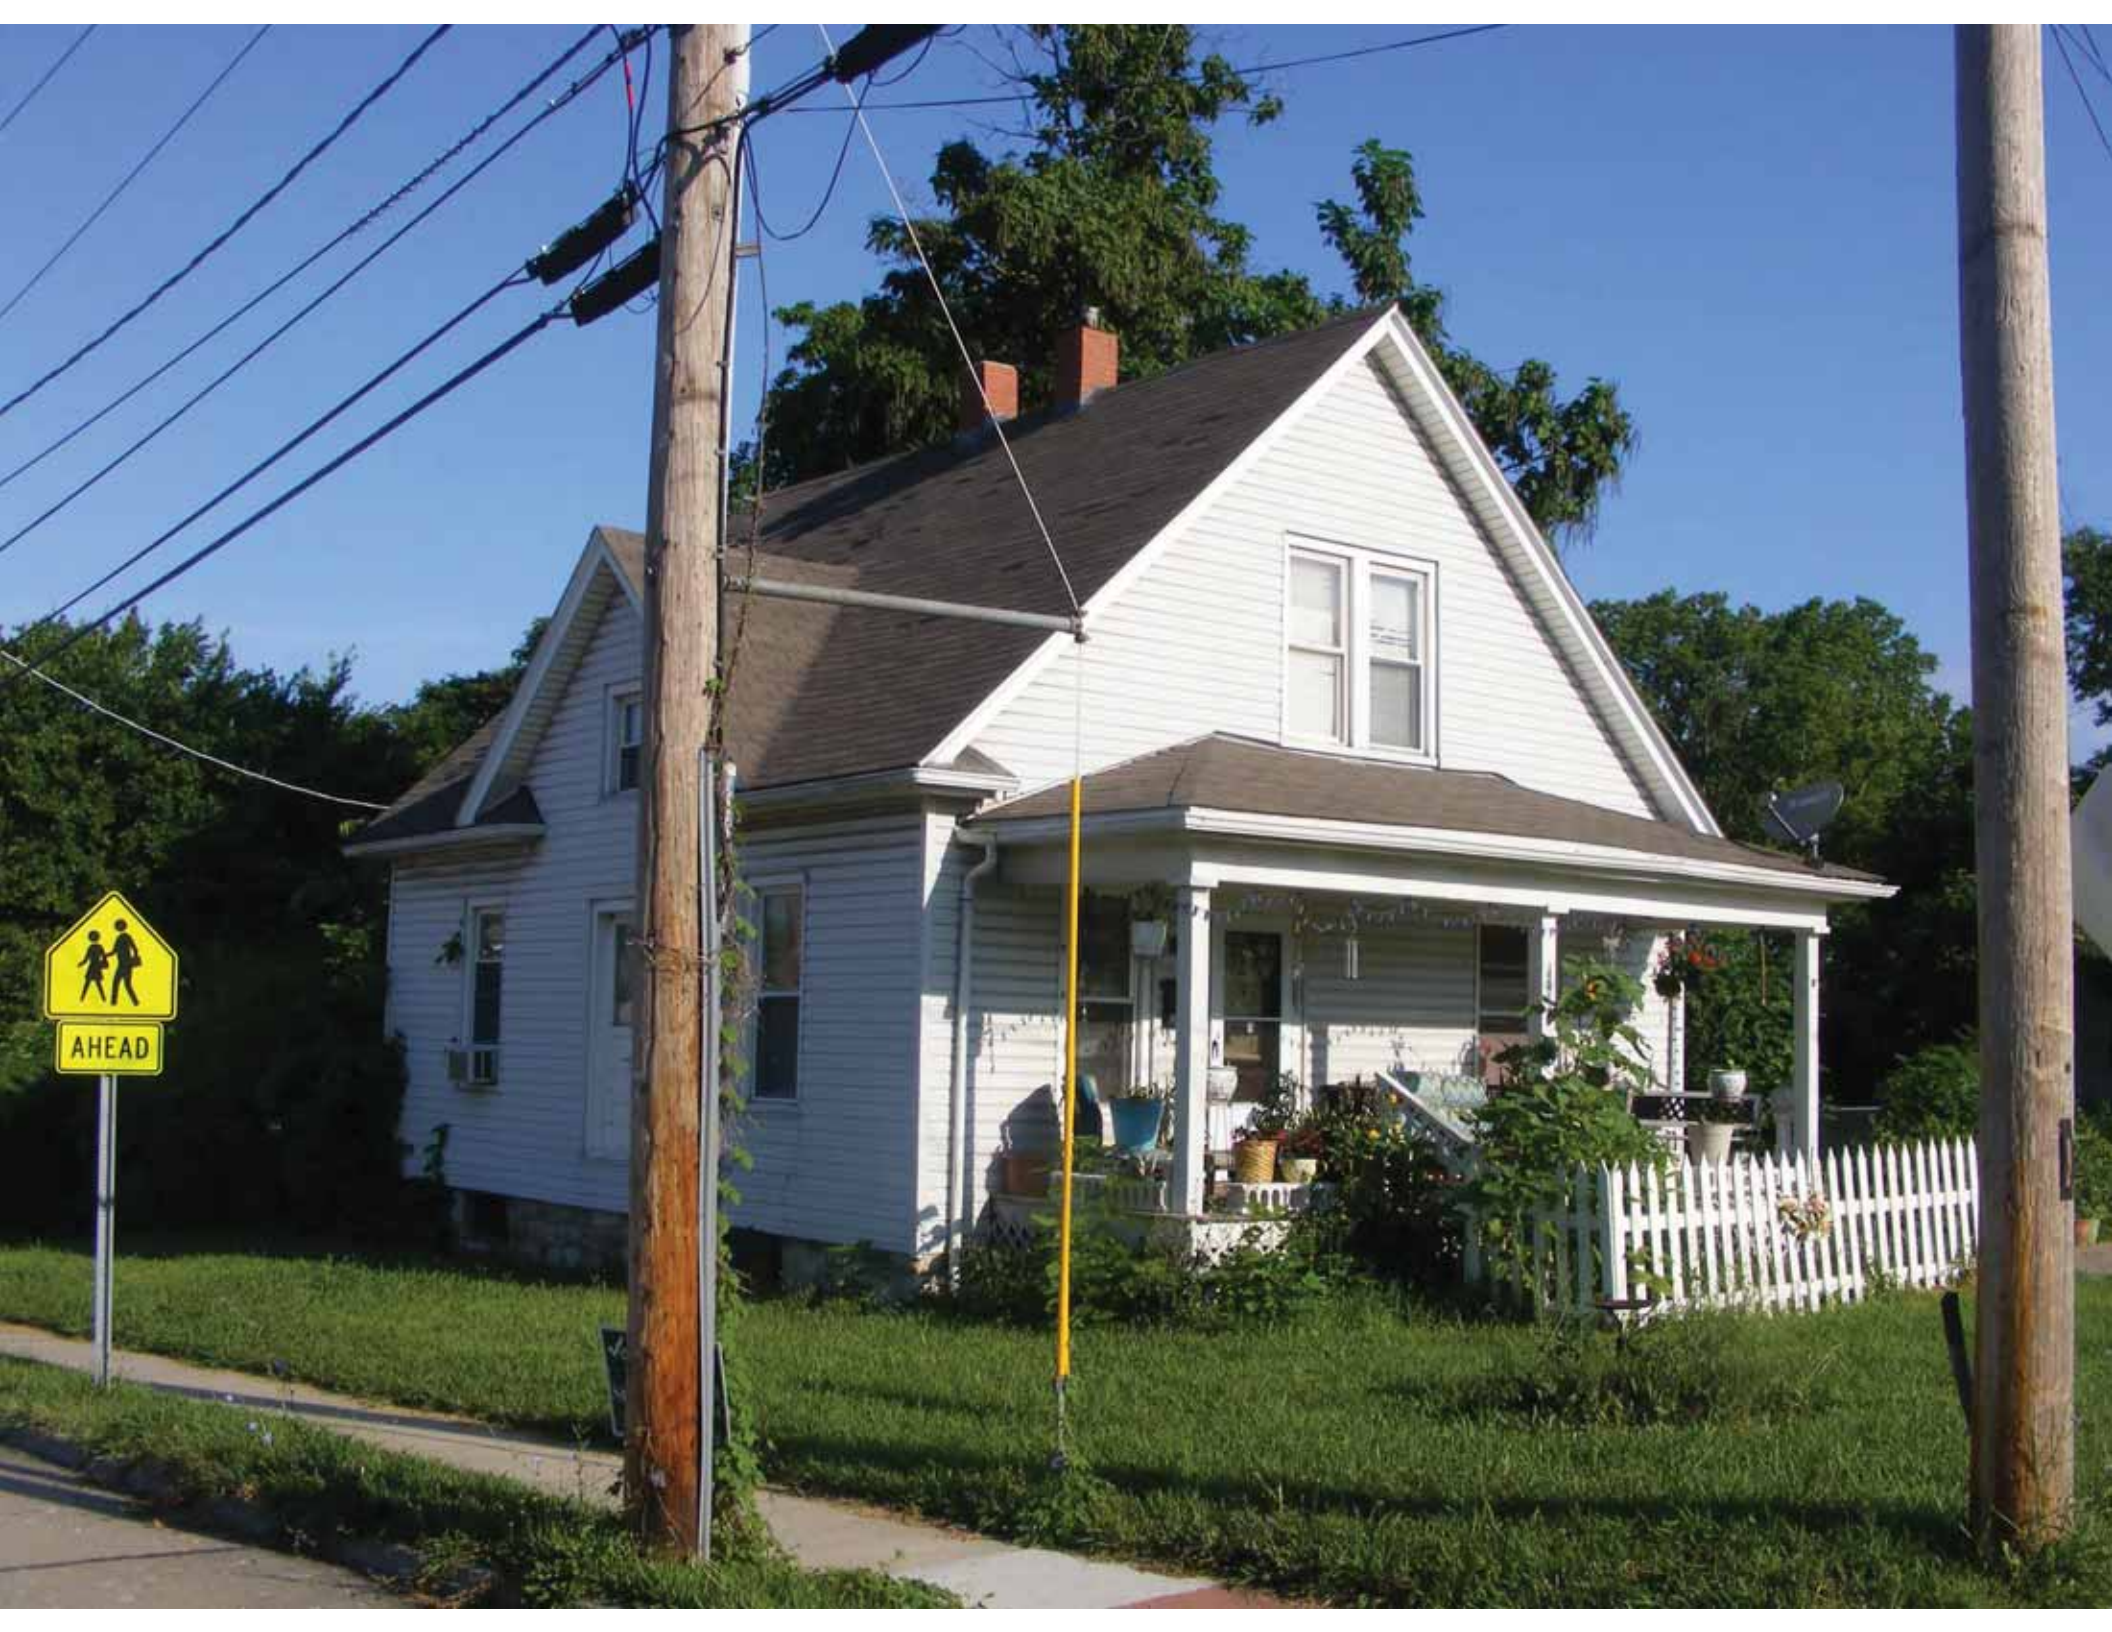
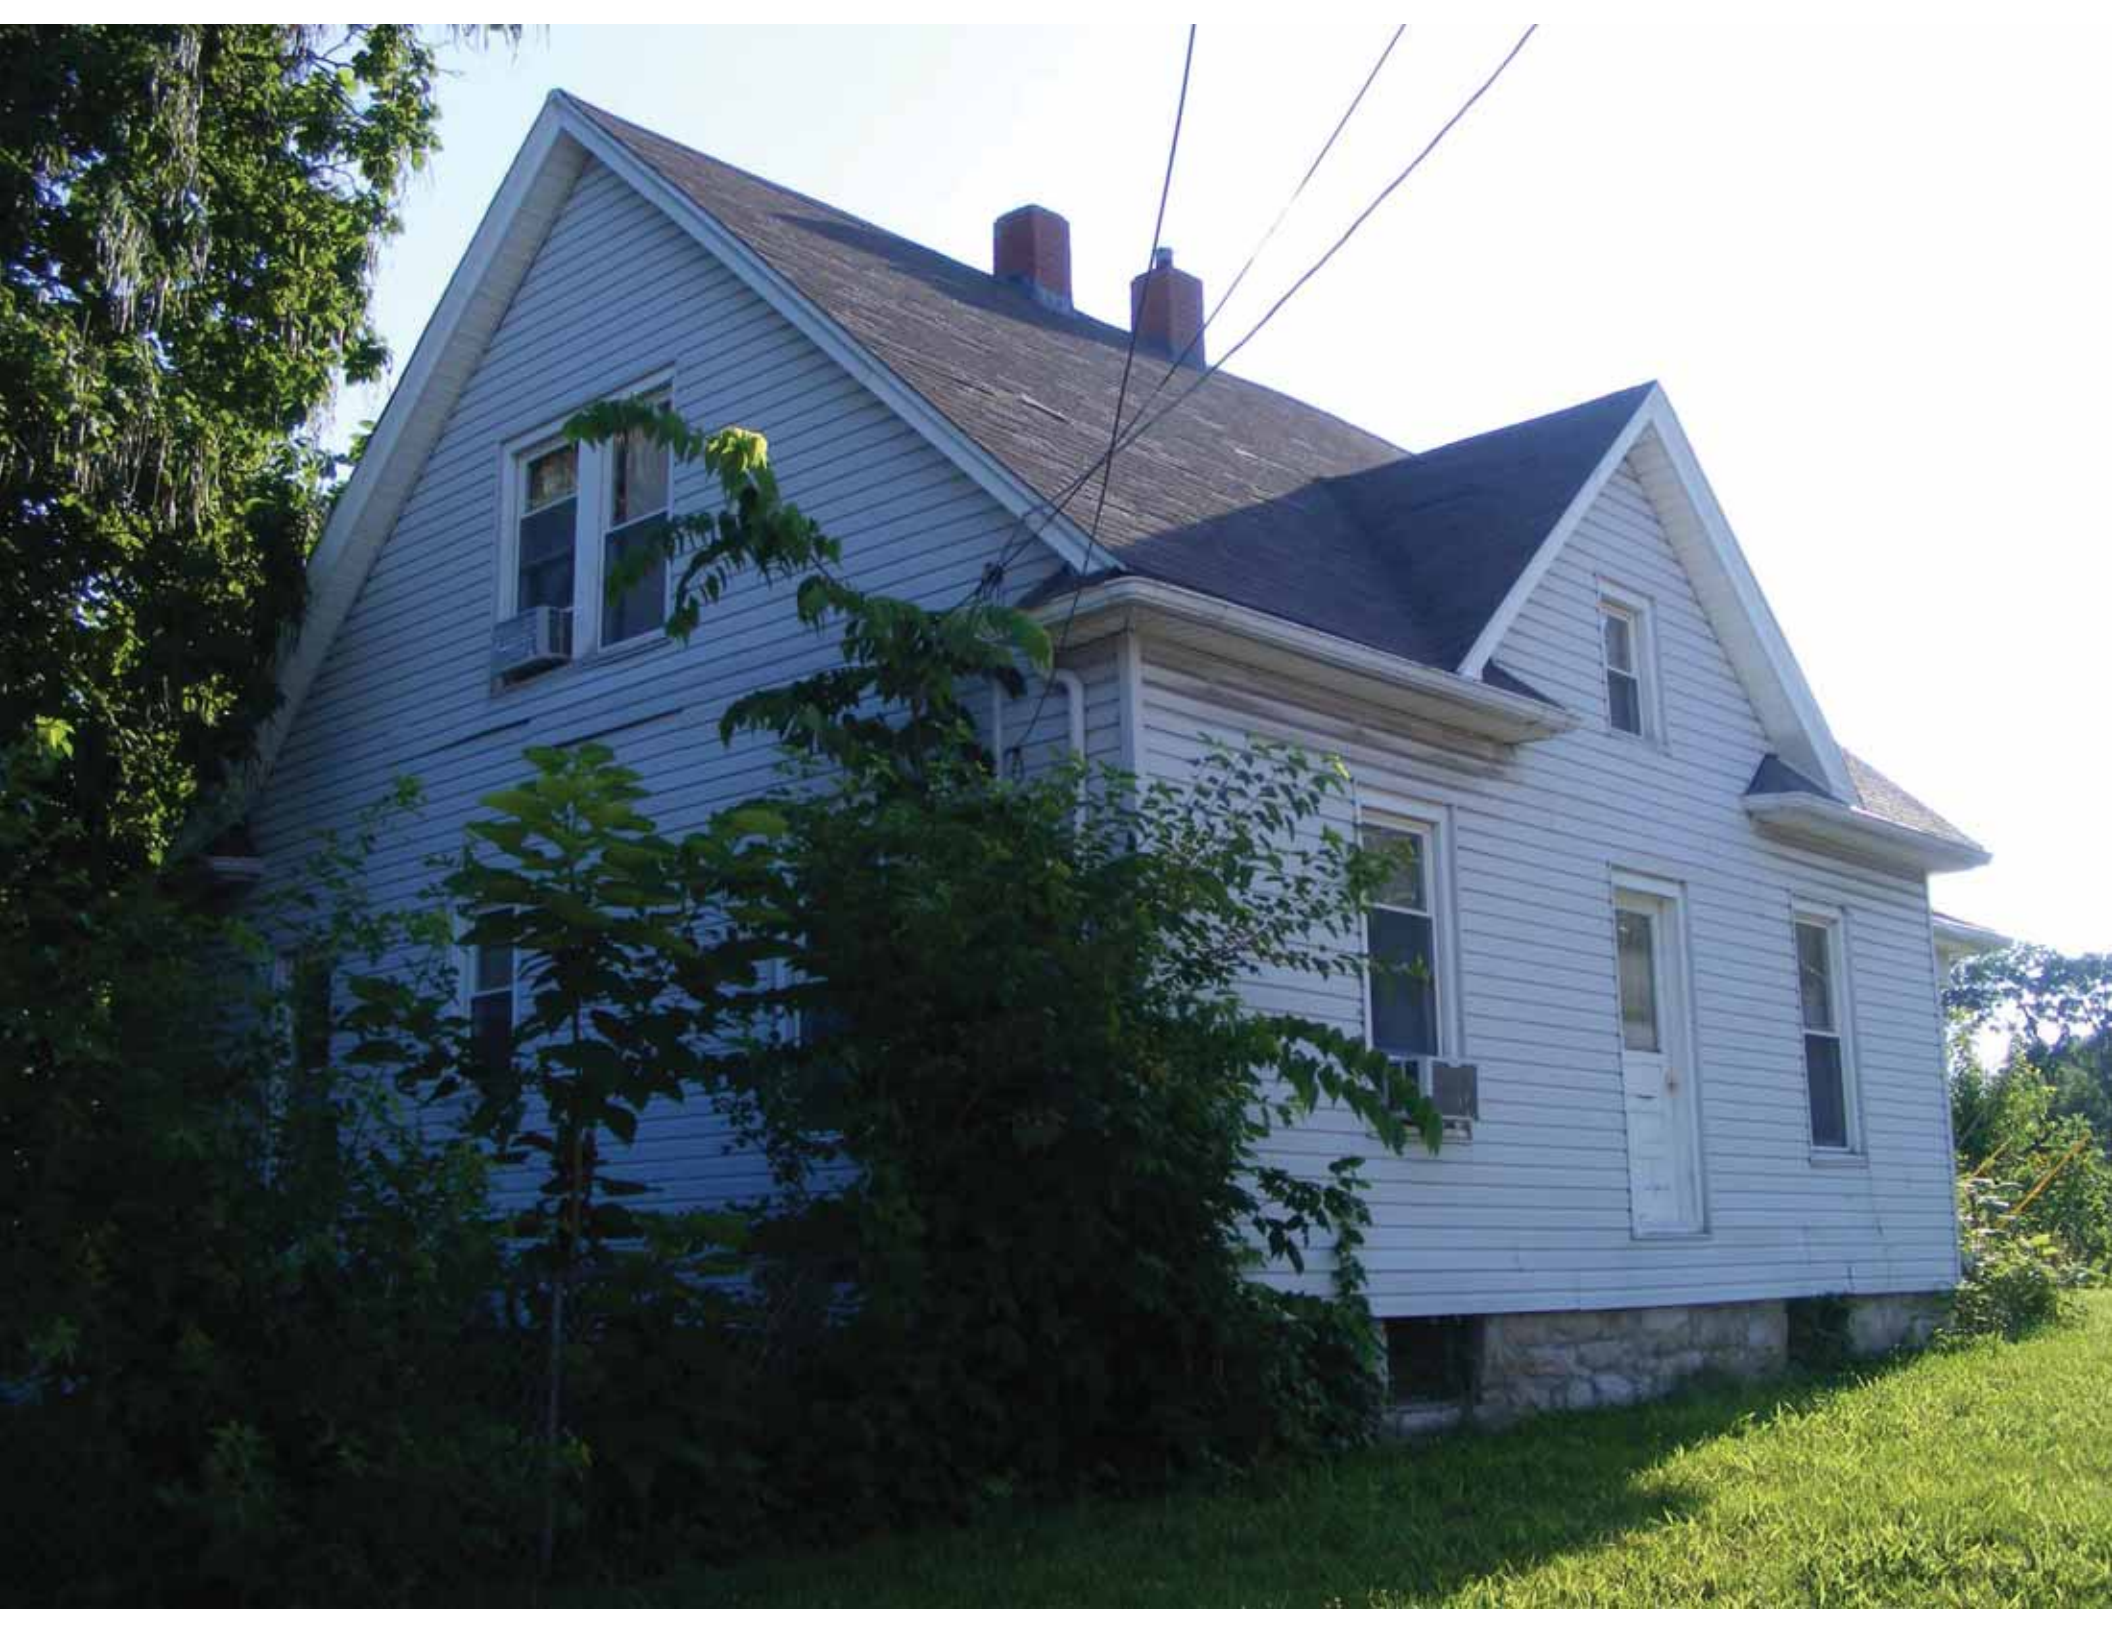
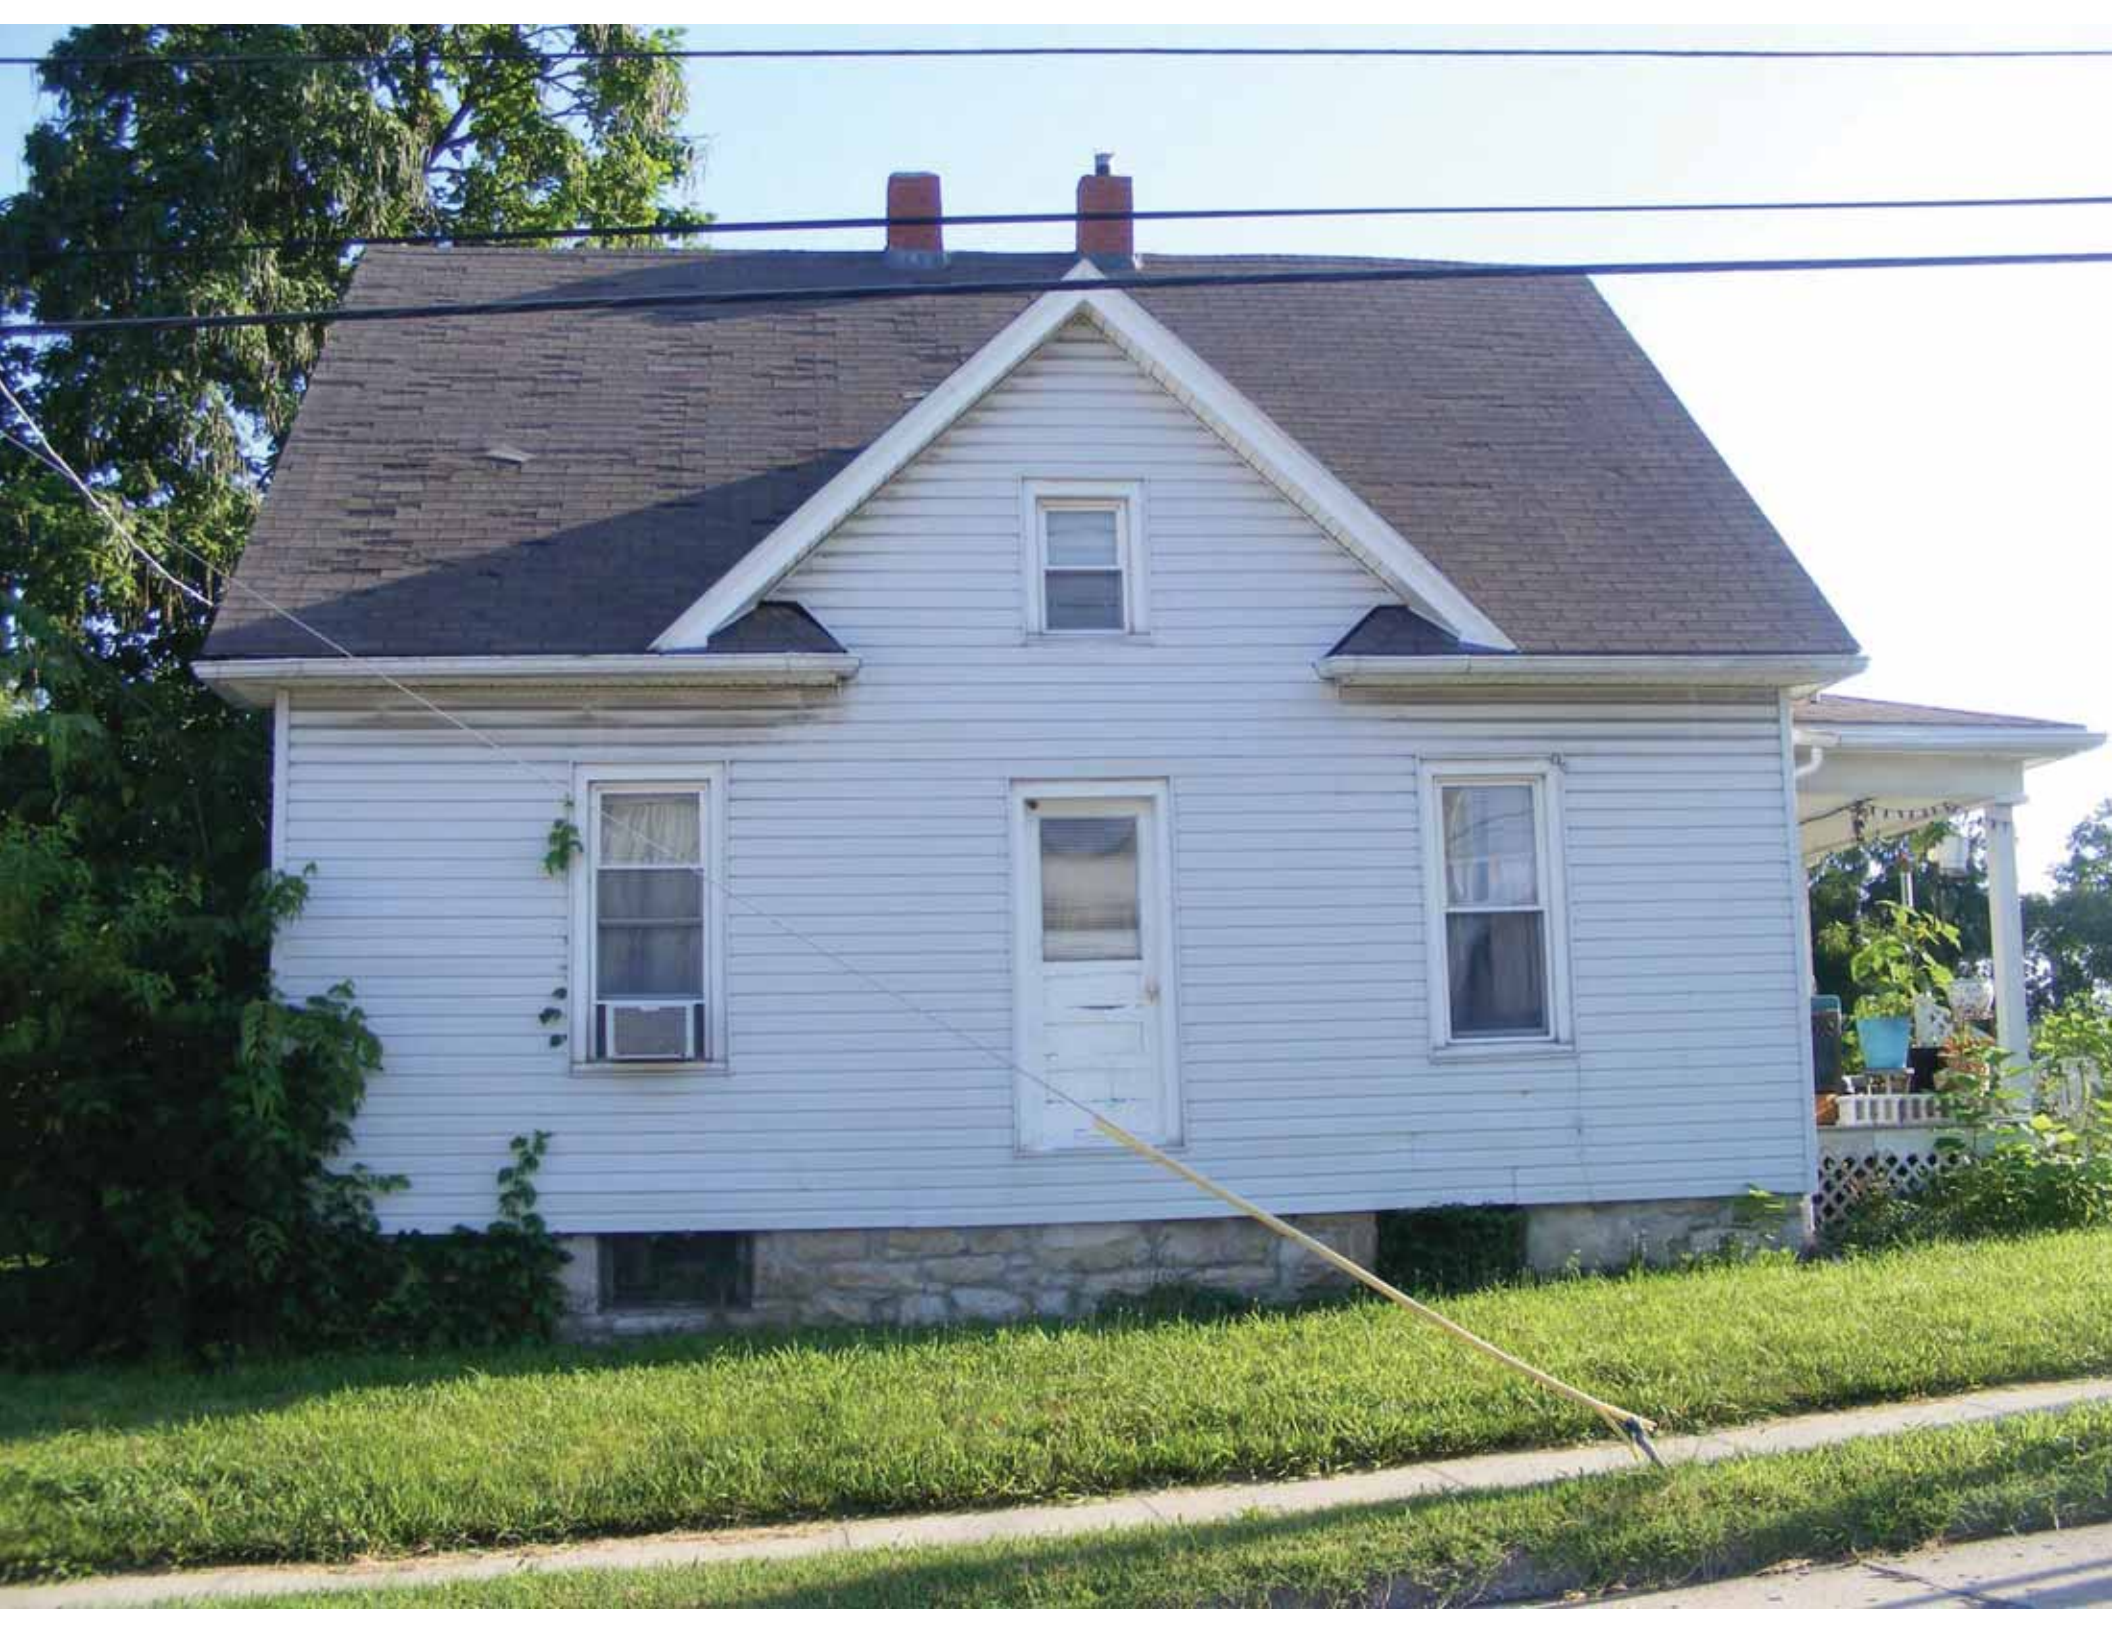
41. (cont.) Description of primary resource. Expand box as necessary, or add continuation pages.
A 1.5 story vinyl clad dwelling with a steeply pitched asphalt-shingled front gable to centered gable (south elevation) and a limestone block foundation. The façade holds an asphalt-shingled hipped porch (open) supported by square columns and features wood decking. Entrance is off-centered and flanked by one-over-one windows; gable end holds a paired one-over-one window. The north elevation holds a one-over-one window. At the west corner of the north elevation is a projecting wing with an asphalt-shingled shed roof; a stoop entrance fronts Fay Street. A hipped dormer with a one-over-one windows is found on the north elevation sloping roofline. The south elevation holds a side entrance (original wood panel/glass door, no access to door) on the lower section of the centered gable and a one-over-one window in the gable end. The door is flanked by one-over-one windows.
