MISSOURI DEPARTMENT OF NATURAL RESOURCES
STATE HISTORIC PRESERVATION OFFICE, P.O. Box 176, Jefferson City, MO 65102
ARCHITECTURAL/HISTORIC INVENTORY FORM

1. Survey No. BO-AS-011-0087		2. Survey name: North Central Columbia Survey Phase II	
3. County: Boone		4. Address (Street No.) 902	Street (name) N. Seventh Street
5. City: Columbia	Vicinity: <input type="checkbox"/>	6. Geographical Reference:	7. Township/Range/Section: T: R: S:
8. Historic name (if known):		9. Present/other name (if known):	
10. Ownership: <input checked="" type="checkbox"/> Private <input type="checkbox"/> Public		11a. Historic use (if known): Domestic/single dwelling	11b. Current use: Domestic/single dwelling

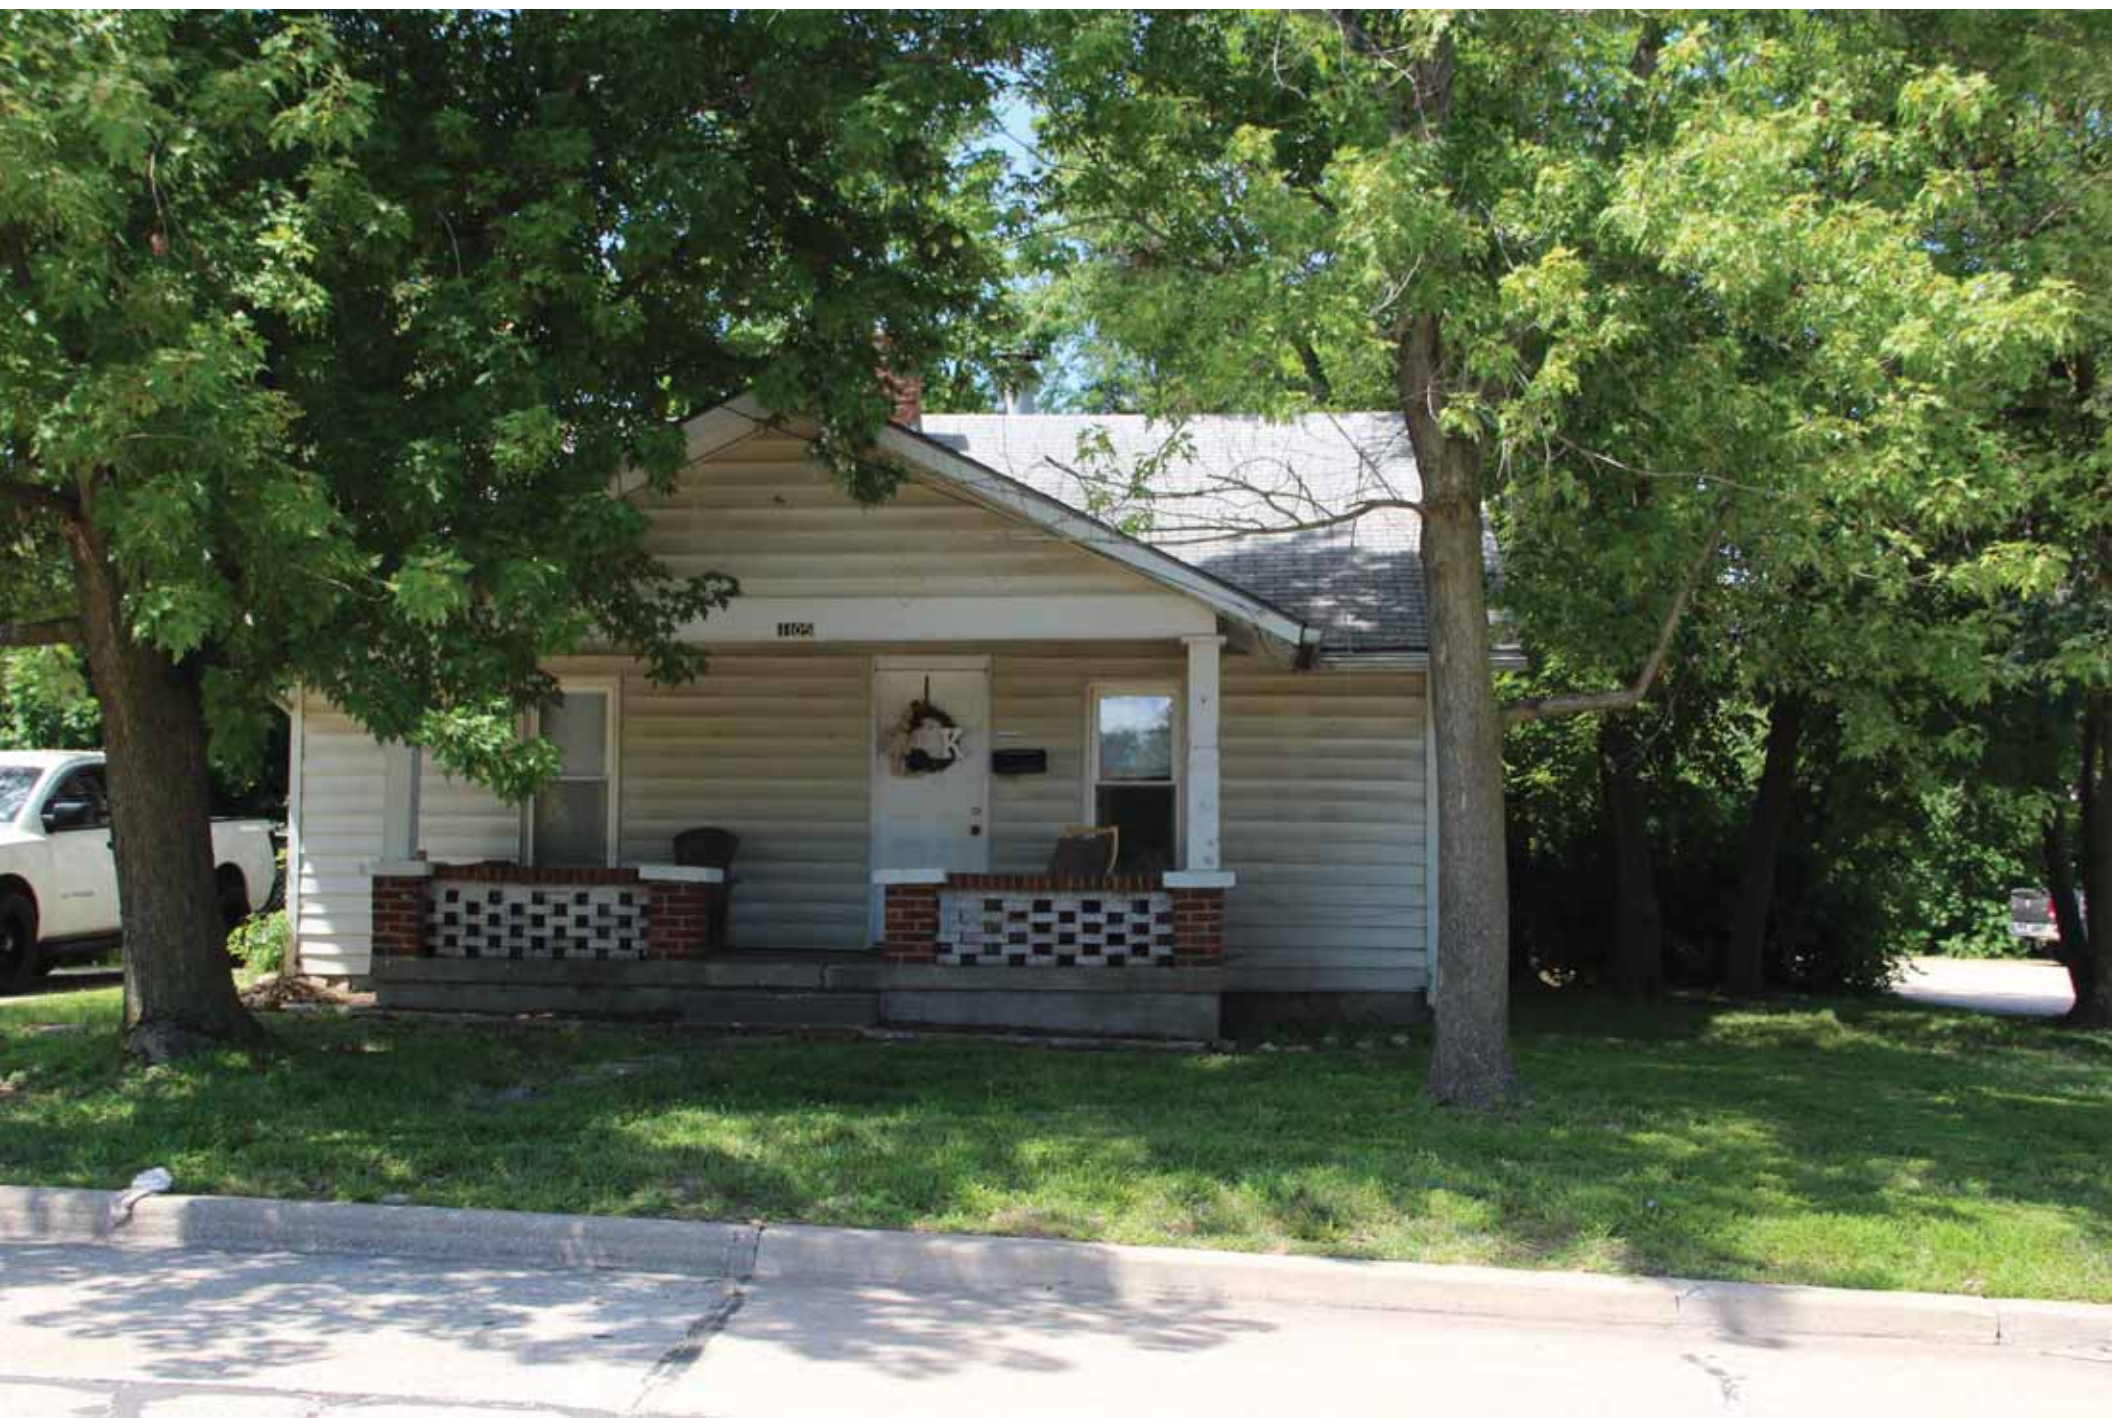
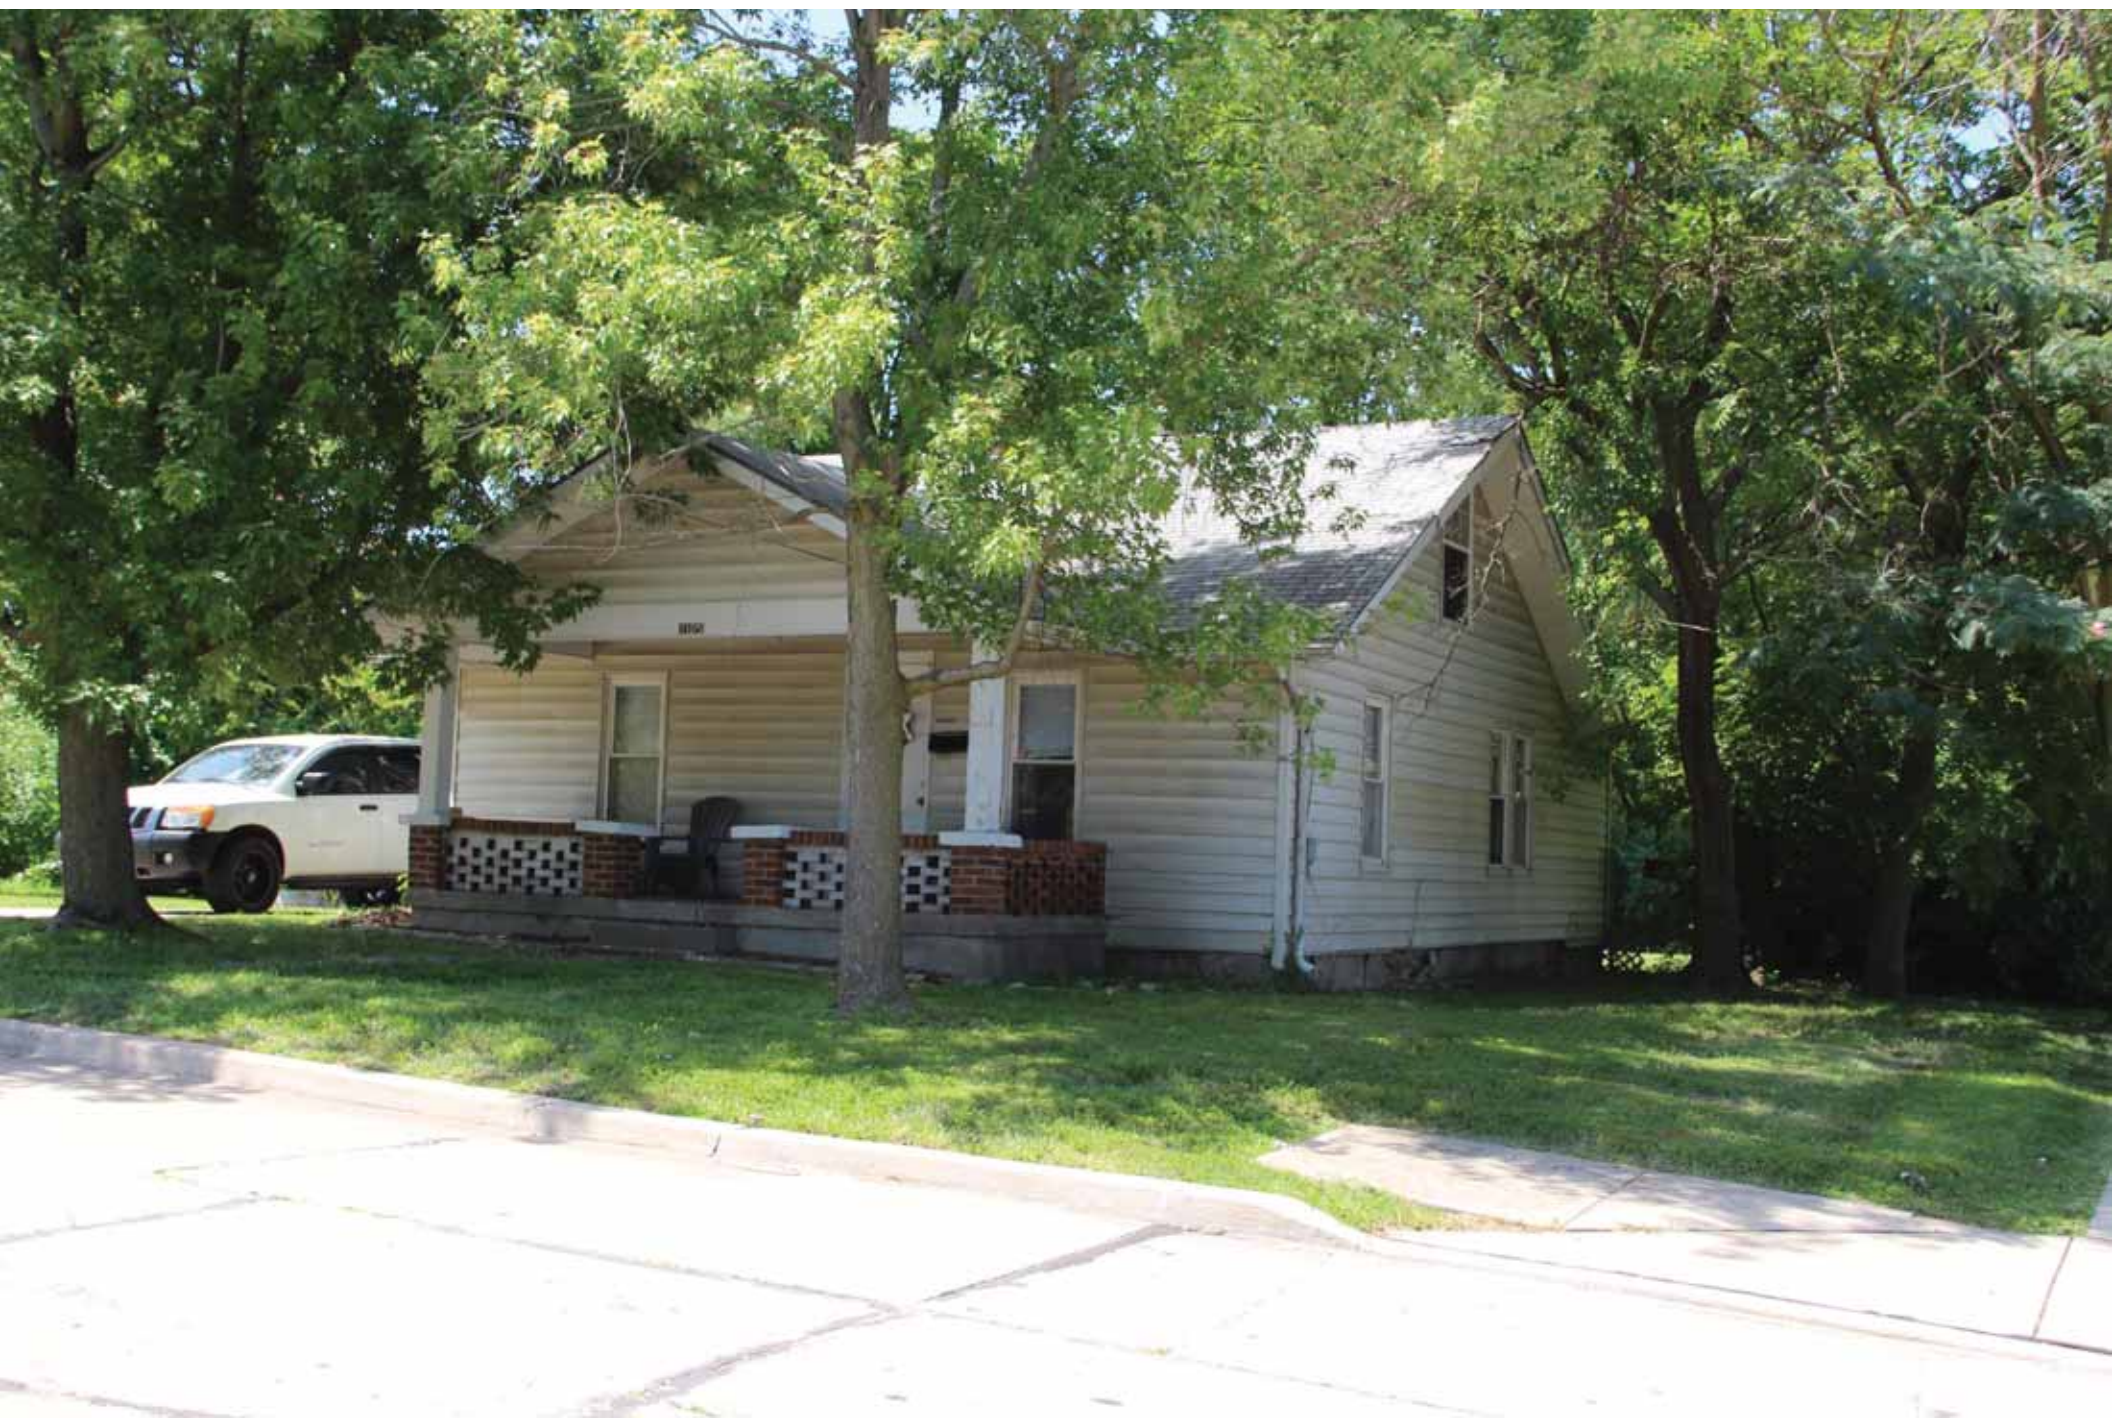
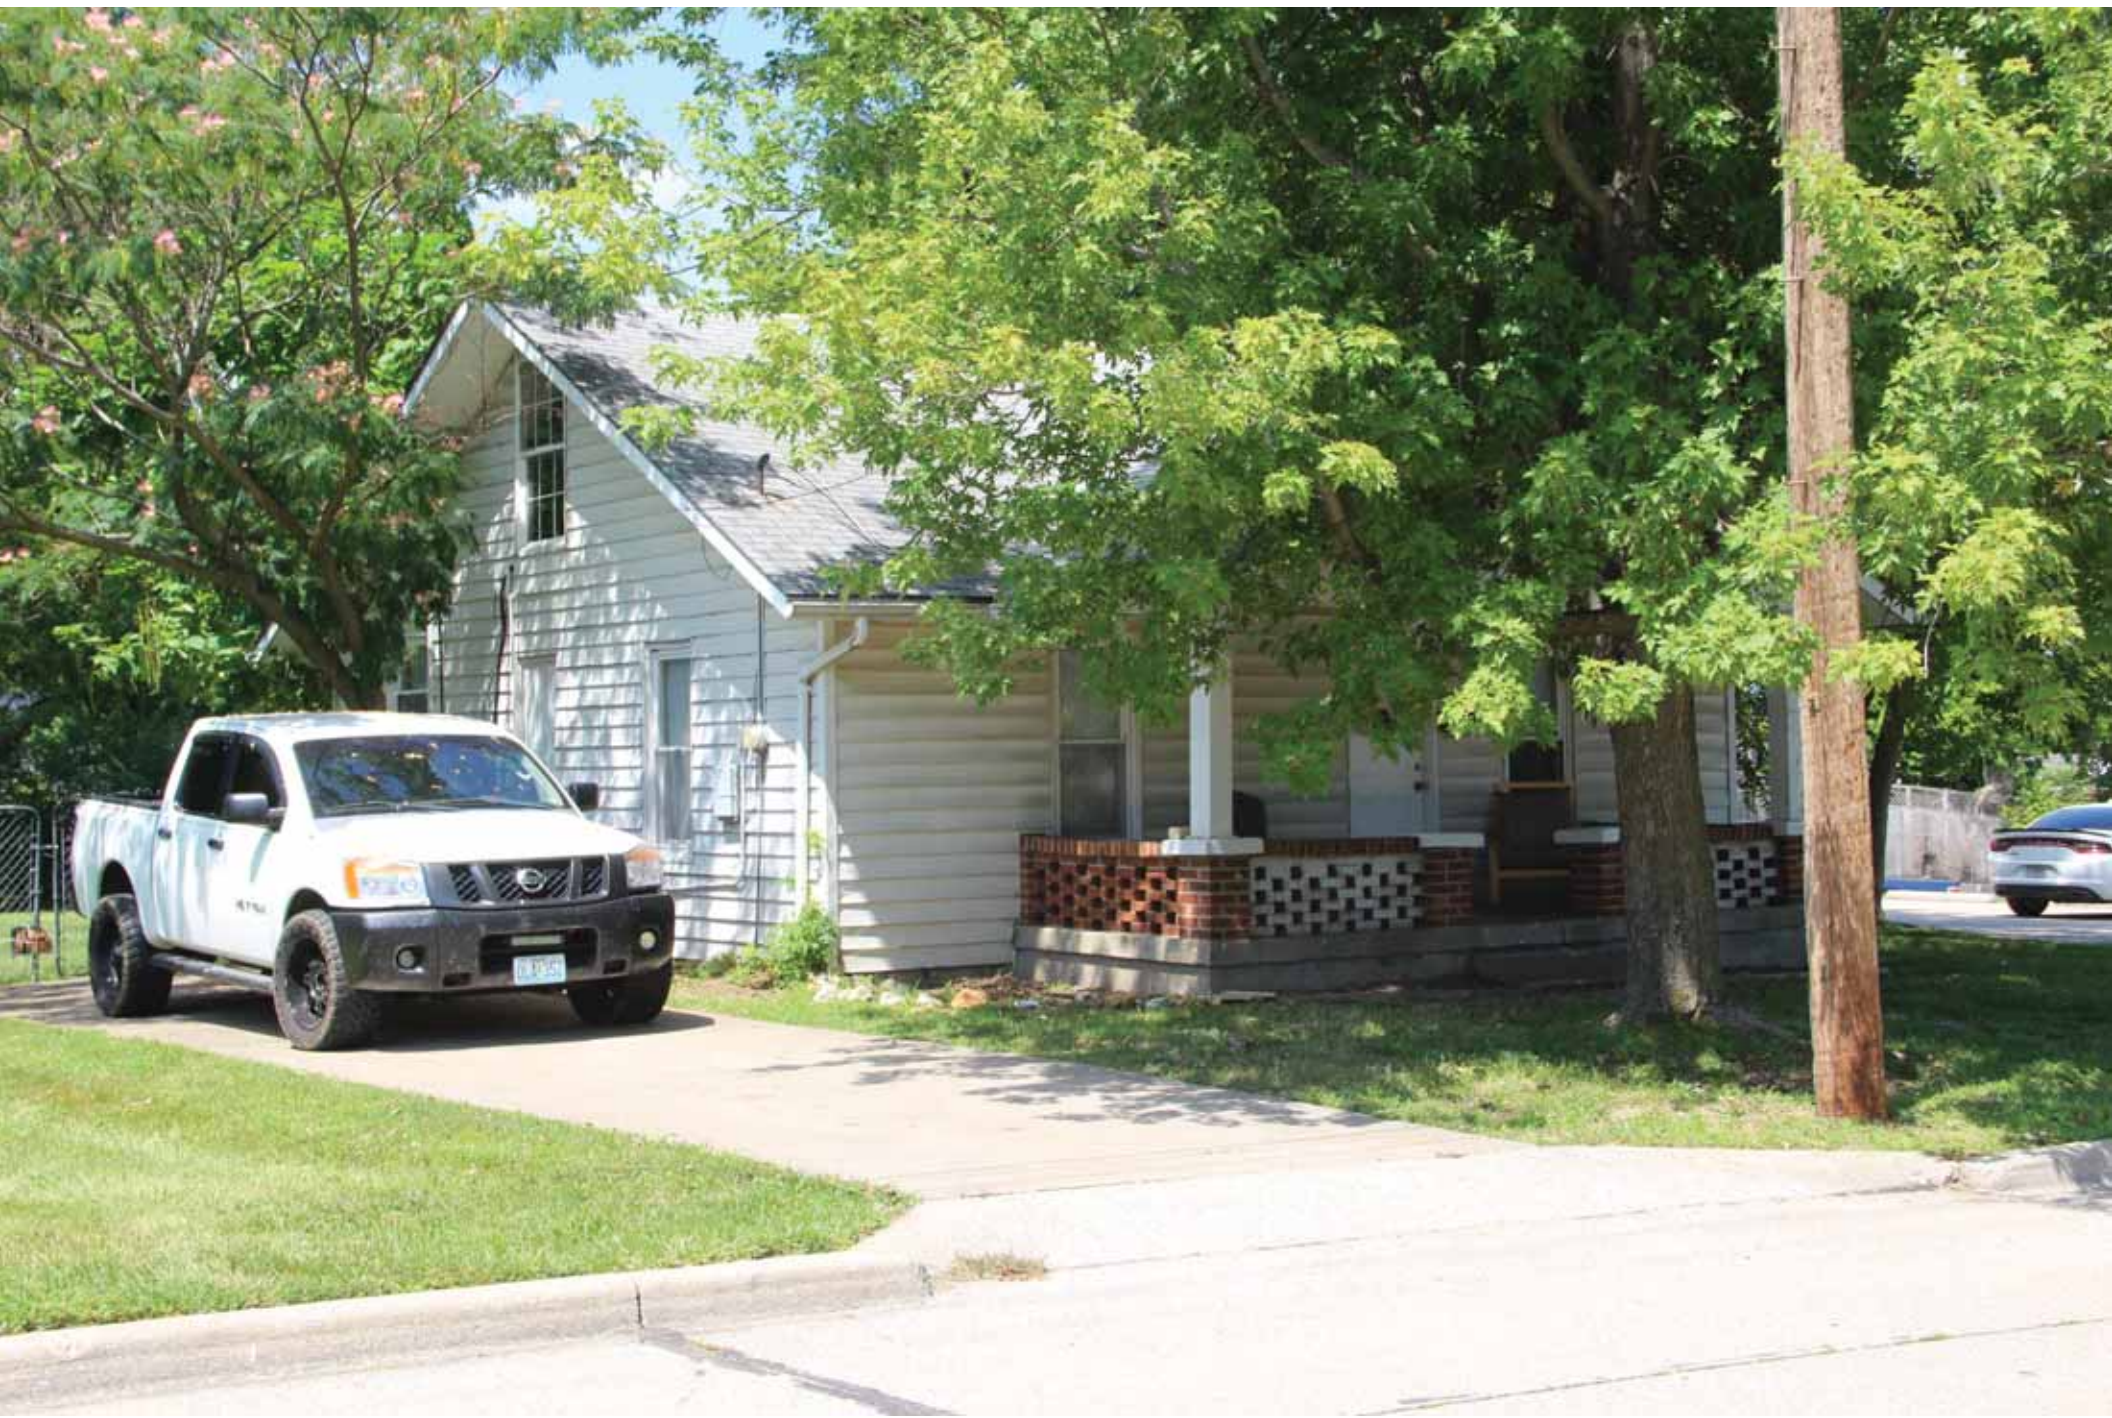
This is a one story asphalt-shingled cross gable clad in wood siding with a concrete foundation. The façade holds a partial-width porch sheltered under the front gable supported by wooden square columns on brick piers with concrete caps. Porch decking is concrete; a low brick wall with an open basket weave pattern with brick coping infills between the piers. Entrance is off-centered and flanked by one-over-one windows. Side elevations hold single and paired one-over-one windows; gable ends hold one-over-one windows.

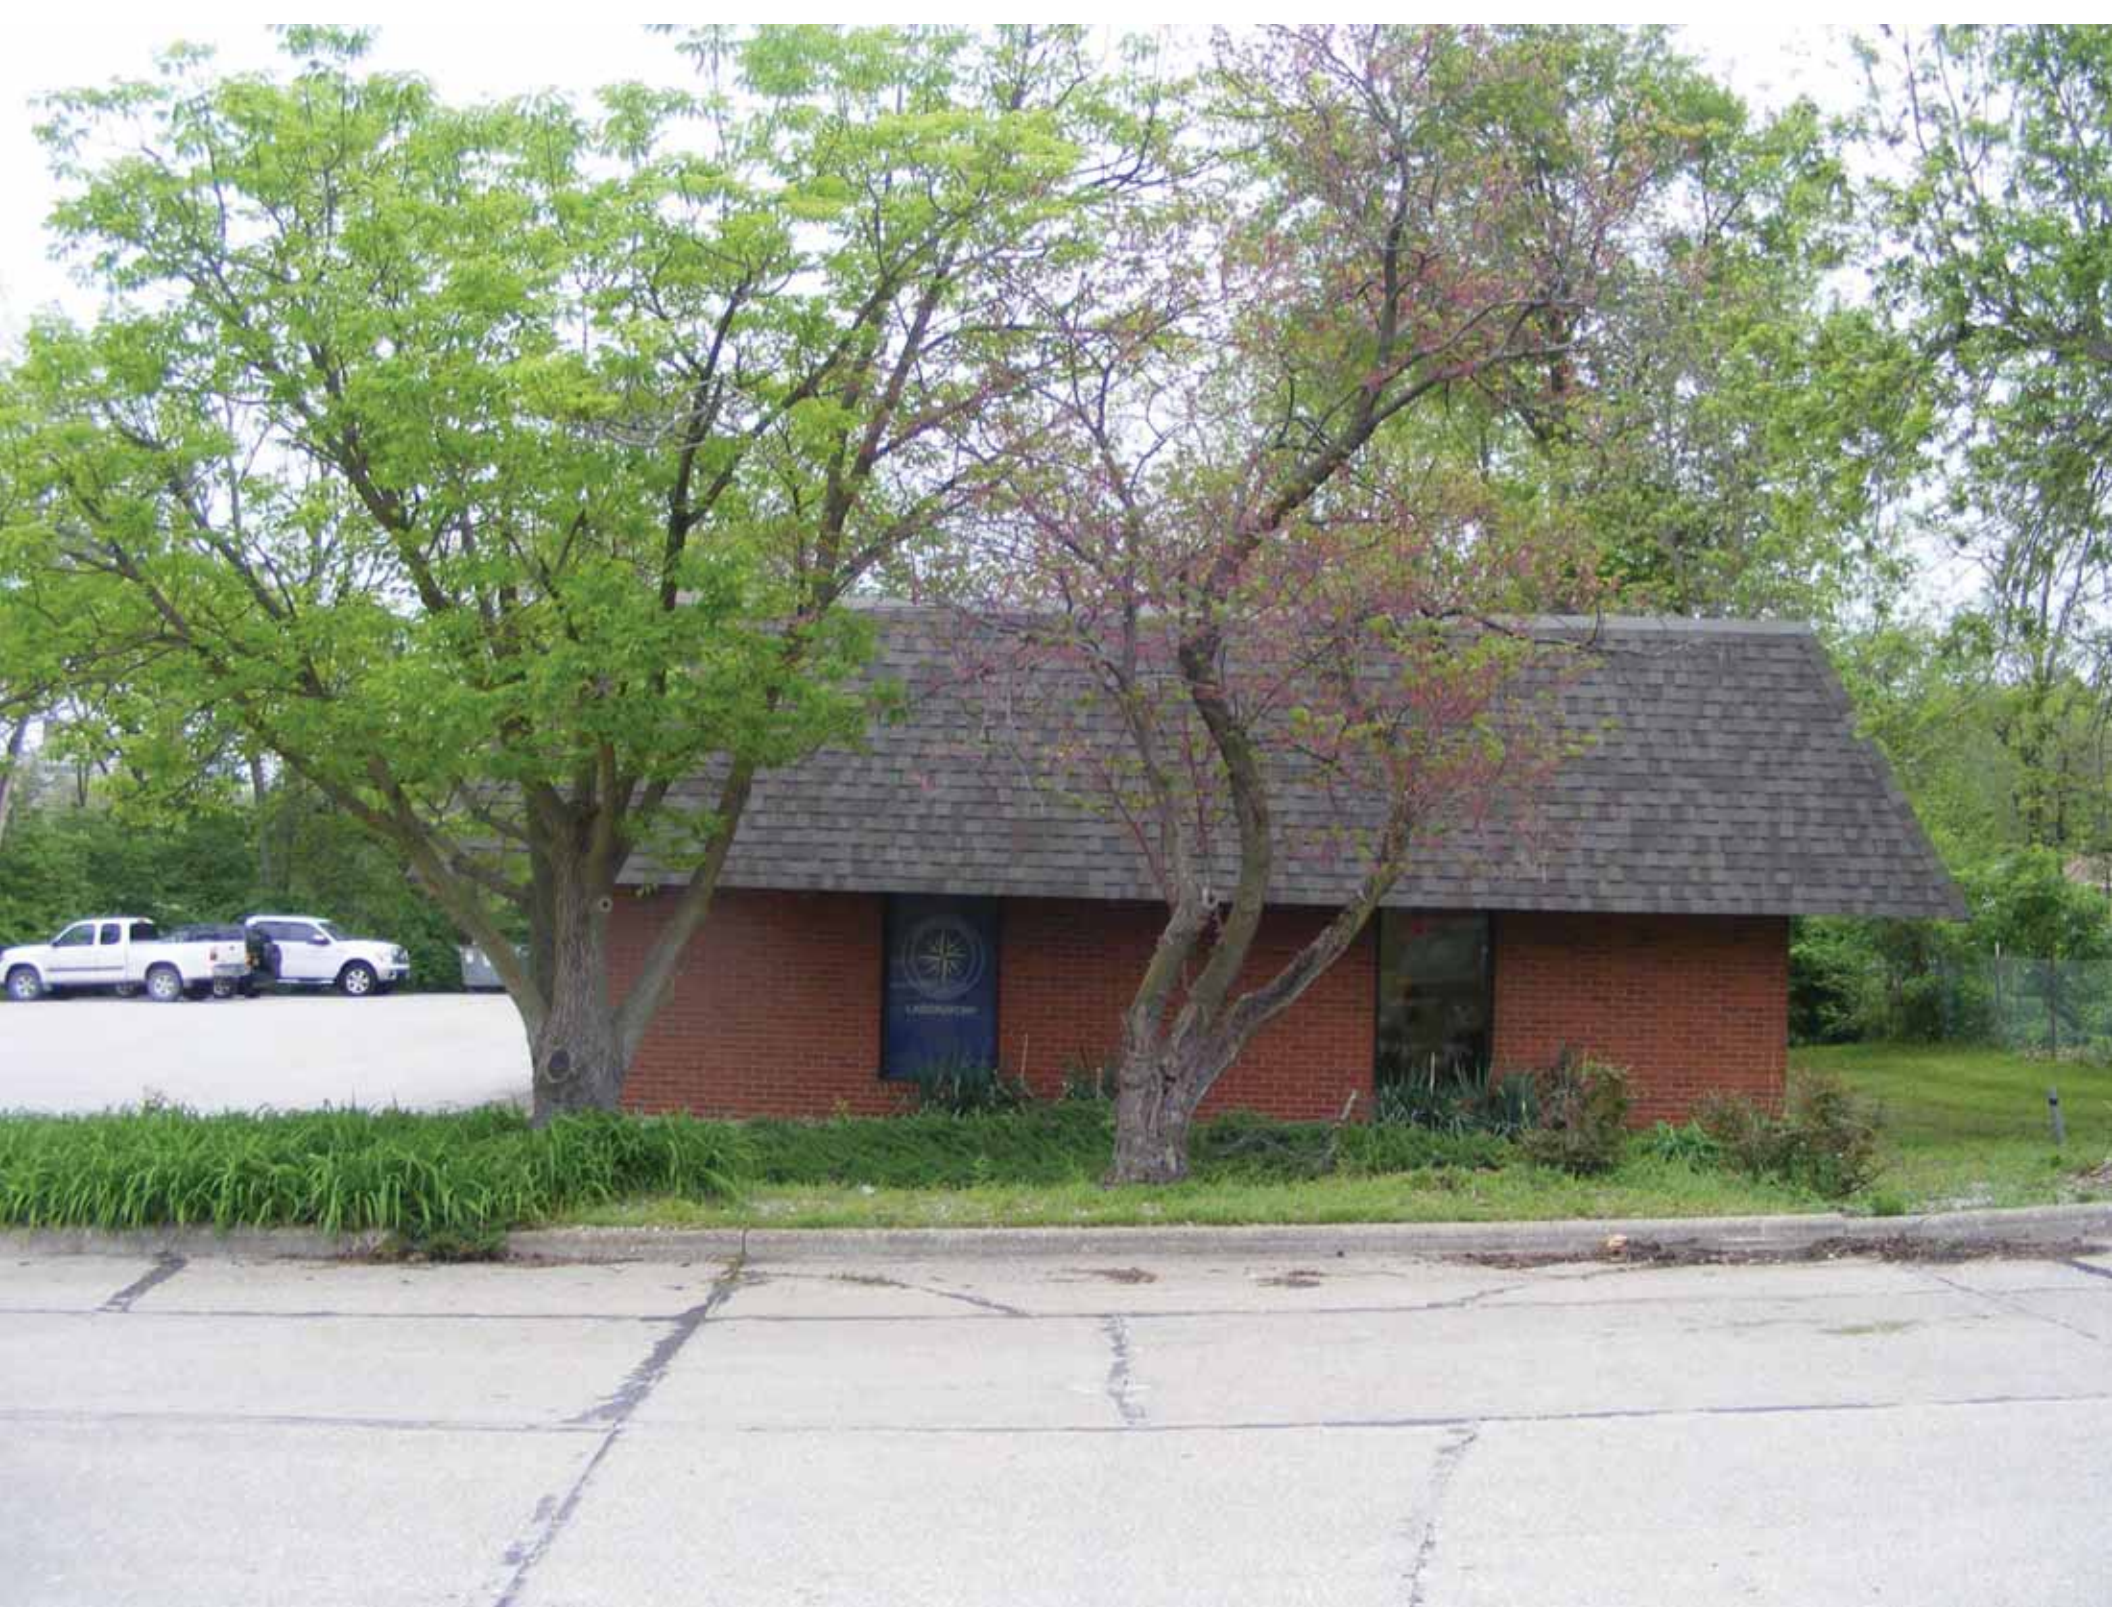
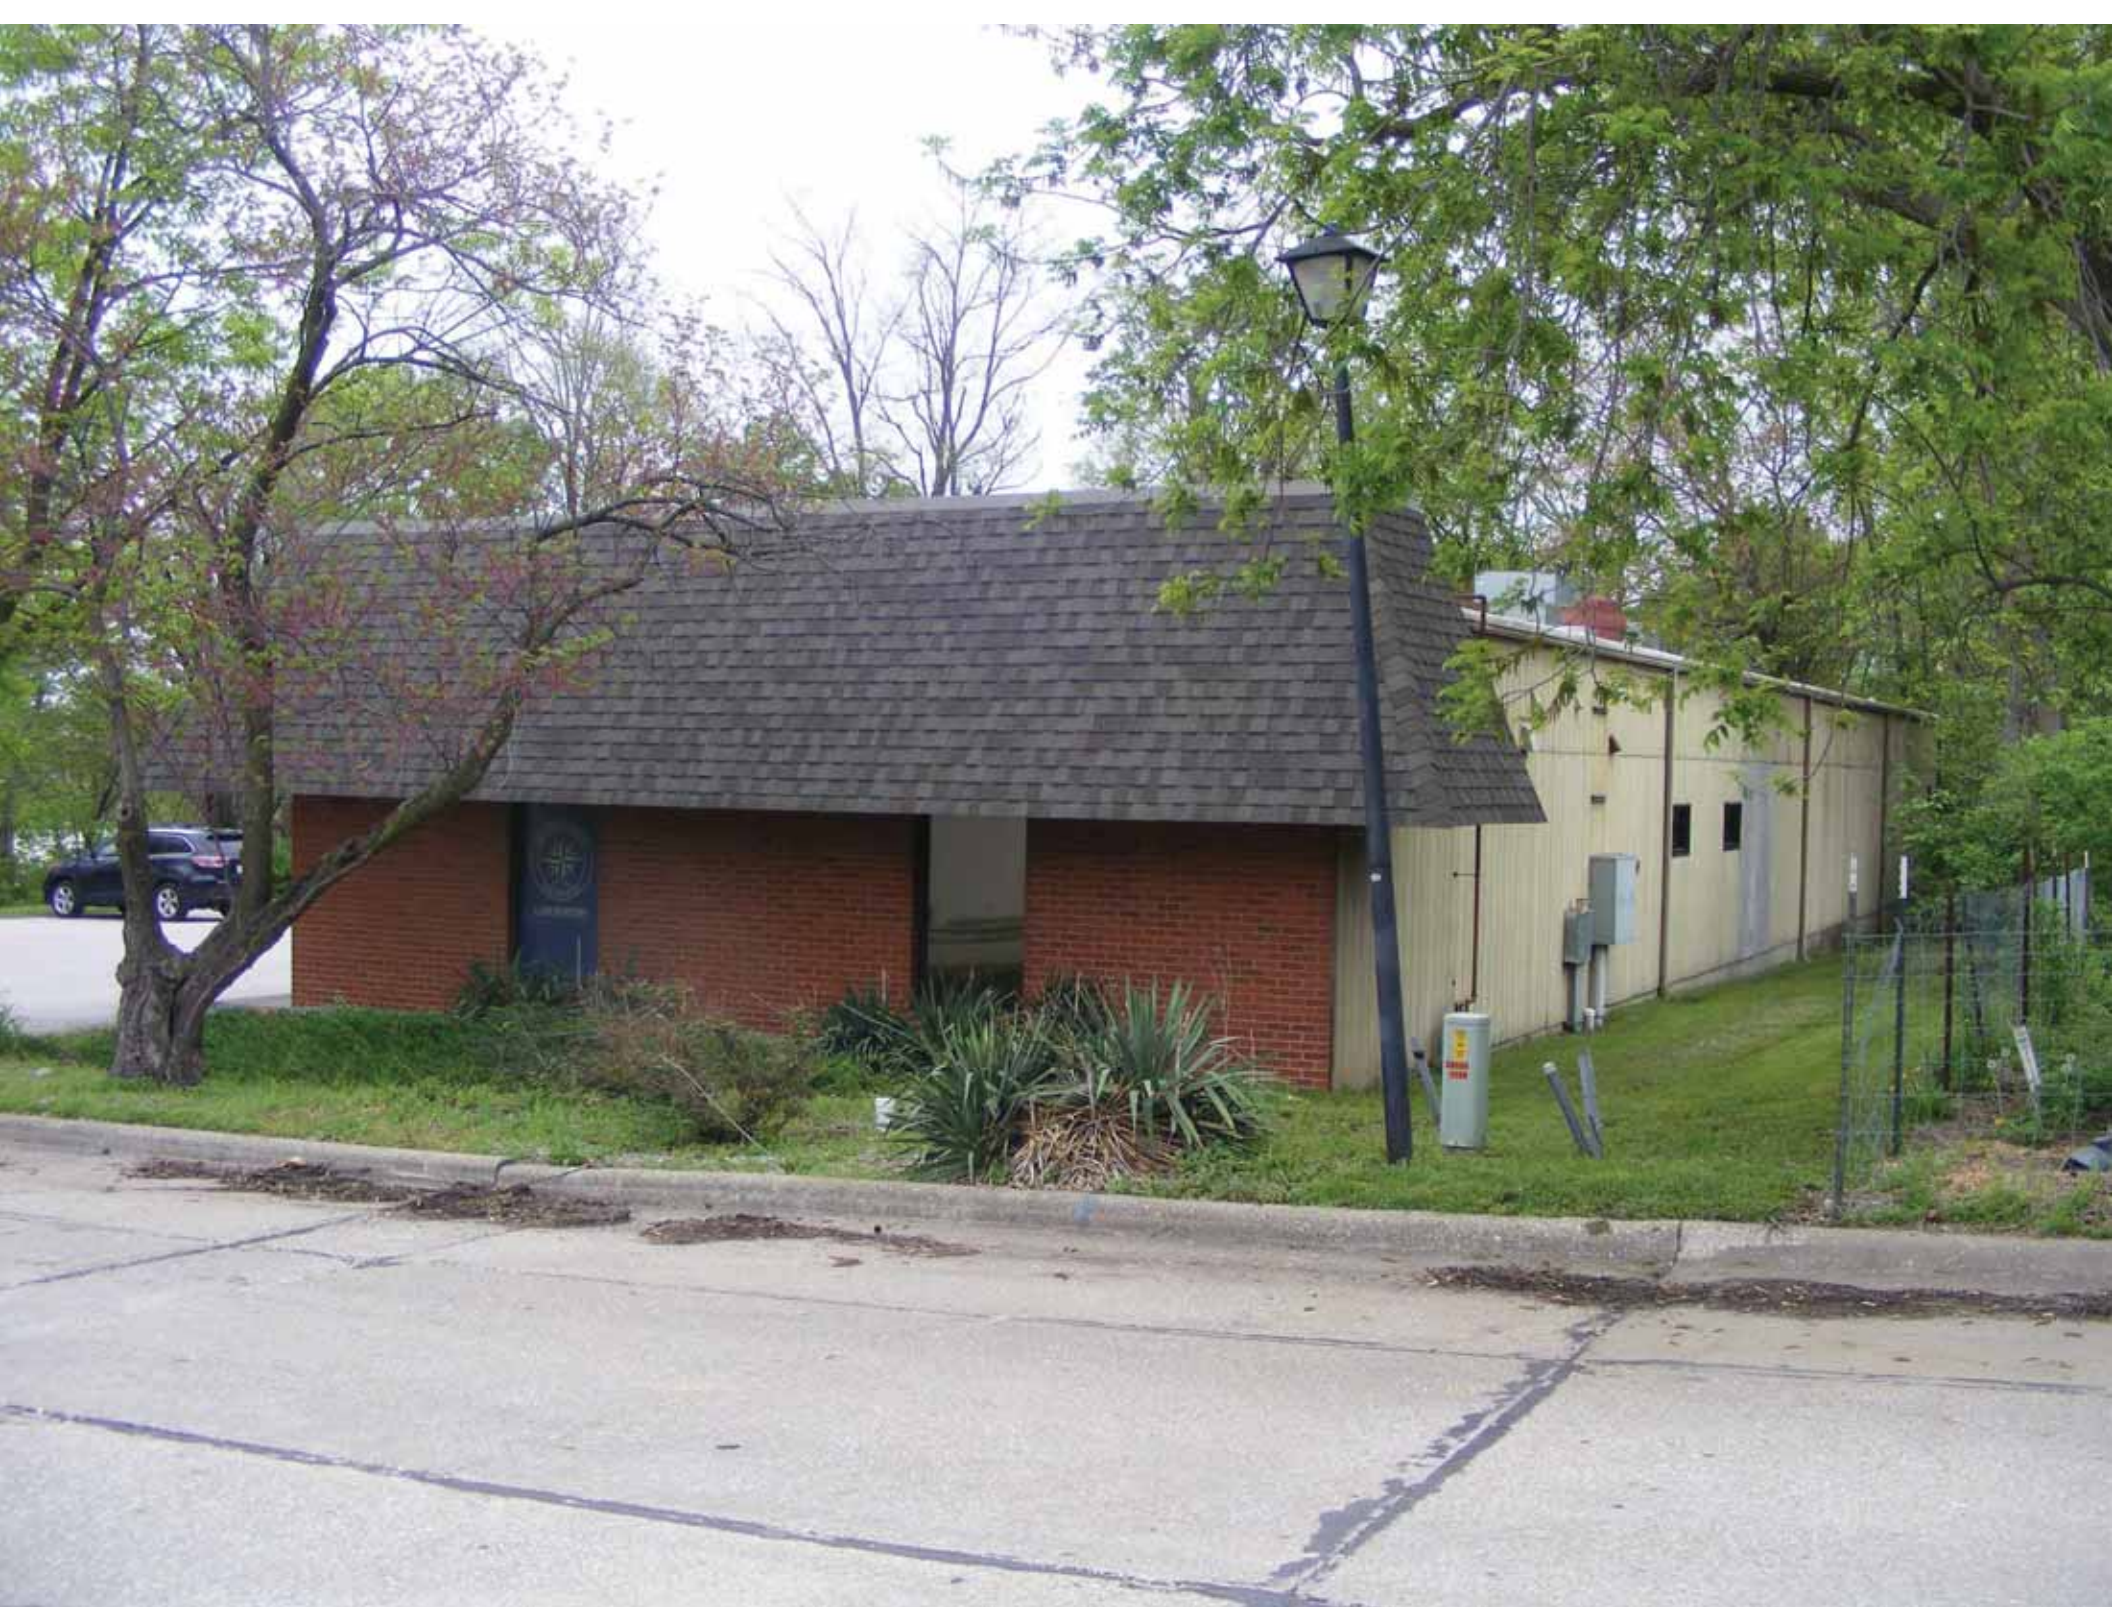
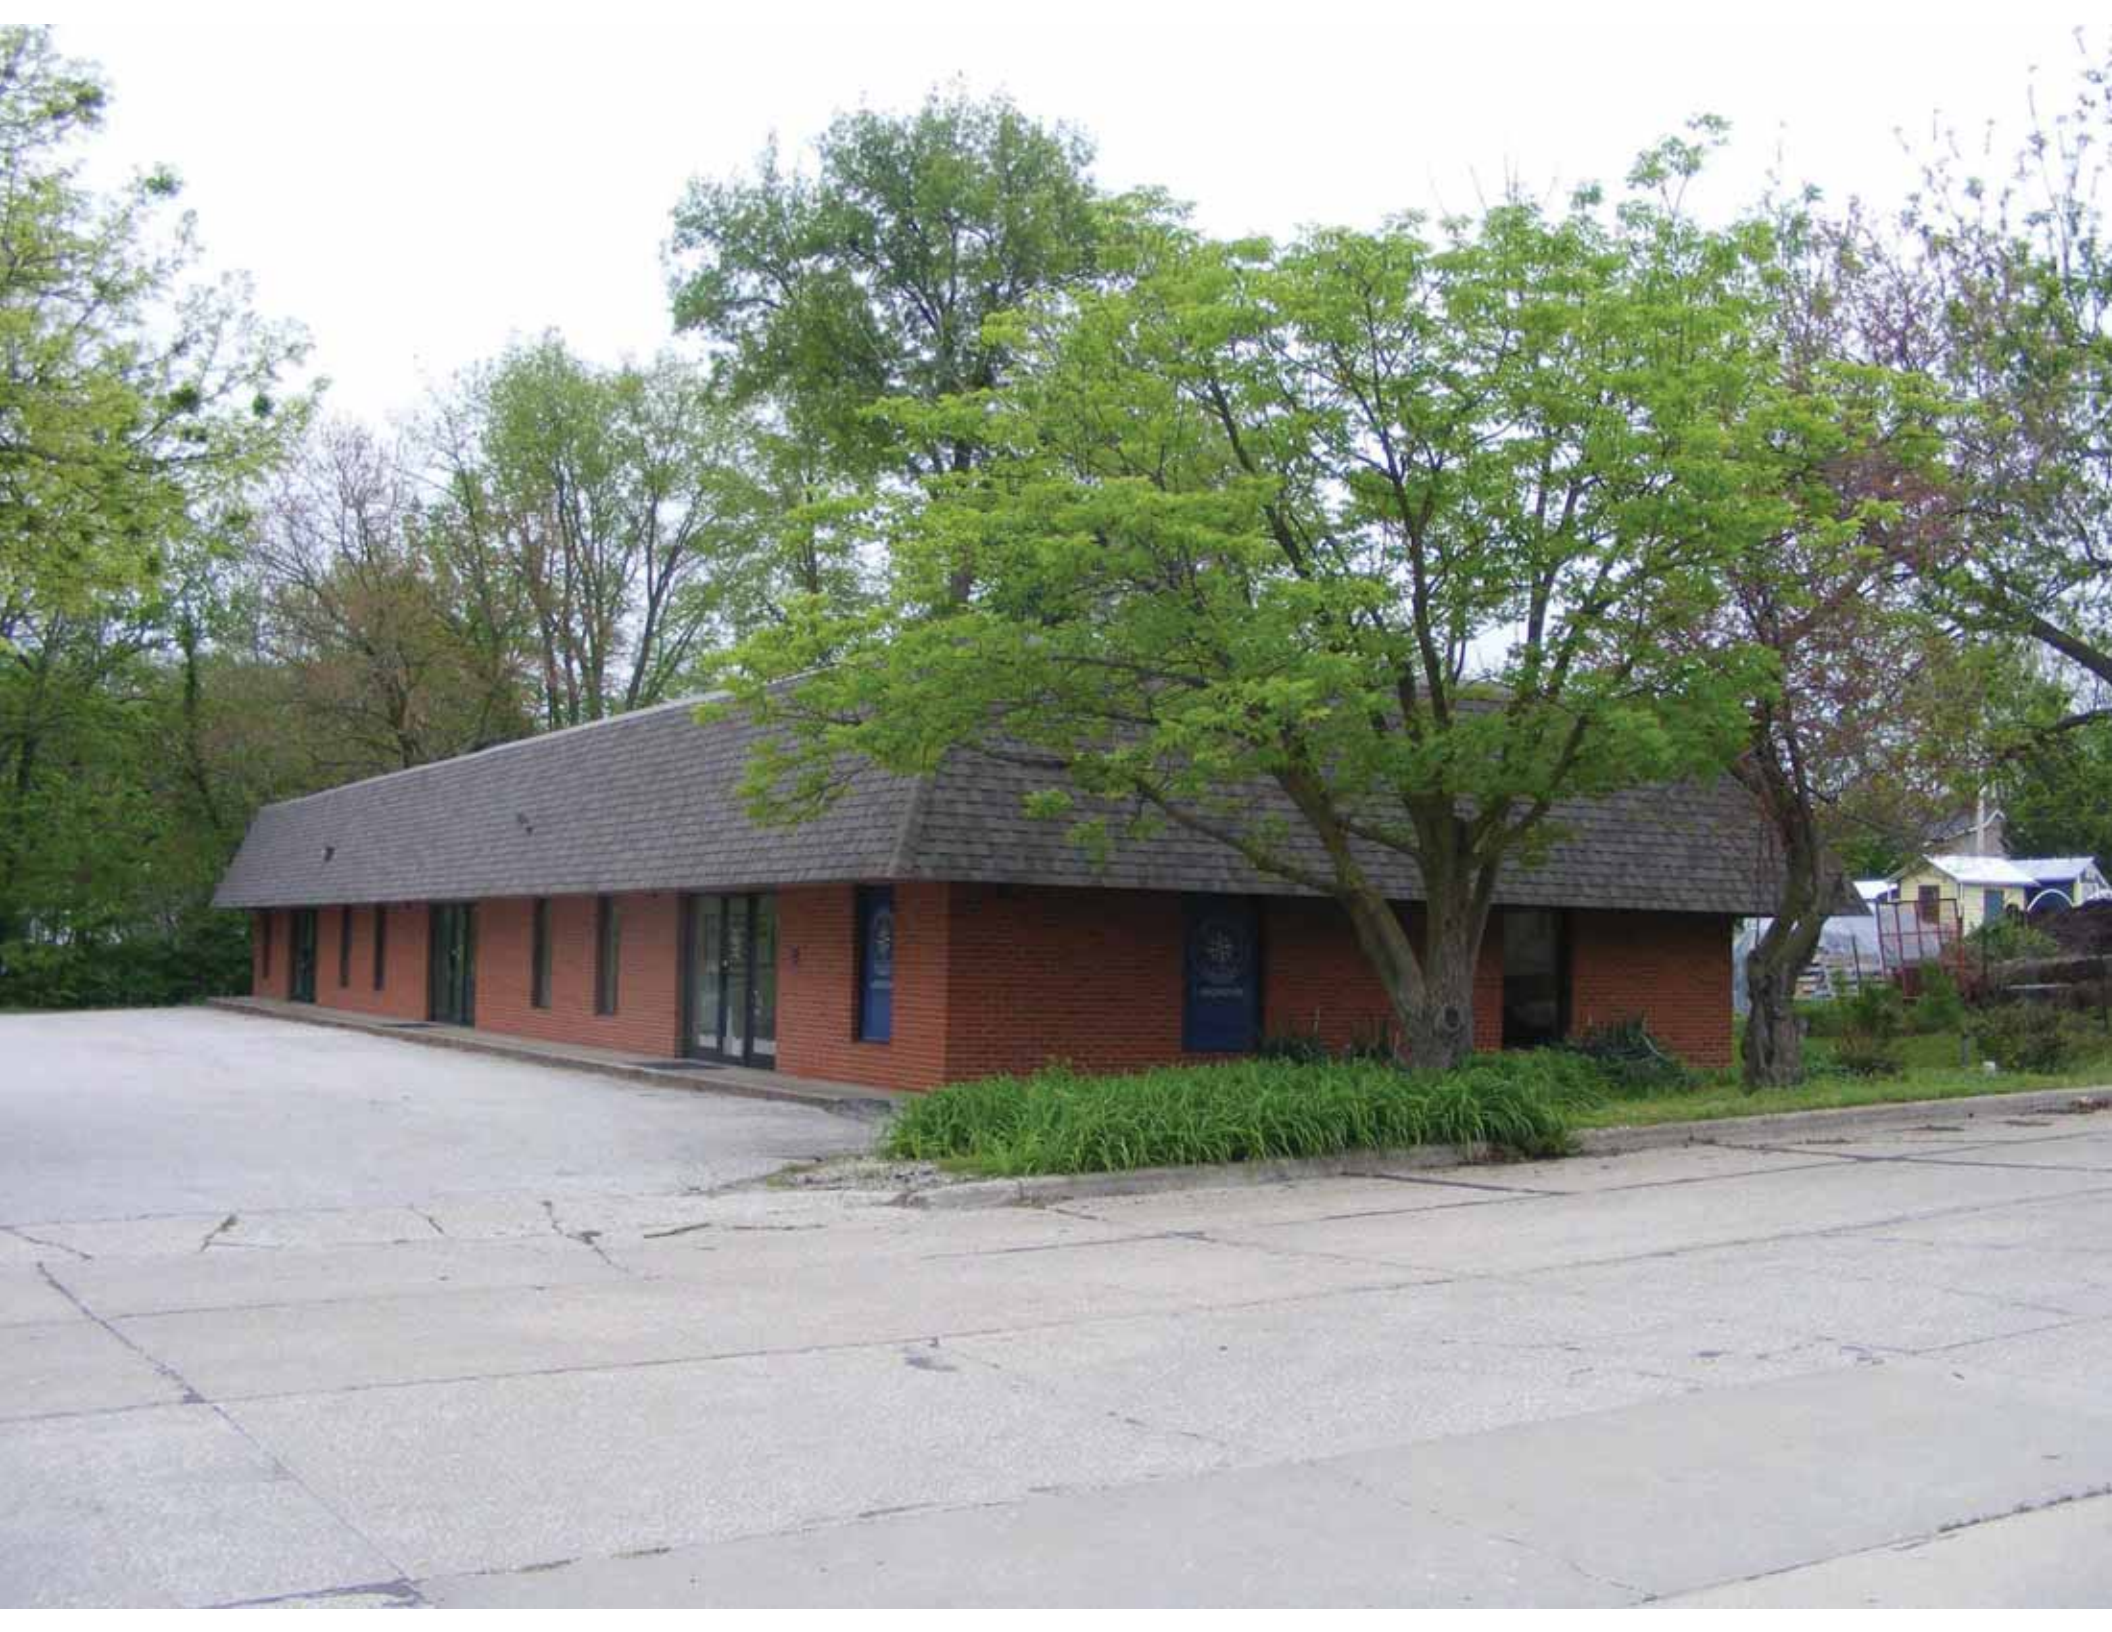
41. (cont.) Description of primary resource. Expand box as necessary, or add continuation pages.
A one story Post Modern Mansard commercial building with a concrete slab foundation. The building is clad in brick on the west and north (primary) elevations with vertical wood siding on the south (rear). The building features an asphalt-shingle mansard type roof to flat. The façade holds nine bays, left to right; fixed display, glass/metal door with sidelights, two fixed windows, glass/metal door with sidelights, two fixed windows; glass/metal door with sidelights and one fixed window. A concrete sidewalk runs the width of the façade and is sheltered un the mansard roof. The west elevation holds two fixed windows. The rear elevation has two small square windows.
