MISSOURI DEPARTMENT OF NATURAL RESOURCES
STATE HISTORIC PRESERVATION OFFICE, P.O. Box 176, Jefferson City, MO 65102
ARCHITECTURAL/HISTORIC INVENTORY FORM

1. Survey No. BO-AS-011-0087		2. Survey name: North Central Columbia Survey Phase II	
3. County: Boone		4. Address (Street No.) 902	Street (name) N. Seventh Street
5. City: Columbia	Vicinity: <input type="checkbox"/>	6. Geographical Reference:	7. Township/Range/Section: T: R: S:
8. Historic name (if known):		9. Present/other name (if known):	
10. Ownership: <input checked="" type="checkbox"/> Private <input type="checkbox"/> Public		11a. Historic use (if known): Domestic/single dwelling	11b. Current use: Domestic/single dwelling

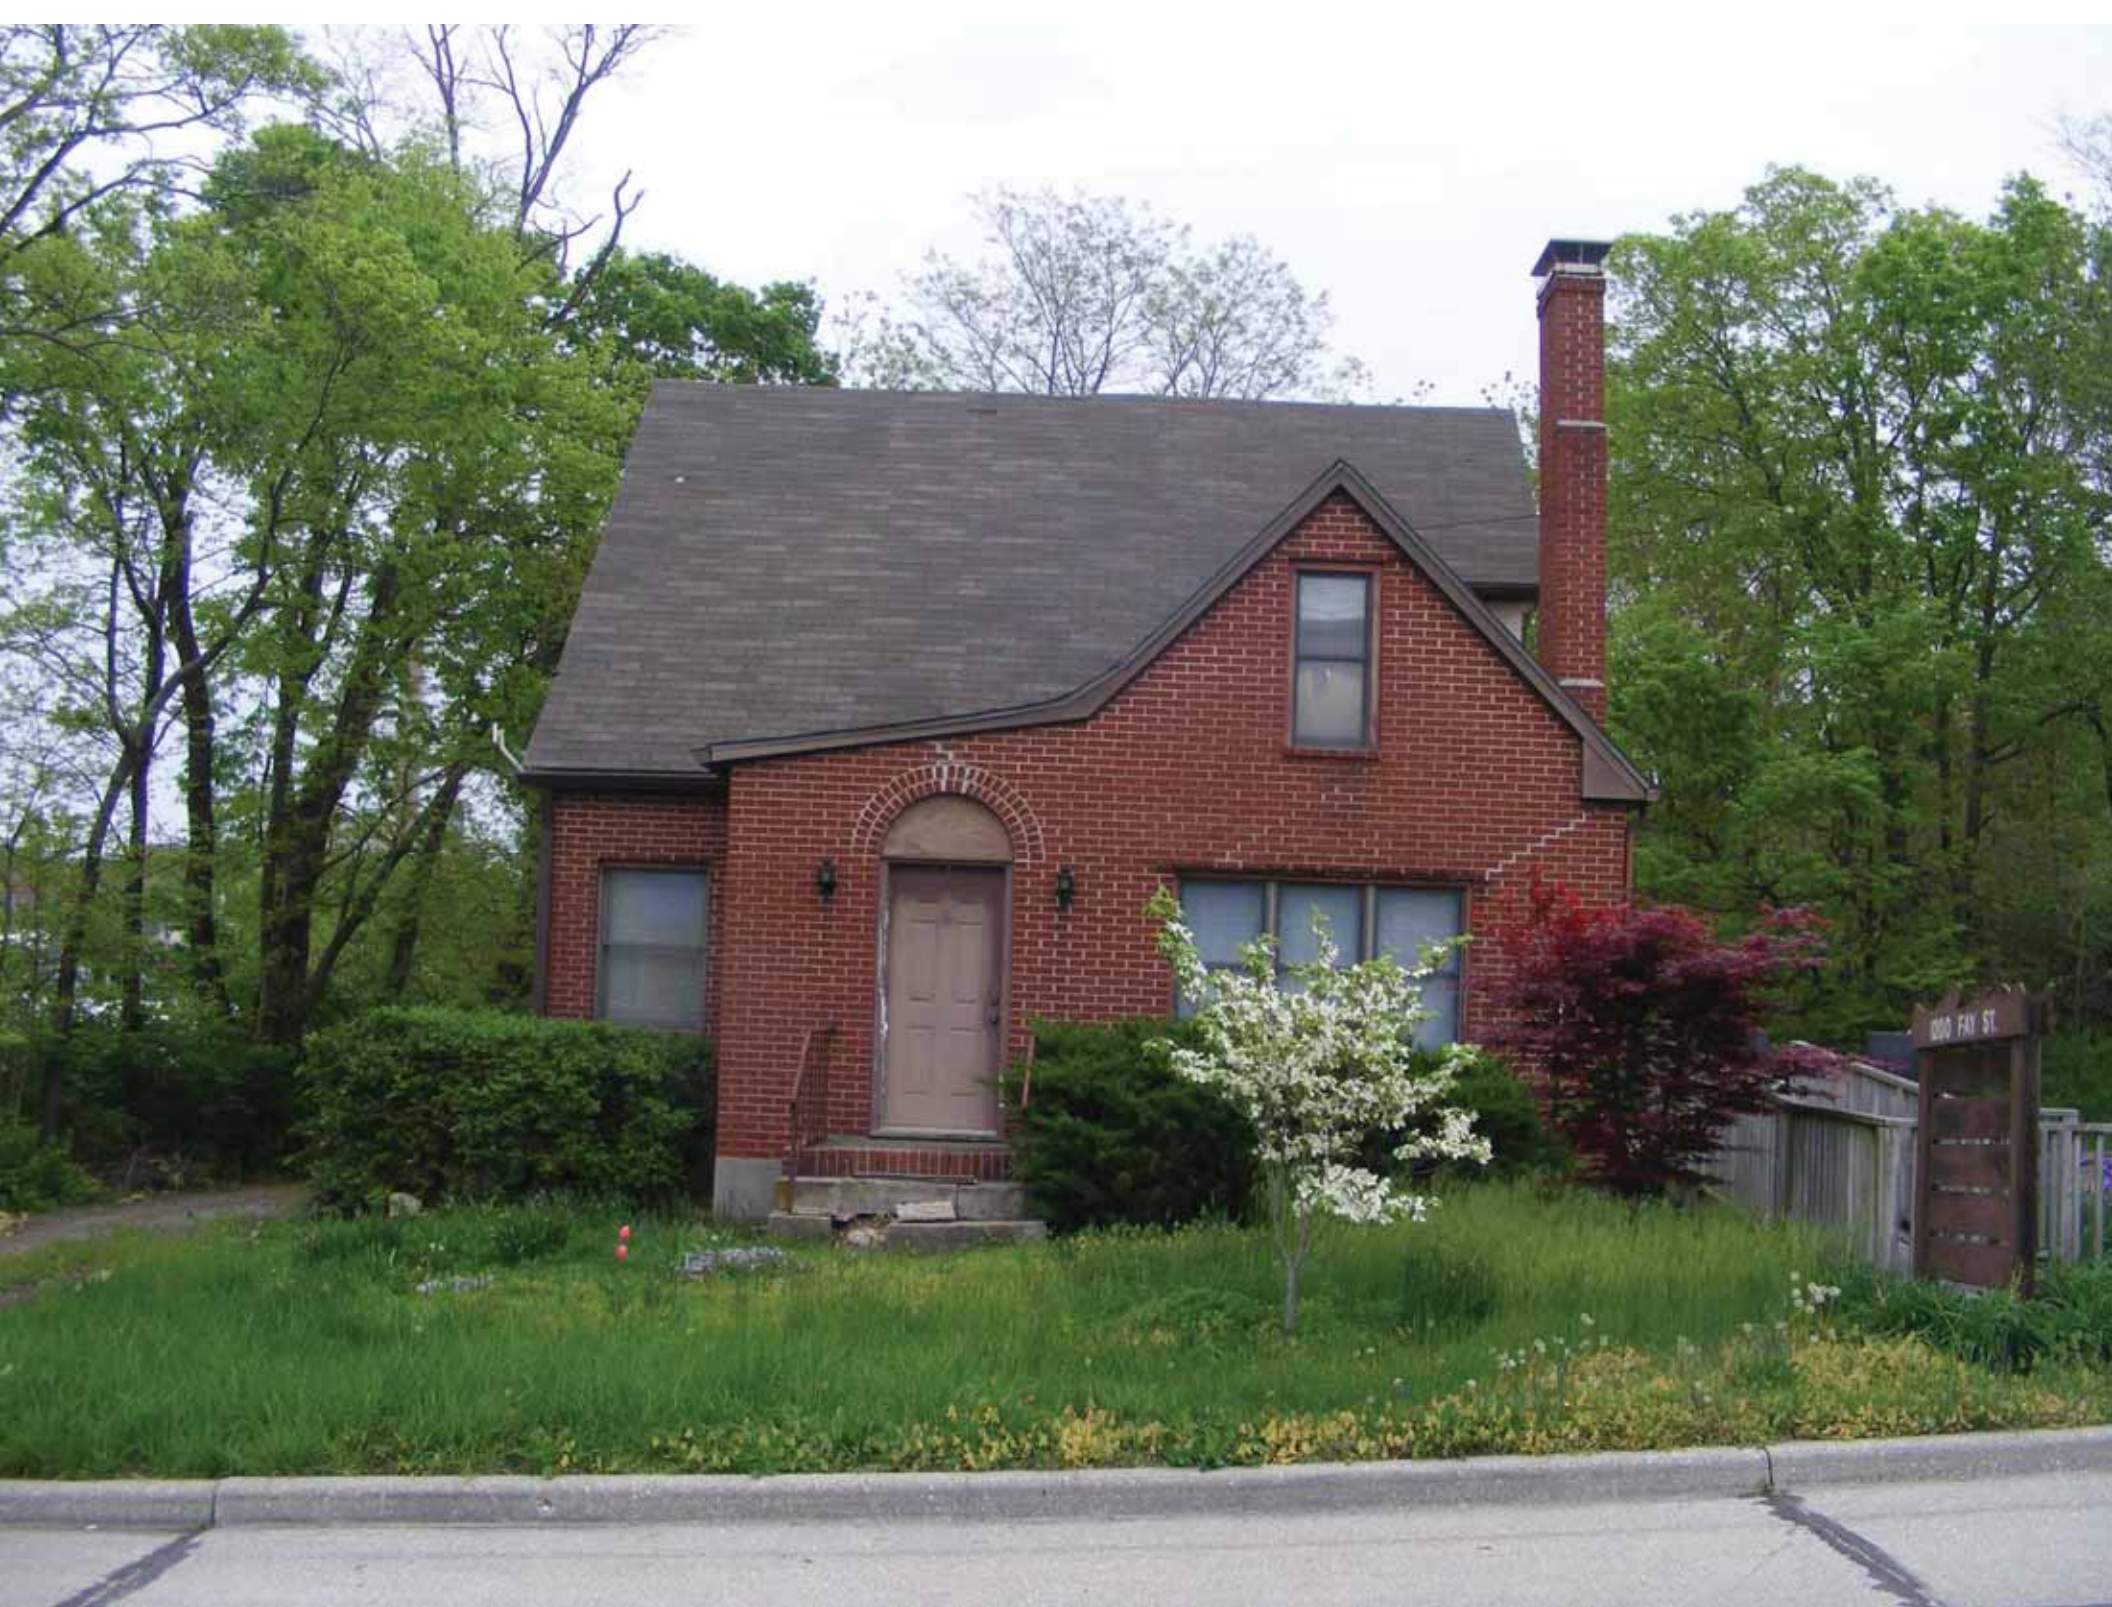
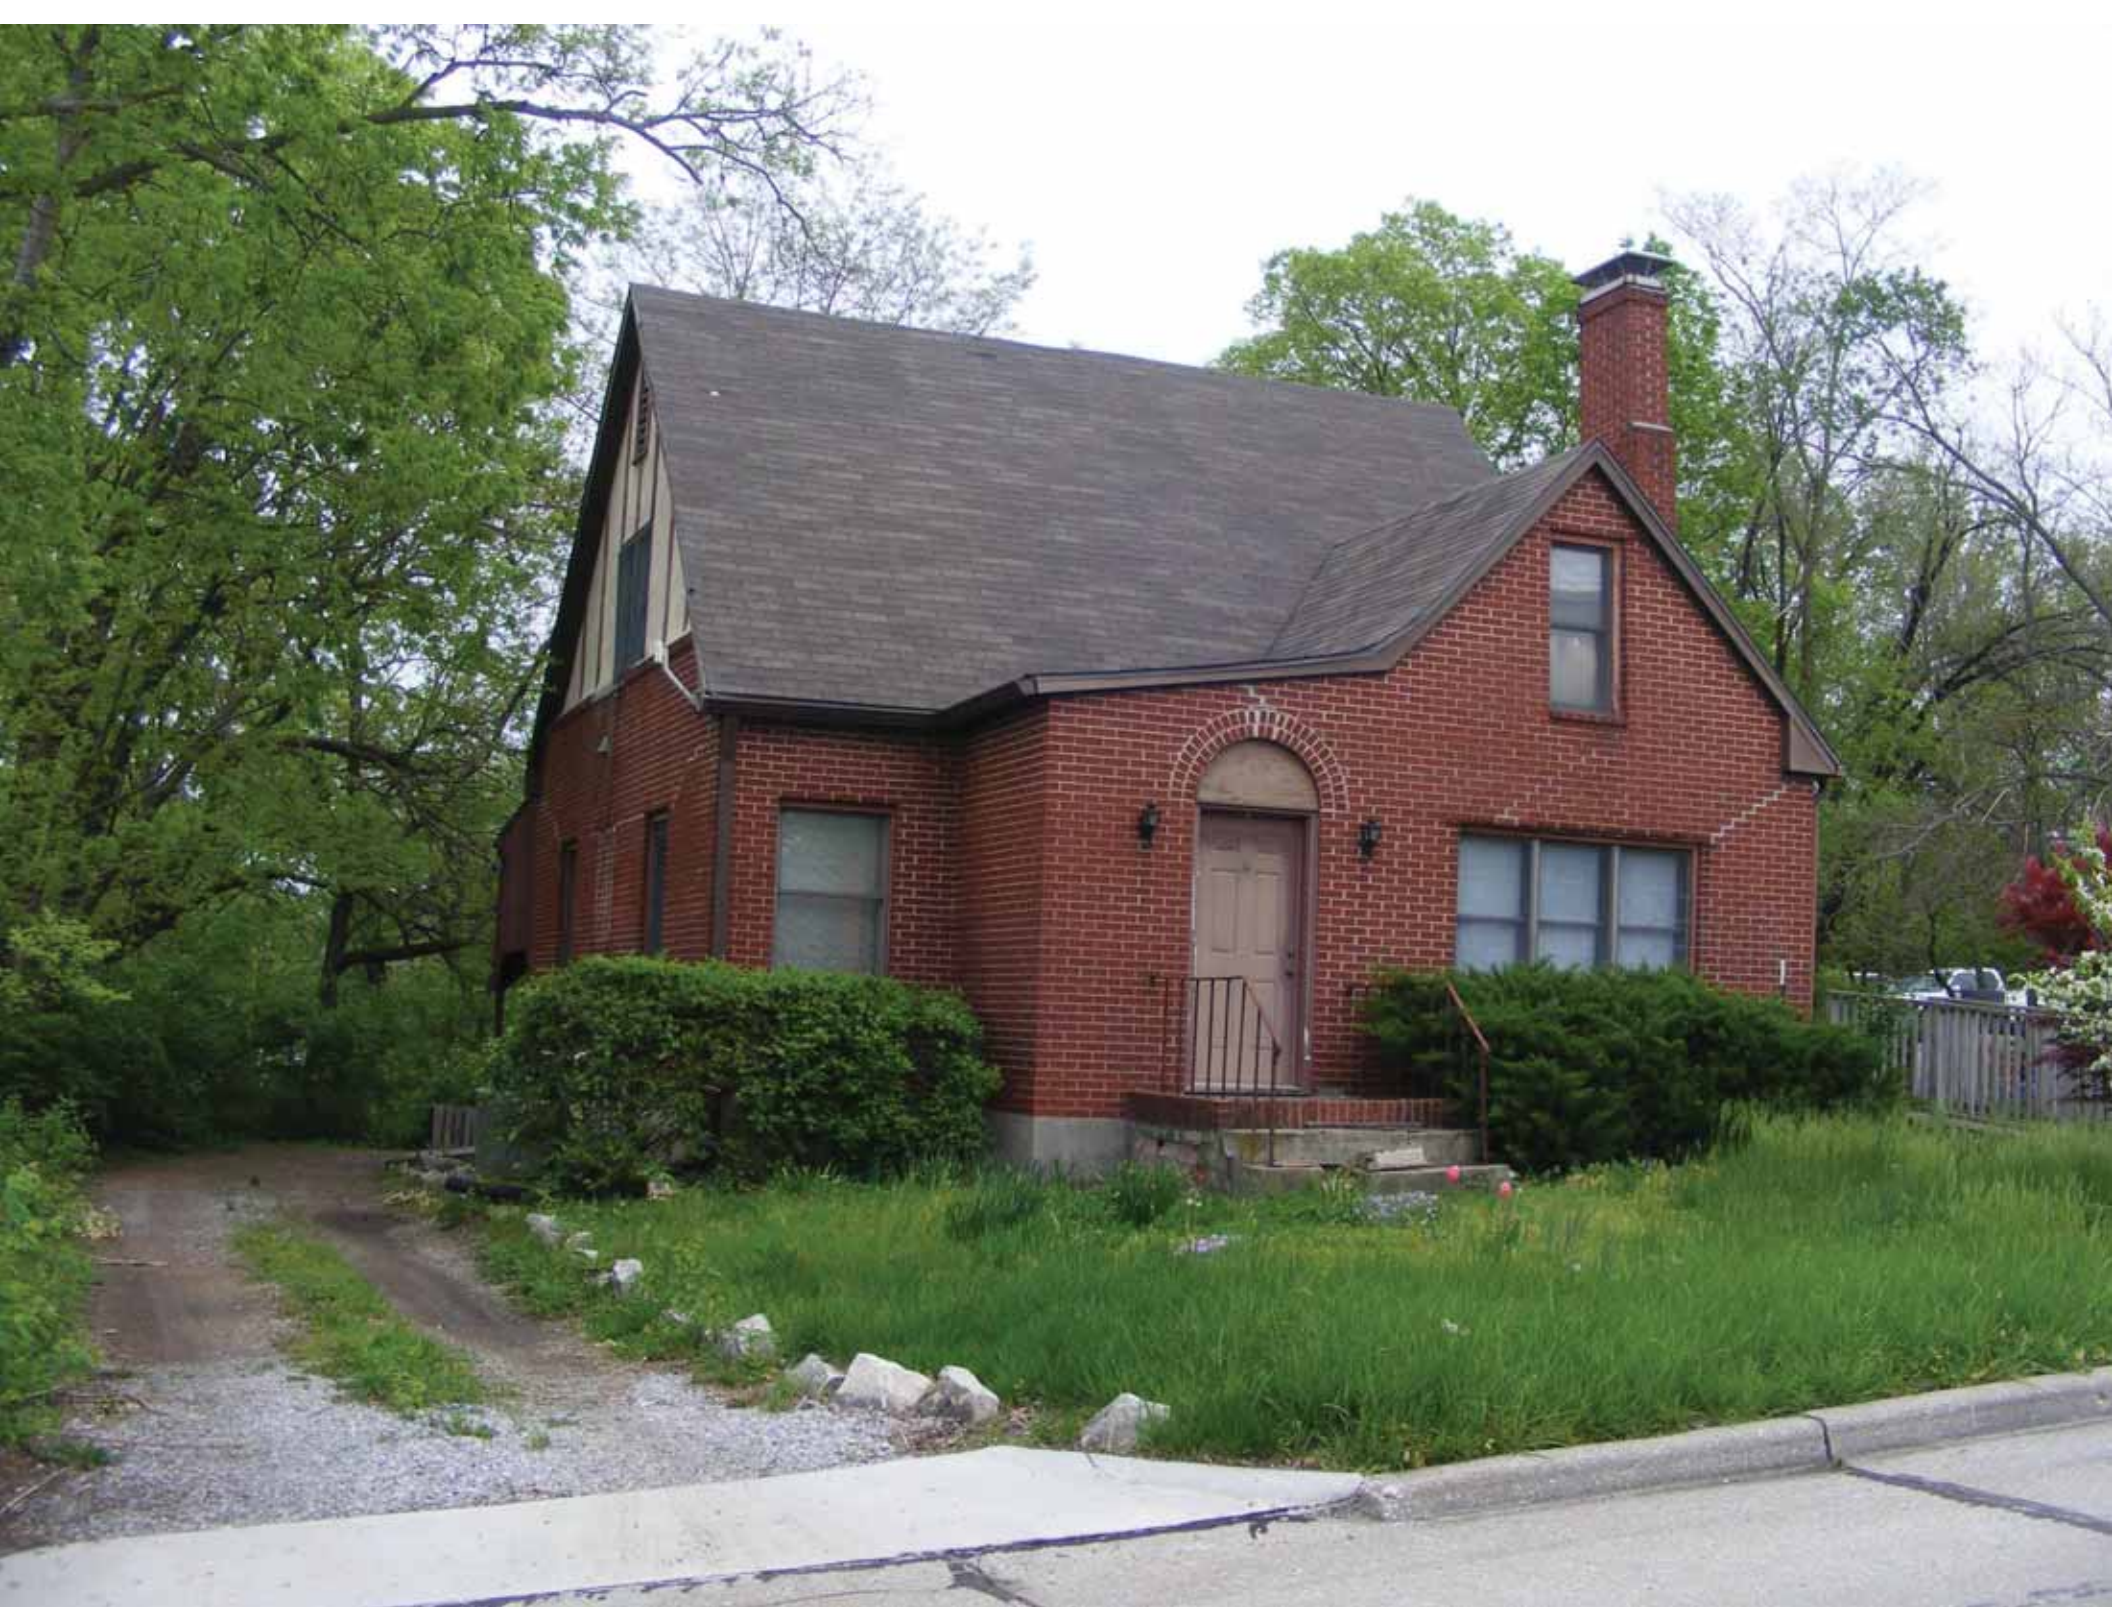
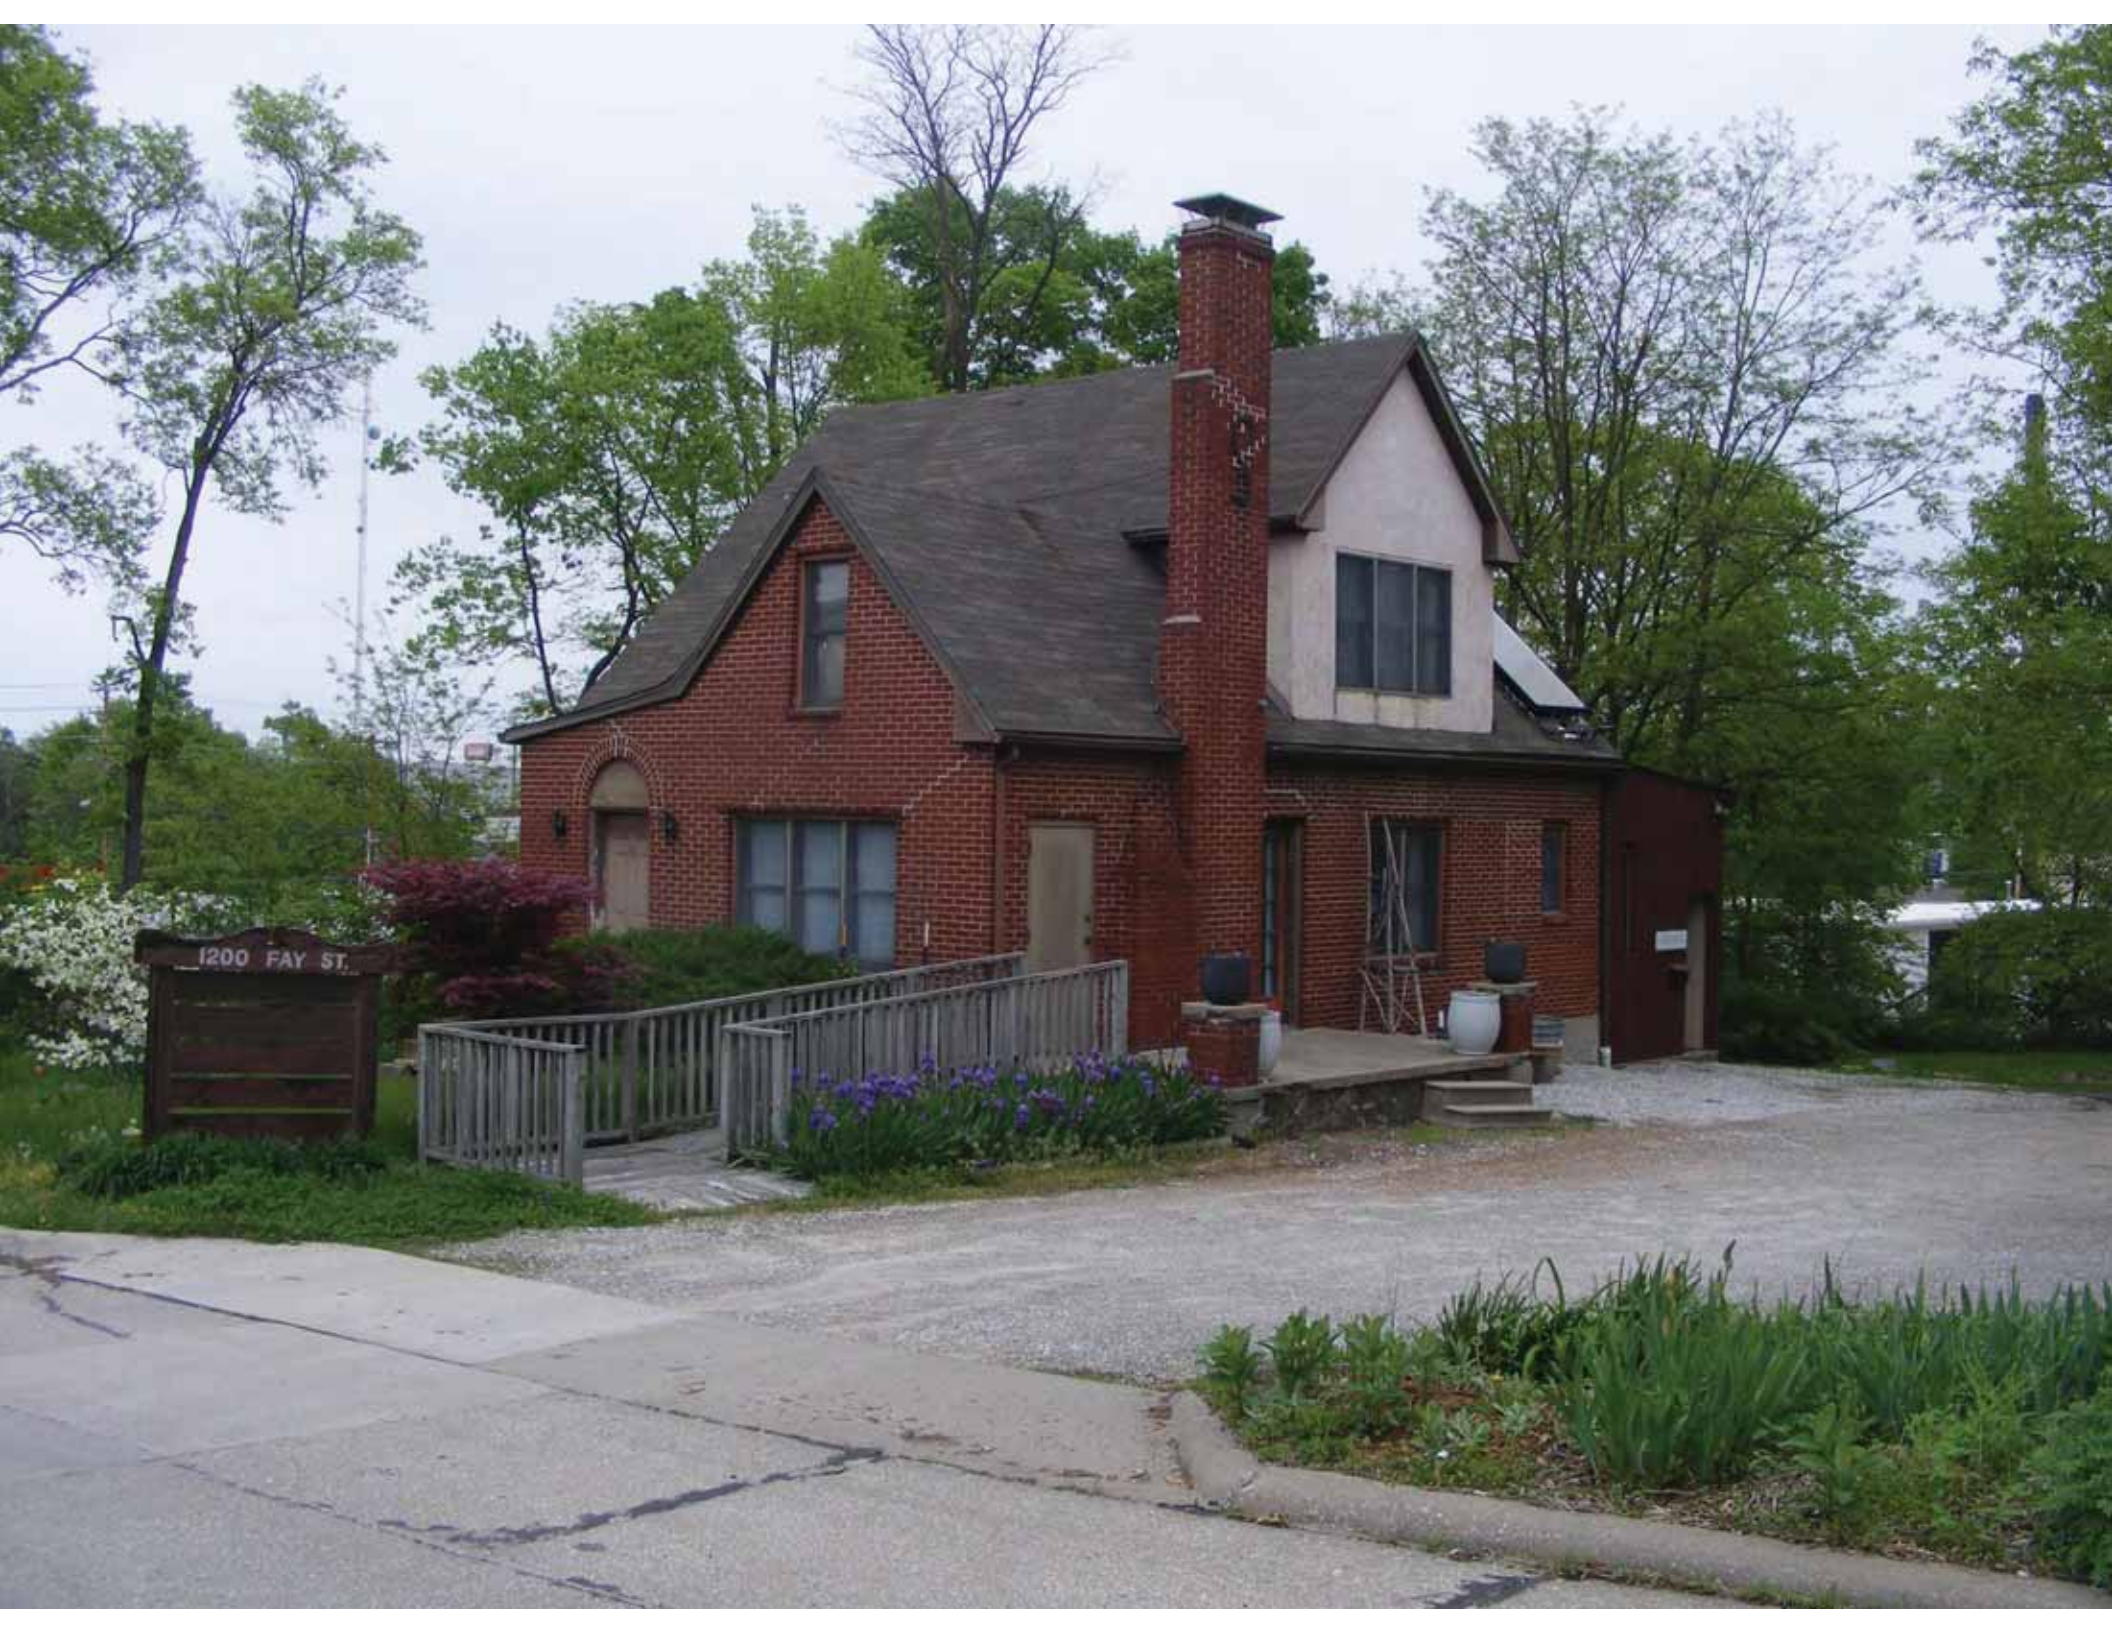
1200 FAY ST.

41. (cont.) Description of primary resource. Expand box as necessary, or add continuation pages.
This is a 1.5 story brick dwelling with an asphalt-shingled cross gable roof and a concrete foundation. The façade features a projecting front gable to shed. A concrete stoop with iron railings and arched entrance way is found within the shed area and holds a replacement door and covered fan transom. Entrance is offset to the right by a tripled paired one-over-one window with a one-over-one window in the gable end. To the left of the entrance, setback in the side gable is a one-over-one window. The south elevation holds an open concrete porch at the southwest corner with a wooden ADA ramp with wood railings at the corner and concrete steps on the south elevation. A solid metal door is located at the southwest corner followed by an exterior brick chimney and a French door. To the right of the French door is a picture widow and a one-over-one window. The south sloping roofline features a tripled paired one-over-one window in the cross gable; gable is clad in stucco. At the southeast corner is a wood frame addition with and entrance. A skylight is found on the southeast corner of the roofline. The north elevation holds one-over-one windows. The gable end is clad in stucco with half-timbering and holds a one-over-one window.

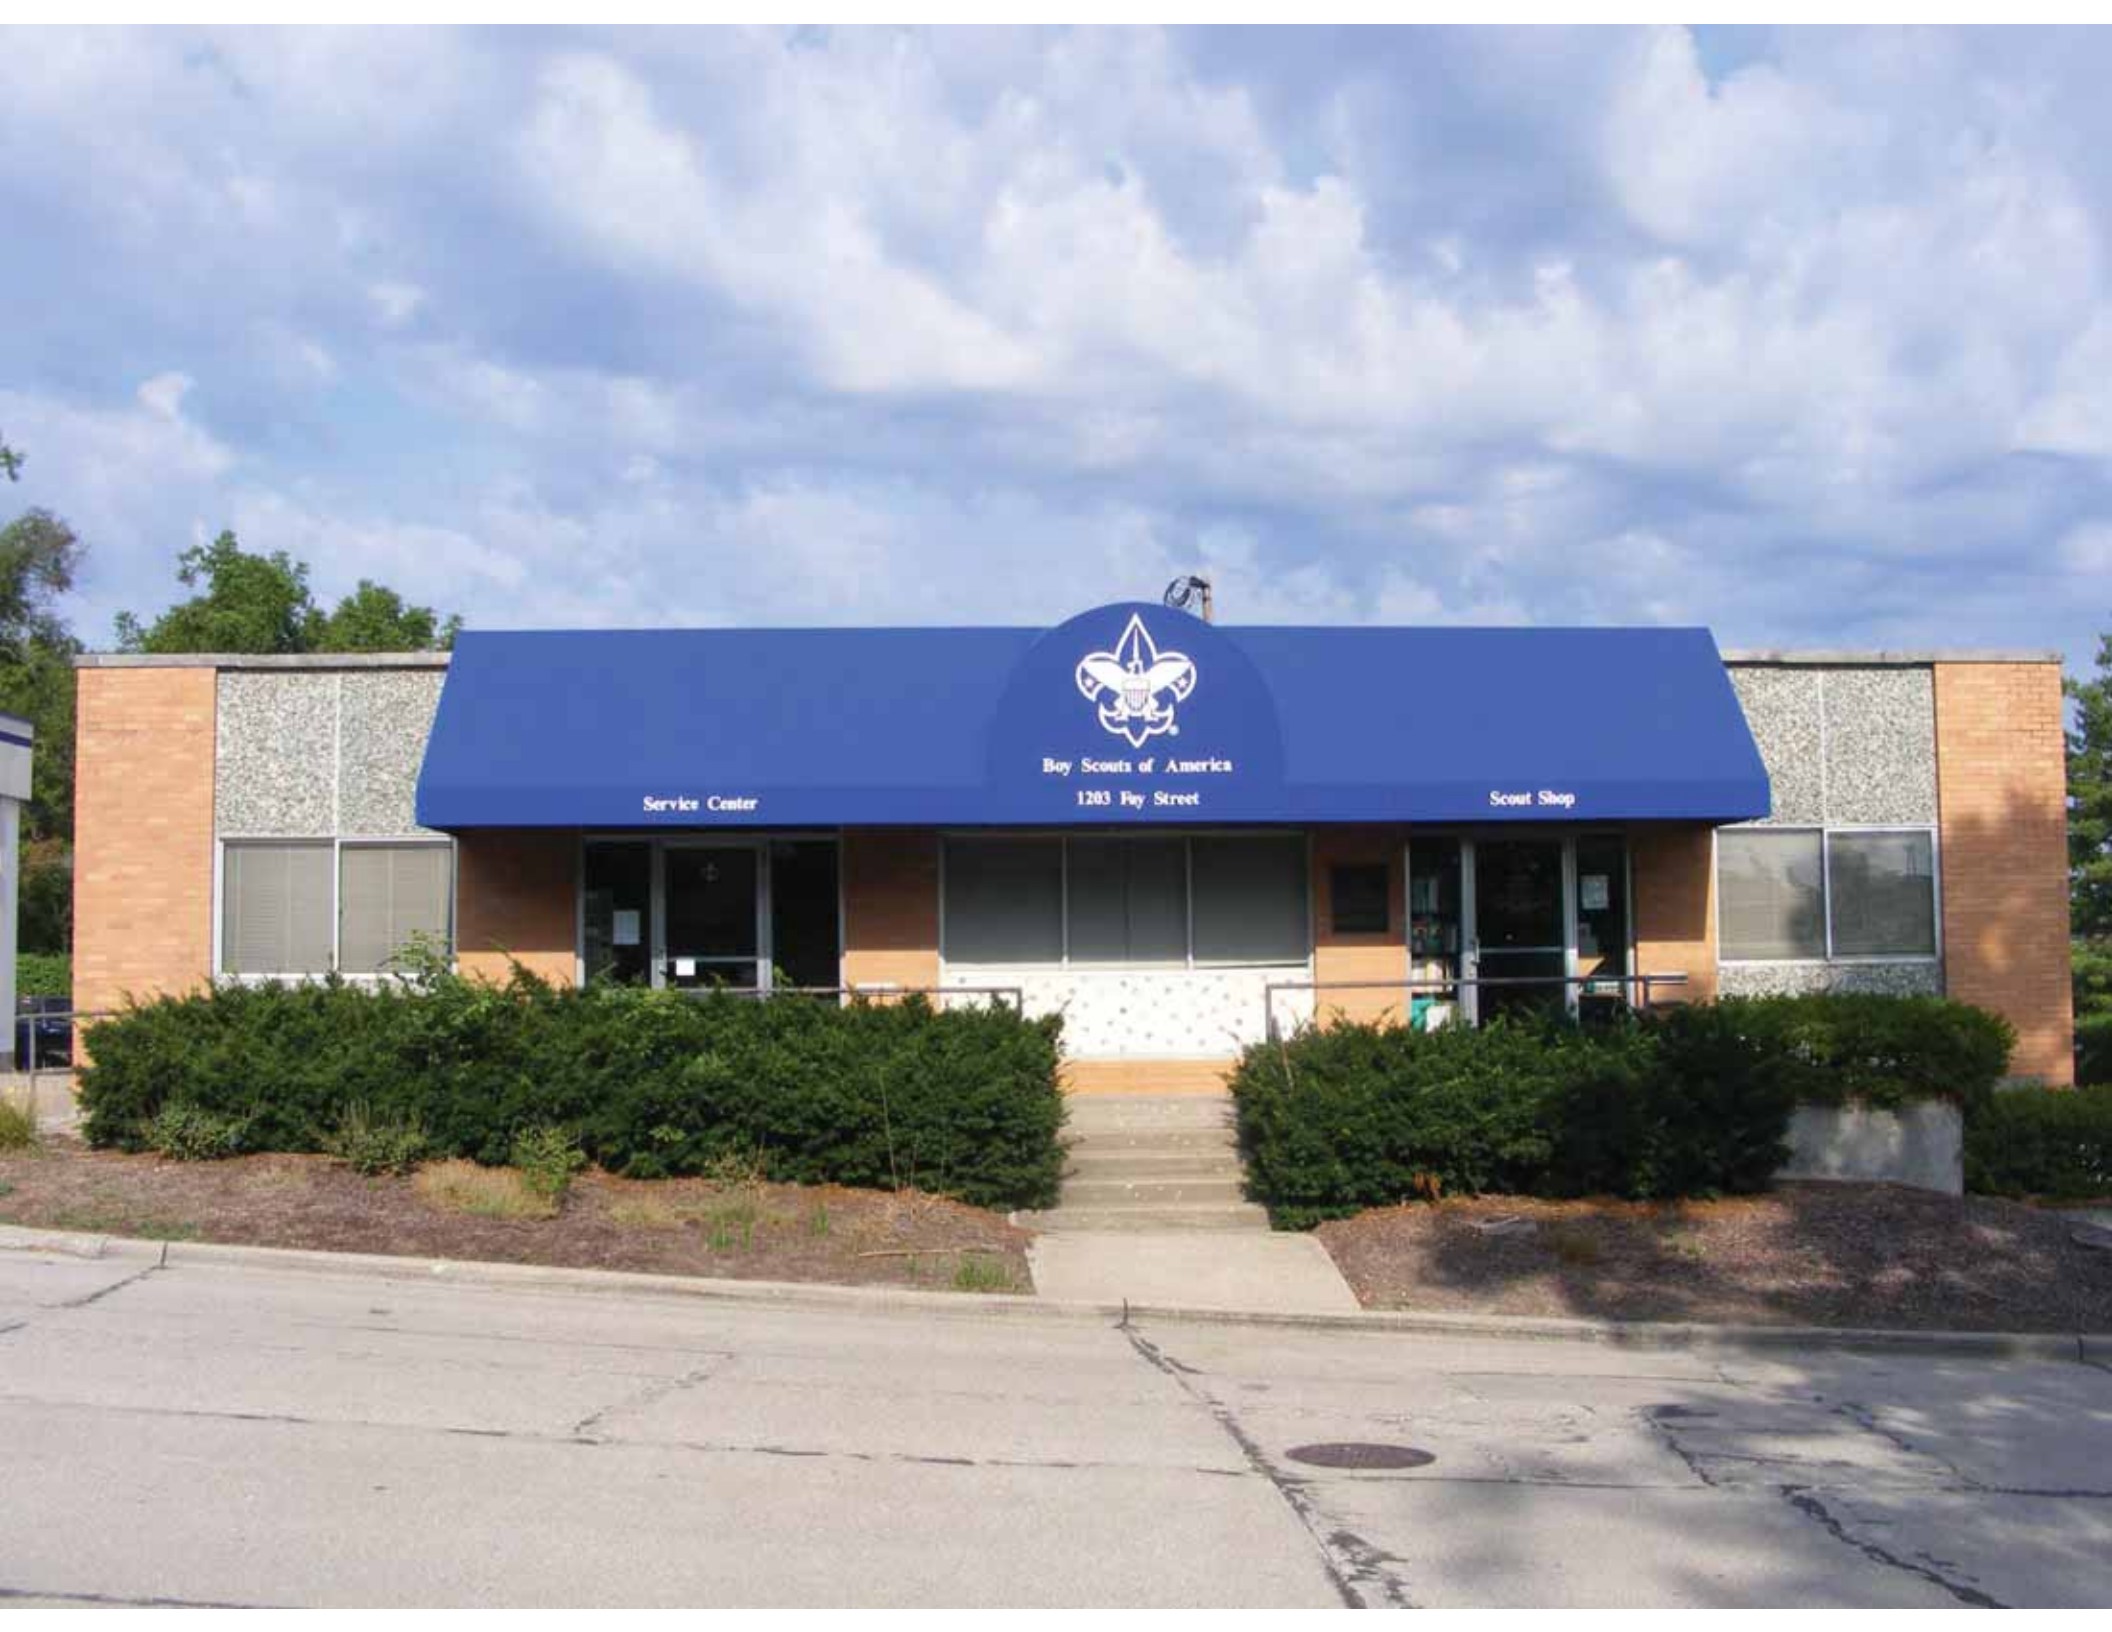
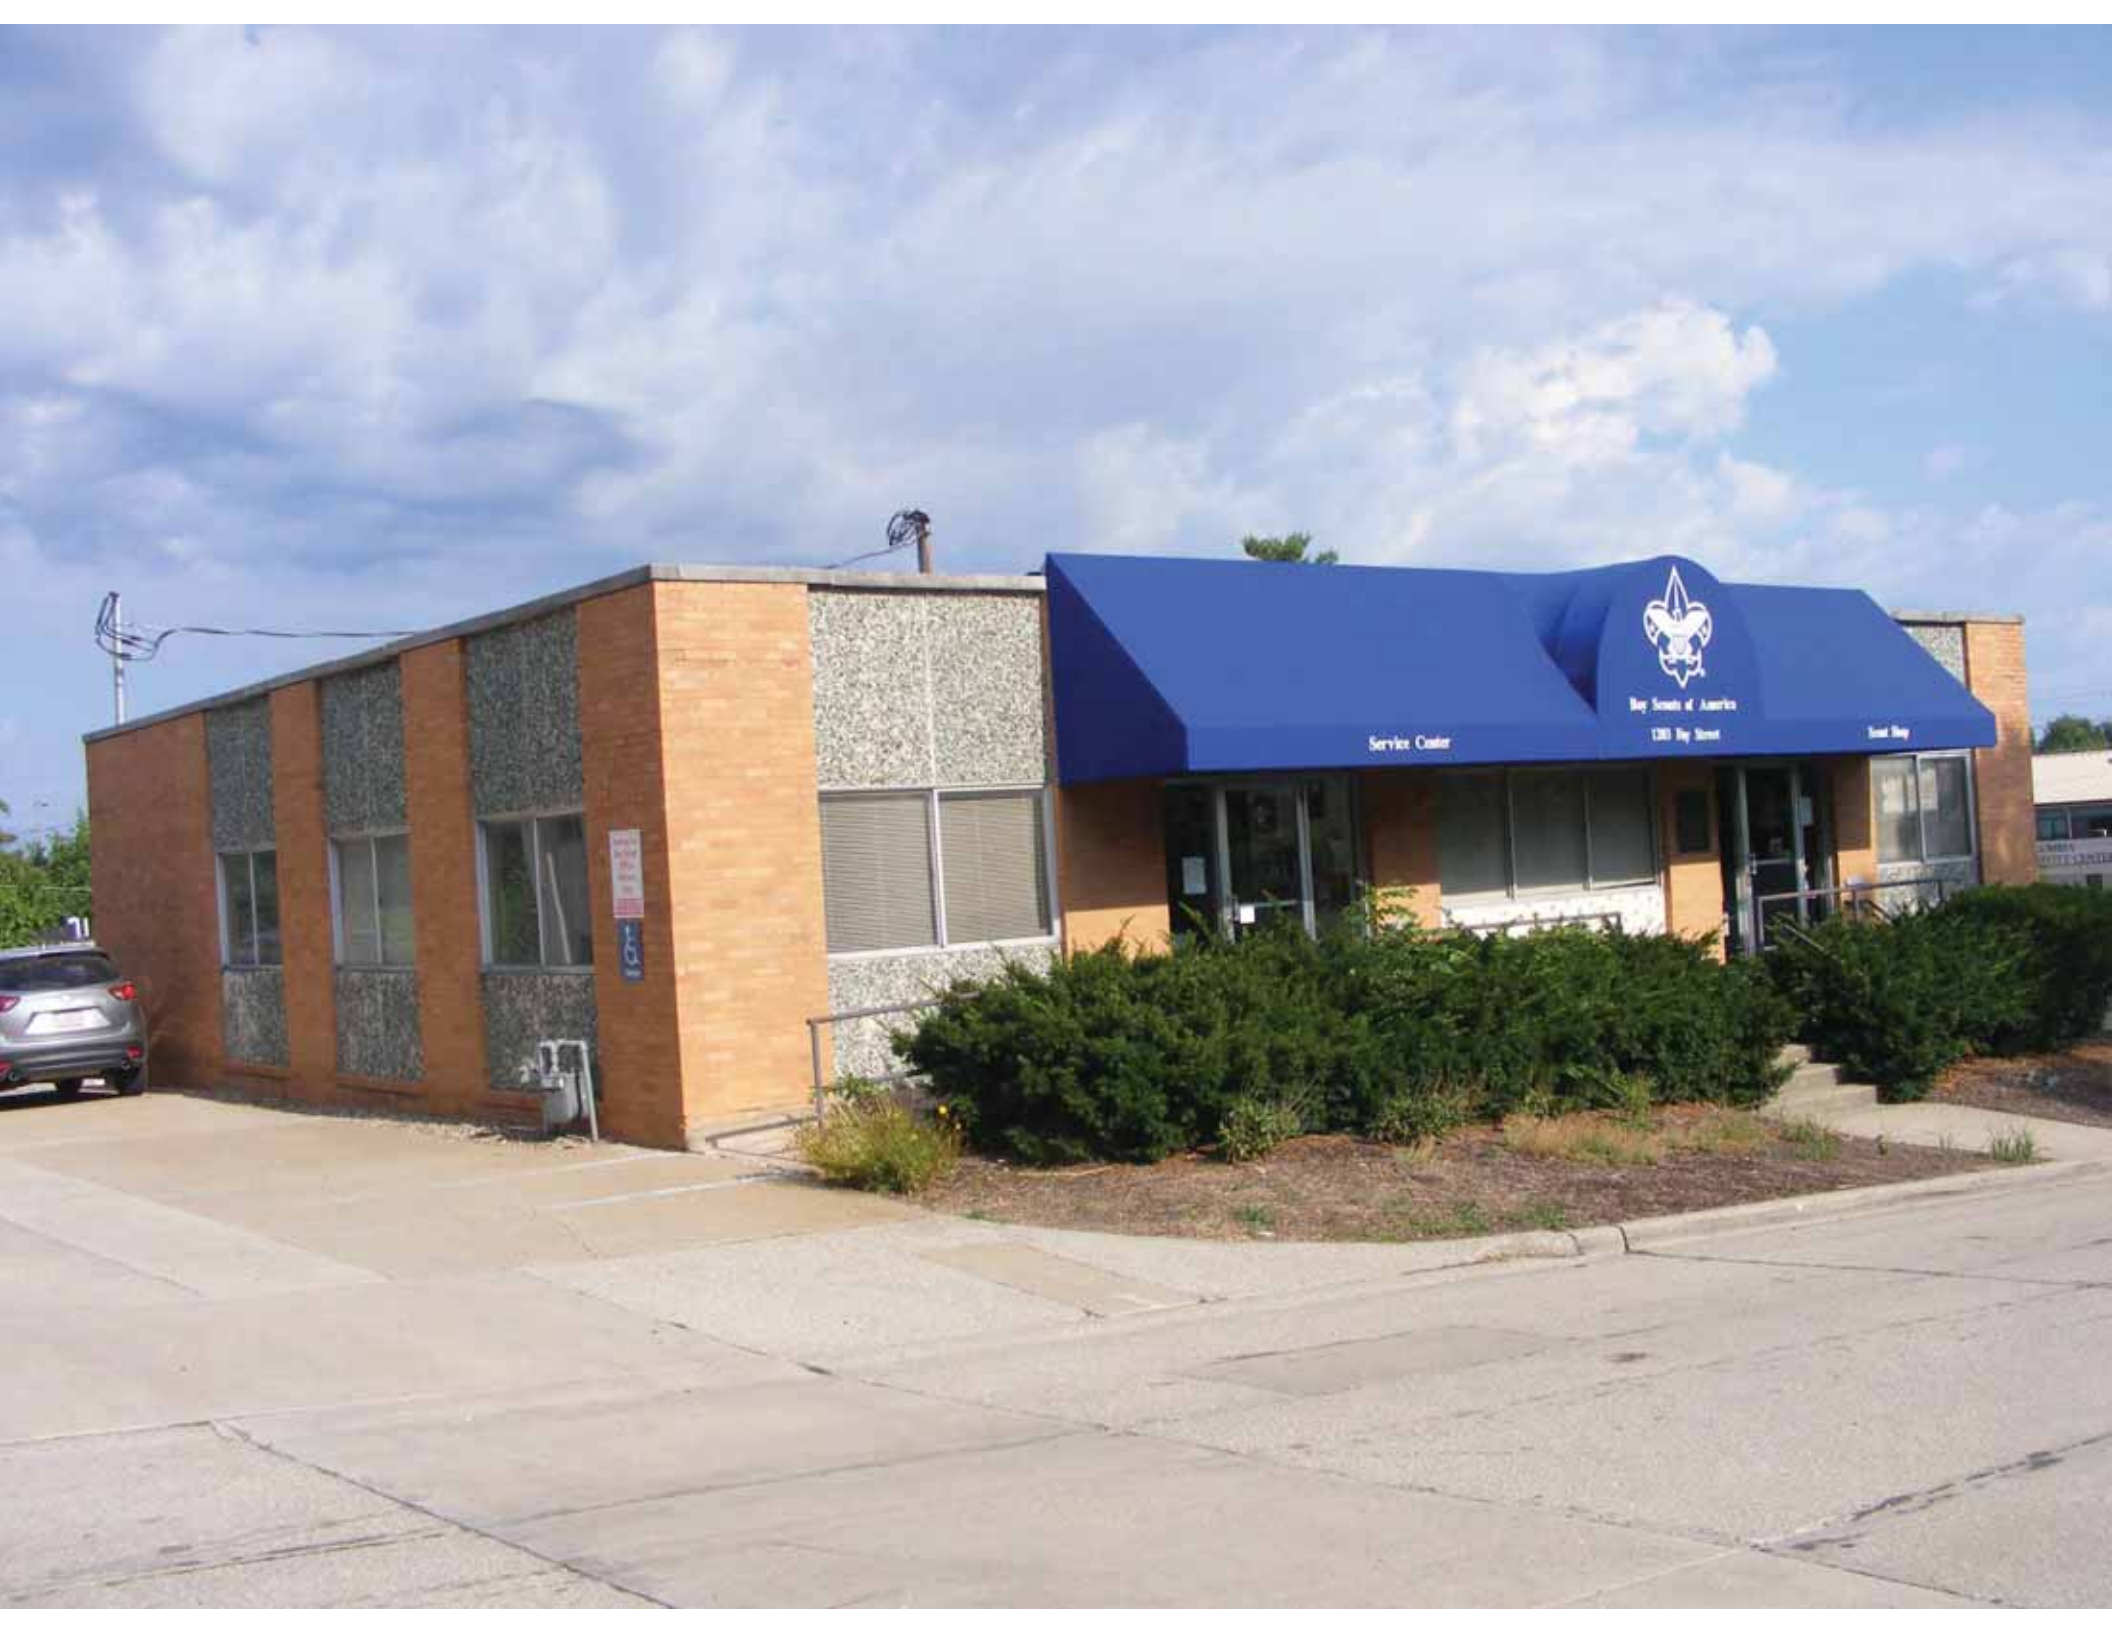
This two-story building has a flat roof and a concrete foundation. Walls are clad with vertical bands of buff brick and what appear to be original precast concrete panels. The bands of precast concrete hold original aluminum framed one-by-one sliding windows (all elevations). The building is banked on the east and south, providing the façade and south elevations with the appearance of a single-story building. A stepped wide concrete wall spans the primary elevation. Between the low wall and the façade is a concrete walk with steps on the north end. The north wall features the building's two-story appearance. The façade features two commercial entry bays near the north and south ends of the elevation. These entrances hold central single-light glass and aluminum doors flanked by single-sash aluminum frame sidelights. Centered on the façade are three original fixed sash aluminum frame windows. A decorative patterned wall below the windows appears original. Offsetting each entry at the north and south ends of the elevation are original paired windows (single-sash). A c. 2000 awning extends above the doors and central windows, bearing the name of the current occupant.
