MISSOURI DEPARTMENT OF NATURAL RESOURCES
STATE HISTORIC PRESERVATION OFFICE, P.O. Box 176, Jefferson City, MO 65102
ARCHITECTURAL/HISTORIC INVENTORY FORM

1. Survey No. BO-AS-011-0087		2. Survey name: North Central Columbia Survey Phase II	
3. County: Boone		4. Address (Street No.) 902	Street (name) N. Seventh Street
5. City: Columbia	Vicinity: <input type="checkbox"/>	6. Geographical Reference:	7. Township/Range/Section: T: R: S:
8. Historic name (if known):		9. Present/other name (if known):	
10. Ownership: <input checked="" type="checkbox"/> Private <input type="checkbox"/> Public		11a. Historic use (if known): Domestic/single dwelling	11b. Current use: Domestic/single dwelling

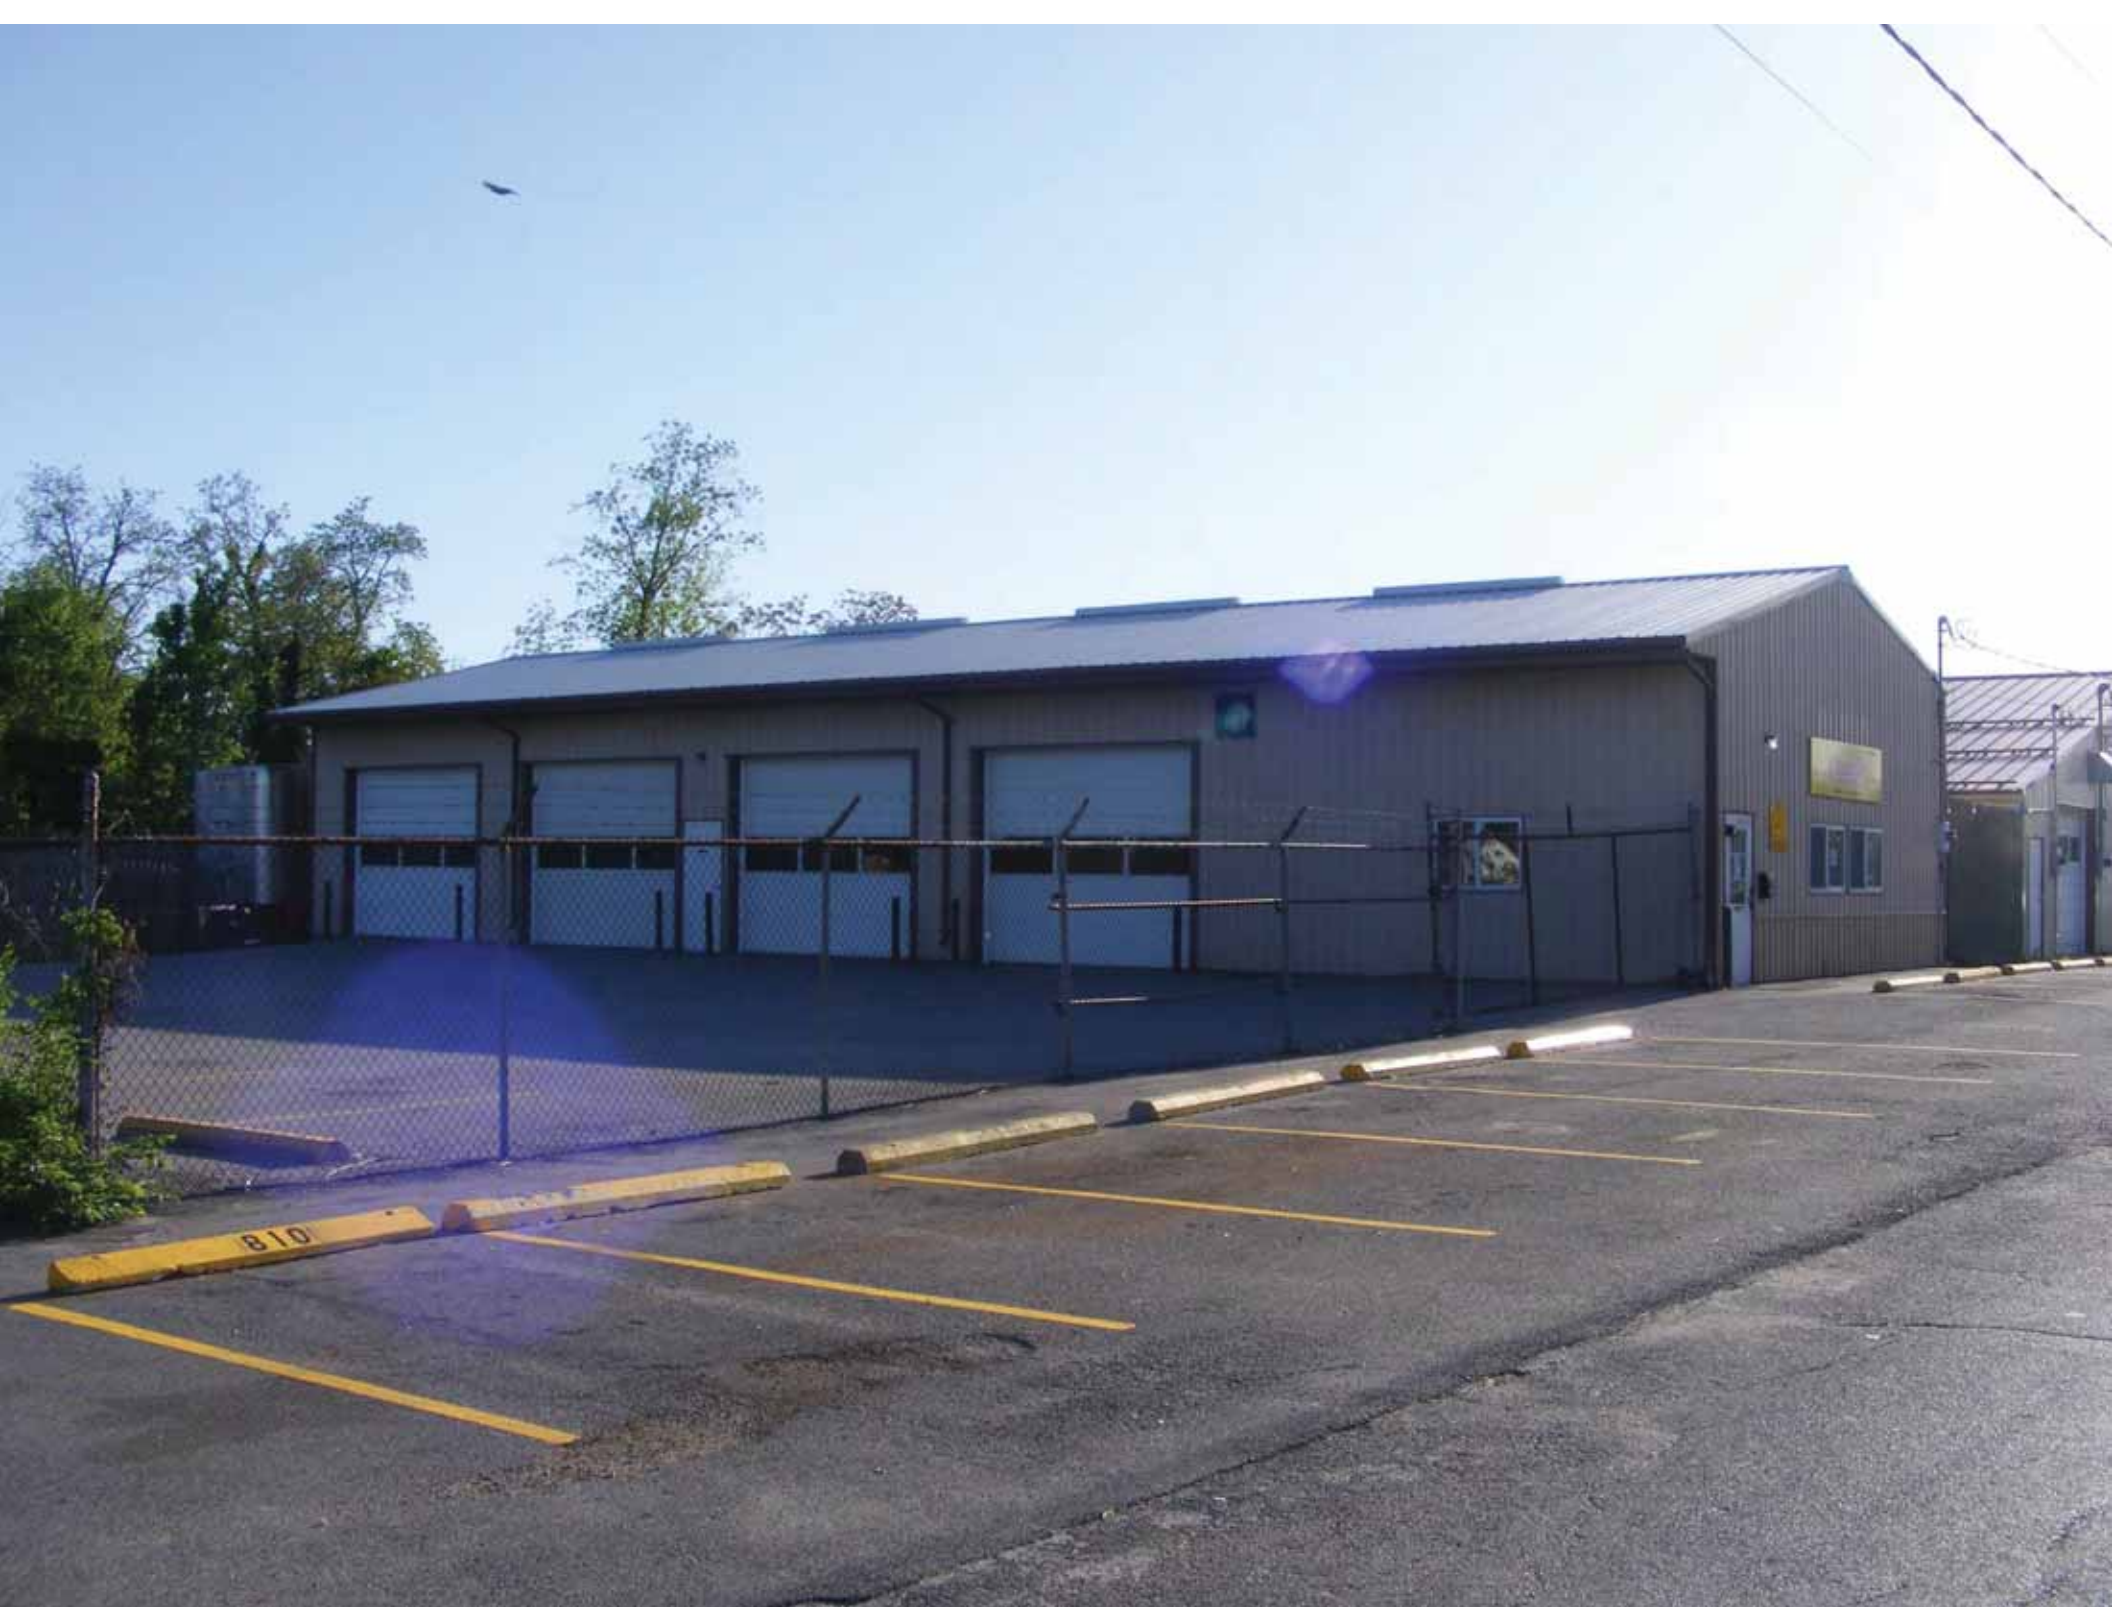
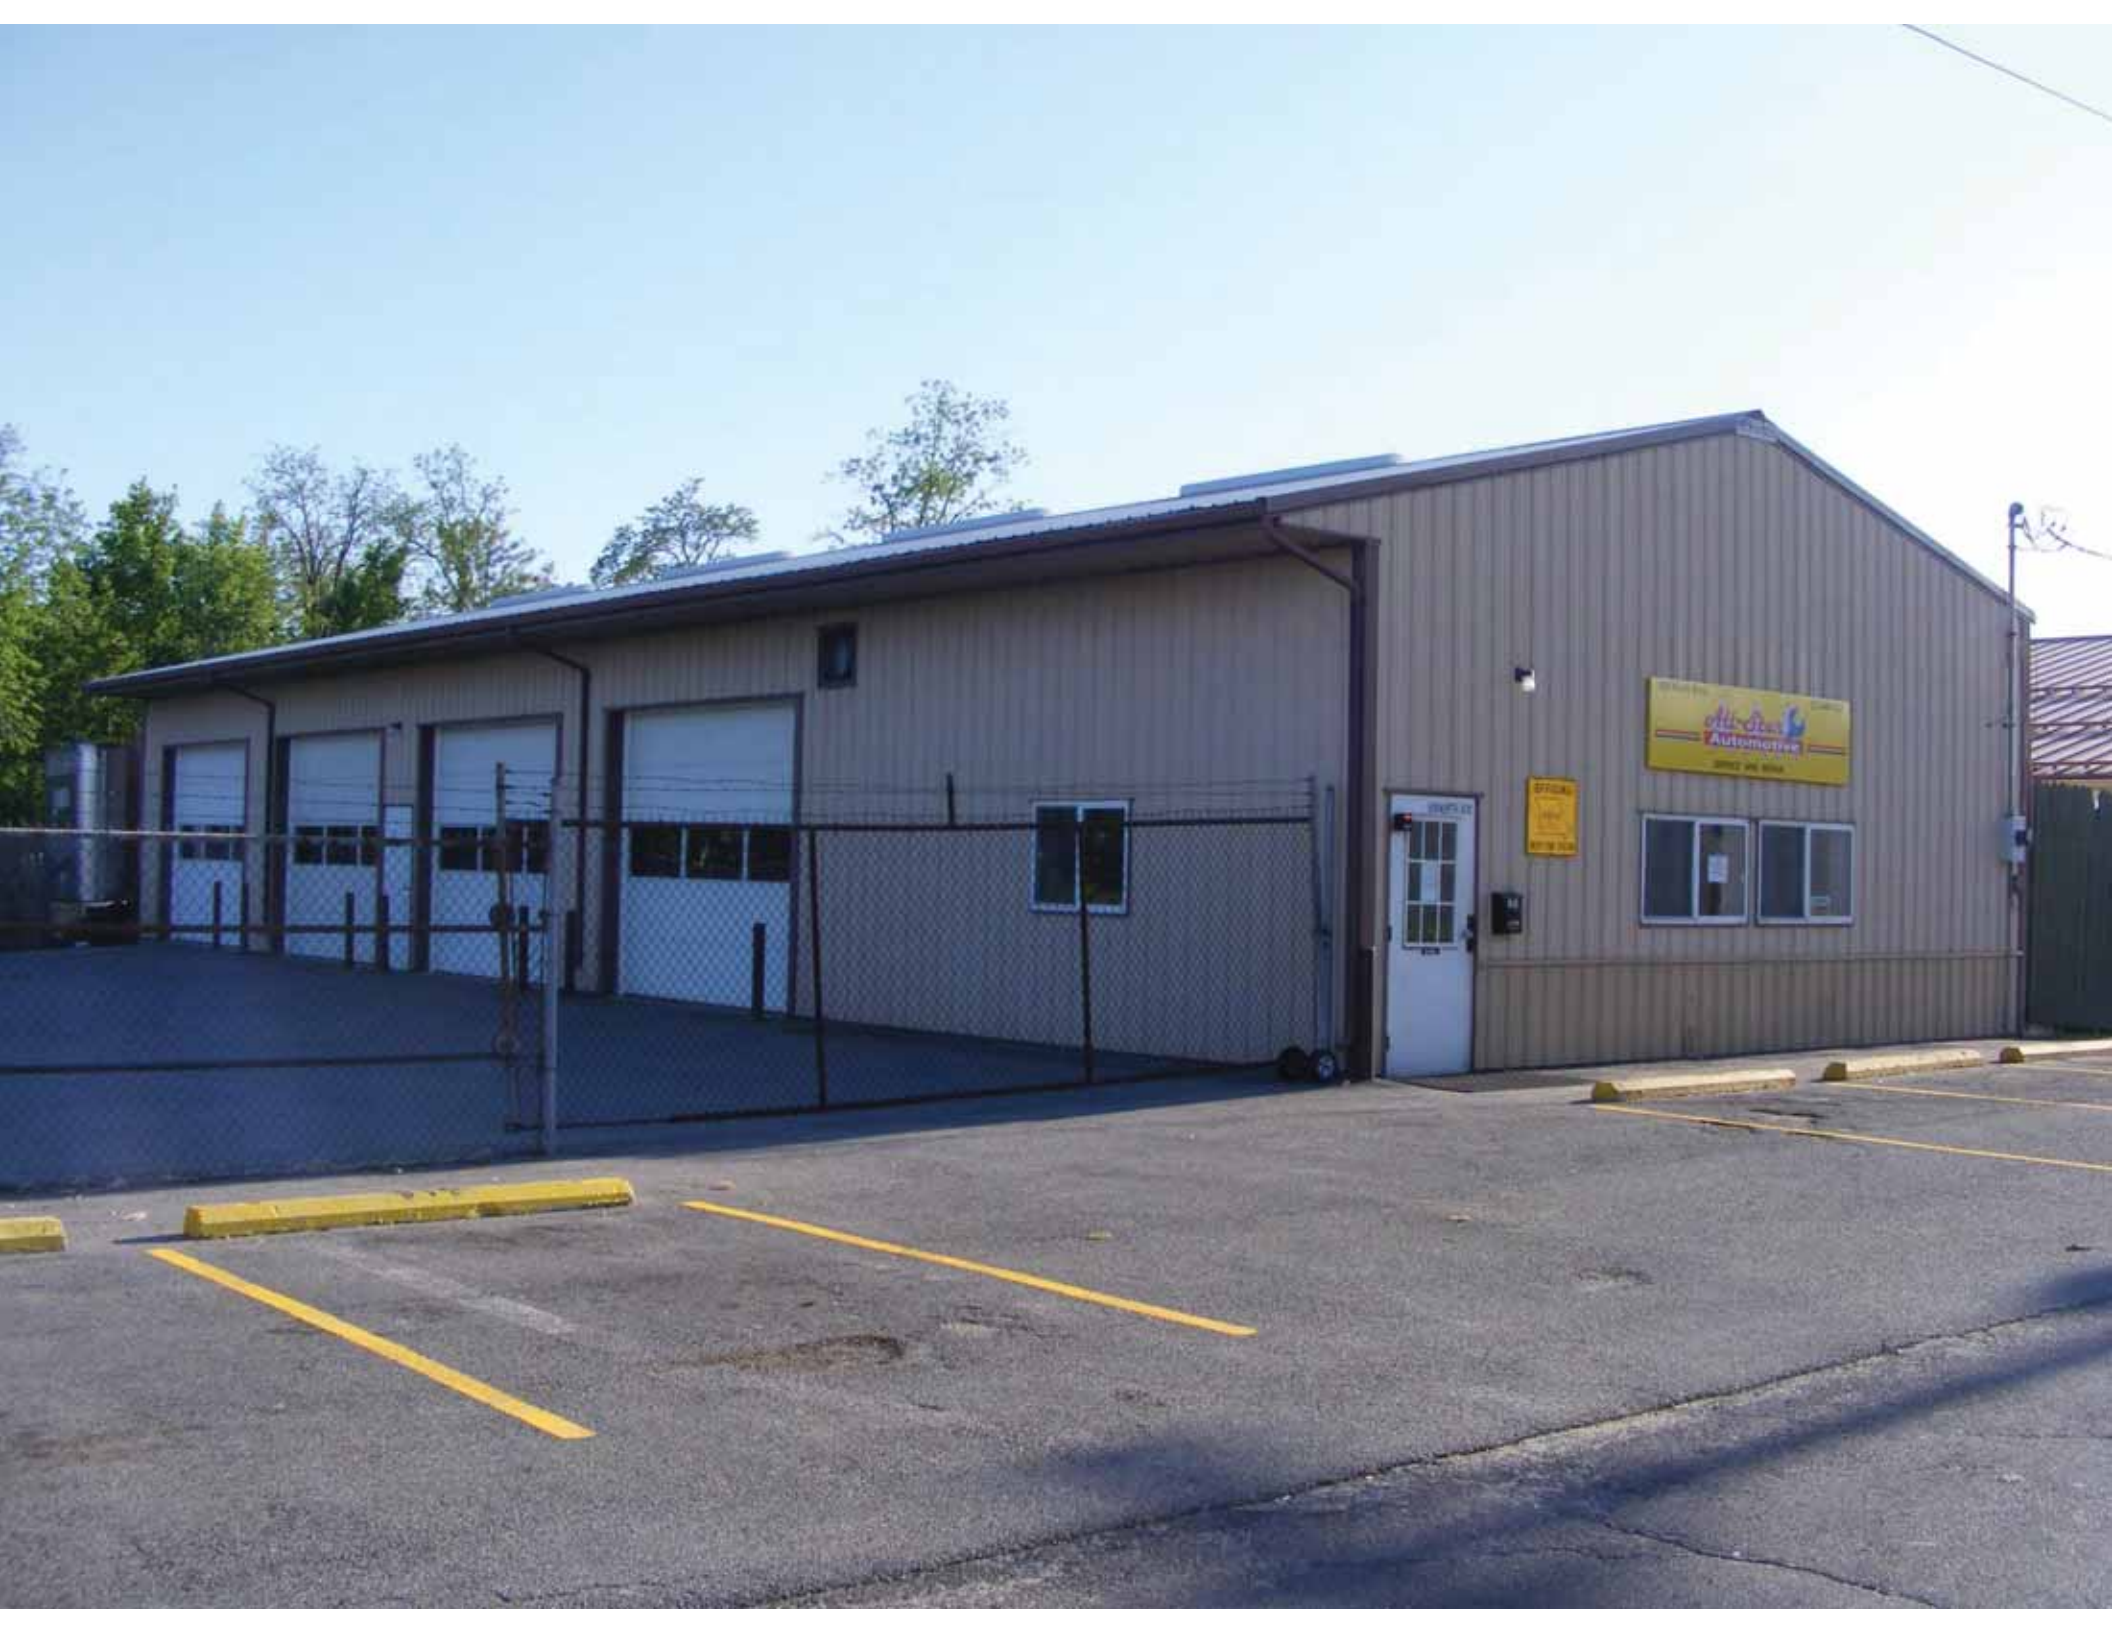
The gabled prefabricated warehouse has a metal roof, ribbed metal walls and a concrete slab foundation. The north elevation serves as the façade with an off-center nine-light paneled door offset by paired two-light sliding windows. The business sign is attached to the wall above the windows. The east elevation holds four overhead track doors with three-light window bands. Offsetting the service bays on the north is a two-light sliding window. There was no access to the west and south elevations.

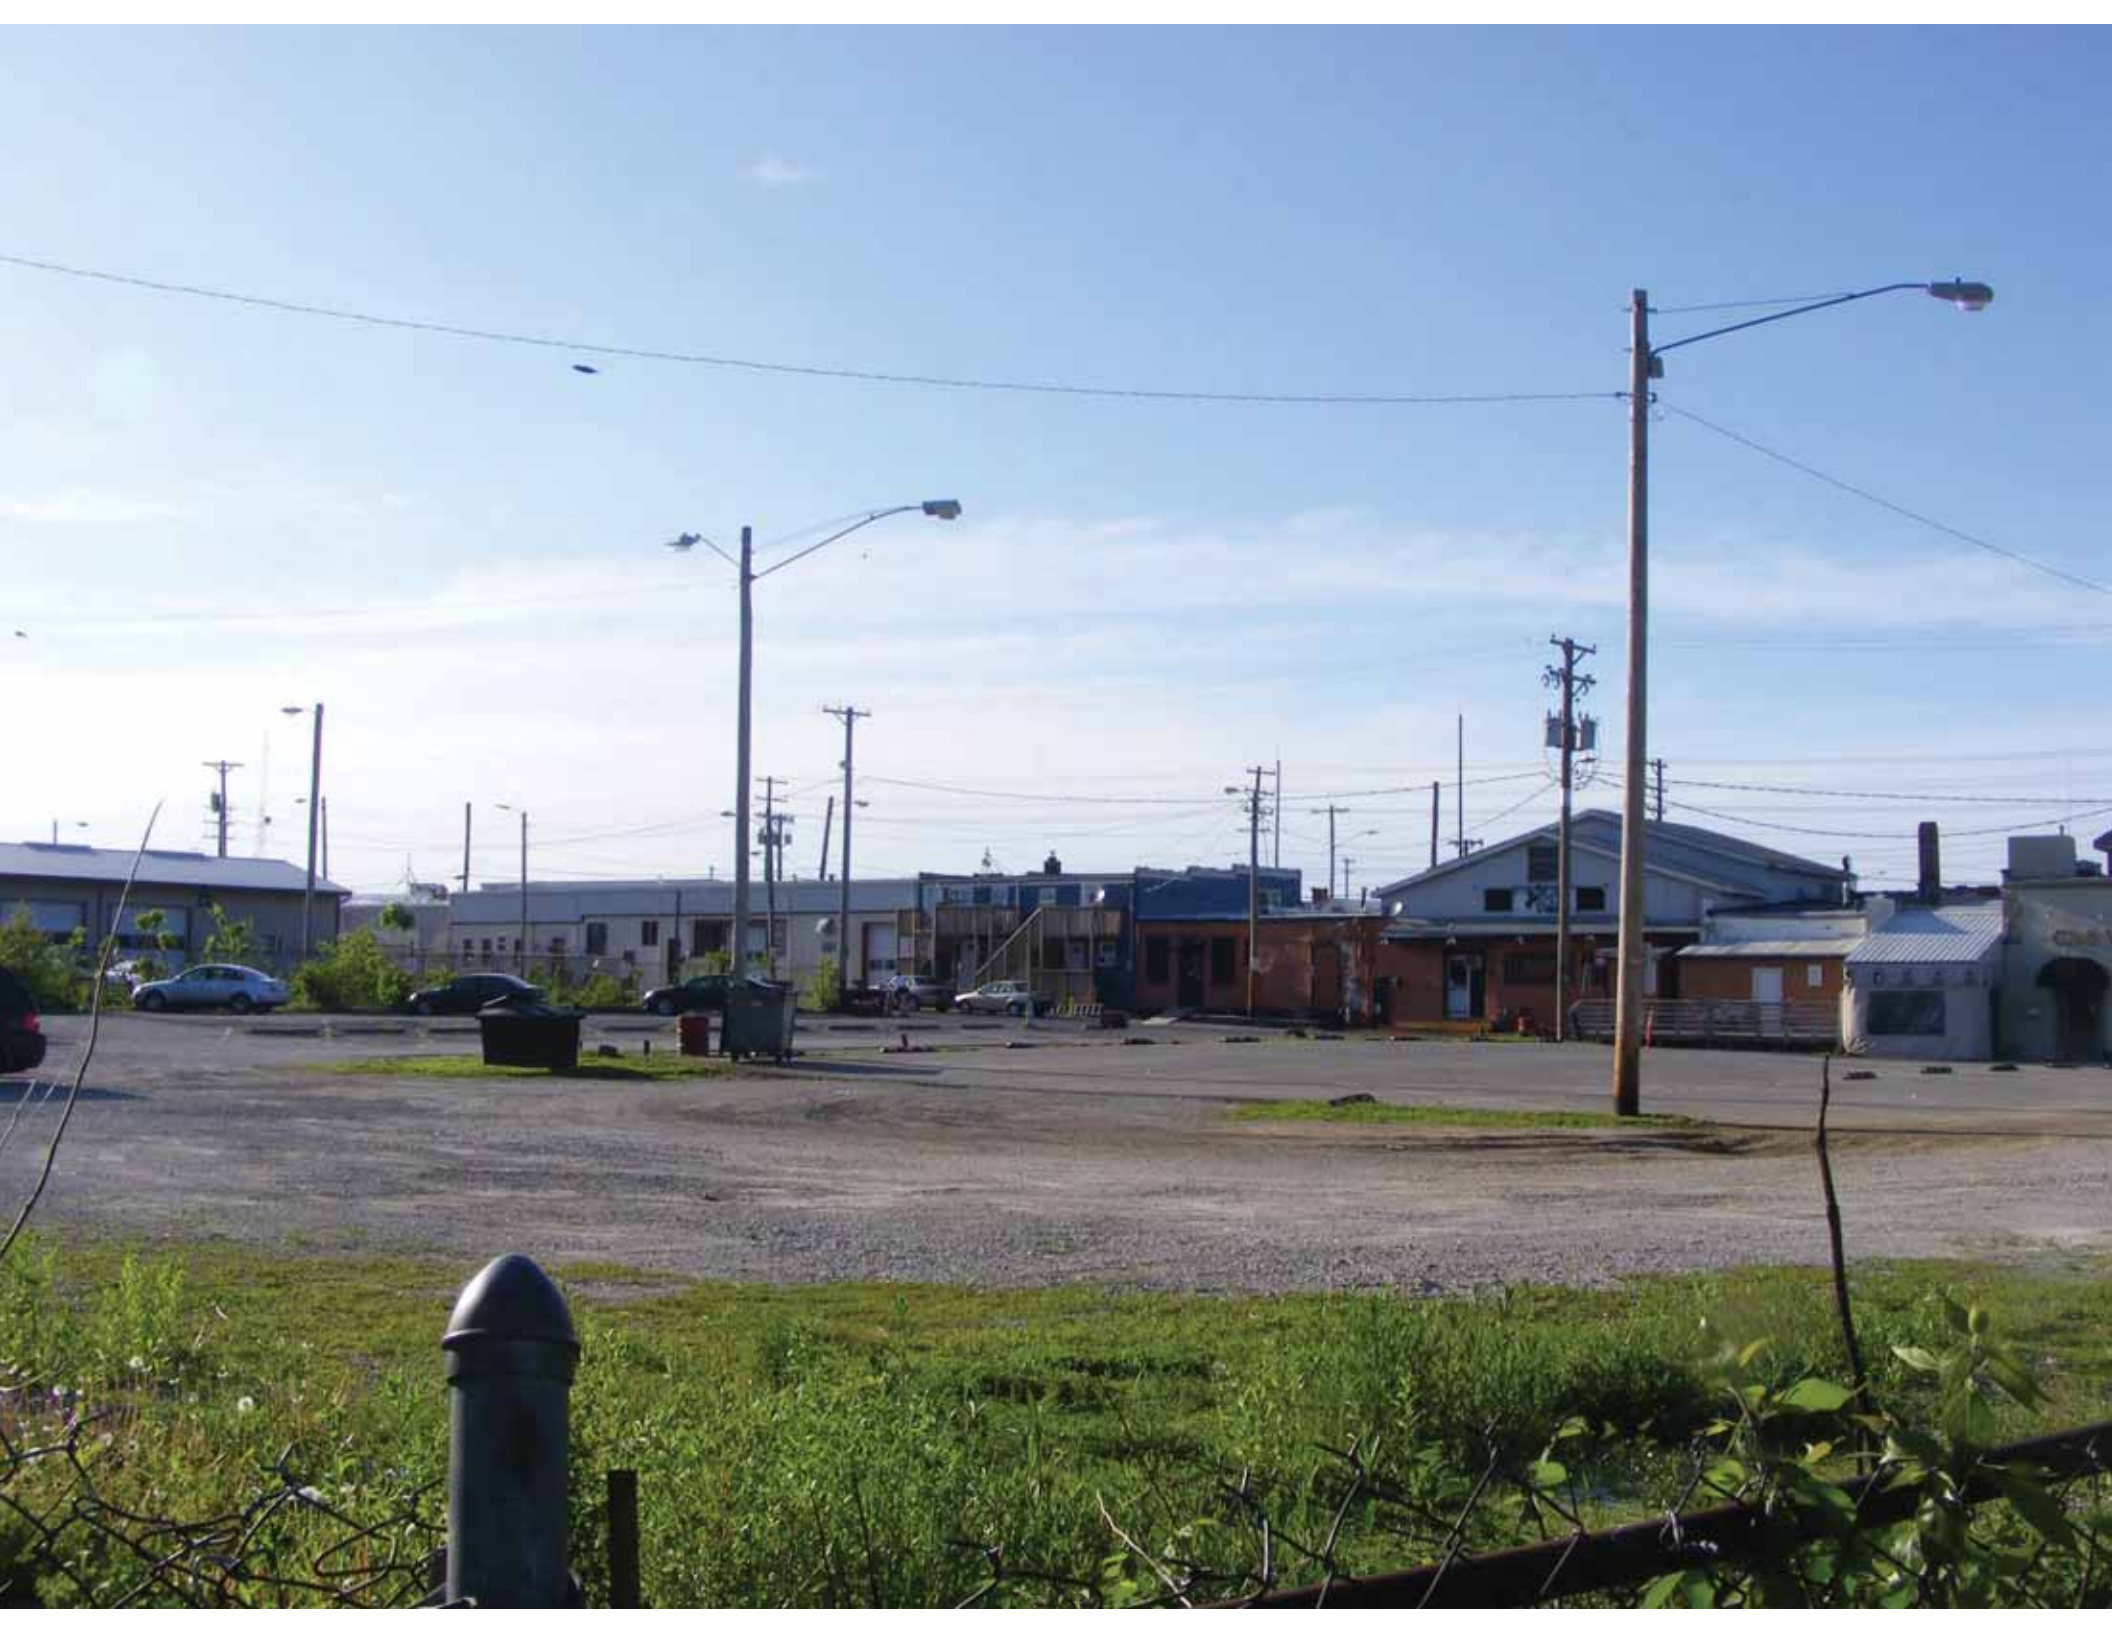
This 0.76 L-shaped parking lot is as described above – paved with asphalt and marked with paint to provide individual parking spaces.

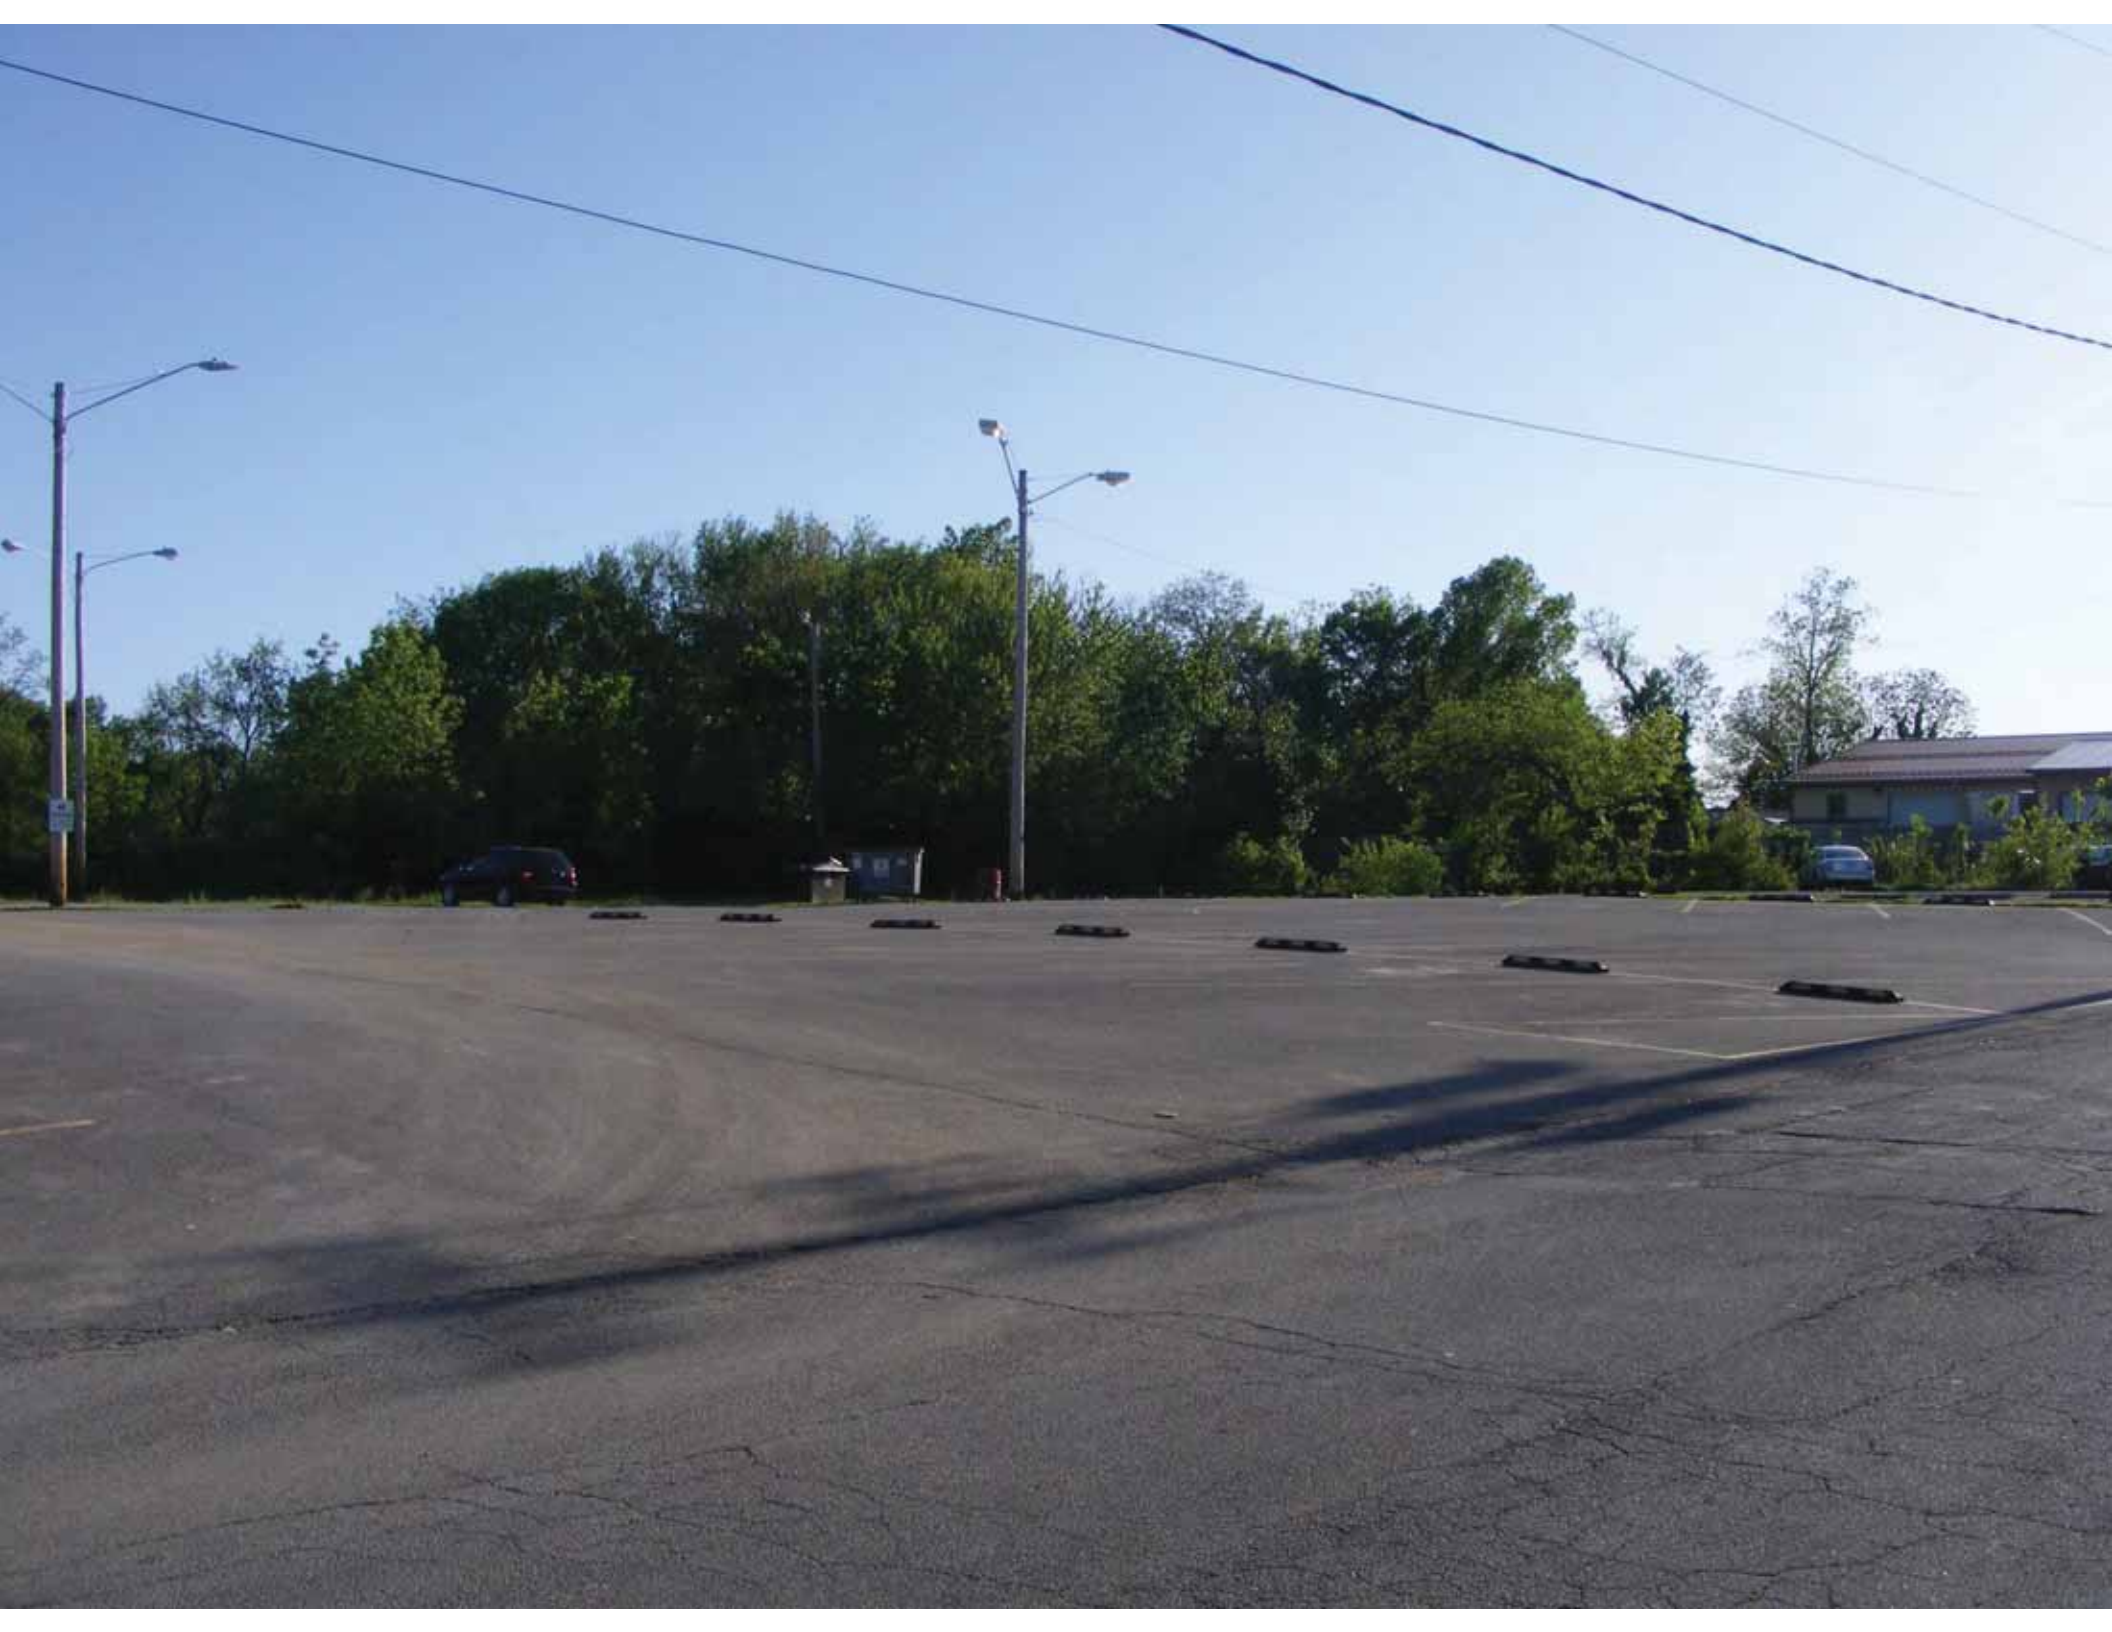
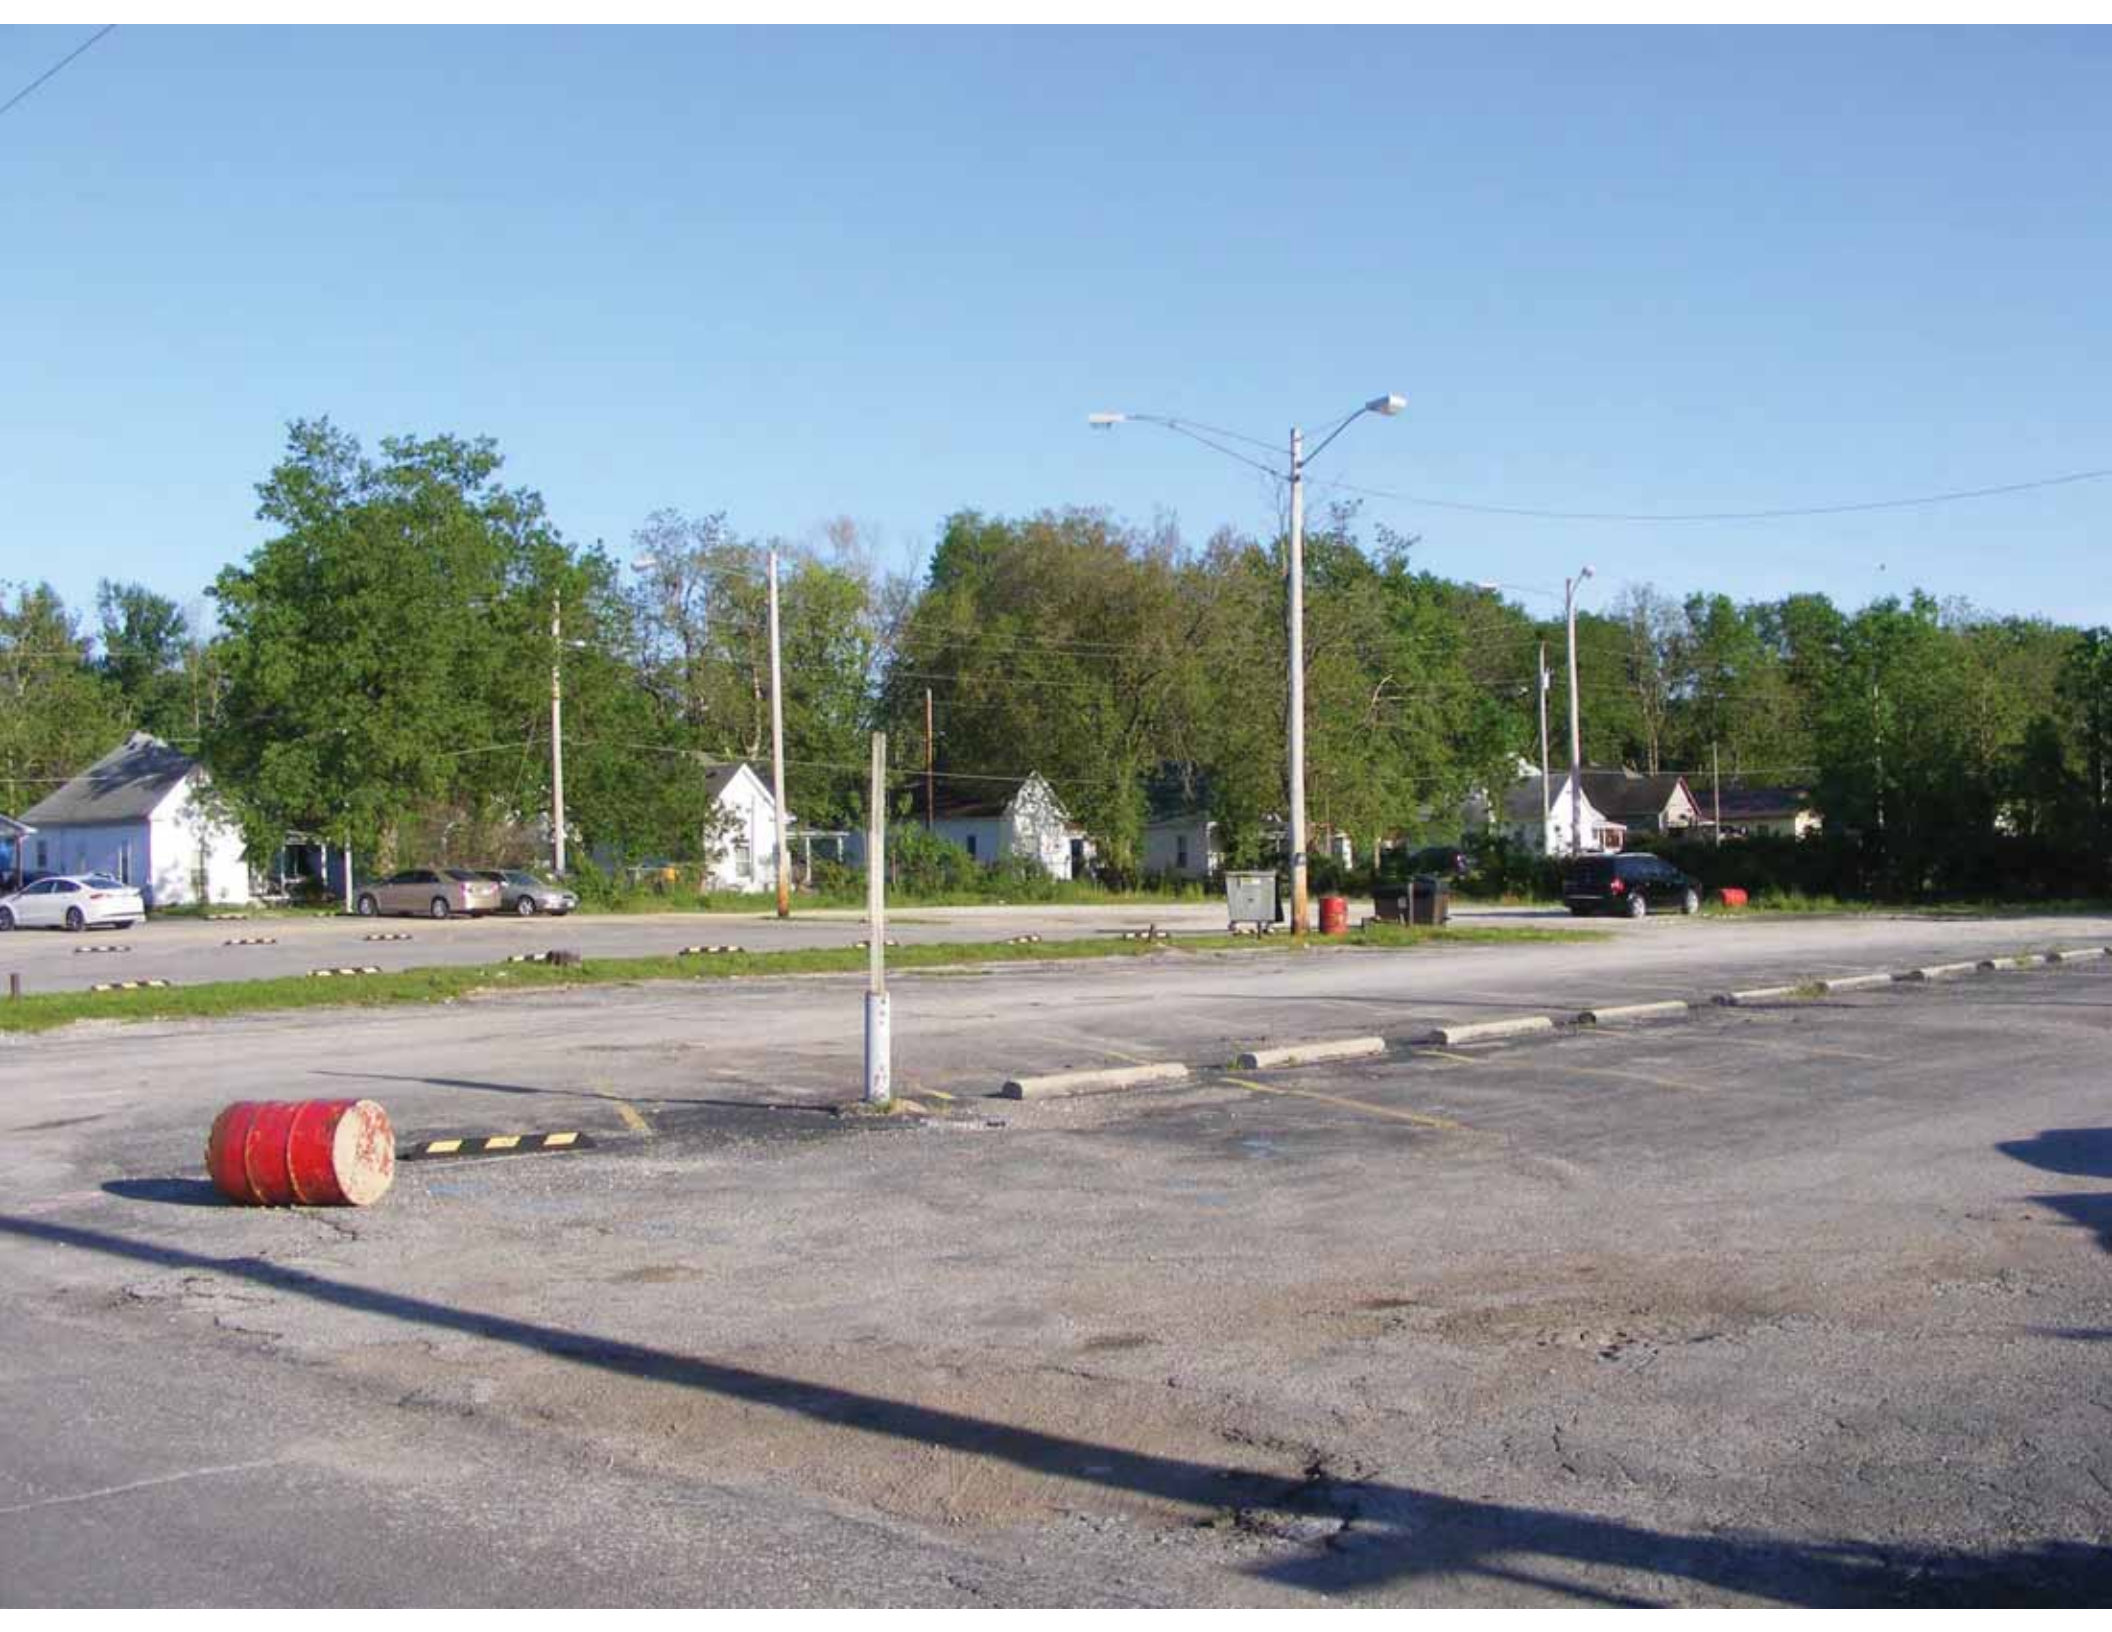
This 0.36 parking lot is as described above – paved with asphalt and marked with paint to provide individual parking spaces.
