MISSOURI DEPARTMENT OF NATURAL RESOURCES
STATE HISTORIC PRESERVATION OFFICE, P.O. Box 176, Jefferson City, MO 65102
ARCHITECTURAL/HISTORIC INVENTORY FORM

1. Survey No. BO-AS-011-0087		2. Survey name: North Central Columbia Survey Phase II	
3. County: Boone		4. Address (Street No.) 902	Street (name) N. Seventh Street
5. City: Columbia	Vicinity: <input type="checkbox"/>	6. Geographical Reference:	7. Township/Range/Section: T: R: S:
8. Historic name (if known):		9. Present/other name (if known):	
10. Ownership: <input checked="" type="checkbox"/> Private <input type="checkbox"/> Public		11a. Historic use (if known): Domestic/single dwelling	11b. Current use: Domestic/single dwelling

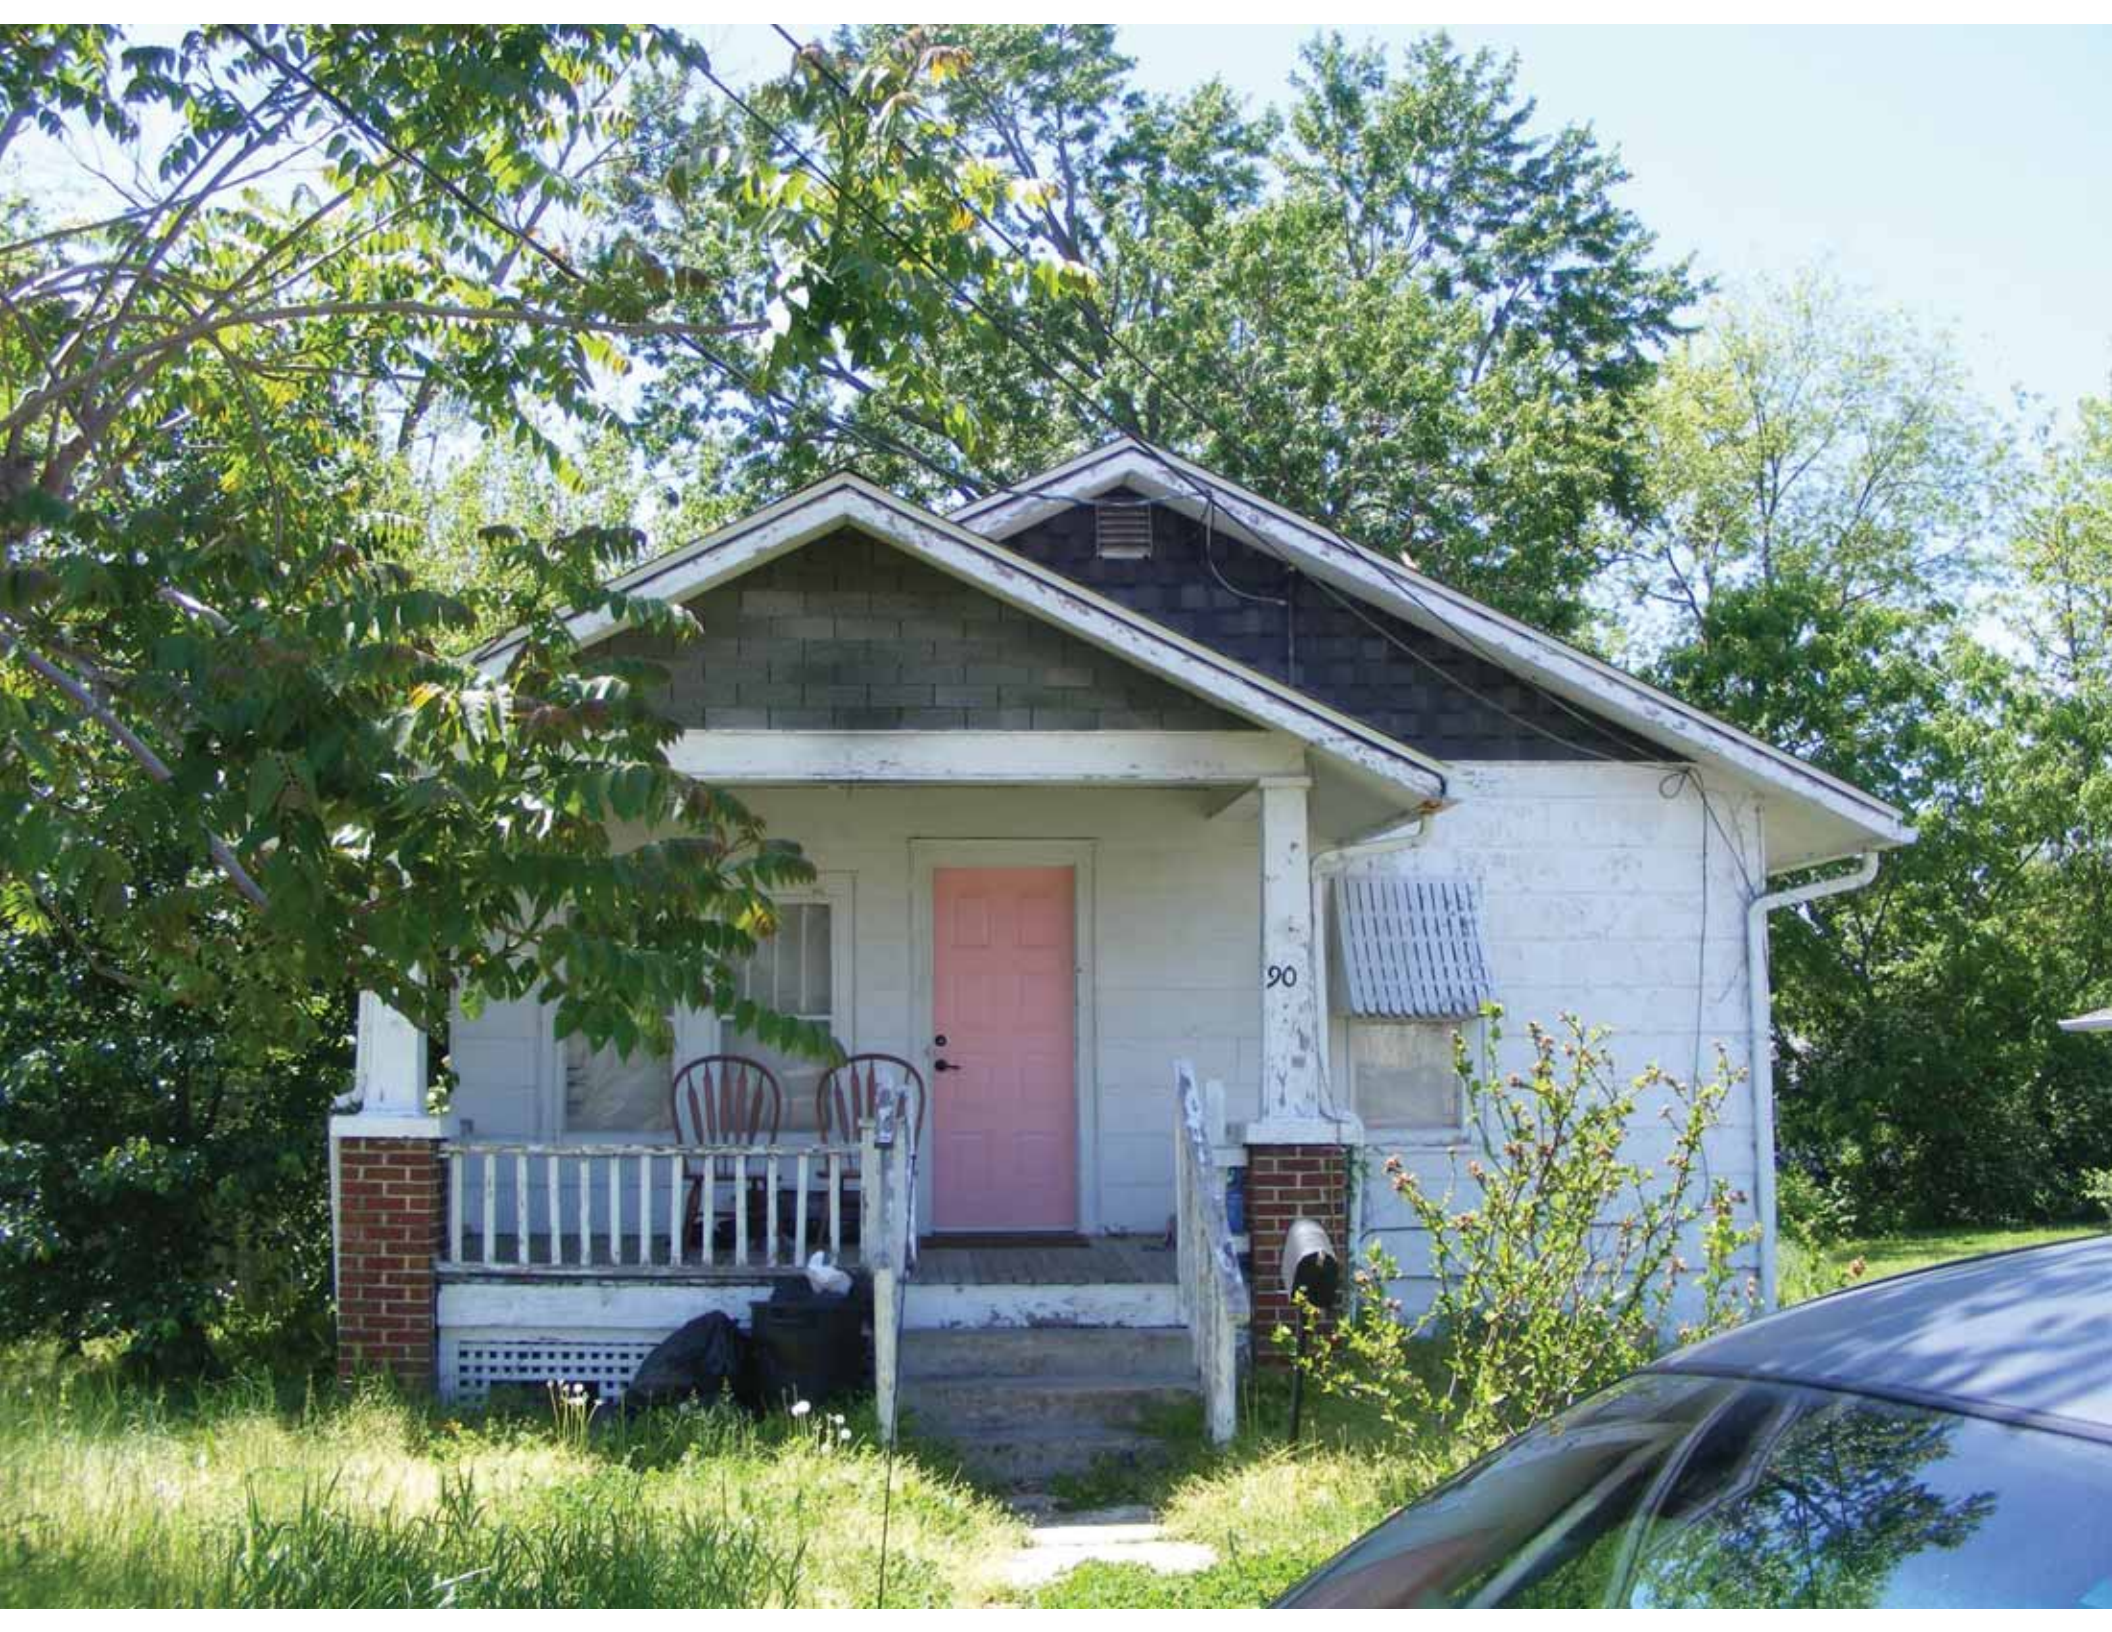
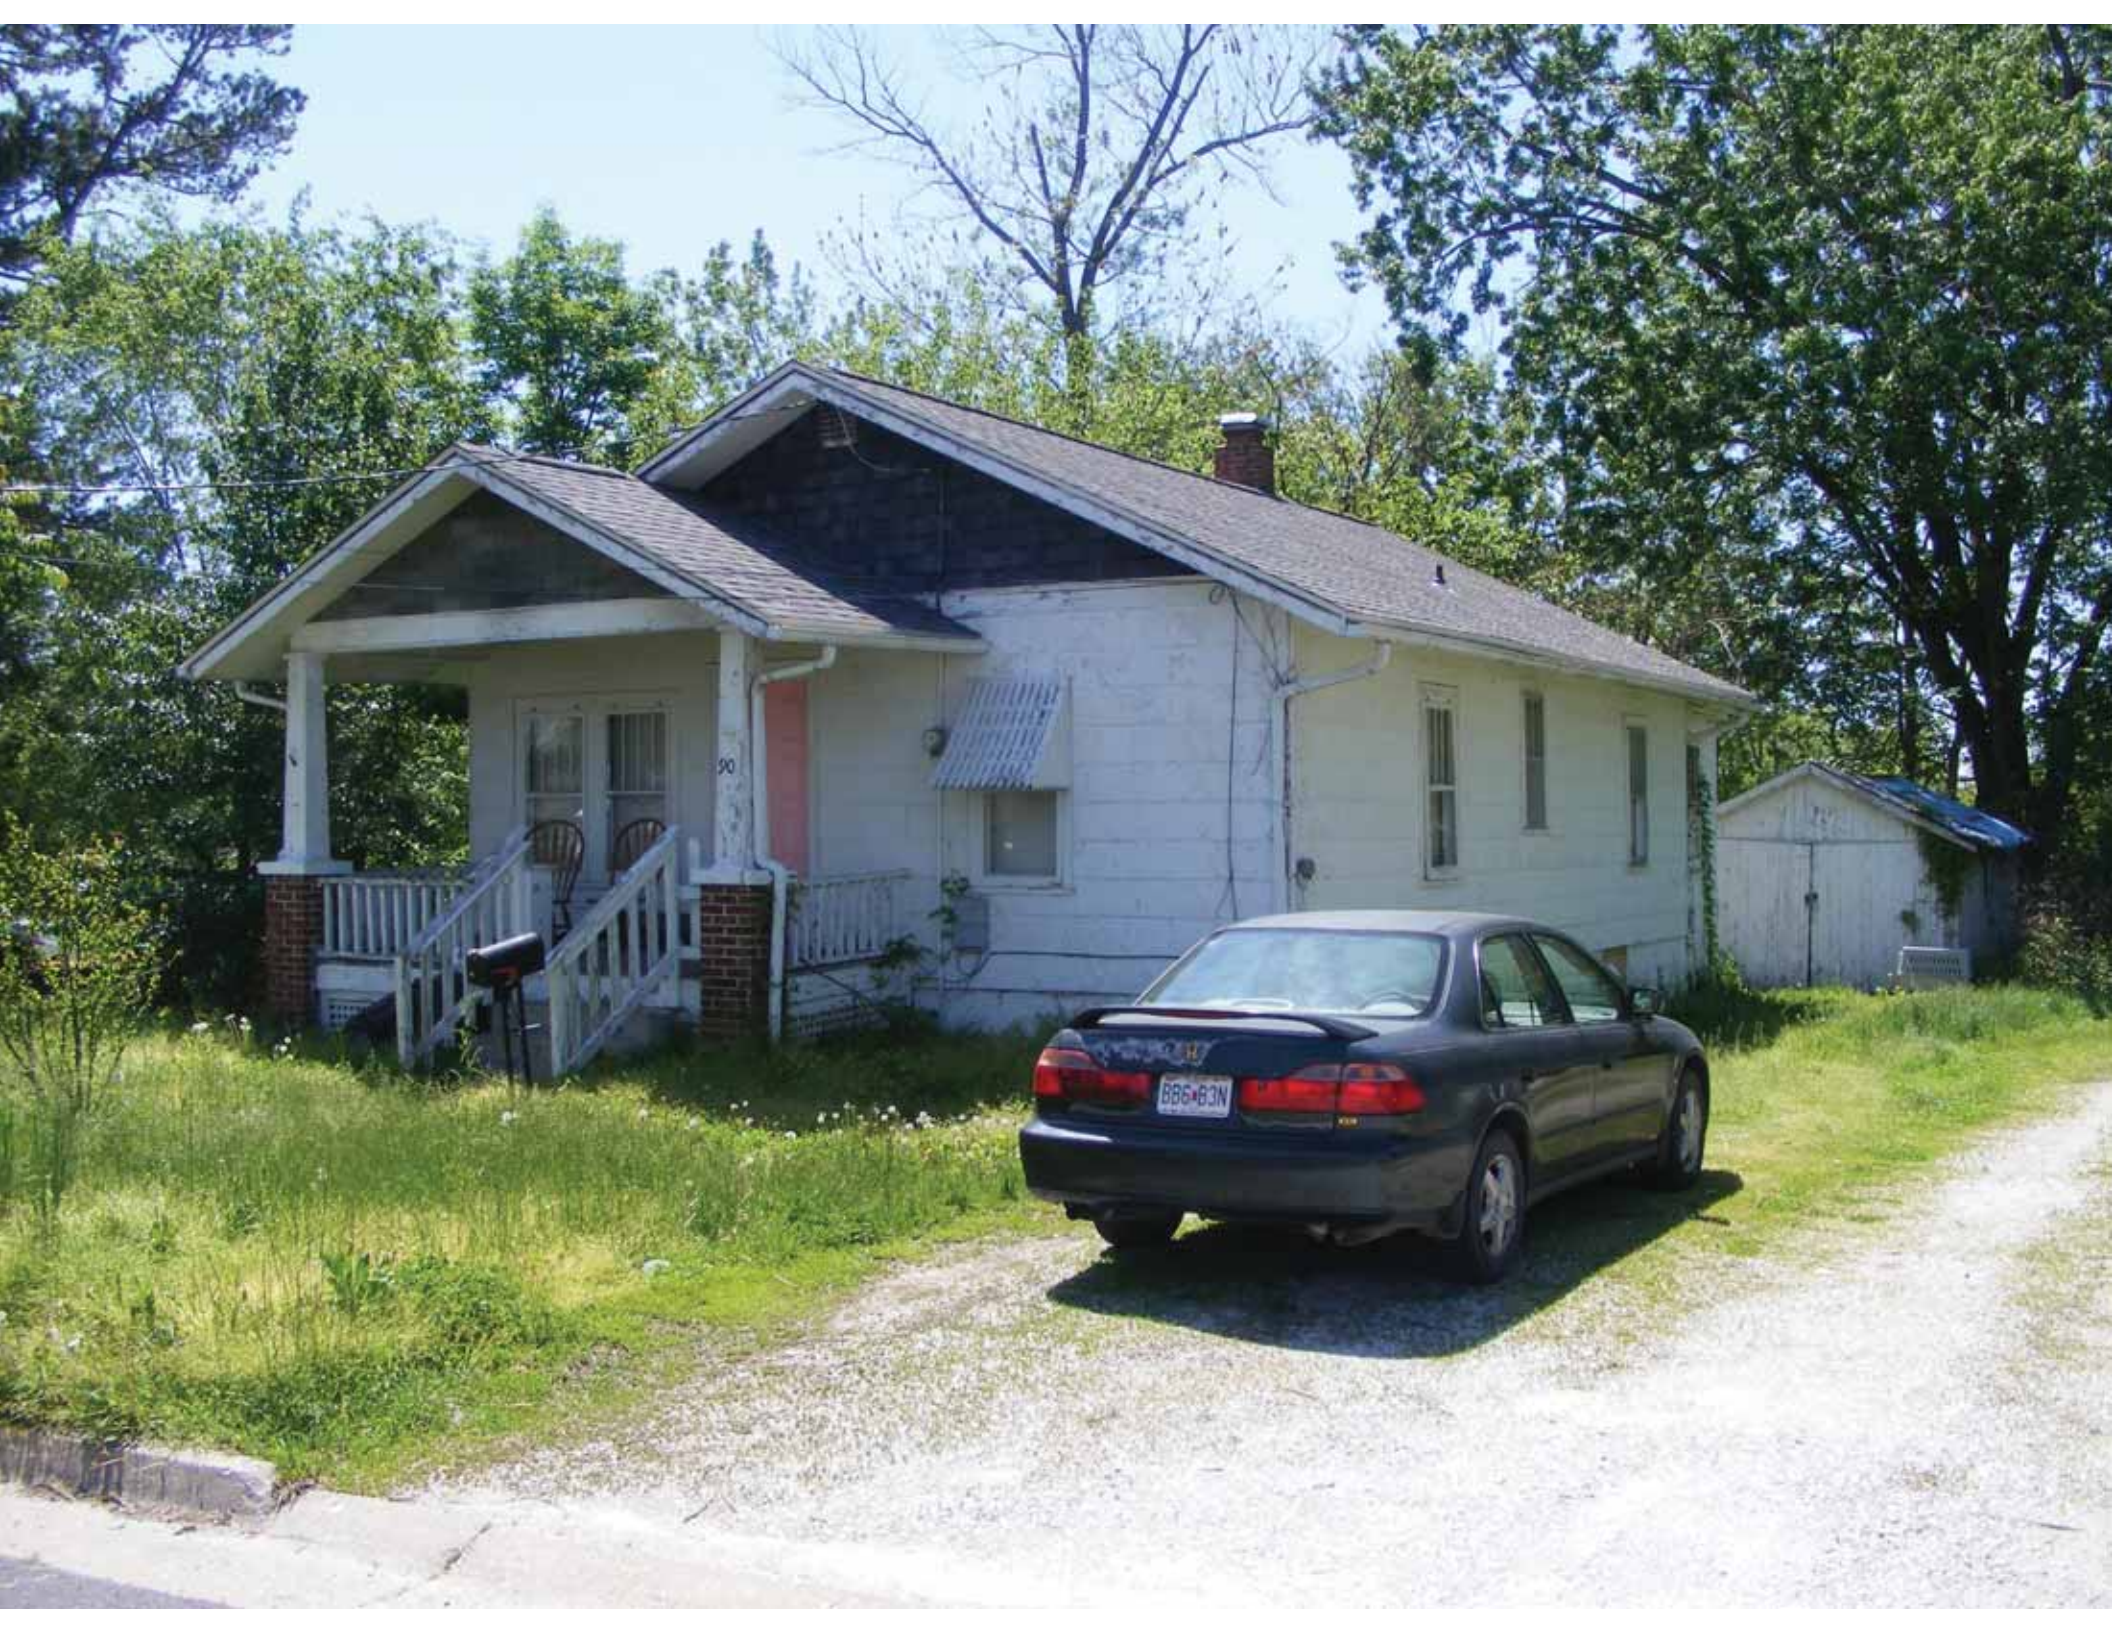
41. (cont.) Description of primary resource. Expand box as necessary, or add continuation pages.
The dwelling is a one story asphalt shingled front-gabled roof, exterior wide wood siding, and a concrete foundation. The façade holds a lower front gable open porch with wood decking, railings, tapered columns with brick piers. Porch bay area holds an off-centered entrance offset to the left by paired four-over-one craftsman style window. To the right of the entrance is a window with a metal awning. Gable ends are clad in asphalt shingles. Side elevations feature four-over-one craftsman style windows.

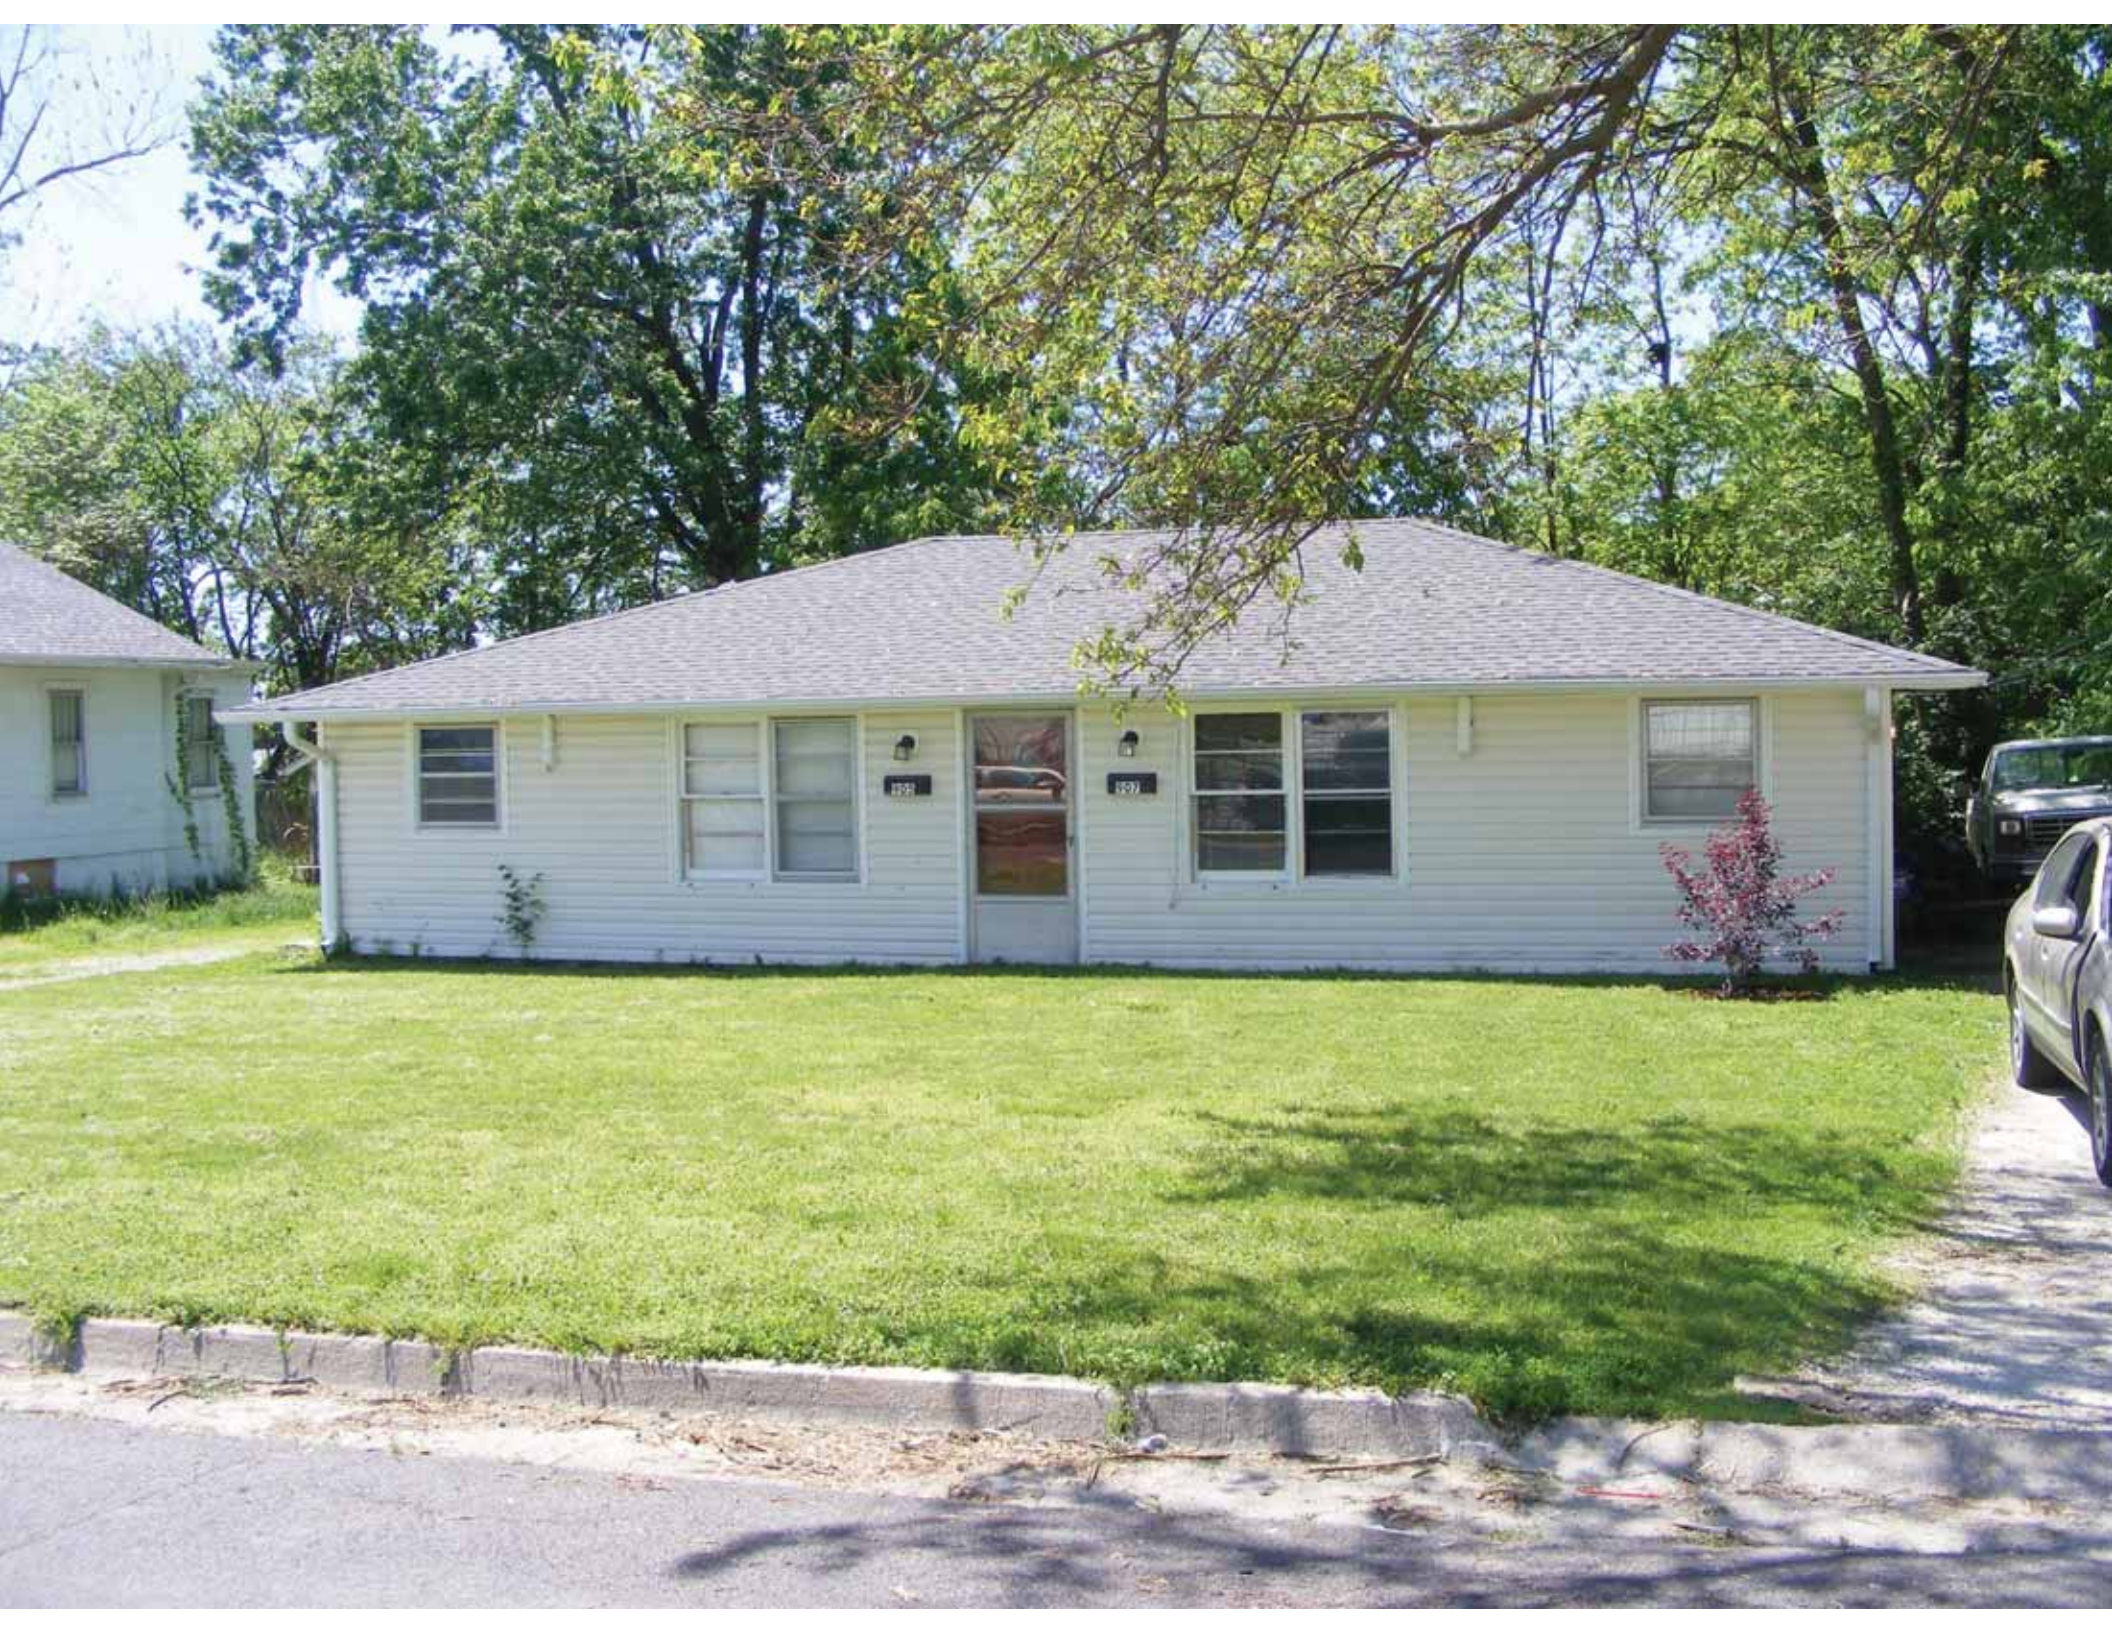
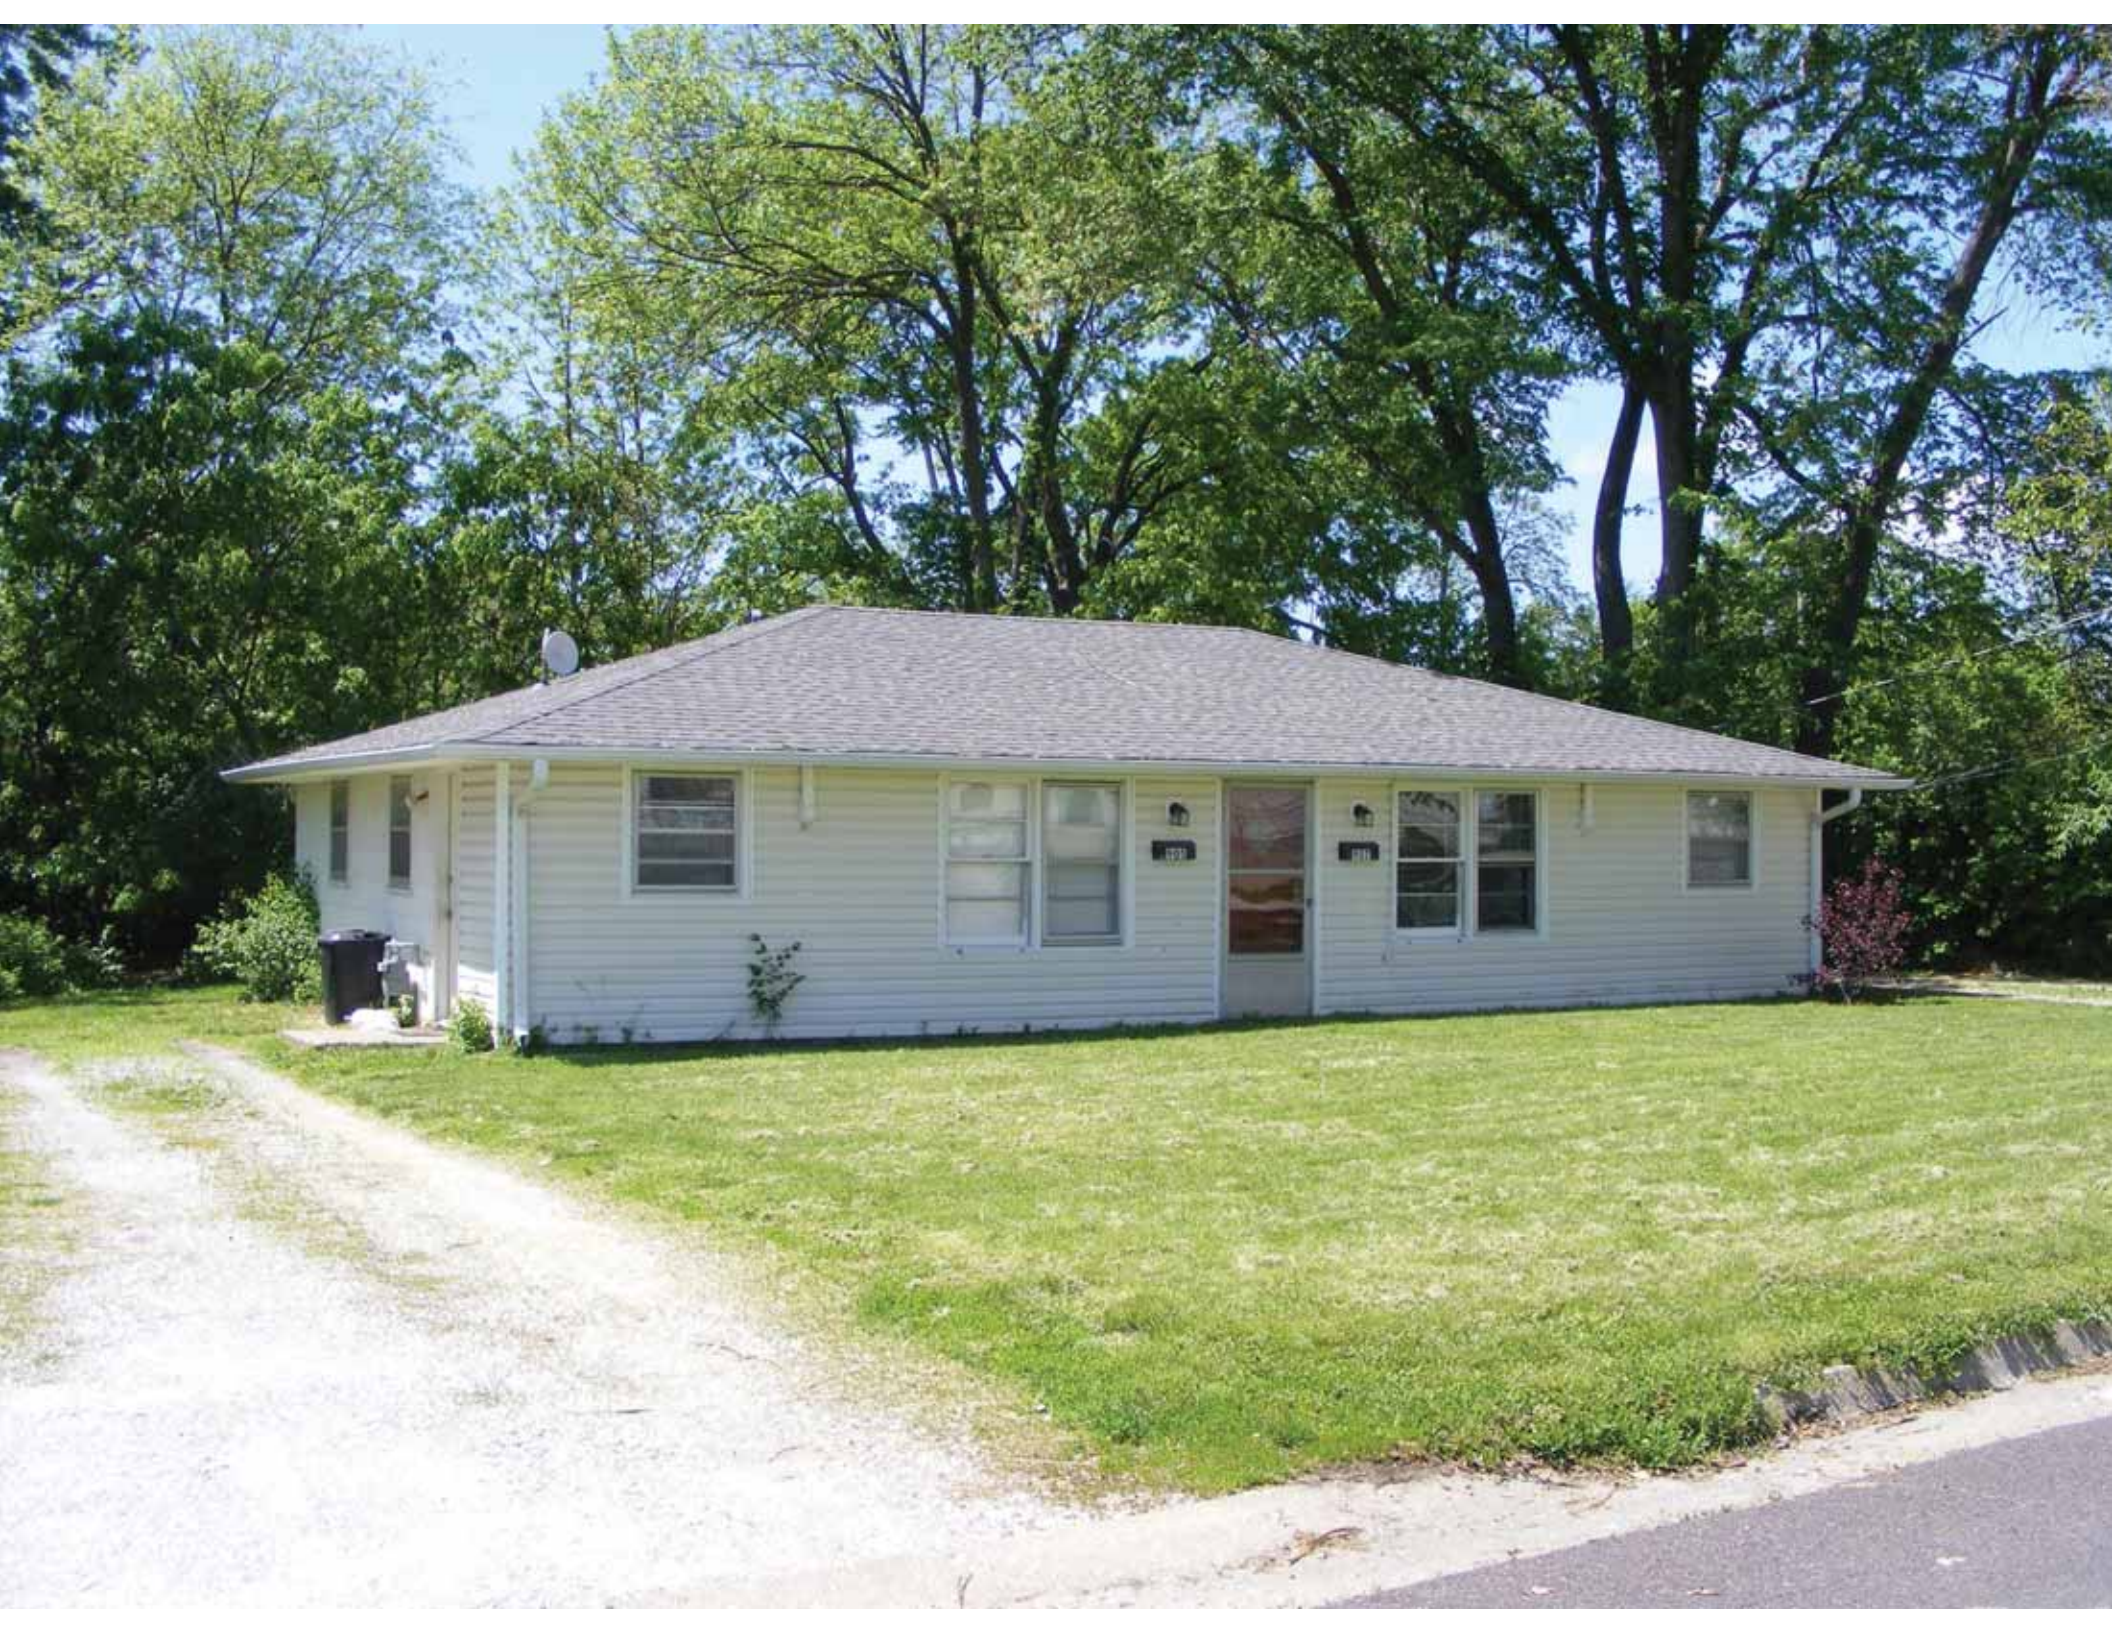
41. (cont.) Description of primary resource. Expand box as necessary, or add continuation pages.
The dwelling is a one story asphalt shingled low hip with wide overhanging eaves, clad in vinyl siding and a concrete foundation. Façade holds an off-centered entrance with paired and single vertical two-over-two windows. Side elevations hold two-over-two windows. West elevation holds a stoop entrance.
