MISSOURI DEPARTMENT OF NATURAL RESOURCES
STATE HISTORIC PRESERVATION OFFICE, P.O. Box 176, Jefferson City, MO 65102
ARCHITECTURAL/HISTORIC INVENTORY FORM

1. Survey No. BO-AS-011-0087		2. Survey name: North Central Columbia Survey Phase II	
3. County: Boone		4. Address (Street No.) 902	Street (name) N. Seventh Street
5. City: Columbia	Vicinity: <input type="checkbox"/>	6. Geographical Reference:	7. Township/Range/Section: T: R: S:
8. Historic name (if known):		9. Present/other name (if known):	
10. Ownership: <input checked="" type="checkbox"/> Private <input type="checkbox"/> Public		11a. Historic use (if known): Domestic/single dwelling	11b. Current use: Domestic/single dwelling

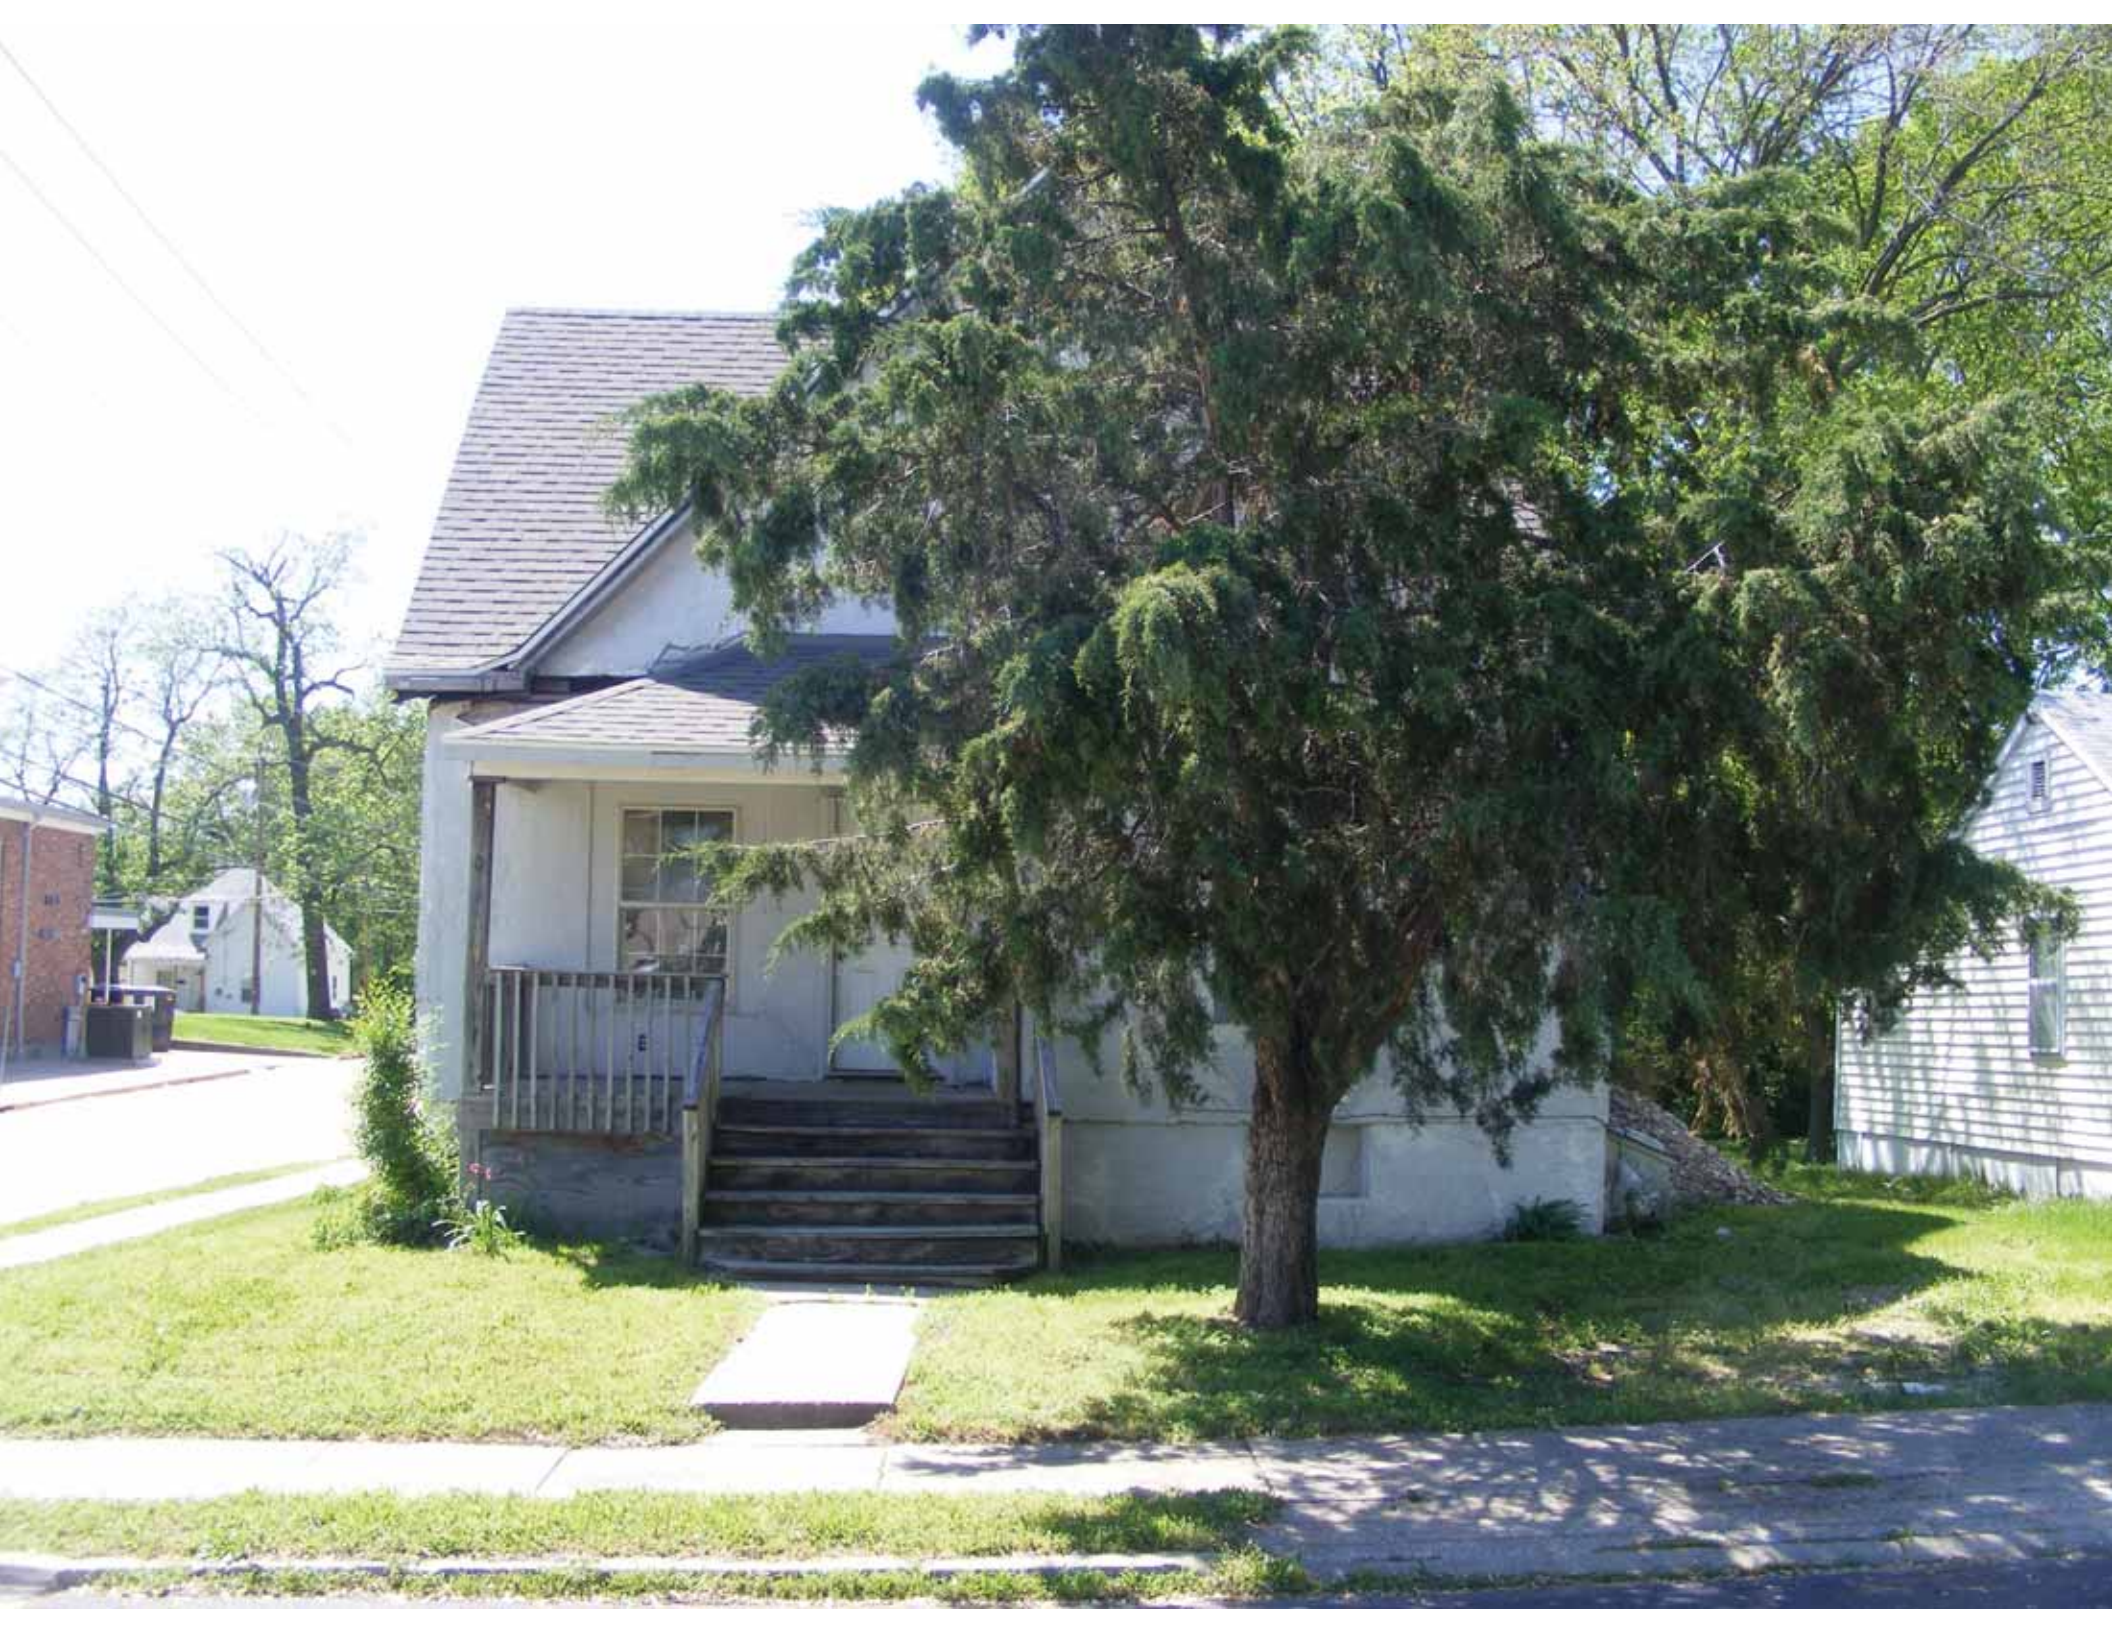
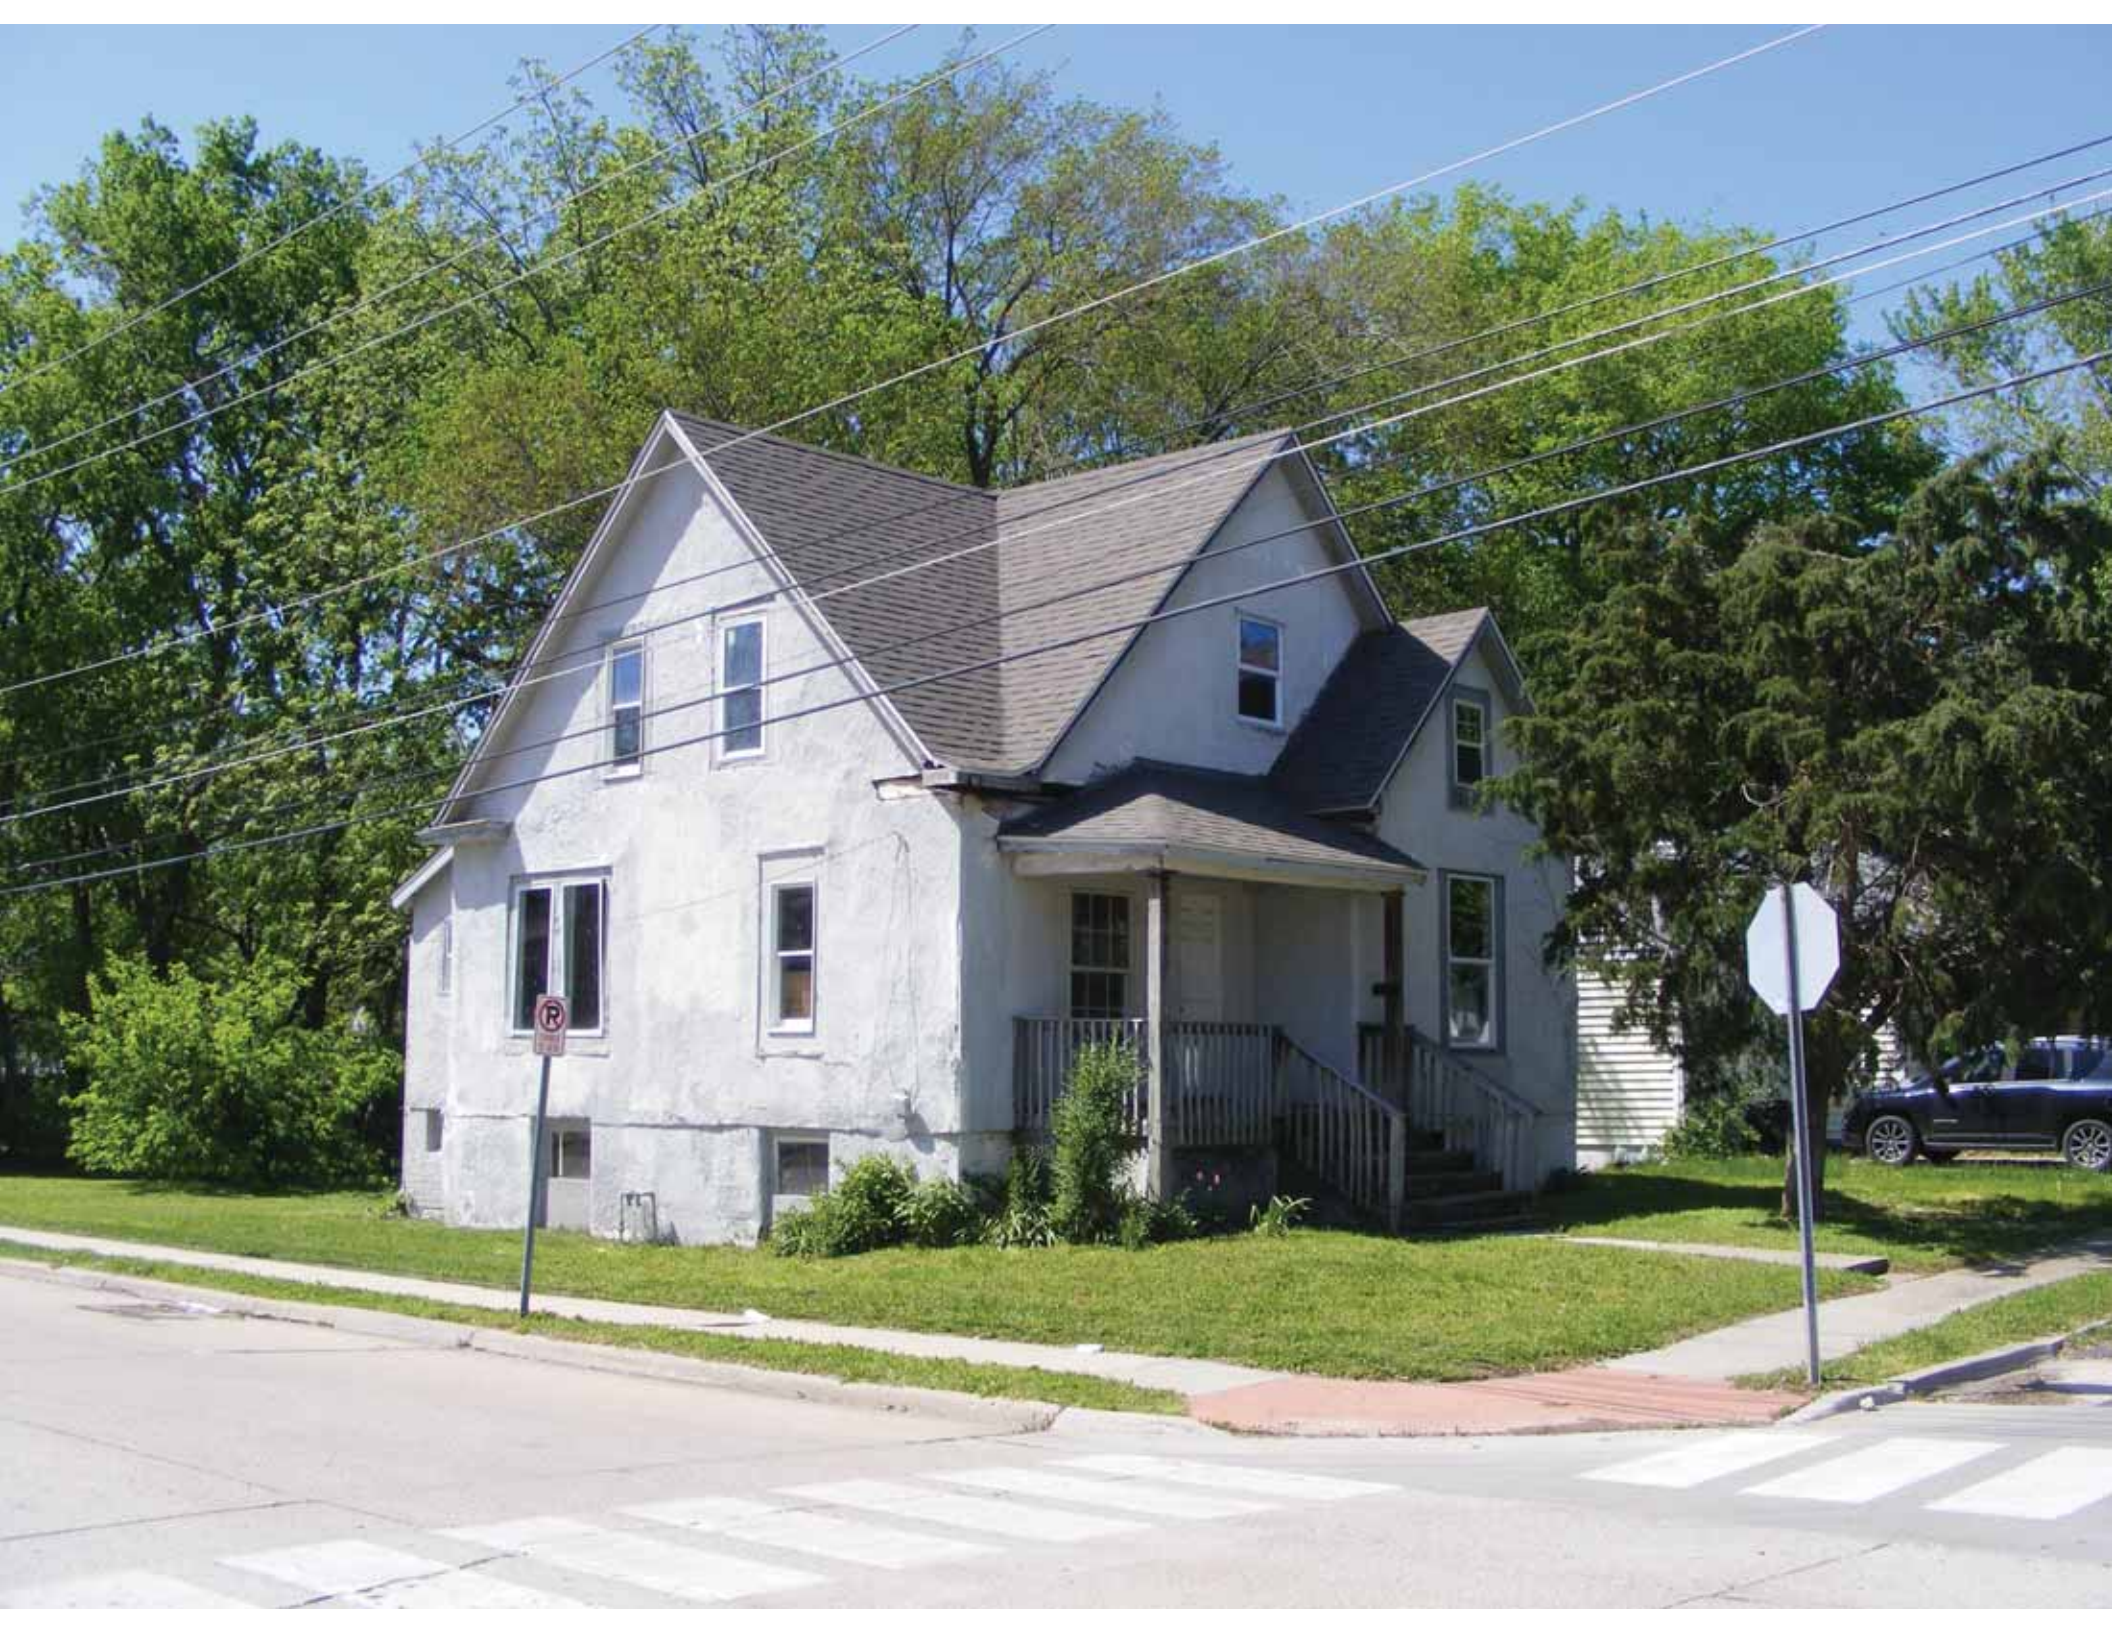
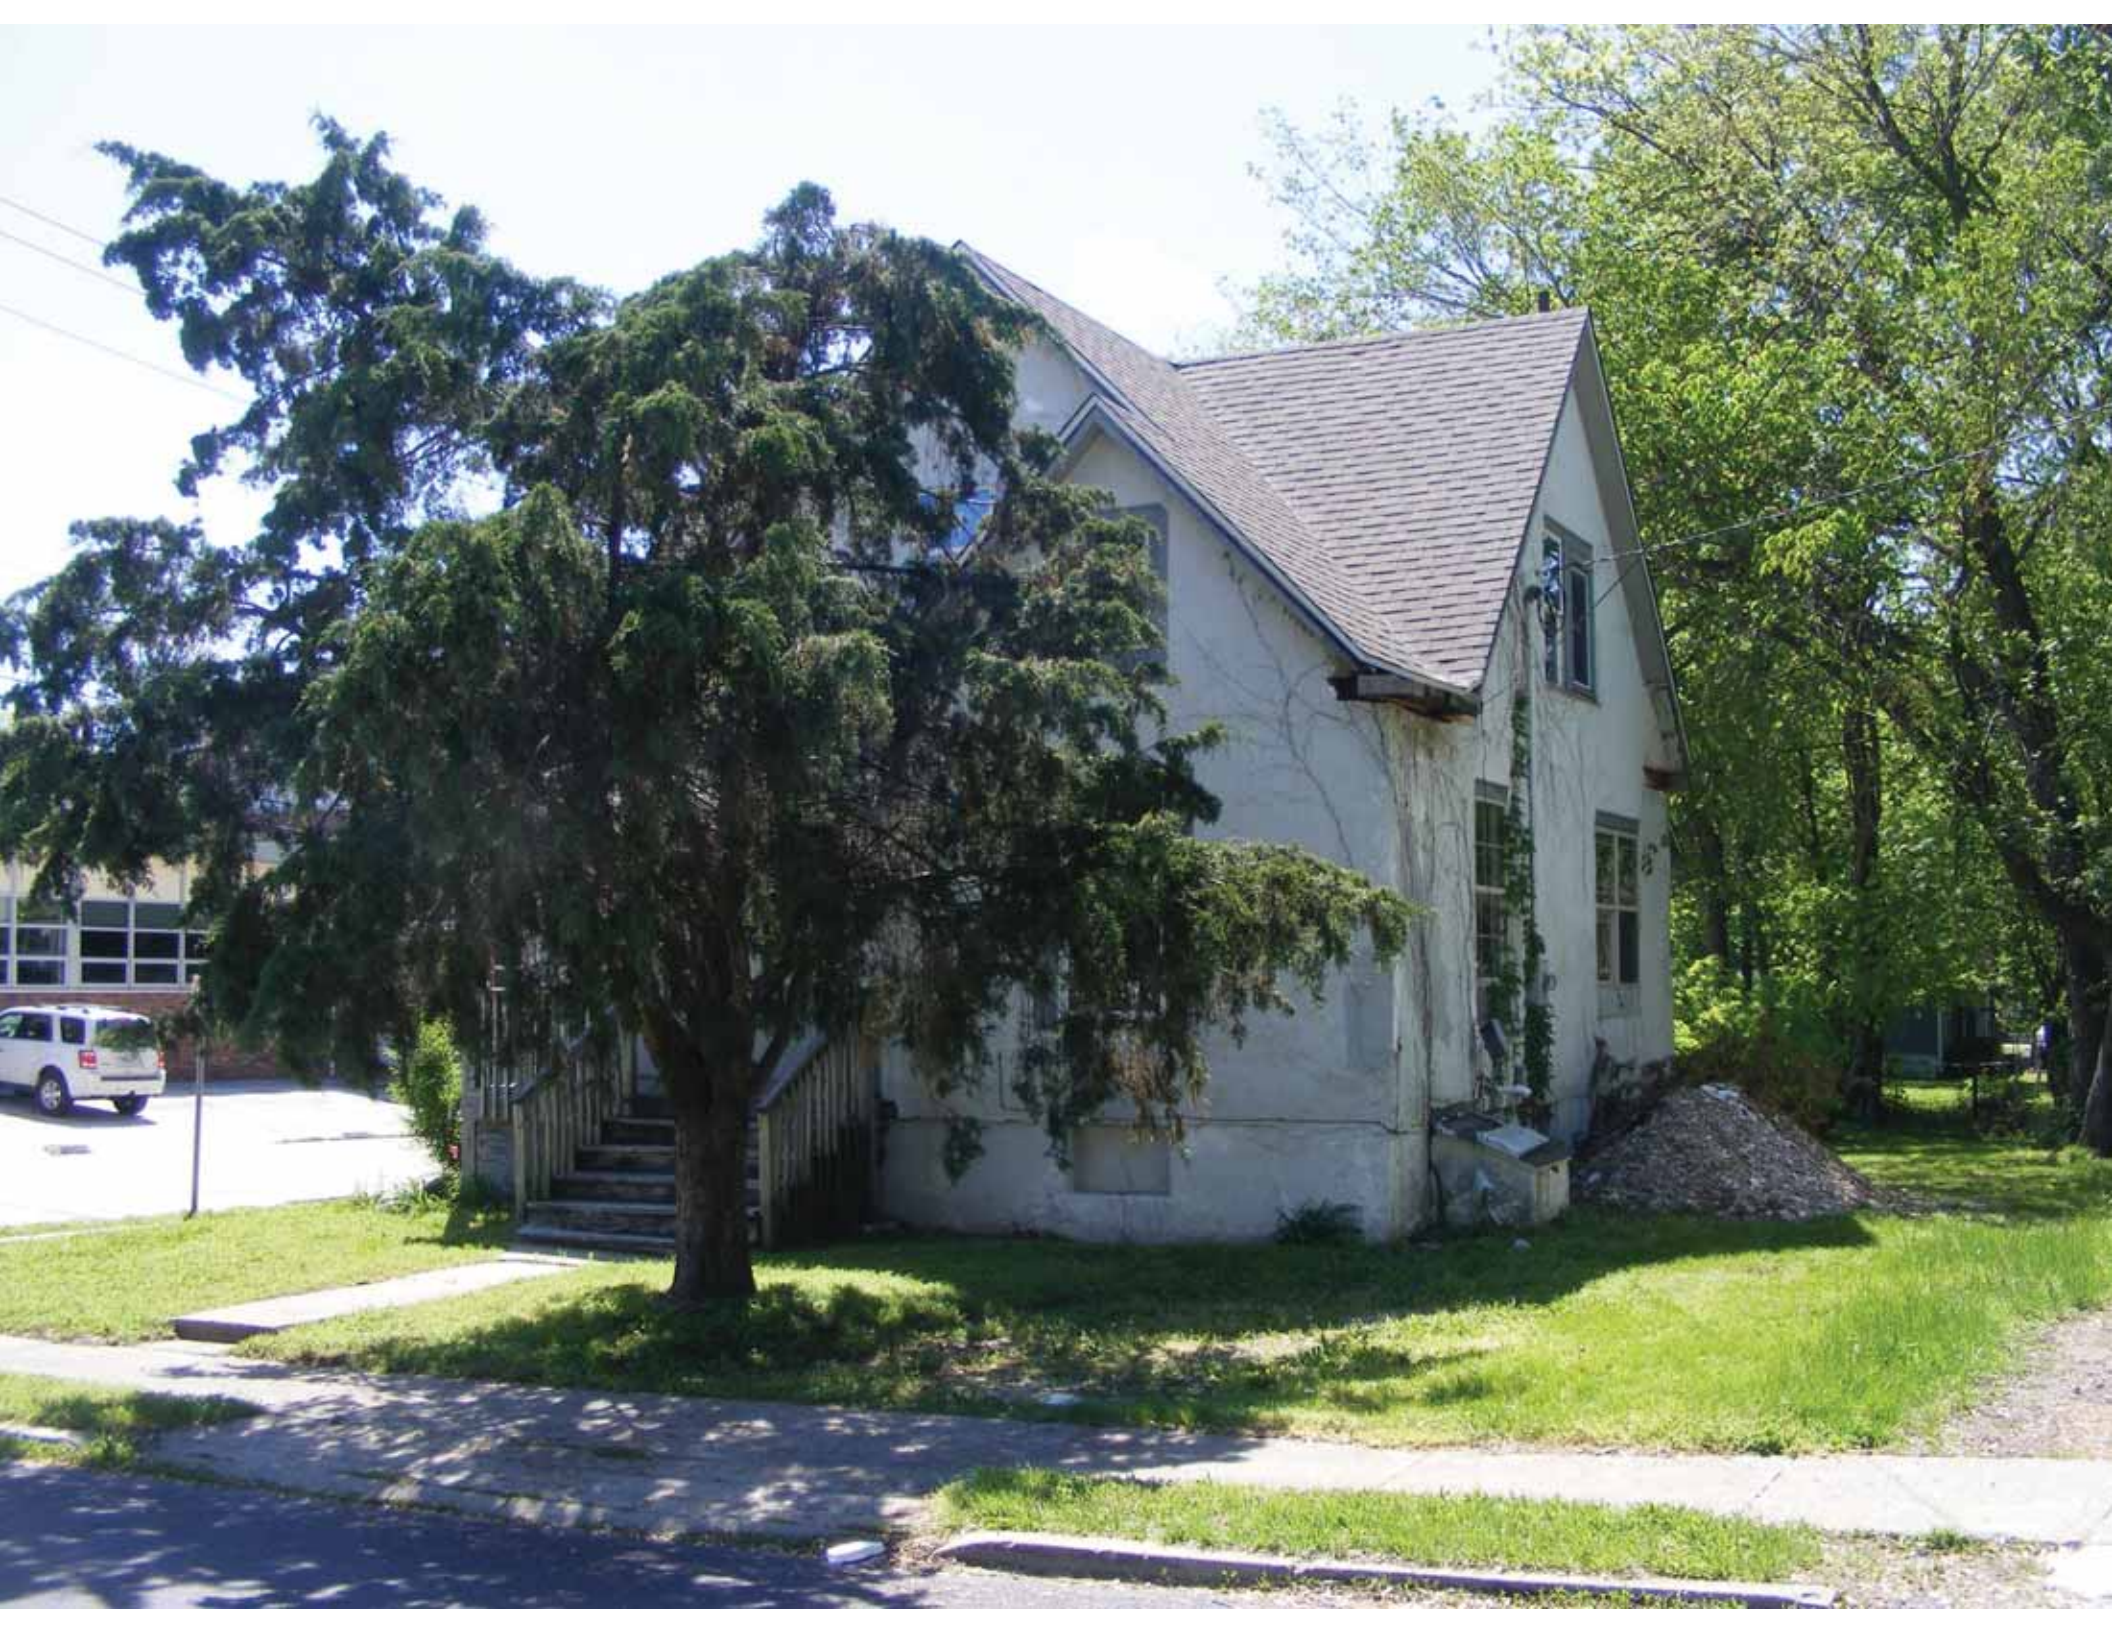
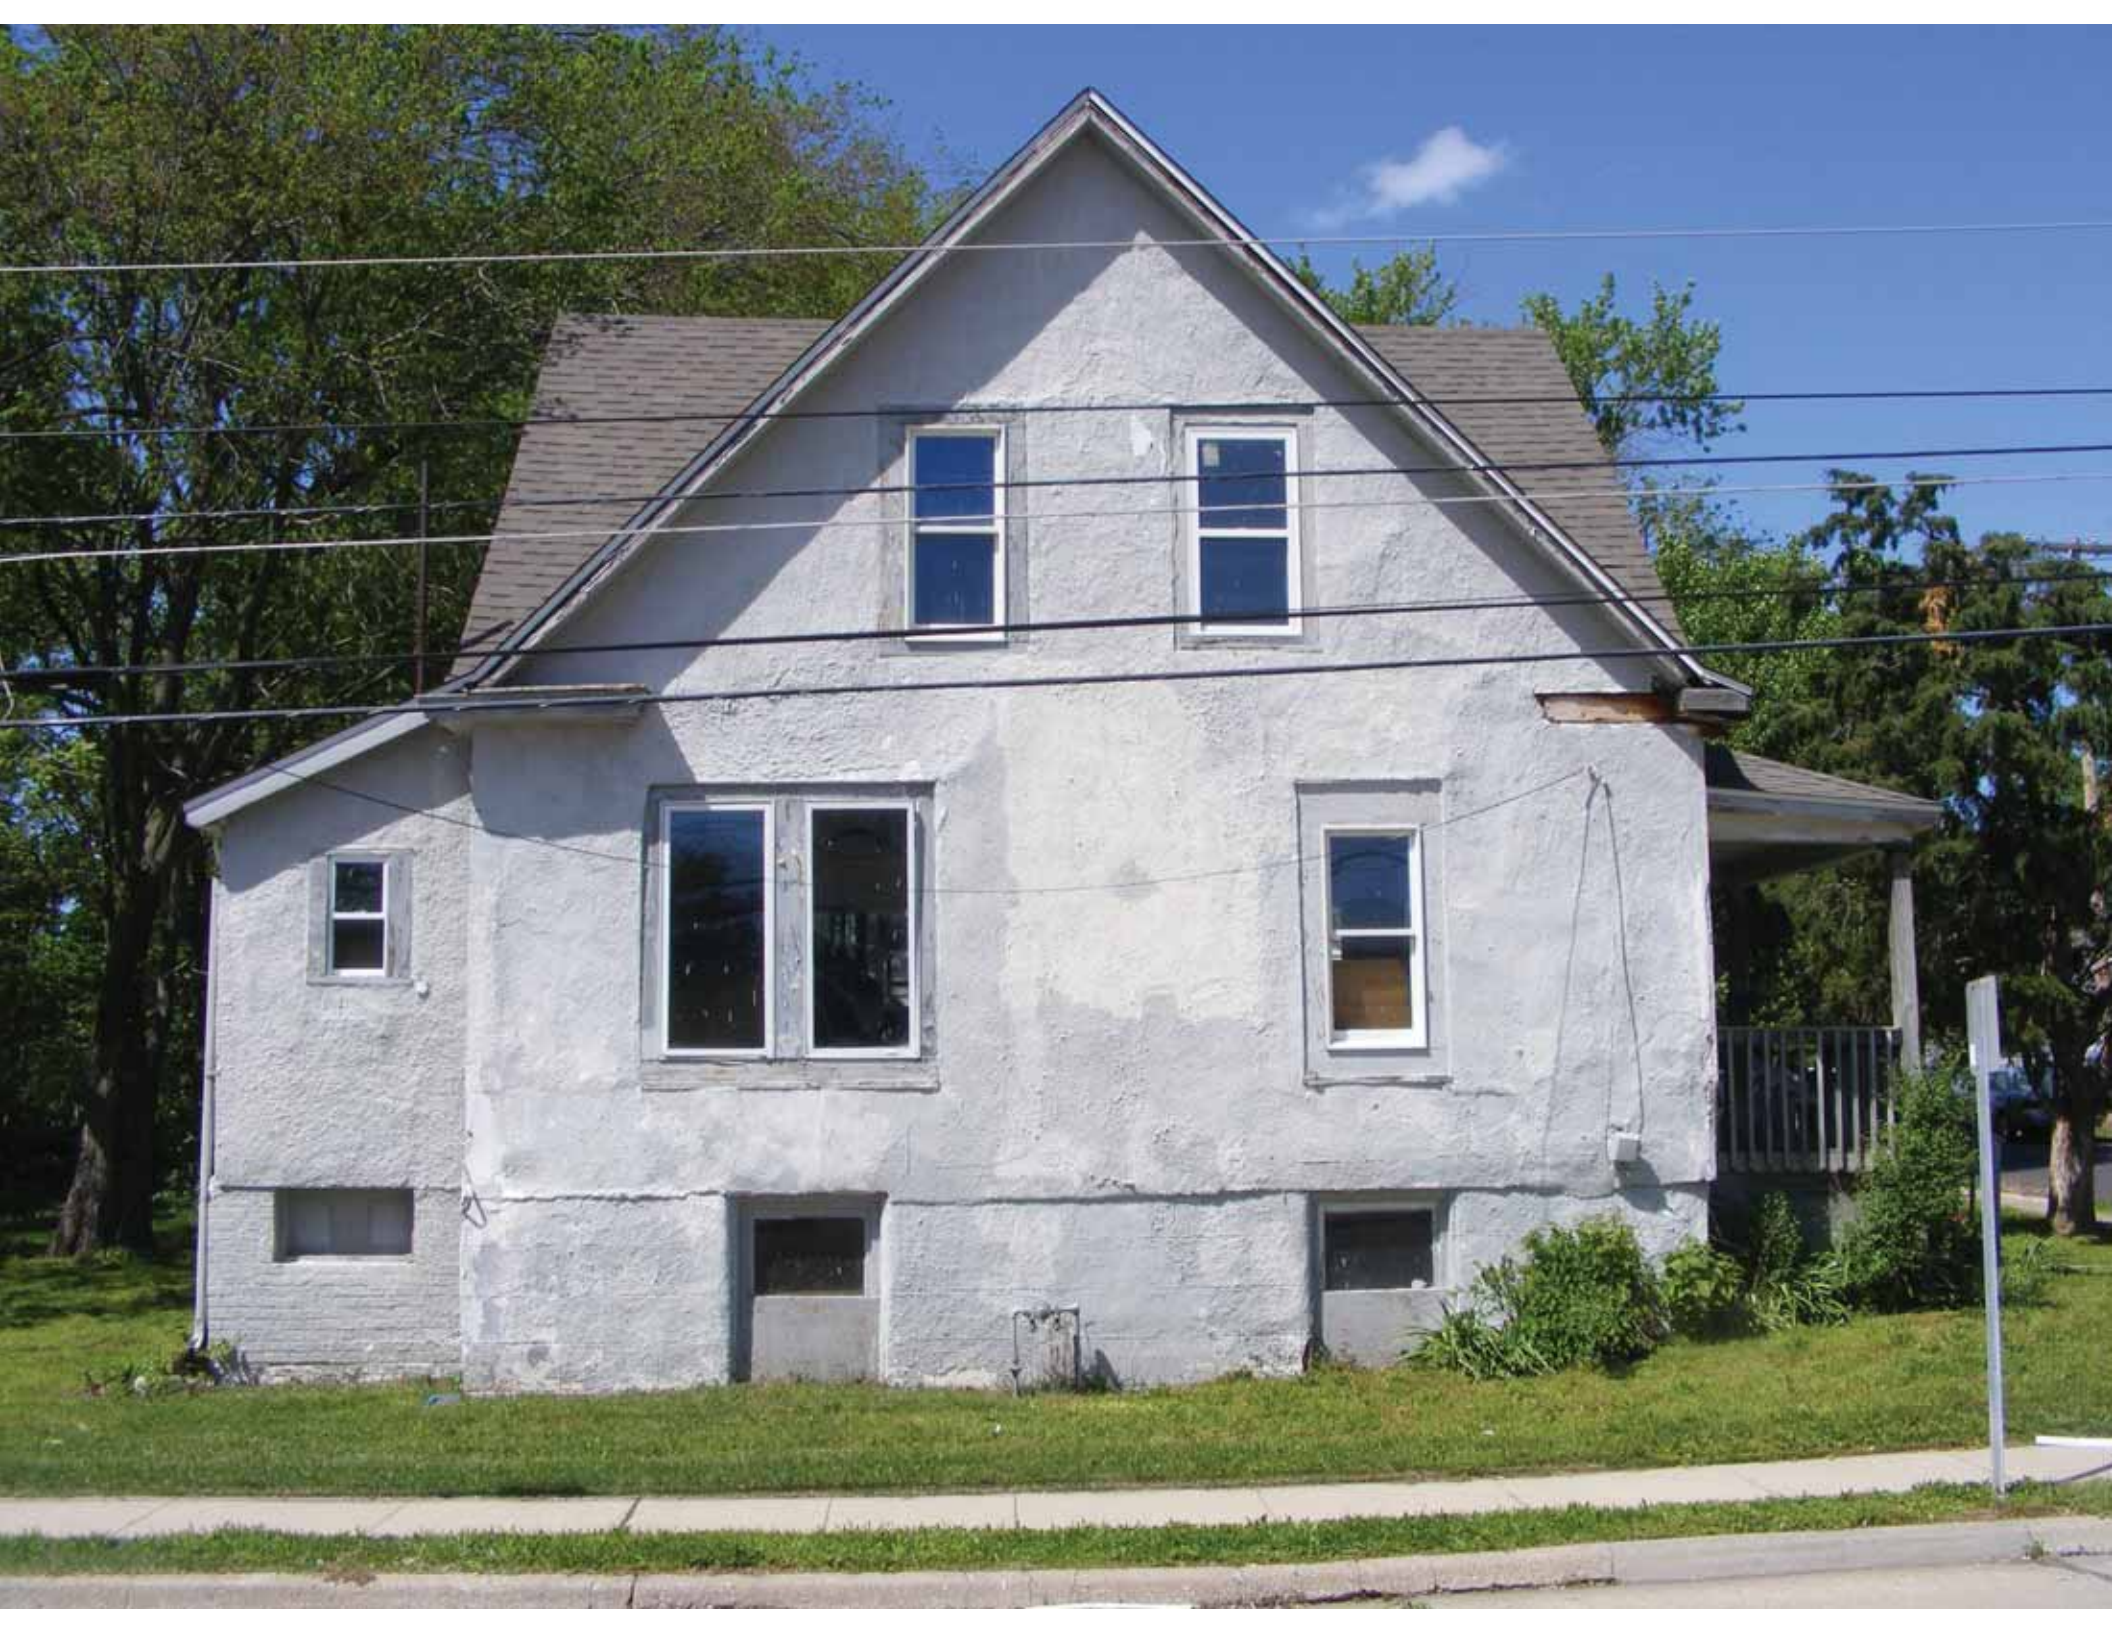
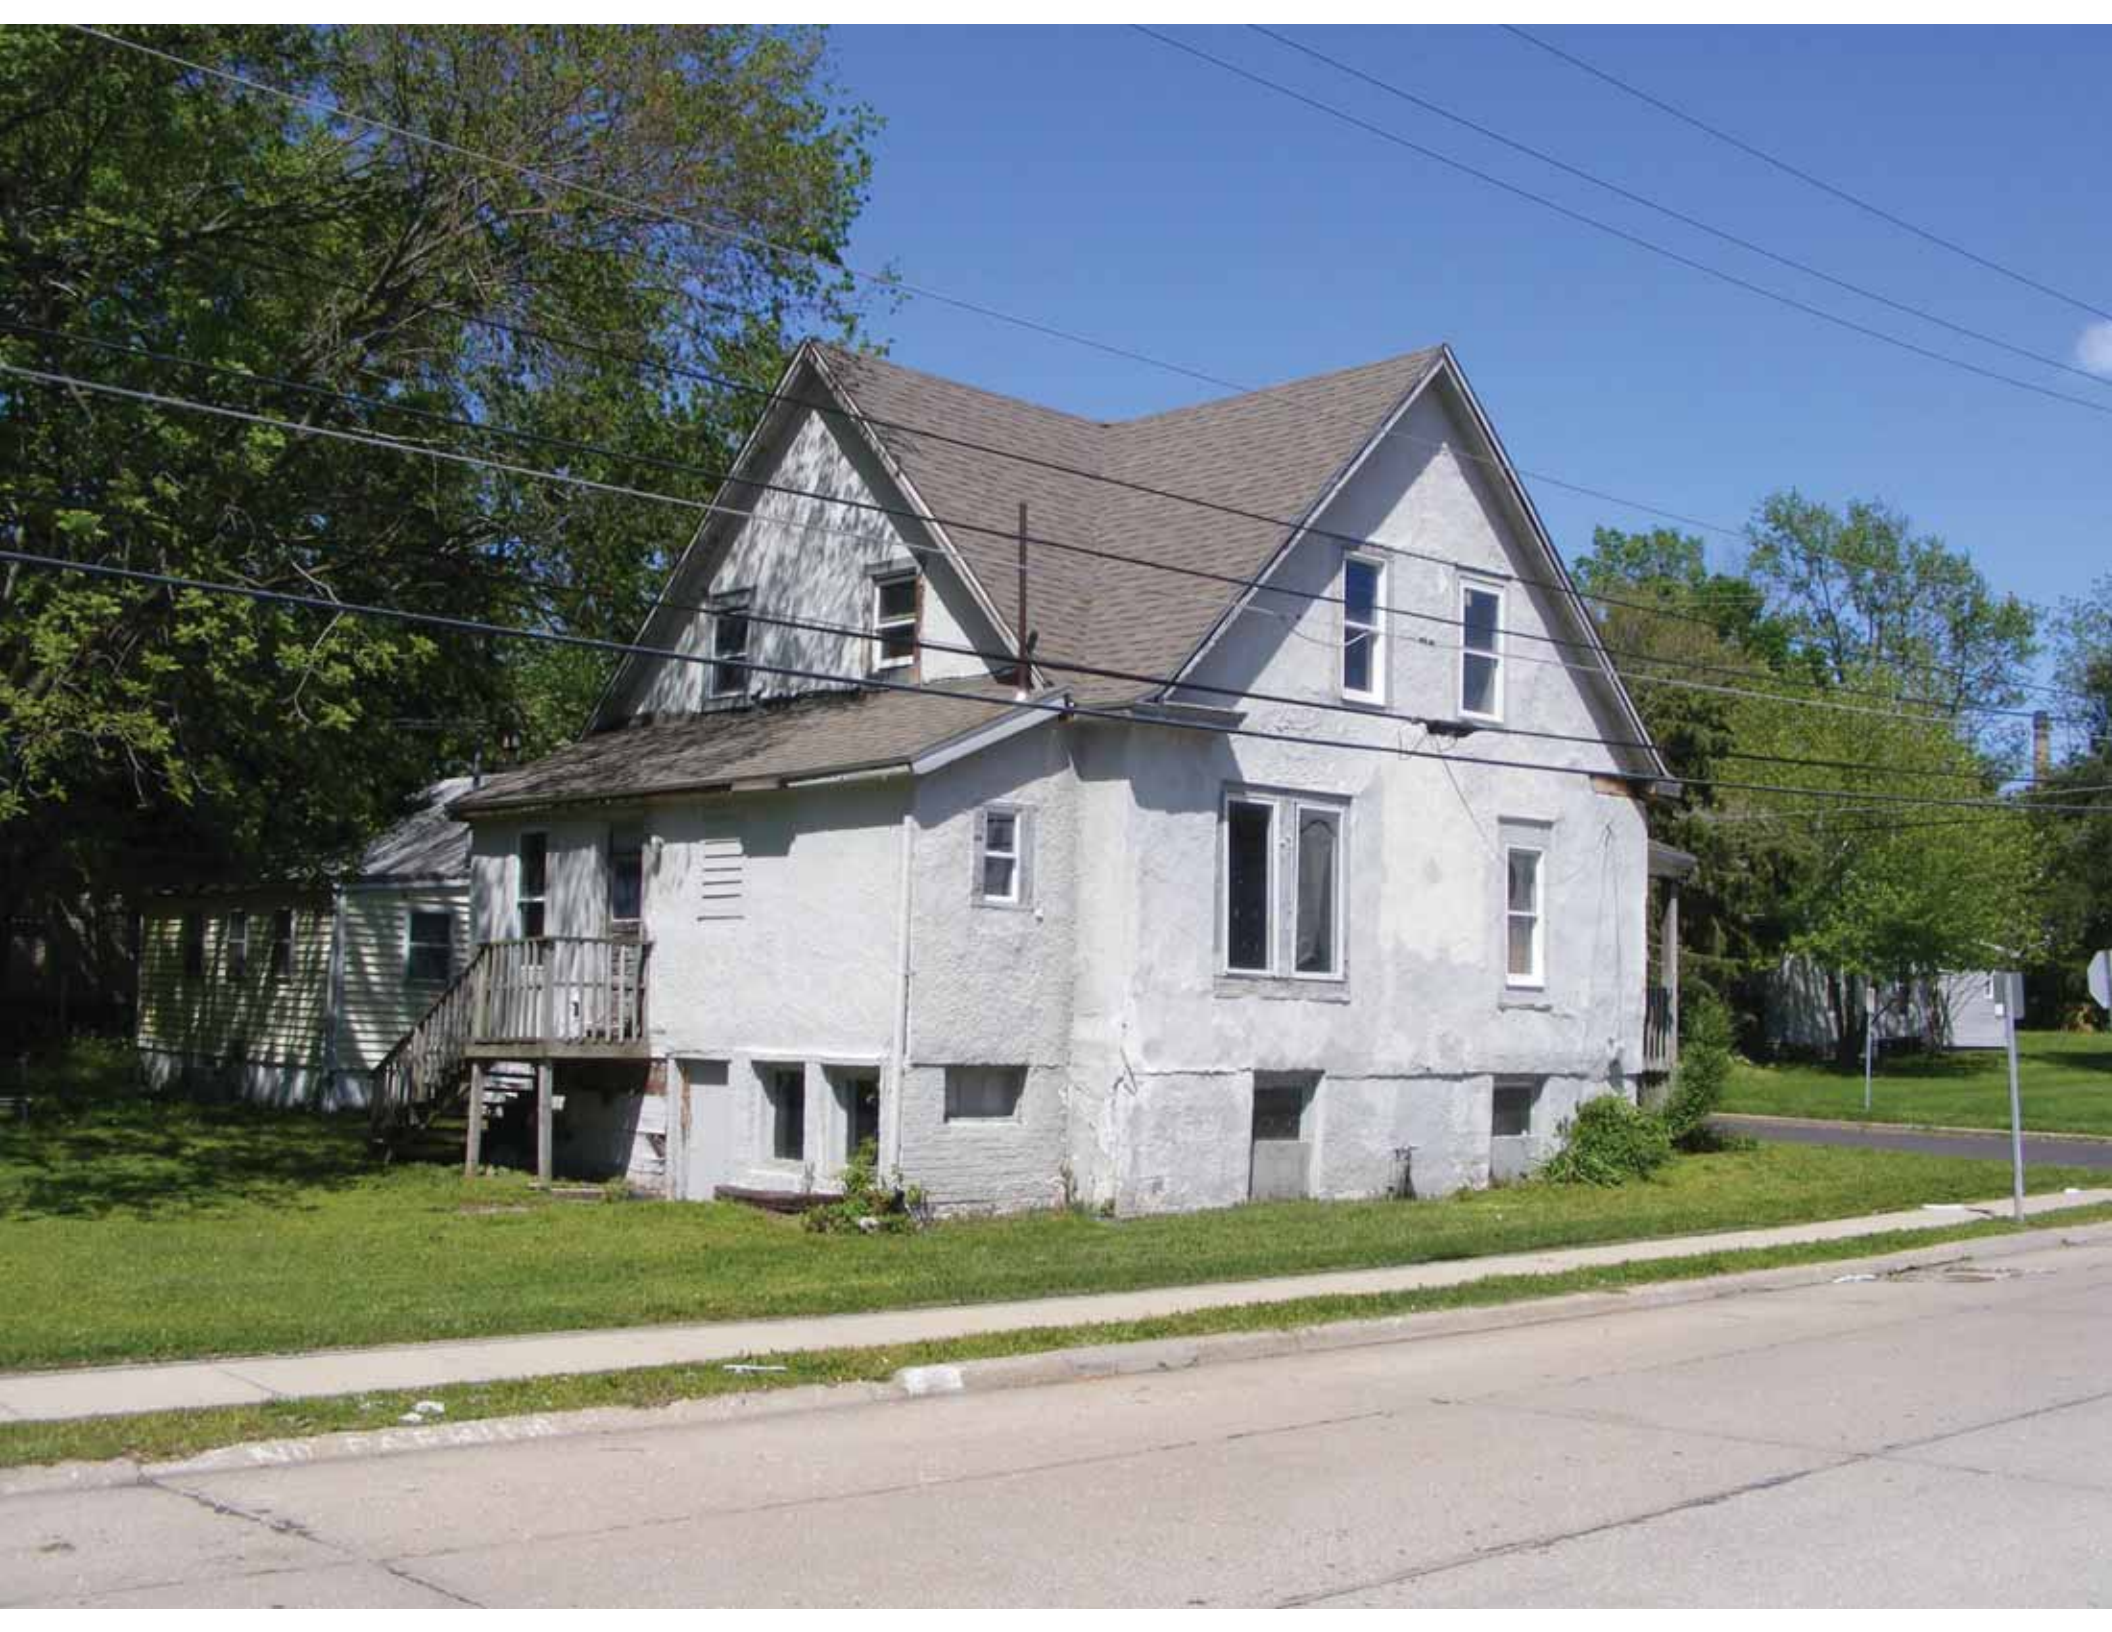
41. (cont.) Description of primary resource. Expand box as necessary, or add continuation pages.
This two story stucco clad dwelling has an asphalt shingled cross gable with multiple front gables and a raised concrete foundation. The façade holds a partial-width porch sheltered by an asphalt shingled roof supported by replacement wooden square post with replacement wooden railings (ca. 1995). Porch bay holds an entrance offset to the left by a six-over-six window. Upper level holds a one-over-one window. A projecting front gable is to the right of the porch and holds a one-over-one window on both levels. Side elevations hold one-over-one windows, paired fixed and basement window wells. Rear elevation holds an enclosed porch addition with a stoop entrance, wood railing and decking. All windows are replacement.

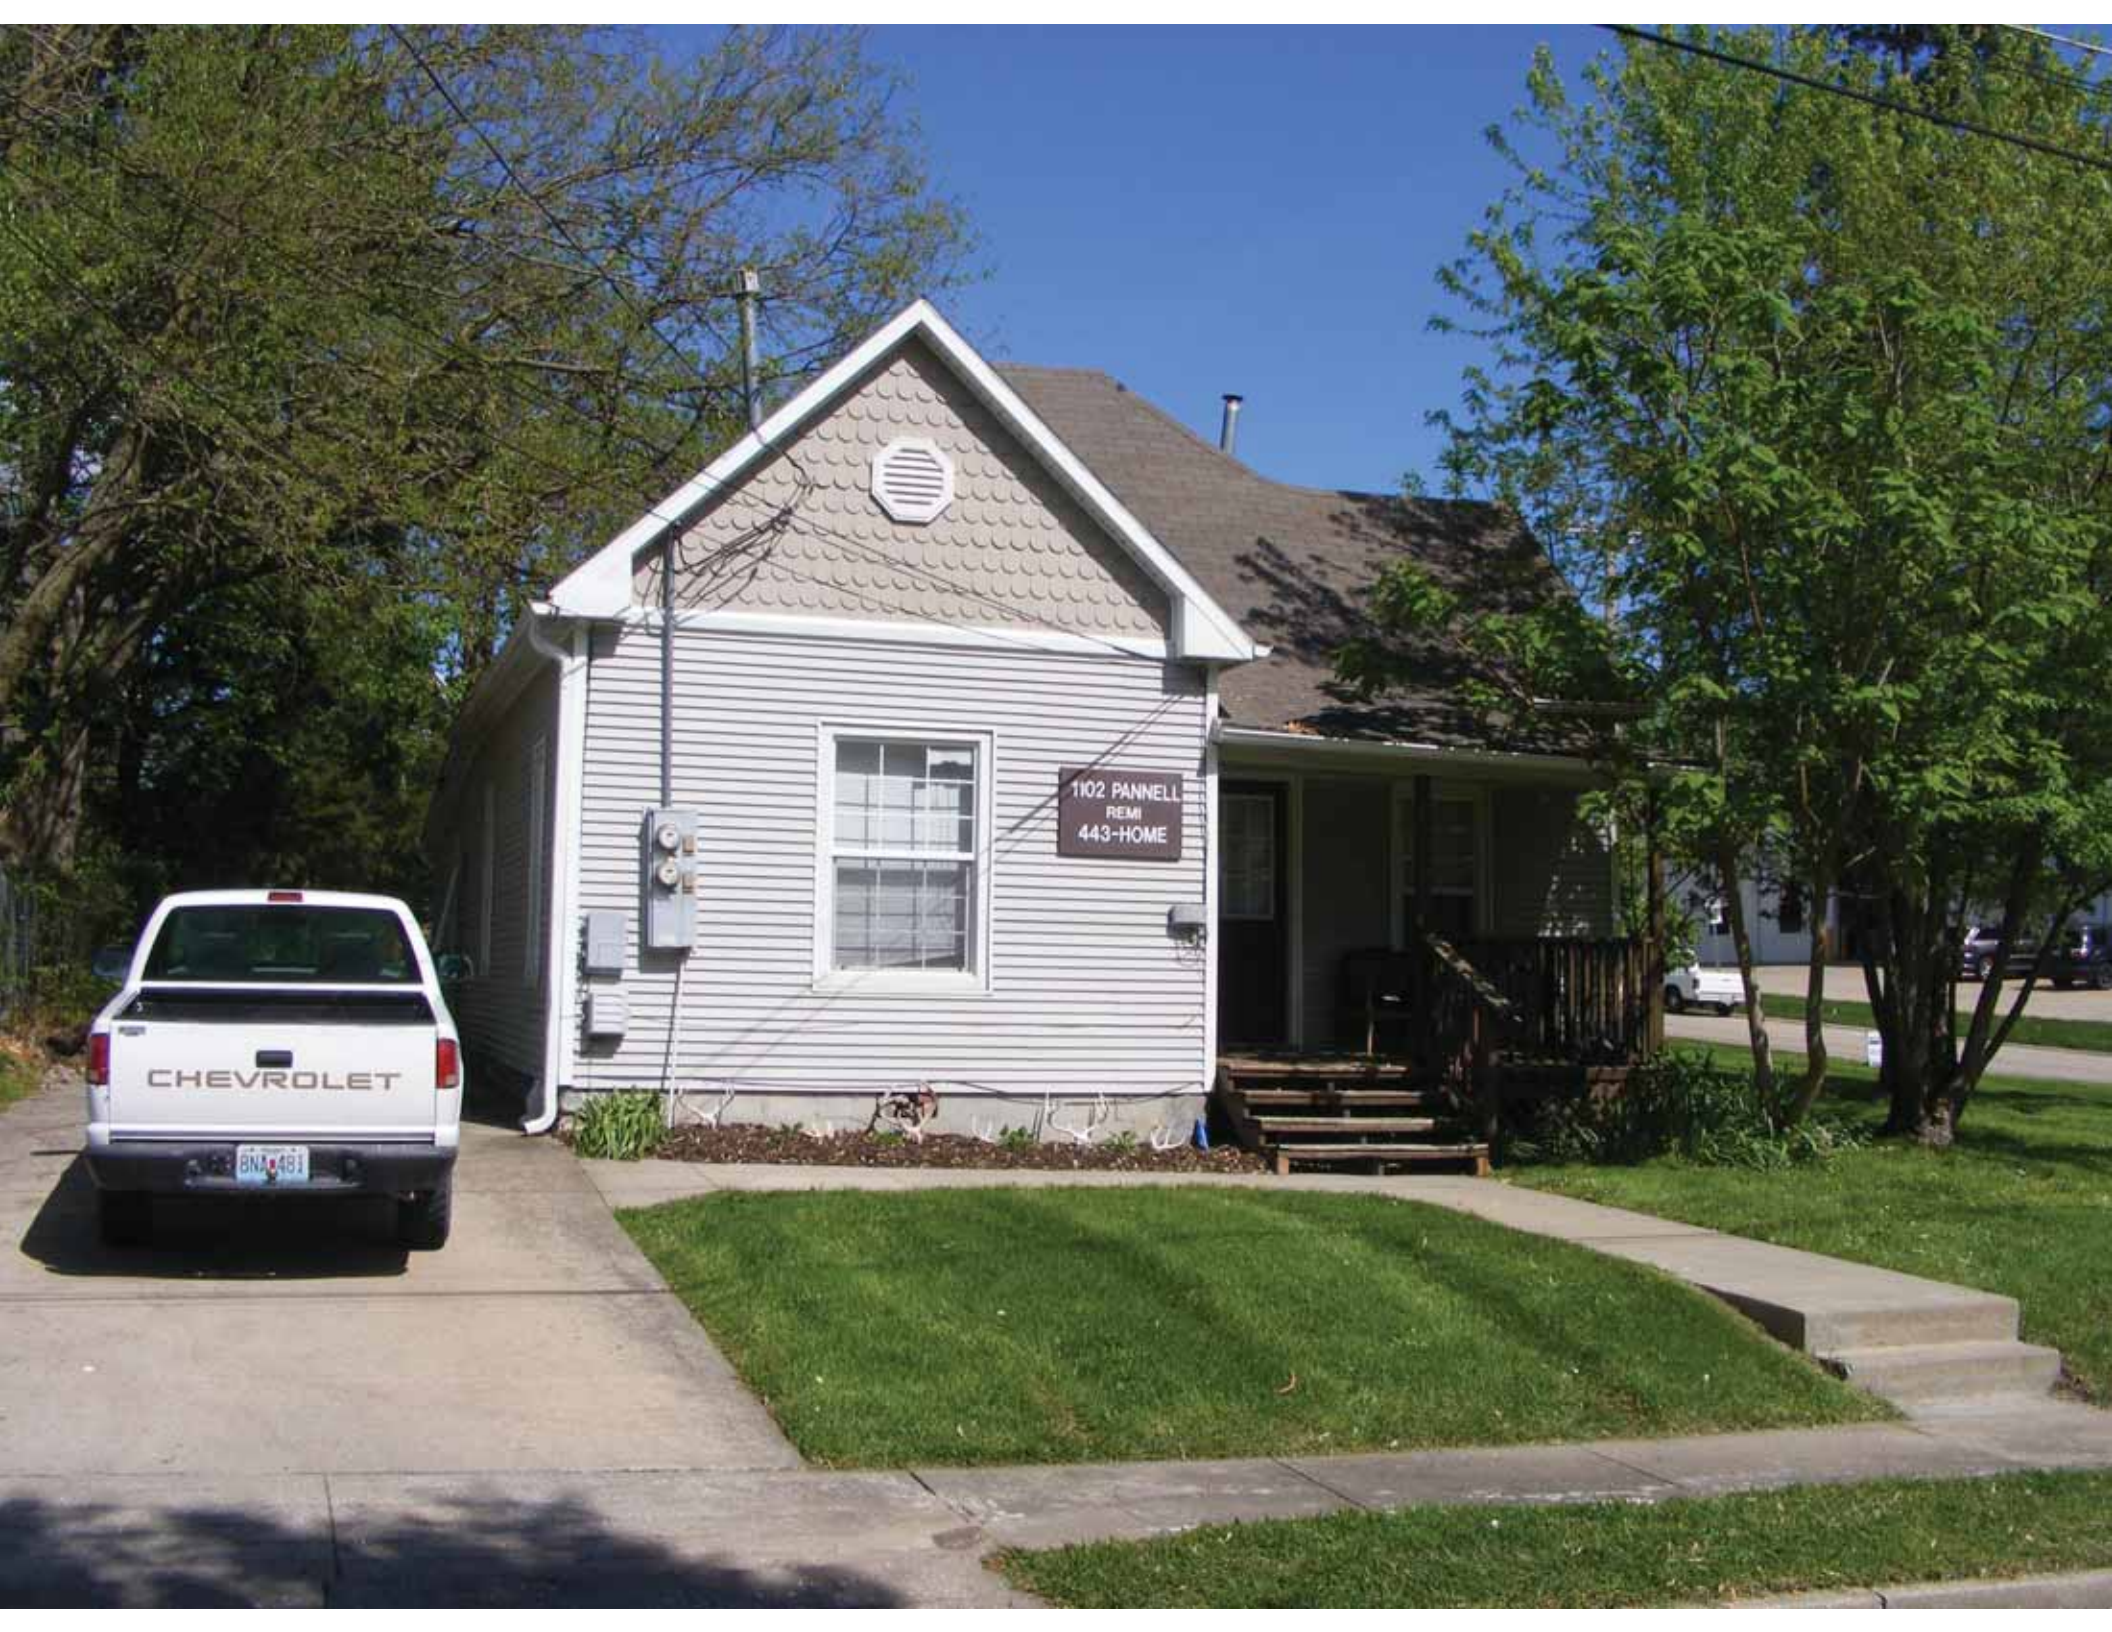
41. (cont.) Description of primary resource. Expand box as necessary, or add continuation pages.
The one story vinyl clad dwelling has an asphalt shingled cross-gable on hip roof and a concrete foundation. The façade features asphalt shingled hipped partial-width porch (right side) supported by replacement (ca. 1990) wooden post with wood decking and railings. Porch bay area holds a metal and six-light door offset to right by a six-over-six window. A second entrance with a metal and six-light door is found on the south elevation wall. The front gable end holds a nine-over-nine replacement window; gable end infilled with vinyl scalloped shingles and octagonal louvered vent. Side elevations hold replacement six-over-six windows.
