MISSOURI DEPARTMENT OF NATURAL RESOURCES
STATE HISTORIC PRESERVATION OFFICE, P.O. Box 176, Jefferson City, MO 65102
ARCHITECTURAL/HISTORIC INVENTORY FORM

1. Survey No. BO-AS-011-0087		2. Survey name: North Central Columbia Survey Phase II	
3. County: Boone		4. Address (Street No.) 902	Street (name) N. Seventh Street
5. City: Columbia	Vicinity: <input type="checkbox"/>	6. Geographical Reference:	7. Township/Range/Section: T: R: S:
8. Historic name (if known):		9. Present/other name (if known):	
10. Ownership: <input checked="" type="checkbox"/> Private <input type="checkbox"/> Public		11a. Historic use (if known): Domestic/single dwelling	11b. Current use: Domestic/single dwelling

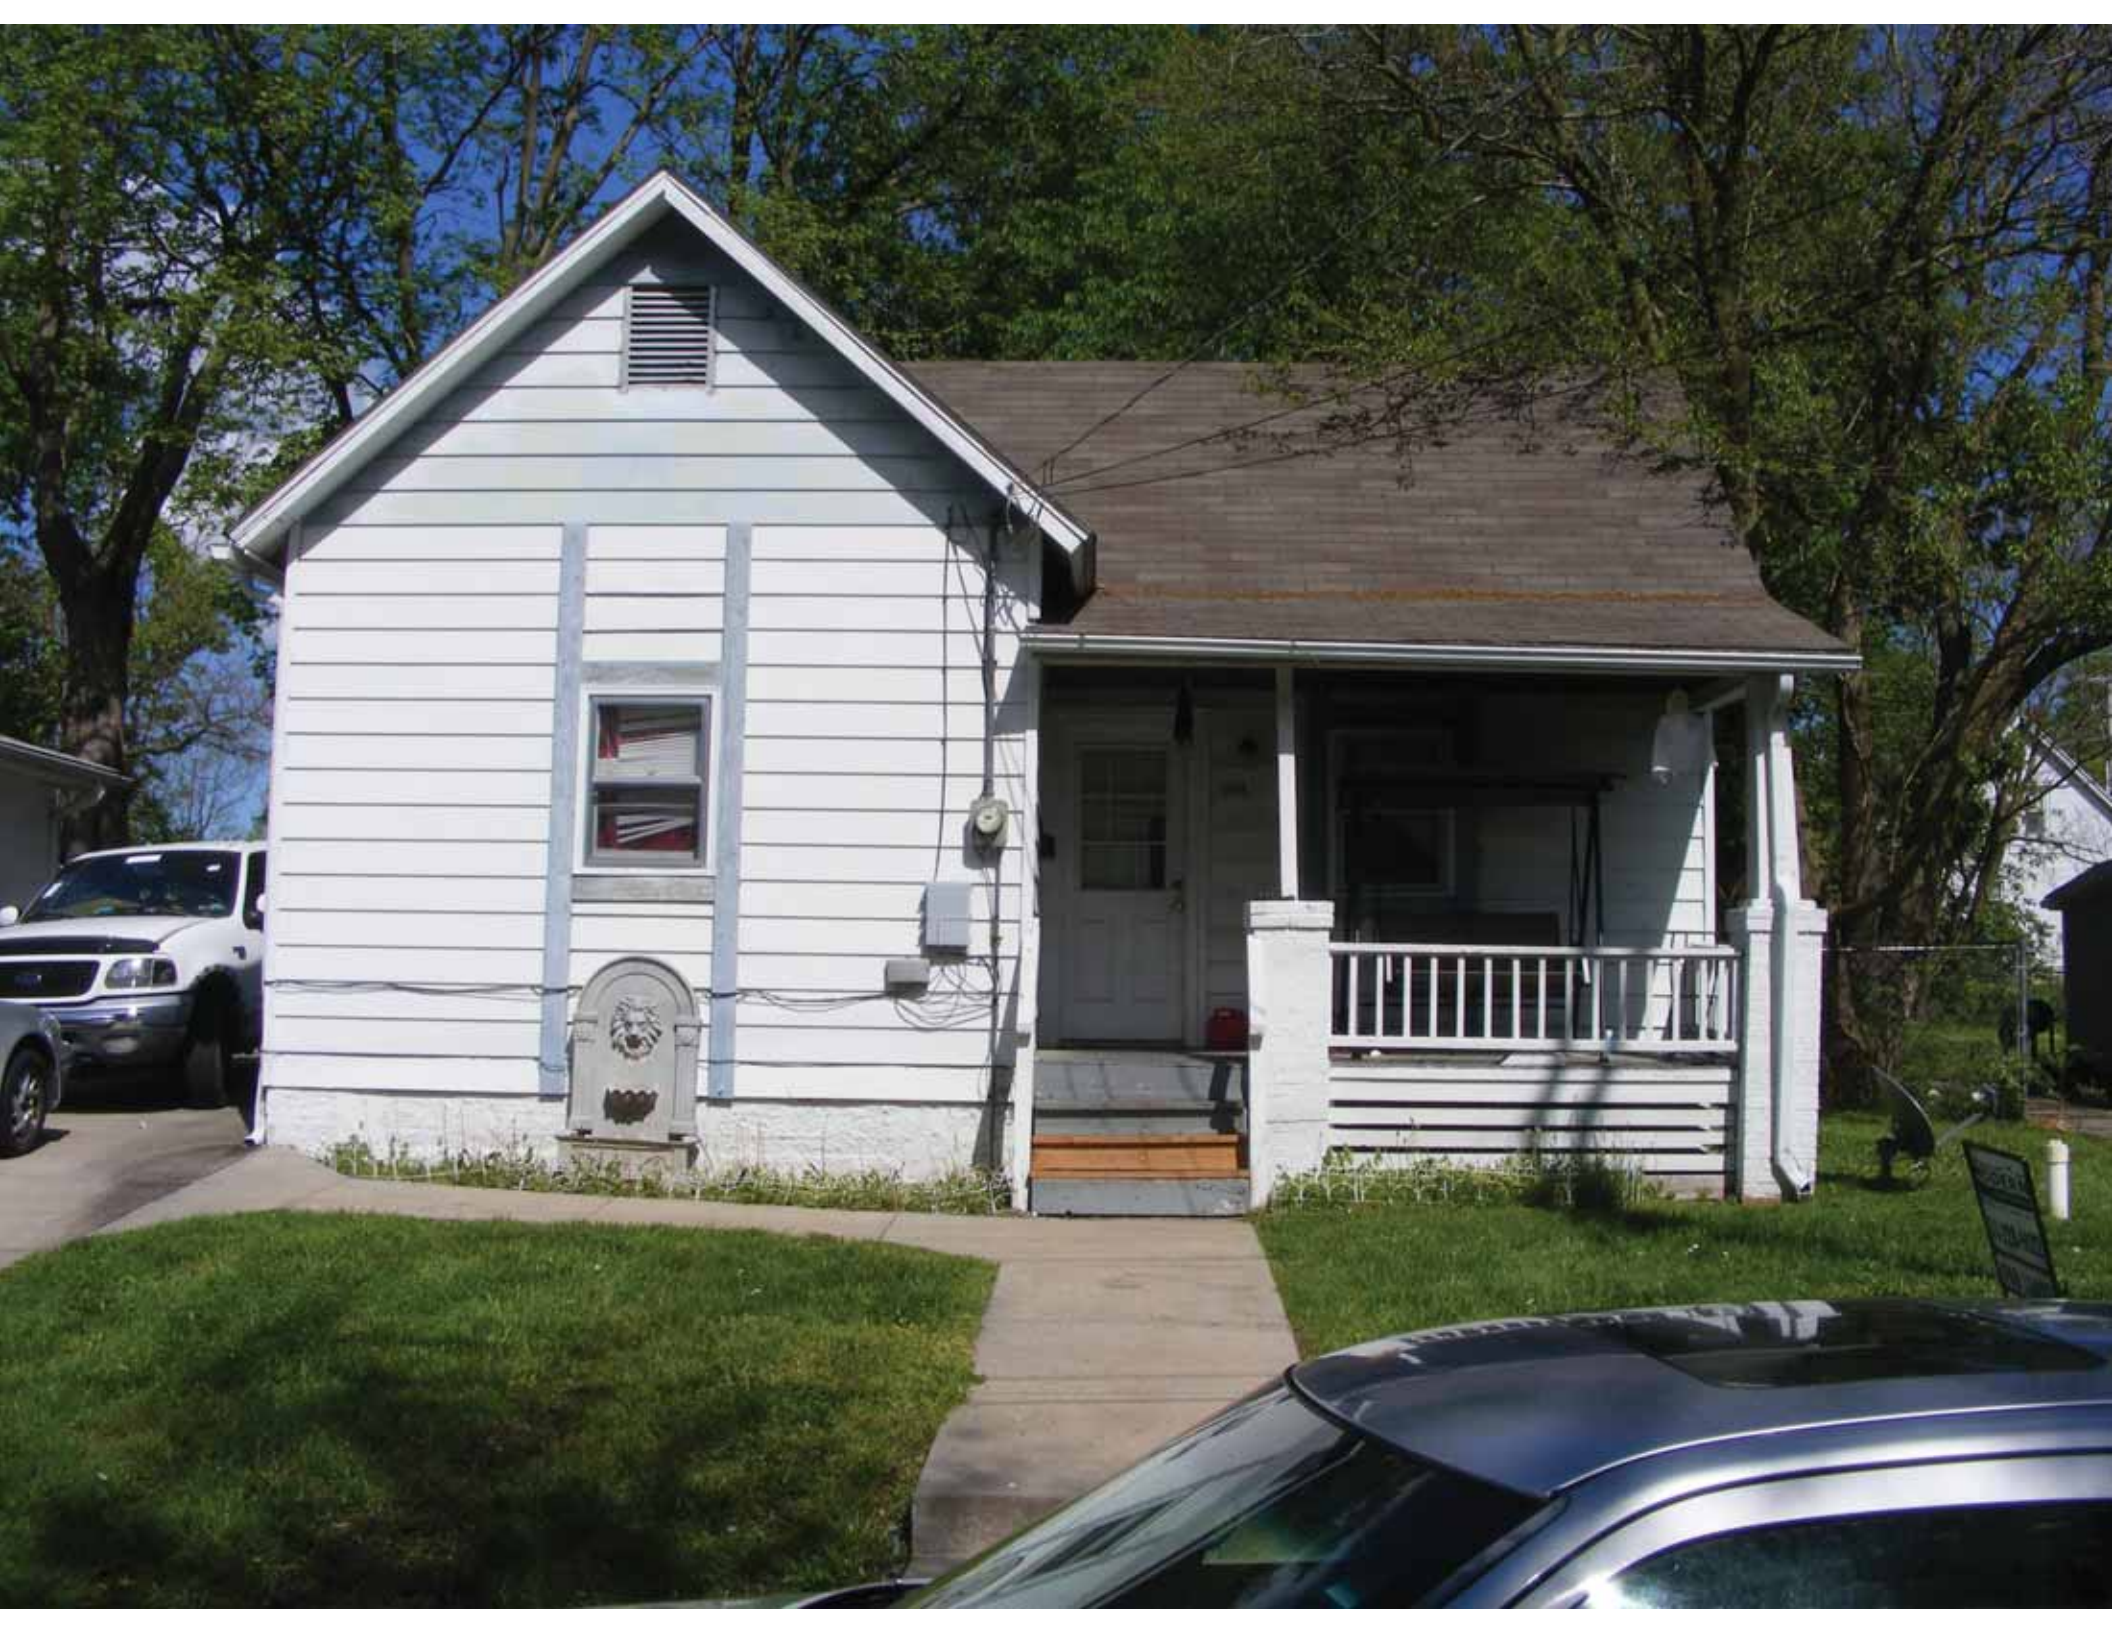
41. (cont.) Description of primary resource. Expand box as necessary, or add continuation pages.
The wood sided dwelling is a one story with an asphalt shingled cross-gable to shed (façade porch) and concrete foundation. The façade holds a partial-width porch under the shed roof supported by a tapered column and a narrow square post (replacement) on painted brick piers with wood decking and railings. Entrance is at the "L" and offset to right by a paired one-over-one window. The front gable holds a louvered vent in the end; lower section holds a one-over-one window. The window features a wooden lintel and sill and intersect vertical wooden boards (narrow) that extend to the length of the lower section (ends at gable end and foundation); frames the window in an "H" shape. Side elevations hold one-over-one windows and identical wood framing.

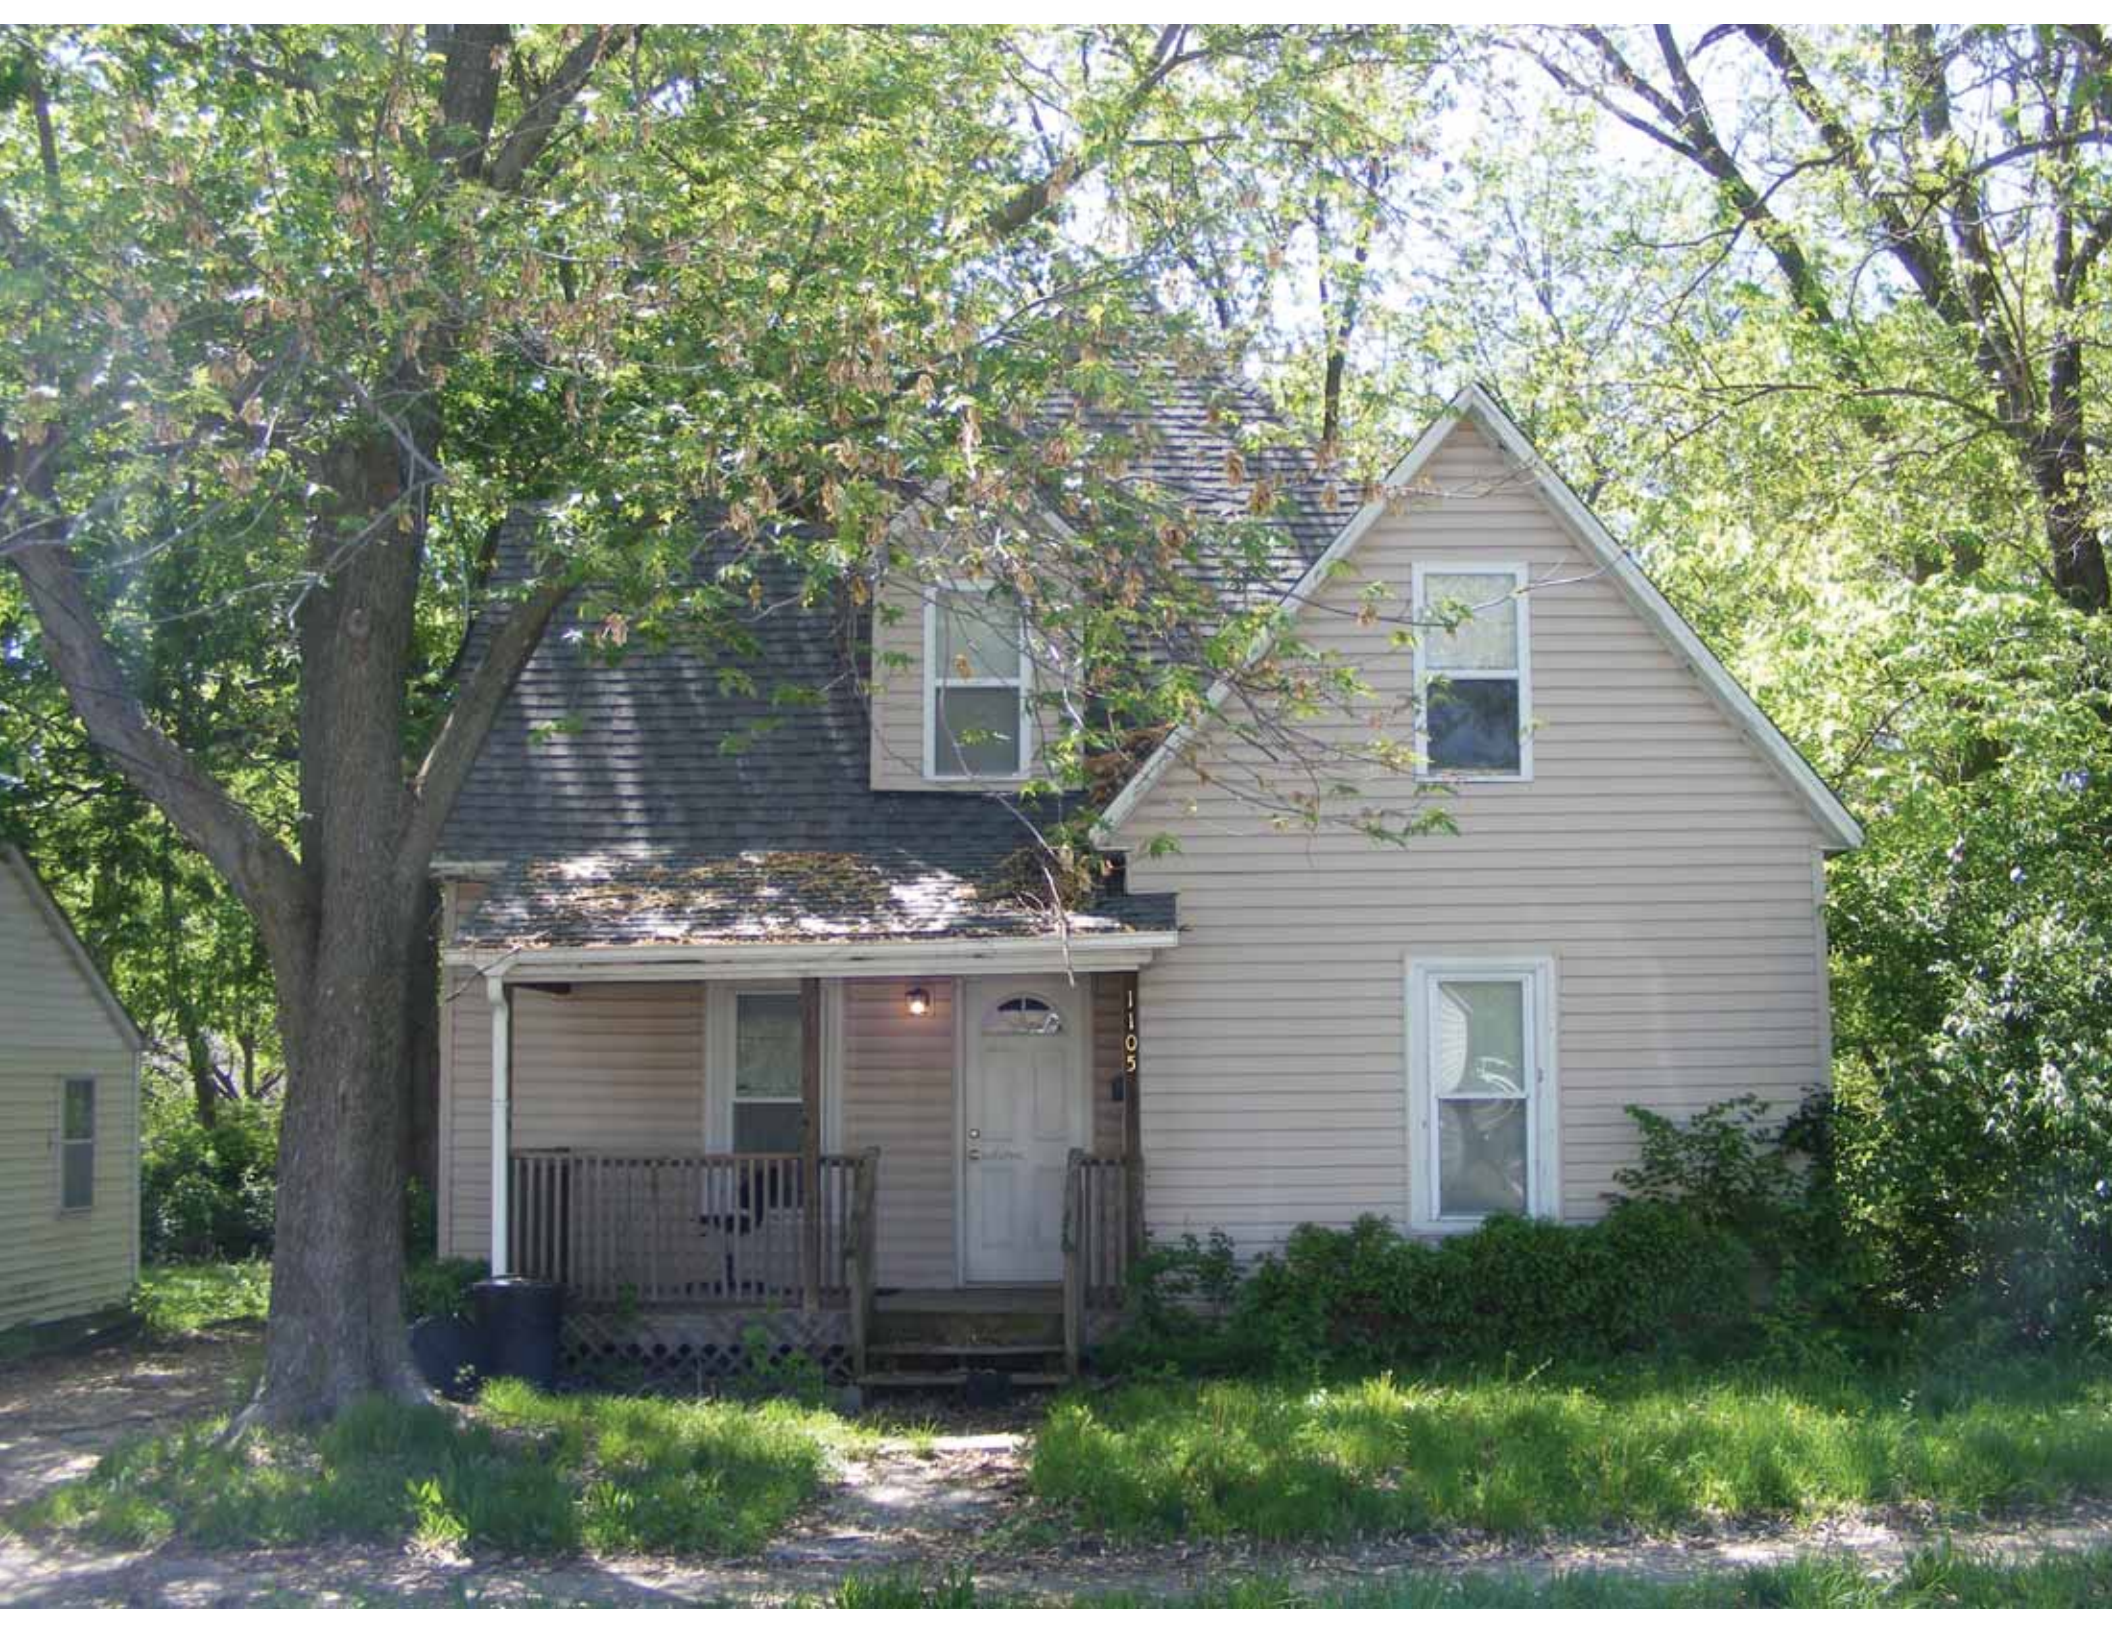
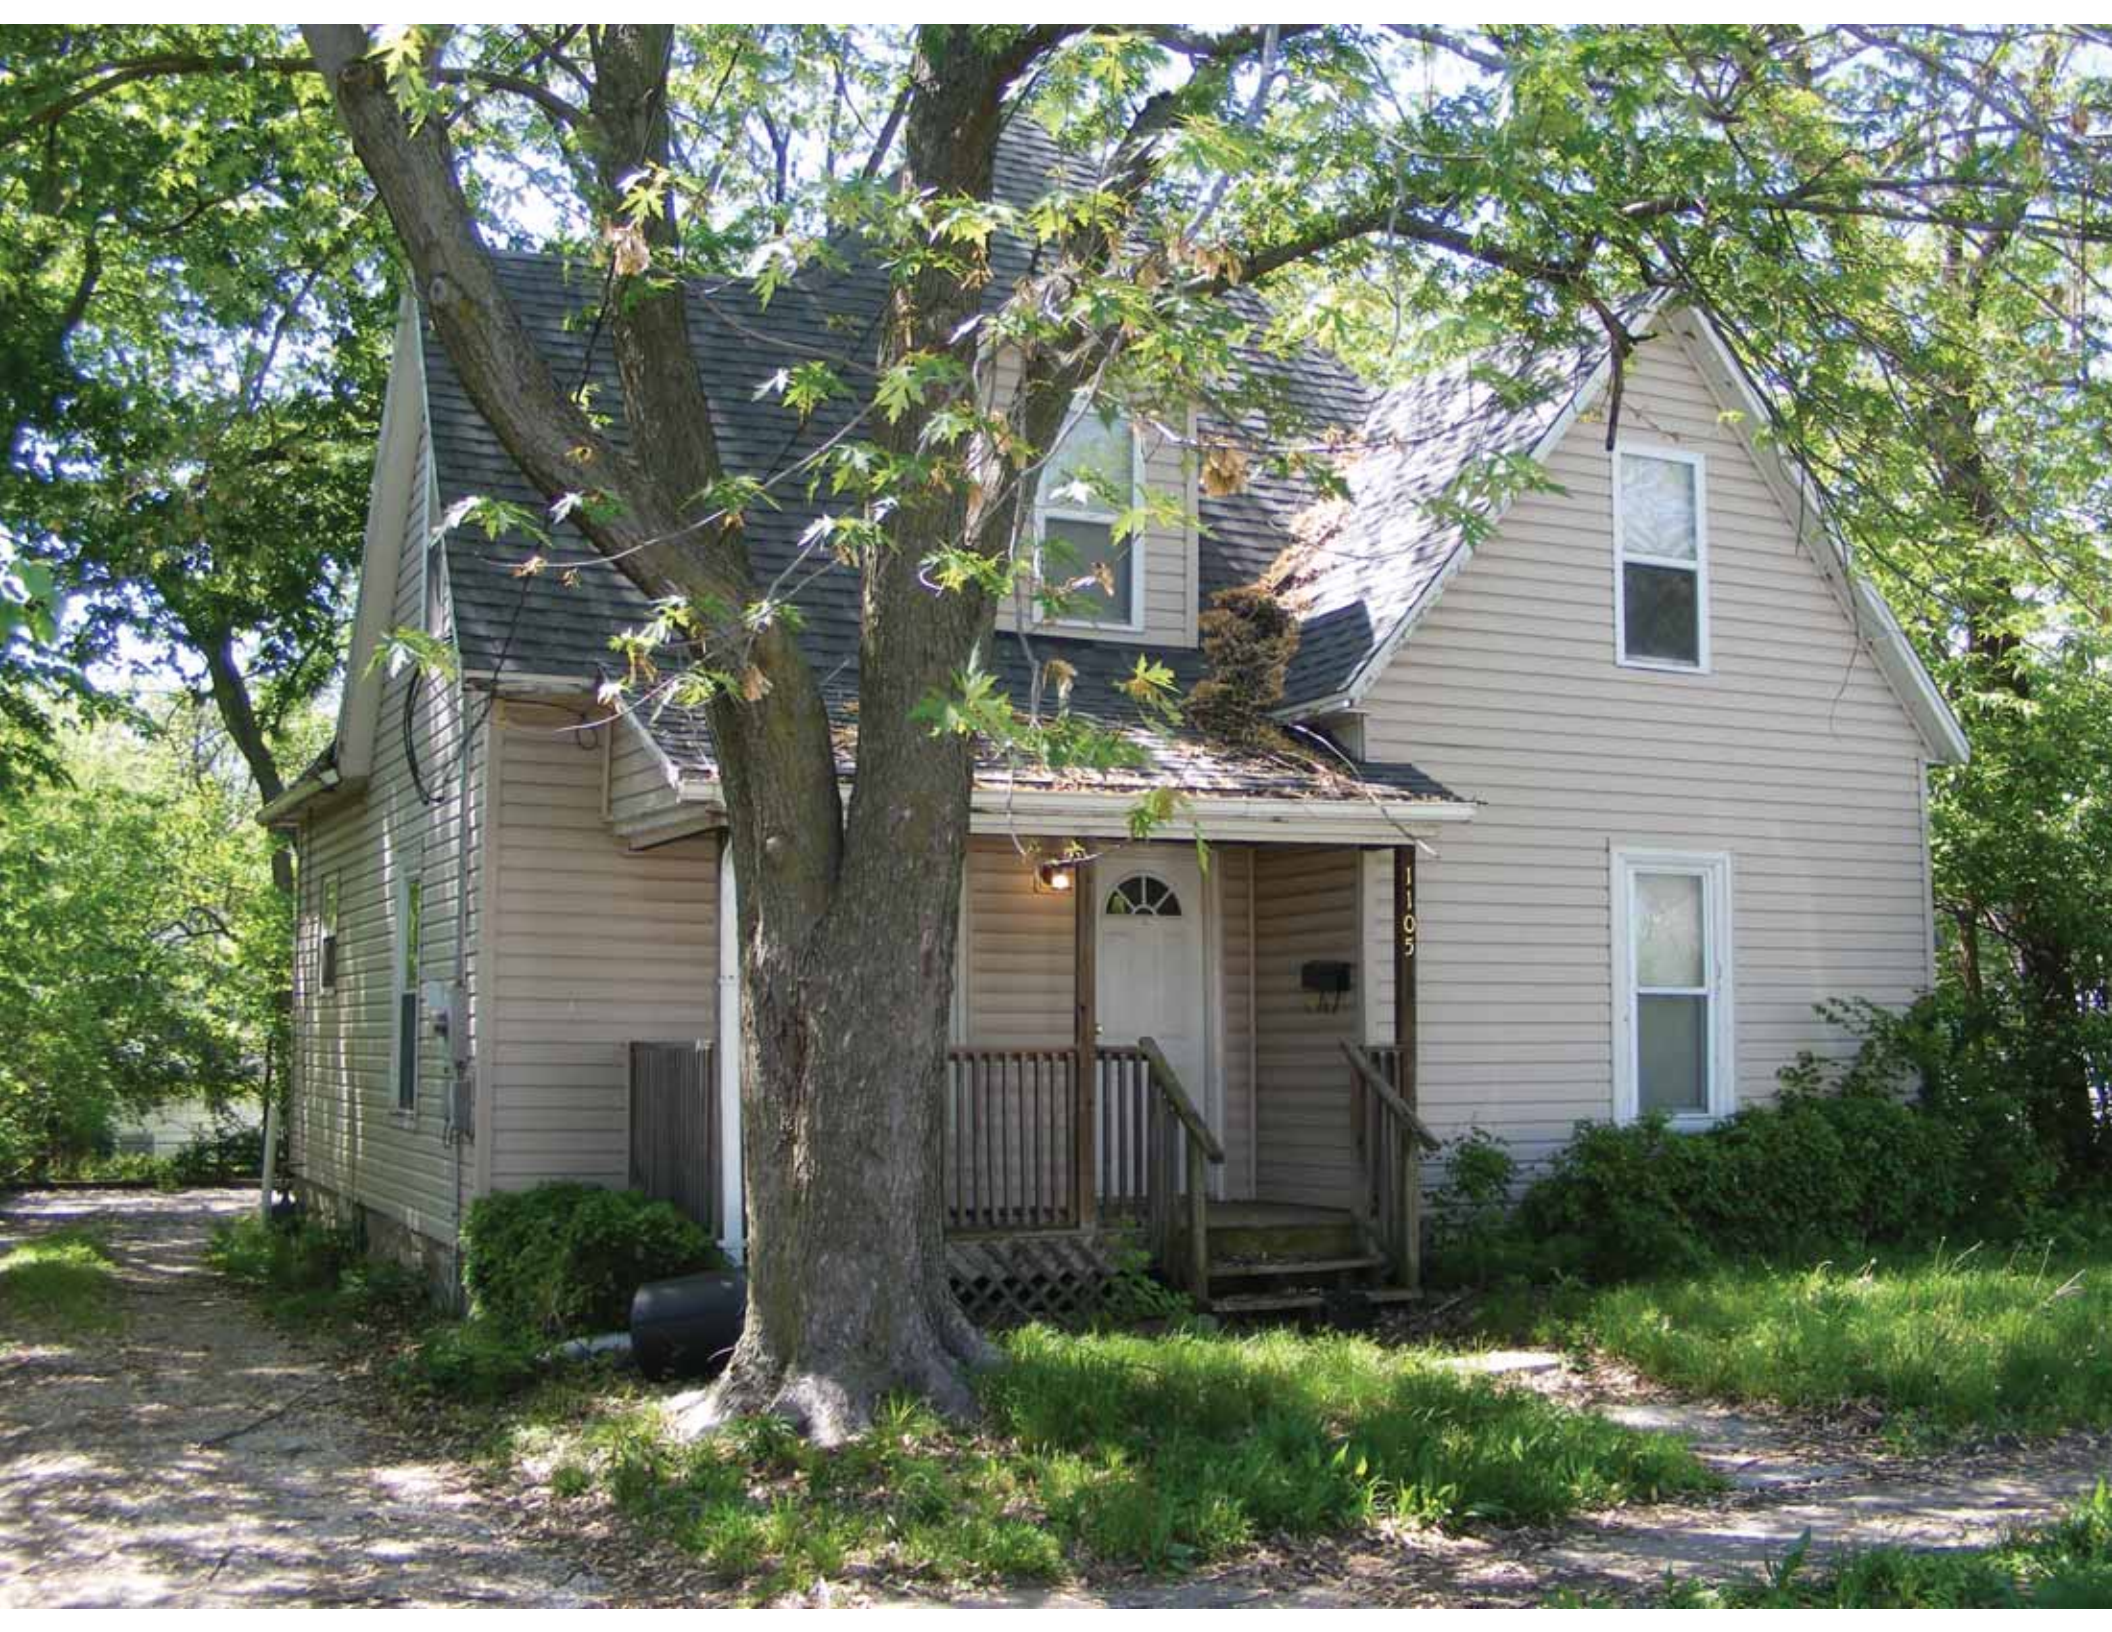
41. (cont.) Description of primary resource. Expand box as necessary, or add continuation pages.
A vinyl clad 1.5 story asphalt shingled cross gable with a front gable dormer (one-over-one window) on the front sloping roofline and a concrete foundation. The façade holds a partial-width porch (non-original 1990) sheltered under a shed roof supported by square wooden posts with wood railing and decking. The entrance is at the "L" and offset to the left. The gable front holds a one-over-one window on the lower and gable end. Side elevations holds one-over-one windows.
