MISSOURI DEPARTMENT OF NATURAL RESOURCES
STATE HISTORIC PRESERVATION OFFICE, P.O. Box 176, Jefferson City, MO 65102
ARCHITECTURAL/HISTORIC INVENTORY FORM

1. Survey No. BO-AS-011-0087		2. Survey name: North Central Columbia Survey Phase II	
3. County: Boone		4. Address (Street No.) 902	Street (name) N. Seventh Street
5. City: Columbia	Vicinity: <input type="checkbox"/>	6. Geographical Reference:	7. Township/Range/Section: T: R: S:
8. Historic name (if known):		9. Present/other name (if known):	
10. Ownership: <input checked="" type="checkbox"/> Private <input type="checkbox"/> Public		11a. Historic use (if known): Domestic/single dwelling	11b. Current use: Domestic/single dwelling

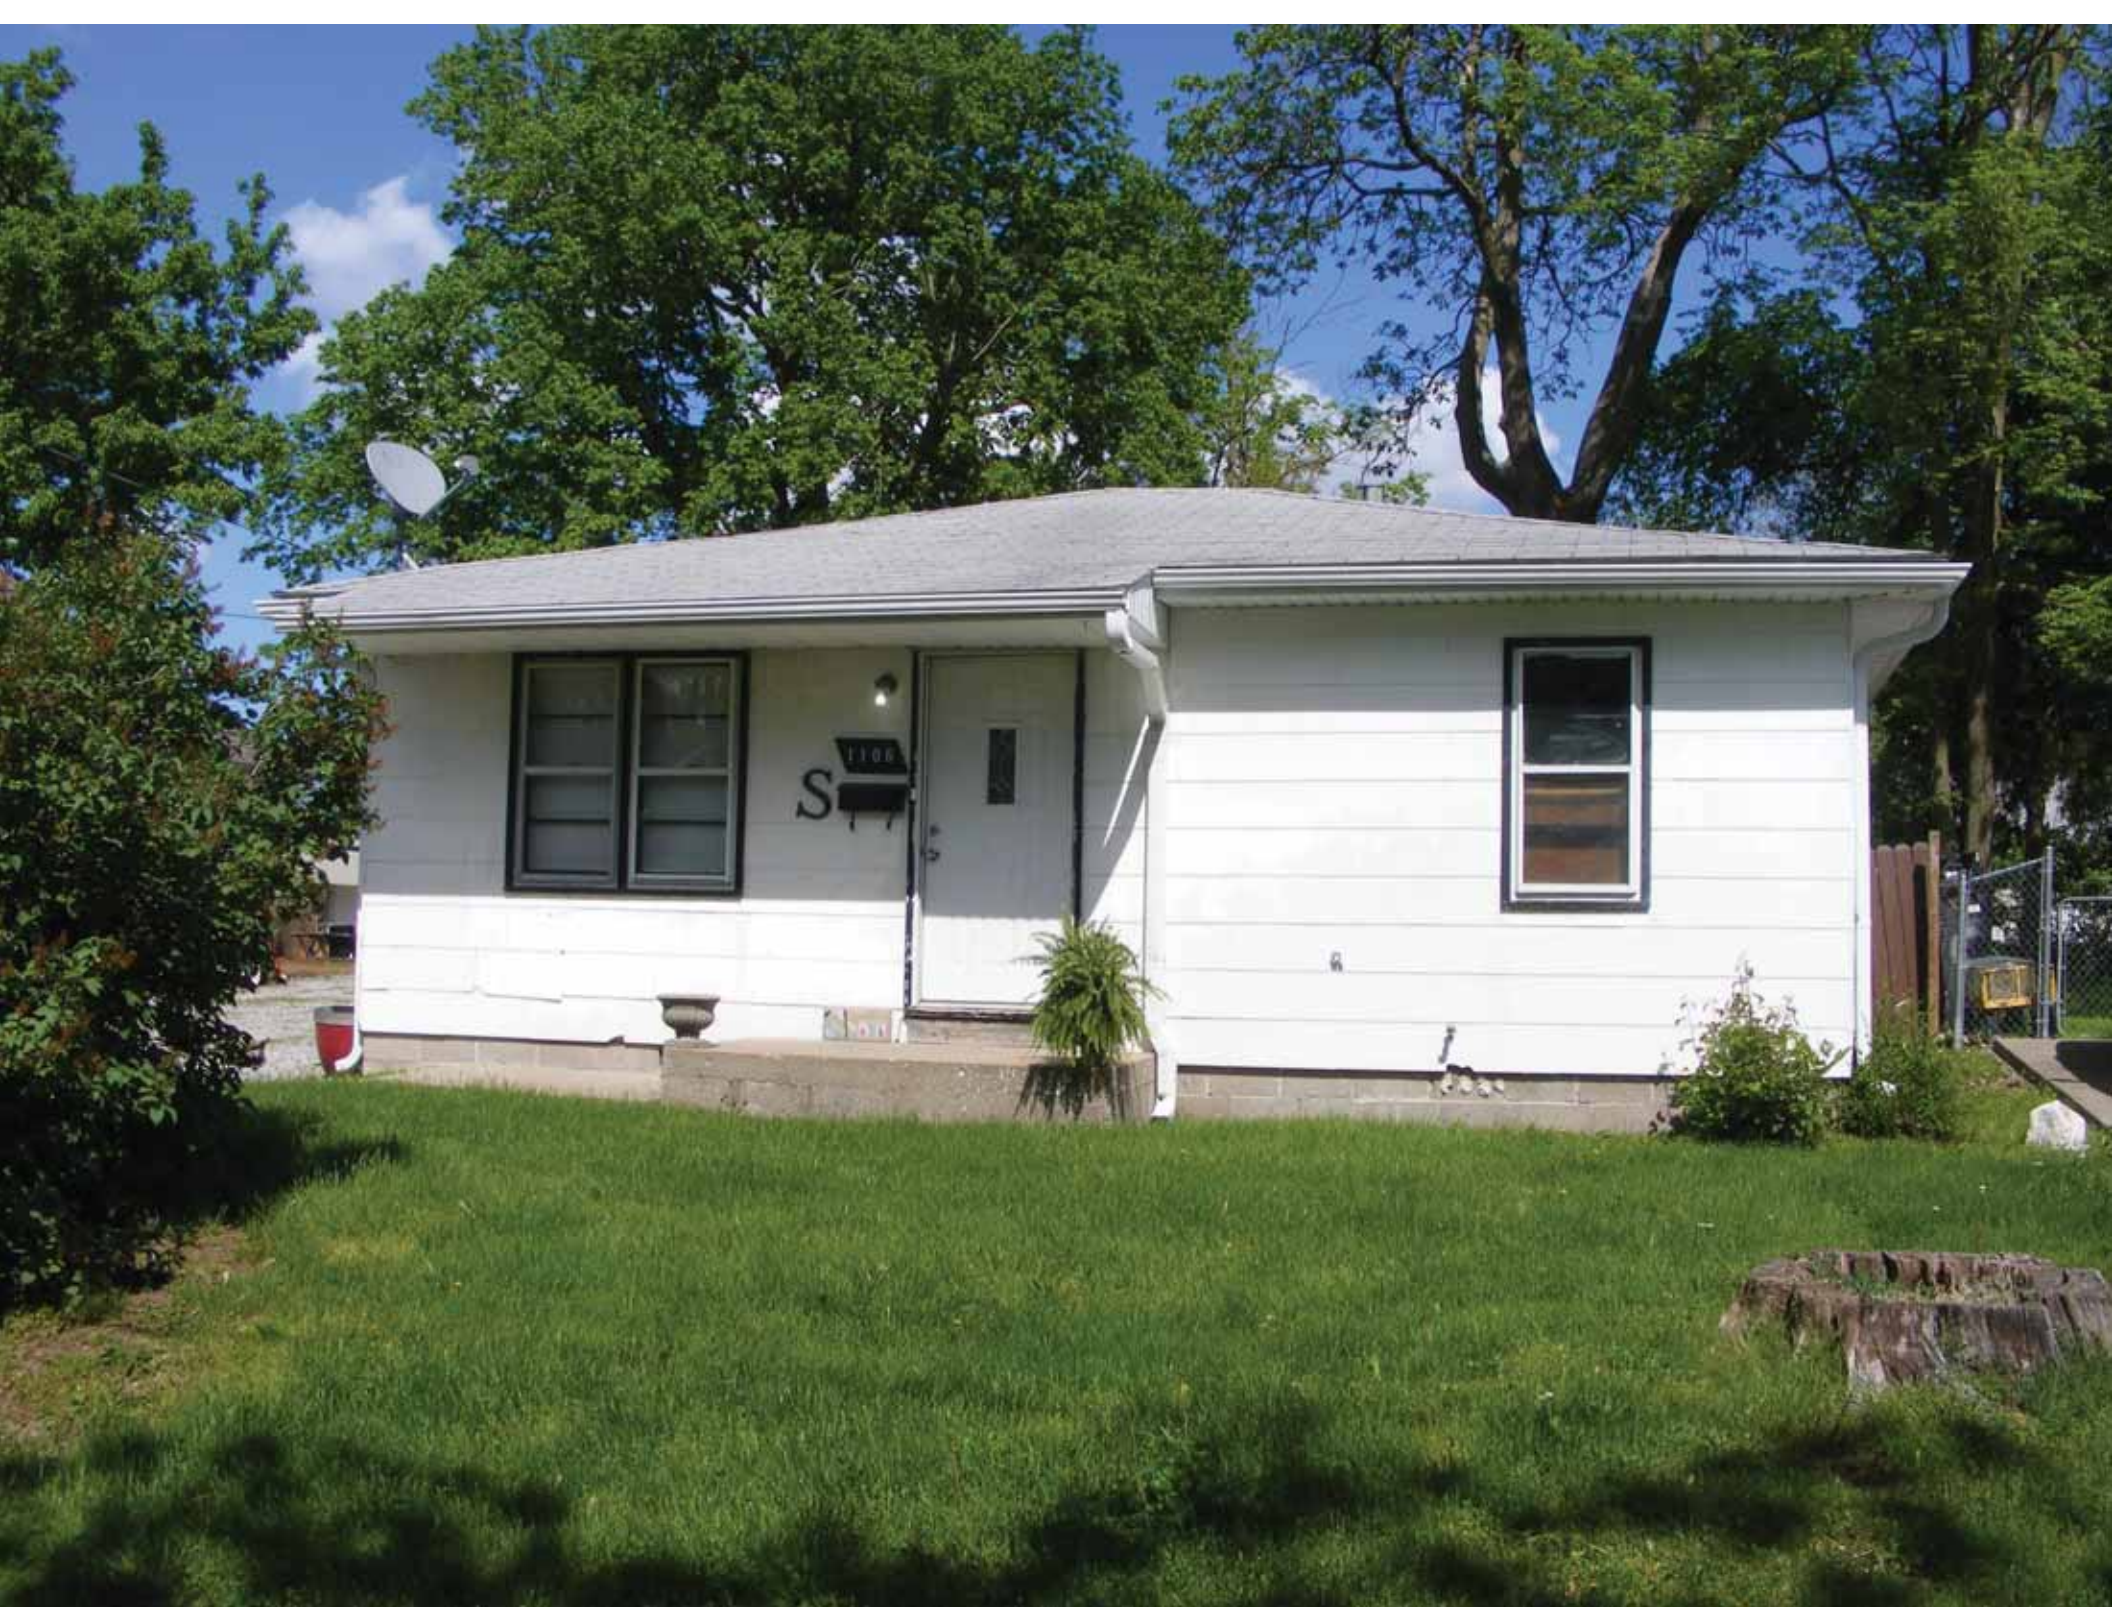
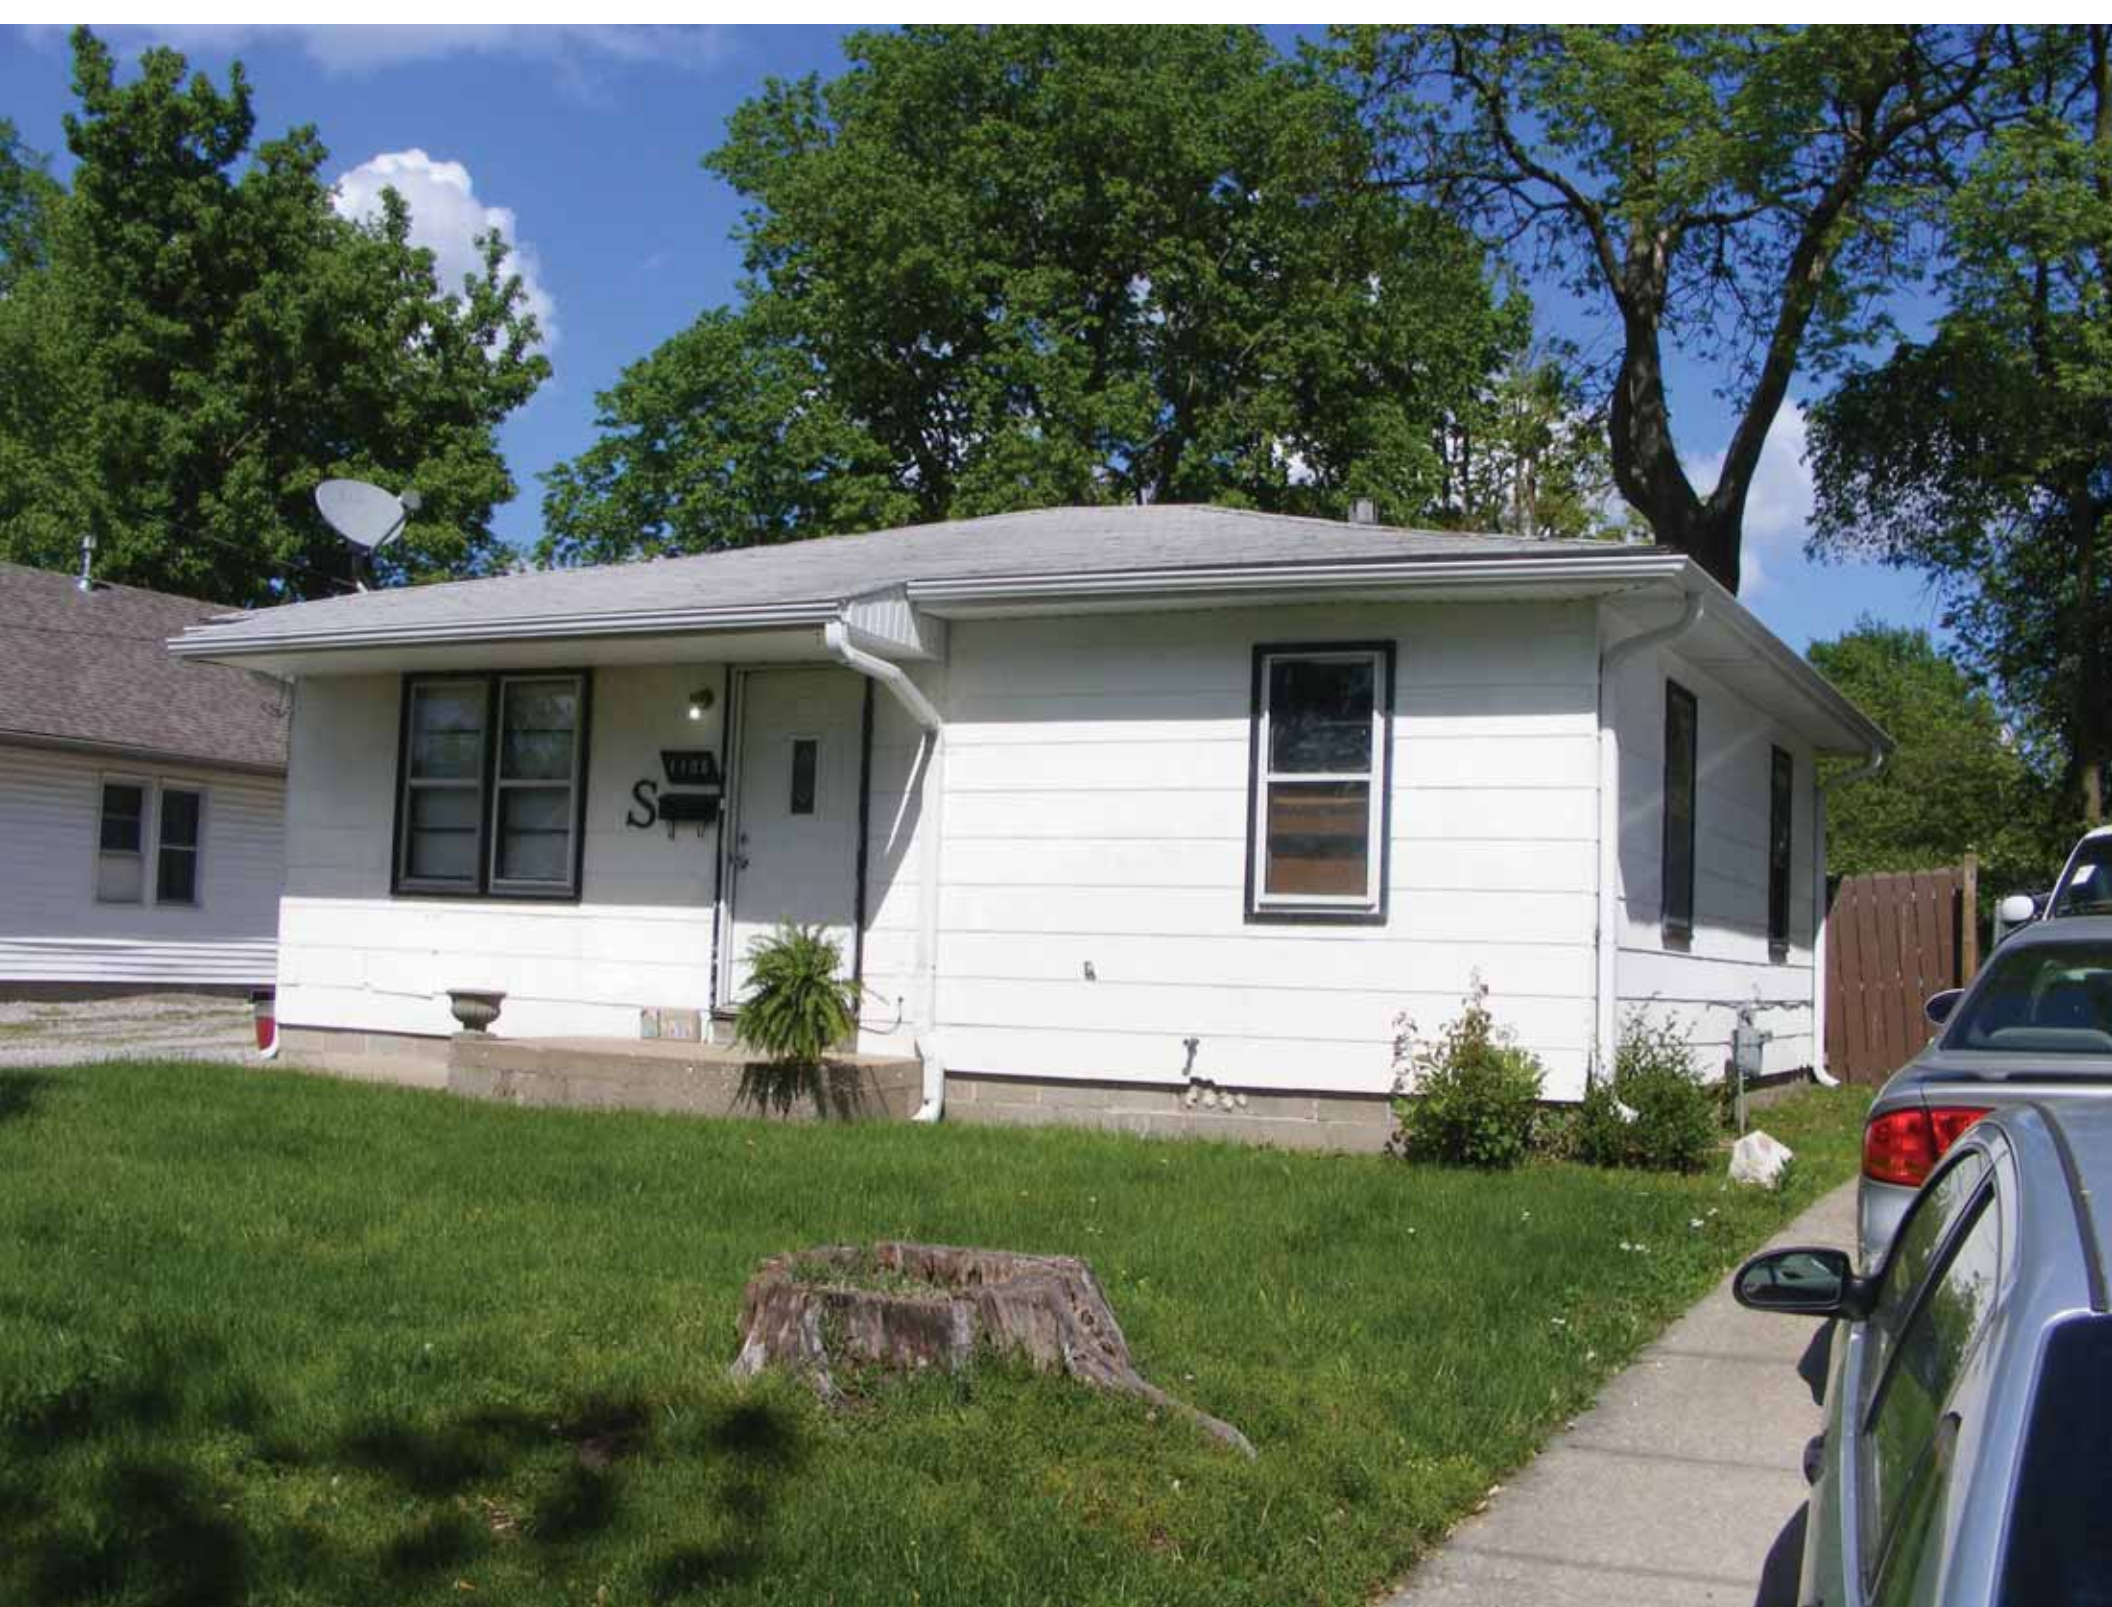
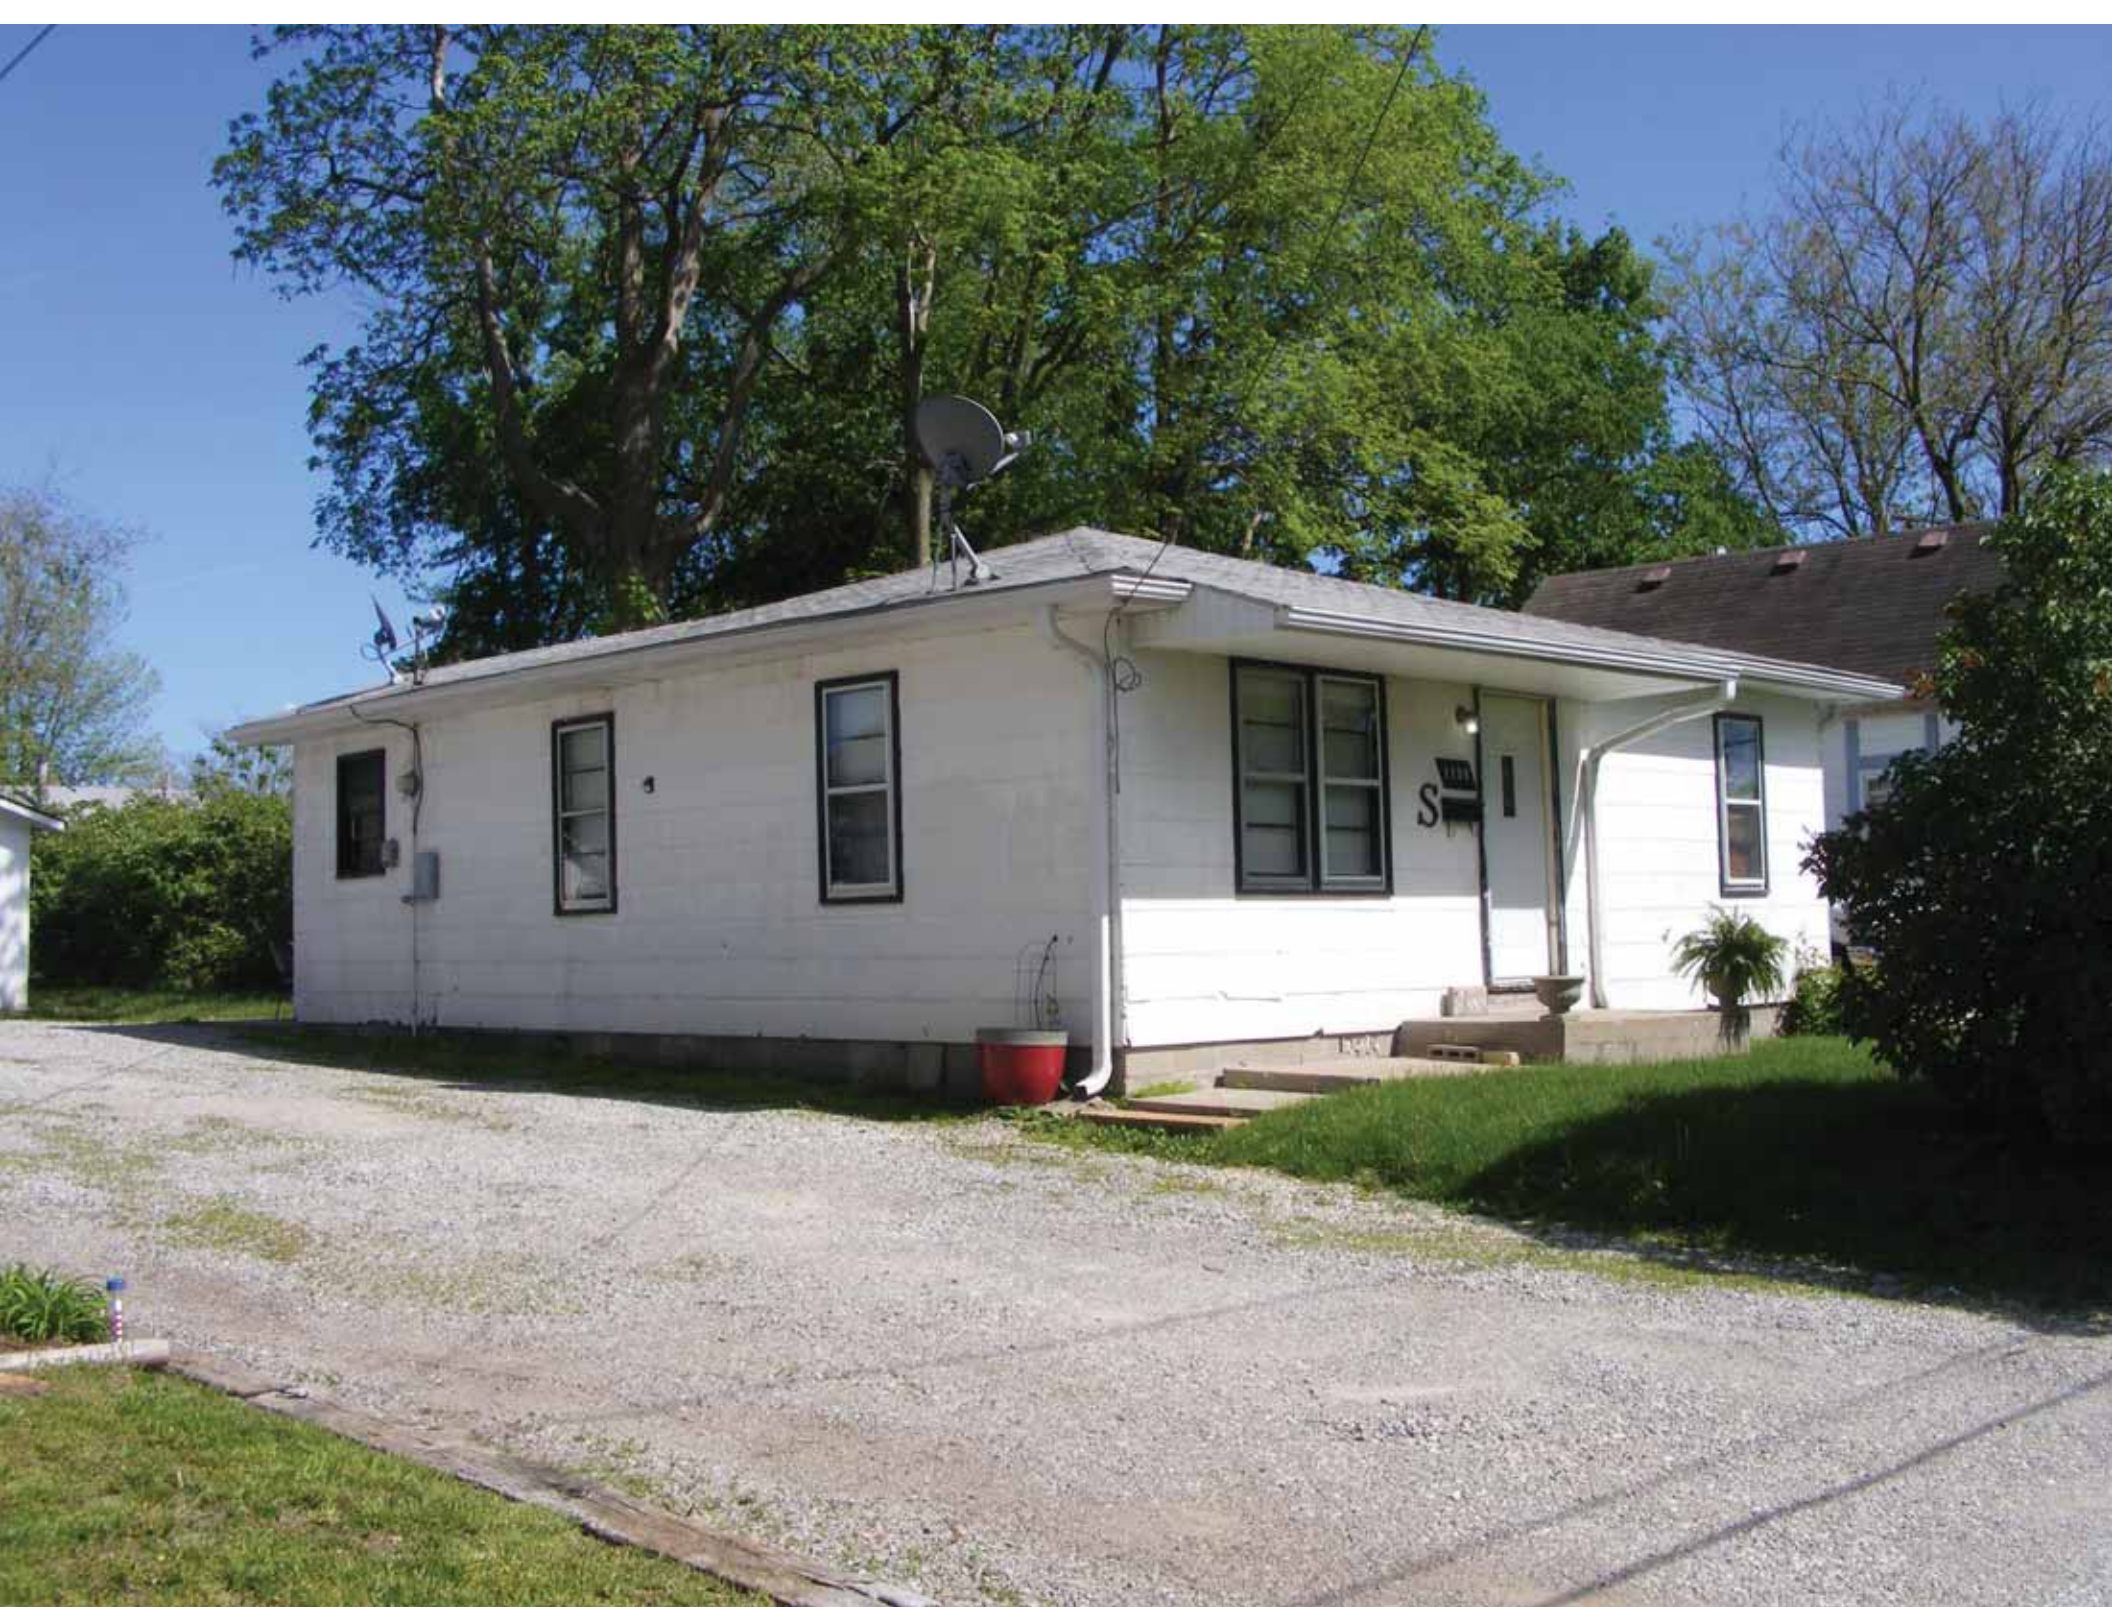
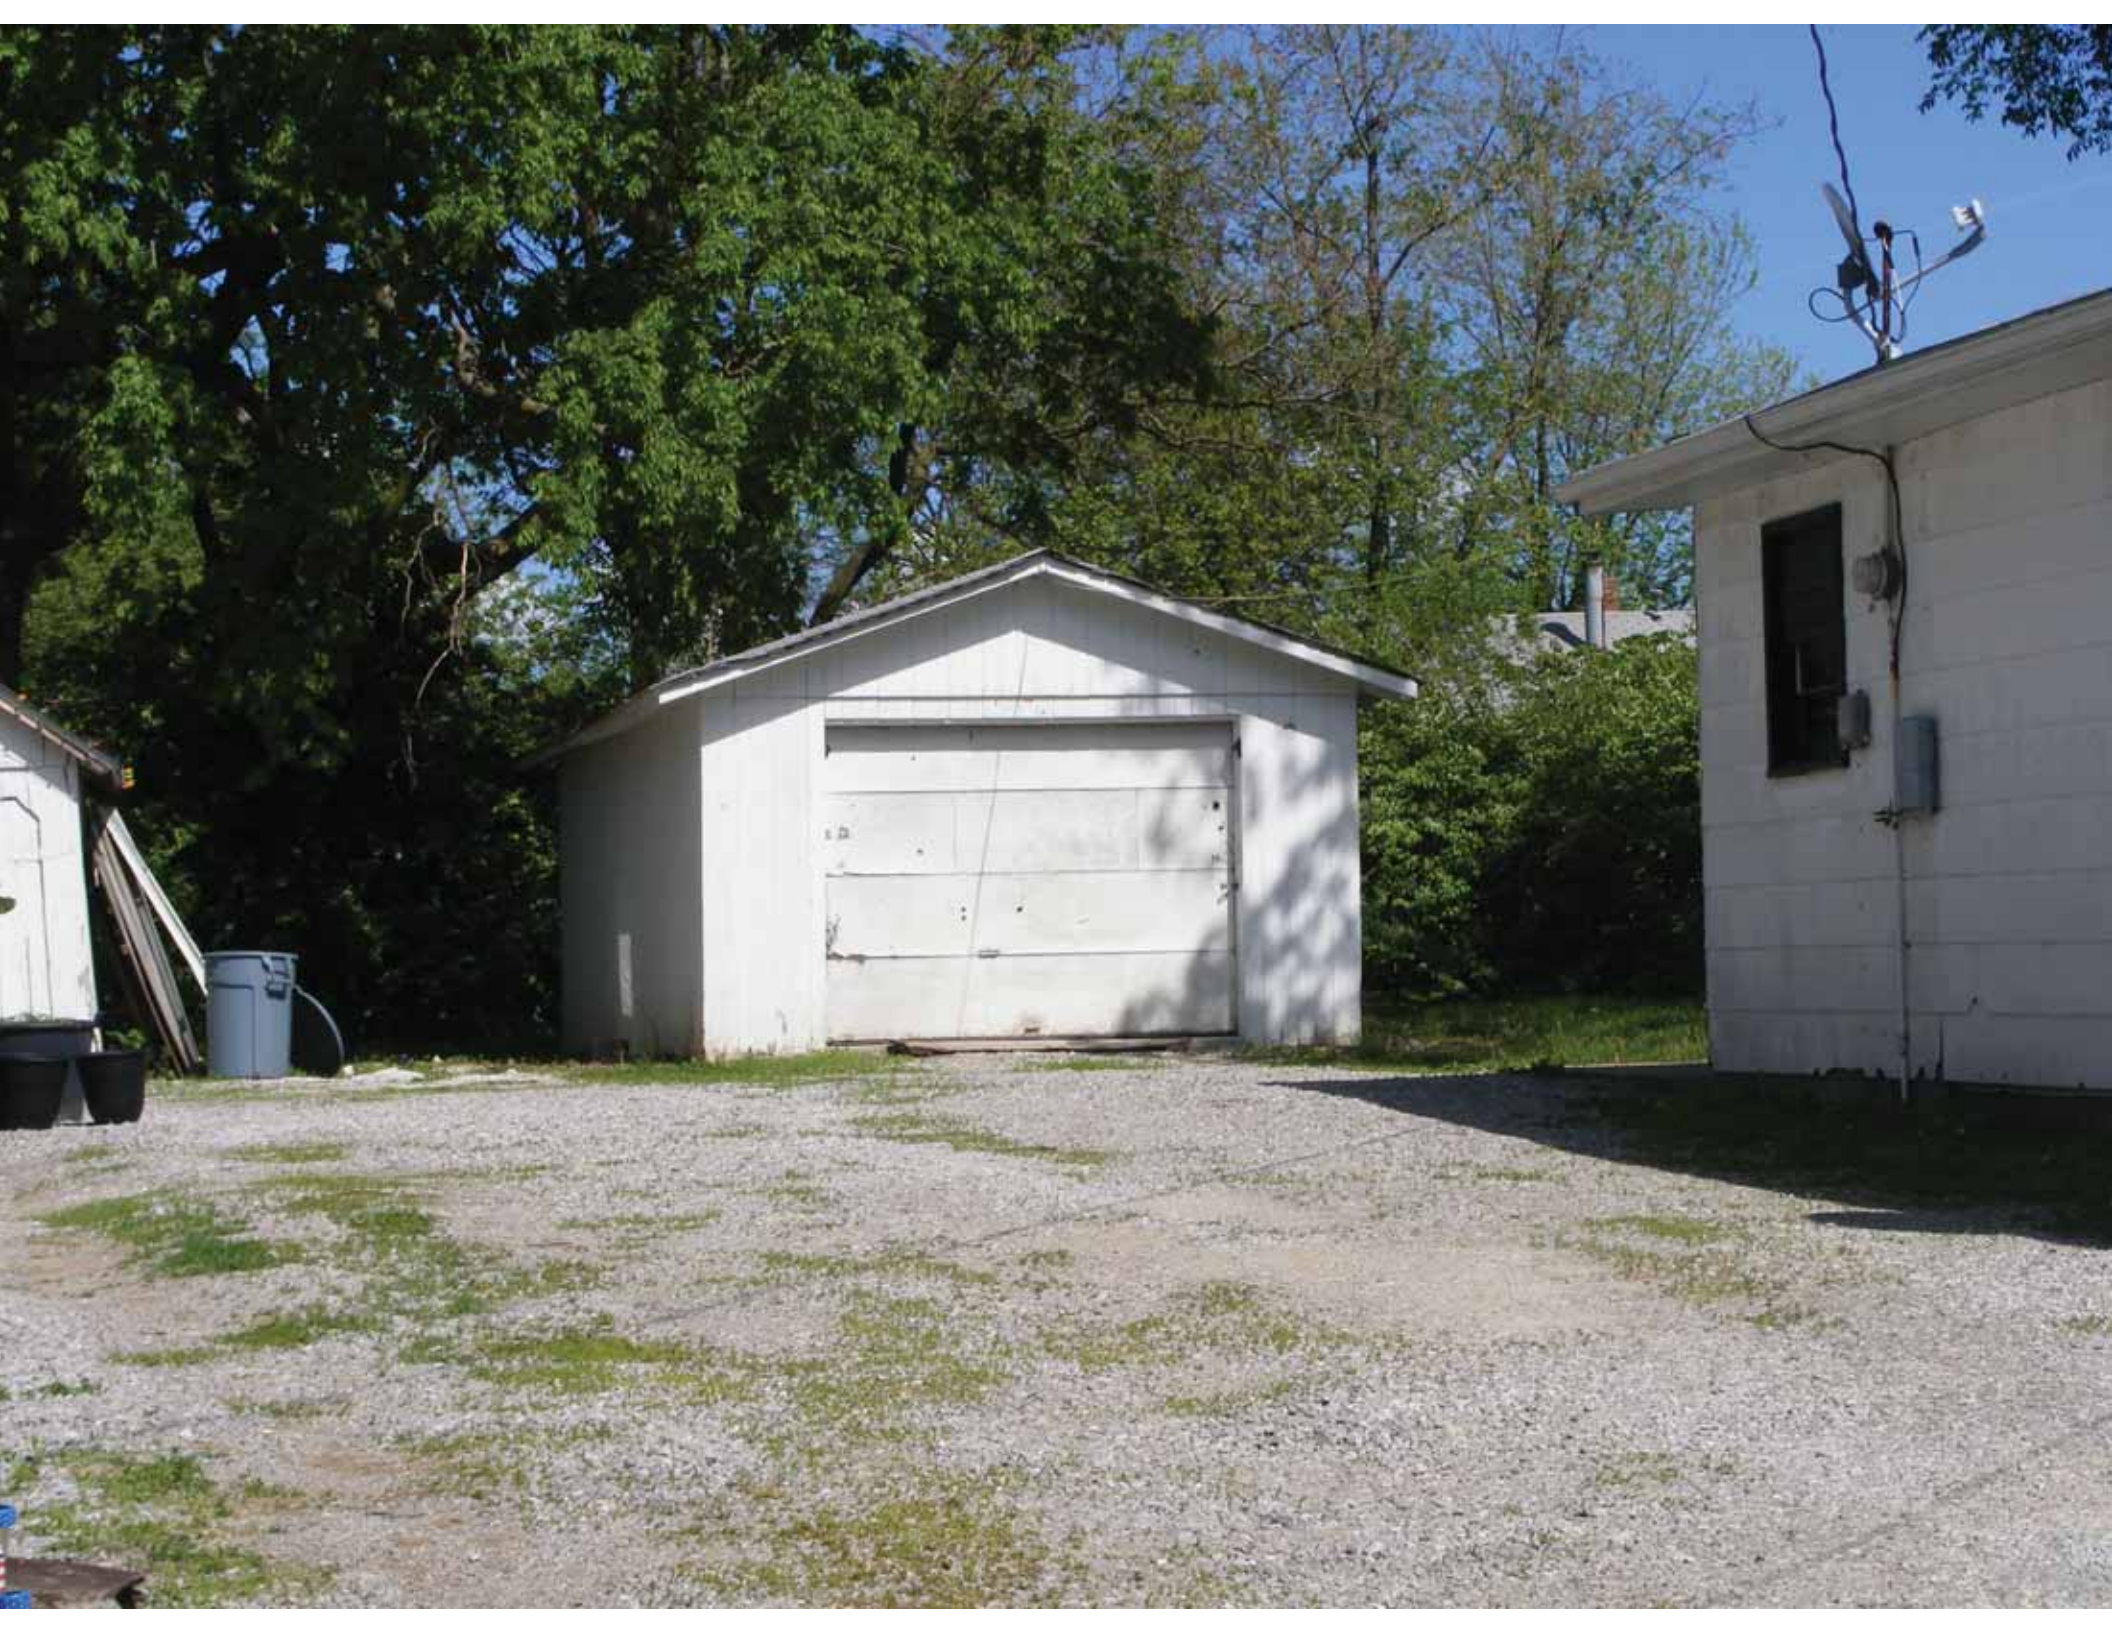
41. (cont.) Description of primary resource. Expand box as necessary, or add continuation pages.
The dwelling is one story, asphalt shingled low hip roof with wide overhanging eaves, clad in asbestos and has a concrete block foundation. The façade features a slightly off-centered concrete stoop, sheltered under the eaves, original wooden panel and light door, flanked by a paired vertical two-over-two window and a one-over-one window. Side elevation hold two-over-two vertical windows.
