MISSOURI DEPARTMENT OF NATURAL RESOURCES
STATE HISTORIC PRESERVATION OFFICE, P.O. Box 176, Jefferson City, MO 65102
ARCHITECTURAL/HISTORIC INVENTORY FORM

1. Survey No. BO-AS-011-0087		2. Survey name: North Central Columbia Survey Phase II	
3. County: Boone		4. Address (Street No.) 902	Street (name) N. Seventh Street
5. City: Columbia	Vicinity: <input type="checkbox"/>	6. Geographical Reference:	7. Township/Range/Section: T: R: S:
8. Historic name (if known):		9. Present/other name (if known):	
10. Ownership: <input checked="" type="checkbox"/> Private <input type="checkbox"/> Public		11a. Historic use (if known): Domestic/single dwelling	11b. Current use: Domestic/single dwelling

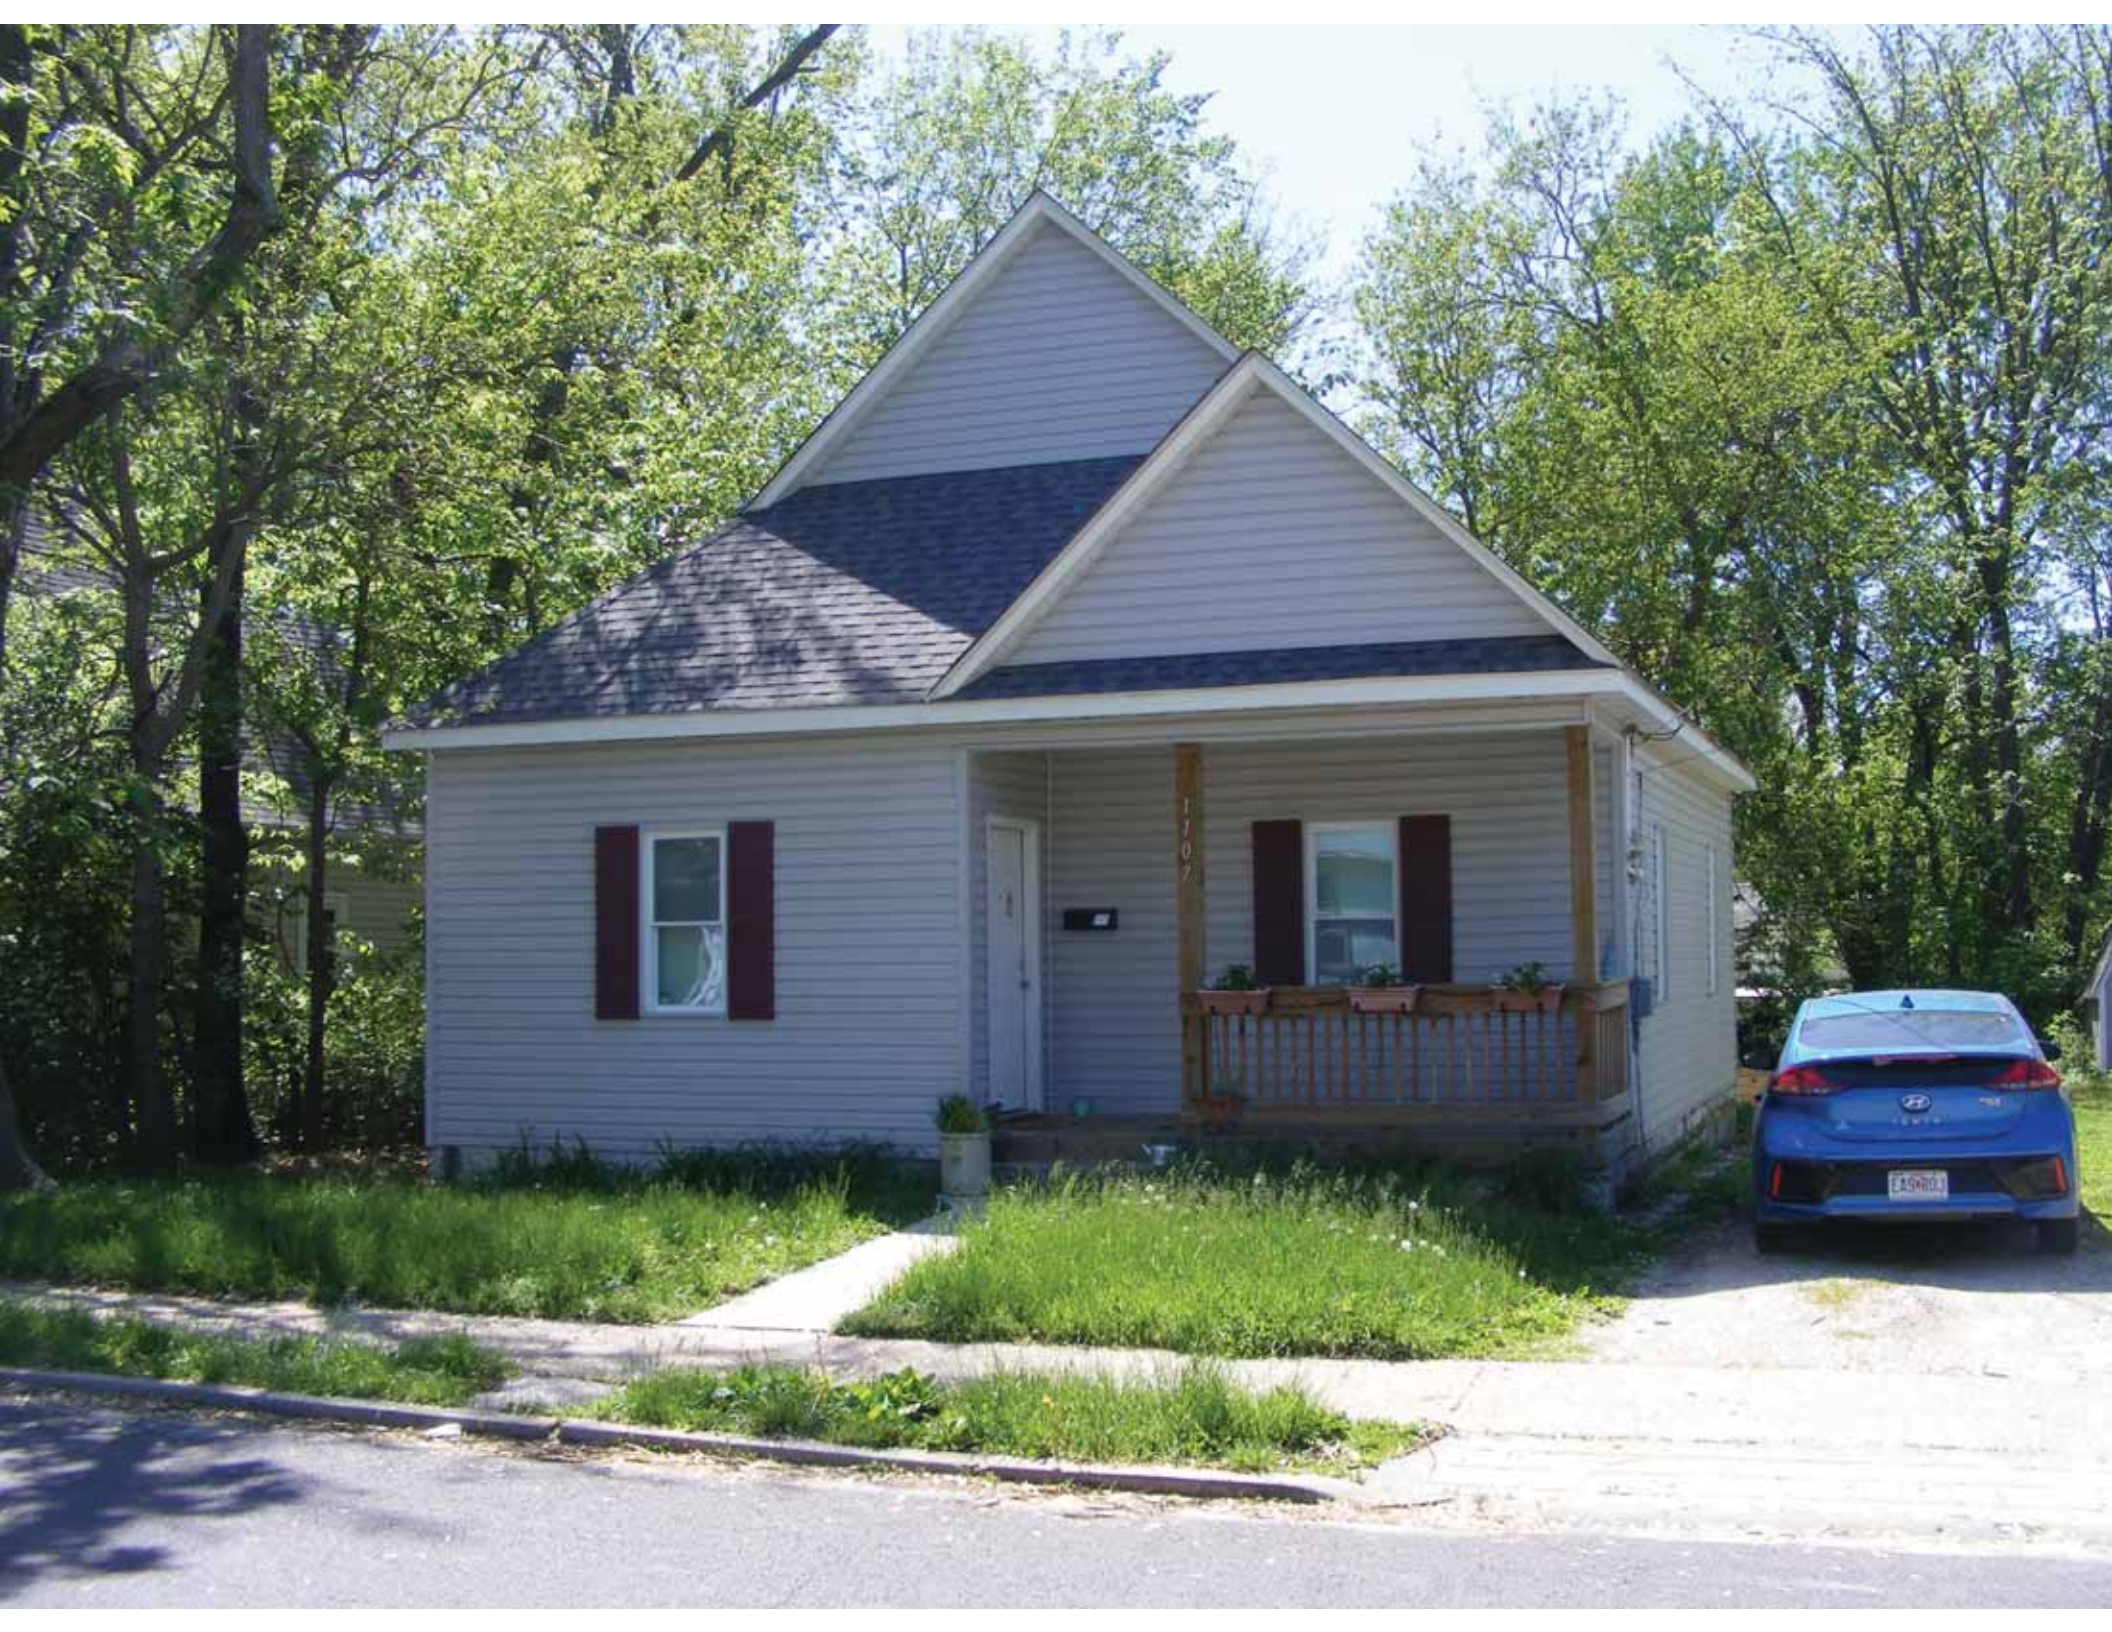
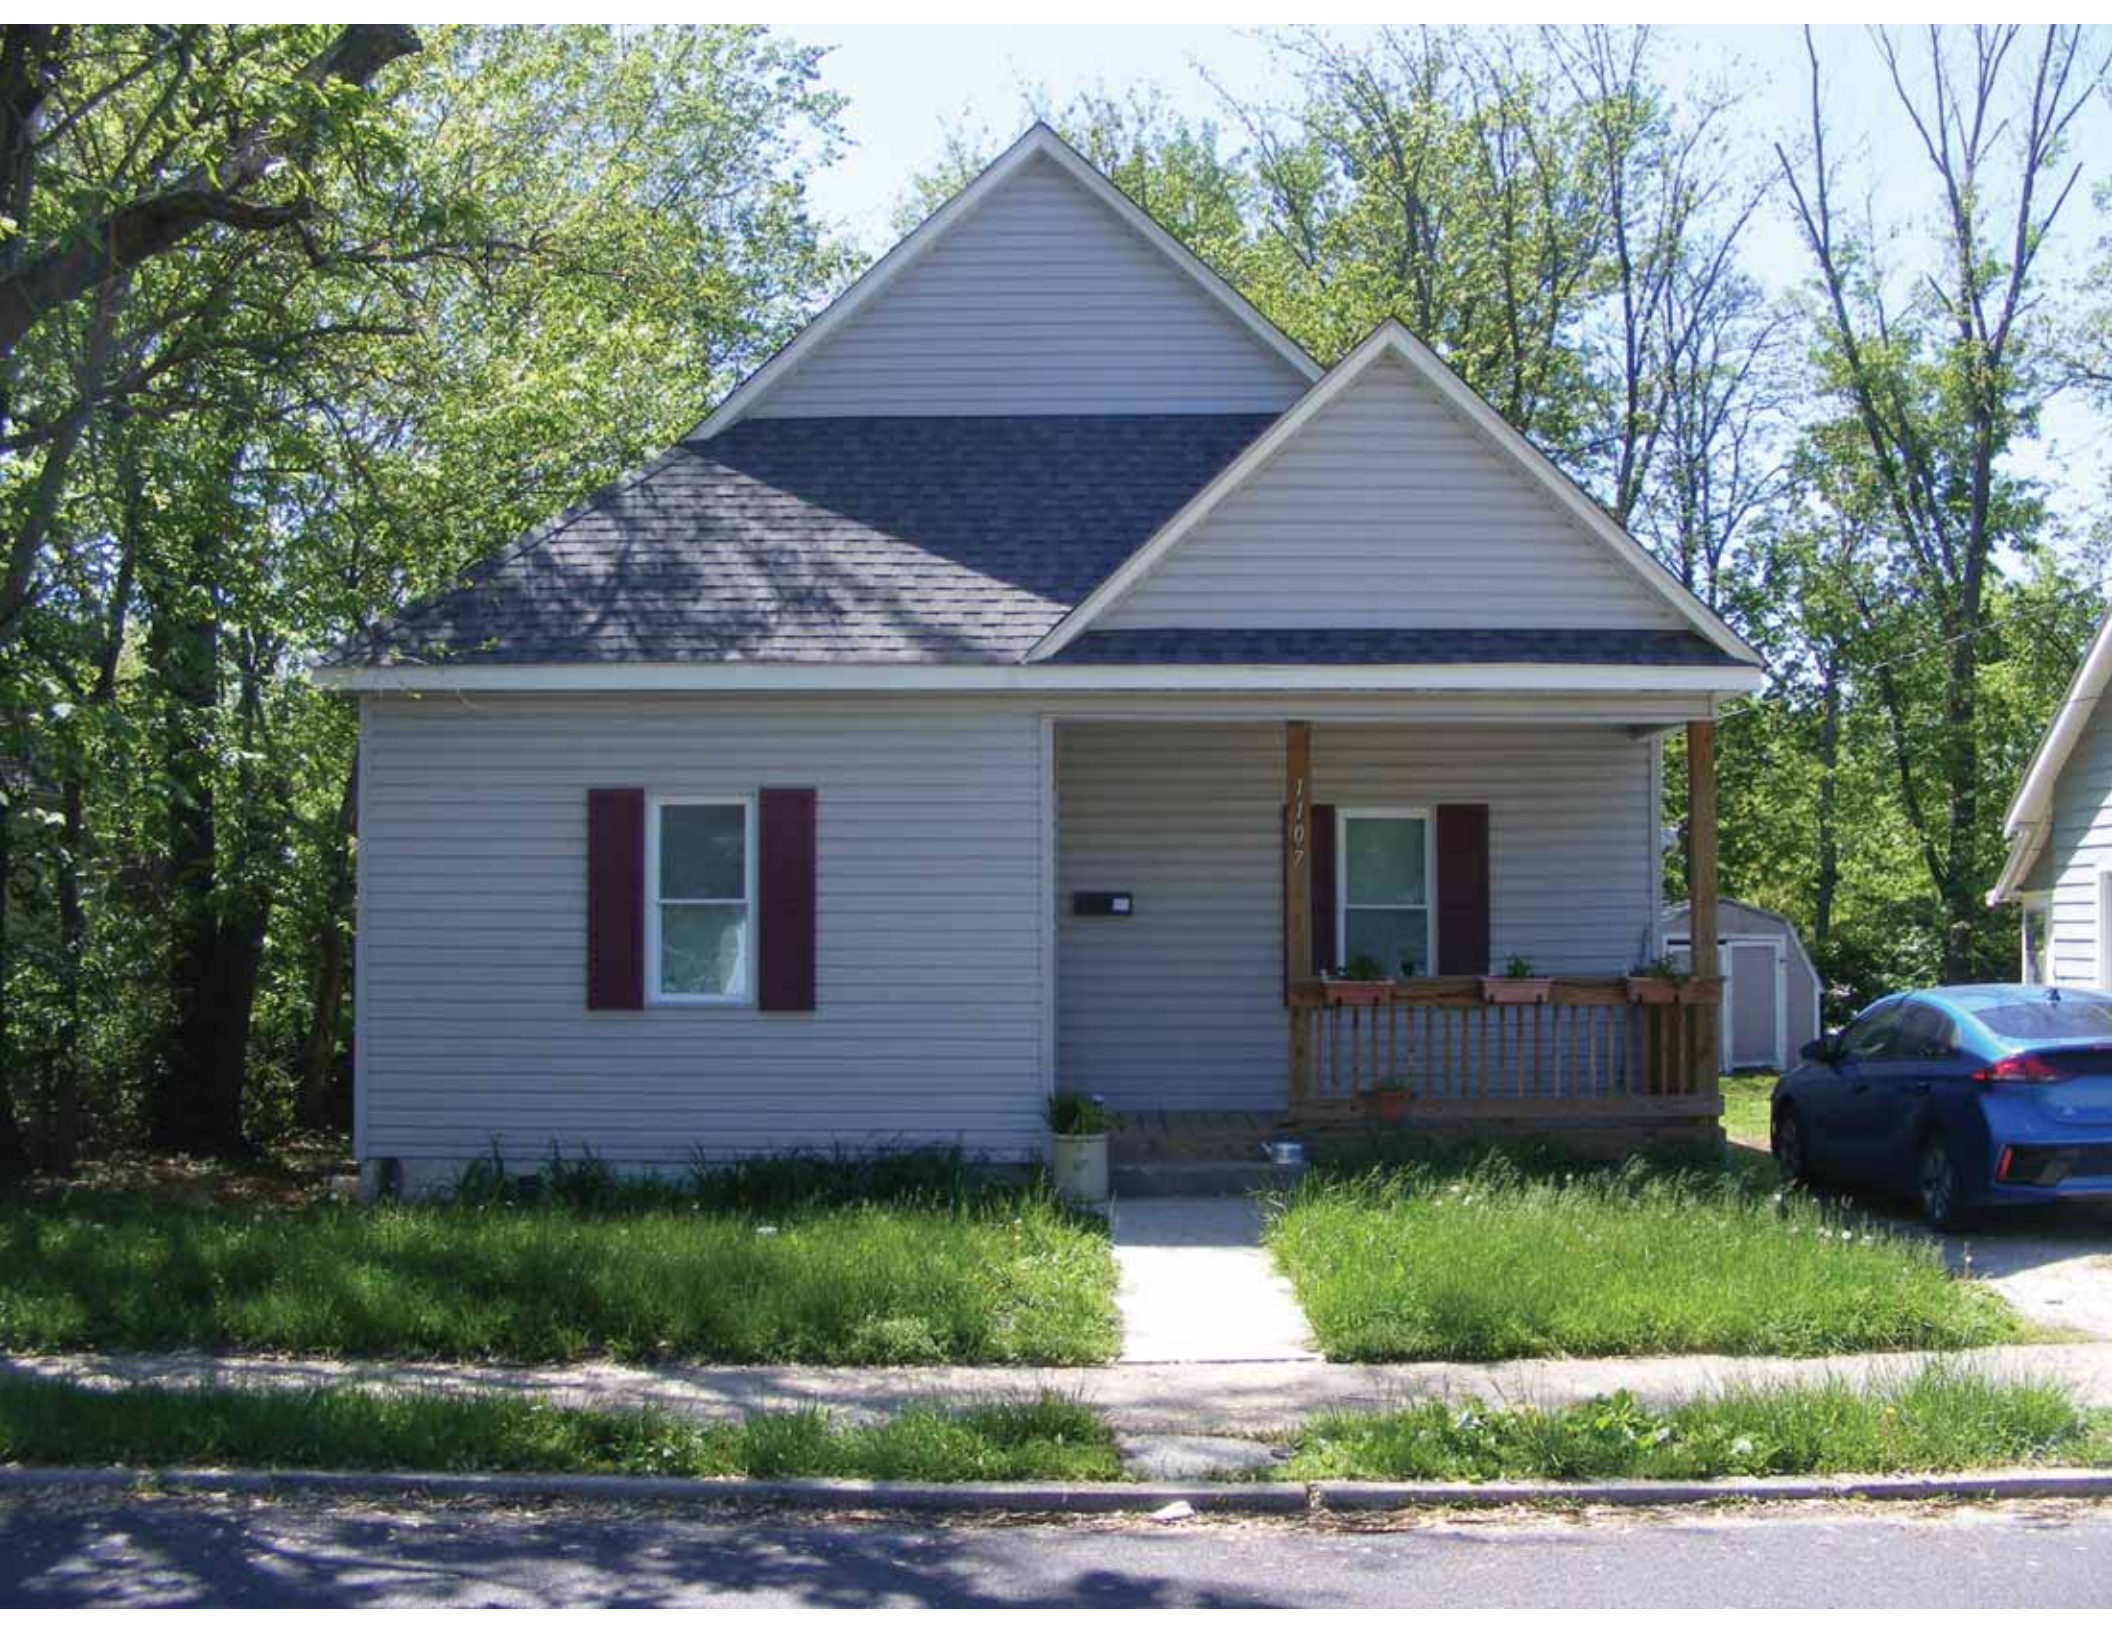
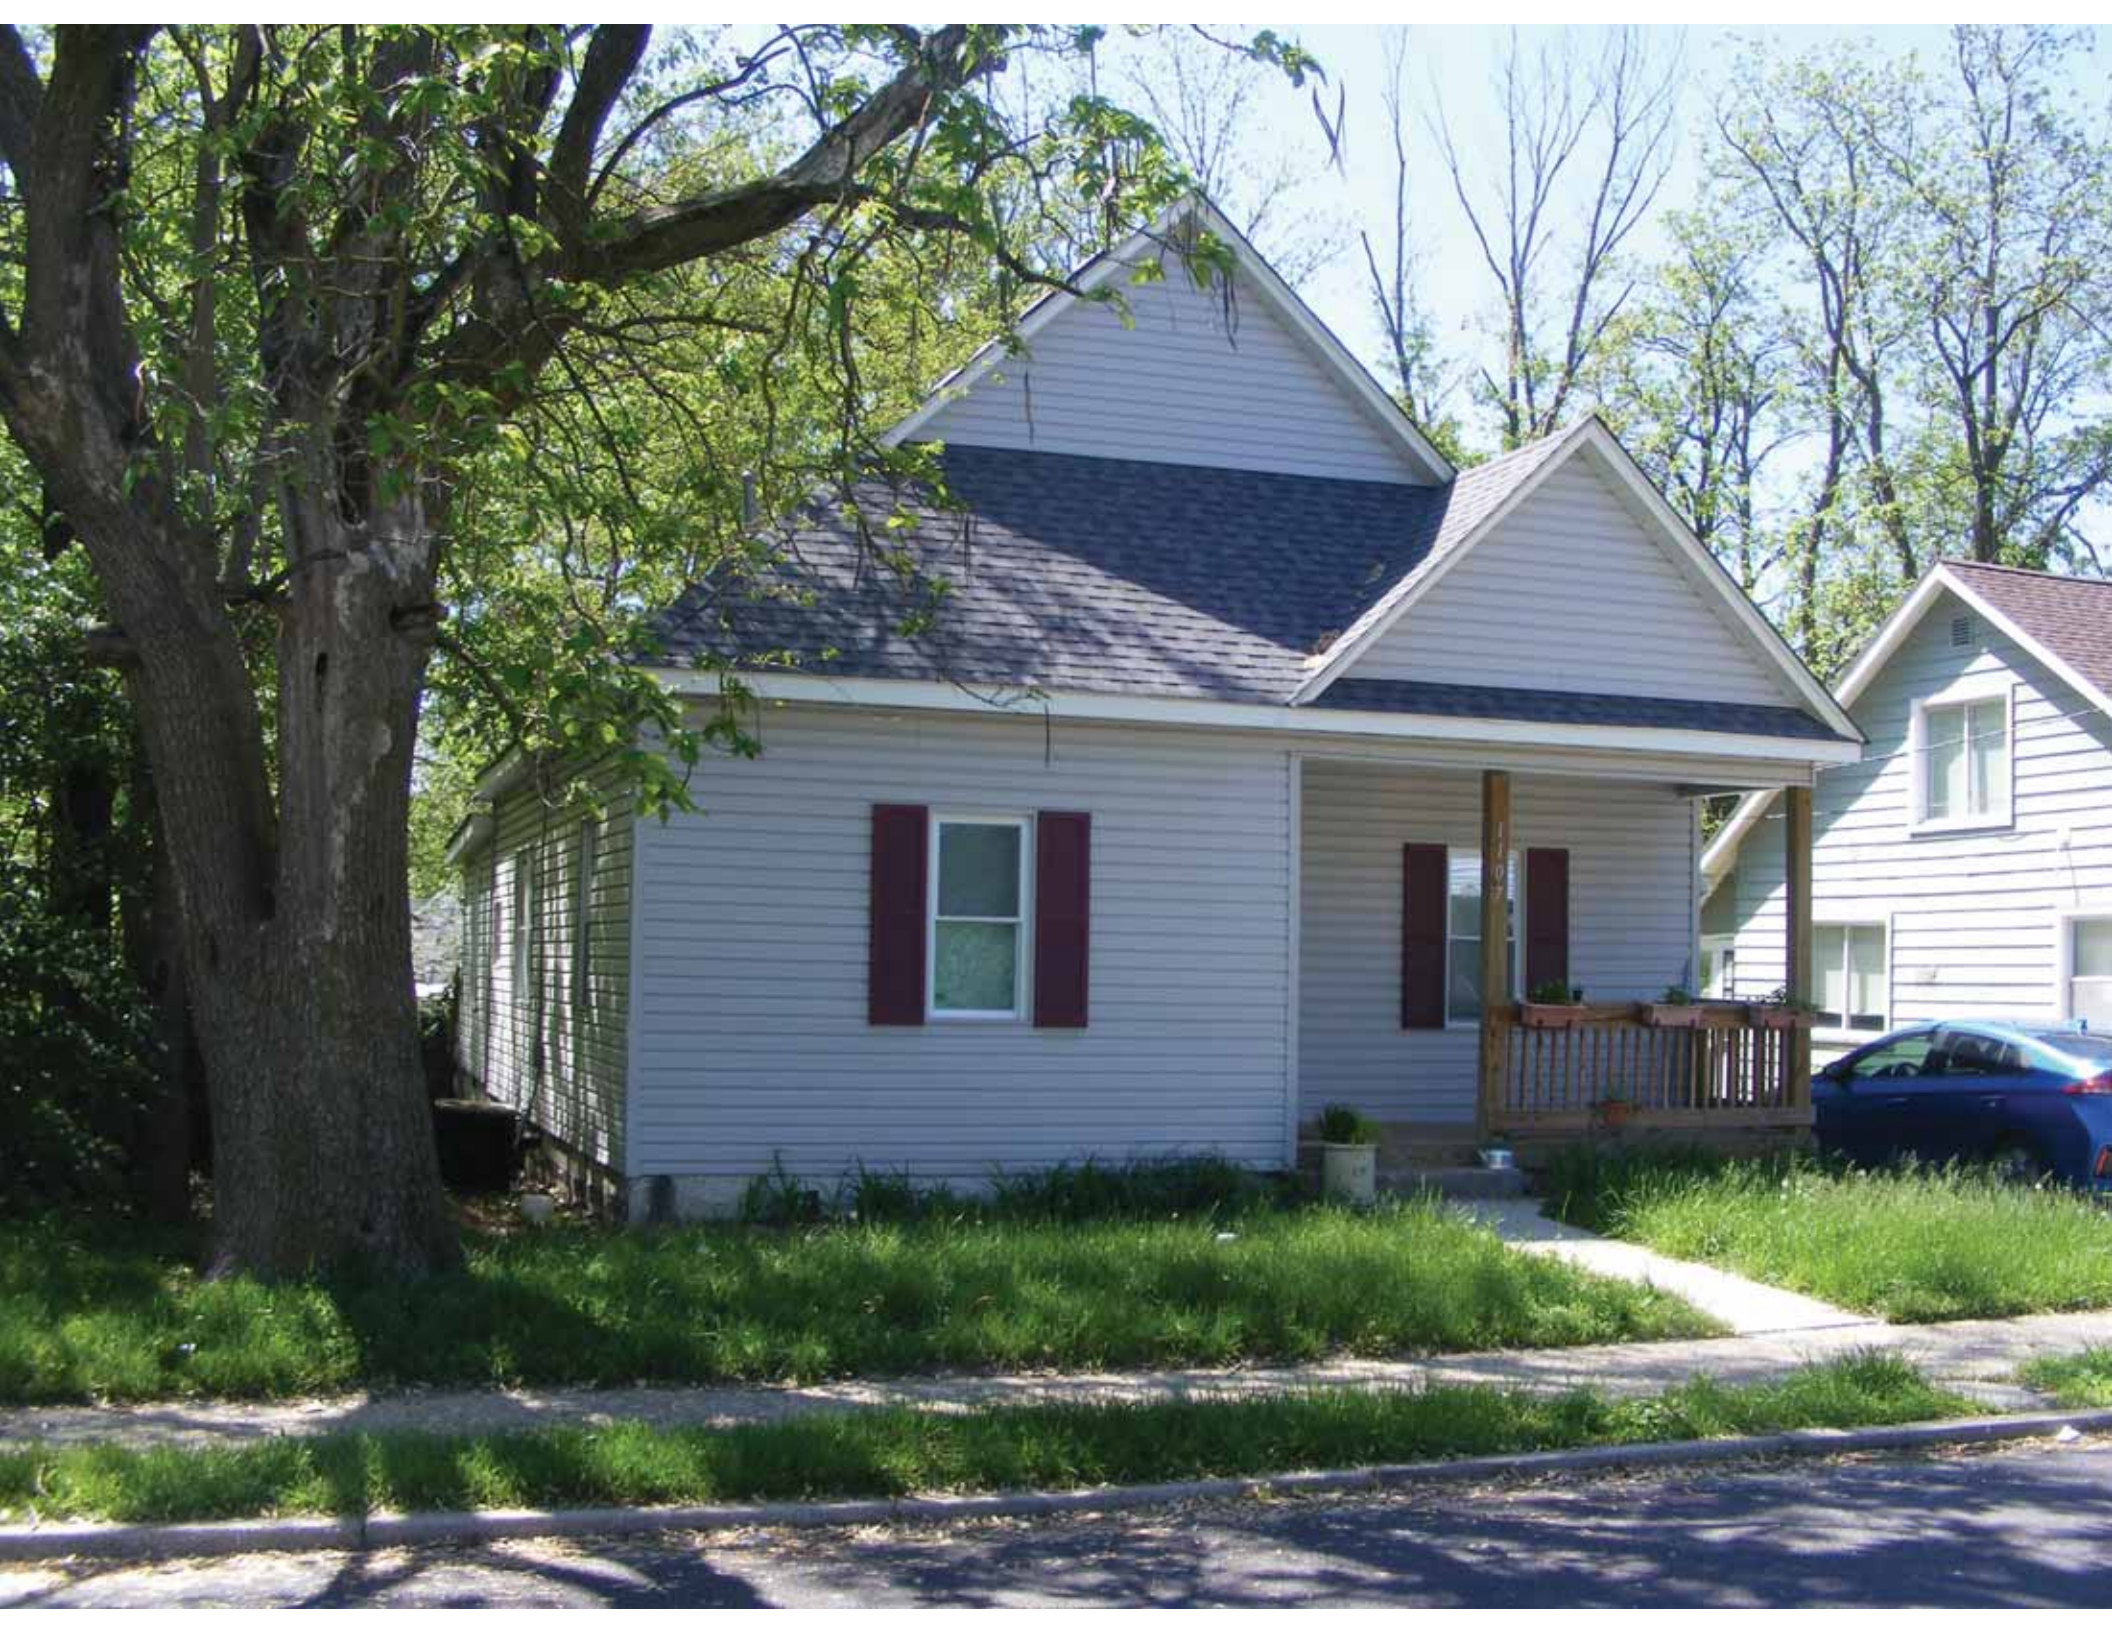
41. (cont.) Description of primary resource. Expand box as necessary, or add continuation pages.
The dwelling is a one story asphalt shingled multiple front gable clad in vinyl siding and concrete foundation. The house was remodeled in 2017 and has replacement one-over-one windows on each elevation. Façade holds a partial-width porch sheltered under the lower front gable with replacement wood decking, railing and post. Entrance is located in the porch bay area on the north elevation wall.
