MISSOURI DEPARTMENT OF NATURAL RESOURCES
STATE HISTORIC PRESERVATION OFFICE, P.O. Box 176, Jefferson City, MO 65102
ARCHITECTURAL/HISTORIC INVENTORY FORM

1. Survey No. BO-AS-011-0087		2. Survey name: North Central Columbia Survey Phase II	
3. County: Boone		4. Address (Street No.) 902	Street (name) N. Seventh Street
5. City: Columbia	Vicinity: <input type="checkbox"/>	6. Geographical Reference:	7. Township/Range/Section: T: R: S:
8. Historic name (if known):		9. Present/other name (if known):	
10. Ownership: <input checked="" type="checkbox"/> Private <input type="checkbox"/> Public		11a. Historic use (if known): Domestic/single dwelling	11b. Current use: Domestic/single dwelling

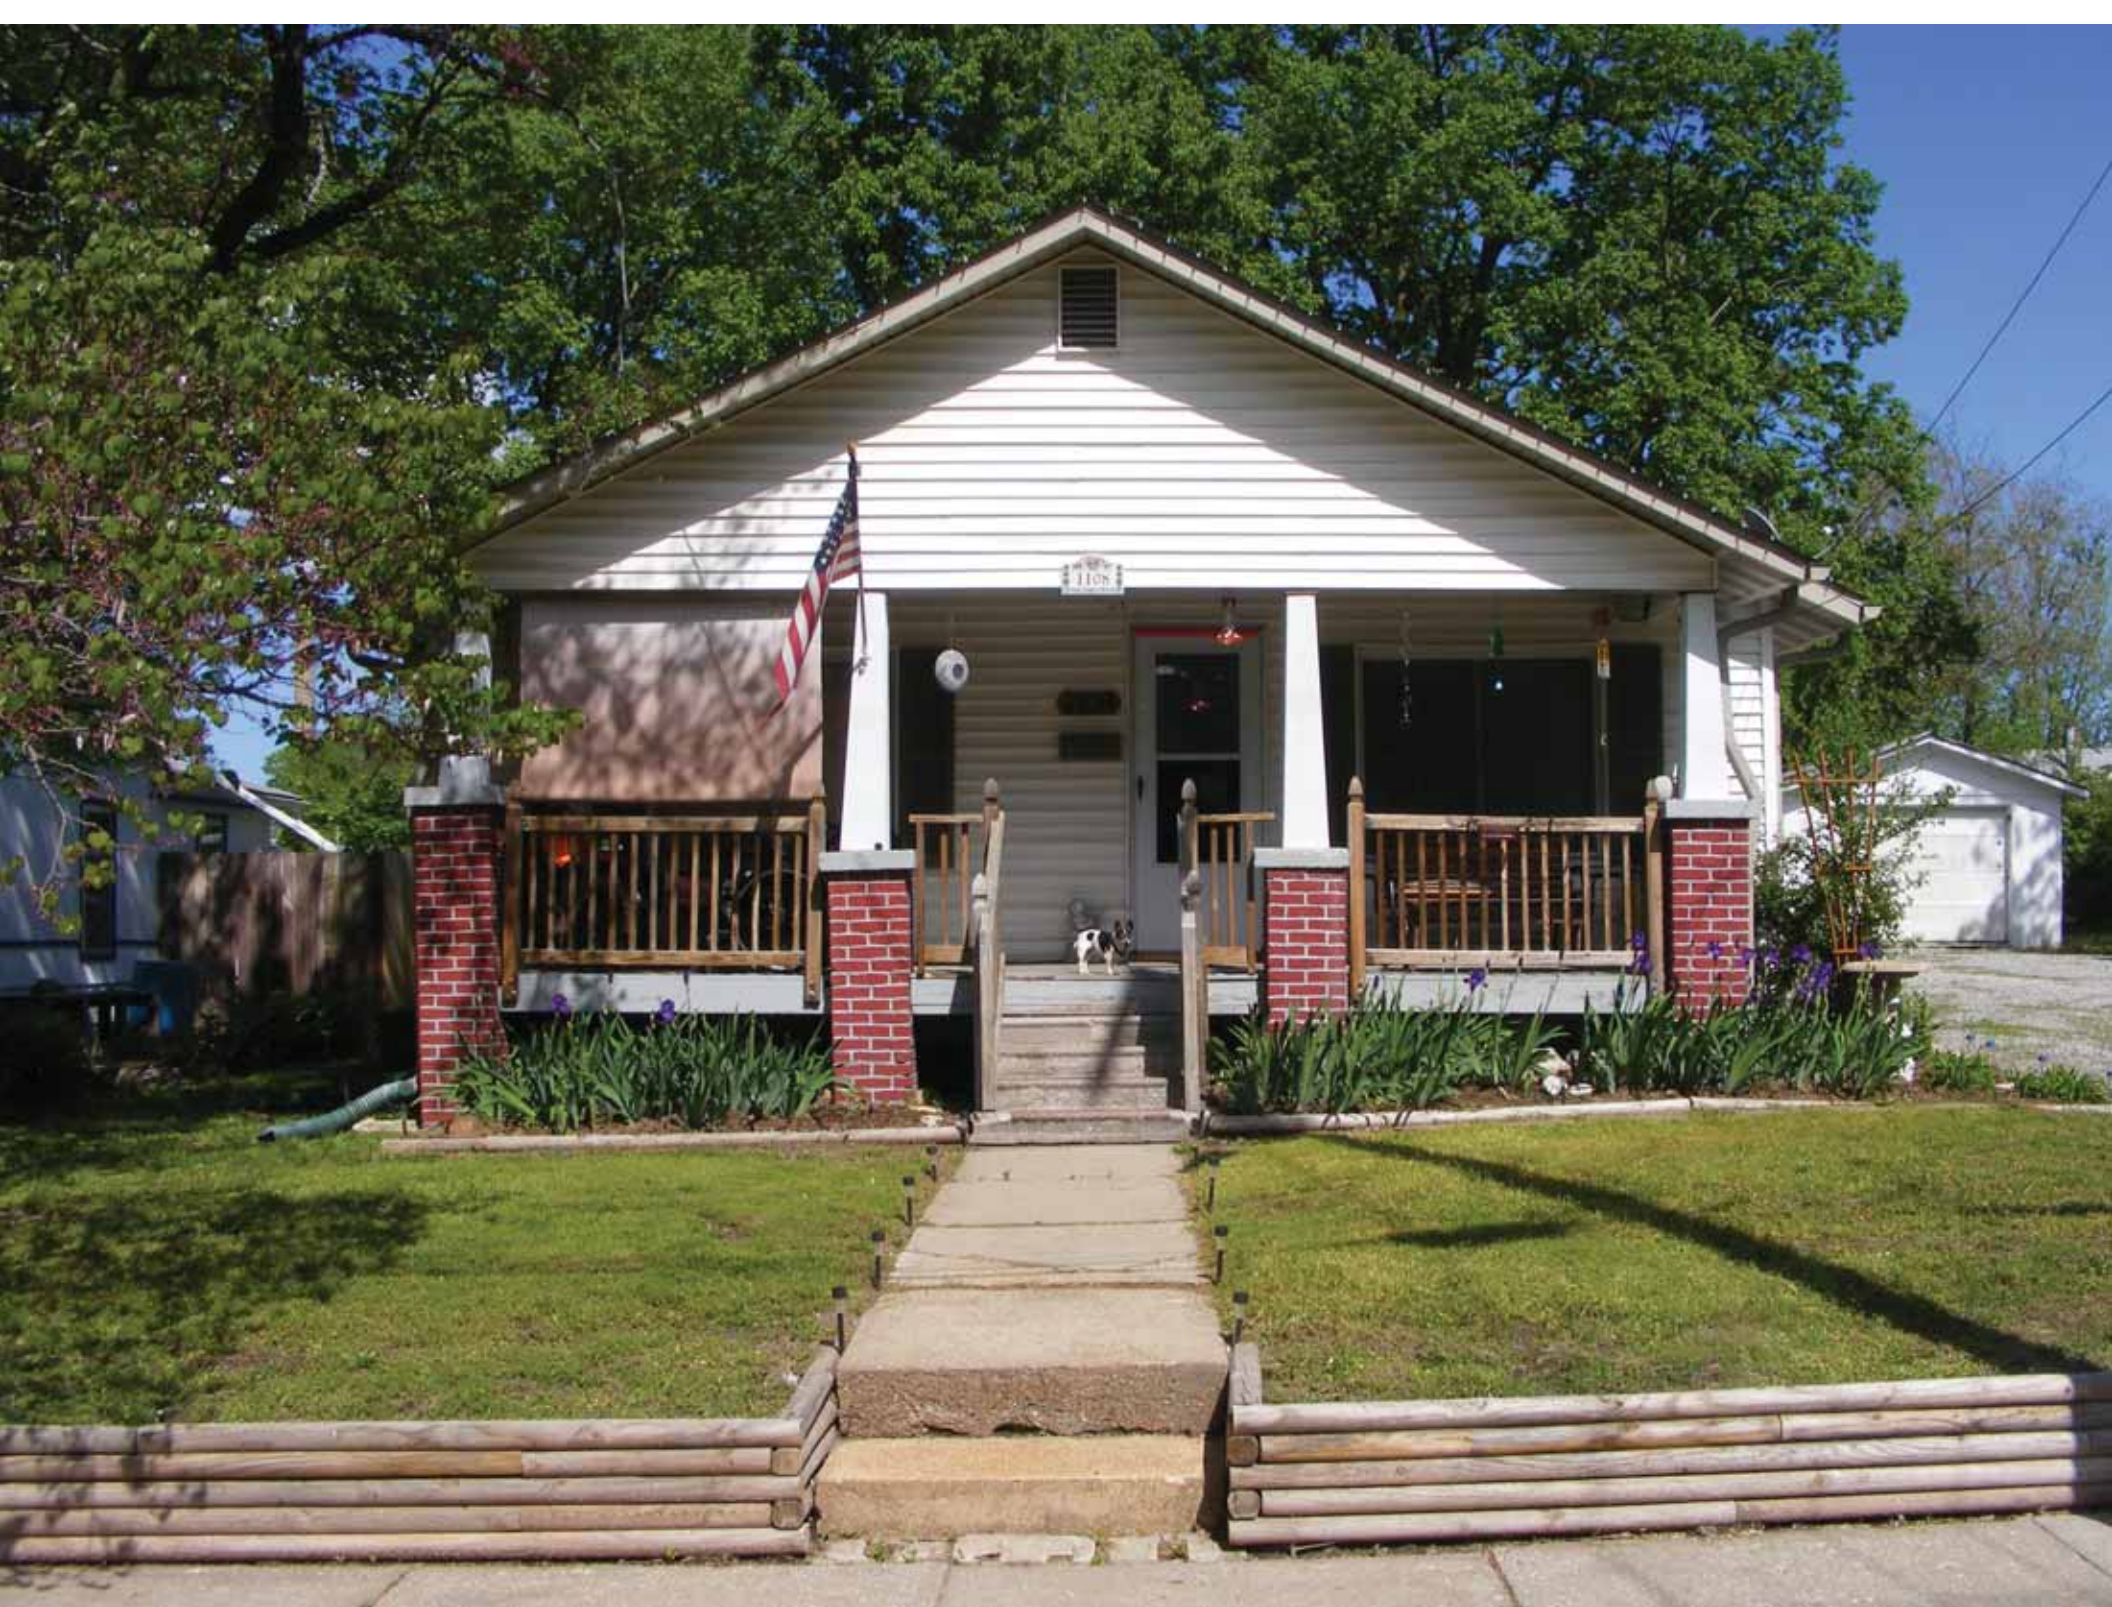
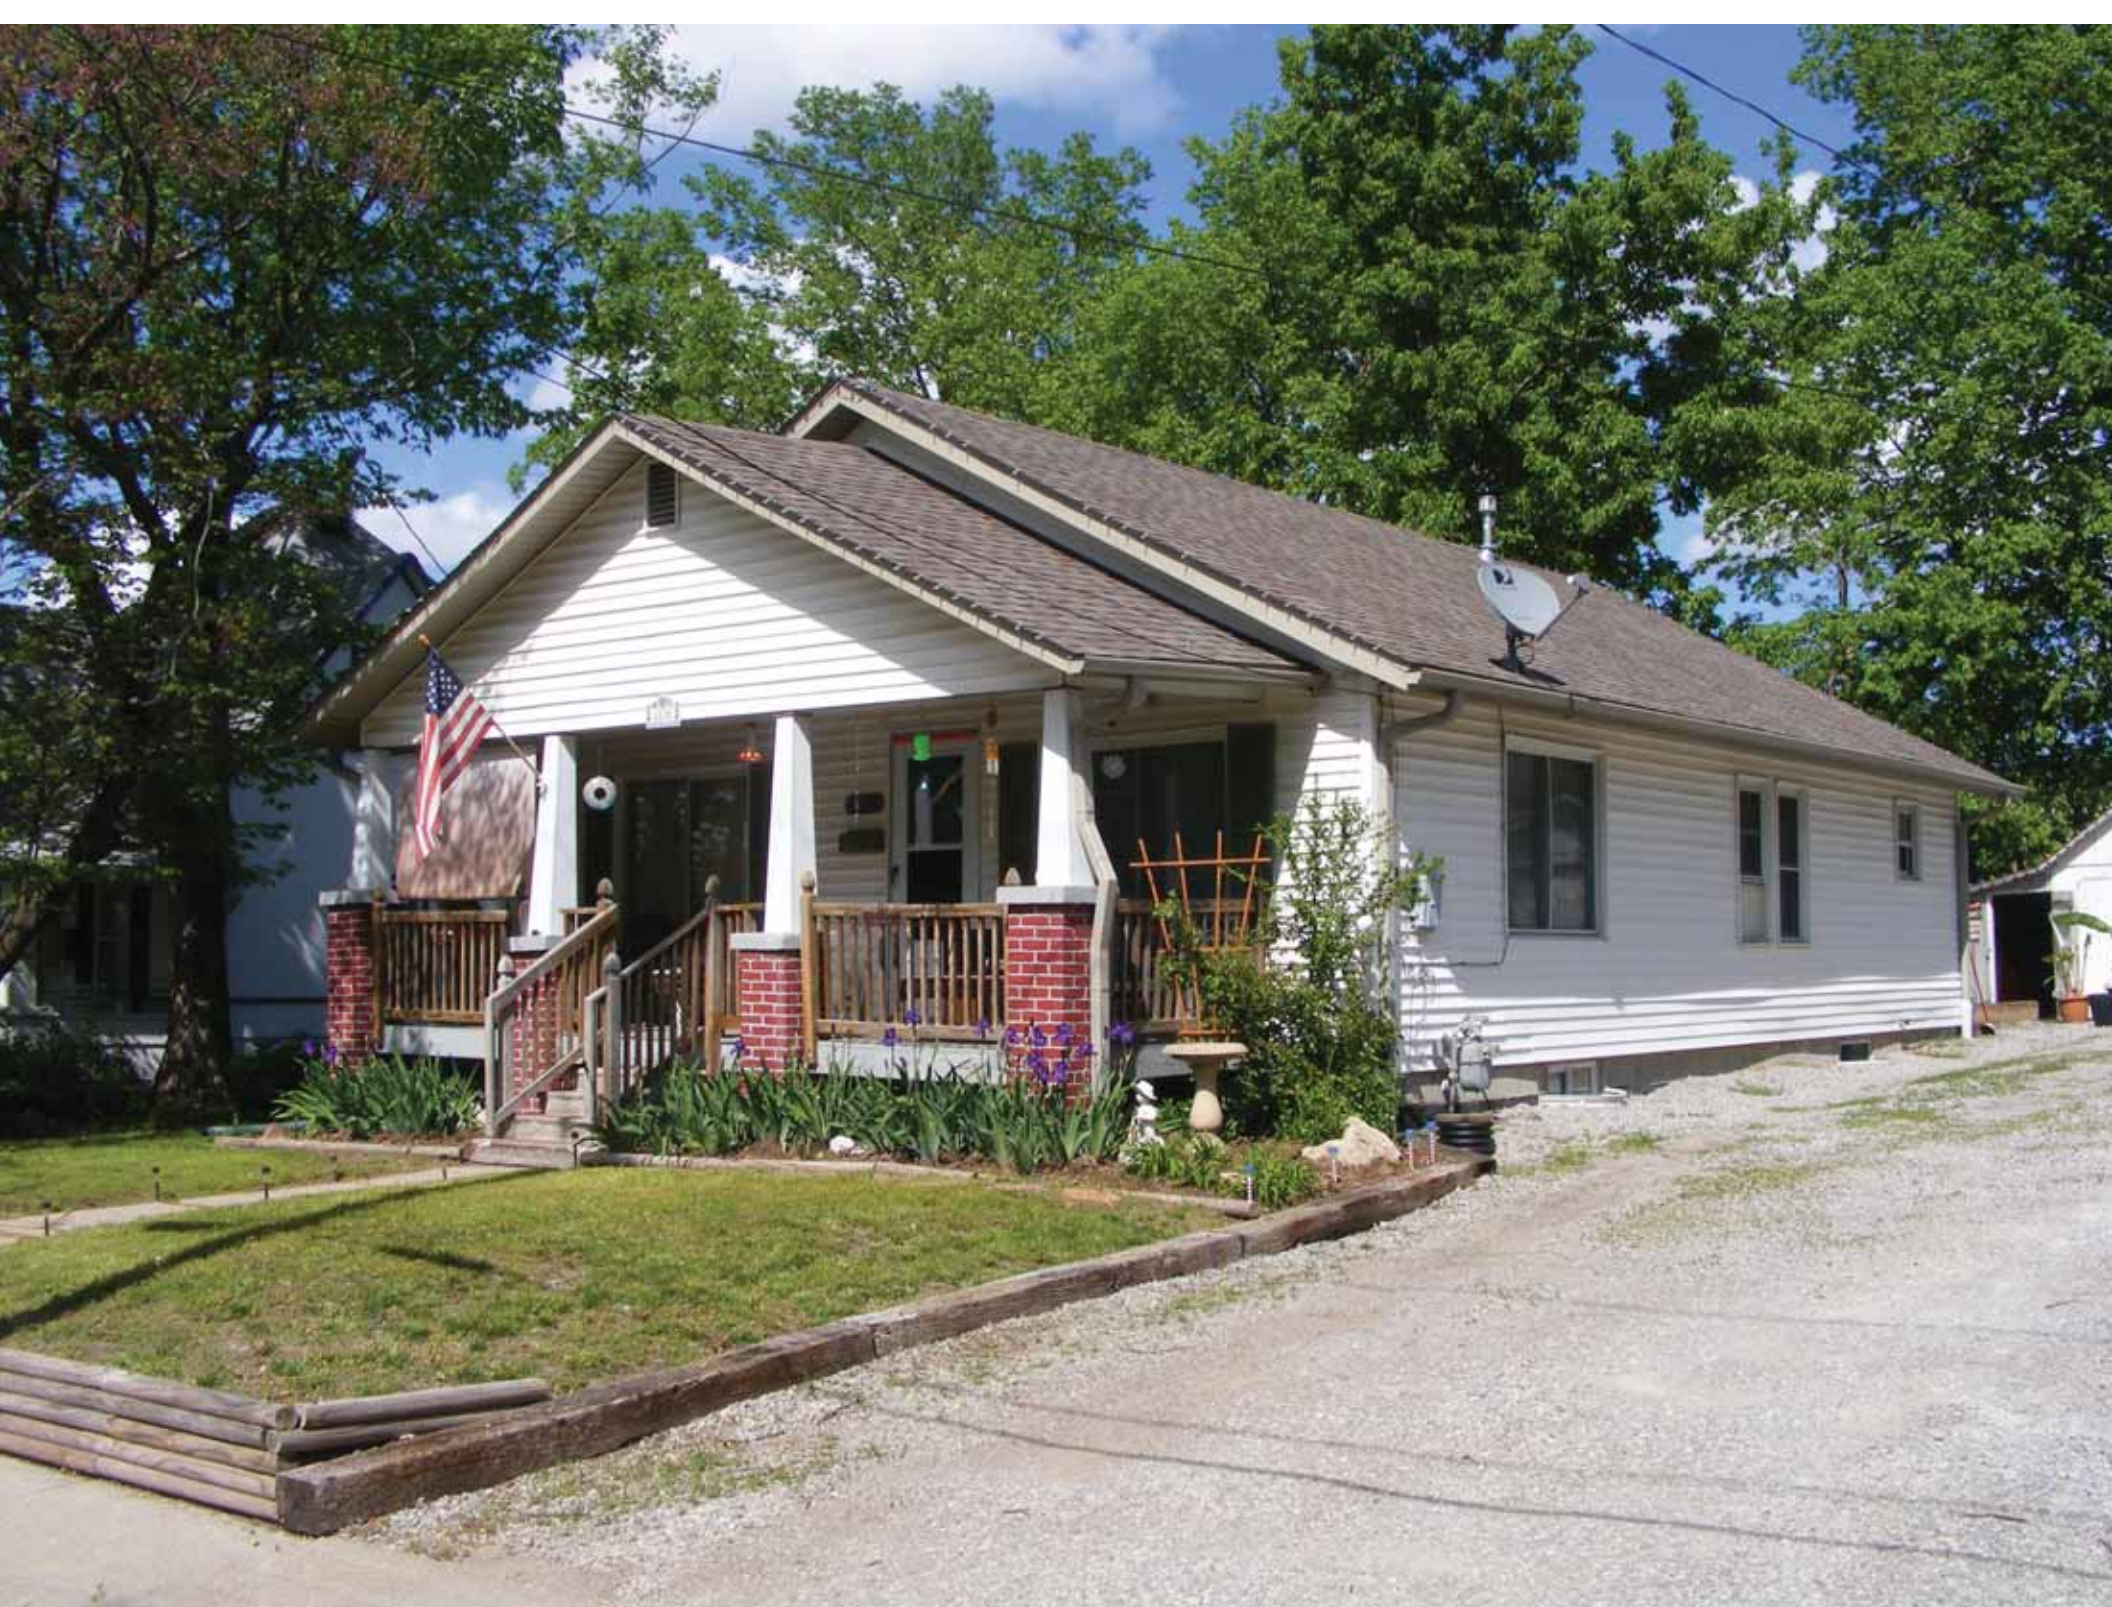
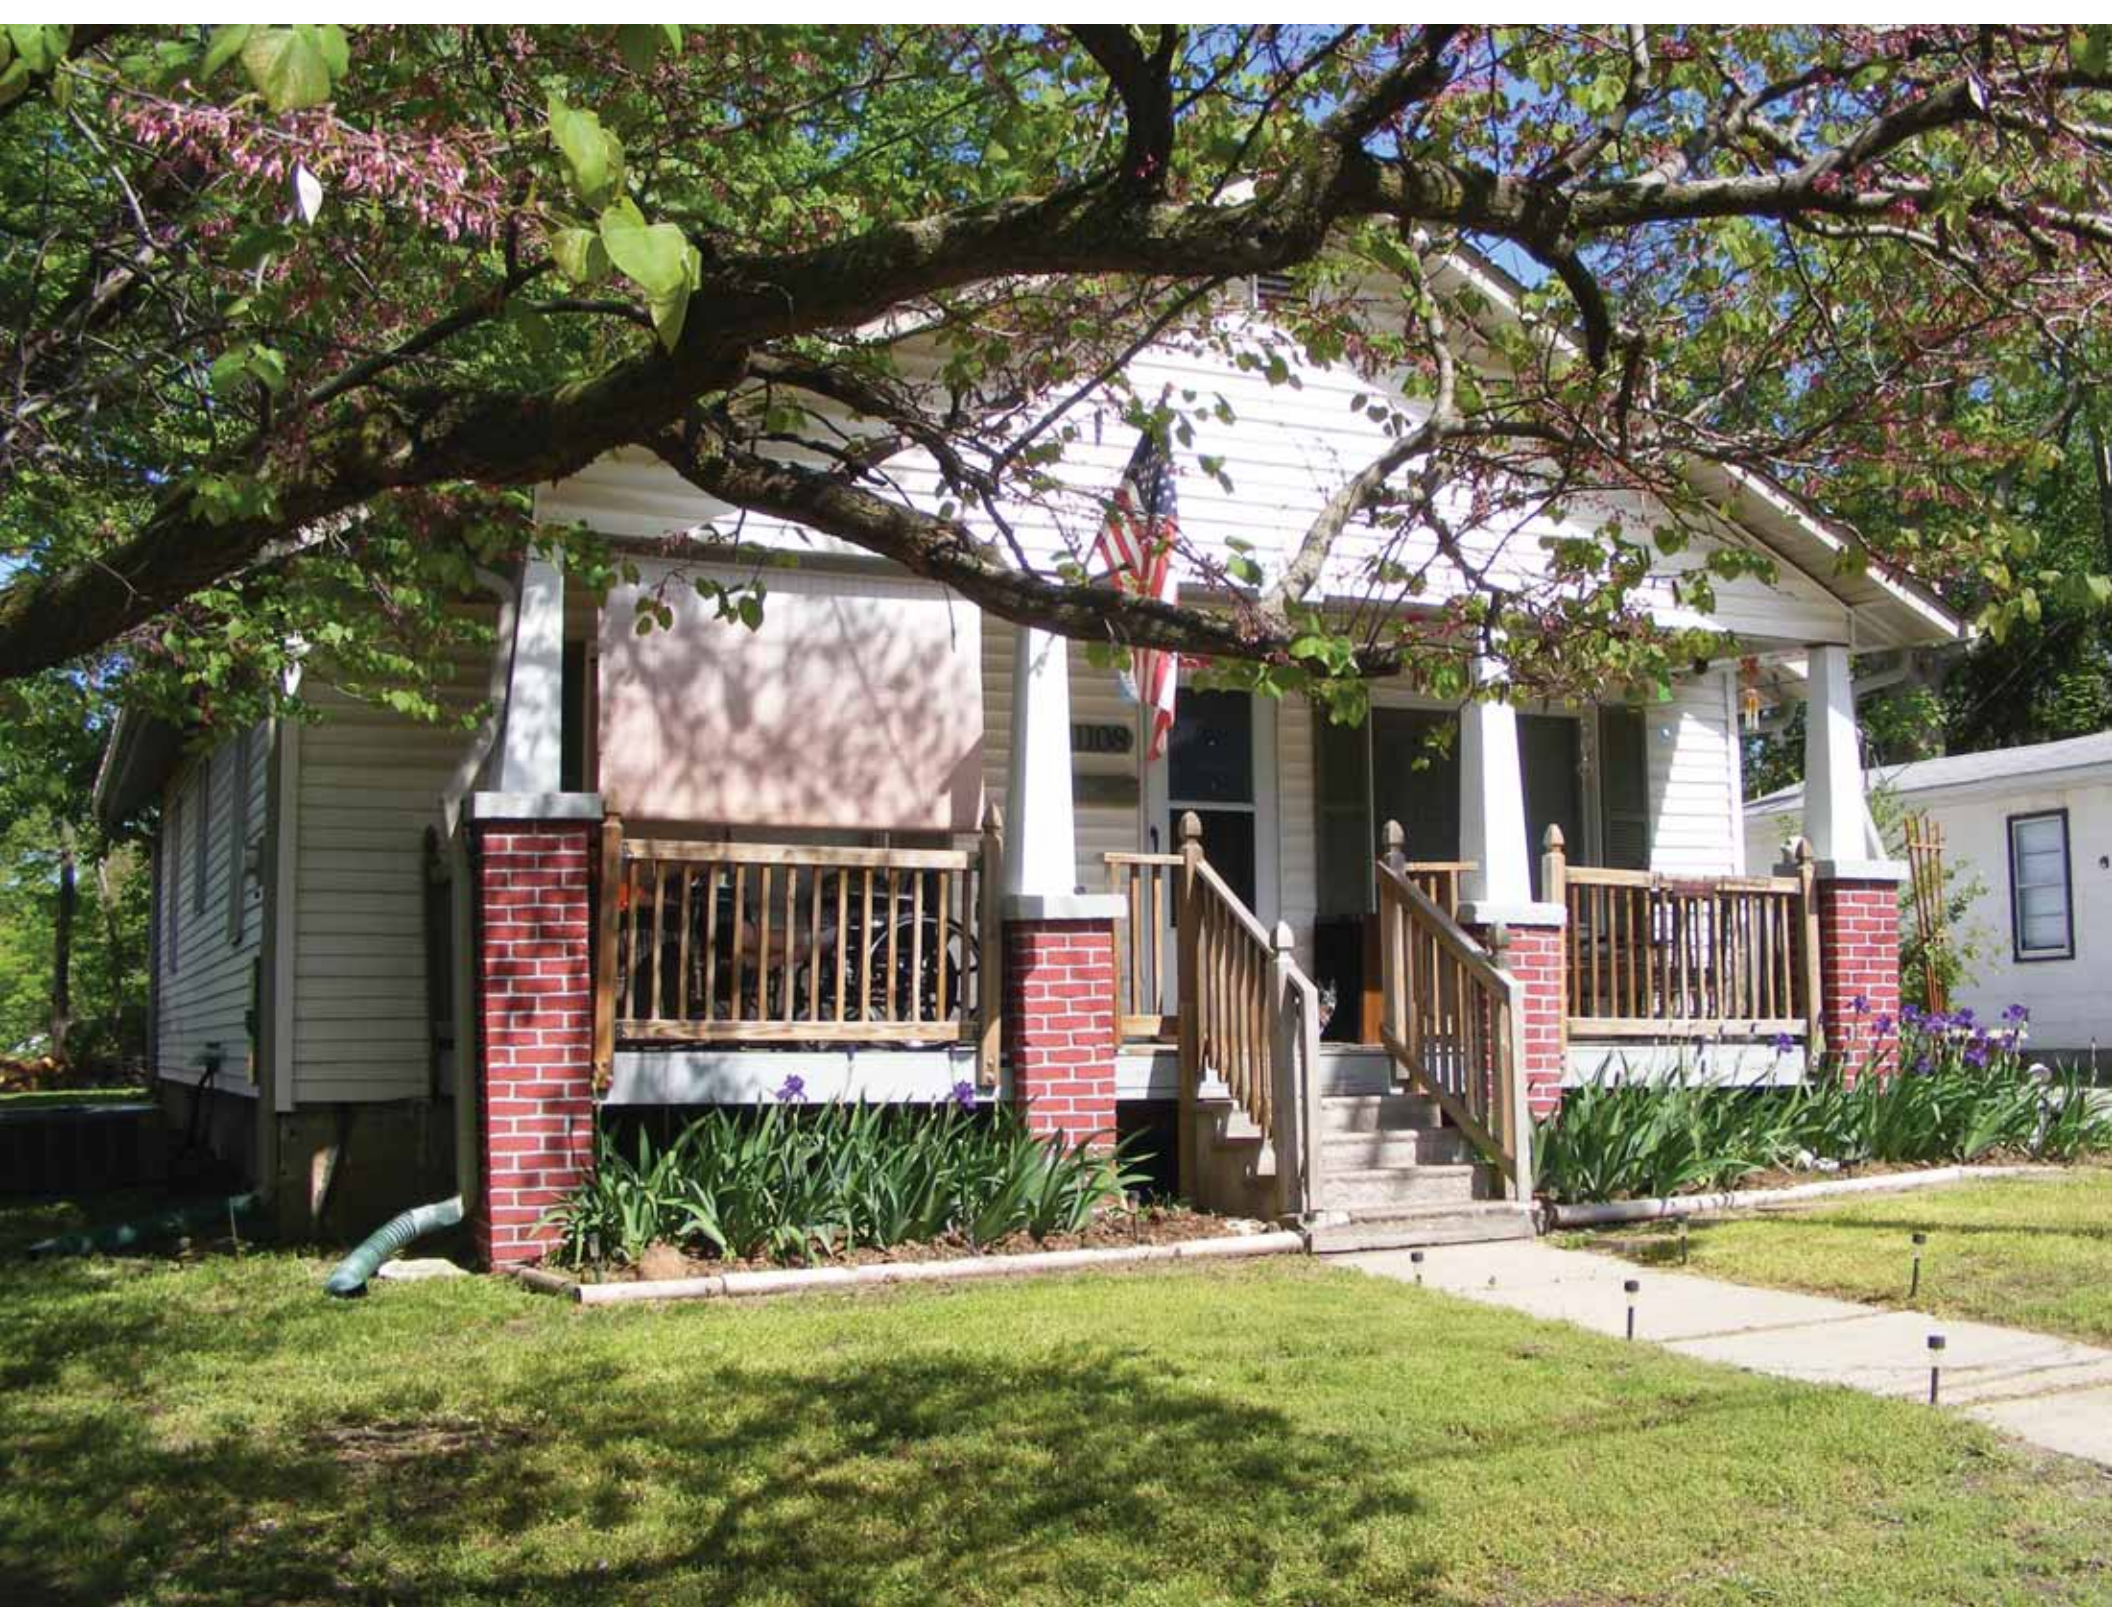
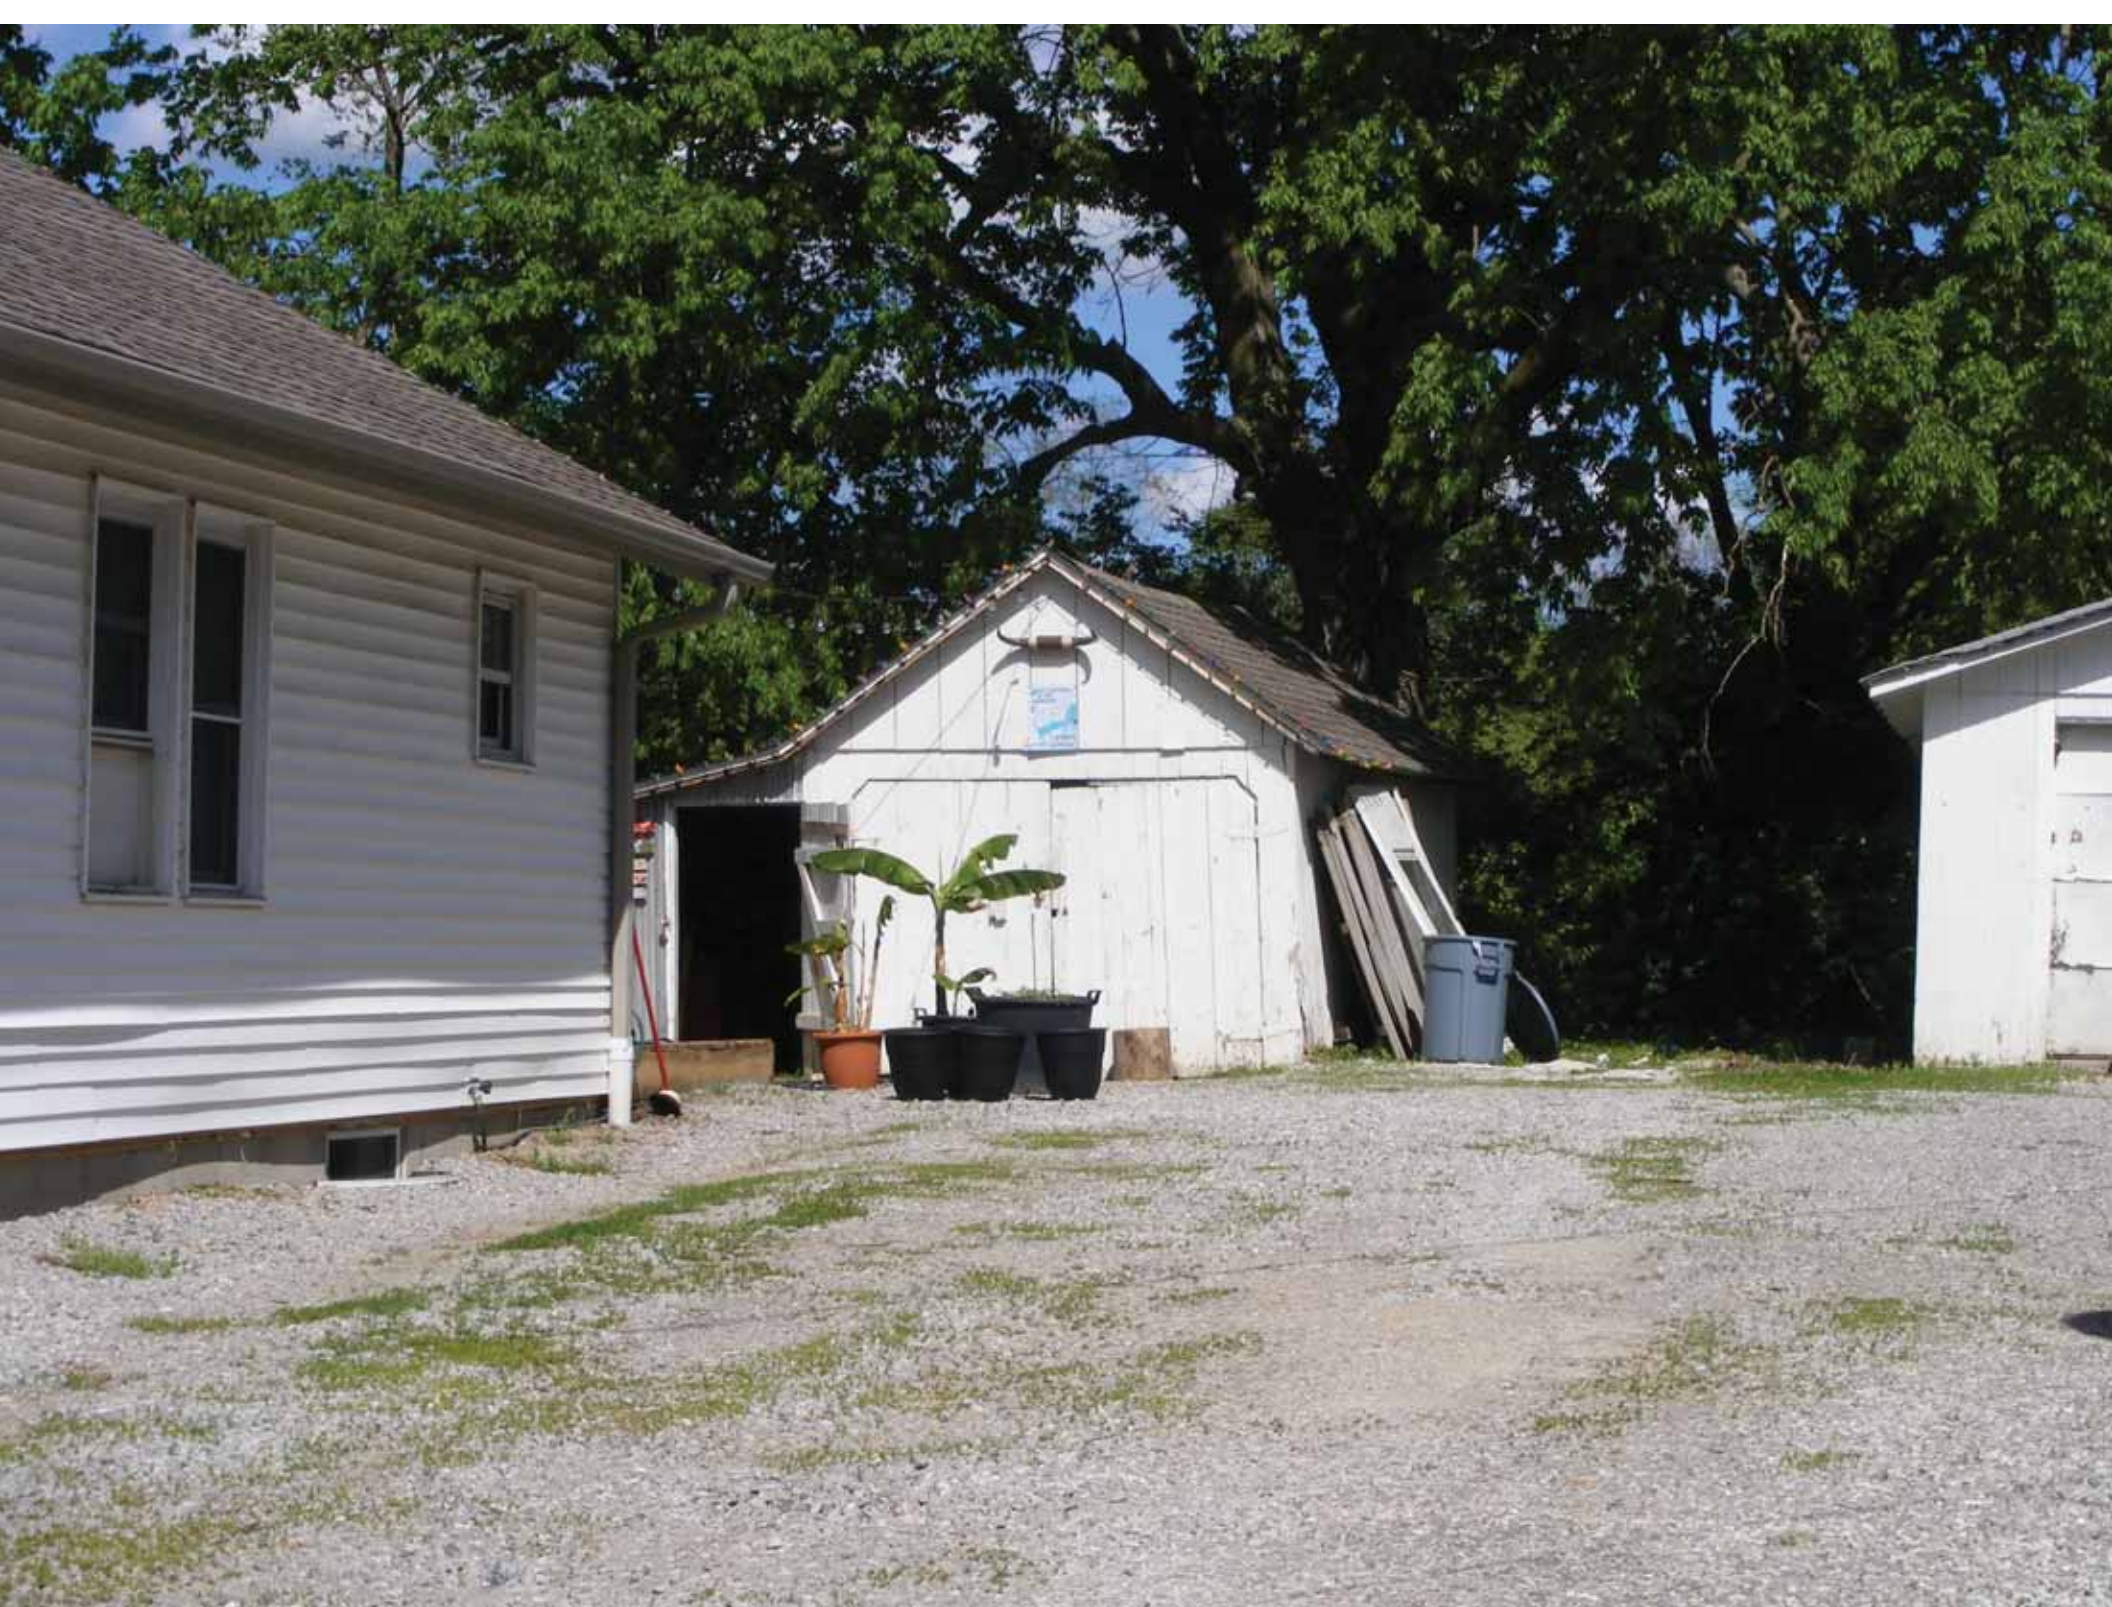
The gable-front plan Bungalow has an asphalt-shingled roof, exterior synthetic siding and a concrete foundation. The primary (west elevation) supports a gabled porch supported by tapered columns on brick piers. A frame balustrade surrounds the porch and extends as handrails along the steps. Within the porch bay is a central door flanked by replacement windows with faux shutters. Windows are one-by-one sliding design. Remaining windows are of similar design and one-over-one replacement. The front gable field has a louvered vent.
