MISSOURI DEPARTMENT OF NATURAL RESOURCES
STATE HISTORIC PRESERVATION OFFICE, P.O. Box 176, Jefferson City, MO 65102
ARCHITECTURAL/HISTORIC INVENTORY FORM

1. Survey No. BO-AS-011-0087		2. Survey name: North Central Columbia Survey Phase II	
3. County: Boone		4. Address (Street No.) 902	Street (name) N. Seventh Street
5. City: Columbia	Vicinity: <input type="checkbox"/>	6. Geographical Reference:	7. Township/Range/Section: T: R: S:
8. Historic name (if known):		9. Present/other name (if known):	
10. Ownership: <input checked="" type="checkbox"/> Private <input type="checkbox"/> Public		11a. Historic use (if known): Domestic/single dwelling	11b. Current use: Domestic/single dwelling

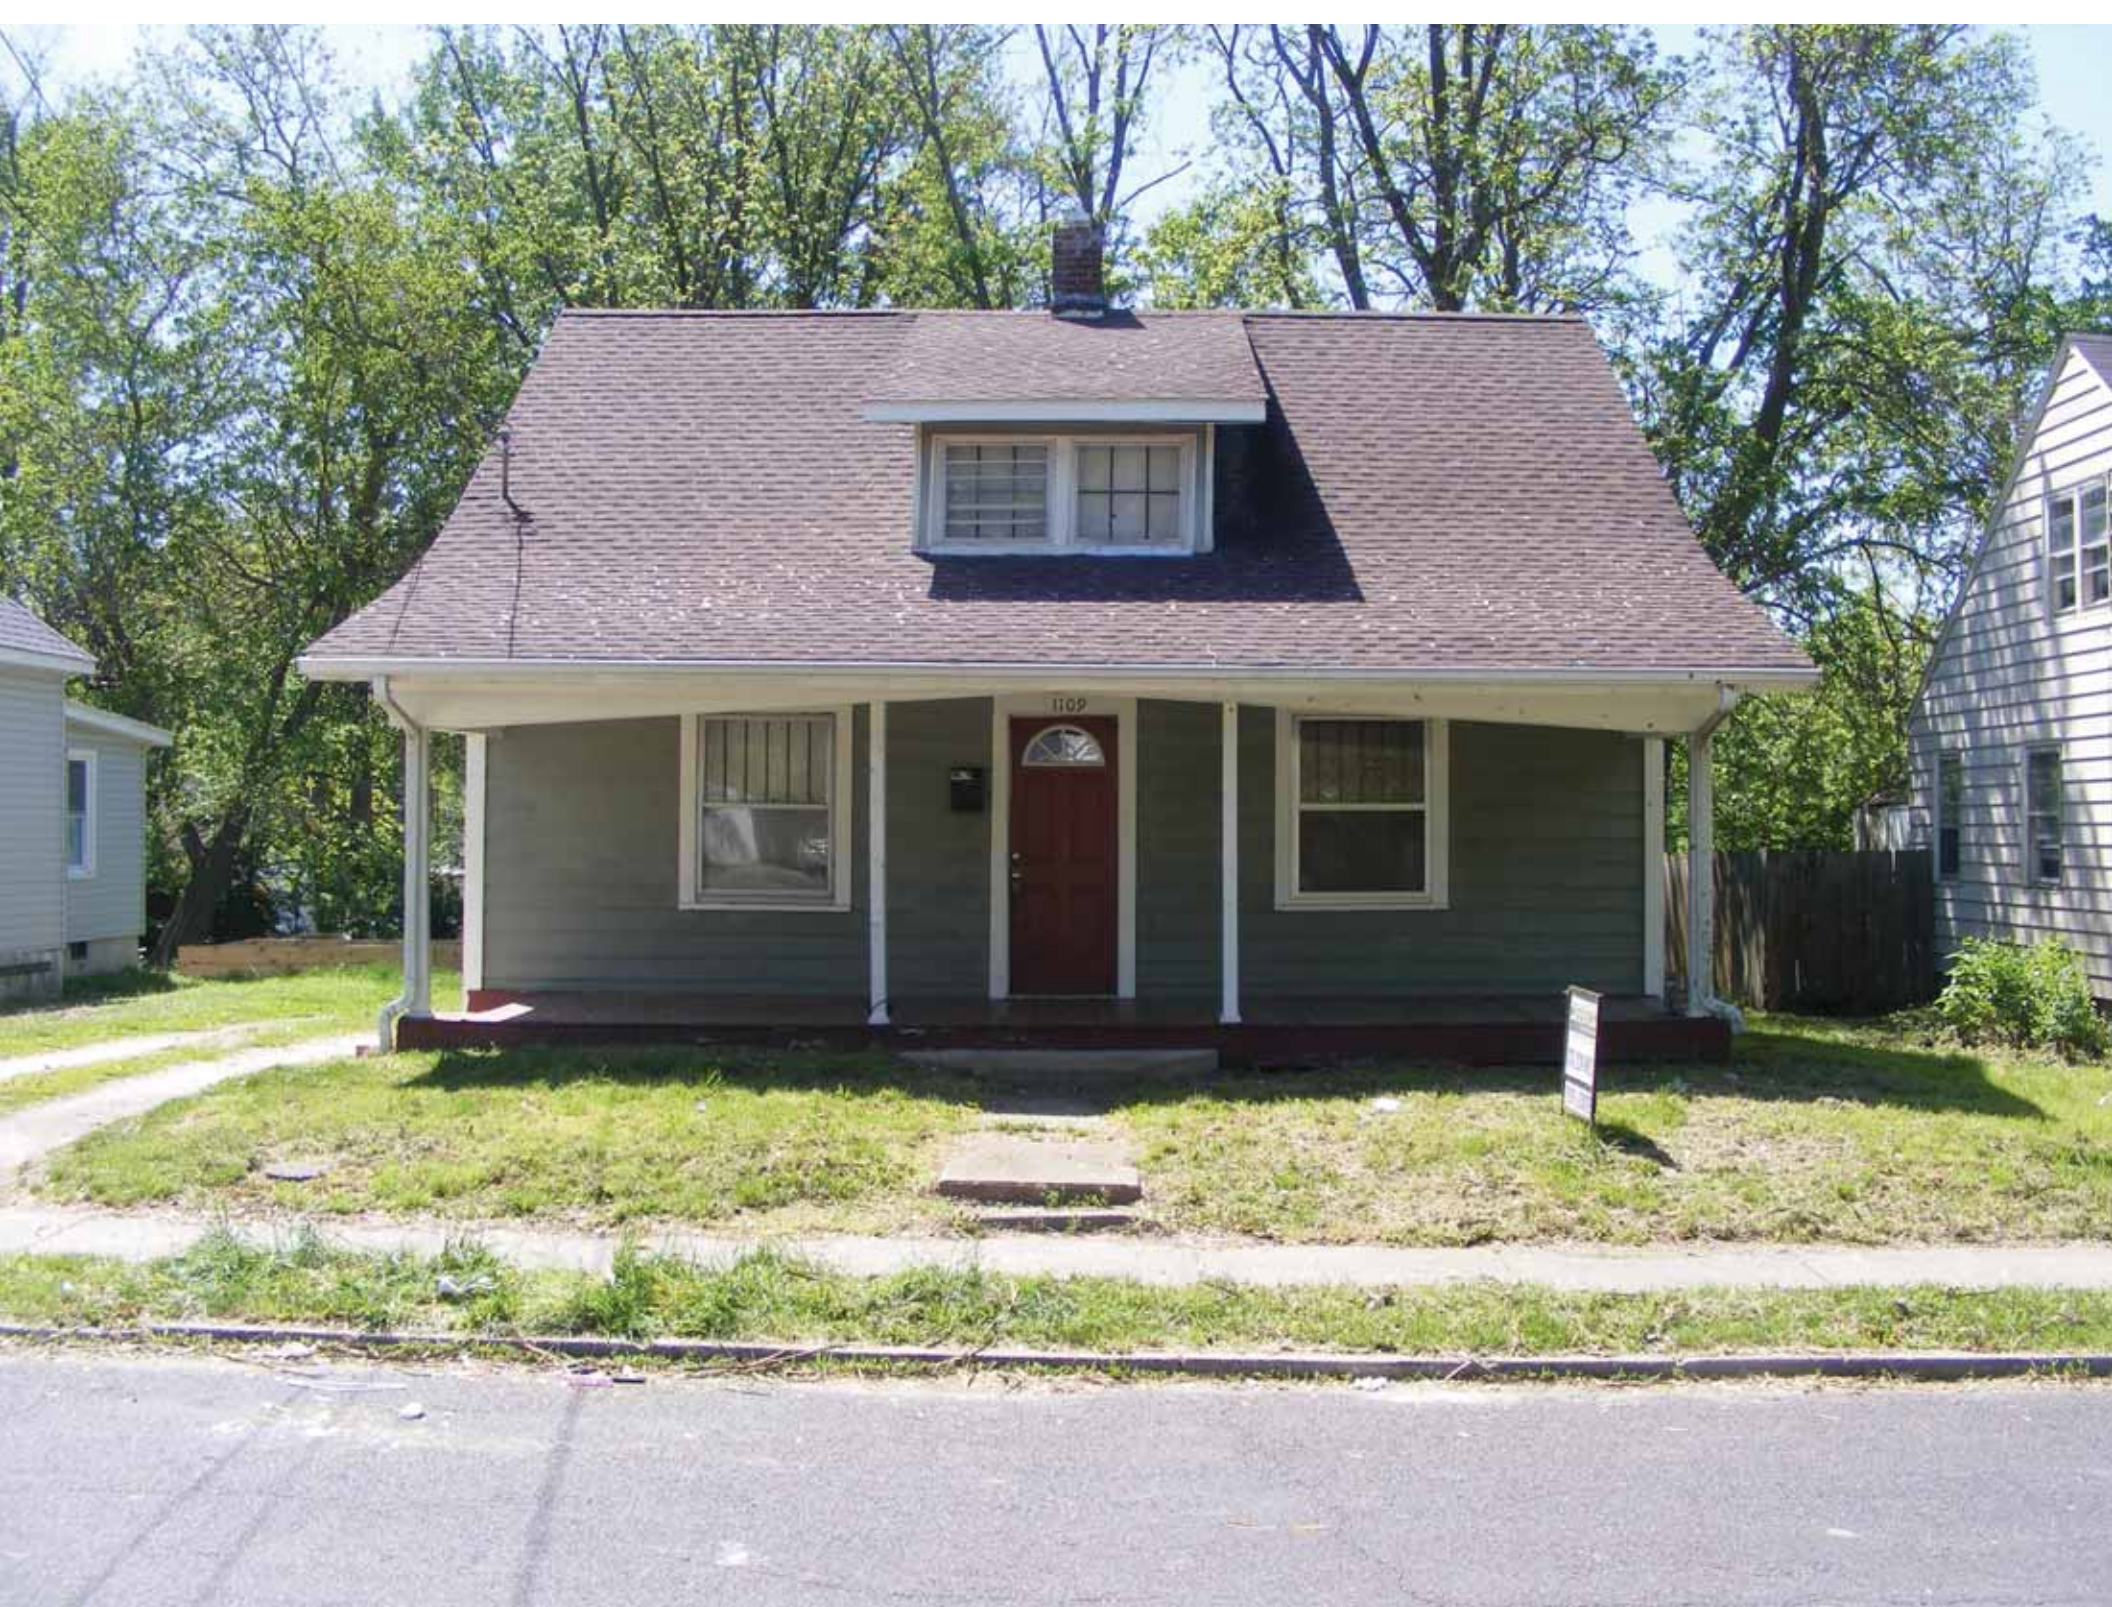
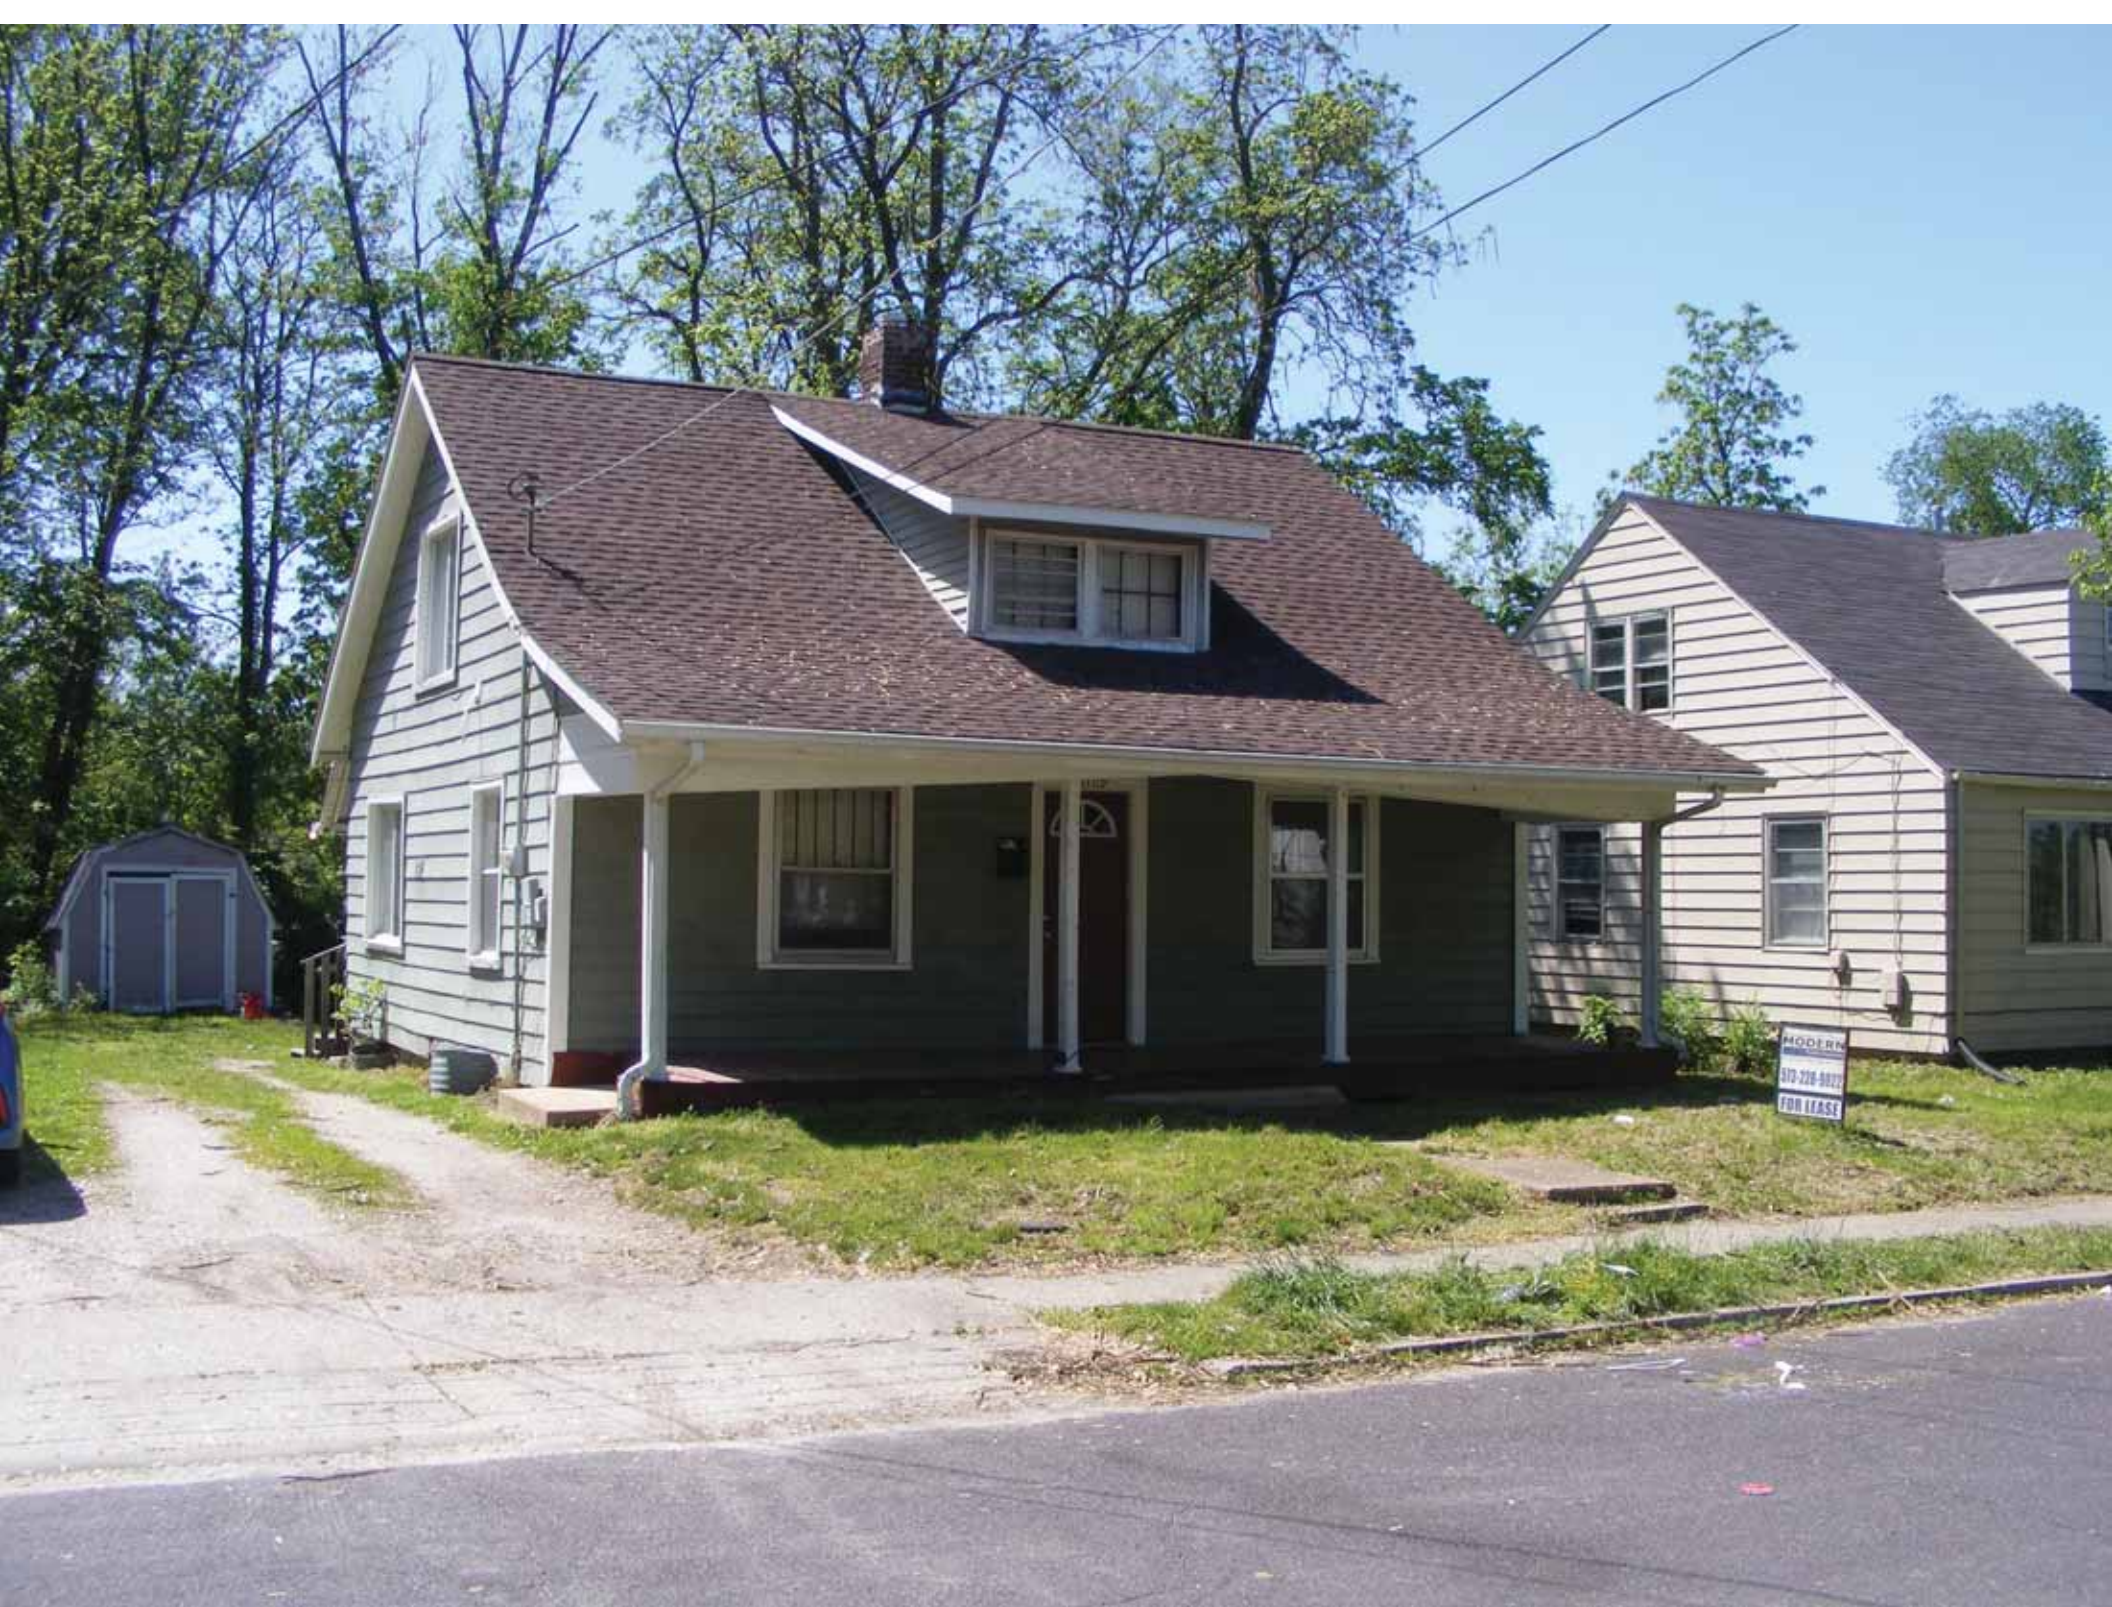
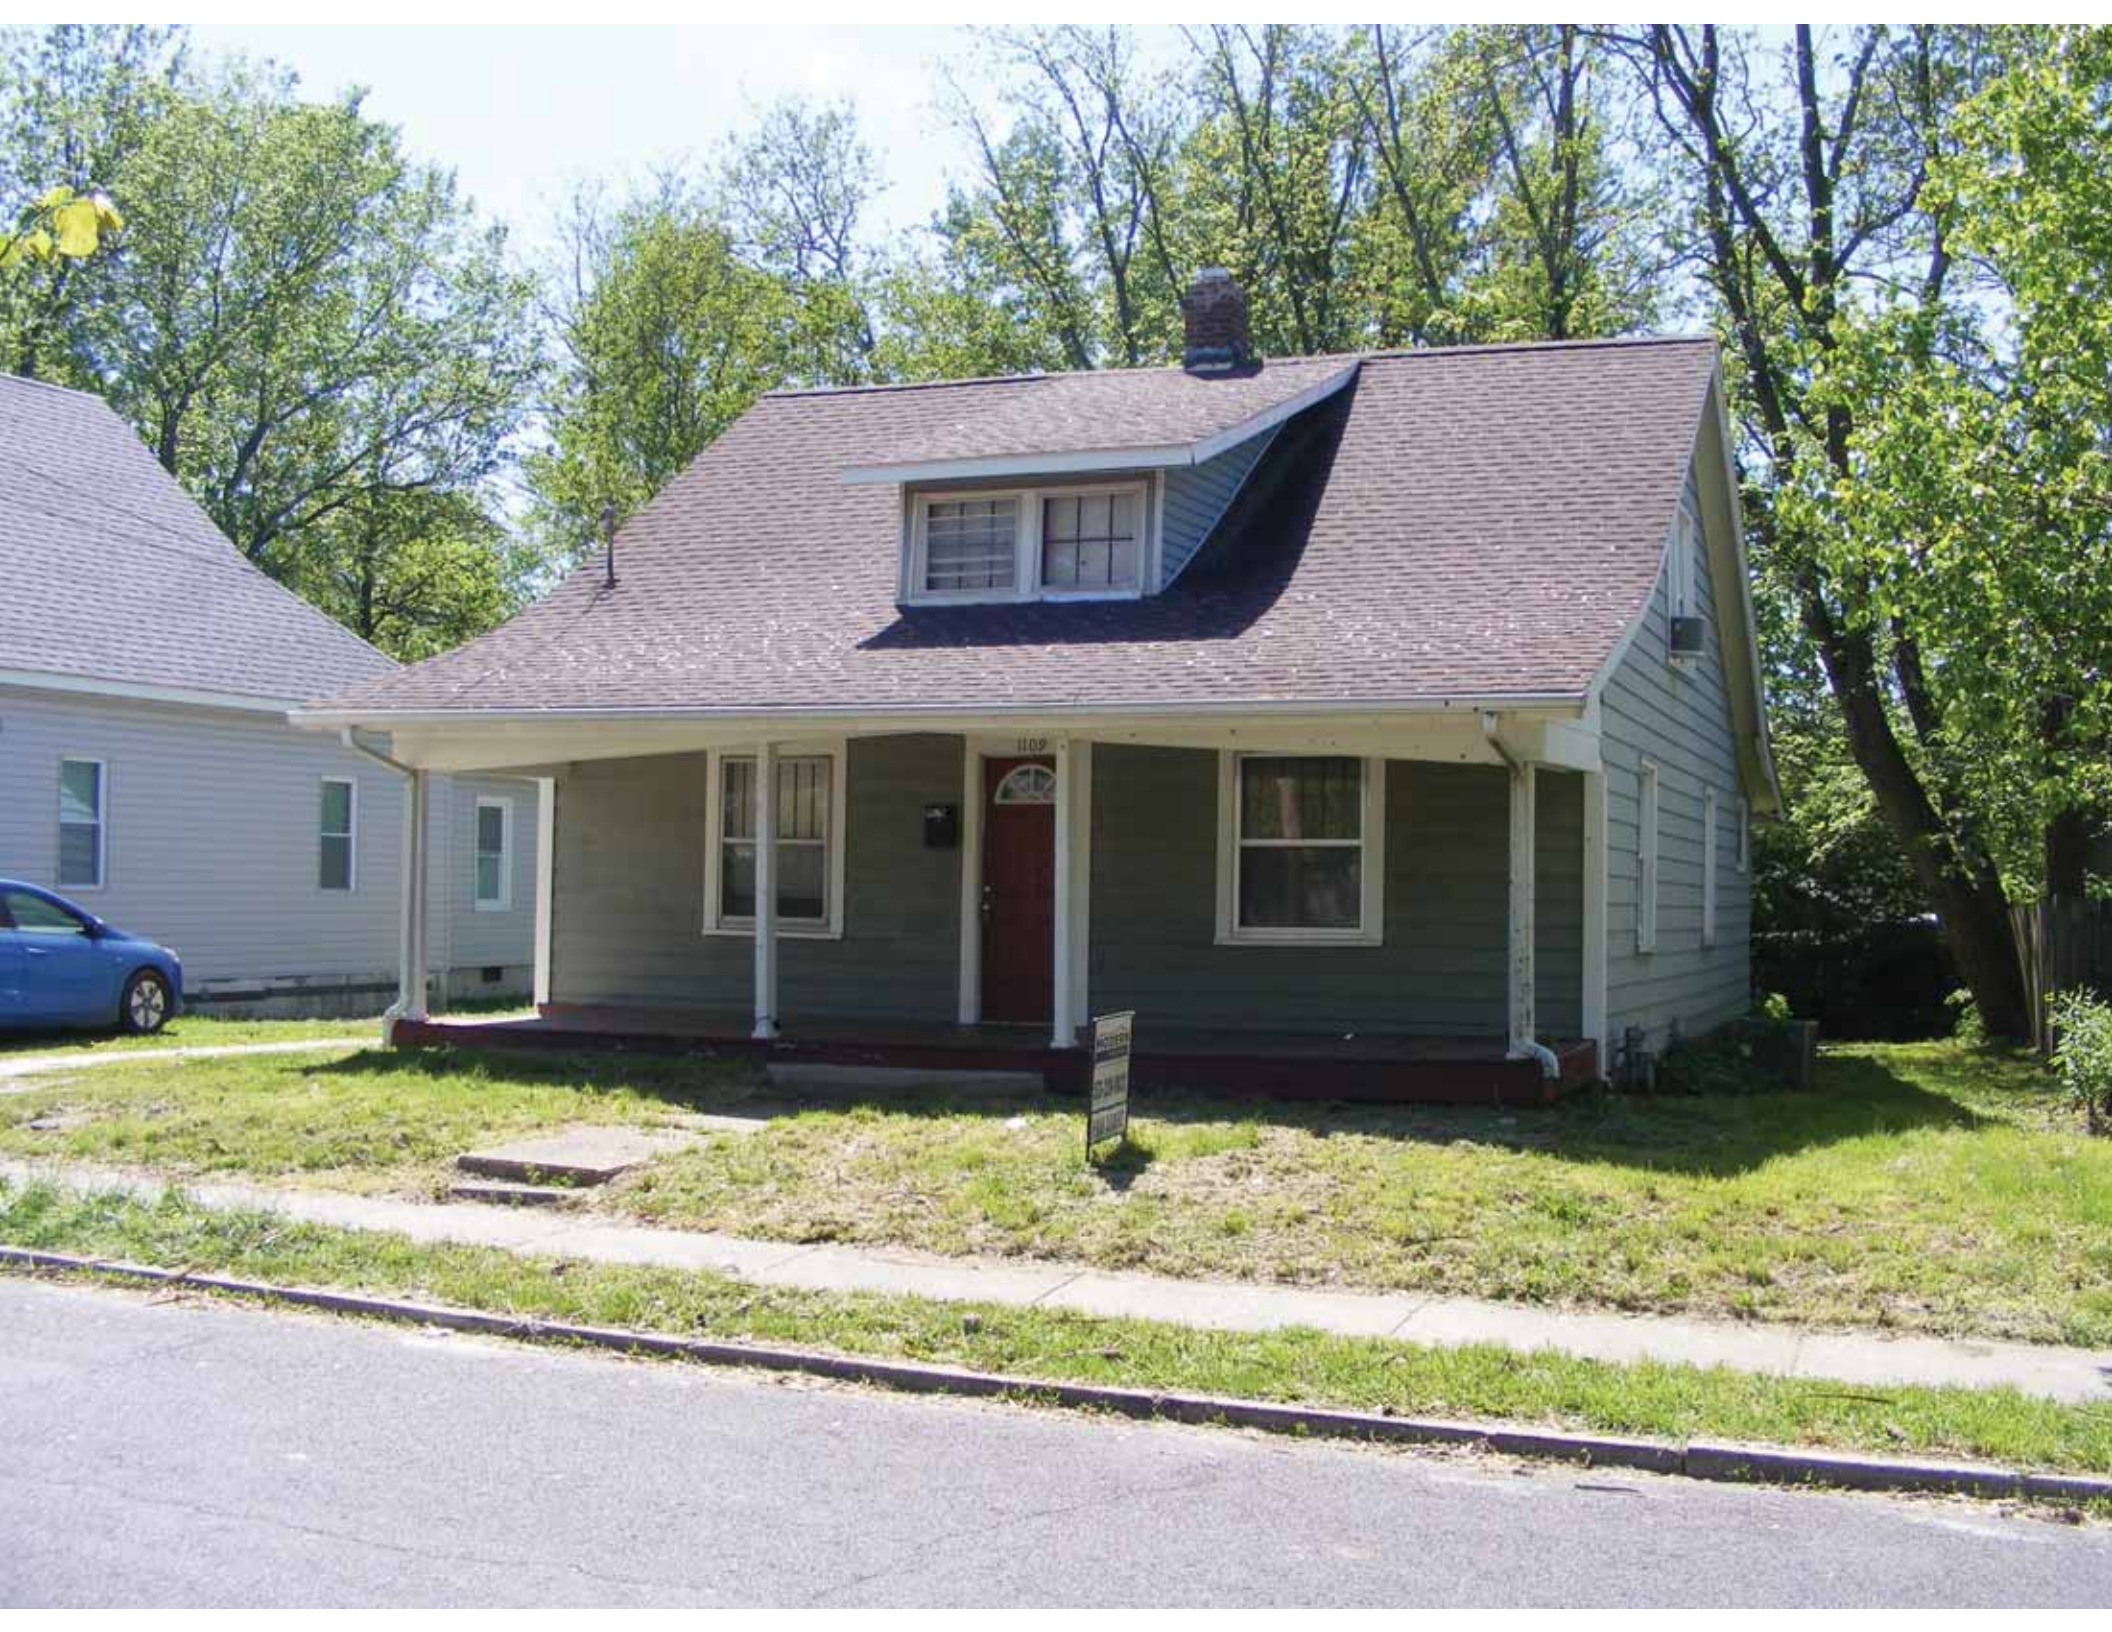
41. (cont.) Description of primary resource. Expand box as necessary, or add continuation pages.
The dwelling is a 1.5 story asphalt shingled side gable to shed with a center shed dormer (paired fix 6 light window) and a concrete foundation. Dwelling is clad in wood siding. Façade features a full-width porch under the shed roof with square wooden posts (c. 1990) and concrete decking. The entrance is centered in the porch bay area and flanked by original 6/1 (vertical) windows. Side elevations hold single and paired windows; gable ends hold single windows.

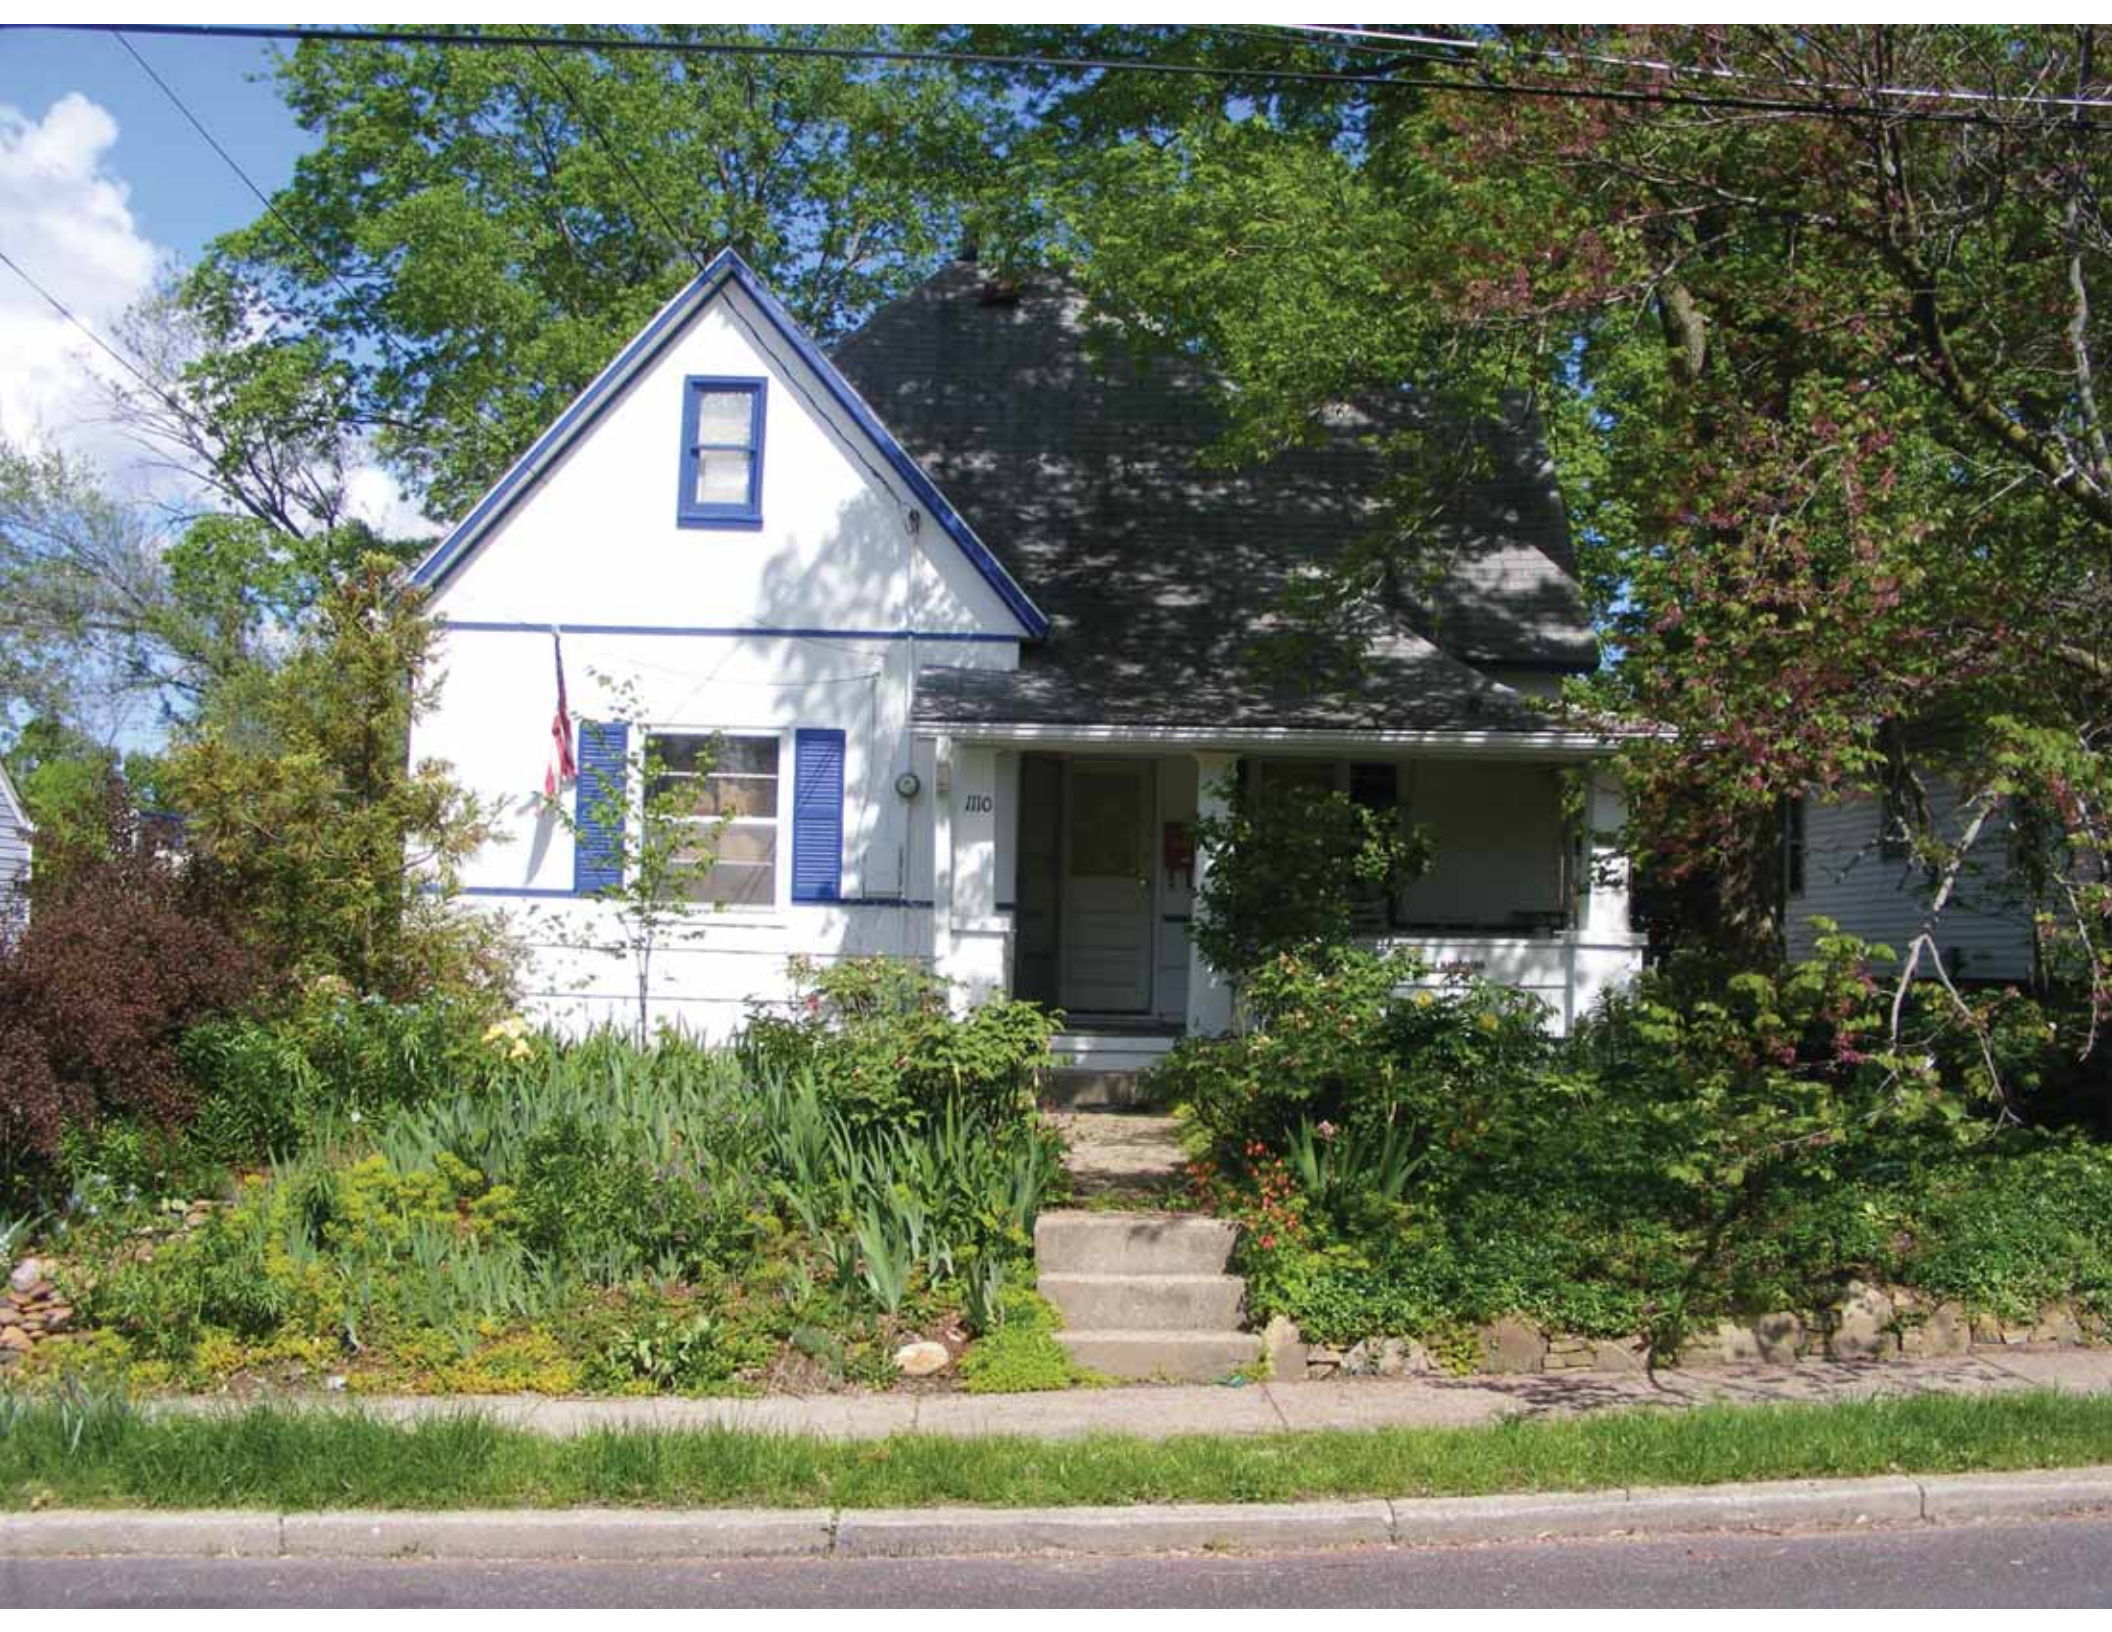
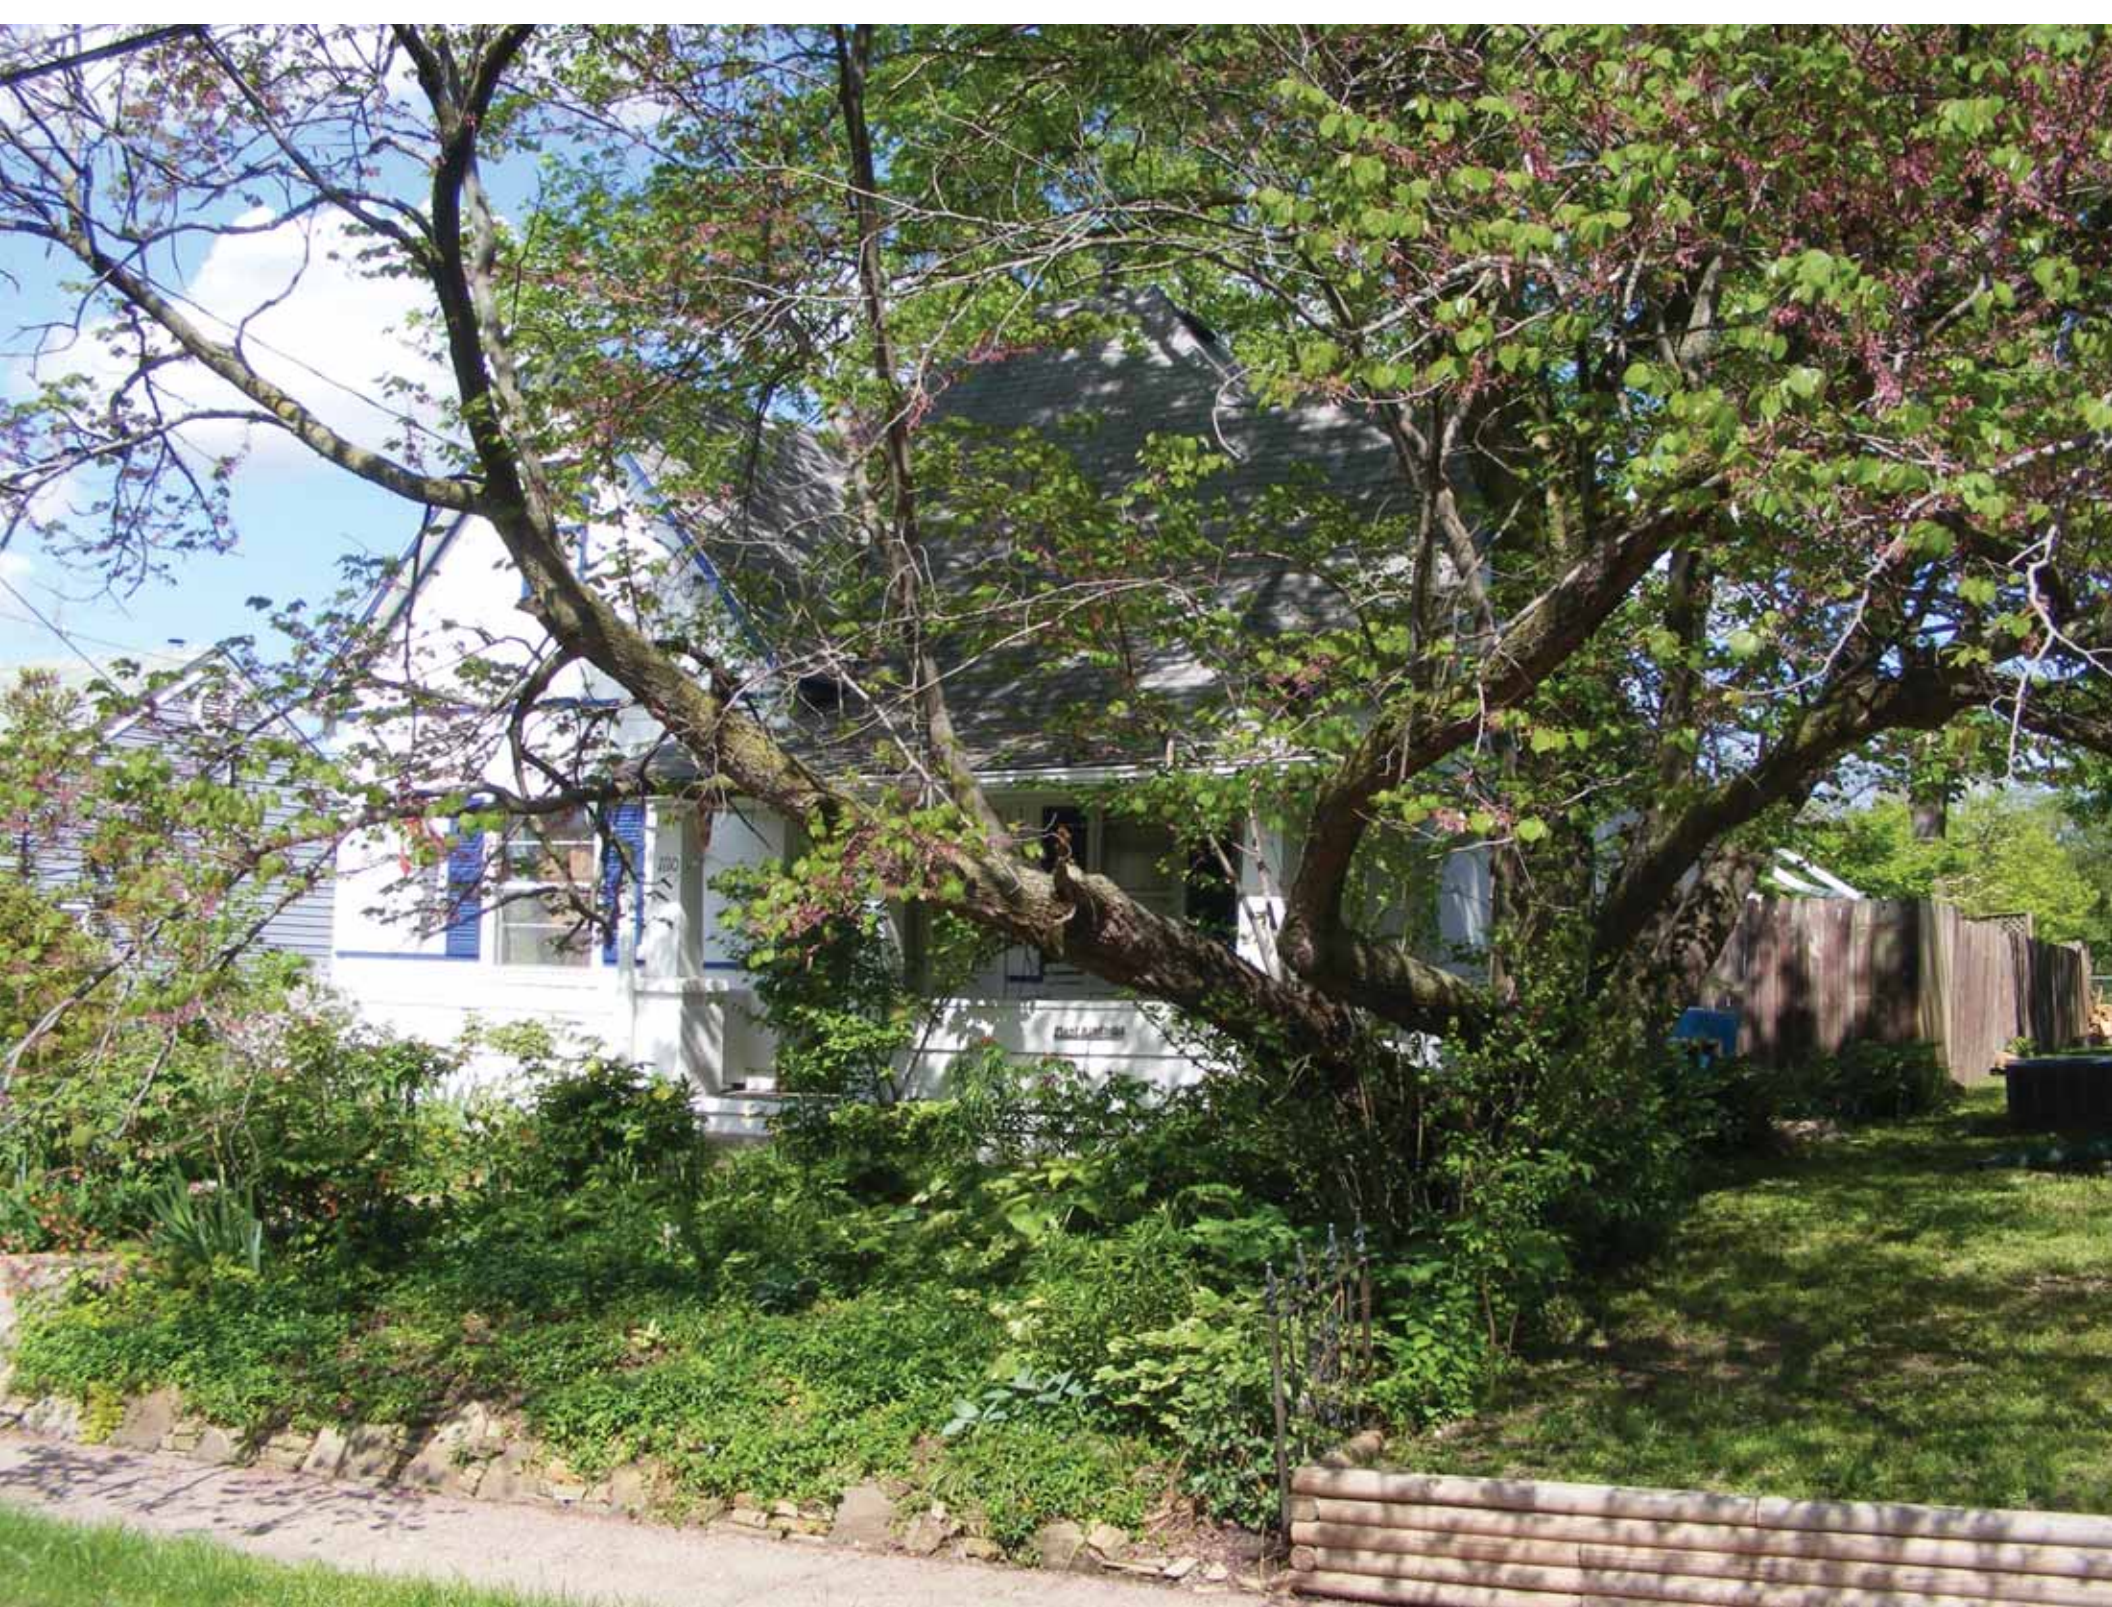
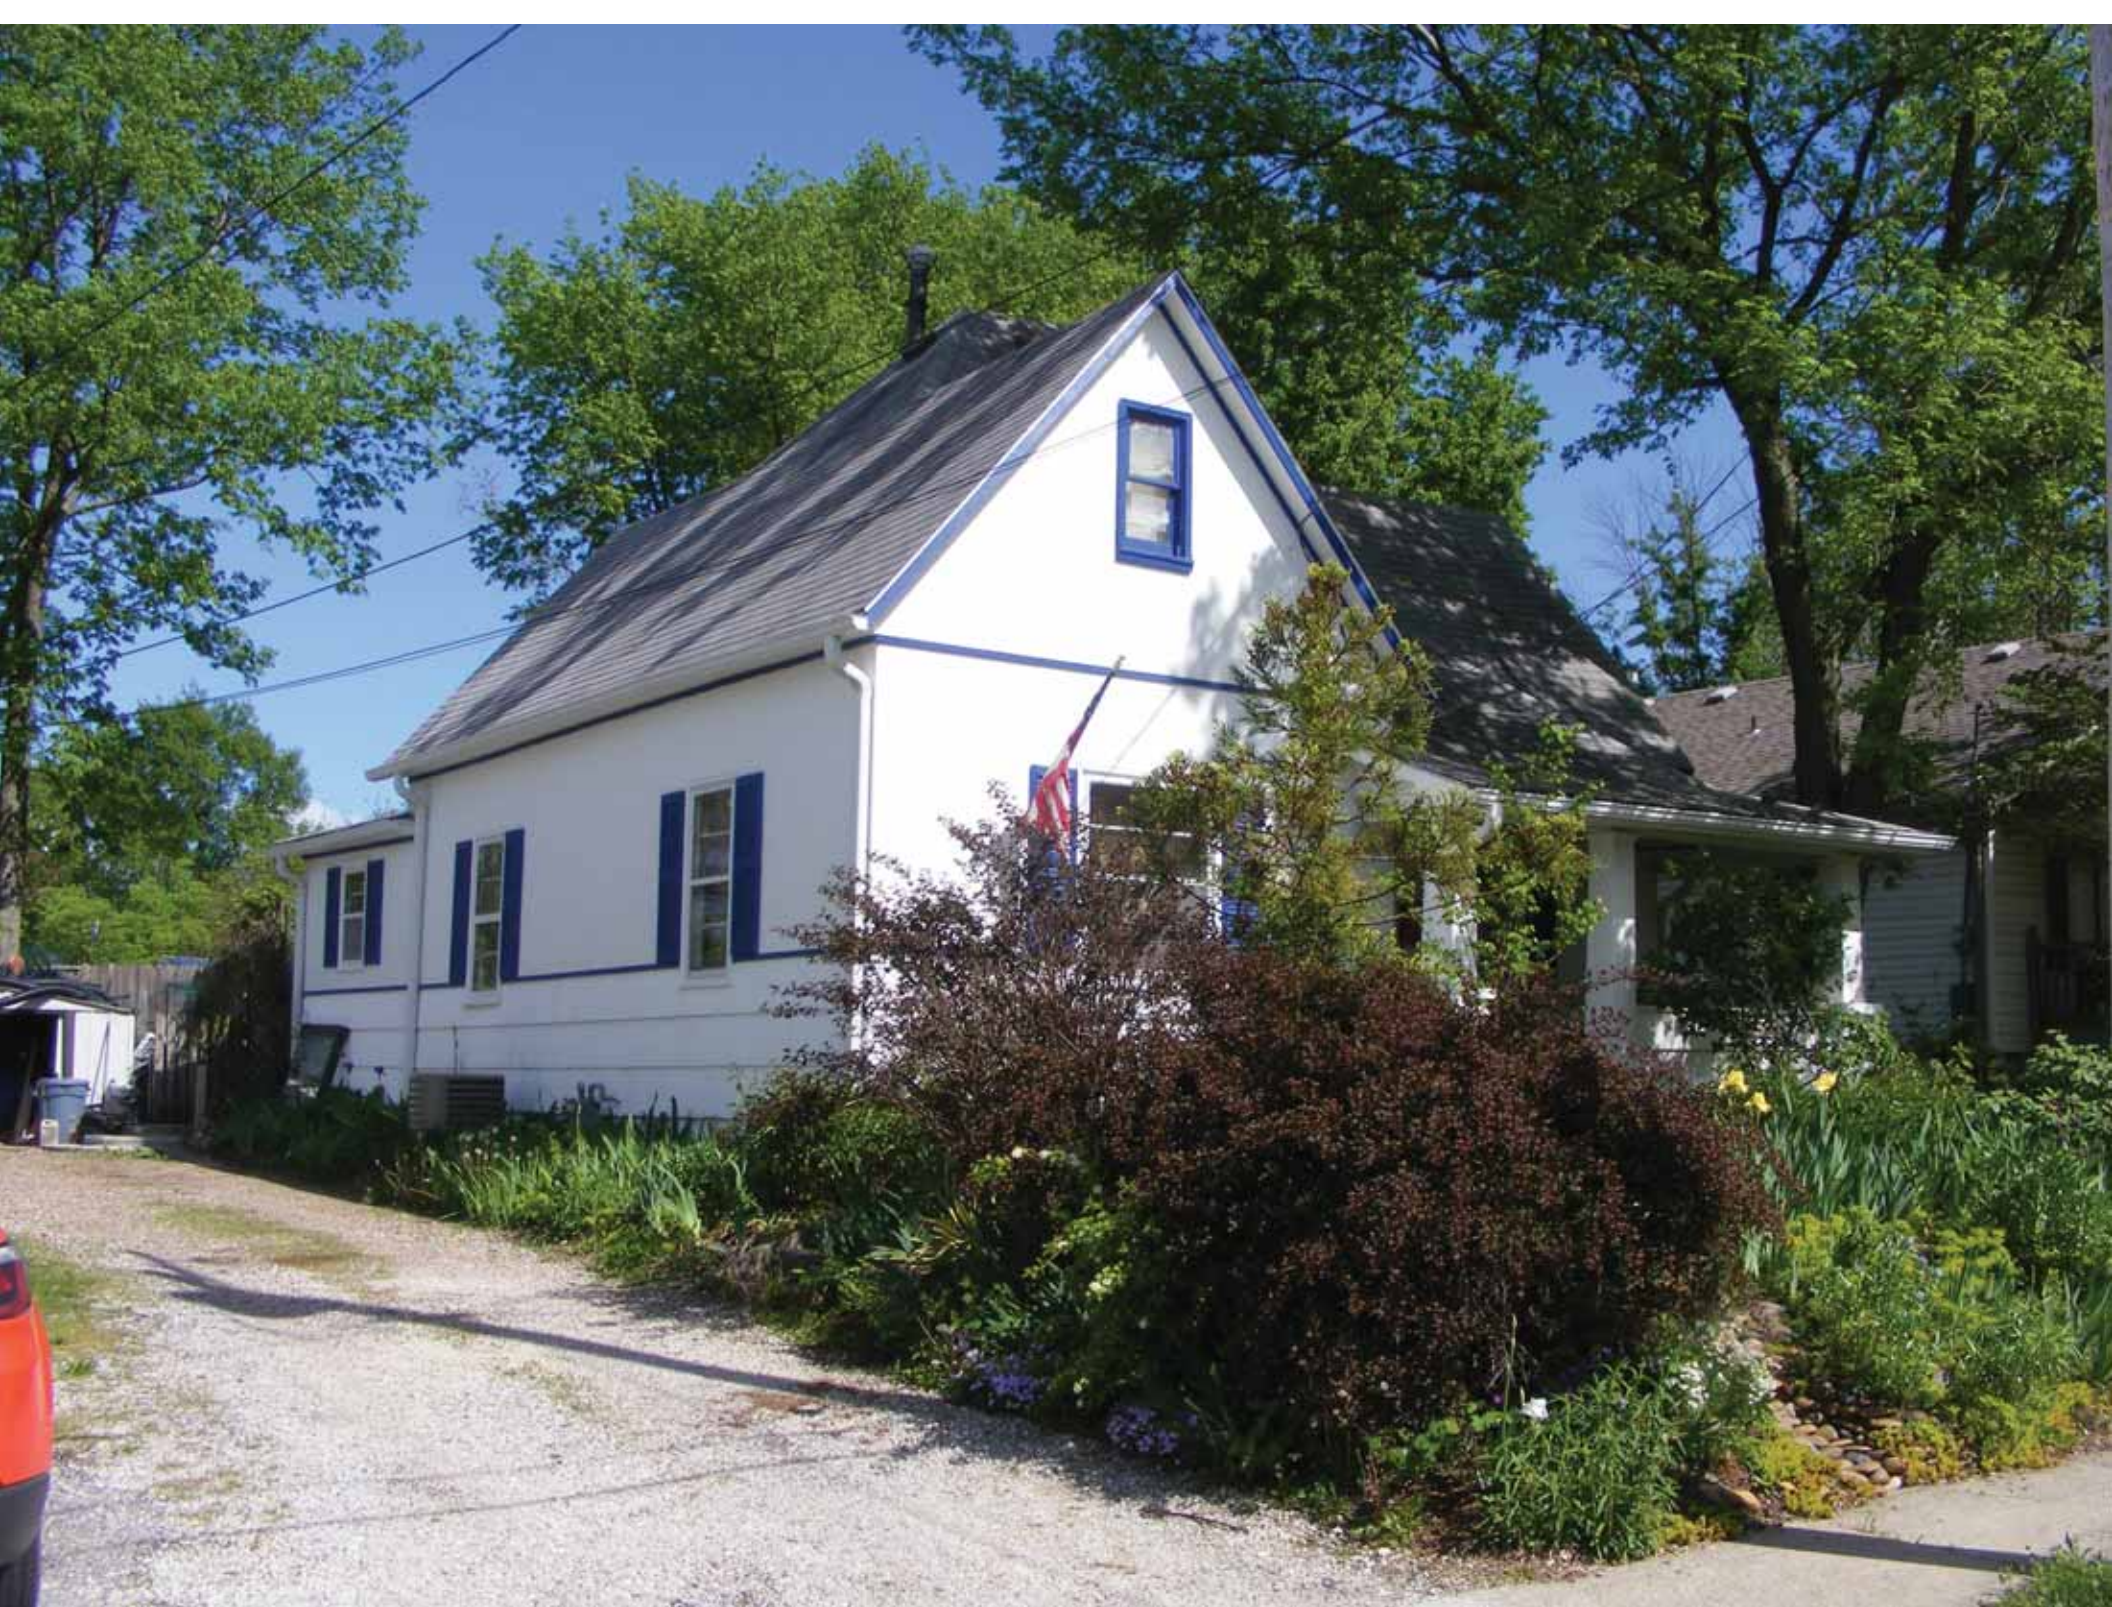
41. (cont.) Description of primary resource. Expand box as necessary, or add continuation pages.
The dwelling is one story, asphalt shingled cross-gable to shed (front porch), asbestos siding on the lower section and stucco on the upper section and has a concrete foundation. The façade features a partial-width porch under the shed supported by tapered wood columns on stucco clad piers with a low wood sided wall between the piers. Entrance is at the "L" and offset to the right by a two-over-two window. The gable front holds a matching window flanked by shutters; gable end holds a small one-over-one window. Side elevations hold two-over-two windows flanked by shutters. A thin wooden stringcourse delineates the asbestos siding from the stucco and at the roofline and delineates the lower wall surface from the gable end.
