MISSOURI DEPARTMENT OF NATURAL RESOURCES
STATE HISTORIC PRESERVATION OFFICE, P.O. Box 176, Jefferson City, MO 65102
ARCHITECTURAL/HISTORIC INVENTORY FORM

1. Survey No. BO-AS-011-0087		2. Survey name: North Central Columbia Survey Phase II	
3. County: Boone		4. Address (Street No.) 902	Street (name) N. Seventh Street
5. City: Columbia	Vicinity: <input type="checkbox"/>	6. Geographical Reference:	7. Township/Range/Section: T: R: S:
8. Historic name (if known):		9. Present/other name (if known):	
10. Ownership: <input checked="" type="checkbox"/> Private <input type="checkbox"/> Public		11a. Historic use (if known): Domestic/single dwelling	11b. Current use: Domestic/single dwelling

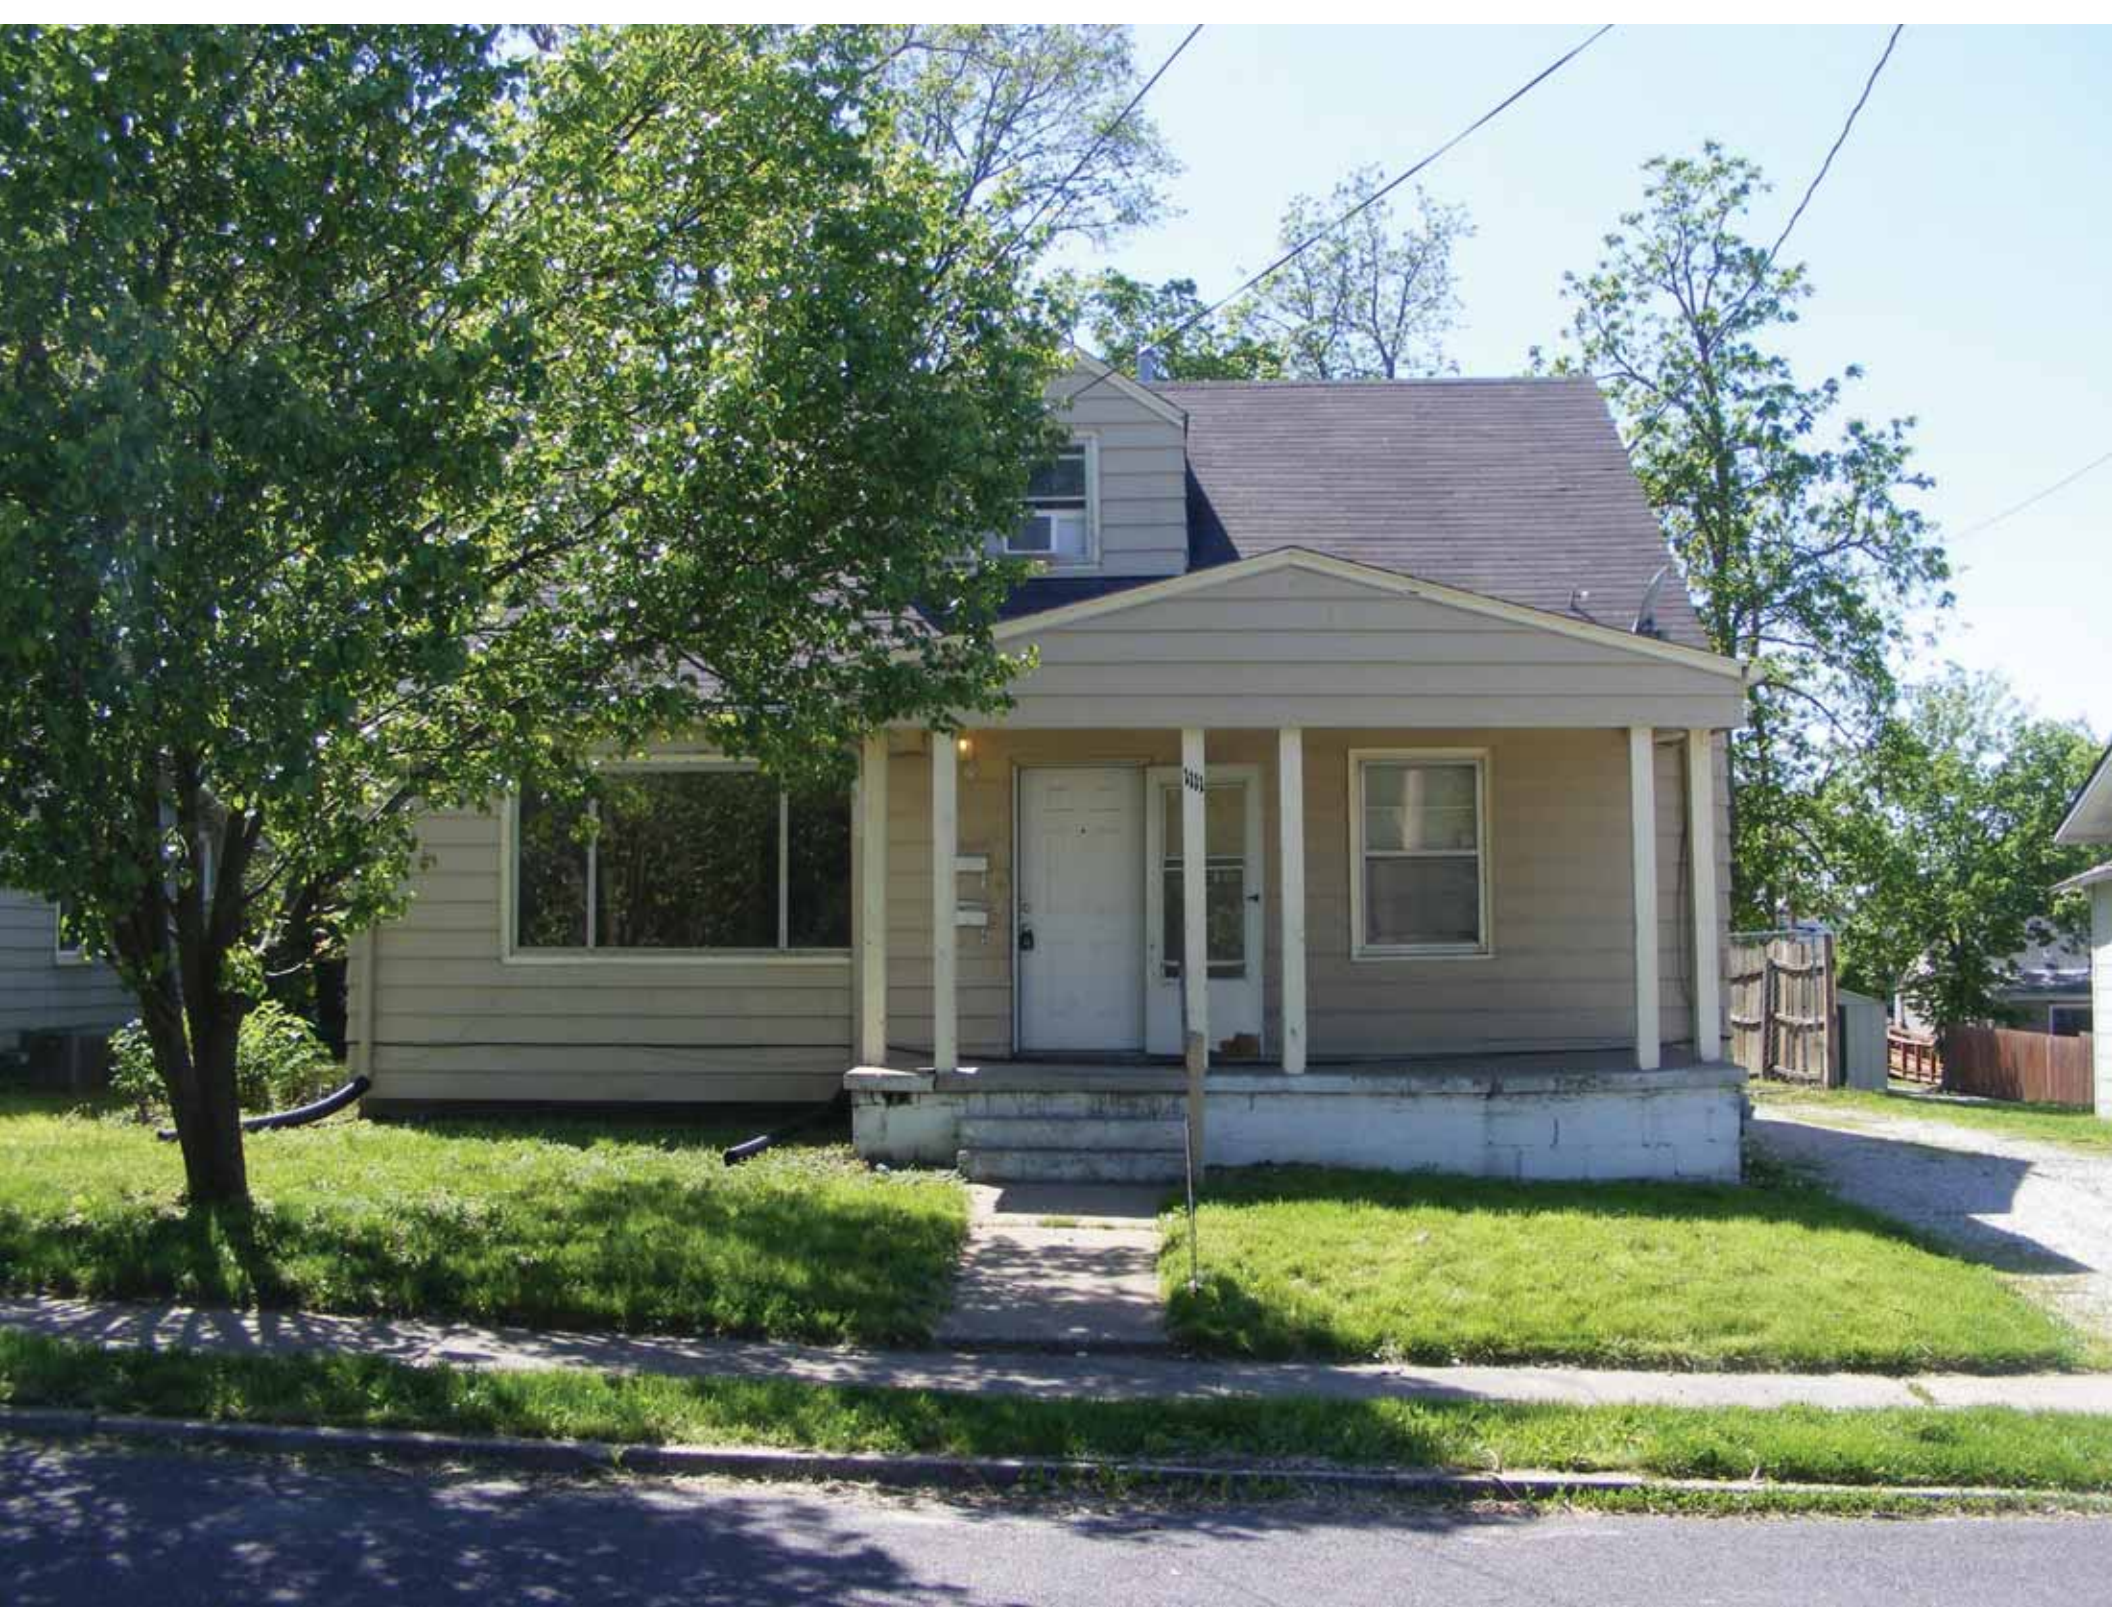
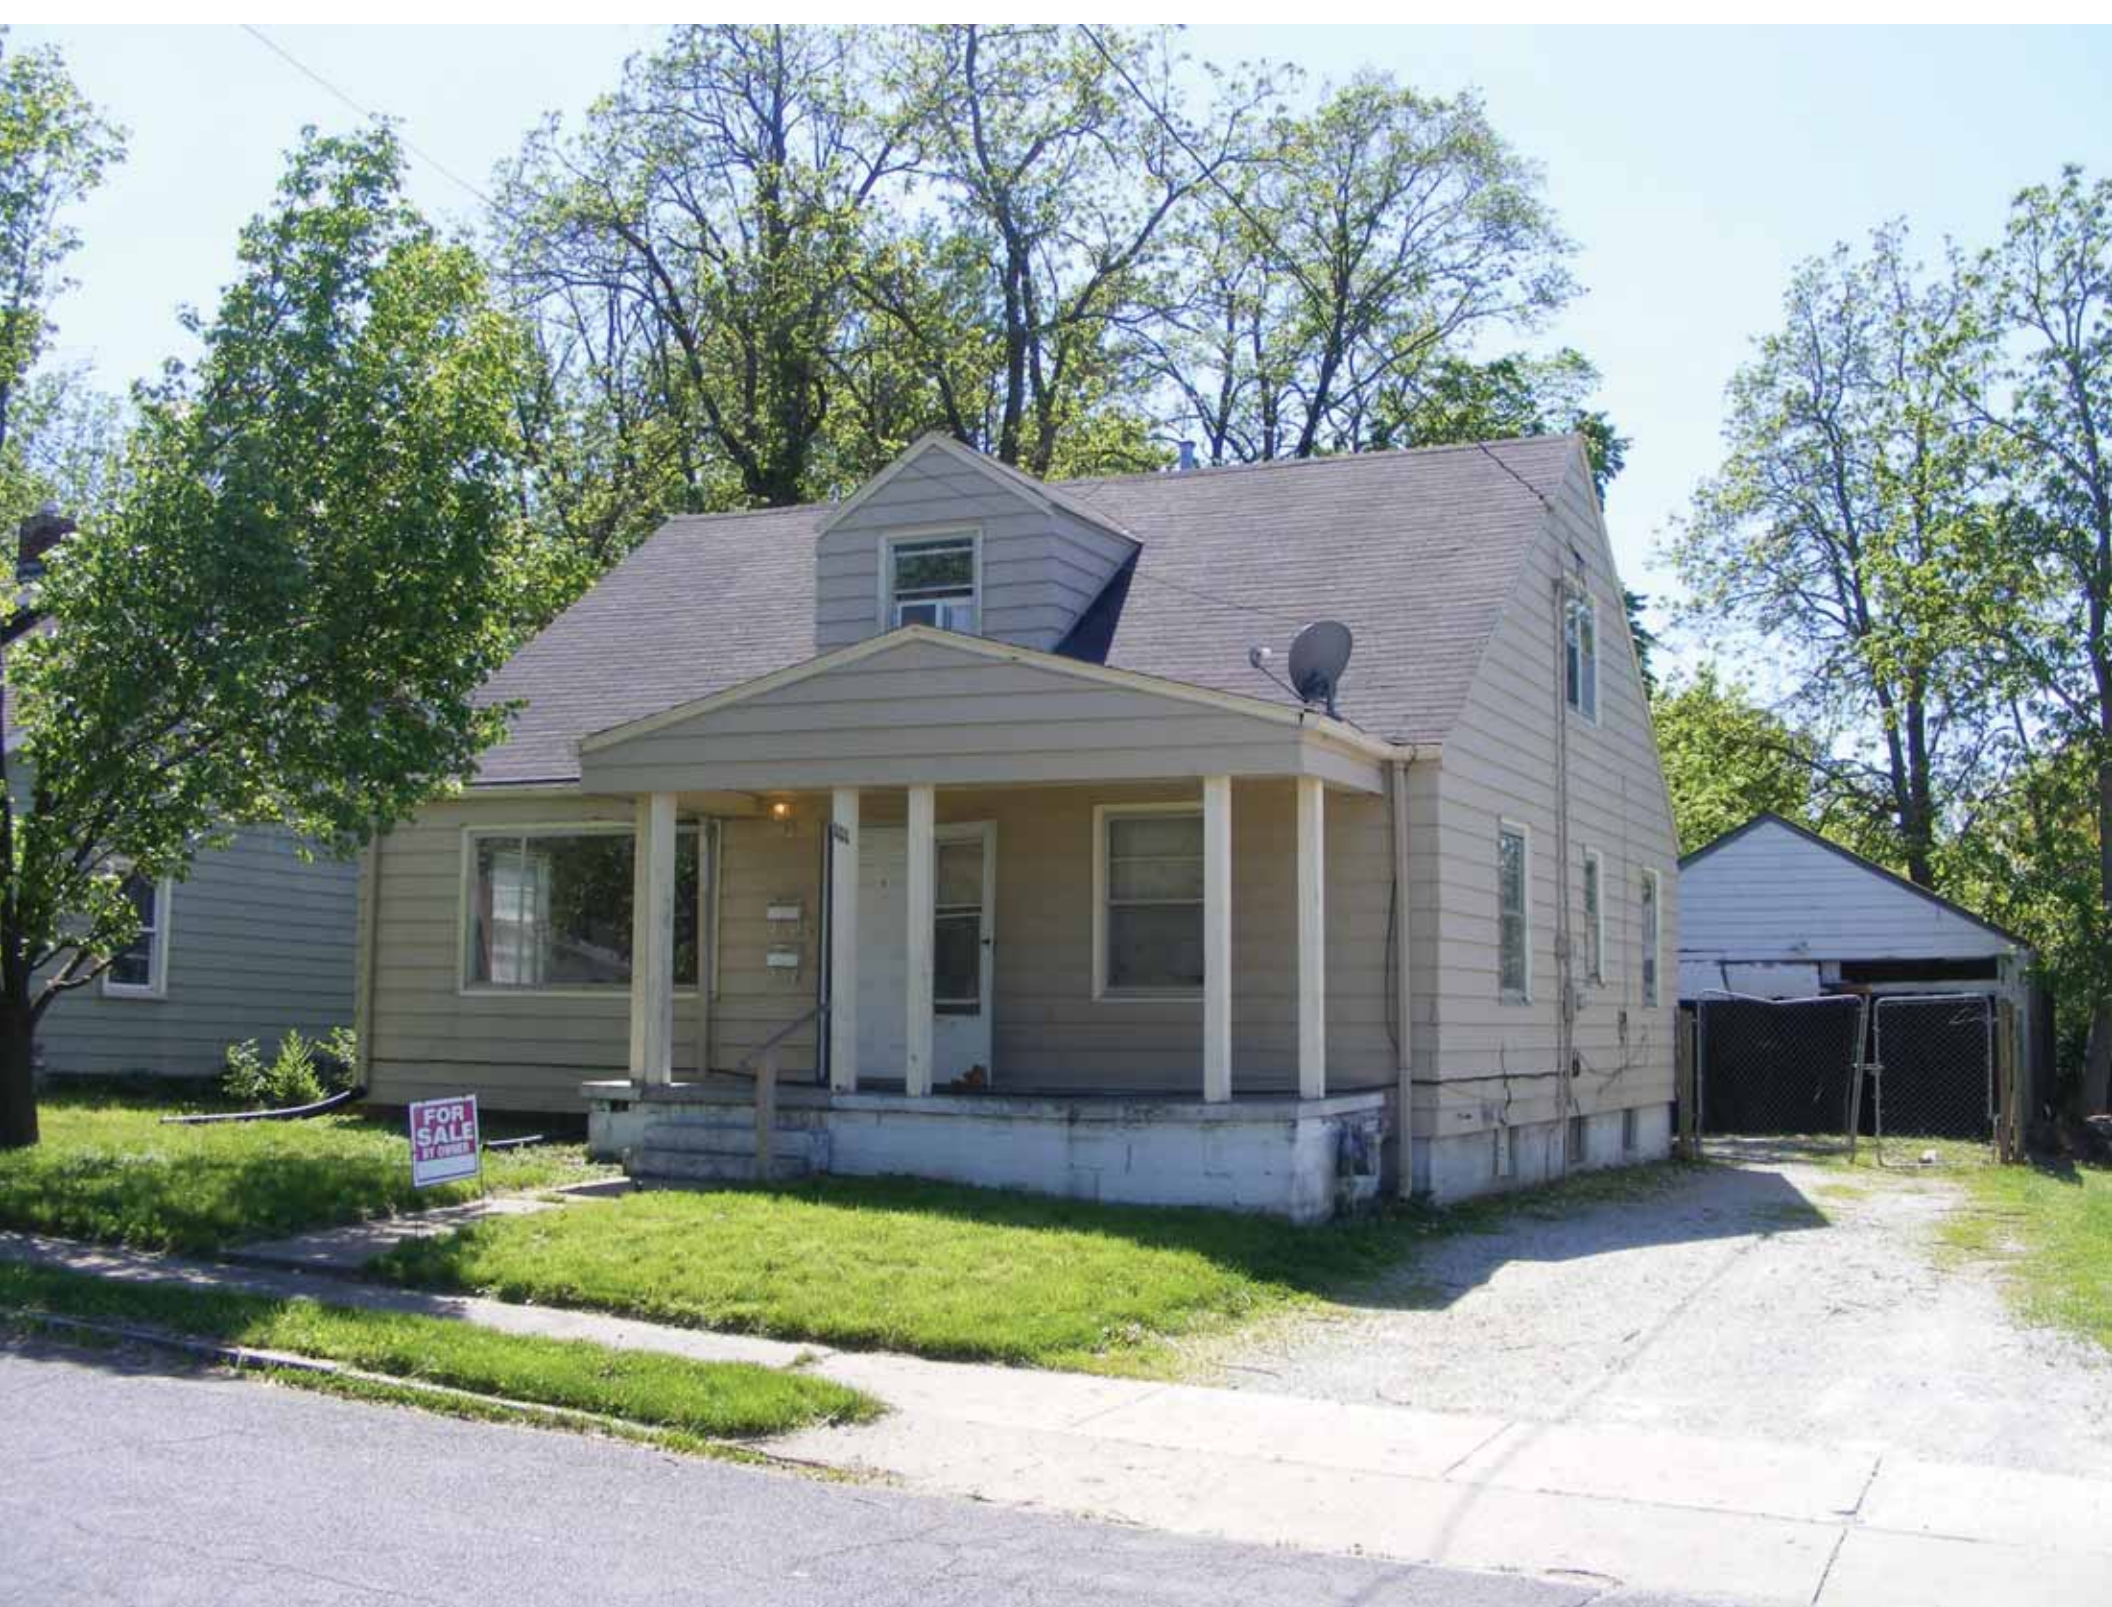
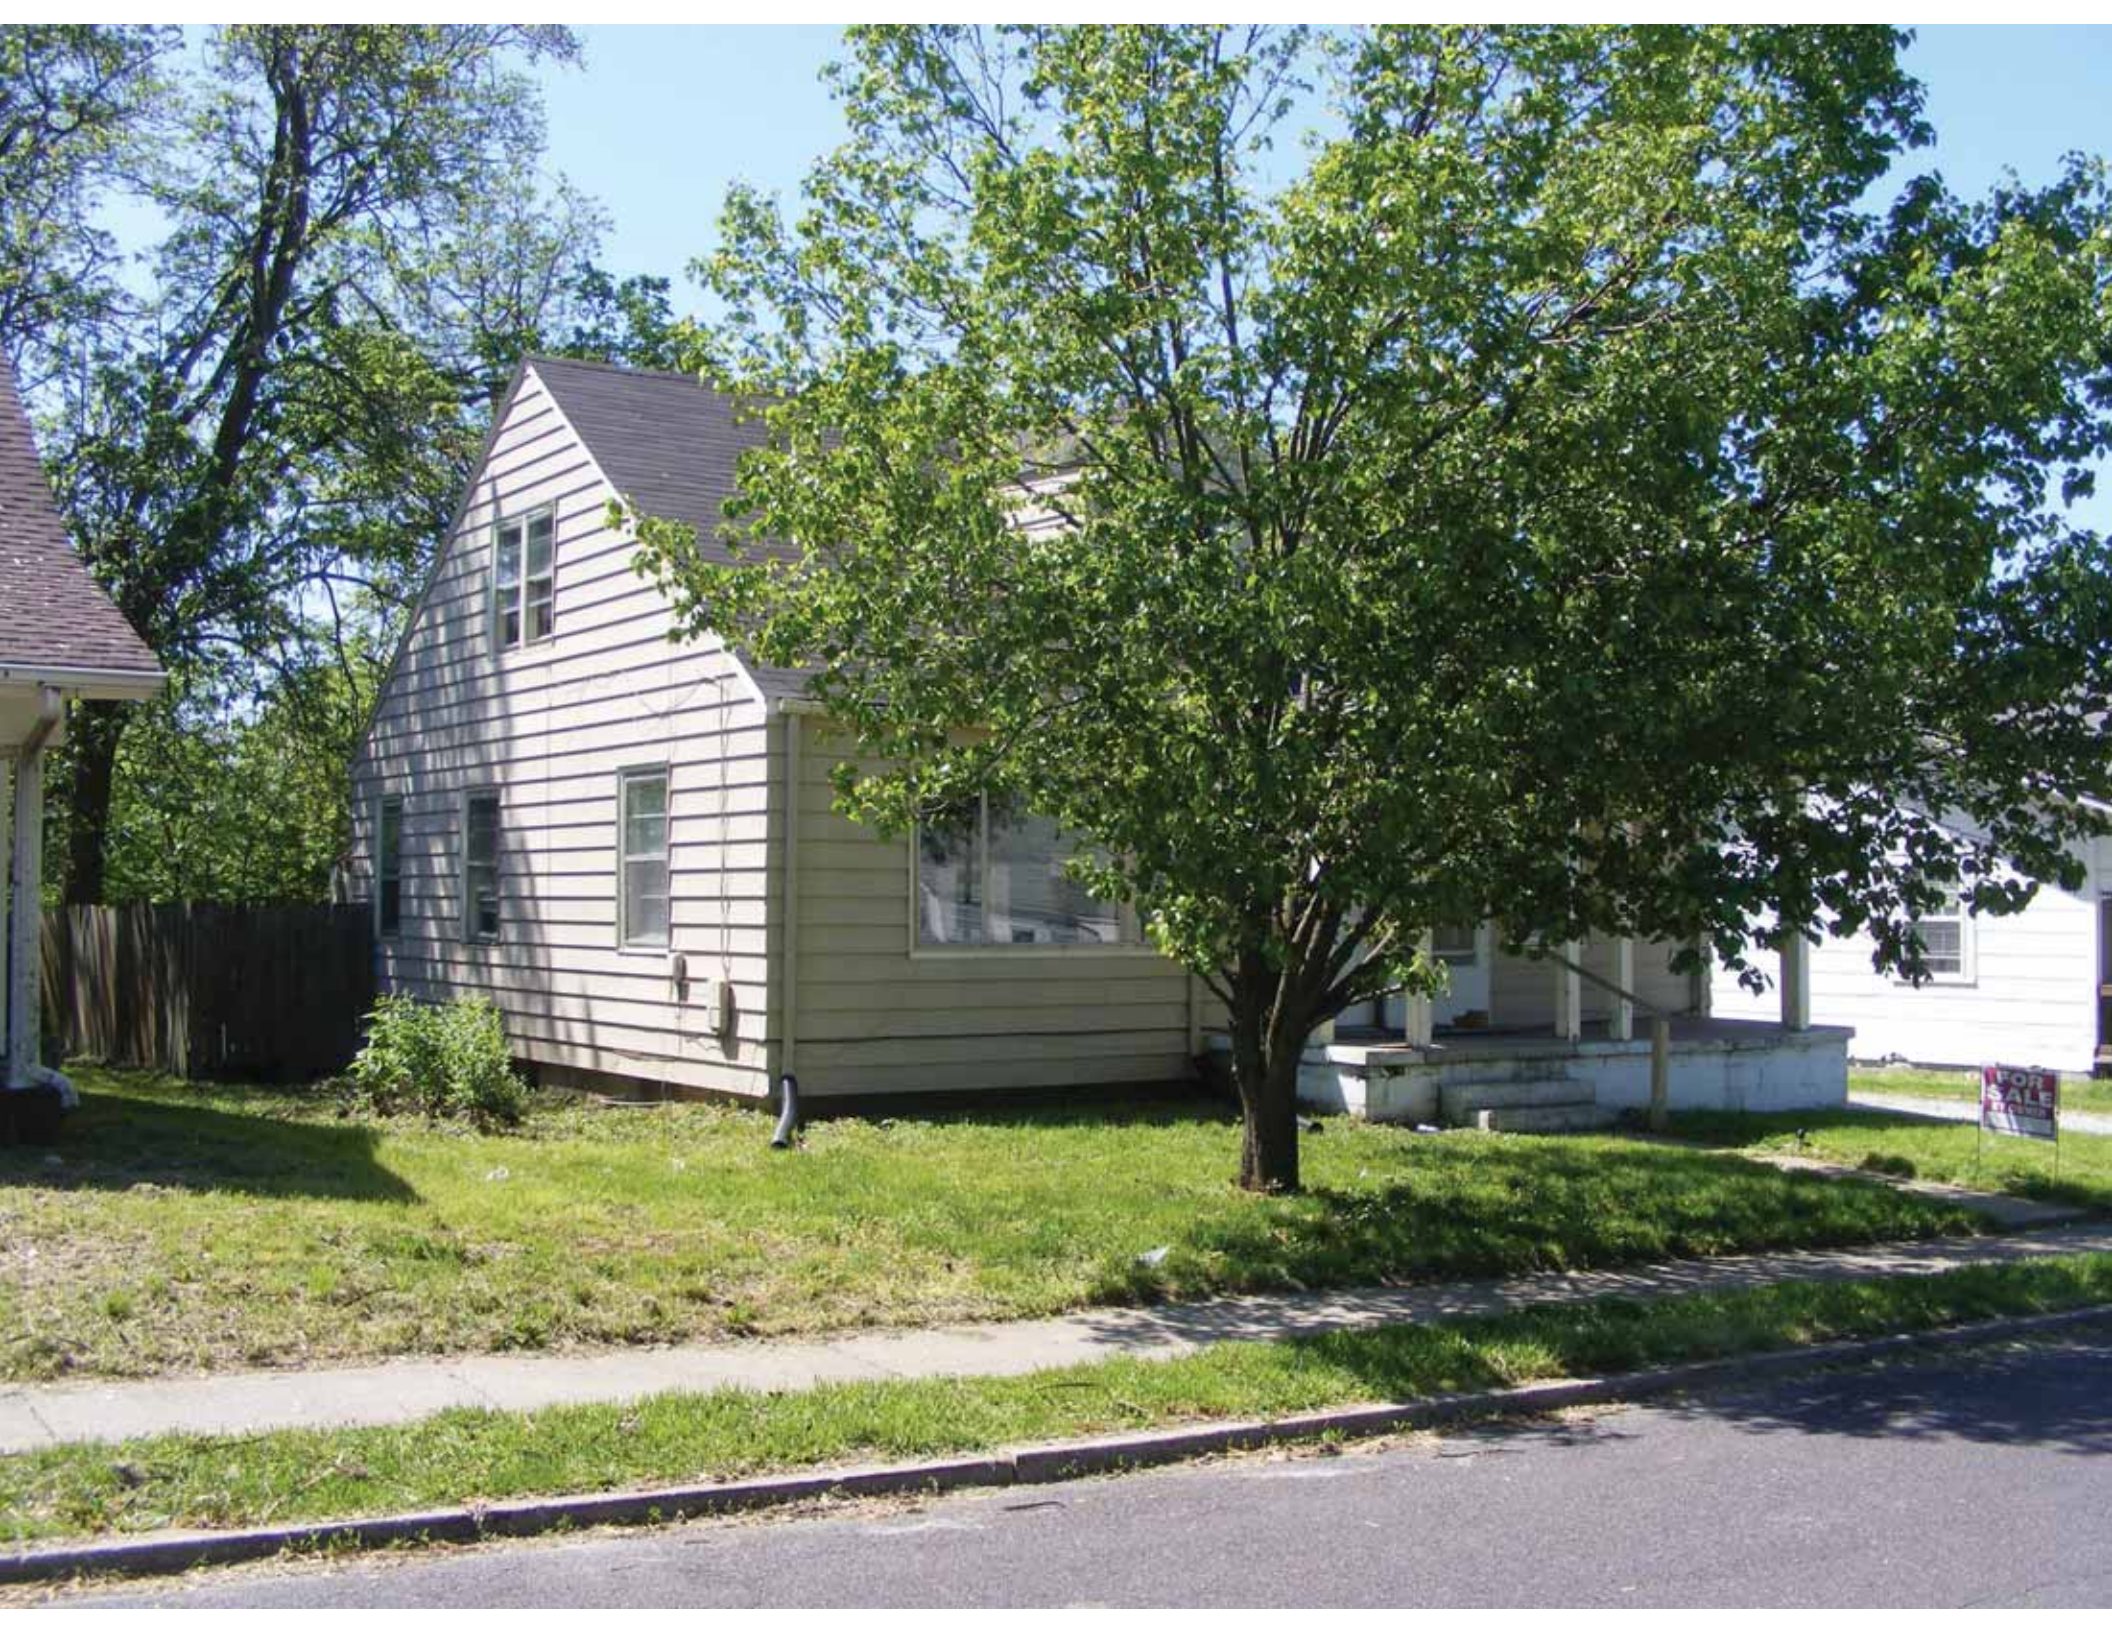
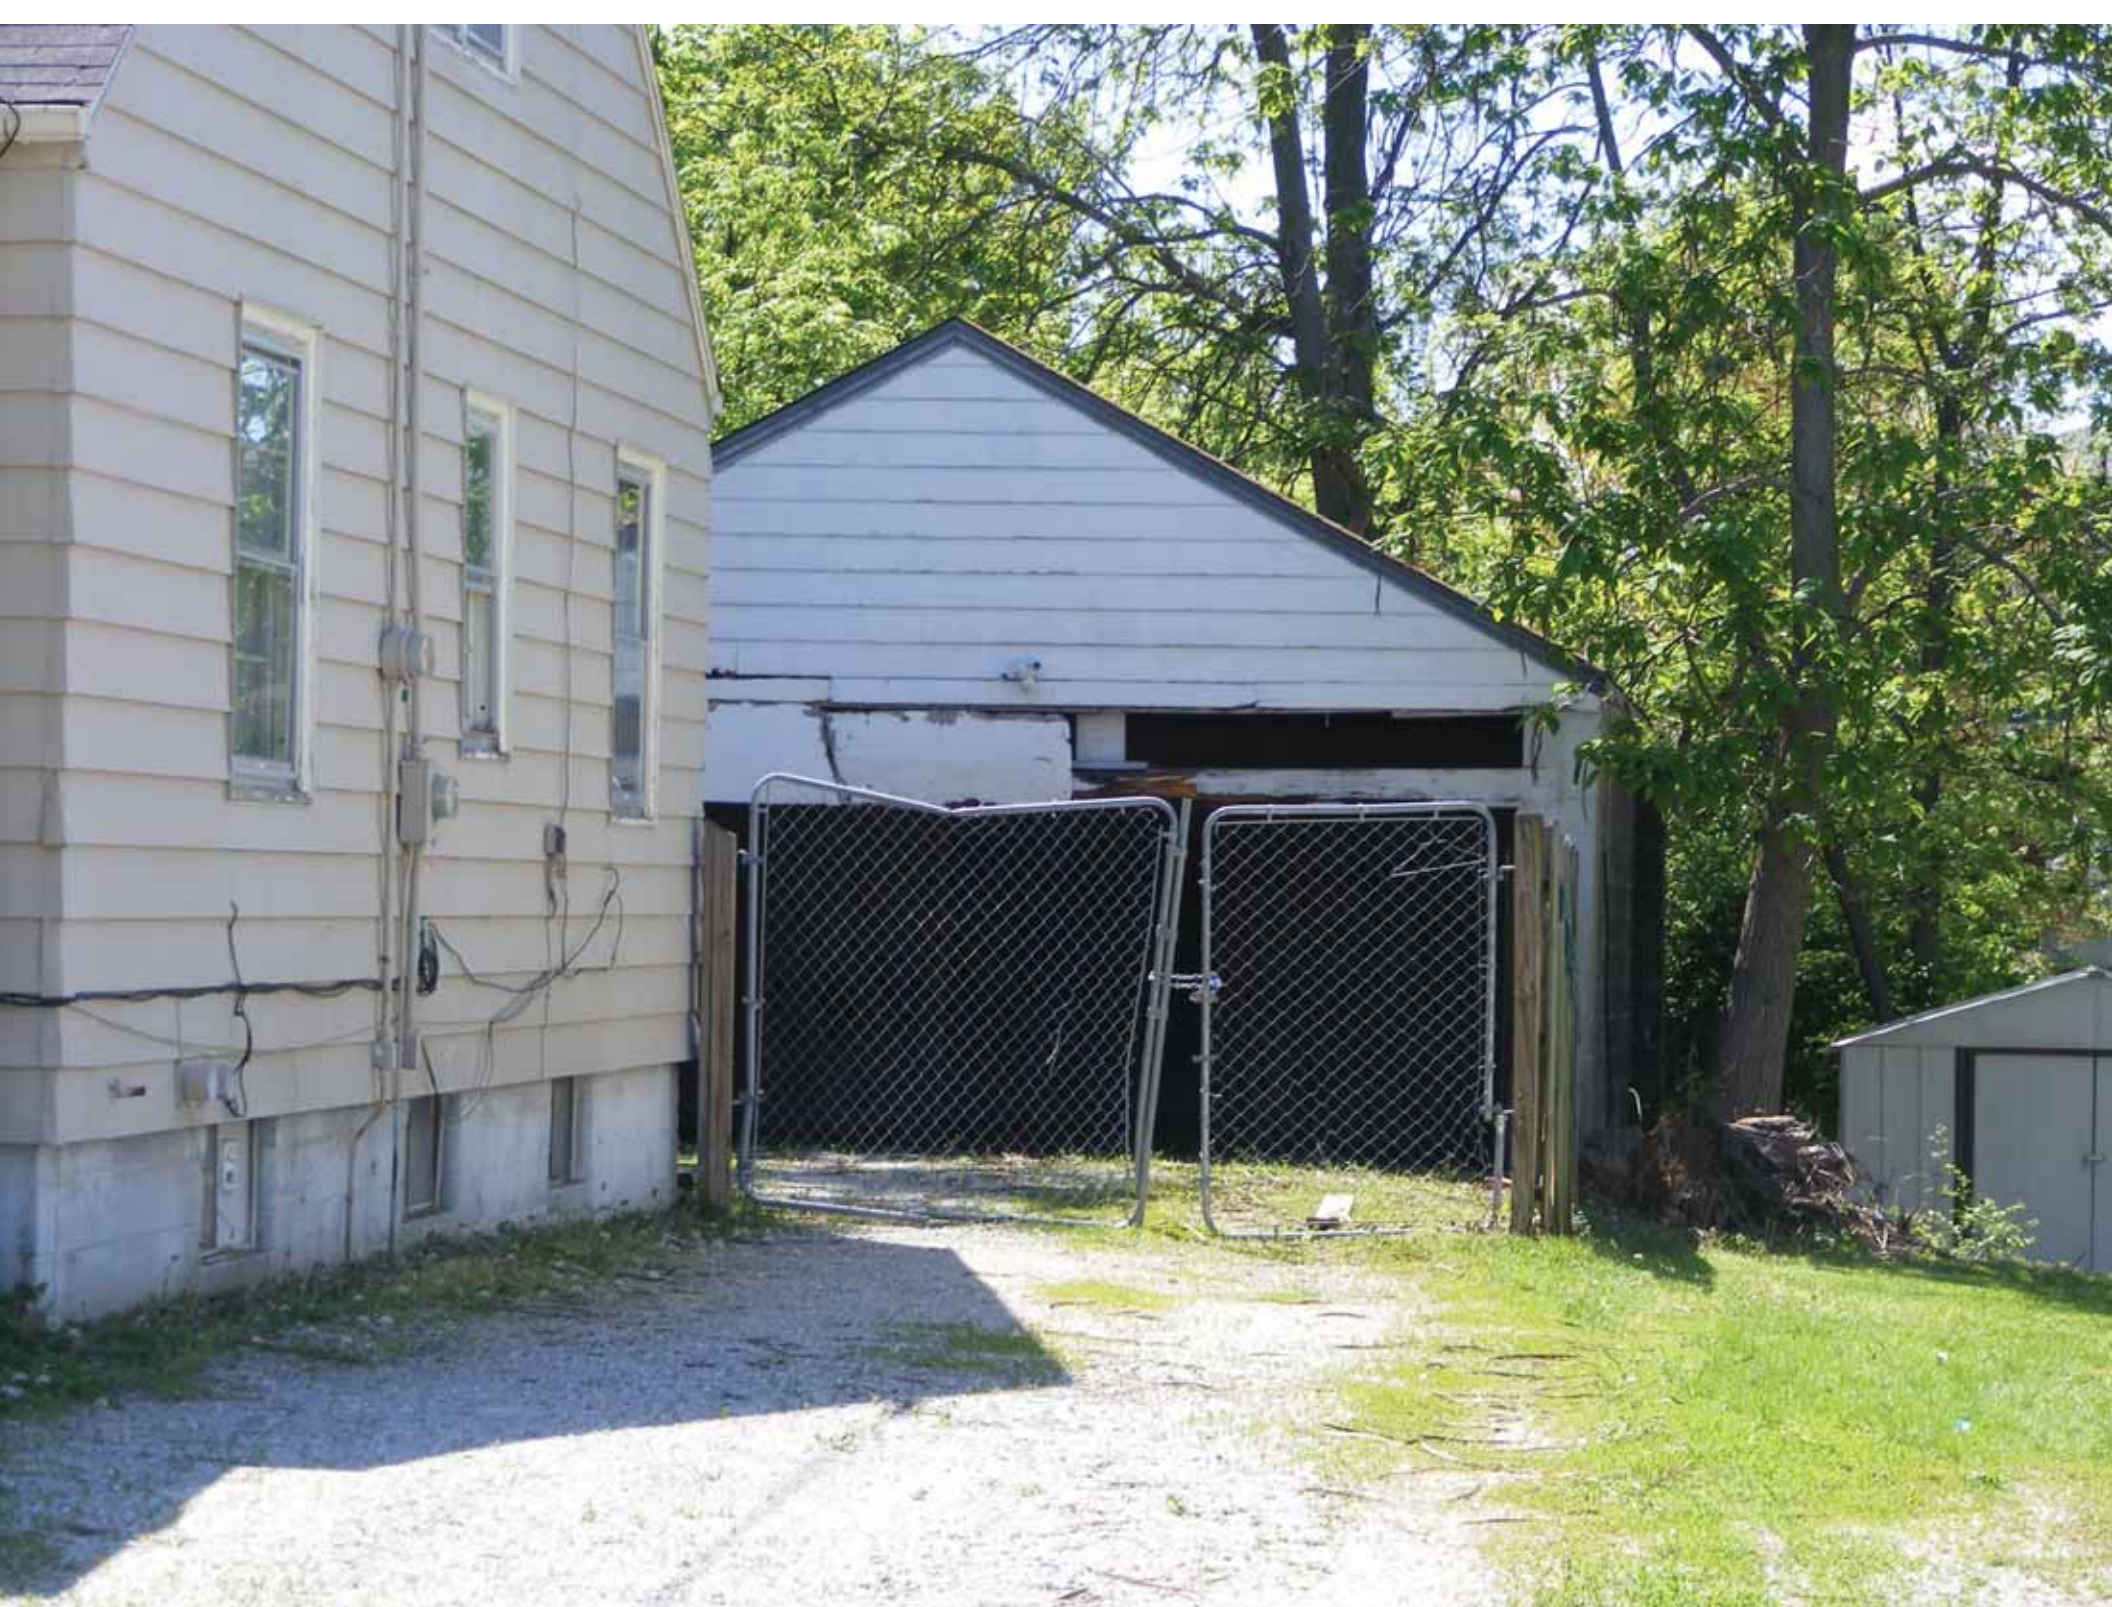
41. (cont.) Description of primary resource. Expand box as necessary, or add continuation pages.
The dwelling is a 1.5 story asphalt shingled side gable with a centered front gable dormer (two-over-two window) on the front sloping roofline and a concrete foundation. The wood sided dwelling features a partial-width lower gable front porch supported by wooden square posts, concrete decking and steps. Entrance is centered offset to left by a picture window and to the right by a two-over-two windows. Side elevations holds single and paired two-over-two windows.

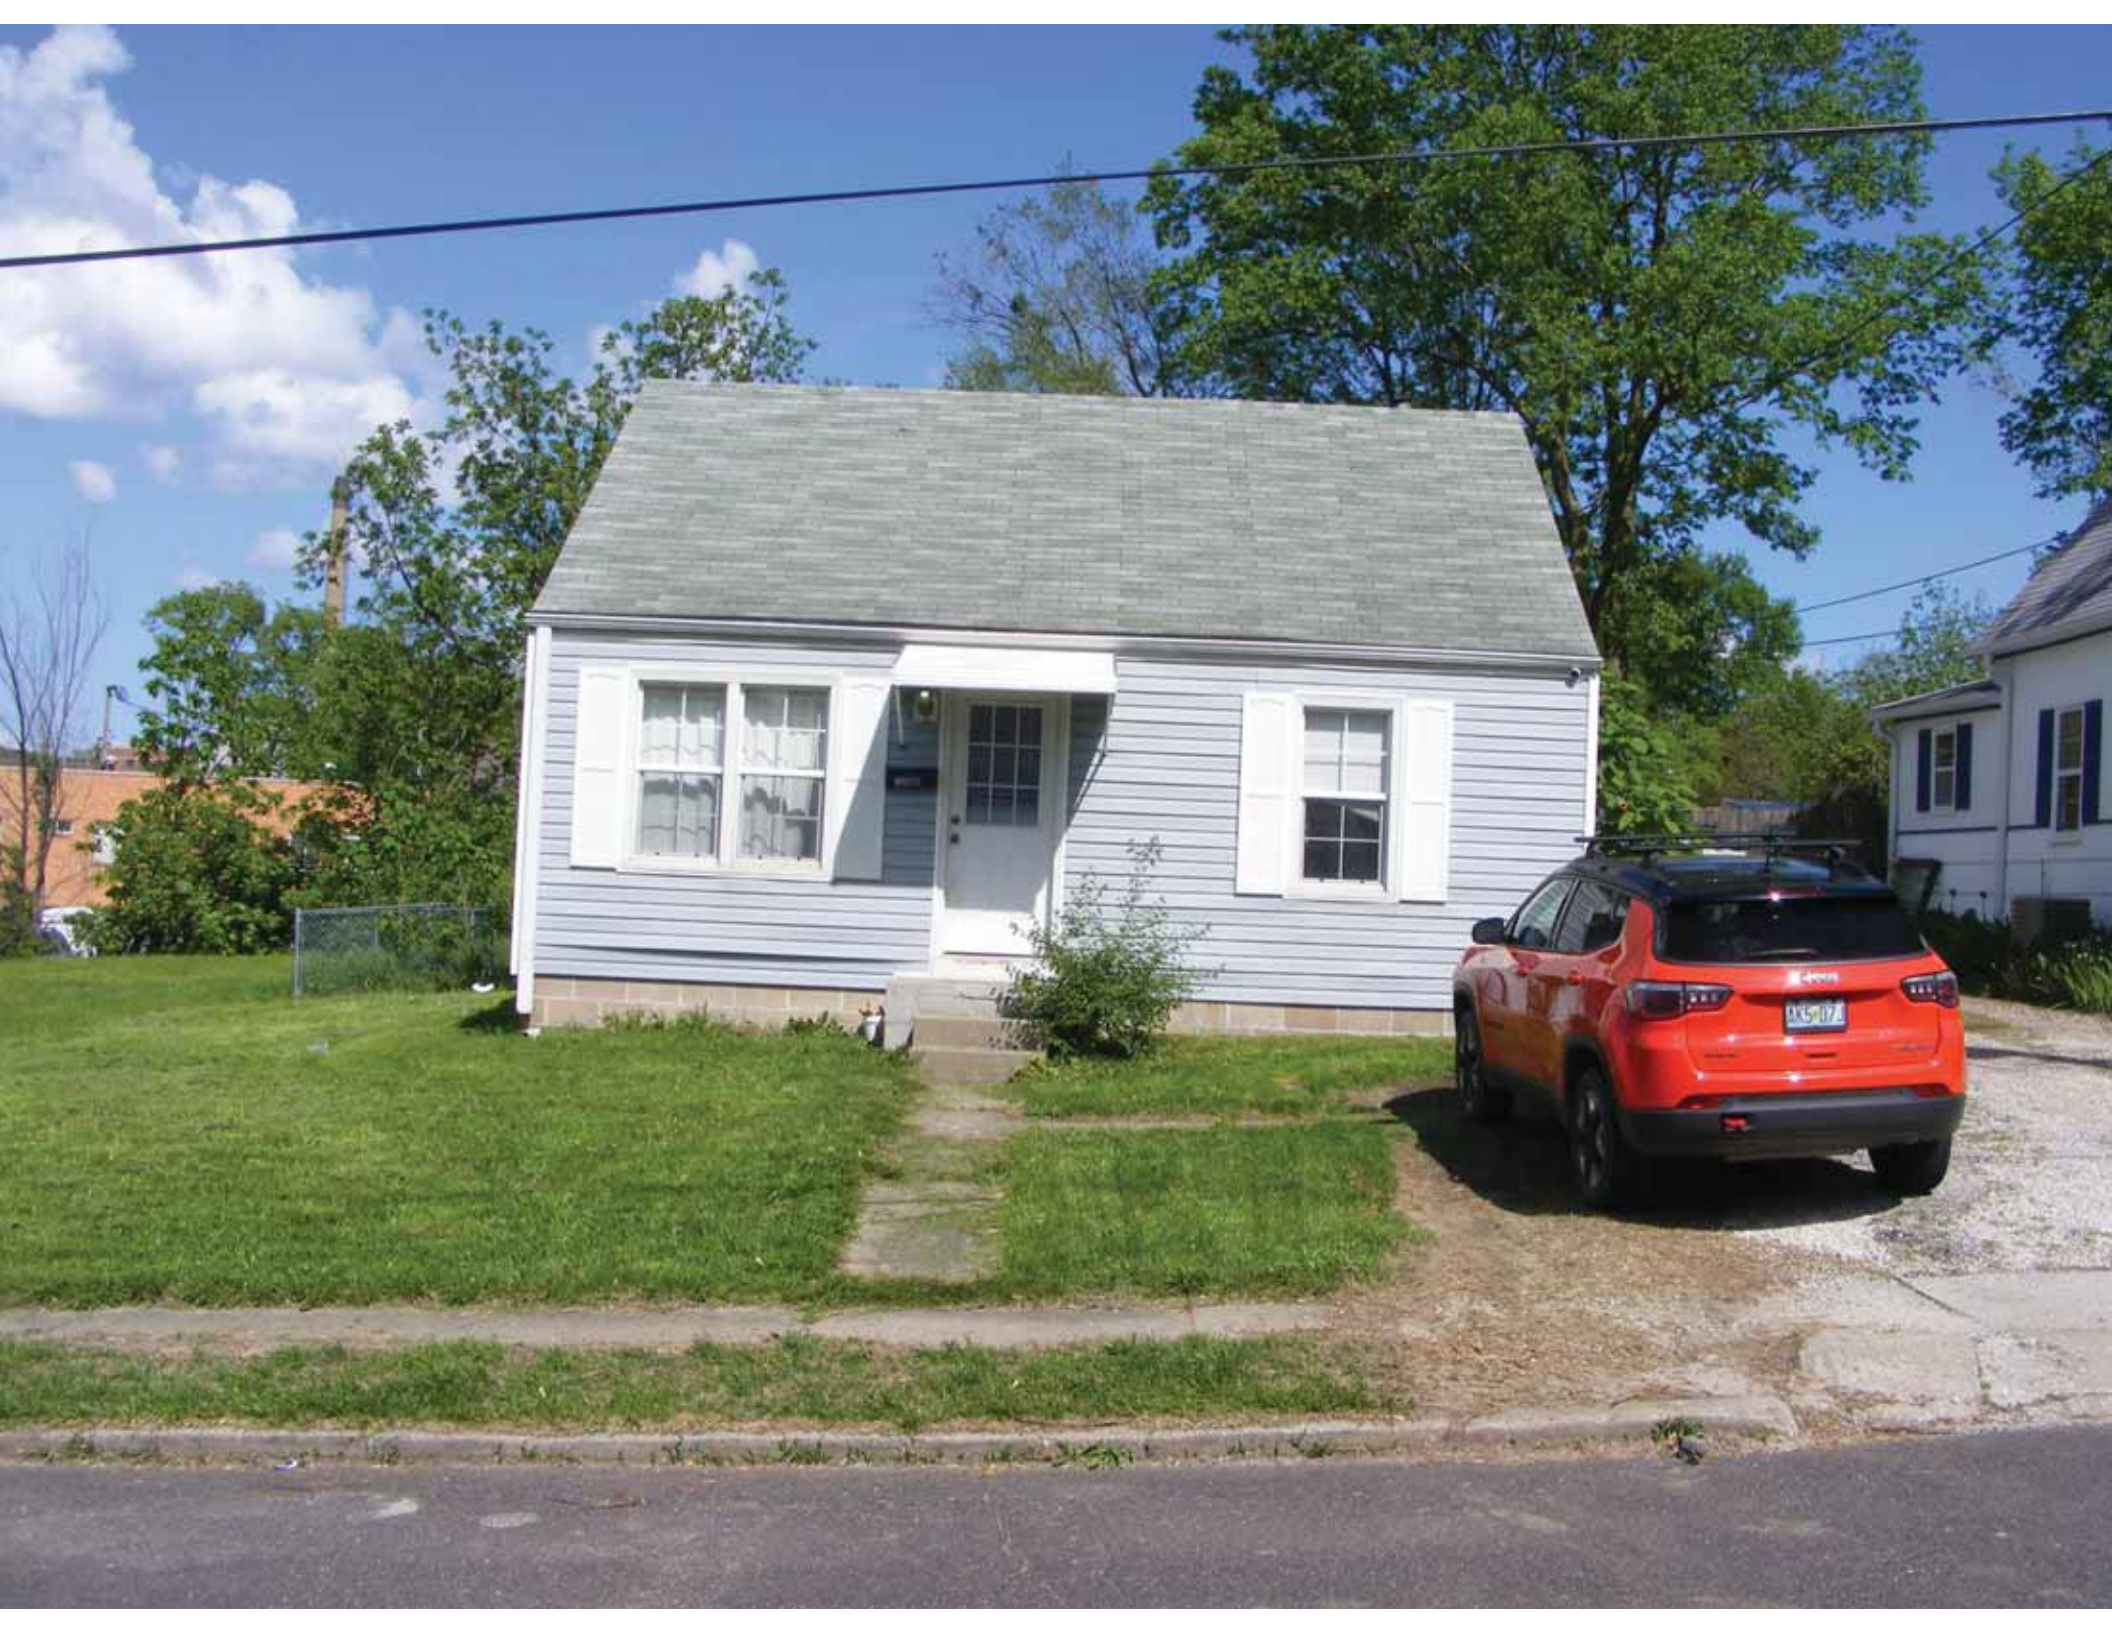
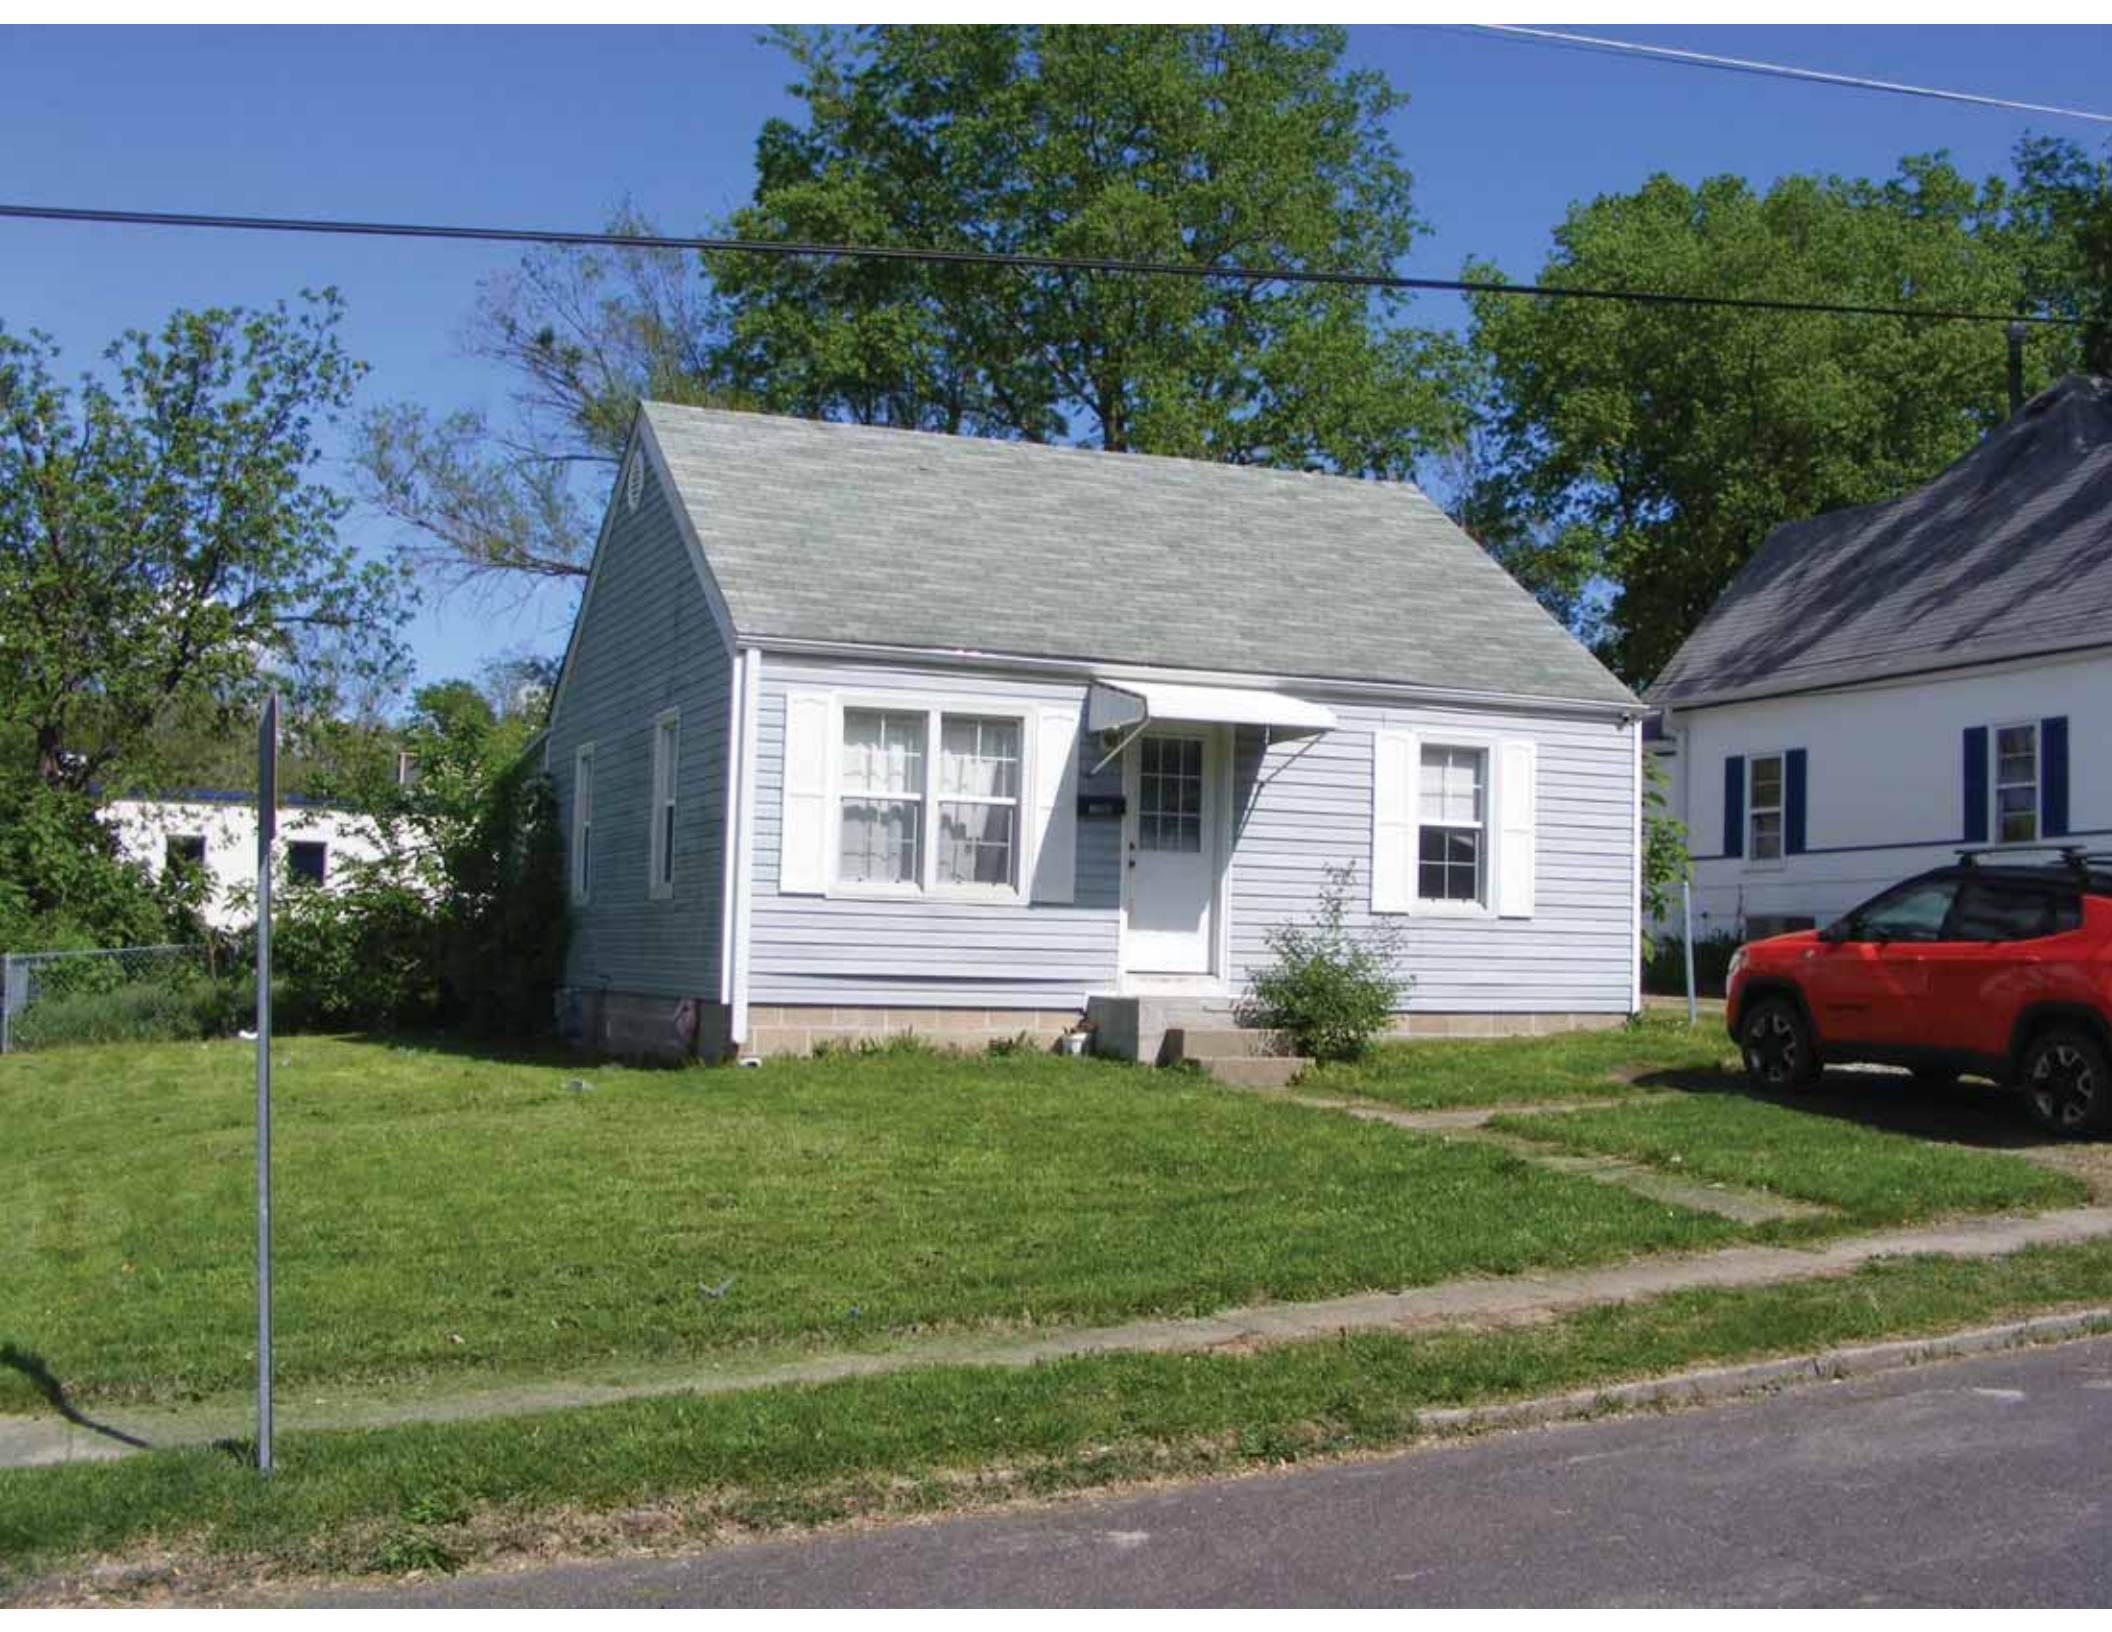
41. (cont.) Description of primary resource. Expand box as necessary, or add continuation pages.
This is a one-story asphalt shingled side gable, exterior vinyl siding and concrete block foundation. The façade holds a centered concrete stoop entrance with a metal shed awning supported by brackets. The entrance (wood paneled with nine lights) is offset to the left by a paired four-over-four window and to the right by a single four-over-four window; shutters flank the windows. Side elevation hold single four-over-four windows, octagonal louvered vents in the gable ends and basement window wells.
