MISSOURI DEPARTMENT OF NATURAL RESOURCES
STATE HISTORIC PRESERVATION OFFICE, P.O. Box 176, Jefferson City, MO 65102
ARCHITECTURAL/HISTORIC INVENTORY FORM

1. Survey No. BO-AS-011-0087		2. Survey name: North Central Columbia Survey Phase II	
3. County: Boone		4. Address (Street No.) 902	Street (name) N. Seventh Street
5. City: Columbia	Vicinity: <input type="checkbox"/>	6. Geographical Reference:	7. Township/Range/Section: T: R: S:
8. Historic name (if known):		9. Present/other name (if known):	
10. Ownership: <input checked="" type="checkbox"/> Private <input type="checkbox"/> Public		11a. Historic use (if known): Domestic/single dwelling	11b. Current use: Domestic/single dwelling

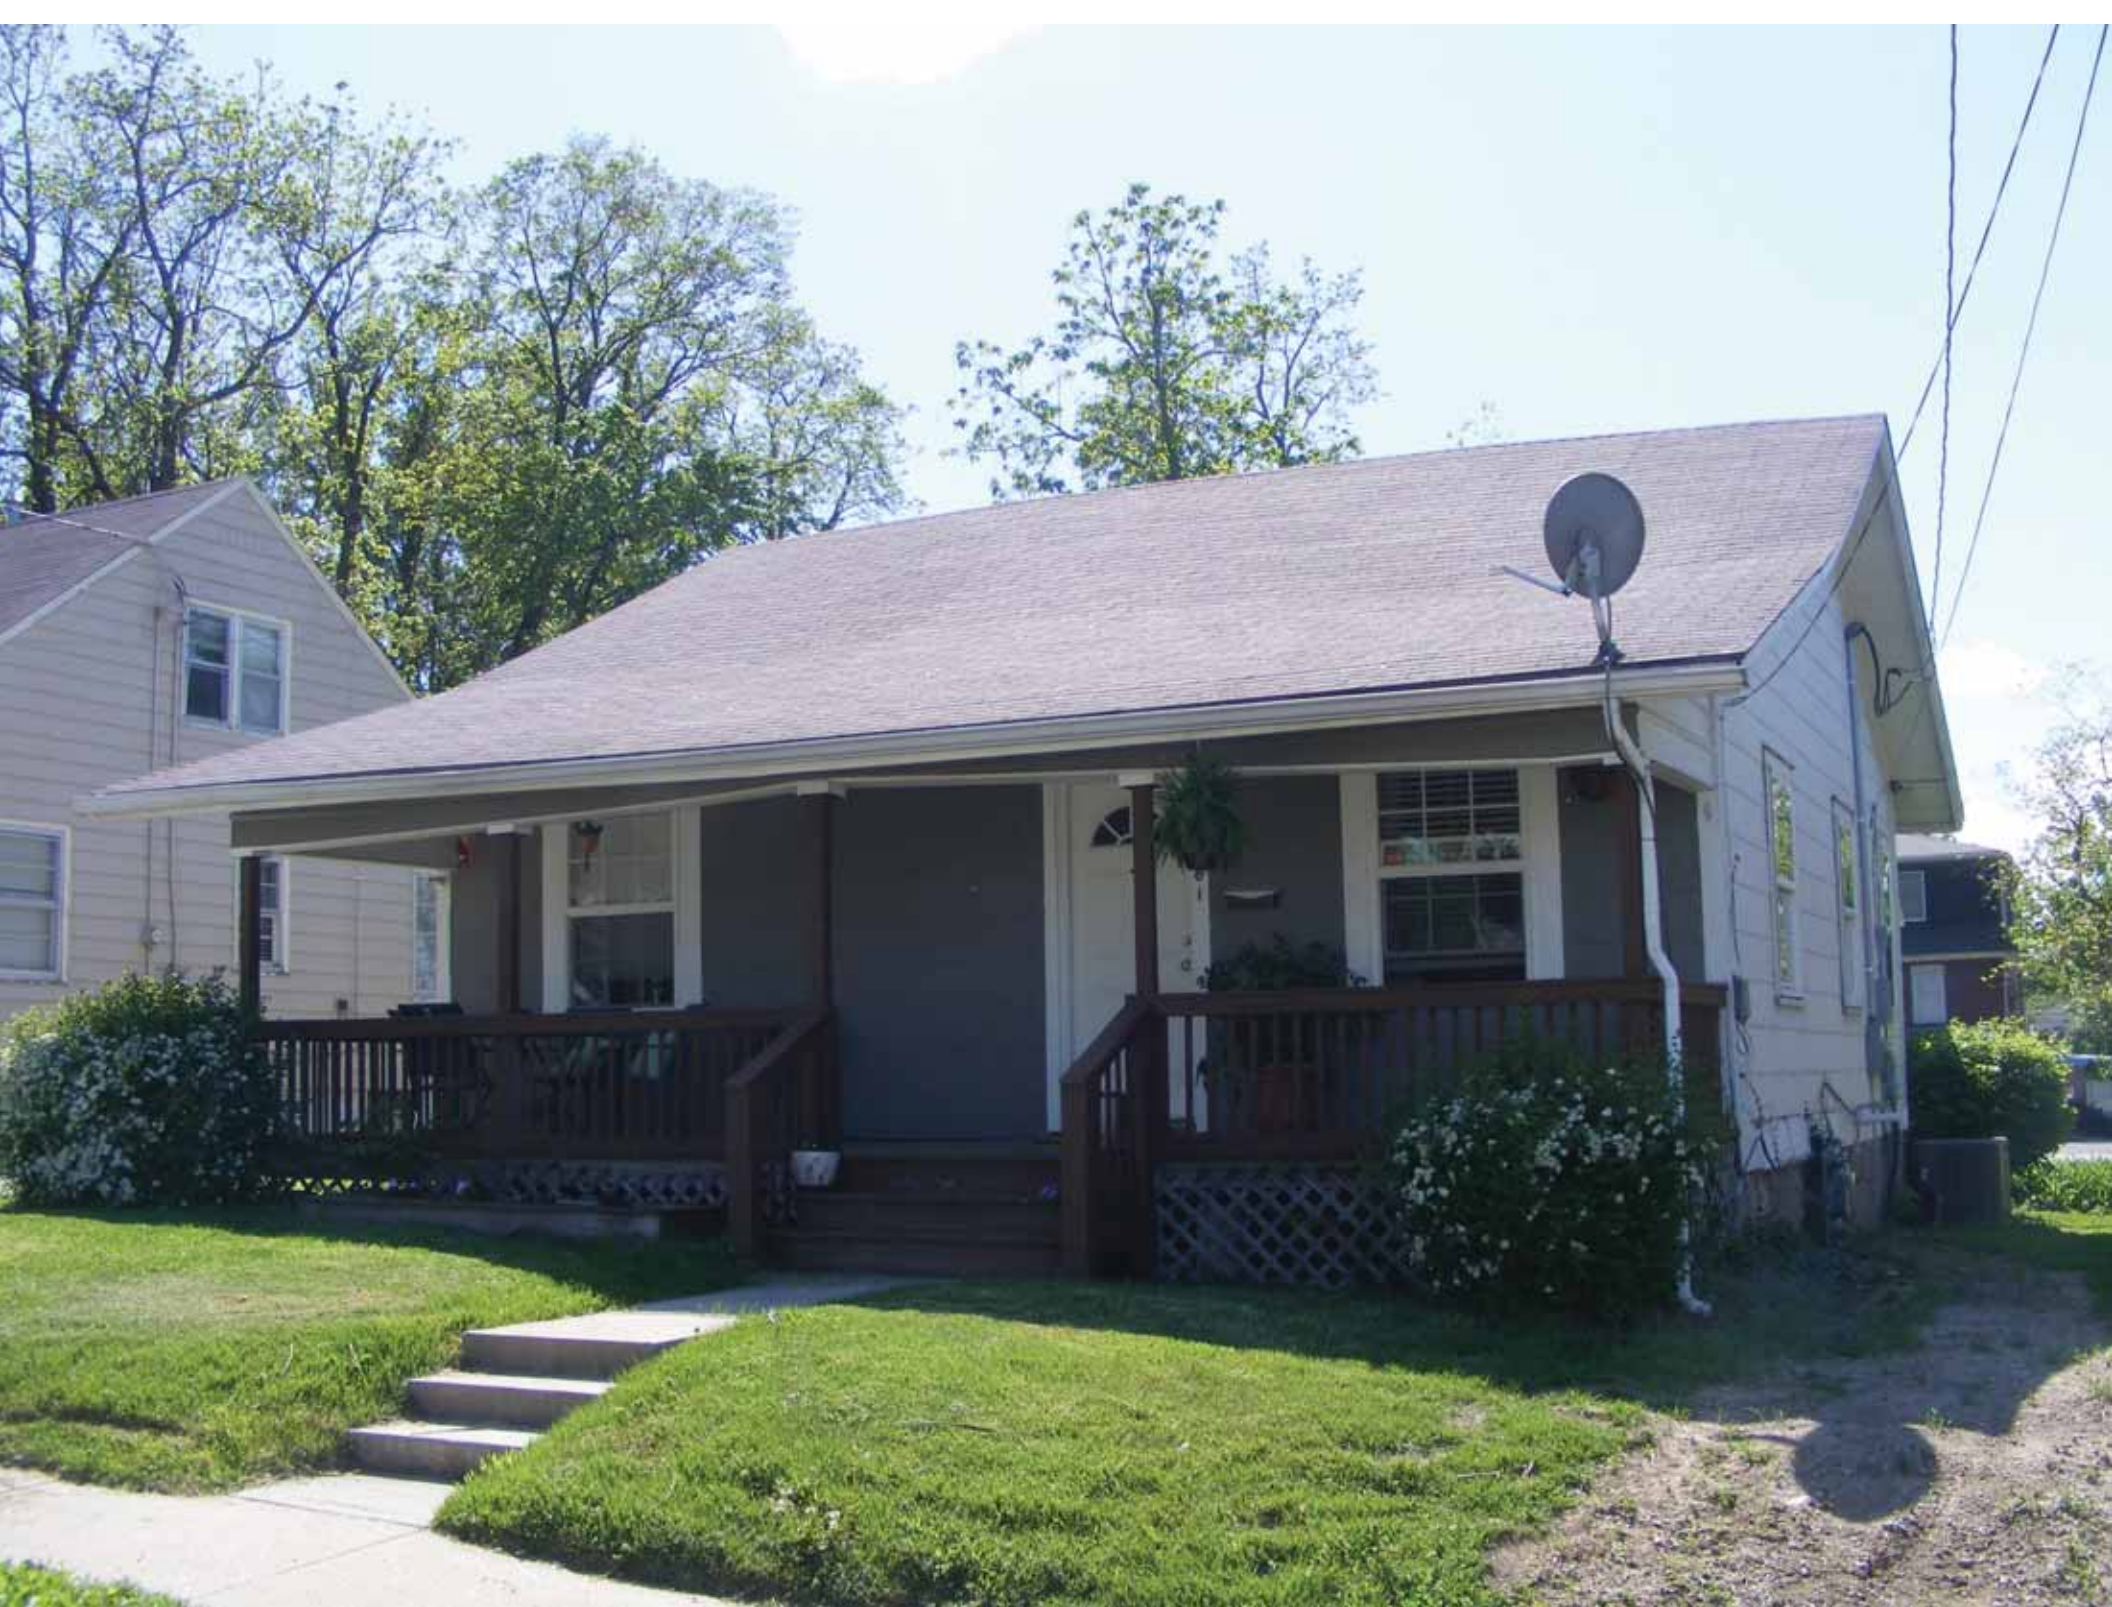
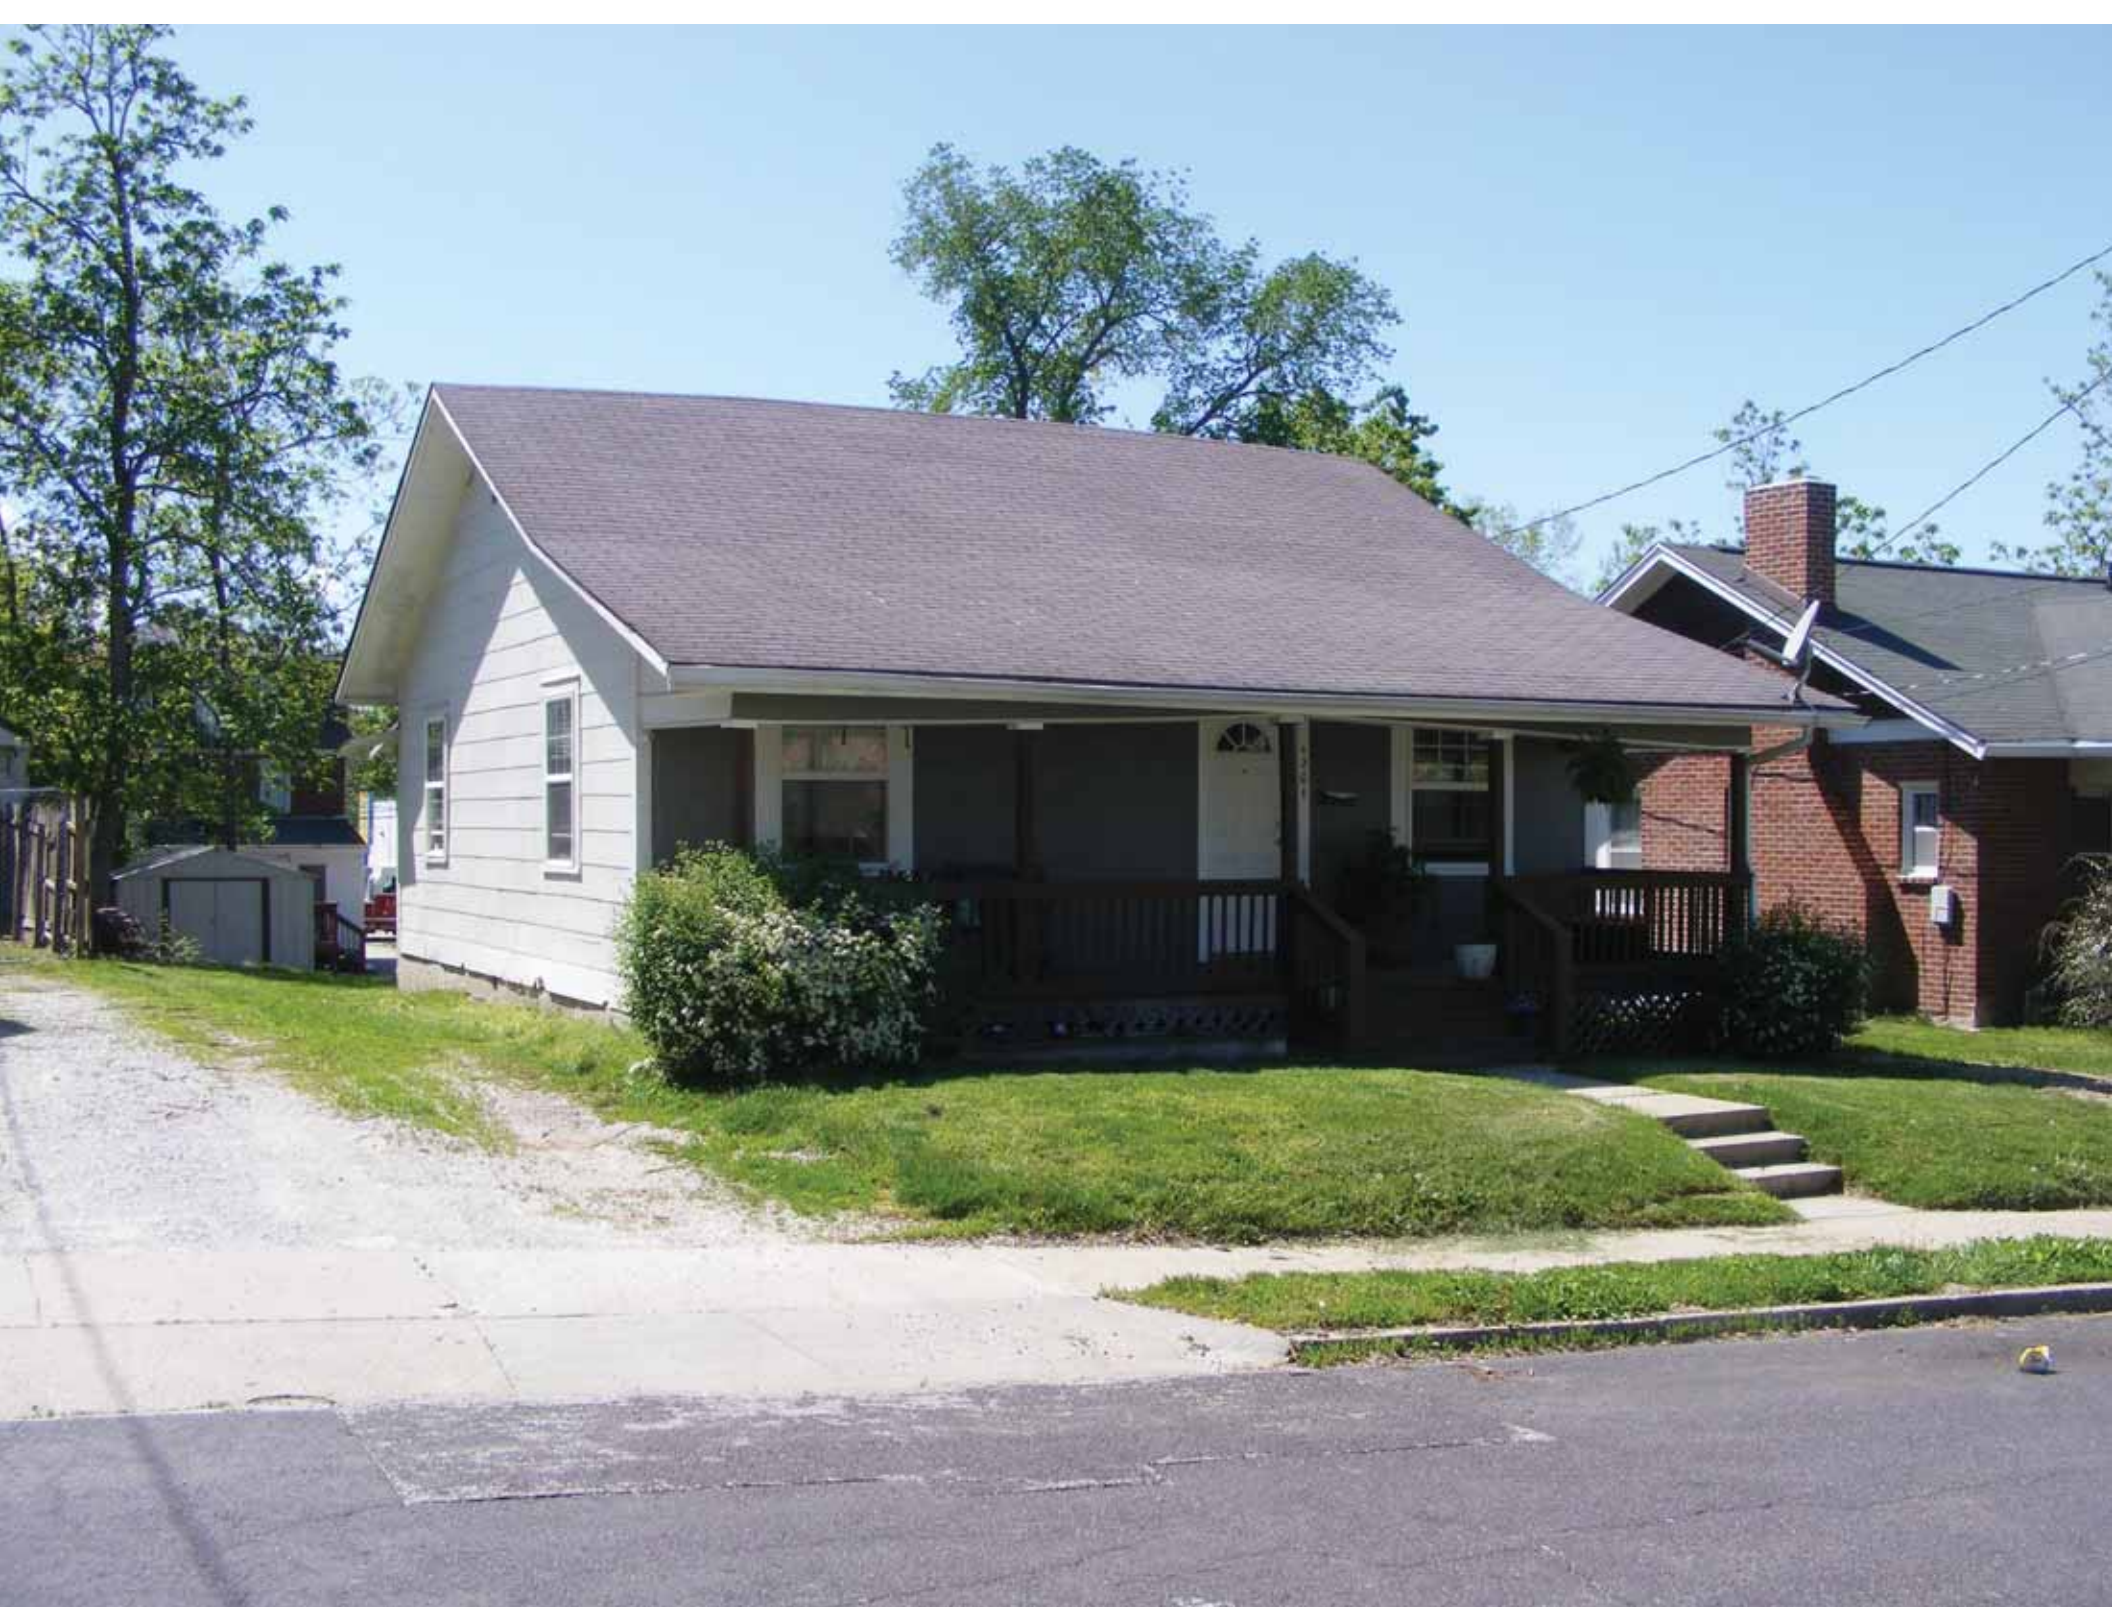
41. (cont.) Description of primary resource. Expand box as necessary, or add continuation pages.
The asbestos clad dwelling is one story with an asphalt shingled side gable to shed (front) roof and concrete foundation. The façade holds a full-width porch under the shed roof supported by wooden posts; wood decking and railings. The entrance is off-centered and flanked by replacement (ca. 2011) six-over six windows offset by shutters. Side elevations hold the same replacement windows.

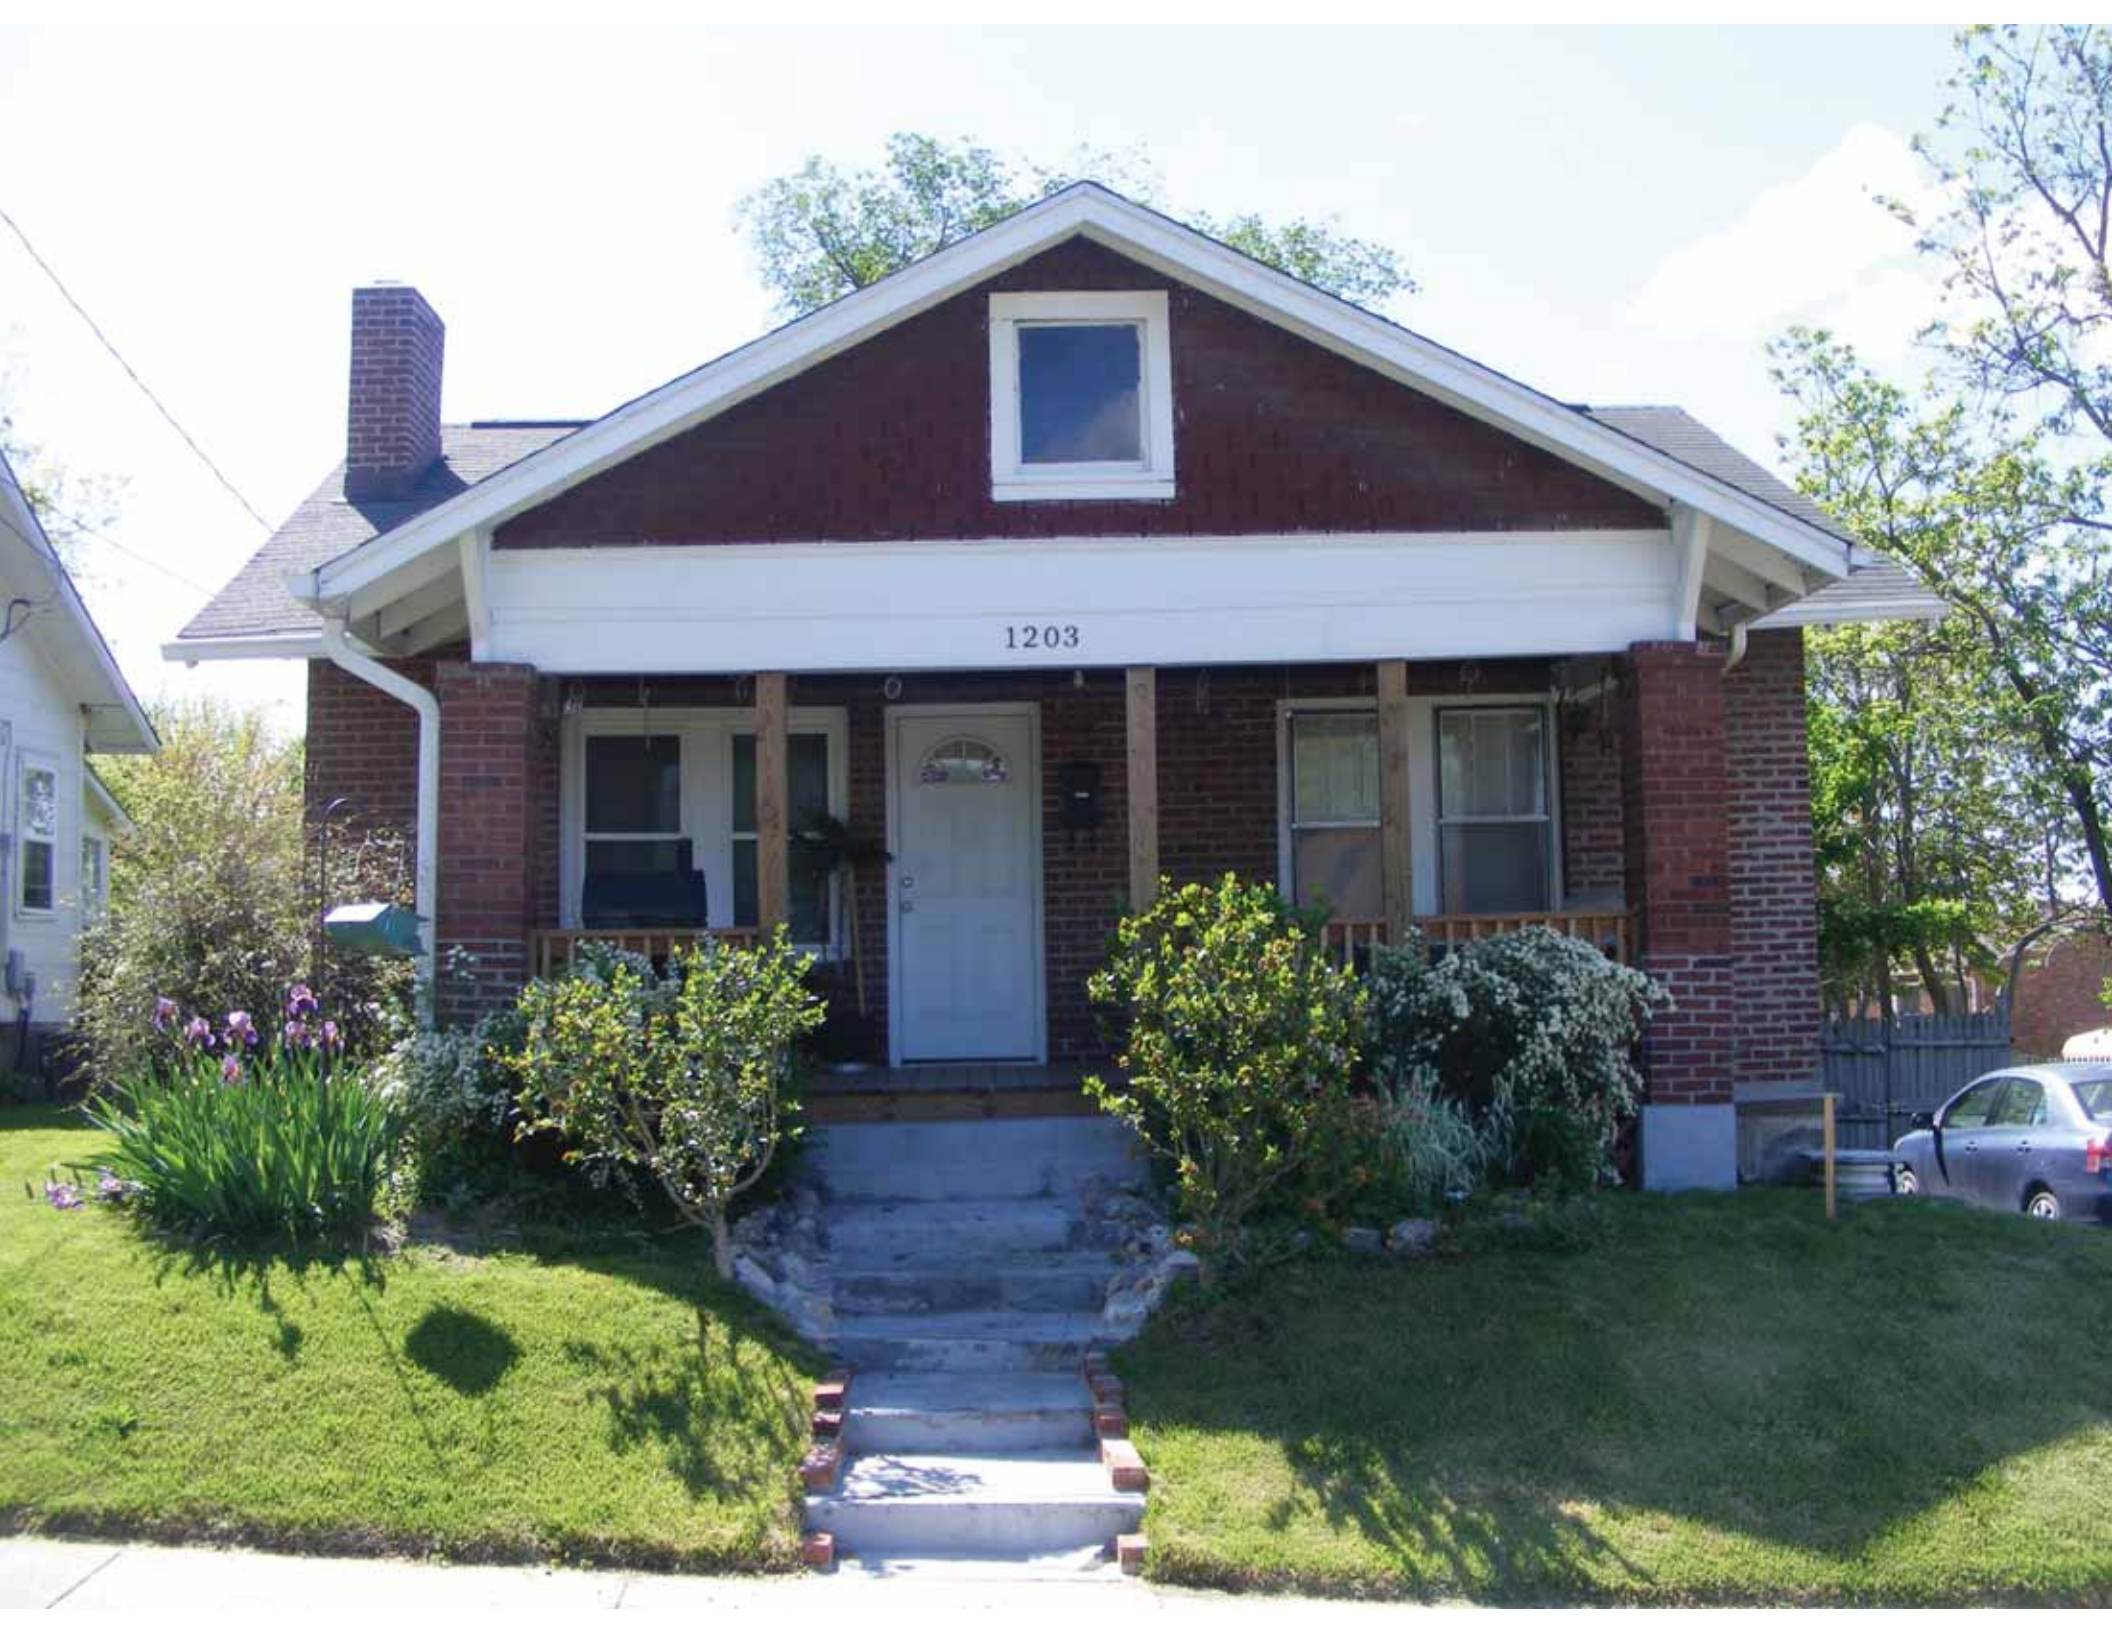
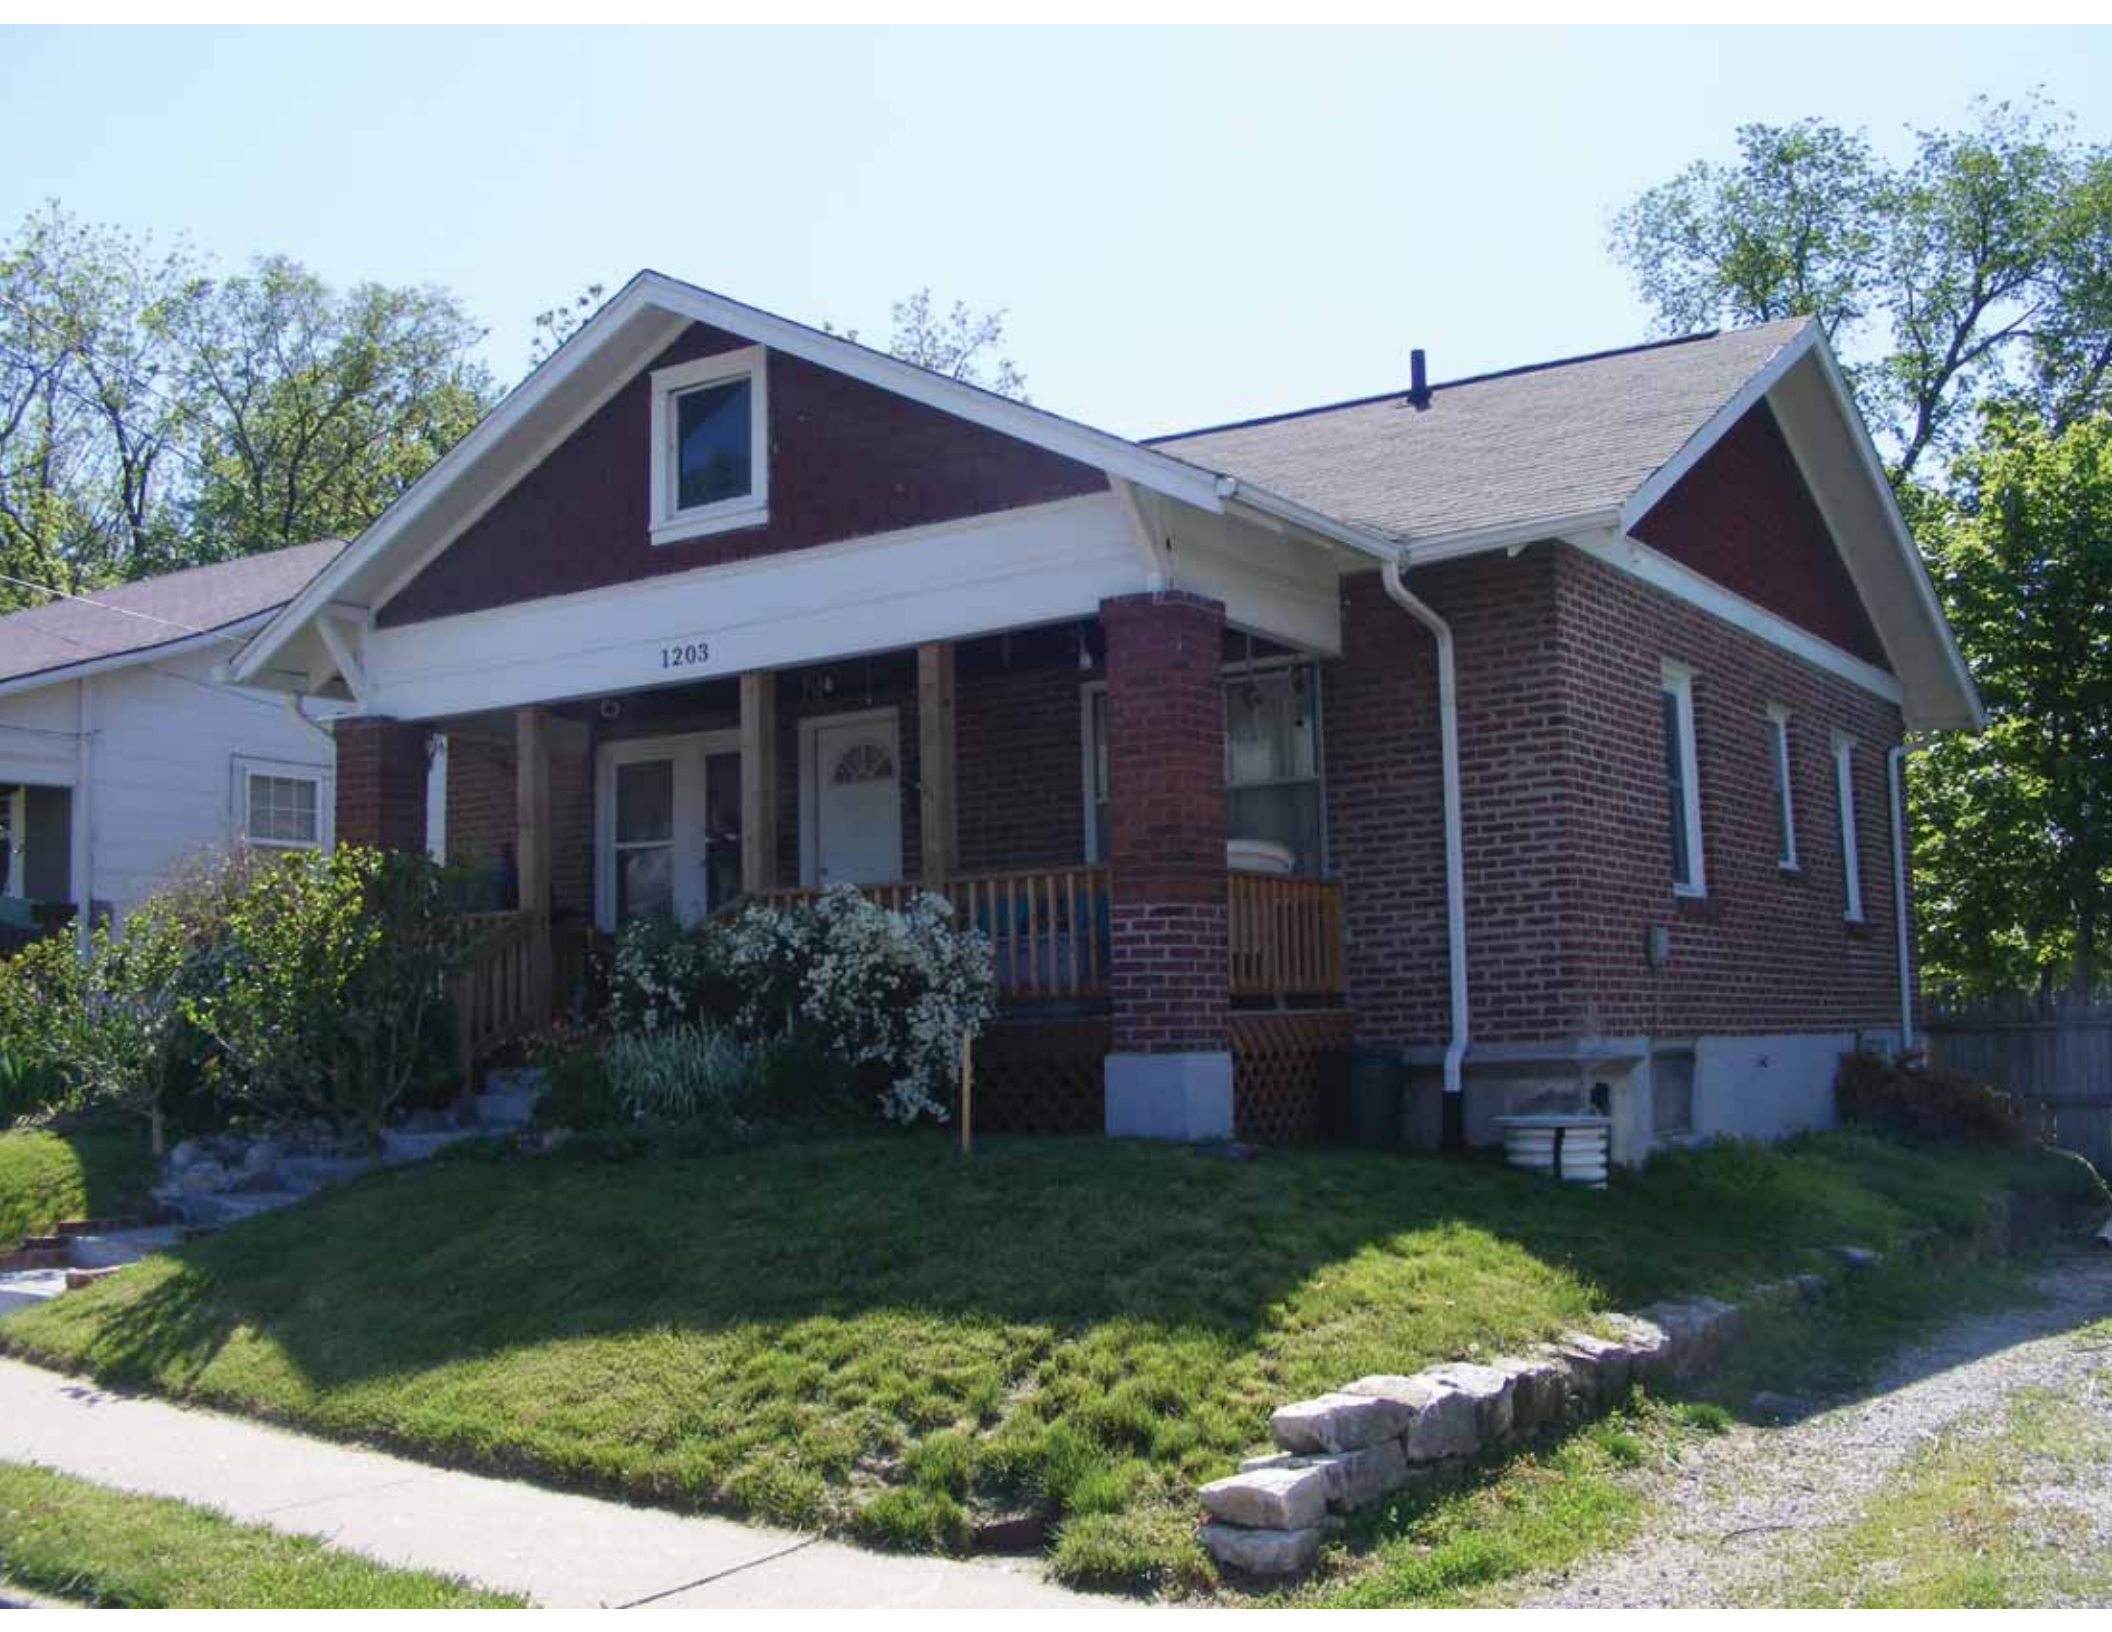
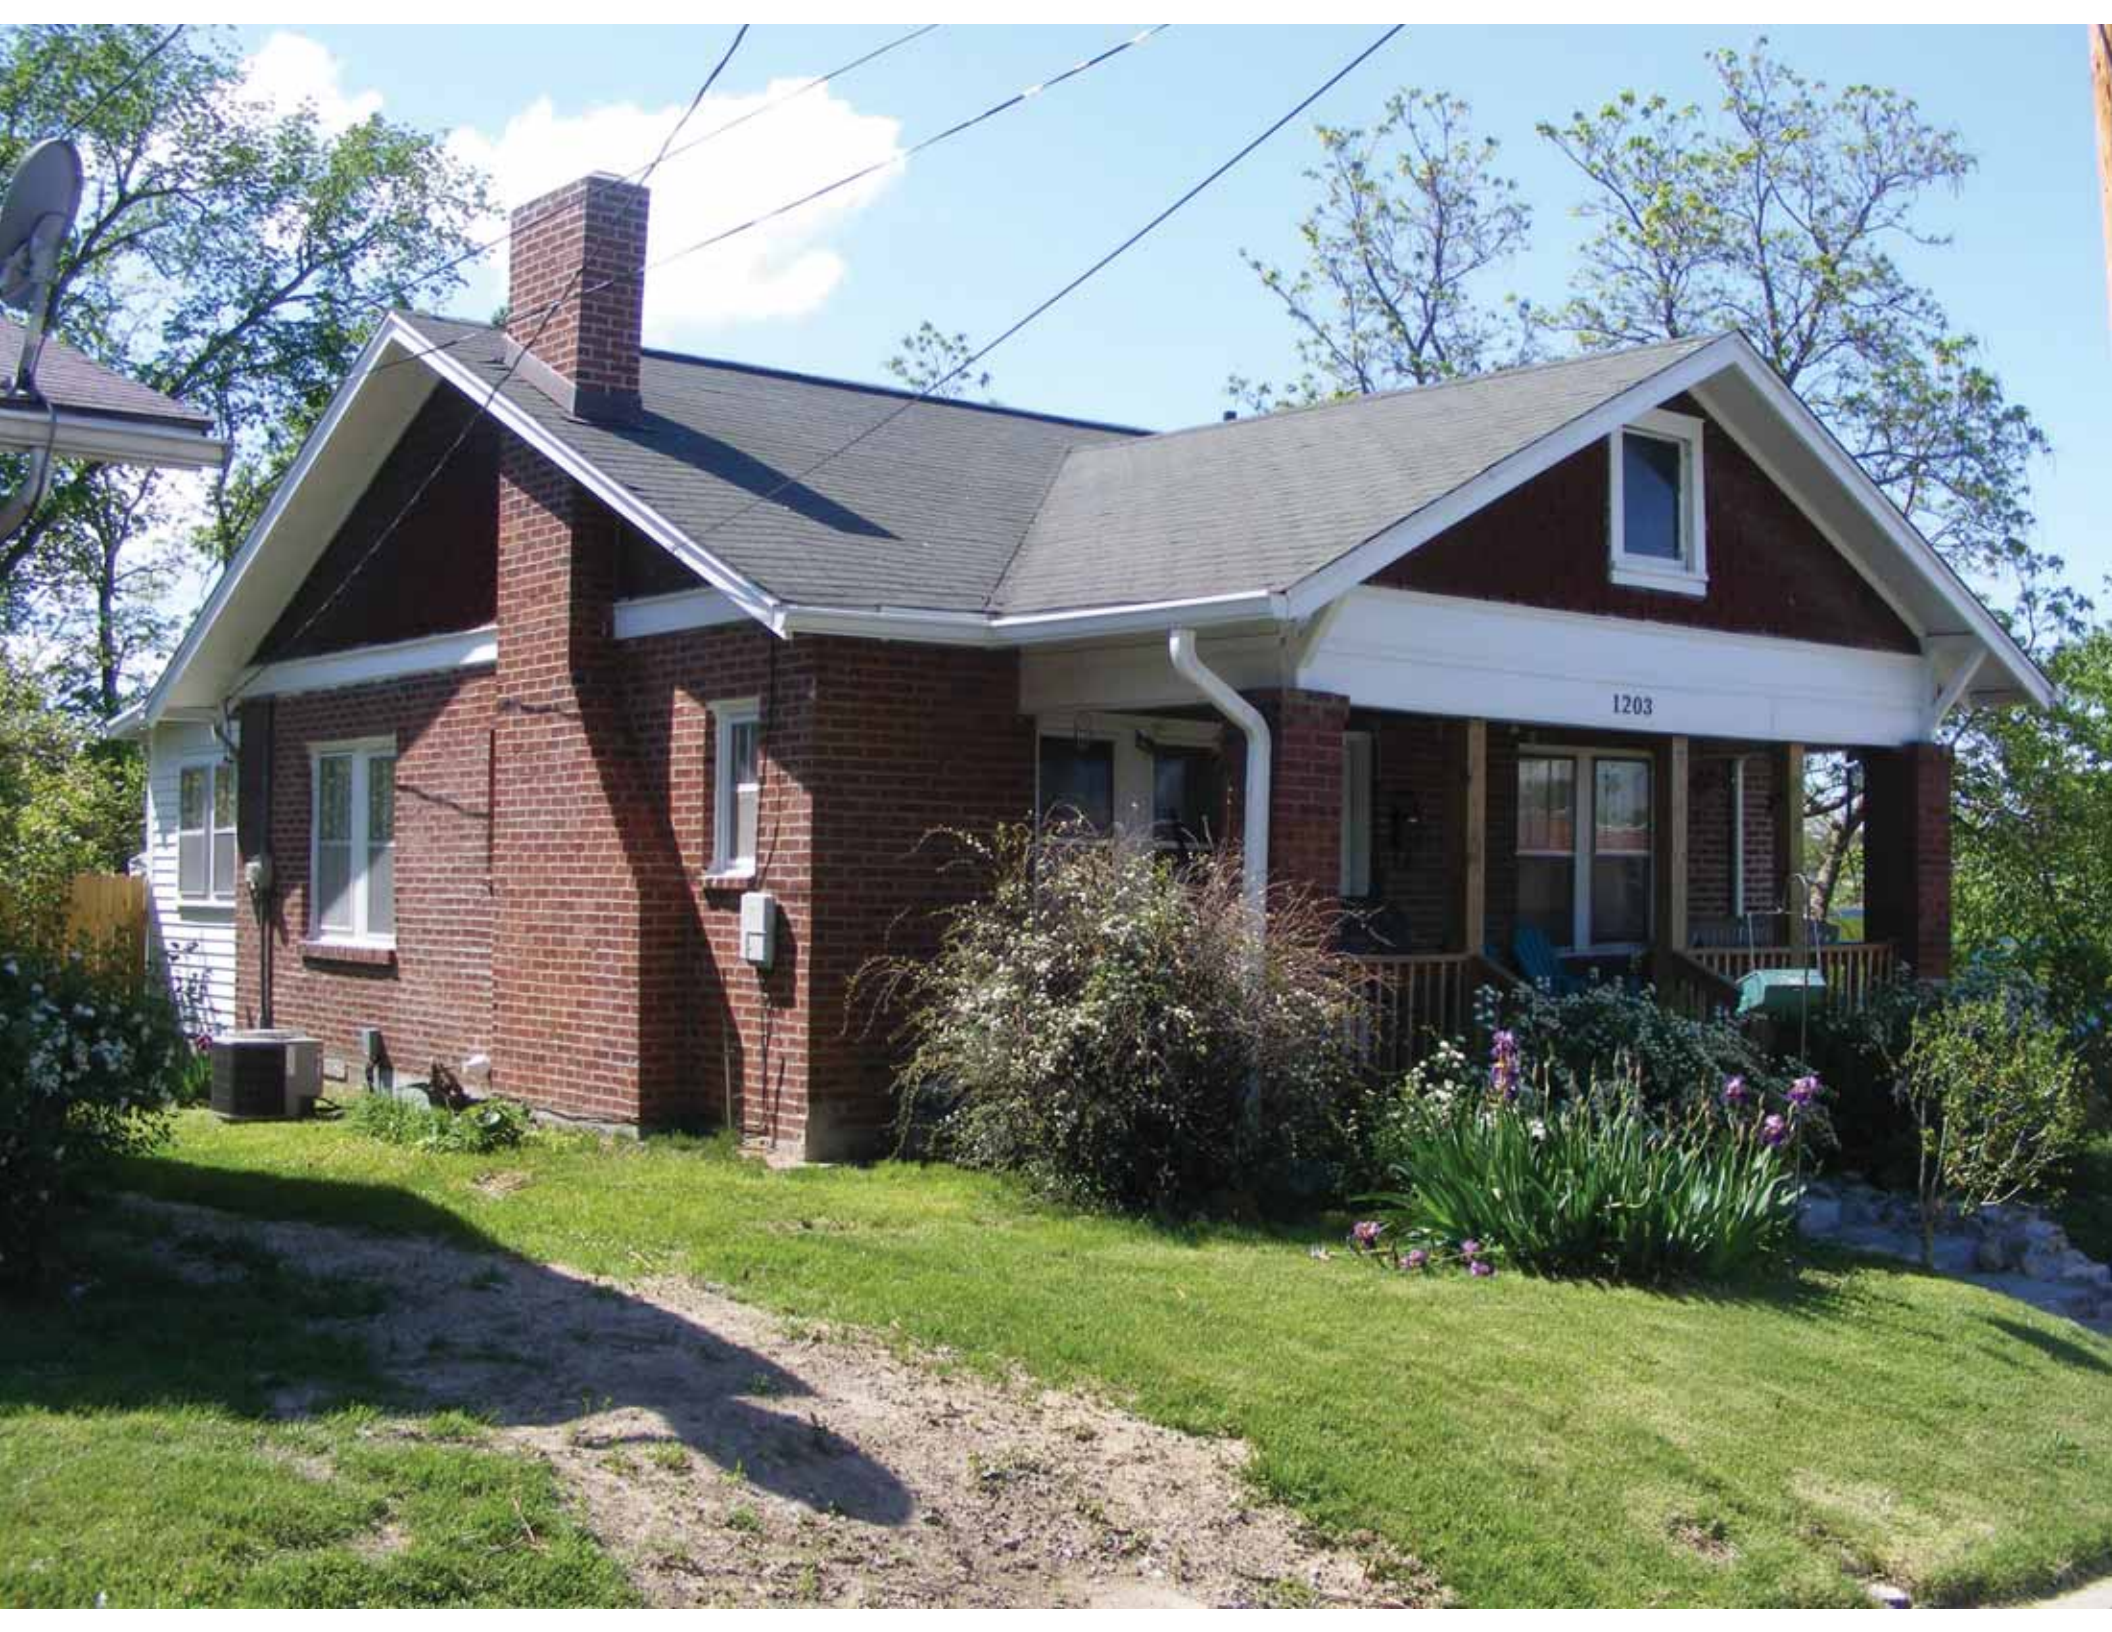
41. (cont.) Description of primary resource. Expand box as necessary, or add continuation pages.
The brick one-story dwelling asphalt shingled side to front gable (porch) roof with wide overhanging eaves, exposed rafters and a concrete foundation. The façade features a full-width porch under the front gable with knee brackets at the corner of the eaves, brick piers on concrete bases and wooden railings and posts. The entrance is centered and flanked by paired three-over-one windows and replacement one-over-one. The front gable end holds a fixed square window. Side elevations hold three-over-one windows. A cornice line delineates the lower level from the side gable ends.
