MISSOURI DEPARTMENT OF NATURAL RESOURCES
STATE HISTORIC PRESERVATION OFFICE, P.O. Box 176, Jefferson City, MO 65102
ARCHITECTURAL/HISTORIC INVENTORY FORM

1. Survey No. BO-AS-011-0087		2. Survey name: North Central Columbia Survey Phase II	
3. County: Boone		4. Address (Street No.) 902	Street (name) N. Seventh Street
5. City: Columbia	Vicinity: <input type="checkbox"/>	6. Geographical Reference:	7. Township/Range/Section: T: R: S:
8. Historic name (if known):		9. Present/other name (if known):	
10. Ownership: <input checked="" type="checkbox"/> Private <input type="checkbox"/> Public		11a. Historic use (if known): Domestic/single dwelling	11b. Current use: Domestic/single dwelling

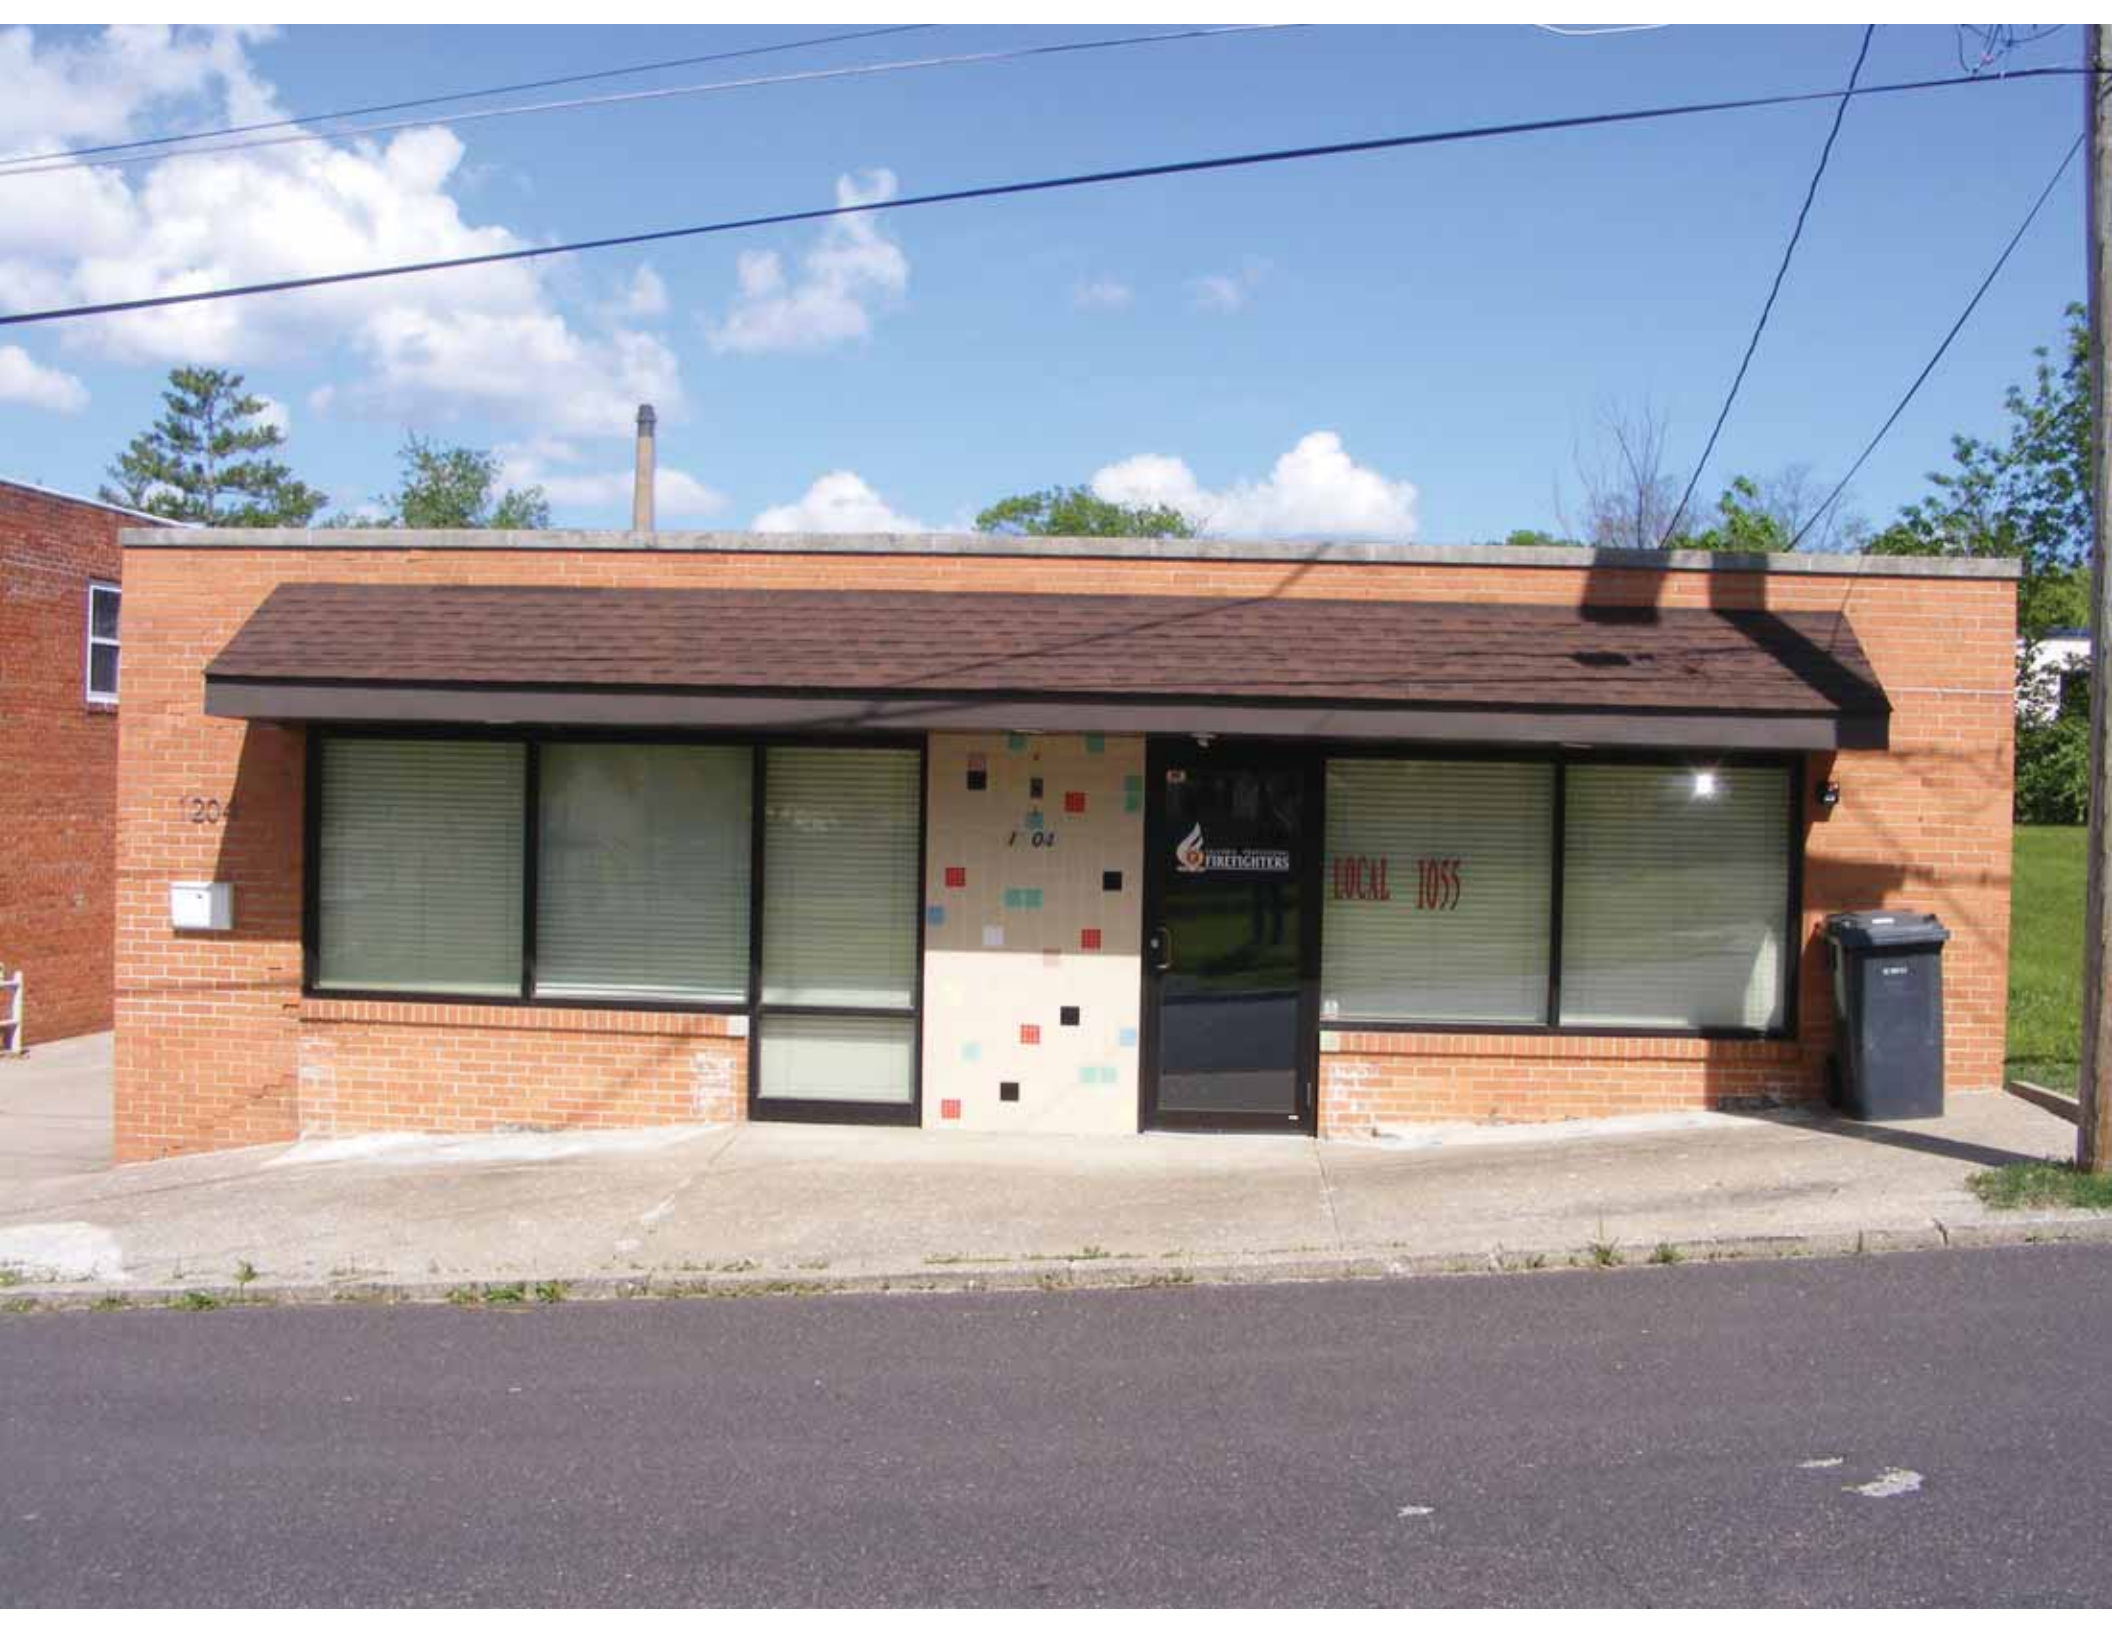
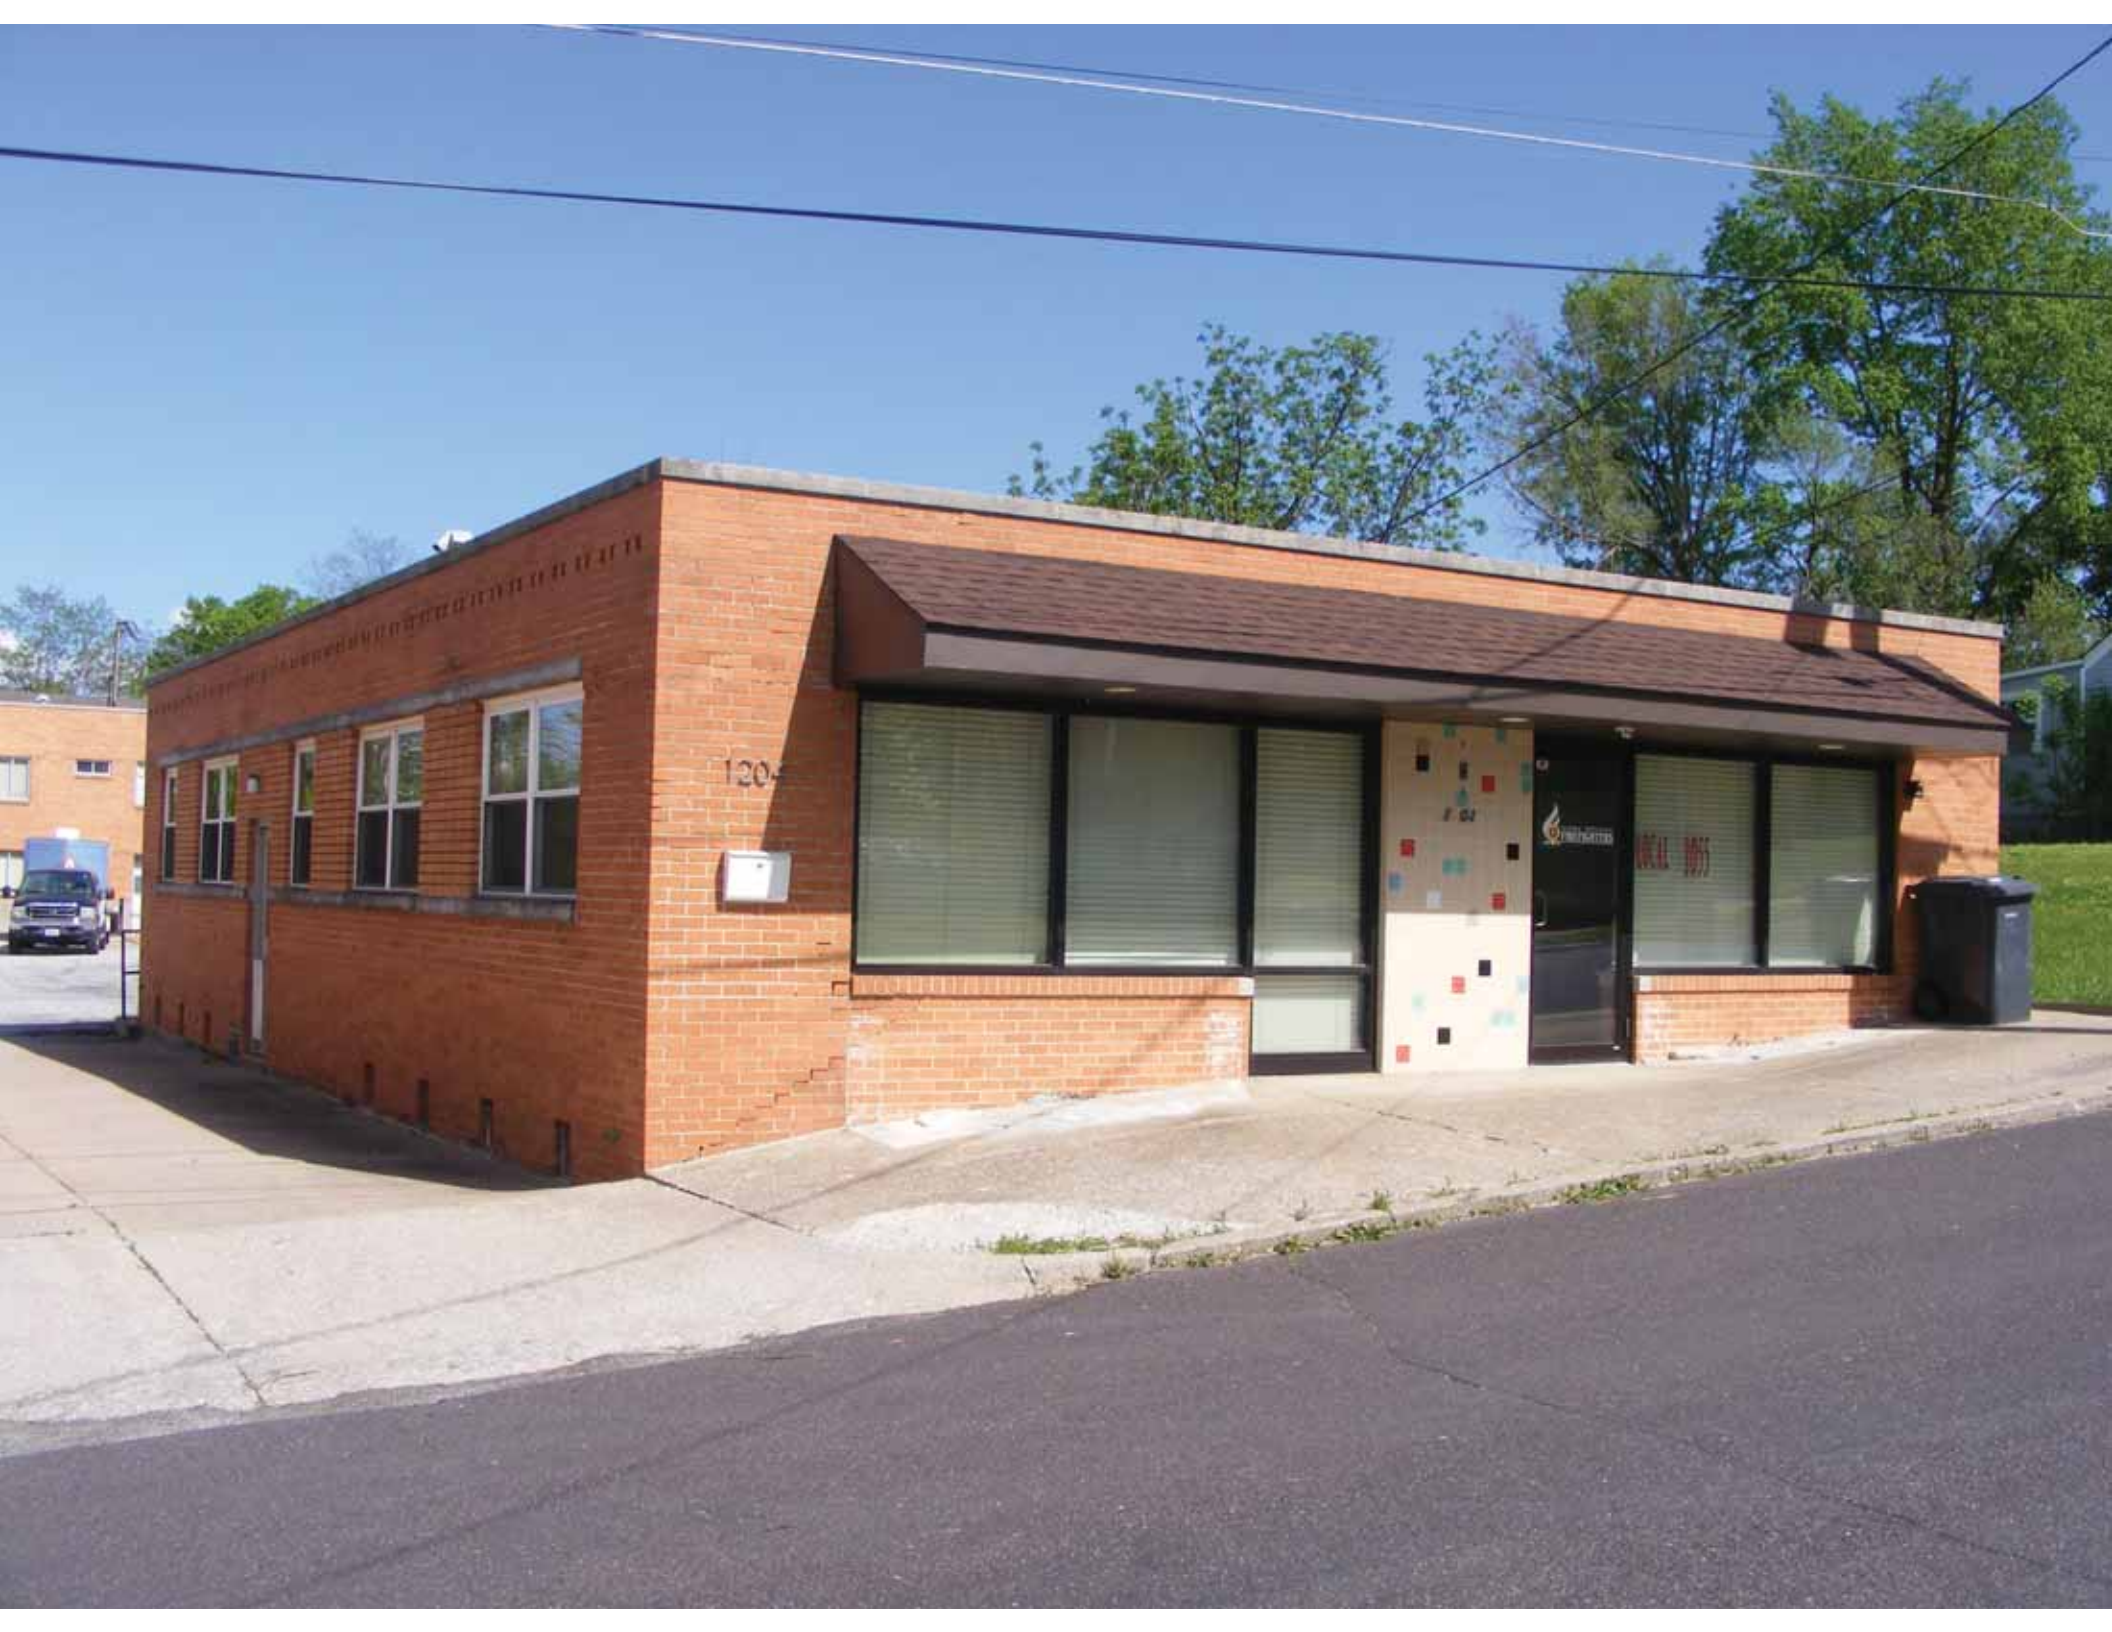
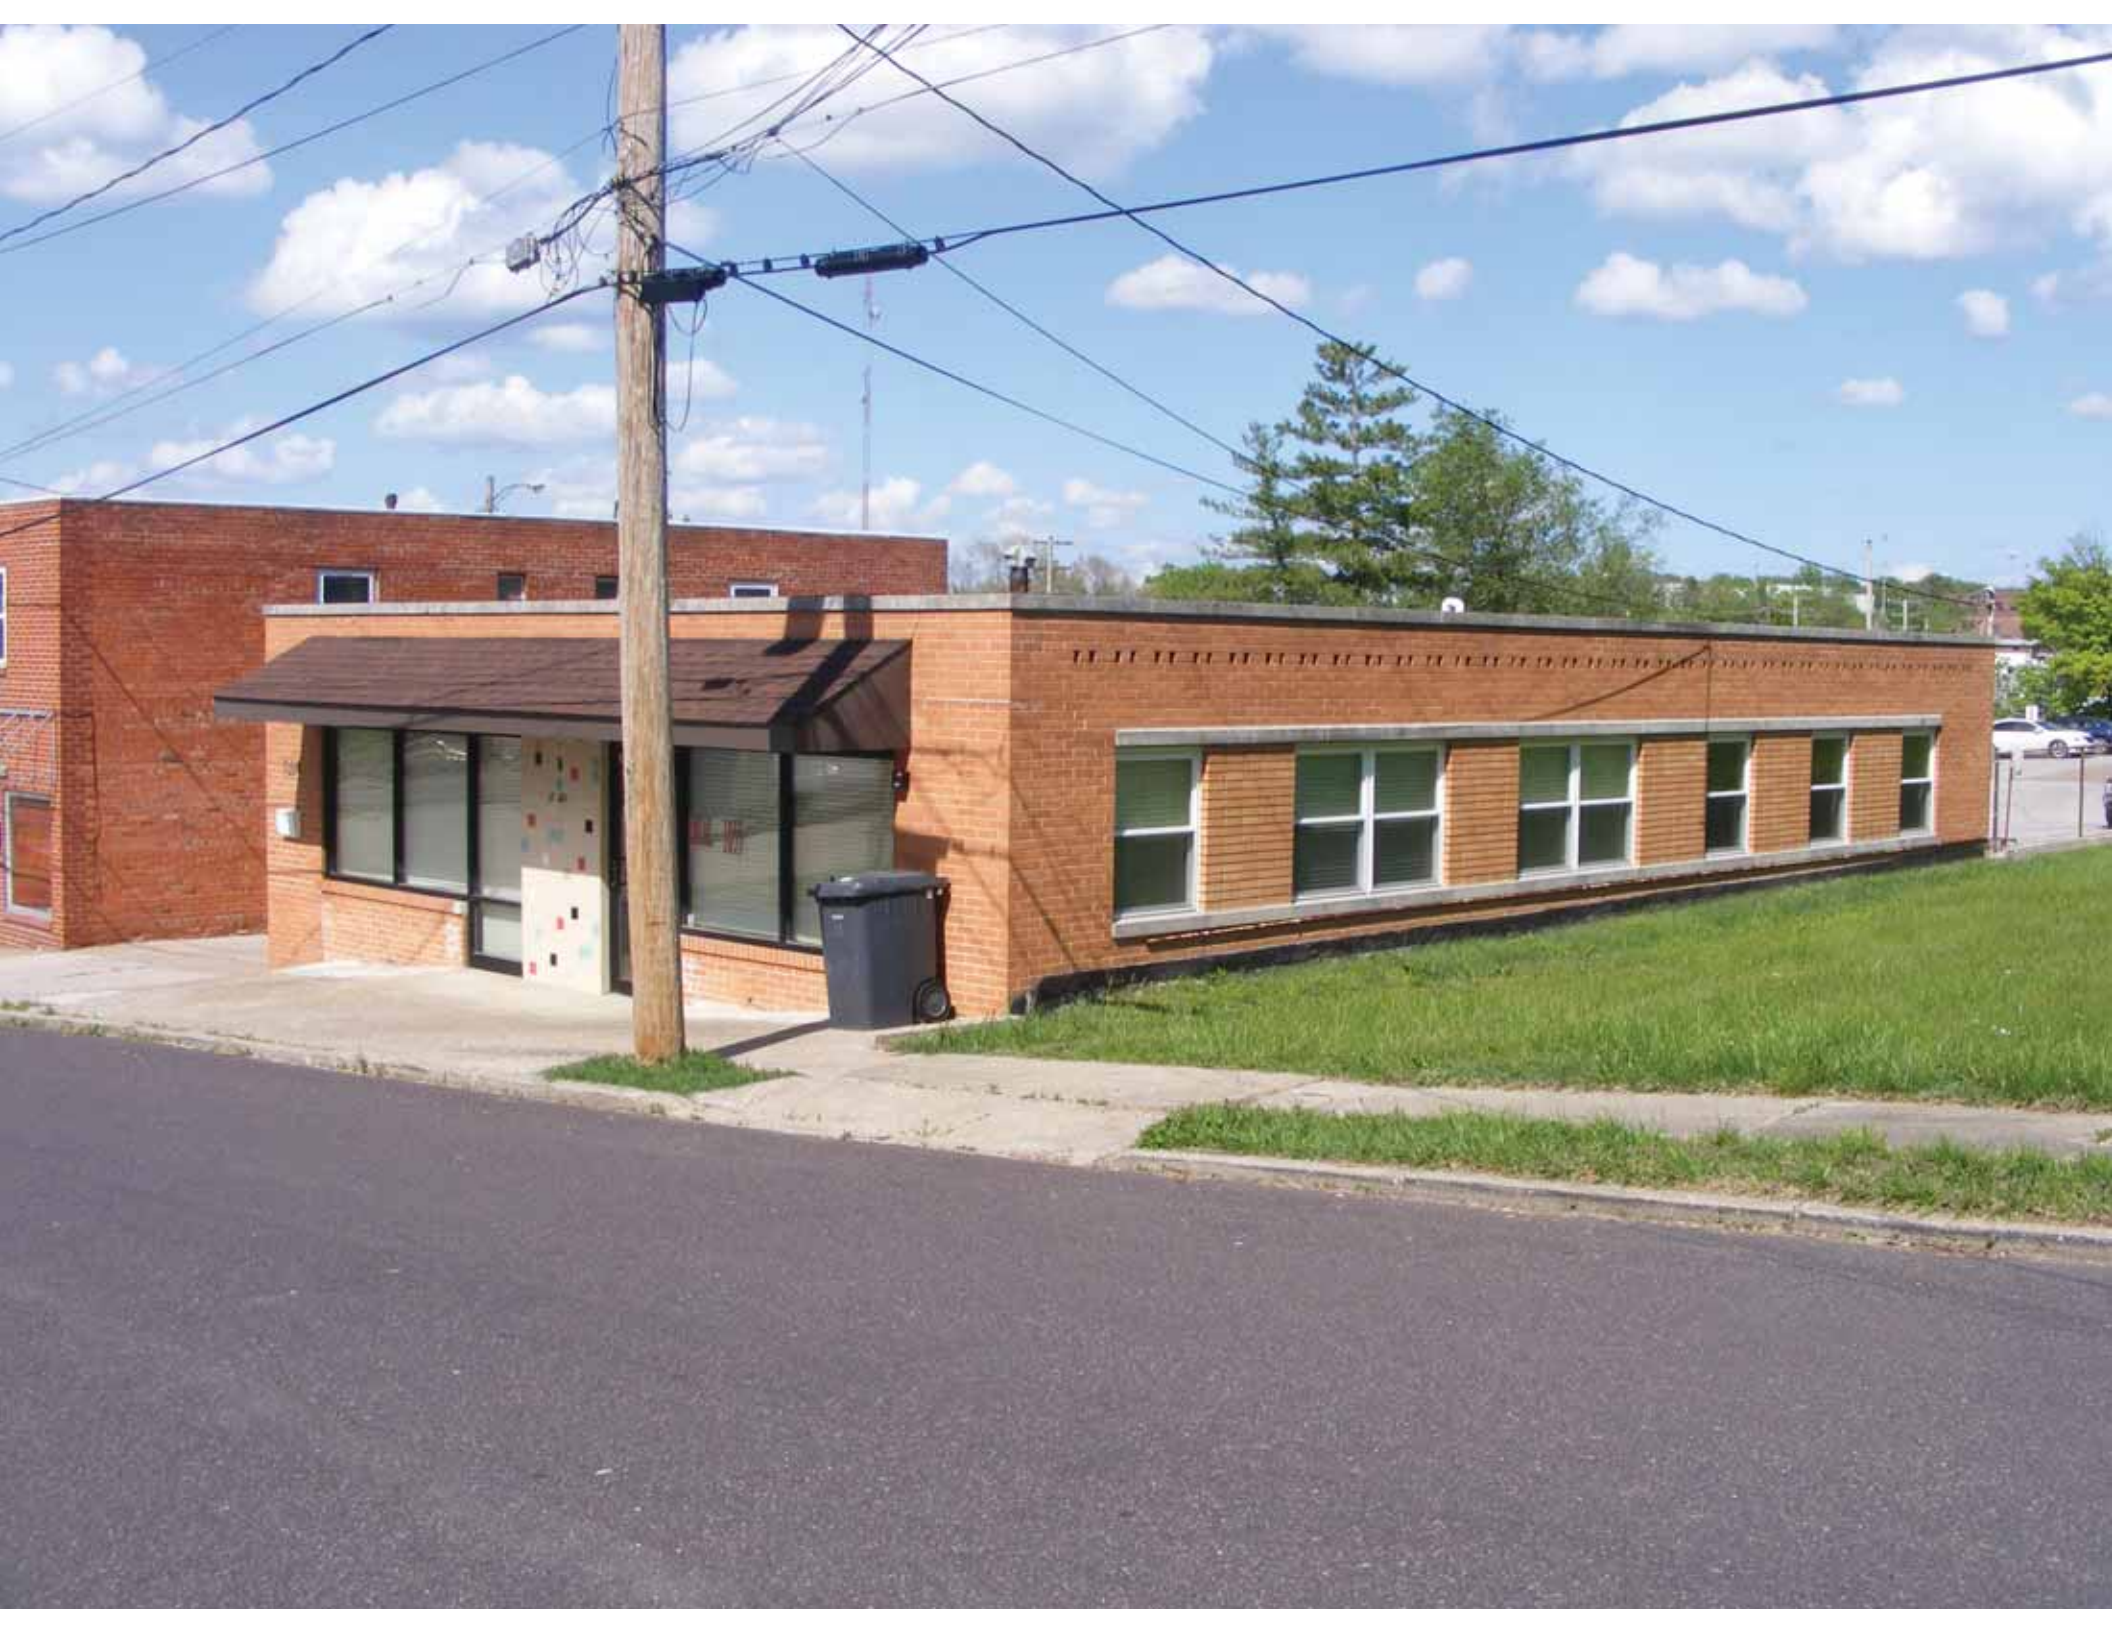
41. (cont.) Description of primary resource. Expand box as necessary, or add continuation pages.
This is a one-part commercial brick building with a flat roof and a brick foundation. The façade features an off-entrance (glass/metal door) with paired display windows to the right. To the left of the entrance is a tiled wall surface comprised of small square tiles of beige, red, blue, black and white in color. To the left of the tiled wall is another storefront, the door bay has been replaced with a fix display window over a rectangular fixed window and flanked by paired display windows. An asphalt shingled shed awning shelters the storefront. The north and elevation holds paired and single one-over-one windows with continuous concrete sills and header and a stringcourse of alternating header and stretcher course. The north elevation holds a side entrance off-centered and window wells. A concrete coping runs the perimeter of the roofline.

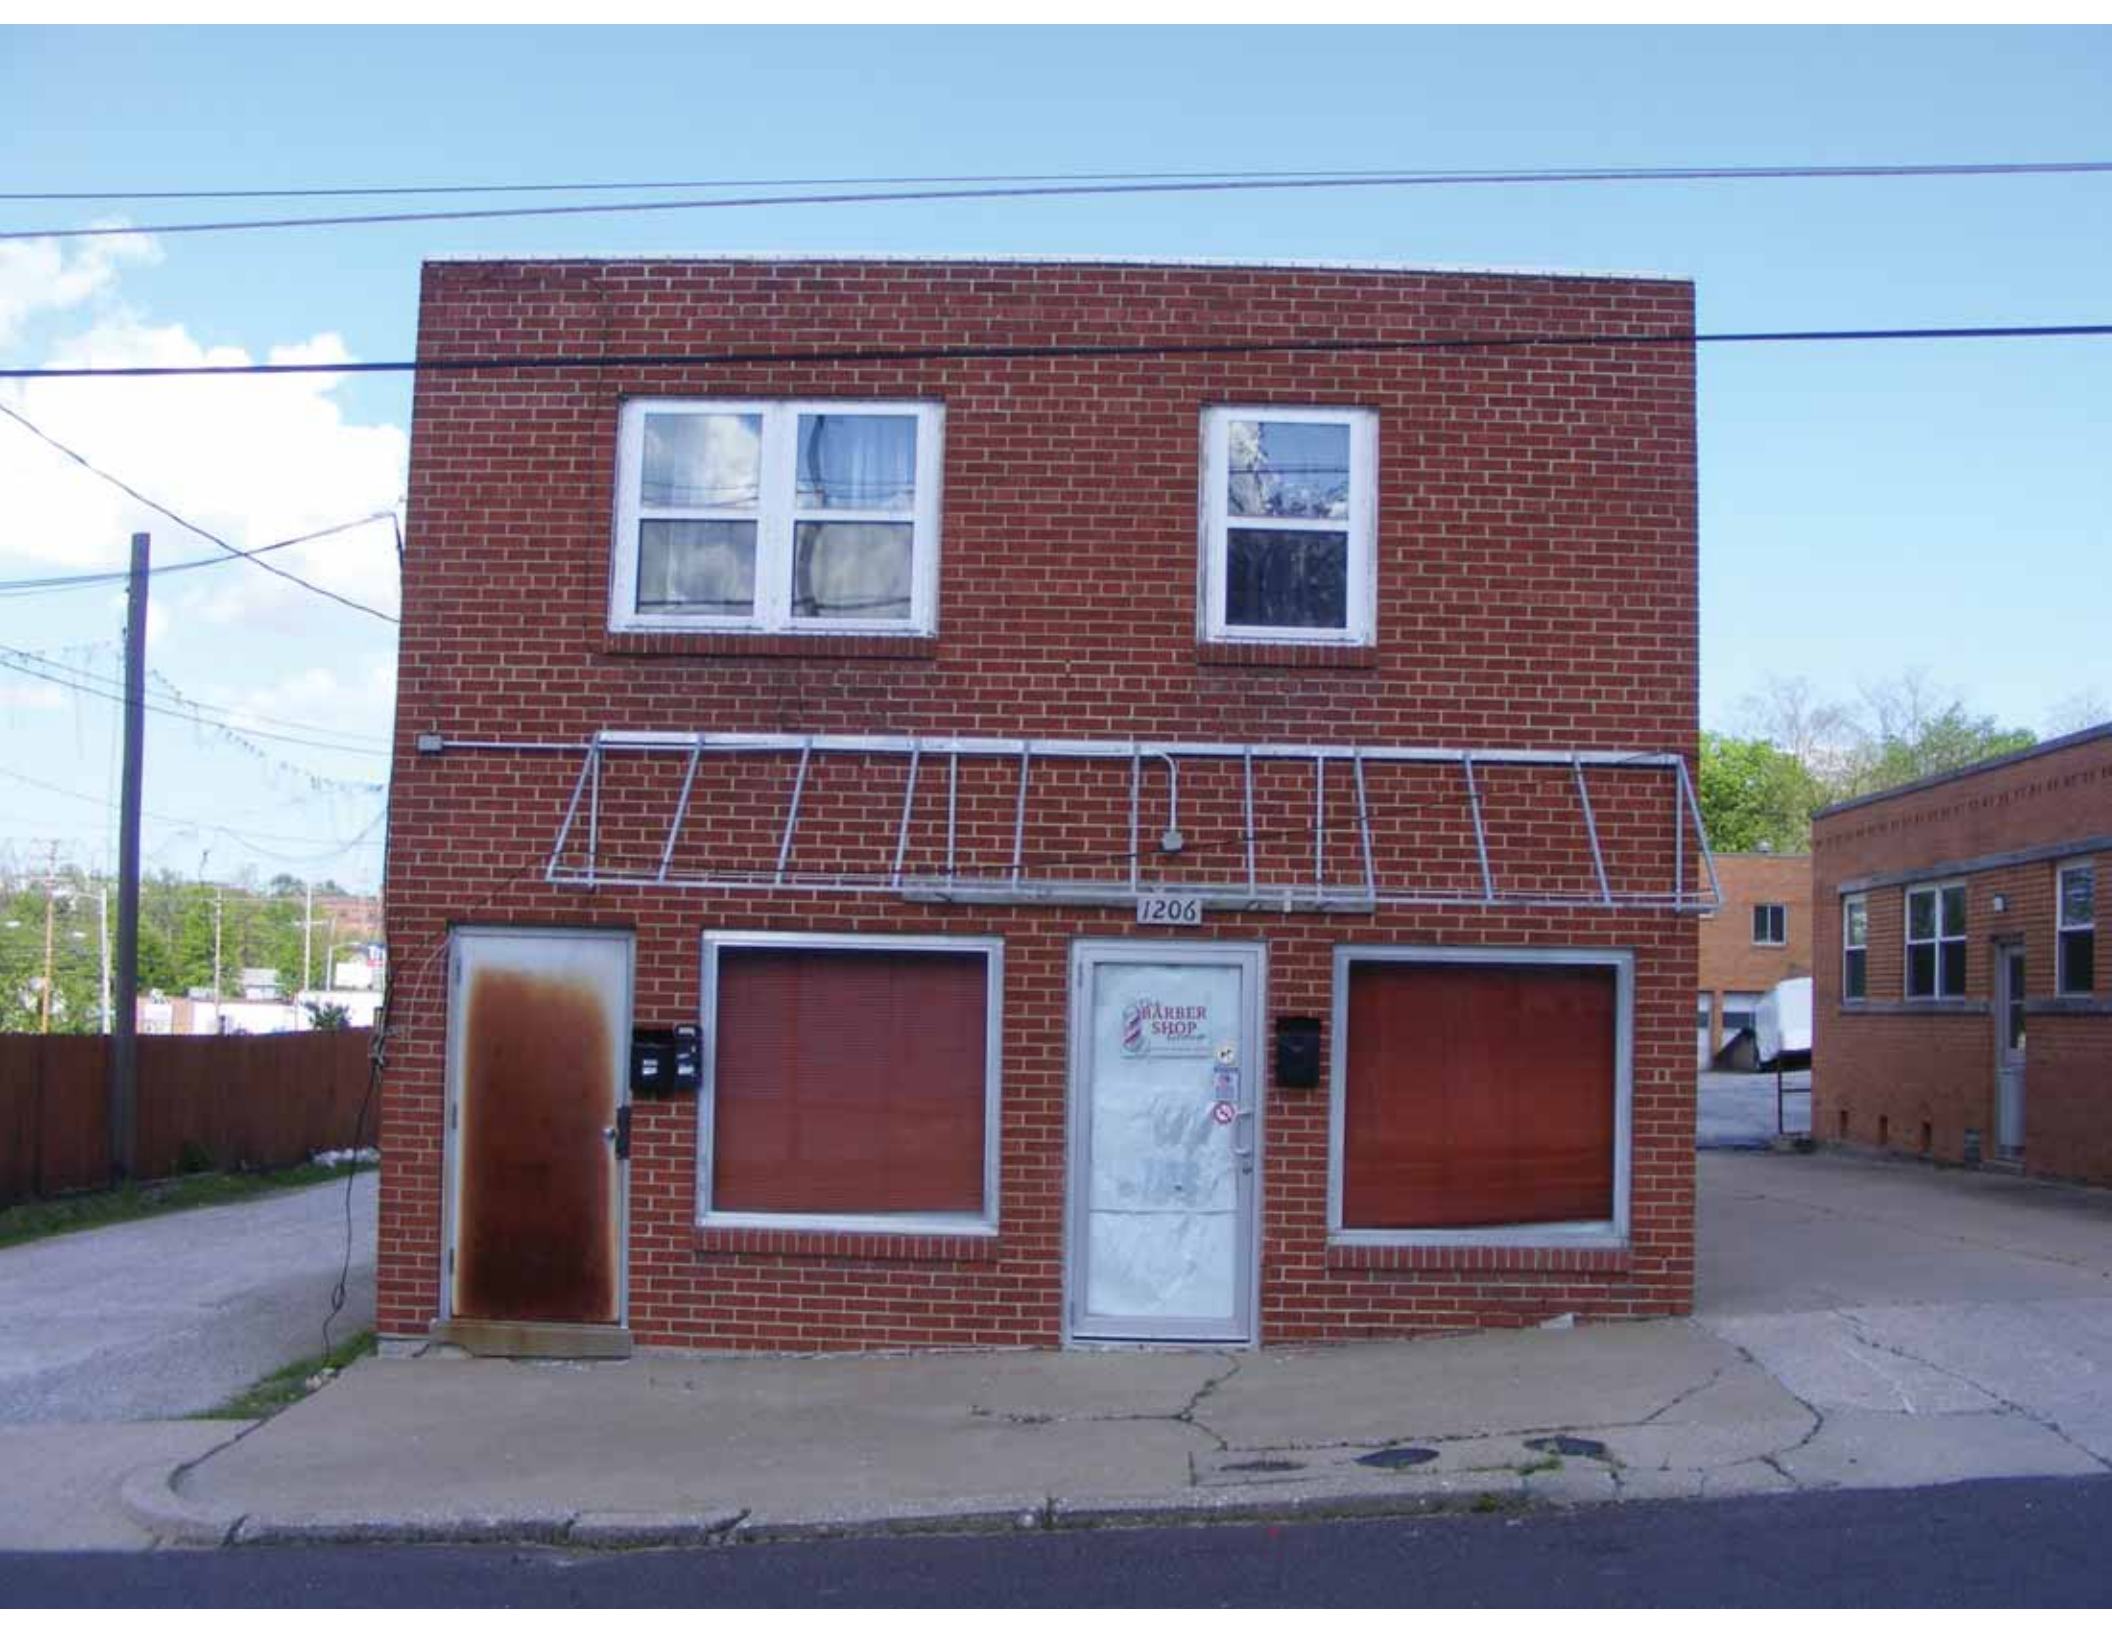
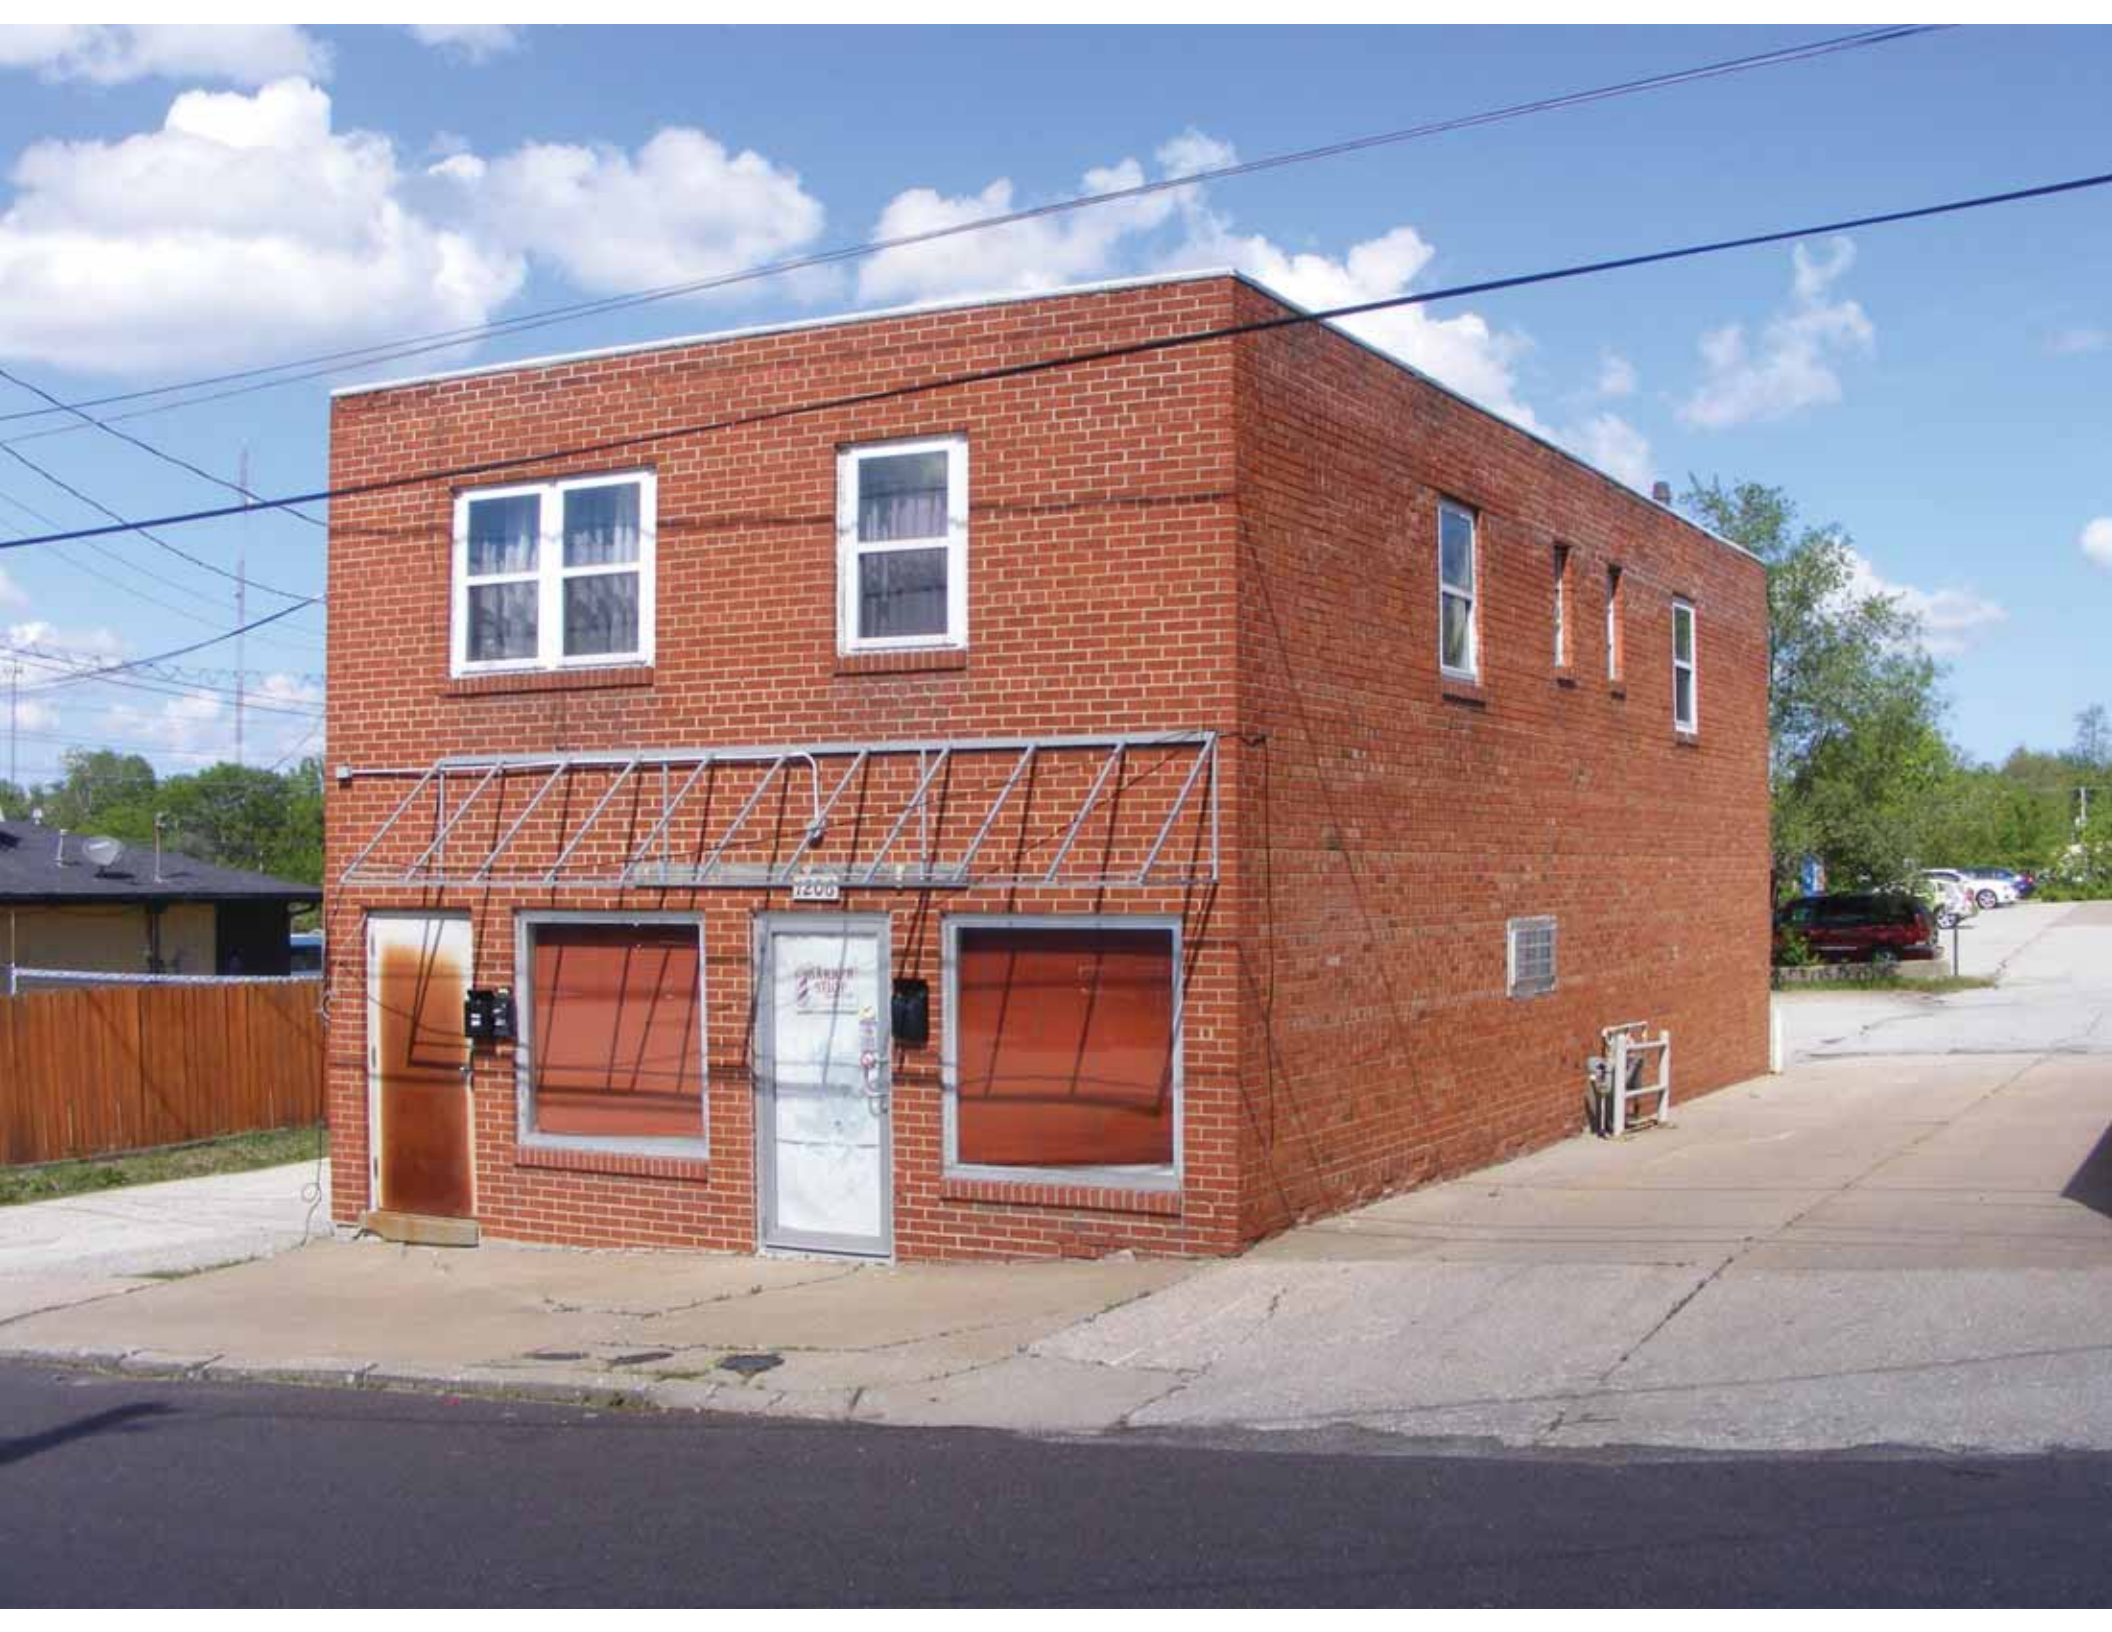
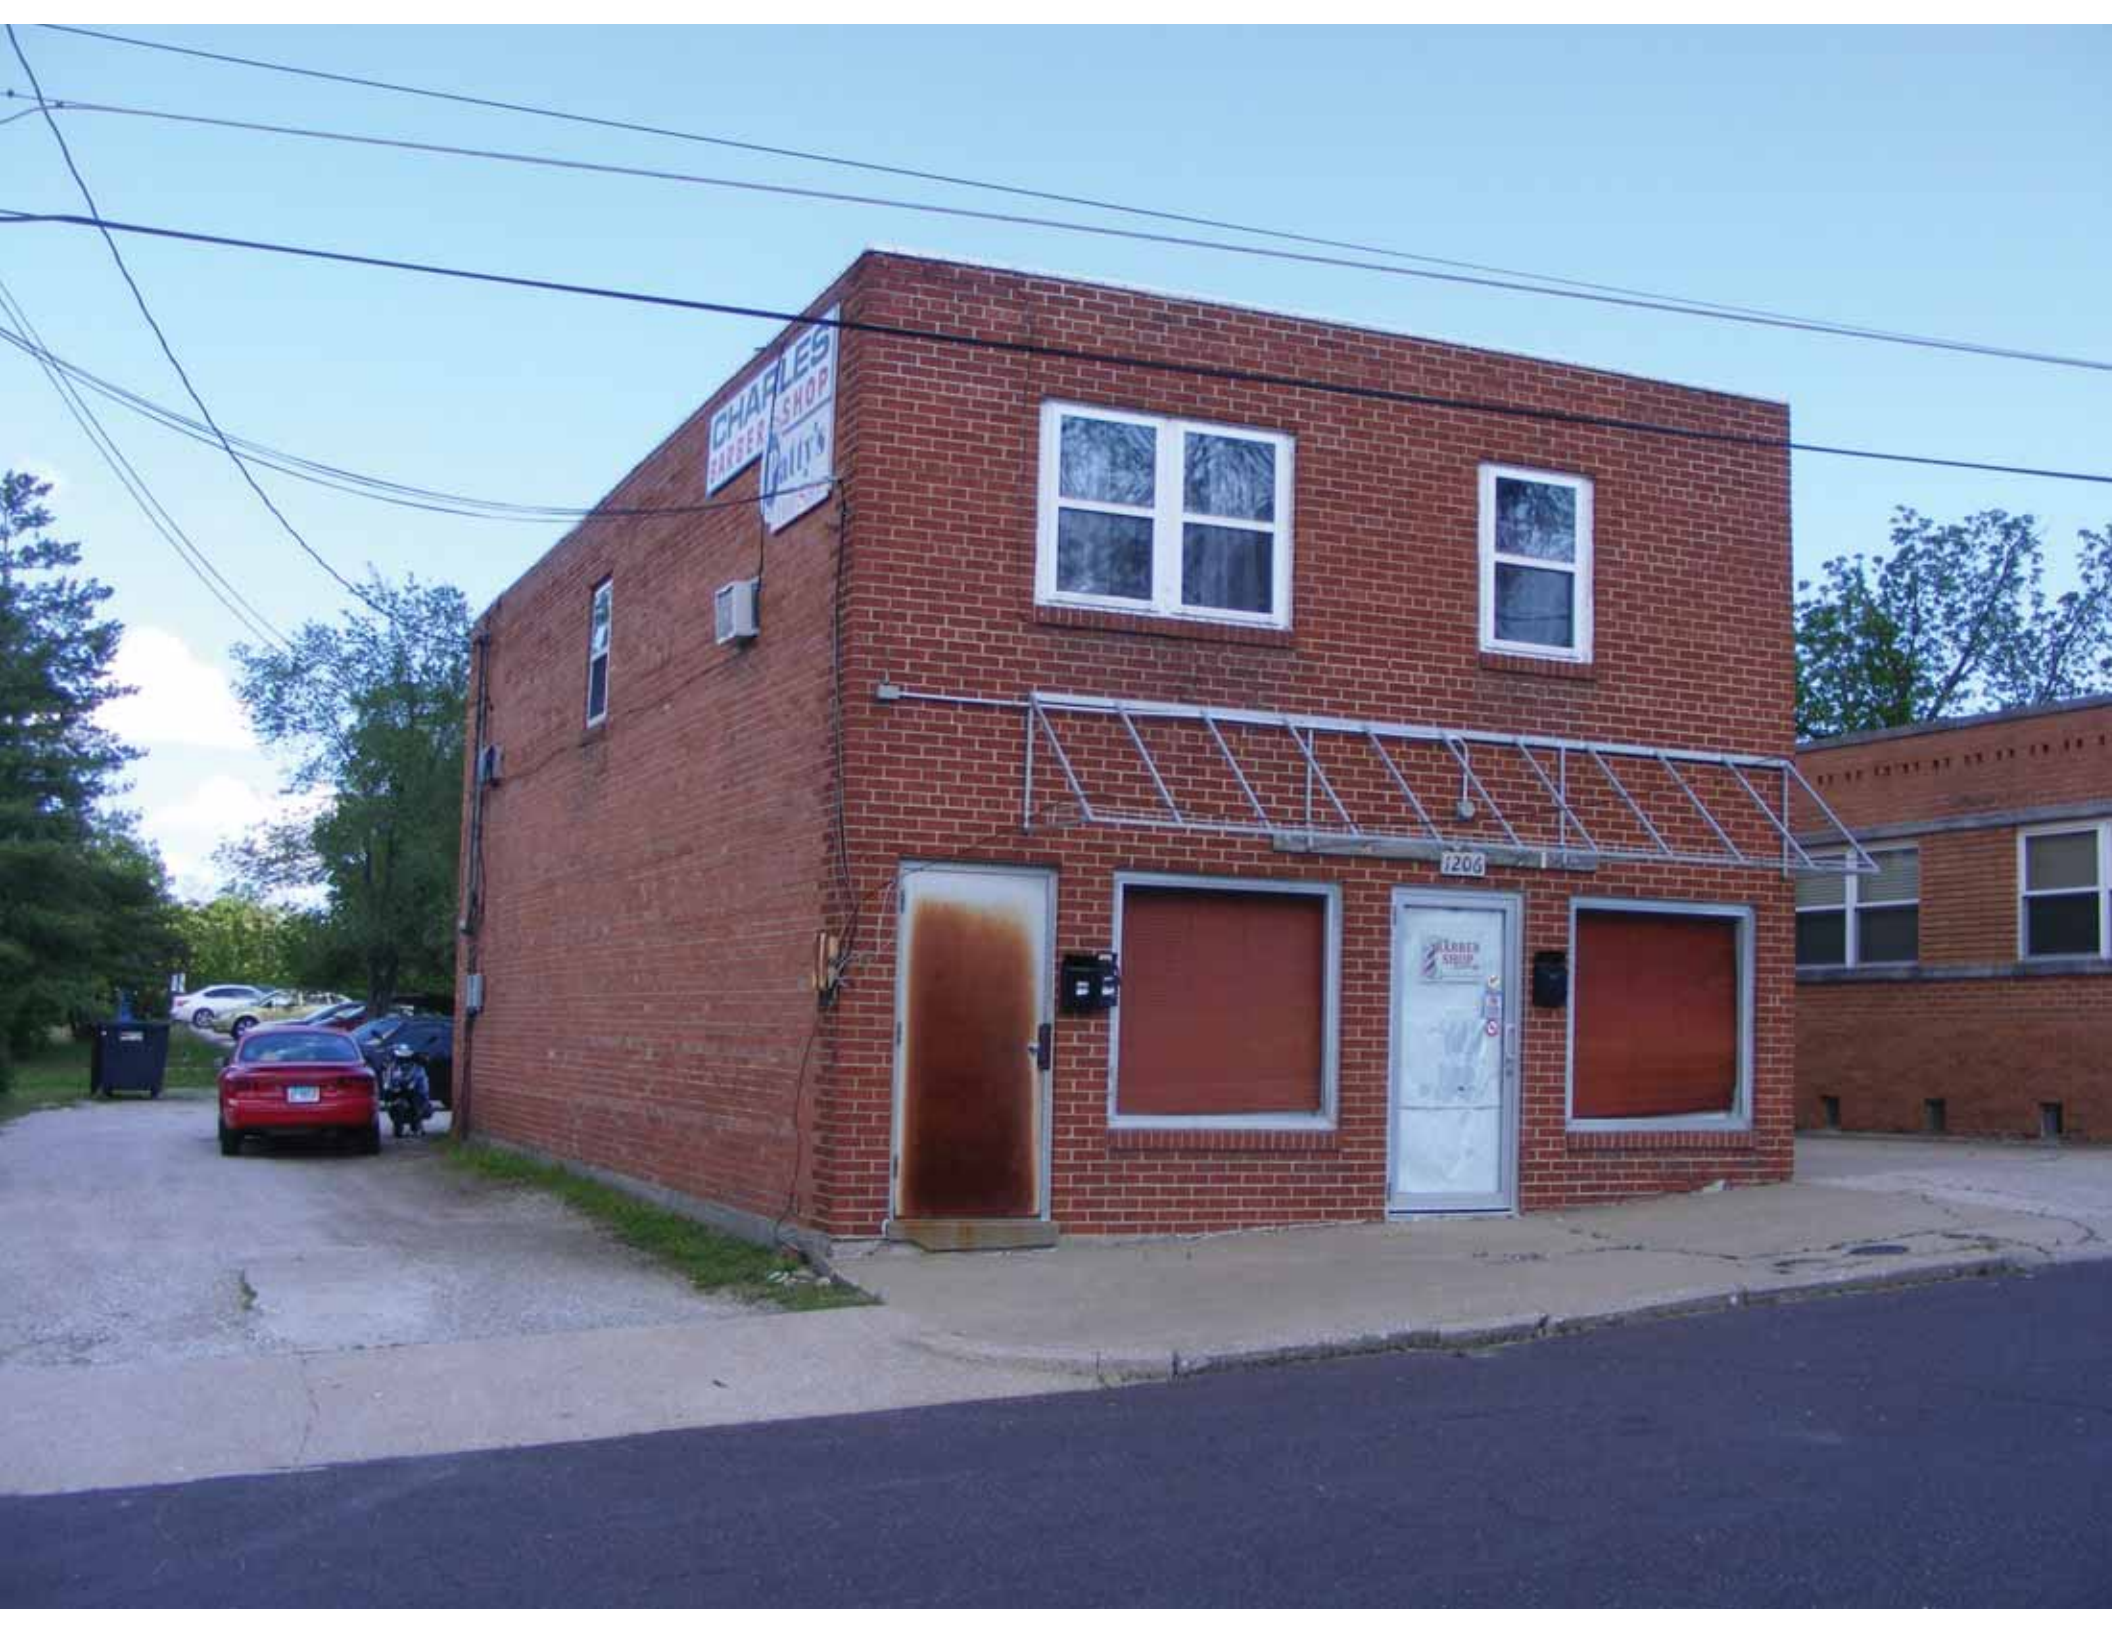
41. (cont.) Description of primary resource. Expand box as necessary, or add continuation pages.
This is a two-part commercial block brick building with a flat roof and metal coping along the roofline and a concrete foundation. The façade holds four bays from left to right; metal entrance door, display window, glass/metal door and display window. Above the storefront is a metal frame for a shed awning. Upper level holds a paired and single one-over-one window. North elevation holds a centered one-over-one window on the second level with an air condition unit toward the front installed in a cut opening in the brick. South elevation on the upper level holds four, one-over-one windows. All windows are replacement and the storefront is ca. 1960.
