MISSOURI DEPARTMENT OF NATURAL RESOURCES
STATE HISTORIC PRESERVATION OFFICE, P.O. Box 176, Jefferson City, MO 65102
ARCHITECTURAL/HISTORIC INVENTORY FORM

1. Survey No. BO-AS-011-0087		2. Survey name: North Central Columbia Survey Phase II	
3. County: Boone		4. Address (Street No.) 902	Street (name) N. Seventh Street
5. City: Columbia	Vicinity: <input type="checkbox"/>	6. Geographical Reference:	7. Township/Range/Section: T: R: S:
8. Historic name (if known):		9. Present/other name (if known):	
10. Ownership: <input checked="" type="checkbox"/> Private <input type="checkbox"/> Public		11a. Historic use (if known): Domestic/single dwelling	11b. Current use: Domestic/single dwelling

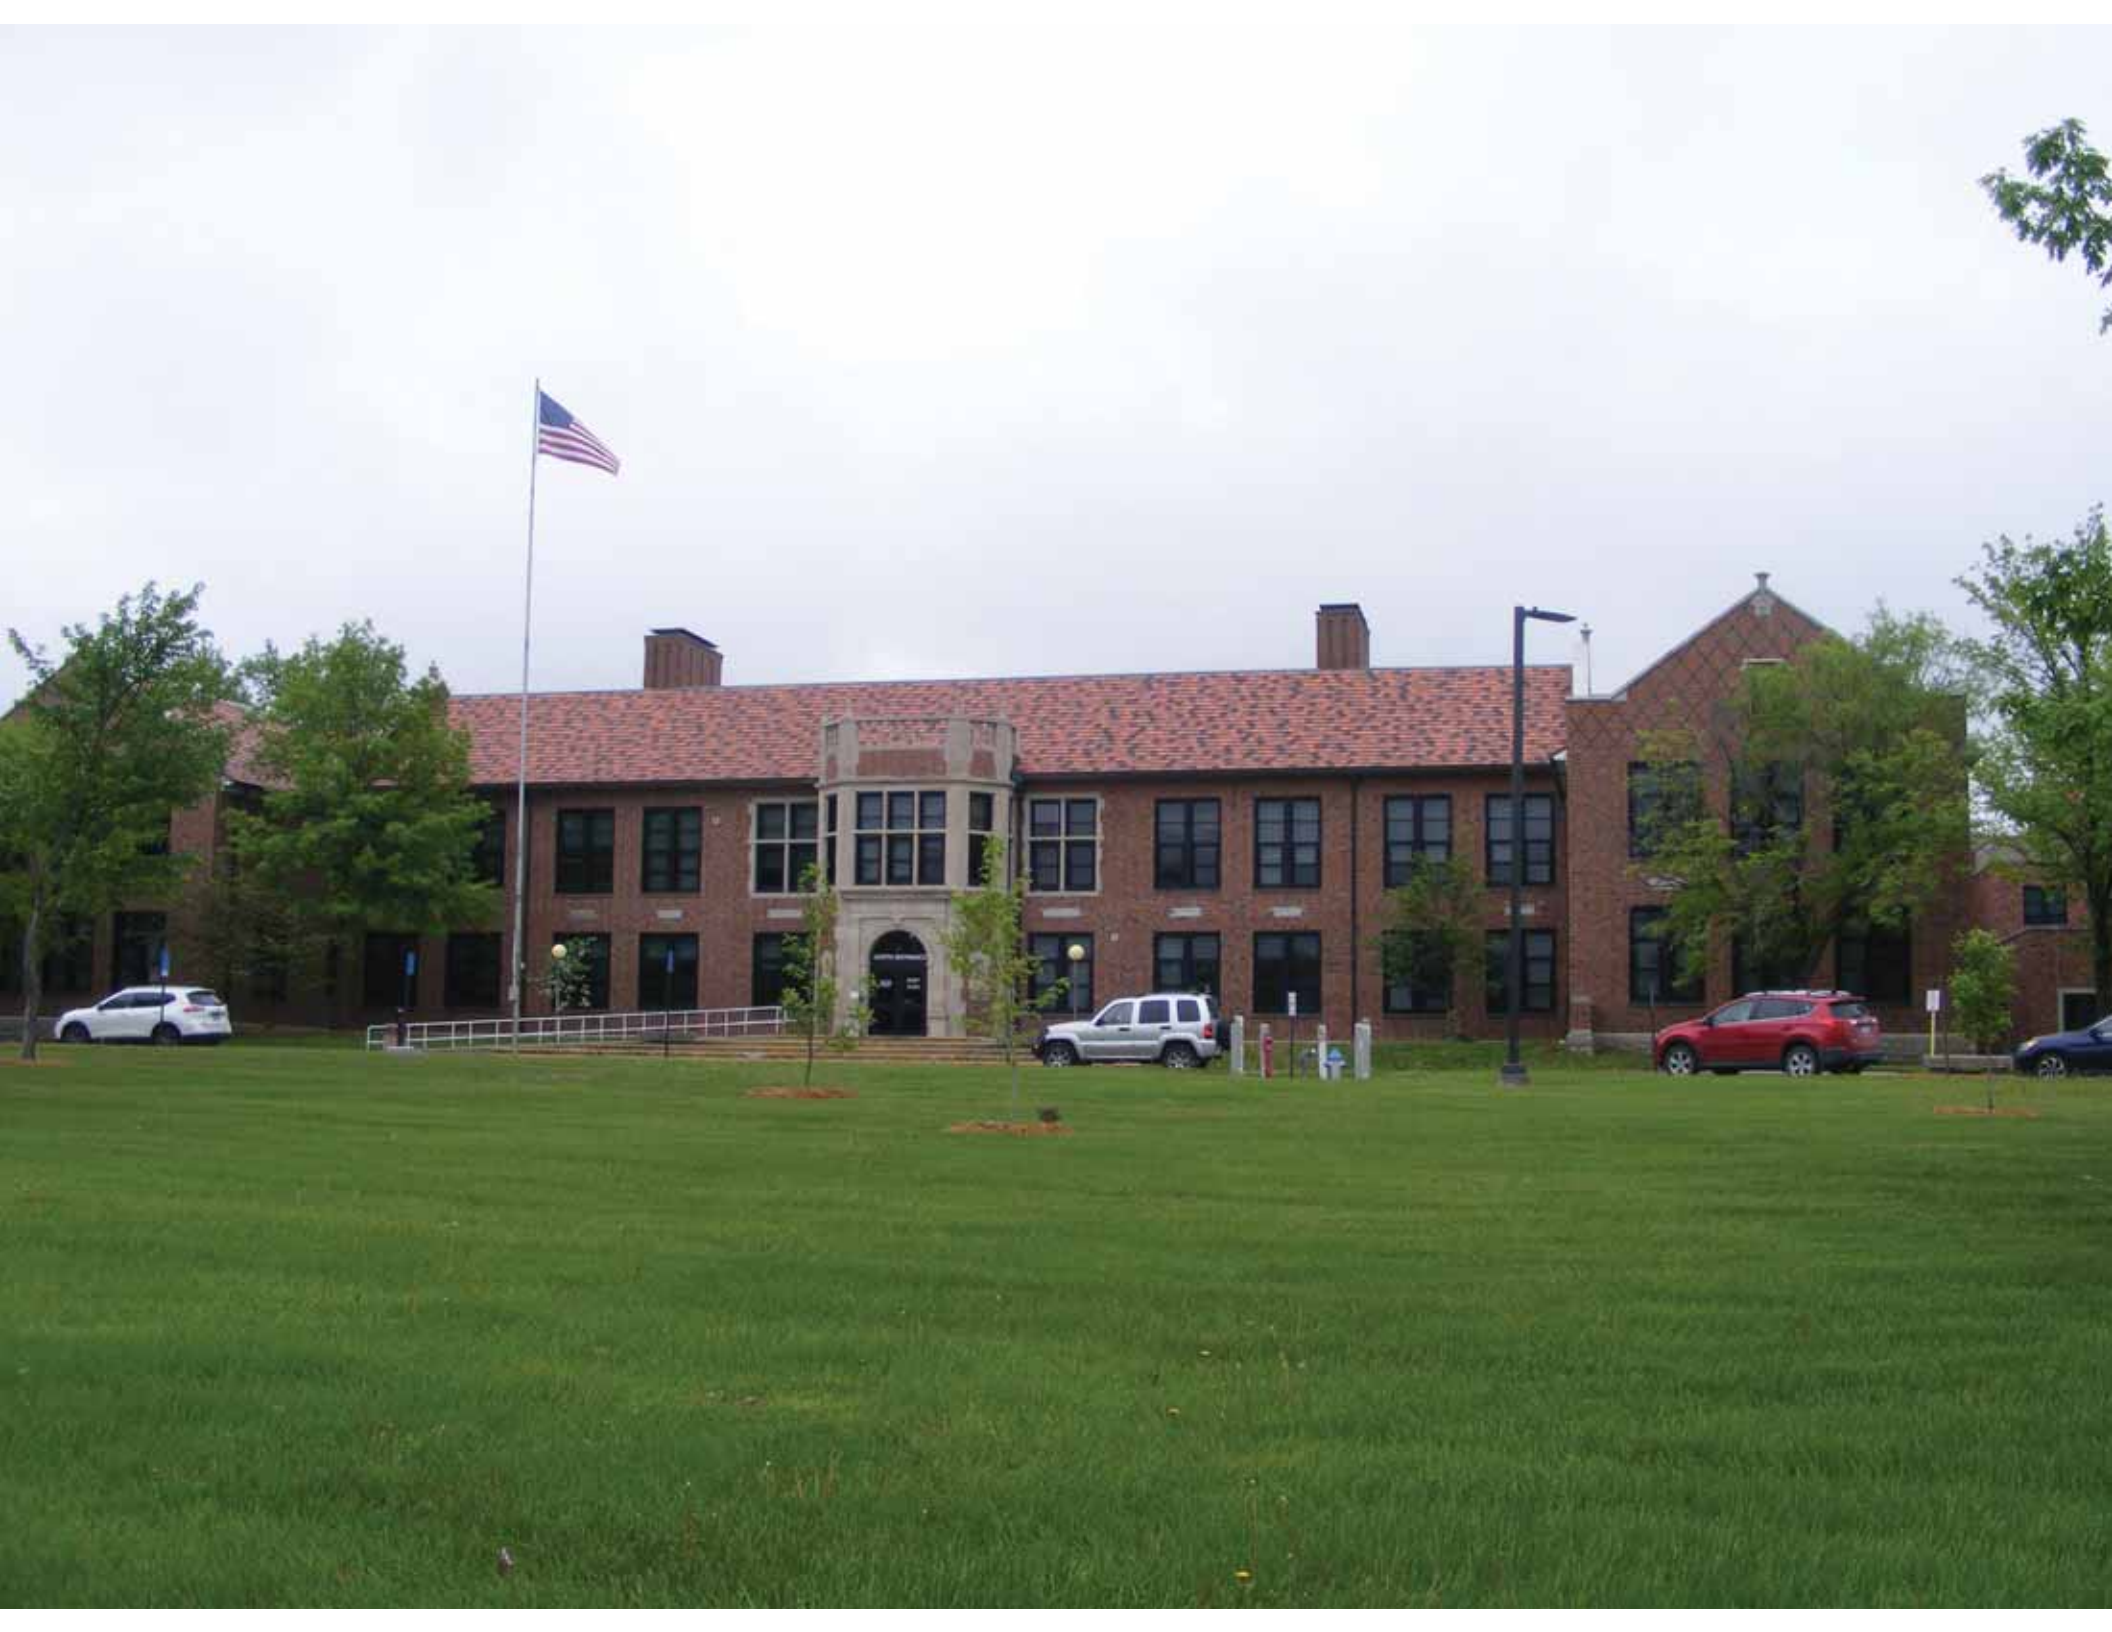
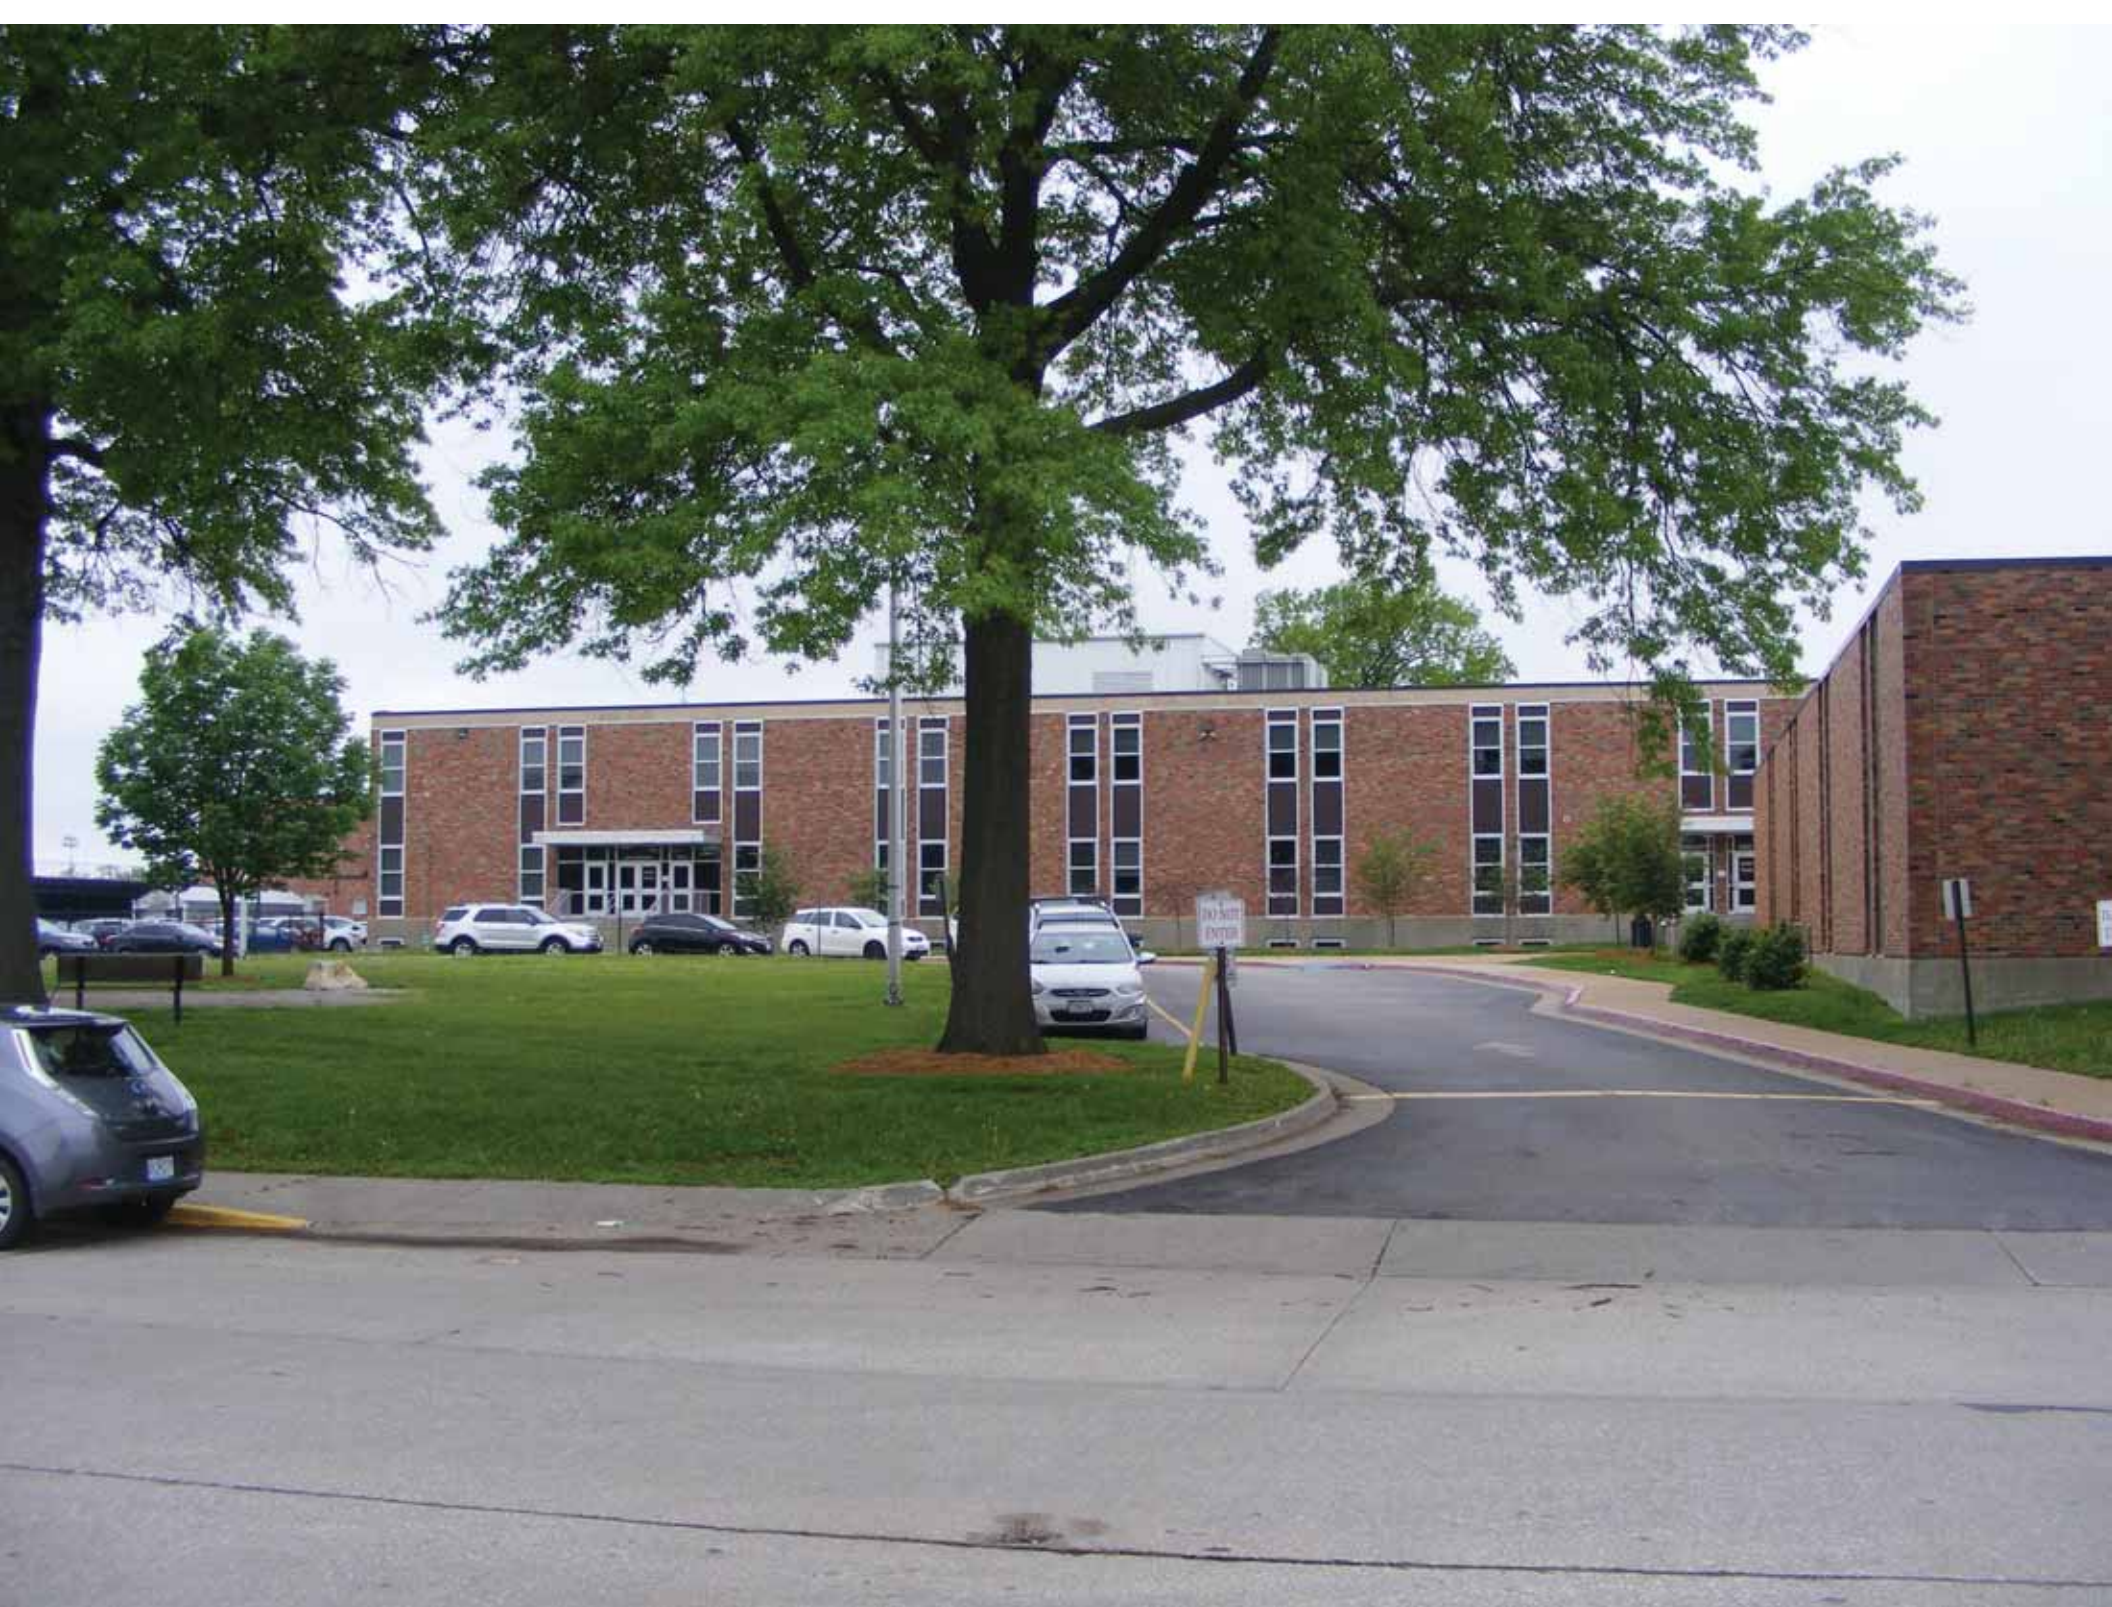
Hickman High School, constructed in 1926, has been added on to many times, beginning in the mid-1950s and extending through c. 2000. The original school has a clay tile clad gabled roof, exterior brick walls and a limestone foundation. The building is designed in Ittner's classic Jacobethan Revival style (H-plan). The roof of the building has patterned tile that mimics the building's exterior Flemish bond brick walls. At either end of the roofline are wide decorative chimney stacks with Tudor-inspired detailing. Windows are replacement but retain the original fenestration of double-hung below transom lights. A projecting central two-story bay on the façade has ashlar stone detailing with an upper balconette, quoins and a classical entry surround. The entry bay is arched and filled with replacement single-light doors/transom. The name of the school is inscribed above the entrance within the limestone surround. Projecting gabled wings extend north at the east/west ends of the central wing. The roofline has parapet walls dividing each of the wings. Parapet walls are capped with decorative finials and terra cotta tiles. Additions are all similar in appearance with flat roofs, exterior brick patterned walls (in imitation of the original wing), concrete foundations and single-sash windows. The additions constructed in the 1950s-1960s (east end) have aluminum framed windows and doors. Entrances are recessed with single and paired doors below fixed transoms. More recent additions/buildings likewise have brick walls; some have concrete detailing on elevations (below brick). Windows on more recently constructed buildings are fixed sash with metal framing.

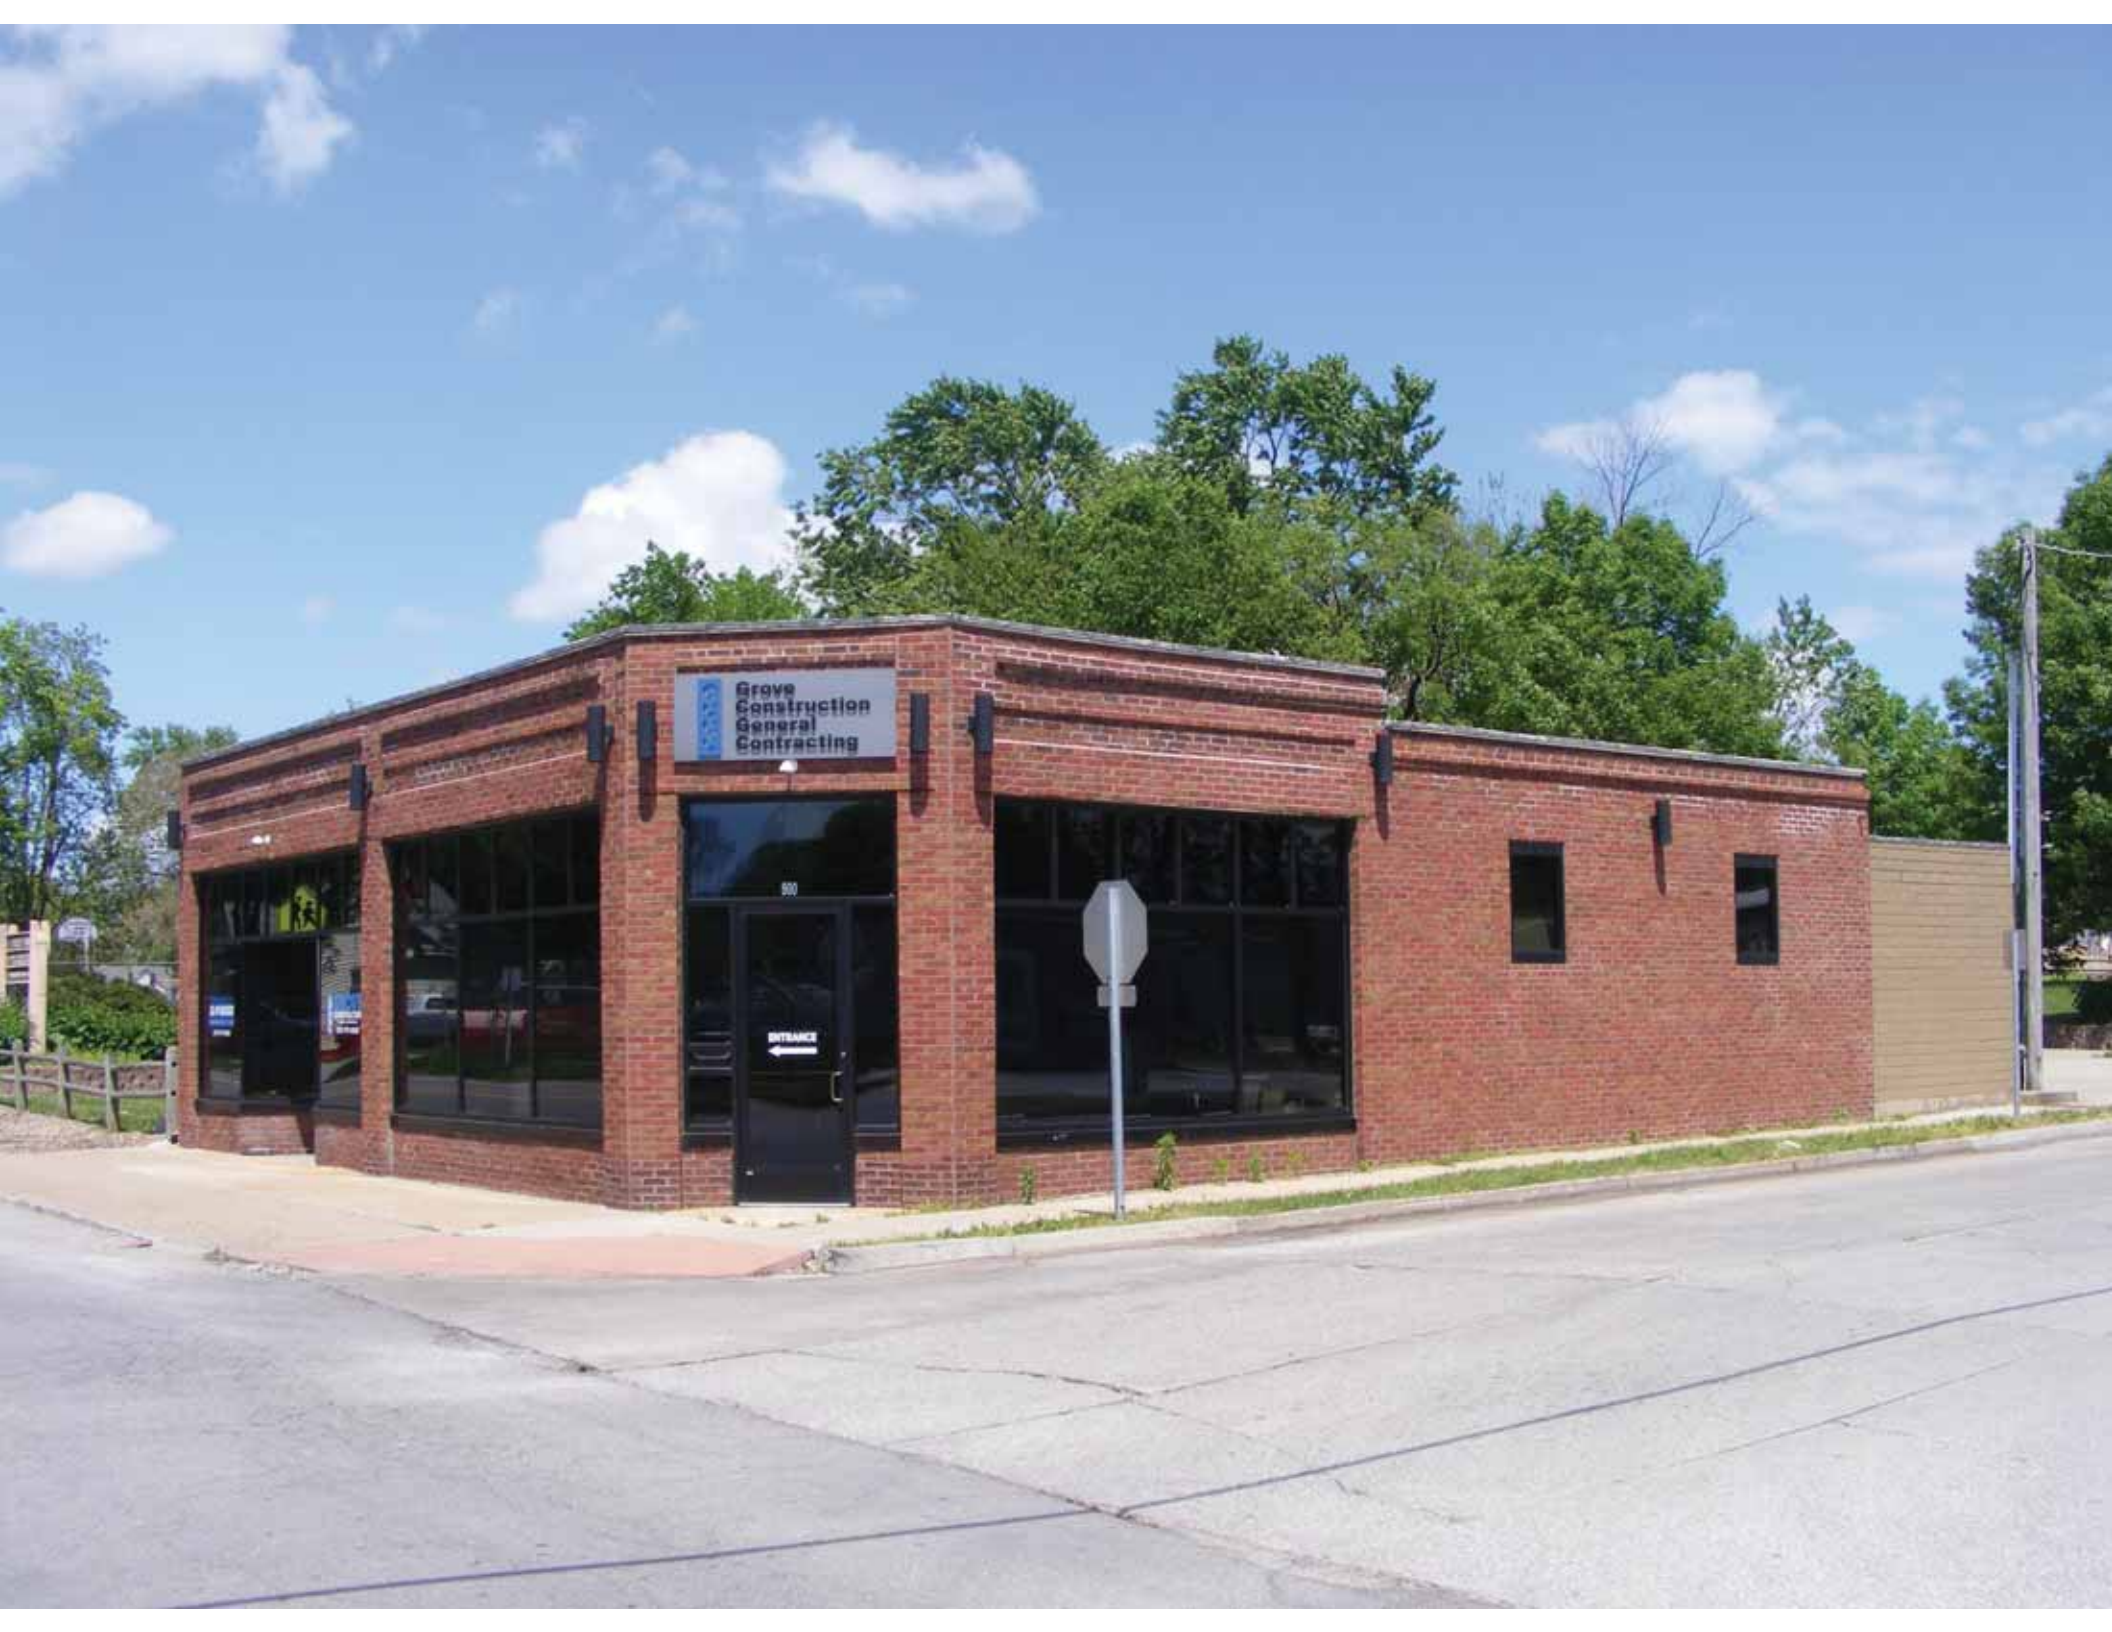
This is a one story commercial building with a flat roof and clad in brick. All windows and bays hold modern (ca. 2000) glass and metal doors/window with transoms. The primary elevation holds two bays delineated by brick pilasters. The left bay holds an inset entrance flanked by display windows with multi-light transoms. The second bay holds a tripled paired display window with transoms. Above the storefront near the roofline is two rows of inset brick. A chamfered entrance that holds an entrance door with sidelights and a transom flanked by brick pilasters and connects the Range Line Rd. elevation to the Wilkes Blvd. elevation. Above the chamfered entrance is an inset brick panel with a sign that says "Grove construction General Contracting." The Wilkes Blvd. elevation holds a tripled paired display window with transoms. Above the display window is two rows of inset bricks. The window bay is offset to the right by two small fixed windows. Each bay area has a brick bulkhead. The rear elevation holds a one story concrete block addition that runs the width of the elevation. It holds two single entrances and the electrical meters.

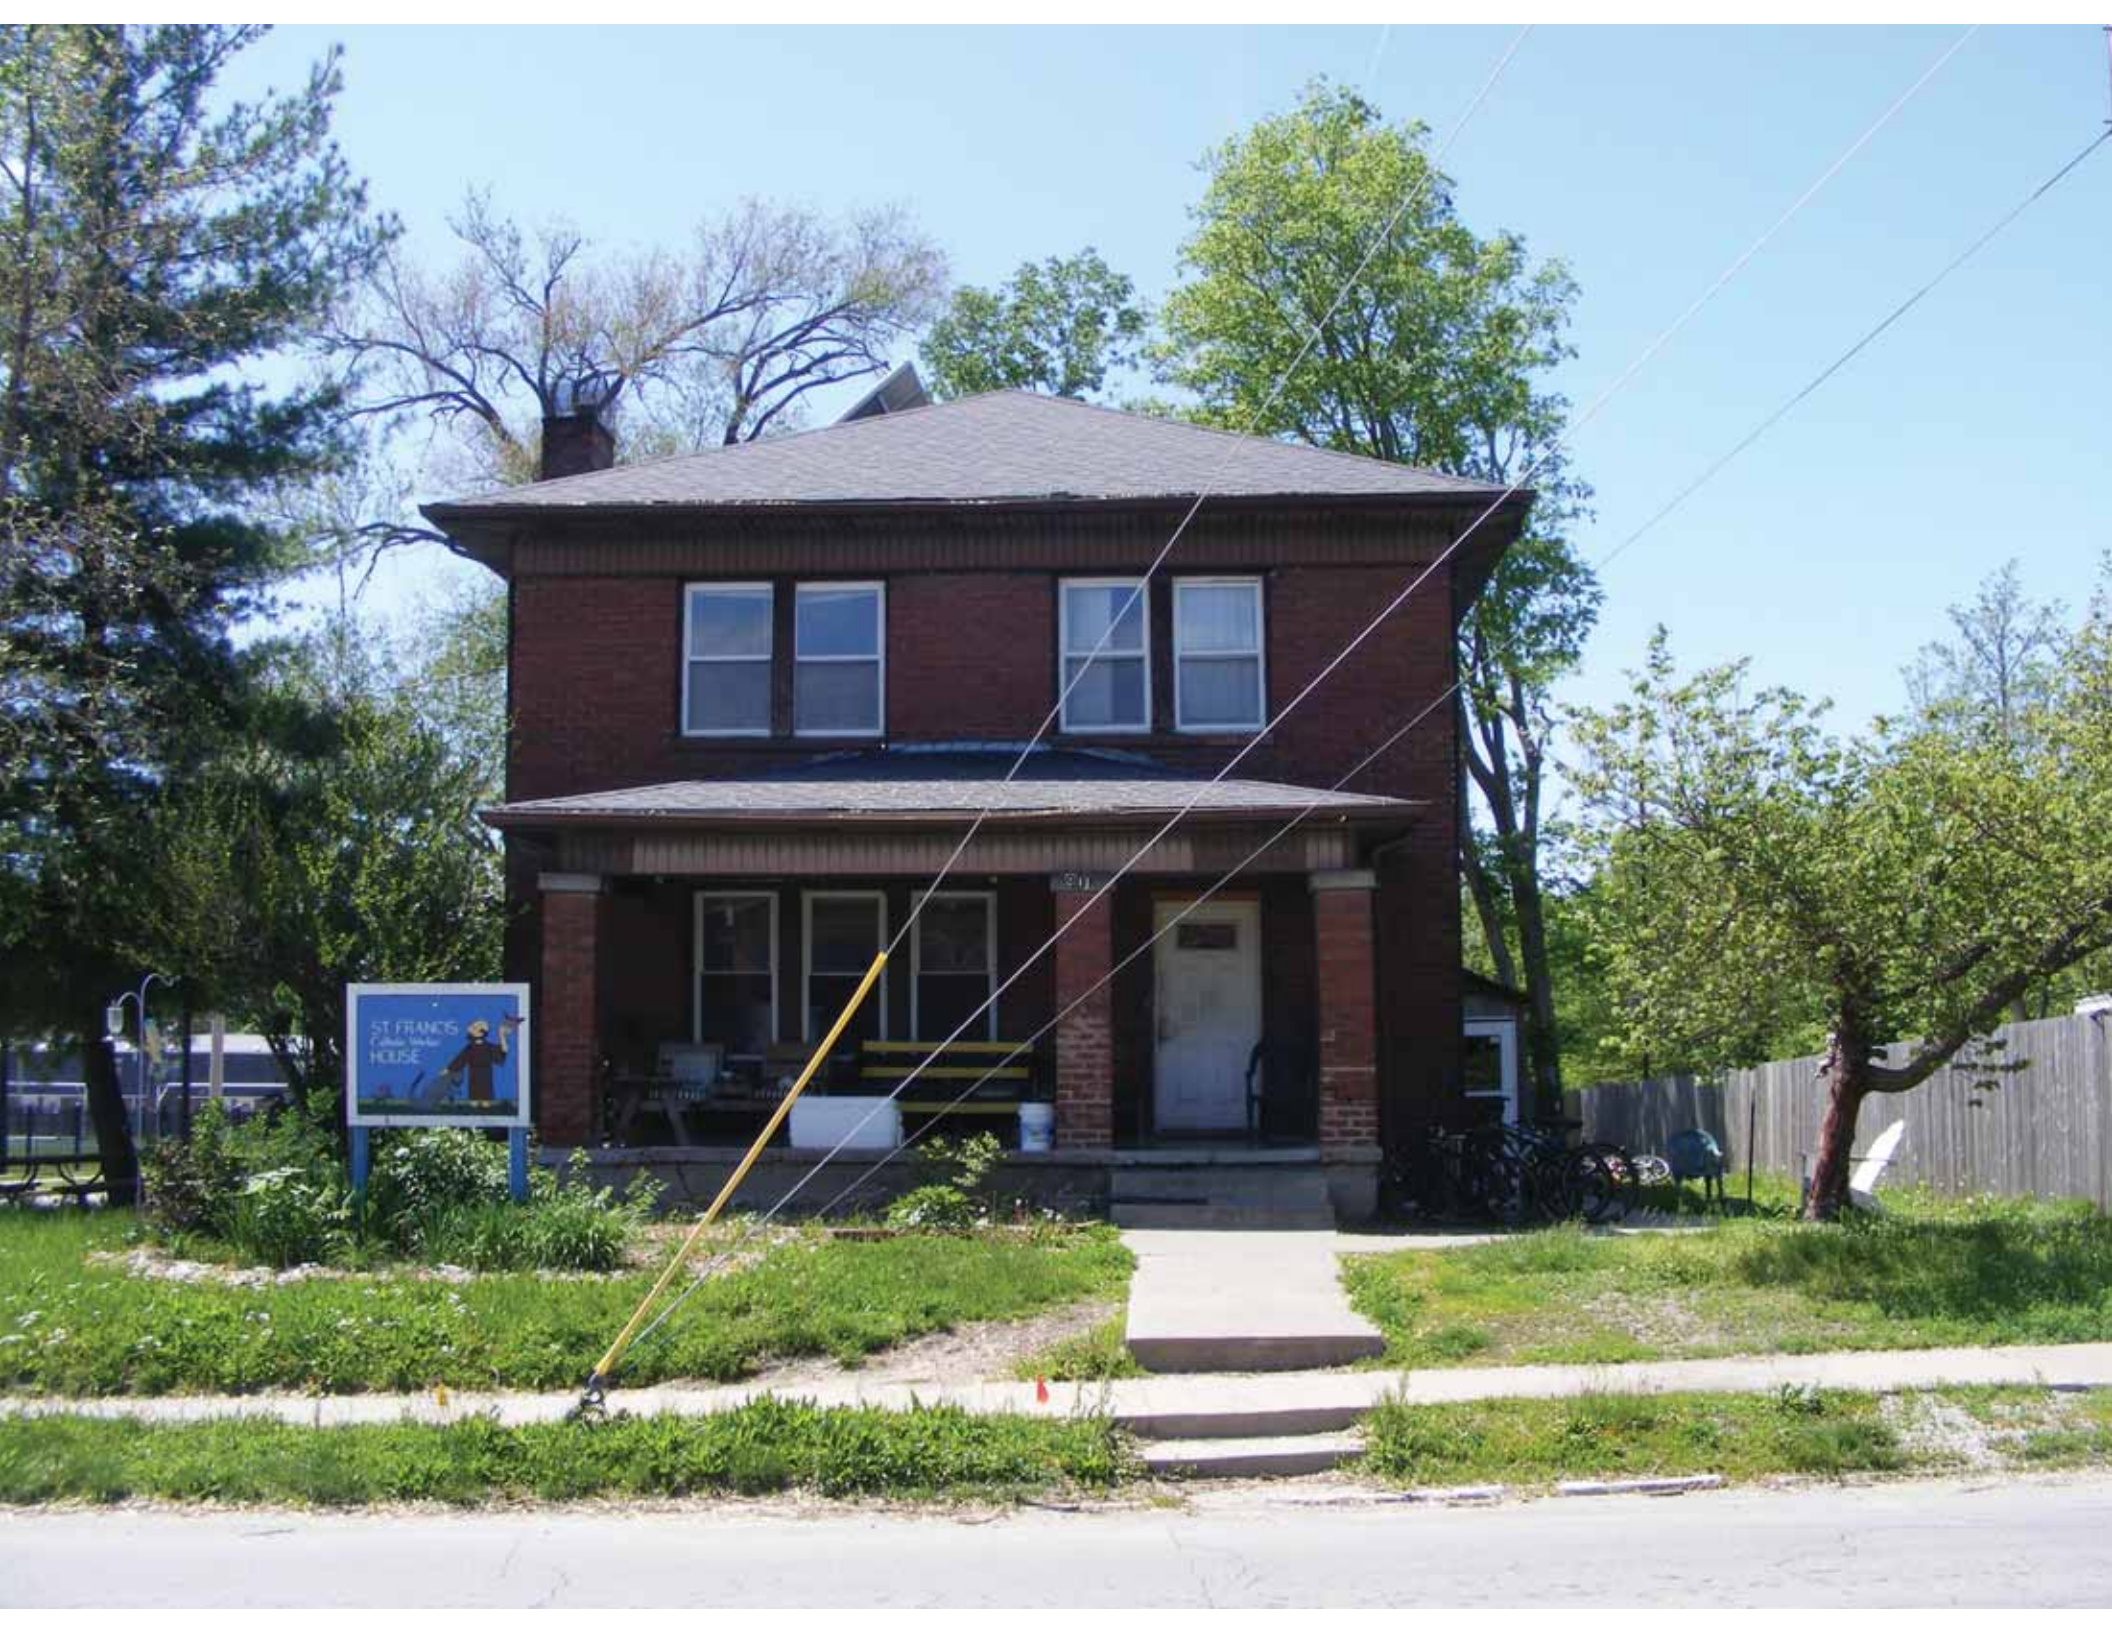
The two-story brick dwelling has a hipped asphalt shingled roof and a concrete foundation. The primary (east) elevation supports a single-story hipped porch supported by square brick columns. Eaves of the porch and roof are enclosed. Within the porch bay is a replacement paneled door with an upper light. Offsetting the door to the south are three one-over-one replacement windows. Remaining windows are similar in design. Above the porch, the façade wall holds two sets of paired windows. The dwelling has a large two-story rear wing clad with synthetic siding. The wing has a hipped asphalt-shingled roof and rear (northwest corner) first-story incised porch. Windows on the rear wing are six-over-six. A small one-story wing on the north elevation is clad with synthetic siding. The wing has a single door on the east wall.

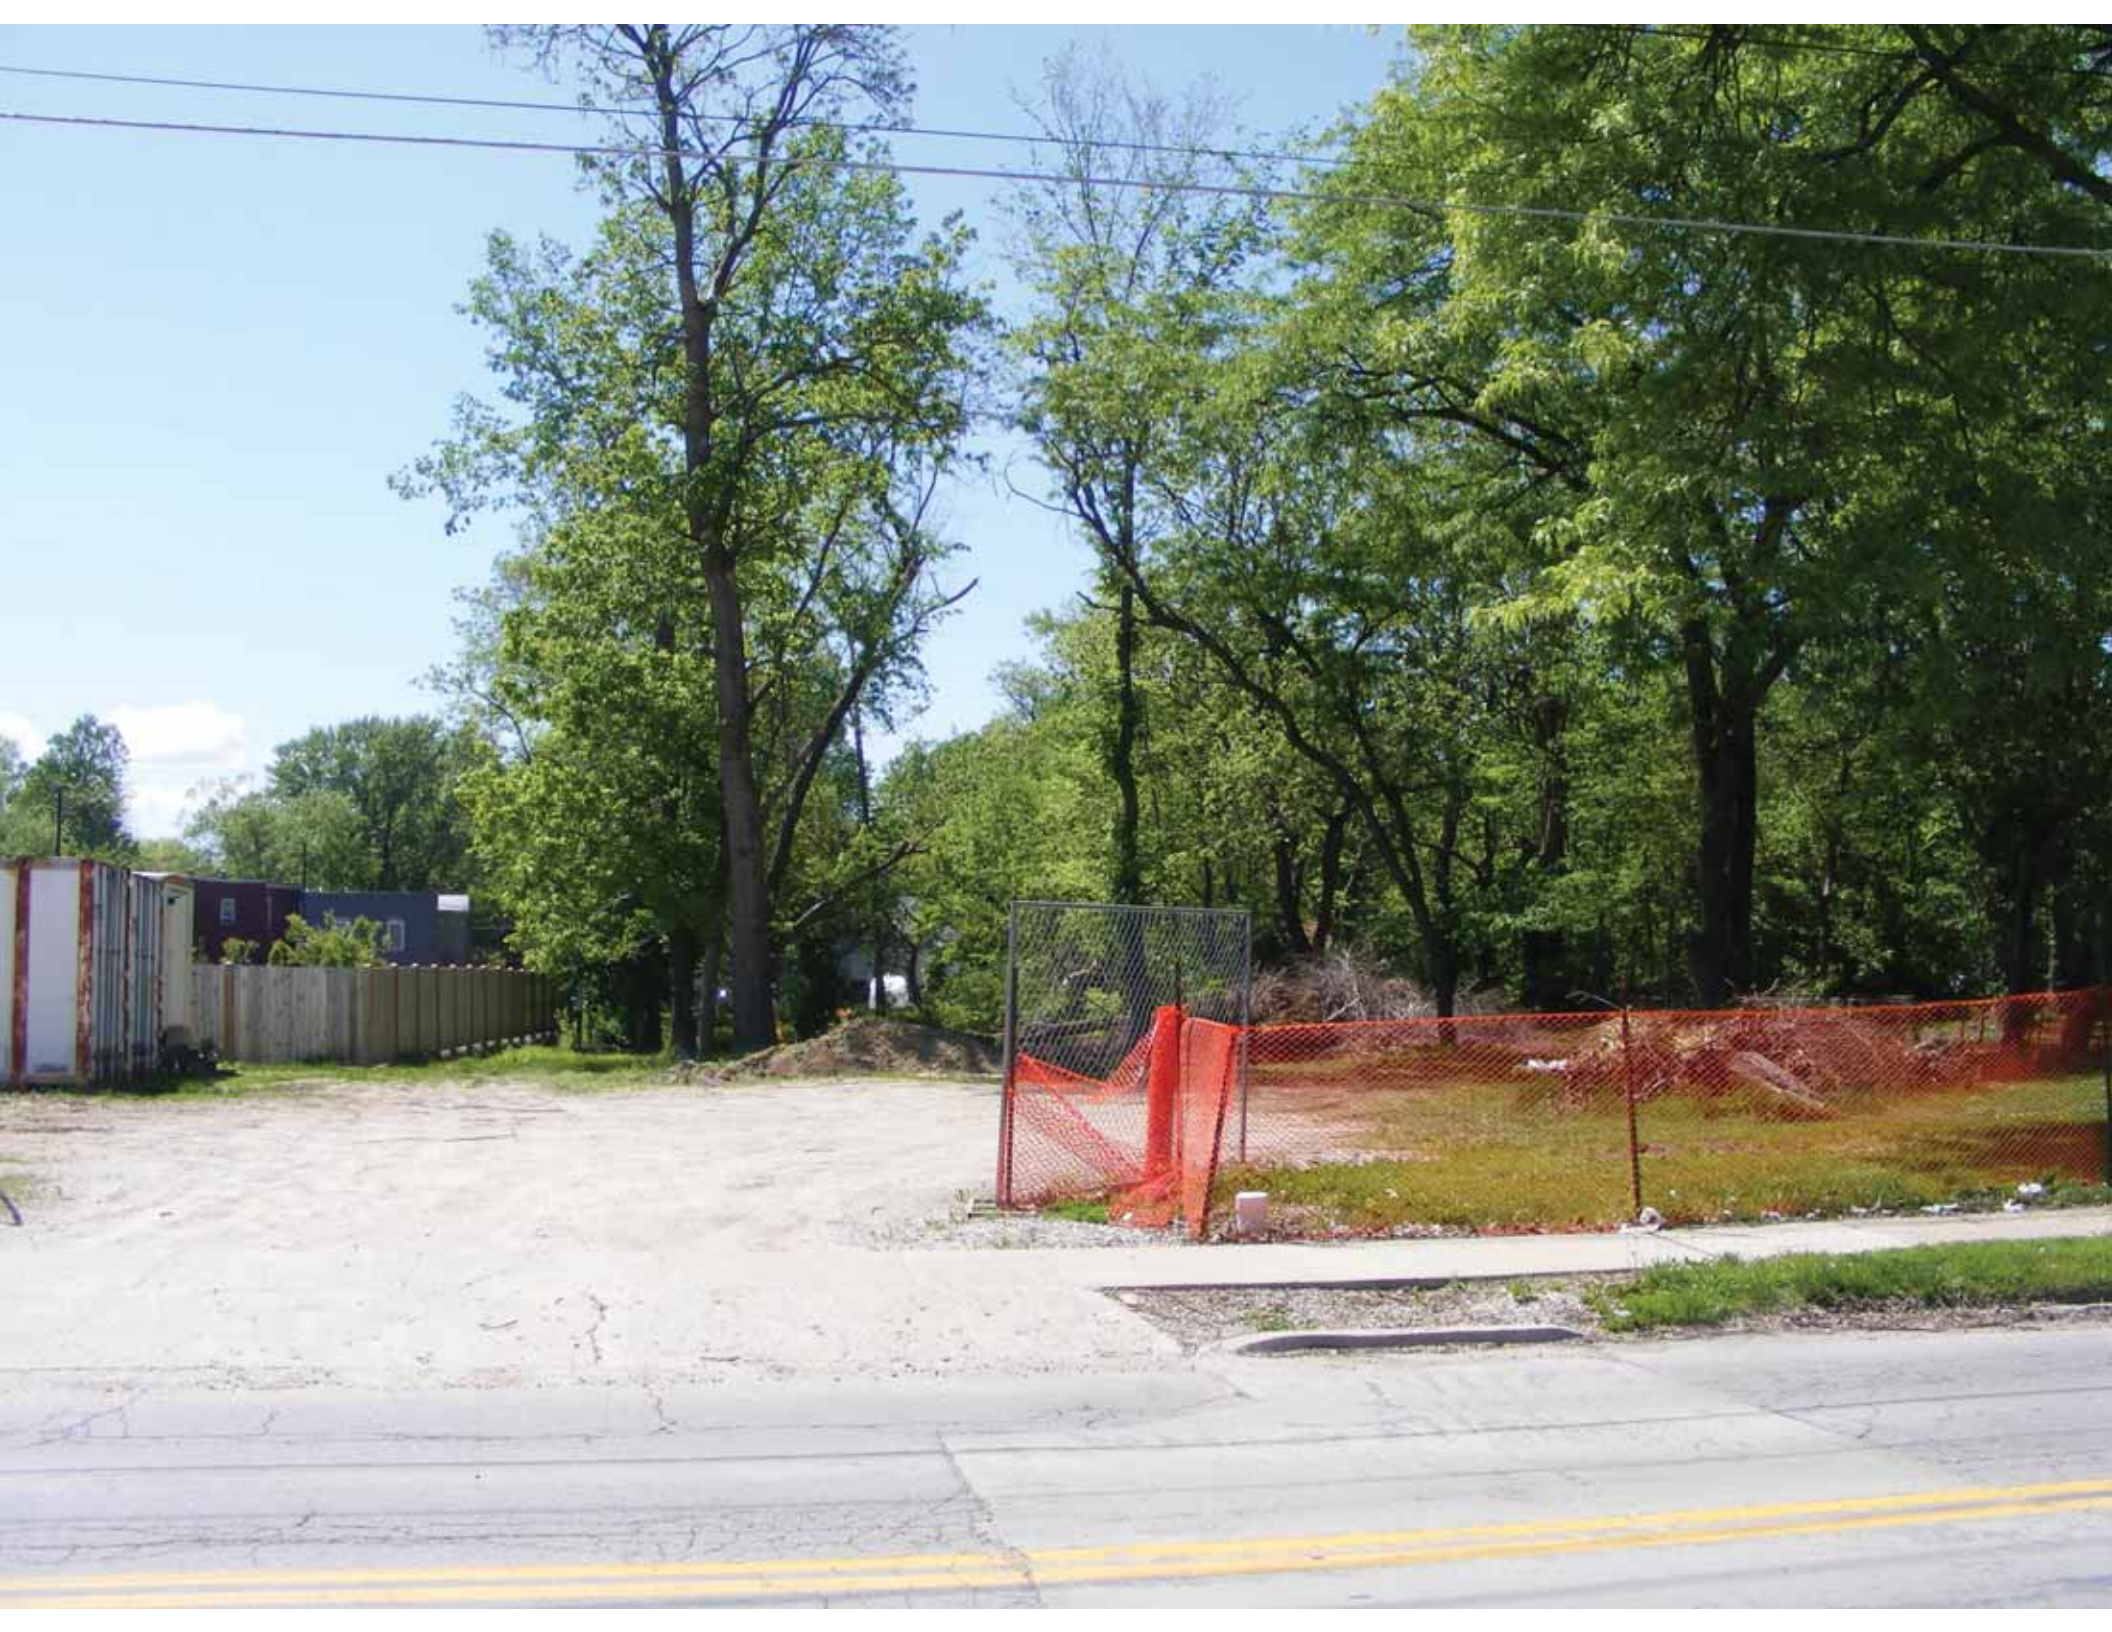
The irregular shaped vacant lot, largely covered with grass and trees, encompasses 1.48 acres that front Range Line Street (east) and Wilkes Boulevard (south). The lot is as described above.

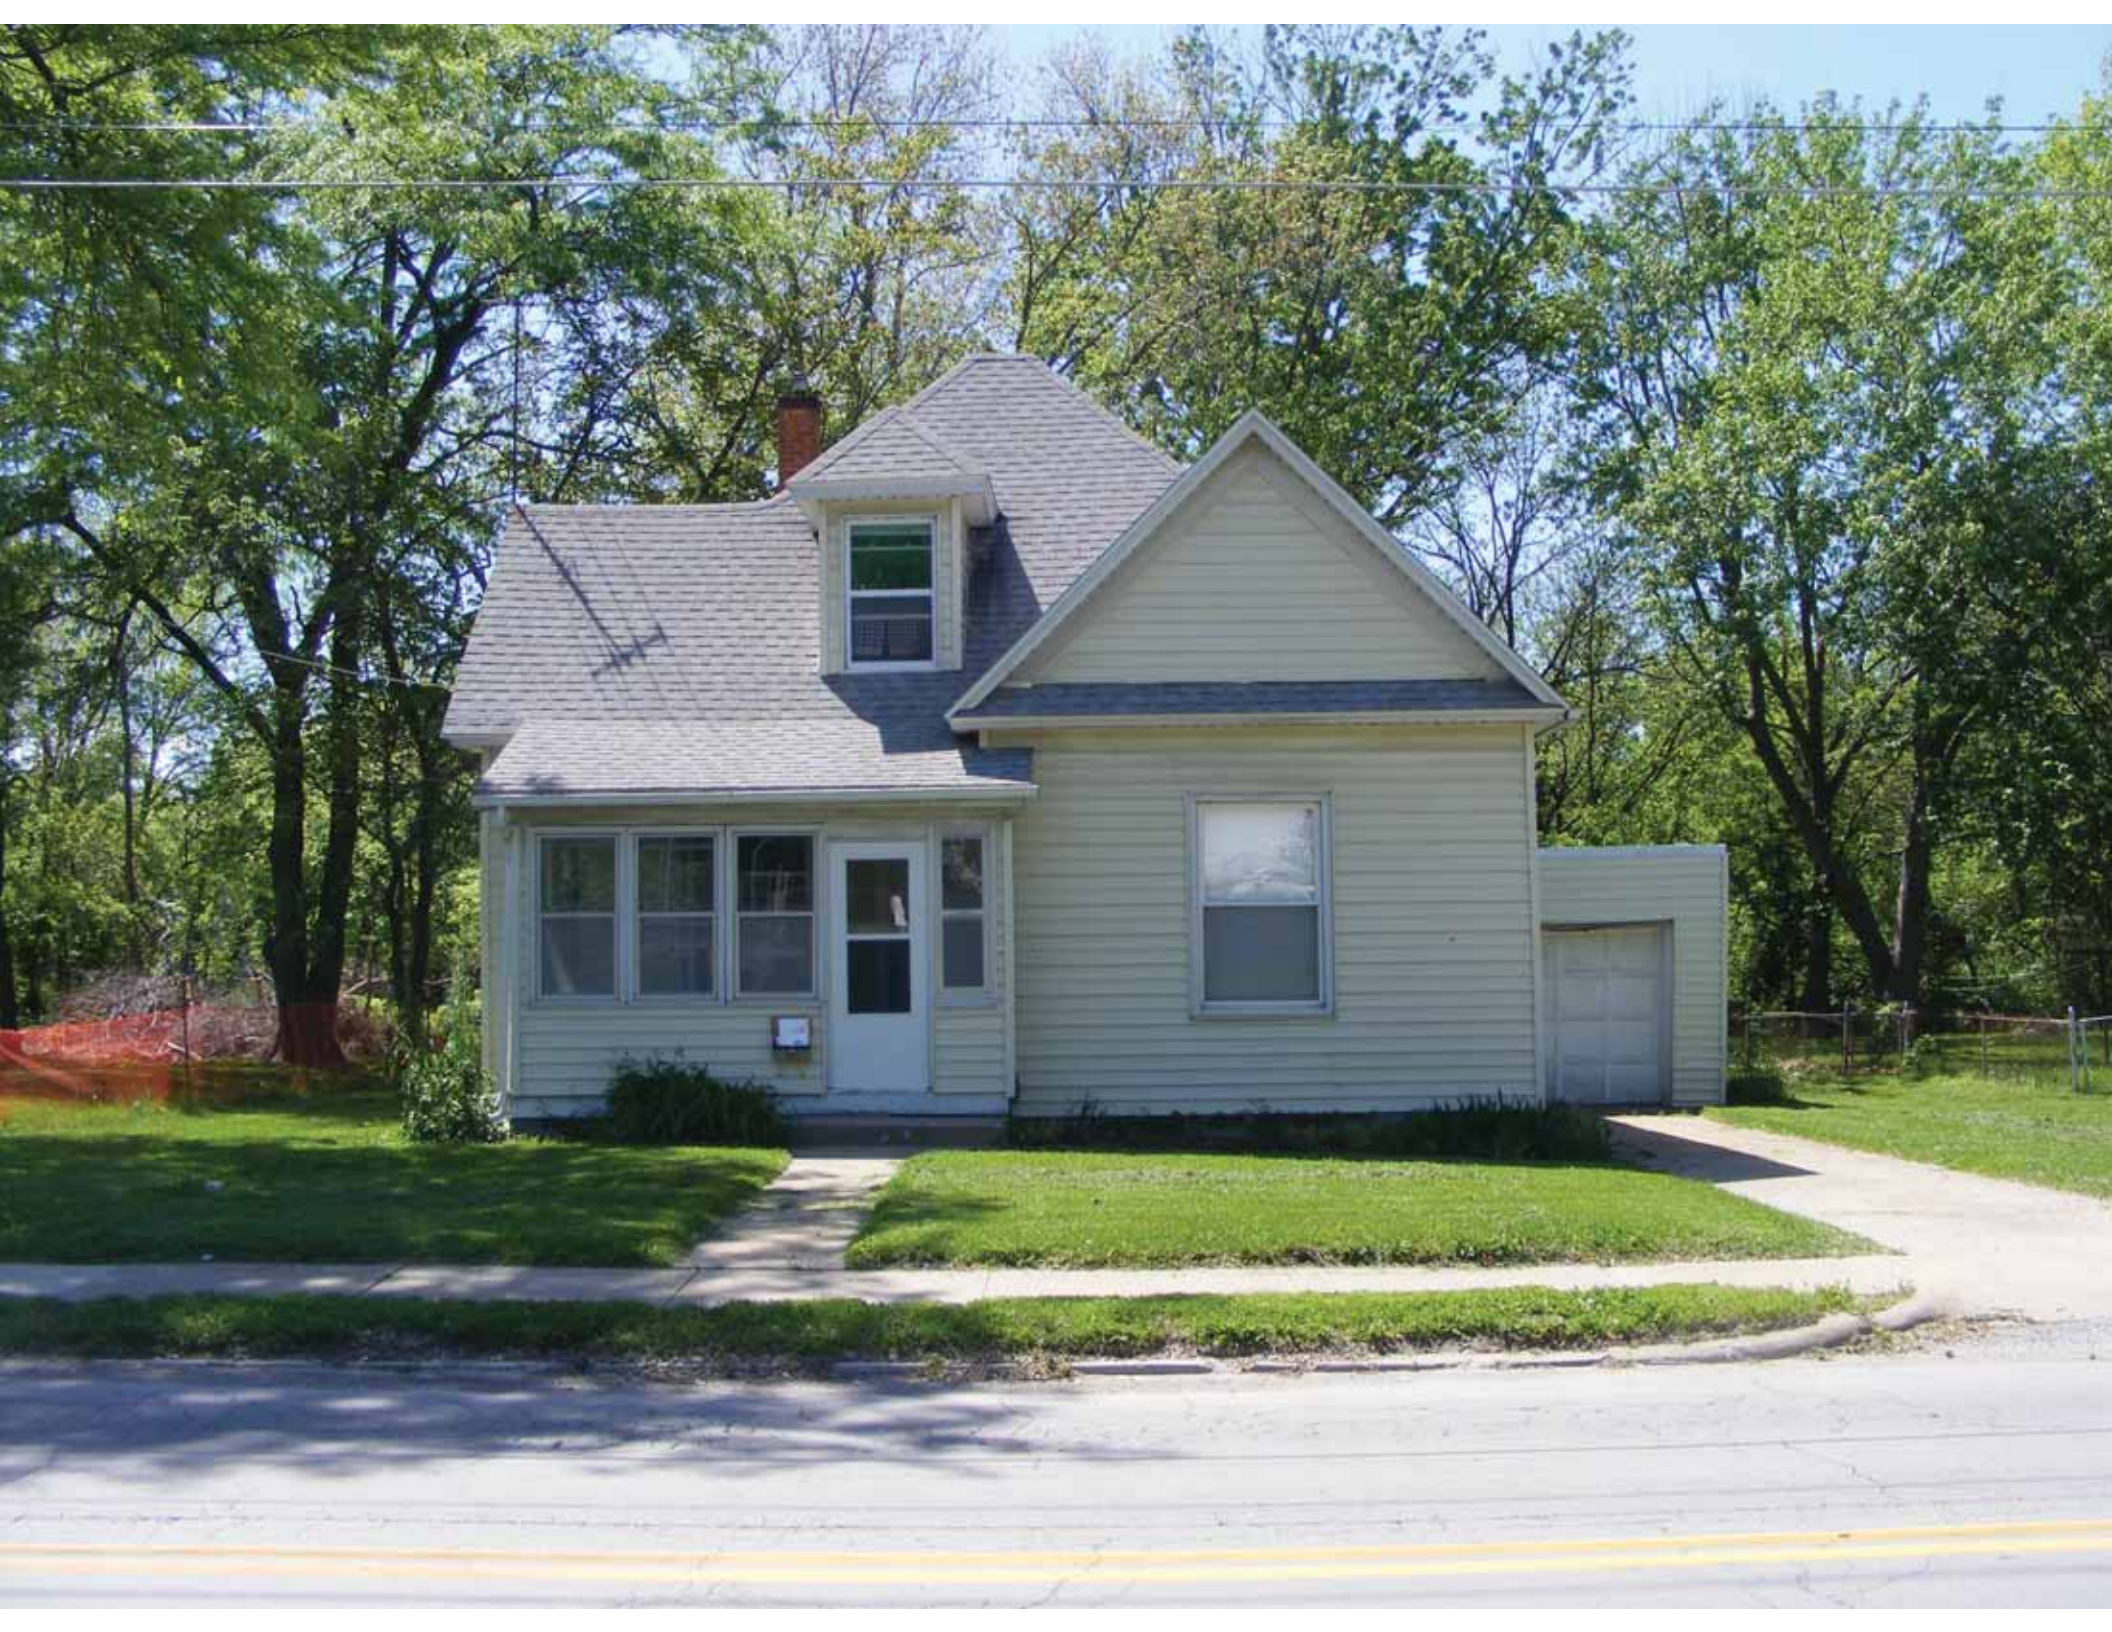
The dwelling appears to have been constructed in the Folk Victorian style although decorative features are obscured (or have been removed). The dwelling has a hip on gable asphalt shingled roof, interior brick chimney, exterior synthetic siding and a concrete foundation. The windows are replacement one-over-one. Eaves are enclosed. On the façade is an enclosed shed roof half-story porch. The east elevation of the porch enclosure has a storm door flanked by continuous one-over-one windows. Offsetting the porch on the north is a front gabled wing which has a pedimented gable and one-over-one (lower elevation) window. Above the porch is a hipped dormer with a one-over-one window. The northwest corner of the dwelling features a single-story garage with a flat roof and overhead replacement door. The garage is clad with vinyl siding.
