MISSOURI DEPARTMENT OF NATURAL RESOURCES
STATE HISTORIC PRESERVATION OFFICE, P.O. Box 176, Jefferson City, MO 65102
ARCHITECTURAL/HISTORIC INVENTORY FORM

1. Survey No. BO-AS-011-0087		2. Survey name: North Central Columbia Survey Phase II	
3. County: Boone		4. Address (Street No.) 902	Street (name) N. Seventh Street
5. City: Columbia	Vicinity: <input type="checkbox"/>	6. Geographical Reference:	7. Township/Range/Section: T: R: S:
8. Historic name (if known):		9. Present/other name (if known):	
10. Ownership: <input checked="" type="checkbox"/> Private <input type="checkbox"/> Public		11a. Historic use (if known): Domestic/single dwelling	11b. Current use: Domestic/single dwelling

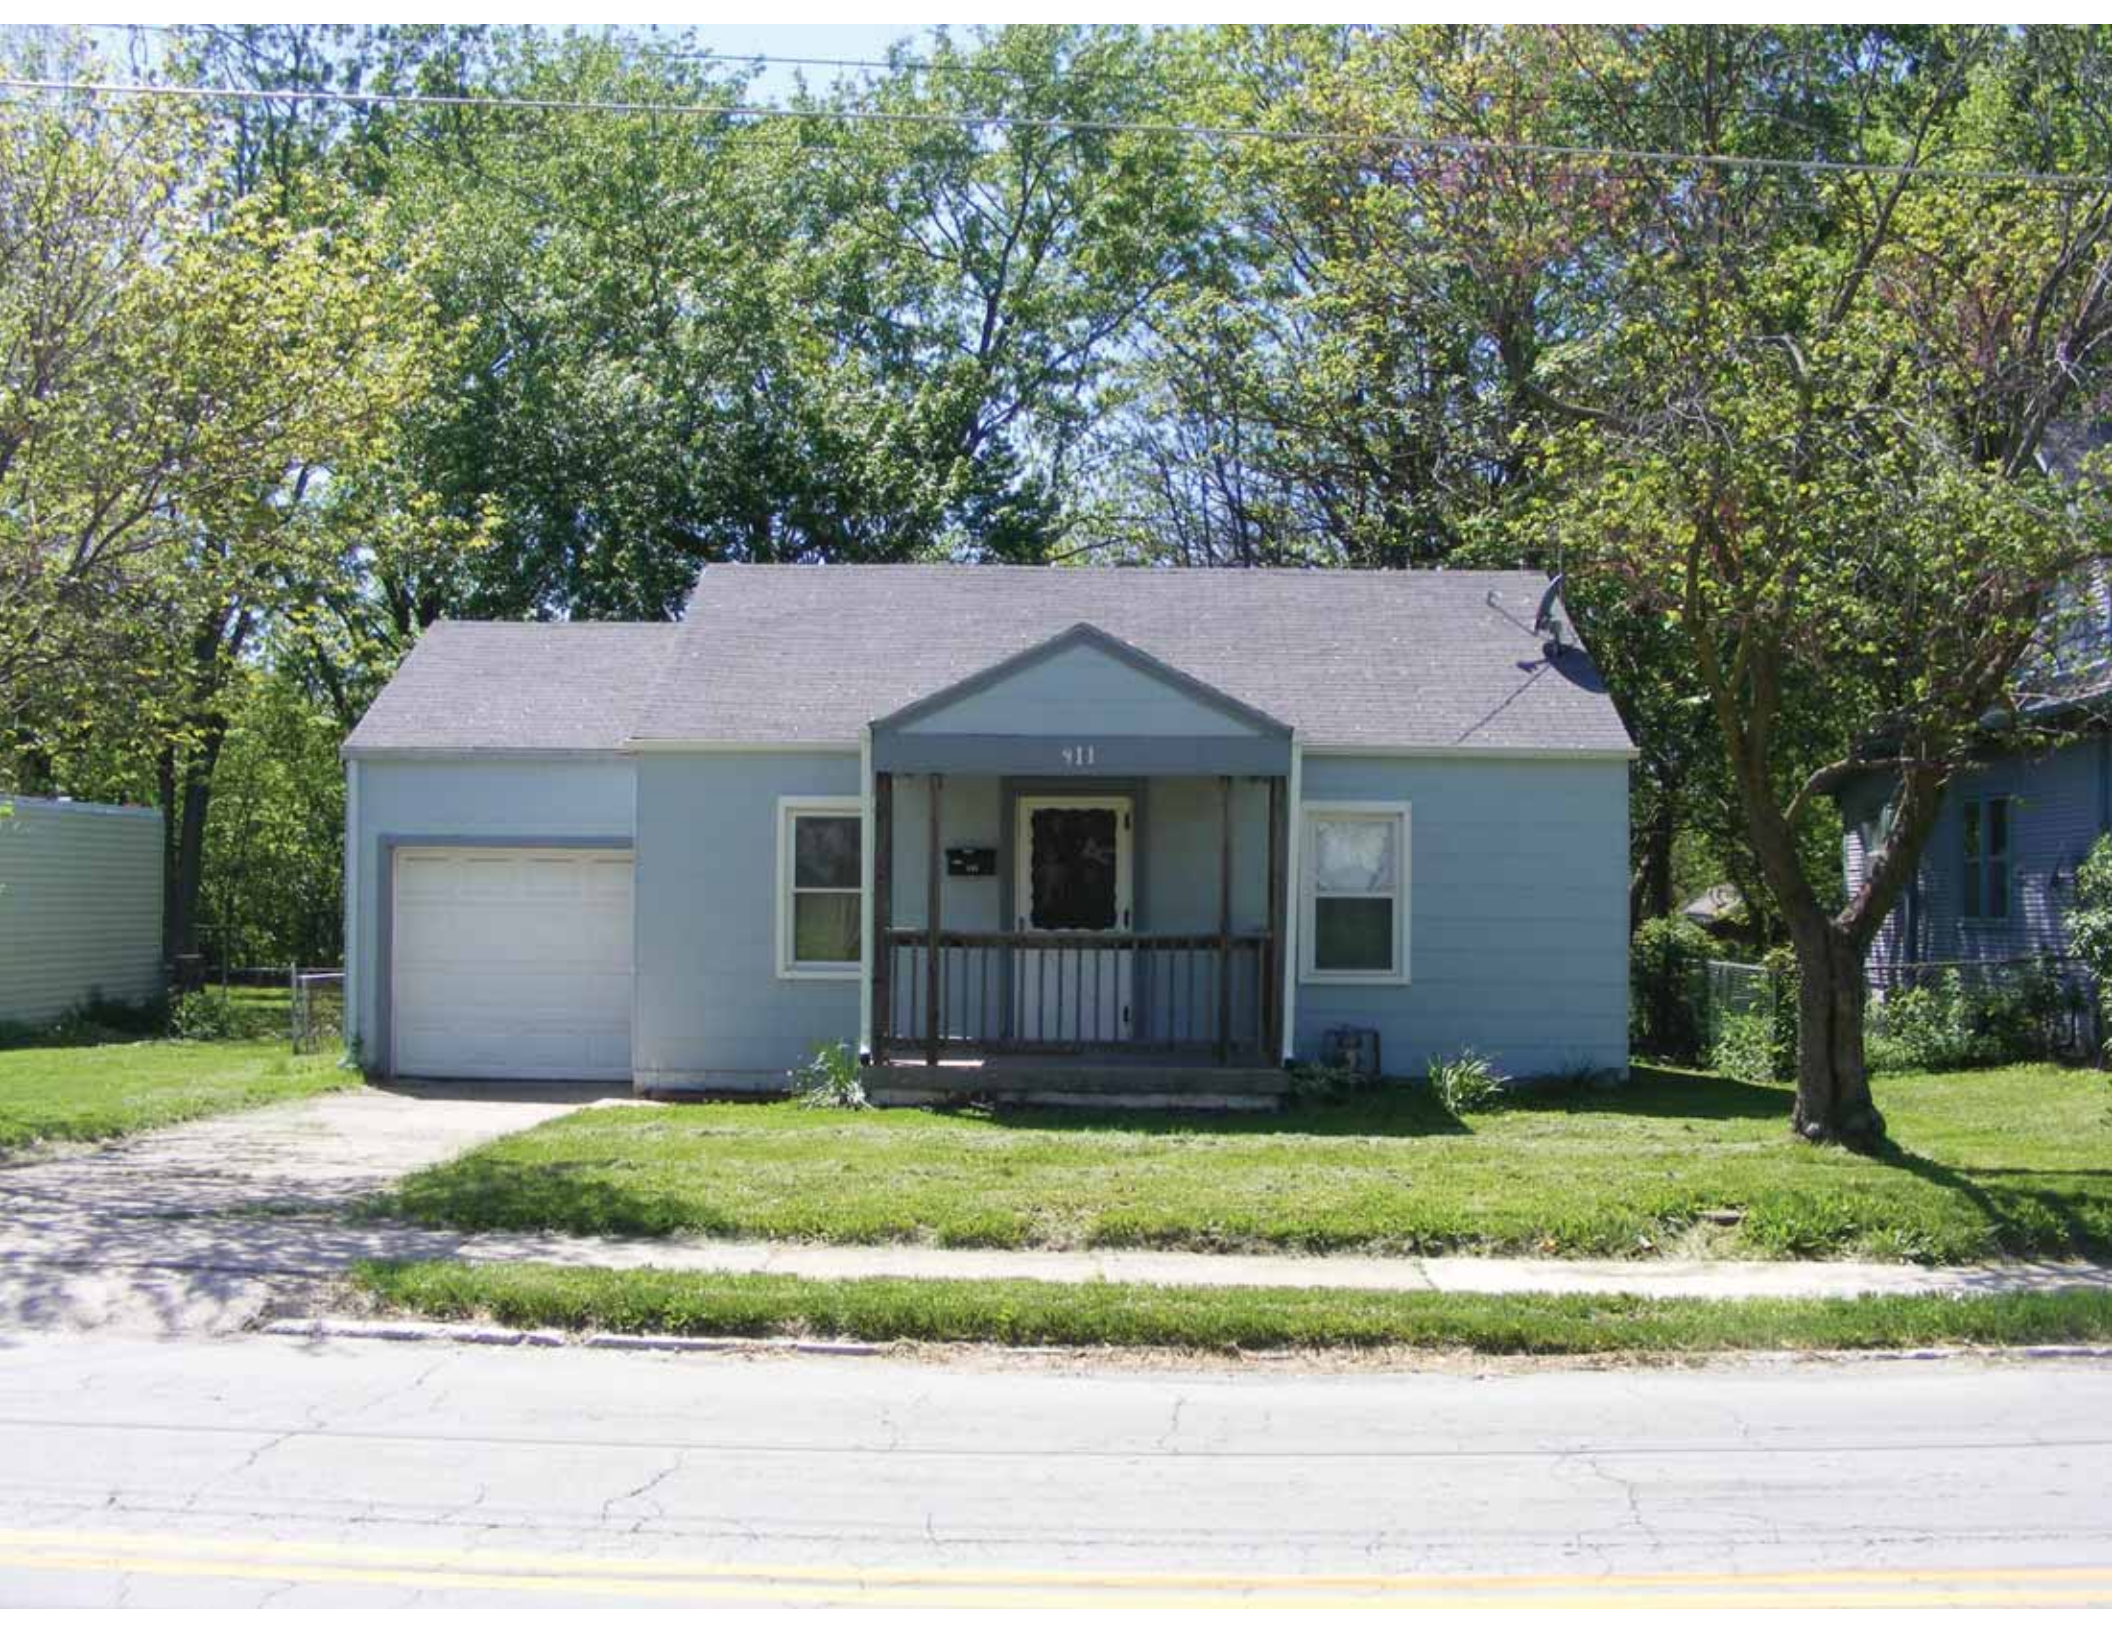
The end gable plan dwelling has an asphalt-shingled roof, exterior asbestos shingle siding and a concrete foundation. The primary (east) elevation supports an original portico with replacement wood columns and a non-original frame balustrade. Within the porch bay is a centered multi-light wood door. One-over-one replacement windows flank the portico. Remaining windows are of similar configuration. At the south end of the dwelling is an attached end-gable garage with an overhead track replacement door.

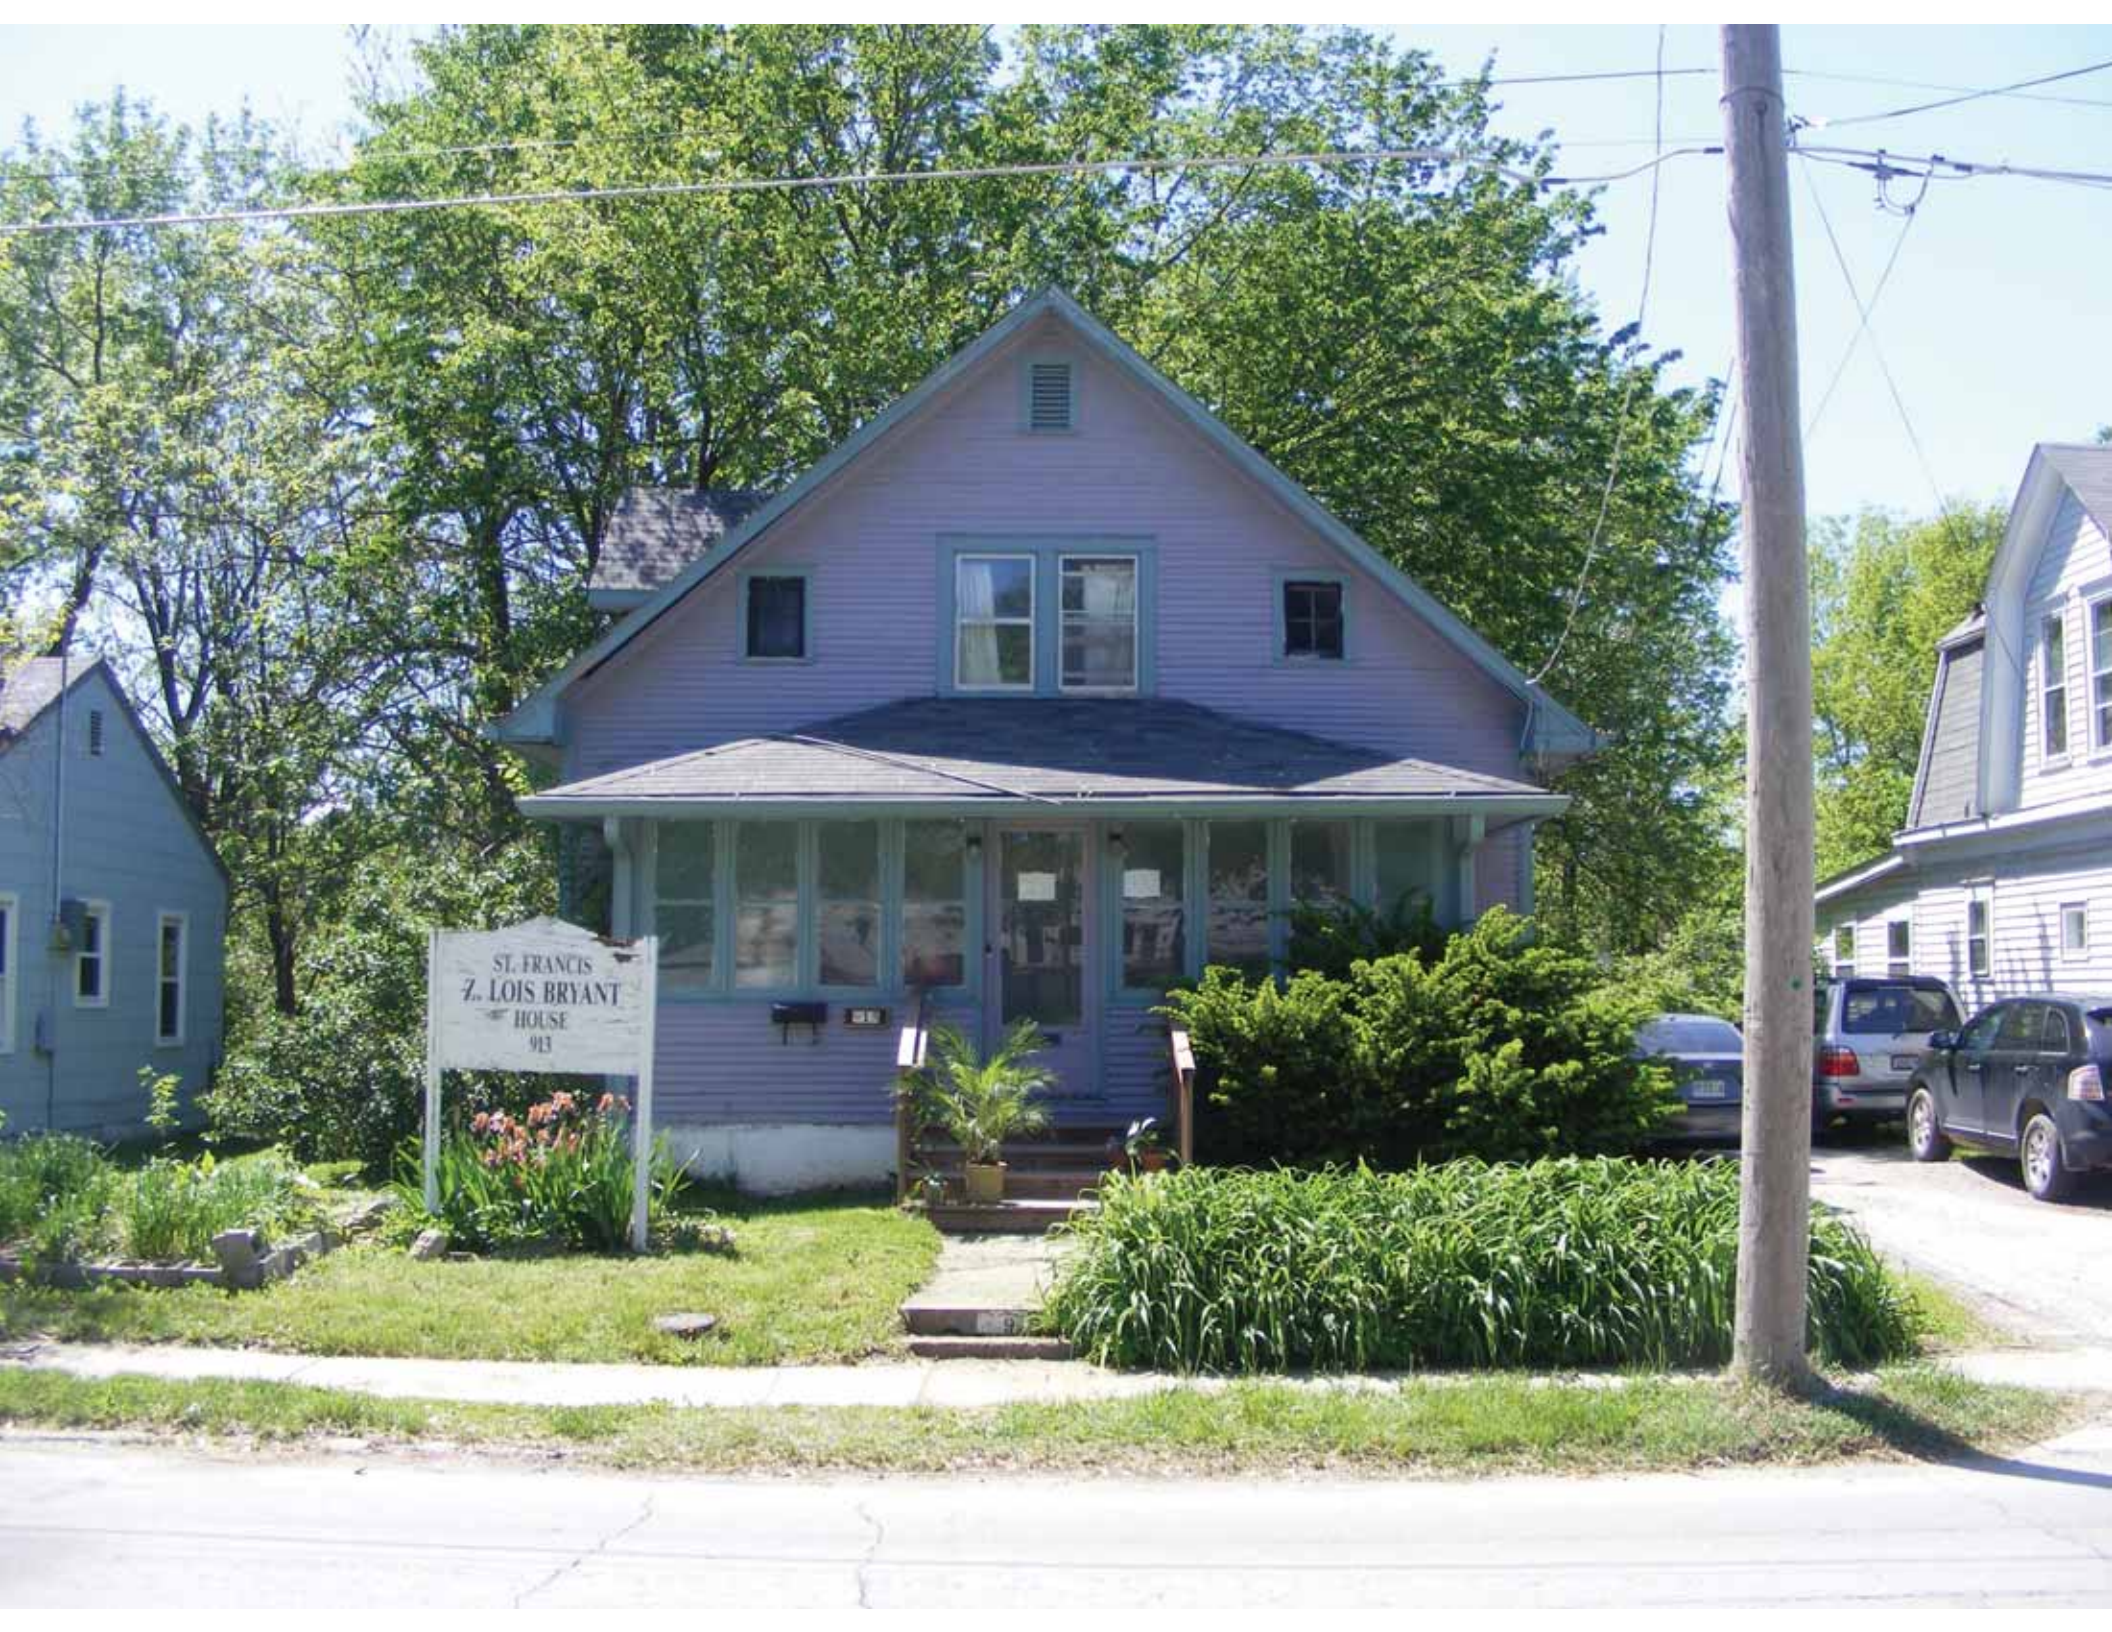
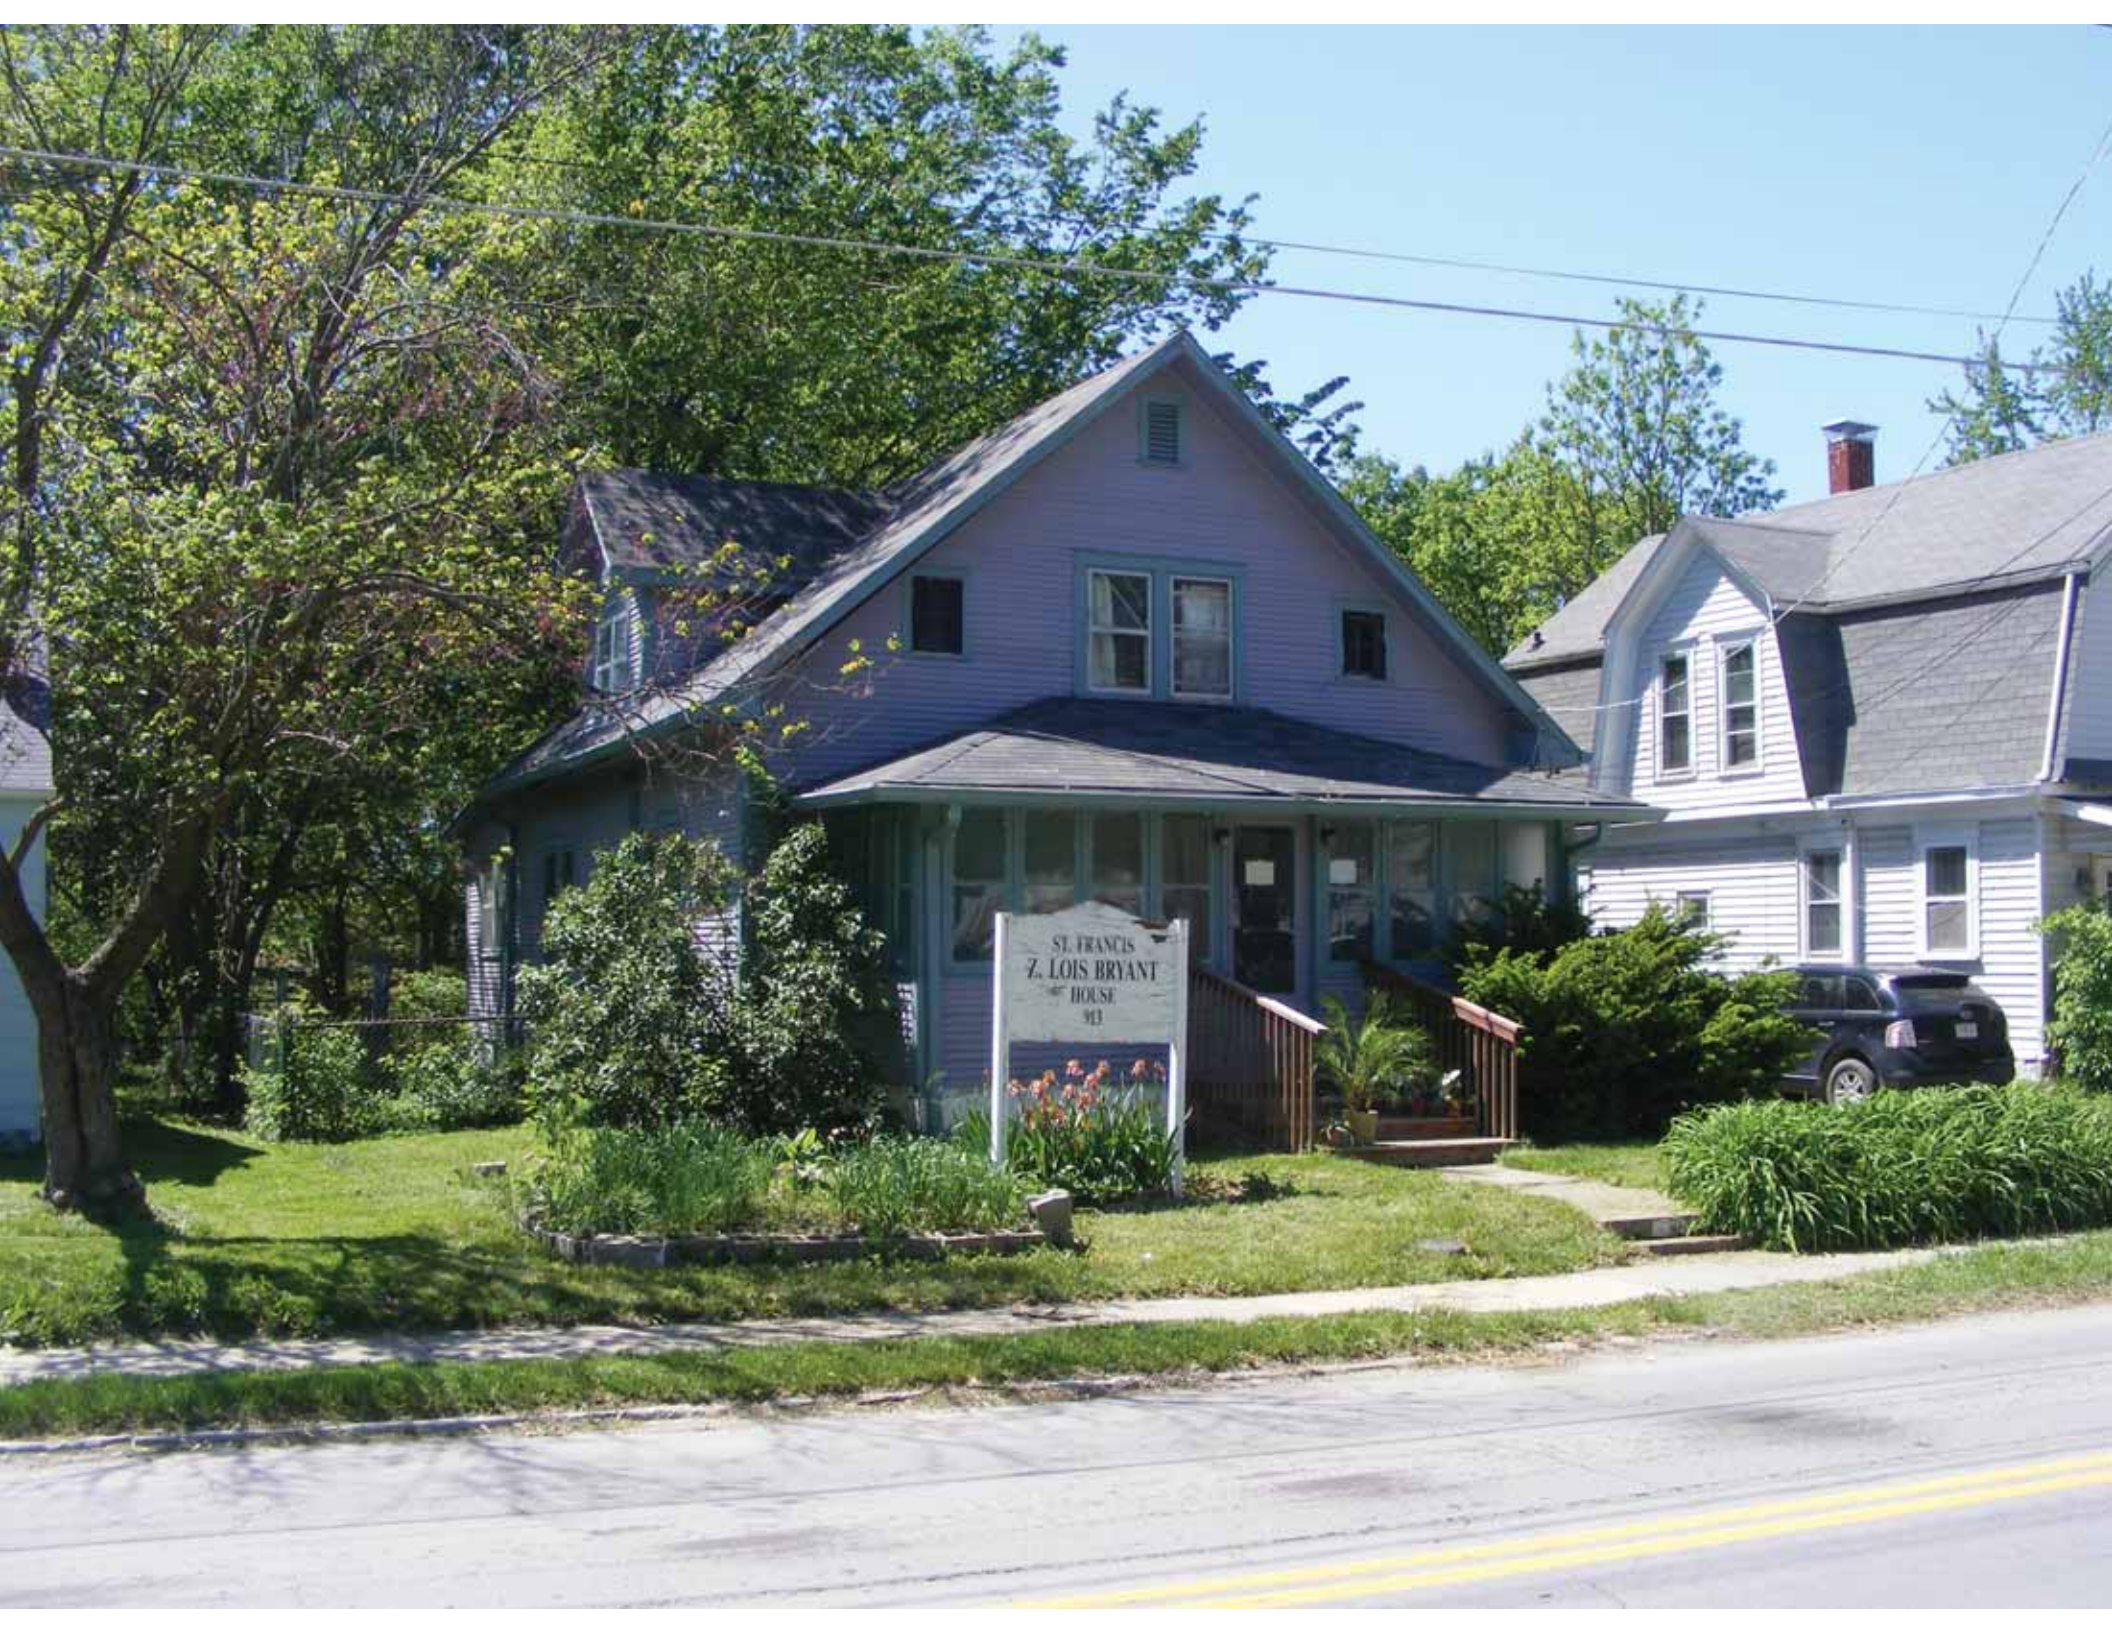
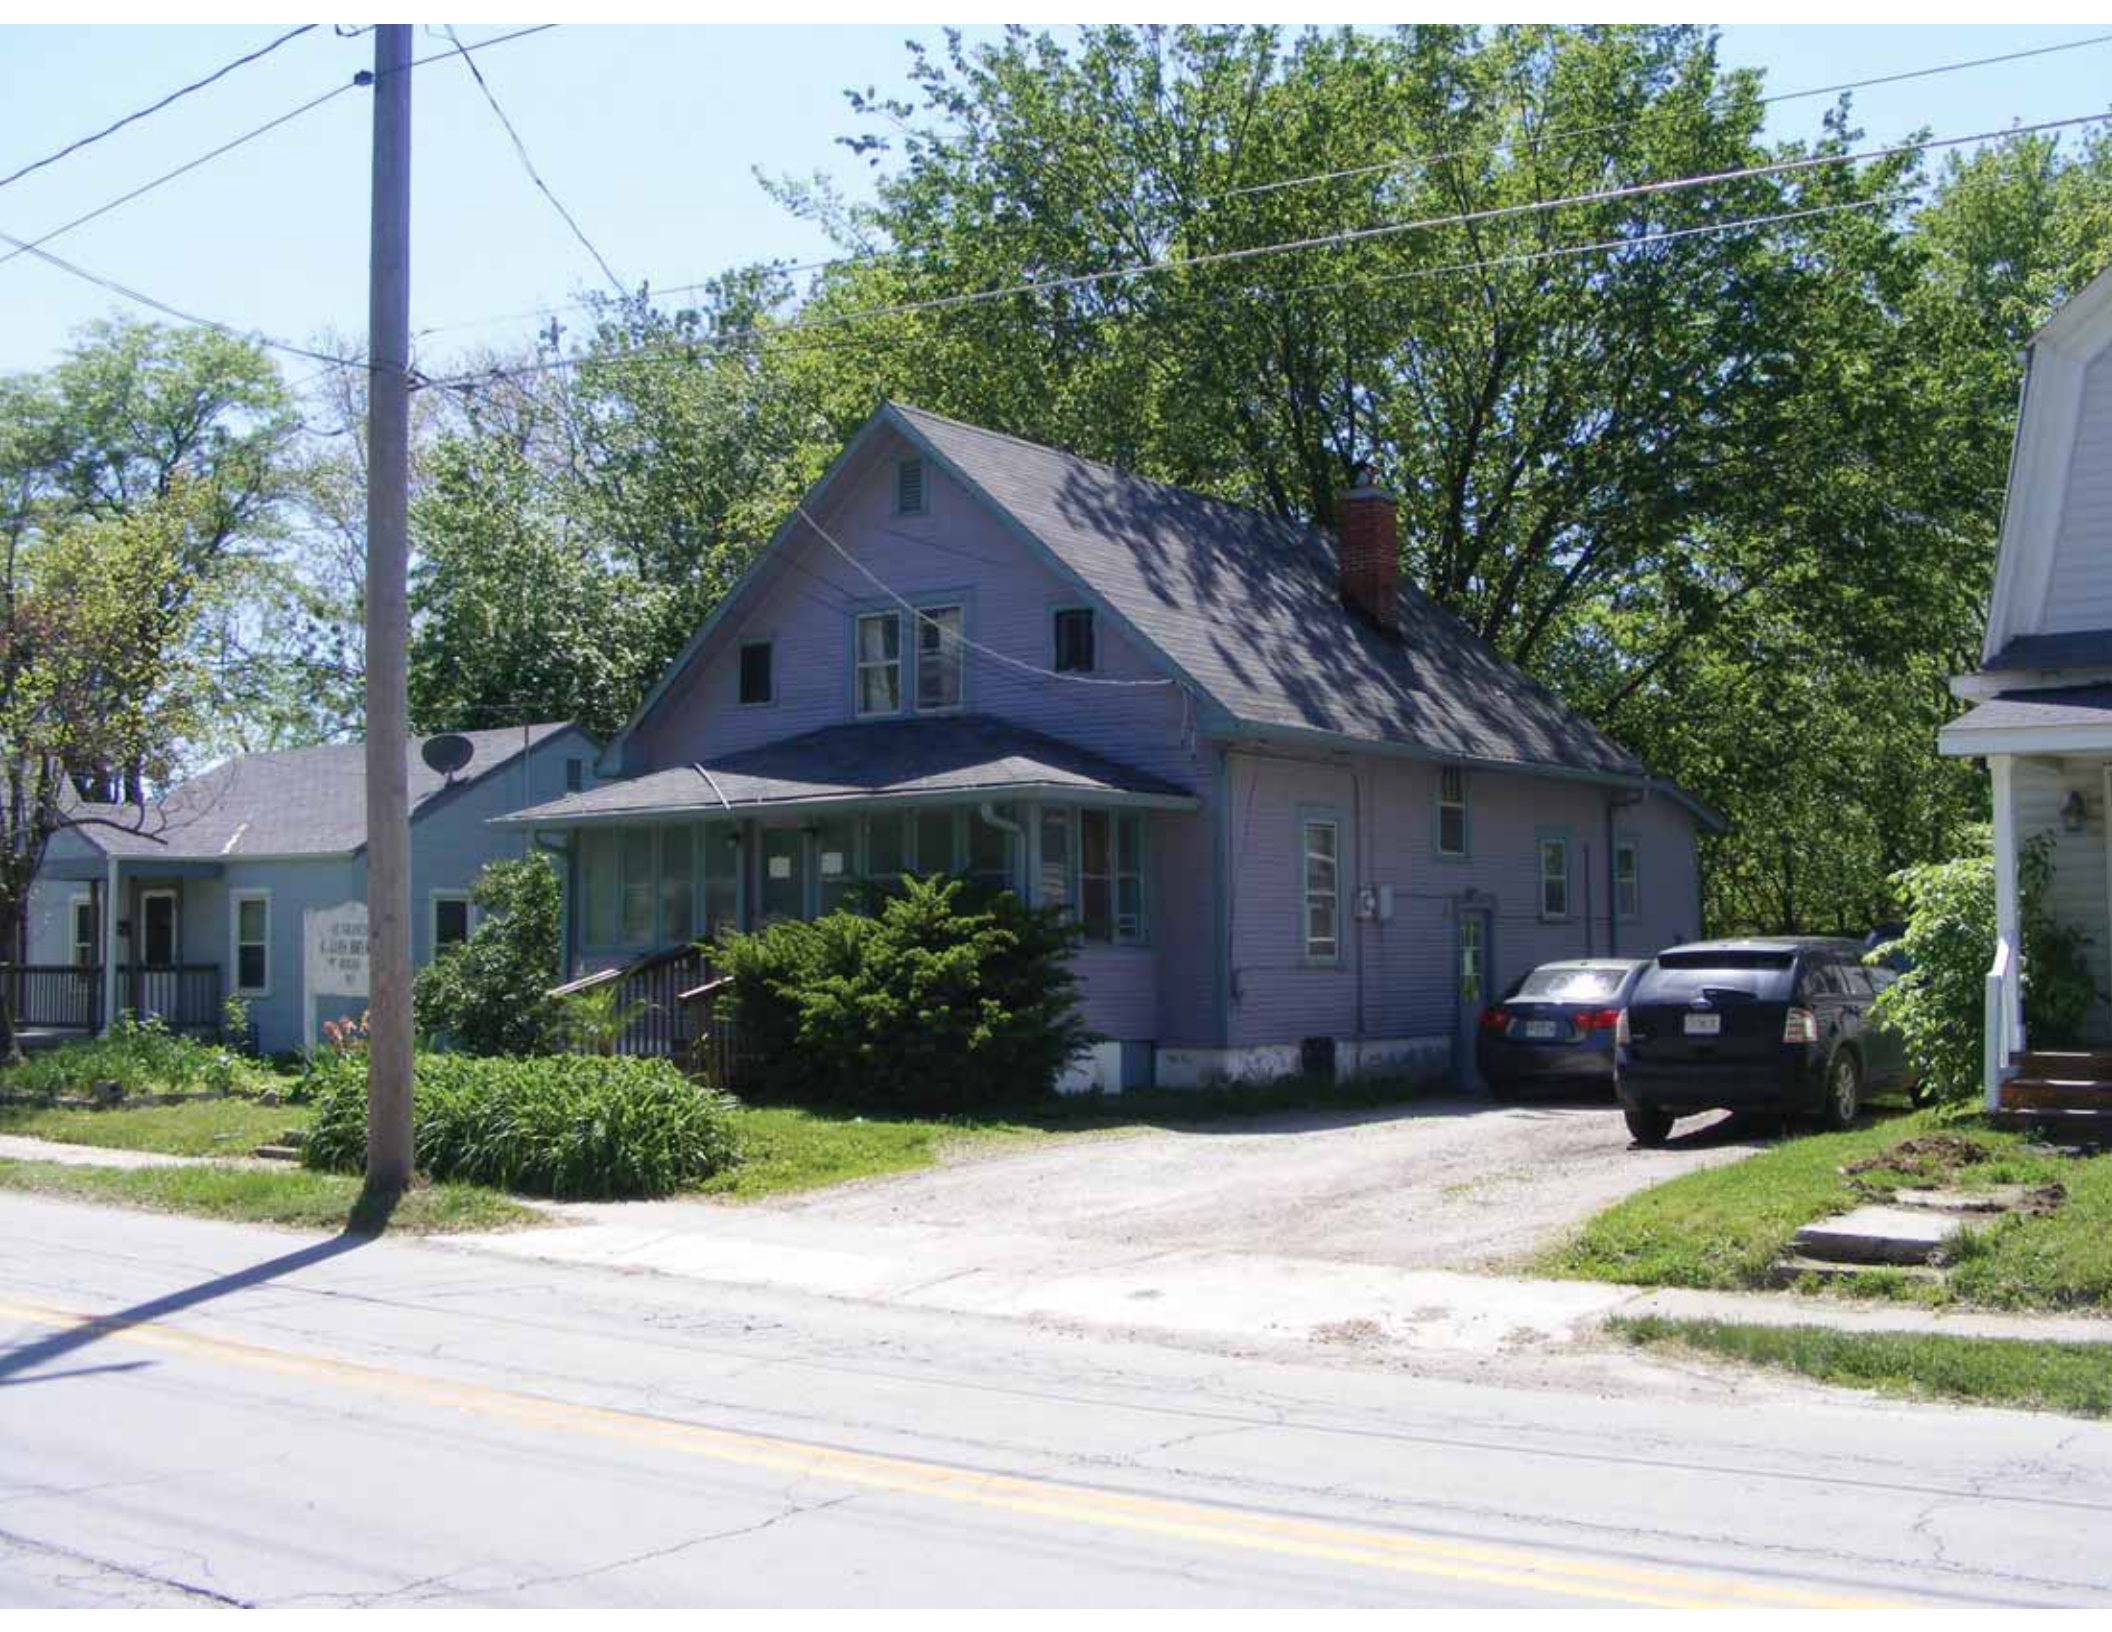
The gable-front plan dwelling has an asphalt shingled roof, exterior weatherboard siding and a raised concrete foundation. The primary (east) elevation supports a hipped enclosed porch with frame handrails flanking the porch steps. The enclosed porch has a central storm door flanked by continuous one-over-one windows. Above the porch are paired one-over-one windows. Original four-light windows flank the paired windows. The gable field holds a louvered vent. An interior brick chimney is situated near the north end of the dwelling. The north elevation supports a secondary original entry bay with a replacement six-light door. The dwelling has a rear shed wing.
