MISSOURI DEPARTMENT OF NATURAL RESOURCES
STATE HISTORIC PRESERVATION OFFICE, P.O. Box 176, Jefferson City, MO 65102
ARCHITECTURAL/HISTORIC INVENTORY FORM

1. Survey No. BO-AS-011-0087		2. Survey name: North Central Columbia Survey Phase II	
3. County: Boone		4. Address (Street No.) 902	Street (name) N. Seventh Street
5. City: Columbia	Vicinity: <input type="checkbox"/>	6. Geographical Reference:	7. Township/Range/Section: T: R: S:
8. Historic name (if known):		9. Present/other name (if known):	
10. Ownership: <input checked="" type="checkbox"/> Private <input type="checkbox"/> Public		11a. Historic use (if known): Domestic/single dwelling	11b. Current use: Domestic/single dwelling

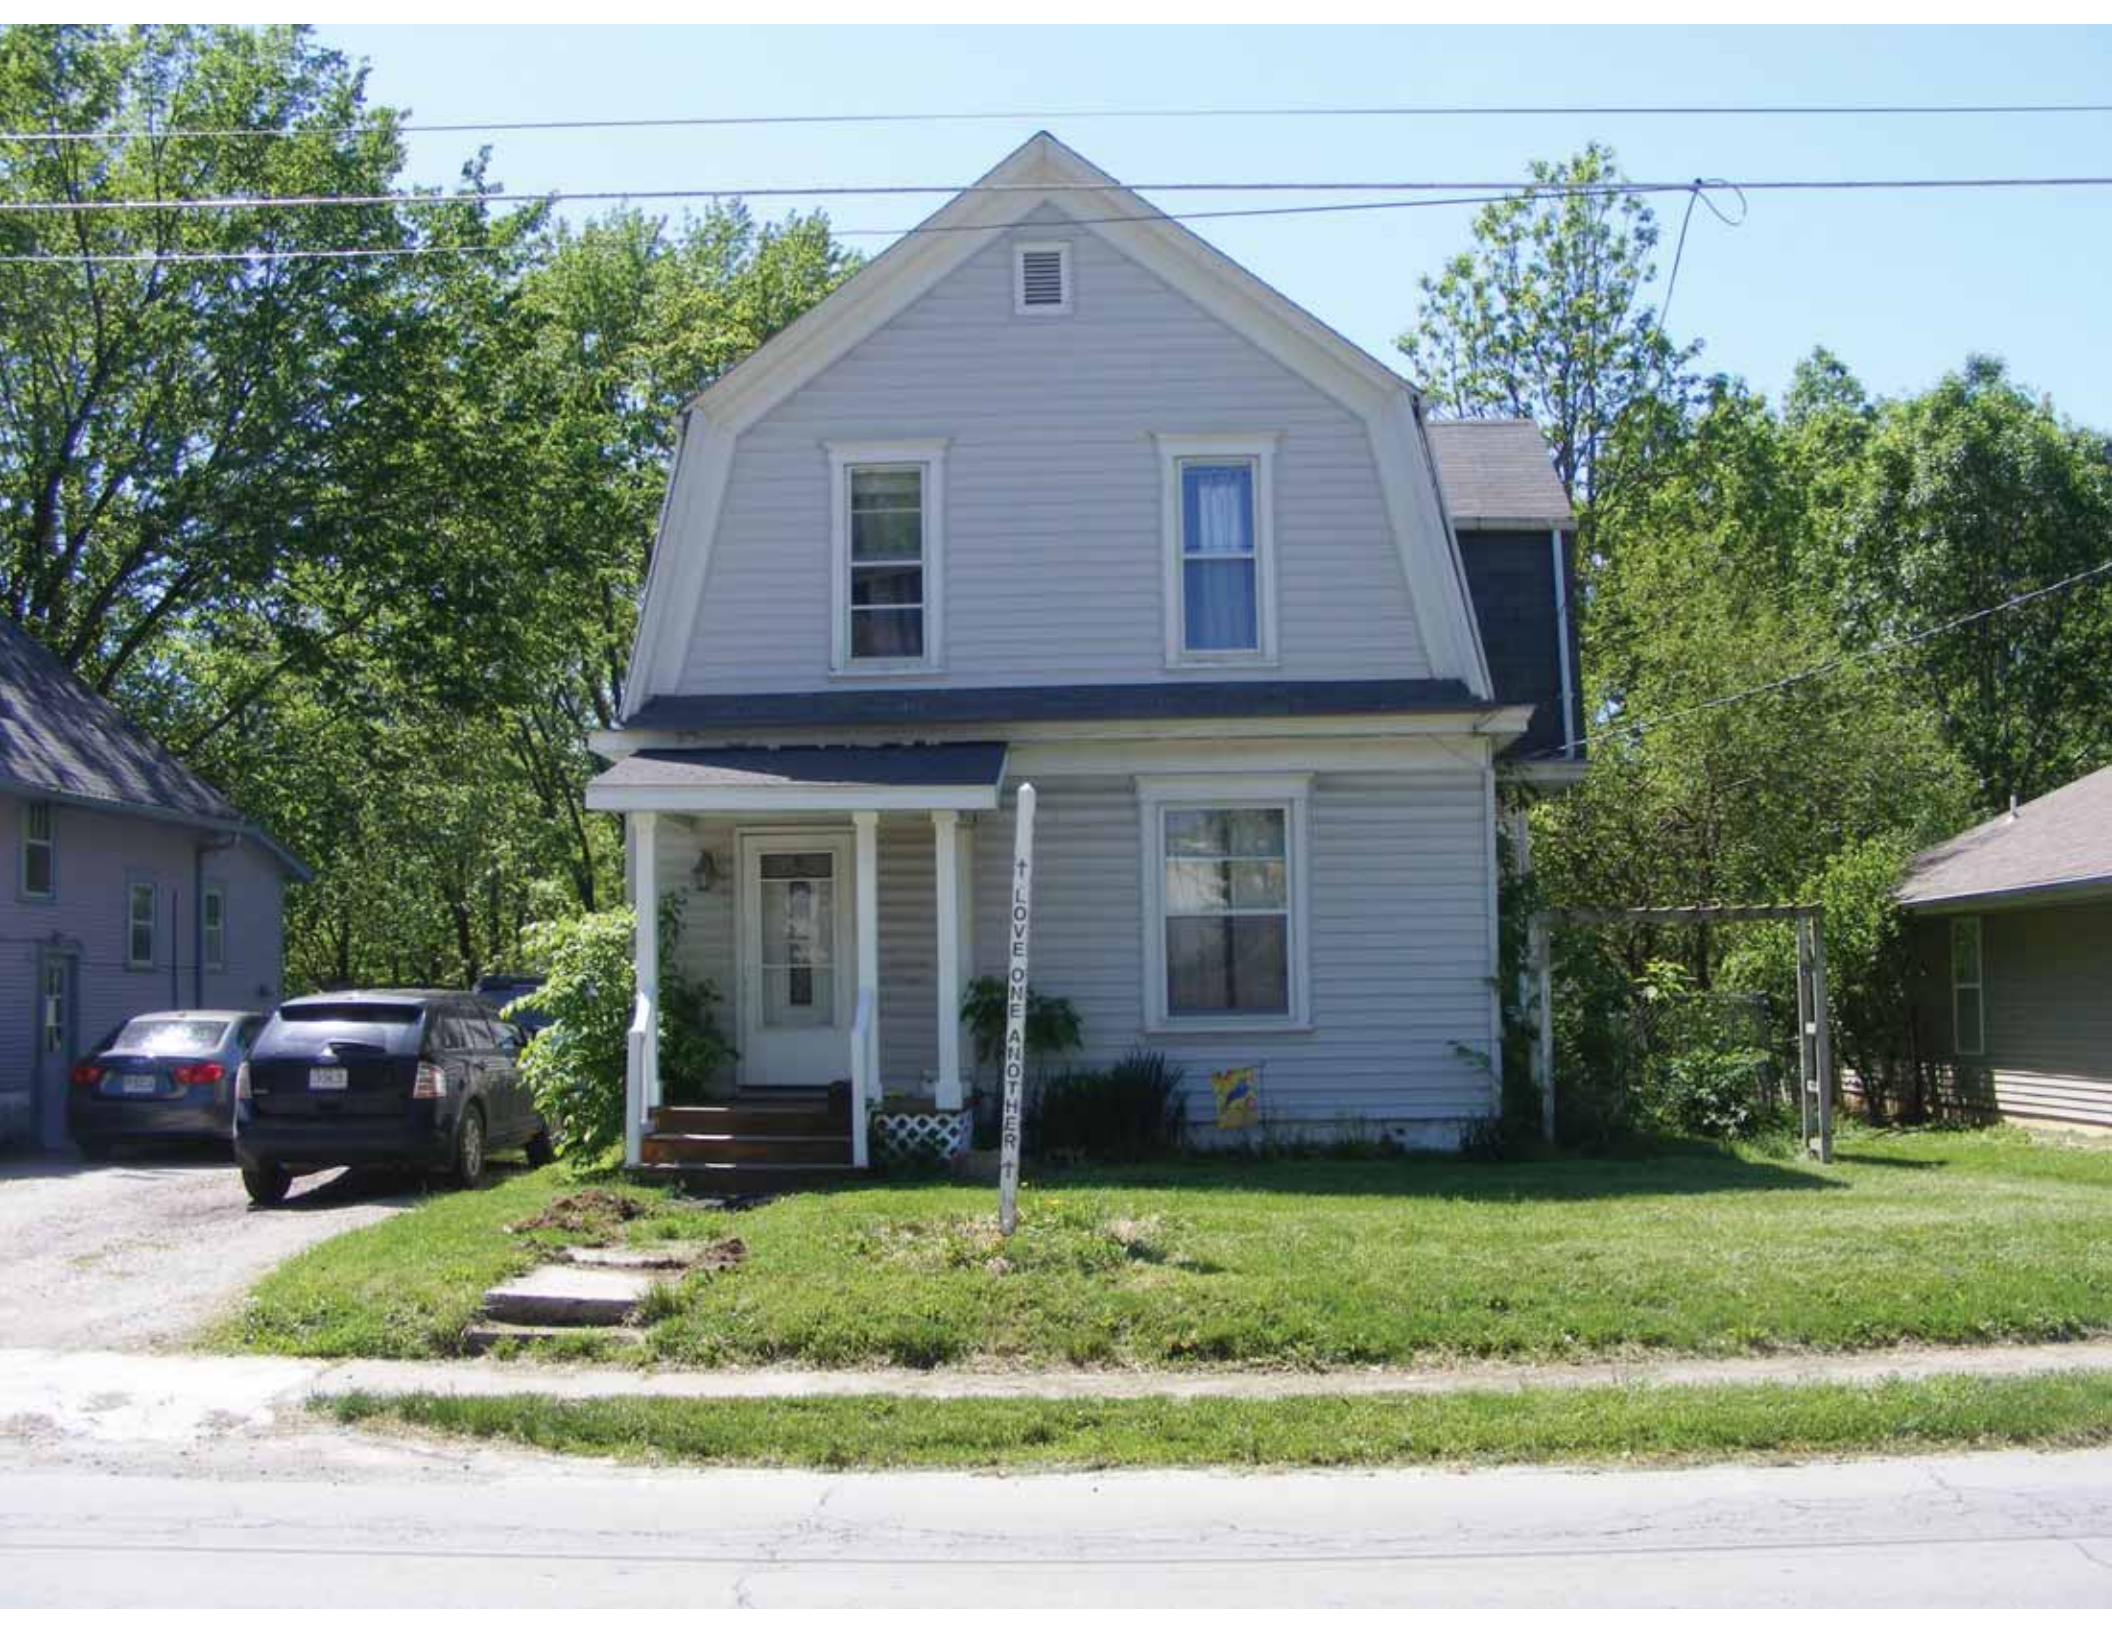
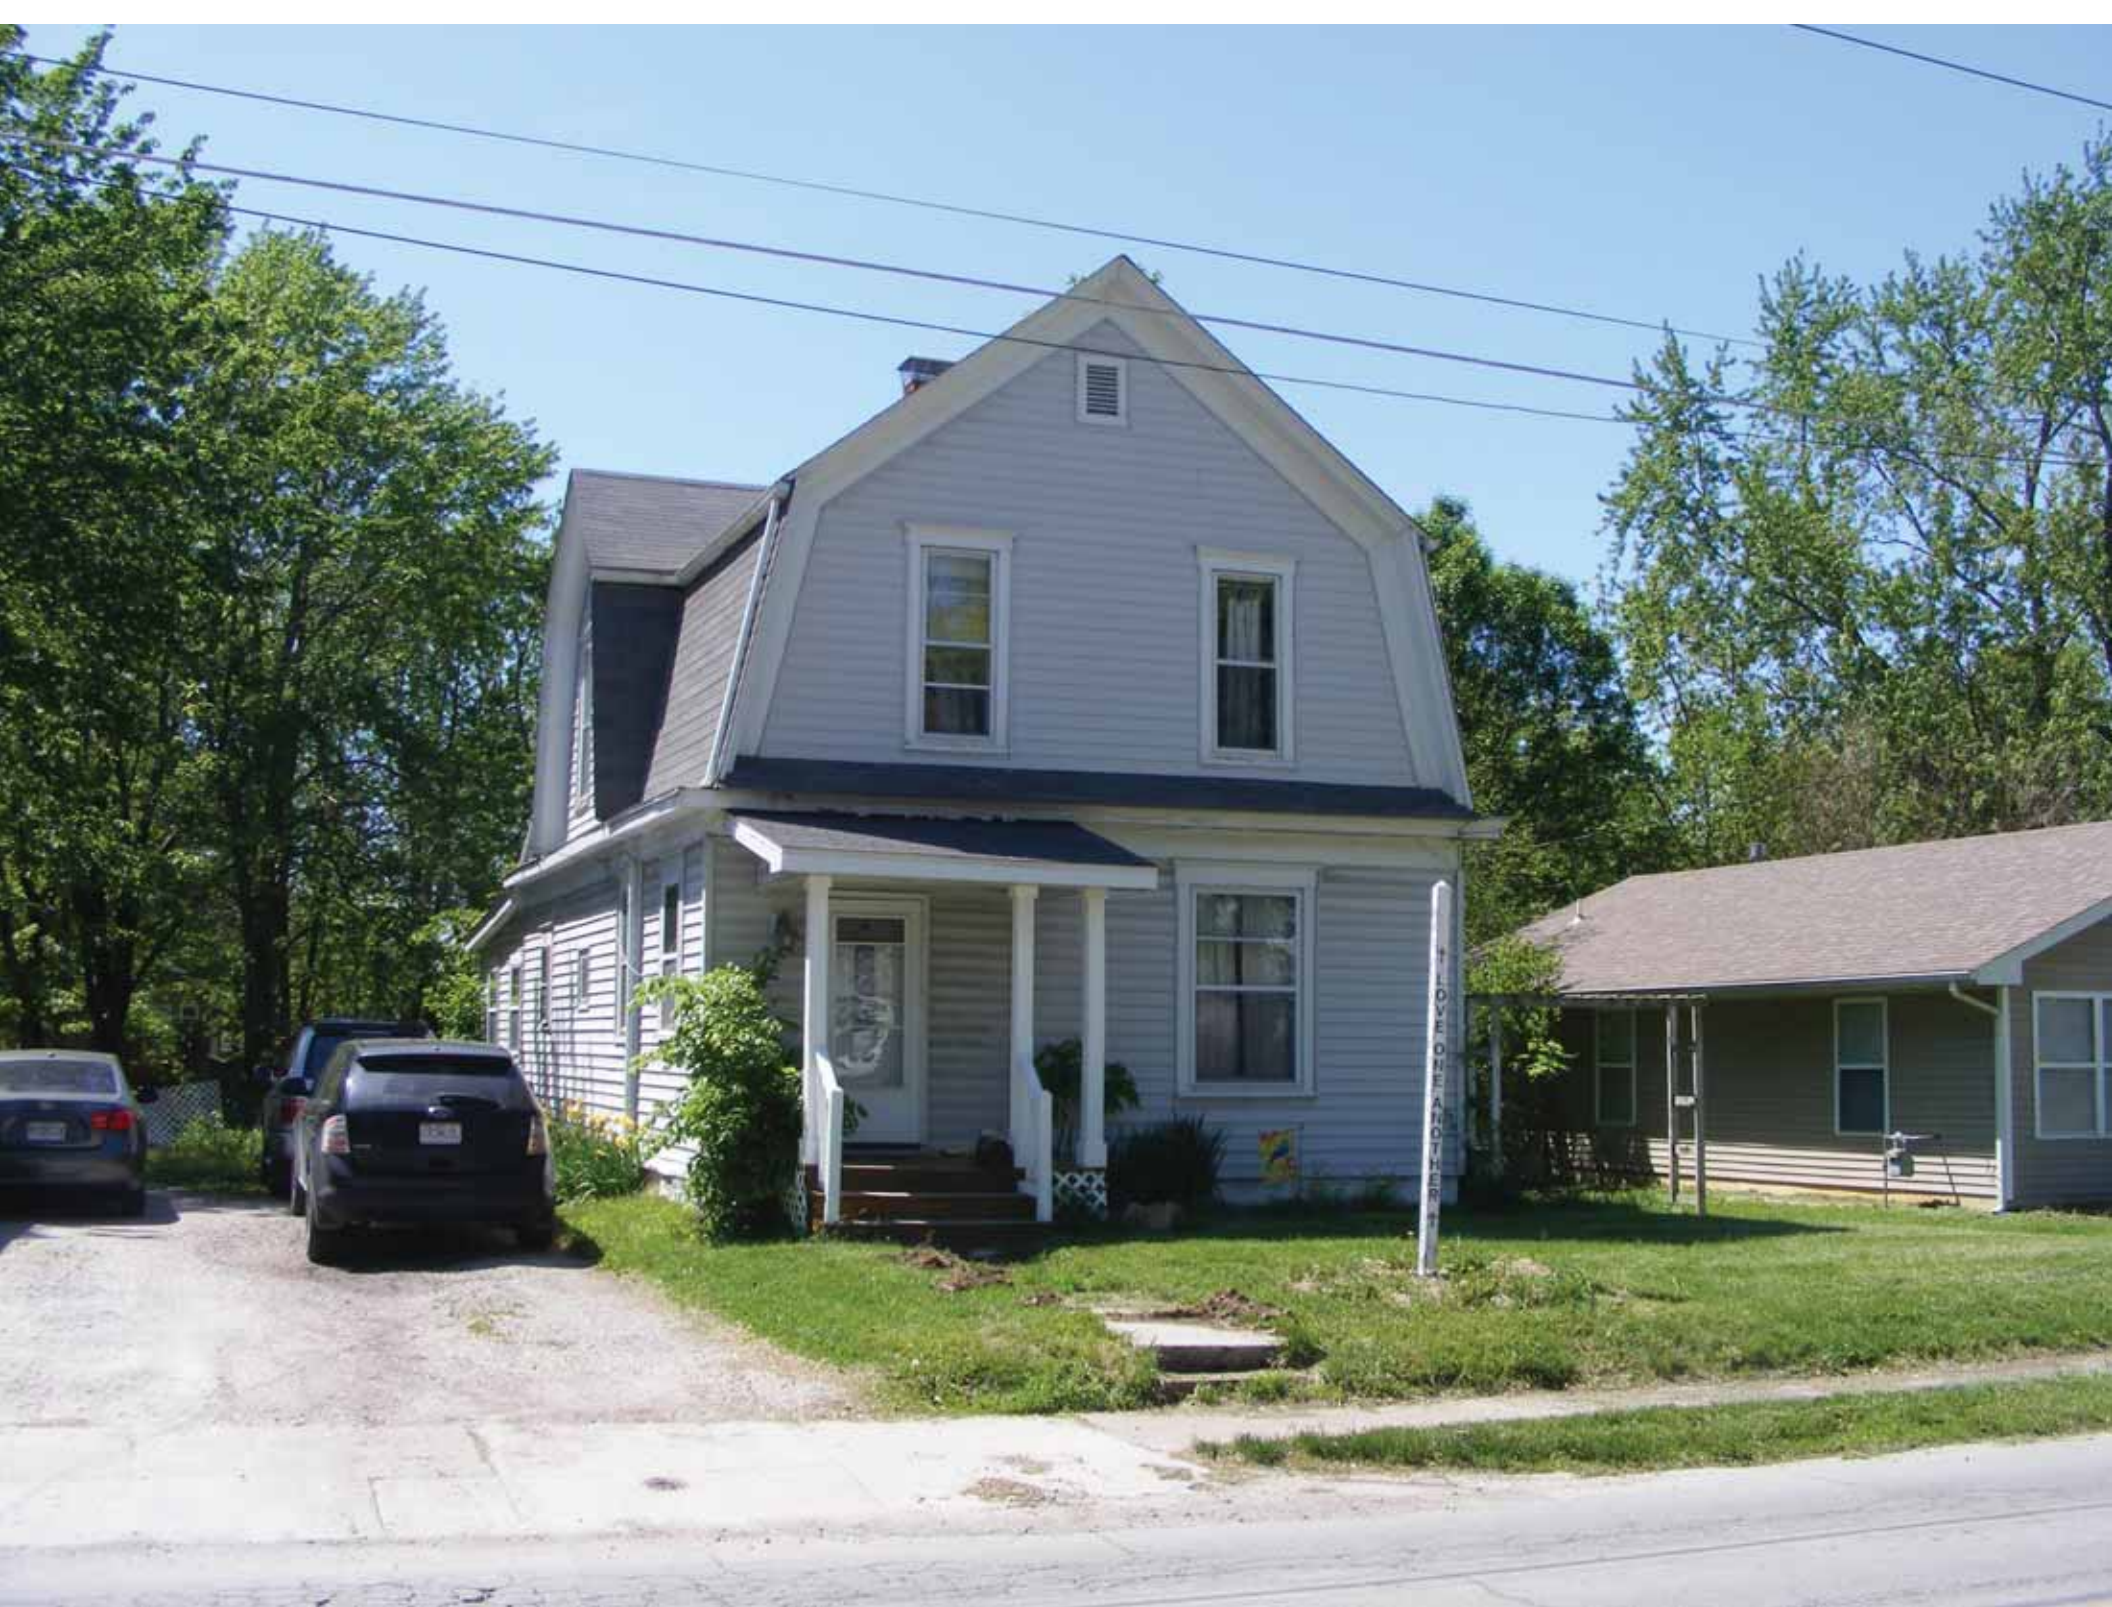
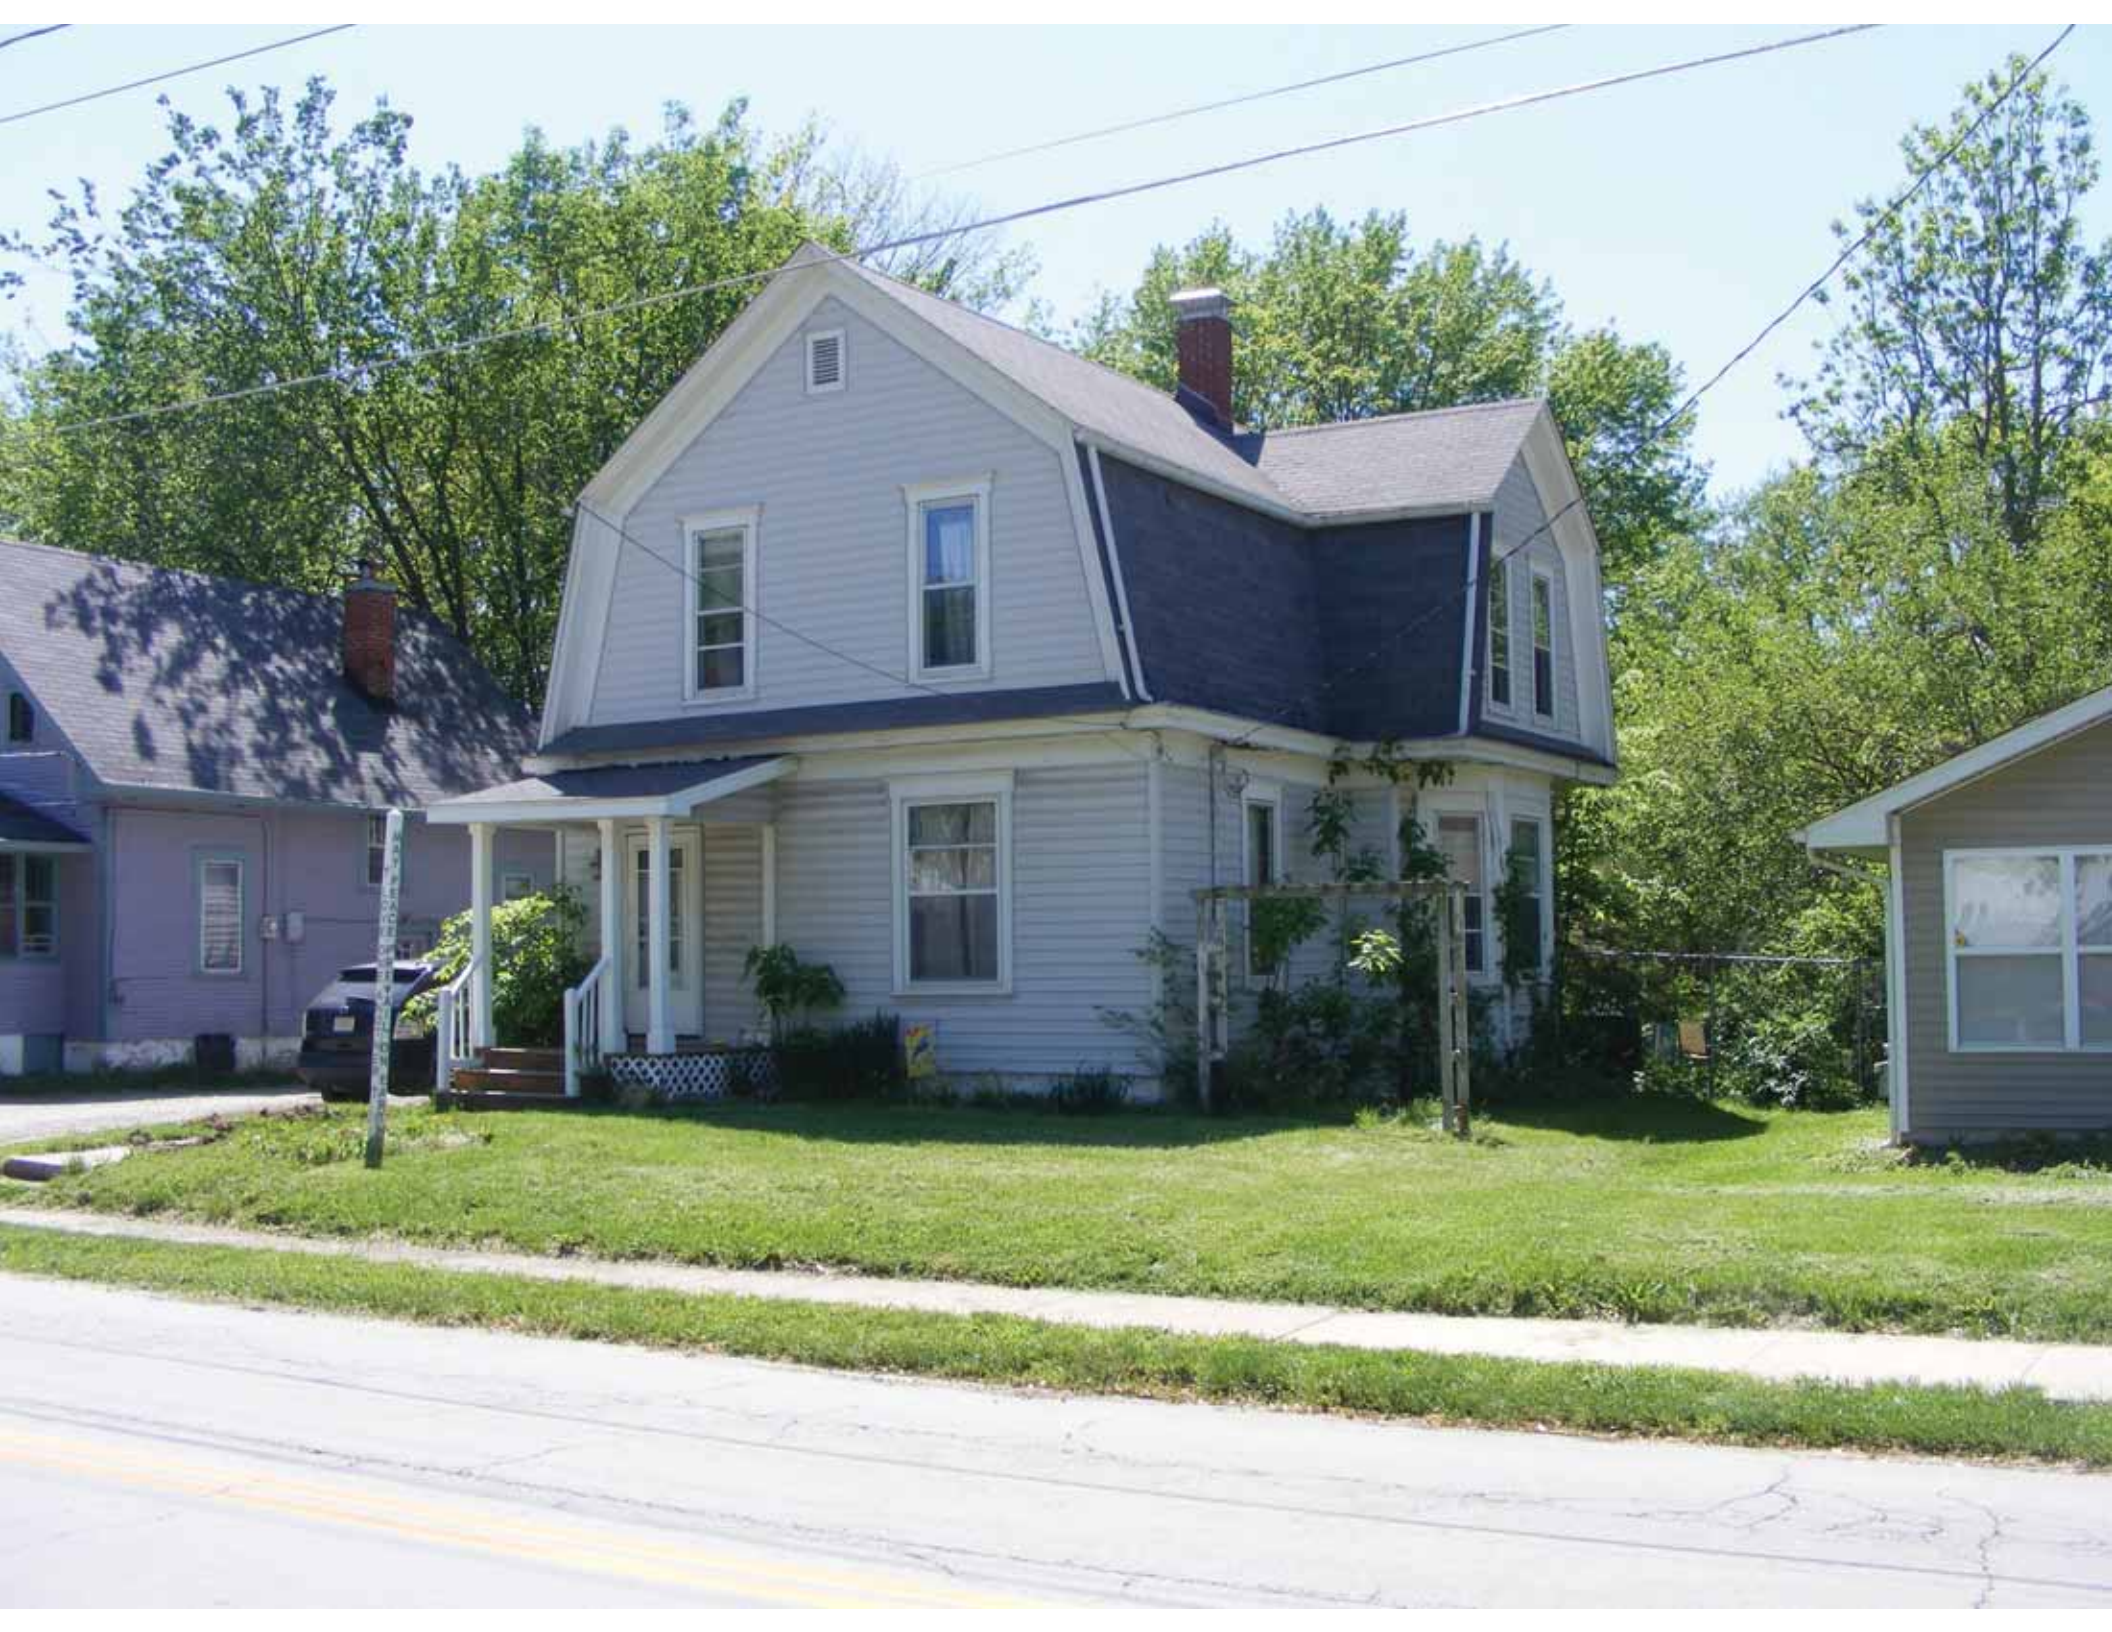
The dwelling has a front facing gambrel roof clad with asphalt shingles, exterior synthetic siding and a concrete foundation. The primary (east) elevation has an off-center shed portico supported by wood columns. A frame balustrade (not original) flanks the steps and sides of the portico. Within the entry bay is a c. 2000 single-light door. The portico is offset by a one-over-one replacement window. Remaining windows are of similar configuration. The roofline ridge supports an interior brick chimney. The upper façade holds two double-hung windows. The gable field supports a louvered vent. Side elevations (north and south) have gambrel cross gables supporting single double-hung windows on the upper elevation walls. Below the north cross-gabled gambrel, the first-story has a projecting window bay (original) with three windows. The dwelling has a rear shed wing.

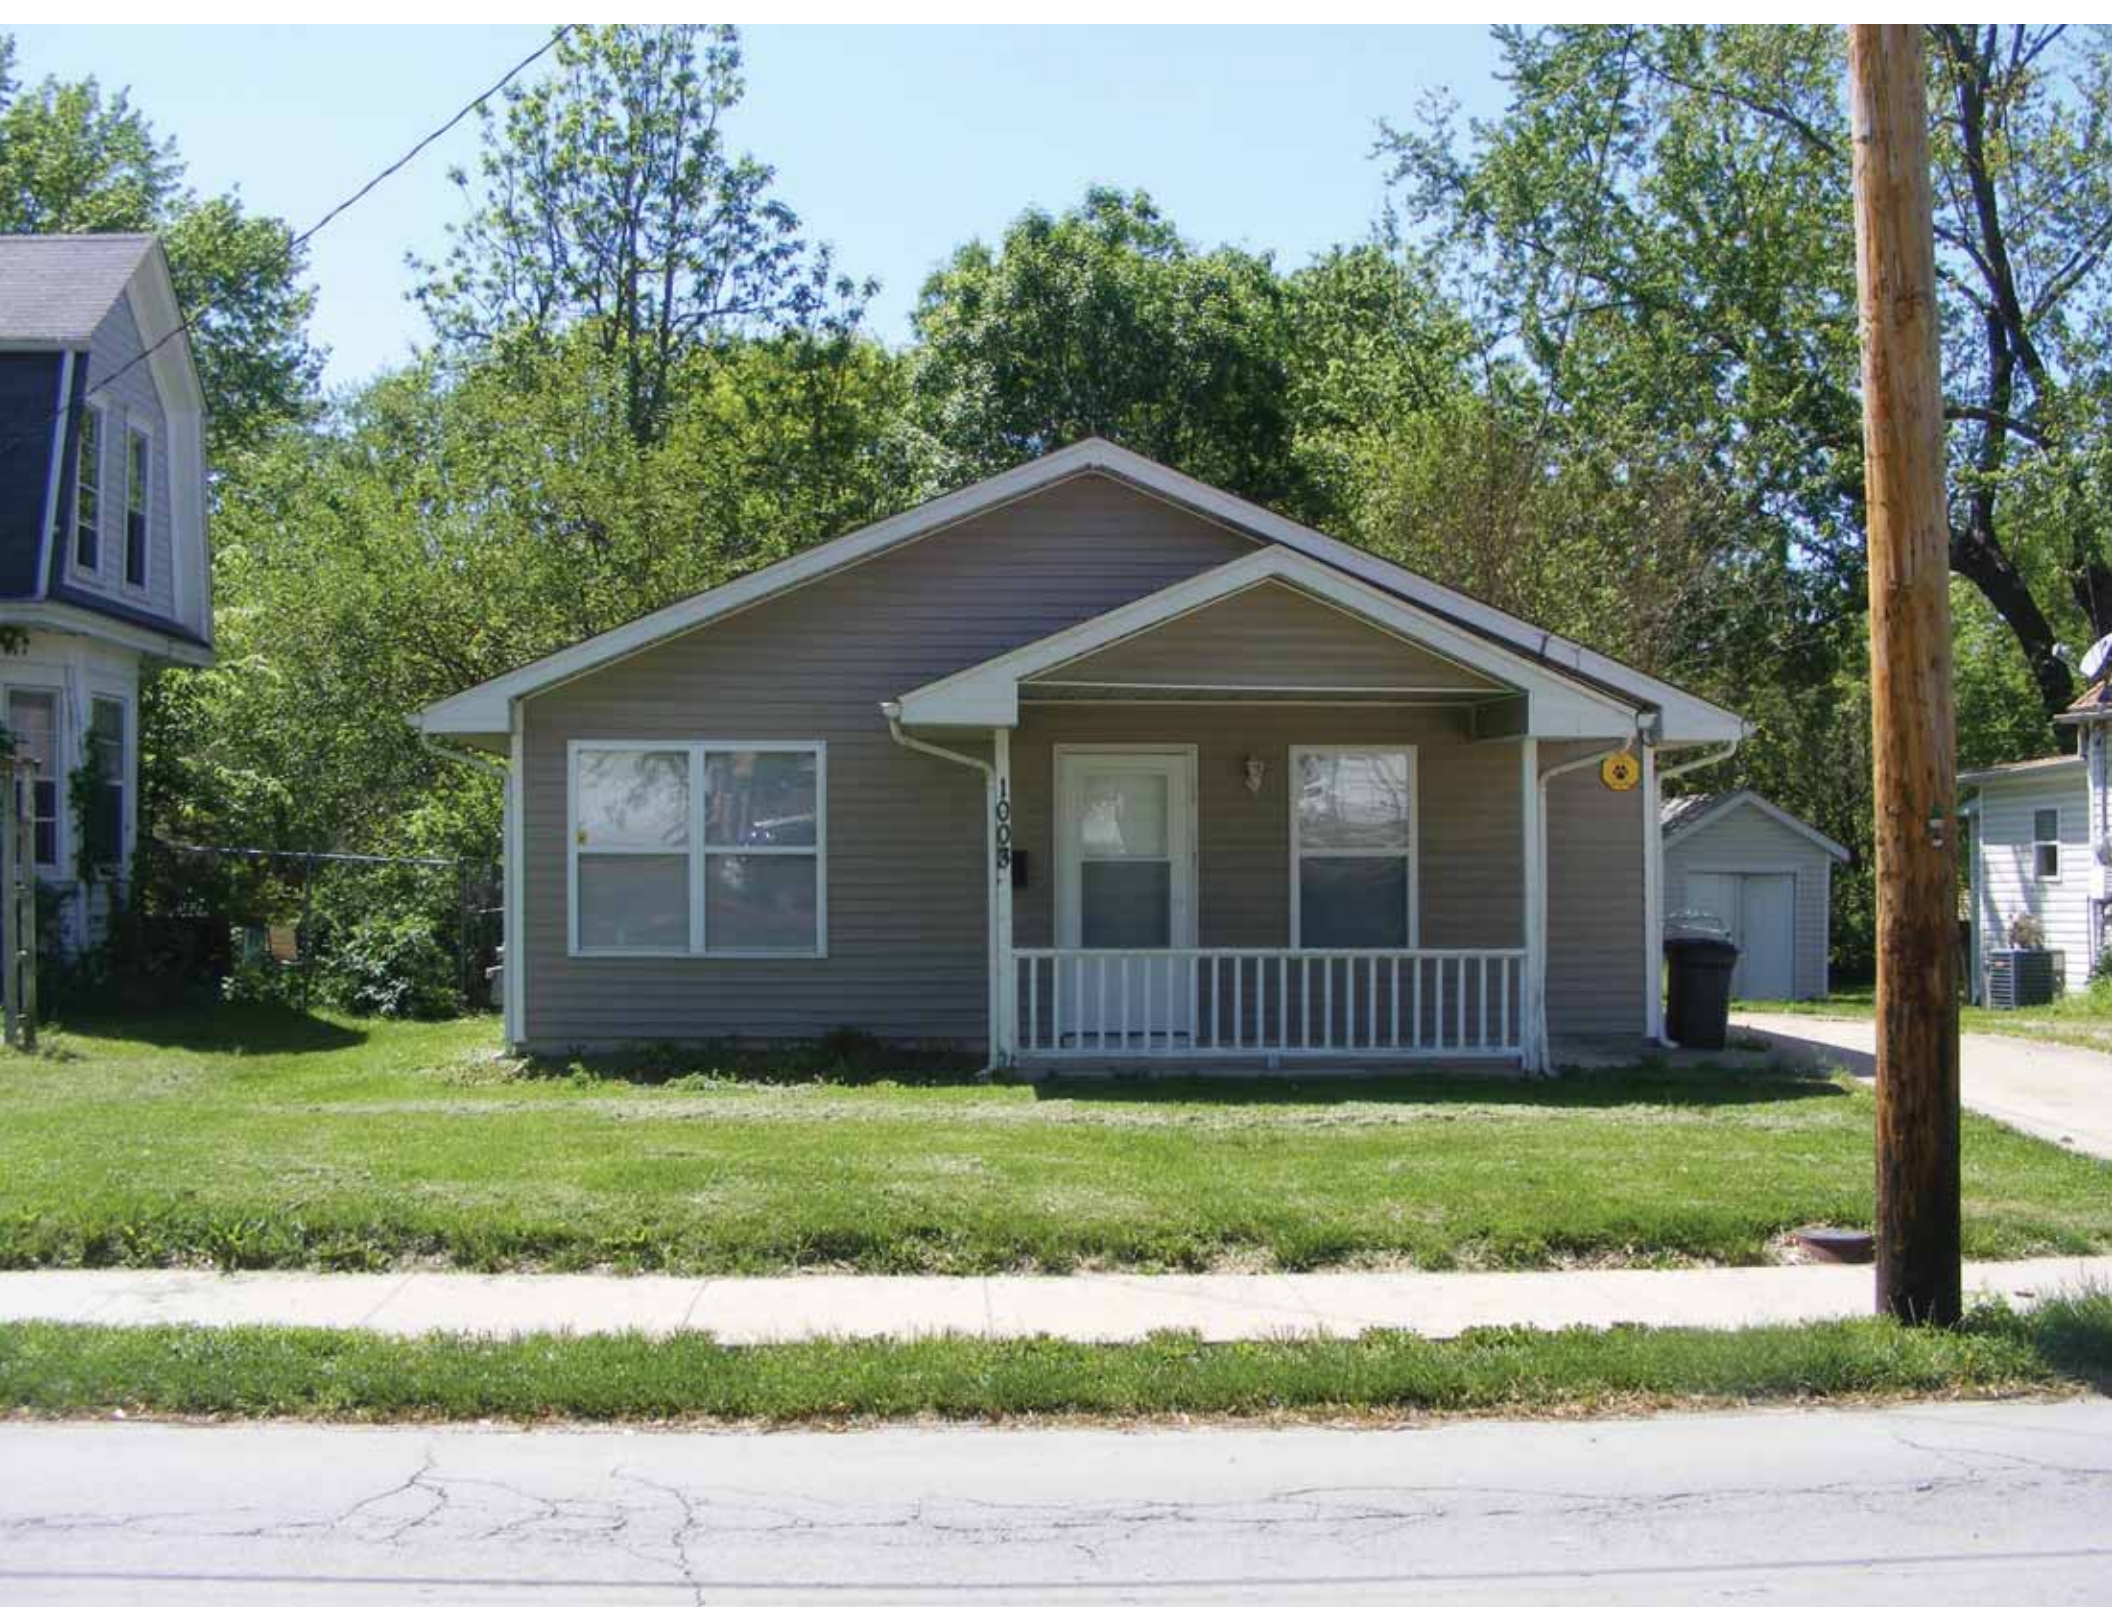
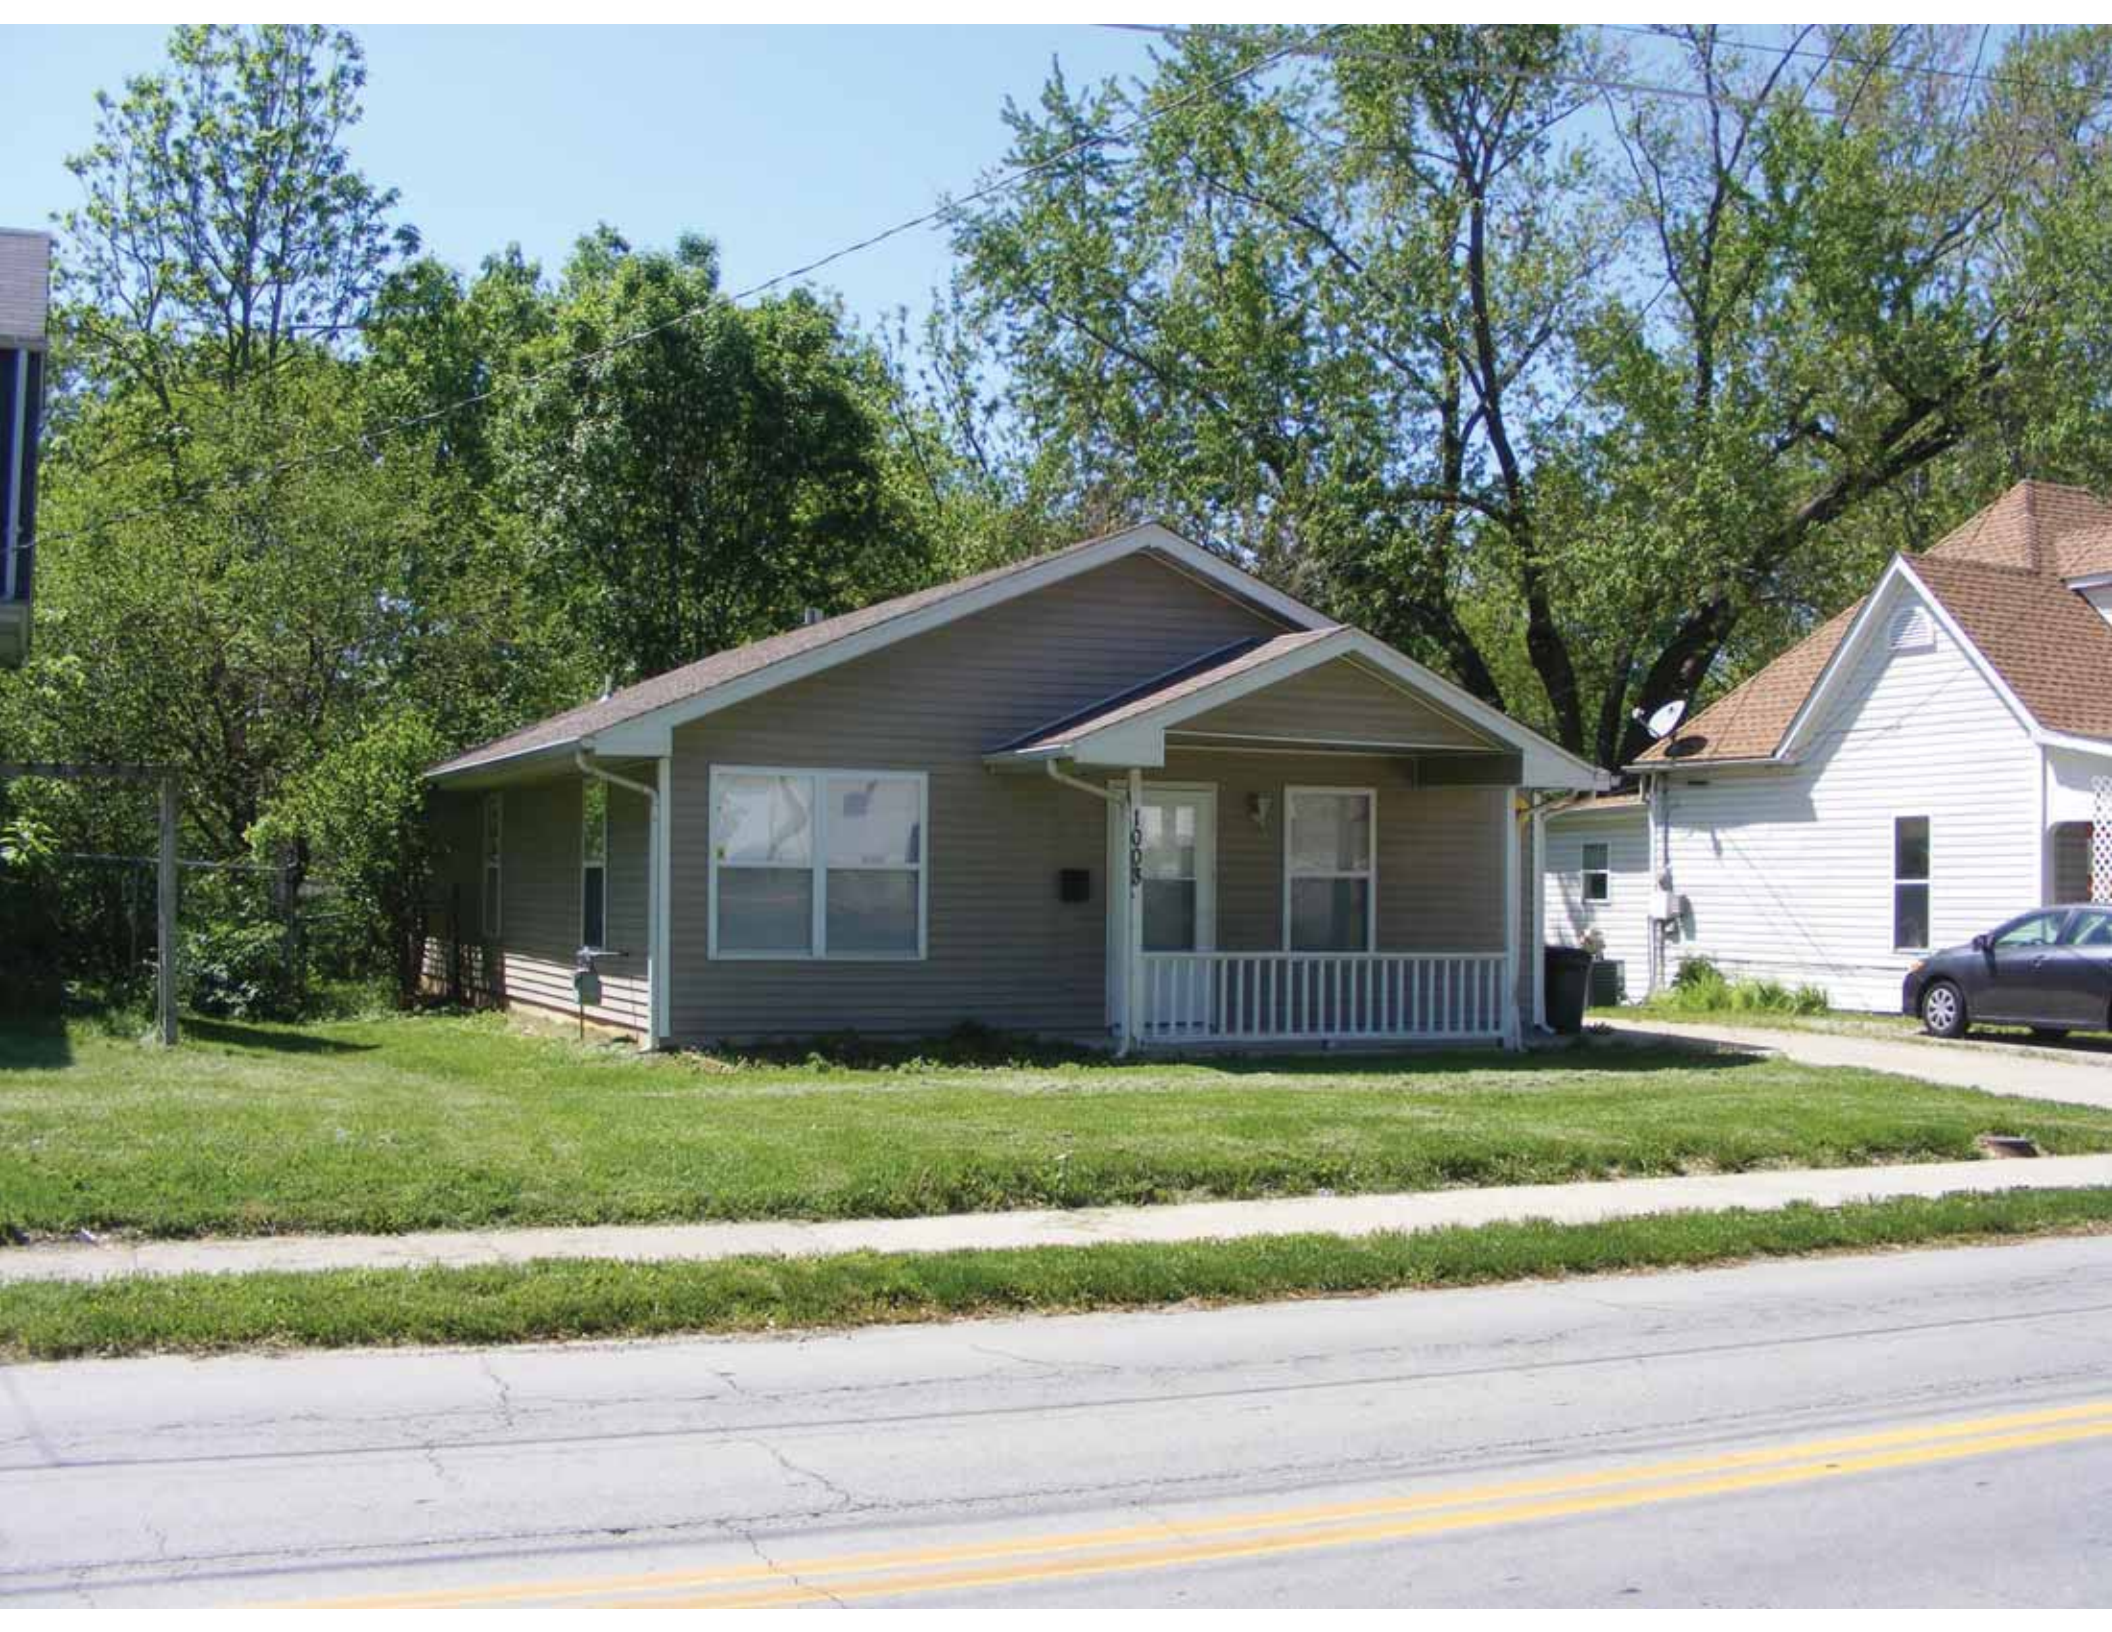
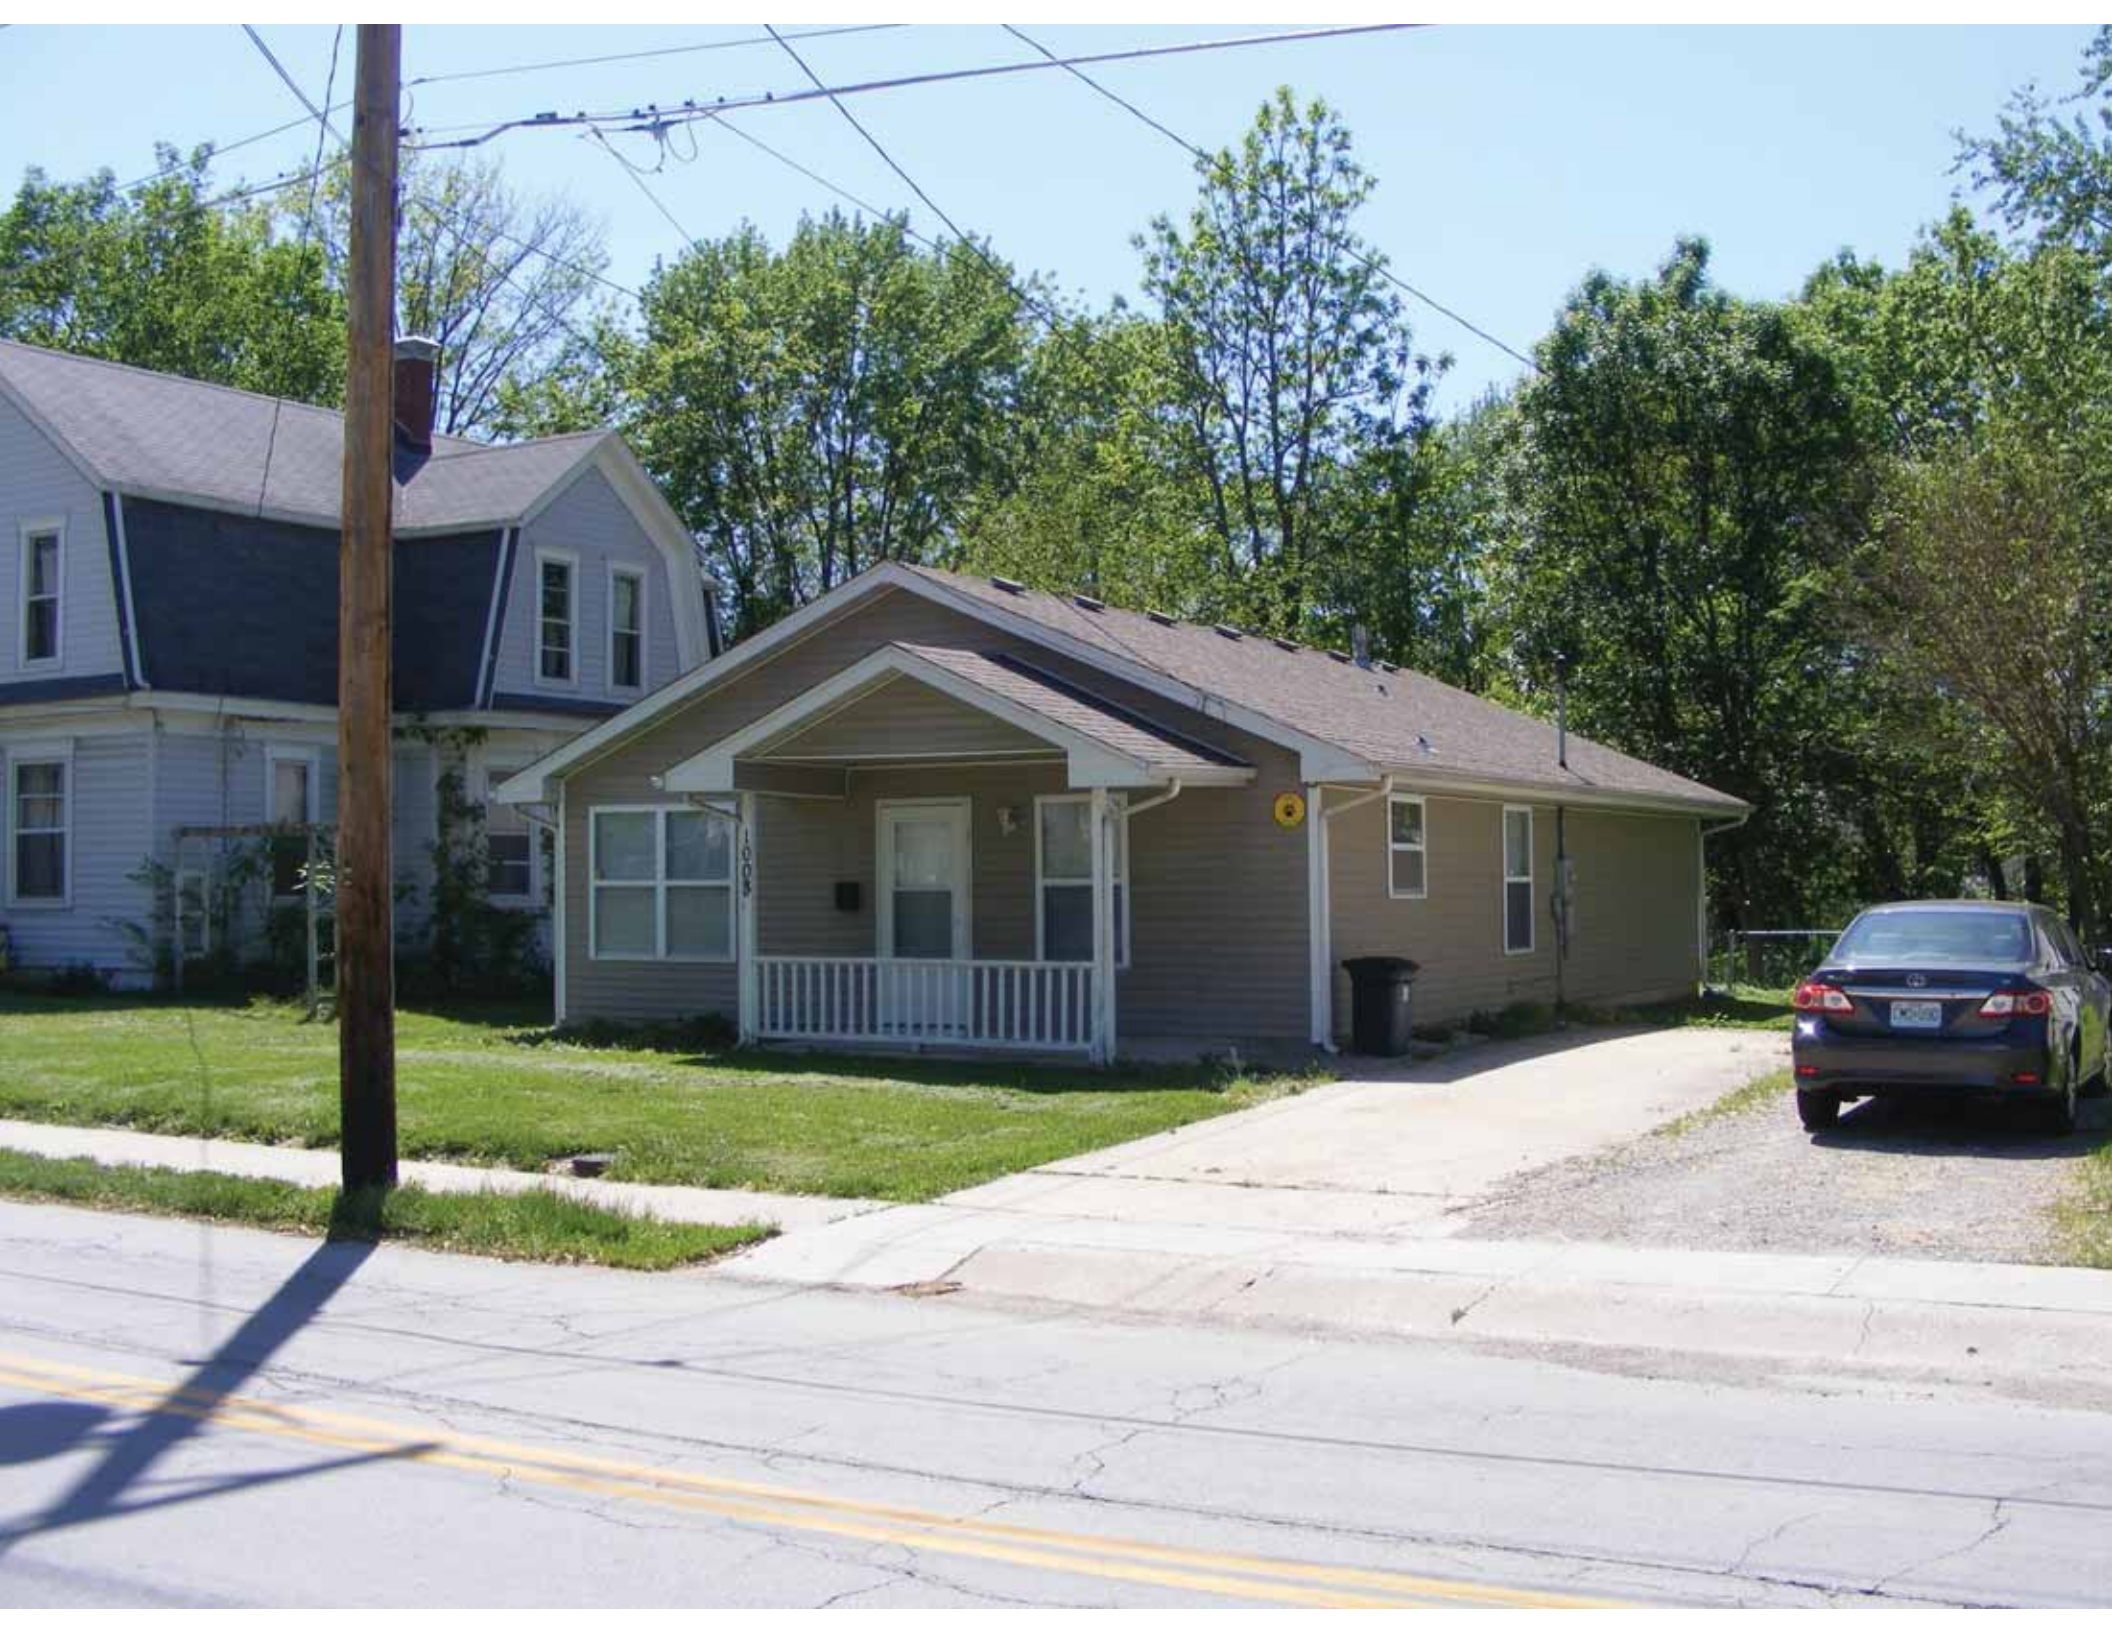
The gable-front plan dwelling has an asphalt shingled roof, exterior synthetic siding and a concrete foundation. The primary (east) elevation has an off-center gabled porch supported by two square wood columns. A frame balustrade extends between the columns. Within the porch bay is a paneled door offset by a one-over-one windows. Remaining windows are of similar configuration.
