MISSOURI DEPARTMENT OF NATURAL RESOURCES
STATE HISTORIC PRESERVATION OFFICE, P.O. Box 176, Jefferson City, MO 65102
ARCHITECTURAL/HISTORIC INVENTORY FORM

1. Survey No. BO-AS-011-0087		2. Survey name: North Central Columbia Survey Phase II	
3. County: Boone		4. Address (Street No.) 902	Street (name) N. Seventh Street
5. City: Columbia	Vicinity: <input type="checkbox"/>	6. Geographical Reference:	7. Township/Range/Section: T: R: S:
8. Historic name (if known):		9. Present/other name (if known):	
10. Ownership: <input checked="" type="checkbox"/> Private <input type="checkbox"/> Public		11a. Historic use (if known): Domestic/single dwelling	11b. Current use: Domestic/single dwelling

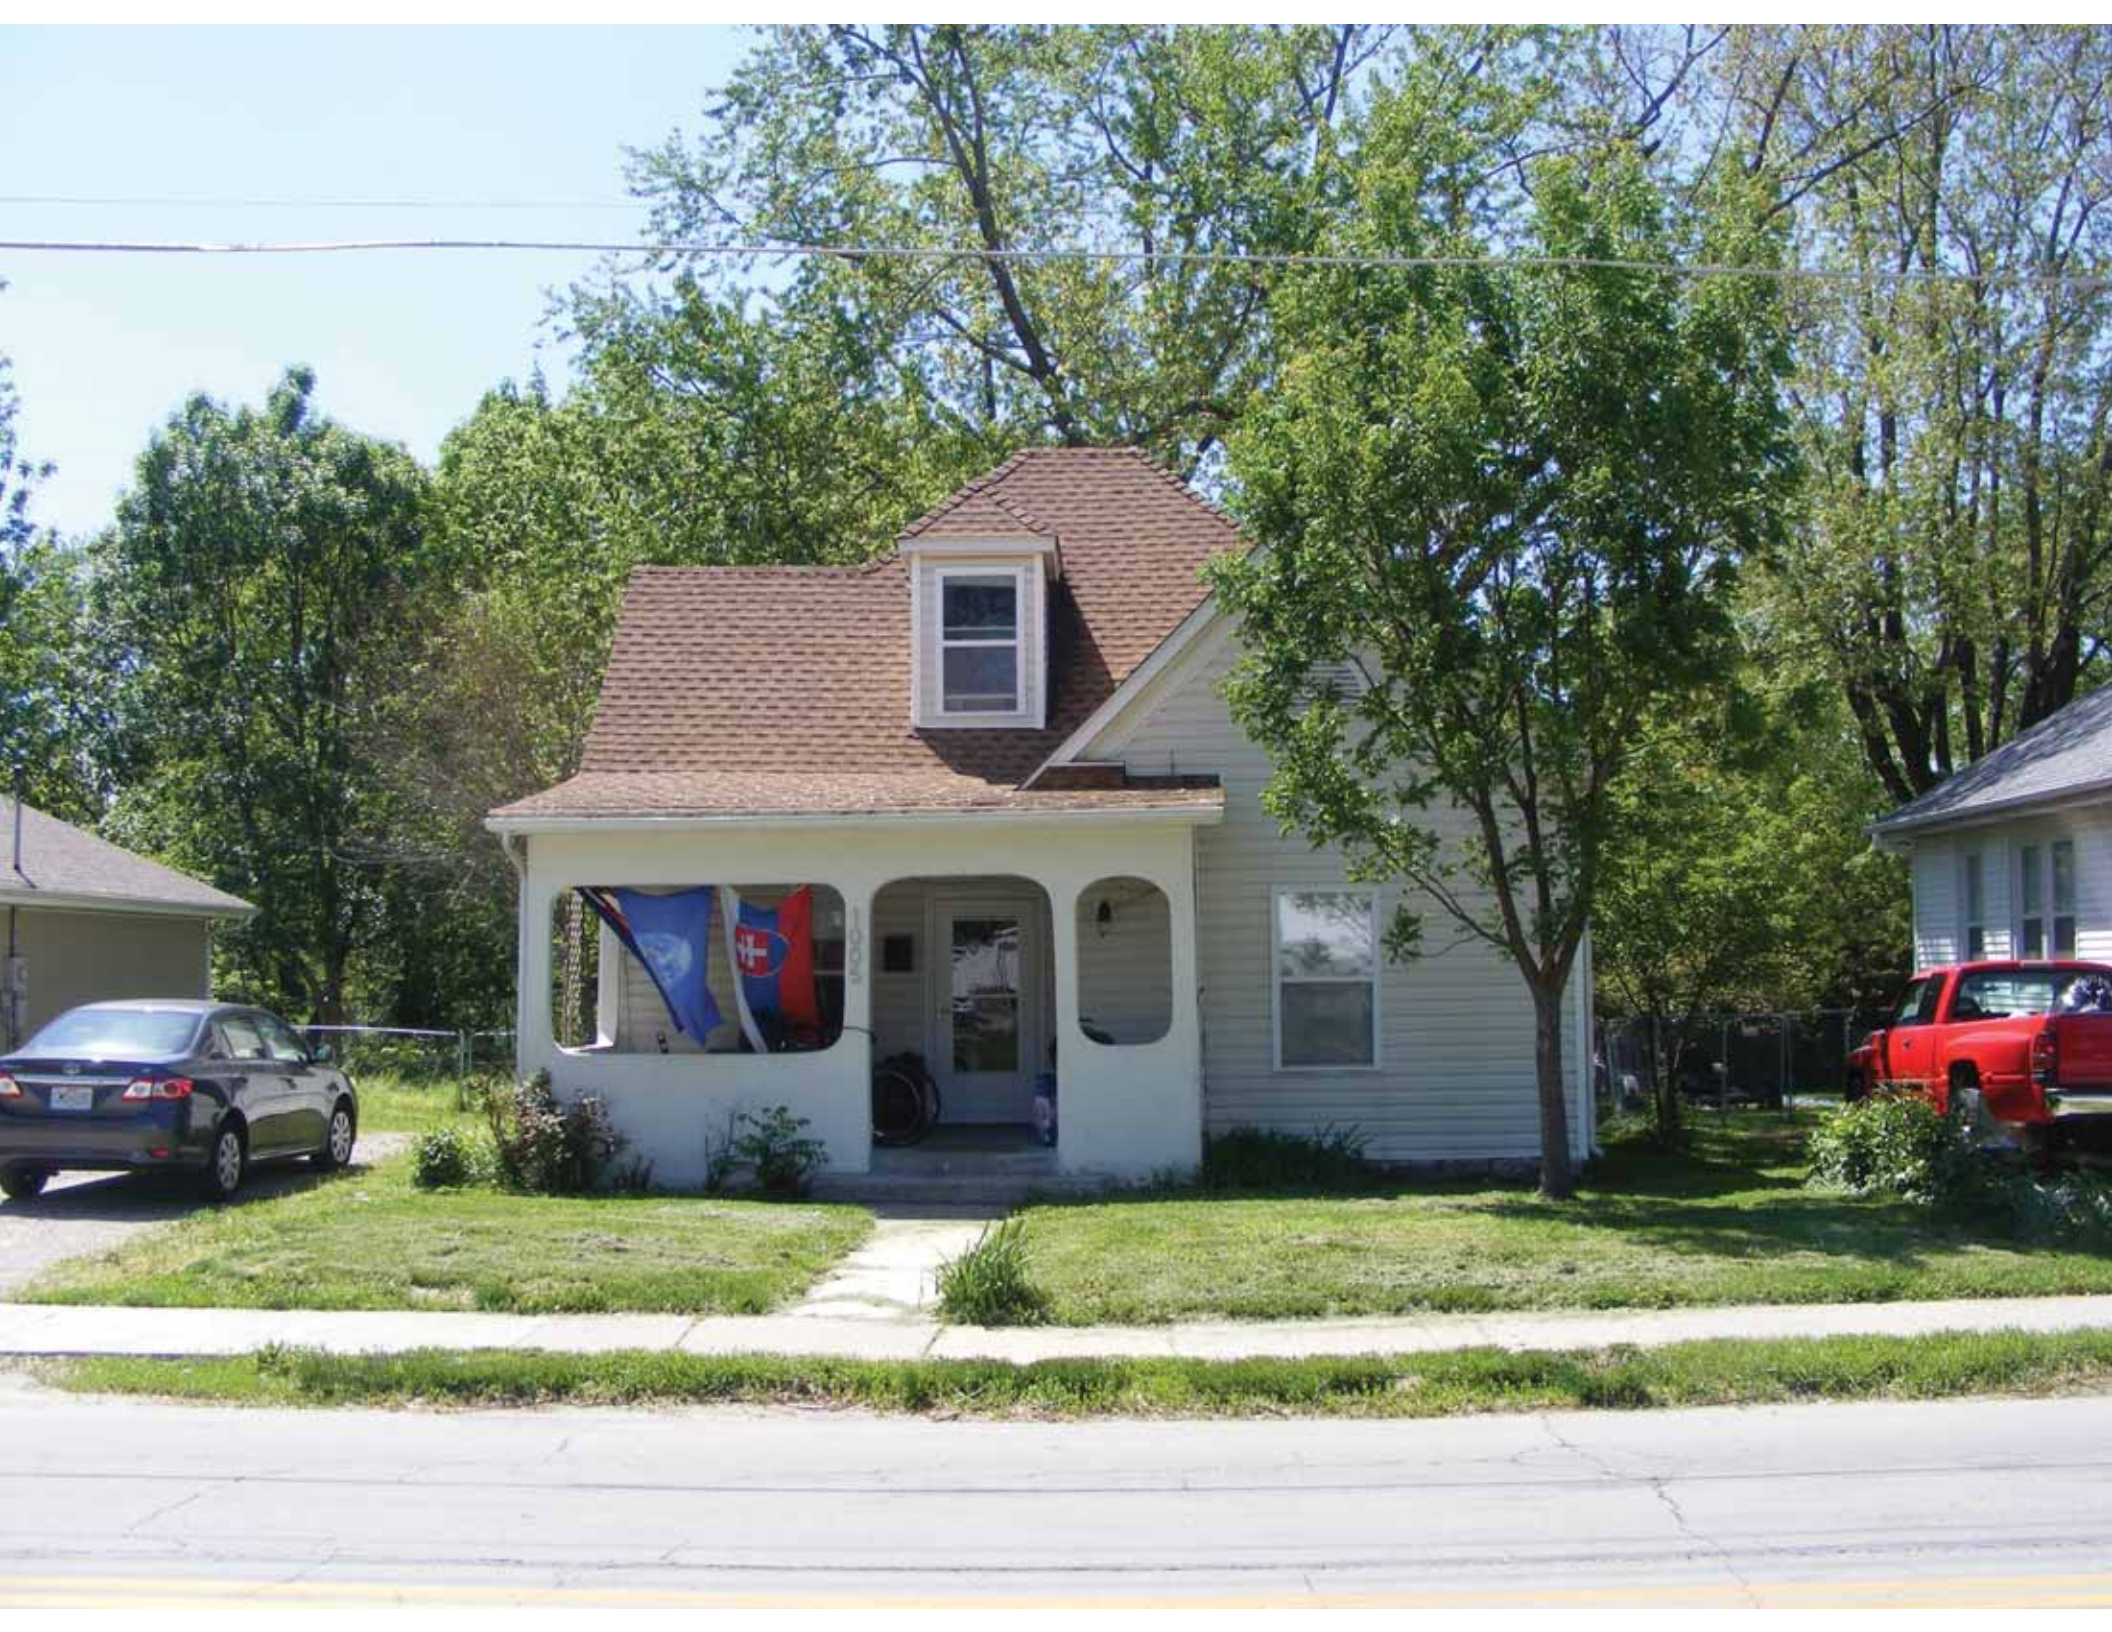
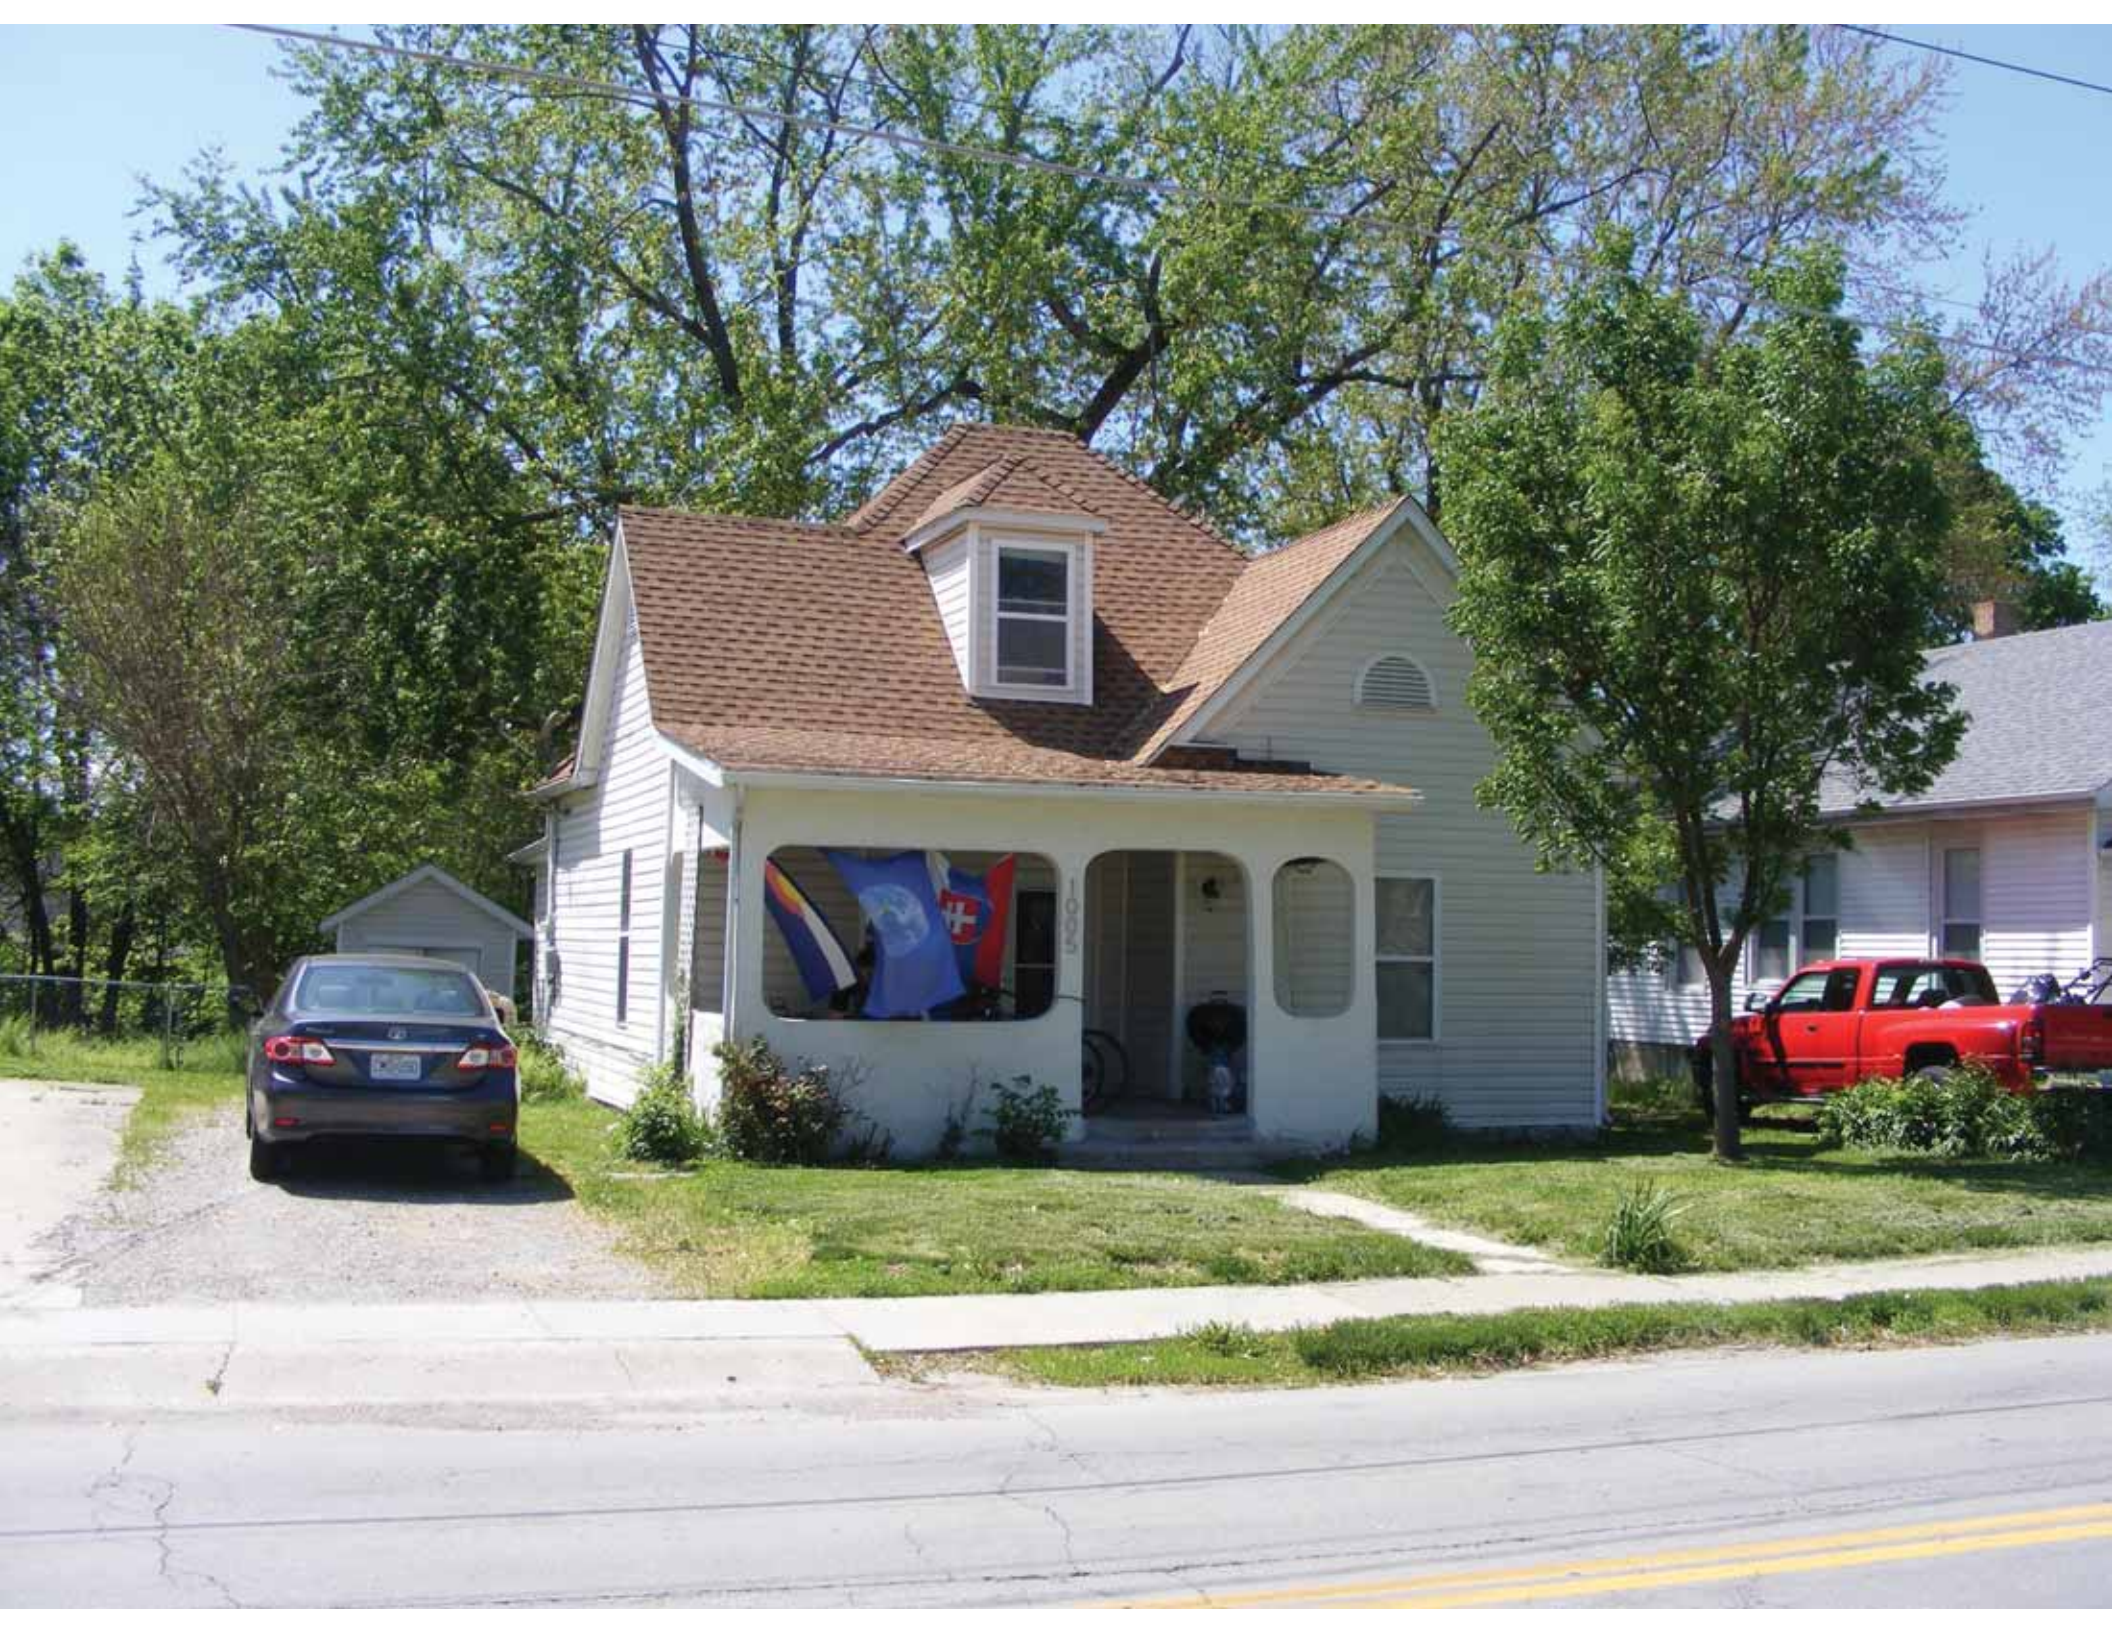
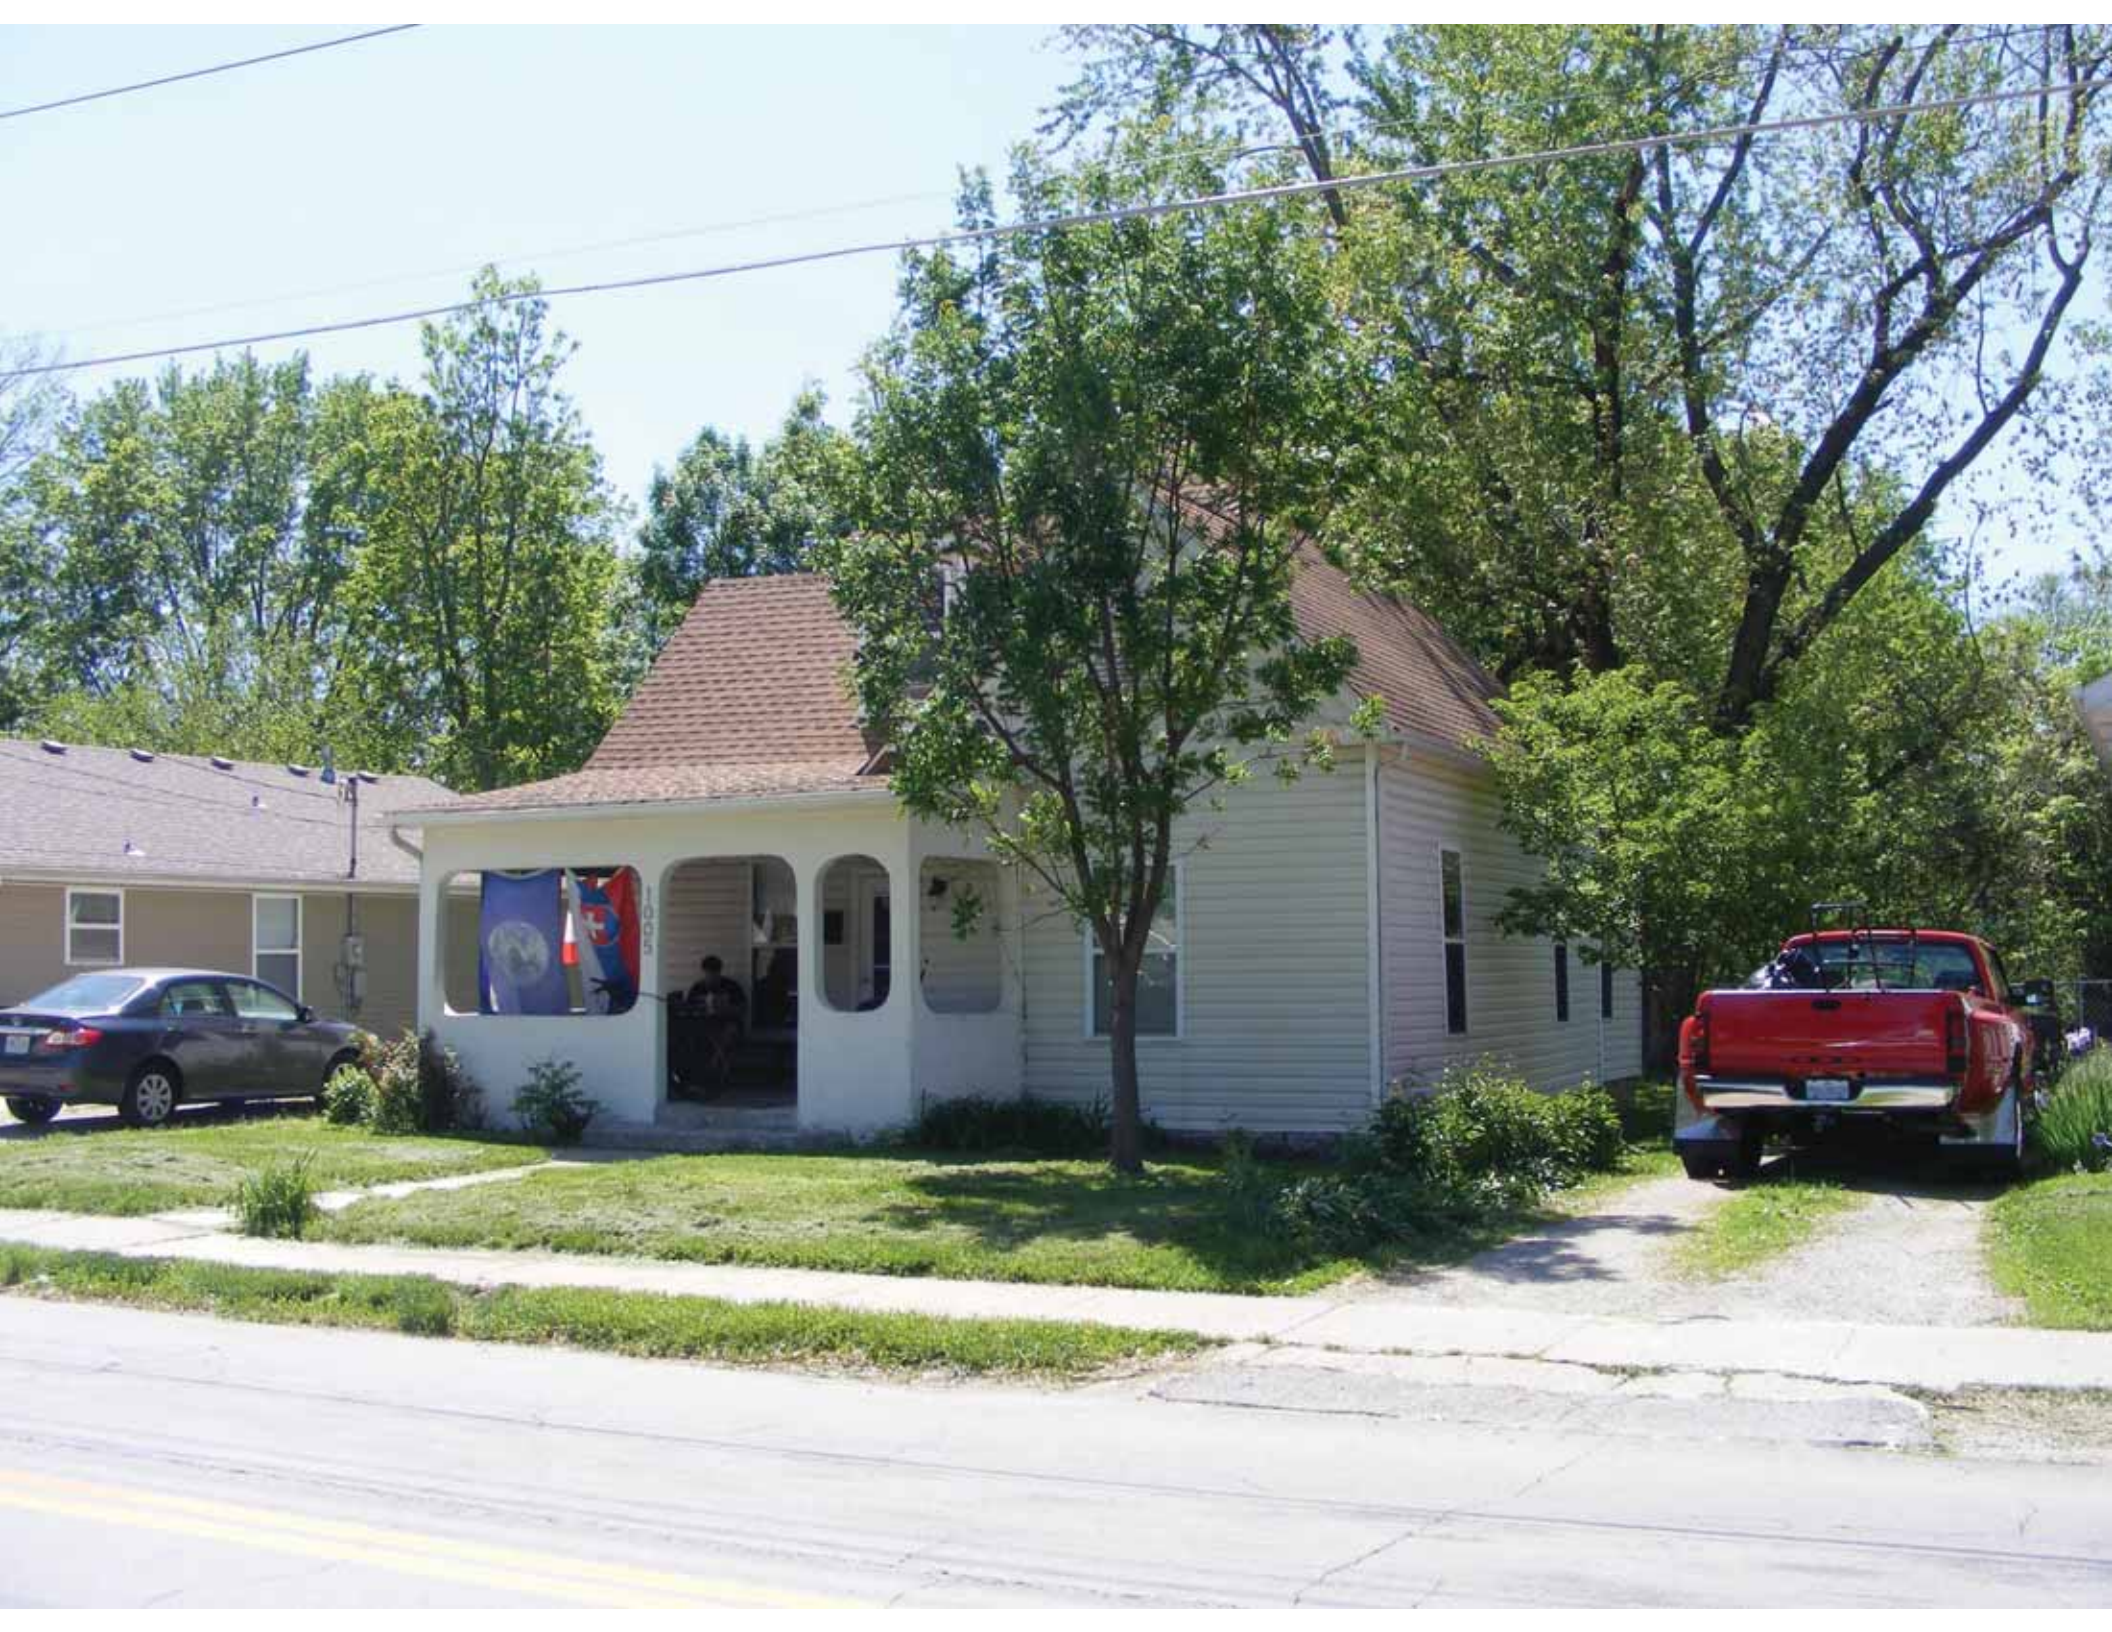
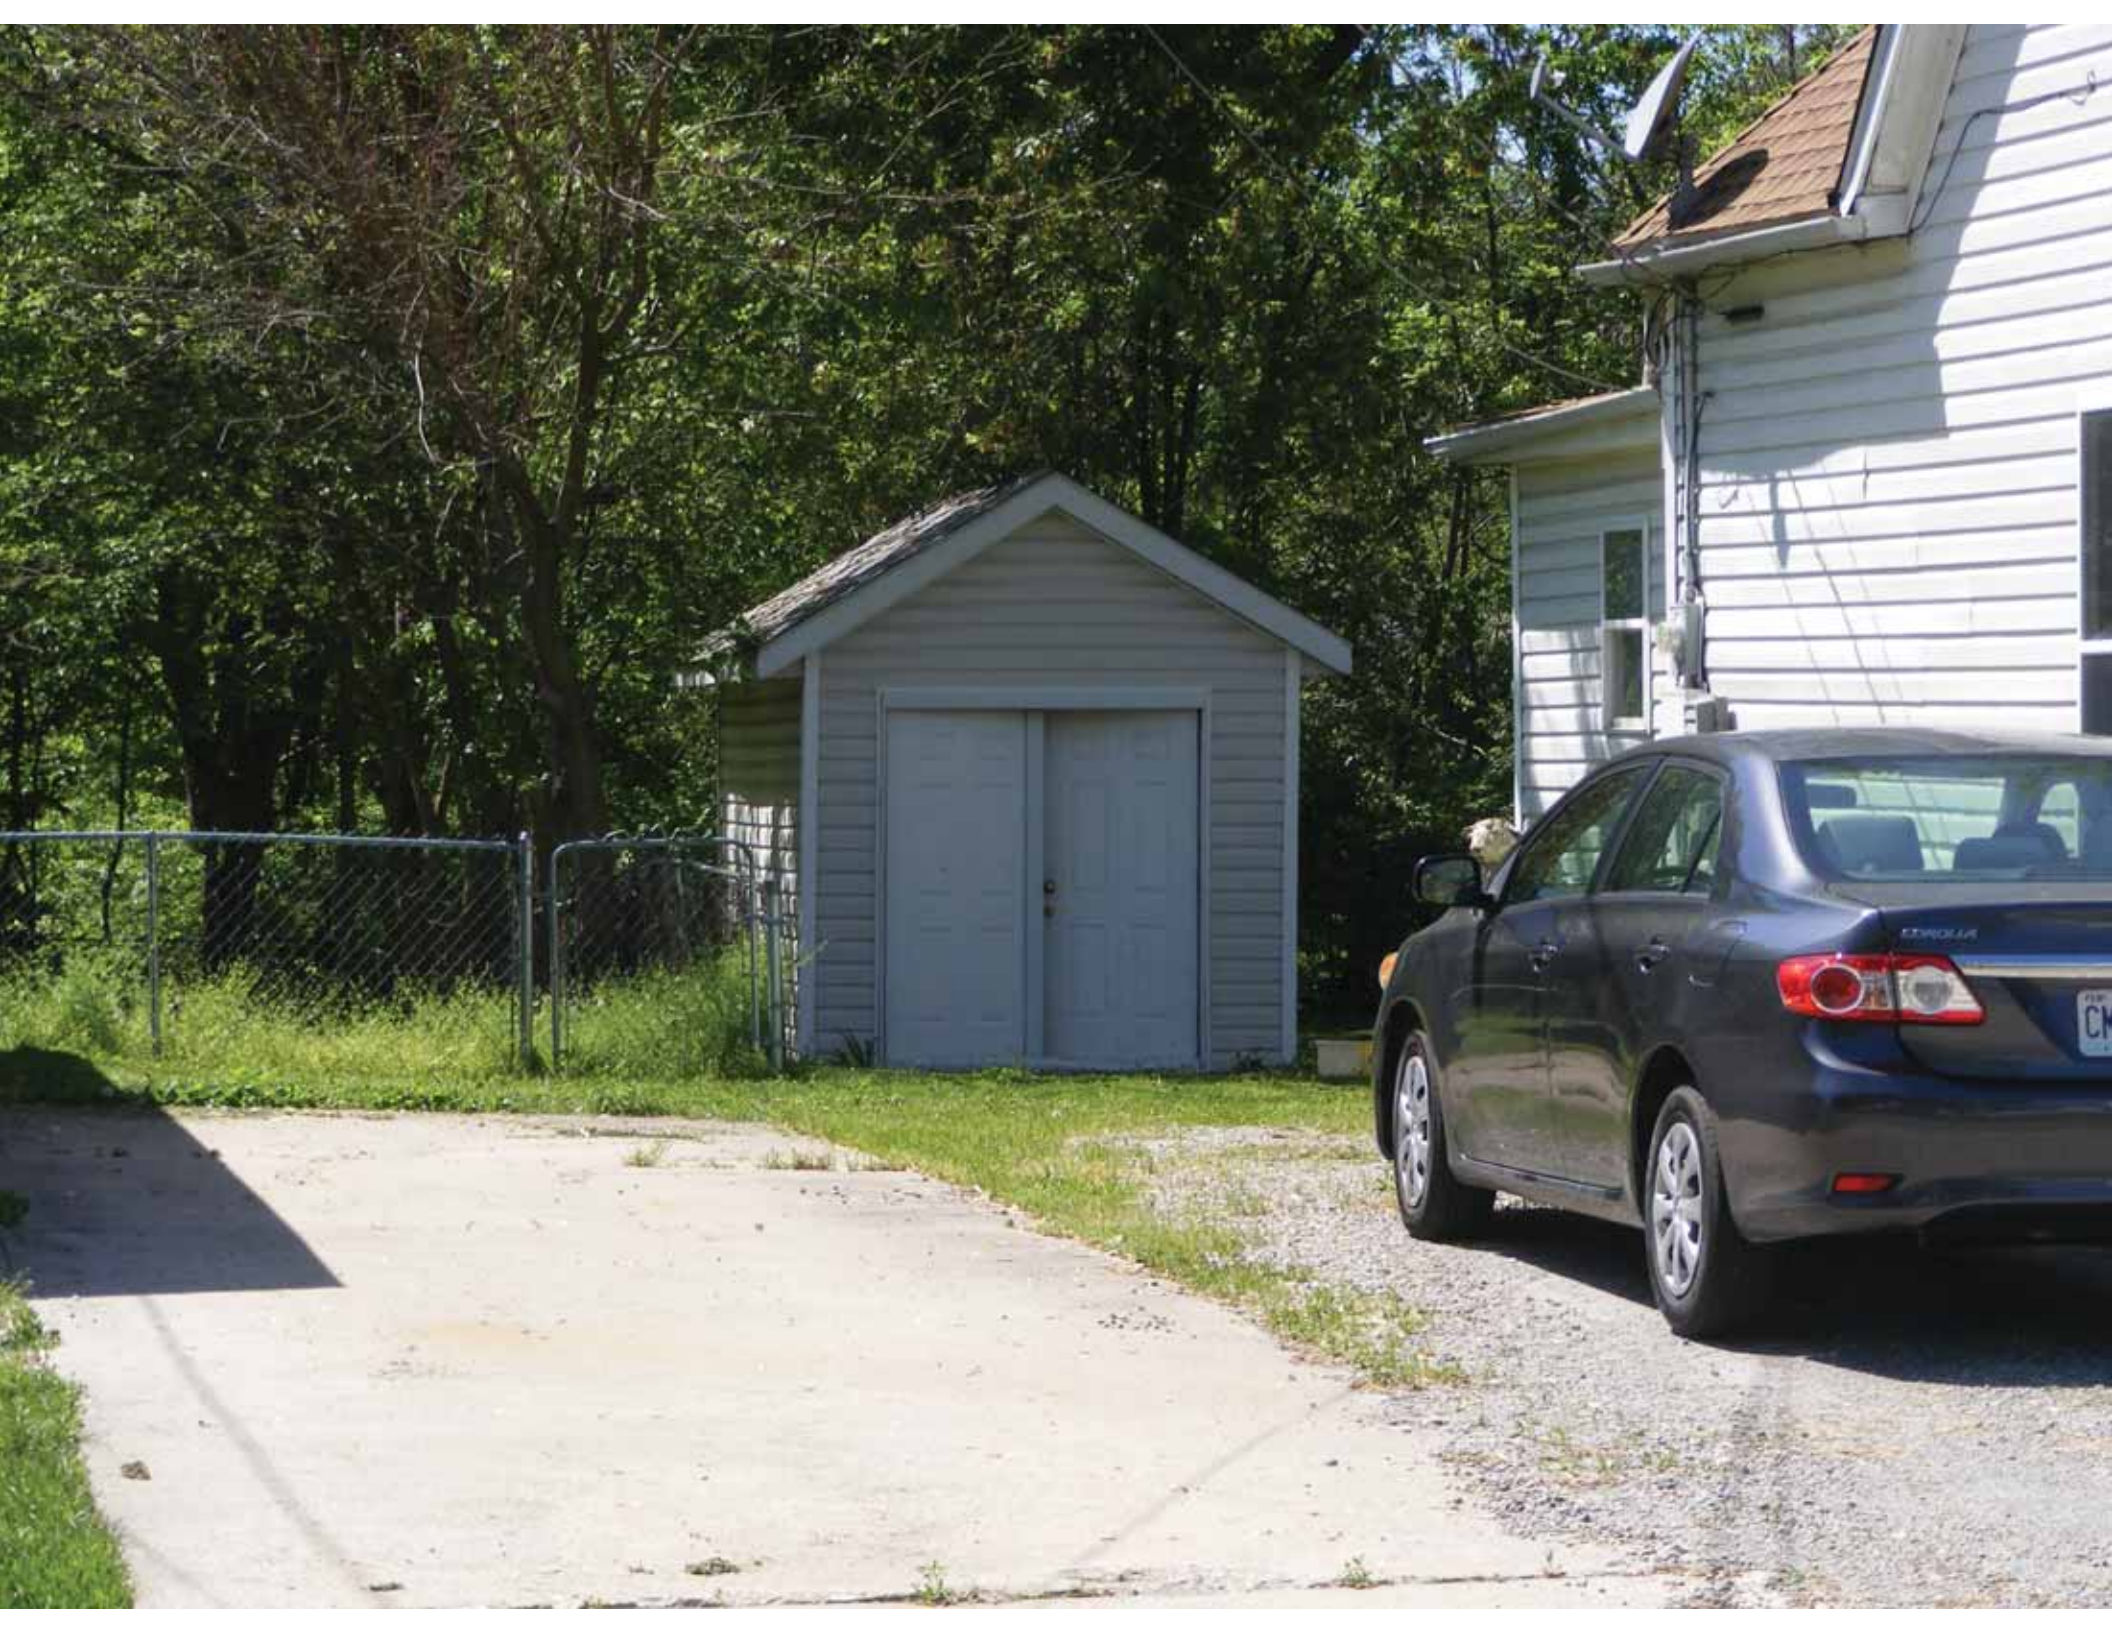
The dwelling has an asphalt-shingled hip on gable roof, exterior synthetic siding (some original weatherboard is visible near the lower south elevation) and a limestone foundation. The primary (east) elevation has a c. 1960 remodeled porch clad with stucco and featuring rounded openings. Within the shed porch, the primary elevation holds a door offset by a one-over-one replacement window. Remaining windows are of similar configuration. The primary entry bay holds a c. 2000 paneled door with upper fanlight. The front gabled wing holds a single window on the east elevation. The gable field has an original arched louvered vent. A gabled dormer is situated above the porch. The dormer has a pyramidal roof and one-over-one window.
