MISSOURI DEPARTMENT OF NATURAL RESOURCES
STATE HISTORIC PRESERVATION OFFICE, P.O. Box 176, Jefferson City, MO 65102
ARCHITECTURAL/HISTORIC INVENTORY FORM

1. Survey No. BO-AS-011-0087		2. Survey name: North Central Columbia Survey Phase II	
3. County: Boone		4. Address (Street No.) 902	Street (name) N. Seventh Street
5. City: Columbia	Vicinity: <input type="checkbox"/>	6. Geographical Reference:	7. Township/Range/Section: T: R: S:
8. Historic name (if known):		9. Present/other name (if known):	
10. Ownership: <input checked="" type="checkbox"/> Private <input type="checkbox"/> Public		11a. Historic use (if known): Domestic/single dwelling	11b. Current use: Domestic/single dwelling

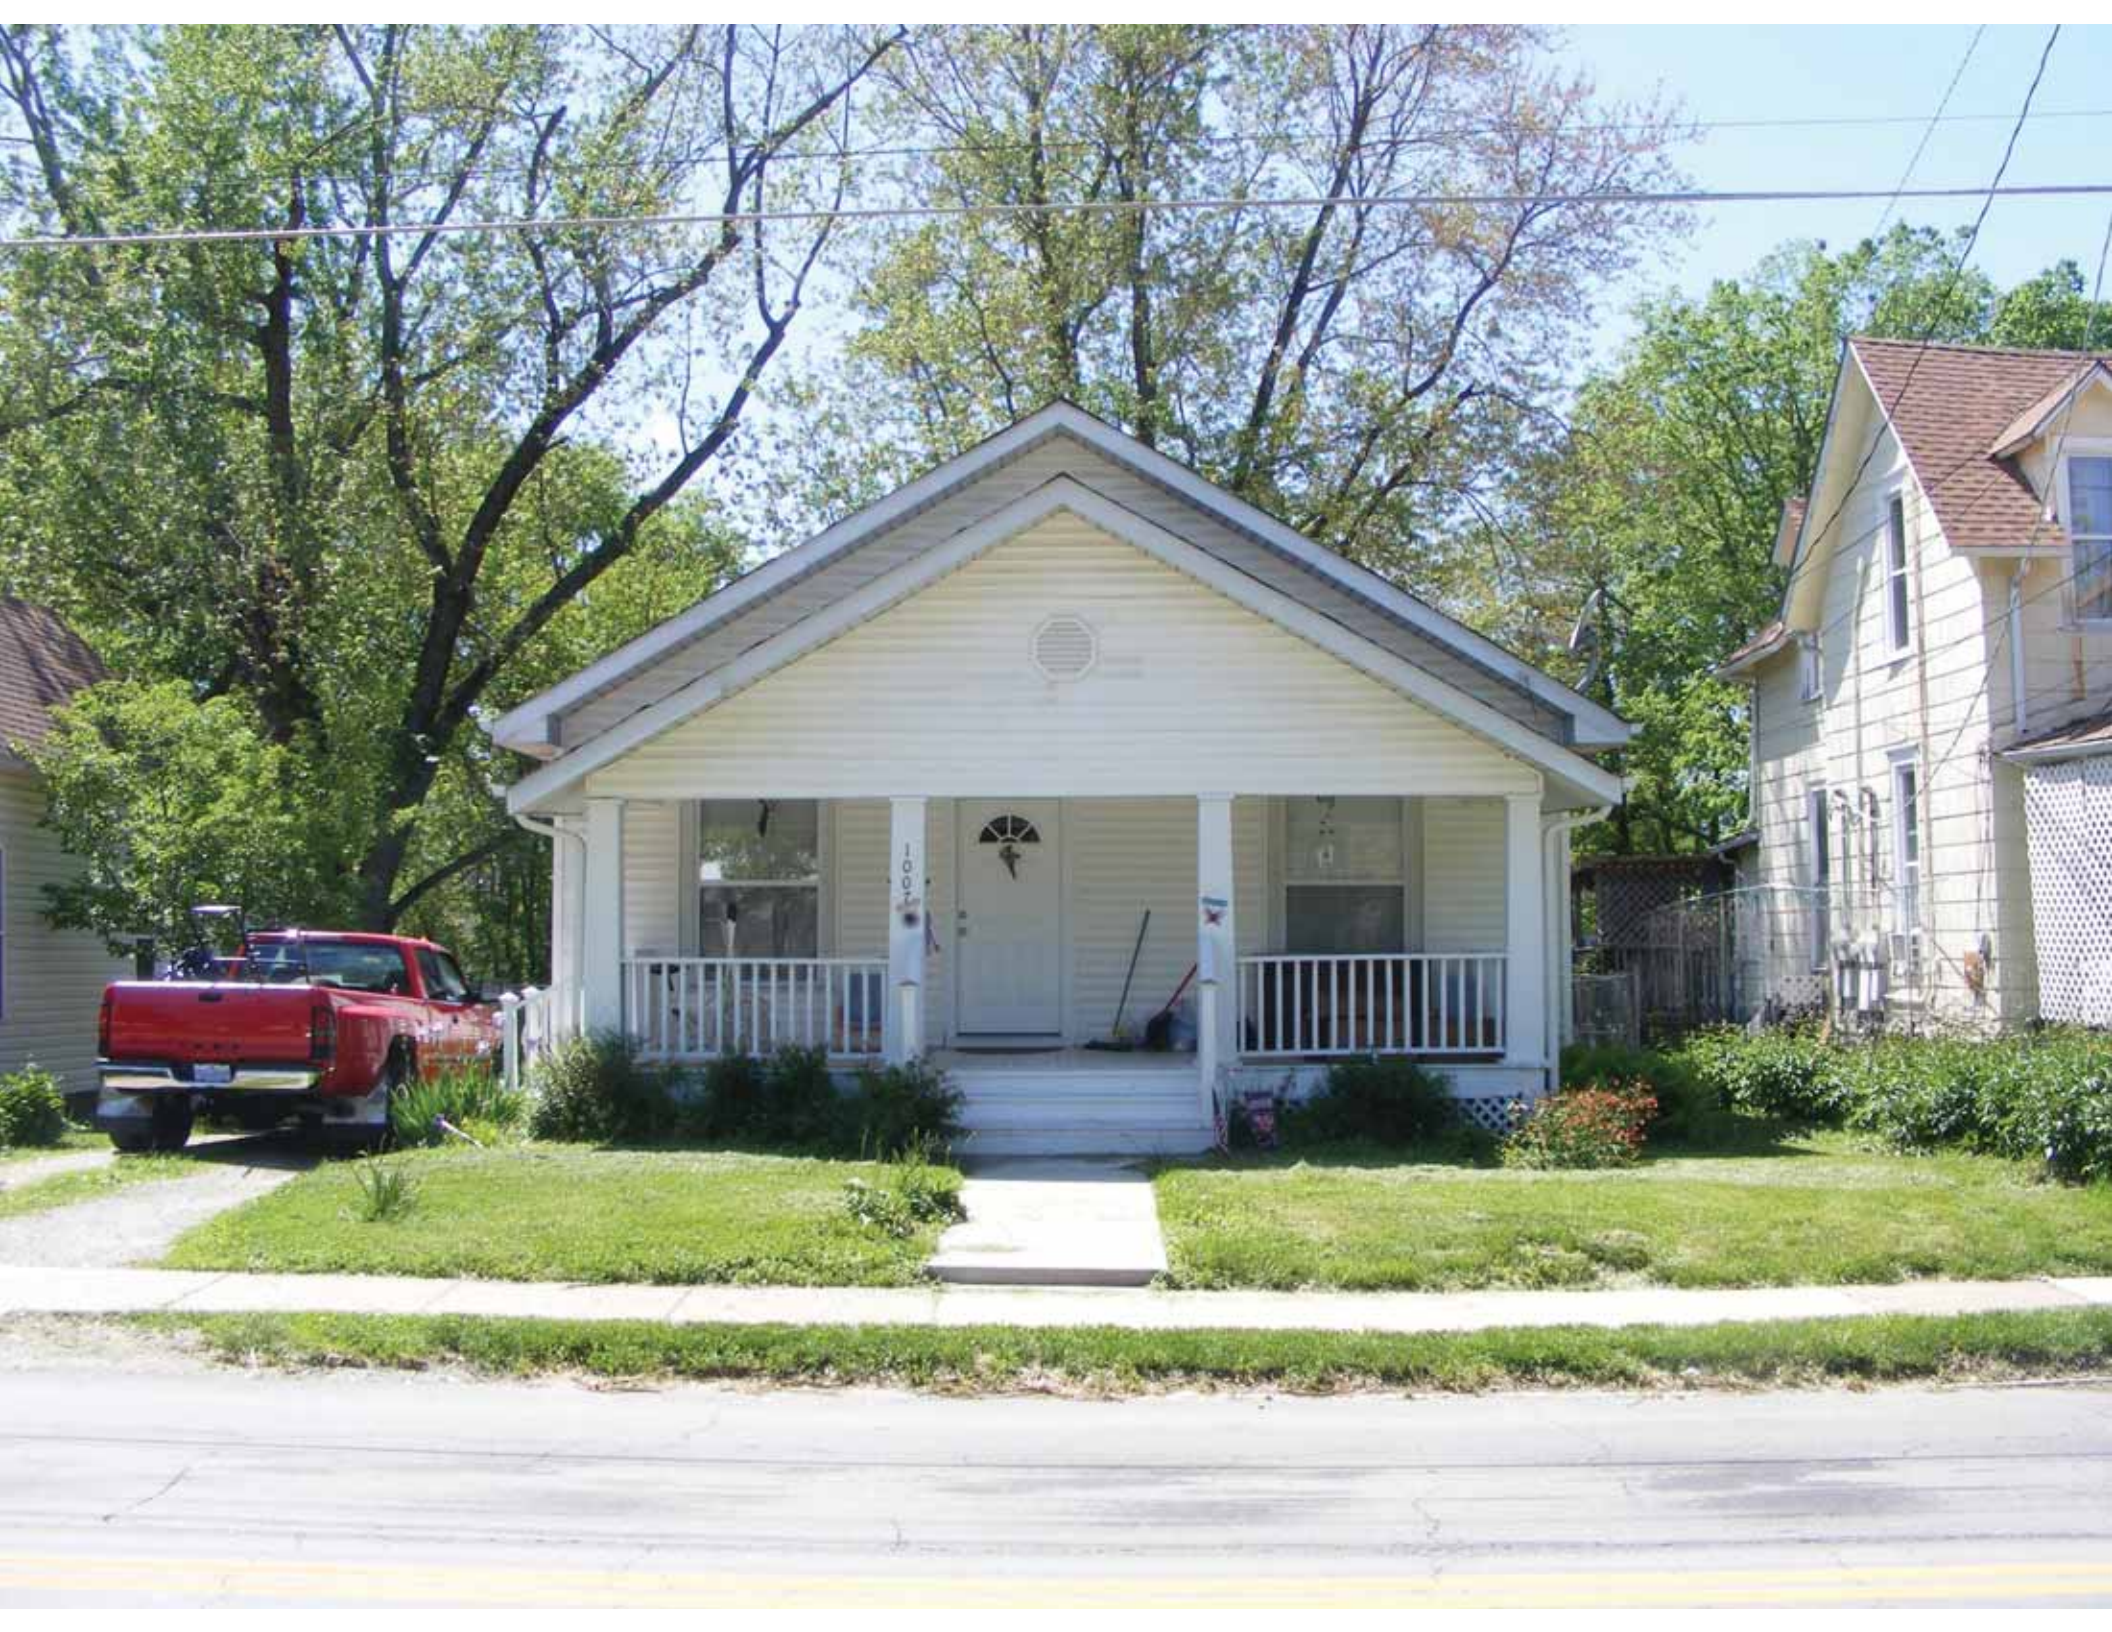
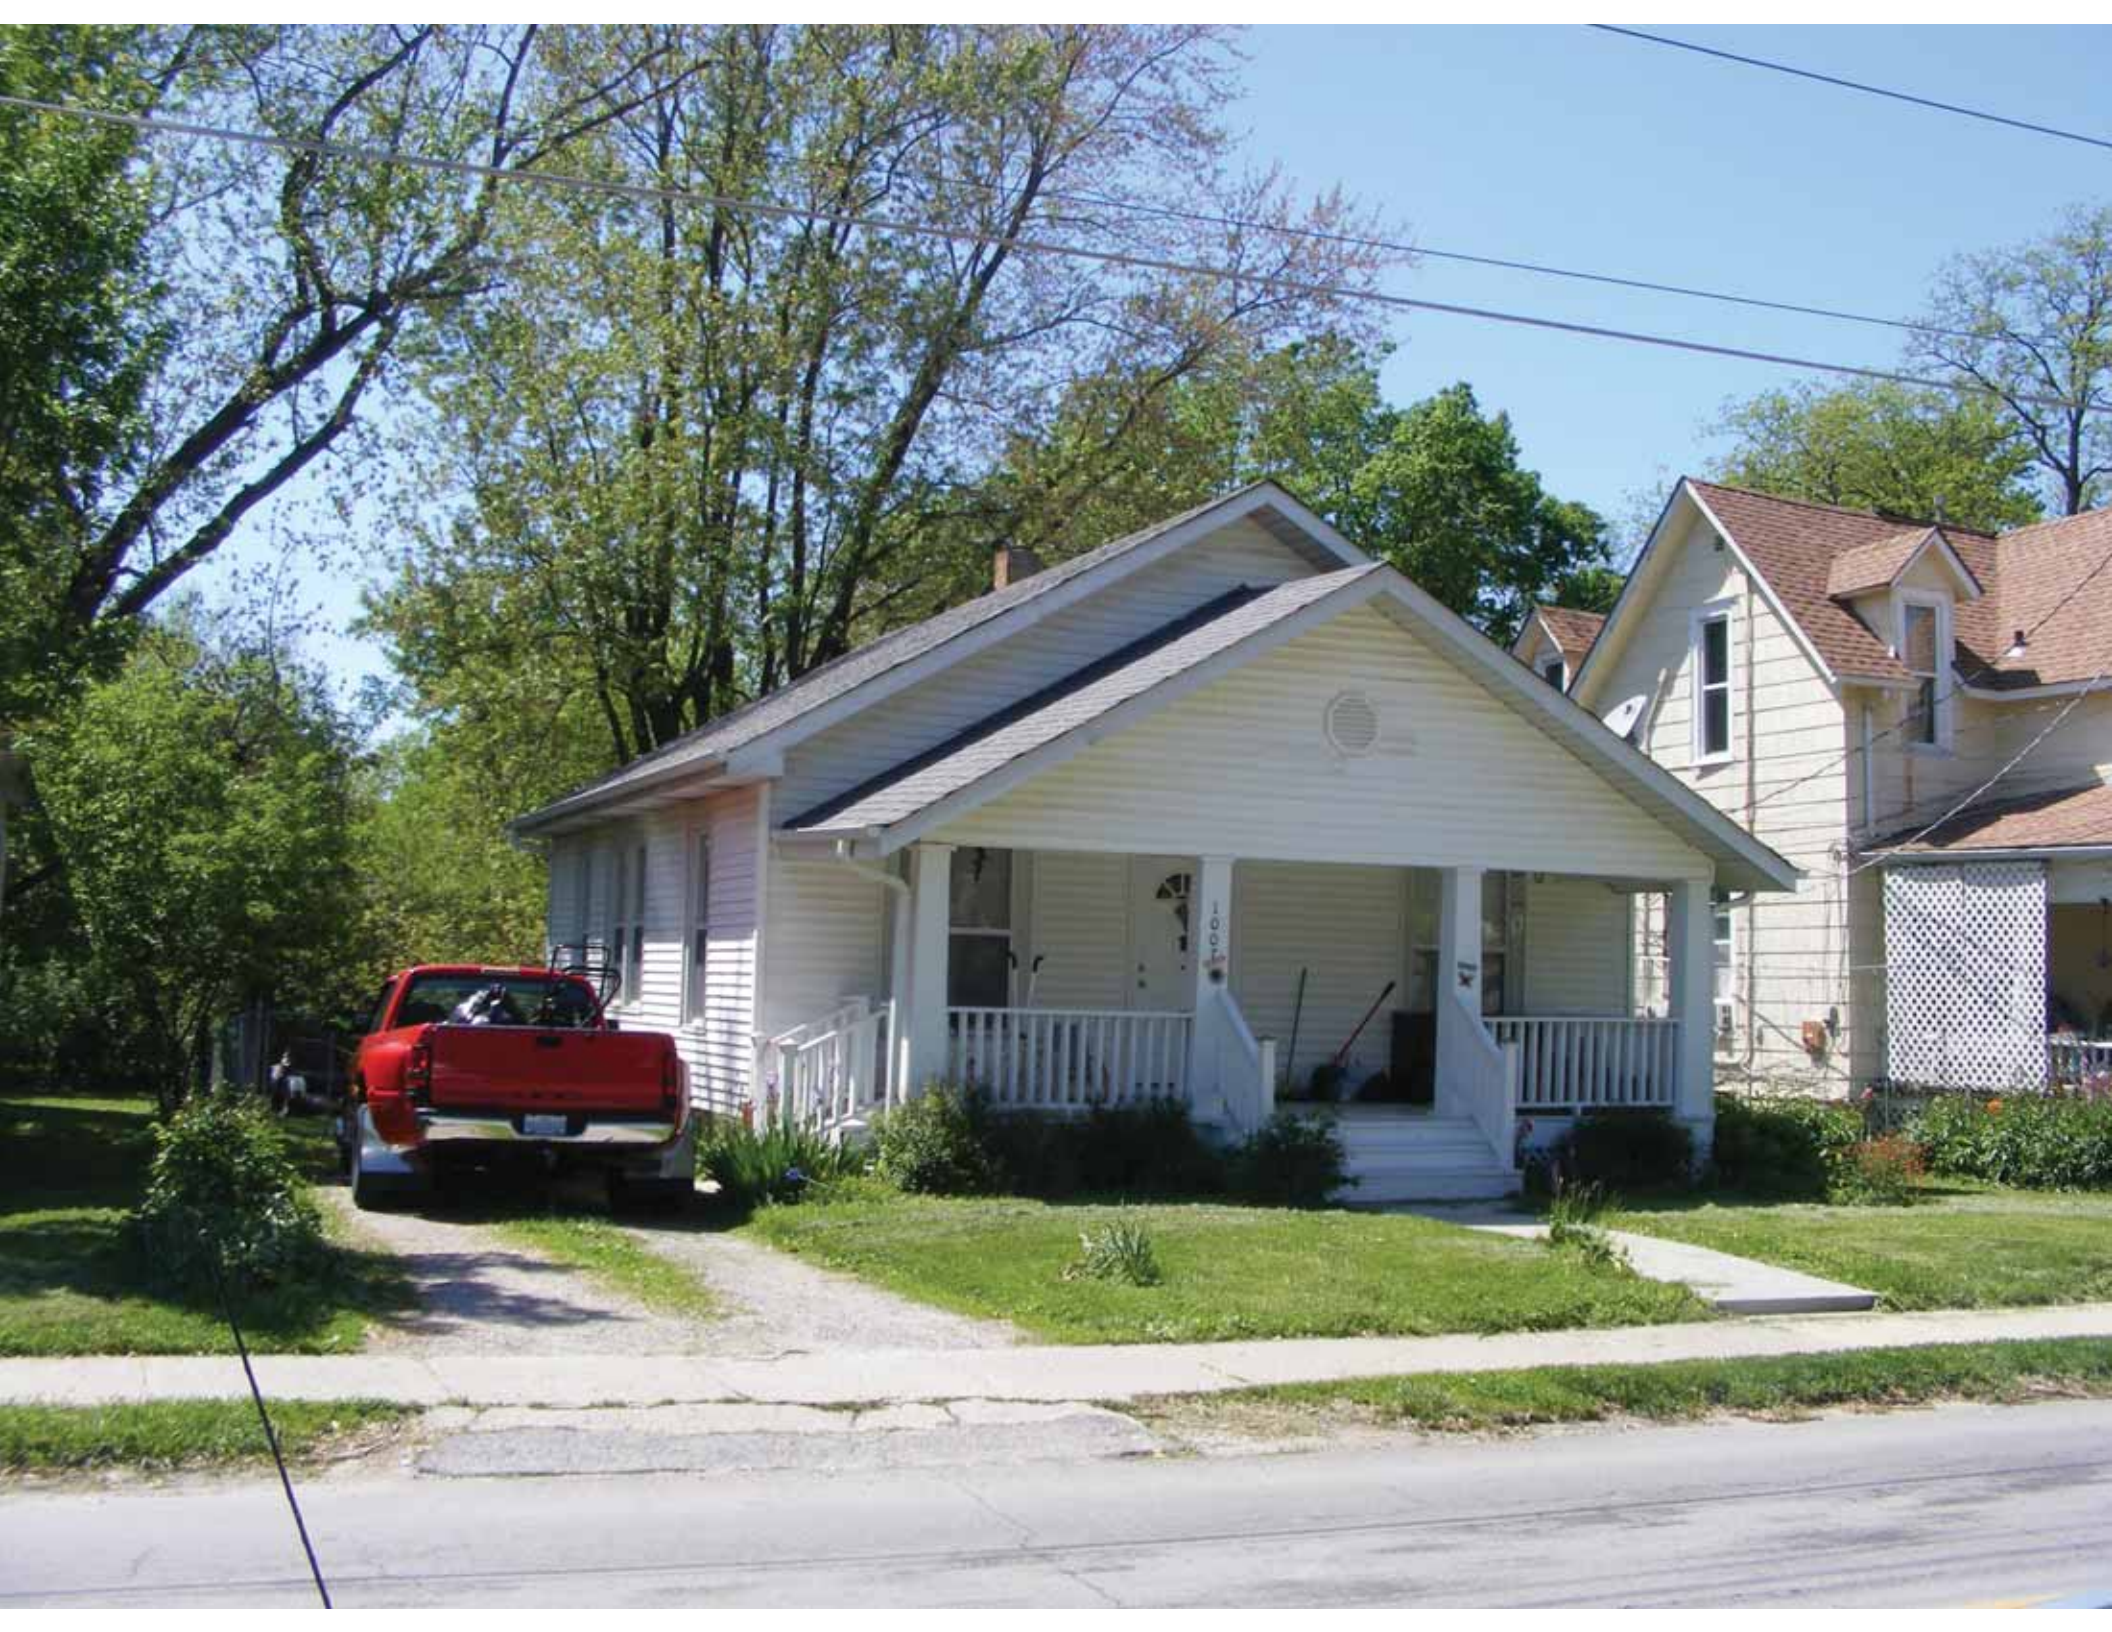
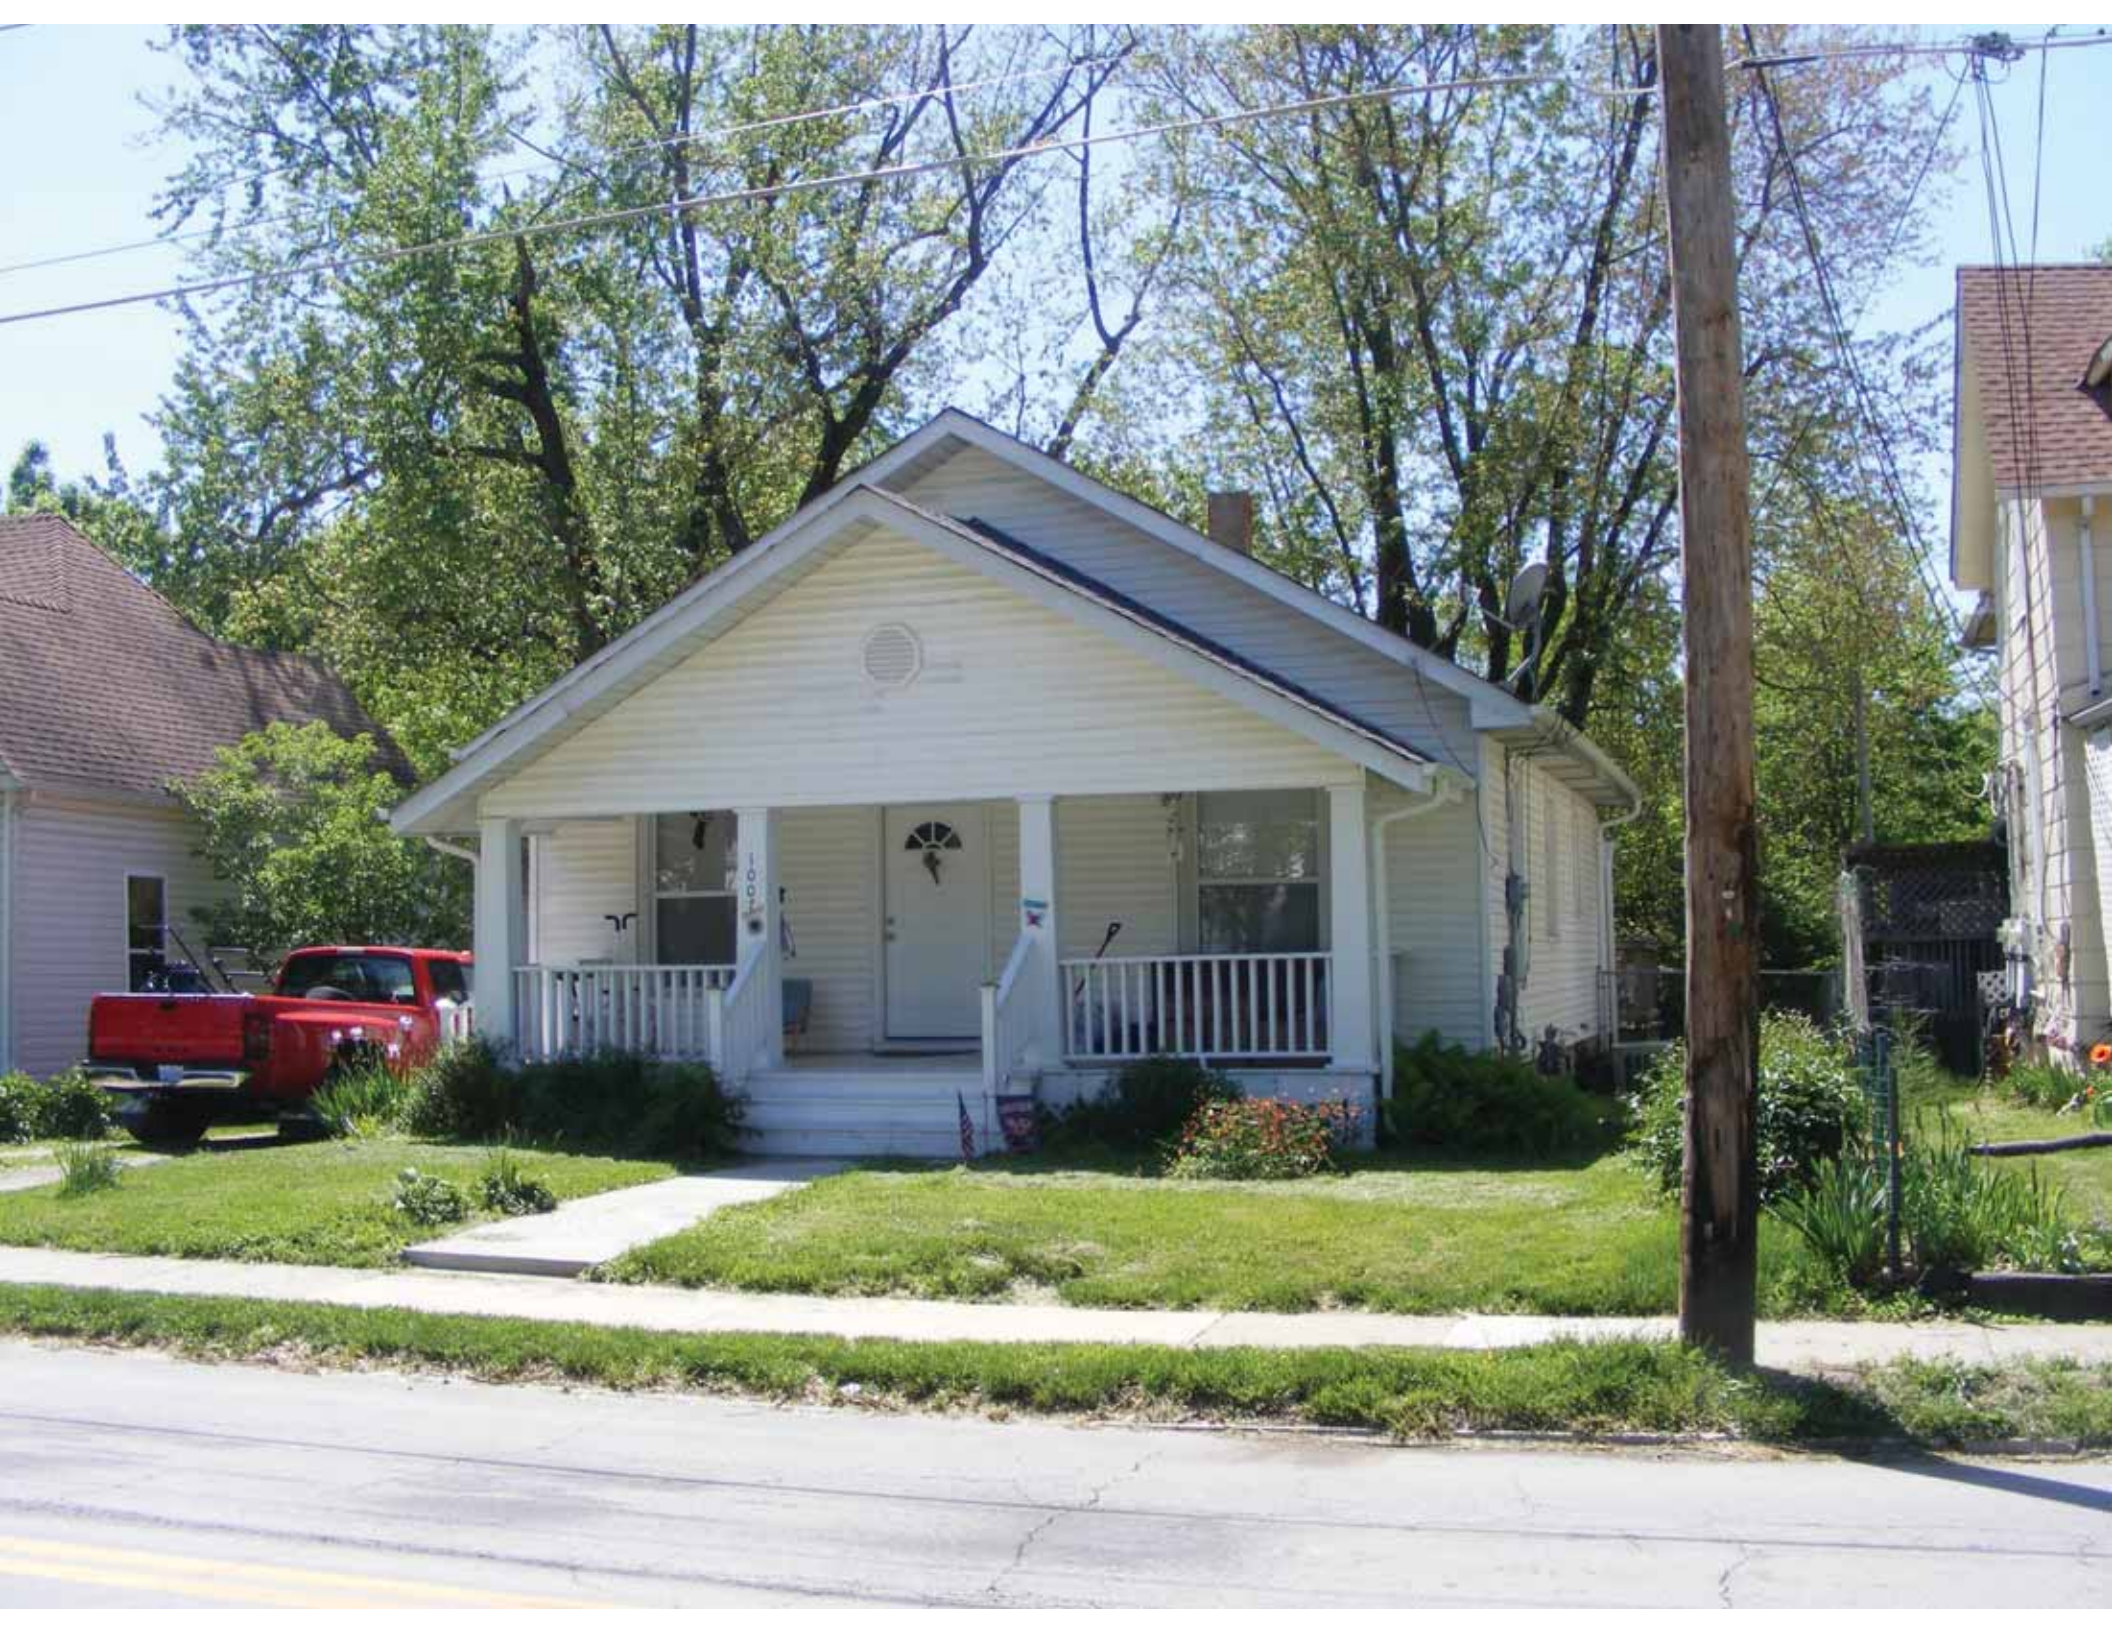
The dwelling has a front-gabled roof clad with asphalt shingles that supports an interior brick chimney. The dwelling is clad with synthetic siding and has a concrete foundation. The primary (east) elevation has a three-quarters width gabled porch supported by four tapered piers. The porch has a frame balustrade. Centered within the porch bay is a c. 2015 paneled door with an upper fanlight. The door is flanked by one-over-one replacement windows. Remaining windows are of similar configuration. The porch gable field has an octagonal vent.

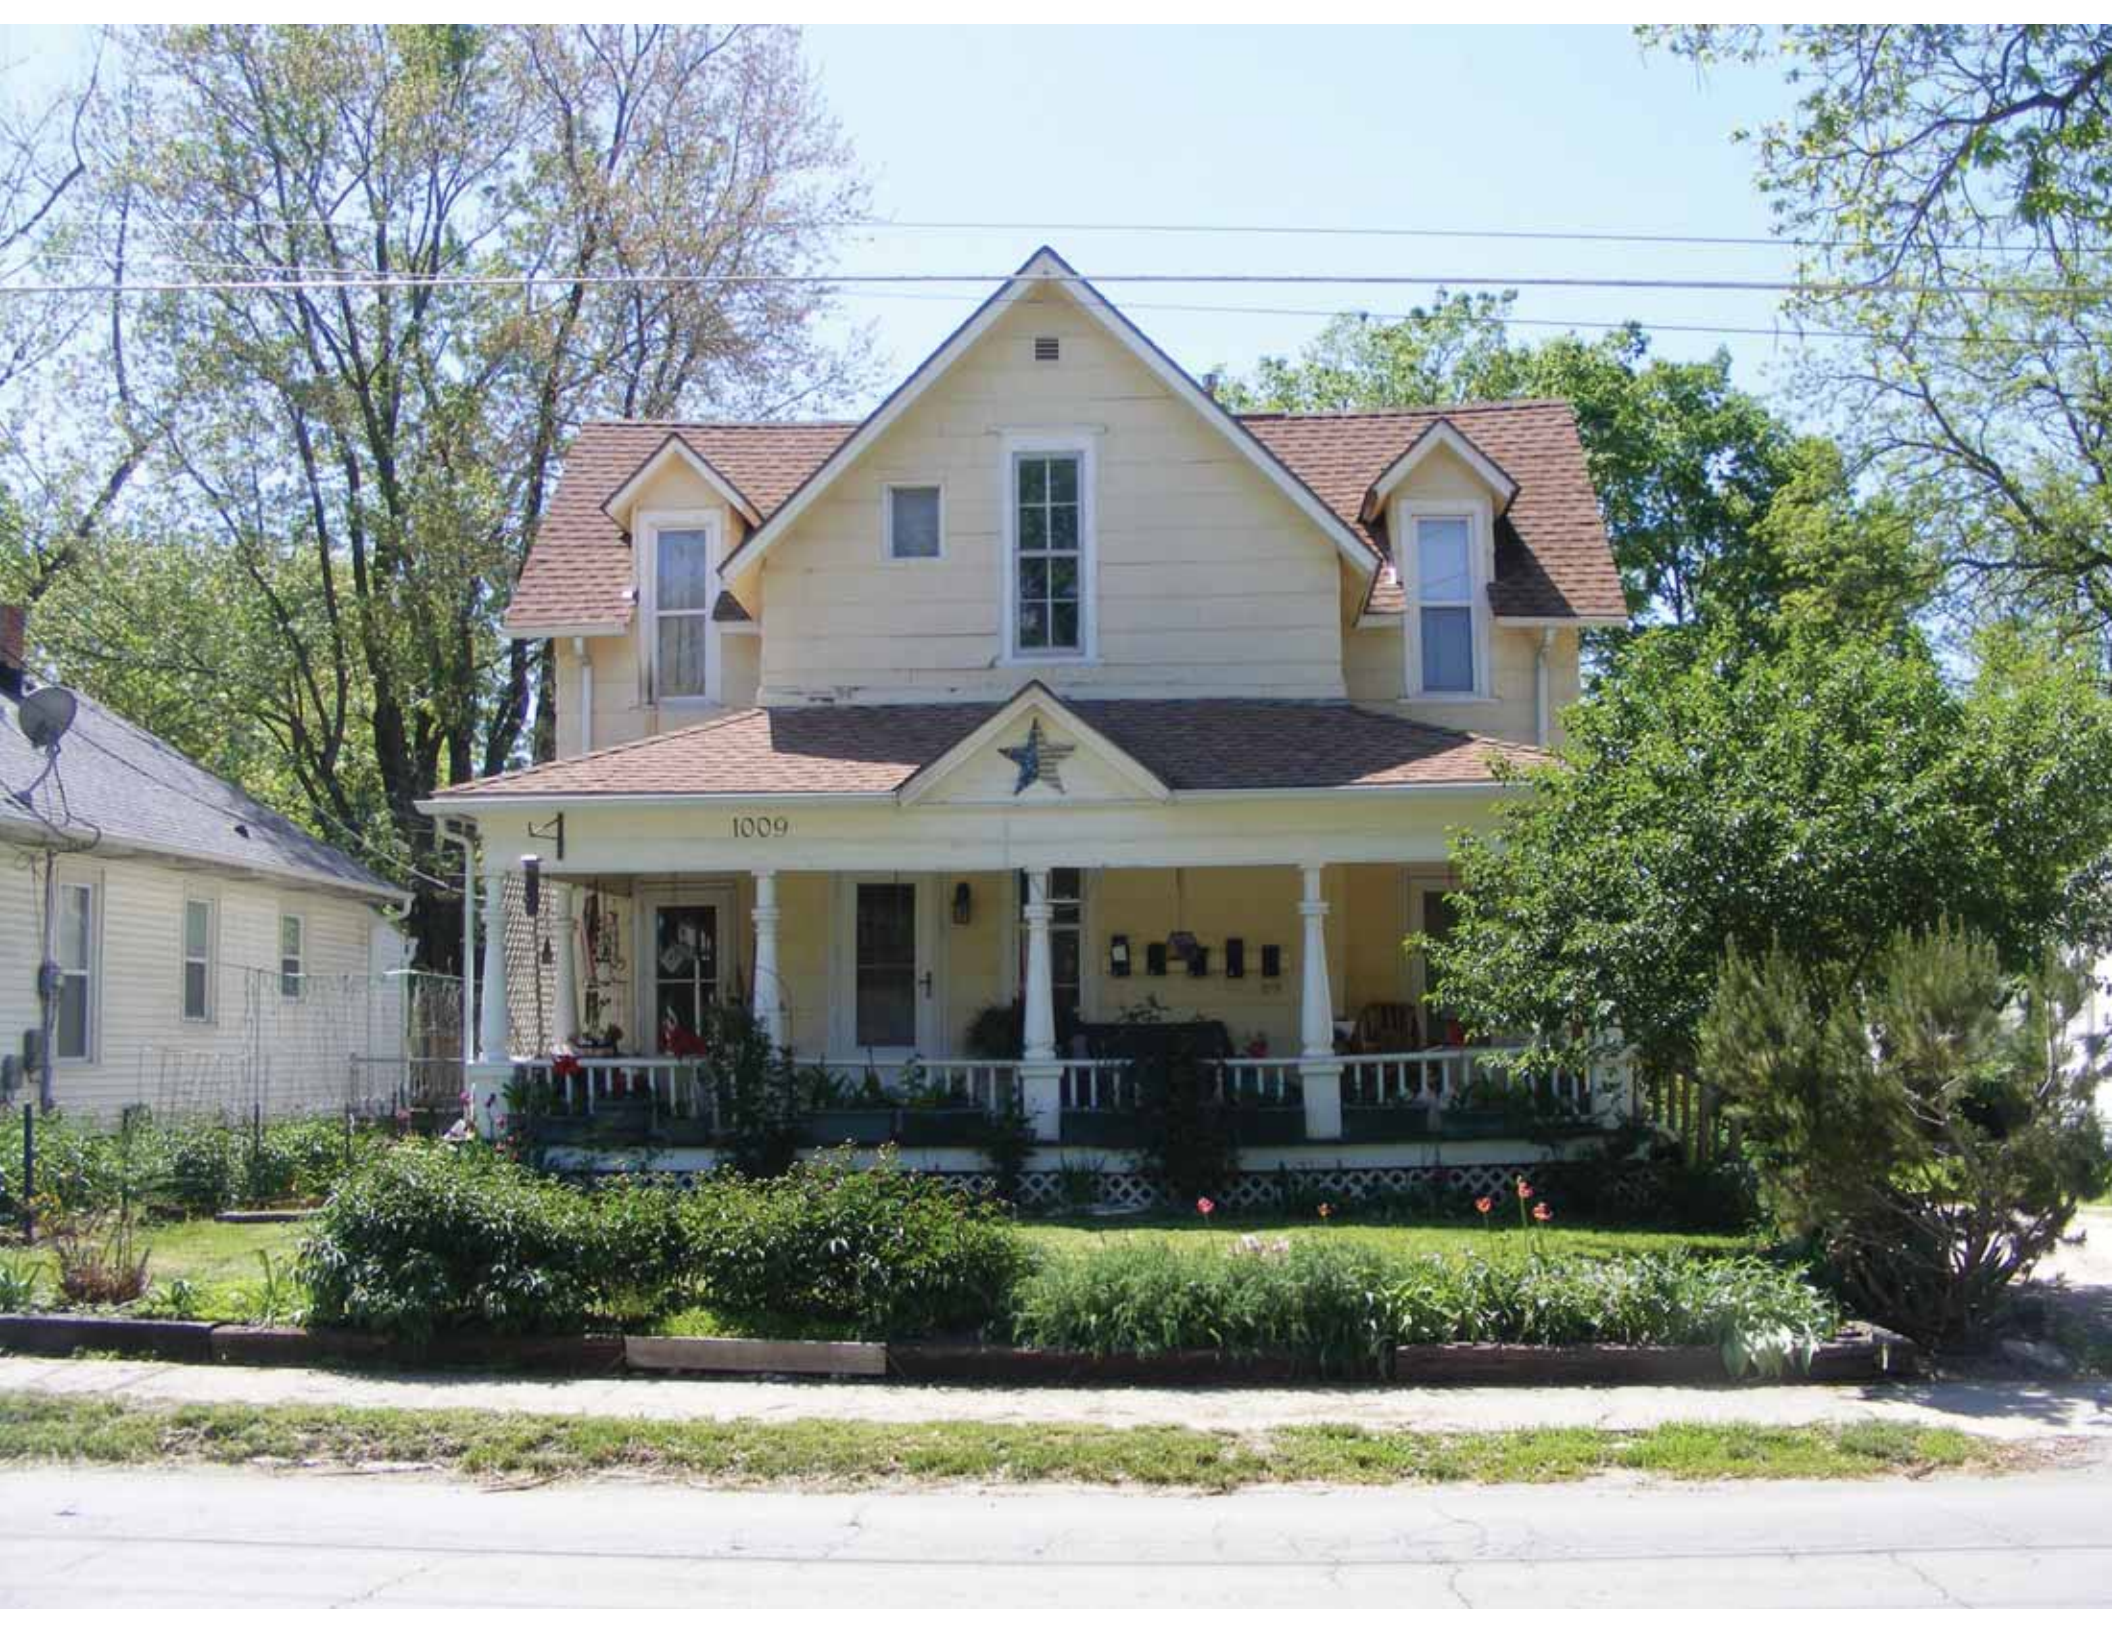
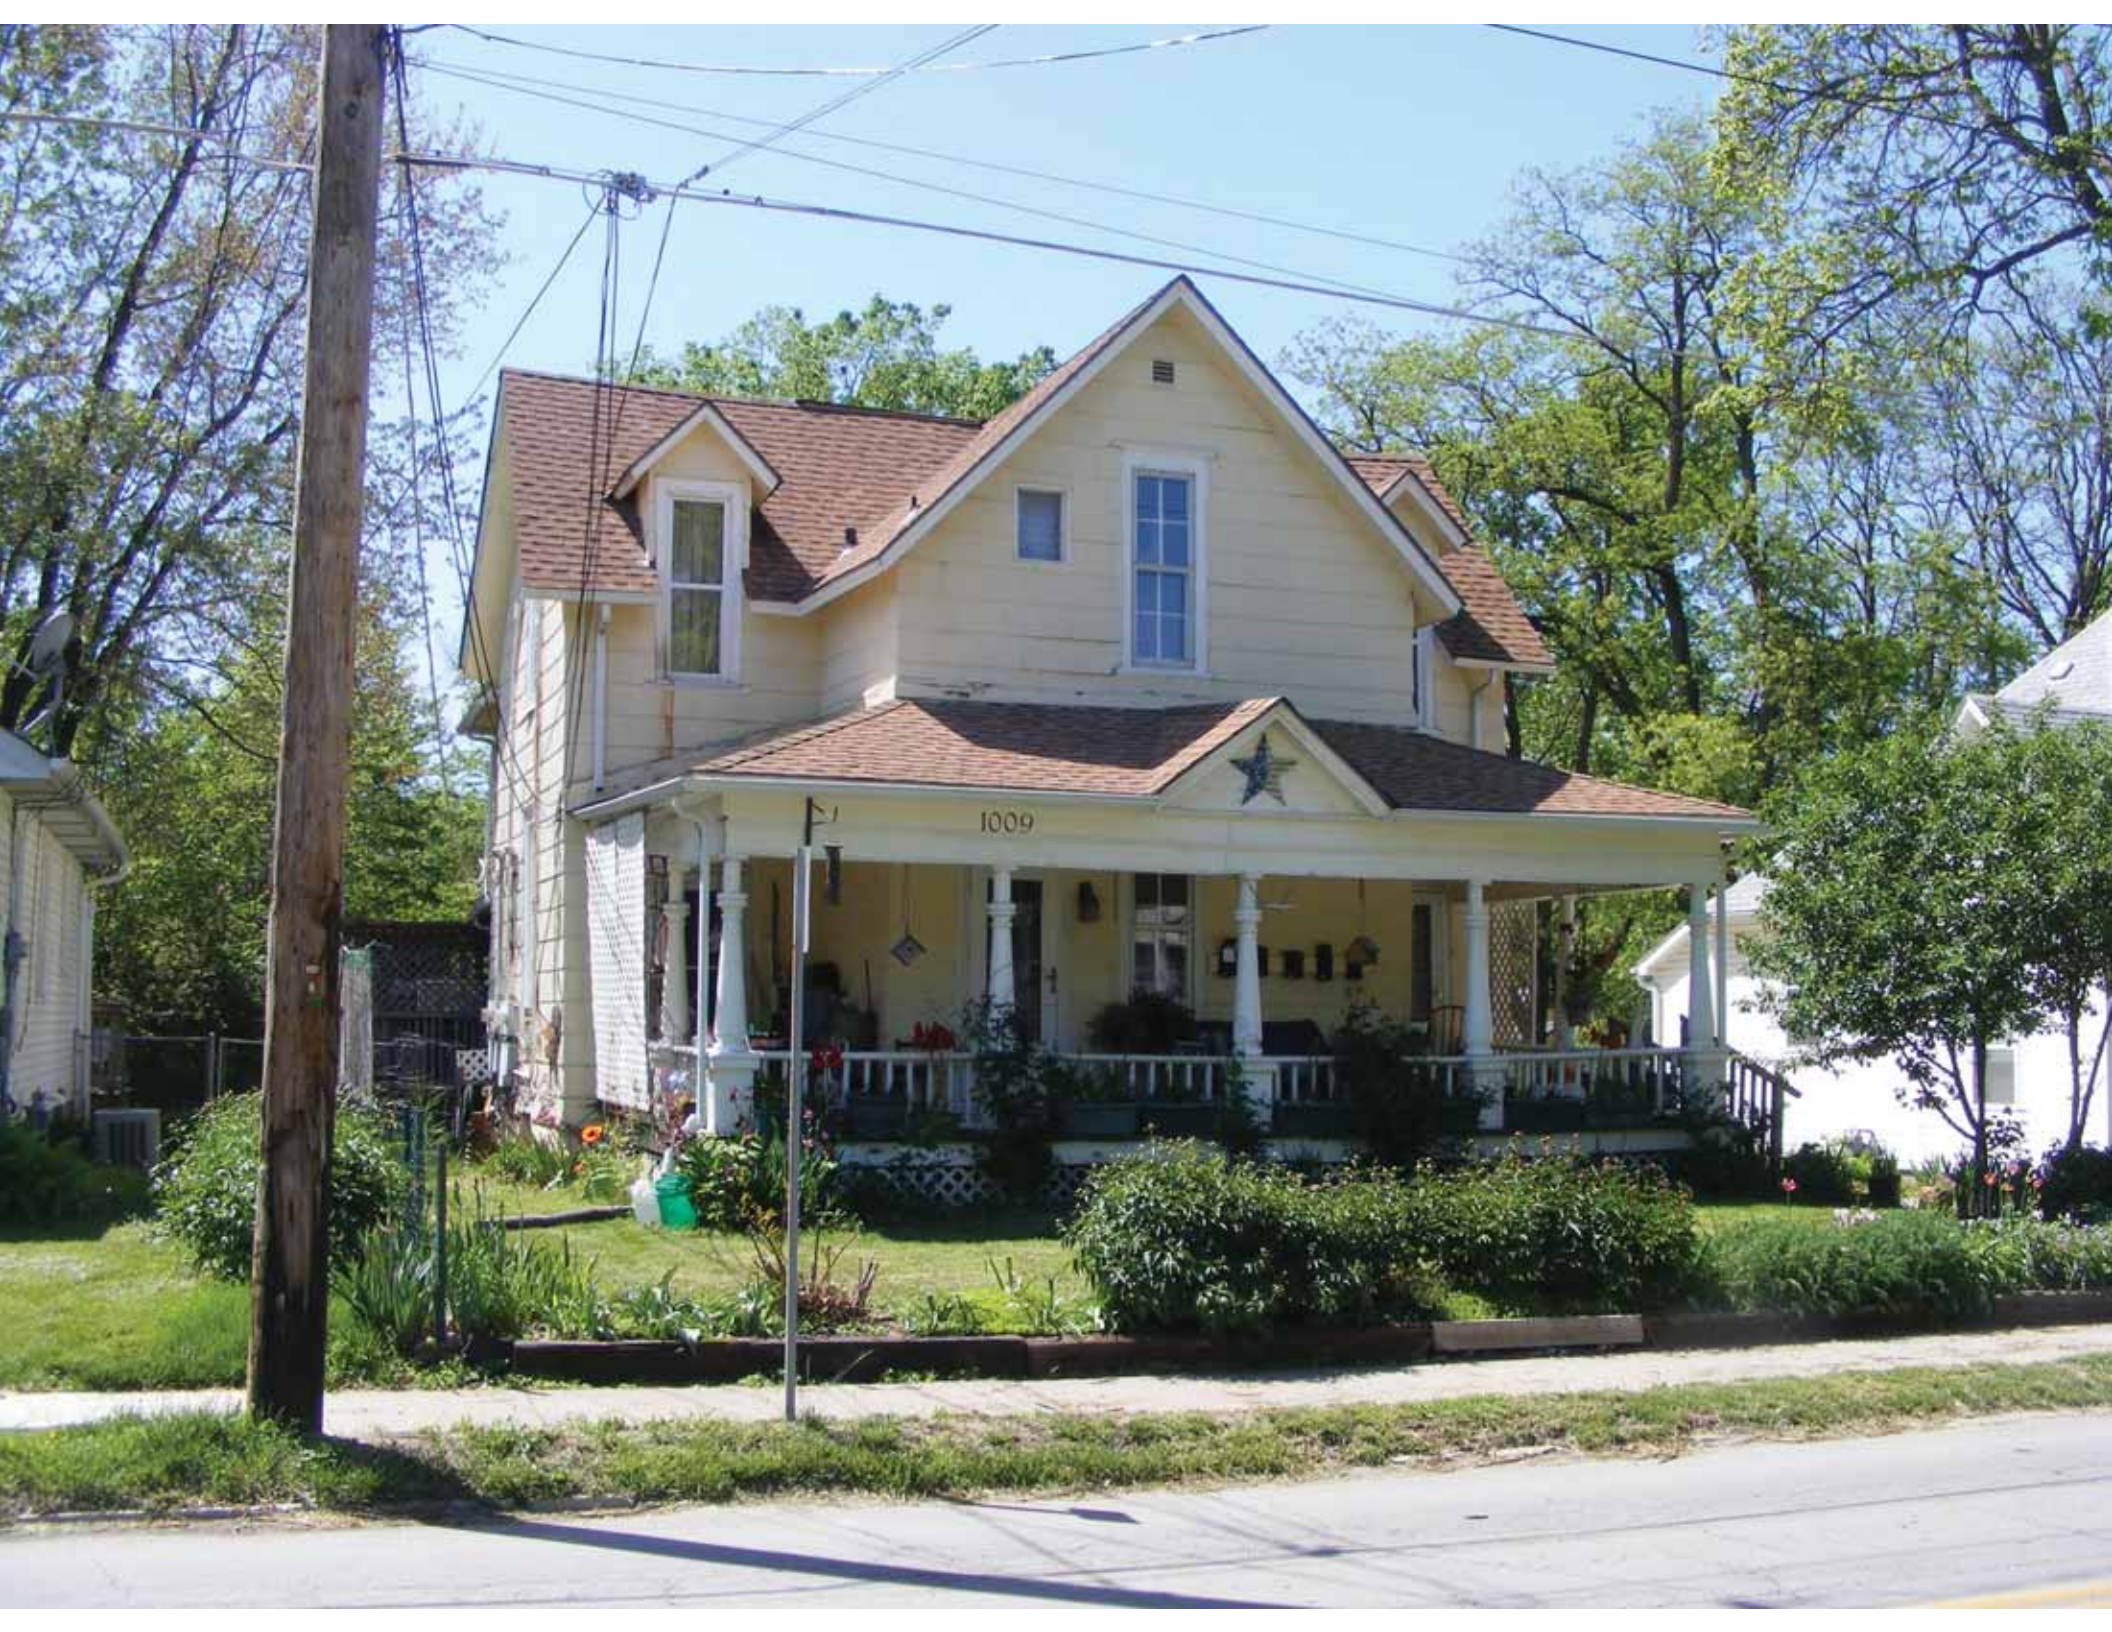
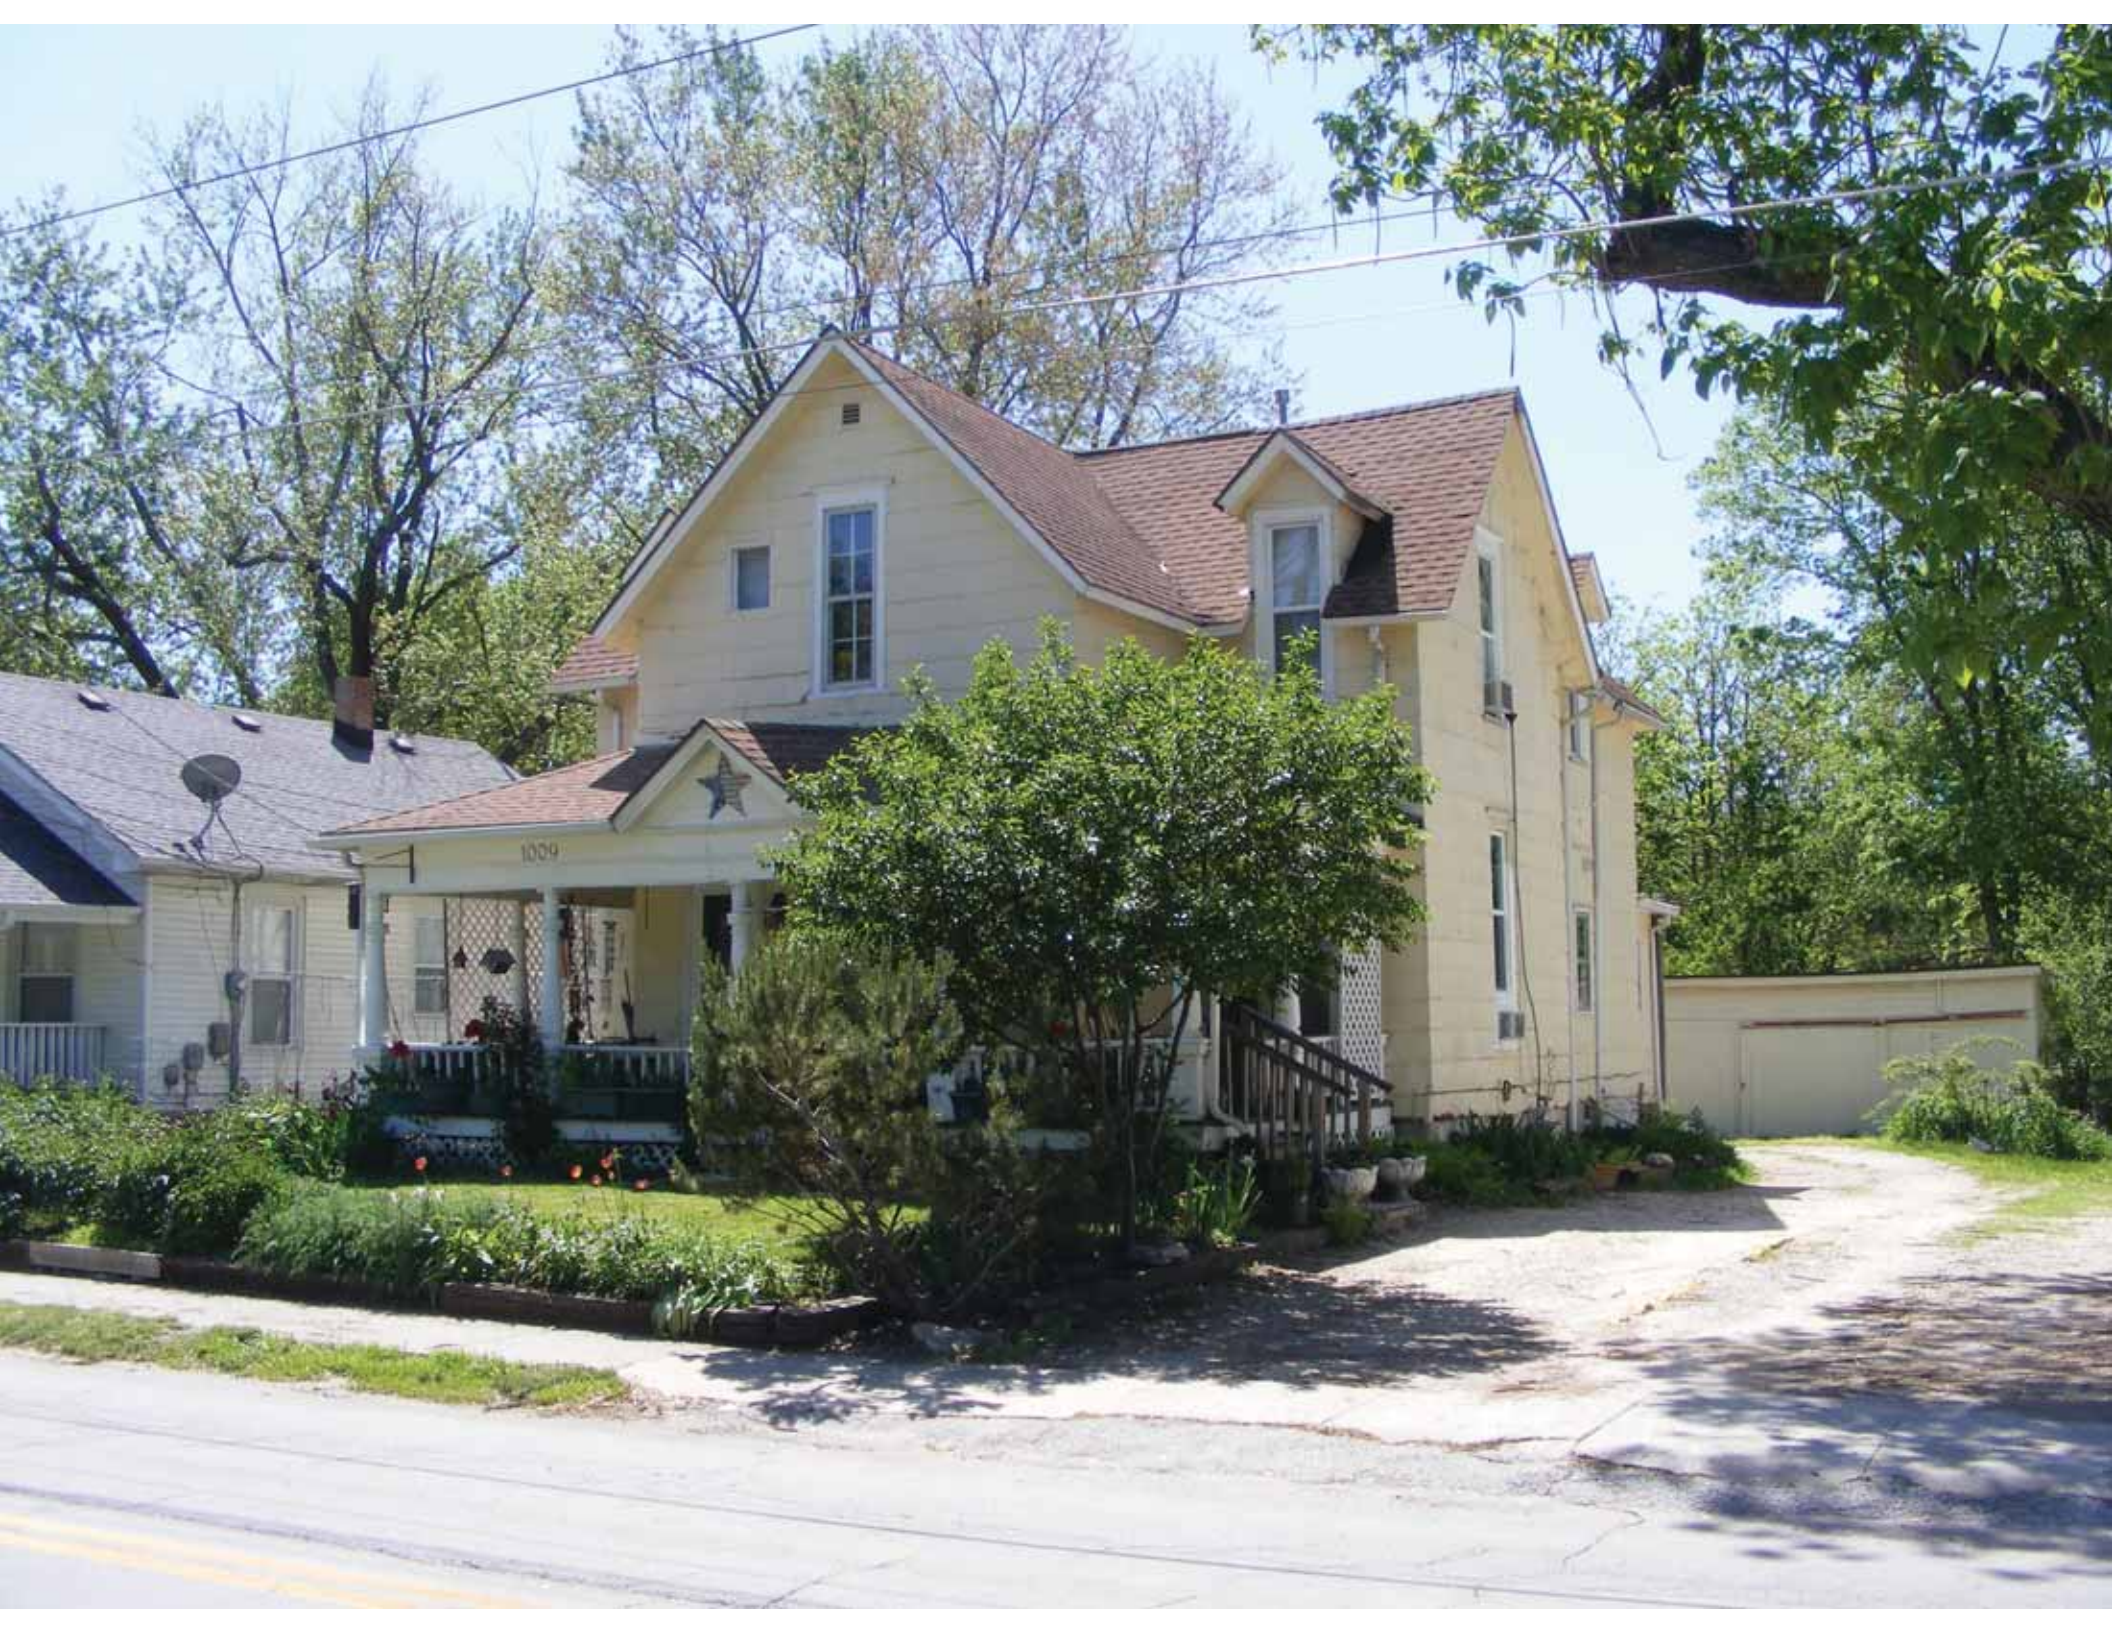
1009

The dwelling has a cross-gabled and rear hipped roof clad with asphalt shingles. The exterior is clad with asbestos shingles and the foundation is limestone or textured concrete block, largely obscured by plantings. The primary (east) elevation has a full hipped porch with a central gable. The porch is supported by unique columns with upper ringed detailing and rounded, larger bottoms. The columns rest on brick piers. A balustrade surrounds the porch which wraps the north end of the front wing. Lattice frames the north and south ends of the porch and obscures the foundation below the porch floor. Within the porch bay are two doors. The doors are obscured by storm doors but appear to have multi-light windows in the upper half. Windows flank door near the center of the elevation. The south window is one-over-one replacement. The north window is original four-over-four. The front gabled wing (centered on the façade above the porch) holds a one-over-one window offset by a louvered c. 1940 window. The remainder of the upper façade, which flanks the front gabled wing, has (on either side of the projecting wing) single wall dormers with original one-over-one windows.
