MISSOURI DEPARTMENT OF NATURAL RESOURCES
STATE HISTORIC PRESERVATION OFFICE, P.O. Box 176, Jefferson City, MO 65102
ARCHITECTURAL/HISTORIC INVENTORY FORM

1. Survey No. BO-AS-011-0087		2. Survey name: North Central Columbia Survey Phase II	
3. County: Boone		4. Address (Street No.) 902	Street (name) N. Seventh Street
5. City: Columbia	Vicinity: <input type="checkbox"/>	6. Geographical Reference:	7. Township/Range/Section: T: R: S:
8. Historic name (if known):		9. Present/other name (if known):	
10. Ownership: <input checked="" type="checkbox"/> Private <input type="checkbox"/> Public		11a. Historic use (if known): Domestic/single dwelling	11b. Current use: Domestic/single dwelling

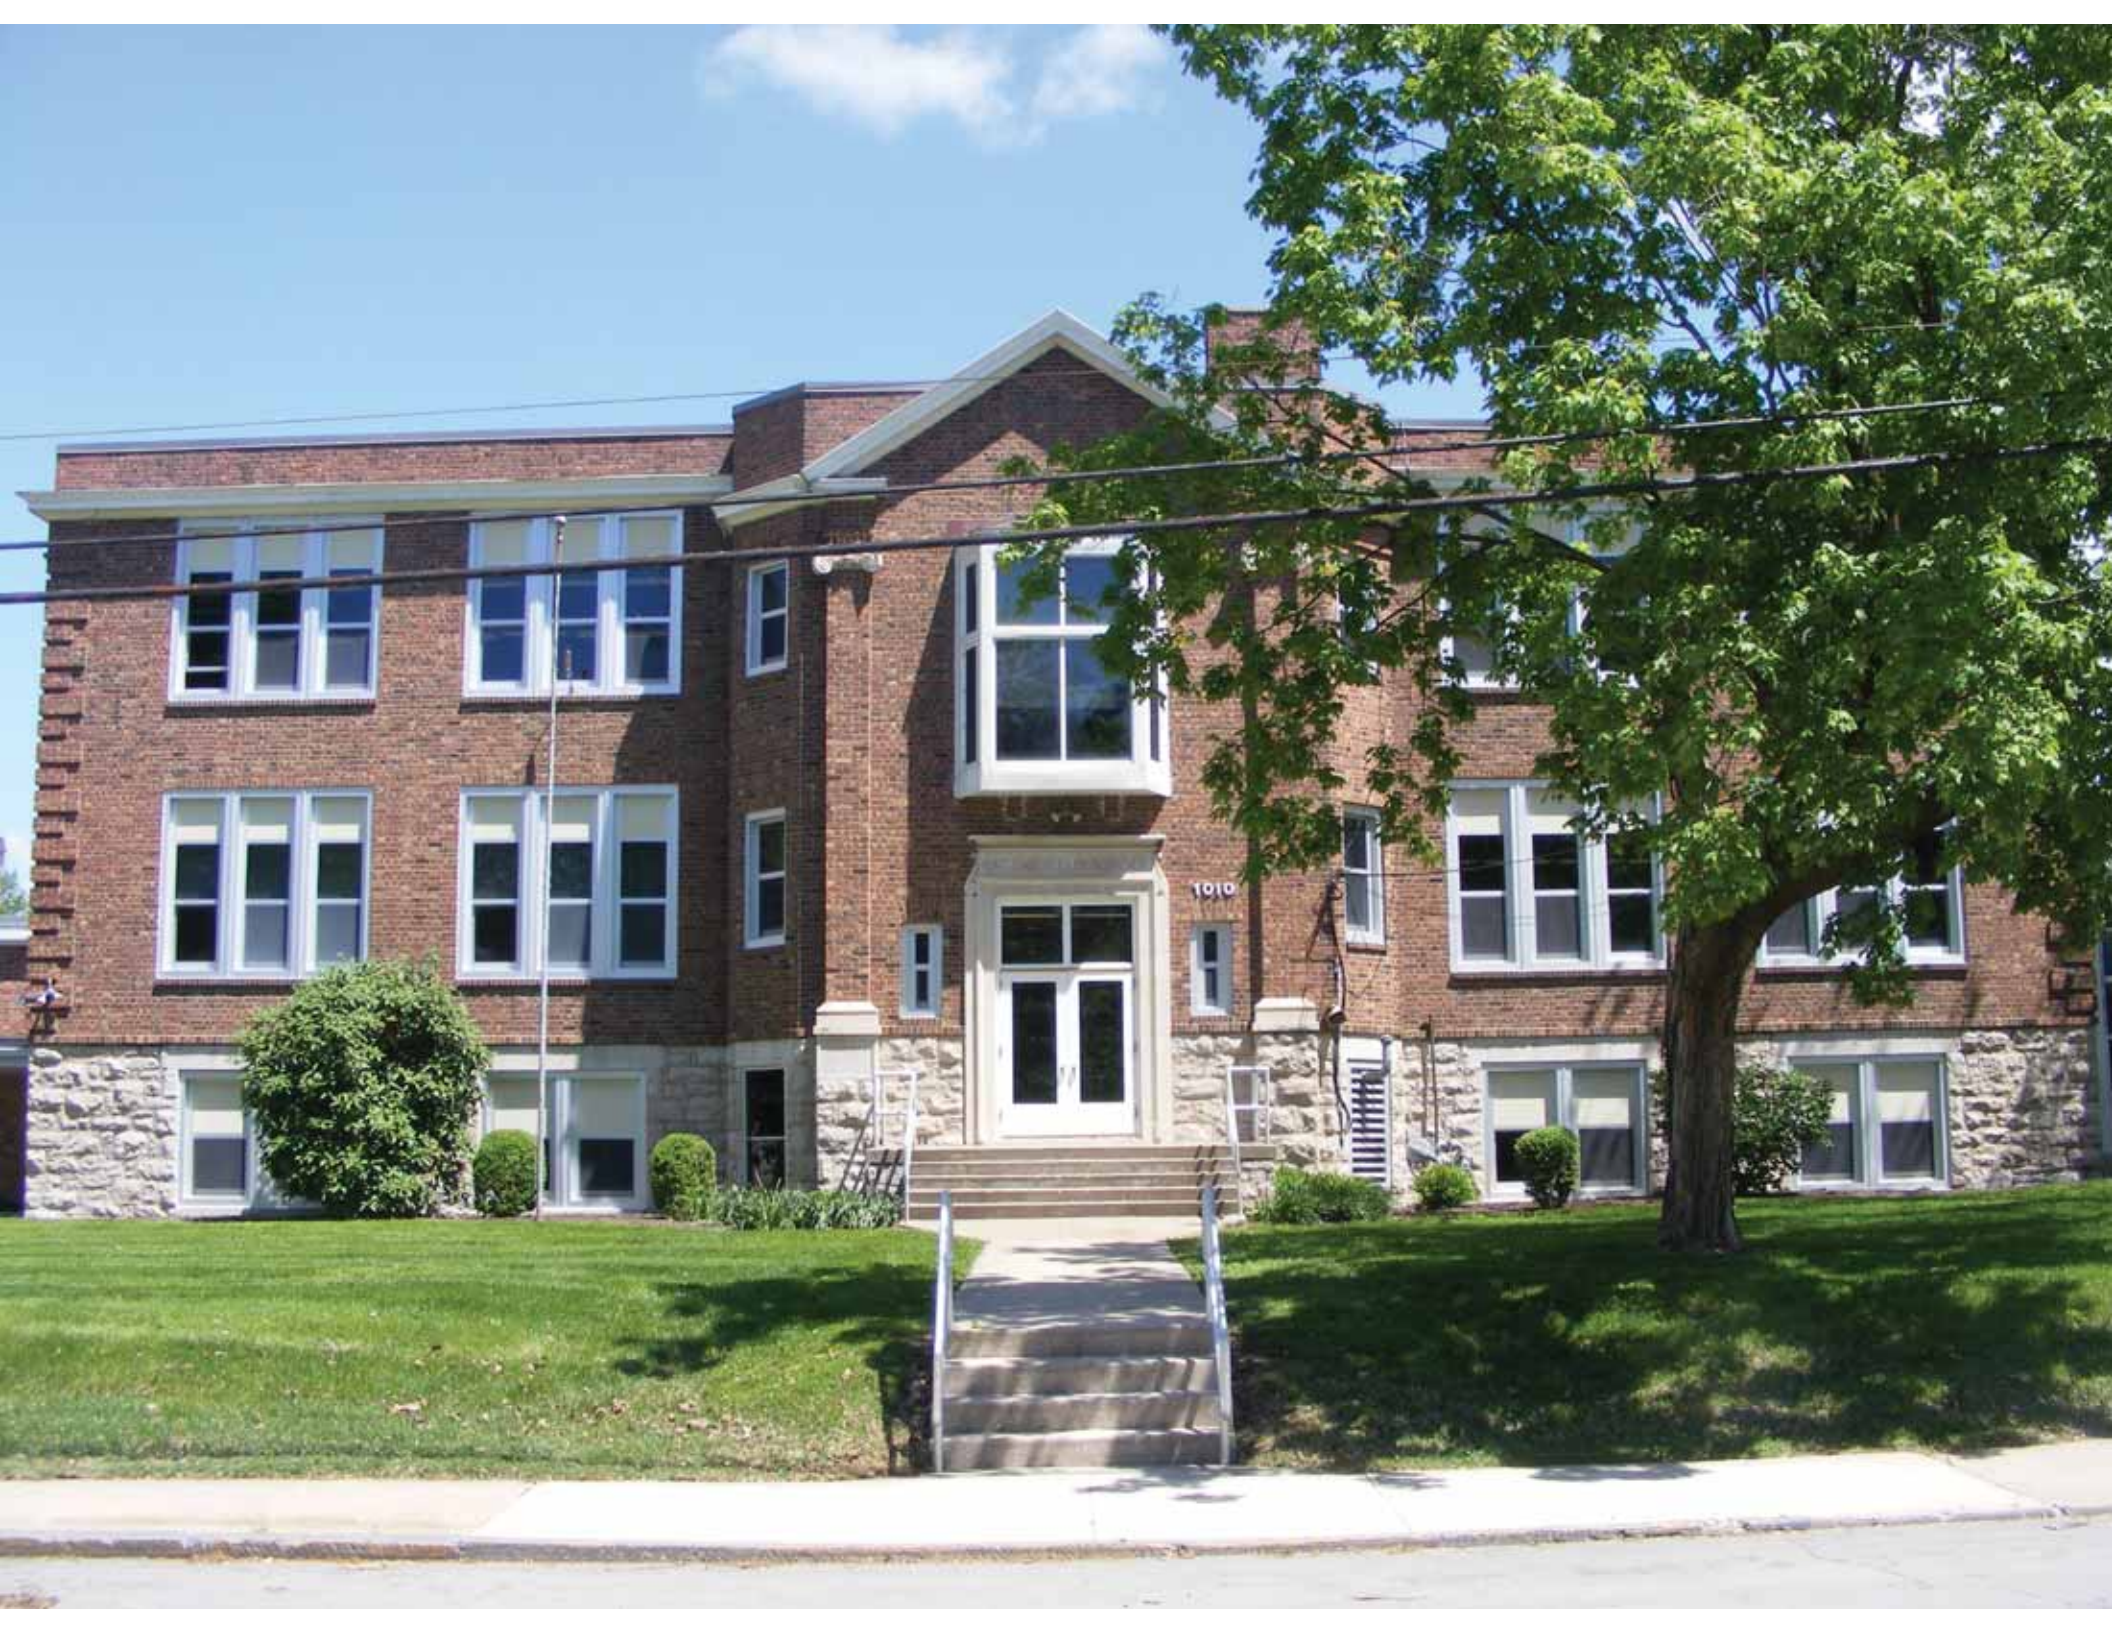
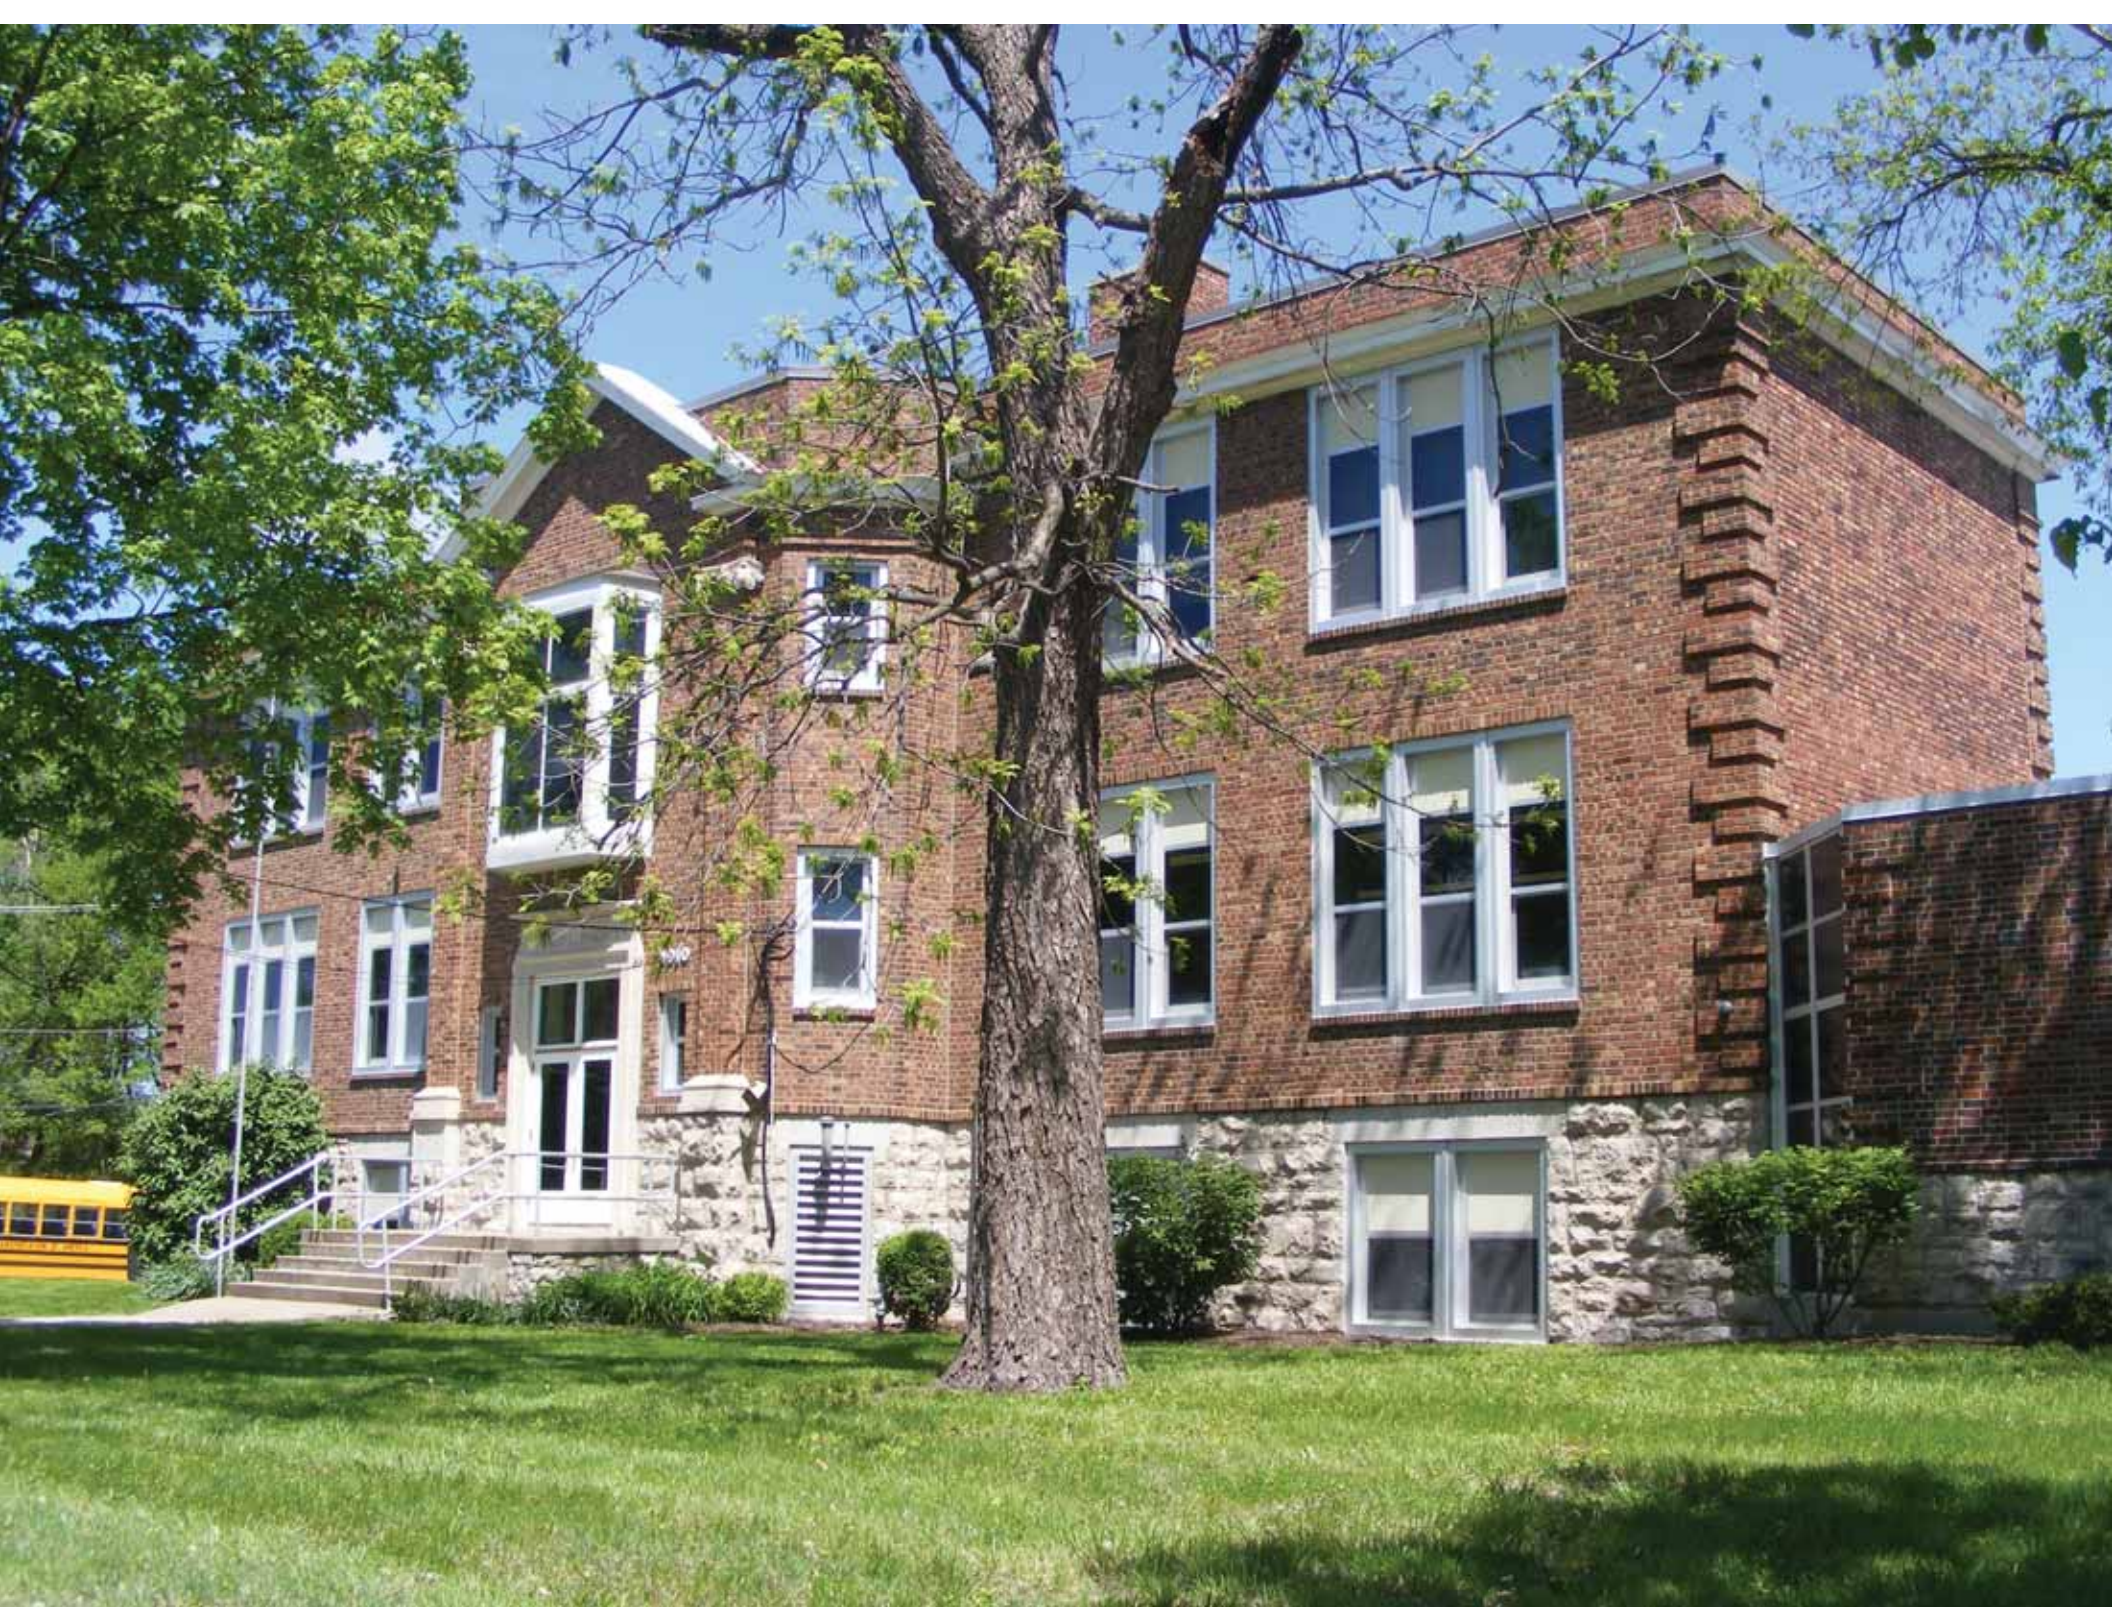
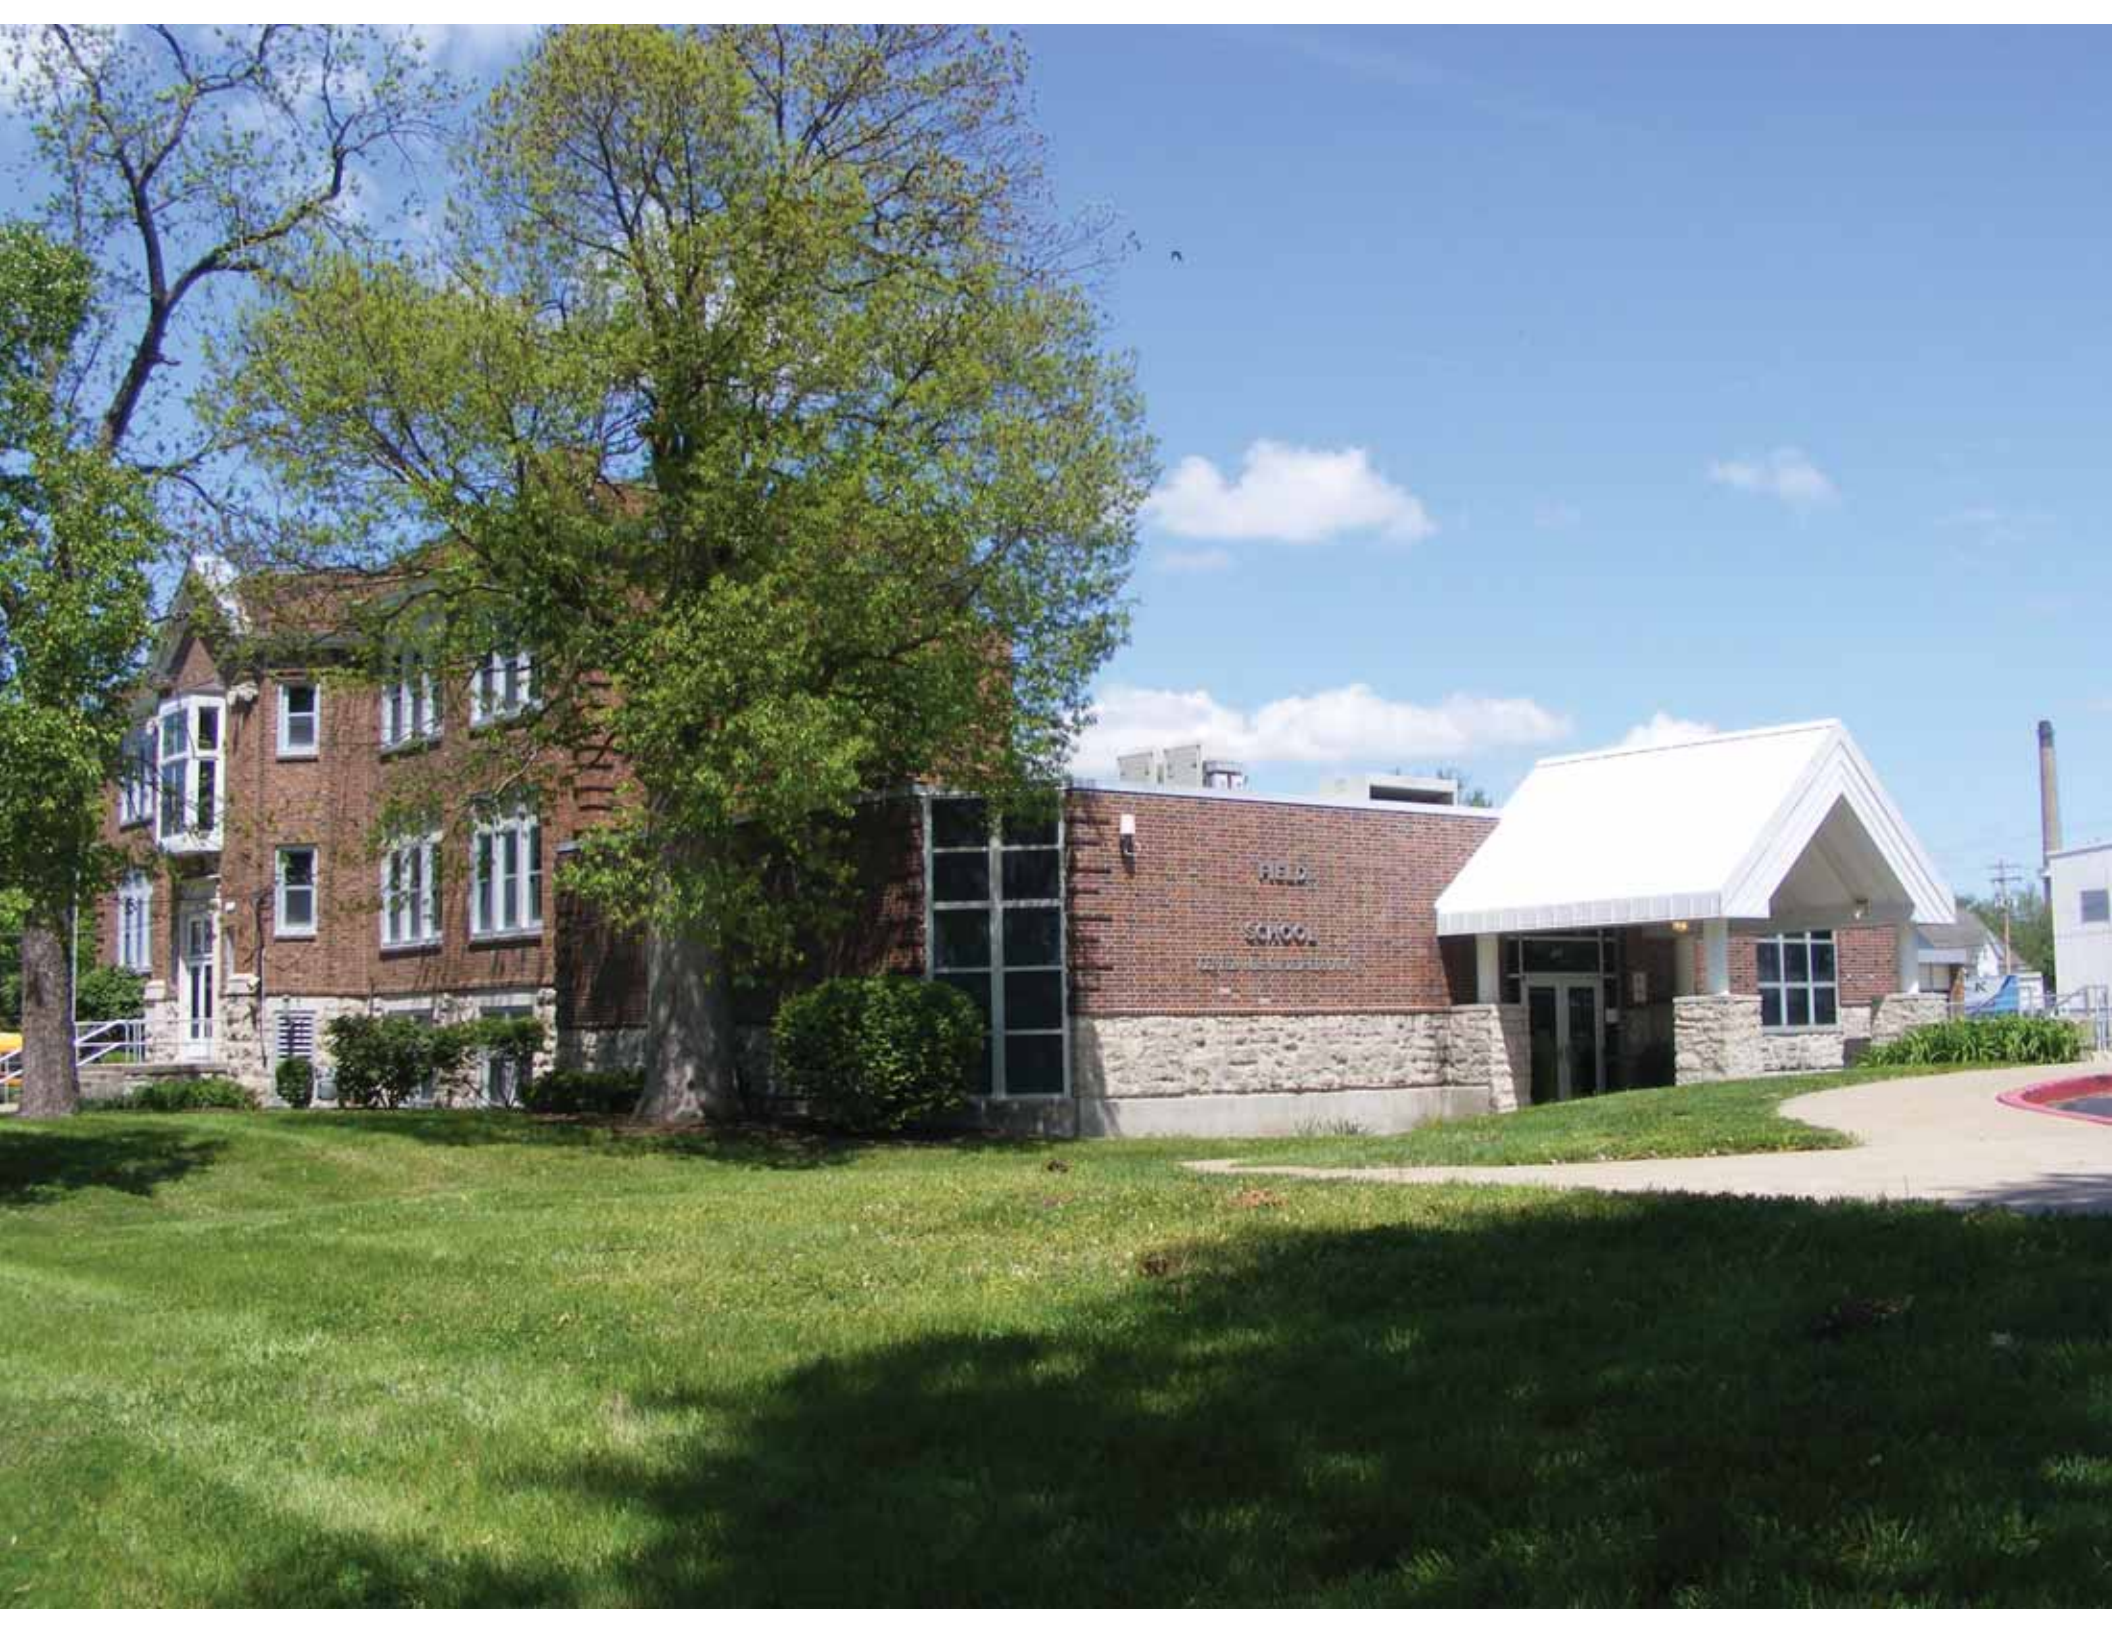
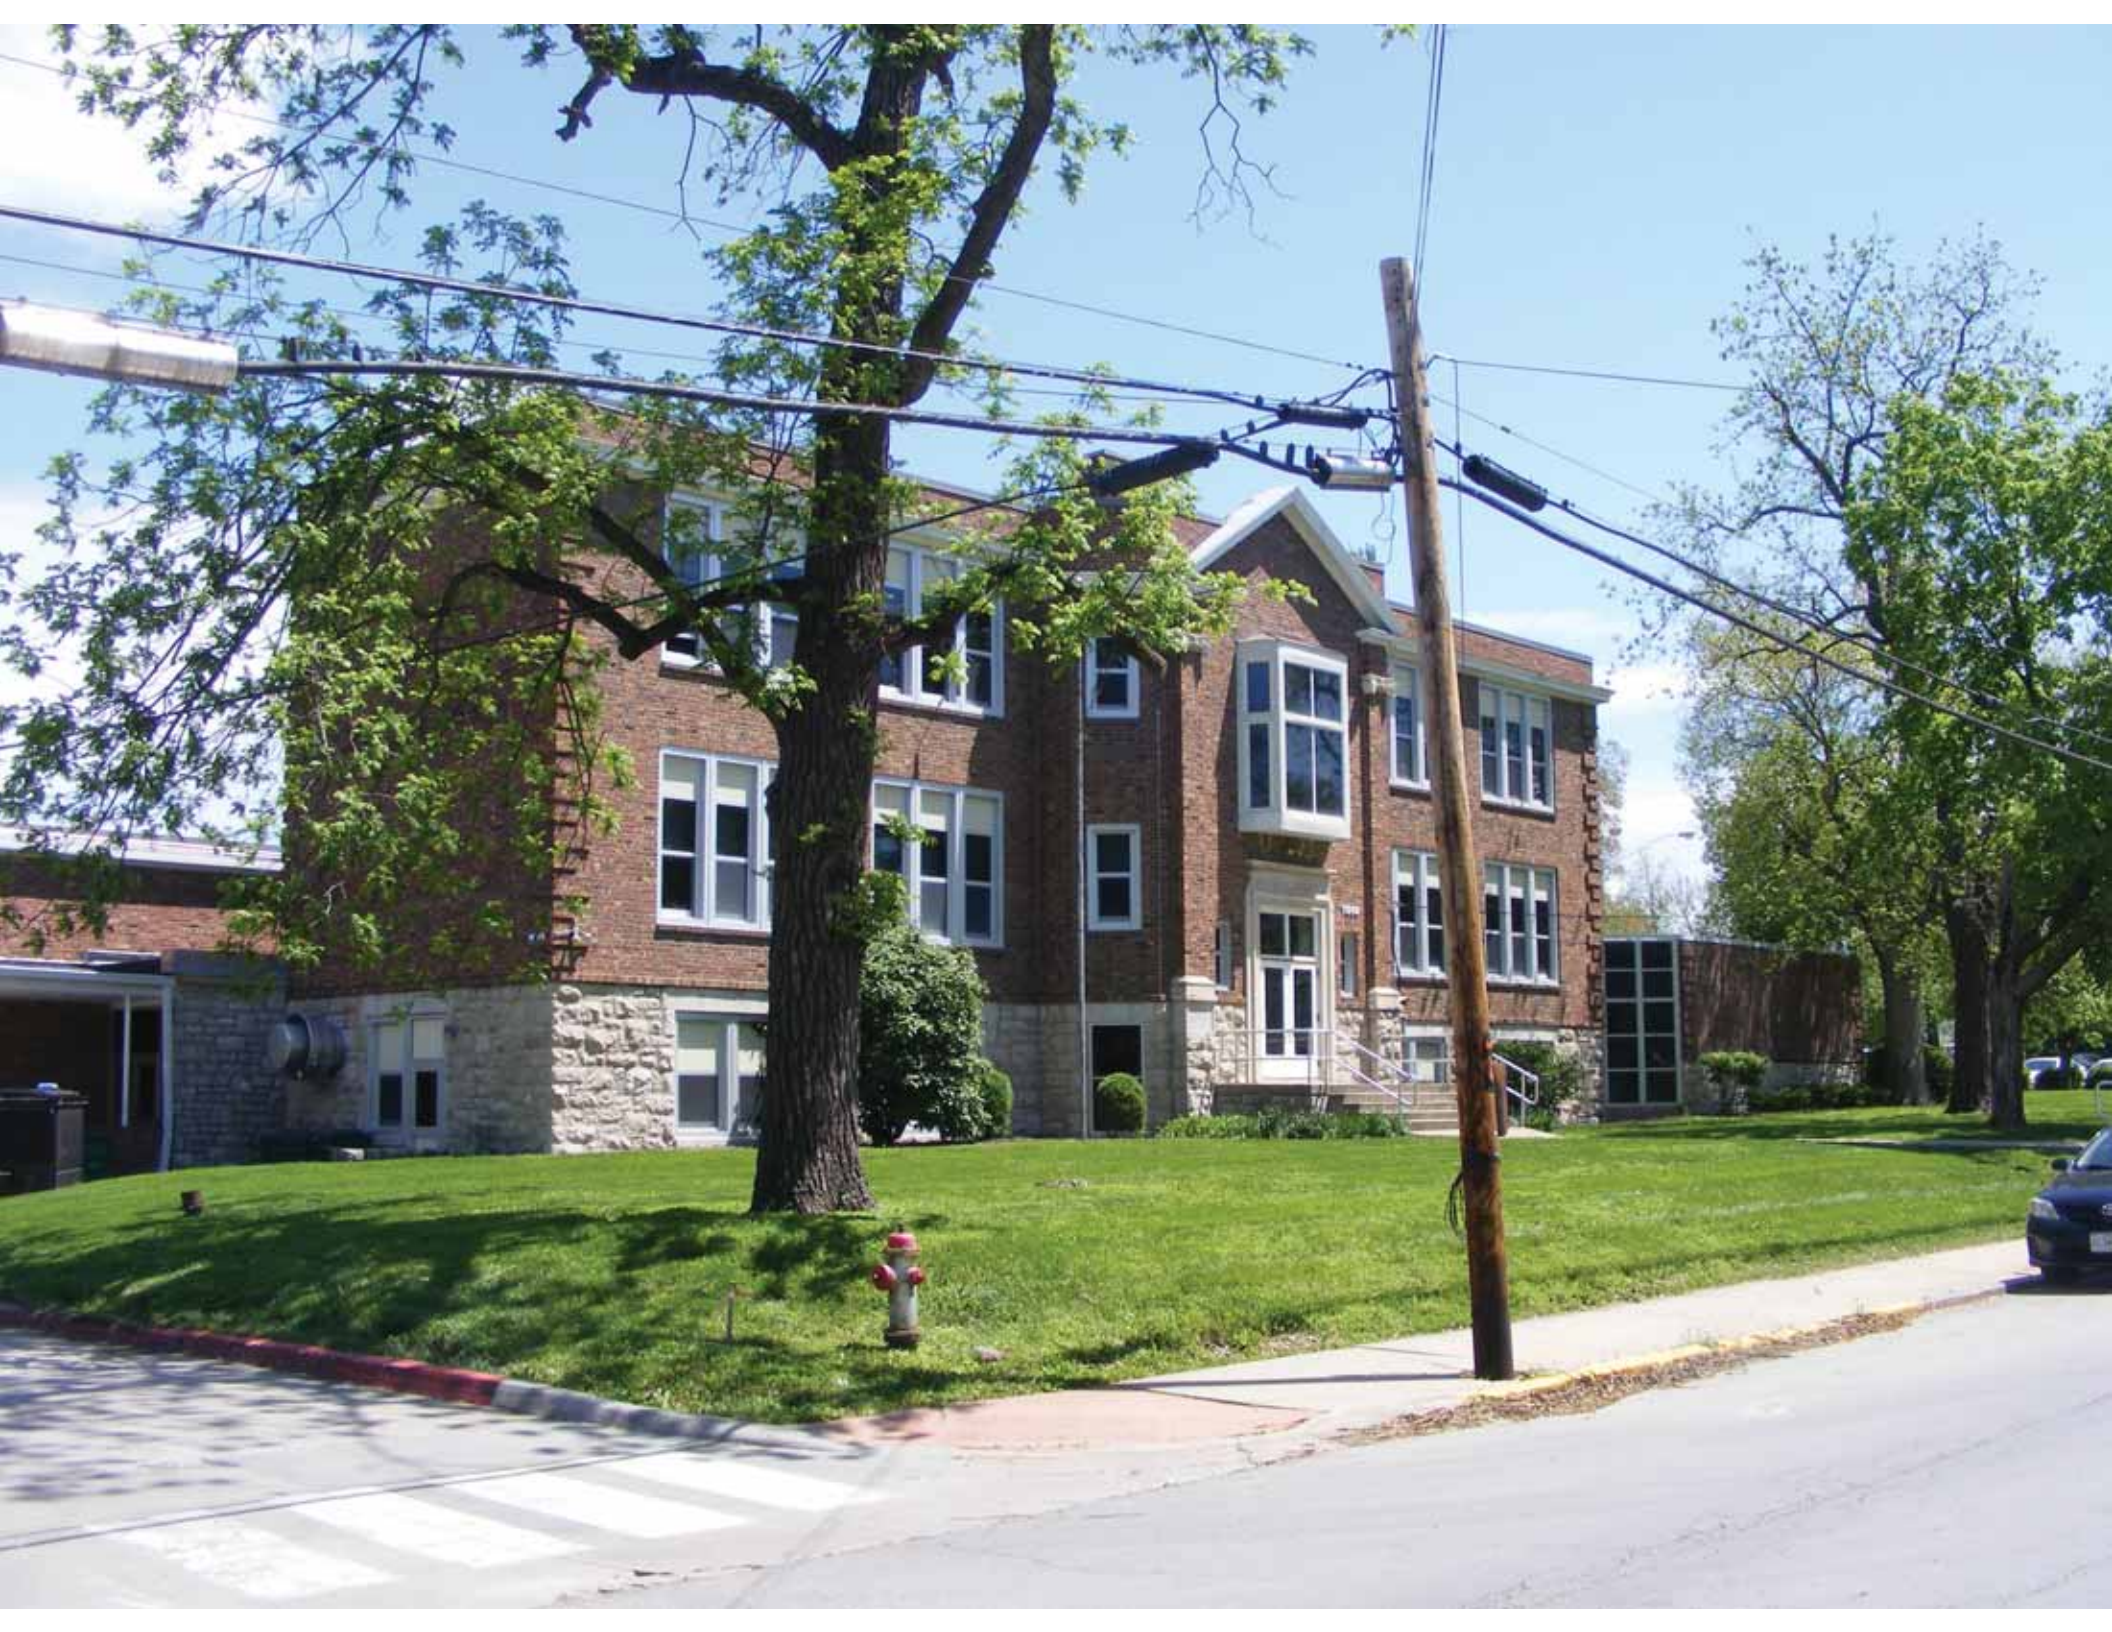
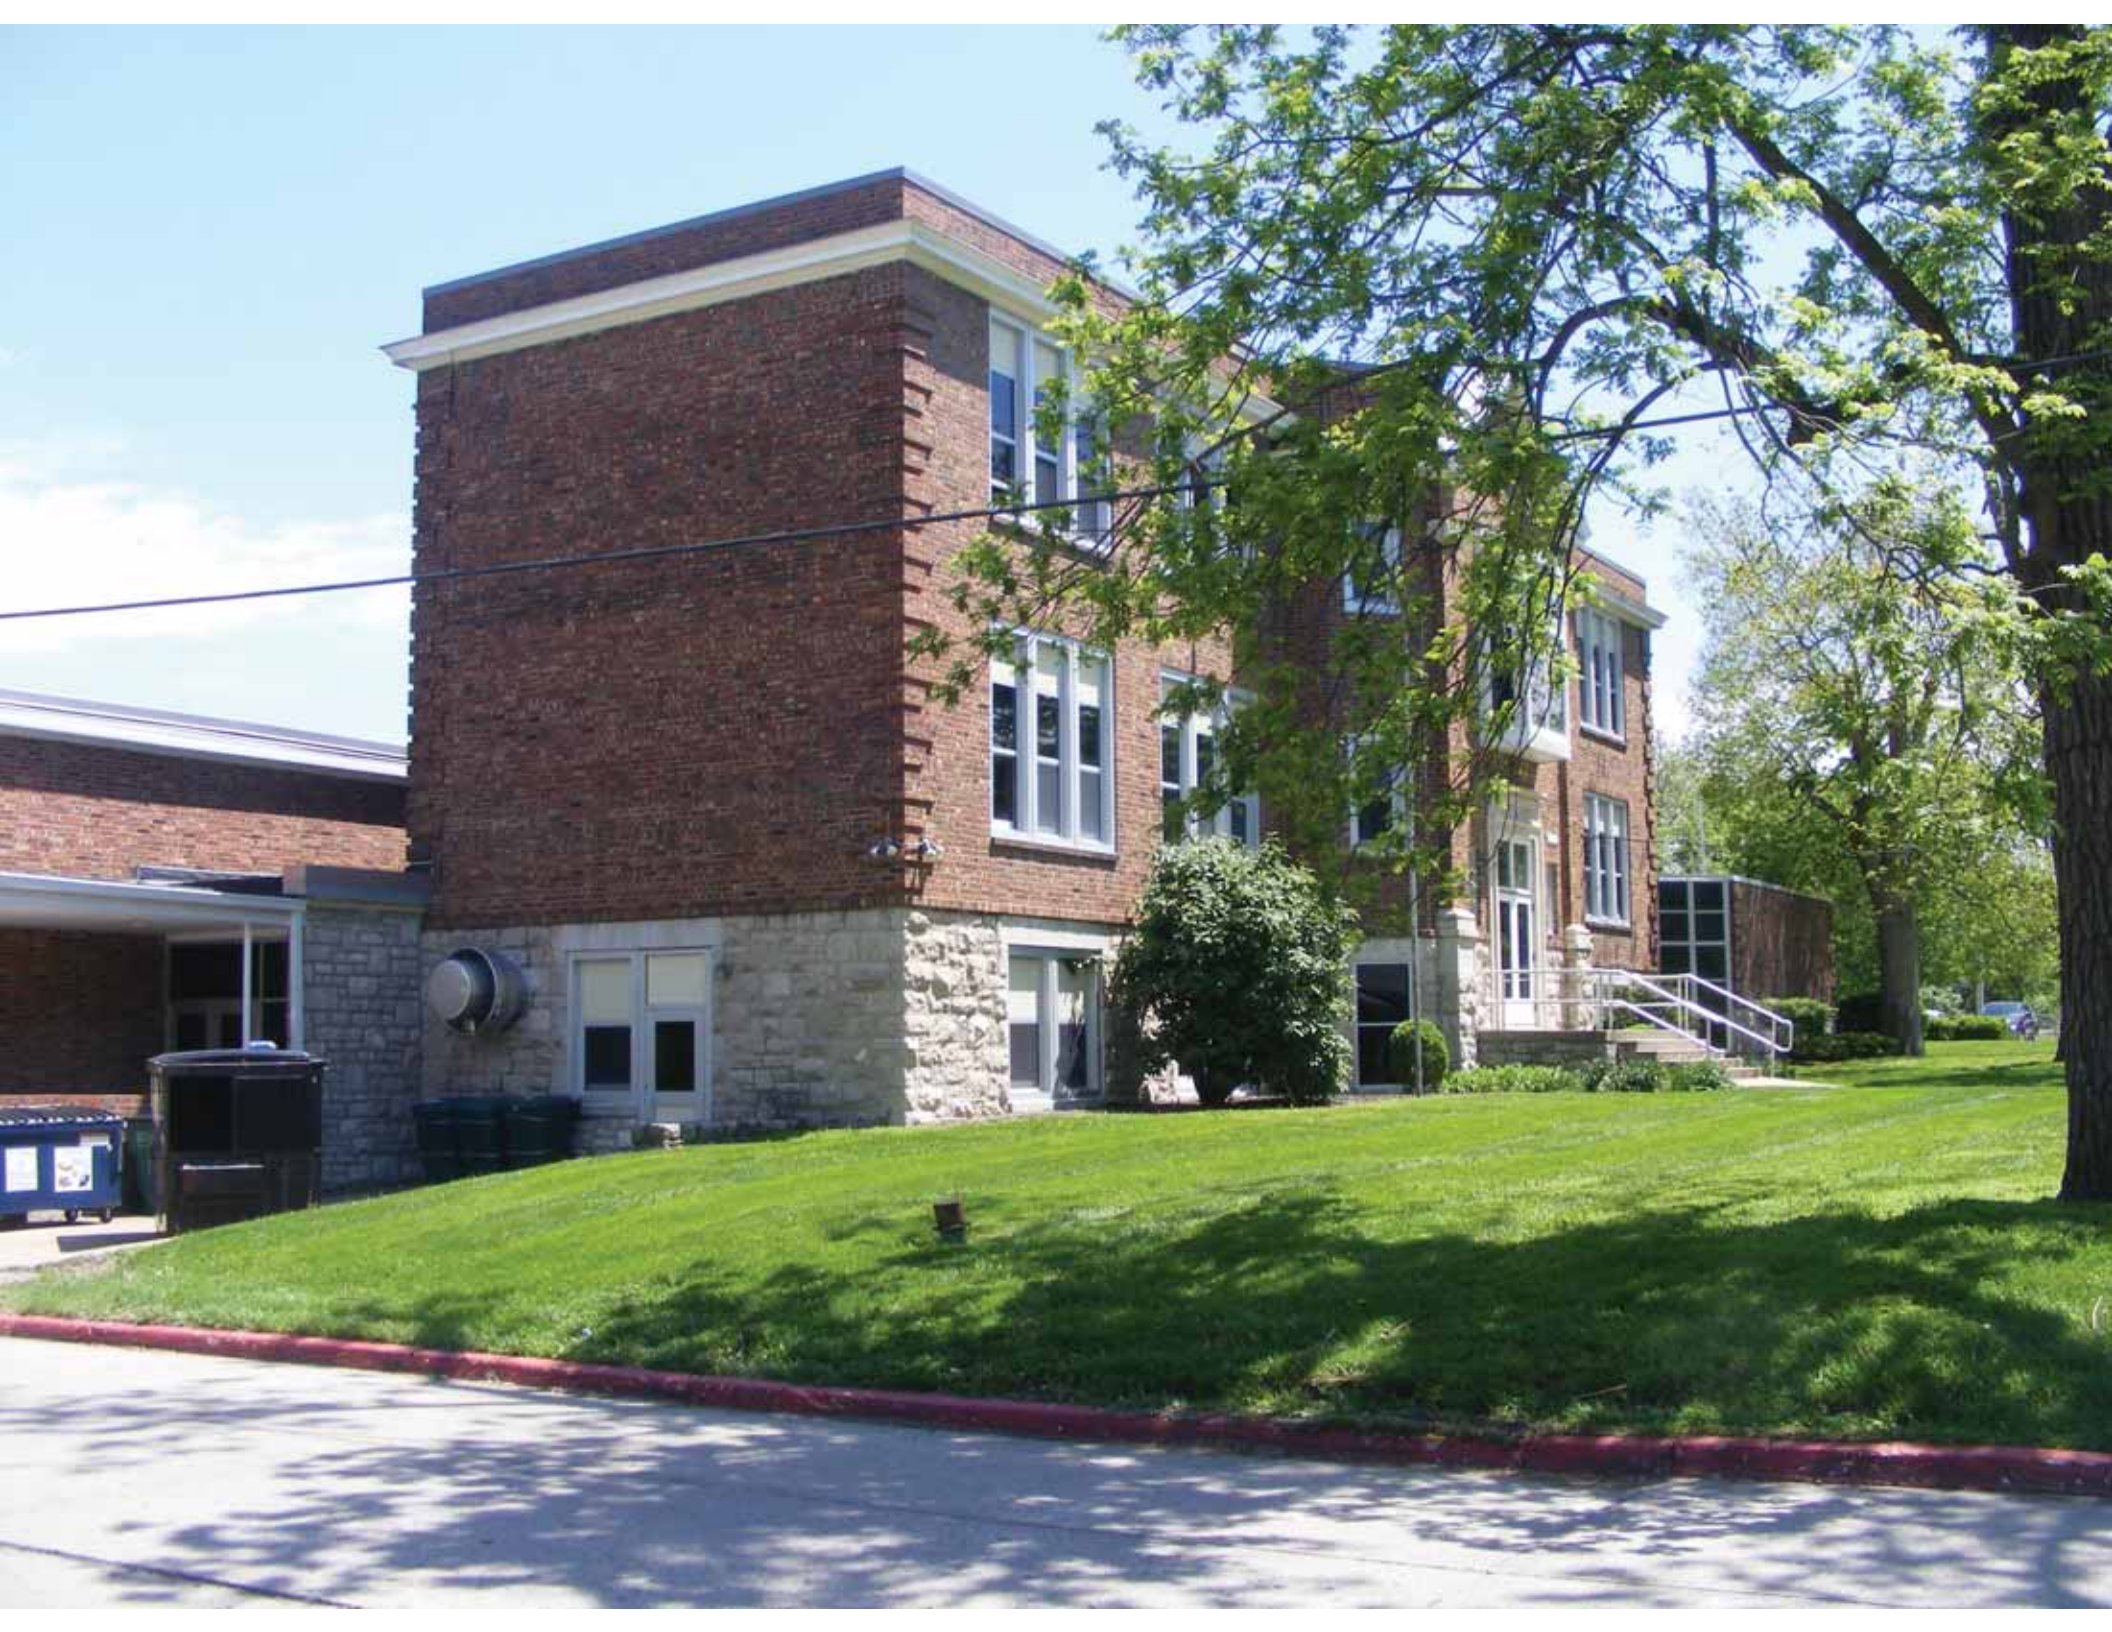
This is a 2.5 story Second Renaissance Revival style brick building with a raised limestone block foundation (ca. 1917) with a one story wing addition, Modern in design (1962); both have a flat roof. The 1917 building's façade (west facing) holds a full-height projecting center bay with a flat to front gable with end returns. Entrance is centered in the bay with original wood/glass double doors with a two-light transom and a terra cotta door surround. The terra cotta lintel features a projecting header; the area between the transom and header has the school's name engraved "Eugene Field School." Terra Cotta scroll work frames the upper part of the lintel. The entrance is flanked by narrow one-over-one windows. Centered above the entrance is a projecting bay with paired fixed windows with transoms and sides of the bay hold a fixed window and transom. The centered bay is offset with brick pilasters capped with terra cotta scrolls and terra cotta bases. Side elevations of the center bay hold one –over-one windows. A concrete stoop with steps and iron railings provide access to the entrance. Symmetrical fenestration patterns flank the centered bay on each level; first and second level exhibit triple paired one-over-one windows and basement level holds paired one-over-one windows. A projecting cornice line runs the width of the façade and is broken by the center bay. Brick quoins are featured at the corners of the building and a brick stringcourse delineates the basement level from the first level. Rear elevation (east) holds a centered projecting wing with windows matching those on the façade. The 1962 one-story addition adjoins the centered wing (description below); at the southeast corner at the intersecting of the two buildings is a metal two-story fire escape. The south elevation of the centered wing (1917 building) the upper level holds a paired one-over-one window; lower level window has been bricked infilled. Attached at the south elevation is another one-story brick wing. The south elevation of the addition holds a centered entrance under a projecting metal front gable supported by round columns on limestone piers. Entrance is a double glass/metal door with sidelights and transom. At the southwest corner is a chamfered window bay of paired vertical five square lights offset by brick quoins. The lower section of the wing is clad in limestone block and upper section brick.

The north elevation features a double door entry on the basement level. A second entry is found in the setback area where the north and east elevation adjoin and is covered by a flat roof canopy supported by metal posts on a brick wall; entry is double doors with two-light sidelight and transom. Attached to the canopy is the 1962 addition.

The 1962 addition on the north elevation holds paired tall narrow four-light windows; this is adjoined to a setback section and it holds a band of 1960s style vertical four-light hopper style windows; south elevation holds the same windows. The west elevation holds a double glass/metal door with sidelights and transom.
